Technology &
Development
Program

Response of Road- Stream Crossings to Large Flood Events in Washington, Oregon, and Northern California

**USDA Forest Service
Six Rivers National Forest
Pacific Southwest Region**

September 1998

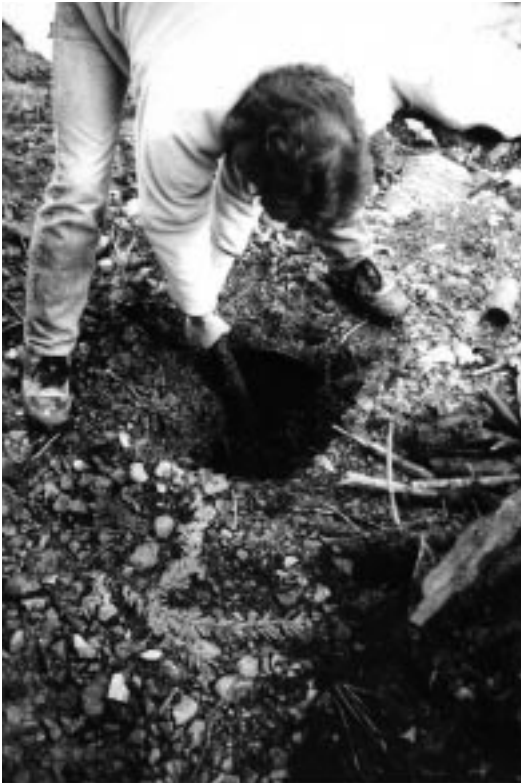
R9800126

Figure 2—Woody-debris plugging often results in burial of the inlet, suggesting sediment plugging as the cause. However, upon excavation several pieces of wood were discovered here, lodged across the inlet, indicating that woody debris initiated the plug.

Sediment slugs (36 percent) and debris torrents (26 percent) were the most common failure mechanisms we observed (Figures 2 and 3). Sediment slugs were commonly the result of rapid deposition of colluvium from an upstream landslide or cutbank failure. Debris torrents were often initiated by a pulse of sediment and organic material entering the stream from a channel streambank or hillslope failure.

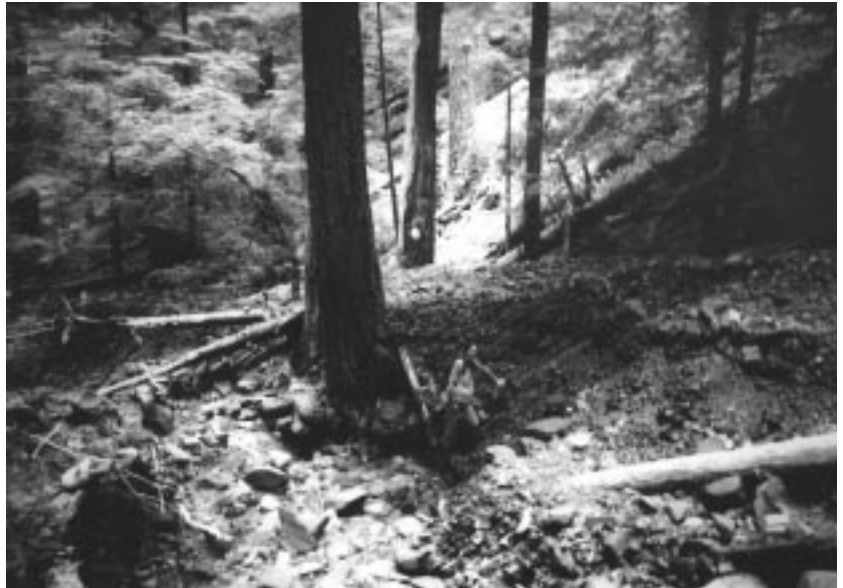
R9800127

Figure 3—Debris flows were relatively easy to identify. Evidence consisted of either evacuated channels upstream of the crossing or, as in this photo, large, poorly stratified deposits where the flow was impounded against the road fill.

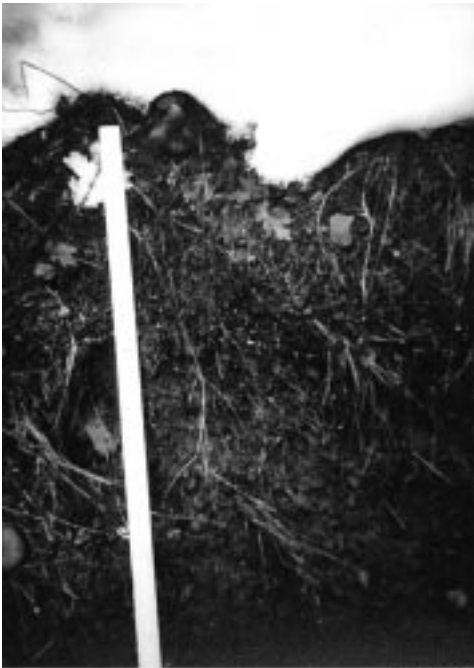
R9800128

Figure 4—Hydraulic exceedence was often difficult to determine. At this site, evidence consisted of a debris line near the center of the photo and removal of litter in the bottom half of the photo. Snow cover during flooding and surveys resulted in different evidence than would have occurred without snow cover. Evidence was rapidly obscured by litter-fall, new growth, and additional rainfall.

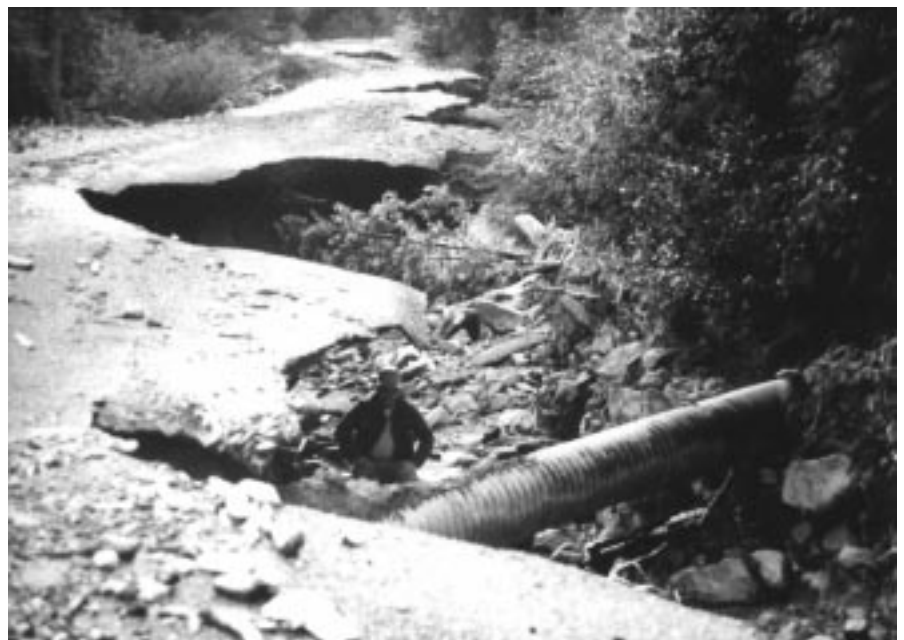
R9800129

Figure 5—Consequences of failure are usually simpler to characterize than mechanism of failure. Here, diversion of stream flow out of the natural channel and onto the road surface and ditch produced erosional consequences much greater than if the flows had flowed over the road surface and re-entered the natural channel near the culvert outlet. [Photo courtesy of R. Ettner, Siskiyou National Forest.]

- **Avoid stream diversion. Diversion of streams at overtopped crossings and plugged cross-drains is a major source of preventable effects.** Diversion can be prevented by locating and designing crossings to ensure that streamflow that overtops a crossing fill cannot leave its channel. For existing roads, diversion-prevention dips or other structures can be inexpensively constructed to “storm-proof” crossings that have diversion potential (Furniss et al. 1997).

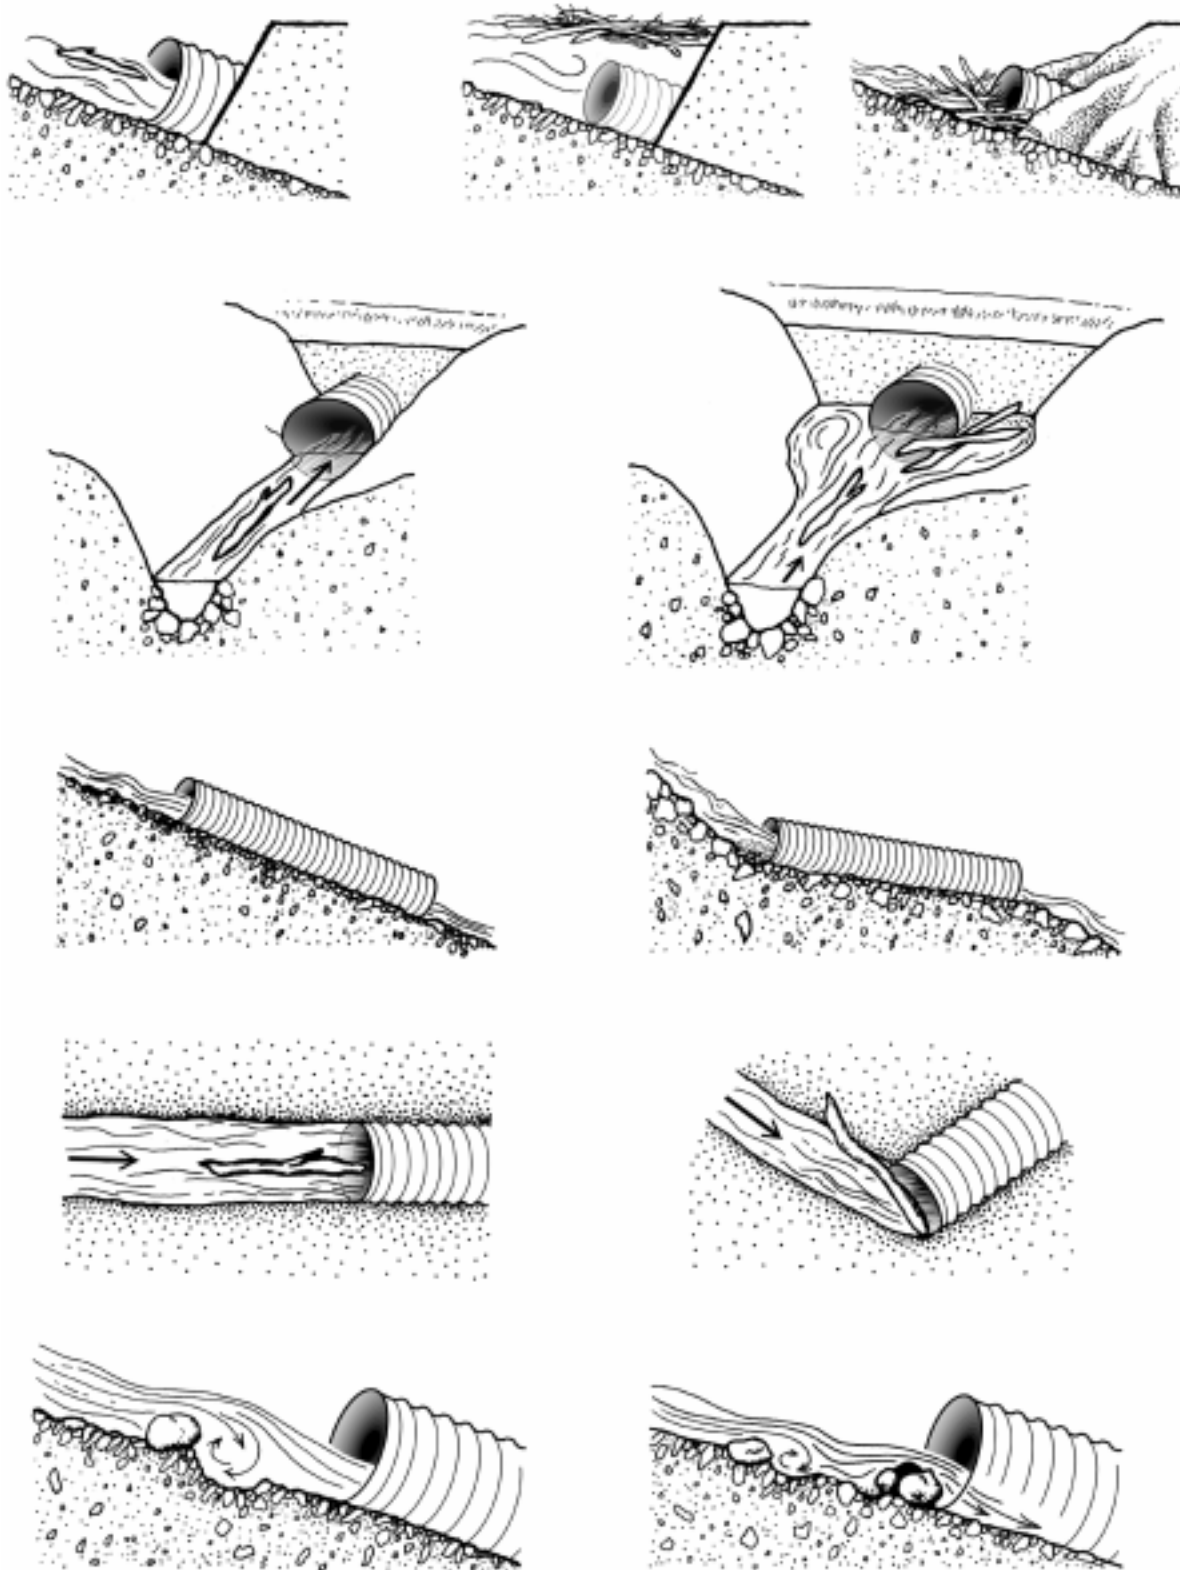
R9800164

Accumulation of headwater (water level above the top of the culvert) at culvert inlets will increase plugging hazard by retarding the passage of floating debris and by decreasing streamflow velocity and the capacity for sediment transport. Ponding at the inlet basin led to the accumulation or "rafting" of woody debris. When the inlet was re-exposed, it was instantly faced with an interlocking raft of wood exceeding the capacity of the inlet, therefore resulting in plugging (Figure 11a).

The behavior of sediment and debris at culvert inlets was crucial to stream-crossing performance. Crossings that presented the least change to channel cross-section, longitudinal profile, channel width, and alignment were most likely to pass sediment and debris (Figure 11b, c, d).

- Increases in channel width immediately upstream of the culvert inlet promoted accumulation of both woody debris and sediment at the inlet. In widened channels, woody debris can rotate and present larger effective widths to the culvert inlet, increasing the likelihood of lodgment, and resulting in reduction or plugging of the inlet. Narrow channels are more likely to present woody debris to the culvert inlet oriented with the flows and the culvert, and thus more effectively entrain and move sediment through the culvert. (Figure 11b). Wider channels also result in flows

Figure 11—Illustrations of increasing plugging hazard.

$HW/D = 0.5$ or 0.67 . We believe this criterion is prudent in any situations where woody debris and sediment must be passed (Figure 11a).

- **Culverts as wide, or nearly as wide, as the stream channel minimize the cross-sectional change in the channel and are least likely to plug.** For small streams, matching the culvert diameter to the channel width is a practical approach (Figure 11b). For larger streams, this approach may be cost-prohibitive and other inlet-configuration measures can be used to mitigate the narrowing of the channel cross-section caused by the culvert. Culverts should be set on the same or greater gradient as the natural stream channel to avoid accumulation of sediment at the inlet (Figure 11c).
