**United States  
Department of  
Agriculture**

Project Record  
8424 1205

July 1984

# Evaluation of The Marden Model 200 Spot Planter

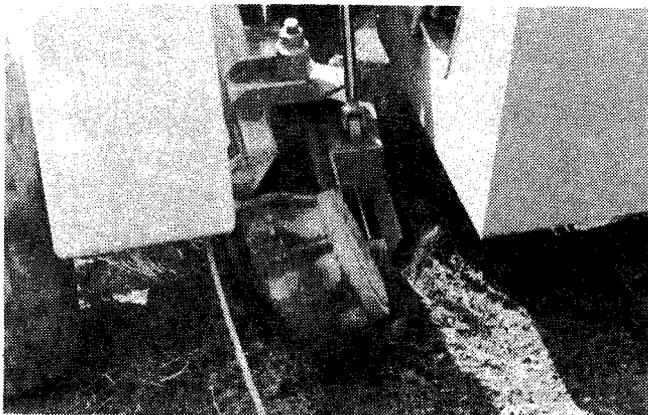
The packing system on the Model 200 has only one packing wheel which has a very sharp angle in order to move the dirt sideways against the seedling roots. This resulted in a very large depression alongside the seedlings. On the Modoc, the packing wheel was modified by reducing the sharp angle (fig. 4), but results were not improved enough for the silviculturist to want to continue to plant. Seventeen attempts were made to adjust the packing wheel and packing wheel pressure on the day the modified packing wheel was operated. While results were greatly improved with the modified packing wheel, they were still judged unsatisfactory.

**Figure 4. The sharp angle of the packing wheel of the Model 200 was rounded off as shown in an attempt to improve packing and reduce the depression alongside the seedlings.**

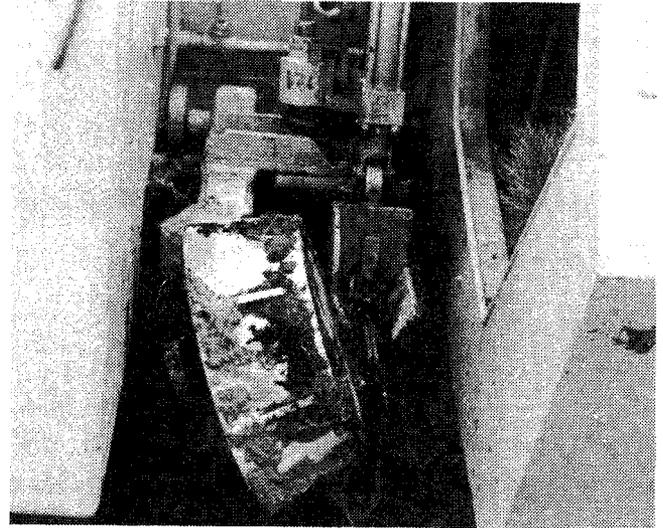
For the evaluation on the Superior, a narrower packing wheel with a flatter angle (fig. 5) was made available by the manufacturer. This packing wheel appeared to work better, but the required number

**Figure 5. Model 200 equipped with narrower packing wheel with a flatter angle.**

of adjustments and results were far from satisfactory. The original packing wheel was made narrower (fig. 6), but results were also not completely satisfactory.

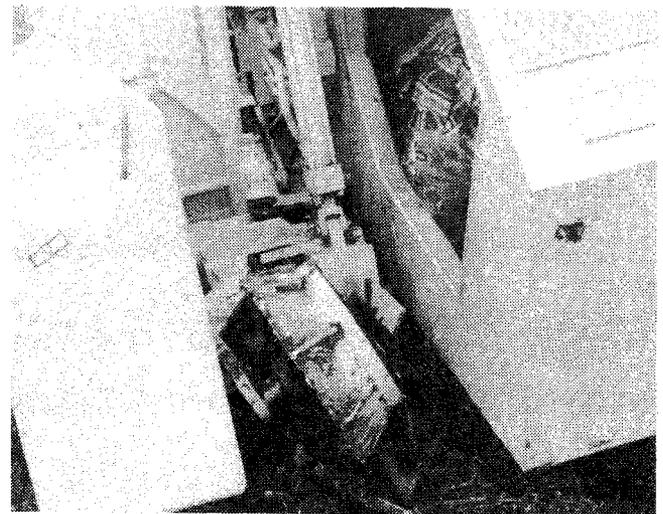
**Figure 6. Original packing wheel made narrower by cutting off 2½ in (6.4 cm).**
