**United States
Department of
Agriculture**

Project Report
8671 1201

Evaluation of Nonmetallic Culverts

James R. Bassel—*Civil Engineer*
Forest Service
Equipment Development Center
San Dimas, California

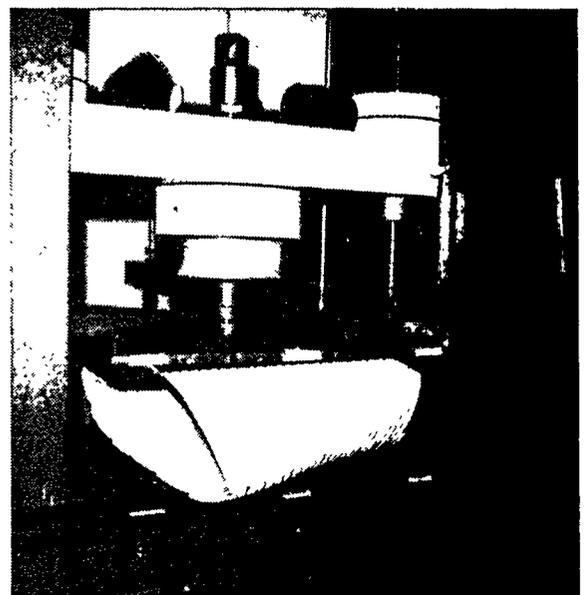
Figure 1. Sono-Loc sample at yield point.

durometer hardness, wall thickness, and inside and outside diameter. Each was placed with its longitudinal axis parallel to the bearing plates of a Tinius Olson—a tensile and compressive testing machine. The specimen then was compressed. The load and deflection were recorded at the first evidence of any significant event. In our case, the yield point. The test ended when the load on the specimen failed to increase with increasing deflection or when the specimen deflection reached at least 40 percent of the inside diameter. (Fig. 1 shows a Sono-Loc sample being tested.)

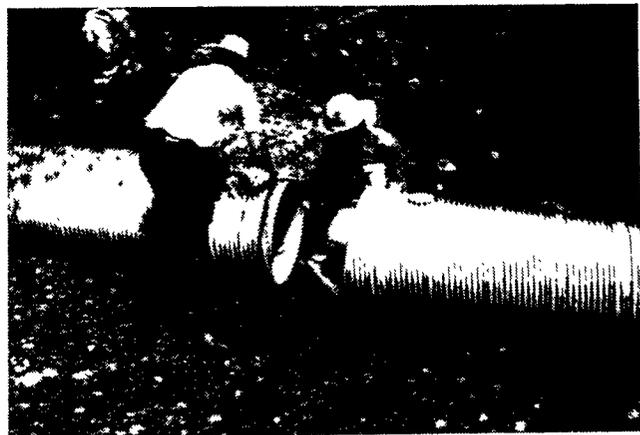
Figure 11. Joining the Perma-Loc with its integral bell gasketed joint.

The Perma-Loc has integral bell gasketed joints (fig. 11). To couple the pipes, the gasket slips into the bell portion of the pipe. This proved to be difficult for the road crew because of the weight and their inexperience working with this type of coupling device. Coupling the PE pipe, which has a collar that screws the two pipes together, was accomplished without difficulty. The Sono-Loc pipe has no particular coupler so the crew used a regular metal dimple band. Because the band was too large, a 1-foot-wide piece of

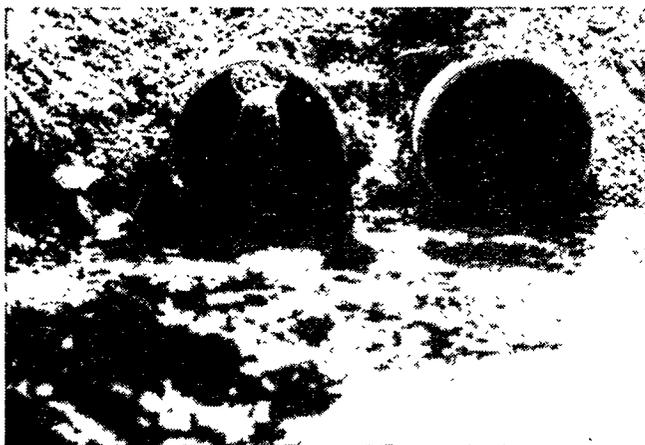
Figure 12. Sonotube installations in a live stream.

In March 1984, two 24-inch diameter Sonotubes were installed downstream from this site (fig. 12). At that time, water was flowing in the stream. The main purpose of this installation was to observe the water flow through the pipes; there was no road above the pipes. After 6 months of dry weather, including a dry summer, the pipes were still functional. During this time, the stream had not been flowing water for approximately 2 months. Three months later, after rain had soaked the ground, the Sonotubes absorbed the moisture, lost their structural strength, and collapsed.

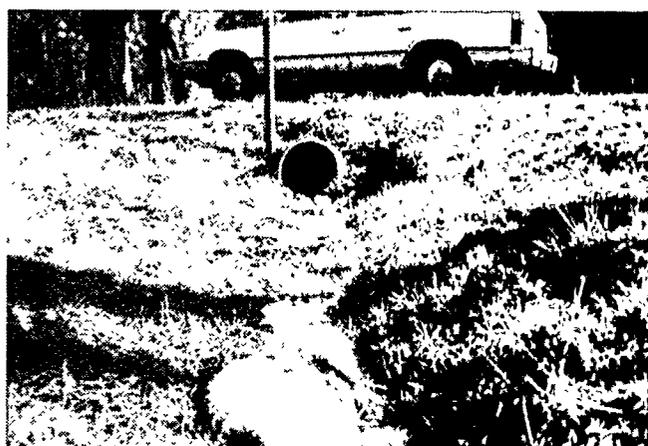
In July 1983, four 18-inch diameter Sono-Loc pipes (fig. 13) were installed on a newly contracted timber sale road. All pipes were delivered in their required length. One pipe broke during transport, and a metal dimple band was used to couple the two pieces. The coupling was the same as that used on the Angeles National Forest. The only problem with installation was cutting the Sono-Loc pipe. A concrete saw was used to obtain a smooth edge.

Figure 13. Sono-Loc installation during the winter season.

In July 1984, 1.0 million board feet of timber was hauled over the road. No apparent problems were detected, and culverts functioned without any distortions.

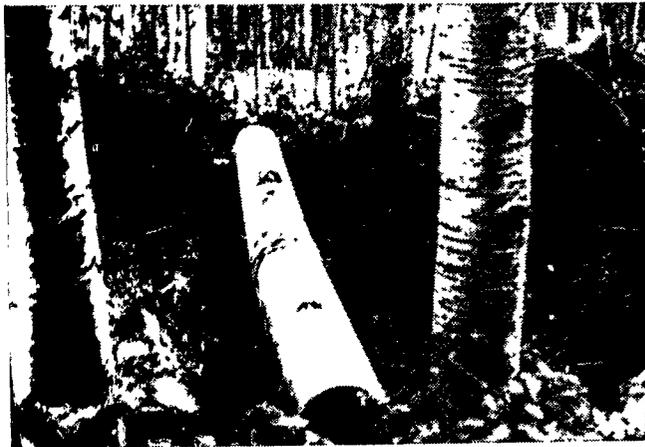
The three Sonotubes were installed without any difficulty. They were coupled together with five-bolt metal bands (fig. 14). The culverts were functional in November 1983. By June 1984, all of the Sonotubes were saturated with moisture, lost all their structural strength, and finally collapsed. All were replaced with metal.

Figure 14. Sonotube with the five-bolt metal coupler.

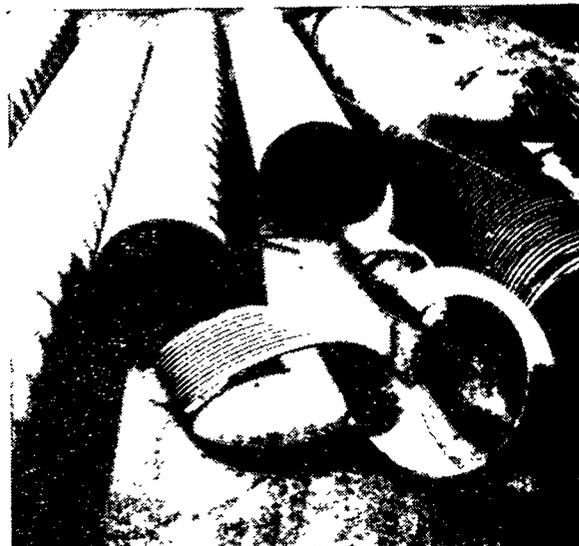
If Sono-Loc pipe is to be a common culvert material, it needs further development. The pipe should be fabricated so that its seams will not separate (fig. 16). Either a better locking device or adhesive is needed. A standard coupling

Figure 16. Example of Sono-Loc seam separation.

similar to PE would make the product more attractive to contractors and road crews. Despite these problems, Sono-Loc has great potential as a culvert product, and the Forest Service should monitor its progress.

1. Sono-Loc, Series 10, should not be used until it becomes cost-competitive with metal and PE, until a more practical coupling is developed, and until better seams are manufactured. When these items are satisfactory, it should be used as a "controlled trial use" in contract situations.
2. Perma-Loc, Series 46, should not be used for ordinary logging road culvert installations.
3. Paper material such as Sonotube should be used only in installations with a design life of one dry season. Sonotube has no salvage value and is biodegradable. Therefore, the pipe should be abandoned when no longer useful.
