McClain Creek Landslide

Installation of Drainage Systems, August to October 2001

Terri Anderson
Civil Engineer
Bitterroot National Forest
Hamilton, MT

Rodney Prellwitz, P.E.
Geotechnical Engineer
Bitterroot National Forest
Stevensville, MT

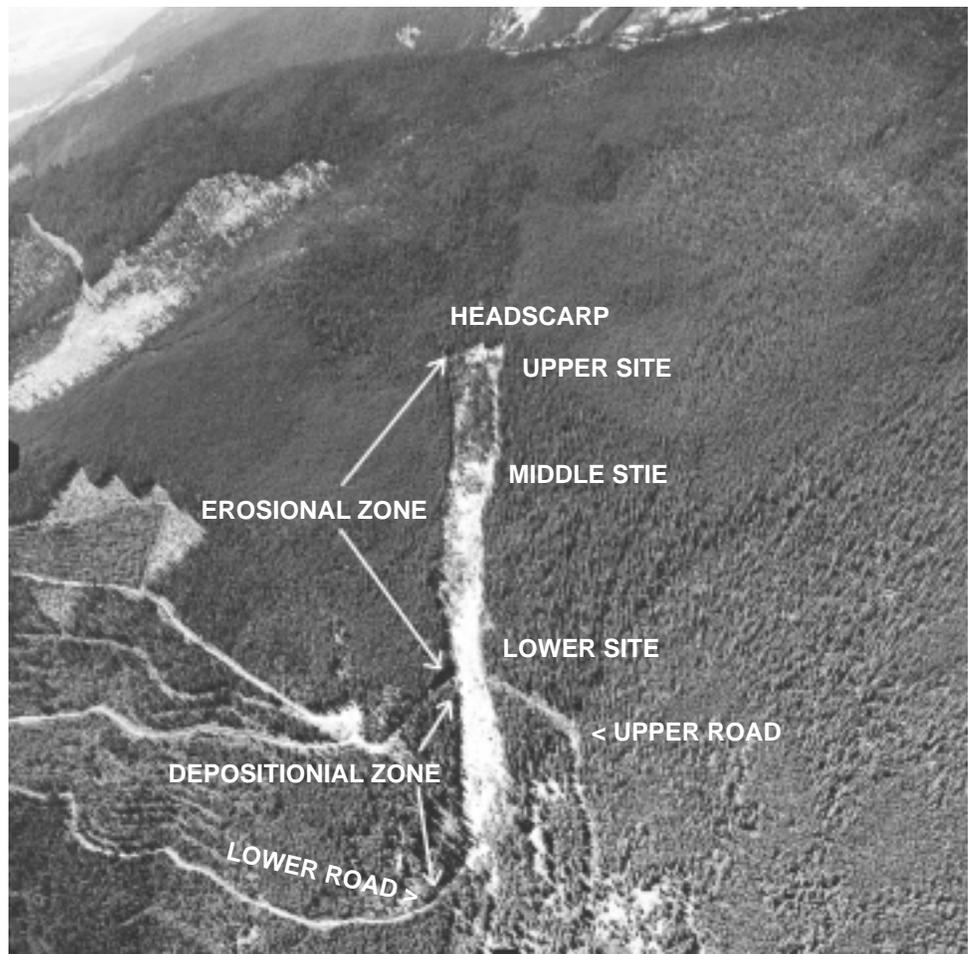
The McClain Creek Landslide is located on National Forest Service lands in the Bitterroot Mountains in the upper drainage area of McClain Creek. The landslide is more than one-half mile long and 200 feet wide (figure 1).

Figure 1. Aerial view of McClain Creek landslide.

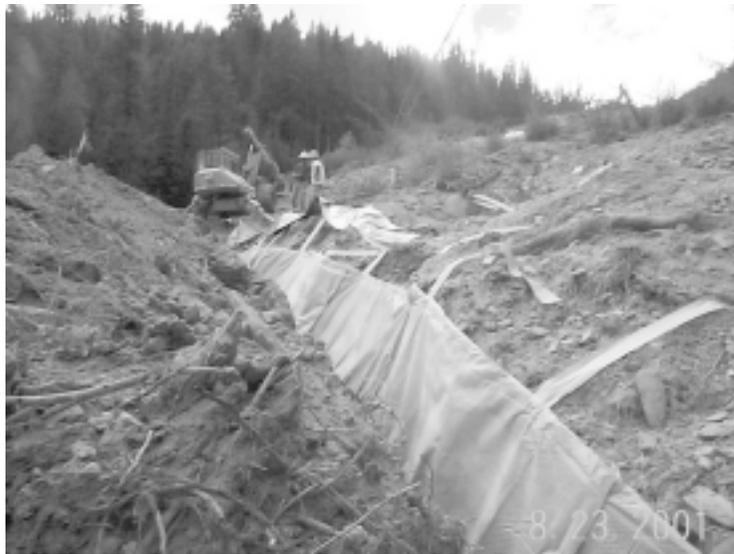
Figure 2. Installation of Eljen drains in depositional zone.

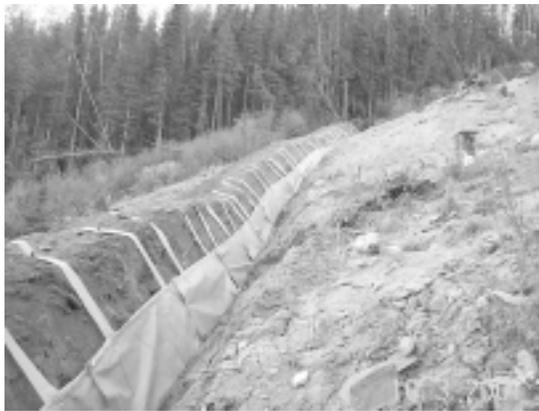
To assemble the Eljen drains, 4-inch perforated ADS (Advanced Drainage Systems) pipe was run through the bottom of the 4- by 10-foot panels, and the panels were pinned together. Typically, the entire assembly was dropped in the trench, and staked at the proper grade for backfilling operations (figure 3). A section of HDPE (high-density polyethylene) liner overlapped the Eljen drain panels to intercept and direct the flows above the panels into the Eljen drains. The downstream ends of the Eljen drains were connected to 4-inch solid ADS piping, or “collector pipes” (figure 4). The collector pipes were then routed to a location where the outflow could be monitored and directed off the landslide. For design purposes, the total drain length for any single collector pipe was limited to 300 feet. The surface water drainage systems were constructed by berming up the sides of the ditch after backfilling operations, then placing a 20-mil HDPE liner over the shaped ditch (figure 5). Initially, the HDPE liner was cut to 6-foot widths, but using 9-foot widths made the installation more efficient.

Figure 3. *Eljen drain panels staked at grade, middle site.*

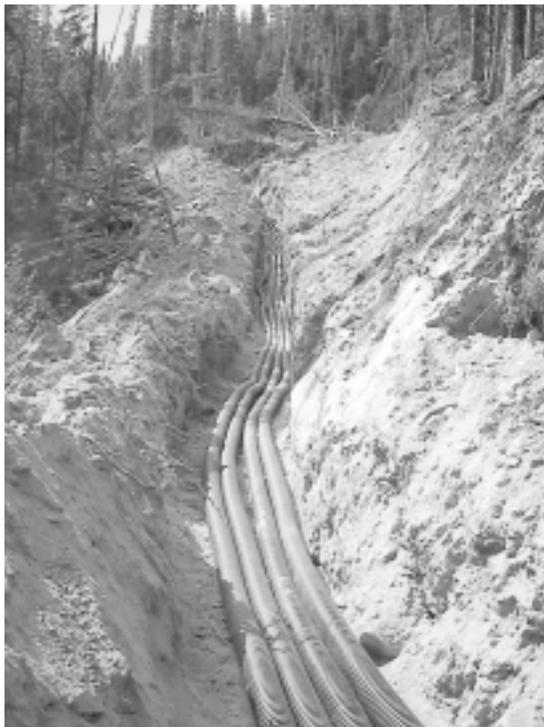
Figure 4. *Collector pipes that drain upper site, located along west pressure ridge.*

The upper site is located at the top of the slide within the vicinity of the headscarp (figure 1). Excavating a trench, through the pressure ridge, between the two monitoring stations for the 8-inch outlet pipe was the first stage. More than 200 feet of 8-inch-diameter solid ADS pipe was installed, then trenching proceeded up the hill for the four 4-inch diameter collector pipes. This piping drains the existing Womack structures and all Eljen drains at the upper site (figure 4).

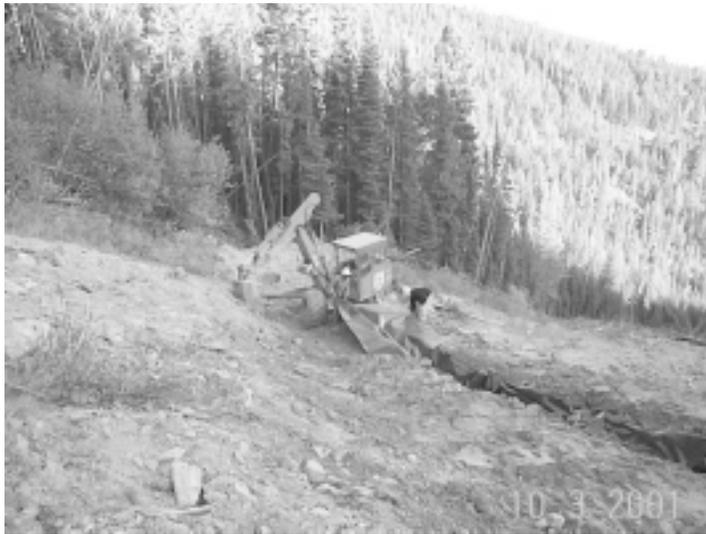
Figure 5. *Installing HDPE liner over bermed ditch to divert surface water runoff from the landslide.*

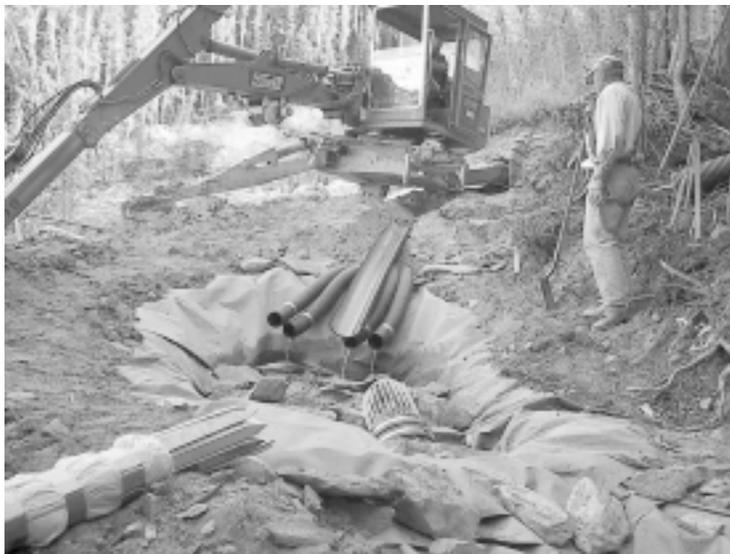
The settlement agreement required a monitoring program to evaluate the effectiveness of the overall project. Monitoring stations were installed throughout the landslide, mainly along the west perimeter of the slide (figure 6). These stations allow measurements of the subsurface ground water collected by the Eljen drains, the surface water being diverted off the landslide by the lined ditches, and the total flow in the various channels, which eventually feed into McClain Creek.

Figure 6. *Monitoring station to measure ground water and surface water flows drained from the middle site.*

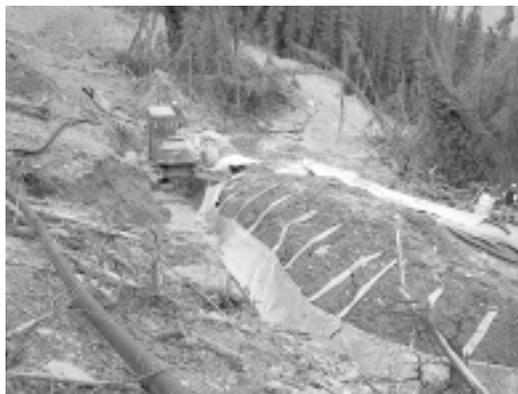
Trenching operations were difficult for three of the Eljen drains at the upper site because of cave-ins caused by saturated ground conditions and groundwater pooling in the bottom of the trench. Therefore, shorter sections of trench were opened, and the Eljen drains were installed immediately and then backfilled. Extremely wet ground conditions and cave-ins from the old slide debris were also encountered during the excavation for an Eljen drain located directly below the headscarp of the slide. McKean and Inouye (December 2000) discussed similar cave-in problems at wet locations at their evaluation sites and recommended Eljen-type drains so they could be preassembled and installed quickly after excavation. This proved to be correct advice for this project, with one additional observation. Cave-in of the trench wall at saturated locations was almost always on the uphill side of the trench (the direction of ground water flow). To maintain drain alignment, it was necessary to abandon the manufacturer's recommendation and place the drain panels on the downhill side of the trench and backfill on the uphill side over the cave-in debris (figure 7). In deeper trench sections, laborers tied off Eljen panels with bailing twine and lowered them into the trench to maintain their position and grade during backfilling.

Figure 7. Excavation for Eljen drain located directly below headscarp. Note trench cave-in onto Eljen drain, mid-photo.

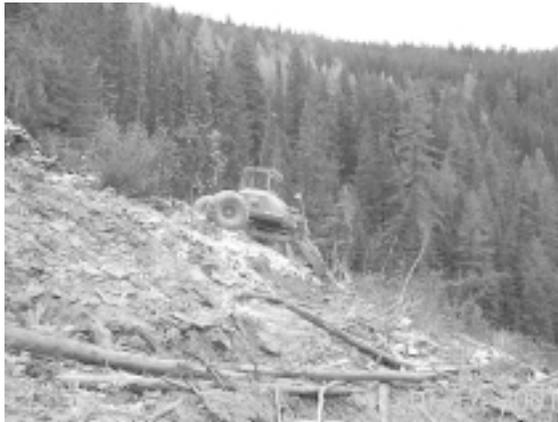
The depositional zone is located between the upper and lower roads. This section contains the steepest slopes on the slide—more than 45 percent. These steep slopes were caused by the eroded material from above, which was deposited in a “bulging” shape near the toe of the slide, hence the name “depositional zone” (figure 8). To control erosion in this steeper section, 15 check dams, constructed from native materials (rocks and dead trees), were added to the original work. This phase of work was completed October 17, 2001.

Figure 8. Spider hoe excavator in depositional zone, located between the upper and lower roads.
