**Technology &
Development
Program**

7100 Engineering
November 2003
0371-2809P-MTDC
WIT-12-0004

Asphalt Paving of Treated Timber Bridge Decks

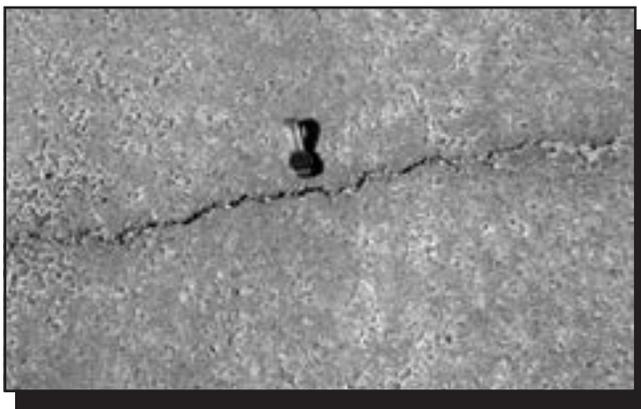
Example 1—The Watchtower Creek Bridge (figures 2 and 3) and West Fork Creek Bridge were constructed on the Bitterroot National Forest in Montana during the summer of 1989. These two-lane, single-span bridges were constructed with transverse glued-laminated deck panels on seven glued-laminated timber beams spaced 48 inches apart. The beams supporting the deck of the Watchtower Creek Bridge are 27 feet long, 8¾ inches wide, and 22½ inches deep. The beams supporting the West Fork Creek Bridge are 35 feet long, 8¾ inches wide, and 28½ inches deep. Deck panels on both

Figure 2—Cracking over panel joints on the Watchtower Creek Bridge at the Bitterroot National Forest, MT, in 1989.

bridges are nailed to the beams and were not mechanically interconnected. The decks were paved shortly after being installed. Within days, the asphalt paving showed reflective cracking (cracking that is reflected up from the deck) directly over all the deck panel joints. The deck panels were treated with pentachlorophenol carried in a heavy oil solvent. The asphalt pavement cracked as soon as the bridges were put in use. The cracking resulted from differential movement of the deck panels, not from panel shrinkage.

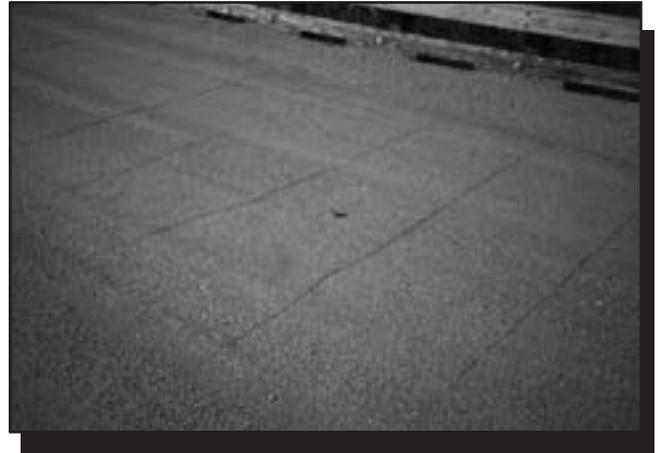
Figure 3—Cracking over panel joints on the Watchtower Creek Bridge at the Bitterroot National Forest, MT, in 2000.

The cracks have opened and raveled somewhat over the 14-year life of the bridges. However, the bridges are functional. No timber deterioration was detected in the deck or superstructure members.

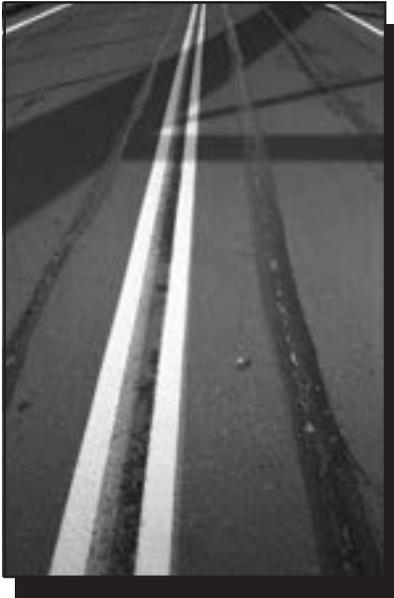
Example 2—The Satsop River Bridge (figures 4 and 5) near Shelton, WA, was constructed in 1996. It is a double-lane, glued-laminated arch bridge with longitudinal glued-laminated deck panels across transverse floor beams. The asphalt pavement cracked within days of installation. The bridge carried a large number of logging trucks. Significant deck movement was observed as loaded trucks crossed the bridge. The longitudinal deck panels were not interconnected with dowels. The deck panels span 10 feet between floor joists and are stiffened with intermediate load distribution beams. The decks are connected to the floor beams and distribution beams with aluminum fasteners.

Figure 4—Longitudinal cracks over the deck panel joint on the Satsop River Bridge near Shelton, WA.

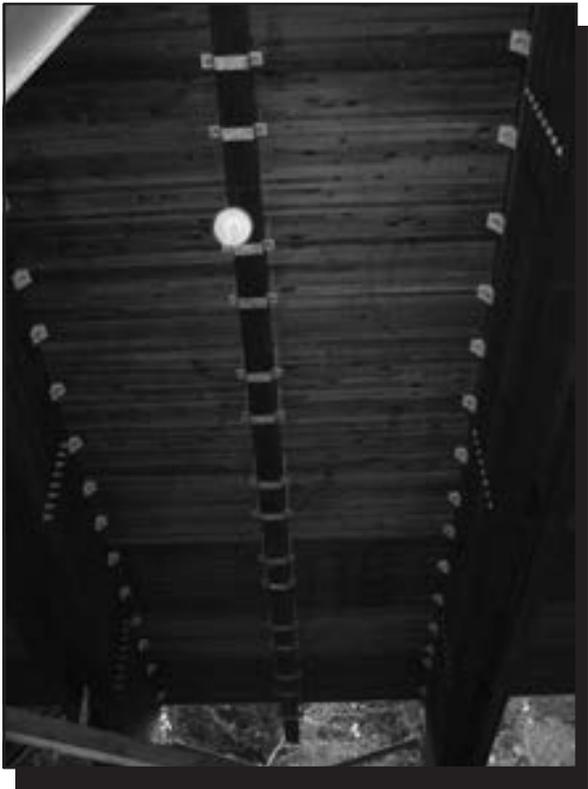
Figure 5—Distribution beam installed under the Satsop River Bridge.

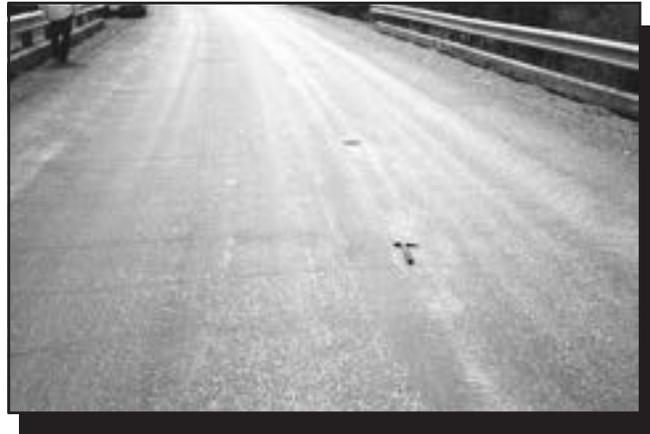
Example 3—Seven bridges (figure 6) on the Wolf Creek Road in Lincoln County, MT, were constructed in 1969. The bridge superstructures are solid beams spaced 25 inches apart. The decks are nail-laminated two by sixes for a deck thickness of $5\frac{3}{4}$ inches. The beams are relatively flexible and the decks are very stiff. The bridges were paved with a cold-mix asphalt shortly after construction. The timber decks have occasional deteriorated laminations that would be logical slip planes for differential deflection, yet the 32-year-old bridges exhibit only random reflective cracking, which would be expected in pavement this old.

Figure 6—Bridge across Wolf Creek near Libby, MT, showing minimal cracking.

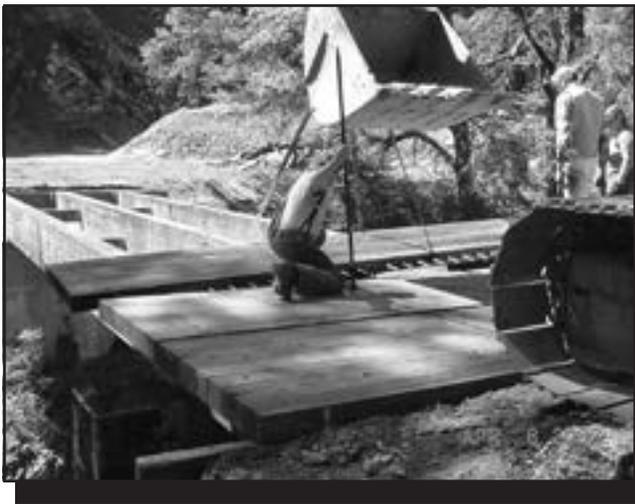
Example 4—The Mill Creek Bridge near Medford, OR, was constructed in 1956. It is a three-span bridge initially designed with a transverse nail-laminated timber deck nailed to three glued-laminated timber beams spaced 5 feet 5 inches apart. In 1978, the nail-laminated timber deck was replaced with transverse glued-laminated timber deck panels lag-bolted to the beams. The deck panels were interconnected with steel dowels (figure 7). The deck was paved with asphalt pavement shortly after the deck panels were installed. The 22-year-old paving shows some reflective cracking over the deck panel joints. However, the cracks are intermittent and small and appeared gradually. The cracking may be caused, at least partially, by shrinkage of the individual deck panels. The deck is functioning well and shows no signs of further deterioration.

Figure 7—Dowel-interconnected, transverse glued-laminated deck panels on the Mill Creek Bridge near Medford, OR.

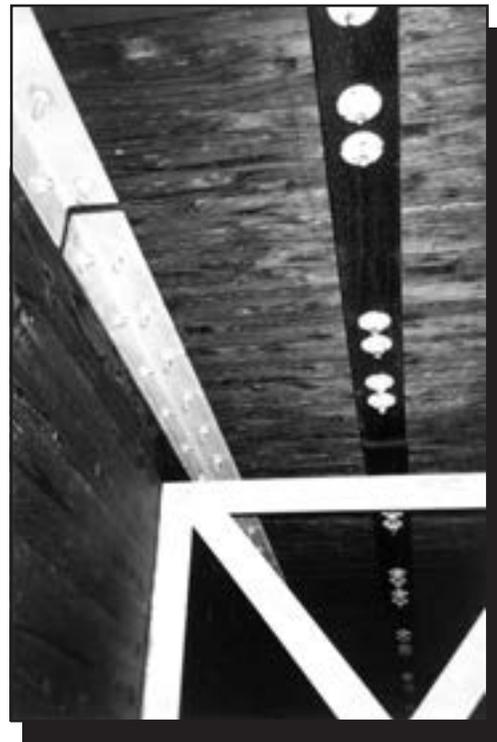
Example 5—The Lighthouse Bridge across Upper Salt Creek in the northern end of the Olympic Peninsula in Clallam County, WA, was constructed in 1994. The 103-foot-long by 34-foot-wide double-lane bridge was constructed with full-length stiffener beams (figures 8 and 9) between the glued-laminated timber beams. The $6\frac{3}{4}$ -inch glued-laminated timber deck is supported by glued-laminated beams spaced 5 feet apart. The asphalt pavement was laid down shortly after the glued-laminated timber deck panels were installed. No cracking (figure 10) had occurred when the bridge was inspected in October 1999. The deck panels are attached to the beams with steel 5- by 5- by $\frac{5}{16}$ -inch angle irons that also help stiffen the deck.

Figure 8—Deck stiffener beams installed under transverse glued-laminated deck panels on the Lighthouse Bridge near Port Angeles, WA.

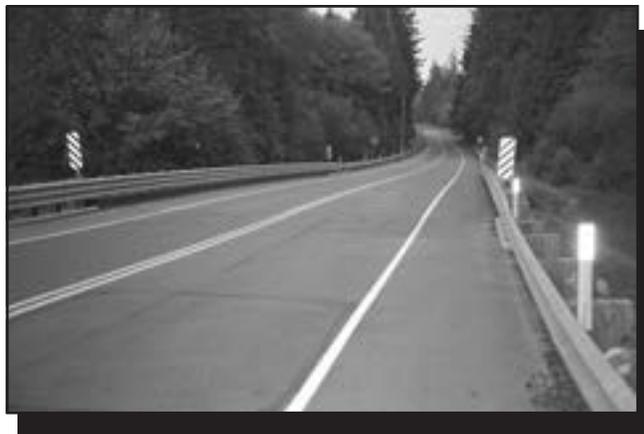
Figure 10—Crack-free deck on the Lighthouse Bridge near Port Angeles, WA.

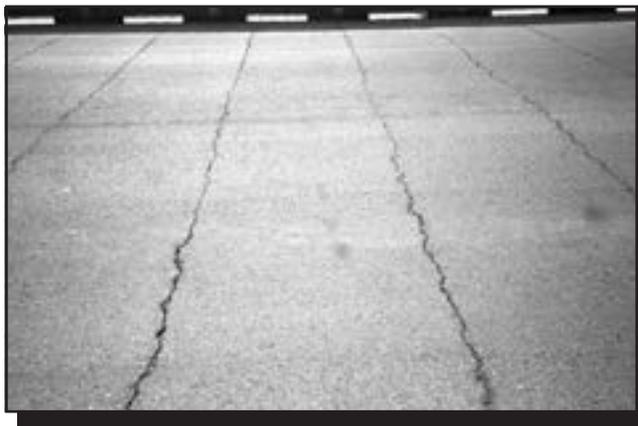
Example 6—The Standish Avenue Bridge in Petoskey, MI, was constructed in the fall of 1999. The 80-foot-long, two-lane bridge was constructed with transversely placed, glued-laminated timber panels treated with chromated copper arsenate, a water-borne treatment. The panels were attached to glued-laminated timber beams spaced every 52 inches with aluminum clips. The deck panels were not mechanically interconnected.

The deck panels fit tightly against each adjoining deck panel when installed. The asphalt pavement was laid down immediately after the deck panels. The pavement showed reflective cracking (figure 11) within days after the bridge was opened to traffic. The cracks continued to grow during the first year of operation. When the bridge was inspected during the summer of 2000, gaps up to $\frac{1}{4}$ inch (figure 12) were observed between deck panels. The early cracking of the asphalt paving on this bridge may have been caused by differential deflection of the deck panels. Shrinkage of the deck panels enlarged the cracks and contributed to the failure of the pavement.

Figure 11—The pavement cracked about 1 year after construction of the Standish Avenue Bridge in Petoskey, MI.

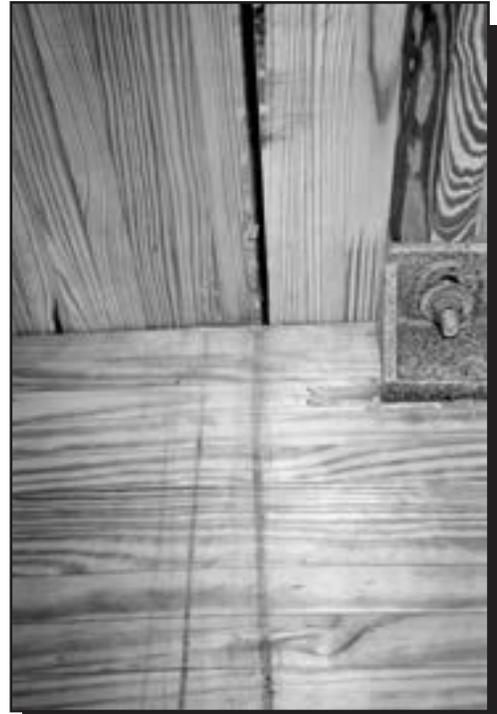
Figure 12—Shrinkage of deck panels contributed to pavement cracking on the Standish Avenue Bridge.

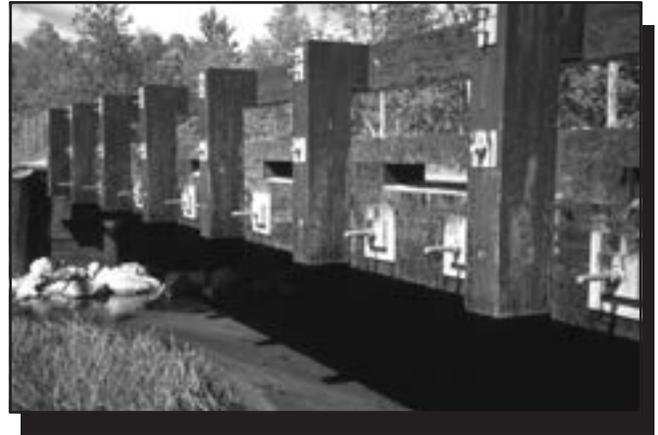
Example 7—The Barlow and Cruzen bridges in Alcona County, MI, are two-lane, single-span, stress-laminated, creosote-treated timber deck bridges. The bridges are similar in design. Both were part of the creosote retention study in Michigan. Timber materials of the Barlow Bridge were cleaned after treatment and show almost no bleeding of creosote (figures 13a and 13b) on exposed treated timber surfaces or through the asphalt pavement. The timber materials of the Cruzen Bridge were not cleaned after treatment and show excessive amounts of creosote (figures 14a and 14b) on timber surfaces and through the asphalt pavement. The American Wood Protection Association (AWPA), formerly the American Wood Preserver's Association, set minimum creosote retention levels for these bridges as 12 pounds per cubic foot. The average measured retention levels were 46.2 pounds per cubic foot for the Barlow Bridge and 52.2 pounds per cubic foot for the Cruzen Bridge. Creosote retention levels were excessive for both bridges. However, the Barlow Bridge shows no significant bleeding. The difference appears to be that the Barlow Bridge received the BMP-recommended cleaning procedures after treatment.

Figure 14a—The Cruzen Bridge in Alcona County, MI, was made from timbers that had not been cleaned properly after being treated with preservative.

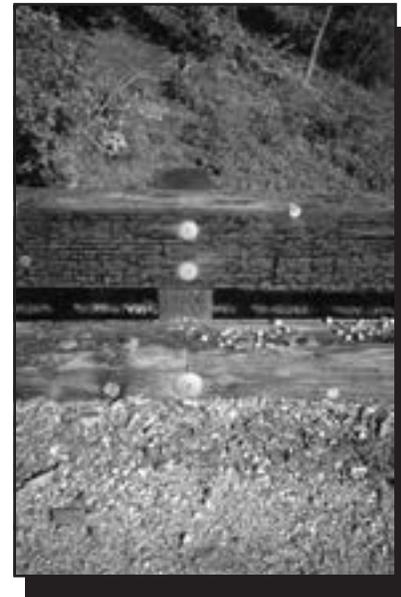
Figure 14b—Creosote-treated timbers on the Cruzen Bridge were not cleaned after treatment. Creosote is leaching from the timbers.

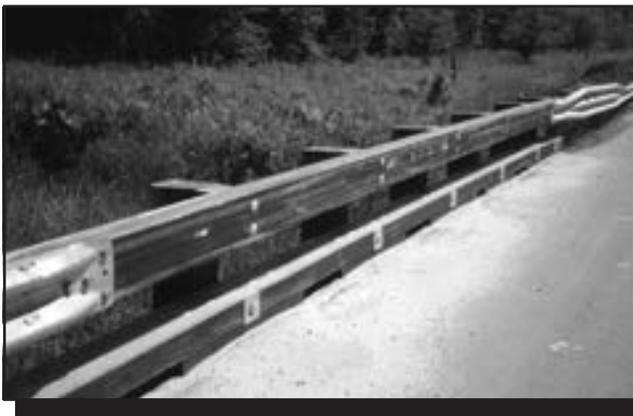
Figure 13b—Proper cleaning prevented creosote-treated timbers from bleeding through the asphalt pavement on the Barlow Bridge.

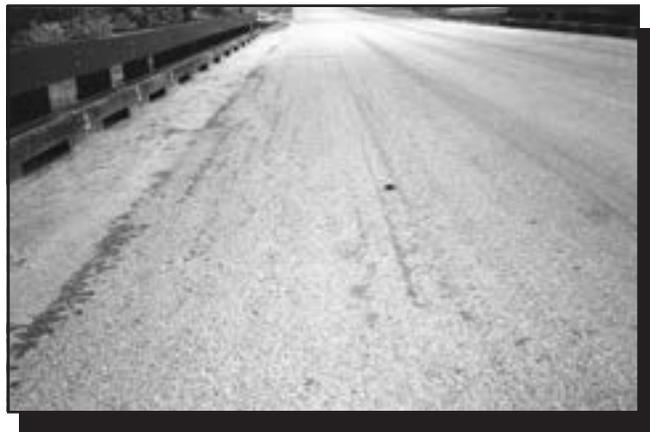
Example 8—The Cameron Bridge across the Manistee River in Crawford County, MI, was constructed in 1995 as a two-lane, two-span, stress-laminated timber box-beam bridge. The deck is comprised of a laminated box section with southern pine glued-laminated webs spaced every 24 inches. Solid pin oak dimensional wood stressed between the glued-laminated webs forms the box section. This bridge was also part of the Michigan creosote-treated bridge study. The glued-laminated webs had an average creosote retention of about 12.5 pounds per cubic foot. The solid wood had an average creosote retention of about 5.1 pounds per cubic foot. Although these are not exceptionally high retention levels, excess creosote dissolved the asphalt-impregnated paving membrane between the deck and the asphalt paving over the tops of the glued-laminated members (figure 15). The long stripes of creosote bleeding through the asphalt paving show the locations of the glued-laminated beams.

Figure 15—The Cameron Bridge in Crawford County, MI, had asphalt bleeding over glued-laminated webs.

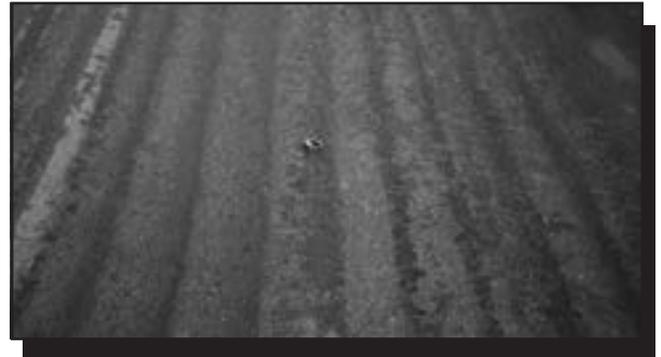
of southern yellow pine and red pine. When laminated decks are stressed, preservatives are squeezed out. A higher concentration of preservatives occurs at the junctions of the deck laminations. At the Cruzen Bridge, these concentrations of creosote bled up through the asphalt pavement. The spacing of the asphalt lines on the surface of the pavement match the width of the glued-laminated beams in the stressed deck. This bridge did not have a paving membrane, so the visible bleeding is pavement asphalt and excess creosote.

Figure 16—Asphalt bleeding directly over creosote concentrations on the Cruzen Bridge in Alcona County, MI.

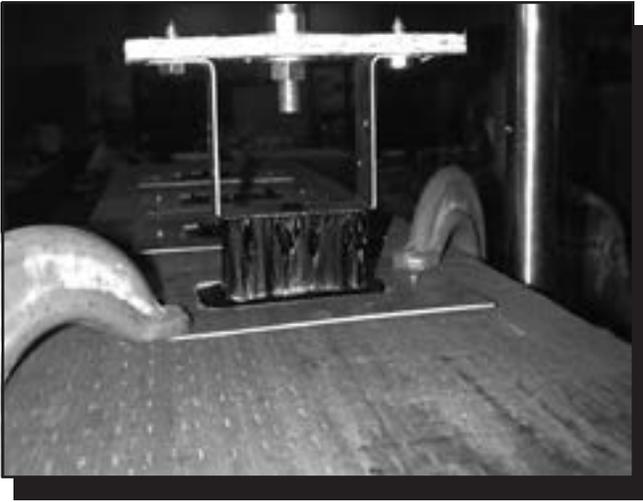
Figure 19—Asphalt adhesion test after the asphalt failed when it had elongated.

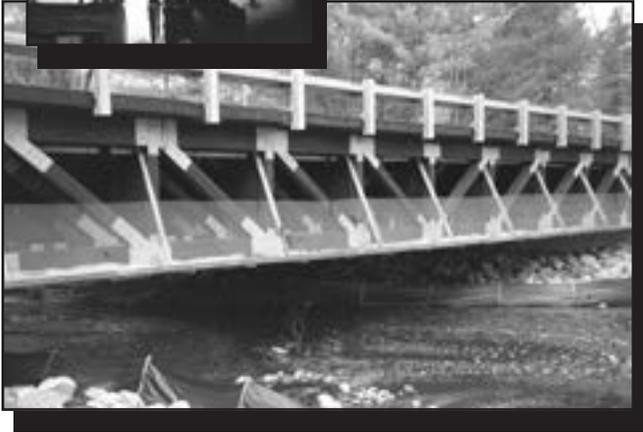
Figure 20b—A collection system catches the creosote and rubberized asphalt dripping from the underside of the bridge.

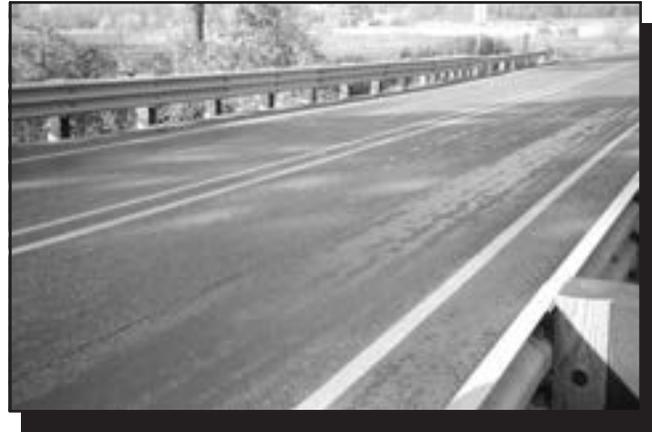
All three decks treated with oilborne preservatives showed significant dripping of the rubberized asphalt from the paving membranes. The pavement surfaces of these three bridges

Figure 21—Alternating longitudinal deck panels treated with penta and copper naphthenate on a bridge in Washington County, OR.

were rutted and showed signs of asphalt bleeding. One bridge deck had two large potholes near the center of the bridge. The deck panels treated with penta exhibited more asphalt bleeding than the deck panels treated with copper naphthenate. The extra bleeding may have occurred because the penta panels were in the wheel paths.

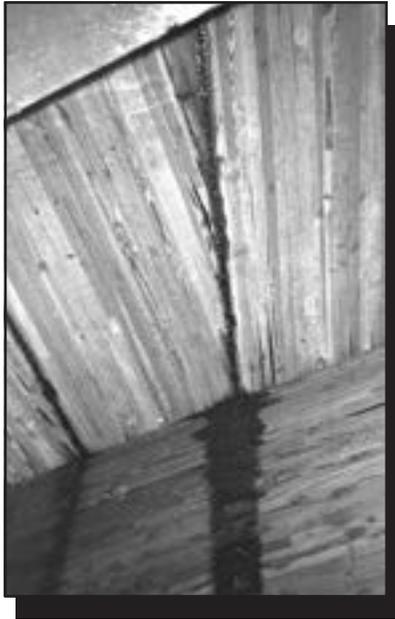
Figure 22—Rubberized asphalt dripping from paving membranes on the Rogue River Bridge near Medford, OR.

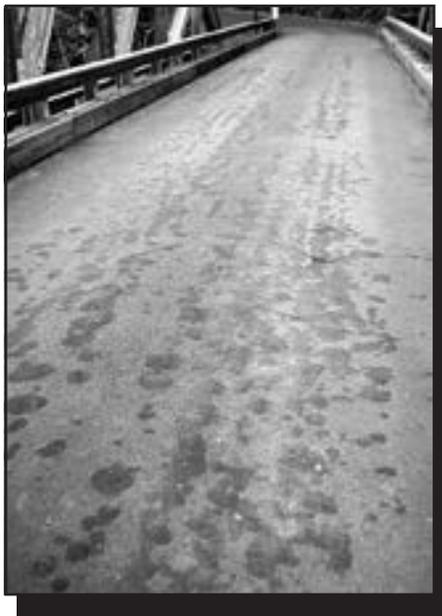
Another Forest Service bridge, crossing the Little North Fork of the Santiam River, showed a puzzling pattern of membrane dripping. The Shady Cove Bridge (figure 23) was constructed in 1991. The deck is longitudinal glued-laminated timber panels treated with pentachlorophenol in a type C light oil solvent. The deck was sealed with a primer before the rubberized paving membrane and asphalt overlay were installed. Some paving difficulties were experienced, but the deck was relatively tight with no apparent asphalt dripping for almost 9 years. In the spring of 2000, rubberized asphalt began dripping from the bridge (figure 24a). The asphalt that has dripped onto the bedrock under the bridge clearly reveals the location of the deck panel joints above (figure 24b).

Figure 23—Asphalt leaching to the pavement surface of Shady Cove Bridge near Eugene, OR.

Asphalt bled to the pavement surface, forming pools about 6 inches in diameter. Forest personnel cut out a 12-inch-square piece of asphalt pavement. The bottom 1 inch of the 2-inch-thick pavement was semiliquid.

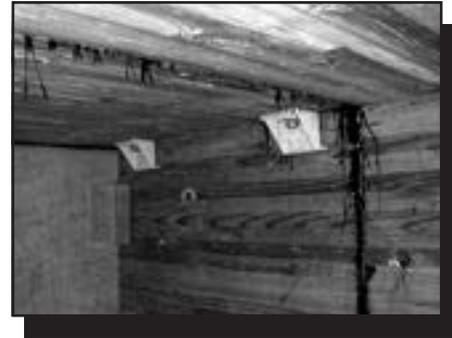
Figure 24a—Rubberized asphalt dripping from the underside of the Shady Cove Bridge.

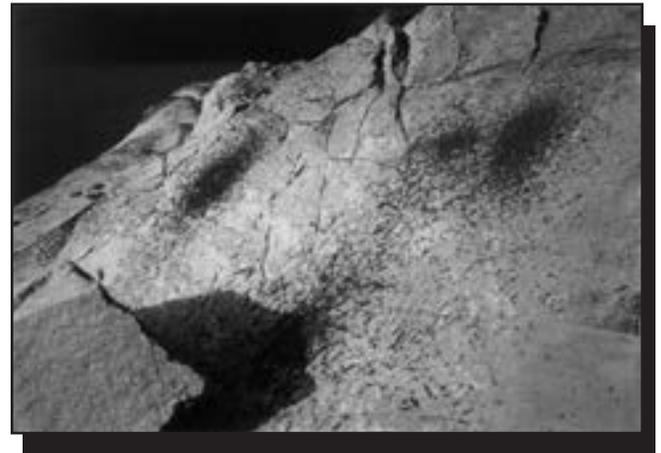
Figure 24b—Asphalt dripping onto rocks under the Shady Cove Bridge.
