Case Studies and Failures

Case studies can show the problems and concerns that arise when FRP bridges are used in the national forests. The author and engineering staff from local forests inspected five FRP bridges that have been installed since as early as 1991. The bridges were in the Gifford Pinchot, Medicine Bow-Routt, Mt. Hood, Tahoe and Wallowa-Whitman National Forests. The problems found on each structure fell into three categories:

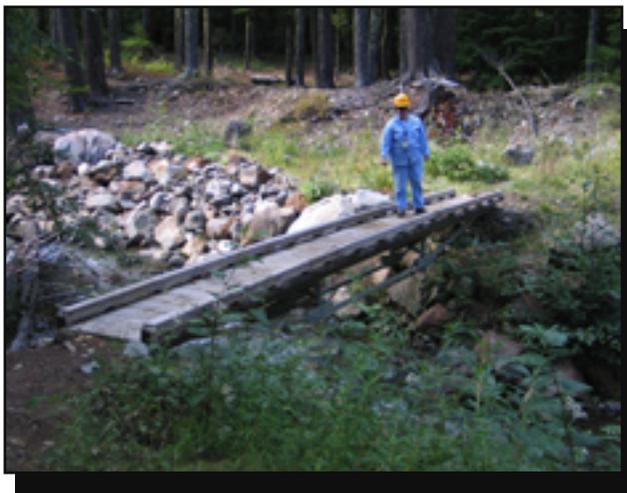
Members of the queen-post bridge (figure 40) on the Mt. Hood National Forest were scratched when they were

Figure 40—This deck-truss FRP bridge in the Mt. Hood National Forest has an inverted queen-post configuration.

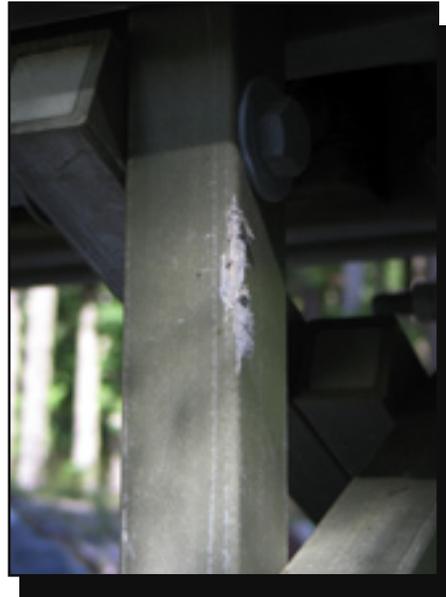
dragged to the site (figure 41). These scratches can be fixed by sealing them to prevent moisture from wicking into the member.

Figure 41—This truss was damaged when it was dragged or handled improperly.

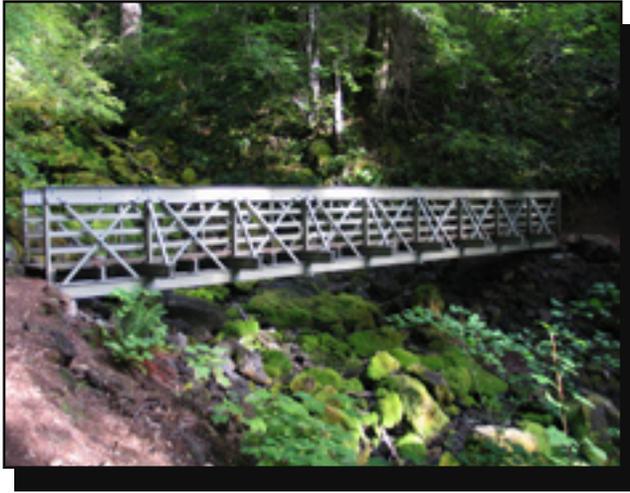
The Falls Creek Trail Bridge (figure 42) is a good example of construction problems. Some bolts were overtightened with a pneumatic power wrench, cracking some members at the connections when the bridge was assembled at the Forest Products Laboratory. Figure 43 shows a rectangular tube with an $\frac{1}{8}$ -inch sidewall, only half the thickness recommended for trail bridges.

Figure 42—A side-truss FRP bridge in the Gifford Pinchot National Forest.

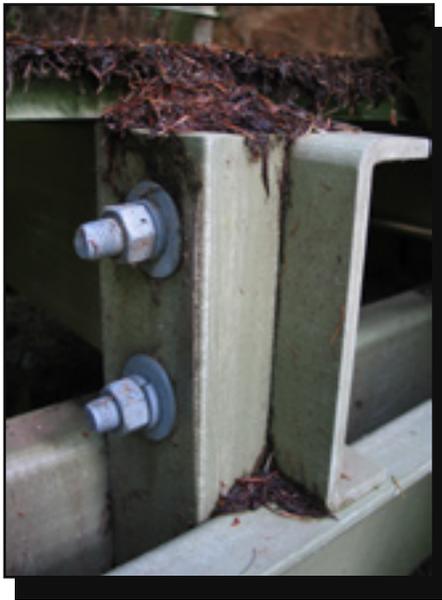
Figure 43—This floor beam tie was damaged when bolts were overtightened.

Cracked connections may have been prevented by just tightening bolts until the lock washers began to flatten out and by being careful not to overtighten the nuts. Sometimes, connections with minor hairline cracks can be sealed with protective coating and monitored. If minor cracks are not sealed, the exposed fibers will wick water into the material. As the water freezes and thaws, the member will deteriorate. If members have

major cracks, they should be replaced. Otherwise, the entire structure could fail.

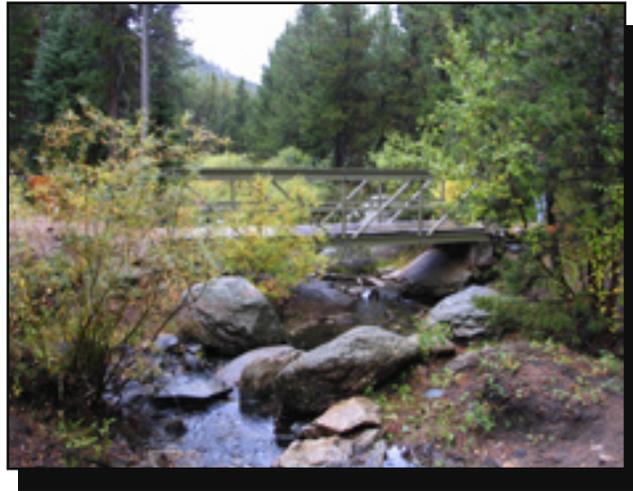
Construction problems also occurred on the Medicine Bow-Routt and Wallowa-Whitman National Forests. The Medicine Bow-Routt bridge is a 20-foot-long by 5-foot-wide side-truss structure (figures 44 and 45), built in 1995. The Wallowa-Whitman National Forest bridge is a

Figure 44—A side-truss FRP bridge in the Medicine Bow-Routt National Forests.

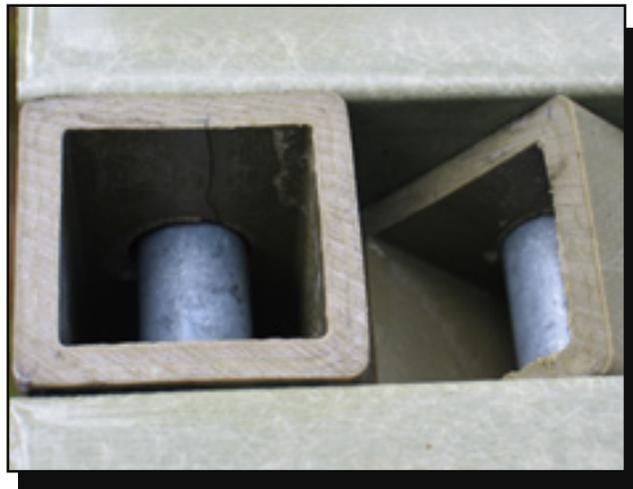
Figure 45—This joint at the top of a vertical post was damaged when bolts were overtightened.

22-foot-long by 6-foot-wide structure (figures 46 and 47), built in 1998. Both bridges had minor cracks at the upper

chord joints. The Medicine Bow-Routt Bridge has large cracks in the bottom chord at the bolt connections (see figure 32) that may have been caused by dynamic loads from ATV traffic, by bolts that were overtightened, or by overloading.

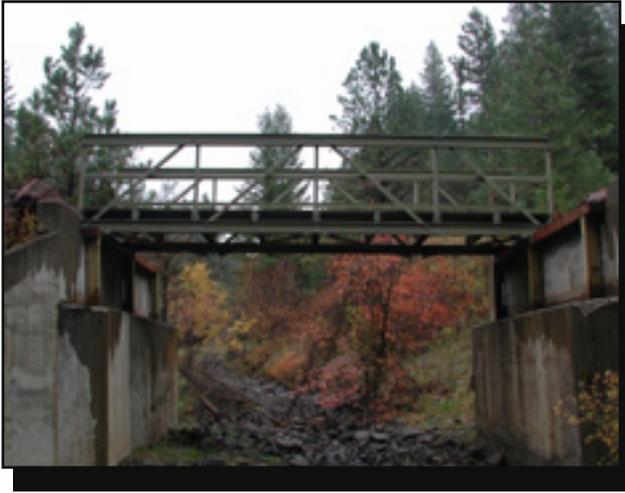
Figure 46—A side-truss FRP bridge in the Wallowa-Whitman National Forest.

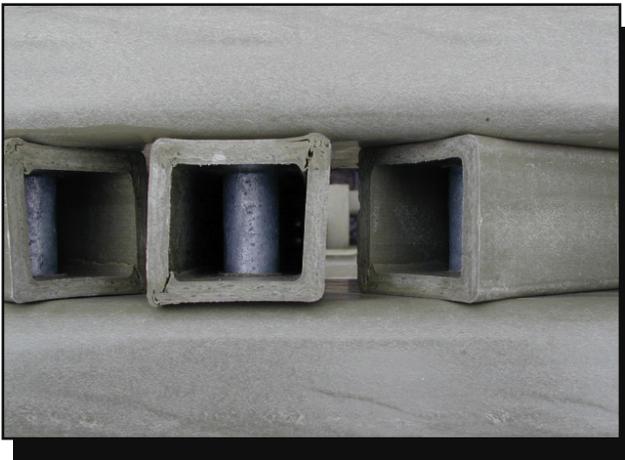
Figure 47— This joint at the top of a vertical post was damaged when bolts were overtightened.

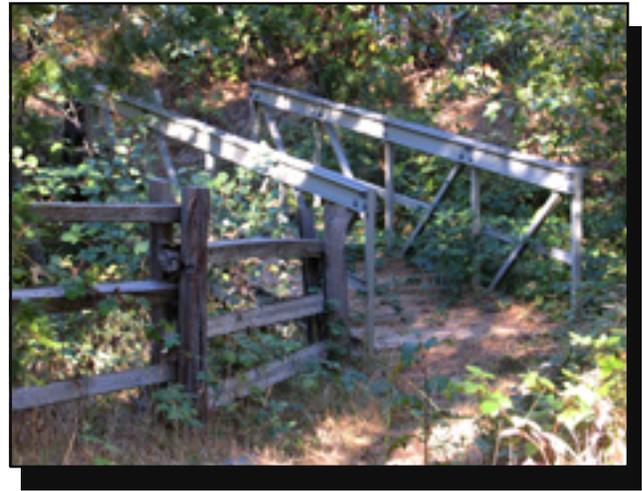
The side-truss bridges (figure 48) on the Tahoe National Forest show the problems of UV degradation. The 20-foot-long by 5-foot-wide bridge was built in 1994. The sides of the bridges exposed to full sun have lost their UV protective coating (see figure 30). Wind abrasion from blowing sand and debris can wear away the sealant that provides UV protection. For optimal protection, the members could be recoated with UV protective sealant about every 5 years. If the members are not sealed, the fibers could eventually be exposed, allowing water to wick into the material. As the water freezes and thaws, the member could deteriorate over time.

Figure 48—A side-truss FRP bridge in the Tahoe National Forest.
