Test Results

Specific burn tests were conducted on three sites between February and July 1996:

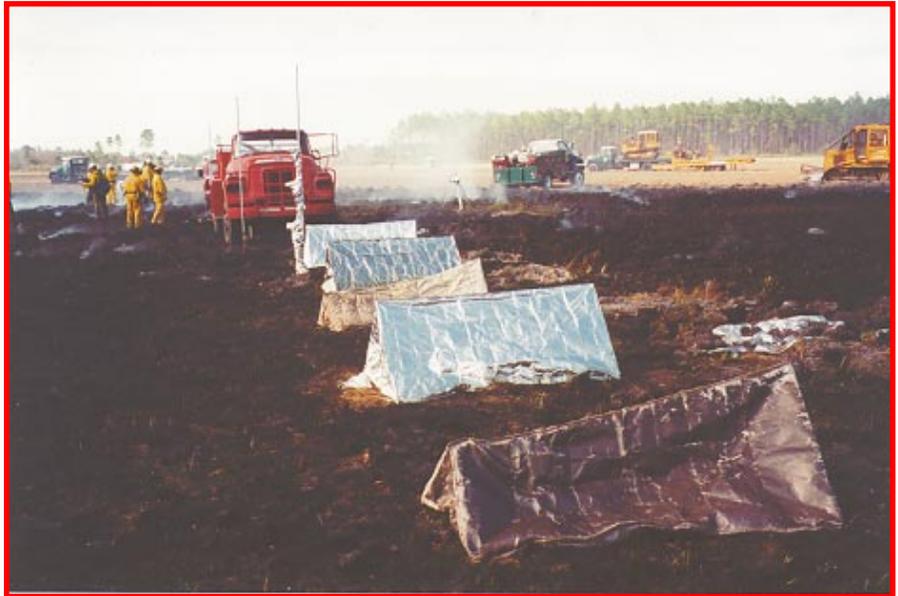
Figure 13—The Florida burn was not intense enough and did not burn for long enough to seriously test survivability inside either the shelters or the vehicles.

The first burn was conducted on February 27, 1996, on an open, grass-covered field that had dry, cured bunchgrasses 30 to 36 inches (76 to 91 cm) tall, with a 2- to 4-inch (5 to 10 cm) mat of cured grass and thatch on the ground. The burn was in late afternoon with a 3- to 5-mile per hour wind. It was over in less than 1 minute, and had neither the intensity nor the duration to seriously test the survivability of the shelters or the engines (Figure 13).

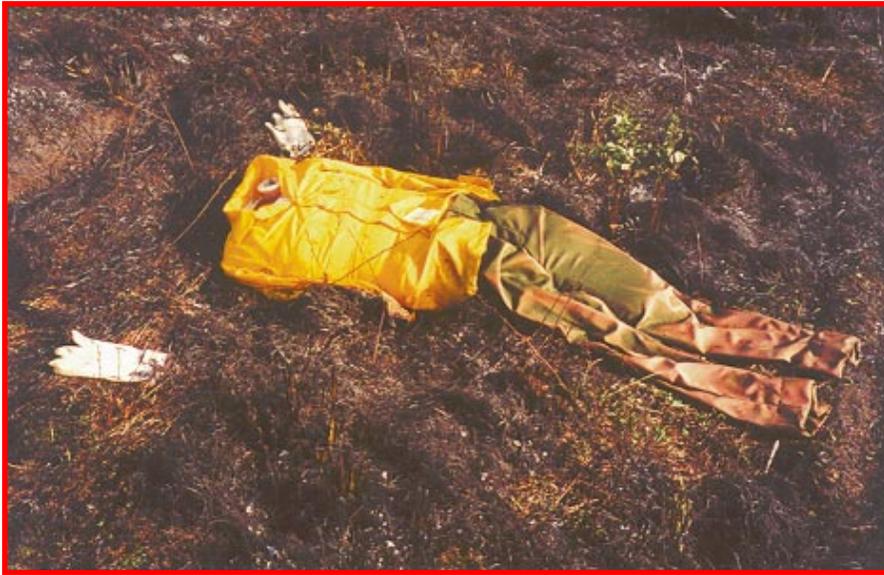
- ◆ Personal protective equipment laid out in the fuels suffered varying degrees of damage: the Military Nomex flight suit was badly damaged, as was the FR cotton brush coat. The standard FS Nomex shirt and trousers showed signs of the heat, but were not destroyed. They would have offered some protection from serious burns (Figure 14).

Figure 14—The change in color of the pants shows the effect of heat. Water bags inside the fire shirt and upper pants served as a heat sink, keeping them from becoming as hot as the pant legs.

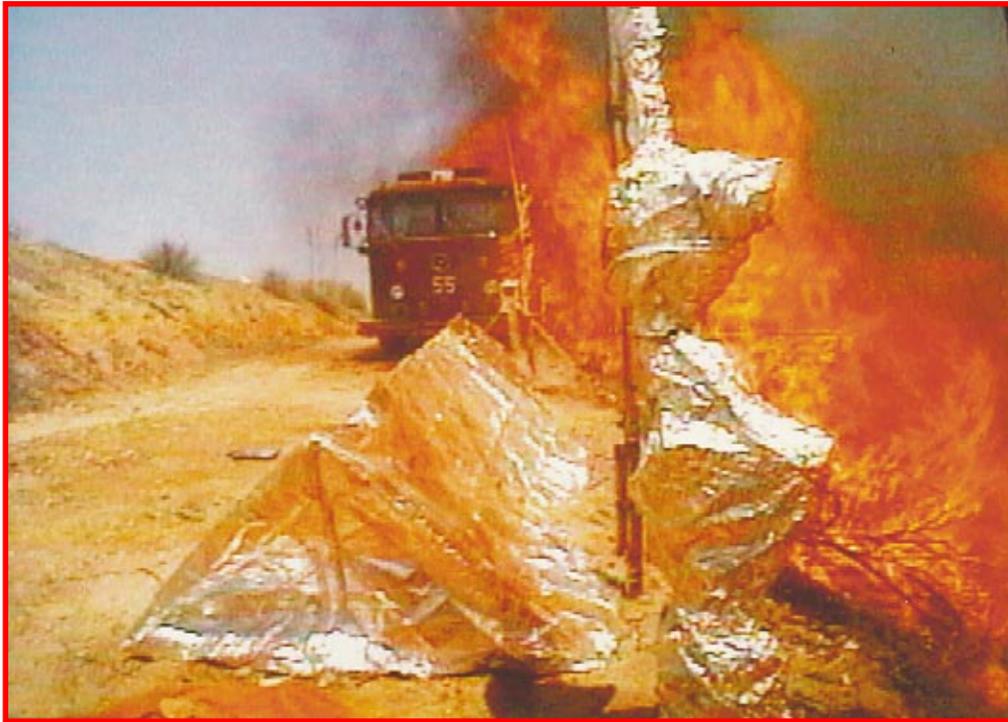
The June 5th burn took place on slopes averaging 70%. The engines, fire shelters, and PPE were on a road near the top of the slope (Figure 3, page 3). Flames came in direct contact with the engines and shelters, since they were positioned at the road’s edge to receive the maximum effect of the flaming front (Figure 15).

Figure 15—This image (taken from video) shows the intensity of the June 5 burn in Los Angeles County.

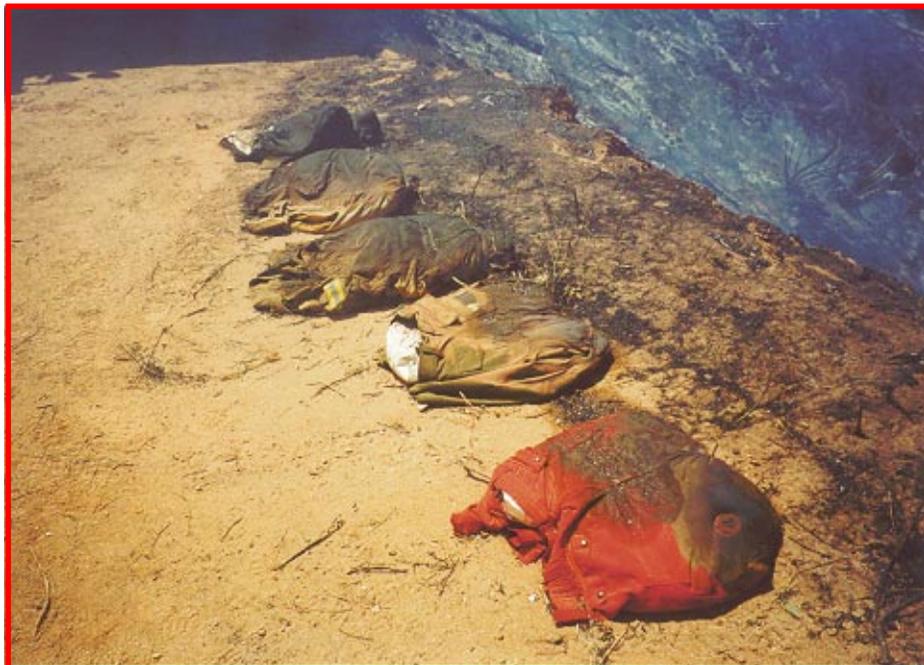
- ◆ Items of personal protective clothing laid out beside the engines and shelters showed serious degradation from the intense heat during the burnover. A difference of less than a foot (30 cm) from the fire made a significant difference in damage to the clothing (Figure 16).

Figure 16—These items of personal protective clothing show the effects of the June 5 burn in Los Angeles County. Note the difference made by being just a few feet from the edge of the roadway.

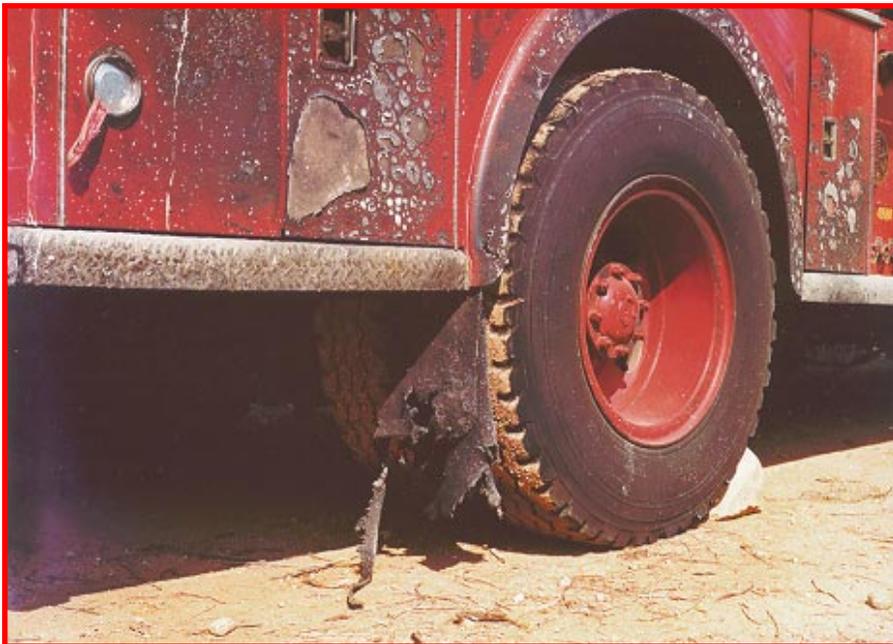
- The mud flap on the rear tire caught fire (Figure 17).
 - The exterior ladder hanging outside the engine was badly scorched.

Figure 17—Mudflaps are just one of the flammable items on the engine's exterior.

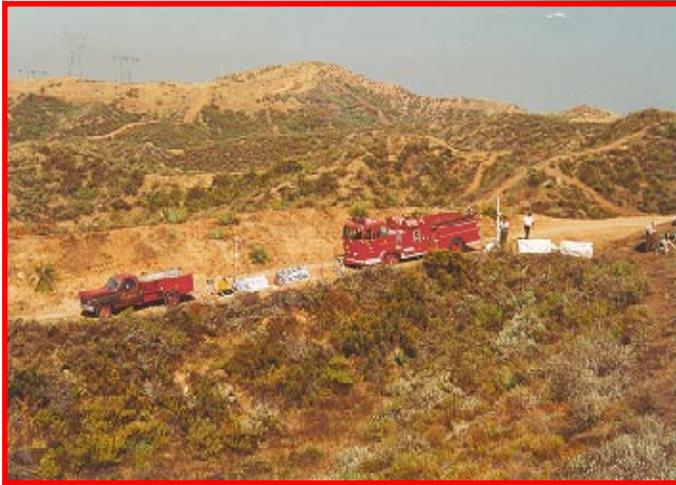
The second burn in Los Angeles County was on June 6th, the next day. Weather conditions were nearly identical, but the slope, aspect, and fuel loading were different. The engines were positioned at the head of a small draw with 35 to 45% slopes (Figure 18). Some chamise

brush was cut and piled next to the engines and shelters to increase the fire's intensity and duration. Because of the topographic effect of some adjacent spur ridges, the flames were diverted from the engines and shelters.

Figure 18—The engine, patrol engine, and fire shelters positioned for the second burn in Los Angeles County, June 6th.

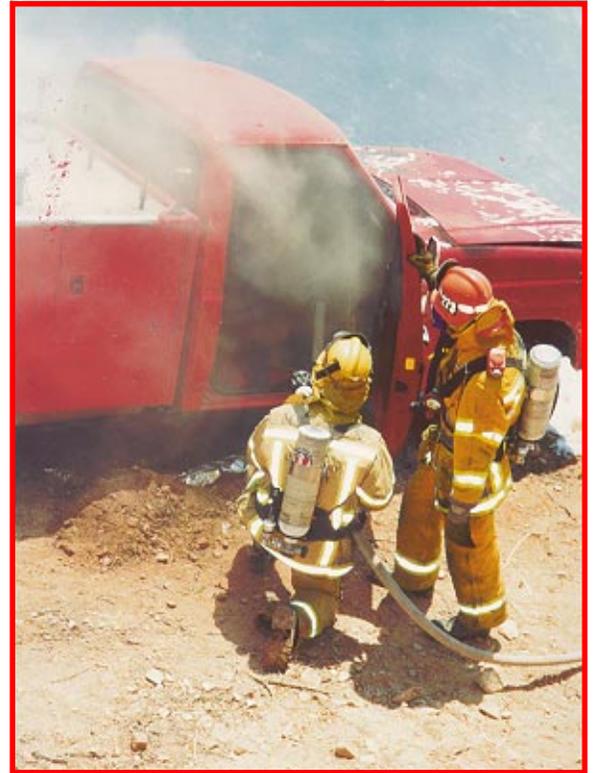
◆ The patrol engine (Figure 19) had outside air temperatures of 440 °C, with inside air temperatures of 280 °C at the roof. The inside door panel on the driver's side caught fire, leading to the high temperatures inside the cab of the patrol engine (Figures 20 and 21). Floor temperatures were 45 °C.

Figure 19—The patrol engine caught fire during the June 6 burn in Los Angeles County.

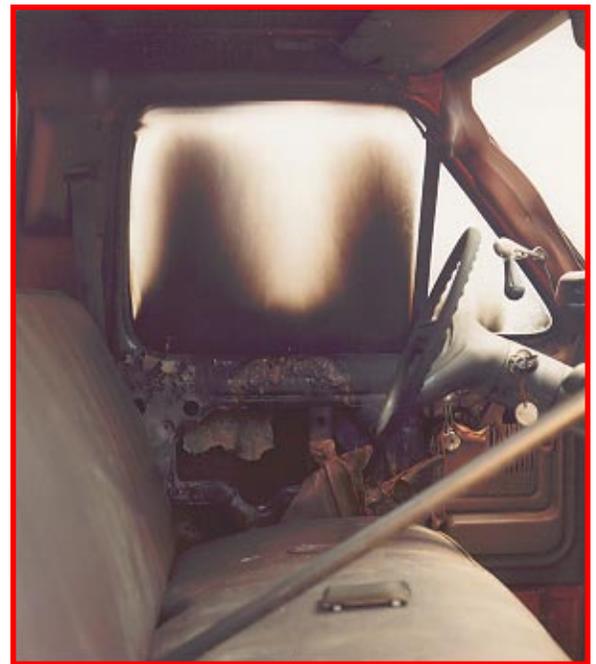
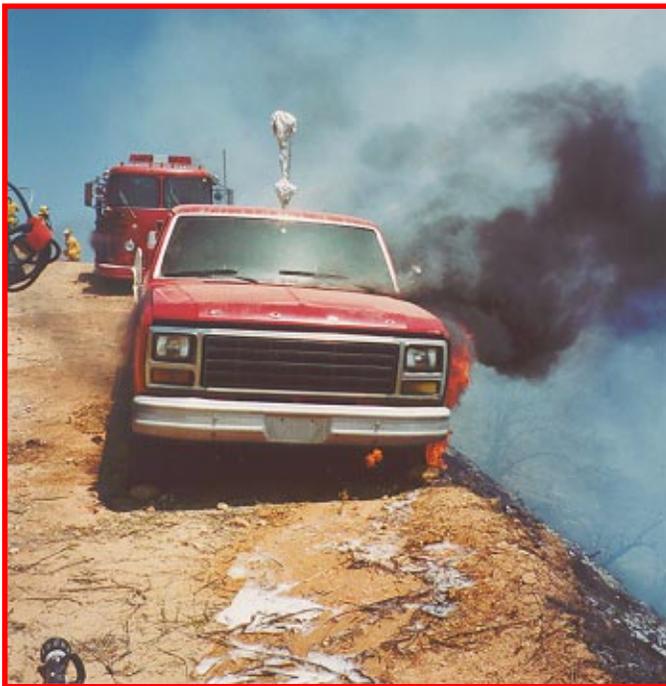
◆ Video footage showed that the cab of the patrol engine filled with dark smoke in less than 60 seconds. The driver's side door panel caught fire from radiant heat on the outside of the door;

Figures 20 and 21—Firefighters put out the fire in the cab of the patrol pickup. Material on the inside door panel burned, emitting smoke that would have forced entrapped firefighters to leave the truck.

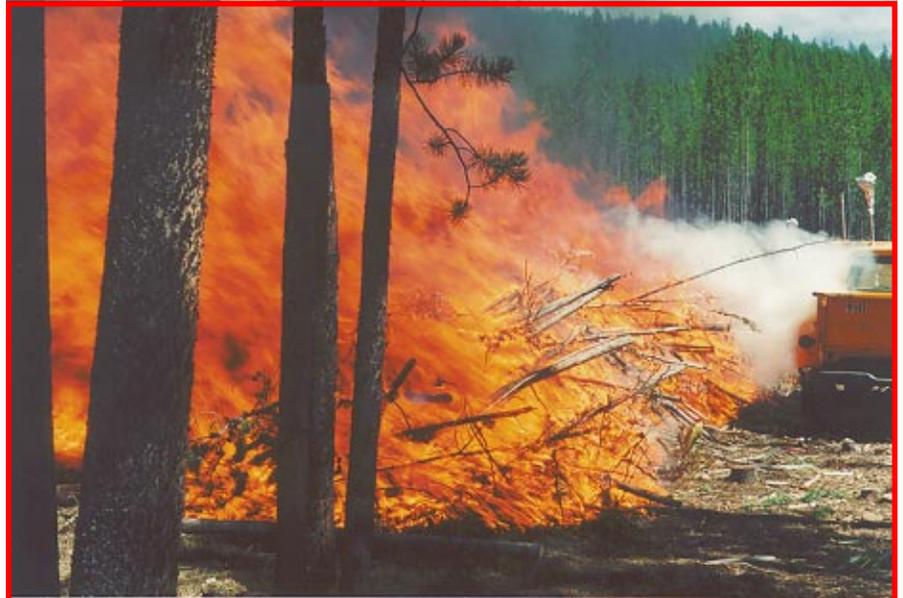
An unforecast wind shift just before ignition prevented direct flame contact on the vehicles and shelters being tested (Figure 22). However, satisfactory results were obtained:

Figure 22—Wind prevented flames from directly contacting vehicles during the test burn near Dillon, MT.

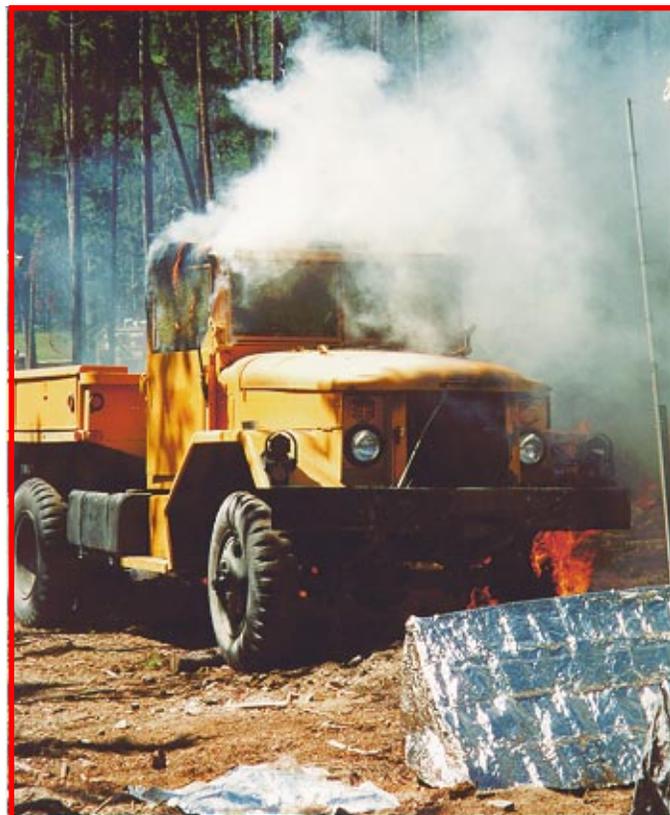
- ◆ Maximum air temperature outside the 2½-ton engine was 400 °C, while temperatures inside the cab exceeded 700 °C. The inside of the engine cab caught fire (Figure 23) and burned, resulting in the higher temperatures.
- ◆ The crew cab truck outside air temperatures were less than 200 °C. Air temperatures inside the cab exceeded 250 °C because the interior caught fire.
- ◆ Surface temperatures on the fire shelter at the rear of the 2½-ton engine reached 150 °C, although they generally

Figure 23—Even though flames did not directly contact the 2½-ton truck, its cab caught fire.

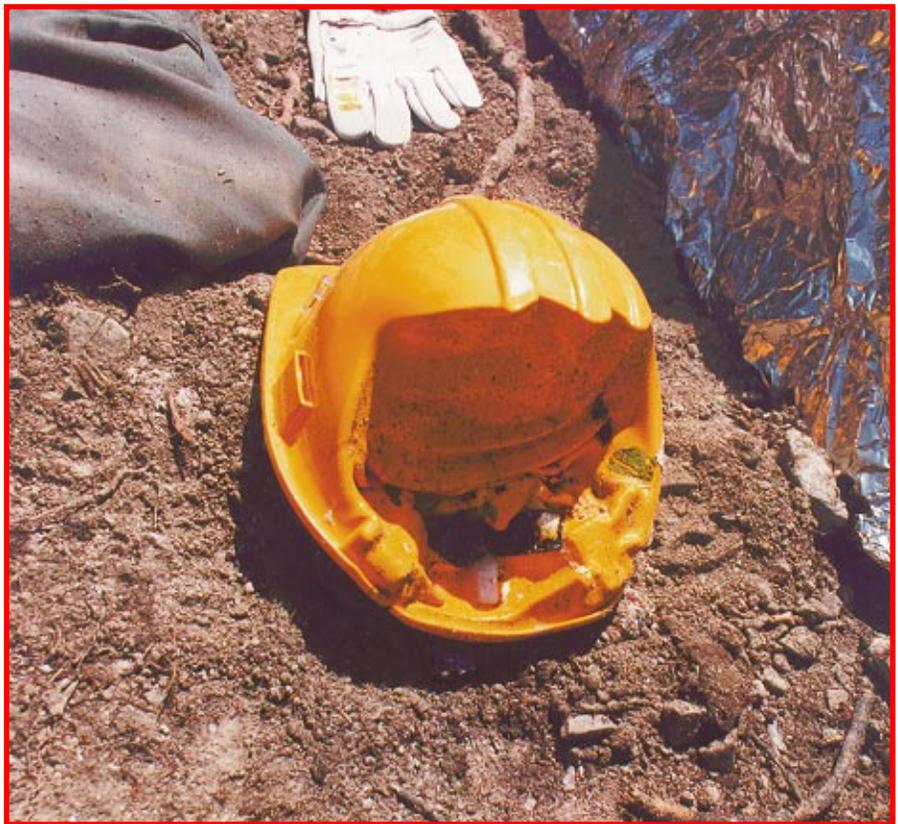
–A GSA firefighter's hardhat (Model 5100-P) was placed on the ground beside the fire shelter in front of the crew cab engine. It showed significant melting for about 5 inches (13 cm) from its edge, but the rest of the helmet showed no melting or damage (Figure 24).

Figure 24—This hardhat shows the difference a few inches can make at ground level. The hardhat melted where it was closest to the fire, but wasn't damaged just a few inches away from the heat.
