# PACIFIC SOUTHWEST Forest and Range Experiment Station

## PAINTABILITY OF FOUR WOODS IN HAWAII

Roger G. Skolmen

*USDA Forest Service*  
*Research Note PSW-267*  
1972

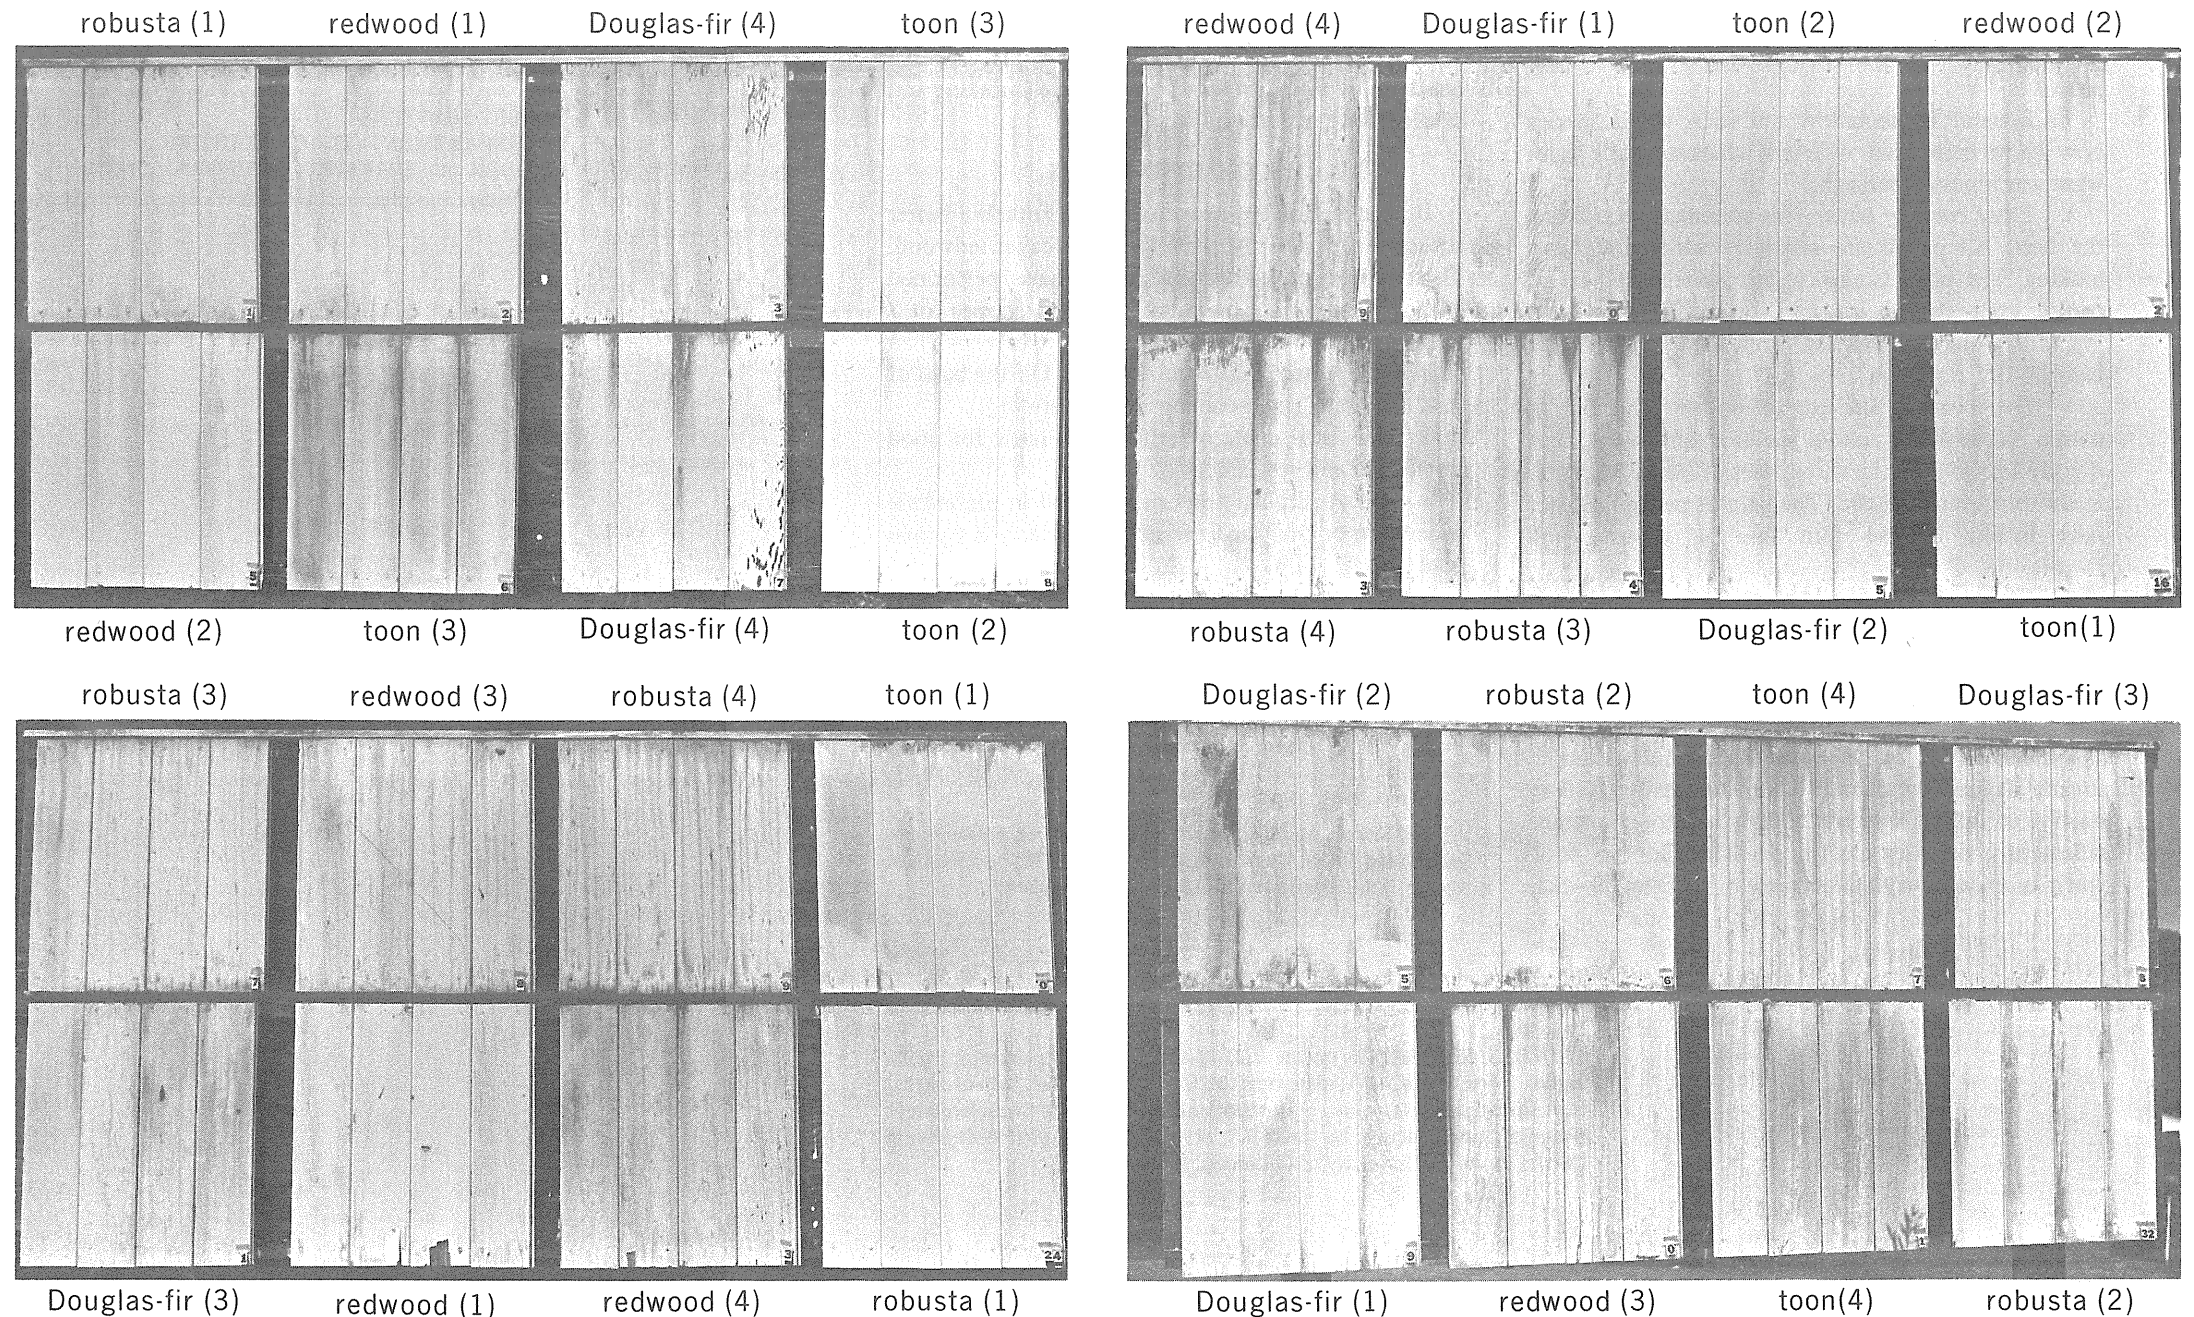
After 7 years, all paint combinations except the self-primed latex are showing some failure on all species of wood except Australian toon. Judged solely by the relative amount of bare wood showing on each board in each panel, the least successful paint combination is the two-coat oil base treatment, and the least paintable wood is Douglas-fir (*table 1*). Robusta is slightly better than Douglas-fir as a substrate. The three coats of oil paint are faring considerably better than two coats of oil base, but neither combination compared well with the latex paints—particularly the self-primed latex.

Figure 1—Appearance of panels in the four test units after 7 years of exposure, November 1971. Each panel is identified by species, and by treatment as follows: (1) three coats of latex paint; (2) one coat of oil base, two coats of latex; (3) three coats of oil base paint; (4) two coats of oil base.

- *Three coats of latex:* This combination is faring the best. All panels are relatively white and clean looking. The paint is chalky, but adheres well on all panels even though minute surface checking and separation have occurred on the robusta and Douglas-fir.

- *Two coats of latex on oil primer:* This combination is generally clean looking and white, but slightly less so than the three-coats of latex. Adhesion is also not quite as good. The paint is peeling slightly near breaks in the film on the robusta and Douglas-fir.

- *Three coats of oil base:* This combination shows extensive minute crazing and erosion on all wood species and now has a rather unique sand-paper-like surface. Peeling away from breaks in the film is now common on robusta and Douglas-fir.

- *Two coats of oil base:* This combination is already failing on robusta and Douglas-fir, and is starting to fail on redwood. But it is still completely satisfactory on Australian toon. The film has poor integrity except on Australian toon. It crazes, checks,

and then flakes free, baring the wood in places where checking, wood separation, or excessive shrinking and swelling have occurred.

- Use three coats of self-primed latex for good service life and appearance.

- Use Australian toon or redwood in preference to robusta or Douglas-fir where paintability is a prime concern.

- Use three coats, rather than two coats of paint for extended service life.
