# PARKING LOT SHADE STUDY

A Critical Examination of Davis Parking Lot Tree Shade

Tin-Wah Wong

by  
Tin-Wah Wong  
June, 1996

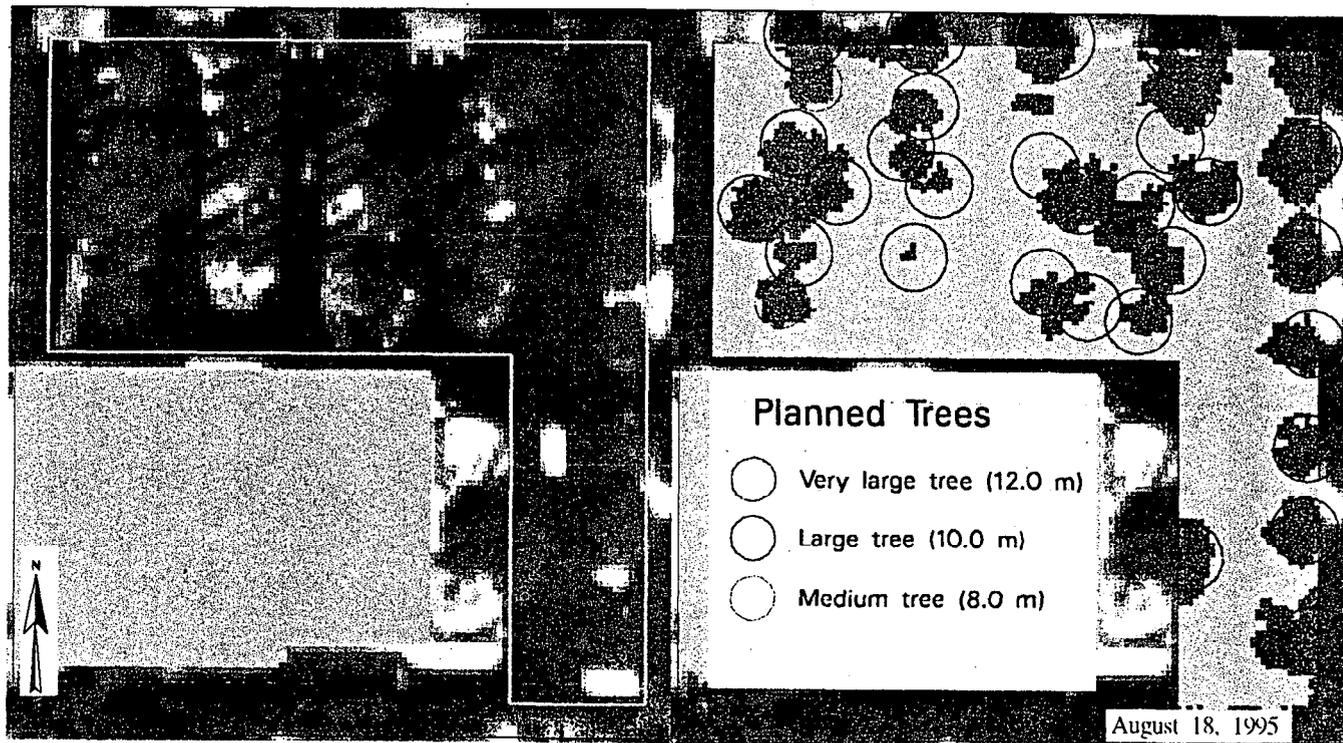
# Tree Cover Survey

The initial tree coverage designed for the Albertson's parking lot is 38%, yet the actual current tree shade is 29% (Table 2). Since this parking lot was renovated in 1978, it is currently 18 years old. Three years after the parking lot's fifteenth year, it still has not achieved its 50% shade tree coverage. Reasons for the noncompliance of the Davis Parking Lot Shade Ordinance are mainly due to the parking lot design: 1) too few trees initially,

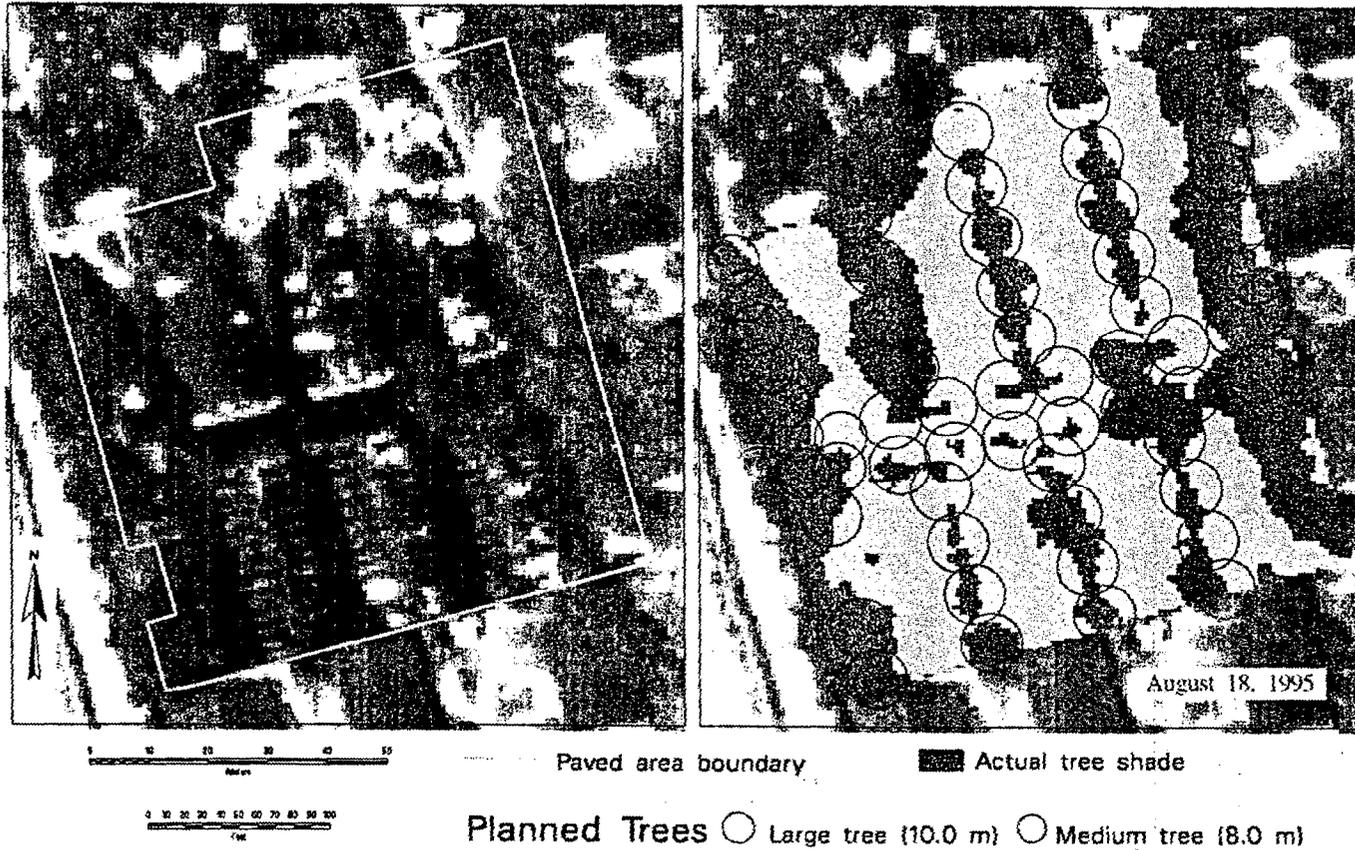
# Tree Cover Survey

Percent of Paved Area Shaded - Planned 47%  
Percent of Paved Area Shaded - Actual 45%

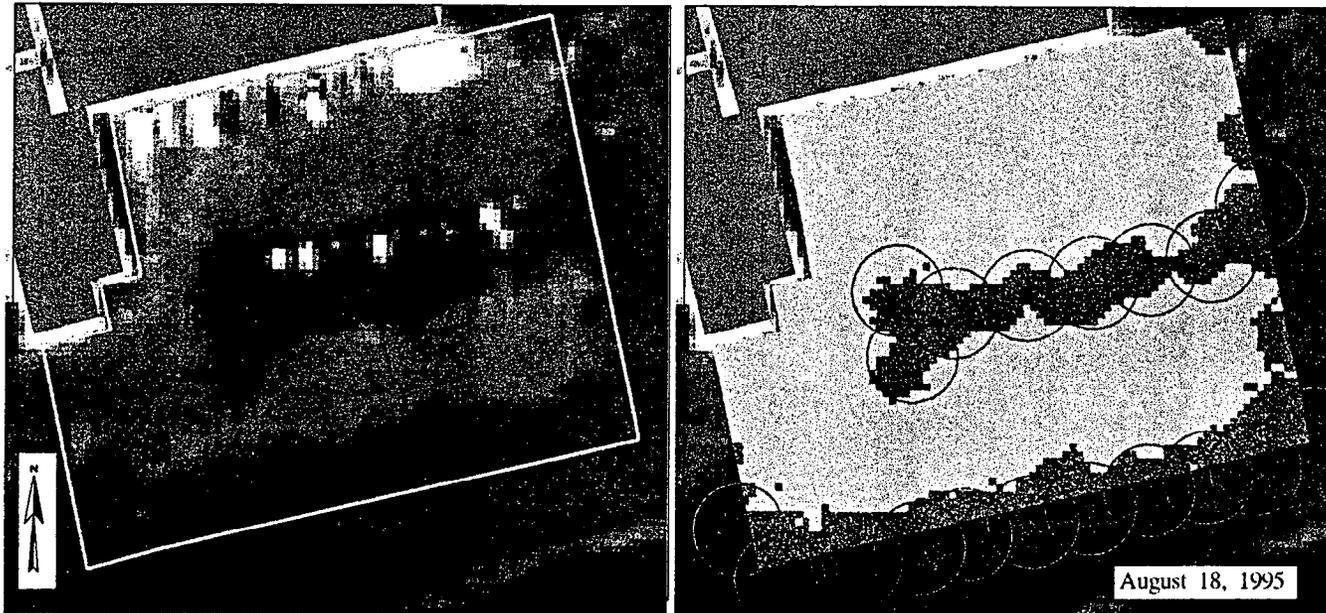
# Tree Cover Survey

Percent of Paved Area Shaded - Planned 18 %  
Percent of Paved Area Shaded - Actual 22 %

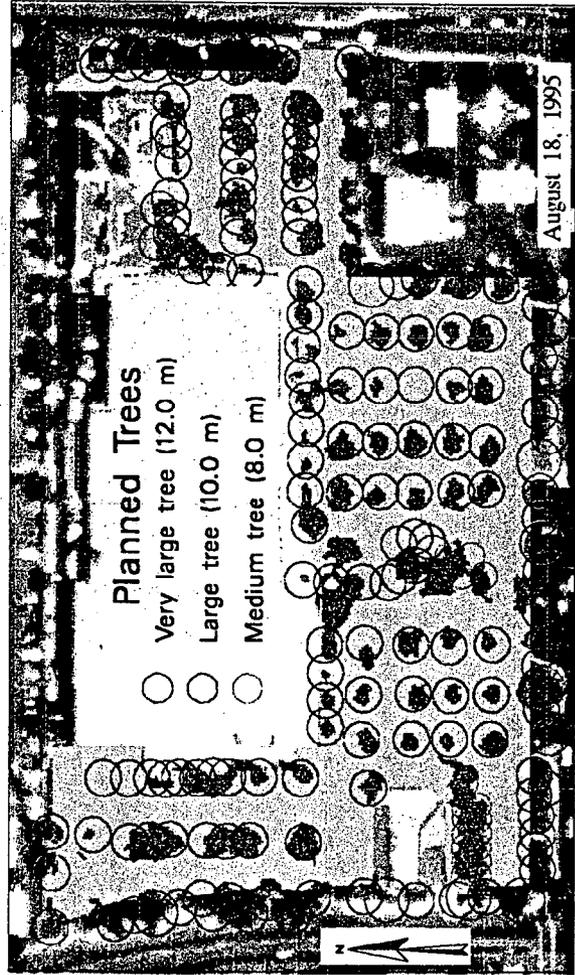
Tree Cover Survey  
 (University Mall Parking Lot, Davis, California)

Percent of Paved Area Shaded - Planned 43%  
 Percent of Paved Area Shaded - Actual 23%

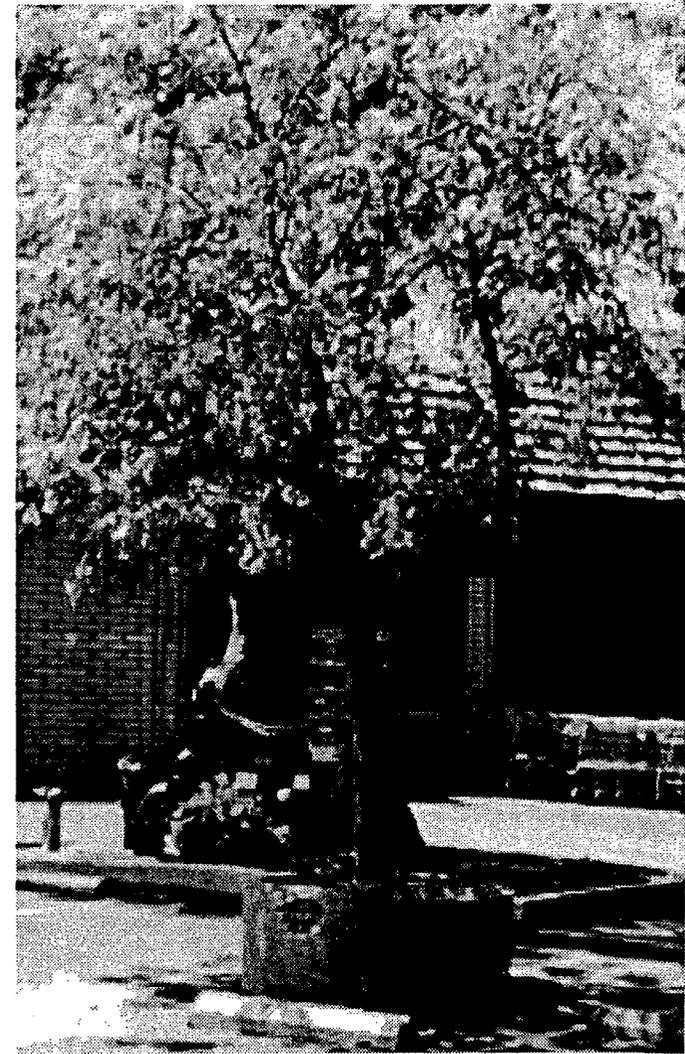
Figure 18: Raised round planter in Albertson's parking lot.

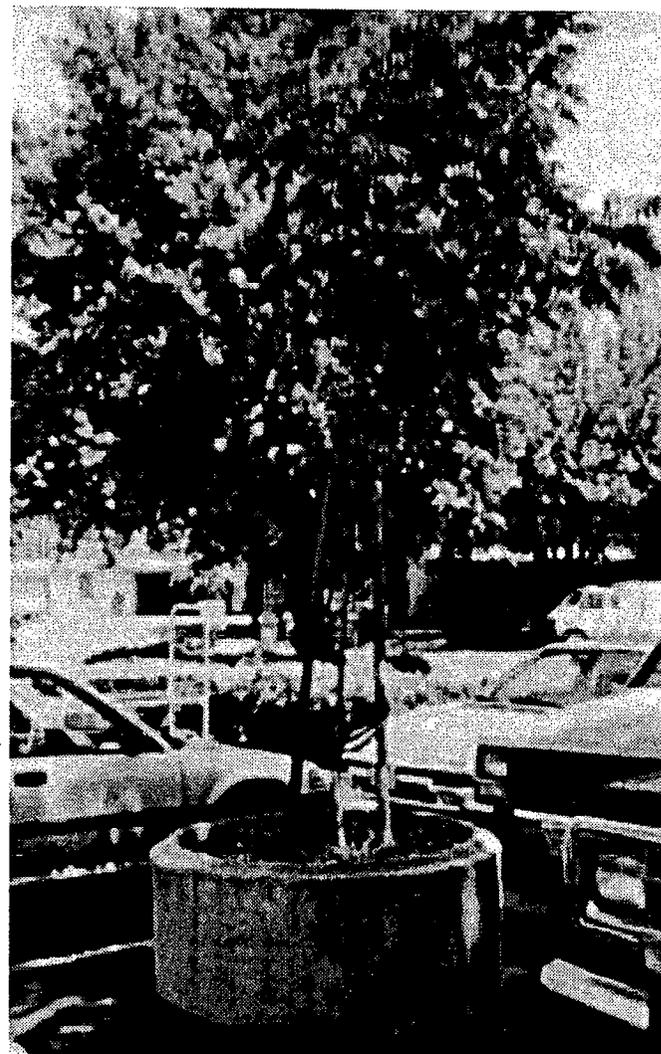
Stakes are left on new replacement trees. The stakes appear to be unnecessary since the trunks of the replacement trees are of good, stable, independent size and the stakes are also conflicting with branches and tree trunks. Black plastic linings were left in the large interior planting beds. Some interior tree canopies are conflicting with the interior lighting. Spray irrigation heads found in raised circular planters may not be appropriate for these smaller planters since most of the water dispersed from the sprayers is not retained in the raised planters but forced outside the planter onto the asphalt. Bubblers would provide more water for trees grown in raised planters.

Figure 19: Stakes left on tree in Albertson's parking lot.

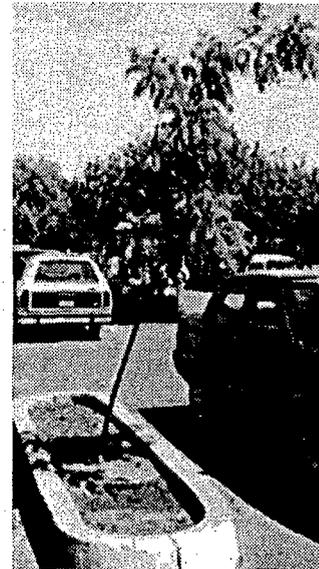
Figure 22: Inadequate planter size.

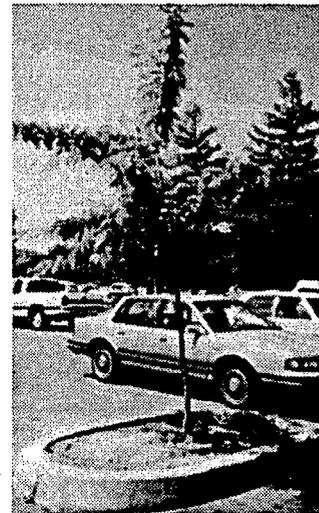
Figure 24: Inadequate planter size.

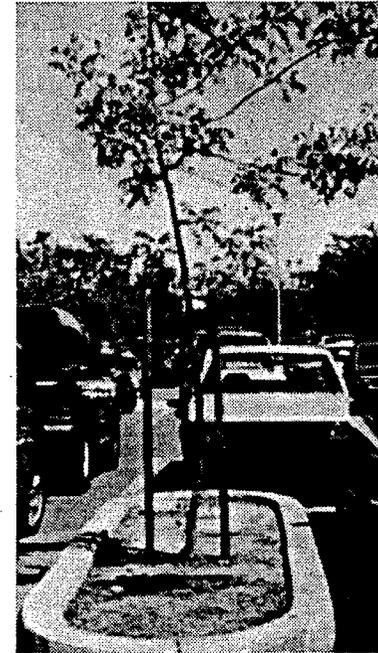
Figure 25: Stakes left on a parking lot tree.

- 1) high vandalism and many young replacement trees,
- 2) inadequate irrigation, and
- 3) stakes left on trees causing damage to tree bark (Table 5).

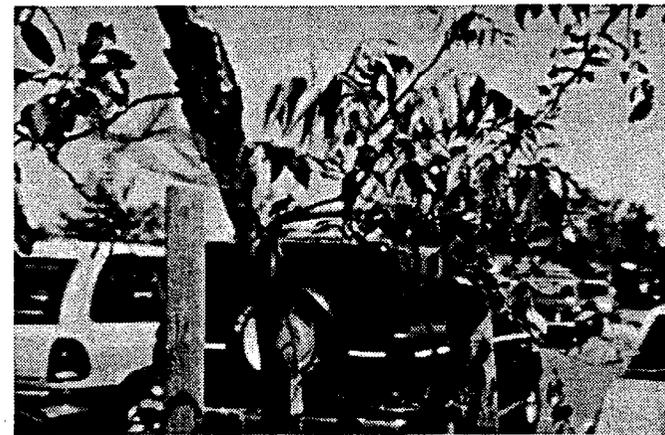
Figure 26: Stakes and plastic ties left on the tree.

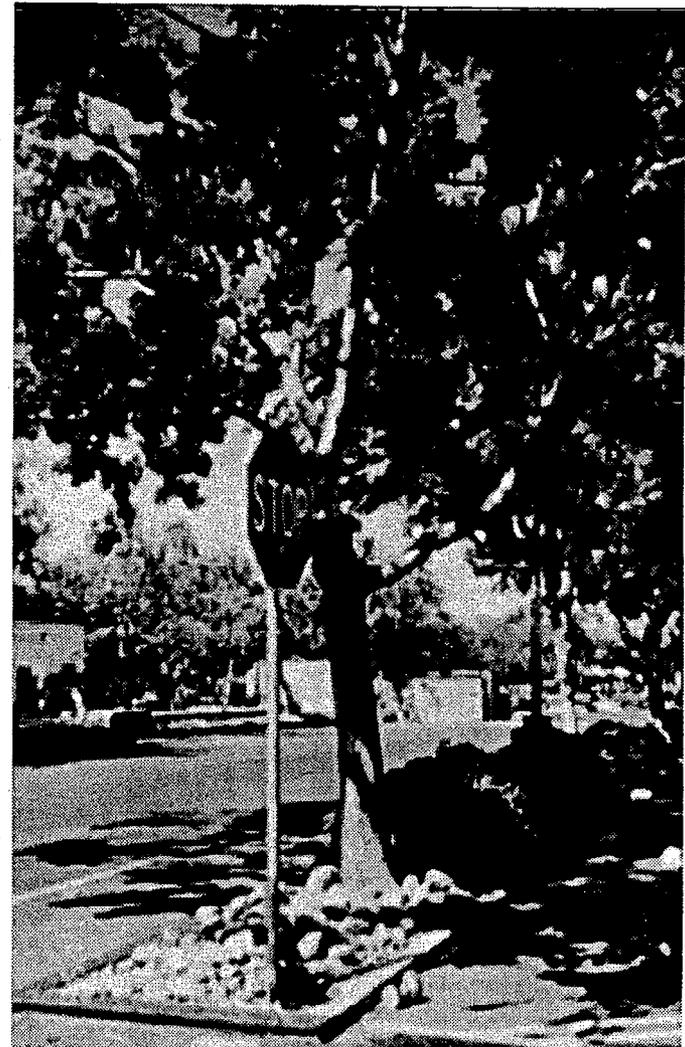
Figure 29: Rectangular planter with 9" cobble stones used as surface material. Mulberry trees have been lowered 12" to prevent surface root damage to asphalt.
