A Defensible Fuel Profile Zone (DFPZ) Gets Put to the Test

11/9/1999
Larry D. Hood

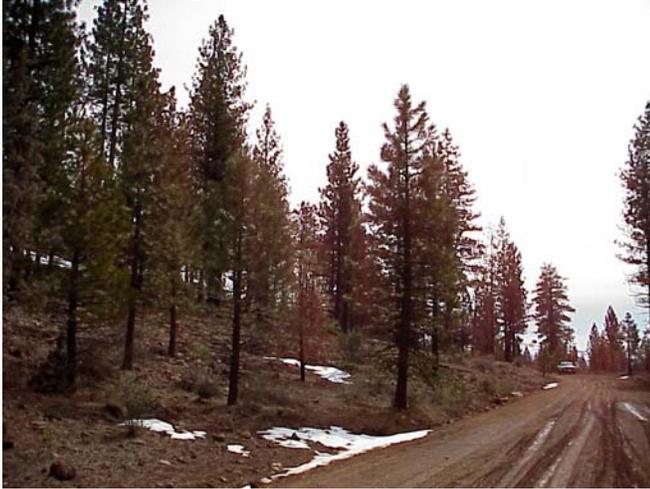
Completed DFPZ*

Treated DFPZ on East Side of road. Fire behavior was lower intensity due to removal of ladder fuels and under-burning of surface fuels.

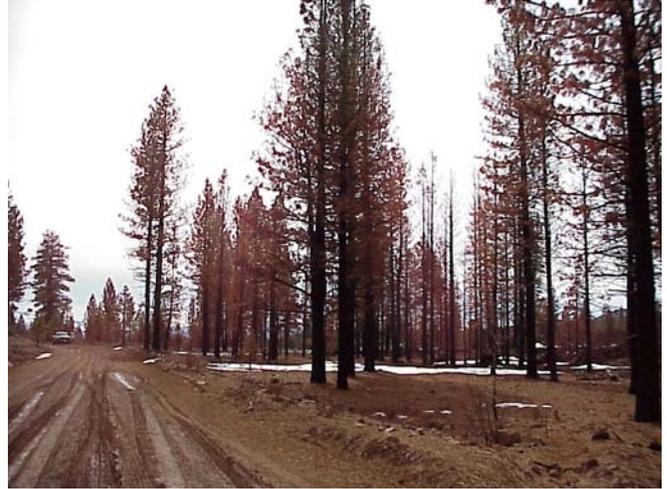
Uncompleted DFPZ*

Untreated section of DFPZ on West side of road. Fuel loadings and ladder fuels created conditions for torching. This started spot fires in and across the treated DFPZ.

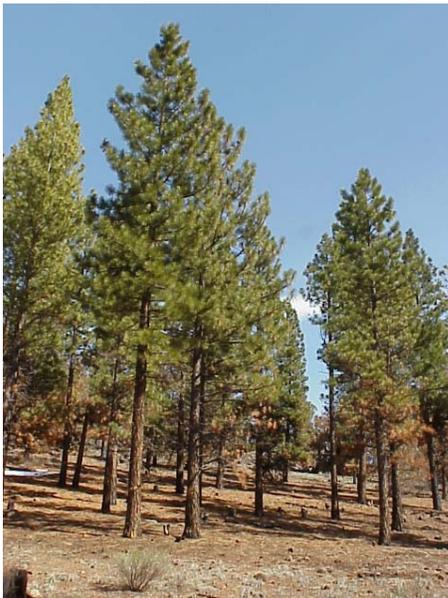
Treated DFPZ with significantly less crown scorch and 0-10% tree mortality.

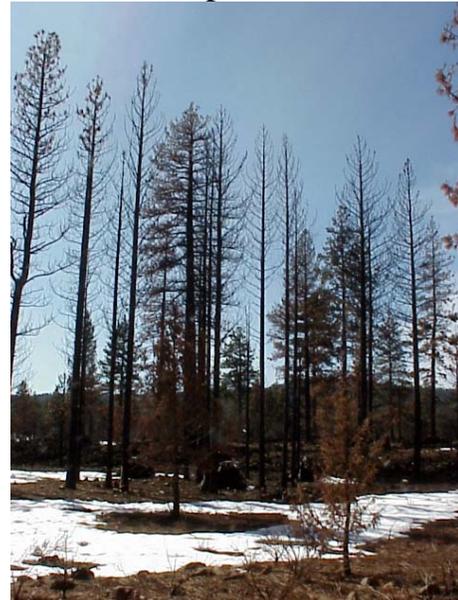
Untreated DFPZ with 100% mortality.
