# CTI <sup>Service</sup> Bulletin #1

July 1997

## STEER AXLE MODIFICATIONS

This is the first in a series of CTI Service and Operation Bulletins prepared by SDTDC, in cooperation with Eaton Corporation, to provide assistance in maintenance, repair and operation of the Eaton Tire Pressure Control System (TPCS).

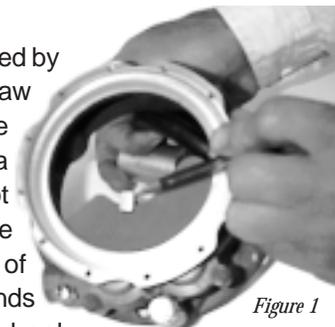
All versions of Eaton's steer axle CTI hardware have experienced some problems due to runout between the rotary joint and hub cap. Runout and interference can impart side loads to the rotary joint which greatly reduce its service life.

Use the modification procedure described below to eliminate the steer axle problem and extend the life of the rotary joints. Figure 1 shows the location of the rotary joint driver tab.

The rotary joint drive tab (figure 1) can be removed by milling or, as shown in figure 2, by using a hacksaw to remove the bulk of the tab and finishing with a half-round file. It is not important to remove the small section of the tab which extends outboard of the wheel valve cavity.
