VOLUME 7 NUMBER 8

Red Mountain Creek Soil Bridge

Log Stringer Bridge Inspection and
Analysis in Alaska

AUGUST 1975

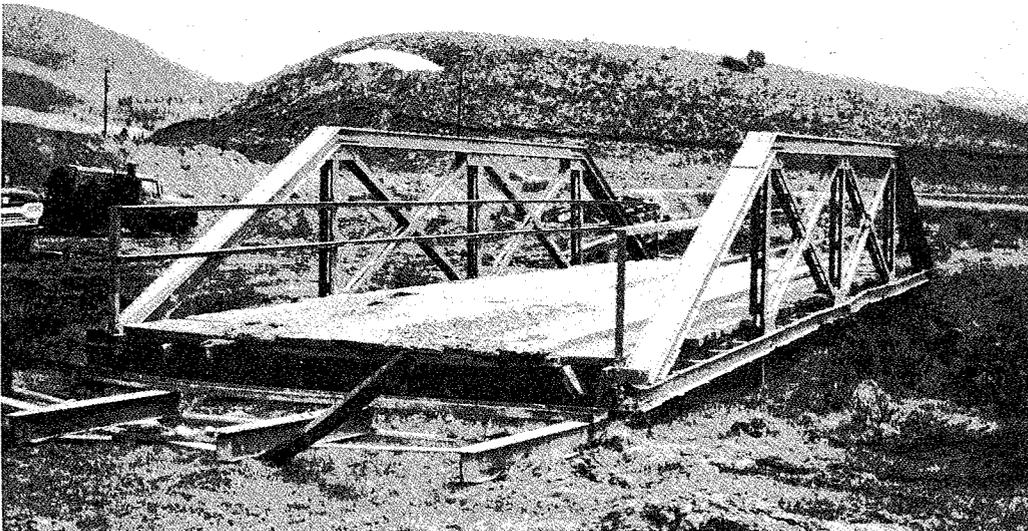
Figure 2. Original steel truss bridge across Red Mountain Creek. Inventory rating for HS loading is 3.3 tons.

Plans for the *Soil Bridge* were developed after a safety inspection showed the existing steel truss bridge (fig. 2) to be unsafe for legal truck loads. Several alternatives, such as a new truss bridge, multiple arch installations, and the *Soil Bridge* were investigated; analysis indicated that the *Soil Bridge* would be the most economical.

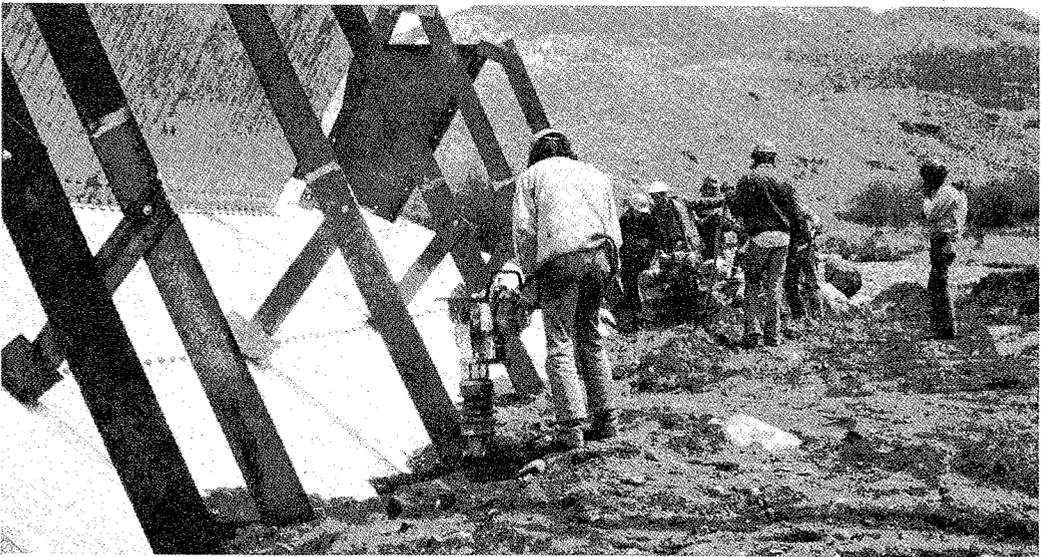
Figure 4: Stiffeners added as a safety factor to stiffen the structure during backfilling. Backfill lifts alternate from side to side, and are placed in approximately one foot lifts.

To reinforce the structure during backfill, stiffener angles were added from the top of the bins to the footing with midpoint ties to the arch (fig. 4). The effect of these stiffeners and the added bins is to form a truss which supports the arch during construction. After backfilling is complete, the truss is no longer functional. If rust destroys the truss, the finished structure will not be damaged. It is understood that U.S. Steel is adding this feature to all *Soil Bridges* designed to span 35 feet or more.

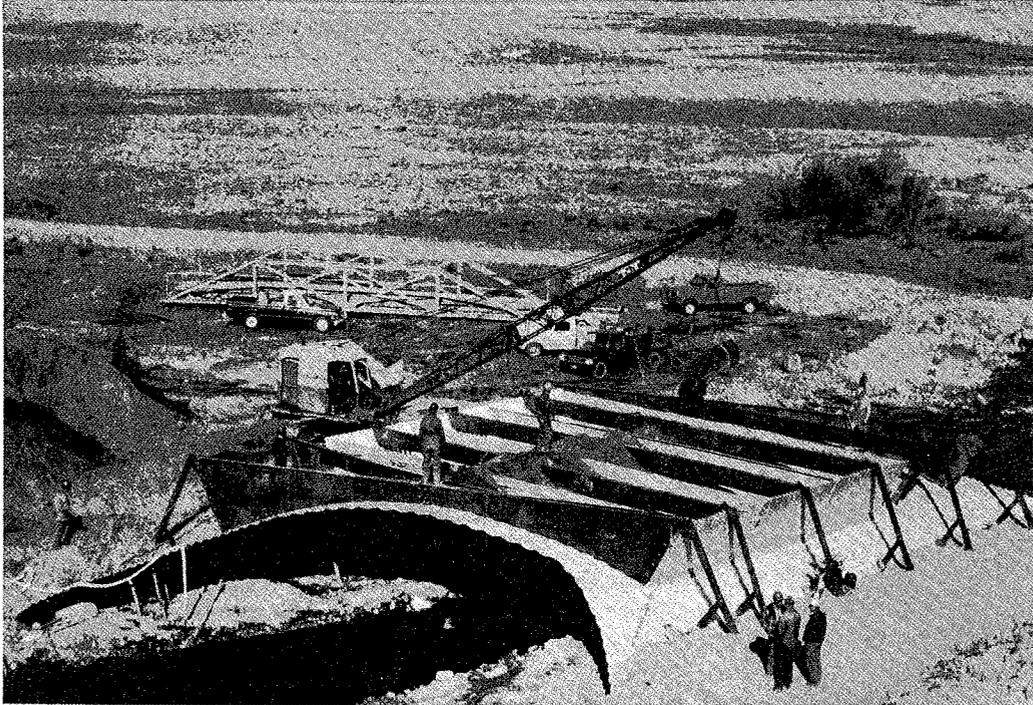
Problems were encountered at the corners where the bevel and skew formed acute angles. The unsupported partial arches at these corners deflected downward and actually formed reverse curvature at the edges (fig. 7).

Figure 7. Failure of unsupported corner of structure. Failure occurred at both acute angle corners of this beveled and skewed structure.

Three steel columns were erected under the two opposite critical corners (fig. 8) and were covered with metal plates to prevent accumulation of debris (fig. 9). These columns detract from the appearance of the bridge and also restrict the waterway to some extent. Figure 9 shows part of the riprap in place. More was added since then, and the exposed diaphragm of the end bins was painted.

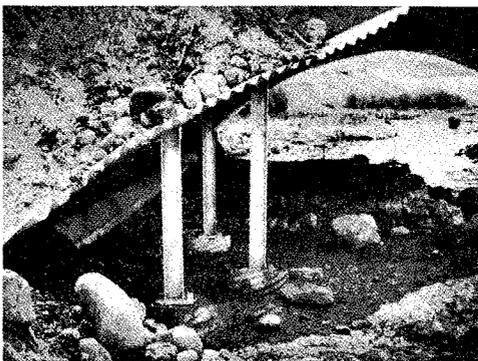
Figure 8. Steel column supports placed under failure at corners.

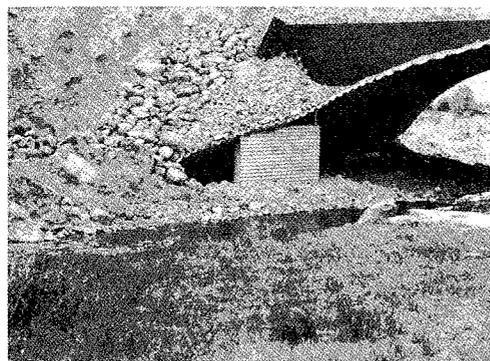
Figure 9. Steel support columns partially covered with steel plate to prevent accumulation of debris.

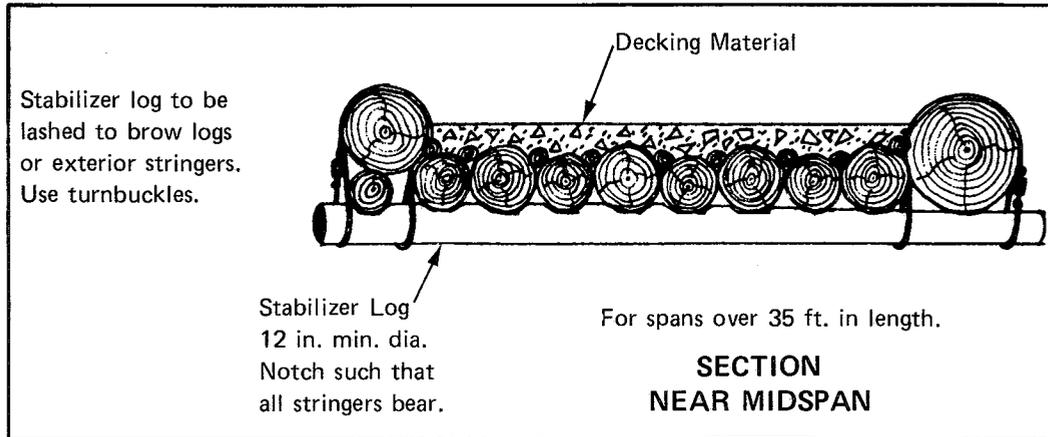
Another interesting finding concerned the use of stabilizer logs. Stabilizer logs are used on some bridges to better distribute the loads to the stringers (fig. 4). Stabilizers are particularly important on bridges exceeding a span length of 40 feet. Observation showed that bridges in this category, or longer, seemed to exhibit more individual stringer deflection without a stabilizer than those that were stabilized. Curiously, even those bridges which had no cables or stabilizer log acted as a unit when loaded. However, cabled logs showed less individual deflection on long spans, and stabilized bridges produced even better distribution.

Figure 4. Stabilizer logs used to distribute load.

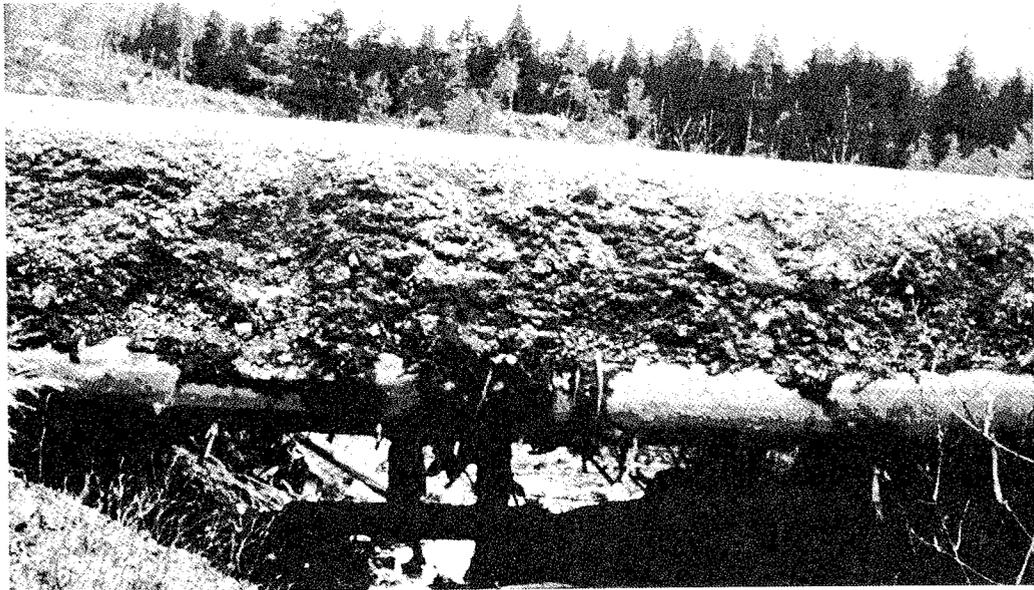
The rock used as a running surface was another deciding factor in the relative strength of a bridge. Three to four feet of cover on a bridge is not uncommon. One 20-foot bridge was found to have 22 feet of cover. This particular bridge had 26 stringers and was over 60 feet wide. This tapered to a roadway width of around 16 feet. Under normal calculations, this bridge would be greatly overstressed with the cover material. However, the bridge did not show any deflection. We felt that the deadload was being distributed by the soil in such a manner that the effective load on the bridge was much less. The material may be forming a "soil bridge." However, it is good design policy to keep cover material to a minimum; 12 inches is the suggested maximum. Figure 5 illustrates an excessive rock-fill as a running surface.

Figure 5. Excessive blast-rock fill on stringers.

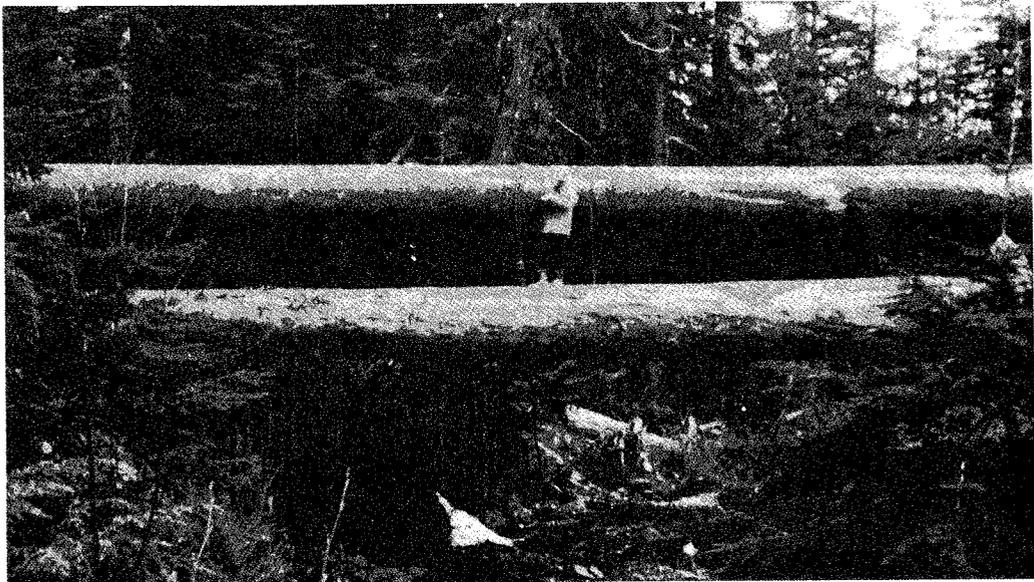
Observation of stringer failures was uncommon. No complete failure of any bridge was observed, but individual stringers had failed in some bridges. Typically, these bridges were not cabled or had cables which were loose. The failed stringers almost always were located under the wheel lines of traffic on the bridge. There were a number of bridges that were composed of several layers of logs (fig. 6).

Figure 6. Multiple-layer log stringer bridge.

In most cases, a stringer had failed on the original bridge, and rather than replace one stringer, another bridge was constructed over the top of the original. However, the original bridge was not removed. One bridge inspected was composed of three layers. Over the years, the road grade on this bridge had apparently changed upward about 10 feet.
