A Comparative Analysis of Forest Recovery After Uncharacteristic Fire in Ponderosa Pine Forest

USDA Forest Service, Kaibab National Forest¹
June 30, 2008

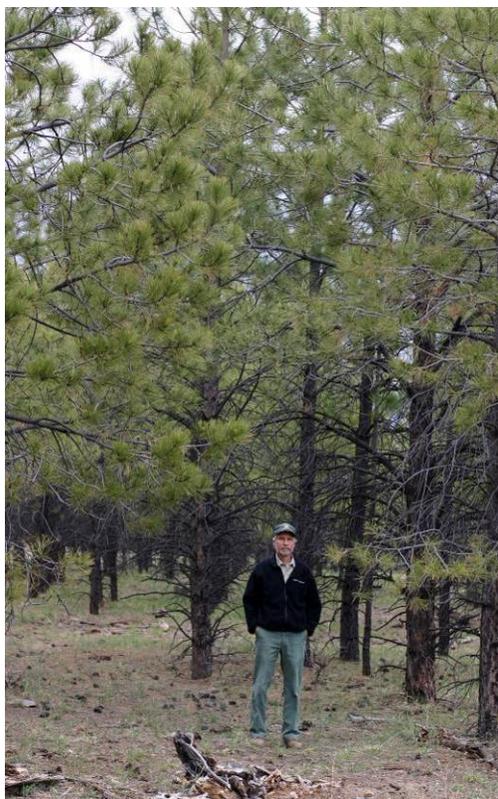
Salvaged/planted areas have more than 130 trees per acre over 25’ - 35’ tall everywhere it was salvage logged (Fig. A.) Tree growth appears to be quite similar to the *unburned/planted* area in terms of heights, diameters, and canopy fullness (Fig. C.) Natural conifer regeneration in the *salvaged/planted* area occurs within 100’ of seed sources outside this portion of the fire, with virtually none within it. Naturally regenerated trees are significantly smaller than the planted trees, probably because they got a later start and are competing with the larger, planted trees. Naturally regenerated trees provide a second age class for this narrow band of the fire perimeter.

Fig A. Summit Fire *Salvaged/Planted*.
Planted in 1973. Note coarse woody debris on left and in background.

The plantation is in need of a thinning to reduce increasing risk of another crown fire, to begin development of a clumpy/groupy pattern, to make space for understory plants and to begin development of a second age class of trees. Planted trees are beginning to produce cones.

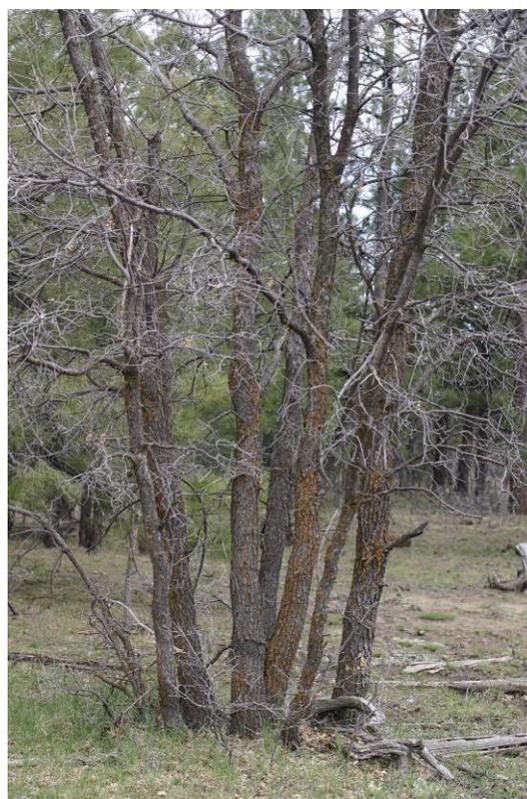
Fig B. Summit Fire *Salvaged/Planted*.
Gambel oak group resprouted since the fire salvage over 5" drc.

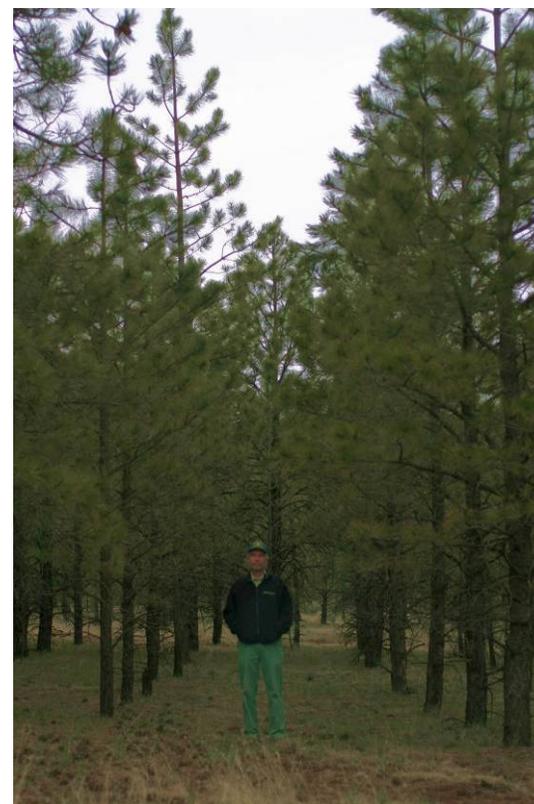
Fig C. *Unburned/Planted near Summit Burn*. Planted in 1974. No coarse woody debris is present. Until recently, "corn row" planting has been the usual practice.

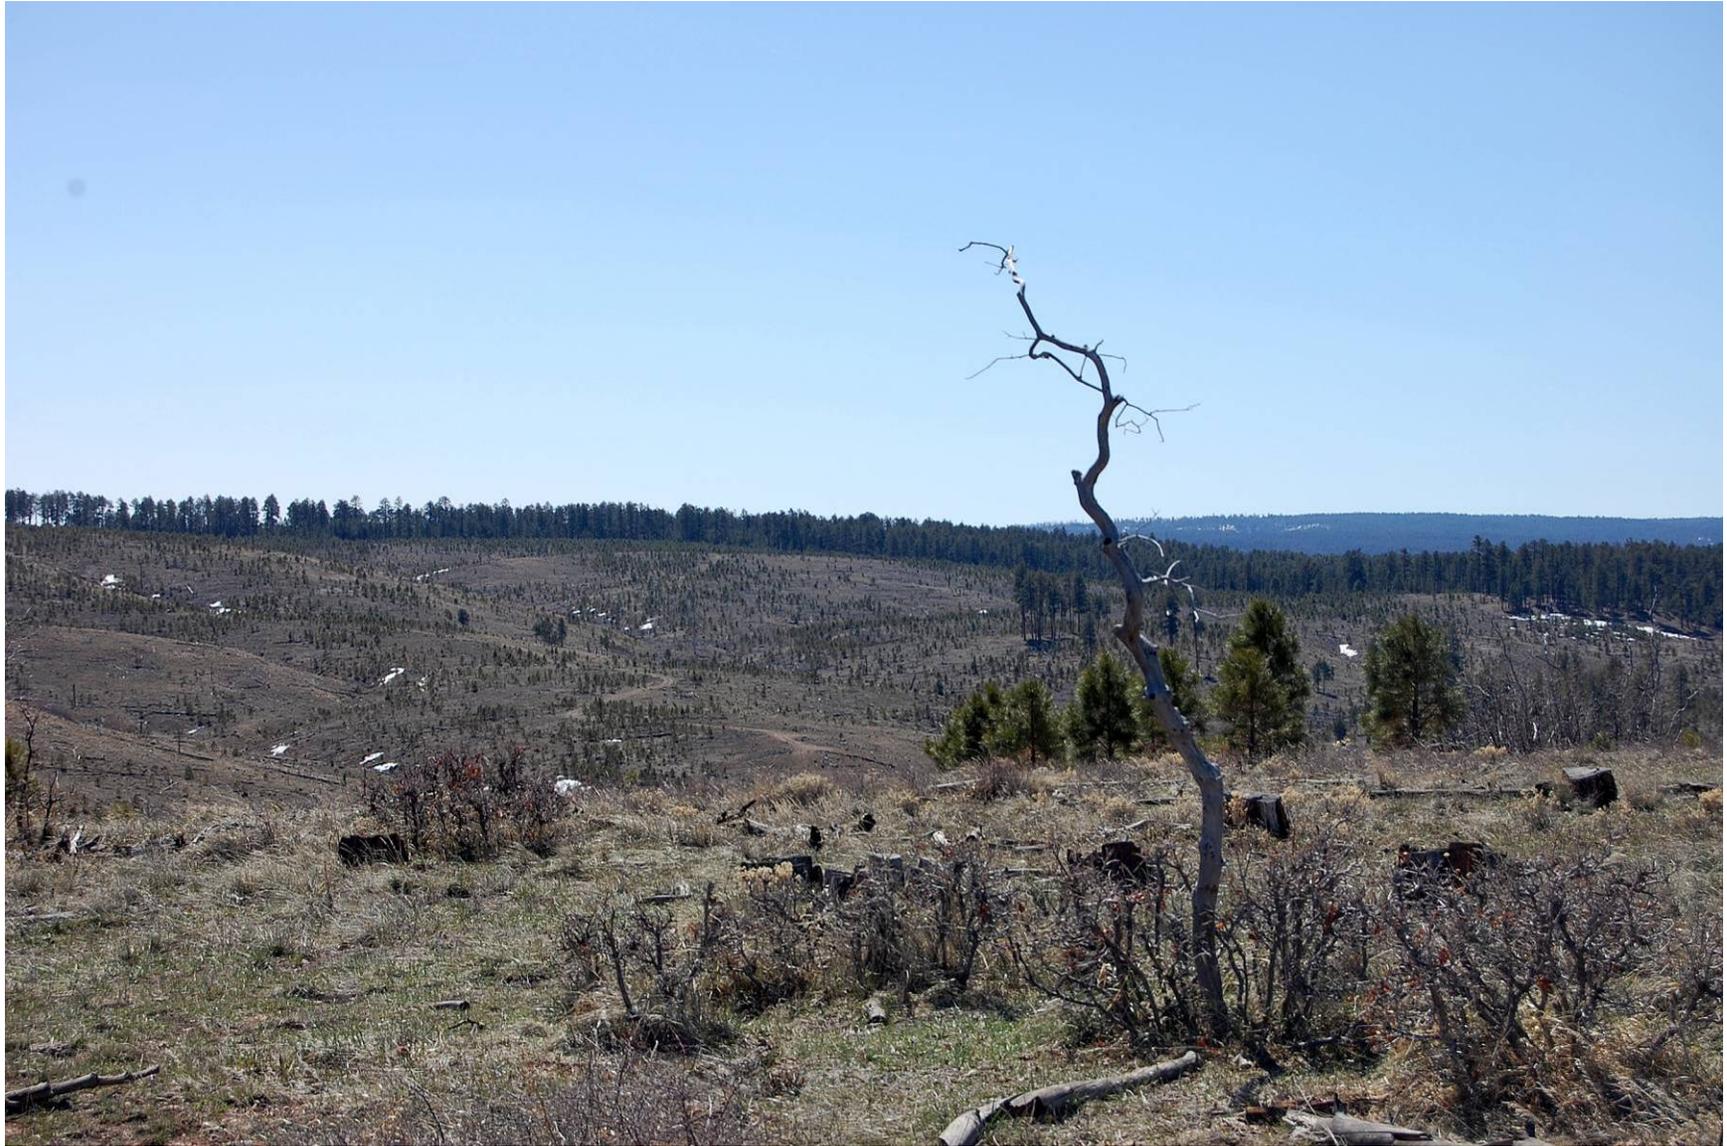
The Willis Burn has a patchy distribution of planted trees 6' to 12' tall in the *salvaged/planted* portion (Fig. D, E & F.) Natural tree regeneration in the areas visited is virtually absent. Only two naturally regenerated trees were noted. Both were within about 150' of seed sources and were both younger and smaller than nearby planted trees. Planted trees are growing at a moderate to rapid pace and have healthy, dark green foliage. Parts of the plantation are in need of a thinning to reduce increasing risk of another crown fire. There are some patches in the salvaged portion fire that were likely planted but support little regeneration. A check of an aerial photo, dated 5-16-1963 (ELE-6-166) shows this portion of the Willis Fire to have at least five patches of two to four acres with less than 20% historic tree cover. Warm, dry conditions and competition from grasses on this rather low-elevation site seem to be the most likely causes for the persistence of these open areas, despite planting efforts.

Figure D. Willis Burn Panorama. Virtually all regeneration is planted and growing rapidly. Understory luxuriant. Oak is shrubby and heavily browsed. Most retained snags have fallen down. Coarse woody debris near desired amount.

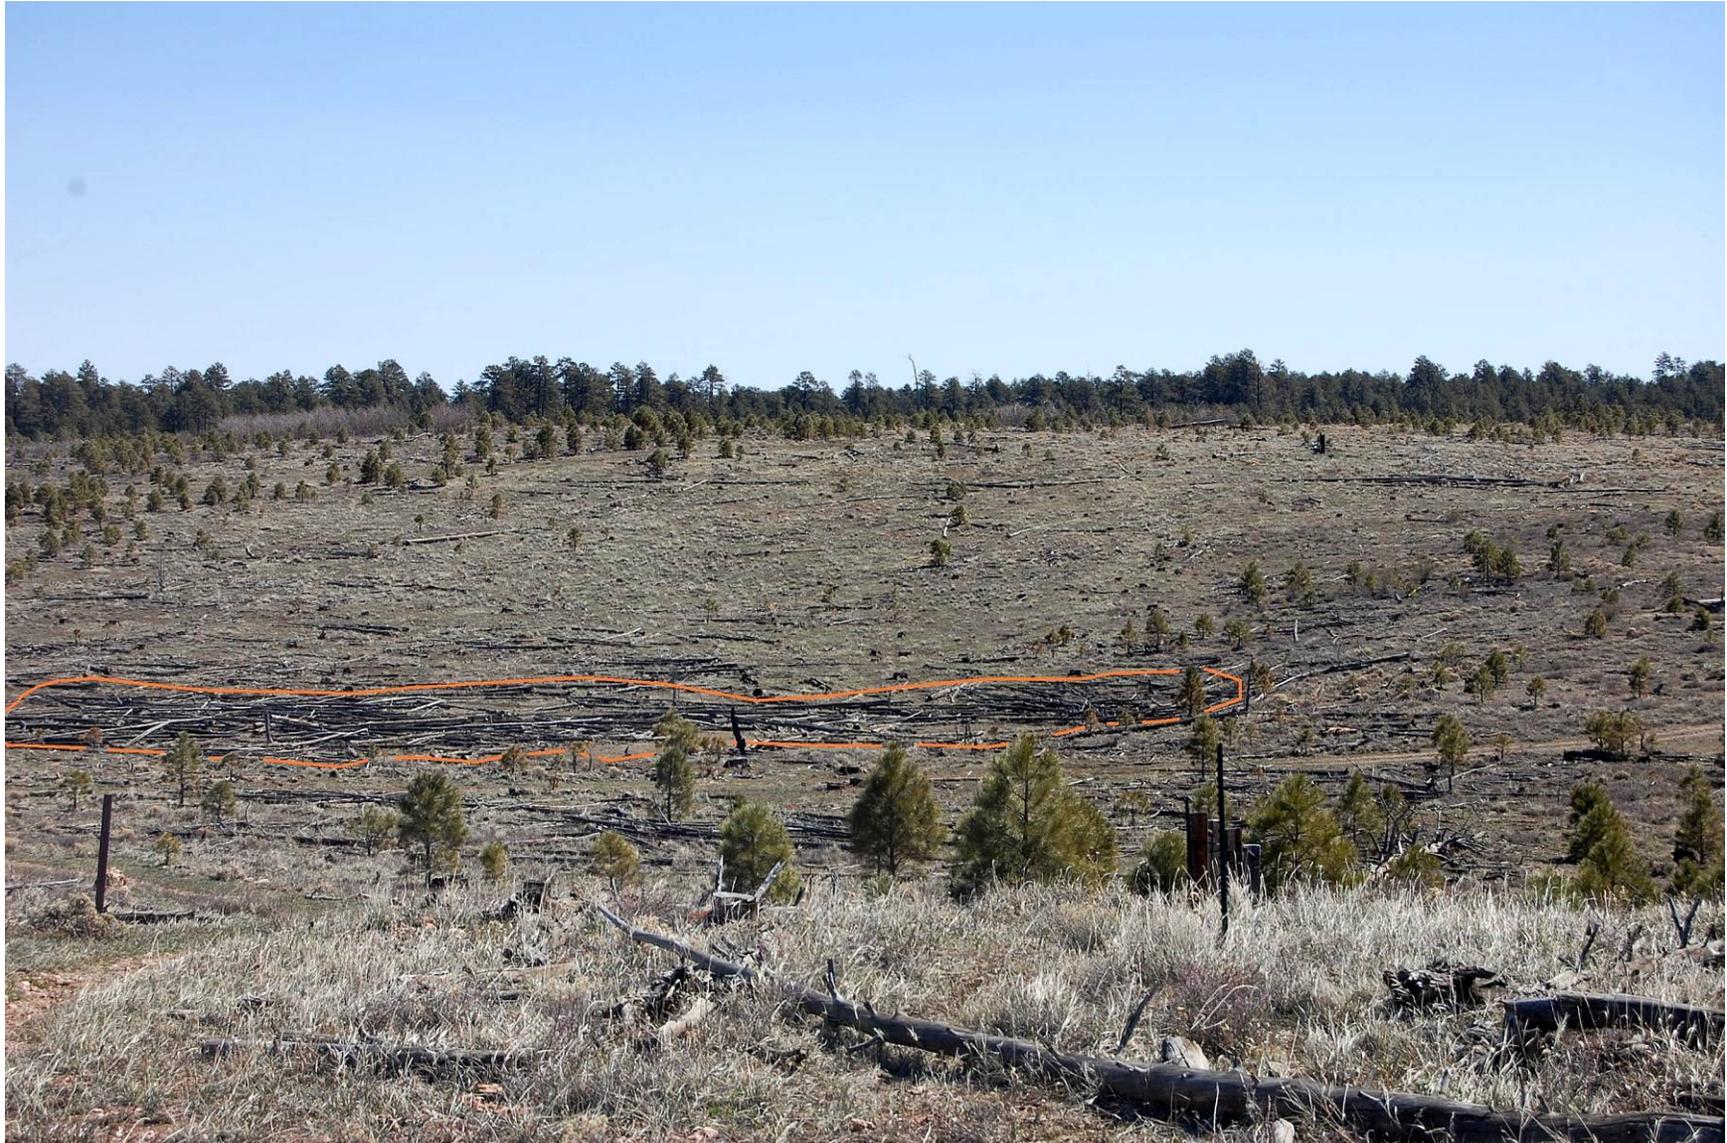
Comparisons are made between the *salvaged/planted* area, and *unsalvaged/unplanted* areas in the burn. One of the unsalvaged areas is a shallow sinkhole (in Fig. E). These were routinely removed from timber harvest for safety concerns for equipment operators.

Figure E. Willis Burn. The no salvage/no plant area, delineated with an orange line, has no natural regeneration evident. The patch in the middle ground with less regeneration than stump evidence is about 3 acres – the largest such case noted in the salvaged area. See text.

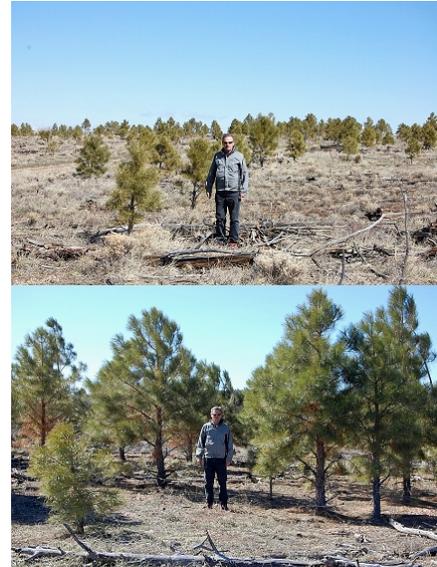
Fig. F. Willis Fire planted trees.

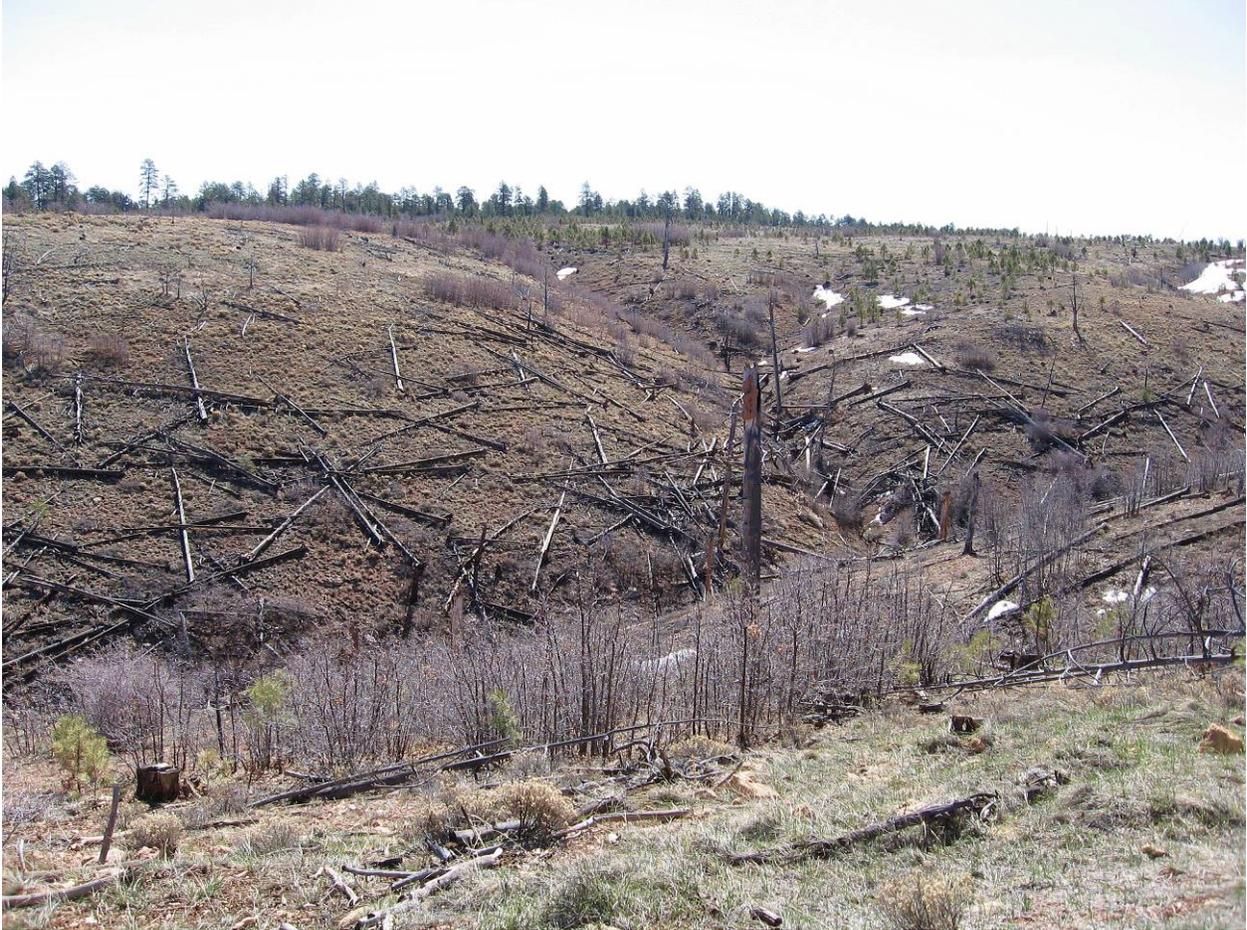
There appears to be very little soil displacement because of post-fire logging activities. One small area on a slope over 30% was noted, where cross-slope skidding displaced soil three to five feet downhill across less than 0.1 acre (Fig. G.)

Fig G. Willis Burn. Steepest *salvaged/planted* and *unsalvaged/unplanted* areas. East-facing foreground is *salvaged/planted*. West-facing back slope is *unsalvaged/unplanted*, except near the top. Most fire-created snags have fallen down.

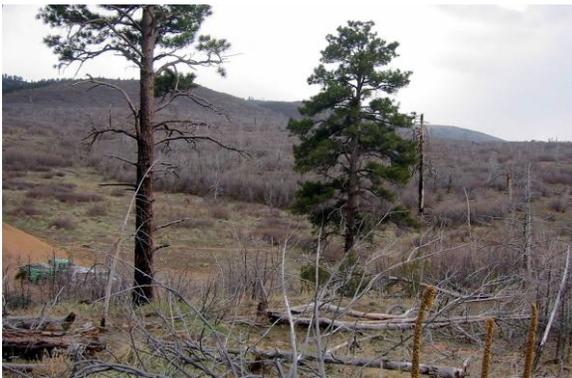
Fig H. Bridger Fire. Foreground unsalvaged.

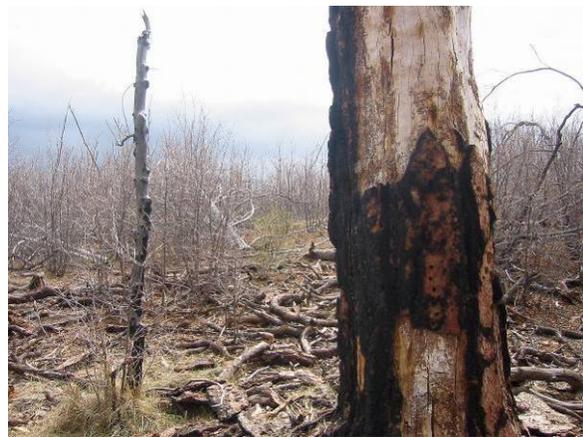
Fig I. Bridger Fire. Salvaged area.

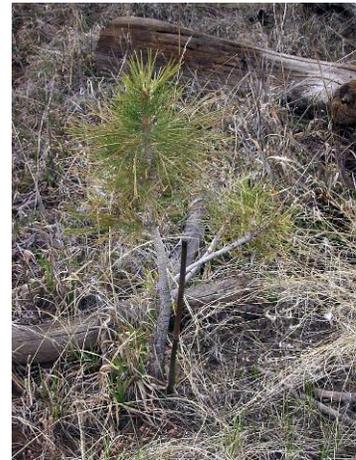
The Bridger Burn has a patchy/scattered distribution of planted trees 1' to 3' tall in *salvaged/planted* areas (Fig. J.) Planted seedling density is less than 130 per acre but present in numbers equal to or exceeding the number of salvaged trees. Planted trees are growing at a moderate pace and have healthy, dark green foliage. Natural tree regeneration in the areas visited is virtually absent; two naturally regenerated trees noted were within about 150' of seed sources. Natural regeneration essentially has not occurred despite the fact that the seed trees have had at least two and probably three good cone years since the fire.

Fig. J. Bridger Fire.
A typical planted seedling.

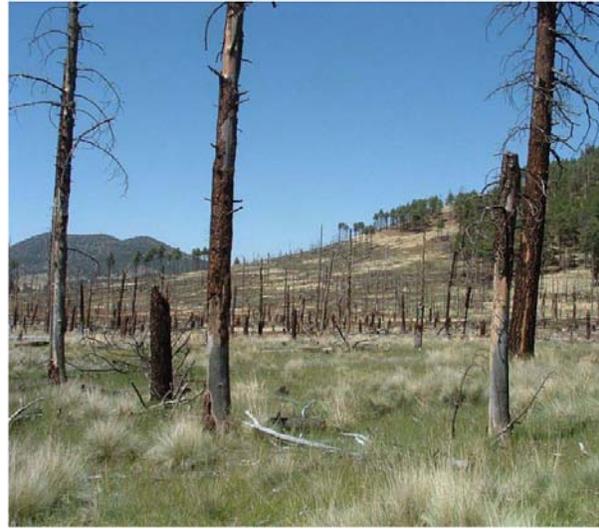
Fig. L. Hockderffer Fire.

Some cheatgrass and toadflax are present most places along the transect. A few shrubs are also present. However the large majority of plant cover is a dense mat of native grasses and sedges. Fuel loadings are above desired conditions in areas that may have historically supported ponderosa pine forest (Figure K) but lighter in areas that may have been historic grassland or savanna inclusions (Figure L.)
