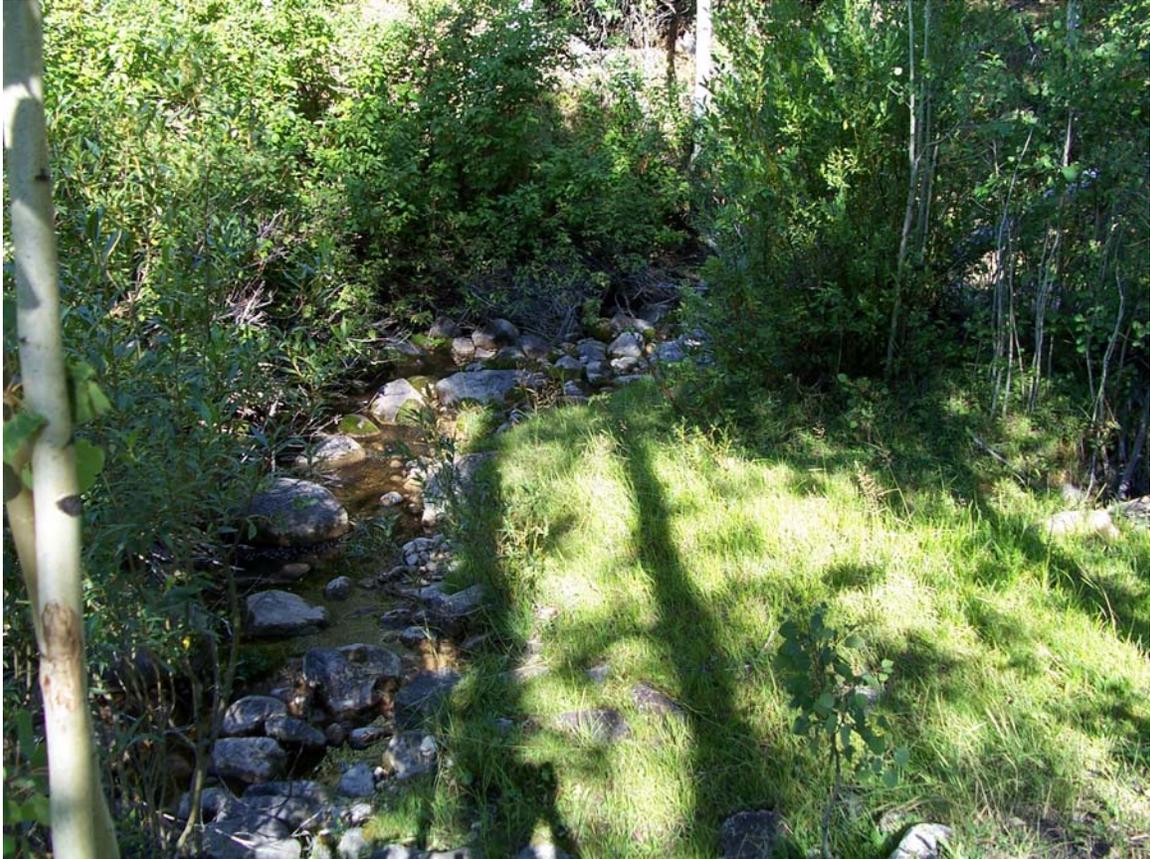
Figure 2. White Pine Creek (08/24/2007) showing good riparian vegetation and good bank stability.

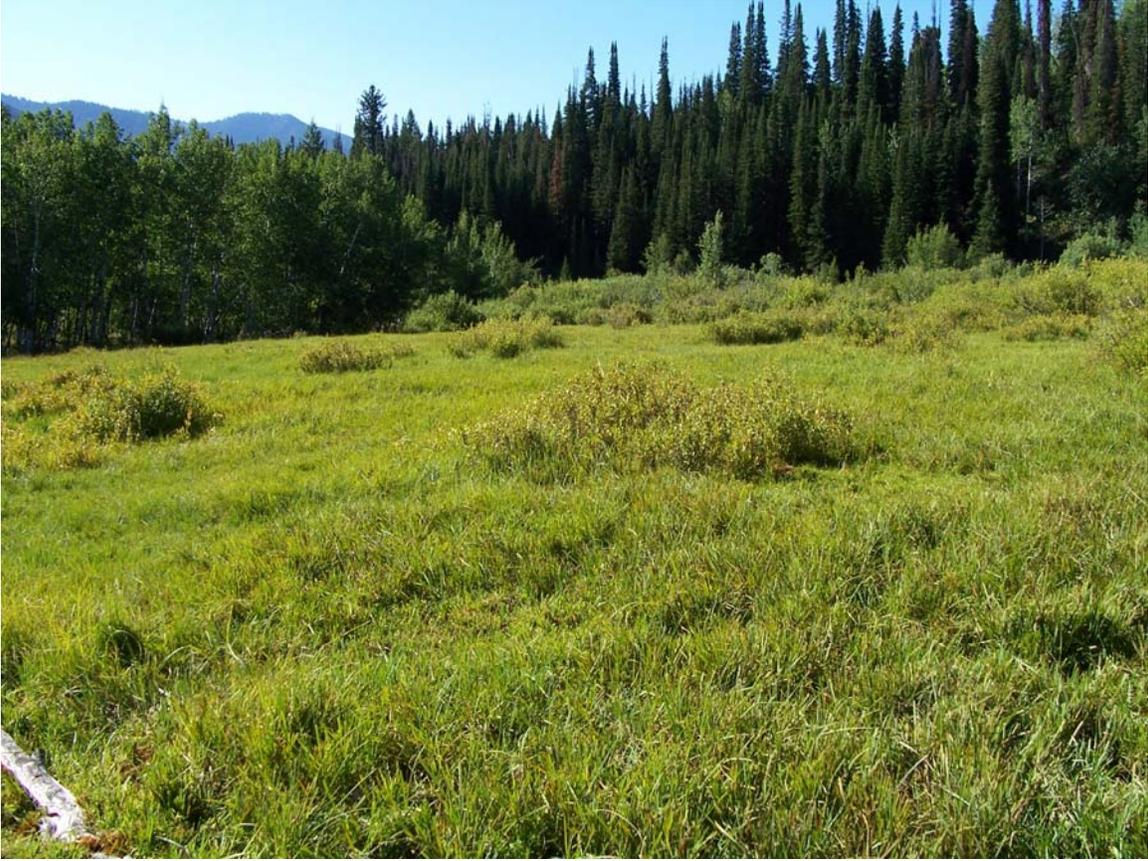
Figure 3. Large wet meadow located at the bottom of White Pine Creek (08/24/2007). While some livestock grazing has occurred in this area, Nebraska sedge heights are over 12” and meadow/stream conditions were good.

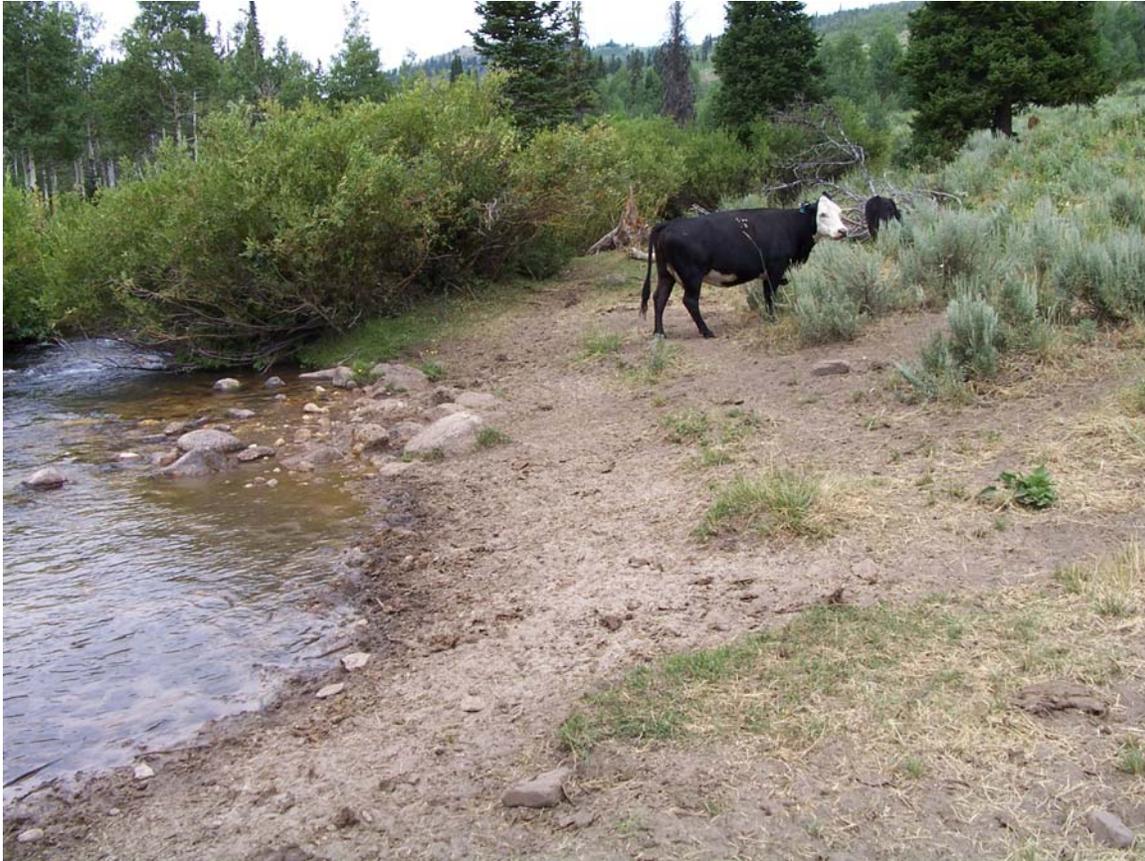
Figure 4. Water from unnamed springs located north of Hansen Hollow (08/4/08) showing poor riparian conditions. Water from springs flows approximately 1/3 mile before entering the Logan River. Heavy cattle use was noted along the entire length of stream.

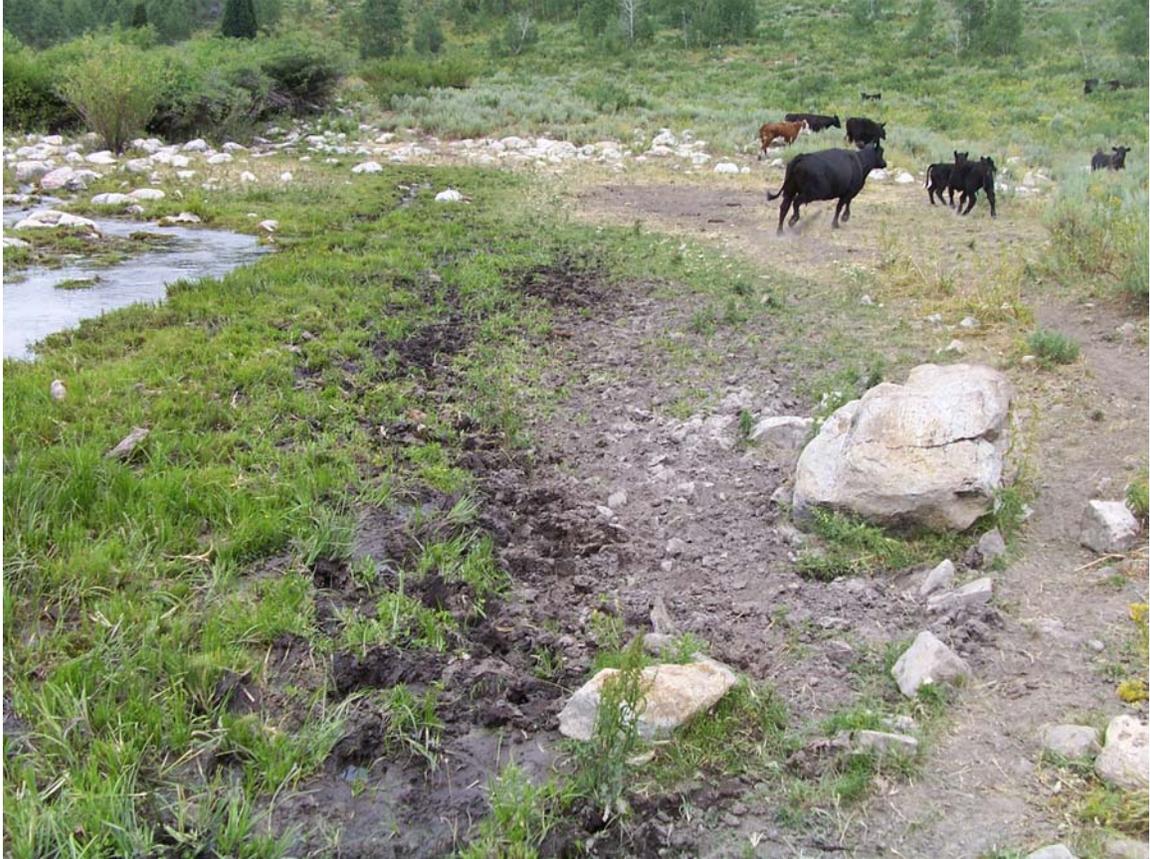
Figure 5. Water from unnamed springs located north of Hansen Hollow (08/4/08) showing poor riparian conditions. Water from springs flows approximately 1/3 mile before entering the Logan River. Heavy cattle use was noted along the entire length of stream.
