Measuring Effects of Roads on Groundwater: Five Case Studies

Keith Kahklen

Jeffry Moll, P. E.

January 1999

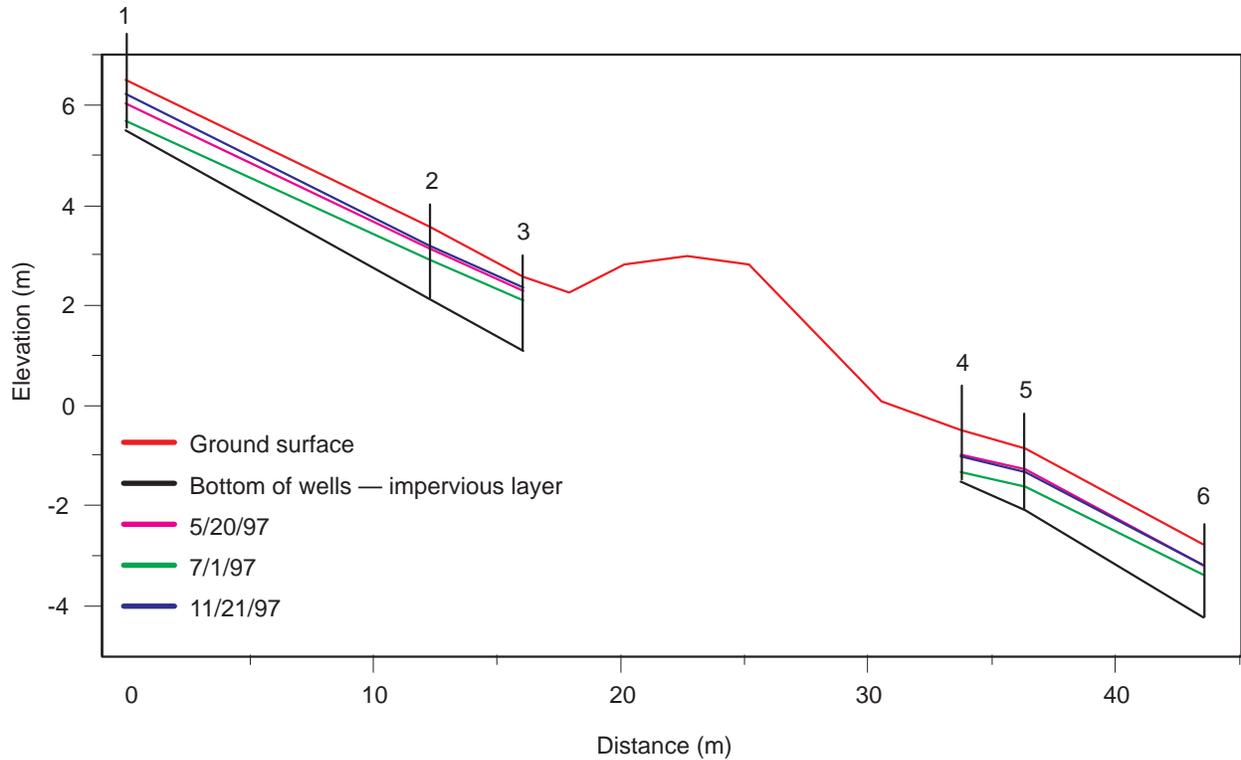
Figure 1 displays the groundwater level data gathered by hand measurement for Greens Creek transect 1 and plotted on a cross section of the hillslope. Measured groundwater levels in all wells are consistently lower during the dry period (7/1/97) than during the wet periods (5/20/97 and 11/21/97). Also evident in figure 1 is that the water levels in wells 5 and 6 are at or near the levels shown in wells 1 and 2. During the dry period (7/1/97) the differences are much more

pronounced, with wells 1 and 4 having very low groundwater levels. The other wells have lower water levels, but still exhibit the general trend observed during the wet periods.

The groundwater levels at well 3 are high compared to well 1. Possible explanations for this include a damming effect from the road fill due to soil compaction causing reduced hydraulic conductivity and rerouting of groundwater from the road prism upslope of the site via the ditch. Underground geologic conditions may also be responsible. The level at well 4 is lower than wells 5 and 6, the wells lowest on the slope. These wells appear to have recovered to the levels in wells 1 and 2. One potential reason for the lowering of water in well 4 is rerouting of moisture due to surface concentration and flow caused by the compacted mineral soil of the traveled way. The ditch may be routing water in the form of surface flow away from the site that otherwise—if the road did not exist—would infiltrate the surface and

Figure 1—Greens Creek transect 1 cross section at given points in time.

contribute to groundwater levels. A second possibility is that despite the road's age and heavy use, the subgrade is porous and is intercepting the water and routing it away from well 4.

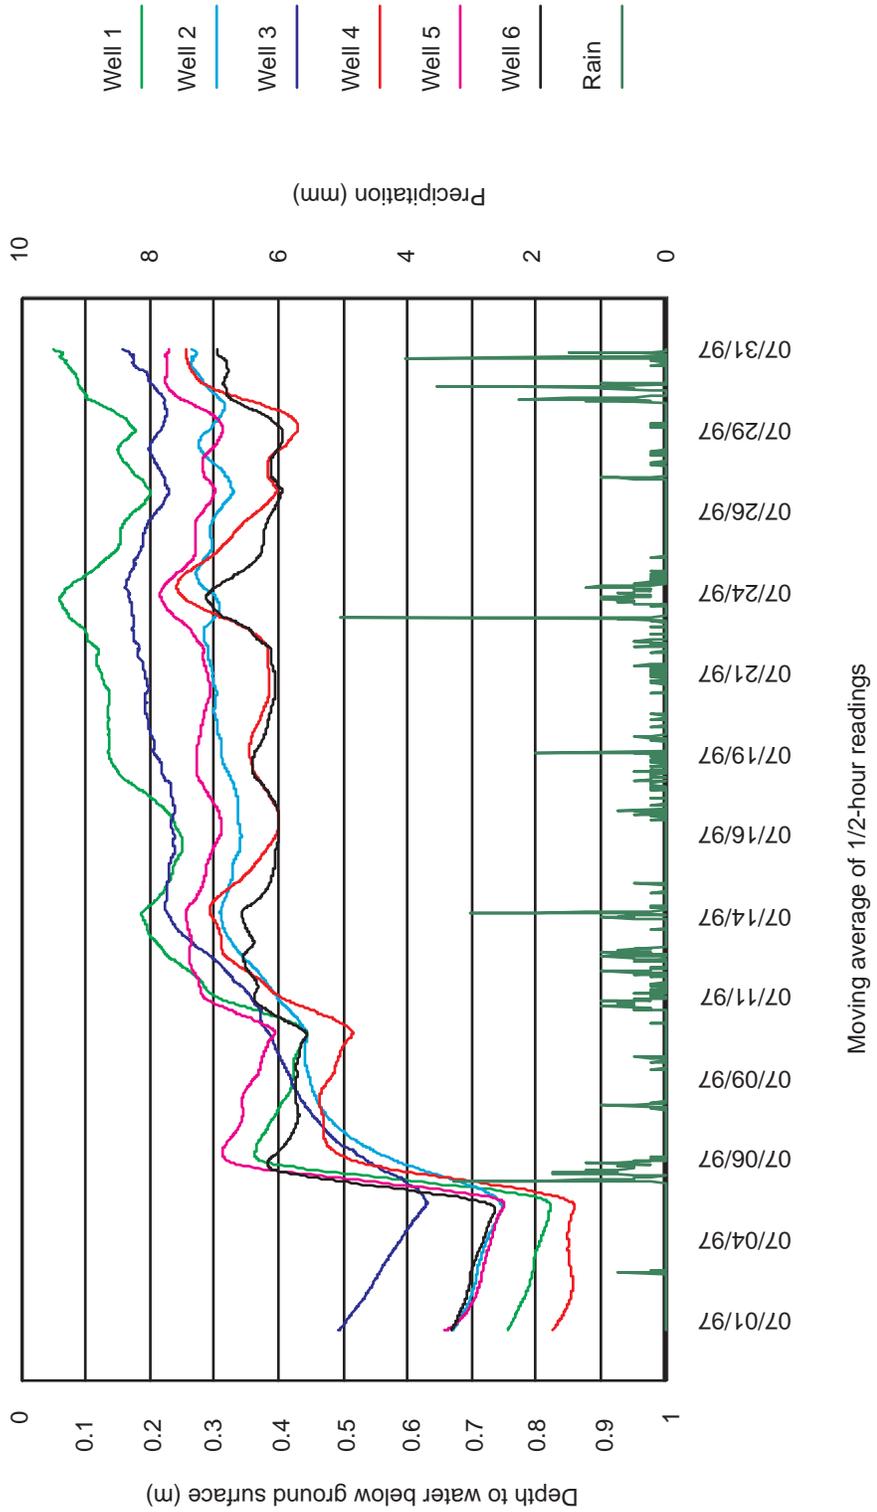
Inspection of figure 2 reveals well 4 almost always displays greater distance from ground surface to water level (lower water level) as compared to wells 1 and 2 above the prism. However, care must be taken in directly interpreting results from the plot

in figure 2 due to possible differences in well depths. It may be useful to note the total depth of water measured in the wells from the bottom of the well which represents an impervious layer. This is shown in figure 1 as the distance from the bottom of the well to the groundwater surface. Examining all components of these plots together is the best method for interpreting effects of roads on groundwater hydrology. Results shown in figures 1 and 2 suggest several possible reasons for differences in groundwater levels in the wells above and below the road.

Figure 2—Continuous groundwater trace for Greens Creek transect 1.

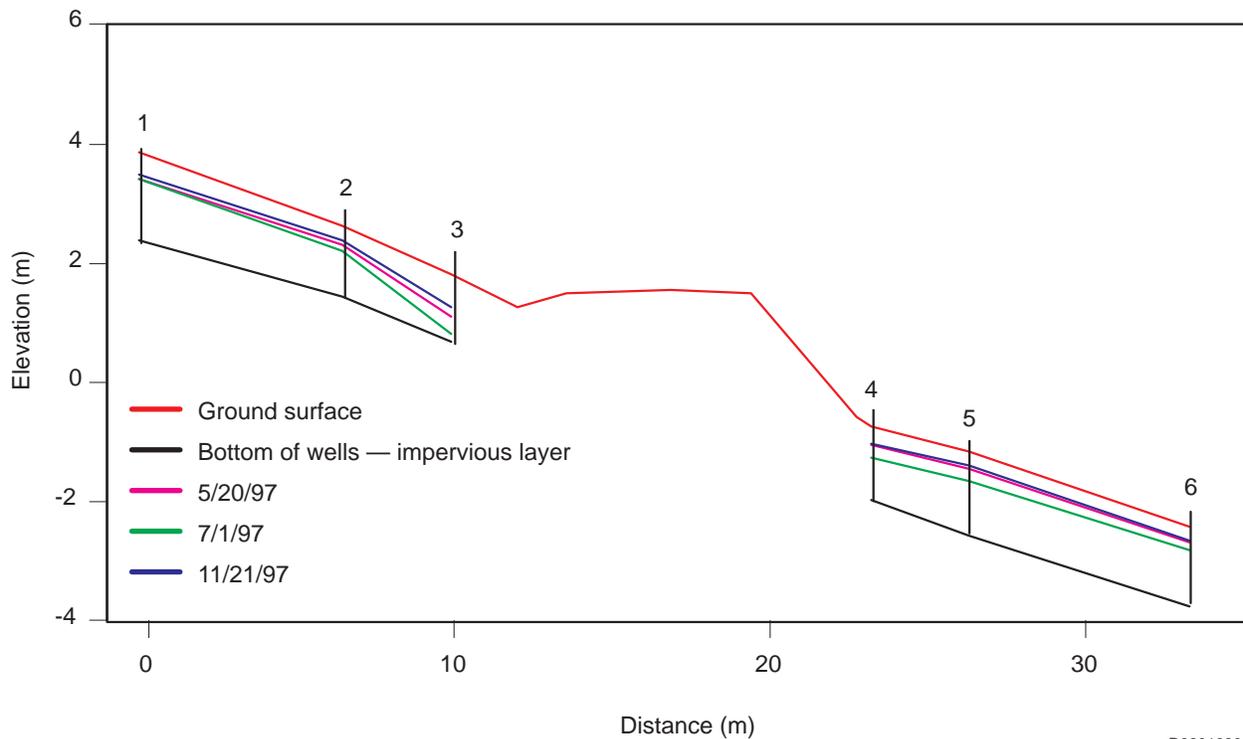
Figure 3, Greens Creek transect 2 cross section, exhibits a large drawdown of groundwater for wet

and dry periods above the road at well 3 (figures 3 and 4). This is possibly caused by interception of groundwater flow by the ditch or by French drain behavior of the road fill at this site. Wells below the road show a rapid recovery of groundwater levels to those exhibited in wells 1 and 2 above the road. Water was observed flowing out of the toe of the fill on the downhill side of the road. This supports the possibility that the fill is acting as a conduit to drain groundwater near the ditch on the uphill side and discharge it downslope. This water could be recharging the groundwater table below the road.

Figure 3—Greens Creek transect 2 cross section at given points in time.

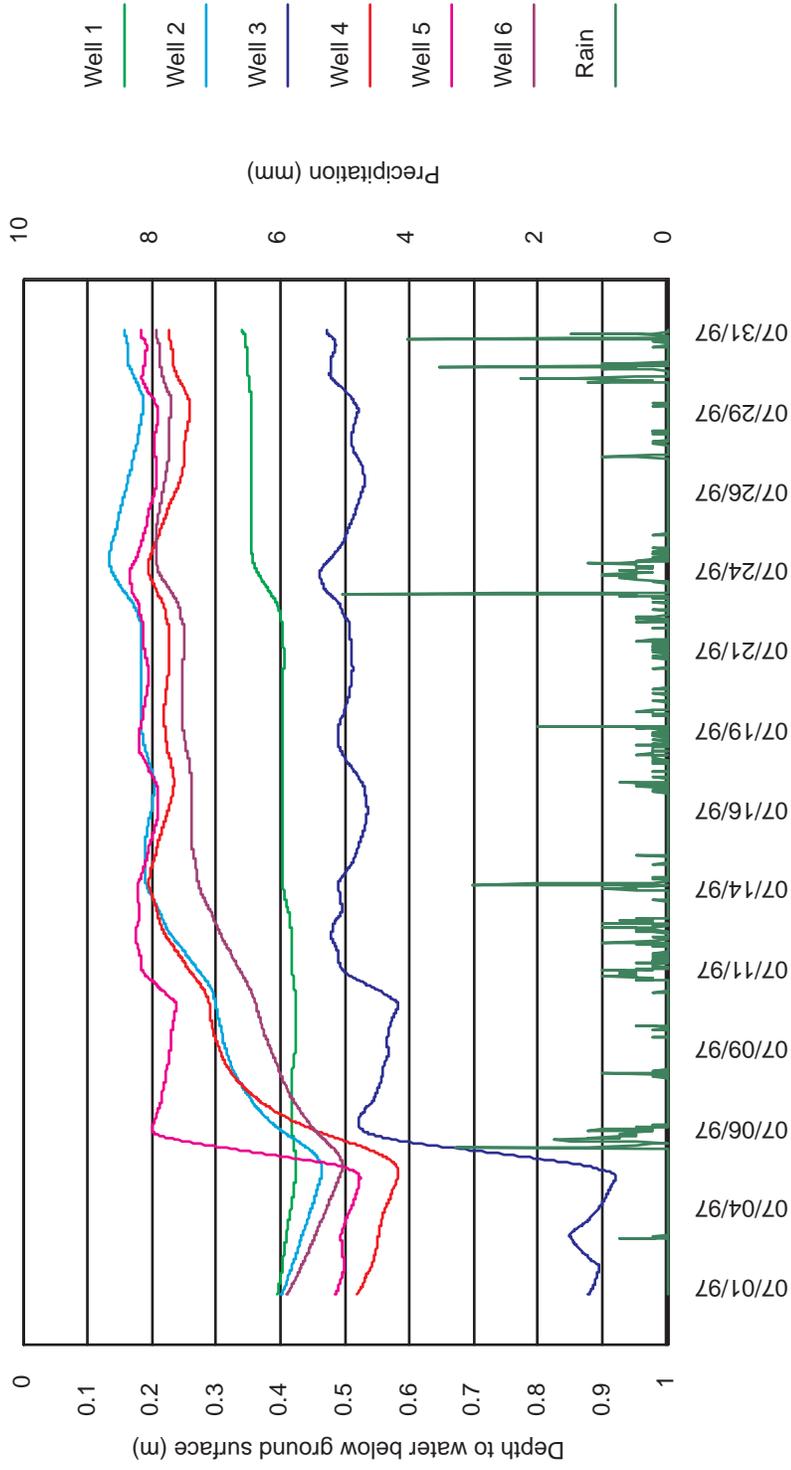
Figure 4 also indicates that well 3 exhibits uniformly low groundwater levels. Well 3 appears flashier or more responsive to precipitation and dry periods than the other wells. Well 1 seems especially flat and unresponsive. It is possible the well tip was driven into impervious till, a pocket of fines, or a perched water table, all of which might buffer response to changing moisture conditions. Plots for the other wells also seem buffered to varying extents as compared to well 3.

Figure 4—Continuous groundwater trace for Greens Creek transect 2.

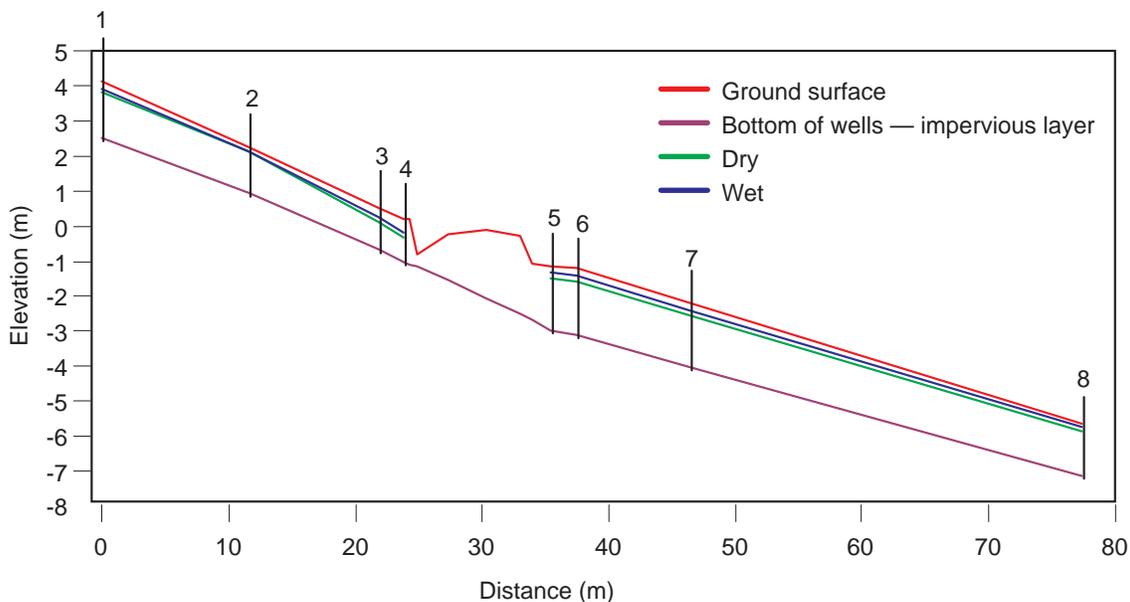
The transect cross section shows a deep ditch cut into the muskeg subgrade (figure 5). The ditch is over a half meter deep with a back slope over a meter (table 1). Wells 3 and 4 show a drawdown, probably due to the deep ditch, with an apparent quick recovery downhill of the road as evidenced by water levels in wells 5 through 8. The ditch is below the water table, and it is likely interception is occurring along the backslope and ditch cut face. The quick recovery in well 5 suggests that the porous nature of the pitrun material used to construct the road is acting as a conduit for water in the ditch to recharge the groundwater table under and downhill of the road.

Figure 5—Wrangell Island transect cross section at given points in time.

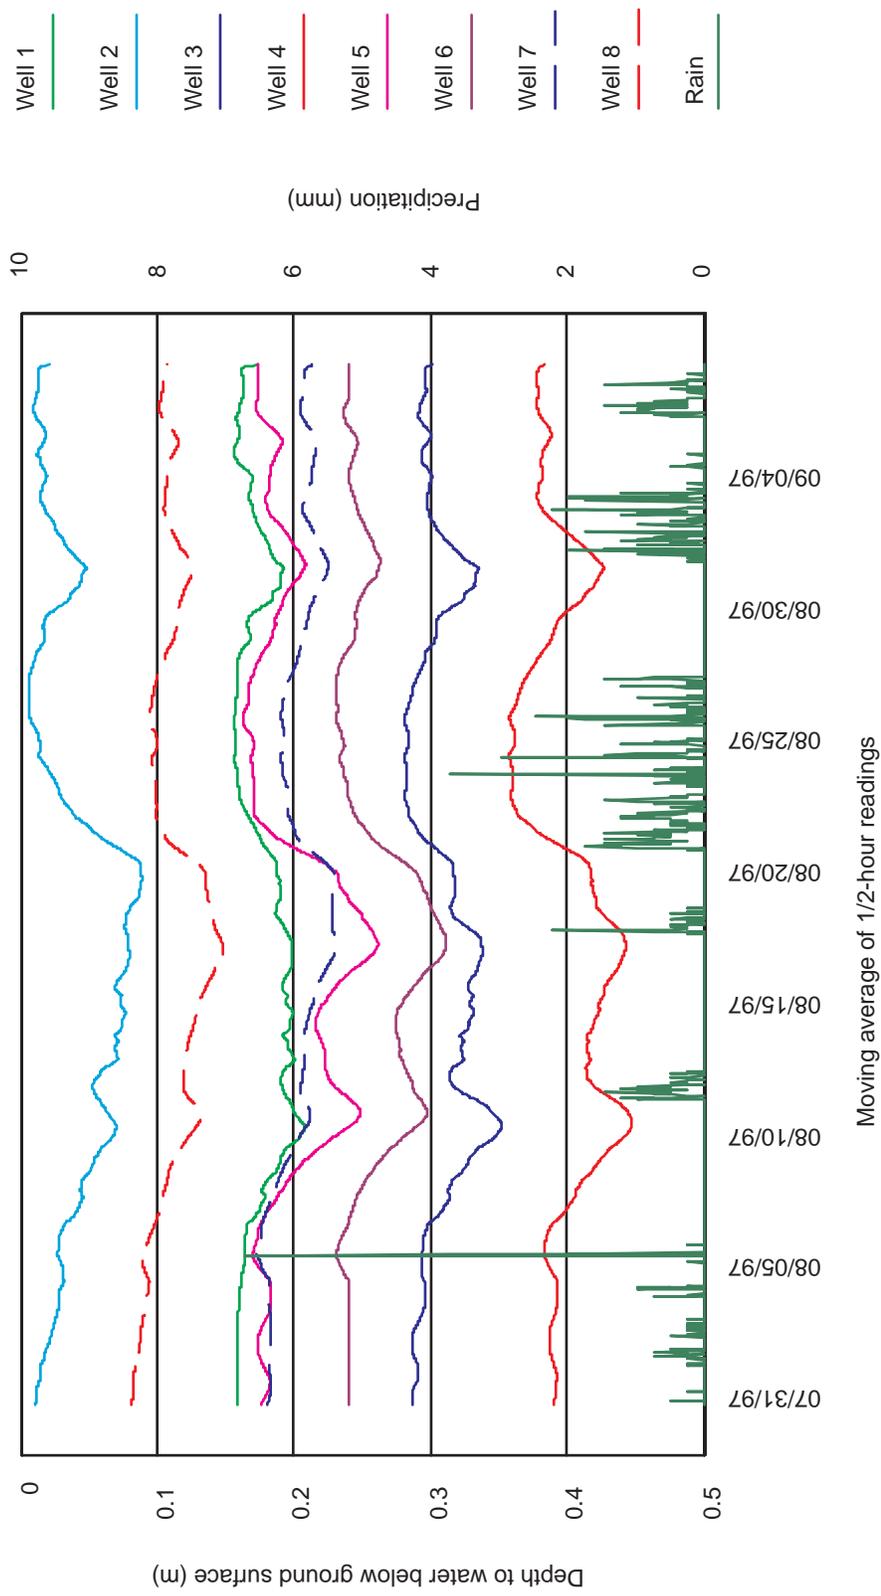
groundwater trace (figure 6). The traces for wells 3 and 4 are consistently lower than the other wells substantiating the drawdown effect near the ditch. The fact that all wells react similarly to precipitation events suggests they are hydrologically connected or soil properties are homogeneous at this site. As was evident at the Greens Creek sites, effects of the road on groundwater appear to be localized to within a few meters of the road.

Figure 6—Continuous groundwater trace for Wrangell Island site.

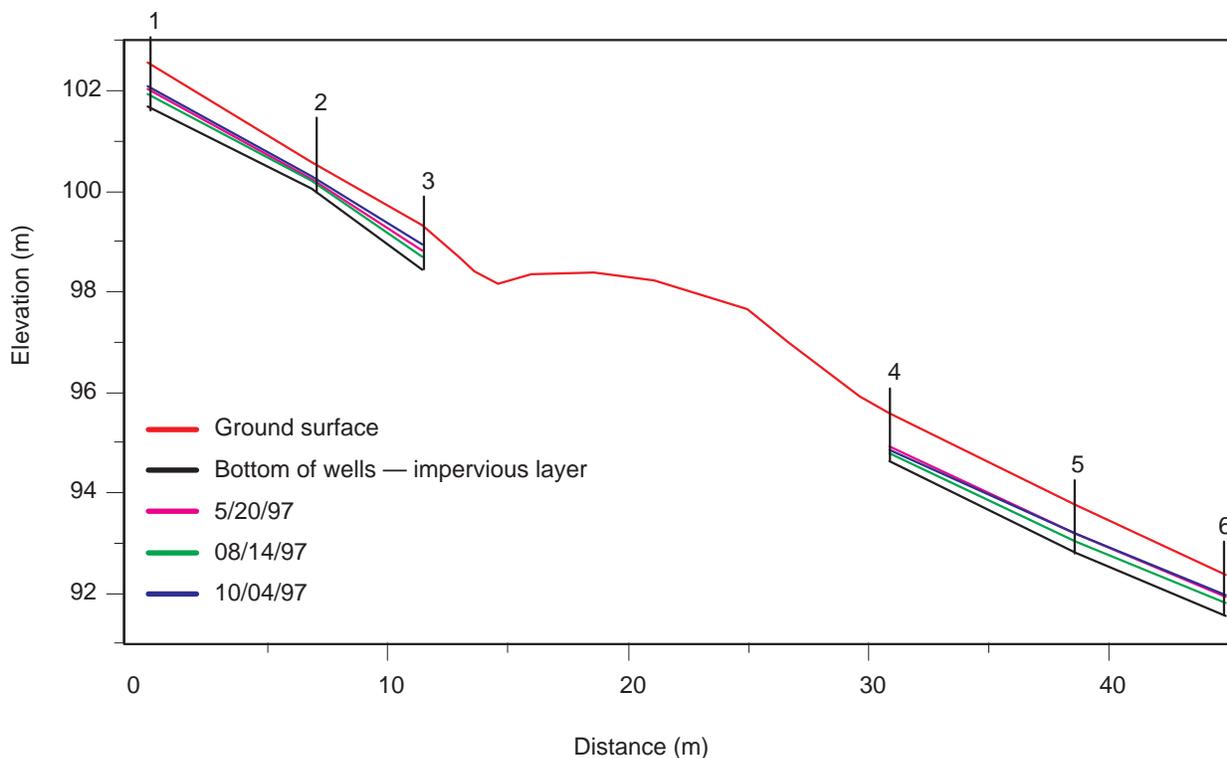
The transect on the Margaret Lake road has similar depths of groundwater for wells 1 and 3 during both wet and dry periods (figure 7). The water levels in well 2 are close to the surface as a result of a shallow impervious layer. As was observed at the two transects at Greens Creek, well 4 just below the road shows a lower groundwater level relative to the surface than observed at any of the other wells. This suggests that the road is intercepting some groundwater flow. As at Greens Creek, water levels are recovering in wells 5 and 6 (figure 7).

The Margaret Lake road prism at this site has a shallow back slope and ditch; interception of groundwater by the ditch was not observed. However, during very wet conditions, a straight line down from well 3 to 4 on figure 7 intersects the ditch, indicating potential interception.

Figure 7—Margaret Lake road cross sections at given points in time.

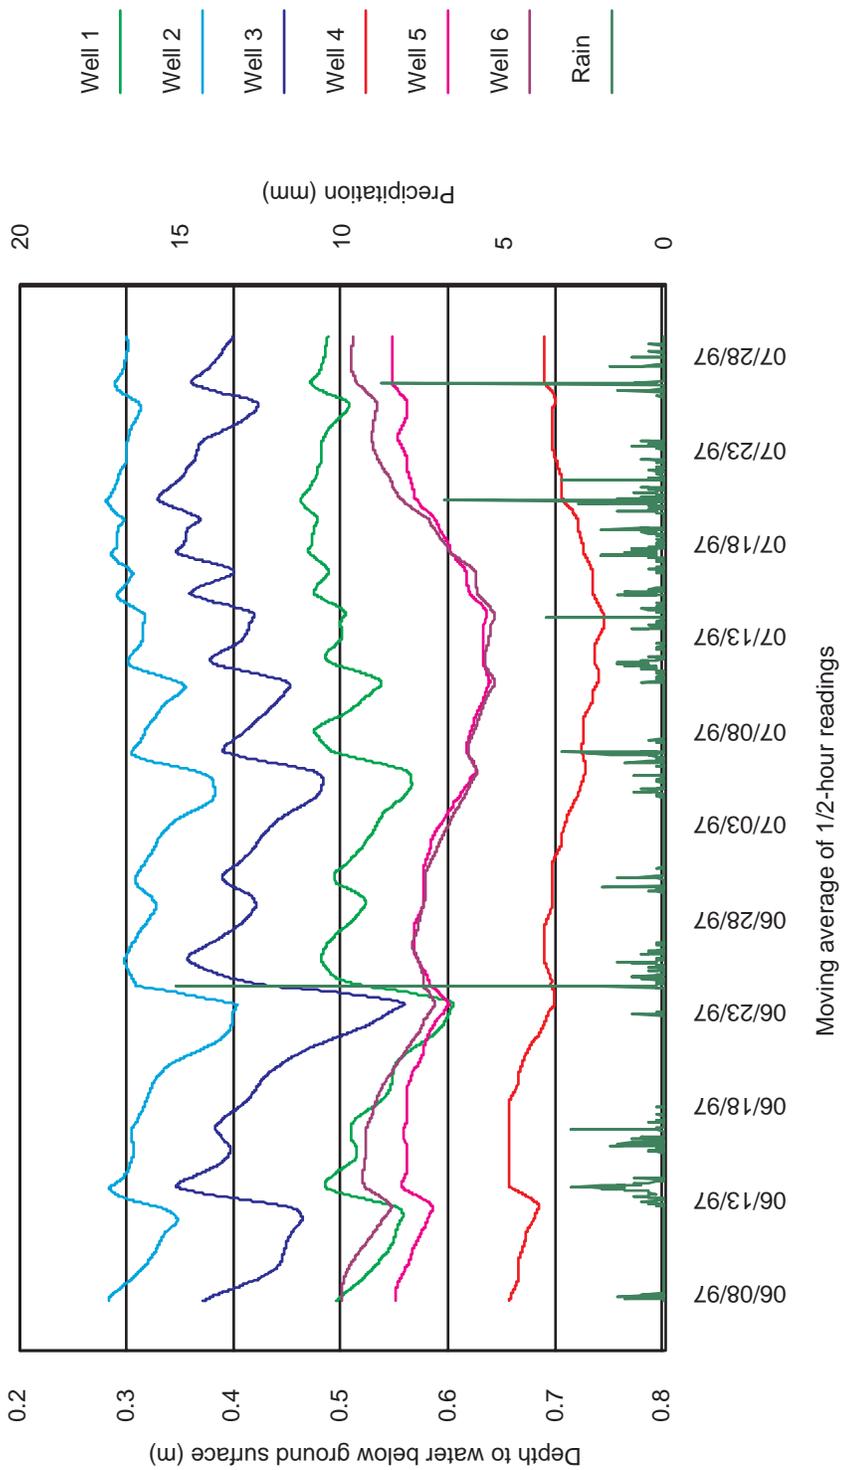
road in this study. The age of the road and the high traffic use may cause a reduction in the porosity of the road prism. Figure 8 shows the groundwater trace recorded for the transect with the wells above the road reacting to precipitation and drying periods much more quickly and at greater magnitude than the wells below the road.

Figure 8—Continuous groundwater trace for Margaret Lake road.

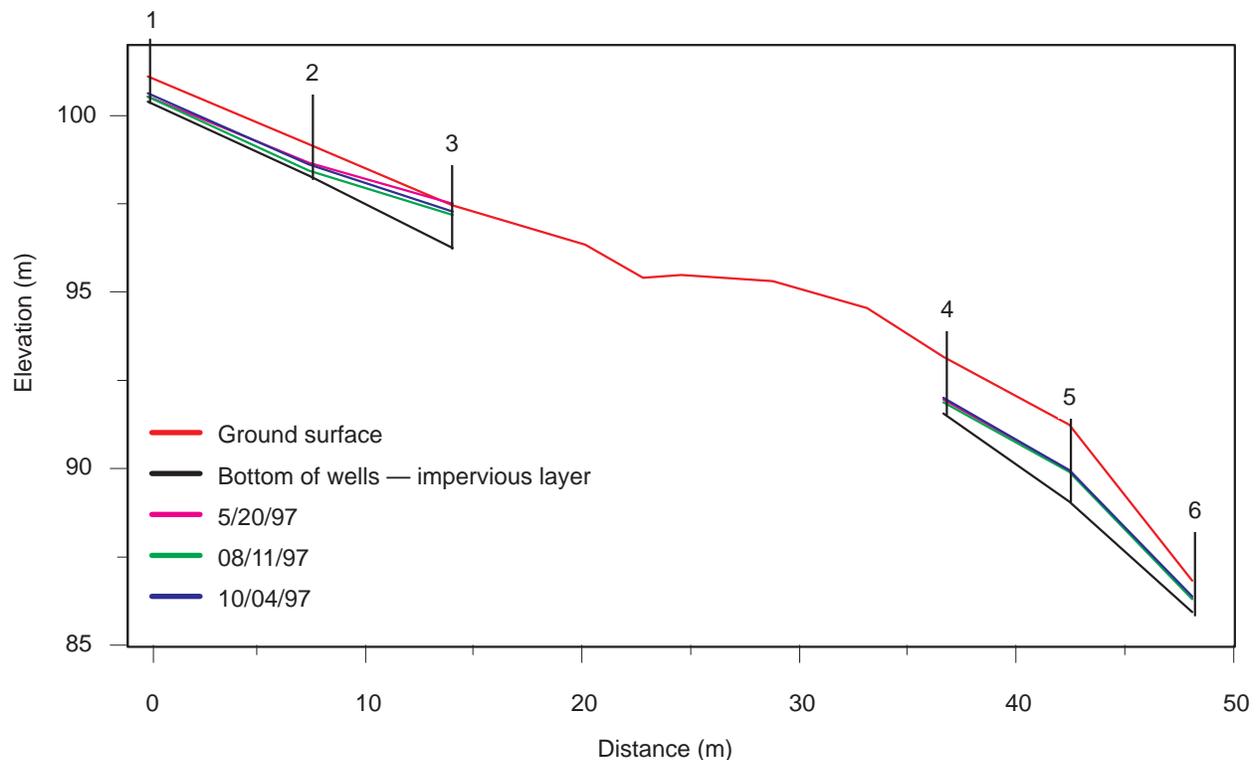
This site had only hand measurement of groundwater levels; no electronic measurements were made (see figure 9).

This road was the least desirable site for a groundwater transect of any site in this study. The well transect was not installed perpendicular to the road due to the desire to install the wells in the fall line of the slope. This resulted in a skewed cross section plot depicting an elongated road cross section. Distances between the wells and the road are exaggerated. The road grade is a steep 14 percent, and excess material was sidecast during road construction 30 years earlier, extending the fill slope for several meters (table 1). This may be the cause of a bulge in the groundwater at well 5 (figure 9). The groundwater levels below the road show similar results found at the other sites. The water levels in well 3 are very elevated and near

the surface, which was also observed at transect 1 at Green Creek. This is probably a result of bedrock blocking water flow downslope near well 3 and causing a ponding effect.

Figure 9—Indian Point road cross sections at given points in time.
