Jake and Bull Mountain Trail Assessment and Management Plan

Promoting Recreation & Environmental Protection through
Assessment, Collaboration and Education

USDA Forest Service
R8, Southern Region
Chattahoochee-Oconee National Forest
Blue Ridge Ranger District

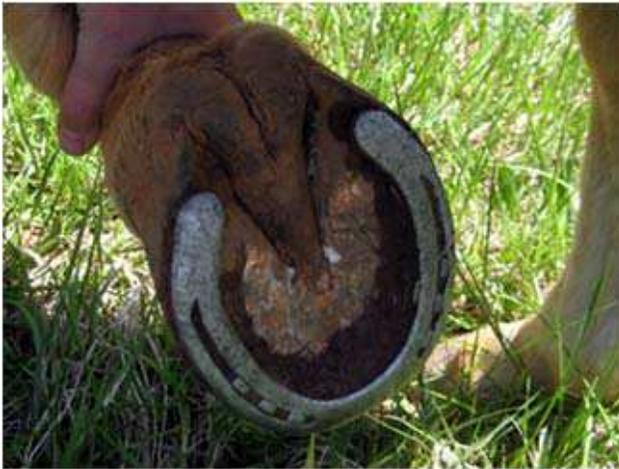
Above: Of all the non motorized users, the shod horse has the highest impact. Horseshoes are made of metal, are harder than any trail surface, and concentrate a horse's weight into a small surface area. When combined with the weight of a 1,000 pound animal, the strength of a horse's powerful legs and the action required to move that horse in a forward fashion (physics of propulsion), the raised and curved shape of a metal horseshoe provides the perfect digging tool.

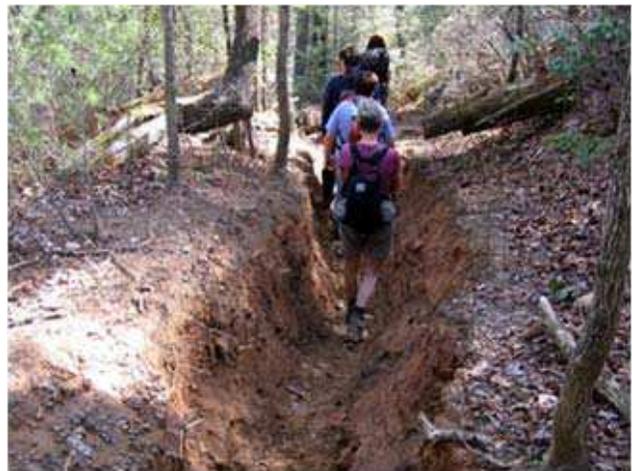
Above: This section of the Jake Mountain Trail shows signs of extreme erosion, a combination of user created impacts (soil displacement) and water based erosion.

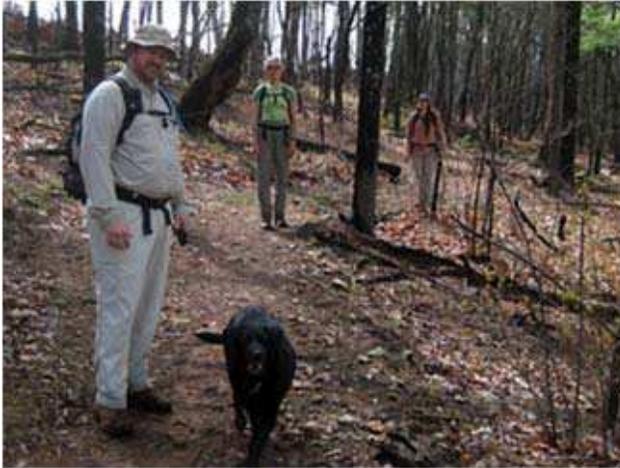
Above: A good example of rolling contour trail on the northern half of the Jones Creek Dam Trail 223E. The pictured grade reversal is a permanent drainage feature that sheds water well, but also adds interest to the trail alignment.

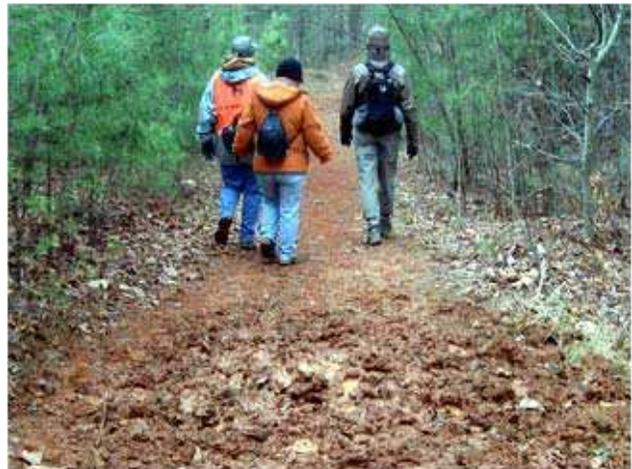
Above: Poorly drained roads can become very problematic as horse trails. The indents from a hoof create pot-holes that hold water and contribute to the build up of mud.

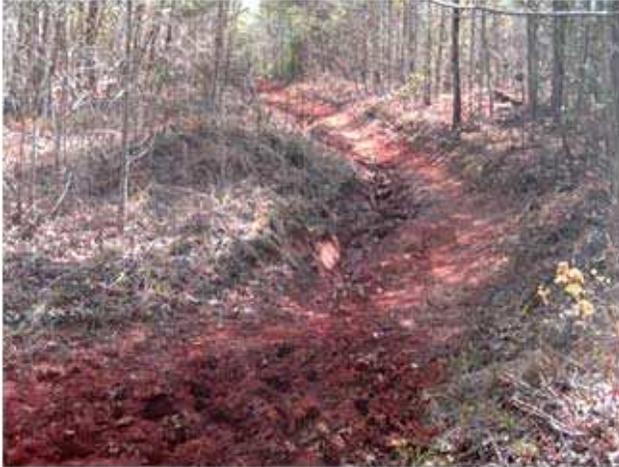
Above: Steep trails (and roads) exhibit high levels of soil loss. When this soil settles out due to a slowing down of water carrying the soil, mud areas can become extreme.

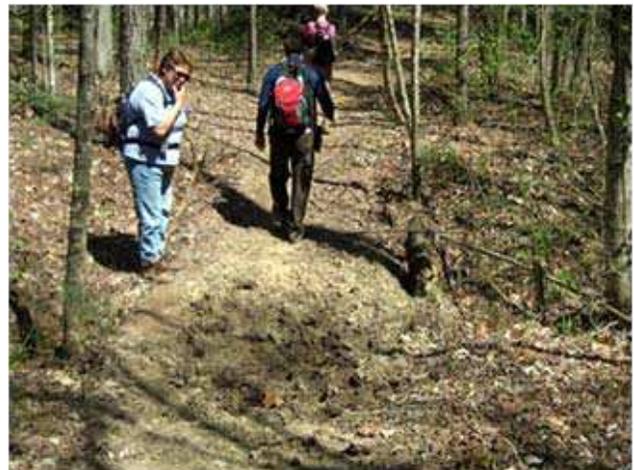
Above: This mud hole was caused by flat conditions along the northern end of the Jake Mountain Trail. This segment is known by some of the local riders as the Beaver Pond Trail. Trails in flat areas lack good drainage and can become very problematic for trail maintainers.

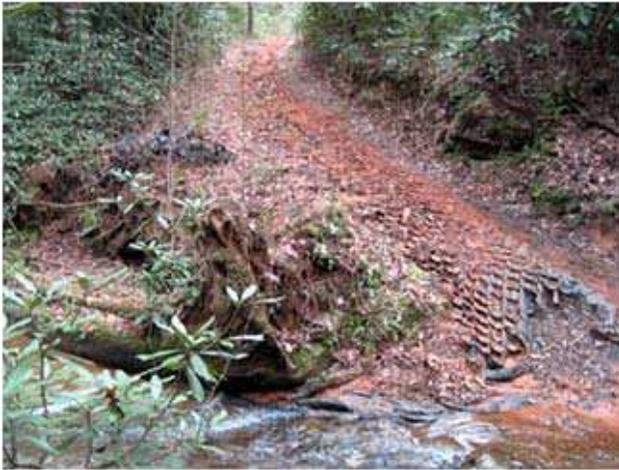
Above: An example of a failed water crossing located on the Moss Creek Trail. This crossing was poorly designed and this coupled with high levels of horse use led to structure failure and increased impacts on water quality.

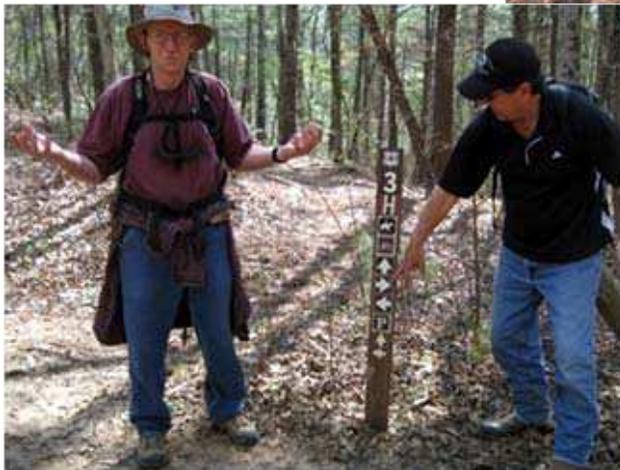
Above: Current signage program is somewhat confusing for many trail users of the Jake and Bull trails.

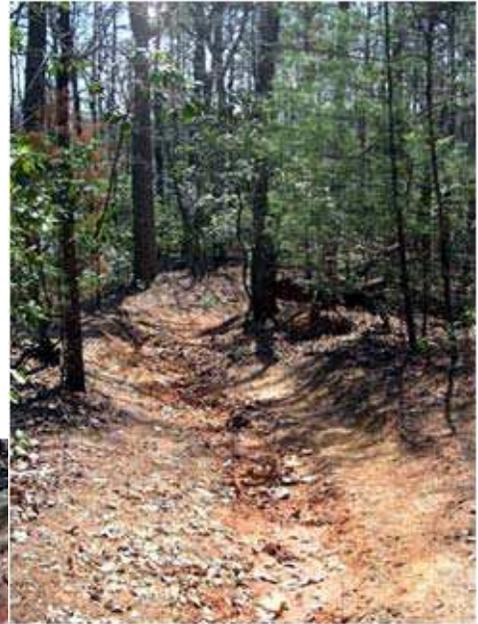
Left, Middle and Right: A continuing look at Bull Mountain Trail.

The beginning section of this trail from its start off the Bull Mountain Rd is well below grade and signs of user impact and water based erosion are problematic. It is recommended to utilize rock armoring and/or surface hardening for this short entrance.

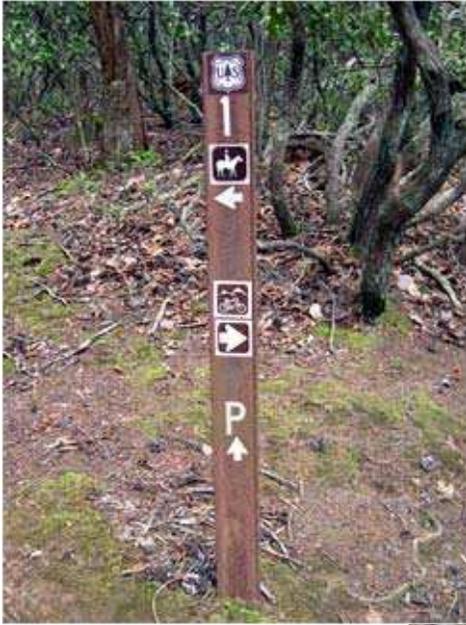
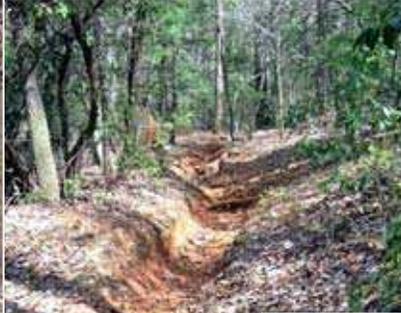
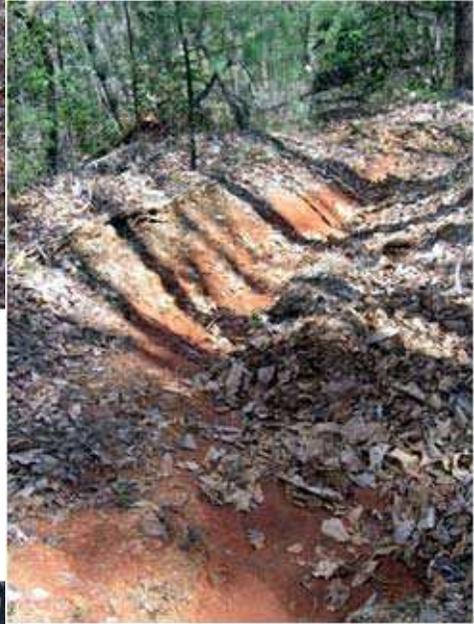
The first 0.5 mile of the Bull Mountain Trail is located on a steep “fall-line” which historically was used as an old extraction route. This section is experiencing moderate to severe erosion that has risk management concerns, enough to justify building a short section of trail (Bull Mountain Spur Trail 223G) to by-pass 0.2 miles of the most severely eroded section of this segment. The Bull Mountain Spur Trail 223G is marked for mountain bikes only and was designed and purpose built by SORBA. It is sustainably hand-built on the contour for most of its alignment and is expected to hold-up over the years. The 0.2 mile section of trail which Trail 223G by-passes is marked for horses (not bikes) and is currently used to gain the main ridge. As would be expected, this steep fall line old extraction route has failed and lost significant amounts of soil. It is recommended to immediately close this section of trail and pursue the re-location option for a new horse-only section that would connect further north with the Whoop-De-Dos-Trail.

The "Horse-Only" section of the Bull Mountain Trail 223 has severe erosion and risk management concerns.

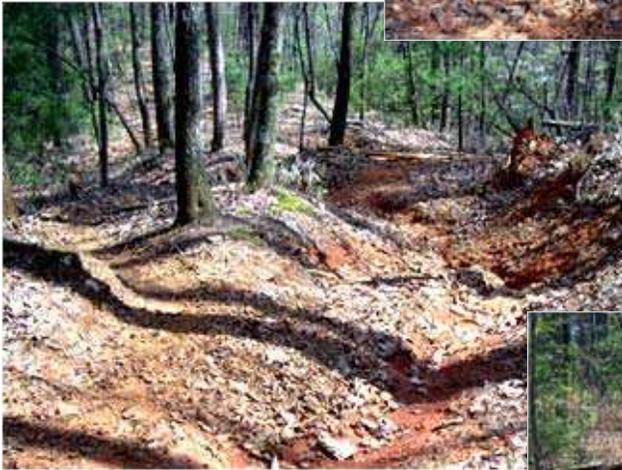
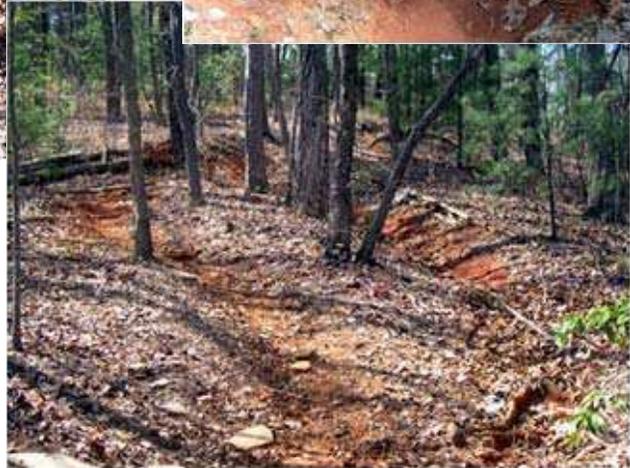
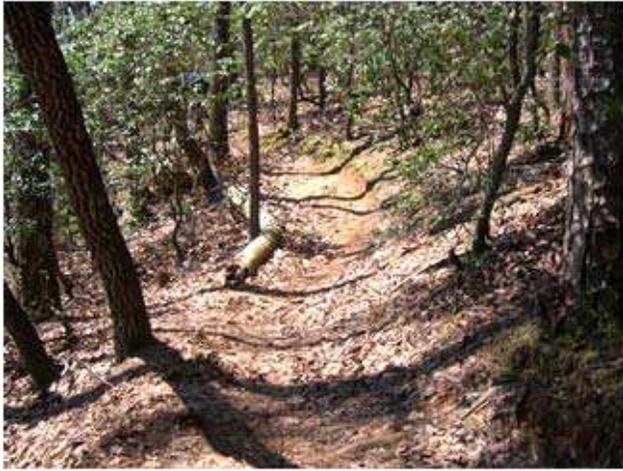
Above and Right: The first half of the Bull Mountain Spur Trail 223G (Bikes Only) is a purpose-built trail that is sustainably hand-built on the contour.

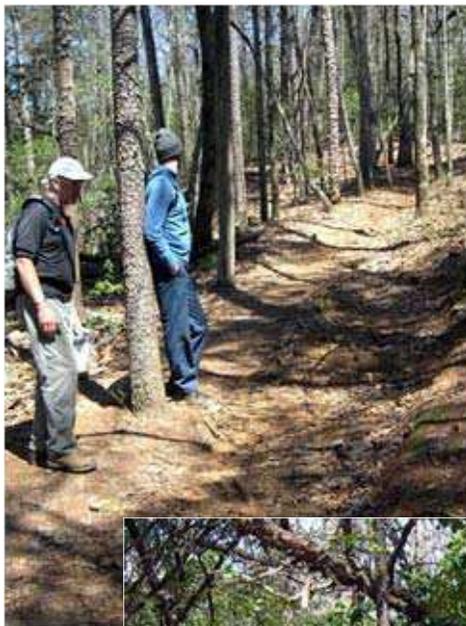
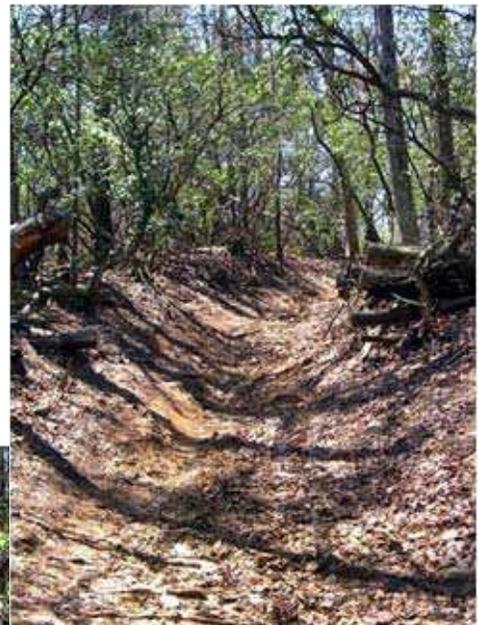
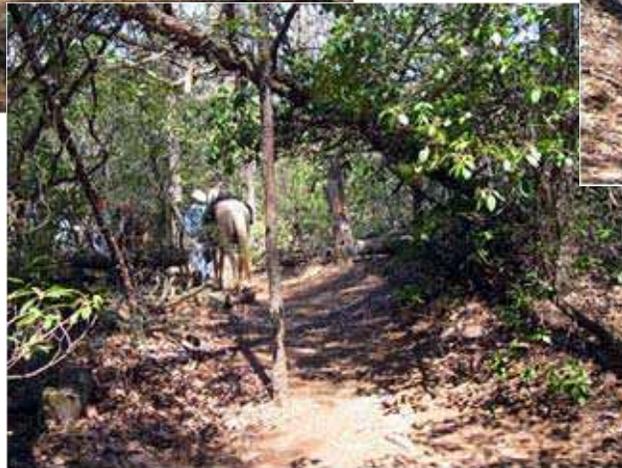
Left, Middle and Right: The second half of the Bull Mountain Spur Trail 223G (Bikes Only) was built on a fall-line in order to connect back to the existing Bull Mountain Trail 223. Moderate work is recommended to manage for sustainability with the additions of undulations and meanders.

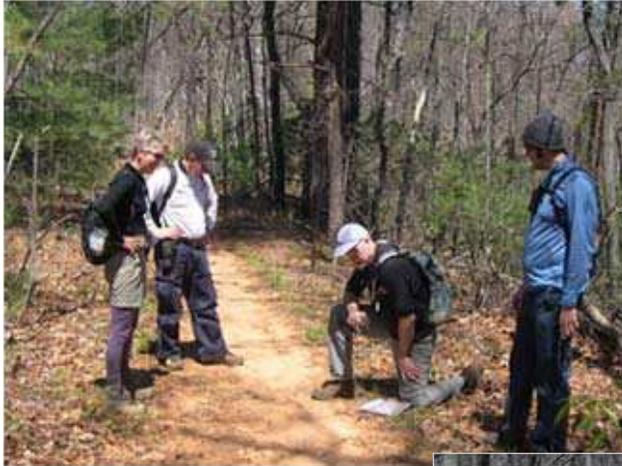
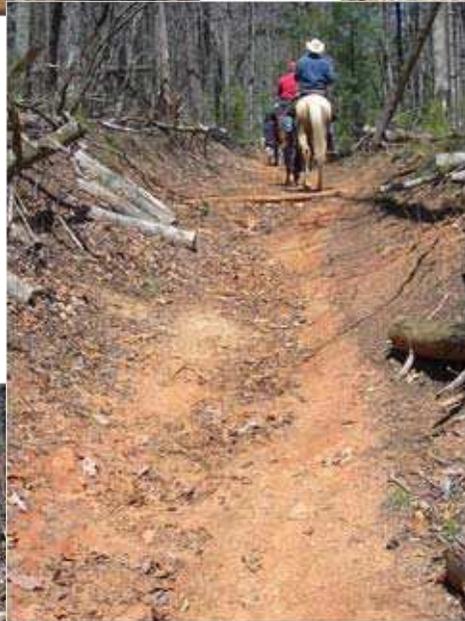
The section of Bull Mountain Trail 223 between its intersection with Spur 223G and Marker 1D at the Whoop De-Dos Trail 223C is also constructed on a fall-line and is showing signs of moderate erosion. This section is in Poor Condition and requires a “Trail Re-Construction Miracle” to be made sustainable. This section is a good candidate for an educational workshop where a Trail Professional would conduct the work and at the same time provide an educational workshop for USFS staff and volunteers on how to do the work. There are very few trail professionals whom can do this work, and therefore it is recommended to carefully consider who is hired so mistakes are not made in the reconstruction of this segment.

A Trail Re-construction Miracle is recommended for the Bull Mountain Trail between its intersection with Spur 223G and Marker 1D at the Whoop-De-Do's Trail 223C. Woody Keen (Trail Dynamics, LLC) explains how erosion is occurring and how to properly re-construct this trail section.

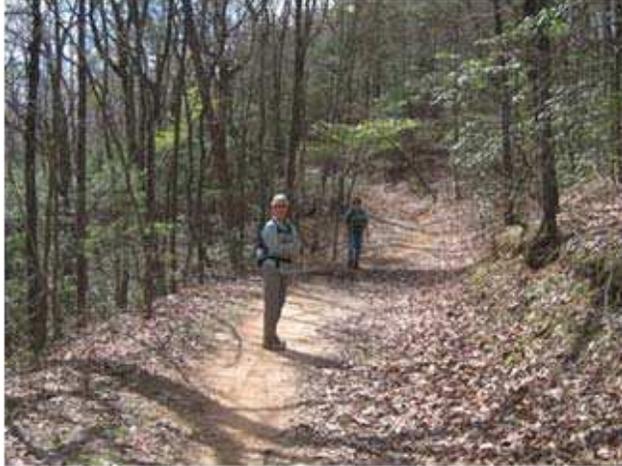
From the Bull Mountain Trail’s intersection with Marker 1D at the Whoop-De-Do’s Trail 223C and Marker 1E, it heads in a northwesterly direction for 3 miles along an old road bed. This section of trail is in fairly good condition due to the contouring nature of the old roadbed. A formal road-to-trail conversion is recommended for this 3 mile segment. This management prescription would take the trail out of the current roadbed where it would have the ideal placement for water management through increased meanders and undulations. A road-to-trail conversion will also provide the trail experience with a feeling of a purpose built trail rather than a trail that was built in the middle of an old road. Such a re-alignment would need to be designed by a trail professional with experience in road to trail conversions. During the assessment of this trail, a flagging exercise was performed as a demonstration. This section is another great opportunity for an educational workshop on “road-to-trail” conversions. Overall, better water management and re-alignment work would benefit long term sustainability of this section but could be considered low priority when compared with many other more significant issues found within the system.

Much of the Bull Mountain Trail is in good shape due to the contouring nature of the old roadbed.

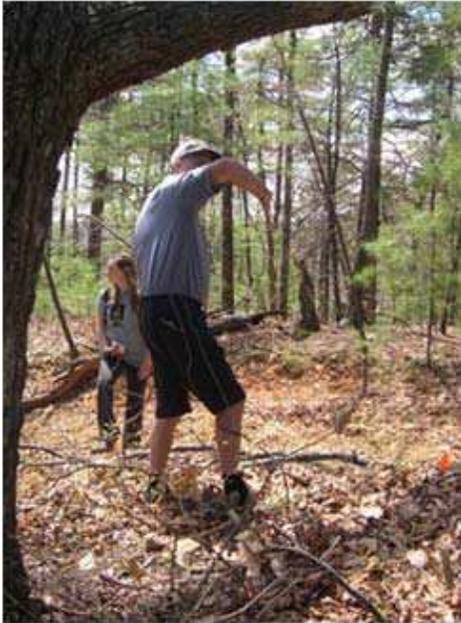
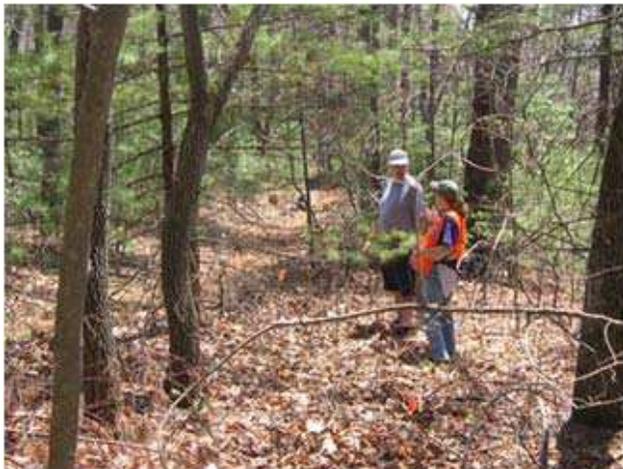
Left and Below: Woody Keen (Trail Dynamics, LLC) provides an education session on the concepts for a “road-to-trail” conversion.

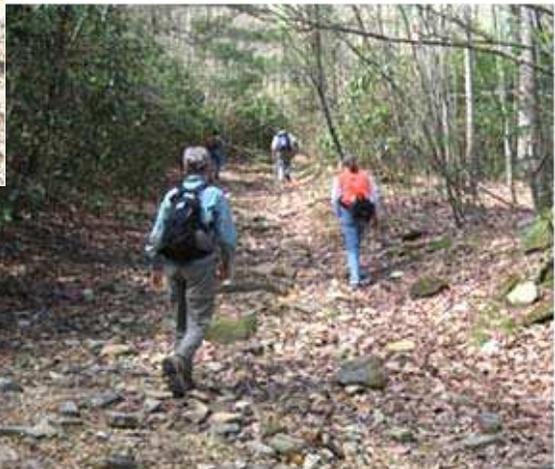
The West Jones Creek Trail begins by dropping-off the ridge for 0.26 miles to reach its crossing with Lance Creek. This short section is located on an old road bed. It shows signs of erosion, but is mostly naturally “armored” with rock and cobble. A formal “road-to-trail” conversion and armoring project that utilizes available rock in the area would benefit long-term sustainability and the trail experience by narrowing the active tread on the roadbed.

The first 0.26 mile section of the West Jones Creek Trail is naturally armored with the presence of much rock and cobble.

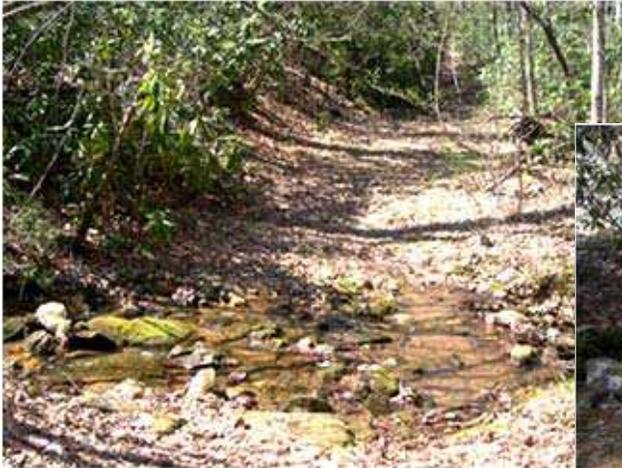
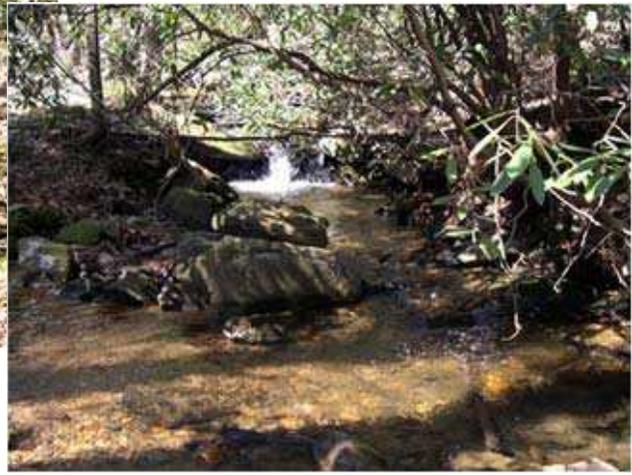
Once the trail reaches the bottom of the steep and cobbled old road bed, it crosses Lance Creek in two locations. These stream crossings are naturally armored with river rock and are working great!!

Above and Right: The West Jones Creek Trail crosses Lance Creek twice.

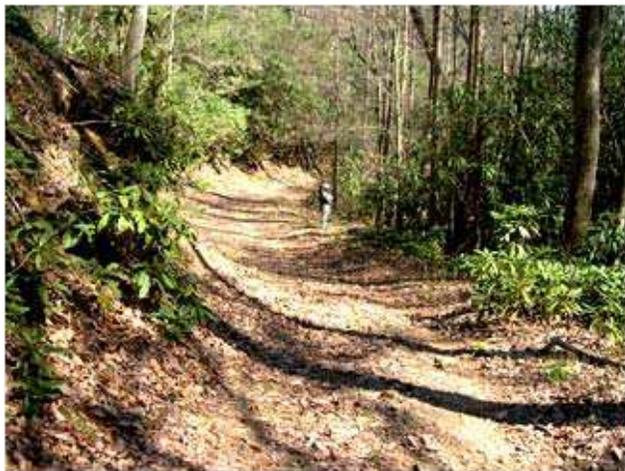
The remaining 2.37 miles of the West Jones Creek Trail is co-located with the West Jones Creek Rd (FDR 77A). It is interesting to note that the body of water this road follows is named Lance Creek on topo maps, and many trail users know this section as the “Lance Creek Road / Trail” more than the current USFS designated name “West Jones Creek Road / Trail”. For most of its length, the existing road corridor is in good shape with frequent broad based dips and water turn outs that are still effective. This should be monitored and some work may need to be scheduled as road conditions deteriorate due to increased traffic and on-going weather events. Despite the wider width associated with the forest road, paralleling the creek provides for an interesting and desirable trail experience.

The West Jones Creek Trail is co-located with the West Jones Creek Rd (FDR 77A) for 2.37 miles.

Forest Development Road (FDR) 77A is seasonally open during hunting season. There are several dispersed campsites throughout the river corridor. It is therefore recommended to remove the 2.37 mile section which is co-located with FDR 77A from the trails inventory and leave it coded as a road only. In order to provide a consistent naming convention it is also recommended to change the name of this Road to be consistent with the body of water it follows, “Lance Creek”.

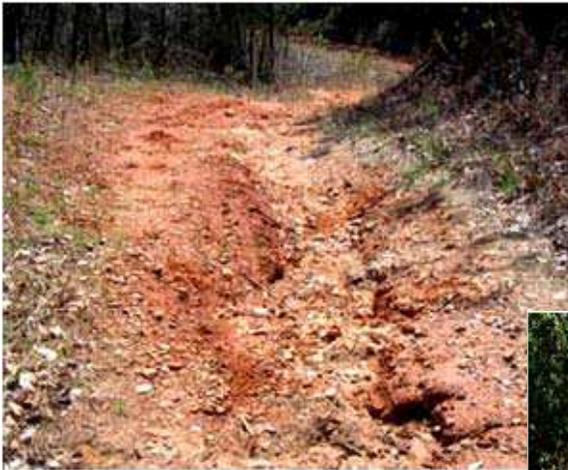
The Saddle Back Trail begins at its intersection with the turn-off from West Jones Creek Rd 77A. The trail is historically known to local users as the “Bear Hare” Trail. The signs along the trail depict this as the trail’s name. It travels northwest to the highest point in the trail system and also the most remote portion of the forest currently contained within the system. Though not apparently inventoried as such, the first 1.4 miles of trail are located on an improved road bed which shows signs of crushed stone surfacing in places and broad-based dips. Some of these dips have failed or are failing and need re-shaping. This road is actively used to access wildlife clearings.

Above, Left and Below: The first 1.4 miles of the Saddle Back Trail is located on an improved road-bed that is used to access wildlife clearings.

It is therefore recommended to remove the 1.4 mile section which is co-located with an un-inventoried road from the trails inventory and inventory it as a road only.

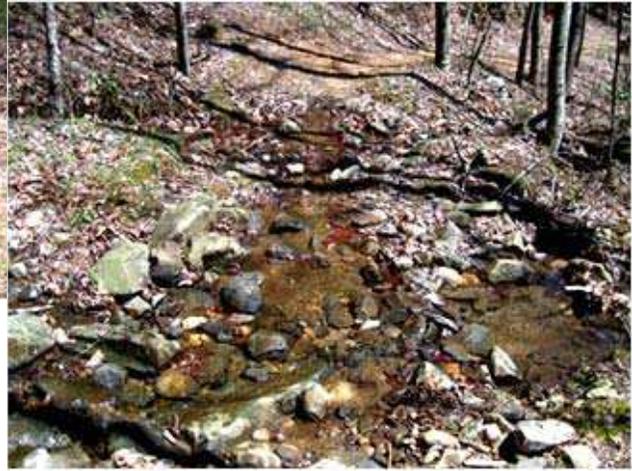
The Saddle Back Trail crosses this small creek draining off of Springer Mountain. This crossing is naturally hardened with native rock and the trail crossing in this location poses no great threat to water quality.

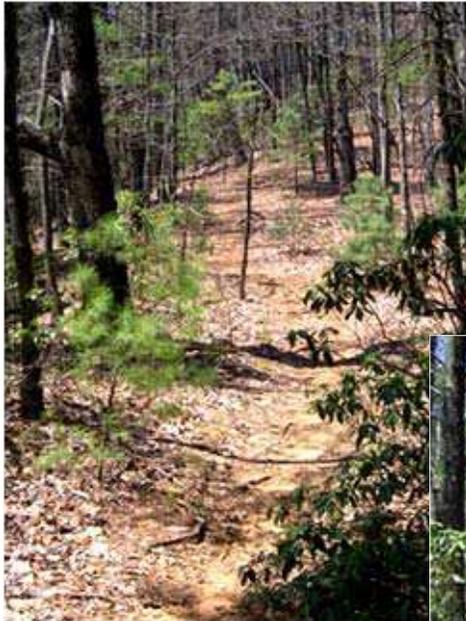
An example of a section of the Saddle Back Trail that rolls with the contour.

At mile 1.4, the improved road-bed ends and the trail enters the forest and becomes single track in nature. The next 2.57 miles of trail is of fair to good design and rolls along contours and ridge-tops, however, this section of trail needs moderate maintenance including: rolling dips, minor re-alignment work, and short sections would benefit from some rock armoring. There are several drainage crossings at the higher elevations with waters flowing off of Springer Mountain, however they are naturally armored and pose no resource concerns.

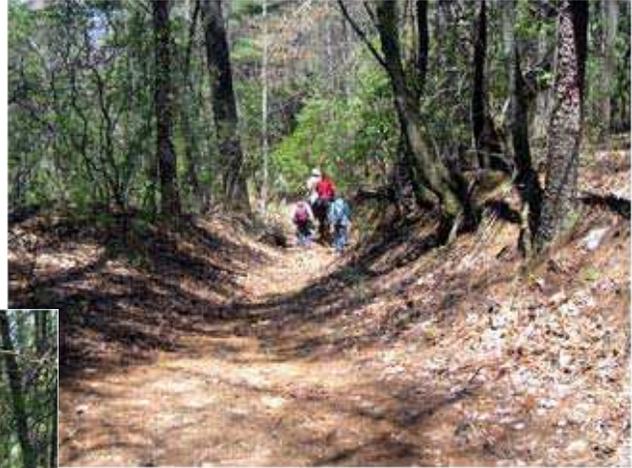
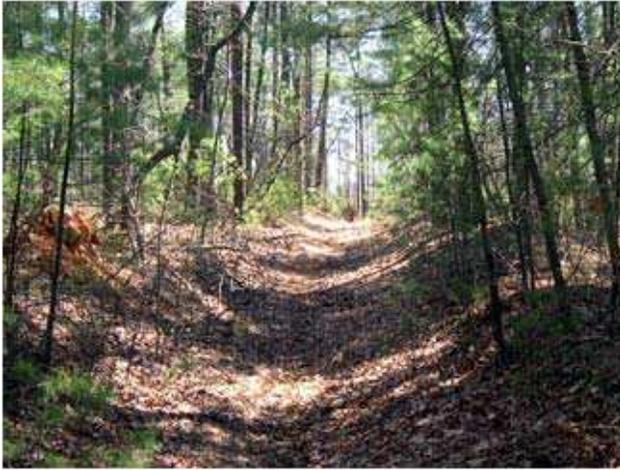
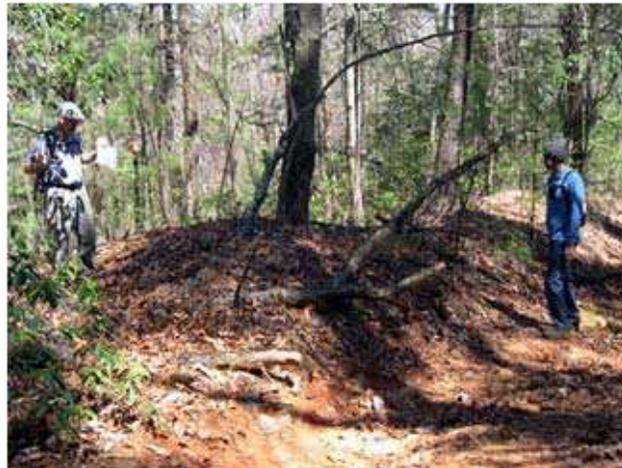
The roadbed shows significant signs of soil loss and water based erosion and is somewhat aggressive in grade. There is, however, no water courses anywhere close to the trail and therefore direct resource impacts are limited. Because this trail is not part of a current road inventory, it could be made sustainable using “road-to-trail” conversion techniques. This management prescription would take the trail out of the current roadbed where it would have the ideal placement for water management through increased meanders and undulations. A road-to-trail conversion will also provide the trail experience with a feeling of a purpose built trail rather than a trail that was built in the middle of an old road. A trail professional should be consulted to design the best location in and out of the current corridor for long term sustainability.

Below and Right: The Whoop-De-Dos Trail is located on an old road-bed.

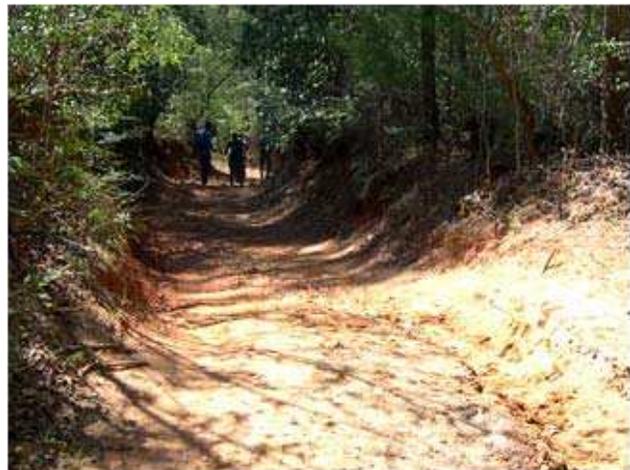
The Whoop-De-Dos Trail meets a T- junction within privately held land that is locally known as “Booger Holler” or the “Jones Creek in-holding”. From this T-junction, the trail in both directions is located on an un-inventoried jeep road that is actively being used to access private land. The west-side of this jeep road is inventoried as the Whoop-De-Dos Trail and the east-side of this jeep road is inventoried as the Bull Mountain Cut-off Trail 223D.

The Whoop-De-Dos Trail is located on a jeep road and private lands.

The jeep road is not inventoried in the roads GIS layer, but it is presumed that it needs to become part of a road inventory as it provides access to private land within USFS managed lands. It is recommended to change the inventory from a trails designation to a roads designation. Trail relocation is not recommended. If a new trail were to be constructed, the sediment problem will still take place within the private lands from the jeep traffic on this road. Changing the inventory to reflect an actively used road will still guarantee that recreational traffic can use this road.

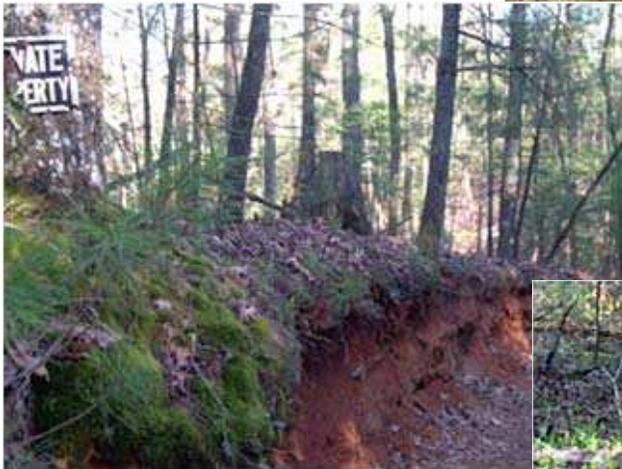
holding describing a large amount of silting that takes place within a creek this road crosses over. The creek meanders through and carries with it a large amount of sediment into the private lands.

Below: The jeep road crosses a creek that is causing silting problems within private lands.

There are drainage problems on this jeep road that will be difficult to remedy, but applying forest road BMPs would certainly help. Some road solutions include: broad based dips with lead-off ditches, and surface hardening with successive layers of surge stone (2-4”) and a top dressing of ABC crusher run. The public open house meeting received comments from locals who own property in this private in-

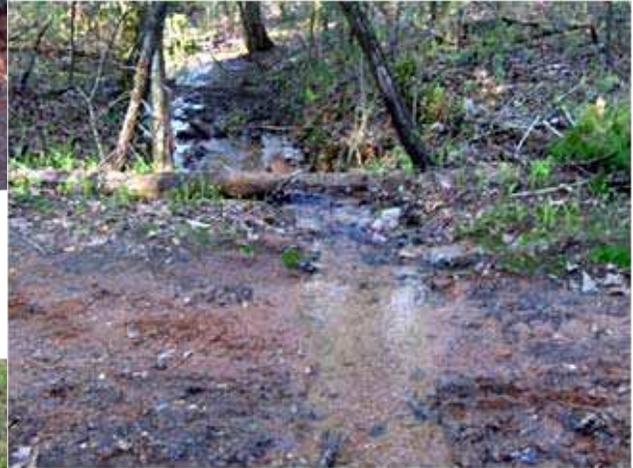
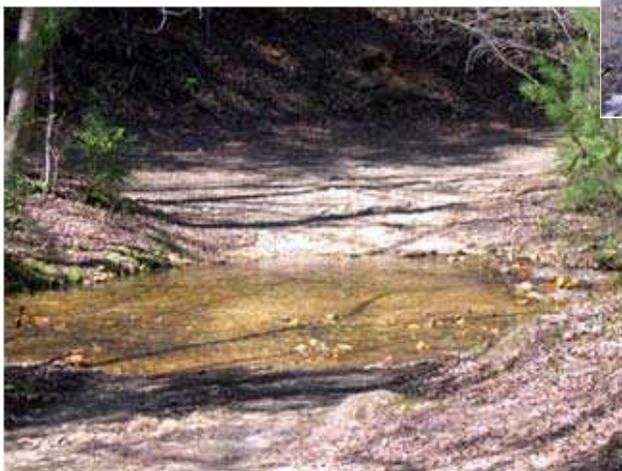
Left: The Whoop-De-Dos Trail crosses Lance Creek before its intersection with the West Jones Creek Trail/Road and the Saddle Back Trail. This stream crossing is naturally armored with river rock and is completely functional with no resource concerns.

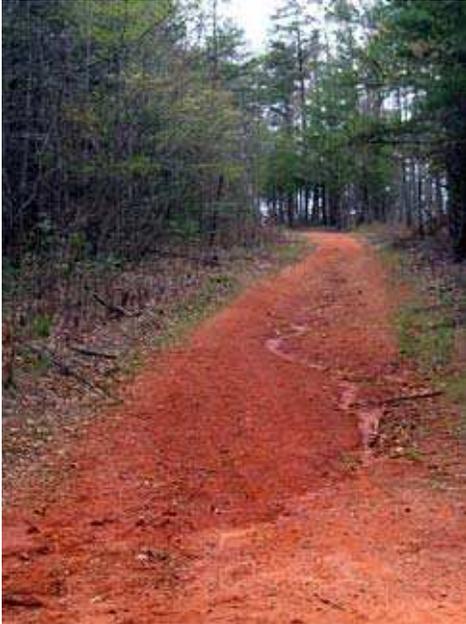
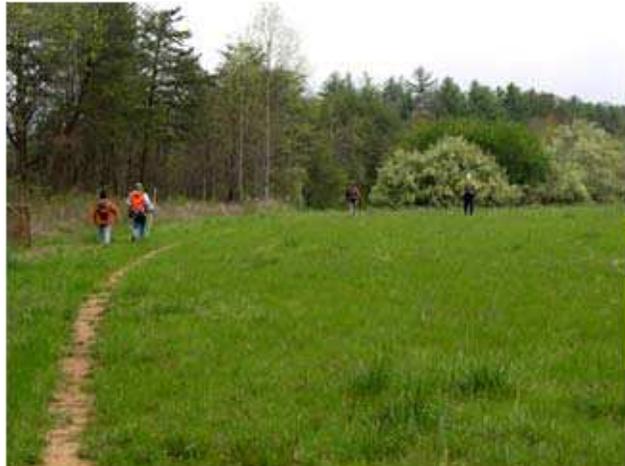
The first 0.93 miles of this trail is co-located along with Jones Creek Dam Rd - FDR 872, and provides access to the dam and wildlife clearings in the area. It appears the inventoried road length should be evaluated for accuracy. The GIS roads layer depicts this road ending prior to the Dam and one of the wildlife clearings. The inventory should not have dual designations as both a road and a trail. It is recommended to remove the section which is co-located with FDR 872 from the trails inventory and leave it coded as a road within the roads inventory. This road has an

aggressive gradient and needs re-shaping with better broad based dips with lead-off ditches and surface hardening to prevent further loss of soil.

Left and Below: The Jones Creek Dam Trail is co-located with the Jones Creek Dam Rd (FDR 872) and provides access to wildlife clearings.

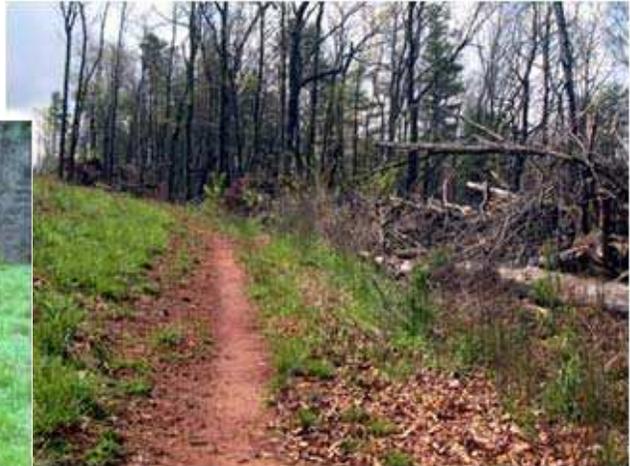
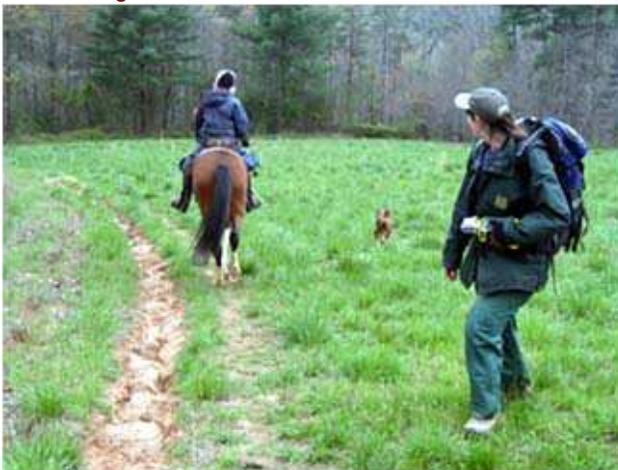
climbs steeply through a wildlife clearing to gain a ridgeline and steeply descends down a fall-line only to again climb steeply to go through another wildlife clearing. This series of “Pointless-Ups-and-Downs” (PUDs) is not sustainable trail construction. The trail at the edge of the clearing continues to move locations due to its fall-line alignment. Once the current active tread erodes to a certain point, users move over several feet and begin wearing in a new tread and duplicating the problem. At the bottom of these PUDs are mud holes that will never properly drain. It is recommended to re-locate this section of trail to avoid the PUDs and steep terrain traveling

Above and Right and Below: Participants during the assessment process examine the many “trails” running through the wildlife clearings north of the dam.

Left: It only takes several passes of a heavy trail user such as a horse for this to begin to look like a trail. It is hard to manage the user on trails through open pastures and these should be avoided when at all possible.

through the edge of the wildlife openings. This will not only create sustainable trails, but it will also help to better manage the user to stay on a designated trail tread. The many trails running through the wildlife clearings will heal fairly quickly if disked and seeded. The new proposed relocation would use more run to gain the same amount of rise and therefore provide for more conservative grades and sustainable trail maintenance.

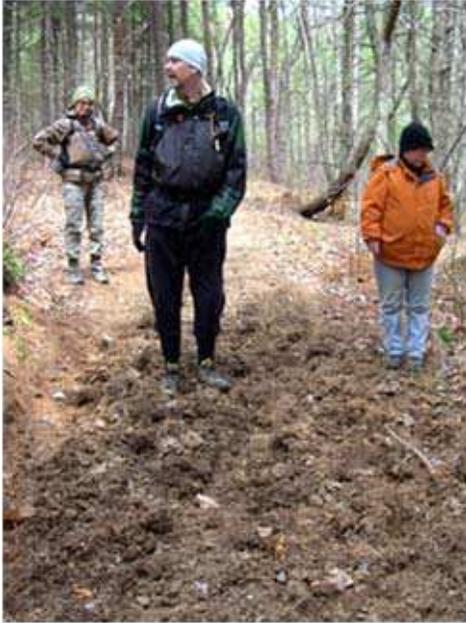
Right: Mud holes that are difficult to properly drain develop at the bottom of sections that are Pointless-Ups-And-Downs (PUDs). These mud holes are the combination of poorly drained flat areas with steep areas above where soil is being displaced.

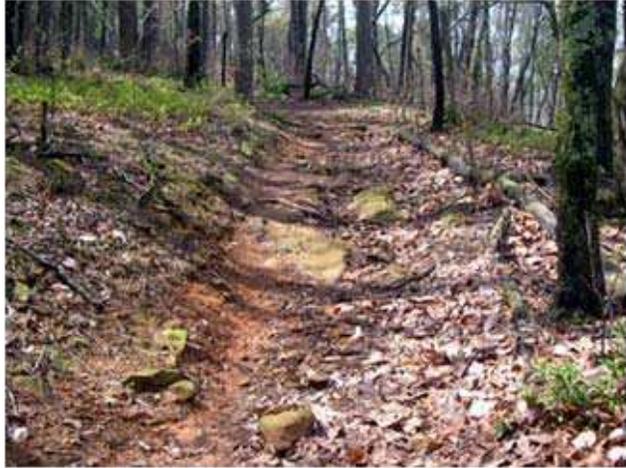
Above: Steep trail construction that results from a PUD is not sustainable and invites erosion.

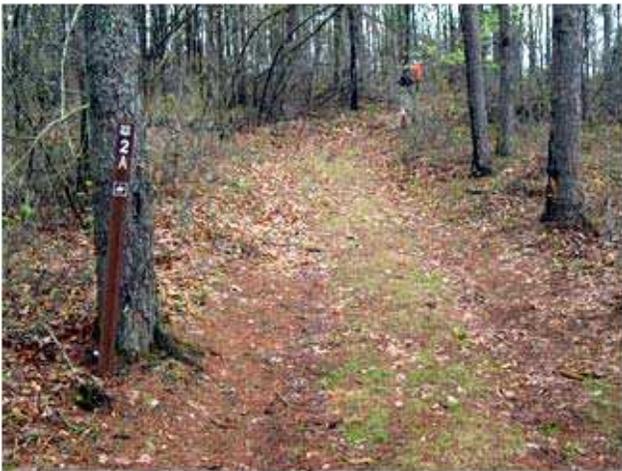
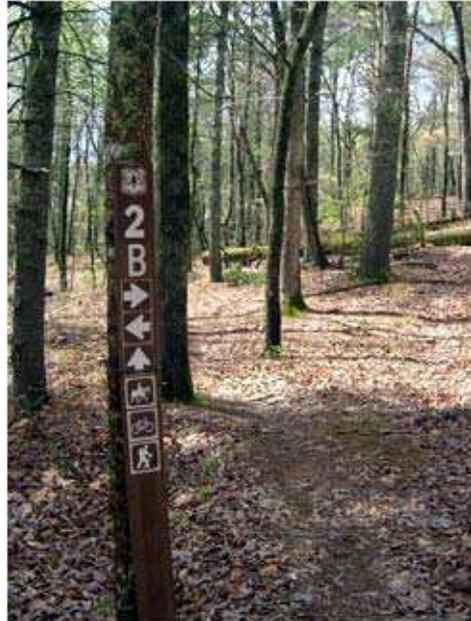
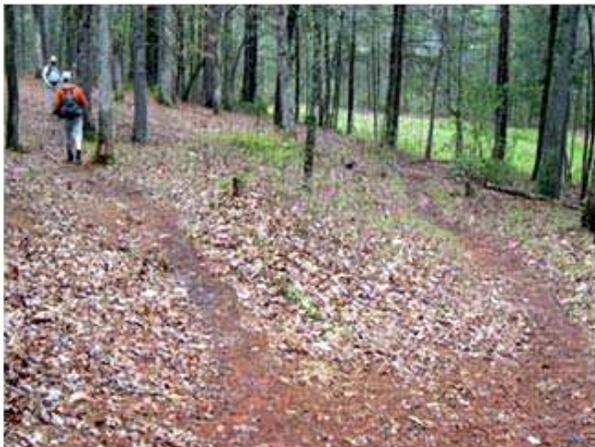
The last 0.14 miles of the Jones Creek Dam Trail functions as a connector trail between FDR 77 (marker 2A) to Nimblewill Branch C Trail 223L (marker 2B). This small section of trail is somewhat steep and difficult to sustain. Improved drainage with the addition of rolling dips and some surface hardening will help if traffic patterns remain low. This small section should be reclassified as part of the Nimblewill Branch C Trail 223L.

Intersection of FDR 77 and Jones Creek Dam Trail 223E. This section of Trail 223E connects between Marker 2A (**above**) and Marker 2B (**right**) to Nimblewill Branch C Trail 223L (below)

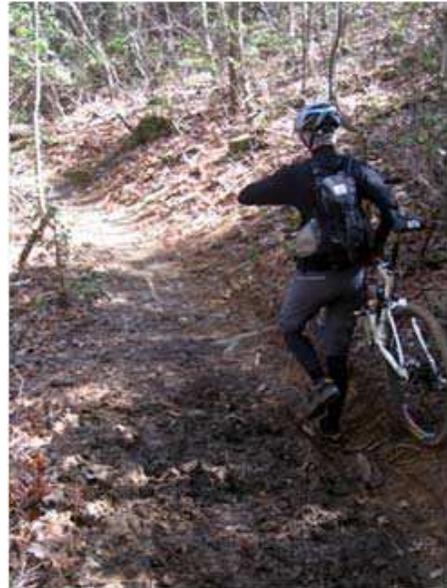
A mountain biker avoids a mud hole on the Trail 223F. Trail maintainers must look at the causes of mud holes before a suitable solution can be designed. Adding additional drainage up trail can help by eliminating soil loss. Some areas may need armoring with rock to prevent additional soil loss.

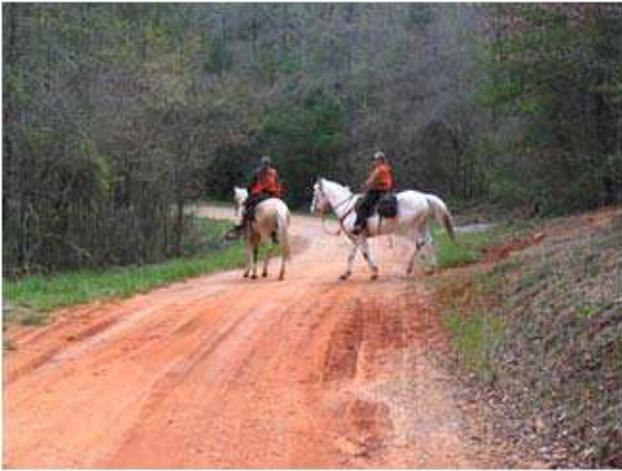
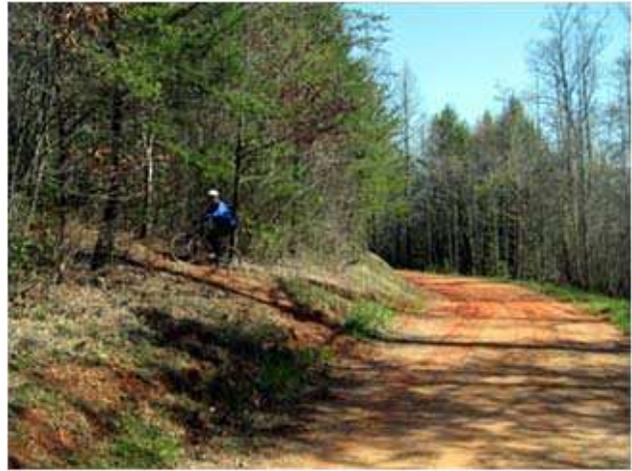
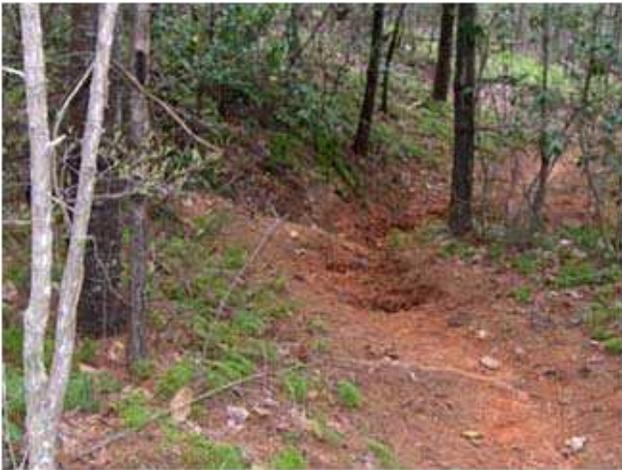
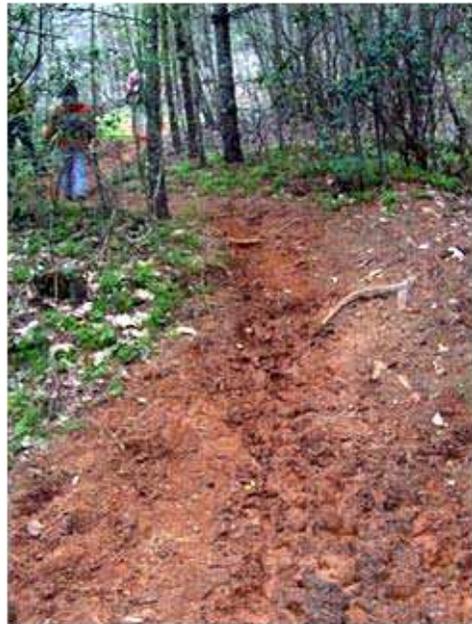
Above: The Bull Mountain Connector Trail shares a short section to cross Bull Mountain Rd – FDR 83. The sections of trail which drop to cross roads like this will need rock armoring to sustain steep fall-line grades.

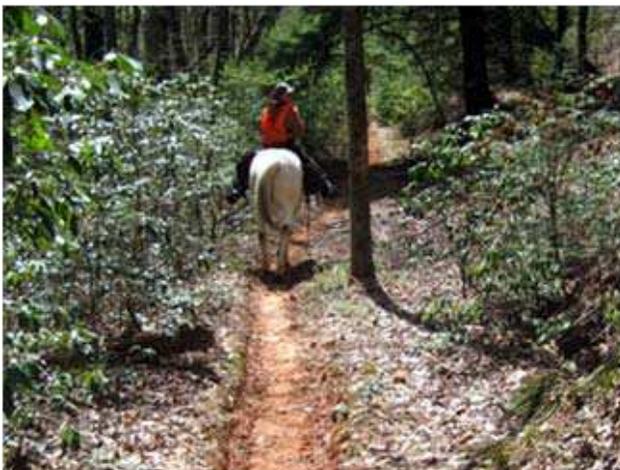
Left: This Horse Only segment of the Bull Mountain Connector Trail lies in the bottom of drainage and is difficult to dry out. Options include surface hardening with crushed stone, adding more meanders to help shed water, or slight re-alignment up slope to shed water.

At its second intersection with FDR 83, the user groups are split with the mountain bikes being co-located with FDR 83 and the horses/hikers on a trail that sits in the bottom of a drainage. The horse/hiker segment sits directly below the FDR 83 and therefore has an extensive amount of surface run-off coming from the road above. There are a number of wet and muddy spots on this section of trail; these are the result of flat areas on the tread and poorly draining soils (clay based). The recommendation to create sustainability is to surface harden with crushed stone, add more meanders to help shed water, and/or re-align the trail onto the eastern slope with meanders and undulations.

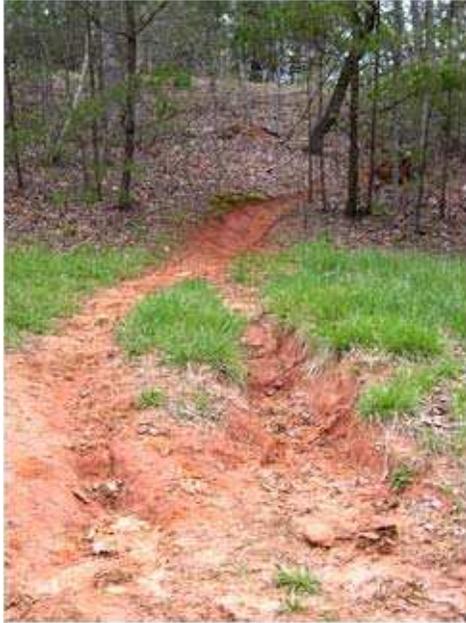
Left: The end of the horse/hiker section which connects to the Bull Mountain Kiosk and Trailhead needs rock armoring to prevent further erosion.

The horses/hiker section passes through the Bull Mountain Parking Lot and onto FDR 83 to connect back with the biker only section. There is severe erosion within the short connector trail between the parking lot and the road. Rock armoring will help this section from eroding any further.

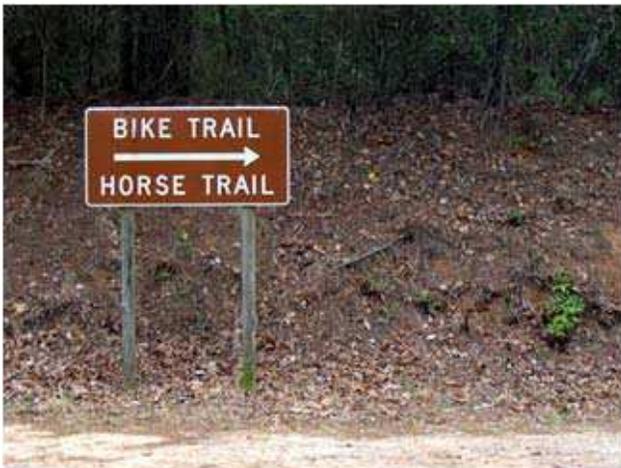
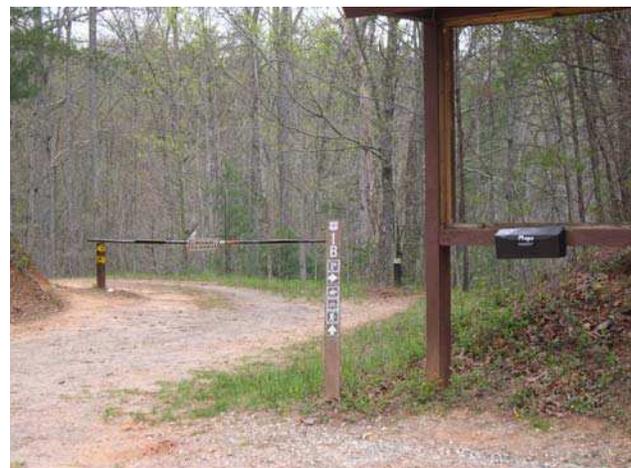
Above: After the biker and horses/hiker section joins back together, it continues north and is co-located with Bull Mountain Road - FDR 83 for 0.30 miles until its intersection with Bull Mountain Trail 223, Bull Mountain Cut-Off Trail 223D, and the Jones Creek Dam Trail 223E.

After the biker and horses/hiker section joins back together, it continues north and is co-located with FDR 83 for 0.30 miles until its intersection with Bull Mountain Trail 223, Bull Mountain Cut-Off Trail 223D (which is also co-located on FDR 83), and the Jones Creek Dam Trail 223E (which is also co-located on FDR 872). Jake Mountain Rd – FDR 299 and FDR 83 are main roads within the roads inventory. The inventory should not have dual designations as both a road and a trail. The recommendation is to remove the trail designation for the sections that are co-located with the inventoried Jake Mountain Rd 299 and FDR 83 and leave them coded only as roads. The biker only section that is co-located on the FDR 83 should be allowed to share the use with the horse/hiker only section that connects from FDR 83 to the Bull Mountain Parking area. Trail relocations are identified to remove the shared-use sections from being co-located with the roads.

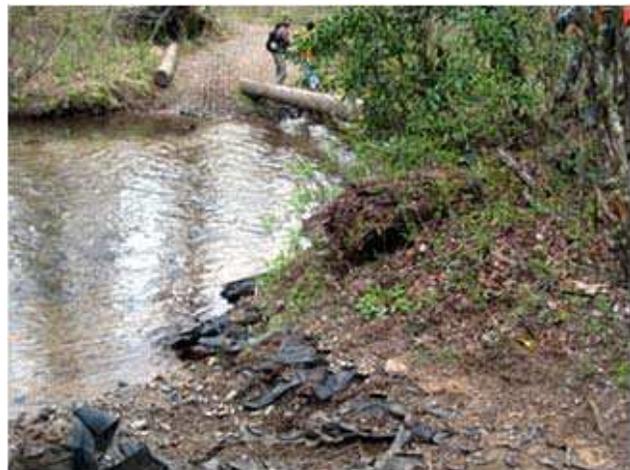
Jake Mountain Trail 223H crossing at Jones Creek. Note the geo-textile webbing hardened ford has failed.

Above: Jake Mountain Trail crossing Jones Creek. The hardened ford has failed at the crossing with Jones Creek.

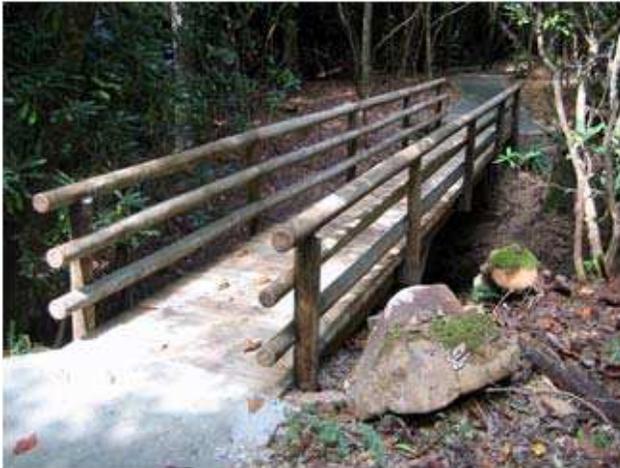
Left: Example of a bridge that can be designed and built strong enough to accommodate equestrian traffic, but such a crossing eliminates an opportunity to water a horse.

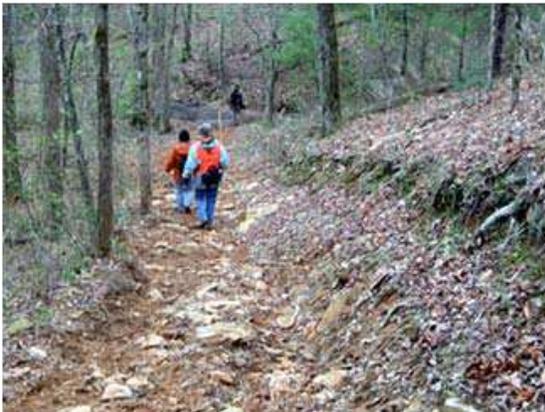
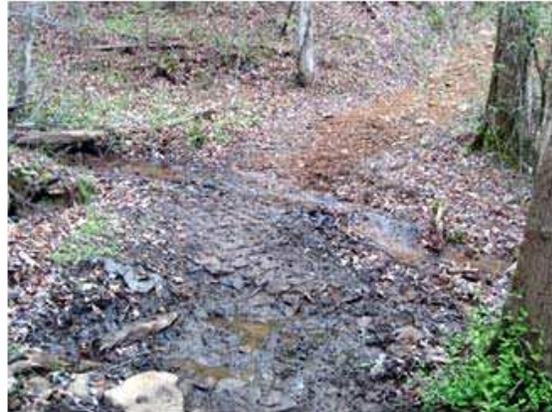
Above: The Jake Mountain Trail steeply descends to cross a small branch of Jones Creek.
