Jake and Bull Mountain Trail Assessment and Management Plan

Promoting Recreation & Environmental Protection through
Assessment, Collaboration and Education

USDA Forest Service
R8, Southern Region
Chattahoochee-Oconee National Forest
Blue Ridge Ranger District

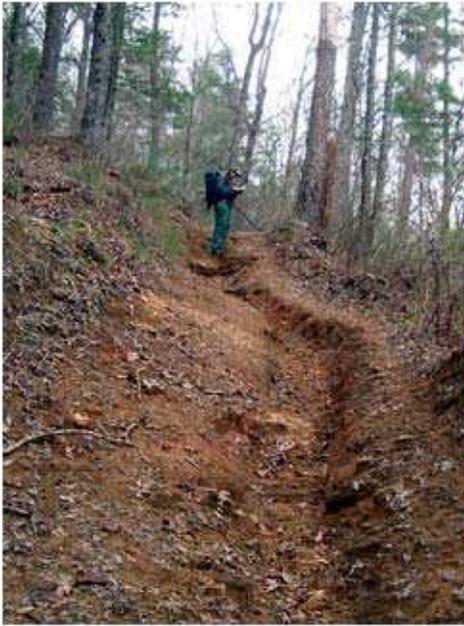
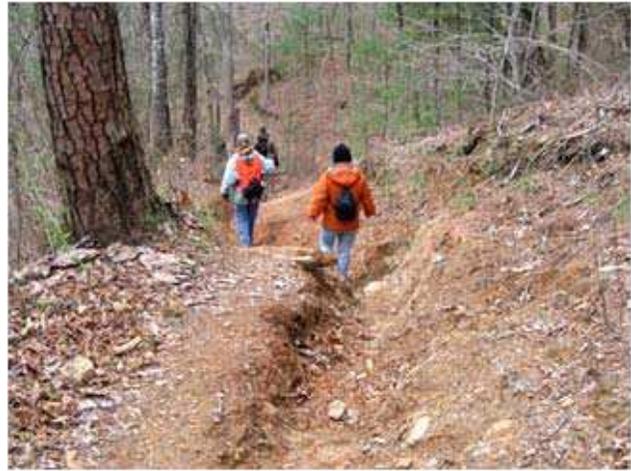
Above and Left: Significant erosion is seen on the Jake Mountain Trail as it climbs a steep ascent to gain a ridge above Jones Creek.

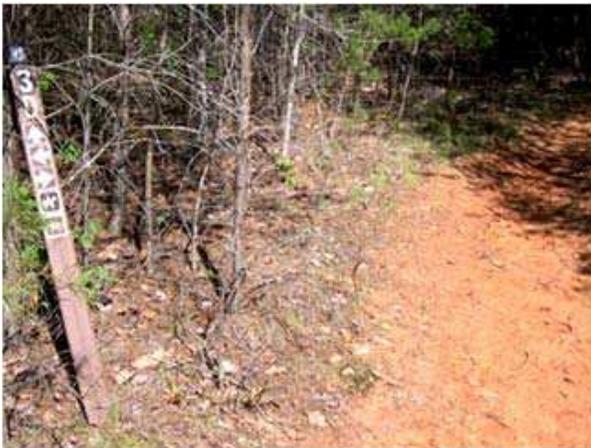
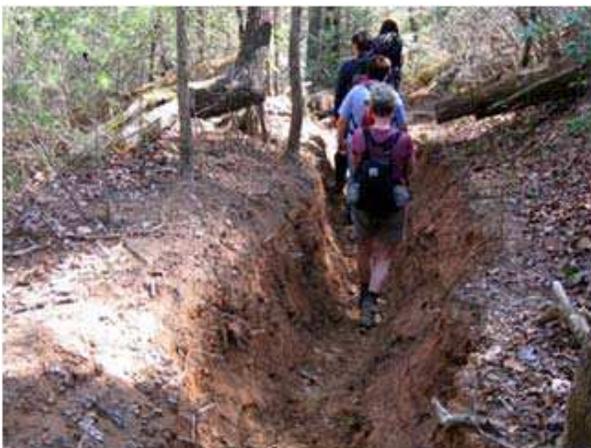
After its crossing with Jones Creek, the trail steeply climbs yet another ridgeline to its intersection with the Moss Creek Trail 223J (Marker 3D). From this intersection, the Jake Mountain Trail continues northbound as the segment locally known as the “Beaver Pond Trail”. This segment is experiencing extreme erosion with gullies reaching up to four-feet deep. This is clearly a risk management concern and does not meet US Forest Service specifications.

Above and Left: The Beaver Pond segment of the Jake Mountain Trail is severely eroded and poses risk management concerns.

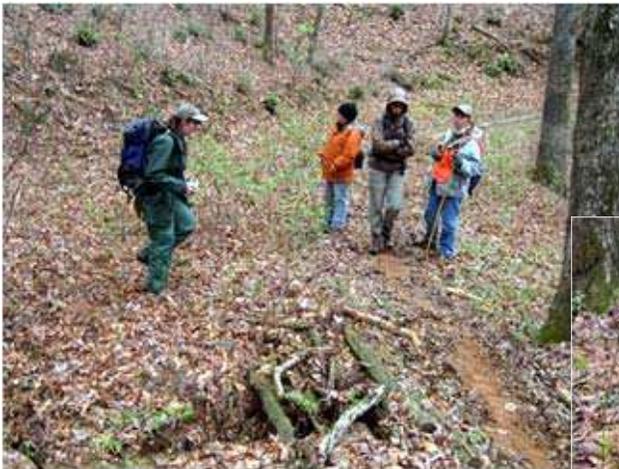
Above and Right: Sinkholes along-side the upper section of Moss Creek Trail pose a hazardous situation for equestrians and other trail users.

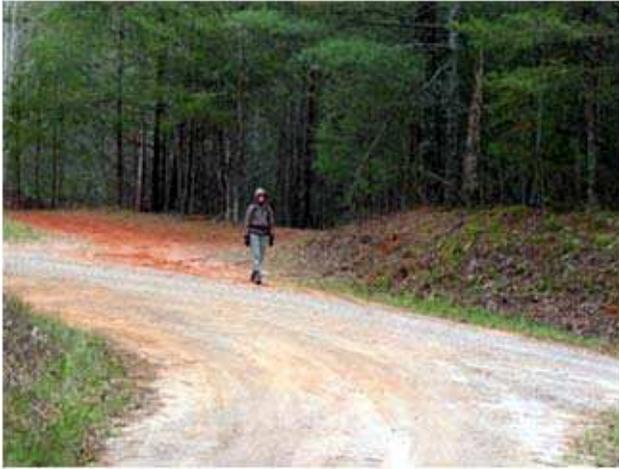
The trail climbs out and crosses FDR 77 and FDR 28-1 and descends to cross Moss Creek with grades exceeding 35+%. This section of trail has very aggressive grades and lacks positive drainage features such as grade reversals or rolling dips. It is impossible to tell at this stage of trail degradation if drainage features were built in during a construction process and have failed, or if they did not get planned and designed into the initial construction. The final stretch runs 1,000+ linear feet without any drainage and is a knee deep below-grade gully.

Above: The trail climbs out and crosses FDR 77 and FDR 28-1 and descends to cross Moss Creek with grades exceeding 35+%.

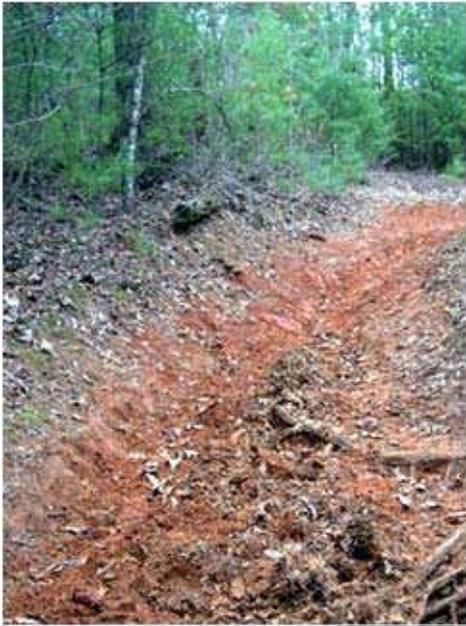
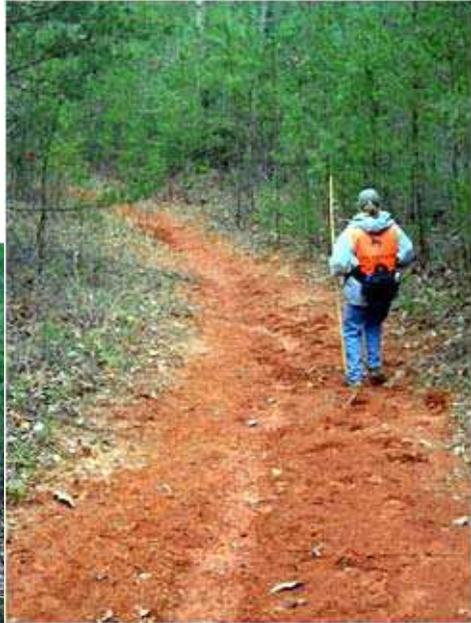
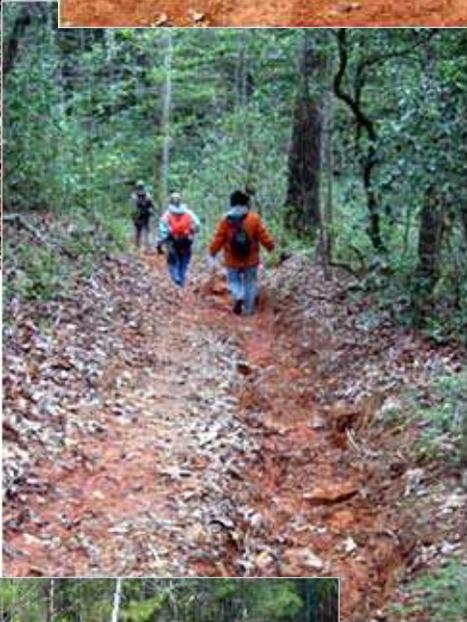
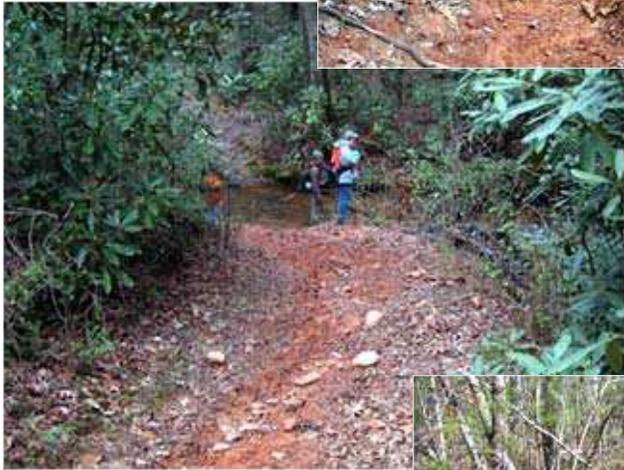
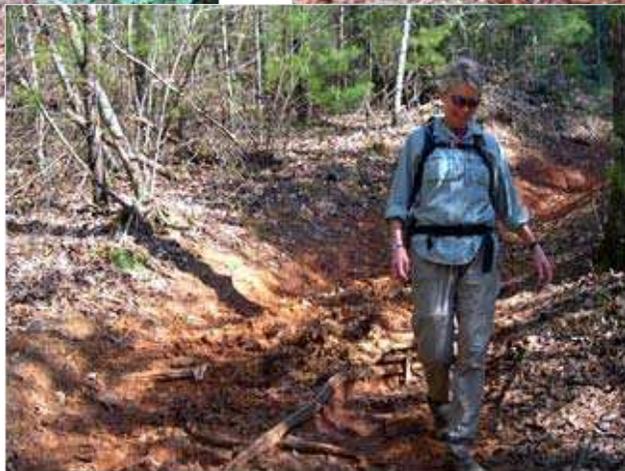
All: The Moss Creek Trail descends with grades exceeding 35+% towards its crossing with Moss Creek, and runs 1,000+ linear feet without any drainage features. This section of trail is having a serious negative impact on water quality and needs to be closed and stabilized.

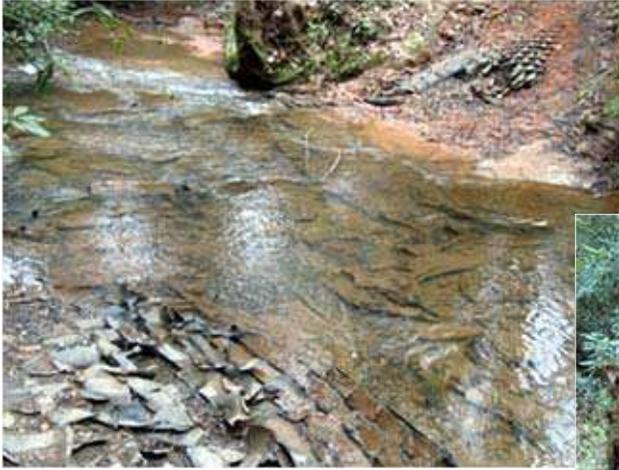
All: The geo-webbing structure within Moss Creek has failed, resulting in impacts to water quality and hazards to equestrian users. Moss Creek is experiencing a tremendous amount of sediment loading with serious negative impacts on water quality.

A temporary solution to this serious resource concern would be to immediately close the trail to all users and place straw bales every

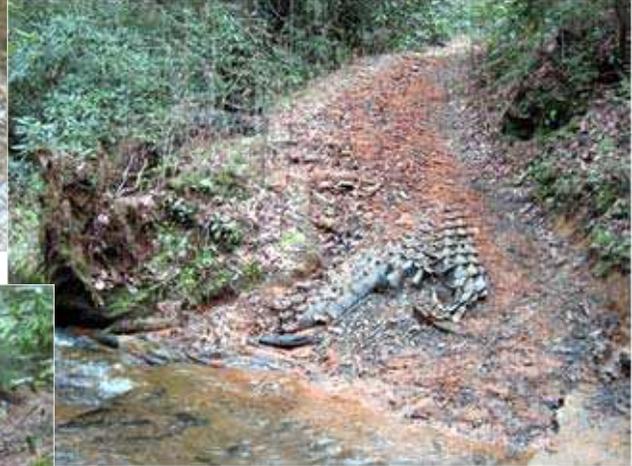
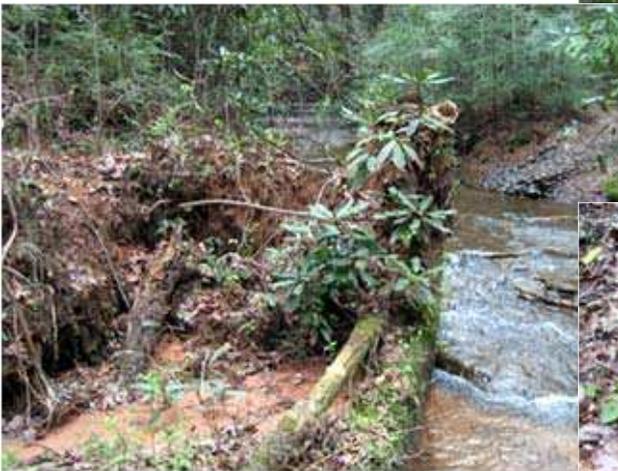
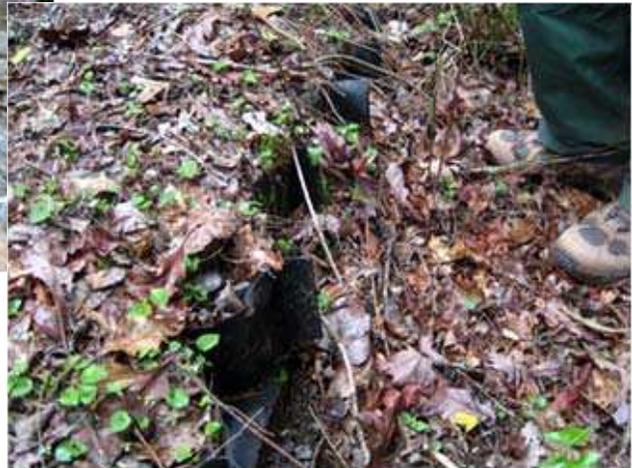
The Moss Creek crossing consists of black plastic geo-cell webbing filled with gravel. This structure has failed and lacks the durability required to withstand extremely high levels of equestrian use and the resulting impacts caused by horses. When this structure failed, the geo-cell webbing had floated freely within the creek, resulting in an equestrian hazard where horses could get their hooves caught within the geo-cells. Apparently the failed and freely floating webbing had been cut-out and removed from the creek to illuminate the greatest

50-100 feet as check dams. Pine straw or hay straw could be used for this application where the key is to have good surface contact between the bale and the eroding trail tread. This will help to reduce the velocity of water by frequently breaking up its force and speed. It does not, however, significantly reduce the volume of water running down the 1000+ linear feet of trail straight into Moss Creek. This stabilization should only be considered a short term solution until a more thorough closure and stabilization can be performed.

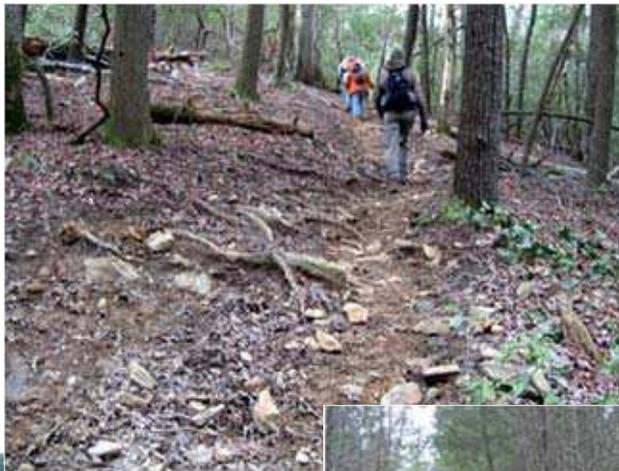
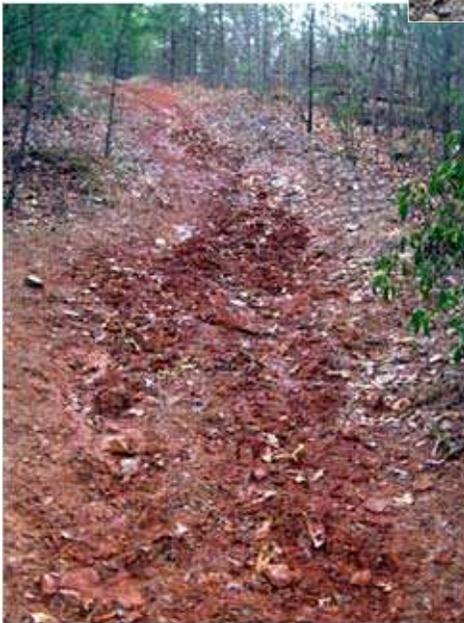
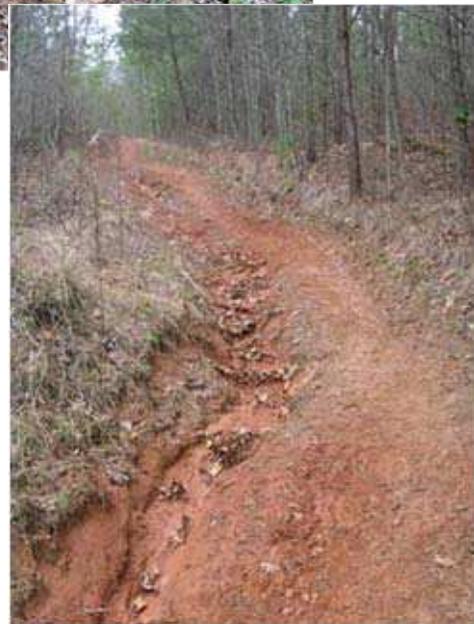
Left, Middle and Right: The Moss Creek Trail climbs aggressively to its intersection with the Jake Mountain Trail.

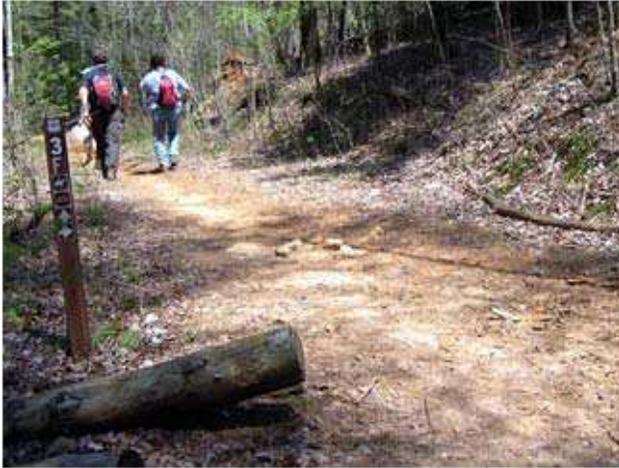
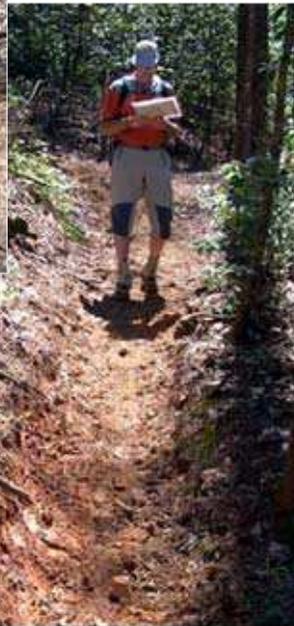
Above and Right: Nimblewill Branch Trail begins at Moss Hill Rd 28B, and then descends an aggressive 35+% grade to its intersection with the terminus of Jake Mountain Trail 223H.

The short segment of Trail 223K that begins at Moss Hill Rd – FDR 28B descends an aggressive 35+% grade to its intersection with the terminus of Jake Mountain Trail

223H. This segment appears to be user created and is mostly fall-line in its alignment. Due to steep fall-line grades, this short 0.15 mile section needs to be closed, stabilized, and removed from the trail system inventory. It is suggested that the

Jake Mountain Trail 223H terminate at the junction with FDR 28-1.

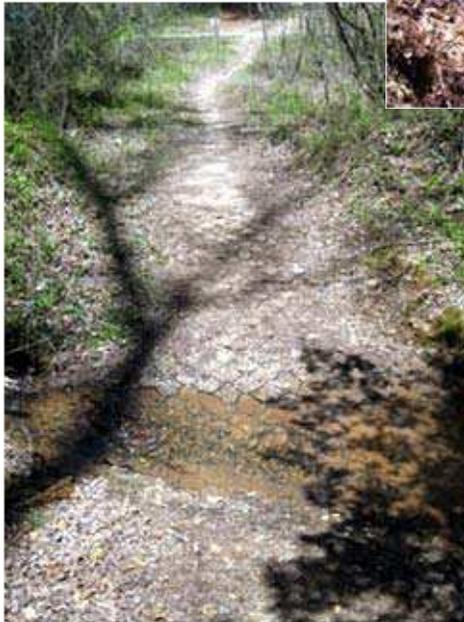
Prior to intersecting with FDR 28-1, Trail 223K crosses over Moss Creek, and again, the geo-webbing is failing. This small stream crossing needs to be hardened with a shallow stream ford to both replace the failing geo-webbing and reduce future user impacts.

Above: The geo-webbing installed at this small crossing of Moss Creek is failing and needs to be replaced with rock armoring.

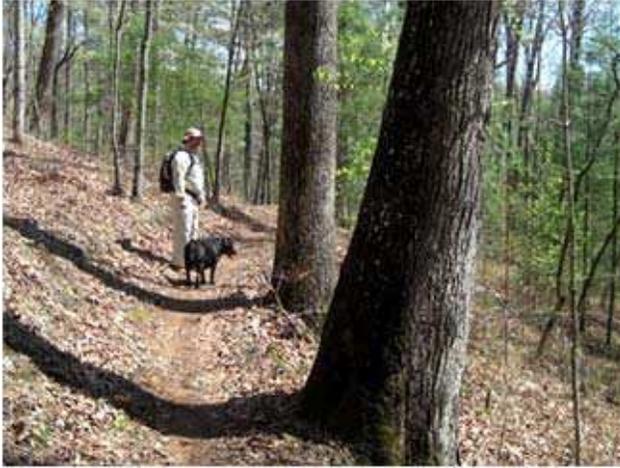
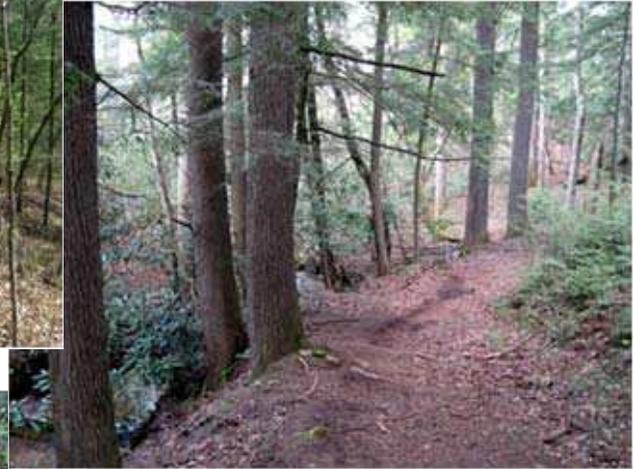
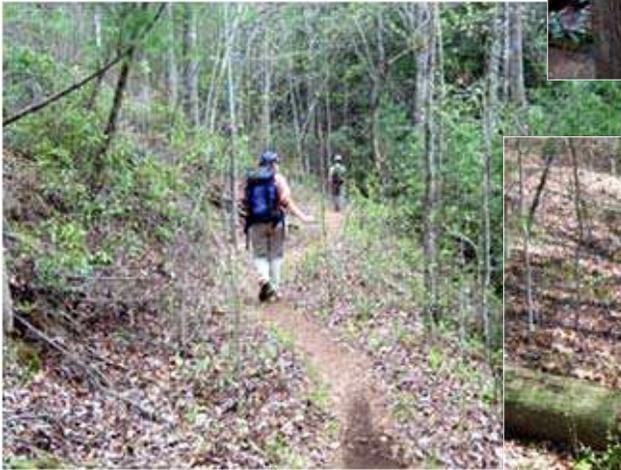
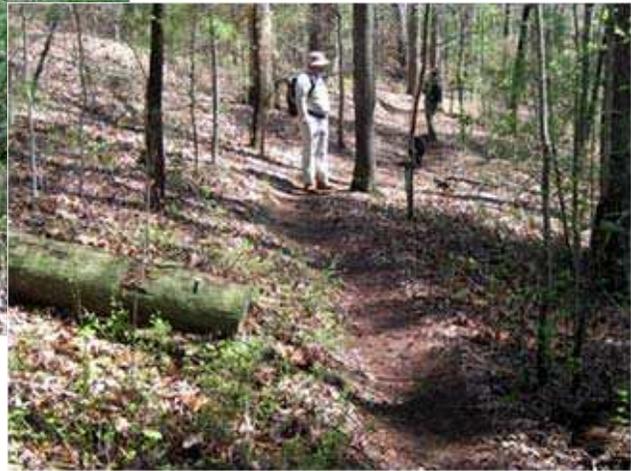
These particular segments of Trail 223L and 223M represents textbook sustainable trail design and construction. The trail is well anchored with interesting trees, is out-sloped, has undulations to effectively shed water, and has conservative grades to withstand user impacts.

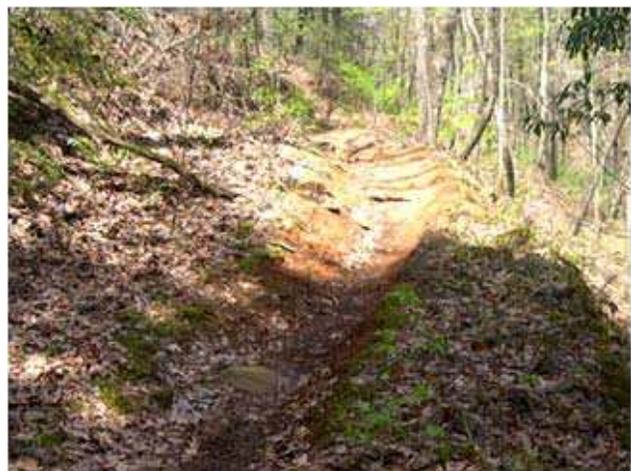
The first 100 yards of where Trail 223L takes-off from its intersection with FDR 77 contains a steep gradient that needs to be rock armored and more aggressively drained to be made sustainable.

(See Photo to Right)

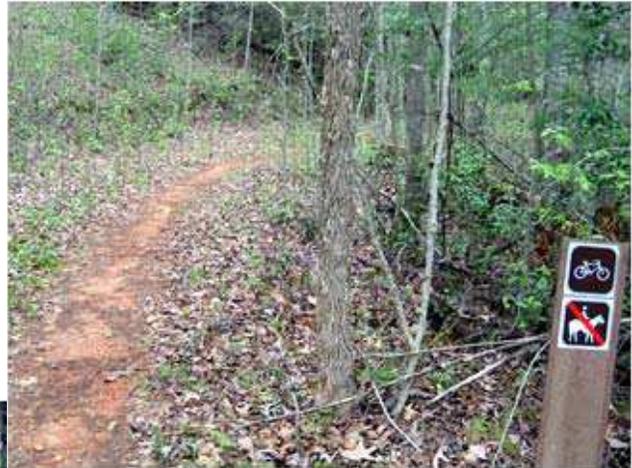
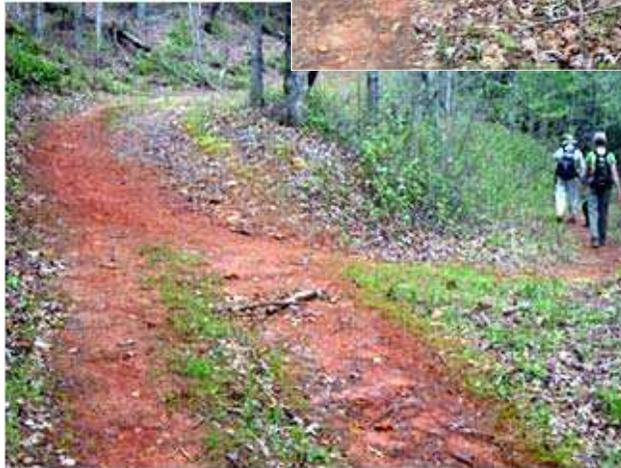
Left and Above: Nimblewill Branch C Spur Trail 223M is designated as bikers only.

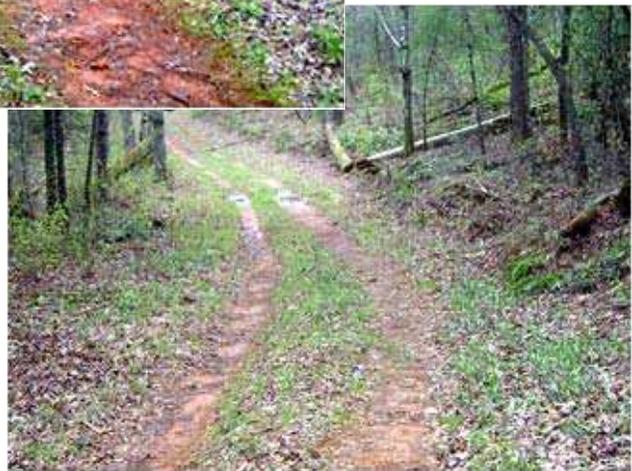
Above: The last half-mile of Nimblewill Branch C Trail 223L is co-located with FDR 28C between its intersection with Trail 223M and FDR 28-1.

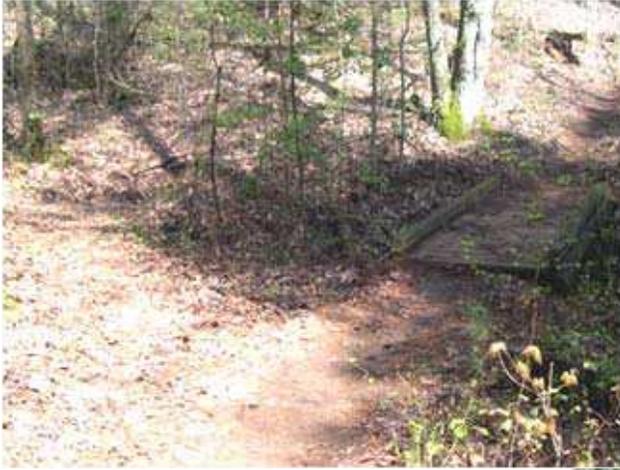
There are 2 bridges on the 223L and 223M trail segments. The first bridge is located on the shared-use half of Trail 223L. Upon inspection, the bridge is in need of being removed. The boards are sagging from the heavy weight of equestrian use. It is obvious that this bridge is not being used to cross the small stream as there is a user-created trail which goes around the bridge. Equestrians typically water their horses at stream crossings, and by doing so, create an area of impact adjacent to bridges. The recommendation is to remove this bridge and construct a shallow stream ford to protect the stream from additional user impacts.

Above: The first bridge is located on the shared-use half of Trail 223L.

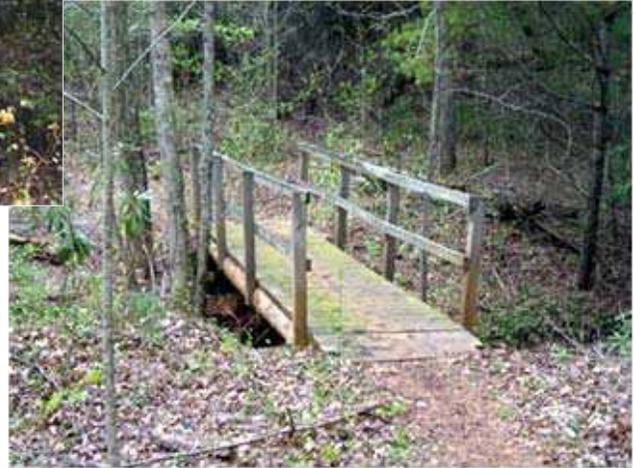
Right: The second bridge is located on the bike only section of the C Spur Trail 223M.

The second bridge is located on the bike only section of the Nimblewill Branch C Spur Trail 223M. Inspection of this bridge deemed it to be in great condition.

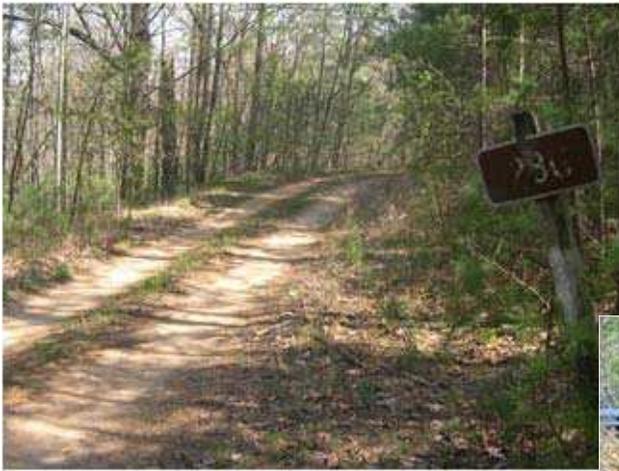
The signage in the field is flip-flopped, with the western half signed as FDR 28G (open road).

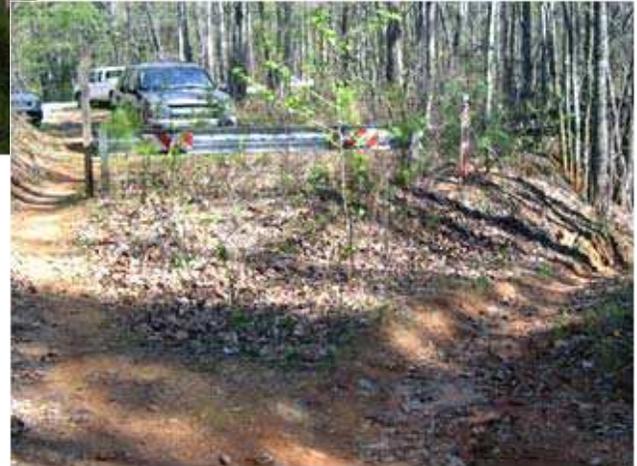
Flip-flopped signage on the eastern half signed as FDR 28F (closed with a permanent barricade).

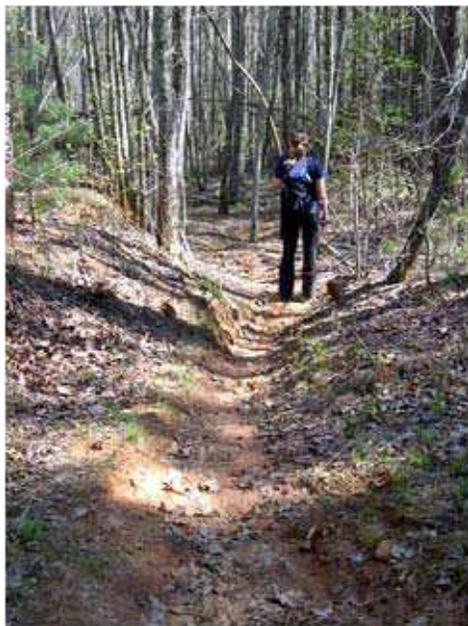
The Black Branch Connector Trail 223O (Photo to Left) is a small 0.12 mile segment which connects from FDR 28-1 to Black Branch Trail 223N. In addition to the 223O connector trail, the Black Branch Trail 223N also takes off from the intersection of FDR 28F and FDR 28-1. This trail is a popular loop when riding within the Jake Mountain area.

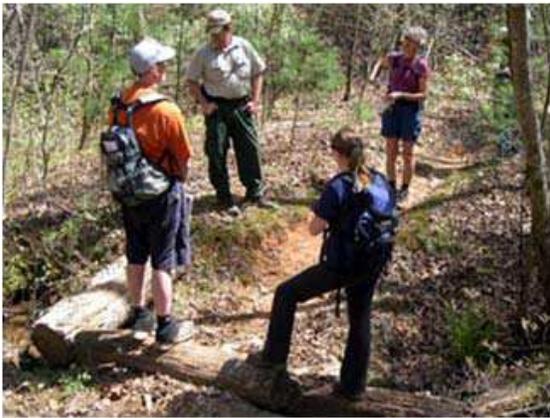
The eastern half of the loop (Upper Nimblewill Rd - FDR 28F) is located on a sustainable contouring old road bed for much of its distance. There is a small creek crossing that needs armoring and a section that crosses private property.

With rock armoring, this small stream crossing will become sustainable from the impacts of equestrian traffic.

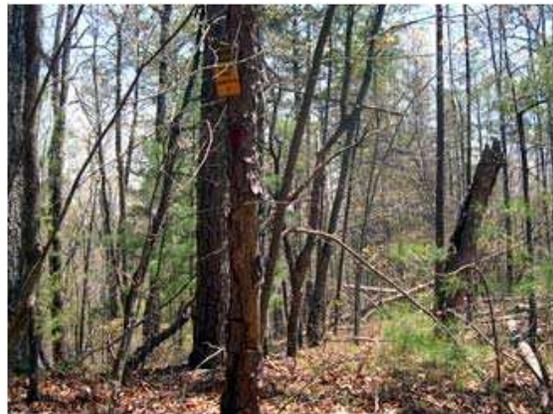
A portion of the Black Branch Trail traverses private property.

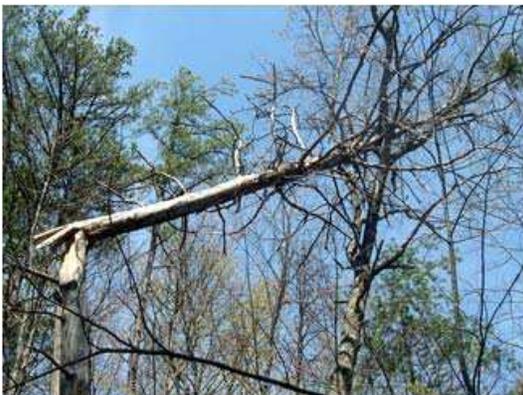
Left: There are several hazard trees located at the higher elevations of the Black Branch Trail.

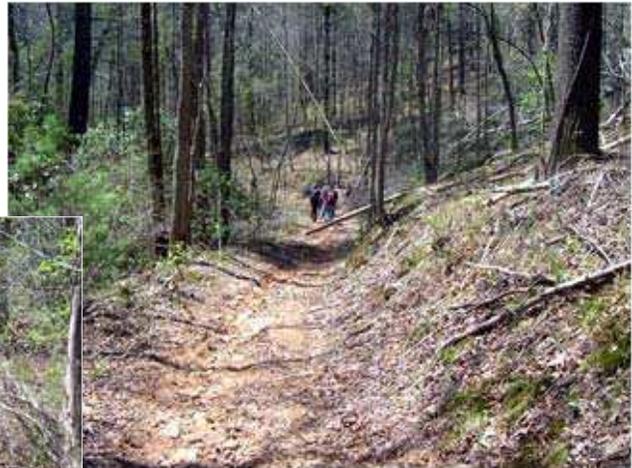
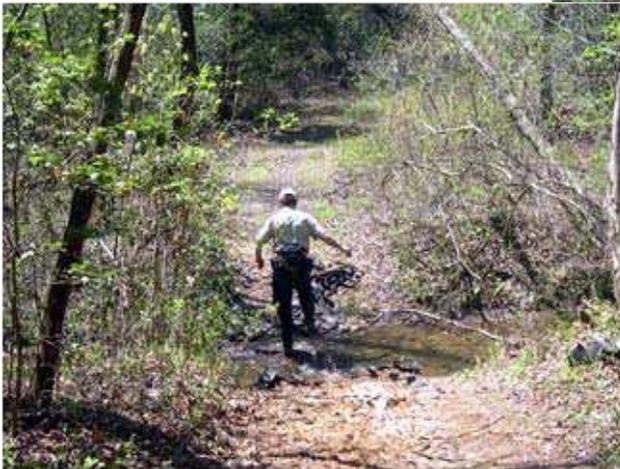
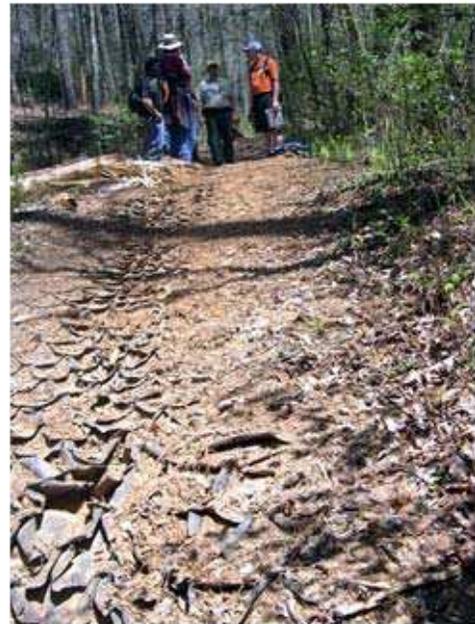
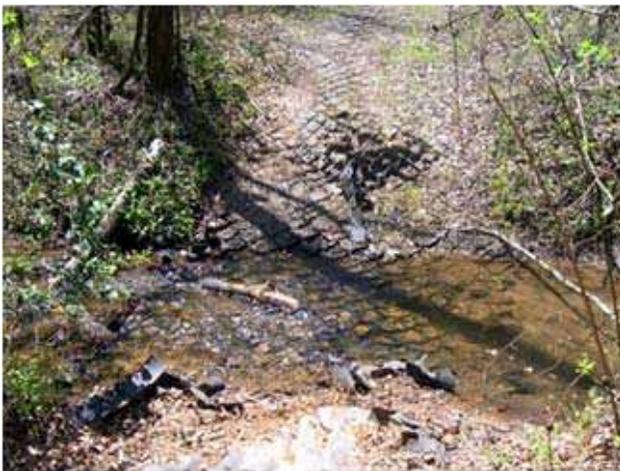
The trail connects with the western half of the loop (FDR 28G) by following an old extraction route which drops elevation aggressively (at a grade greater than 35%) to cross Black Branch Creek, and then climbs aggressively to connect with FDR 28G. As was the case at Moss Creek and Jones Creek, this section of trail is referred to as a “pointless-up-and-down” (PUD) that has steep aggressive grades which descends / ascends to cross two sections of Black Branch Creek with little if any positive drainage. These steep PUD sections are experiencing erosion which is loading heavy amounts of sediment into the stream crossings. As can be expected, the stream crossings have geo-cell webbing that has failed due to not being designed to handle impacts resulting from equestrian use.

All: The Black Branch Trail contains a “pointless-up-and-down” (PUD) aggressive grade which descends / ascends to cross Black Branch in two locations. The geo-cell webbing has failed at both crossings.

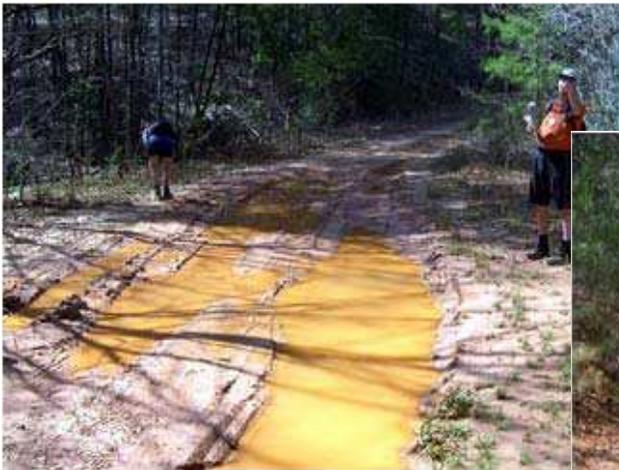
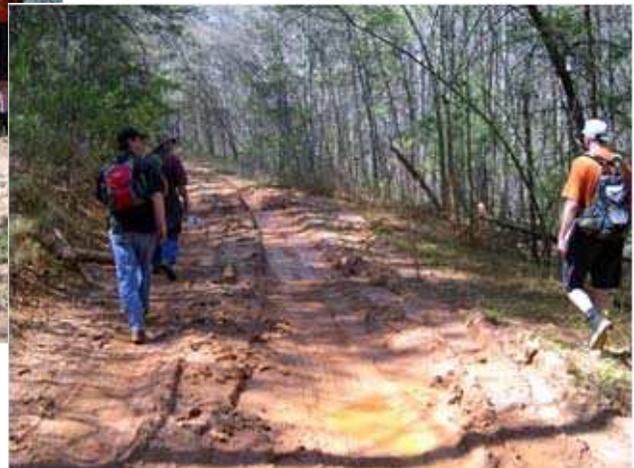
Above and Right: Signs of vehicle traffic and mud bogging in the western portion of Black Branch Rd - FDR 28G.

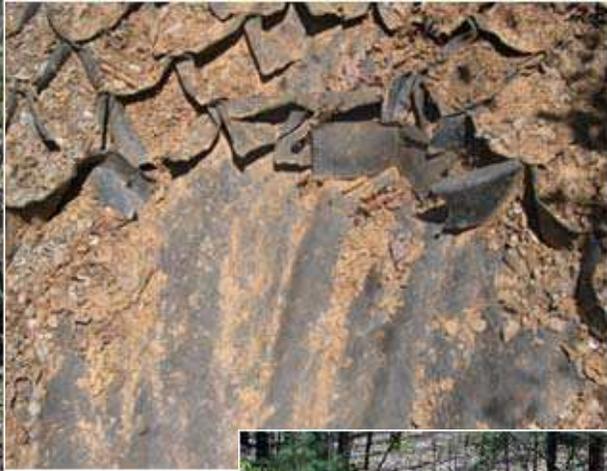
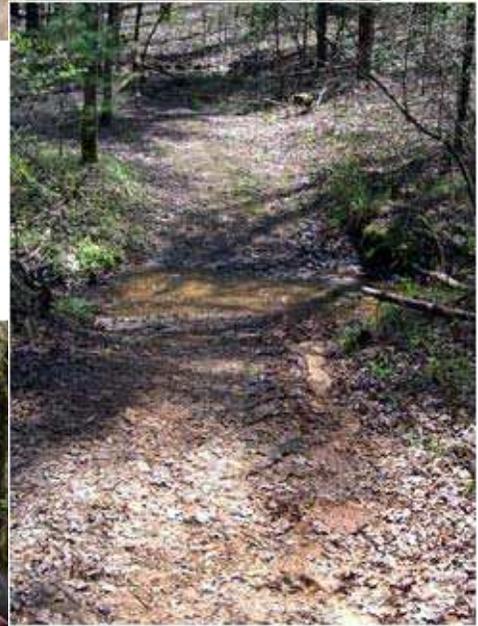
Above, Top Right, Middle Right and Below: Woody Keen provides an education session on the pros and cons of the different options for stream crossings. Rock armoring would provide the best material to stand-up to the heavy impacts resulting from equestrian use.

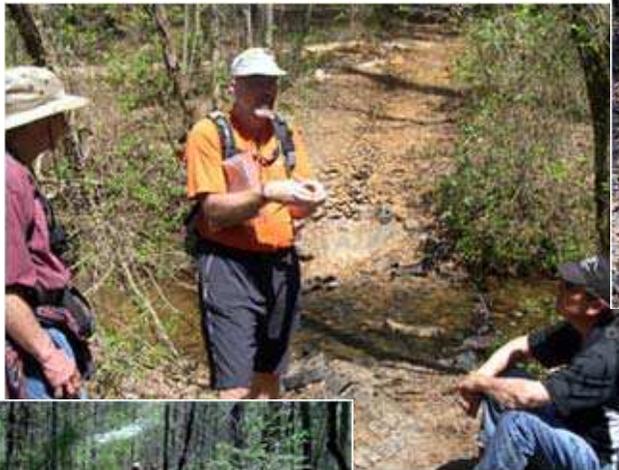
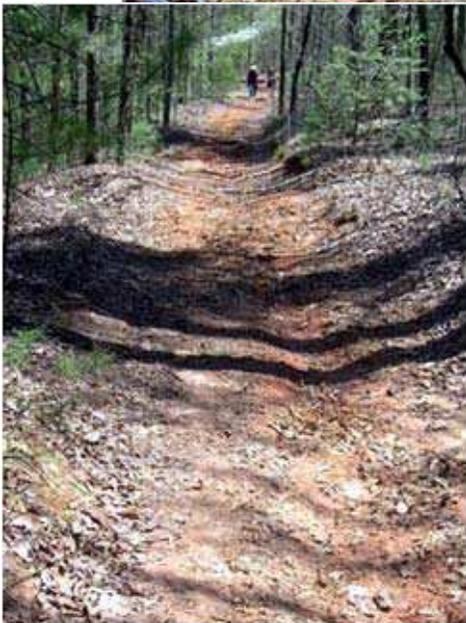
Left and Right: After crossing Black Branch Creek, the trail climbs a steep ascent to its connection with FDR 28G.

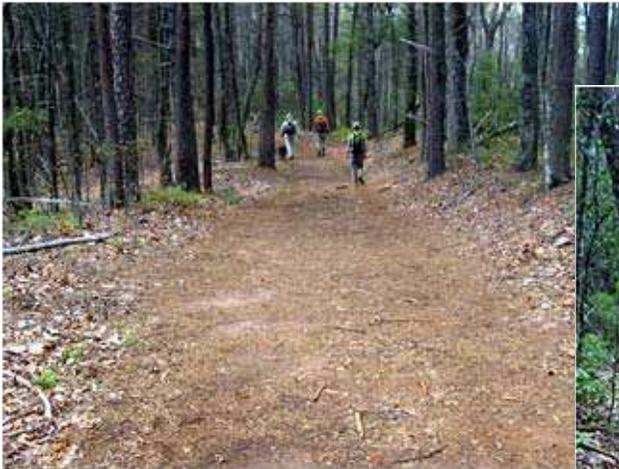
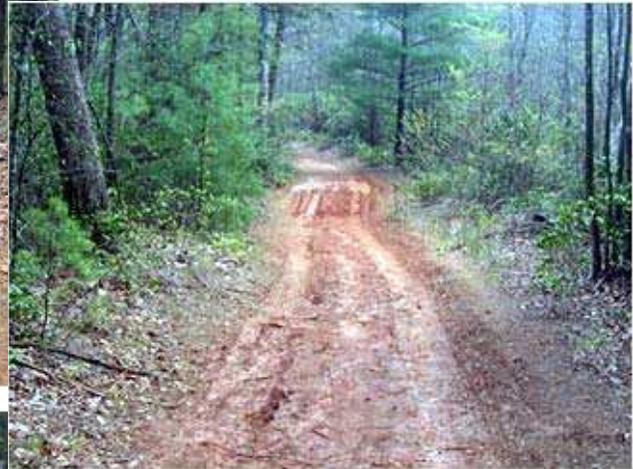
Above and Right: The first mile of No-Tell-Trail is co-located on an un-inventoried road. This road is actively used to access wildlife clearings and should be added to the roads inventory and removed from the trails inventory. The trail departs the road bed and enters forest as pictured to the right.

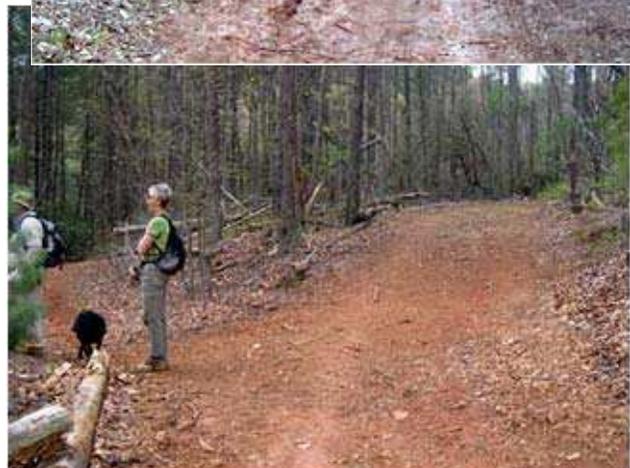
The grade of this road to gain the ridge is not overly steep, however, where the trail turns off and becomes a trail heading southwest; it plunges for 0.2 miles down a steep fall-line and is not sustainable. It is recommended to close this short section of trail and design/build a re-location that will provide for sustainability by contouring with the landscape rather than the current location that gains the high ridge on its way to Little Sal Mountain. The old roadbed can still be used as an access route to wildlife food plots, but this road will need to be closed to recreational traffic. Disking and seeding the 0.2 miles trail which is located on a fall-line and proposed for trail closure with an appropriate wildlife mix will reduce continued soil loss off the road due to excessive un-surfaced soil and steep gradients.

The southwest trail is steep fall-line and is not sustainable.

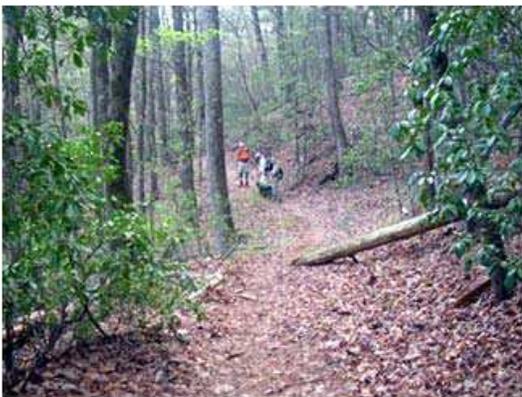
Section of trail in fair condition, but could benefit from minor trail maintenance to include additional undulations and meanders.

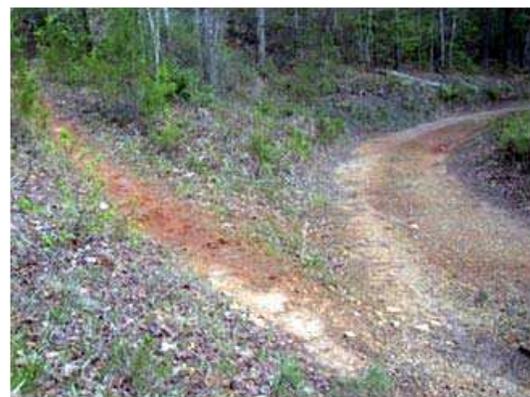
Trail tread ends at the intersection with FDR 28A.

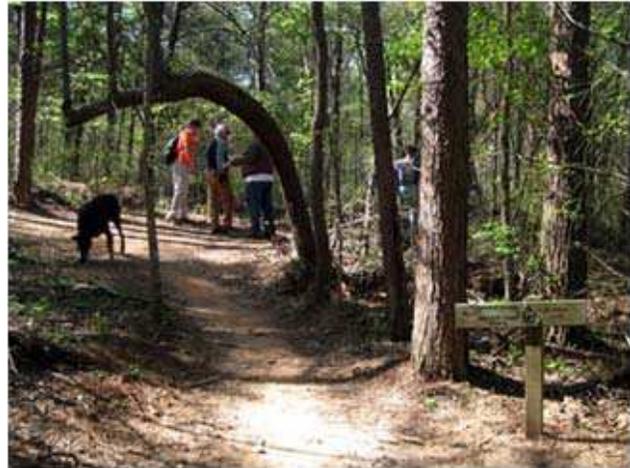
Trails designed and managed for mountain bikes can have a tighter more intimate feel, and overhead clearance is not as high as on a horse trail.

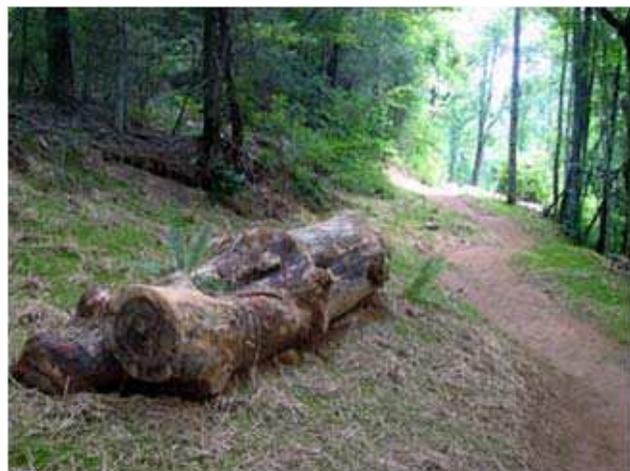
An example of good road-to-trail conversion. The trail is forced to the outside edge making it easier to drain water off the tread. The meander of the trail also helps manage water and makes for a more interesting trail experience. One of the keys of a good road-to-trail conversion is landscaping.

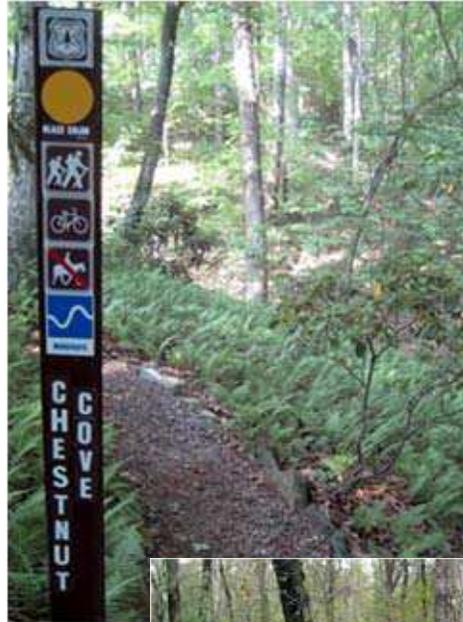
Left: This trail marker sign contains good and important information to convey to trail users, and will help them make better trail use decisions based on provided information.

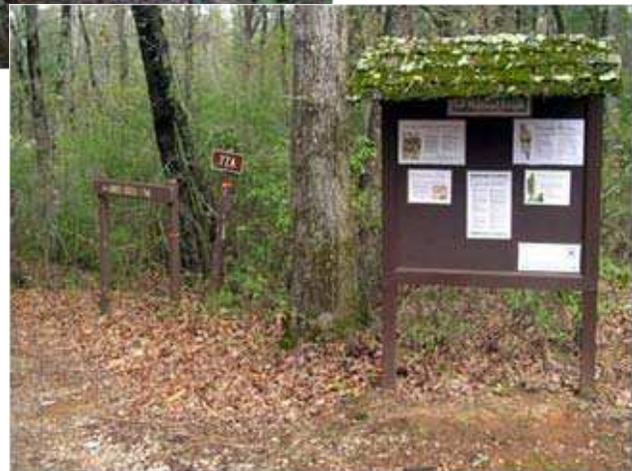
Below: A trail kiosk is the best tool for land managers to convey needed information to users about the trail system. A current map with marking indicating kiosk location is a critical aspect of any good kiosk.

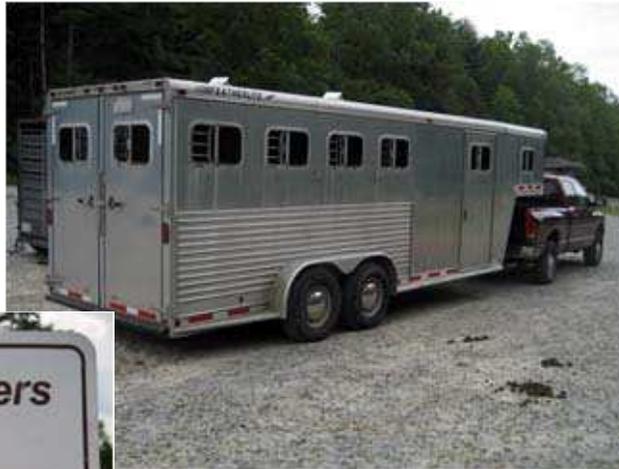
Above: In addition to human waste, horse droppings can become a problem at high use equestrian trailheads and camping areas.

In addition to human waste, there needs to be better management of horse manure droppings both within the parking area and campground. With the amount of horse use this trail system is currently experiencing, and the projected increase in numbers, manure needs to be managed somewhere besides being tossed into the woods. Equestrians should be encouraged to clean up after their horses through better signage; recommendations could entail hauling off any droppings or providing manure storage areas.

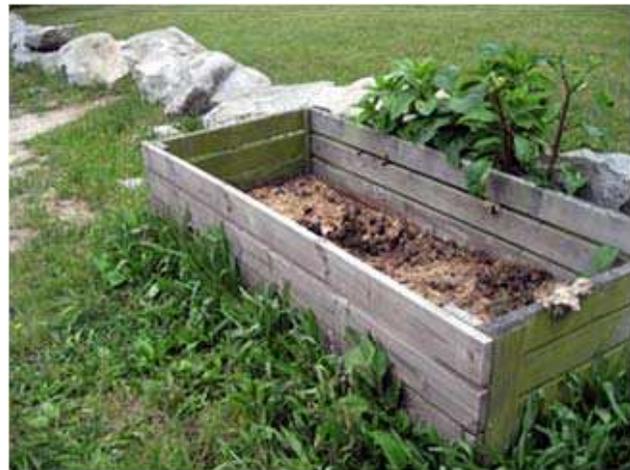
Above: A sample of a collection area for horse droppings as seen in DuPont State Forest.

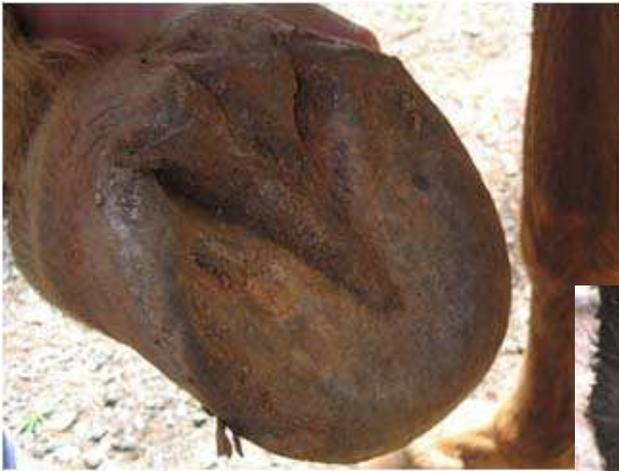
Above: A beautiful example of a barefoot horse with a “natural trim”. This hoof will certainly have less impact as compared with a shod horse.

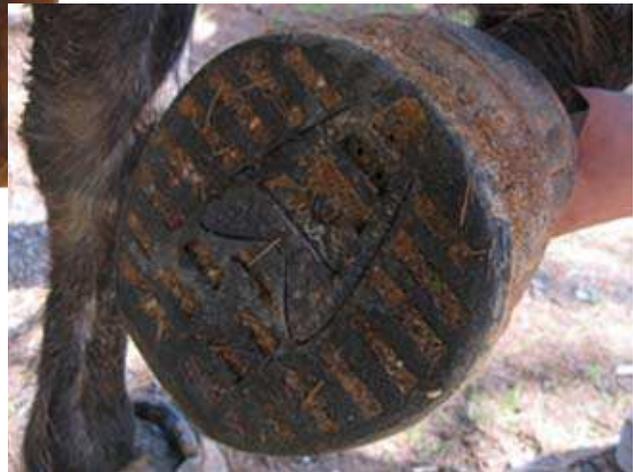
Above: The trend of rubber hoof boots for horses is encouraging as this greatly reduces the impacts of horse travel on trails. The displacement forces are reduced by an increased surface area (lower PSI) and because of the softer durometer of the rubber boot as compared with a shod hoof.

Part of the transition process is the use of hoof boots. Hoof boots greatly reduce the impacts of horse use on trails in several ways. They increase the surface area of the hoof in contact with the trail tread, this in turn decreases the PSI factor, the rubber boot is much softer than the metal

shoe, and the boot eliminates the lip of the raised shoe which has more of a digging effect when traveling.

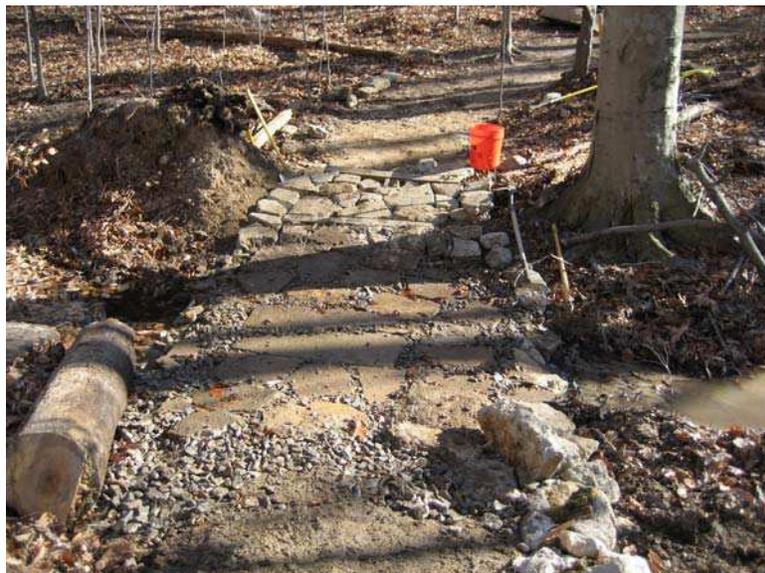
Right: An example of a hybrid stream crossing project utilizing compacted stone for the approach side and more durable flag-stone armoring for a steeper exit.

Hardening the exits and entrances into crossings can be achieved with a layering effect of different sizes of aggregates. Rip-Rap forms the first course layer and provides a very strong and stable base. If extremely wet conditions exist, consider using a layer of geo-textile to help prevent stone loss. The next layer is railroad ballast also sometimes known as surge stone. This 2-4 inch stone is applied directly on top of the rip-rap with no separating layer such as a geo-textile. This course should be 2-4 inches thick preparing for the top dressing of crusher run (ABC stone). This top layer should be 4+ inches thick and wetted and then compacted. Durable flag-stone can be used to provide a tapered effect along the outside edges of the stream channel.

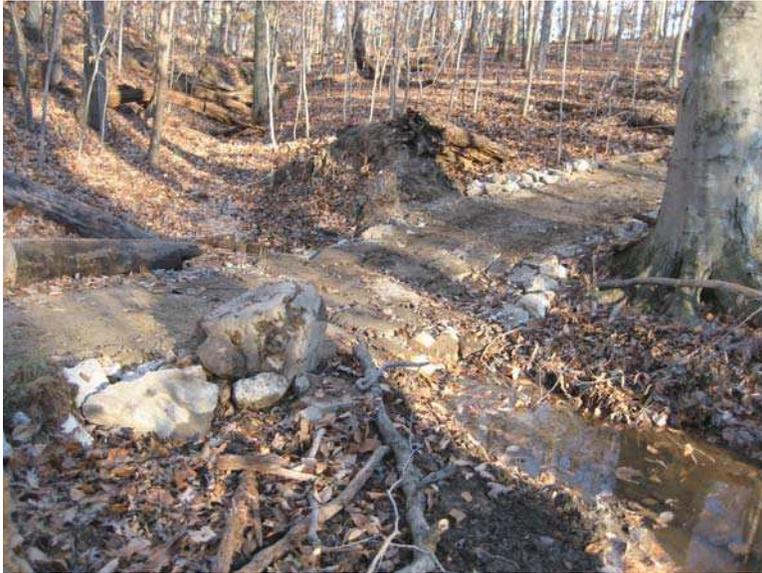
Left and Below: The same example of a hybrid stream crossing project viewed from a different angle.

Left: Flag-stone armoring is used to provide a tapered effect along the outside edges of the stream channel.

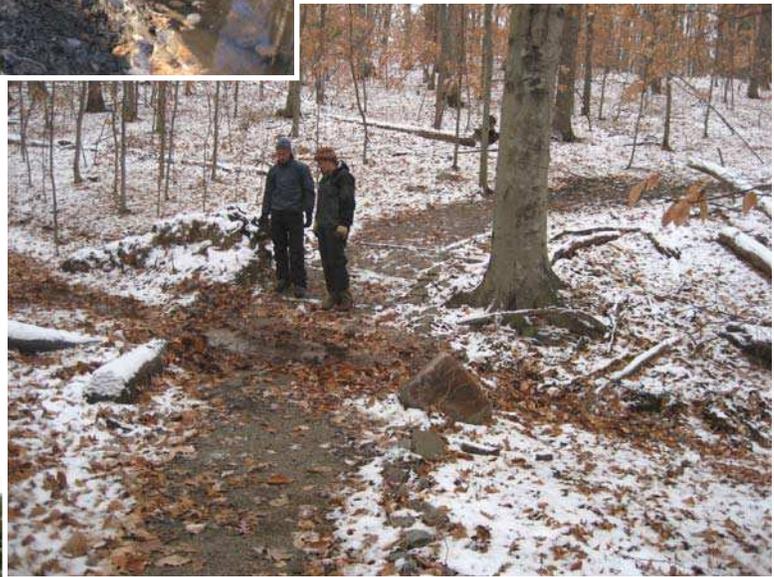
Left: Another example of a hybrid stream crossing.
