United States
Department of
Agriculture

General Technical
Report NE-135

Design and Construction of a Low-Cost Stream-Monitoring Shelter

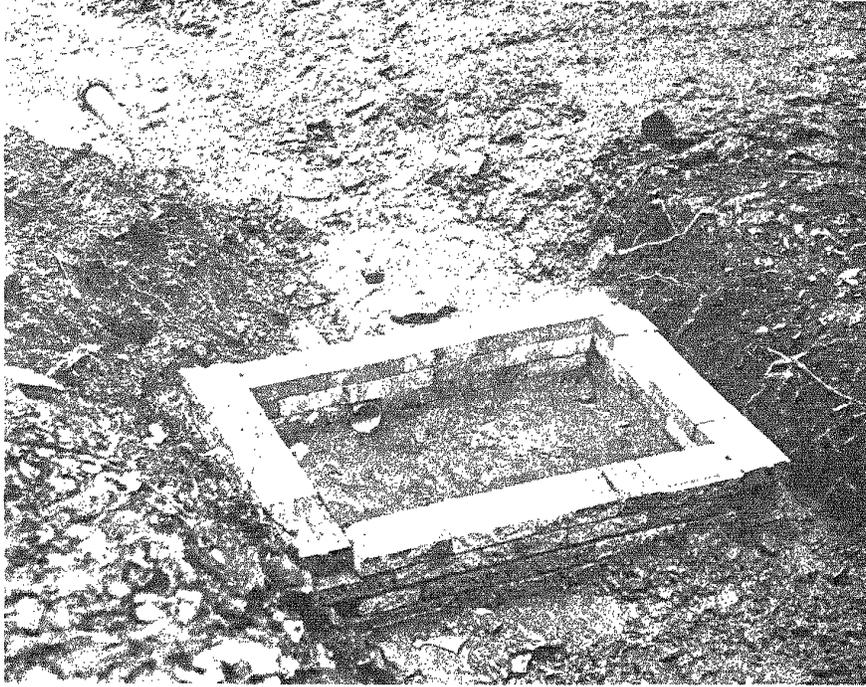
Figure 1.—First phase of construction shows block enclosure centered in 30-foot segment of stream channel excavated to a solid base. A plastic overflow pipe is then laid in the channel. A plastic culvert is laid on the four-block-high wall to provide sufficient room to insert a polyethylene tub under the culvert.

The buildings were not placed directly over the streams until initial excavation work was done. The area of streambed over which each shelter was to be located was leveled and excavated to a solid base with a bulldozer. In addition, an 8- by 10-foot section was excavated about 16 inches deeper than the streambed. In this deeper portion, a 6-inch rigid plastic overflow pipe was positioned parallel to the original stream, and four rows of dry wall concrete blocks² were laid up to the level where the streambed was located initially (Fig. 1). After fill was placed around this block enclosure, a 2-foot high-density polyethylene culvert was centered on the block enclosure. The block walls were extended one block higher than the culvert, and a headwall around the upstream end of the culvert was constructed with native stone removed from the streambed during excavation (Fig. 2). The area around the block enclosure and culvert was backfilled with material that had been removed originally. After backfilling was completed, an emergency spillway to divert large peak flows around the shelter was constructed (Fig. 3). In the central Appalachians, the 2-foot culverts (15 ft³/s capacity) used in these installations will carry drainage only from 50-acre and smaller watersheds at a peak-flow recurrence interval of 20 years (Helvey and Kochenderfer 1988). The spillway is designed to carry these rare peak flows that would exceed the culvert's capacity. To minimize erosion, the spillway was lined with rocks and seeded to grass.

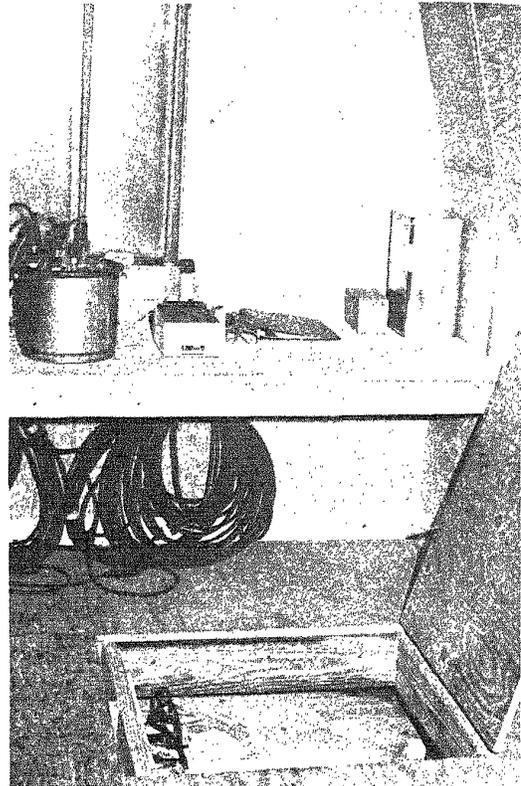
Figure 6.—Interior of a water-monitoring shelter showing the rear window, instrument bench, propane light, and trap door that provides access to the shelter's cellar.

The shelter then was centered and leveled over the block enclosure with the downstream skid on top of the downstream row of blocks. A 30- by 30-inch wooden trap door was constructed in the shelter's wooden floor (Fig. 6). It was located above the portion of the pan which extends from the culvert and is large enough to allow the pan to be removed for maintenance or cleaning. It also provides access to the holes in the culvert that are reamed twice each week with a fiberglass rod to prevent plugging.

The cold temperatures also caused the data logger to operate sluggishly, so a small propane light (Humphrey Products, Kalamazoo, MI) was mounted on one of the walls in each shelter. The lights produce 1,800 Btu per hour and have an illuminating capacity comparable to that of a 50-watt light bulb. The use of two 100-lb tanks connected with automatic pressure regulators that indicate when a tank is empty ensured that the lights burned continuously. The propane fuel tanks were positioned outside of the shelter, directly behind the wall holding the light. The fuel line was run through the wall.
