CHANNEL-DYNAMIC CONTROL ON THE ESTABLISHMENT OF RIPARIAN TREES AFTER LARGE FLOODS IN NORTHWESTERN CALIFORNIA¹

Thomas E. Lisle²

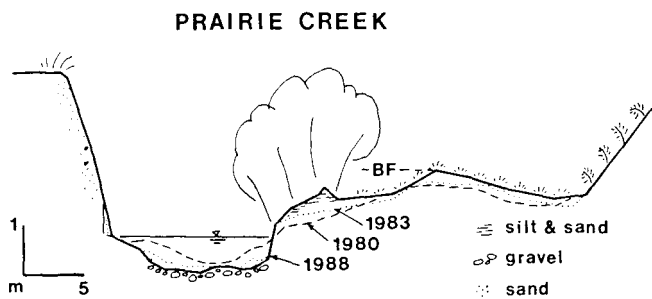
Figure 1 – Cross section of Prairie Creek, showing bed elevation changes from 1980 to 1988 and the distribution of riparian vegetation and substrate. Approximate bankfull elevation is indicated by BF.

A natural levee approximately 0.7 m high had accreted progressively on the inner right bank immediately adjacent to the mobile bed from 1980 to 1988 (fig. 1). The levee, which was composed of fine sand, silt, and organic debris, supported a narrow dense stand of red alder (*Alnus oregona*). The levee was highly irregular, due to locally thick deposits of newly laid fine sediment and local scour around large woody debris caught among the alders. The alders were rooted at about one-half of bankfull stage, and thus were probably flooded several times on average each year. Bankfull elevation in this cross section was poorly defined but, by extrapolation from adjacent reaches, corresponds approximately with the top of the bar.

friction generated by alders rooted low in the water created steep velocity gradients away from the main flow and promoted rapid deposition of fine sand, which is only intermittently suspended. Sand comprises as much as 55 percent of suspended sediment in Prairie Creek (Lisle in press). Sedimentation rates over the remainder of the bar were slower because of its smoothness and the depletion of coarse suspended fractions at the levee. As a result, the levee originated at a lower elevation but built faster than the bar, so that a level floodplain may be formed eventually. Channel incision since 1980 apparently helped to define a higher bank as the levee built (fig. 1). Root strength probably helped to stabilize these higher banks.

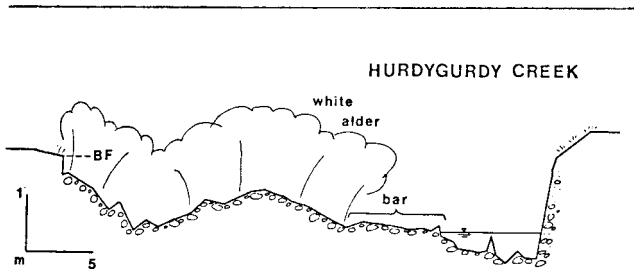
Figure 2 — Cross section of Hurdygurdy Creek surveyed in July 1986, showing growth pattern of riparian trees and substrate. BF indicates bankfull elevation.

White alders (*Alnus rhombifolia*) grew within the channel of Hurdygurdy Creek, but in contrast with trees in Prairie Creek, were not associated with bank formation (fig. 2). The alders were rooted near the low-flow water surface elevation, which was at less than one-half of bankfull stage. At this cross section, alders on the left portion of the channel ended abruptly at a certain point that was not related to elevation, but instead probably defined the left margin of the mobile bed. The bed to the right of the alders had an equal elevation and thus equal availability of moisture. This area was an active bar deposited against the larger, stabilized flood bar upon which the alders had established. The bed among the alders was clearly not mobile enough to cause removal of the trees. The alders grew among mossy boulders that had not moved apparently since the flood of 1964. Cores extracted from the largest trees indicated colonization of the bar was no later than 1966. The alders had trapped abundant large woody debris but little fine sediment.

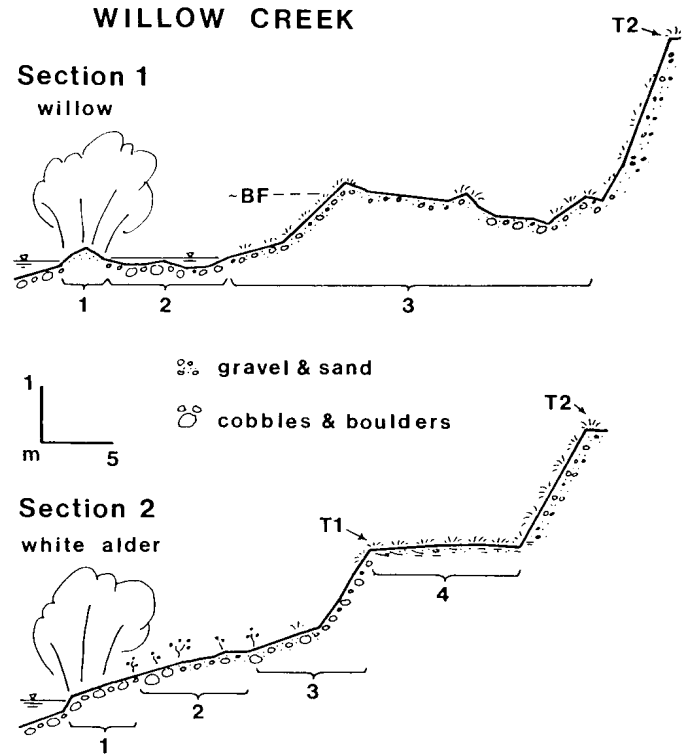
Figure 3 — Partial cross sections of Willow Creek surveyed in June, 1988, showing distribution of riparian vegetation and substrate. Numbered brackets show vegetation zones of table 1. BF indicates approximate bankfull elevation; T1 and T2 are alluvial terraces.

Wet-site trees and herbs, including white alder, willow (*Salix hindsianai*; *S. lasiolepis*), black cottonwood (*Populus trichocarpa*), and sweet clover (*Melilotus albus*), grew in a narrow band (2-5 m wide) along the low-flow water's edge (Zones 1 and 2 in Section 1, Zone 1 in Section 2, fig. 3; table 1). Riparian alders and willows were established no higher than about 0.4 m above a stage typical of late summer, which is approximately 0.3 m below that during the survey. Bankfull was poorly defined, but corresponded roughly with the top of the bar in Section 1. Riparian trees were rooted at less than one-half of bankfull stage as defined. Cores extracted from the largest trees indicated colonization in 1973-1975. Herbaceous species growing on higher, drier sites (Zones 3 and 4) were typical of those that invade disturbed ground and have a wide range of moisture tolerances. The base of the drier zones was 0.2 m (Section 1) and 0.9 m (Section 2) above late summer stage.

Table 1 – Species, relative abundance, and indicated habitat conditions of vegetation along zones of Sections 1 and 2 (fig. 3), Willow Creek.
