CHAPTER 2-- GEOLOGY

This chapter describes the bedrock and Quaternary geology of Snodgrass Mountain, with special emphasis of landslides. Because the area had been mapped several times before, our first task was to compare the various maps.

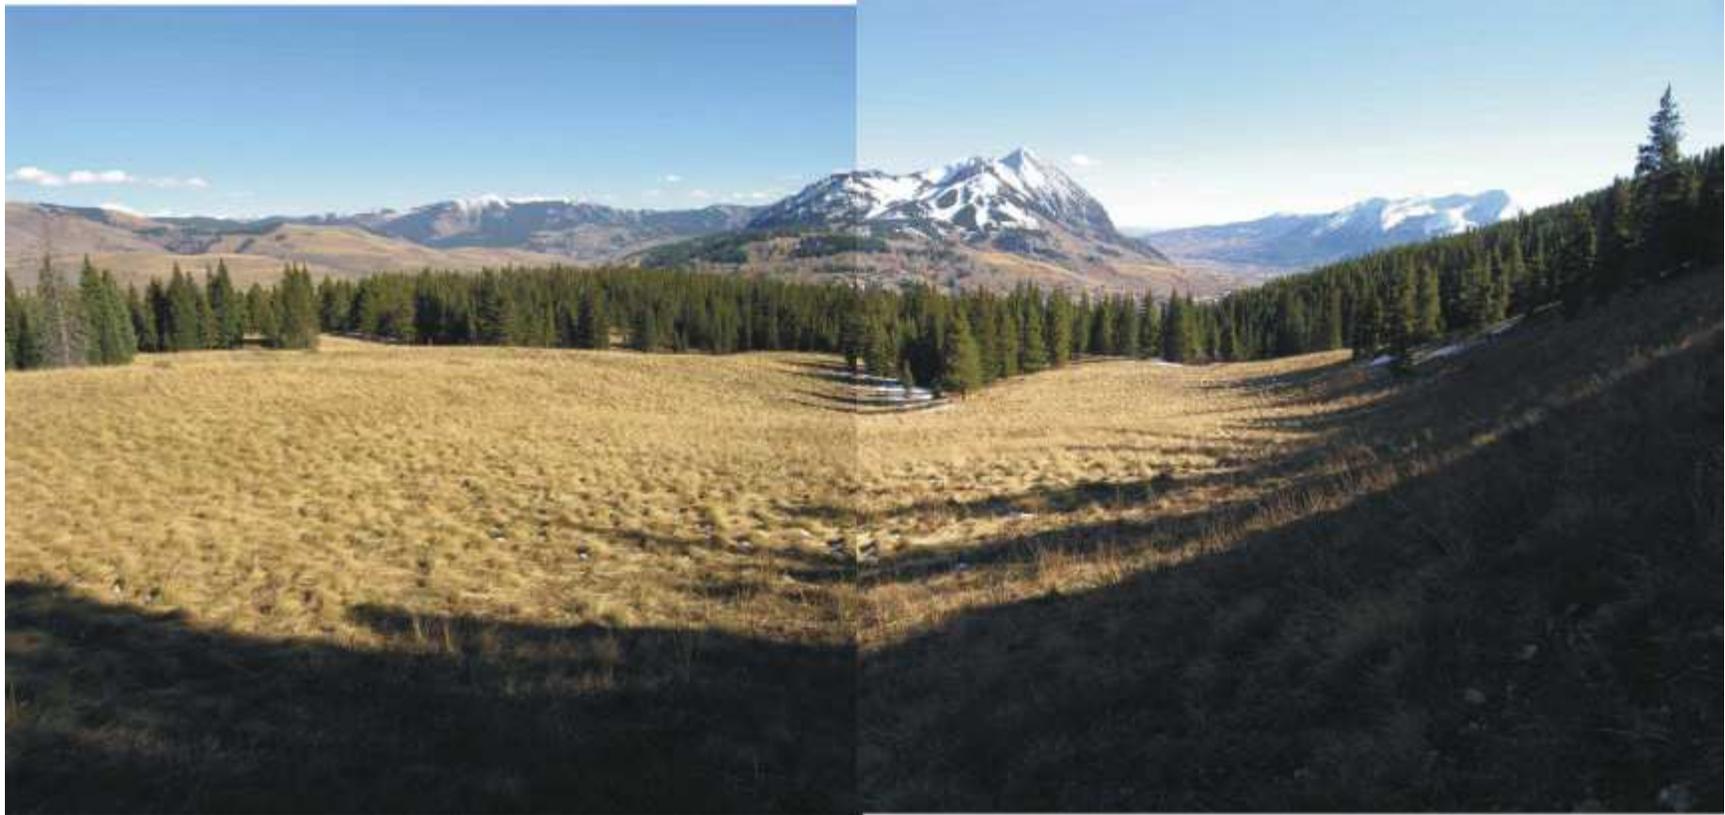
Fig. 2-6. Panoramic photograph of the Chicken Bone meadow area (GHU 6), taken from near its head. View to the SE. Meadow topography consists of asymmetric SE-trending ridges and swales, probably the result of differential erosion of SW-dipping, thin porphyry sills and intercalated beds of Mancos Shale. Compare this topography with the landslide topography shown in Fig. 2-1. This meadow occupies the top of the transition zone between the laccolith and the underlying massive Mancos Shale. The Mount Crested Butte laccolith is visible in center distance. Note the subdued low-angle topography of the lower half of the mountain (underlain by Mancos Shale and many small landslides) compared to the much steeper slopes on the laccolith proper.

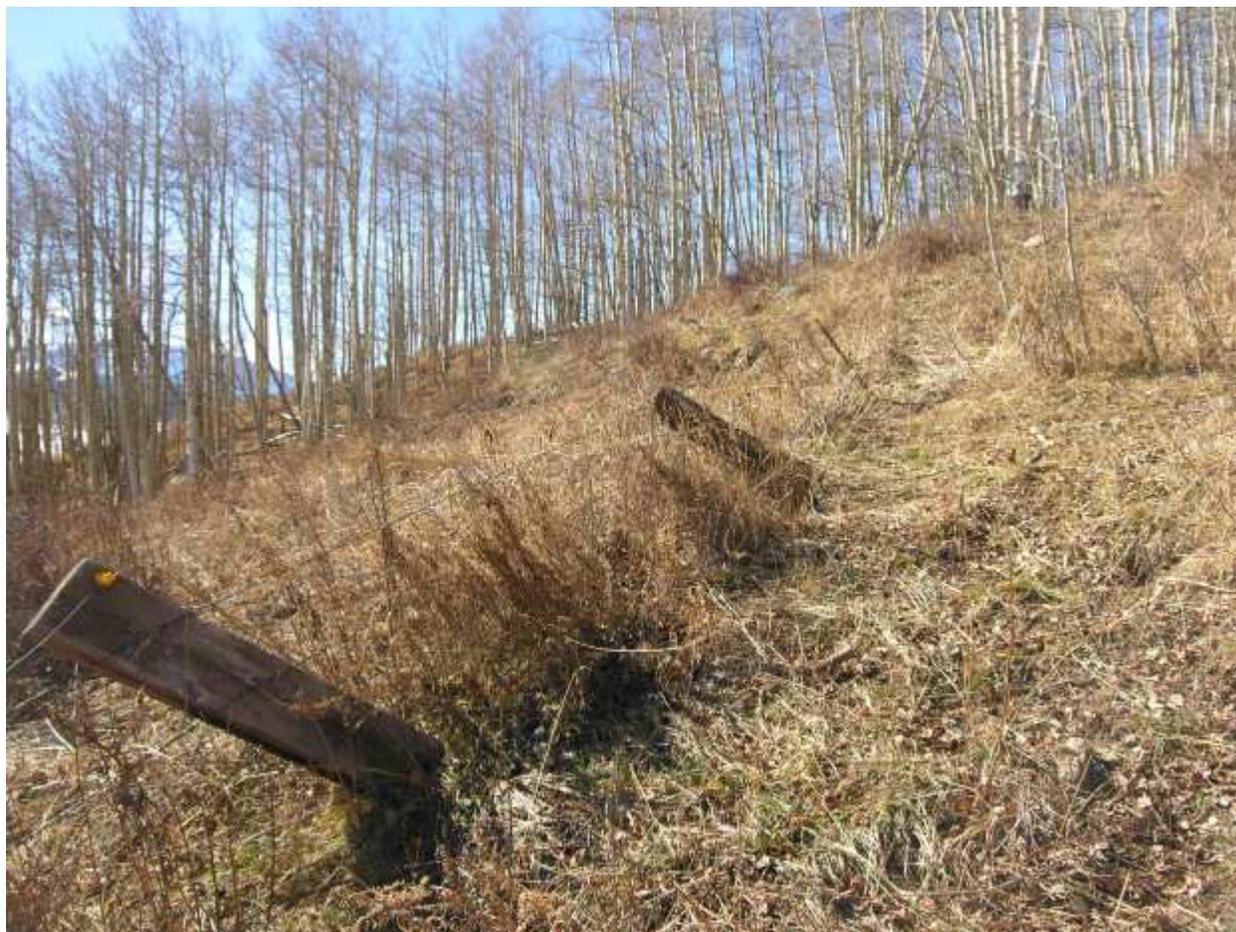
Fig. 2-14. Deformed east-west fence line crossing the southern part of landslide polygon 13 (GHU 2, Qlsh). The leaning fenceposts coincide with a southward bulge in the fence line of about 4 ft. An older set of wooden fenceposts lies flush with the ground, indicating that the tilted fenceposts in this photo are a replacement set of fenceposts, which have been subsequently deformed. Where the fence crosses the crest of the polygon 13 headscarp, there are 2 sets of repair wire installed to accommodate the southward extension of the fence, suggesting 2 different episodes of fence deformation and subsequent repair. Thus, the 4 ft of misalignment of the current fence represents only the latest deformation episode.

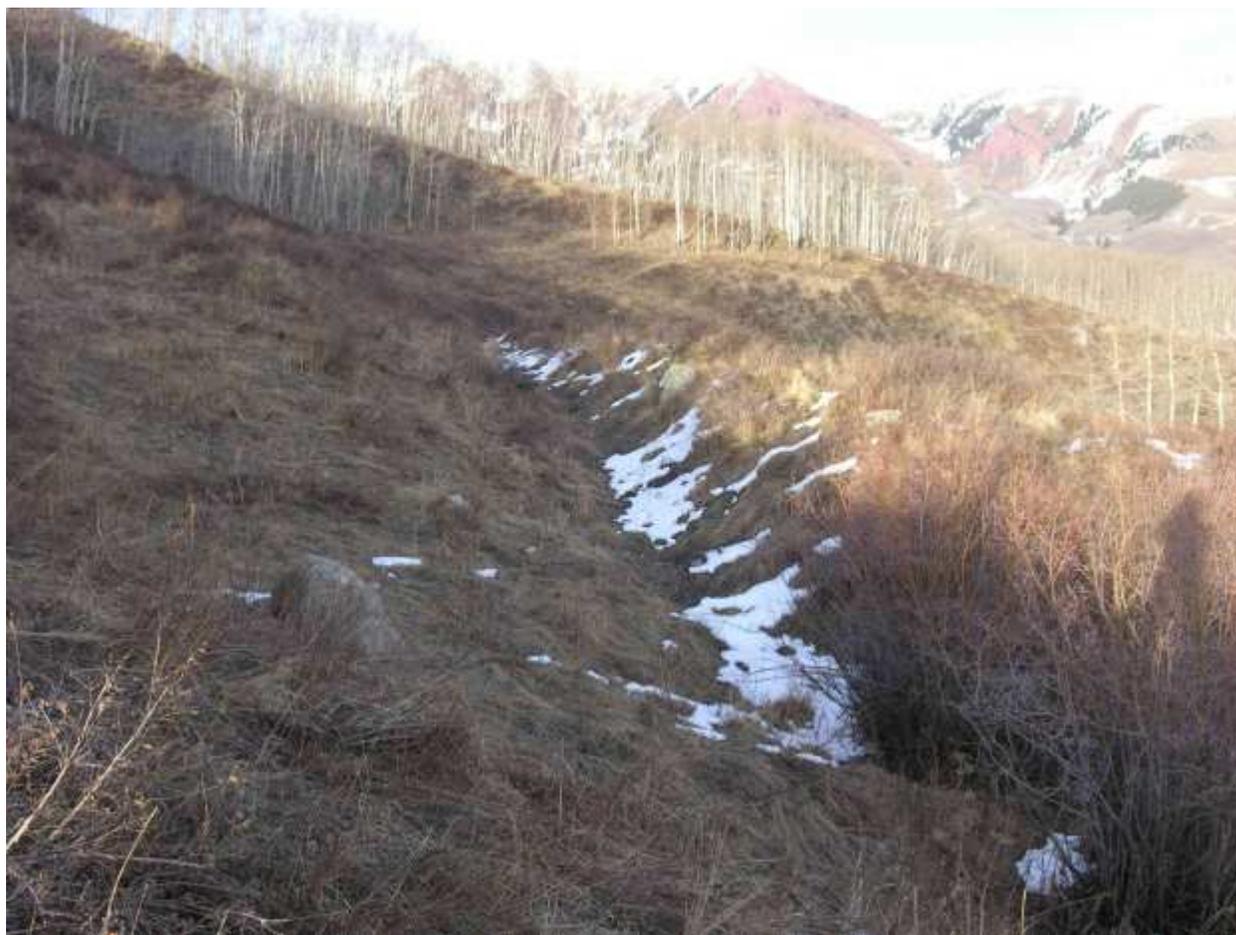
Fig. 2-16. Photo of the slump blocks of the upper east Slide, comprising GHU 5A. Most of the view is composed of polygon 30. View to the NE; mountains in distance are on the eastern side of the East River.

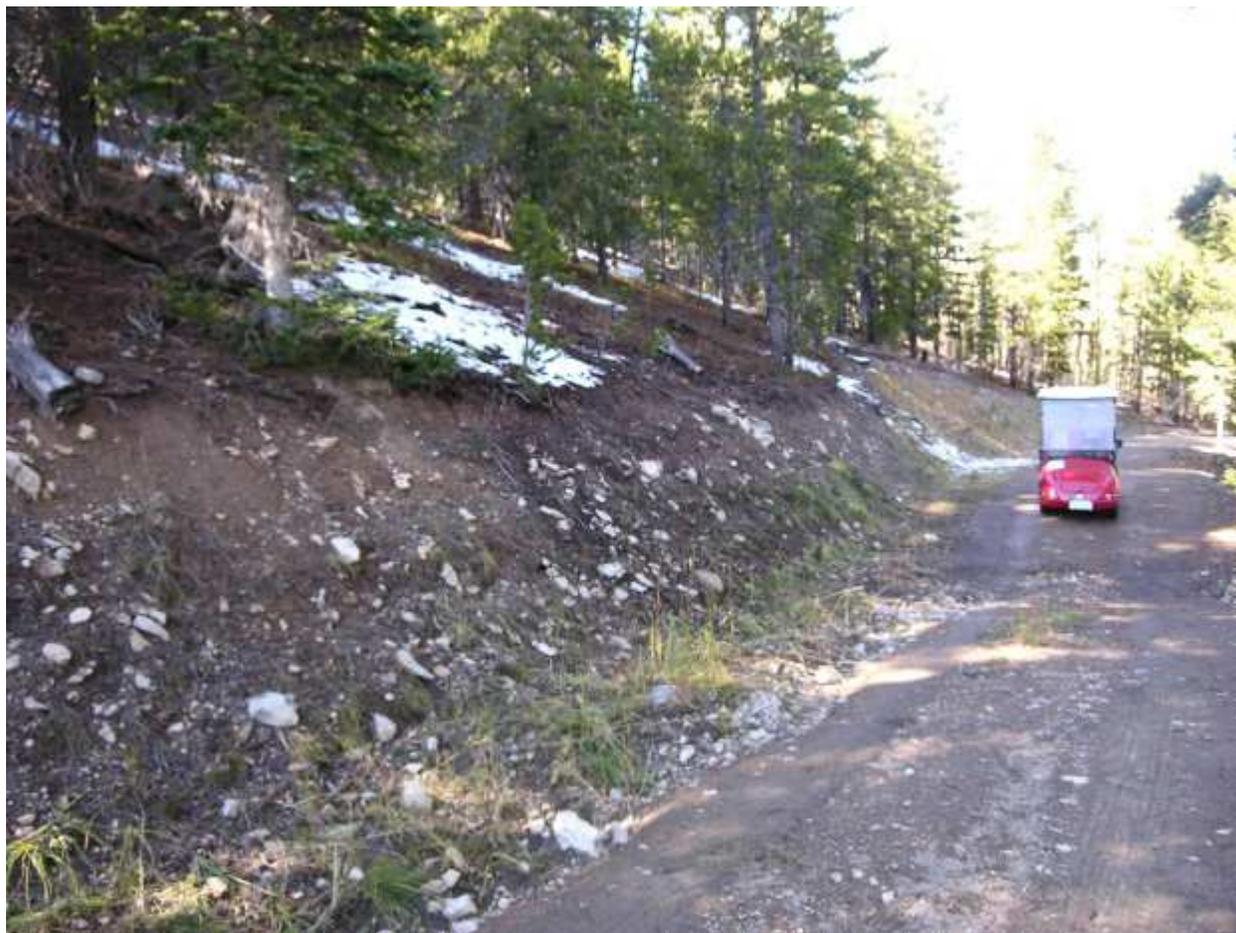
Fig. 2-19x. Roadcut exposures of the colluvium at the base of the East Facet. Clasts are all Tertiary porphyry and most of matrix is grussy. Note field vehicle for scale at right.

Baum (1996) thought there were landslide deposits there, and we cannot observe any on the aerial photographs. RCE (1995) did include the East Facet within their East Slide, but only mapped a single individual scarp there, in contrast to their treatment of the West Facet, where they mapped 14 scarps. However, the 5-ft contours do show benchy terrain on the East Facet, probably the result of differential erosion of porphyry sills and Mancos Shale I the transition zone. Figs. 2-5 and 2-18 show these steep areas as questionable headscarps, without any identifiable landslide deposits downslope. Therefore, we do not think there are significant landslide deposits in the unconsolidated deposits that mantle the lower part of the East Facet. Those deposits are exposed in long roadcuts along the Snodgrass Road, where they appear to be colluvium (Fig. 2-19).

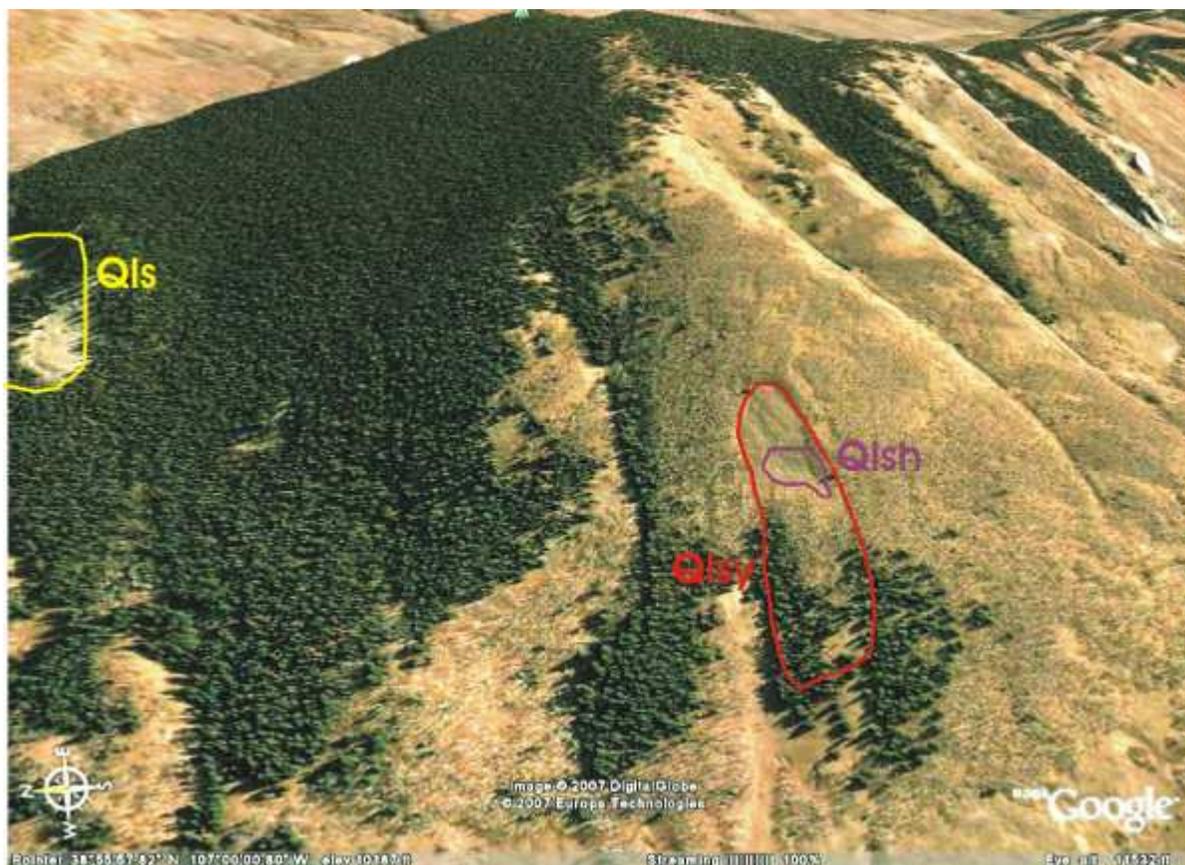
Fig. 2-20. Google Earth image of the southwest face (at center) and Northwest face (at left) of Snodgrass Mountain (summit at top center). View looking east.

The SW face of Snodgrass Mountain slopes steeply down to Washington Gulch (Fig. 2-20). The contact between Mancos Shale and the overlying Tertiary laccolith is mapped about halfway up this face by Gaskill et al. (1991) as a simple contact, with laccolith porphyry extending from the contact up to the summit, and Km from the contact down to the valley floor. However, field checking reveals that the lower face is actually underlain by a transition zone of alternating Km and thin Tp sills, just as was found on the southeastern side of Snodgrass (Fig. 2-21). This transition zone extends from the bottom of the laccolith (located at the head of Qlsy on Fig. 2-20) all the way to the base of the slope where it becomes covered by till (Fig. 2-21b).

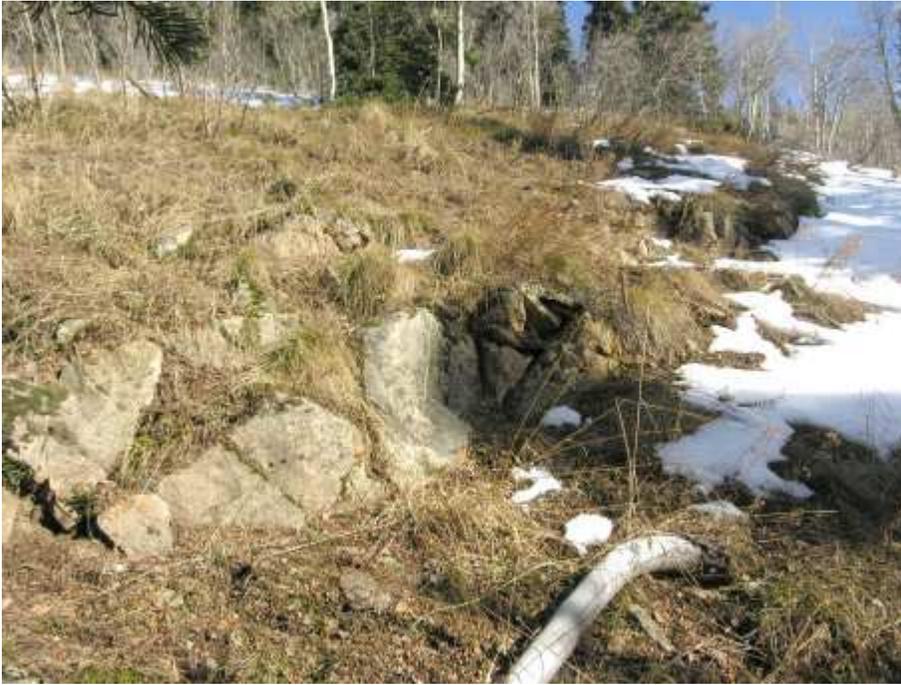
Fig. 2-21a. Thin Tp sill intruded into Km about midway up the SW face of Snodgrass Mountain. View to SE. Note that bed has an apparent NW dip (toward the camera).

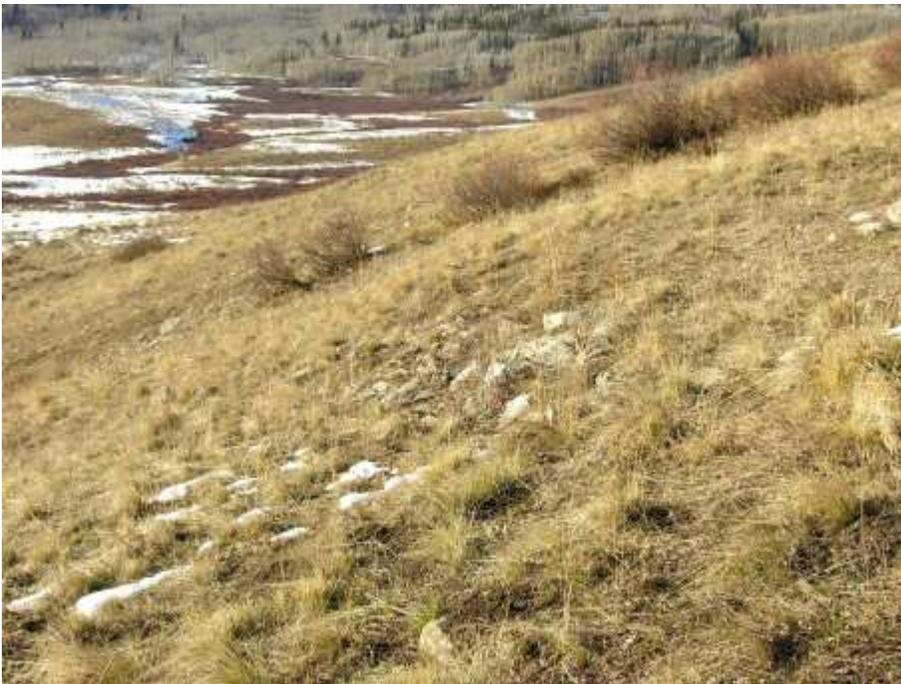
Fig. 2-21b. Thin Tp sill intruded into Km at base of the SW face of Snodgrass Mountain. View to NW toward the floor of Washington Gulch. The sill forms a steepened slope segment extending from center to upper left center. Note that bed has an apparent NW dip (away from the camera).

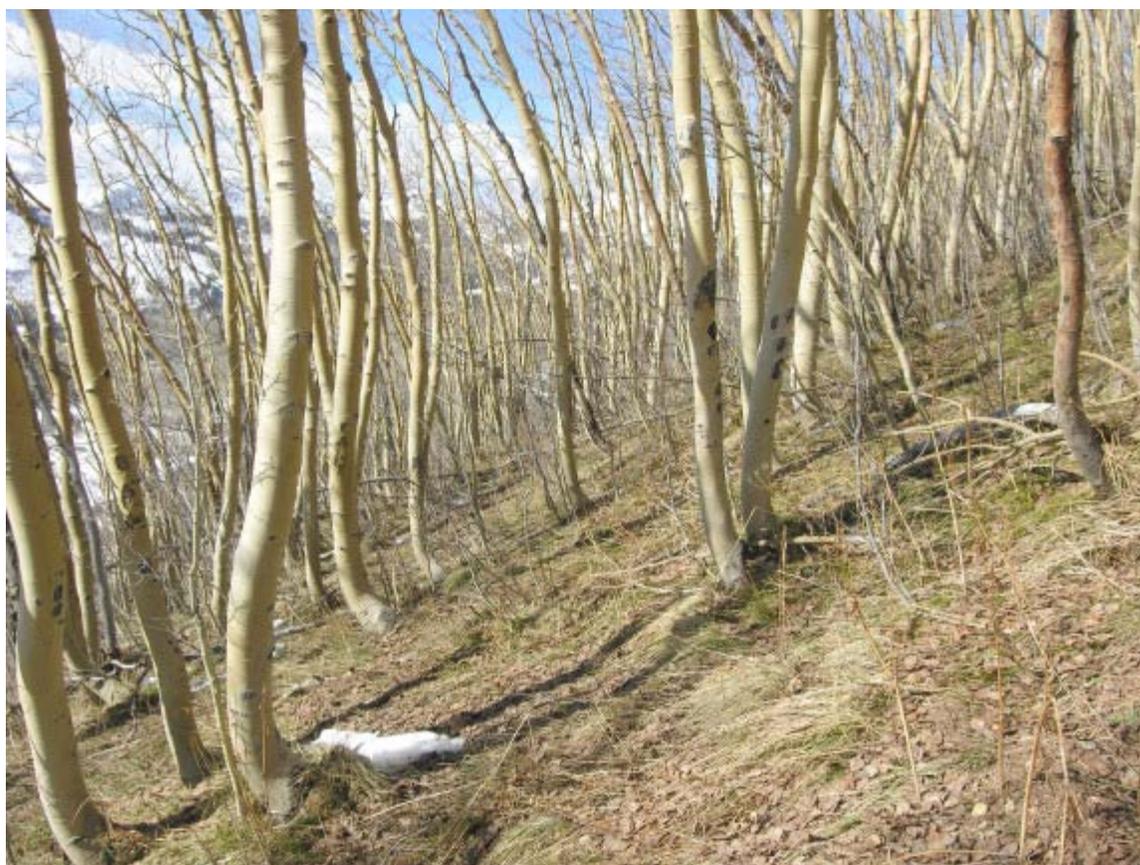
Fig. 2-22. Anomalous tree shapes in an aspen grove at 10,550 ft elevation on the SW face of Snodgrass, on the north side of the S-most gully in the permit area. This is near the top of the transition zone.

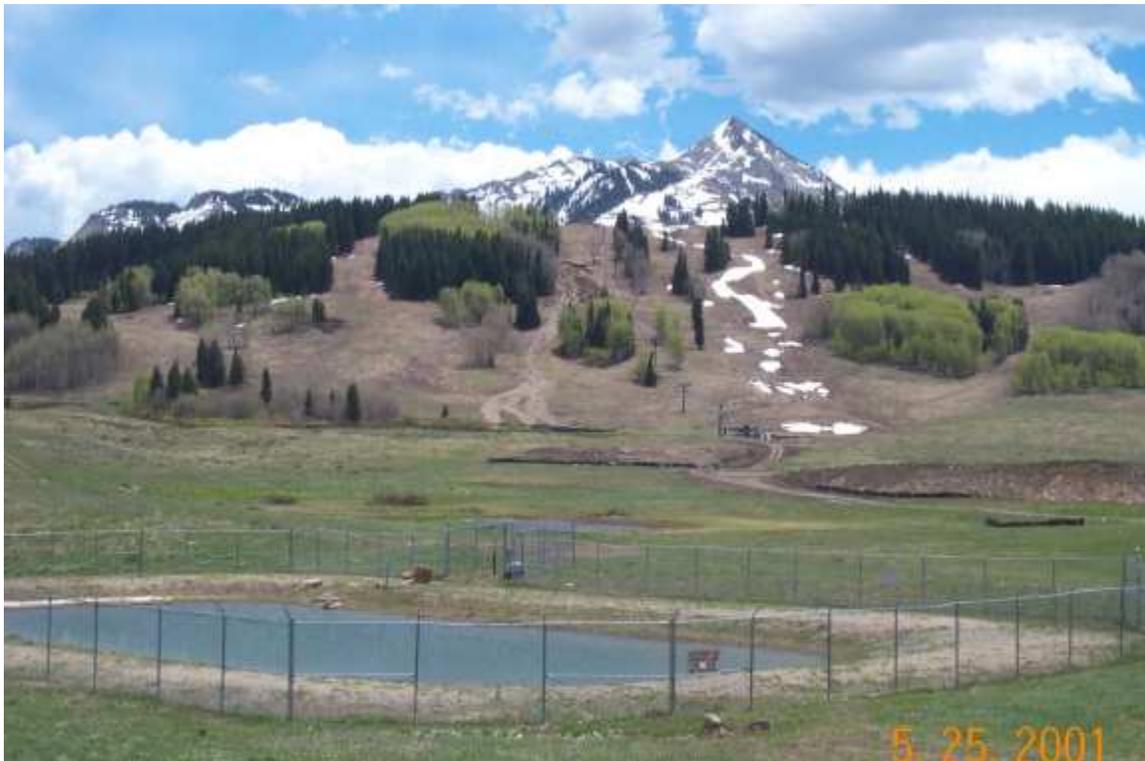
Fig. 2-29. Distant photograph of the 22-MAY-2001 Gold Link landslide (at center) in the Crested Butte ski area, looking south toward Mt. Crested Butte.

an accumulation of material, but did not appear to have any other visible impact.” Based on the above description, the landslide would be classed as a debris flow-debris slide (or “flowslide”) failure (Fig. 2-29).

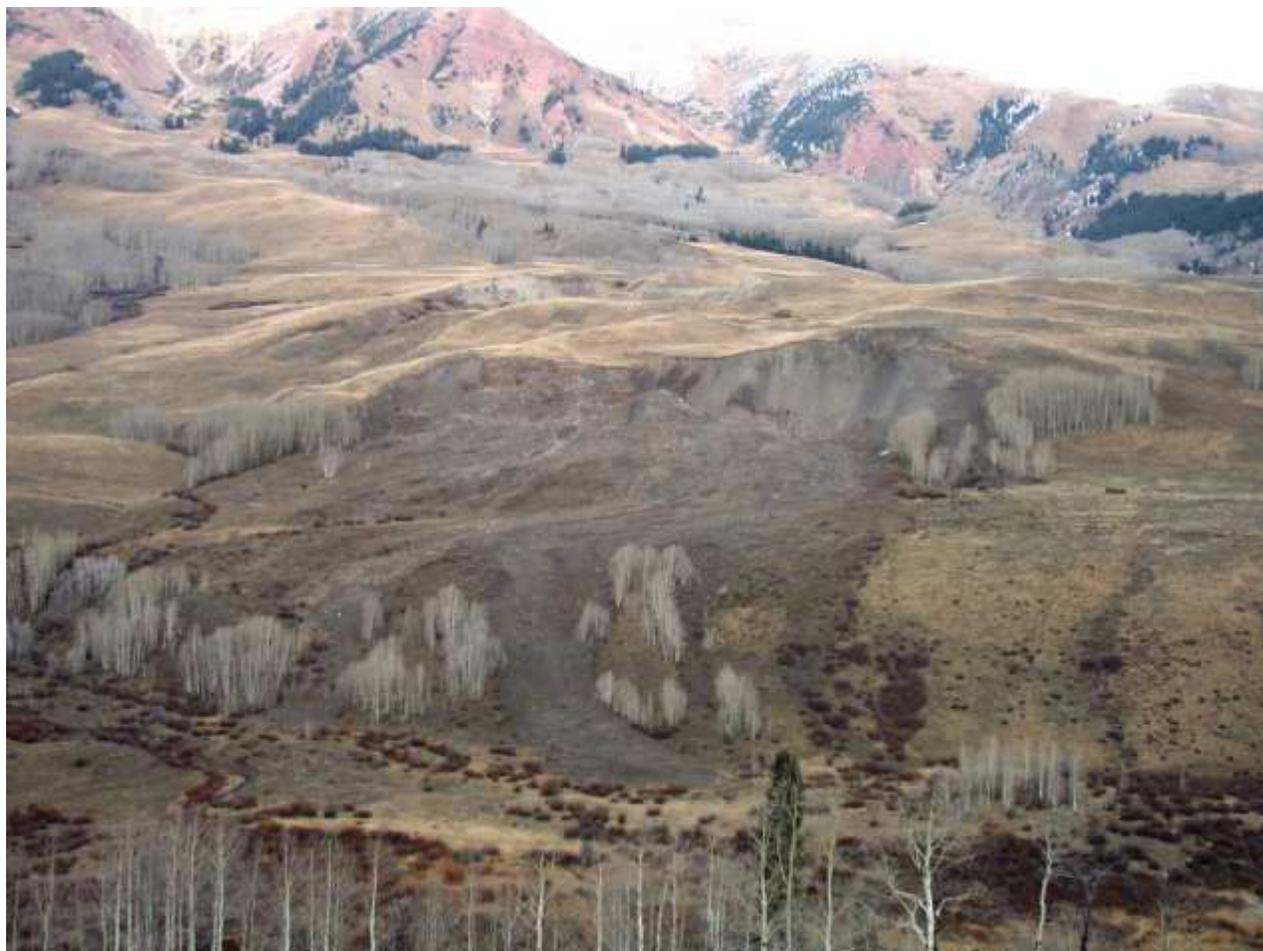
Fig. 2-31. Photograph of a fresh-looking slide-flow failure (center) on the eastern side of the East Fork, somewhere between Snodgrass Mountain and Gothic.

which transitions downslope into a thin blanket of debris. This blanket extends across the landslide bench and down an escarpment onto the floodplain of the East River. From its shape and extent, this blanket appears to be a debris flow of highly fluid character, much more fluid than the pasty hummocky deposit. One explanation for the pattern here is that the original hummocky slump mass below the highest headscarp had such a high water content at failure, that it partially liquefied and turned into a debris flow. In other words, a similar process to that at Gold Link in 2001.
