Buckeye Creek

Mono County, California

2006 Stream Habitat Survey Report

Humboldt-Toiyabe National Forest, Bridgeport Ranger District

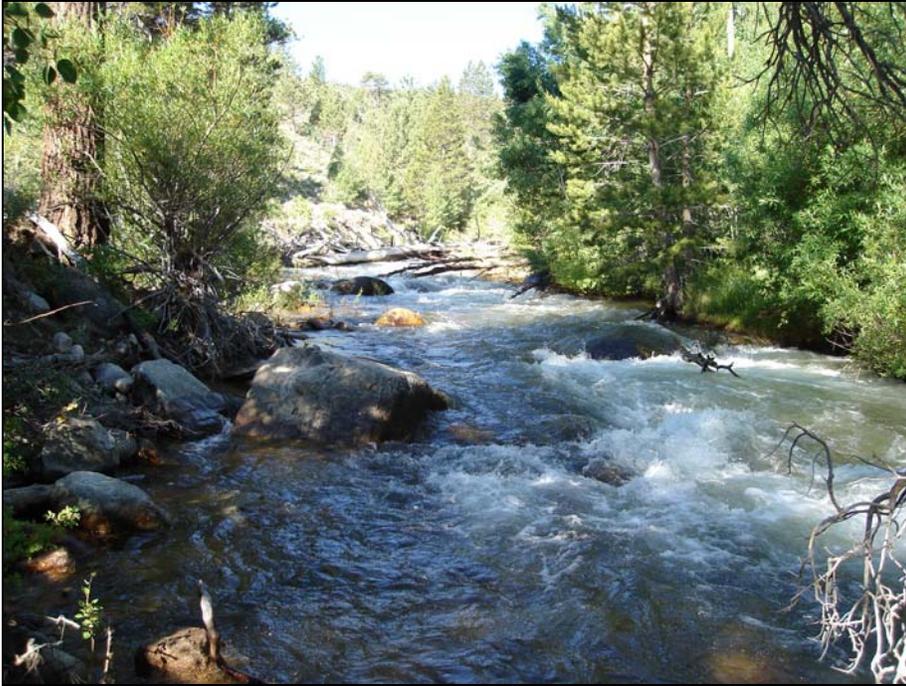
Site 1: Buckeye Creek, Bridgeport Ranger District, looking upstream at the survey start point just upstream from private property boundary in Bridgeport Meadows. The stream is flowing extremely fast and the creek is approximately 20-25 ft wide with lots of debris lining the shores. This site is located at UTM: N: 4234404 & E: 297222, Elevation 2084m.

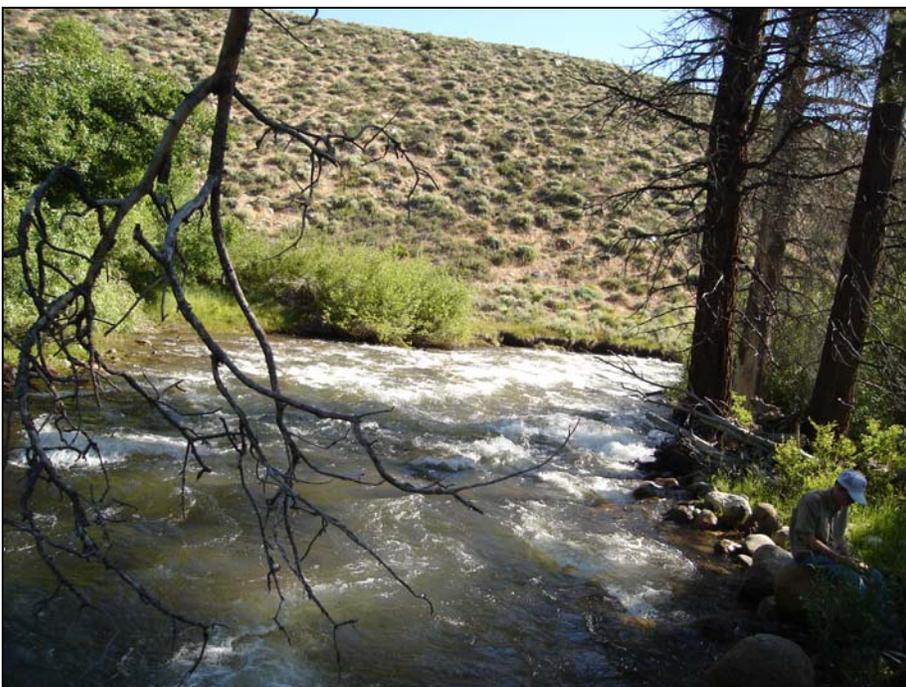
Site 1 continued: Buckeye Creek, Bridgeport Ranger District, looking downstream at the survey start point just upstream from private property boundary in Bridgeport Meadows. This site is located at UTM: N: 4234404 & E: 297222, Elevation 2084m.

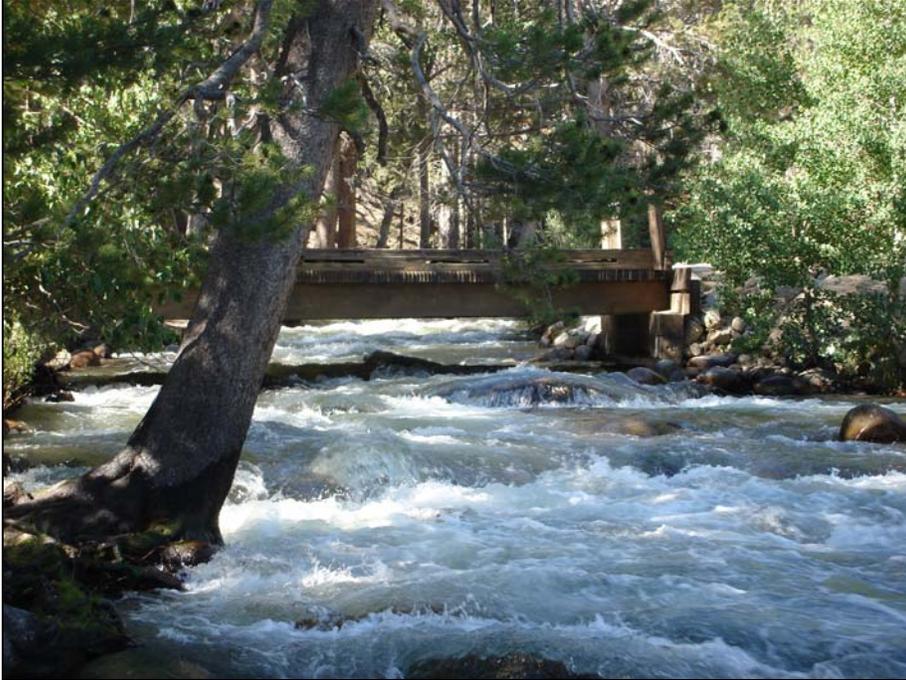
Site 2: Buckeye Creek, Bridgeport Ranger District, looking upstream at where Buckeye Road crosses the creek. The bridge gets heavy usage. On the north side of the stream at this site there is a parking area and a small campsite which looks to get moderate use. This site is located at UTM: N: 4234626 & E: 296038, Elevation 2118m.

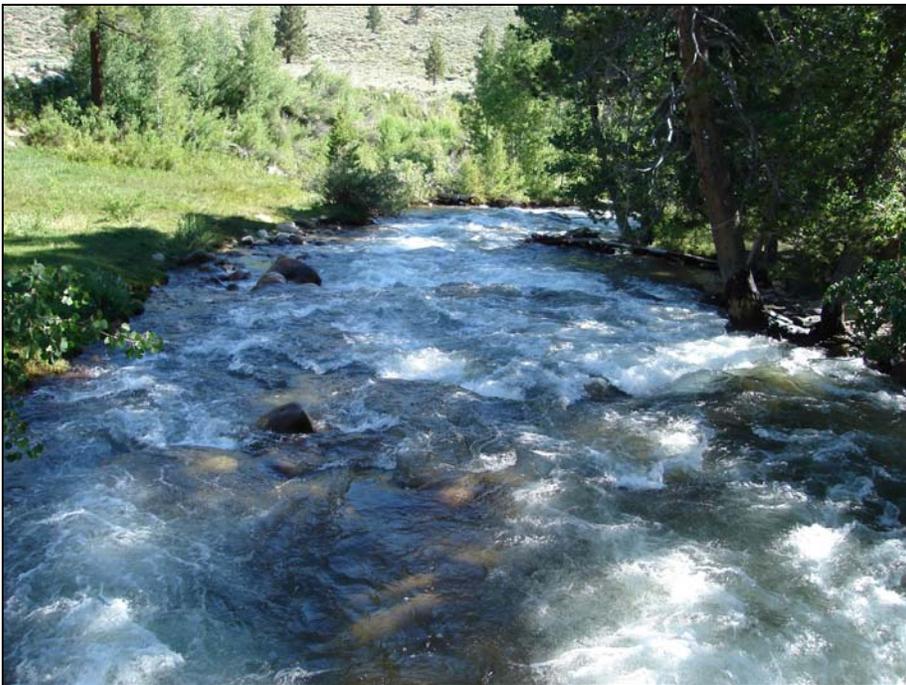
Site 2 continued: Buckeye Creek, Bridgeport Ranger District, looking downstream from the bridge. This site is located at UTM: N: 4234626 & E: 296038, Elevation 2118m.

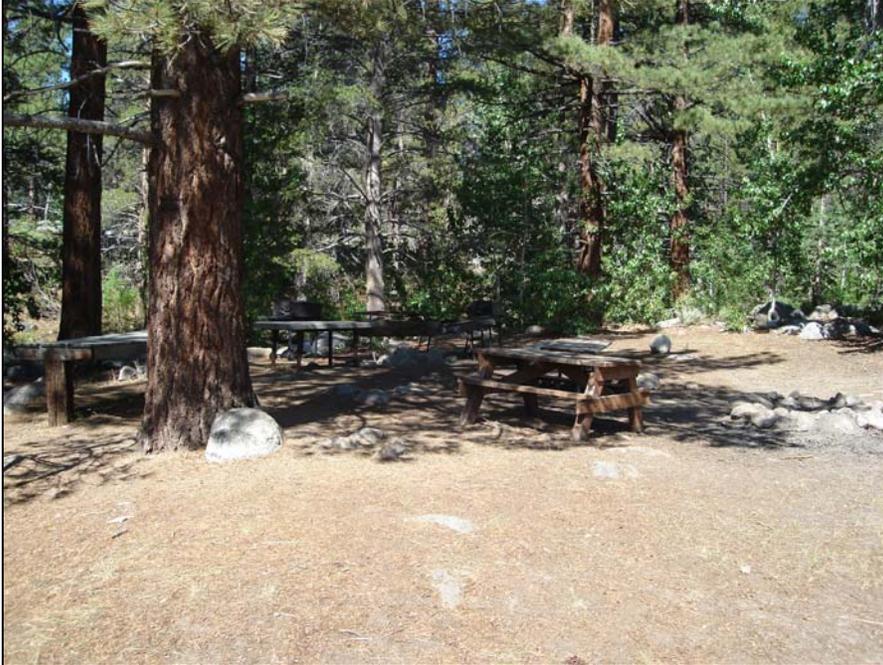
Site 3: Buckeye Creek, Bridgeport Ranger District, a large camping and picnic area located on private property along the side of Buckeye Creek. This site has several permanent tables and grills and also has an outhouse structure that is within 15m of the stream. This site is located at UTM: N: 4234638 & E: 295435, Elevation 2146m.

2. Increase public awareness of Leave-No-Trace principles along Buckeye Creek, (i.e.) more signs at Buckeye Campground and at the main trailhead.
3. Close and decommission all dispersed campsites within 100 feet of Buckeye Creek. Only allow camping to occur more than 100 feet away from the stream edge.

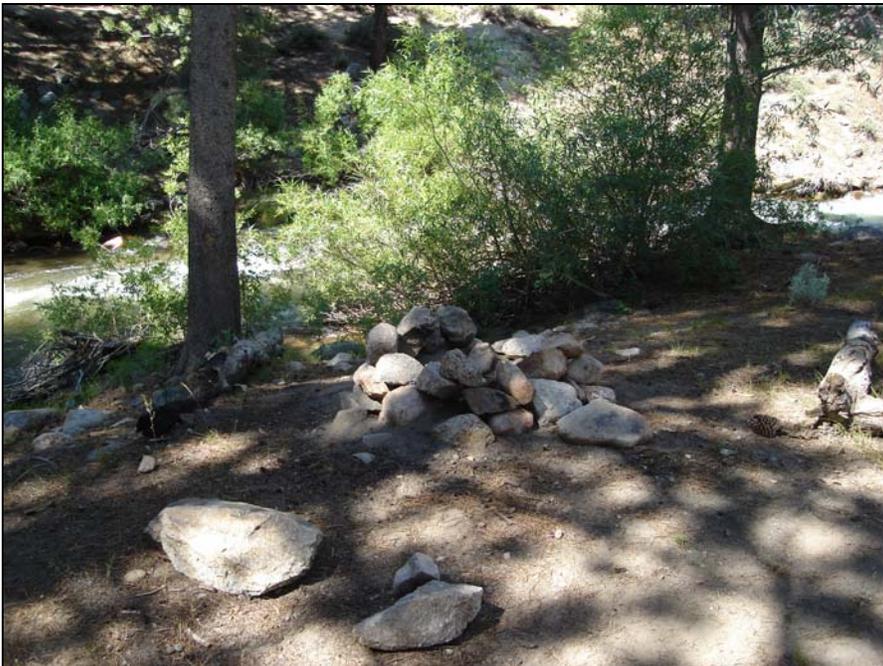
Site 4: Buckeye Creek, Bridgeport Ranger District, this campsite is a small dispersed campsite located directly on the edge of the stream. The campsite is on the north bank and has a fire ring and flat cleared areas for tents. This site is located at UTM: N: 4234686 & E: 295261, Elevation 2152m.

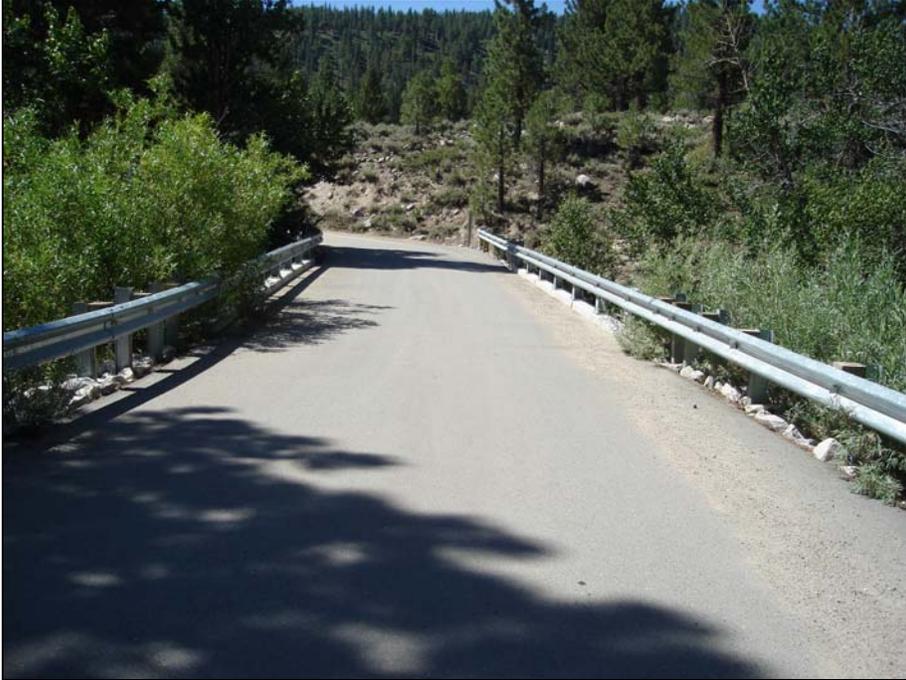
Site 5: Buckeye Creek, Bridgeport Ranger District, this is the bridge that has to be crossed to gain access to the Buckeye Creek Campground. It is a large bridge with cement anchors that channel the water underneath it. There is also cement debris from a previous bridge in the stream bed. This site is located at UTM: N: 4234755 & E: 295110, Elevation 2172m.

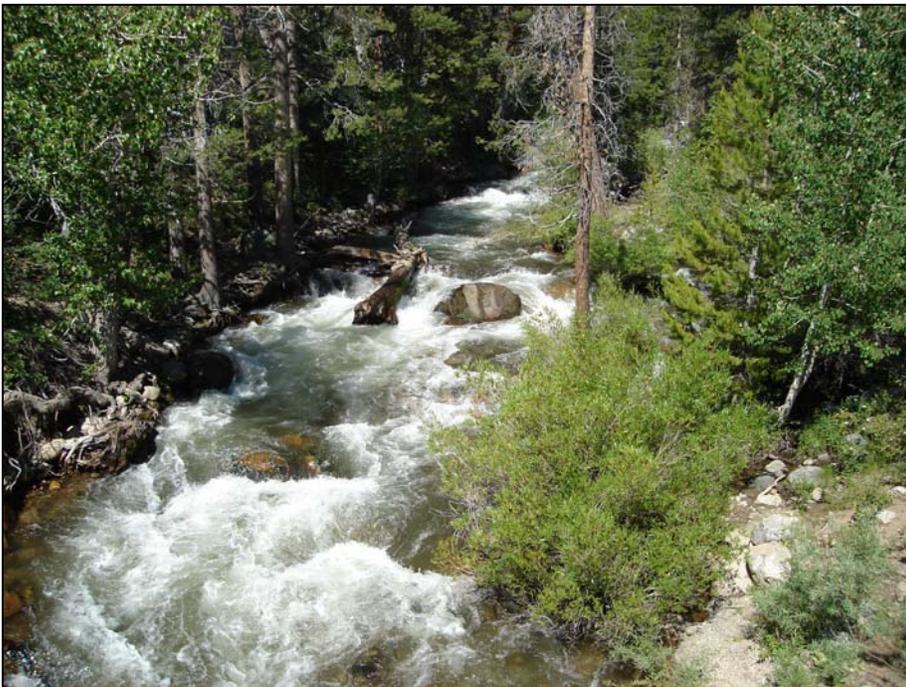
Site 5 continued: Buckeye Creek, Bridgeport Ranger District, looking upstream from the bridge. This site is located at UTM: N: 4234755 & E: 295110, Elevation 2172m.

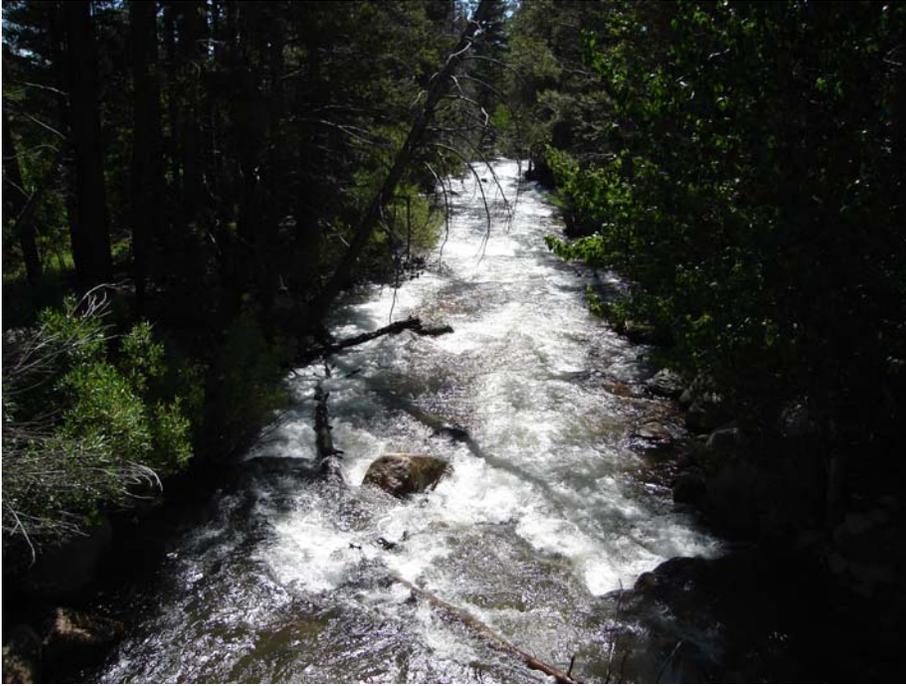
Site 5 continued: Buckeye Creek, Bridgeport Ranger District, looking downstream from the bridge. This site is located at UTM: N: 4234755 & E: 295110, Elevation 2172m.

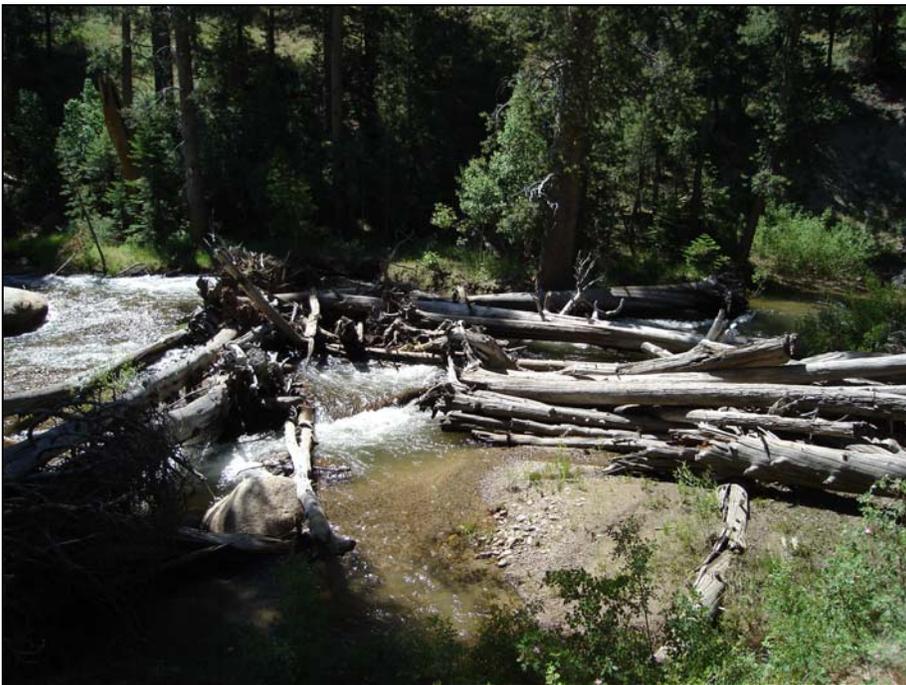
Site 6: Buckeye Creek, Bridgeport Ranger District, this section of stream had many logjams which changed the flow of the stream and created several large deep pools where fish were sighted. This site is located at UTM: N: 4234571 & E: 294525, Elevation 2192m.

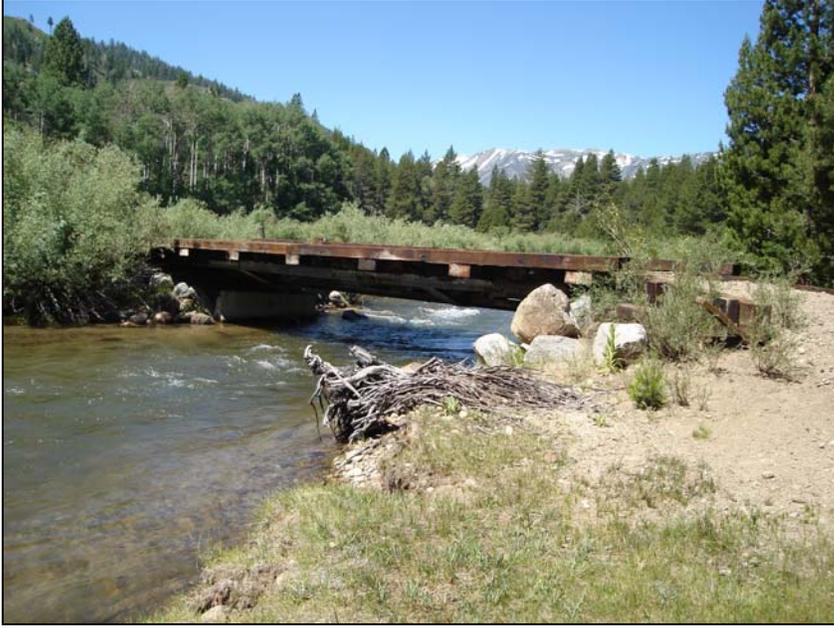
Site 7: Buckeye Creek, Bridgeport Ranger District, looking upstream at a timber framed bridge that crosses the stream to gain access to private property. This site is located at UTM: N: 4234477 & E: 294342, Elevation 2186m.

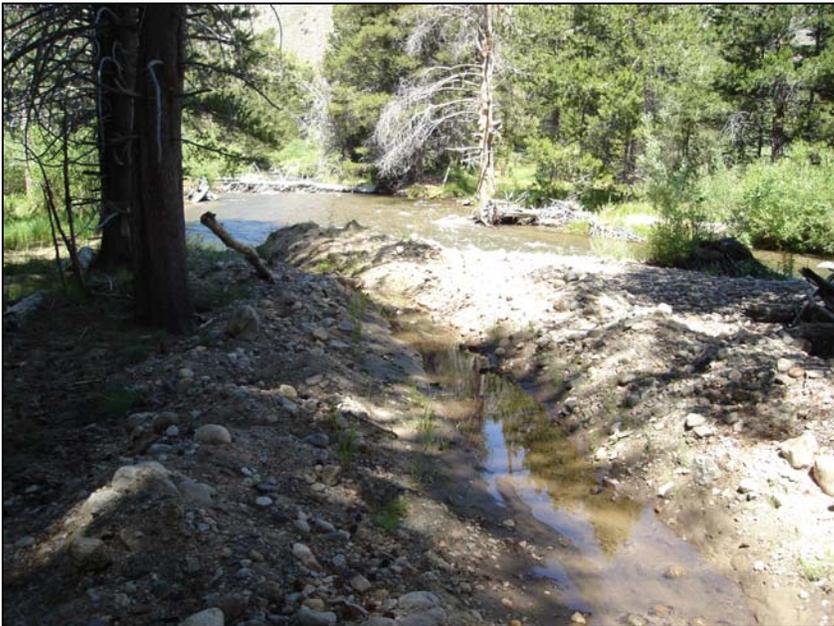
Site 8: Buckeye Creek, Bridgeport Ranger District, this is an irrigation channel that has been dug on the south side of the stream in order to allow for the flooding of a low meadow area. The channel was not dug very deep and there was no valve on the channel so it appears to only be used to divert high water. In the slow moving water several small fish were sighted. This site is located at UTM: N: 4234446 & E: 294088, Elevation 2182m.

4. Further investigate the impact Buckeye Campground is having on the fisheries habitat and water quality in Buckeye Creek.
5. Investigate if/what impacts are occurring as a result of the irrigation channel located at Site 8 and if/what impacts are occurring as a result of using the tributary at Site 13 for irrigation. Ensure that water users are staying within the confines of their adjudicated rights.

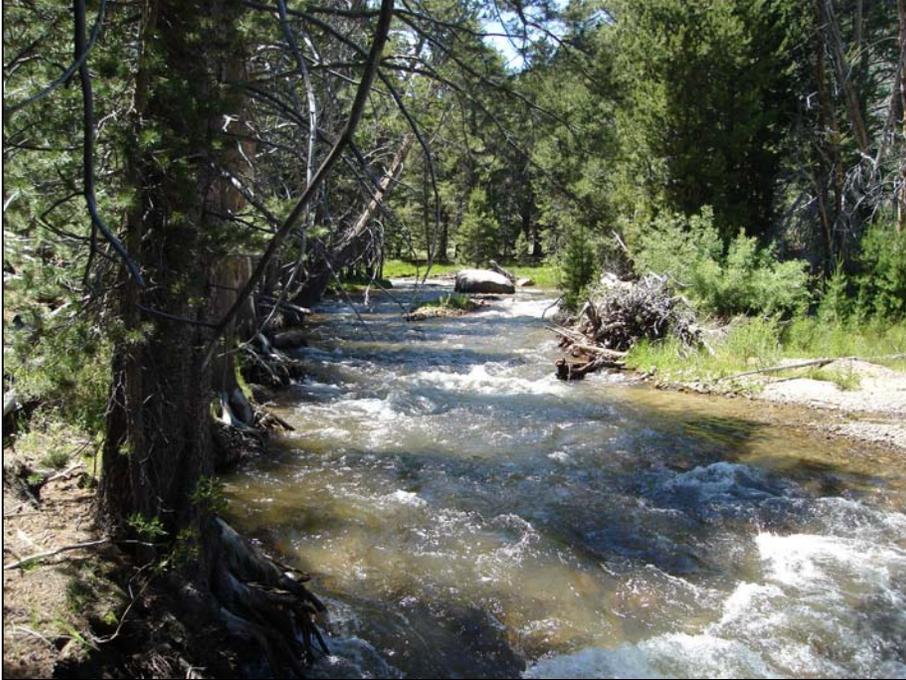
Site 9: Buckeye Creek, Bridgeport Ranger District, this is a photo point looking upstream that shows the stream characteristics for this section. This site is located at UTM: N: 4234009 & E: 291838, Elevation 2231m.

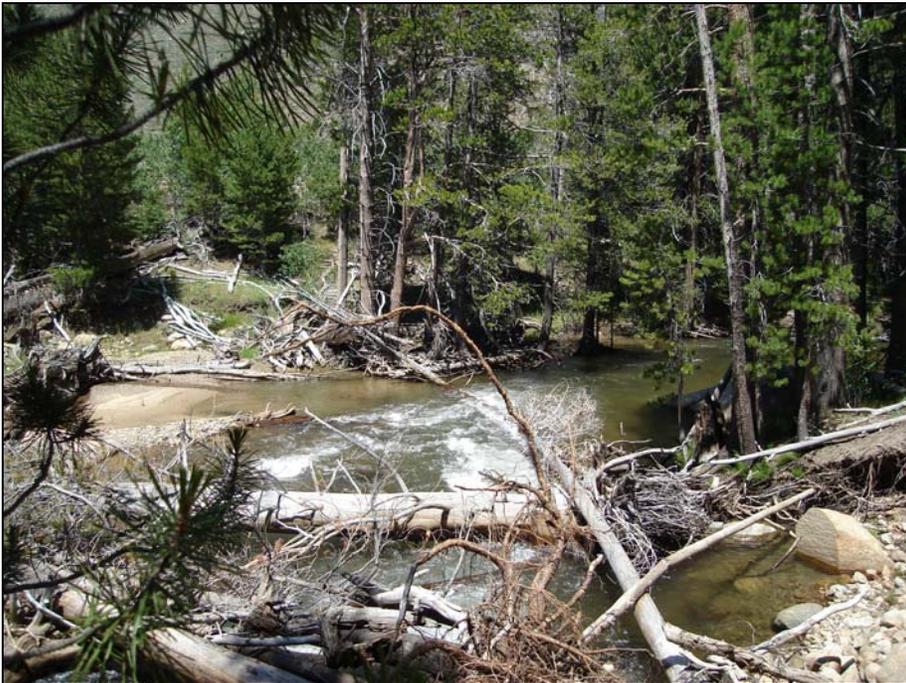
Site 9 continued: Buckeye Creek, Bridgeport Ranger District, this is a photo point looking downstream that shows the stream characteristics for this section. This site is located at UTM: N: 4234009 & E: 291838, Elevation 2231m.

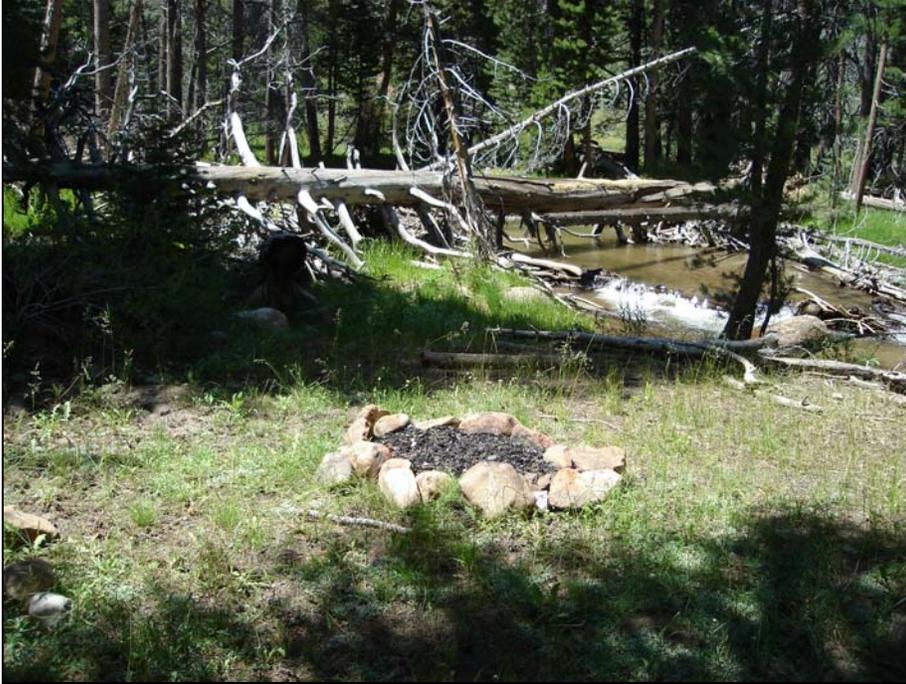
Site 10: Buckeye Creek, Bridgeport Ranger District, a small dispersed campsite located in a large meadow along the stream. This site is located at UTM: N: 4233959 & E: 291689, Elevation 2239m.

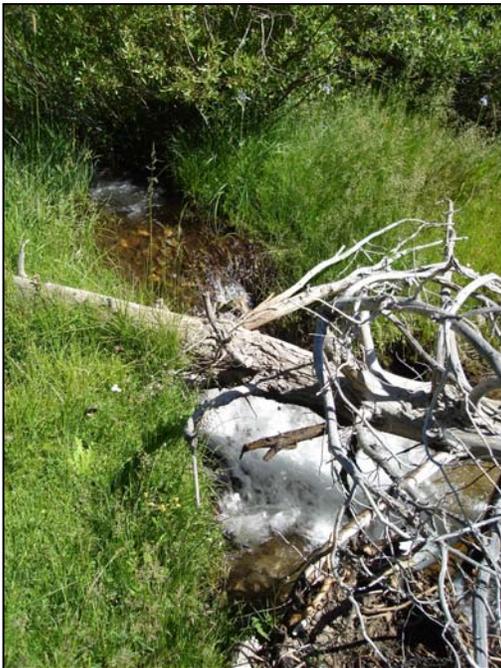
Site 11: Buckeye Creek, Bridgeport Ranger District, a small tributary enters Buckeye Creek on river left. As the tributary enters the stream it falls approximately 0.7m (2.3ft). The tributary contributes less than 5% of overall flow to Buckeye Creek and probably does not add additional fish habitat. This site is located at UTM: N: 4233689 & E: 290631, Elevation 2261m.

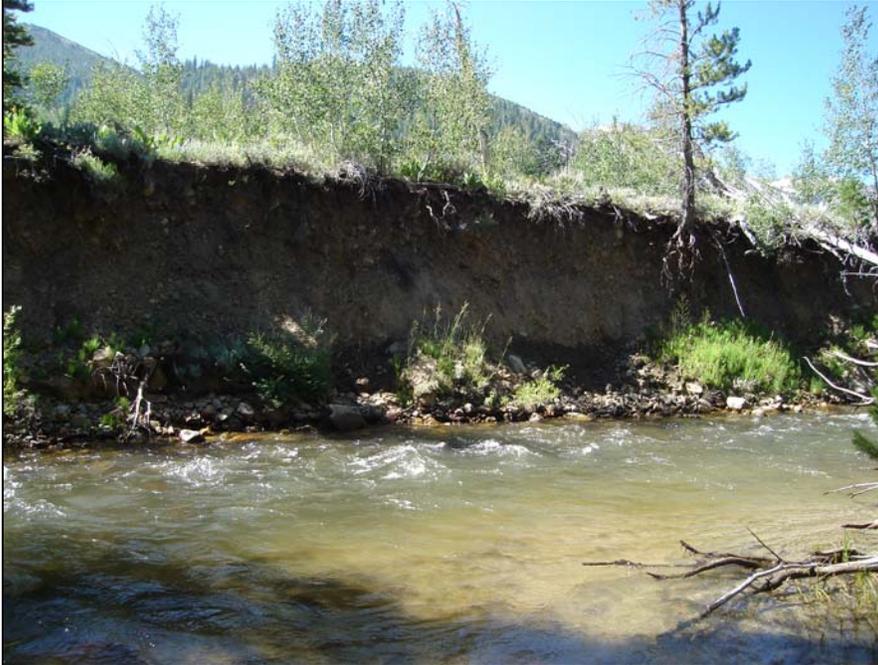
Site 12: Buckeye Creek, Bridgeport Ranger District, a cross-section view of erosion along one stream bank of Buckeye Creek that measures approximately 15m long and is about 4m high. This site is located at UTM: N: 4233519 & E: 290238, Elevation 2276m.

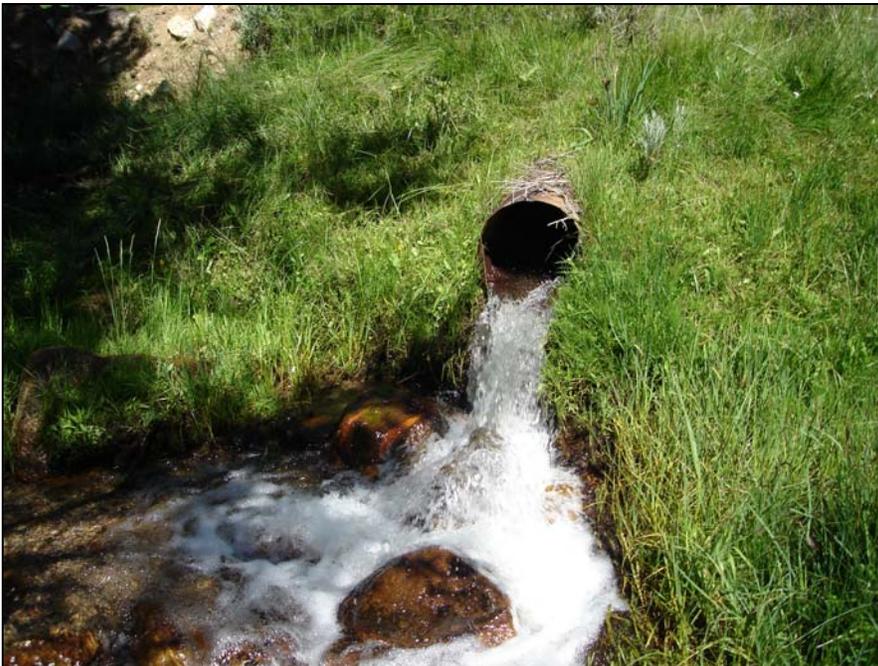
Site 13: Buckeye Creek, Bridgeport Ranger District, a small tributary enters Buckeye Creek on river left. The tributary has been used as a form of irrigation by a rancher where the stream is harnessed through a culvert system that can be blocked for flood irrigating fields. The gates are currently open and water flows into Buckeye Creek. This site is located at UTM: N: 4233468 & E: 290176, Elevation 2279m.

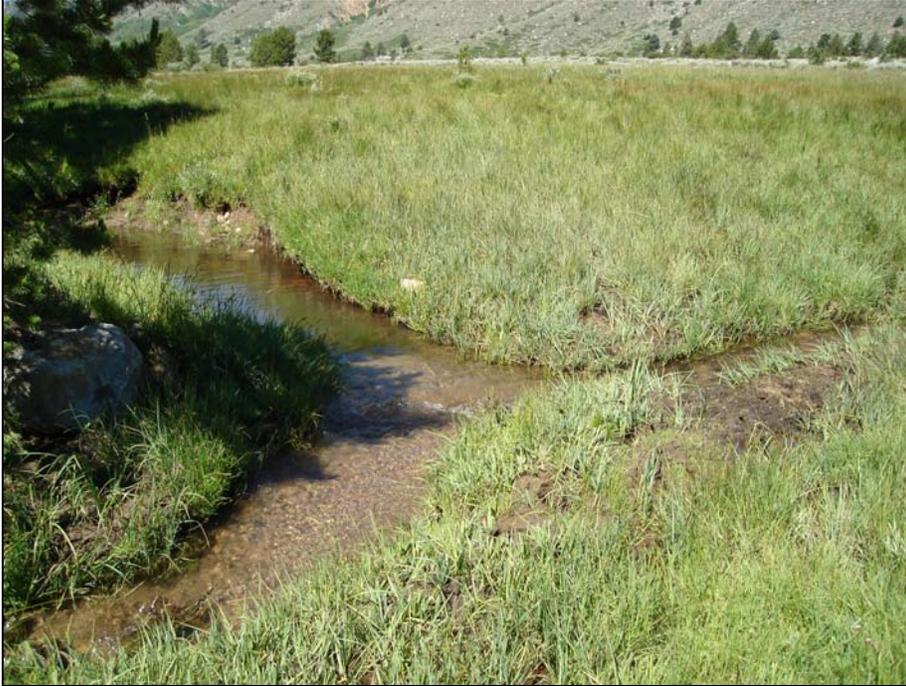
Site 13 continued: Buckeye Creek, Bridgeport Ranger District, a small tributary enters Buckeye Creek on the river left side. This site is located at UTM: N: 4233468 & E: 290176, Elevation 2279m.

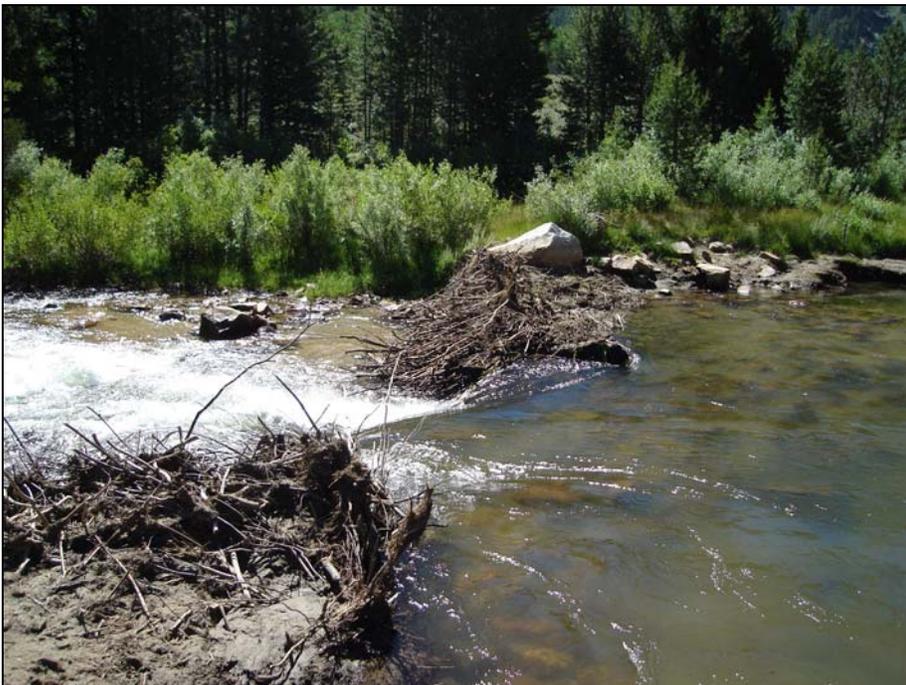
Site 14: Buckeye Creek, Bridgeport Ranger District, this site has a fairly recent beaver dam that is broken in the middle to allow water to pass. This site is located at UTM: N: 4233342 & E: 290057, Elevation 2280m.

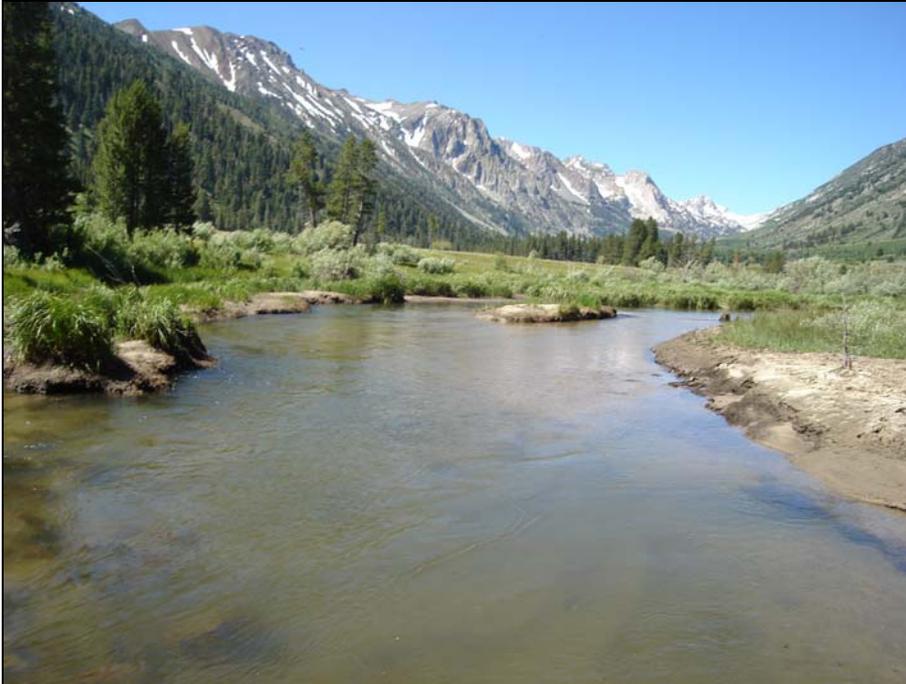
Site 14 continued: Buckeye Creek, Bridgeport Ranger District, looking upstream from the beaver dam. This site is located at UTM: N: 4233342 & E: 290057, Elevation 2280m.

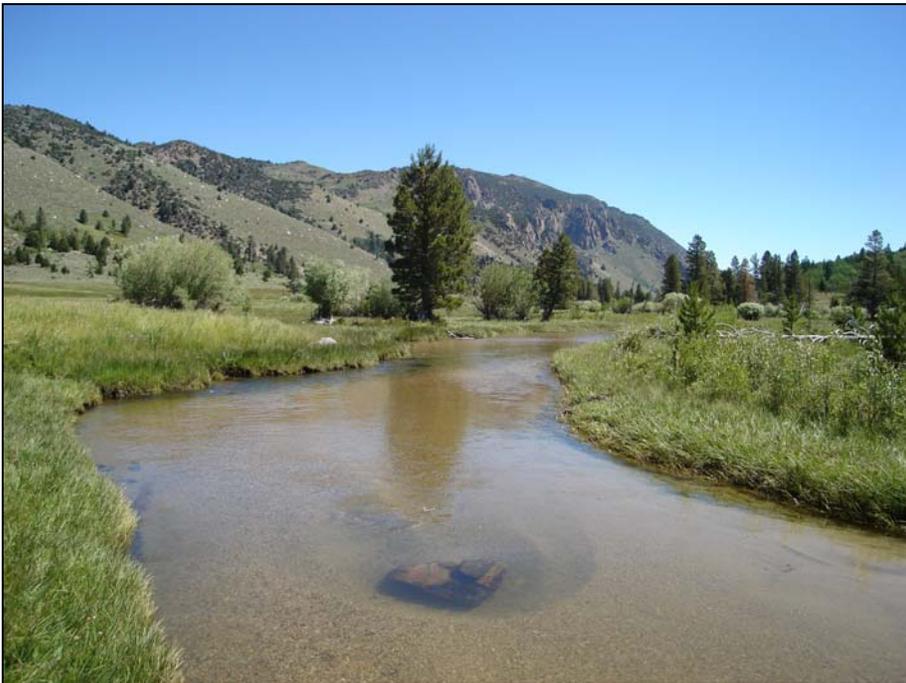
Site 15: Buckeye Creek, Bridgeport Ranger District, this is a photo point showing the stream characteristics for this section of stream. Notice the flow has decreased considerably. At this point the stream is meandering through Big Meadows. This site is located at UTM: N: 4232968 & E: 289604, Elevation 2277m.

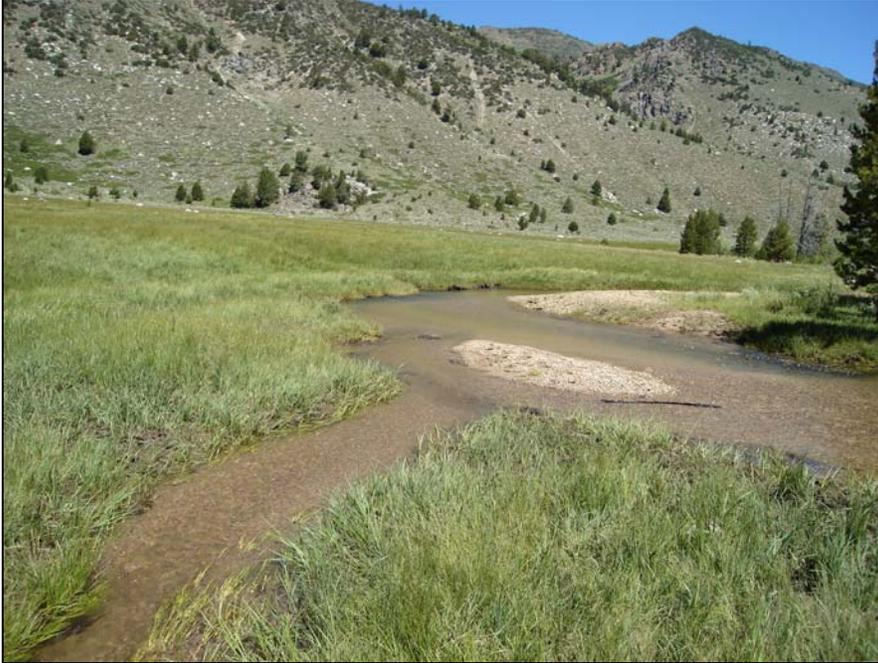
Site 16: Buckeye Creek, Bridgeport Ranger District, a small tributary enters Buckeye Creek on the river left side. This tributary runs through Big Meadows and acts more as a collective drainage spot for water seeping off the meadow. Also at this site is a trail crossing which appears to be more heavily used by cattle than by people or vehicles. This site is located at UTM: N: 4232829 & E: 289642, Elevation 2278m.

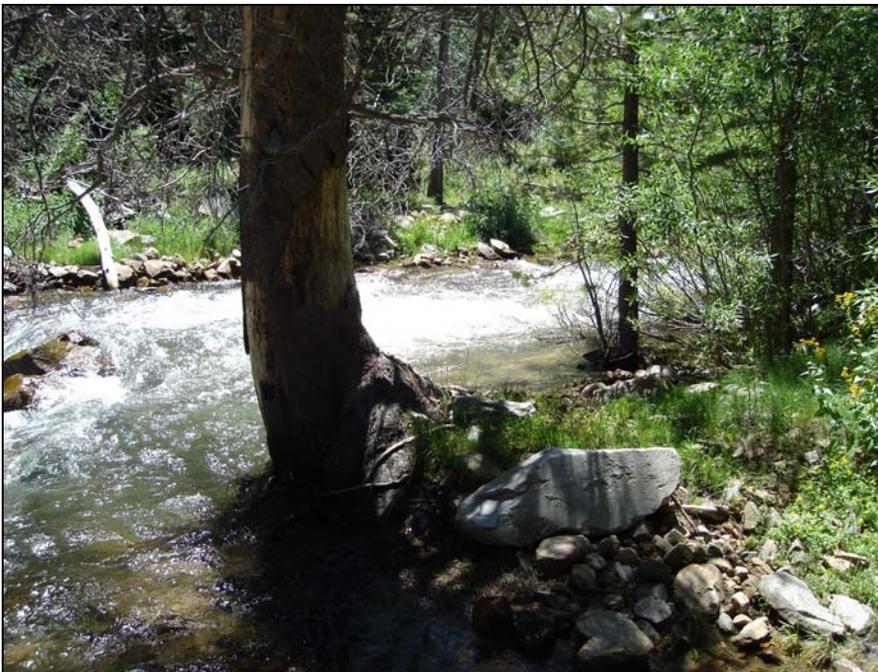
Site 17: Buckeye Creek, Bridgeport Ranger District, this is a small tributary entering Buckeye Creek on the river left side. This site is located at UTM: N: 4232243 & E: 289307.

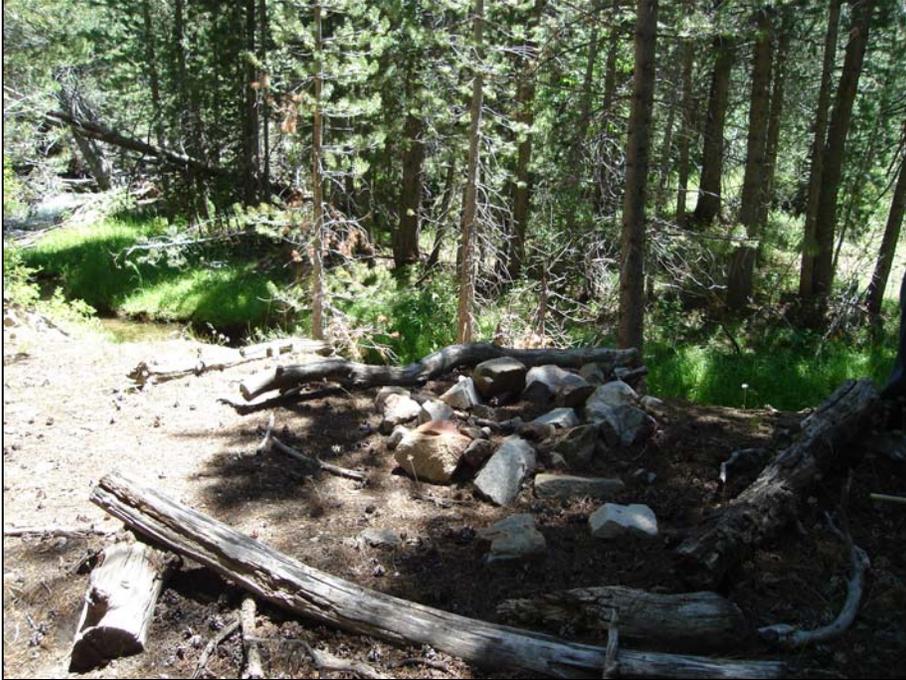
Site 18: Buckeye Creek, Bridgeport Ranger District, this is a small dispersed campsite that appears to get little use; however, a fire ring, old tin cans, and sitting logs mark the site. This site is located at UTM: N: 4231079 & E: 288539.

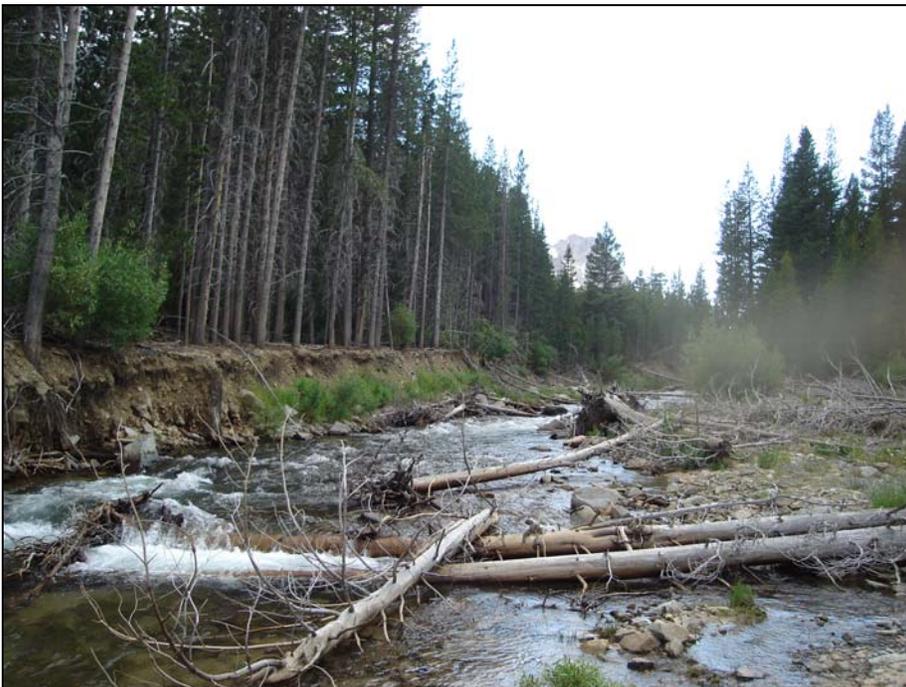
Site 19: Buckeye Creek, Bridgeport Ranger District, looking upstream at the stream characteristics for this section of stream. This site is located at UTM: N: 4230773 & E: 288289, Elevation 2333m.

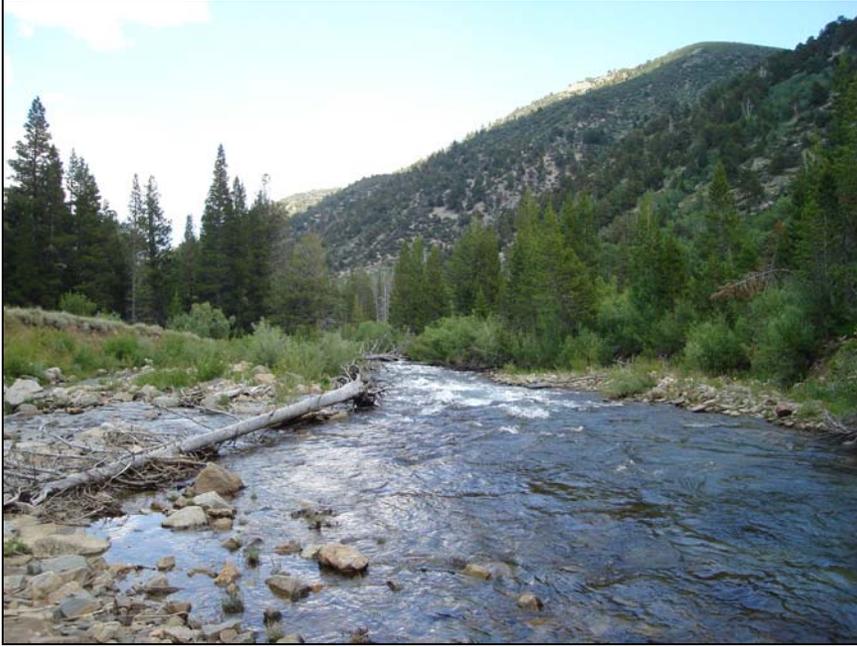
Site 19 continued: Buckeye Creek, Bridgeport Ranger District, looking downstream at the stream characteristics for this section of stream. This site is located at UTM: N: 4230773 & E: 288289, Elevation 2333m.

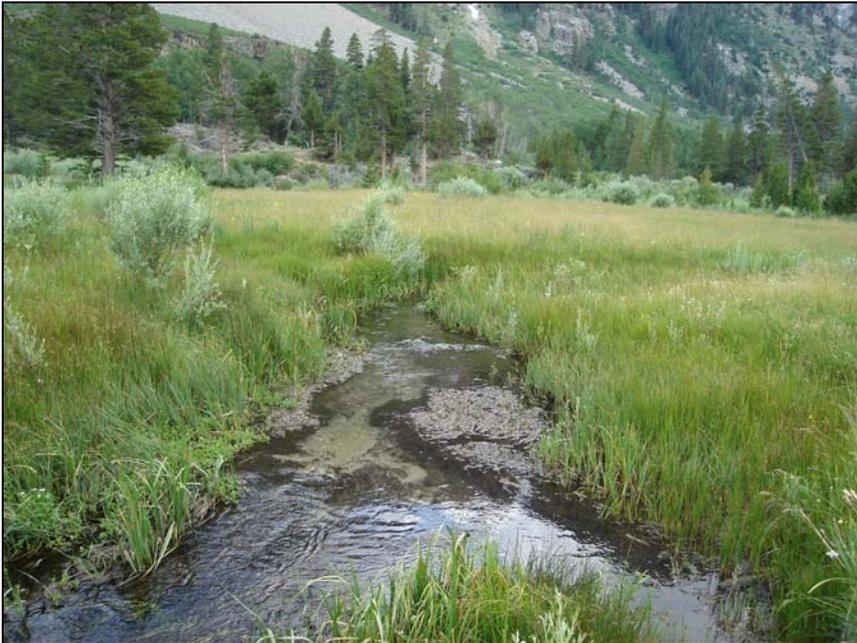
Site 20: Buckeye Creek, Bridgeport Ranger District, a small tributary enters Buckeye Creek on river left. The tributary is contributing about 5% to the overall flow of Buckeye Creek and adds about 100m of additional trout habitat before the tributary gets too small. This site is located at UTM: N: 4230443 & E: 287979, Elevation 2335m.

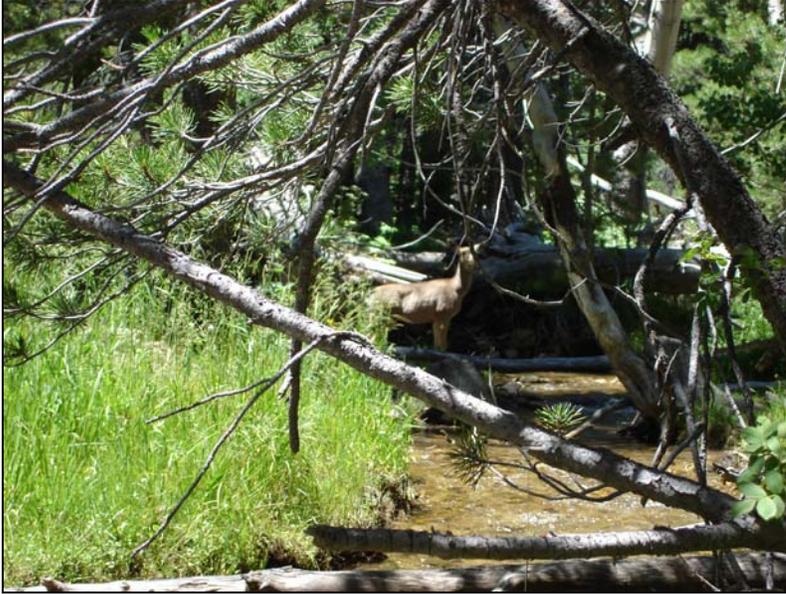
Site 21: Buckeye Creek, Bridgeport Ranger District, a small tributary enters on the river left side and contributes approximately 5% to the overall stream flow in Buckeye Creek. This site is located at UTM: N: 4229270 & E: 286665, Elevation 2374m.

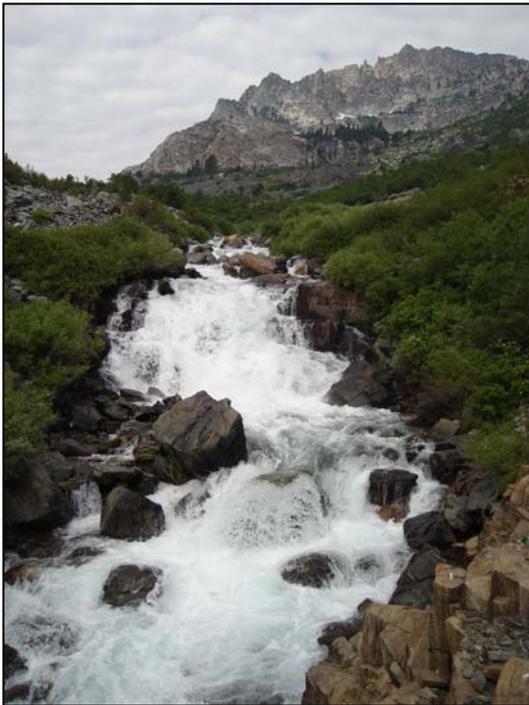
Site 22: Buckeye Creek, Bridgeport Ranger District, looking upstream at a naturally occurring permanent fish passage barrier. Several more waterfalls acting as permanent fish passage barriers occur in this section known as the “Roughs”. The largest of the falls measures approximately 4-5m (13-16.5ft) in height and is accompanied with several 1.5m and 2m drops. This site is located at UTM: N: 4229217 & E: 285731, Elevation 2426m.

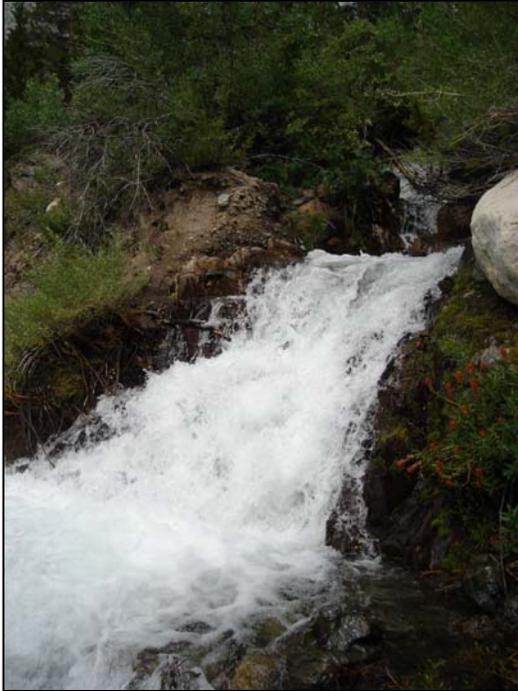
Site 23: Buckeye Creek, Bridgeport Ranger District, a large tributary enters on the river left side and contributes approximately 30% of the overall flow in Buckeye Creek. This tributary is extremely steep with several waterfalls with the largest being approximately 20m (66ft) in height. This site is located at UTM: N: 4228979 & E: 285409, Elevation 2494m.

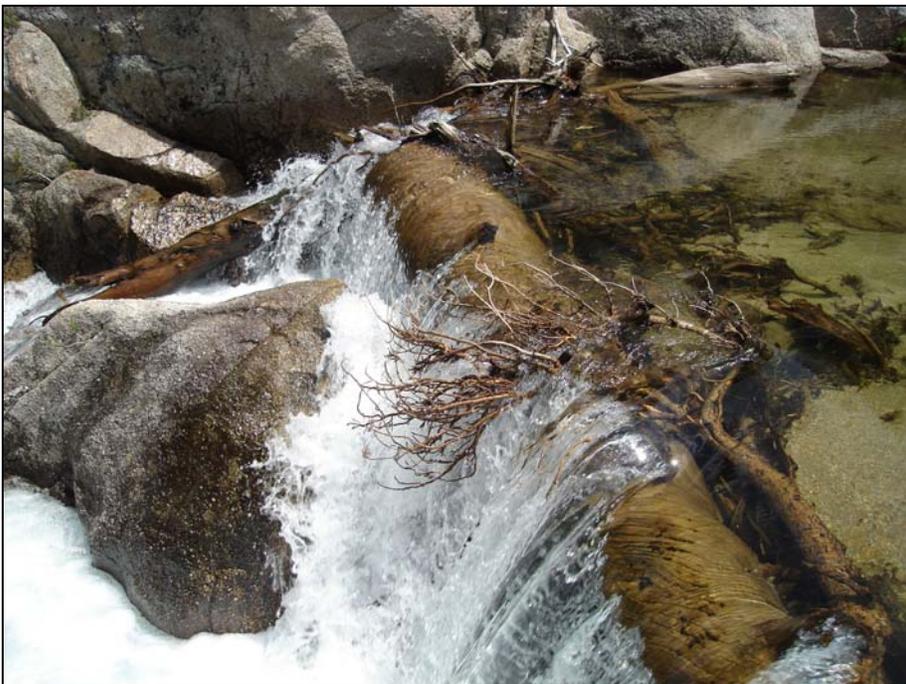
Site 24: Buckeye Creek, Bridgeport Ranger District, a cross-section view of a seasonal fish barrier. This downed log creates a 1.2m fall with a 1m plunge pool. This site is located at UTM: N: 4228154 & E: 284812, Elevation 2505m.

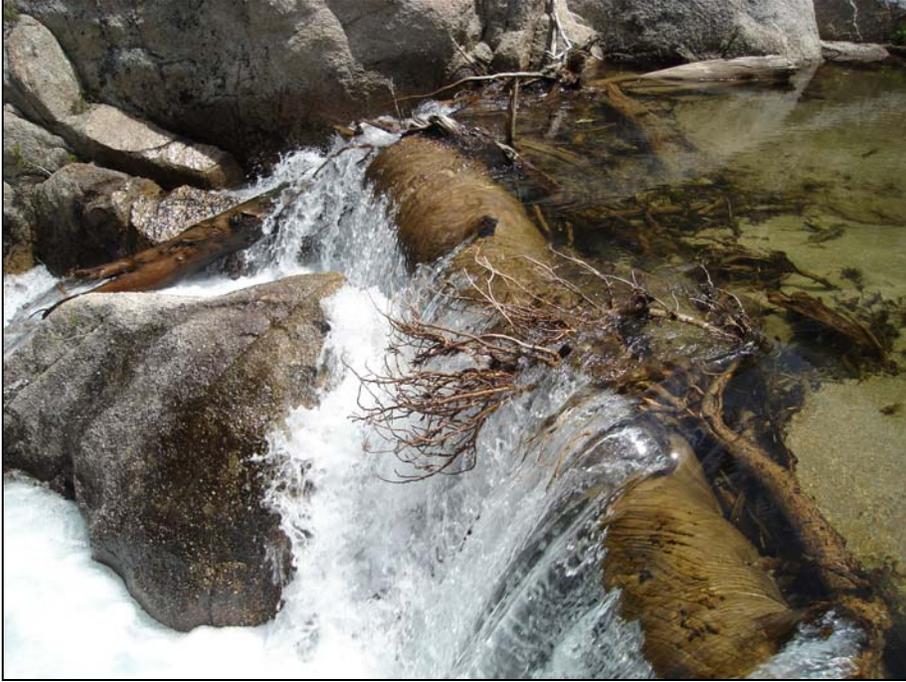
Site 25: Buckeye Creek, Bridgeport Ranger District, a cross-section view of seasonal fish barrier in Site 24. Several 10 inch fish were sighted in this large pool created by the downed tree. This site is located at UTM: N: 4228154 & E: 284812, Elevation 2505m.

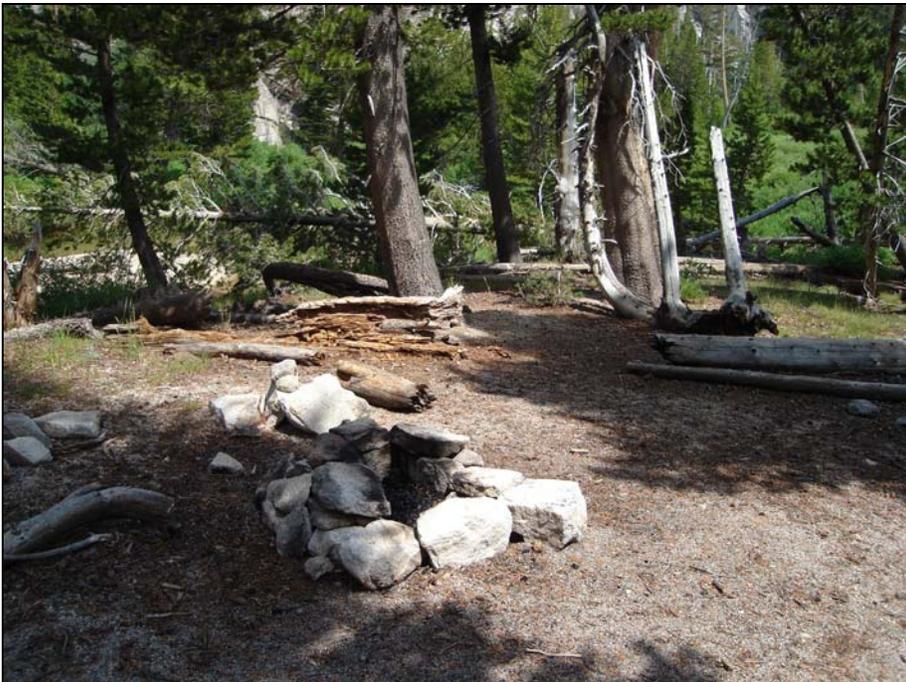
Site 26: Buckeye Creek, Bridgeport Ranger District, a small campsite marked by a fire ring and sitting logs. The site is approximately 8-10m (26-33ft) away from the creek. This site is located at UTM: N: 4228044 & E: 284728, Elevation 2511m.

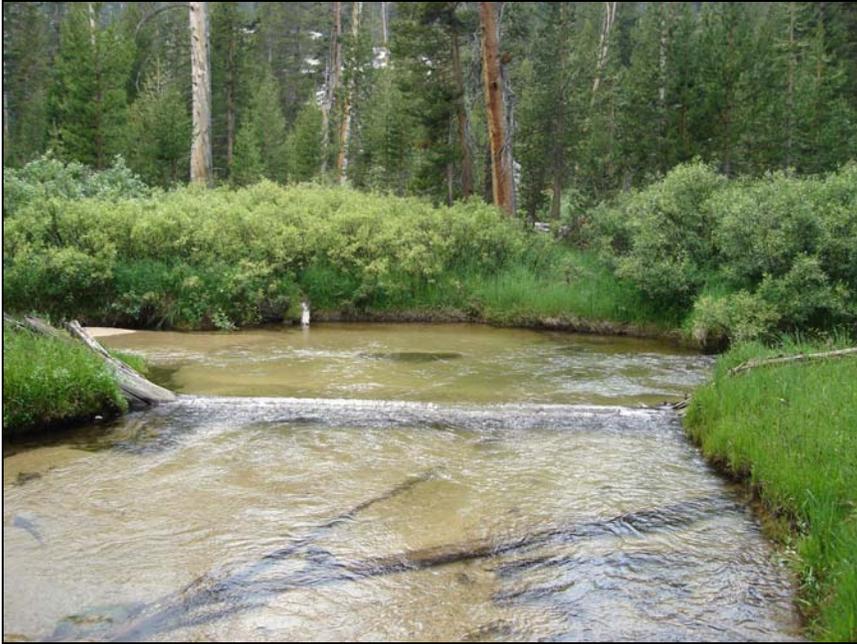
Site 27: Buckeye Creek, Bridgeport Ranger District, looking upstream at an old historical home which is located at the confluence of the North and South Forks of Buckeye Creek. Both the North and South Forks seem to be contributing an equal amount of water and enter at a “T” type intersection. The South Fork enters from the picture left side and the North Fork enters from the picture right side. This site is located at UTM N: 4227517 and E: 283483.
