Buckeye Creek

Mono County, California

2006 Stream Habitat Survey Report

Humboldt-Toiyabe National Forest, Bridgeport Ranger District

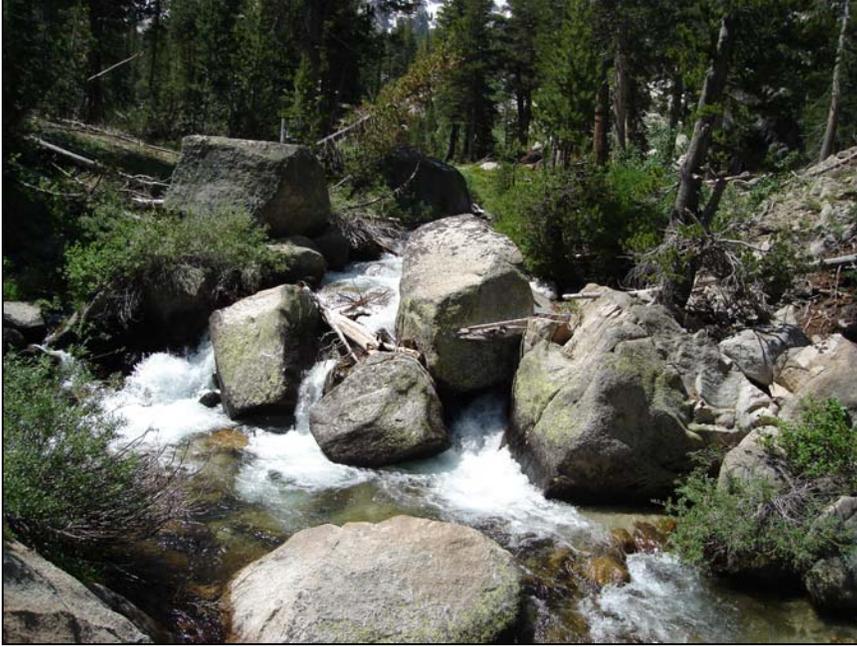
Site 28: South Fork Buckeye Creek, Bridgeport Ranger District, looking upstream at a seasonal fish barrier. This site is located at UTM: N: 4227093 & E: 283352, Elevation 2609m.

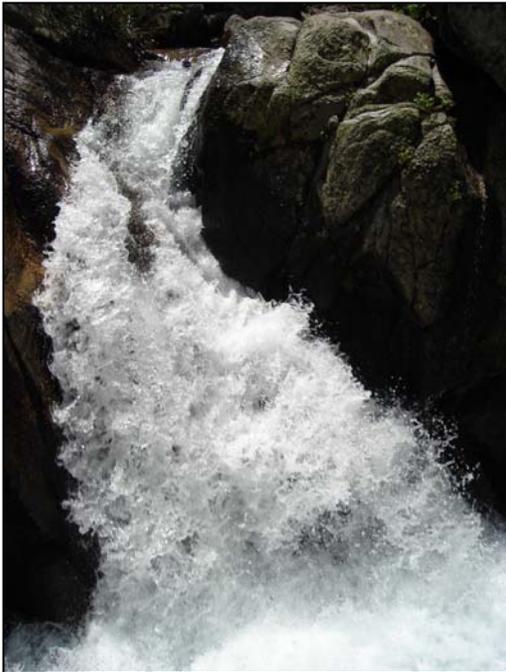
Site 29: South Fork Buckeye Creek, Bridgeport Ranger District, looking upstream at a naturally occurring permanent fish passage barrier. The South Fork of Buckeye Creek is getting to a point where the water flows through a granite canyon with huge boulders and rock formations lining the creek. Several more waterfalls are located near this site. This waterfall measures about 3m (9.8 ft) high. This site is located at UTM: N: 4226833 & E: 283324, Elevation 2616m.

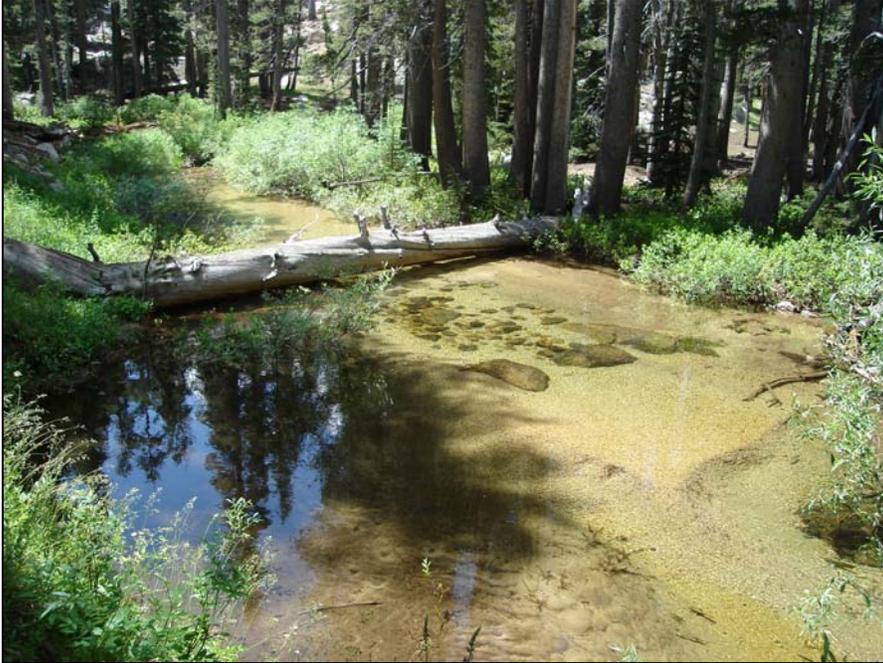
Site 30: South Fork Buckeye Creek, Bridgeport Ranger District, this pool is located upstream of several permanent fish passage barrier waterfalls; however, fish were still sighted in the area. In this pool two 8 inch fish were sighted. This site is located at UTM: N: 4226755 & E: 283371, Elevation 2648m.

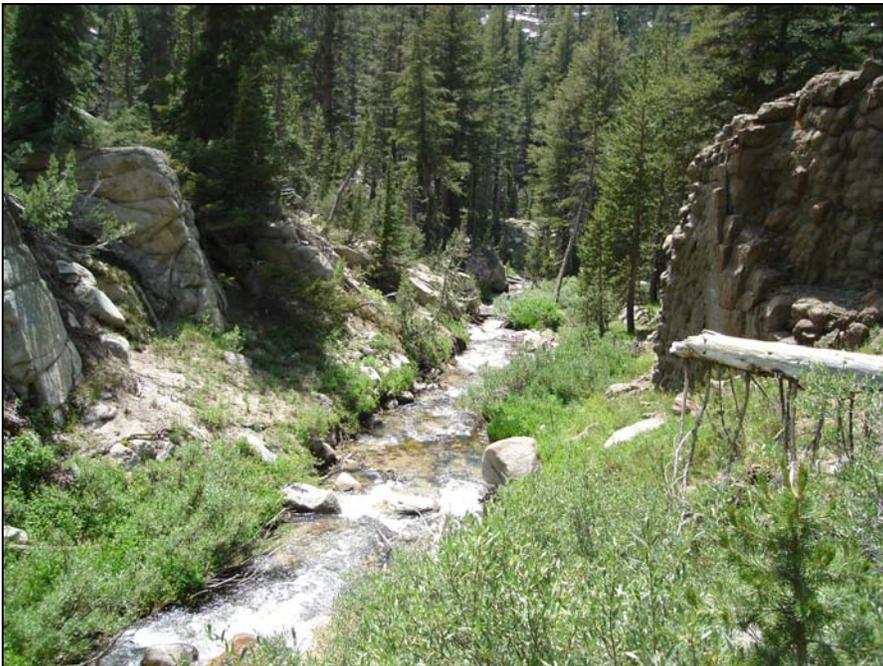
Site 31: South Fork Buckeye Creek, Bridgeport Ranger District, looking upstream from the survey end point. The survey ended at this point due to the steep terrain, several small waterfalls, and few pools. However, fish were still sighted in the few pools that exist. This site is located at UTM: N: 4225191 & E: 284409, Elevation 2767m.
