By-Day Creek  
Mono County, California

2004 Fish & Habitat Survey Report

Bridgeport Ranger District  
Humboldt-Toiyabe National Forest

# By Day Creek Lahontan Cutthroat Trout Survey - 2004

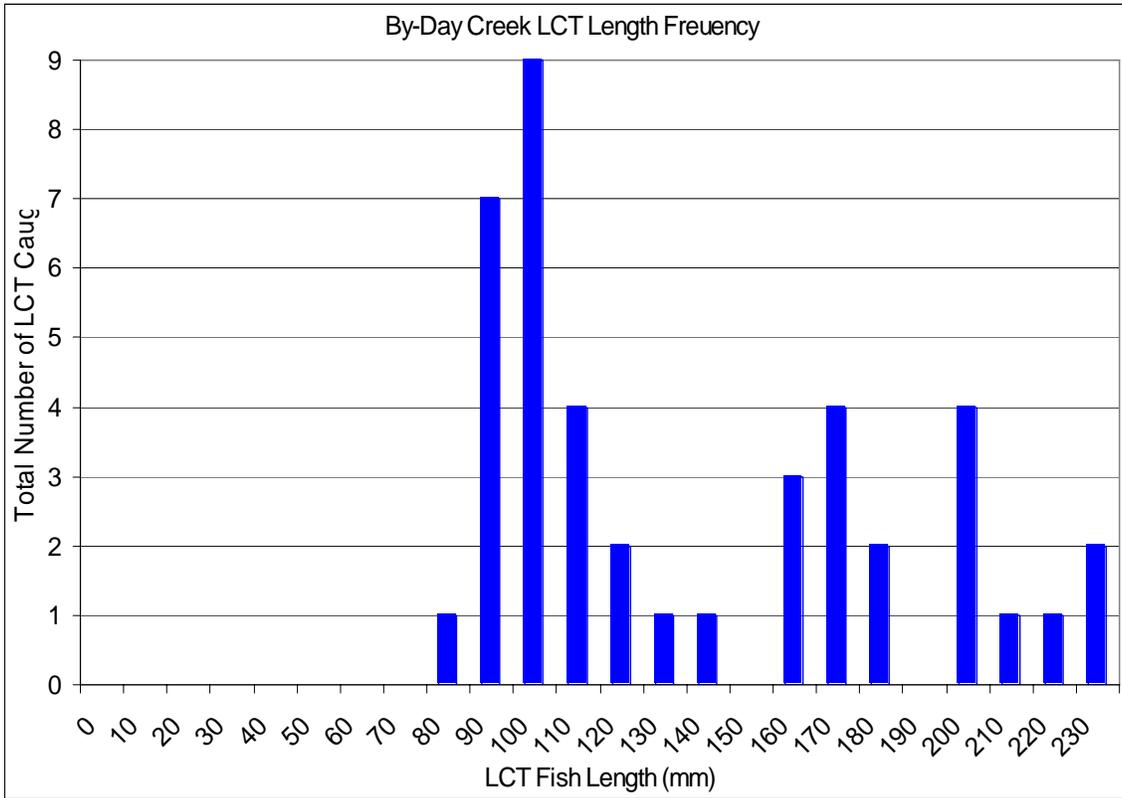
**Figure 1:** Length frequency of Lahontan cutthroat trout caught from By-Day Creek, Bridgeport Ranger District. By-Day Creek was surveyed on October 5 & 6, 2004. The average length of LCT is 133 mm (5 inches).

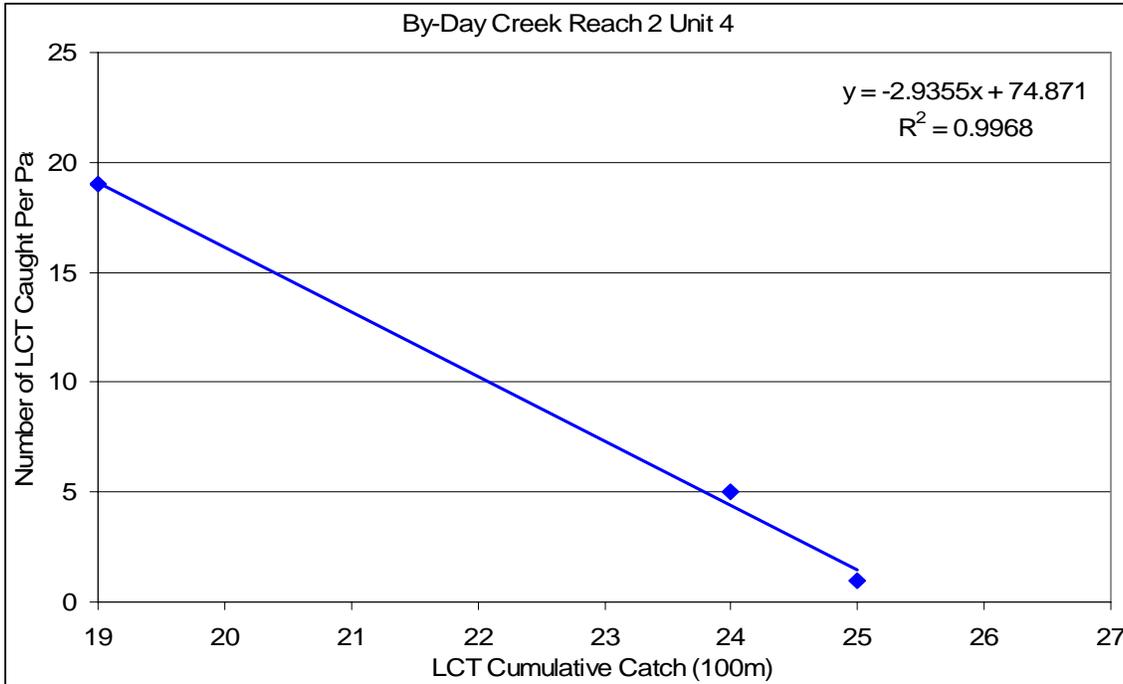
**Figure 2:** Linear regression equation for cumulative number of Lahontan cutthroat trout caught from By-Day Creek, Bridgeport Ranger District, Reach 2/Unit 4. Using the linear regression equation, the estimated total number of LCT within Reach 2 Unit 4 is 26. Reach 2/Unit 4 was 100 meters long and was electroshocked three times. Block nets were set at the top and bottom of the unit to keep fish from entering and leaving the unit. Reach 2/Unit 4 is located at UTM N: 4238199.12 & E: 295624.10. Survey was conducted on 6 Oct. 2004. Nineteen fish caught on the first pass is 73% of the estimated total number of LCT within the 100 meter long unit; therefore, the estimated miss rate of LCT from Reach2/Unit 4 is 27%. Zero fish were caught from Reach 1/Unit 4; also a 100 meter long unit; however, 1 LCT was sited at Reach1/Unit 4 but was not captured.

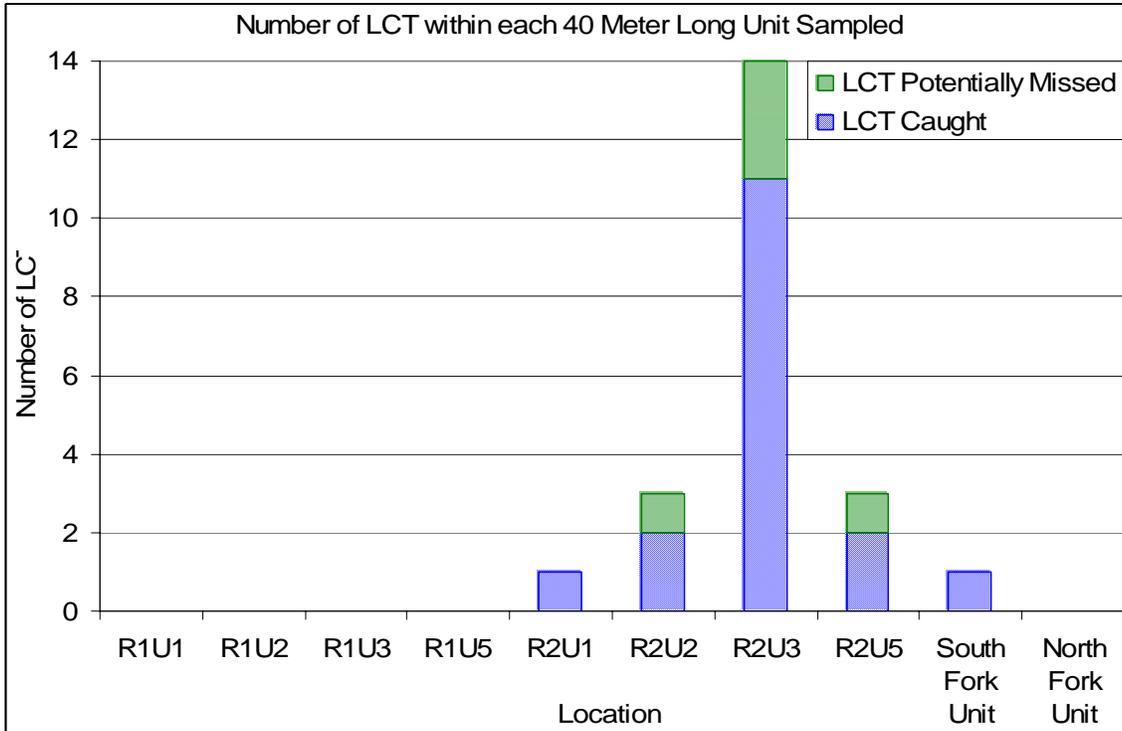
**Figure 3:** Number of LCT captured and potentially missed from each 40 meter long unit sampled on By-Day Creek, Bridgeport Ranger District. Surveys were conducted on October 5 & 6, 2004. Each unit was electrofished one time. The South Fork Unit and Reach 2 Units 1, 2, 3, and 5 all had habitat similar to the habitat on Reach 2/Unit 4. Reach 2/Unit 4 had a miss rate of 27% (Figure 2); therefore, an additional 27% of the captured LCT from each unit was added to the South Fork Unit and Reach 2 Units 1, 2, 3, and 5 to account for potentially missed LCT from each unit.

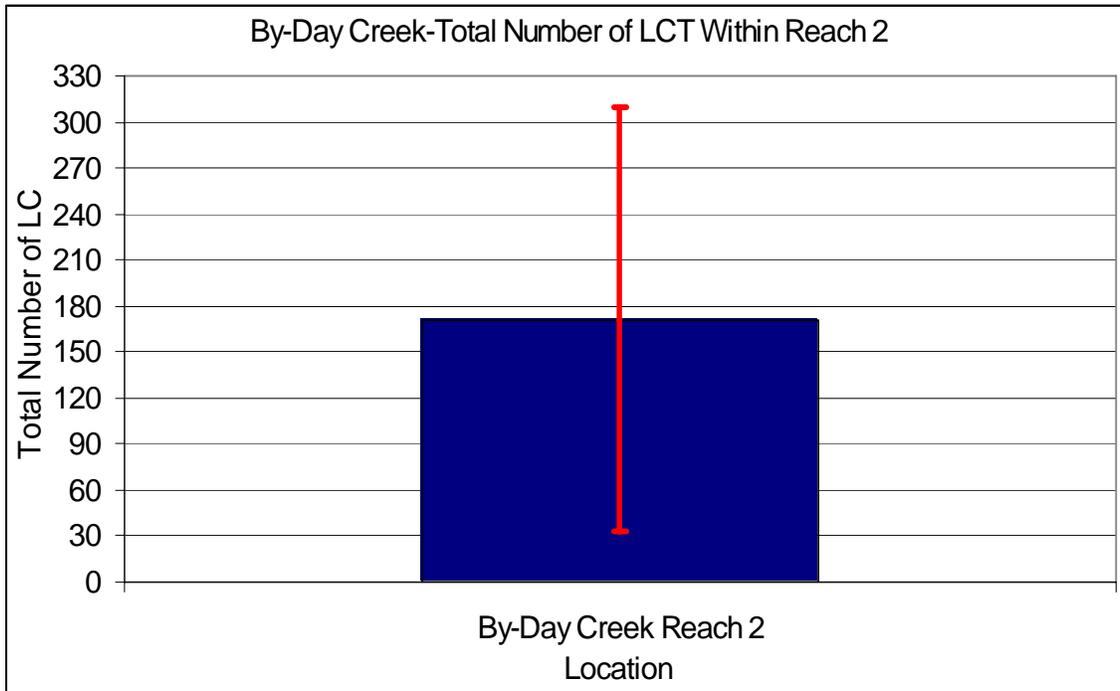
The mean number of LCT within Reach 2 is 171 (Figure 4). The upper 90% confidence interval is 309 and the lower 90% confidence interval is 33 (Figure 4). Reach 2 is approximately 0.7 miles long. The mean number of LCT within the entire watershed of By-Day Creek is 186 (Figure 5). The upper 90% confidence interval is 324 and the lower 90% confidence interval is 48 (Figure 5). The mean number of LCT/mile within the entire By-Day Creek watershed is 169 (Figure 6). The upper 90% confidence interval is 295 and the lower 90% confidence interval is 44 (Figure 6).

**Figure 4:** Mean and 90% confidence interval for the estimated total number of LCT within By-Day Creek Reach 2, Bridgeport Ranger District. By-Day Creek was surveyed on October 5 & 6, 2004. The mean number of LCT is 171, the upper 90% confidence interval is 309, and the lower 90% confidence interval is 33. This area had the highest density of LCT. By-Day Creek Reach 2 is approximately 0.7 miles long.

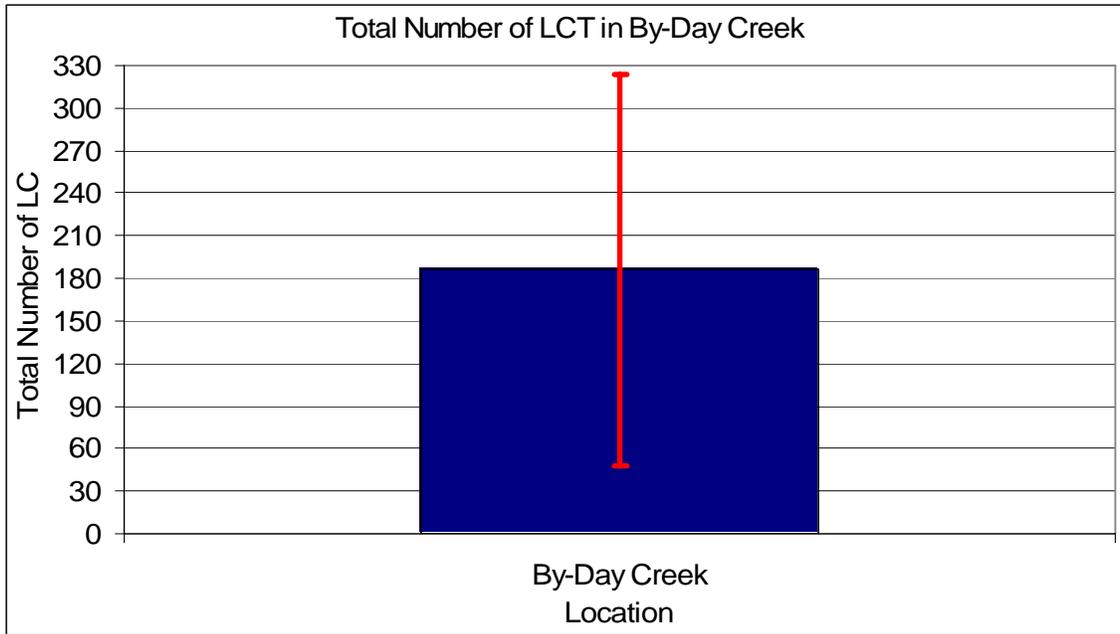
**Figure 5:** Mean and 90% confidence interval for the estimated total number of LCT within By-Day Creek, Bridgeport Ranger District. By-Day Creek was surveyed on October 5 & 6, 2004. The mean number of LCT is 186, the upper 90% confidence interval is 324, and the lower 90% confidence interval is 48. Lahontan cutthroat trout in By-Day Creek are occupying approximately 1.1 miles of stream habitat.

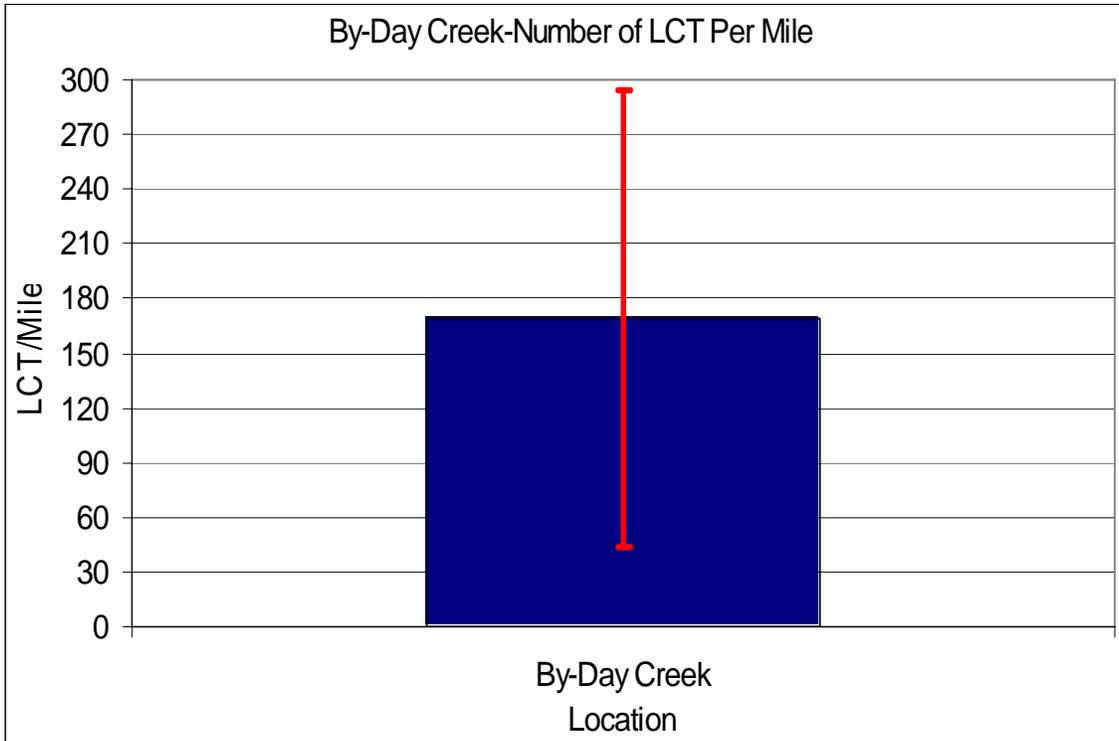
**Figure 6:** Mean number of LCT/mile and 90% confidence interval for LCT in By-Day Creek, Bridgeport Ranger District. By-Day Creek was surveyed on October 5 & 6, 2004. The mean number of LCT/Mile is 169, the upper 90% confidence interval is 295, and the lower 90% confidence interval is 44. Lahontan cutthroat trout in By-Day Creek are occupying approximately 1.1 miles of stream habitat.

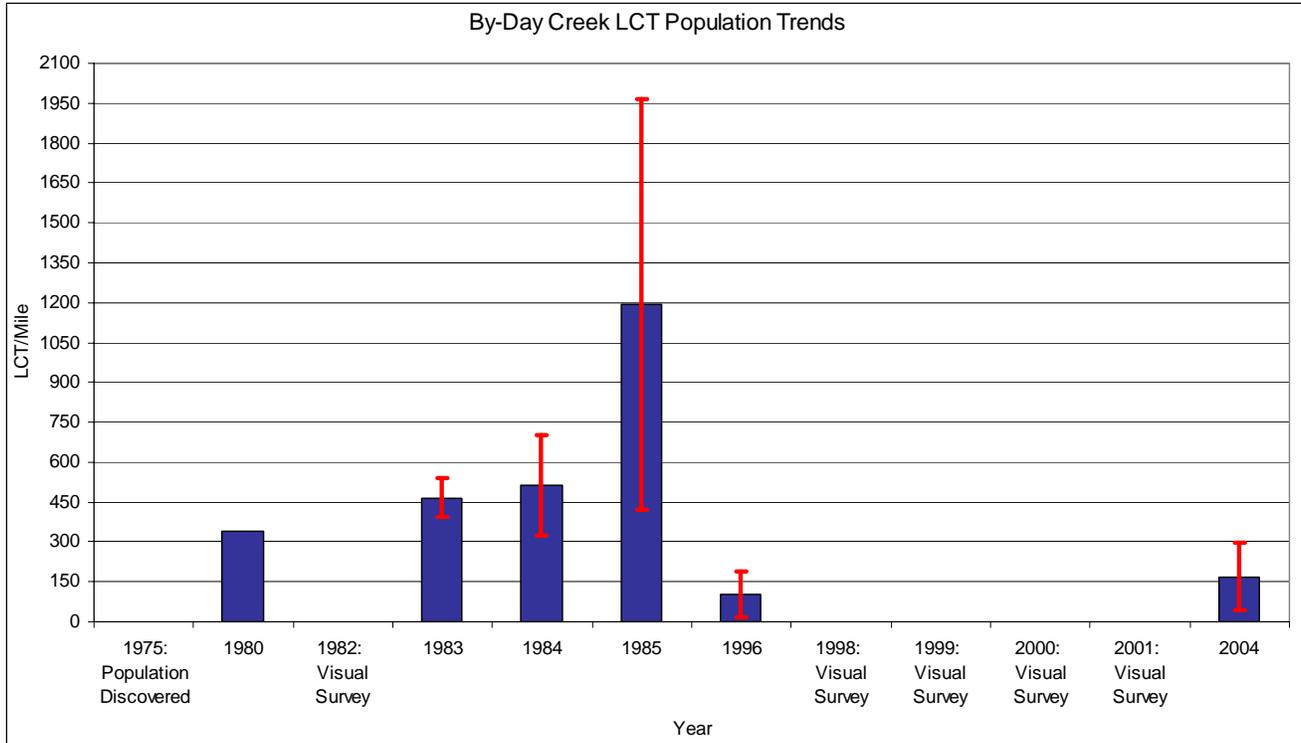
The 2004 Lahontan cutthroat trout population estimate is low compared to the population estimates in 1980, 1983, 1984, and 1985 (Figure 7); however, the 2004 population estimate is higher than the 1996 population estimate (Figure 7). In 1996 only a one pass depletion survey was conducted; therefore, the 1996 population estimate may be conservative. To reduce potential impacts of electrofishing on LCT, visual surveys were conducted from 1998 through 2001 (Figure 7).

**Figure 7:** Mean number of LCT/mile and 90% confidence intervals for Lahontan cutthroat trout in By-Day Creek, Bridgeport Ranger District, between 1980 and 2004. Not enough information was provided in the 1980 report to compute a confidence interval. In 1983, 1984, 1985, and 2004 a 2-3 pass depletion survey was conducted. In 1980 and 1996 only a one pass depletion survey was conducted; therefore, the 338 LCT/mile in 1980 and 103 LCT/mile in 1996 are probably conservative. In 1980 LCT were occupying approximately 1.5 miles of stream habitat. In 2004 LCT were occupying approximately 1.1 miles of stream habitat.

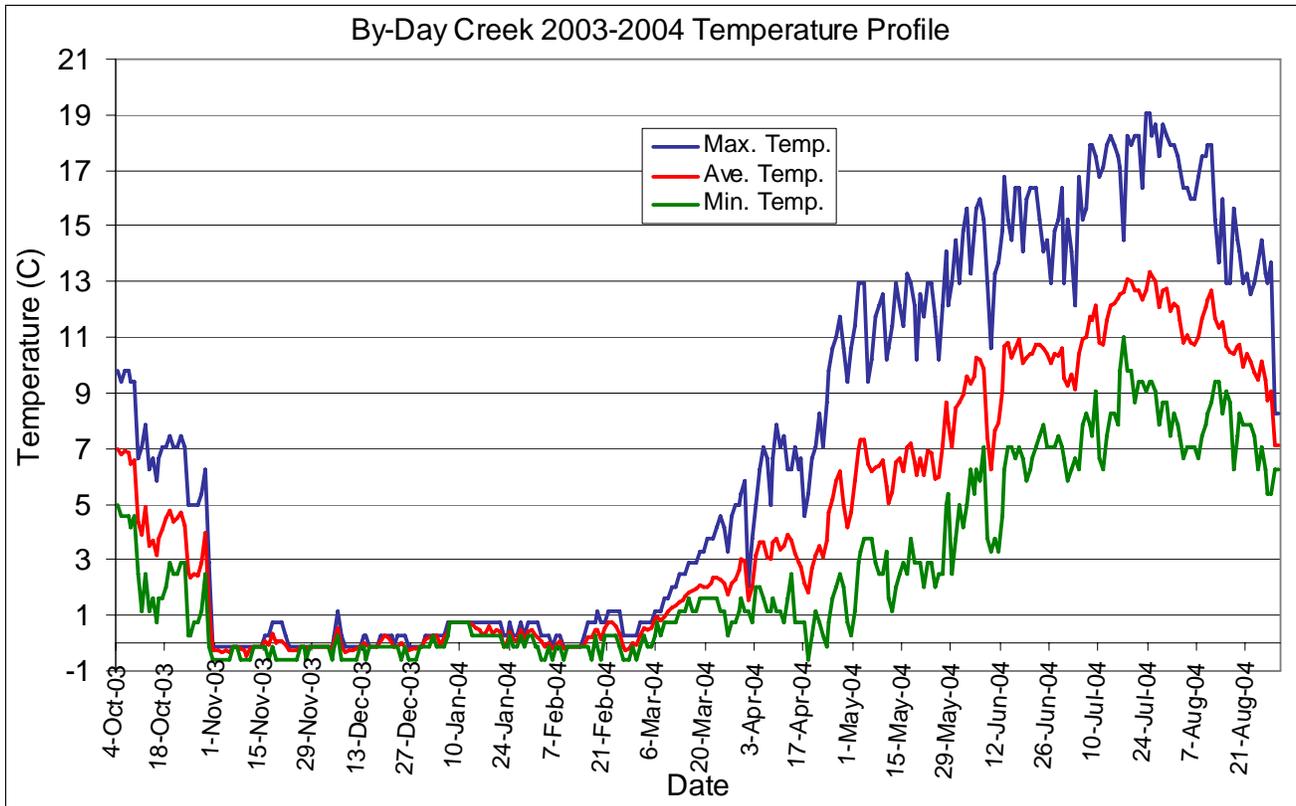
A HOBO Temperature (C) 1996 Onset data logger was used to collect temperature data in By-Day Creek. The HOBO Temp was located just upstream of Reach 2 Unit 3 at 7664 feet elevation. Temperature was collected from 4 Oct. 2003 to 29 Aug. 2004. The overall maximum temperature was 19.04 degrees Celsius, the overall average temperature was 4.42 degrees Celsius, and the overall minimum temperature was -0.61 degrees Celsius. The average temperature between 1 Nov. 2003 and 31 March 2004 was 0.39 degrees Celsius. The average temperature between 4 Oct. 2003 and 31 Oct. 2003, and between 1 April 2004 and 29 Aug. 2004 was 6.23 degrees Celsius (Figure 8).

**Figure 8:** 2003-2004 temperature profile for By-Day Creek, Bridgeport Ranger District. The overall maximum temperature was 19.04 degrees Celsius, the overall average temperature was 4.42 degrees Celsius, and the overall minimum temperature was -0.61 degrees Celsius. The average temperature between 1 Nov. 2003 and 31 March 2004 was 0.39 degrees Celsius. The average temperature between 4 Oct. 2003 and 31 Oct. 2003, and between 1 April 2004 and 29 Aug. 2004 was 6.23 degrees Celsius. A HOBO Temperature (C) 1996 Onset data logger was used to collect the temperature data. The HOBO Temp was located near Reach 2 Unit 3 at 7664 feet elevation. The HOBO Temp was located at UTM N: 4238262 & E: 295999. Temperature was collected from 4 Oct. 2003 to 29 Aug. 2004.

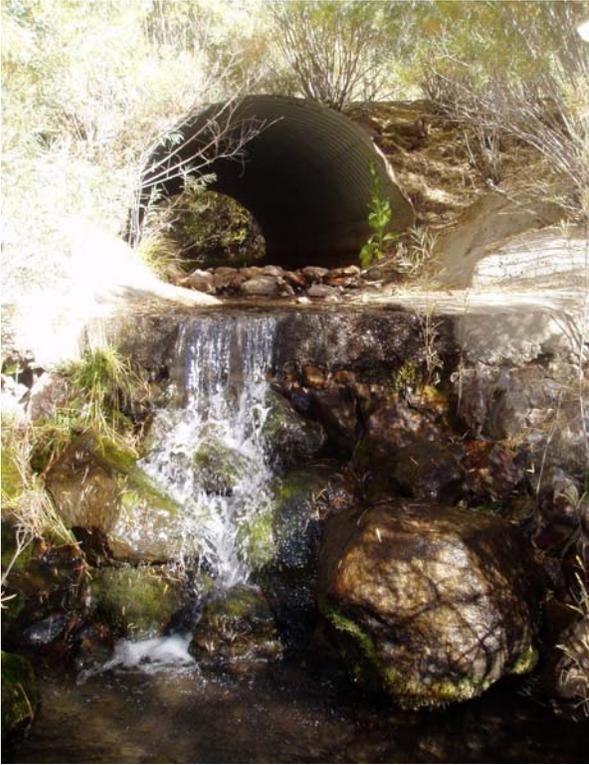
Three man-made fish barriers are located on the mainstem of By-Day Creek. The lowermost barrier is a culvert that was reinforced by CDFG in 1996 at the Buckeye Road/By-Day Creek intersection to prevent non-native fish from Buckeye Creek migrating upstream into the By-Day Creek watershed. The barrier is approximately 5 feet high (Figure 9). The other two barriers are rock gabion barriers (Figures 24 & 28) located within Reach 2. Both rock gabion barriers were originally installed to probably control headcutting. The Bridgeport Ranger District is planning to alter these two rock gabion barriers within Reach 2 in Fall 2005 to provide LCT the ability to migrate up and downstream within the watershed without unobstructed movement. A third rock gabion structure on the mainstem (Figure 29) does not appear to currently be a fish barrier, but the structure needs to be continually monitored. Another rock gabion fish barrier is located on the North Fork of By-Day Creek, approximately 1/3 mile upstream of the North and South Fork confluence (Figure 38).

**Figure 9:** By-Day Creek, Bridgeport Ranger District, fish barrier at the By-Day Creek/Buckeye Road intersection. Picture was taken on 5 Oct. 2004. Barrier is located at UTM N: 4237867.76 & E: 298628.52. This culvert was purposely installed by CDFG in 1996 to keep non-native fish from migrating upstream into the watershed. The barrier is approximately 5 feet high.

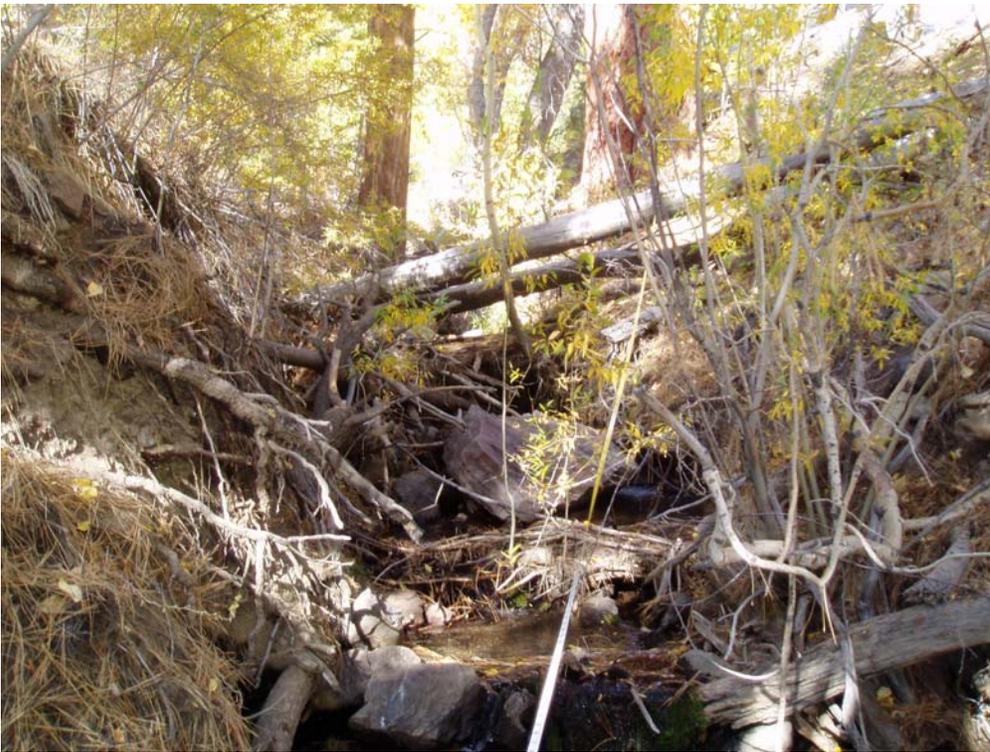
**Figure 10:** By-Day Creek, Bridgeport Ranger District, looking upstream at Reach 1/Unit 1. Unit is right next to the road. This Unit is located at UTM N: 4238050.98 & E: 298323.02. Picture was taken on 5 Oct. 2004.

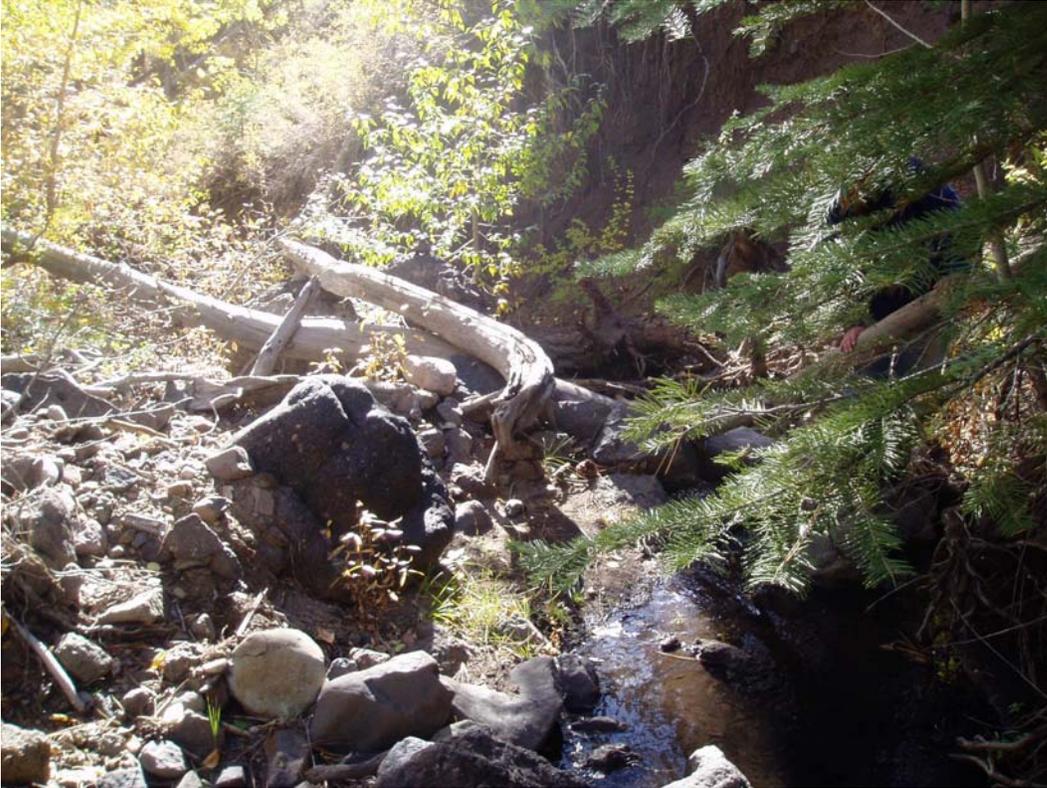
**Figure 11:** By-Day Creek, Bridgeport Ranger District, looking downstream at Reach 1/Unit 1. Unit is right next to the road. This Unit is located at UTM N: 4238050.98 & E: 298323.02. Picture was taken on 5 Oct. 2004.

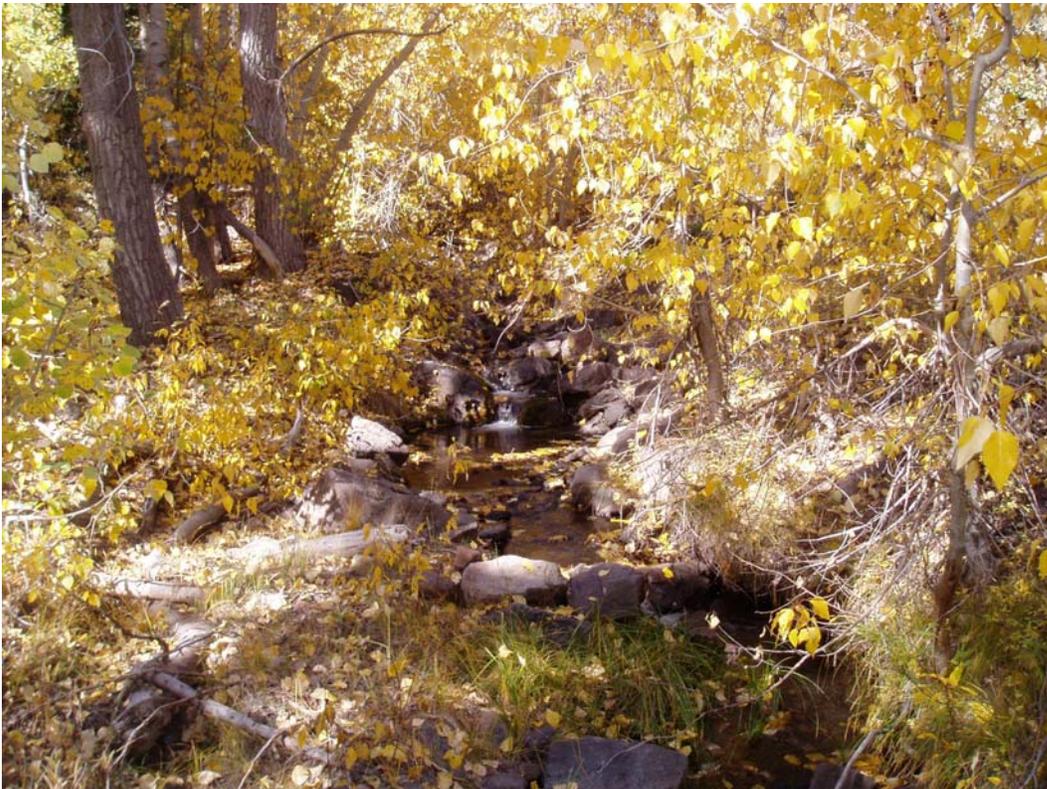
**Figure 12:** By-Day Creek, Bridgeport Ranger District, looking upstream at Reach 1/Unit 2. This Unit is located at UTM N: 4238138.05 & E: 298019.39. Picture was taken on 5 Oct. 2004.

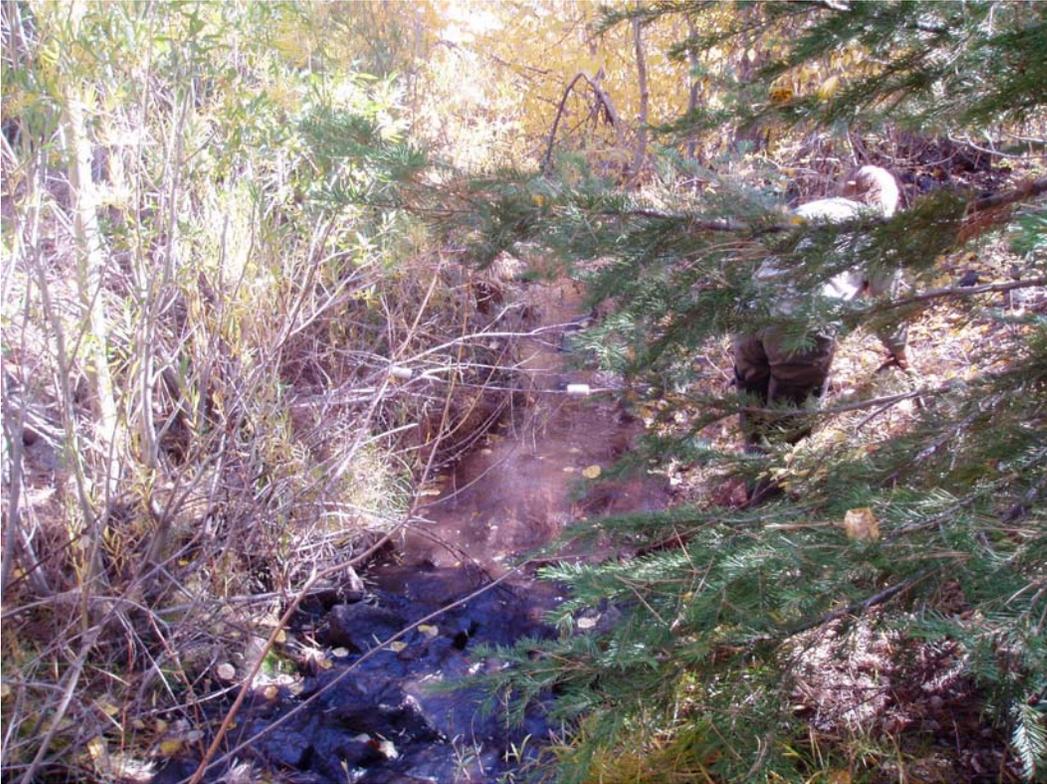
**Figure 13:** By-Day Creek, Bridgeport Ranger District, looking downstream at Reach 1/Unit 2. This Unit is located at UTM N: 4238138.05 & E: 298019.39. Picture was taken on 5 Oct. 2004.

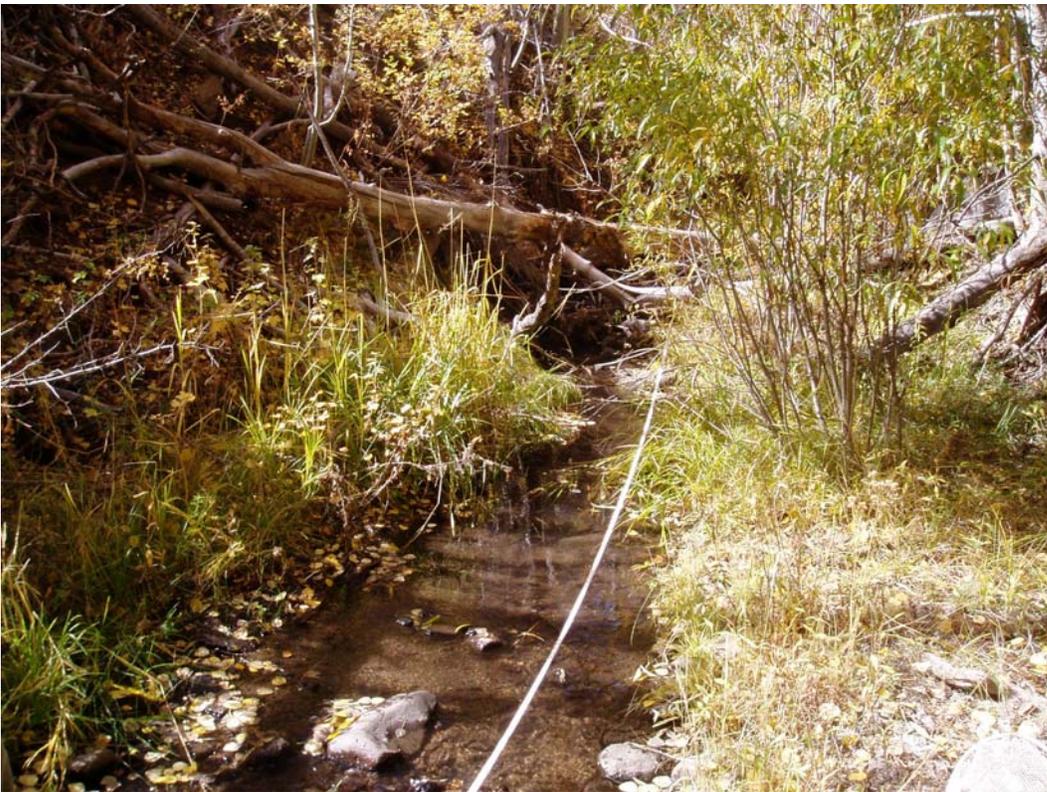
**Figure 14:** By-Day Creek, Bridgeport Ranger District, looking upstream at Reach 1/Unit 3. This Unit is located at UTM N: 4238076.85 & E: 297685.72. Picture was taken on 5 Oct. 2004.

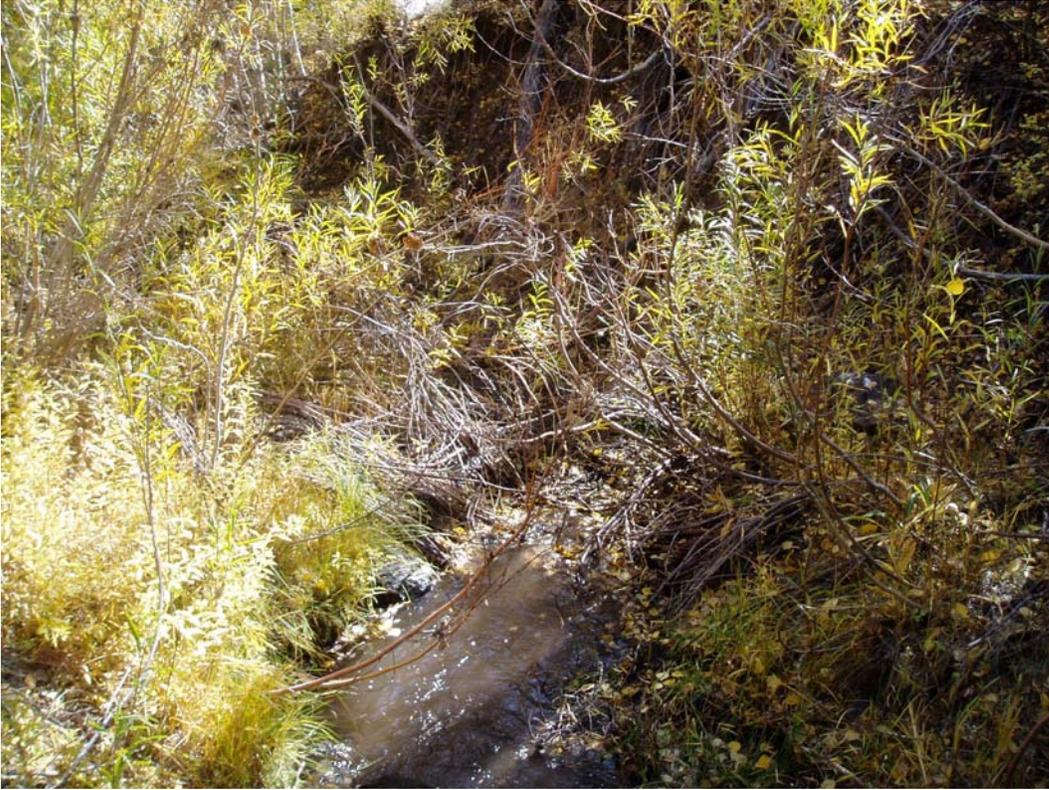
**Figure 15:** By-Day Creek, Bridgeport Ranger District, looking downstream at Reach 1/Unit 3. This Unit is located at UTM N: 4238076.85 & E: 297685.72. Picture was taken on 5 Oct. 2004.

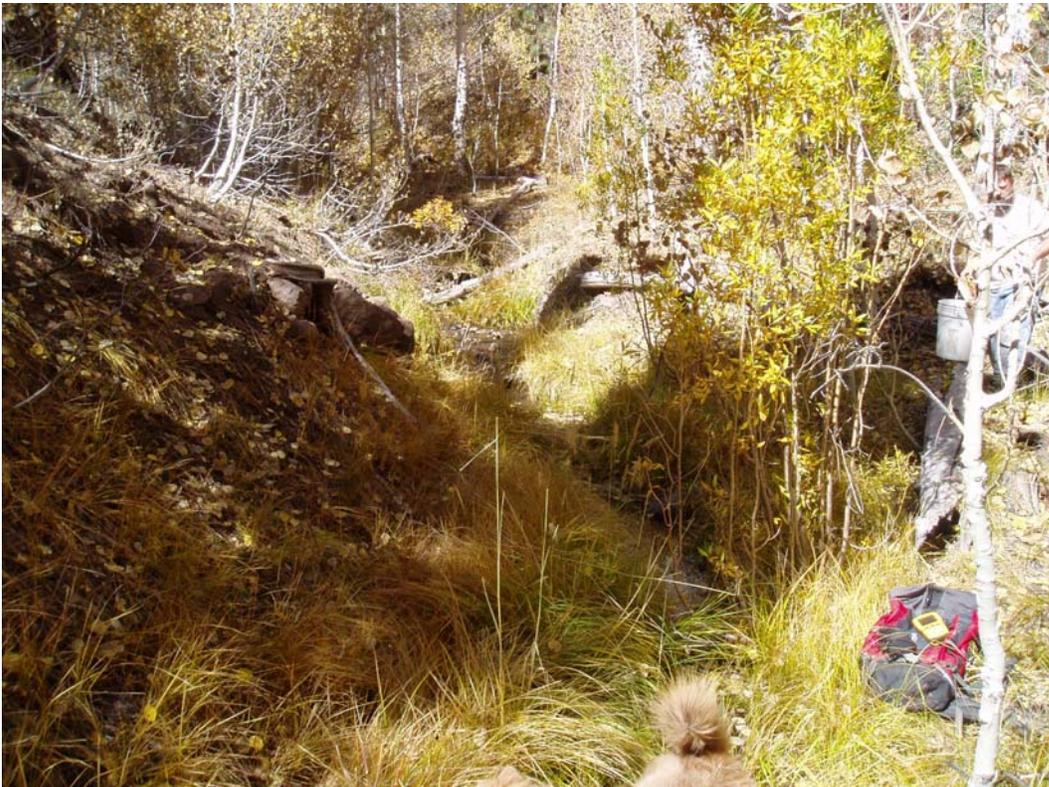
**Figure 16:** By-Day Creek, Bridgeport Ranger District, looking upstream at Reach 1/Unit 4. Unit is located near the CDFG EcoReserve gate. This Unit is located at UTM N: 4238111.46 & E: 297078.05. Picture was taken on 5 Oct. 2004.

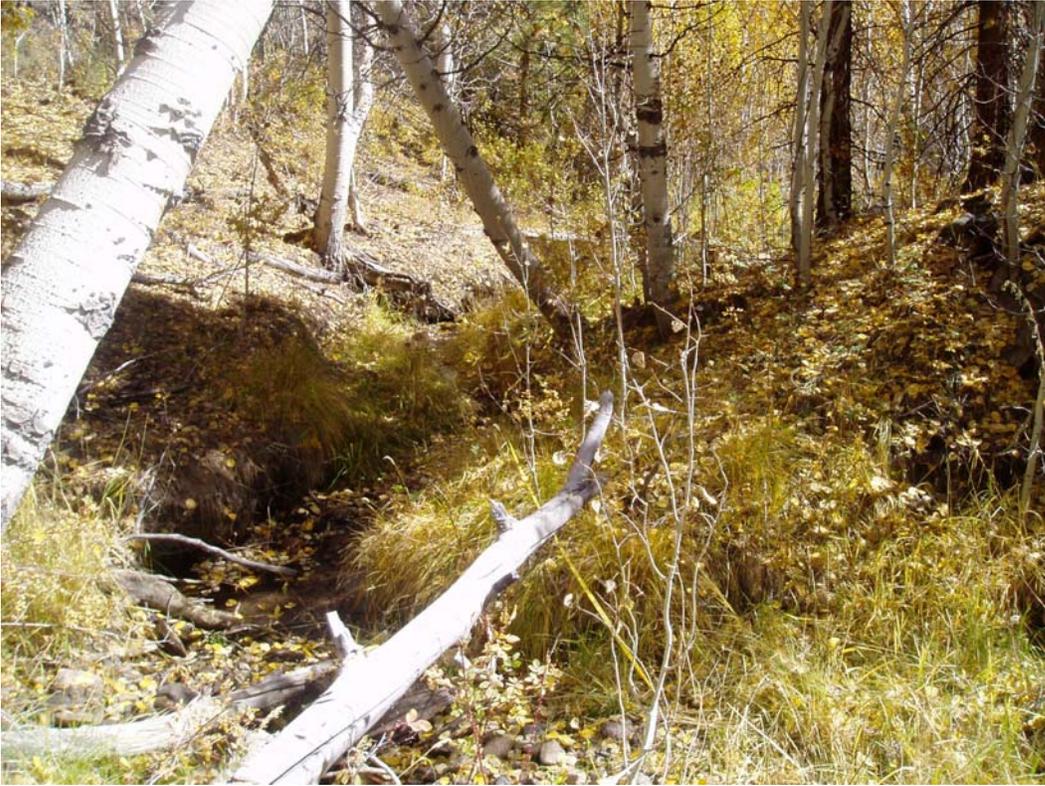
**Figure 17:** By-Day Creek, Bridgeport Ranger District, looking downstream at Reach 1/Unit 4. Unit is located near the CDFG EcoReserve gate. This Unit is located at UTM N: 4238111.46 & E: 297078.05. Picture was taken on 5 Oct. 2004.

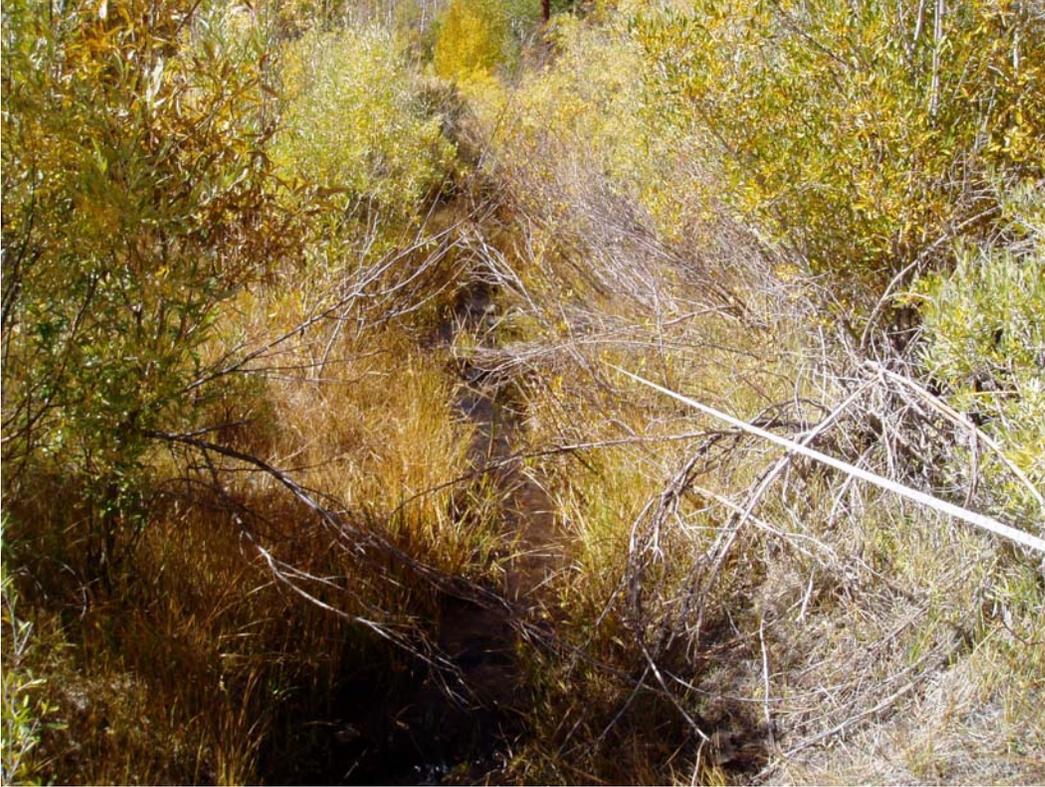
**Figure 18:** By-Day Creek, Bridgeport Ranger District, looking upstream at Reach 1/Unit 5. This Unit is located at UTM N: 4238284.72 & E: 296777.23. Picture was taken on 5 Oct. 2004. Unit is located next to USFS in-stream structure 48.

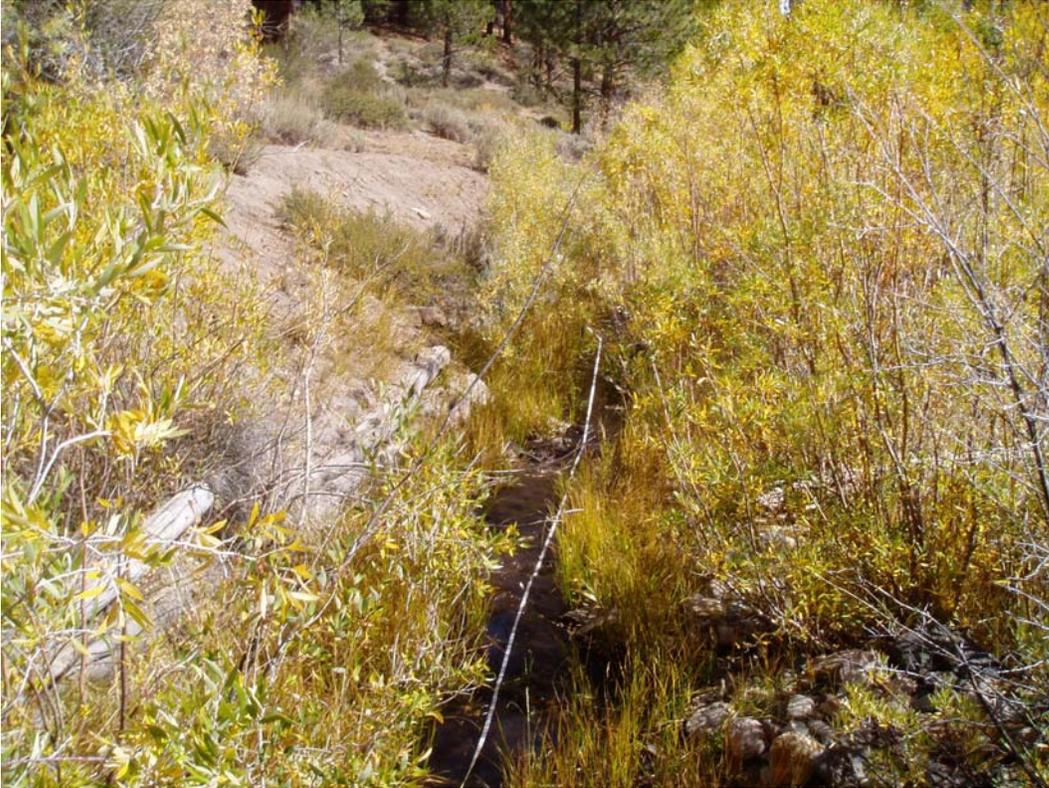
**Figure 19:** By-Day Creek, Bridgeport Ranger District, looking downstream at Reach 1/Unit 5. This Unit is located at UTM N: 4238284.72 & E: 296777.23. Picture was taken on 5 Oct. 2004. Unit is located next to USFS in-stream structure 48.

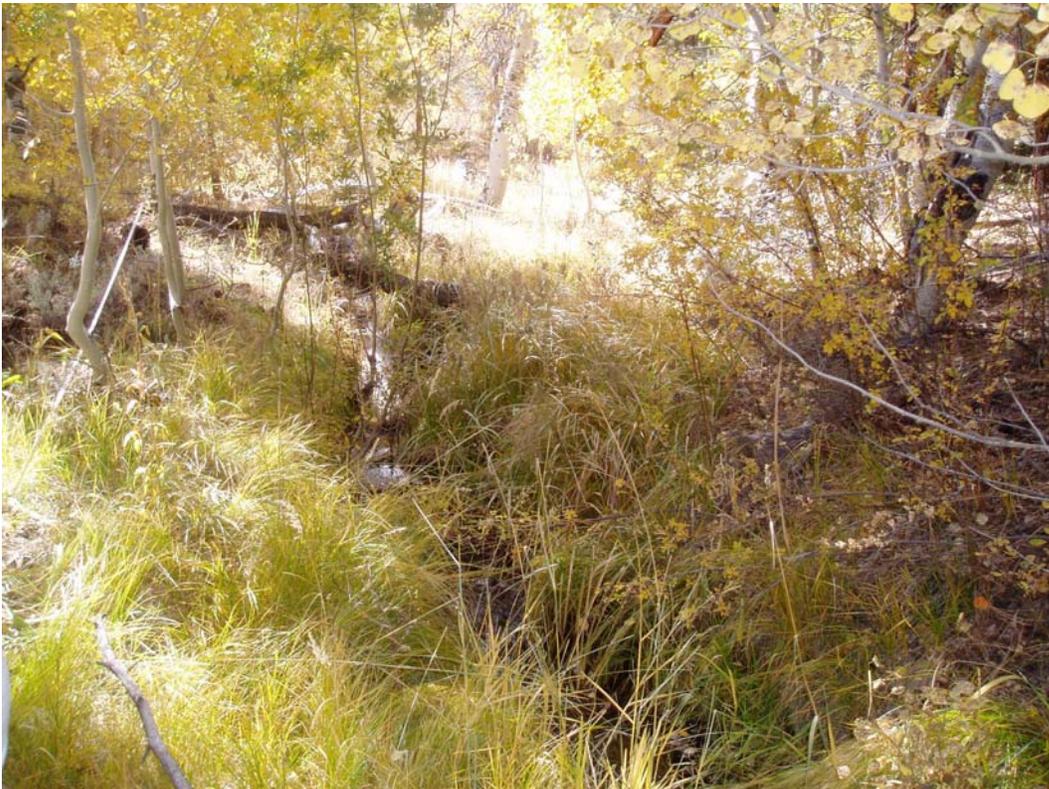
**Figure 20:** By-Day Creek, Bridgeport Ranger District, looking upstream at Reach 2/Unit 1. This Unit is located at UTM N: 4238344.25 & E: 296513.85. Picture was taken on 5 Oct. 2004. Unit is located near USFS in-stream structure 39.

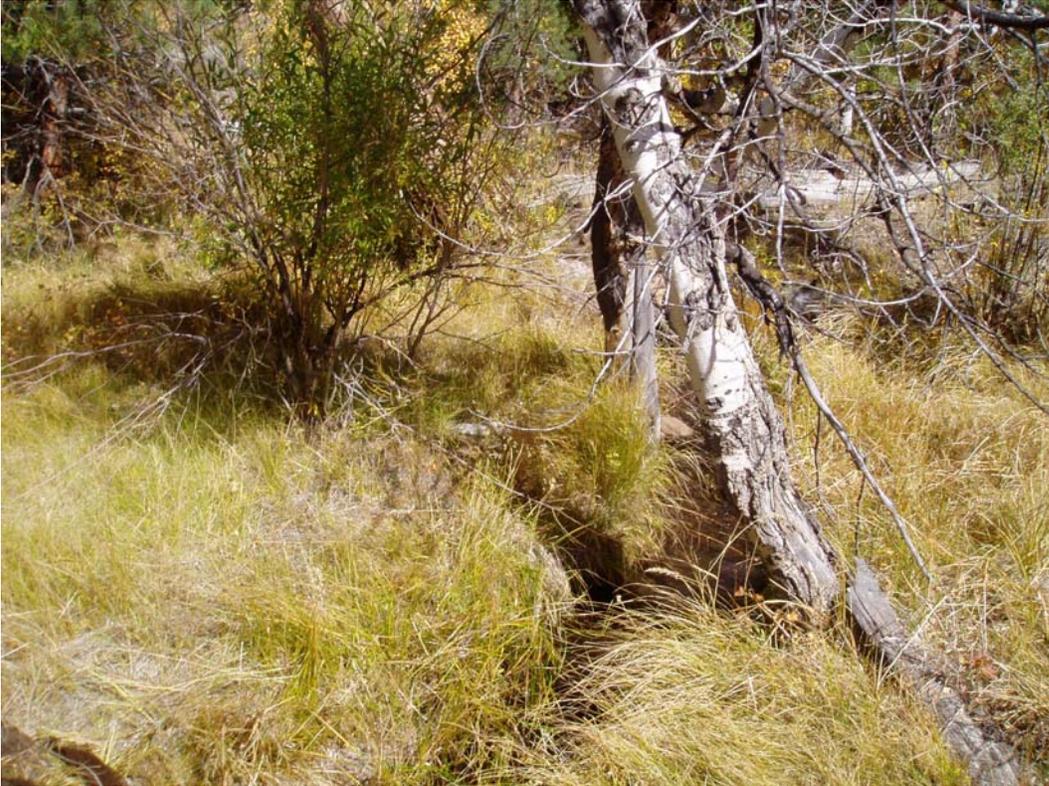
**Figure 21:** By-Day Creek, Bridgeport Ranger District, looking downstream at Reach 2/Unit 1. This Unit is located at UTM N: 4238344.25 & E: 296513.85. Picture was taken on 5 Oct. 2004. Unit is located near USFS in-stream structure 39.

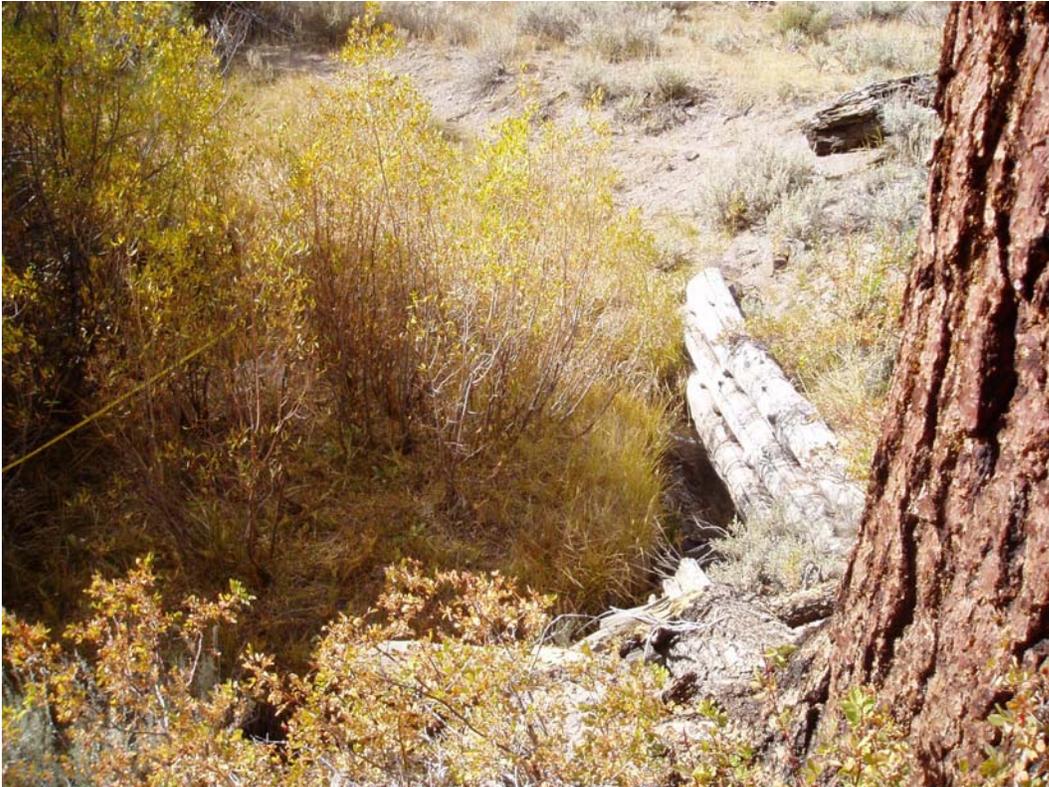
**Figure 22:** By-Day Creek, Bridgeport Ranger District, looking upstream at Reach 2/Unit 2. This Unit is located at UTM N: 4238315.58 & E: 296228.56. Picture was taken on 5 Oct. 2004. Unit is located near USFS in-stream structure 33.

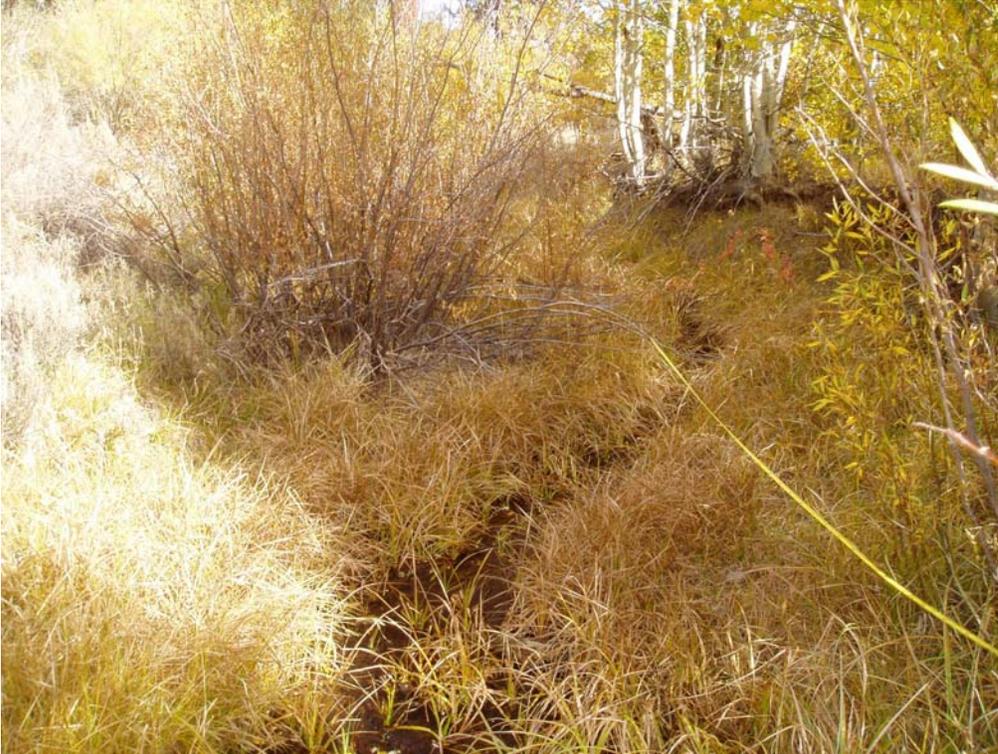
**Figure 23:** By-Day Creek, Bridgeport Ranger District, looking downstream at Reach 2/Unit 2. This Unit is located at UTM N: 4238315.58 & E: 296228.56. Picture was taken on 5 Oct. 2004. Unit is located near USFS in-stream structure 33.

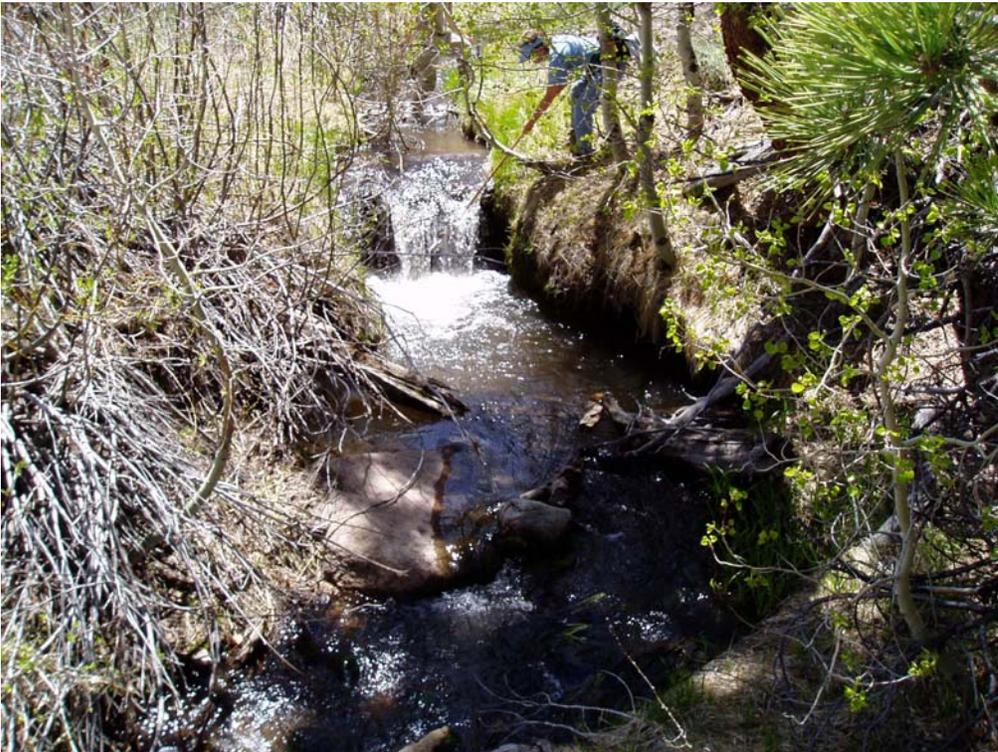
**Figure 24:** By-Day Creek, Bridgeport Ranger District, gabion weir between USFS structure 25 and USFS structure 26 at the bottom of Reach 2/Unit 3. Picture was taken on 20 May 2004. Pool depth below the weir is 0.45 meters. Height of the vertical drop is 0.5 meters. Structure is currently acting as a fish barrier. Barrier is located at UTM N: 4238297.47 & E: 296047.52.

2. In 2009 conduct another similar LCT distribution and density survey. Monitor LCT response to altering the rock gabion barriers (Figures 24 & 28) and to the bridge construction.
