By-Day Creek  
Mono County, California

2004 Fish & Habitat Survey Report

Bridgeport Ranger District  
Humboldt-Toiyabe National Forest

# By Day Creek Lahontan Cutthroat Trout Survey - 2004

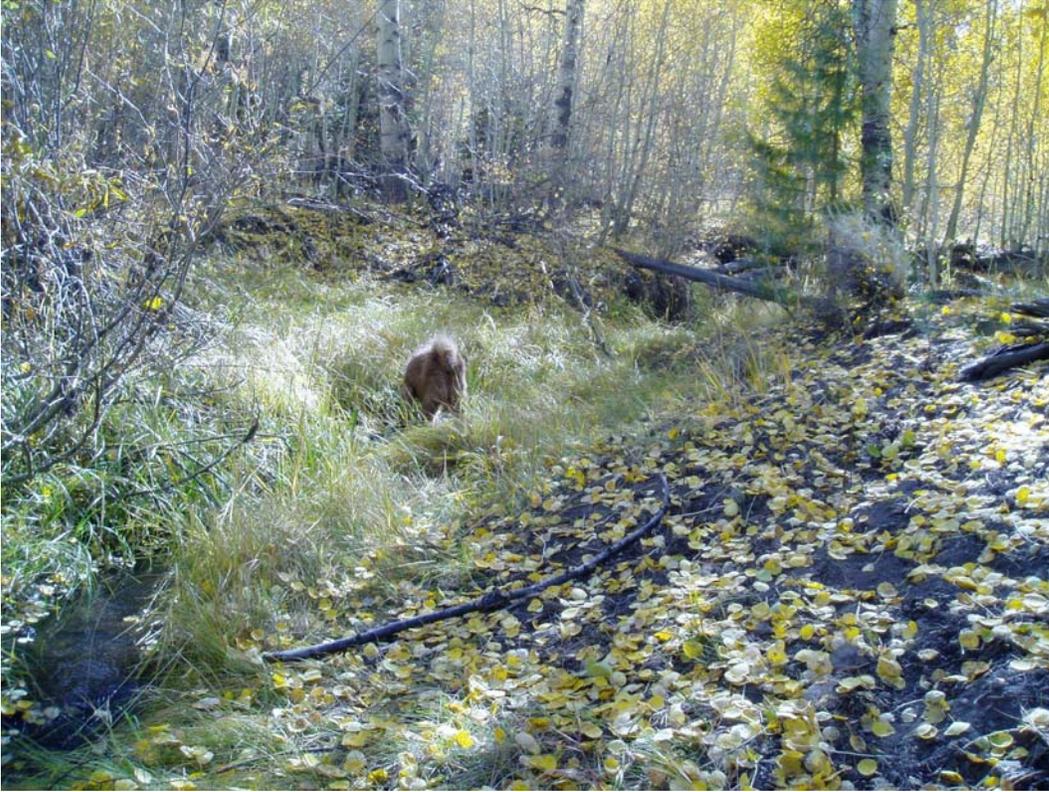
**Figure 25:** By-Day Creek, Bridgeport Ranger District, looking upstream at Reach 2/Unit 3. This Unit is located at UTM N: 4238297.47 & E: 296047.52. Picture was taken on 5 Oct. 2004. Unit started just downstream of an artificial rock gabion barrier.

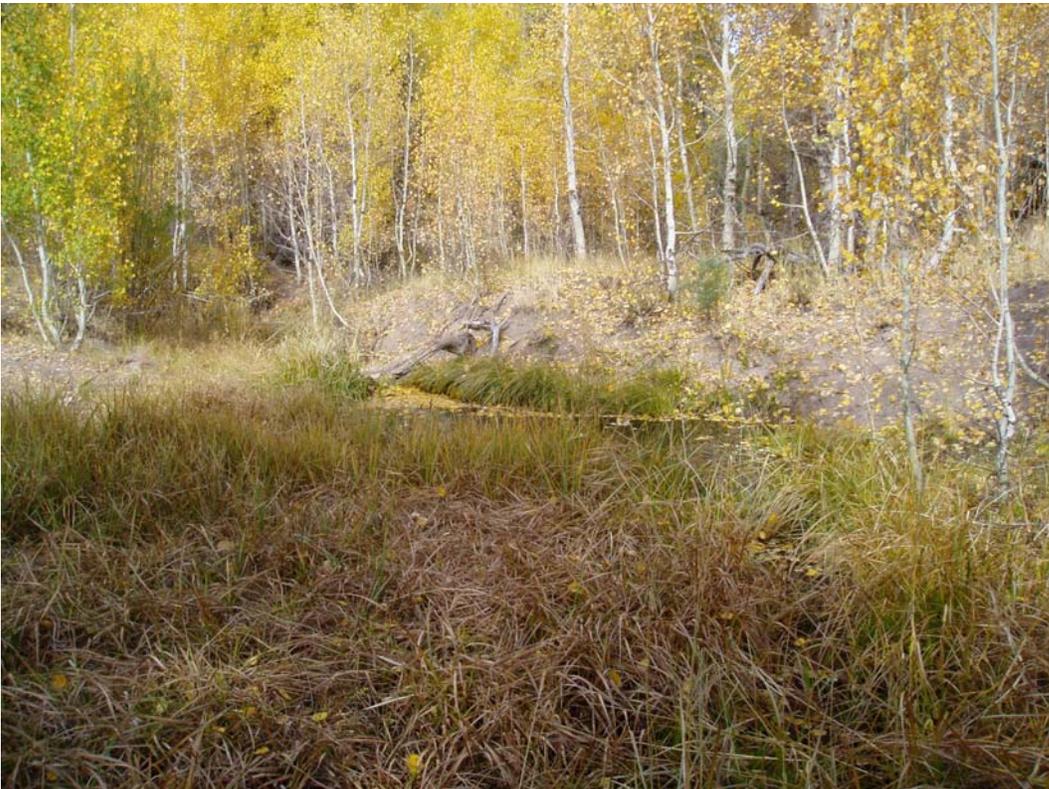
**Figure 26:** By-Day Creek, Bridgeport Ranger District, looking downstream at Reach 2/Unit 3. This Unit is located at UTM N: 4238297.47 & E: 296047.52. Picture was taken on 5 Oct. 2004. Unit ended just upstream of the road-stream ford crossing.

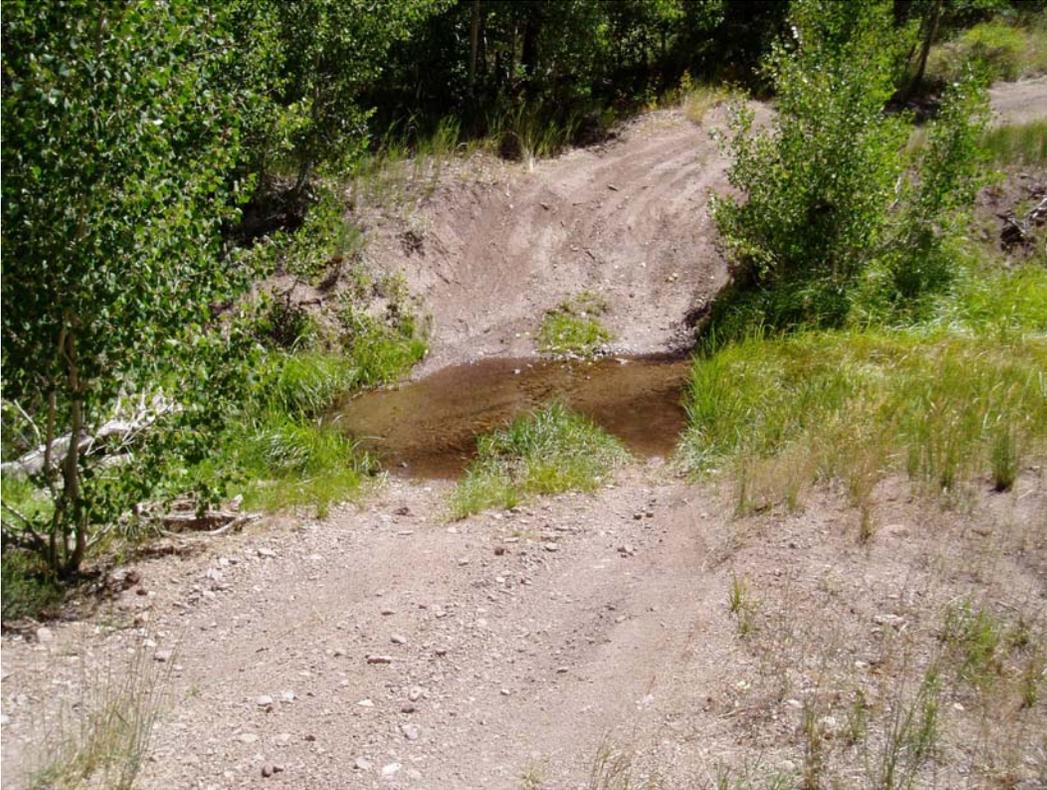
Forest System Road 32076 parallels By-Day Creek and in a few locations comes within approximately 10 feet of the stream. Although the road is closed to public access on CDFG property, reports of illegal motor vehicle use in the watershed are common. Forest System Road 32076 crosses By-Day Creek (Figure 27) at Reach 2 Unit 3. The road crossing is causing increased erosion, sedimentation, and turbidity within By-Day Creek. The Bridgeport Ranger District is planning to construct a 3 sided concrete box bridge at the road crossing in Fall 2005. The Bridgeport Ranger District also plans to conduct general maintenance on Forest System Road 32076 to reduce erosion impacts. In areas where the road pinches the stream, the District also plans to install willow waddles to provide some bank vegetation and reduce the amount of erosion reaching the stream.

**Figure 27:** By-Day Creek, Bridgeport Ranger District, road-stream crossing near the top of Reach 2/Unit 3. Picture was taken on 27 August 2003. The road crossing is located at UTM N: 4238281.70 & E: 296019.87.

5. Maintain Forest System Road 32076 to minimize erosion impacts on By-Day Creek.
6. Once the genetic analysis is completed, implement actions consistent with the conclusions made from the analysis.

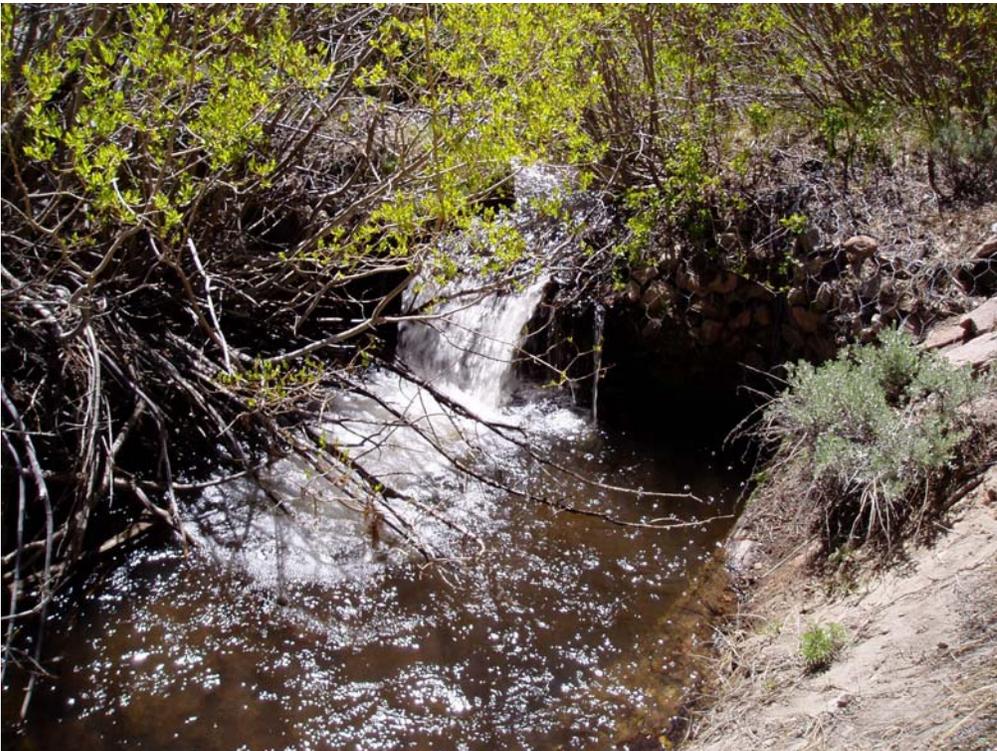
**Figure 28:** By-Day Creek, Bridgeport Ranger District, USFS structure 11. Picture was taken on 20 May 2004. Structure is a fish barrier. Pool depth below structure is 0.45 meters. Height of the vertical drop is also 0.45 meters. Barrier is located upstream of Reach 2/Unit 3 at UTM N: 4238205.55 & E: 295824.03.

2. In 2009 conduct another similar LCT distribution and density survey. Monitor LCT response to altering the rock gabion barriers (Figures 24 & 28) and to the bridge construction.

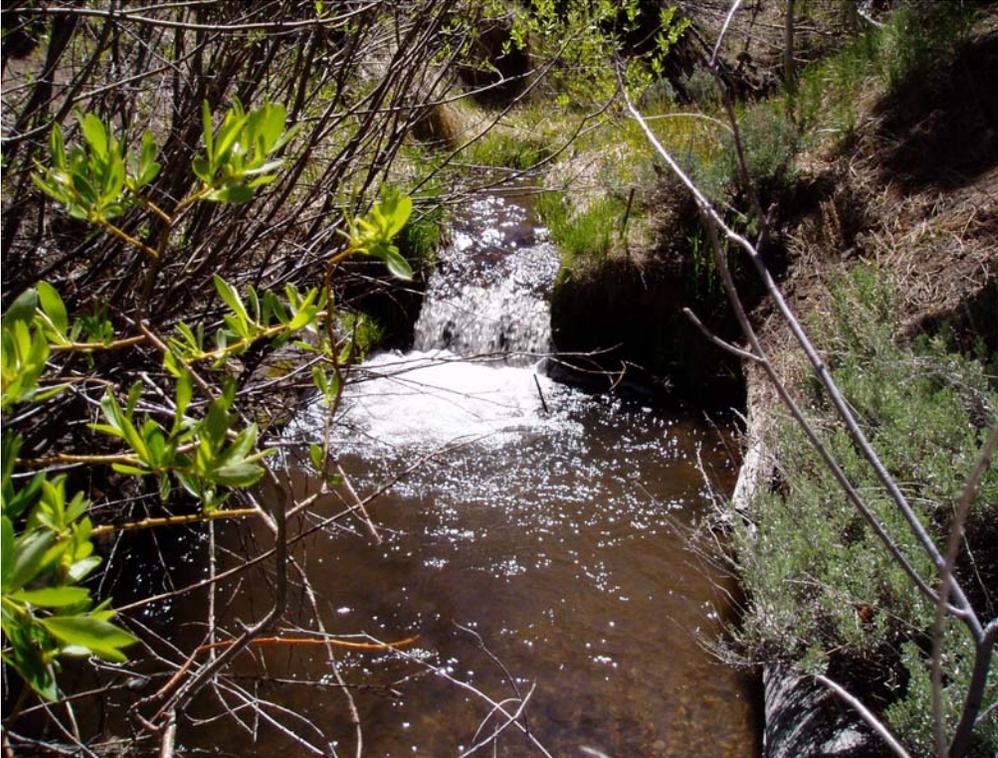
**Figure 29:** By-Day Creek, Bridgeport Ranger District, USFS structure 8. Picture was taken on 20 May 2004. Pool depth below gabion structure is 0.55 meters. Height of the vertical drop is 0.35 meters. At this time the gabion structure does not appear to be a fish barrier. Gabion structure is located upstream of Reach 2/Unit 3 at UTM N: 4238221.74 & E: 295749.11.

3. Conduct electrofishing surveys in the upper reaches of the North and South Forks to determine if LCT are still present from the 1982 transplant.
4. Figure 29 is a rock gabion structure that does not currently appear to be a fish barrier; however, this structure needs to be continually monitored.

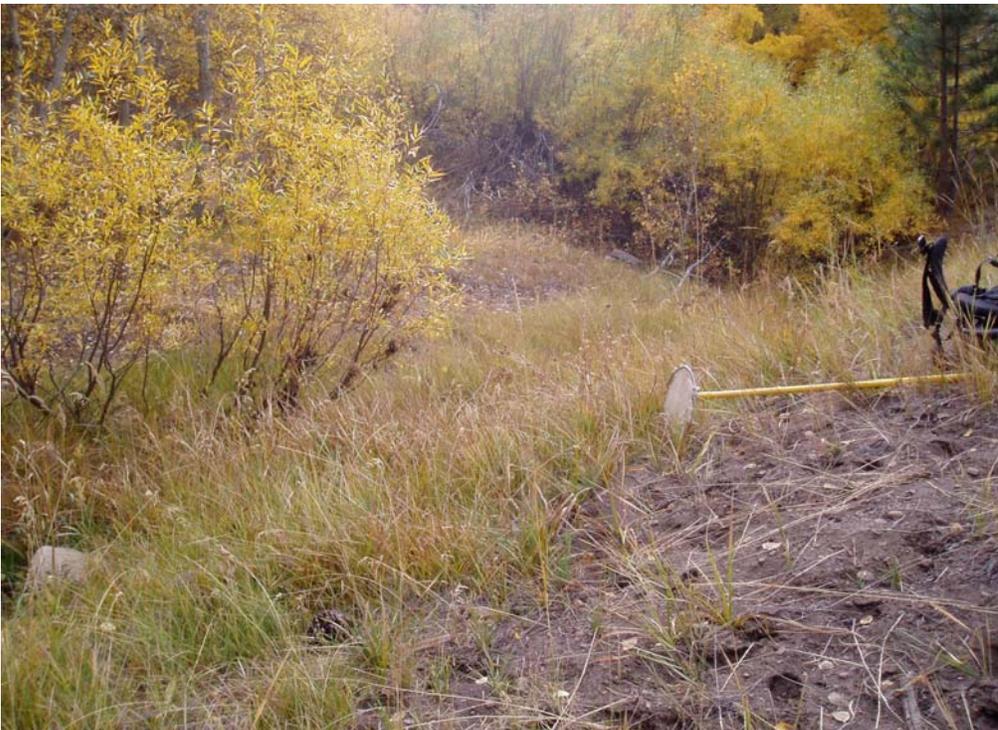
**Figure 30:** By-Day Creek, Bridgeport Ranger District, looking upstream at Reach 2/Unit 4. This Unit is located at UTM N: 4238199.12 & E: 295624.10. Picture was taken on 6 Oct. 2004. Unit is located near USFS in-stream structure 2.

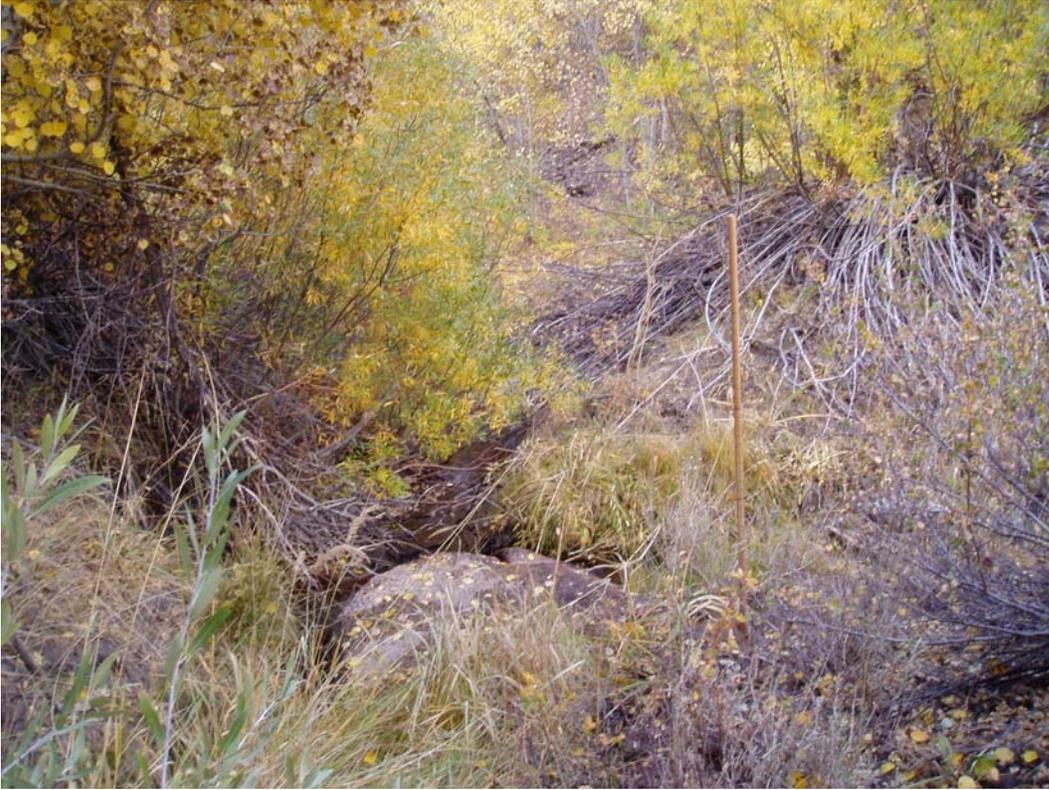
**Figure 31:** By-Day Creek, Bridgeport Ranger District, looking downstream at Reach 2/Unit 4. This Unit is located at UTM N: 4238199.12 & E: 295624.10. Picture was taken on 6 Oct. 2004. Unit is located near USFS in-stream structure 2.

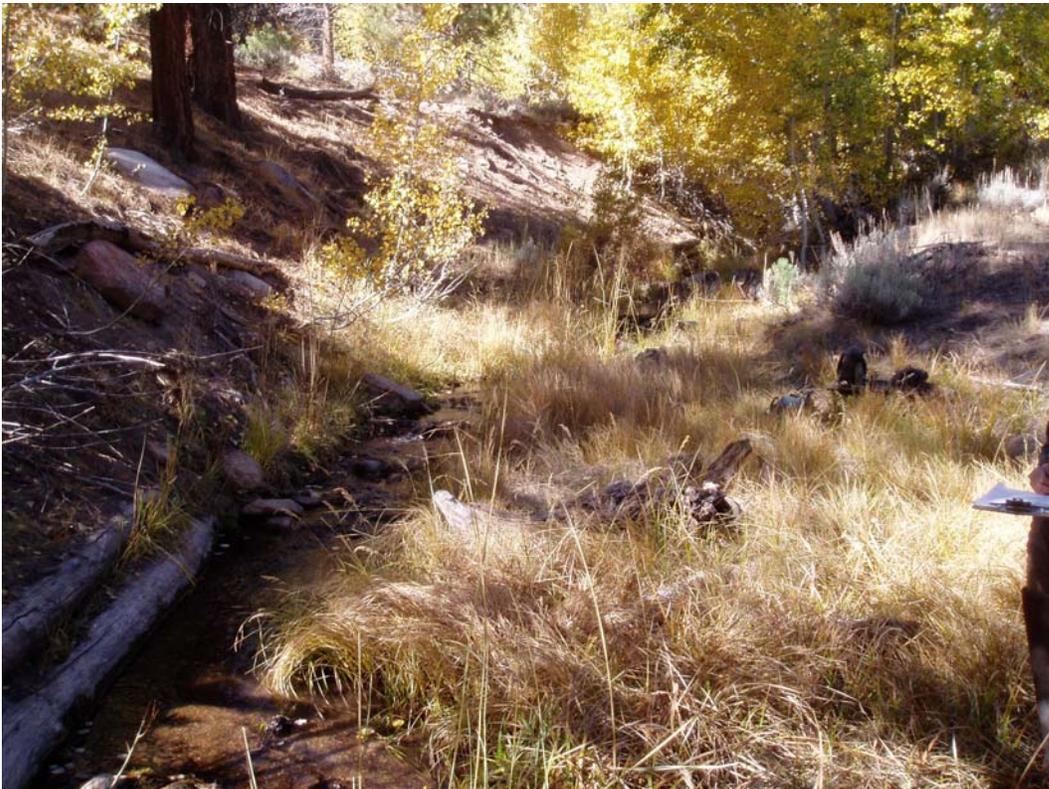
**Figure 32:** By-Day Creek, Bridgeport Ranger District, looking upstream at Reach 2/Unit 5. This Unit is located at UTM N: 4238101.62 & E: 295409.38. Picture was taken on 5 Oct. 2004.

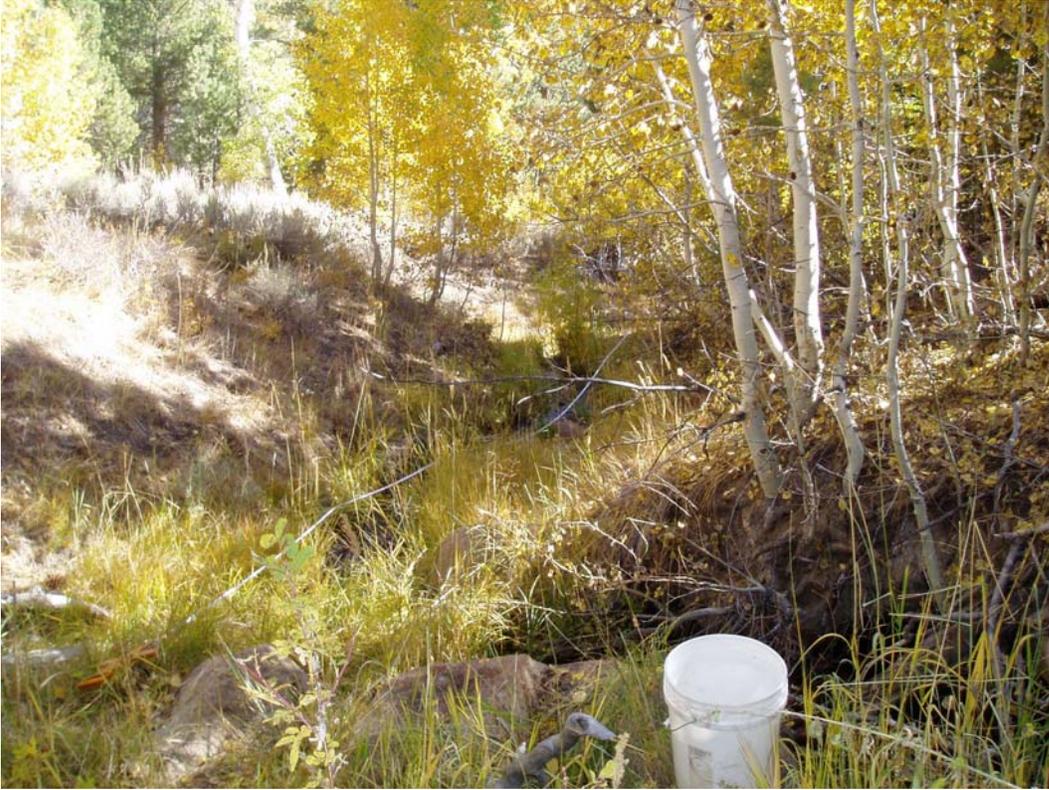
**Figure 33:** By-Day Creek, Bridgeport Ranger District, looking downstream at Reach 2/Unit 5. This Unit is located at UTM N: 4238101.62 & E: 295409.38. Picture was taken on 5 Oct. 2004.

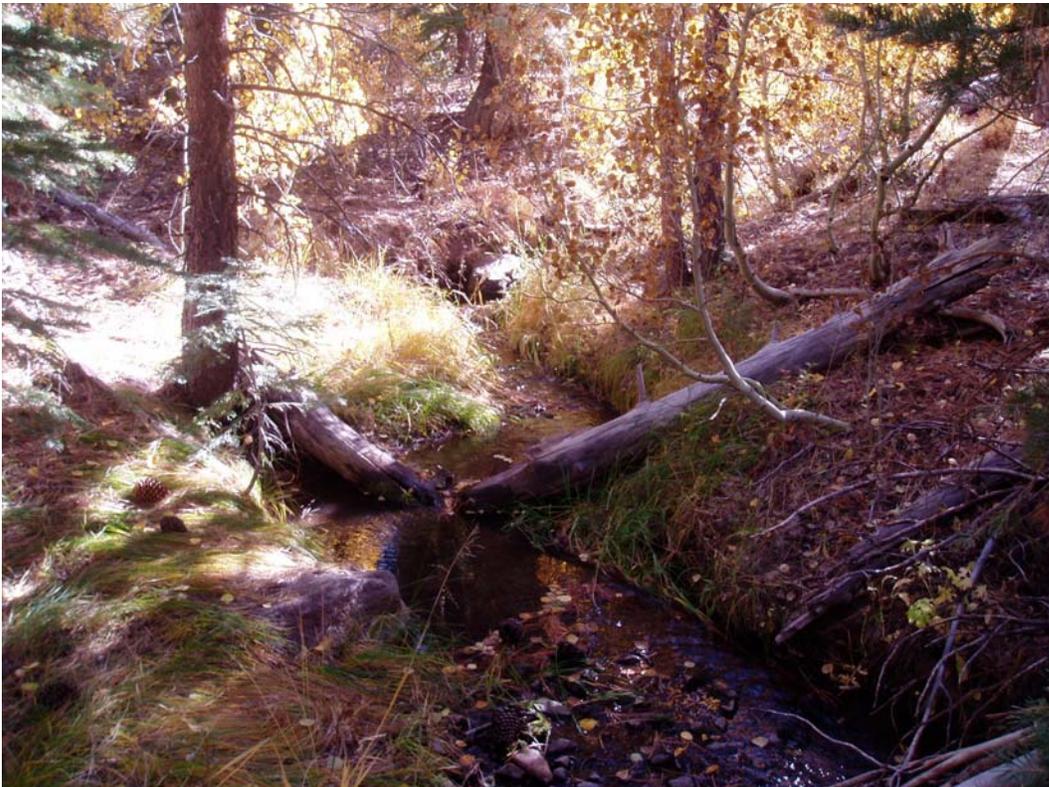
**Figure 34:** By-Day Creek, Bridgeport Ranger District, looking upstream at the South Fork Unit. This Unit is located at UTM N: 4237966.74 & E: 295310.48. Picture was taken on 6 Oct. 2004.

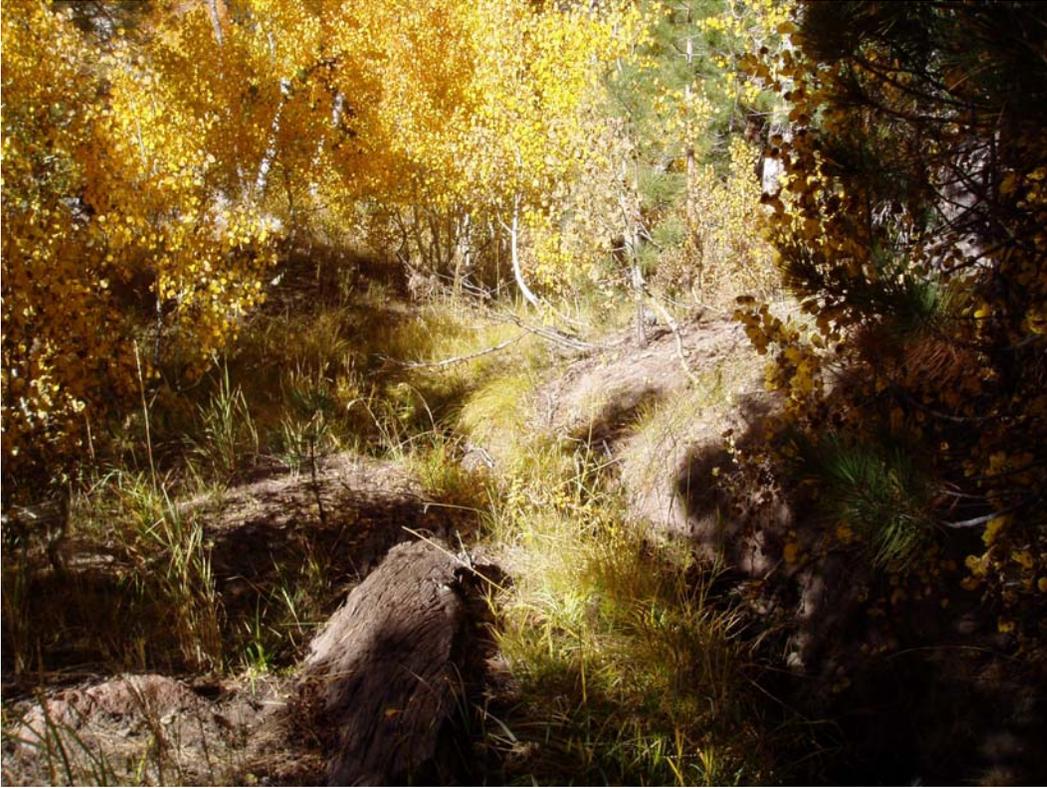
**Figure 35:** By-Day Creek, Bridgeport Ranger District, looking downstream at the South Fork Unit. This Unit is located at UTM N: 4237966.74 & E: 295310.48. Picture was taken on 6 Oct. 2004.

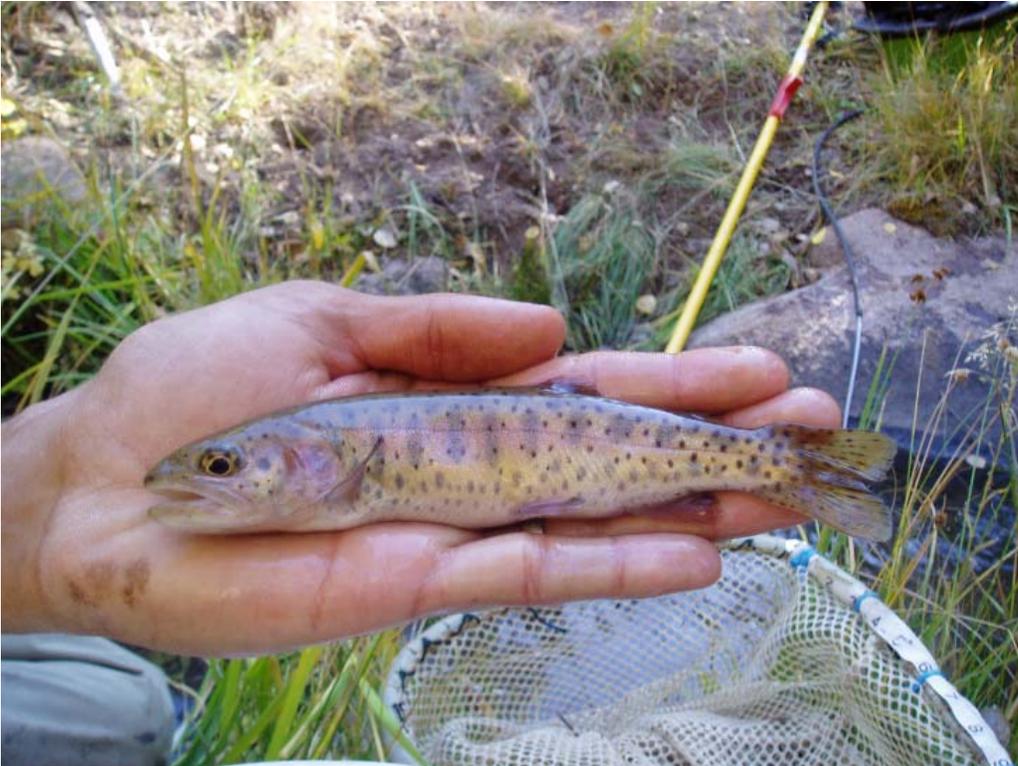
**Figure 36:** By-Day Creek, Bridgeport Ranger District, approximately ¼ mile upstream of the South Fork Unit. This was the uppermost LCT found in the South Fork of By-Day Creek. The LCT was captured at UTM N: 4237797.98 & E: 295217.98. Picture was taken on 6 Oct. 2004.

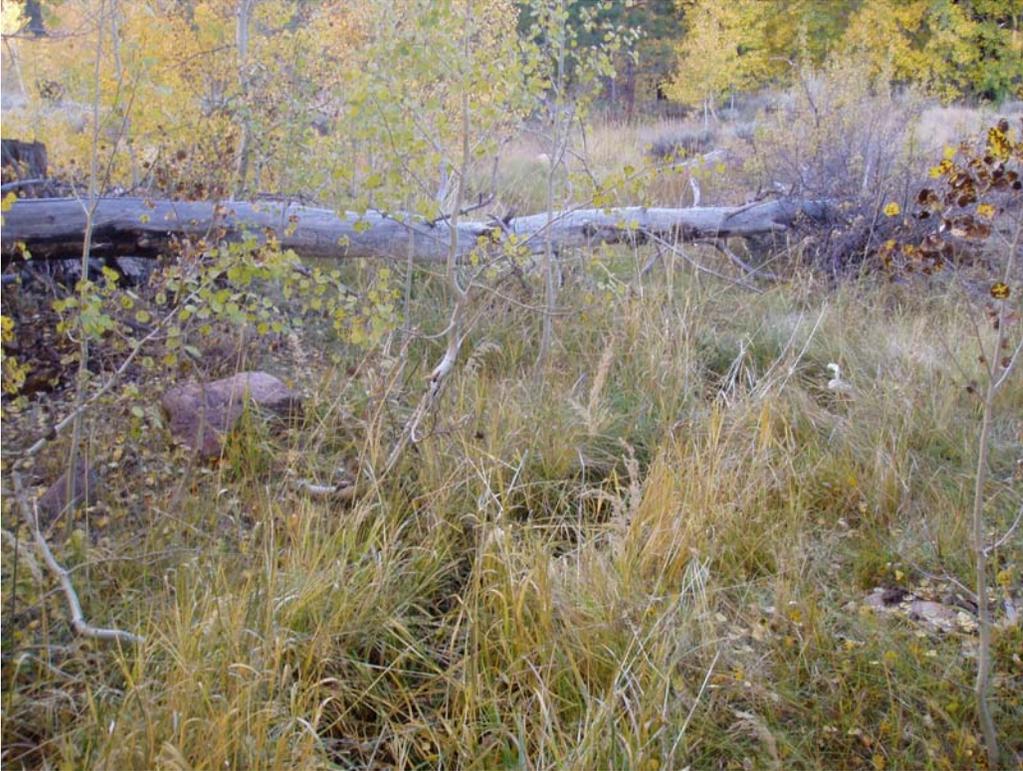
**Figure 37:** By-Day Creek, Bridgeport Ranger District, looking upstream at the North Fork Unit. This Unit is located at UTM N: 4238087.18 & E: 295340.29. Picture was taken on 6 Oct. 2004.

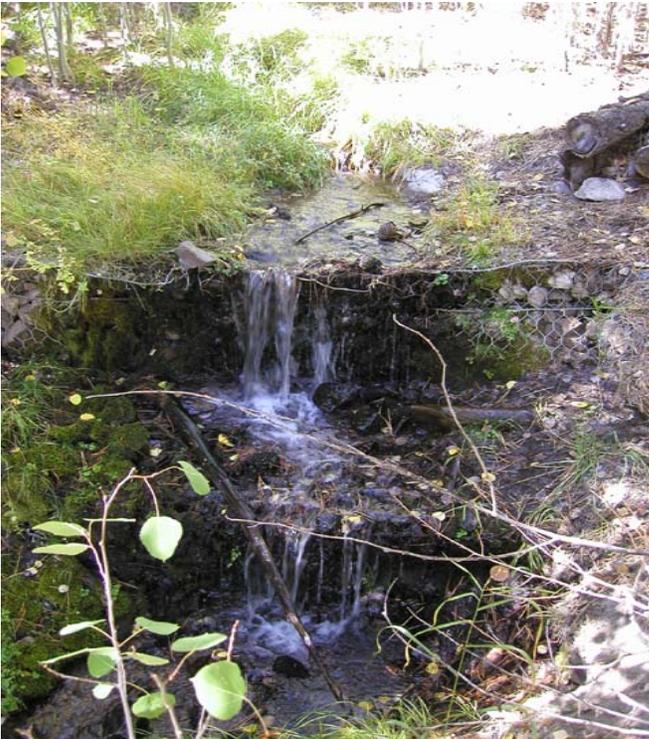
Low water flows are likely the primary reason why LCT are only occupying 1.1 miles of stream habitat. Lahontan cutthroat trout were not found within Reach 1; however, if water flows increased LCT could likely extend their distribution downstream into Reach 1. The gradient within Reach 1 is slightly steeper than Reach 2, but the overall habitat is still good and has supported LCT in the past. Lahontan cutthroat trout in the South Fork of By-Day Creek are unlikely to extend their distribution upstream because of increased gradient >10%. If flows increased LCT could extend their distribution upstream into the North Fork of By-Day Creek to a rock gabion fish barrier (Figure 38). If flows

Three man-made fish barriers are located on the mainstem of By-Day Creek. The lowermost barrier is a culvert that was reinforced by CDFG in 1996 at the Buckeye Road/By-Day Creek intersection to prevent non-native fish from Buckeye Creek migrating upstream into the By-Day Creek watershed. The barrier is approximately 5 feet high (Figure 9). The other two barriers are rock gabion barriers (Figures 24 & 28) located within Reach 2. Both rock gabion barriers were originally installed to probably control headcutting. The Bridgeport Ranger District is planning to alter these two rock gabion barriers within Reach 2 in Fall 2005 to provide LCT the ability to migrate up and downstream within the watershed without unobstructed movement. A third rock gabion structure on the mainstem (Figure 29) does not appear to currently be a fish barrier, but the structure needs to be continually monitored. Another rock gabion fish barrier is located on the North Fork of By-Day Creek, approximately 1/3 mile upstream of the North and South Fork confluence (Figure 38).

**Figure 38:** By-Day Creek, Bridgeport Ranger District, gabion weir on the North Fork of By-Day Creek. Gabion weir is currently a fish barrier. Gabion weir is located on the North fork of By Day Creek approximately 1/3 mile upstream of the North and South Fork confluence. Barrier is located at UTM N: 4238293.69 & E: 294790.06. Barrier is approximately 5-6 feet high.
