Dunderberg Creek

Mono County, California

2008 Stream Habitat Survey Report

Carson Ranger District: Humboldt-Toiyabe National Forest

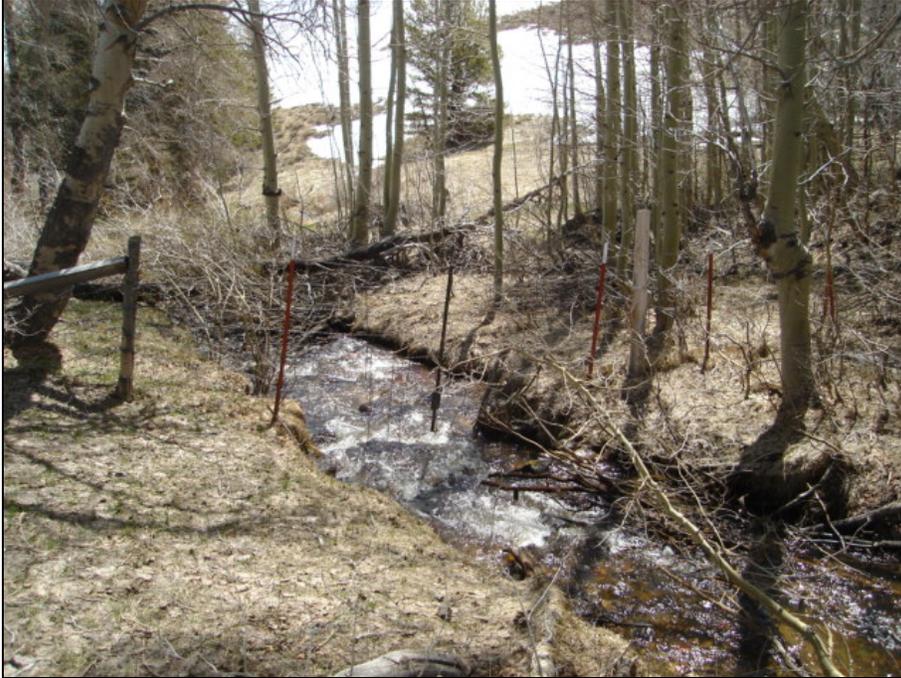
Site 1: Dunderberg Creek, Bridgeport Ranger District. Survey starts where Dunderberg Creek leaves Humboldt-Toiyabe National Forest land. A fence stretches across the creek marking the private property downstream. This site is located at UTM: N: 4220958 & E: 304450, Elev. 2485m.

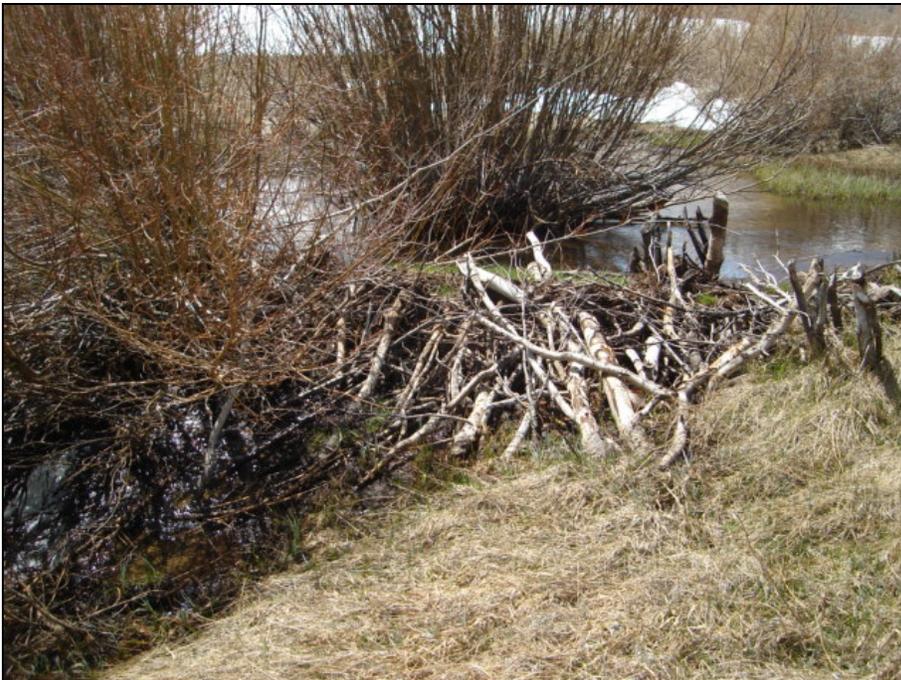
Site 2: Dunderberg Creek, Bridgeport Ranger District. Photo depicts an old beaver dam that is still creating a good sized pool upstream of the dam. This site is located at UTM: N: 4220602 & E: 304014, Elev. 2514m.

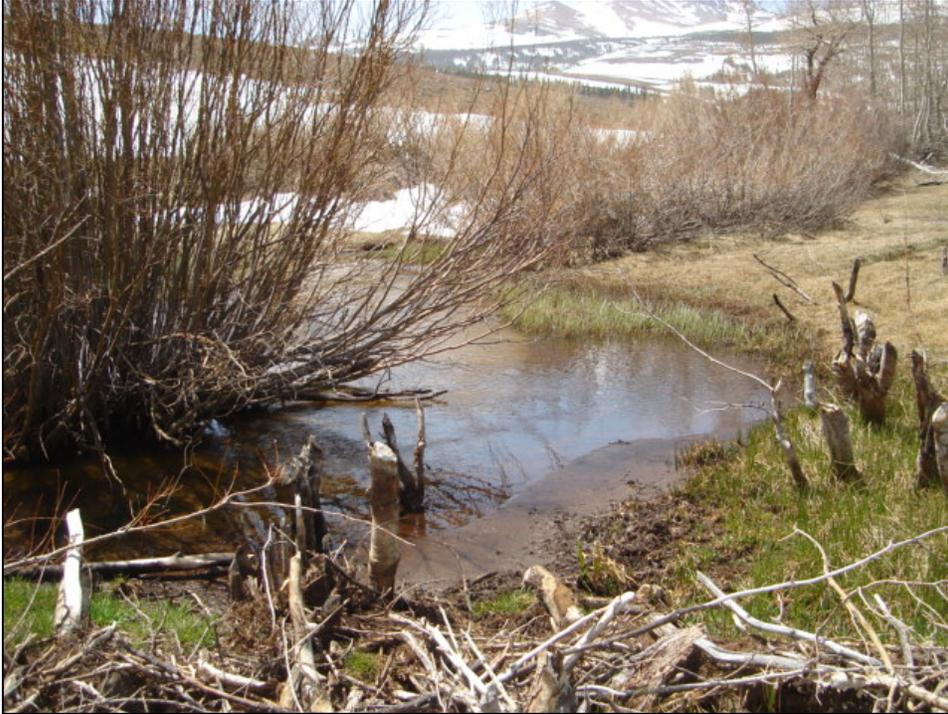
Site 3: Dunderberg Creek, Bridgeport Ranger District. Four 5 to 6 inch fish are seen in the pond created by the beaver dam. This site is located at UTM: N: 4220607 & E: 304014, Elev. 2514m.

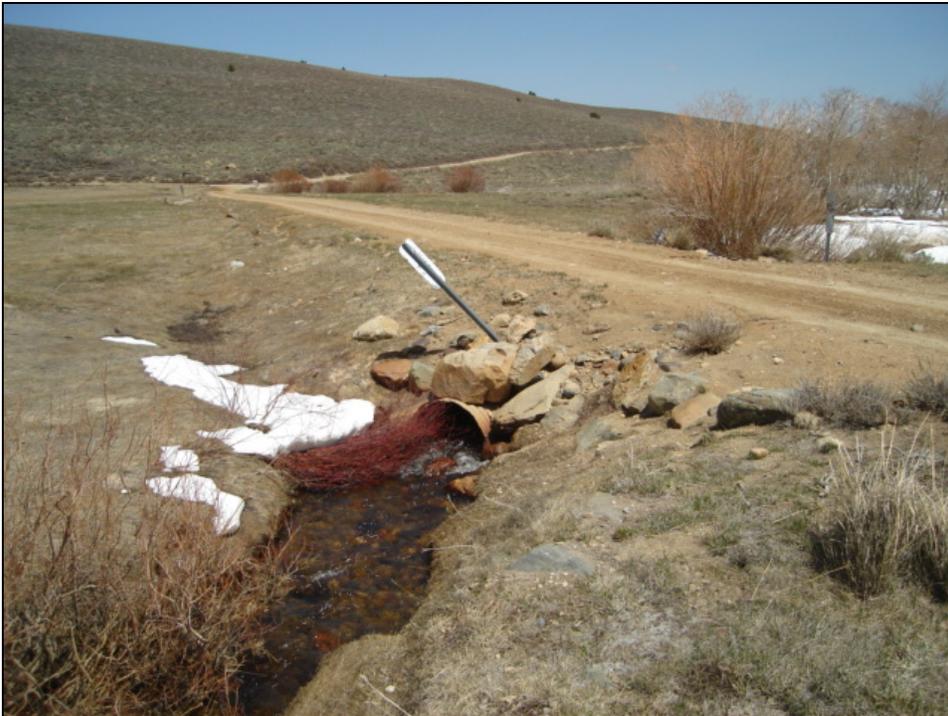
Site 4: Dunderberg Creek, Bridgeport Ranger District. USFS Road 020 intersects the creek via a culvert. The culvert here does not act as a fish passage barrier. This site is located at UTM: N: 4220475 & E: 303871, Elev. 2524m.

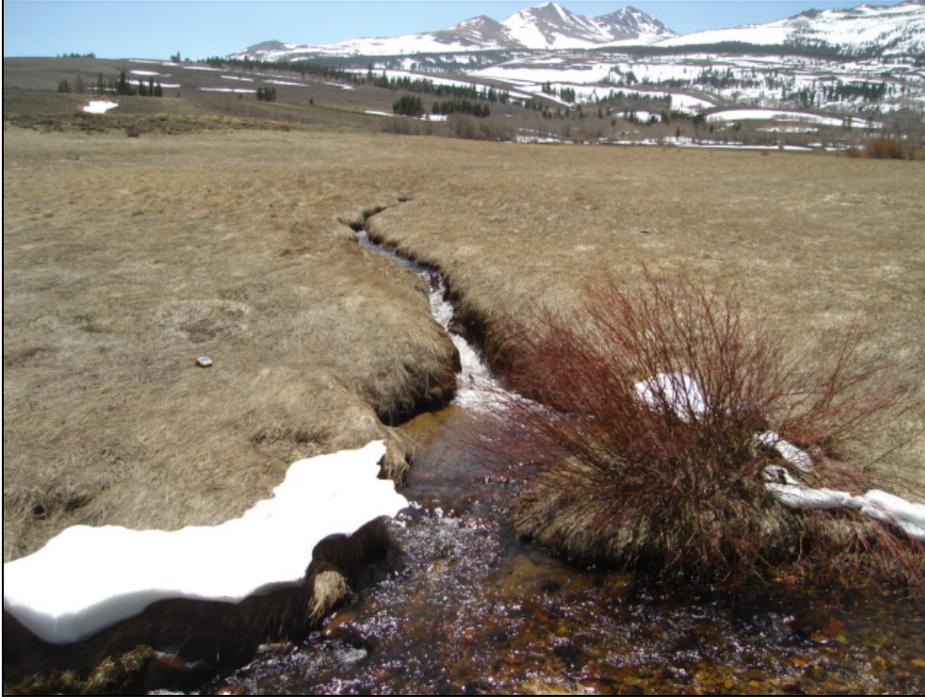
Site 5: Dunderberg Creek, Bridgeport Ranger District. A small tributary enters Dunderberg Creek on river right that contributes 15% of the overall flow. This site is located at UTM: N: 4220391 & E: 303754, Elev. 2527m.

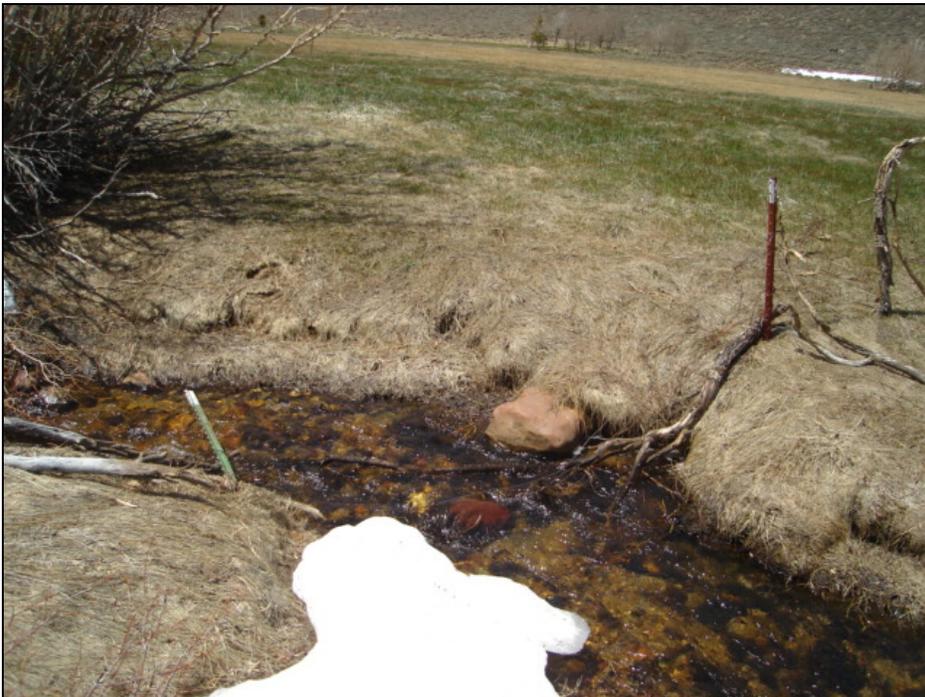
Site 6: Dunderberg Creek, Bridgeport Ranger District. This non barbed wire fence is in poor shape as it lies in the creek channel. This fence marks where Dunderberg Creek leaves private property. This site is located at UTM: N: 4220279 & E: 303627, Elev. 2539m.

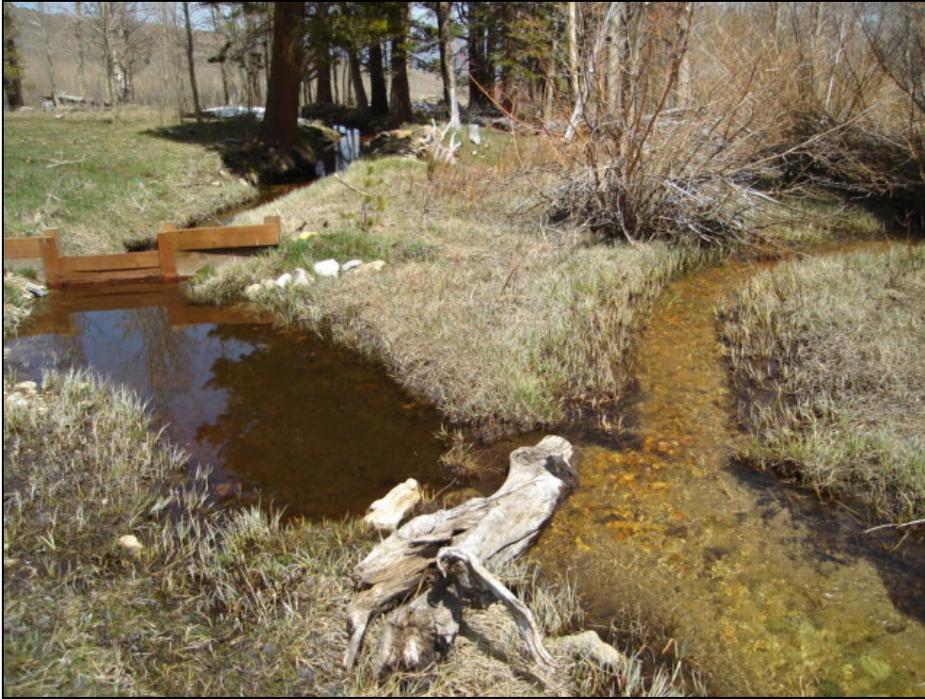
Site 7: Dunderberg Creek, Bridgeport Ranger District. Photo depicts a diversion used to irrigate surrounding lands. The dam is currently not allowing water to pass as the canal is filled with stagnant water. This site is located at UTM: N: 4220018 & E: 302953, Elev. 2579m.

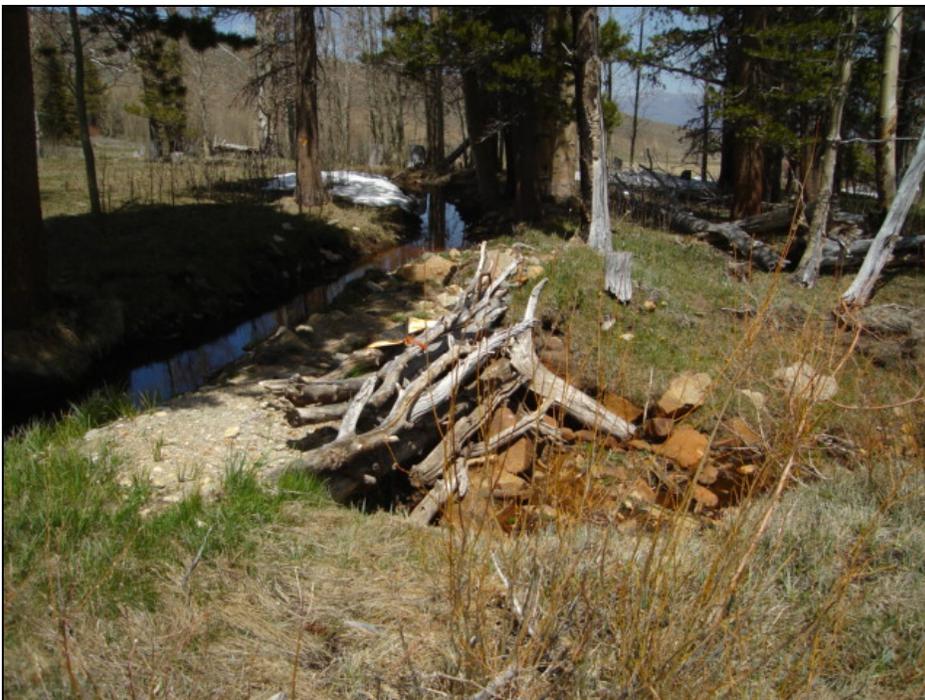
Site 7 (cont'd): Dunderberg Creek, Bridgeport Ranger District. A view of the irrigation canal which has logs to help build a man made bank. This site is located at UTM: N: 4220018 & E: 302953, Elev. 2579m.

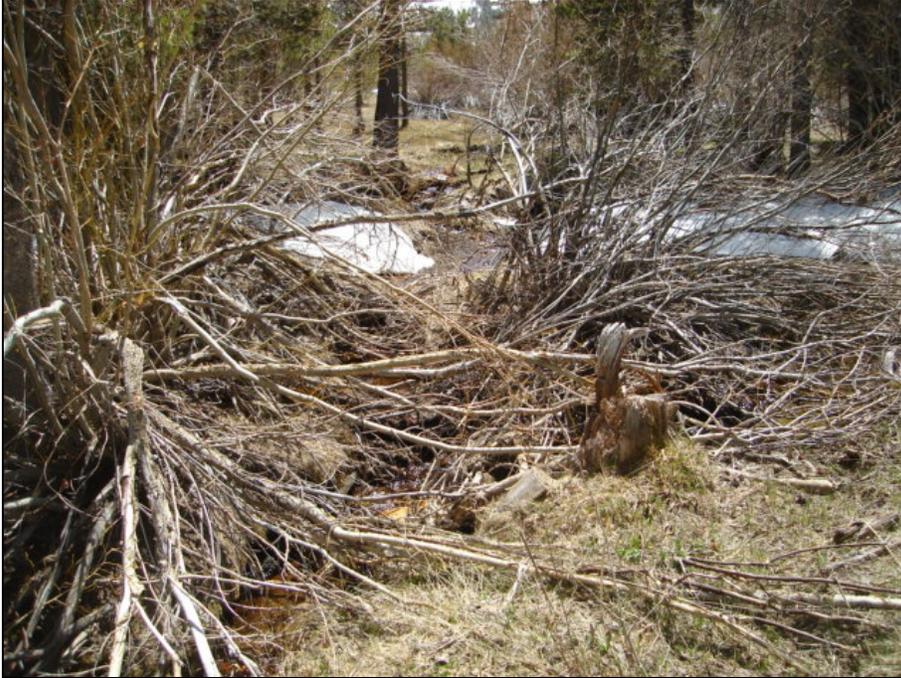
Site 8: Dunderberg Creek, Bridgeport Ranger District. A small tributary enters the main stem on river right adding 15% to the overall stream flow. This stream would actually be larger if not for the dam built at Site 23 to divert water flow from the pond. This site is located at UTM: N: 4219995 & E: 302875, Elev.

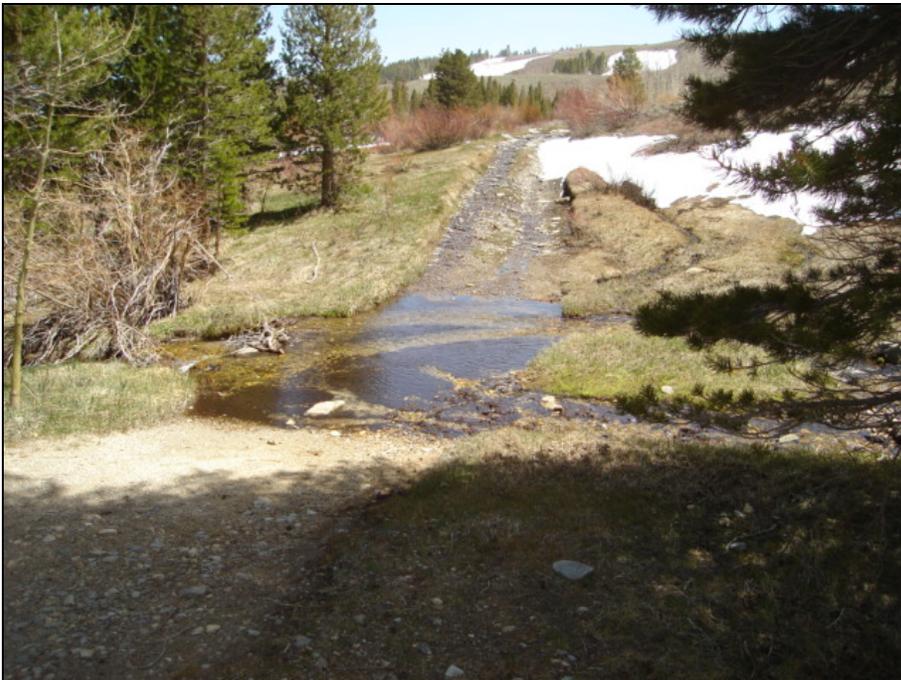
Site 9: Dunderberg Creek, Bridgeport Ranger District. A view of where Forest Service Road 178 crosses the stream. Water flowing down the road is eroding the route as well as adding sediment to the stream. This site is located at UTM: N: 4219886 & E: 302653, Elev. 2601m.

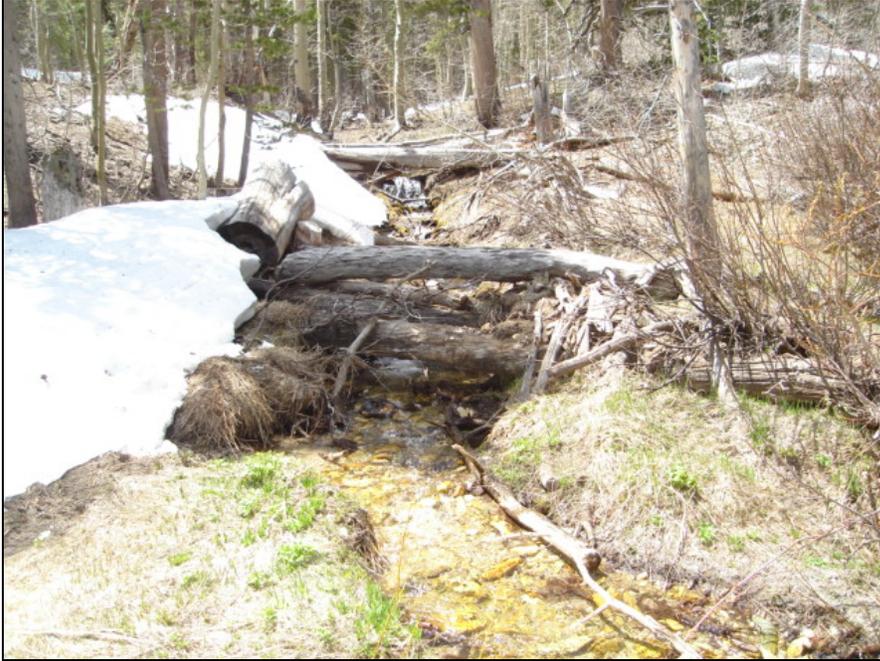
Site 10: Dunderberg Creek, Bridgeport Ranger District. A moderately sized tributary enters the creek on river left but it does not add any potential habitat due to its high gradient. This site is located at UTM: N: 4219837 & E: 302424, Elev. 2631m.

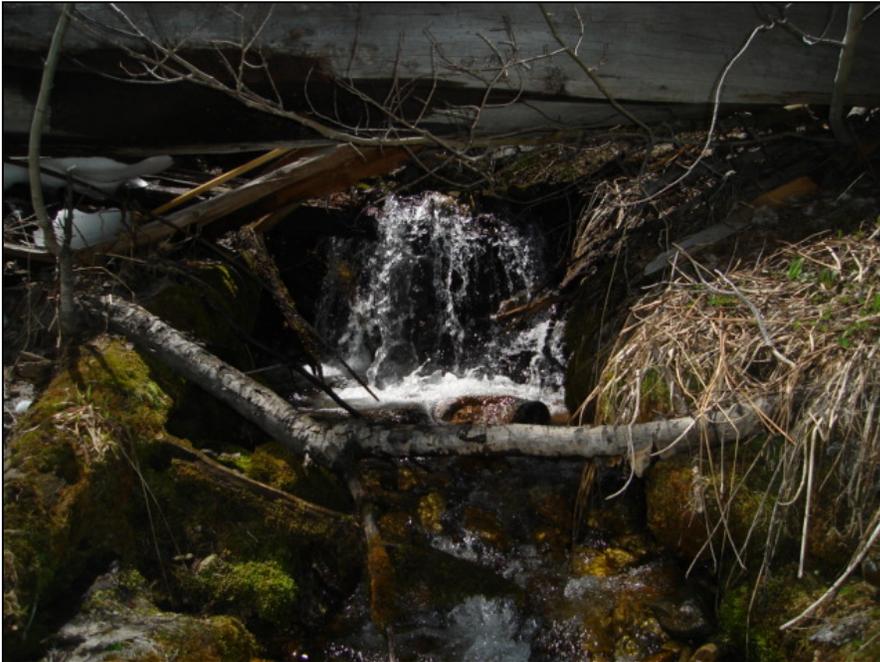
Site 11: Dunderberg Creek, Bridgeport Ranger District. The seasonal barrier pictured here is 2ft high and it has a maximum pool depth of 0.5ft. Different water levels might provide alternate routes for fish passage. This site is located at UTM: N: 4219836 & E: 302400, Elev.2632m.

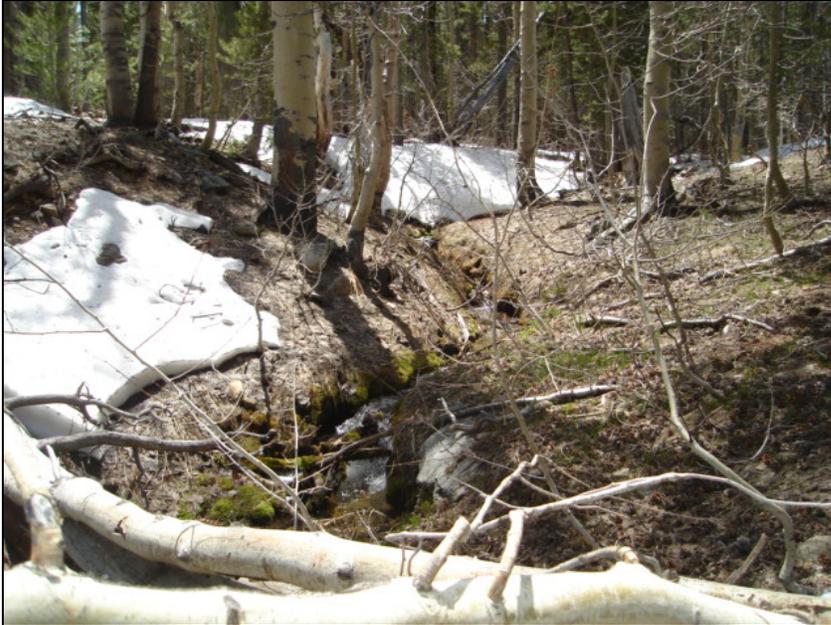
Site 13: Dunderberg Creek, Bridgeport Ranger District. Survey ends at the seasonal fish barrier due to the high gradient upstream of the barrier and the lack of pools. The survey continues at the tributary at Site 5. This site is located at UTM: N: 4219824 & E: 302275, Elev. 2693m.

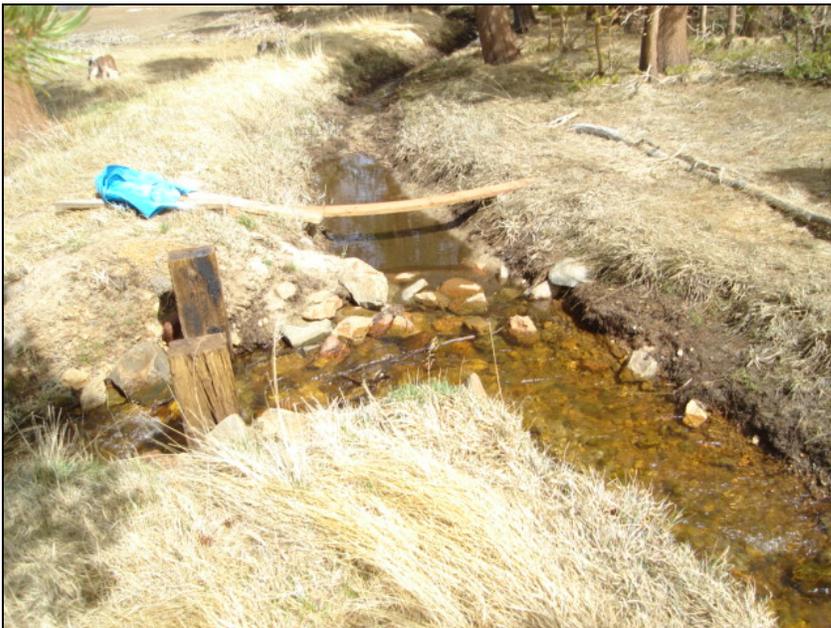
Site 14: Dunderberg Creek, Bridgeport Ranger District. The diversion pictured here sends the diverted water back towards Dunderberg Creek at Site 5. This site is located at UTM: N: 4219843 & E: 303754, Elev. 2581m.

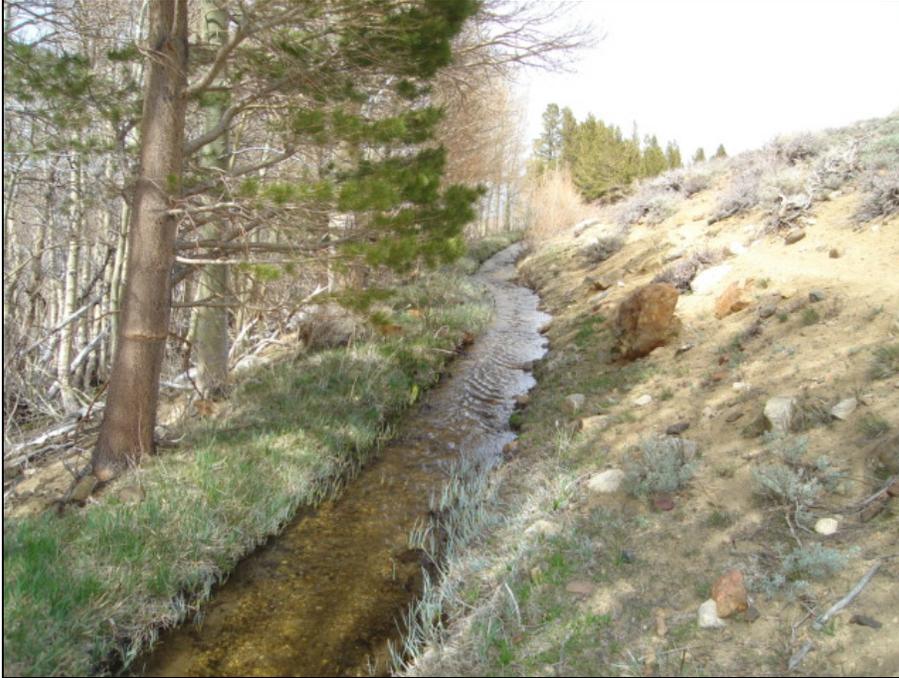
Site 15: Dunderberg Creek, Bridgeport Ranger District. Several fish were seen in this section of the creek where the stream flows along the side slope. The stream flow is slow with few meanders or turbulence. This site is located at UTM: N: 4219699 & E: 303429, Elev. 2578m.

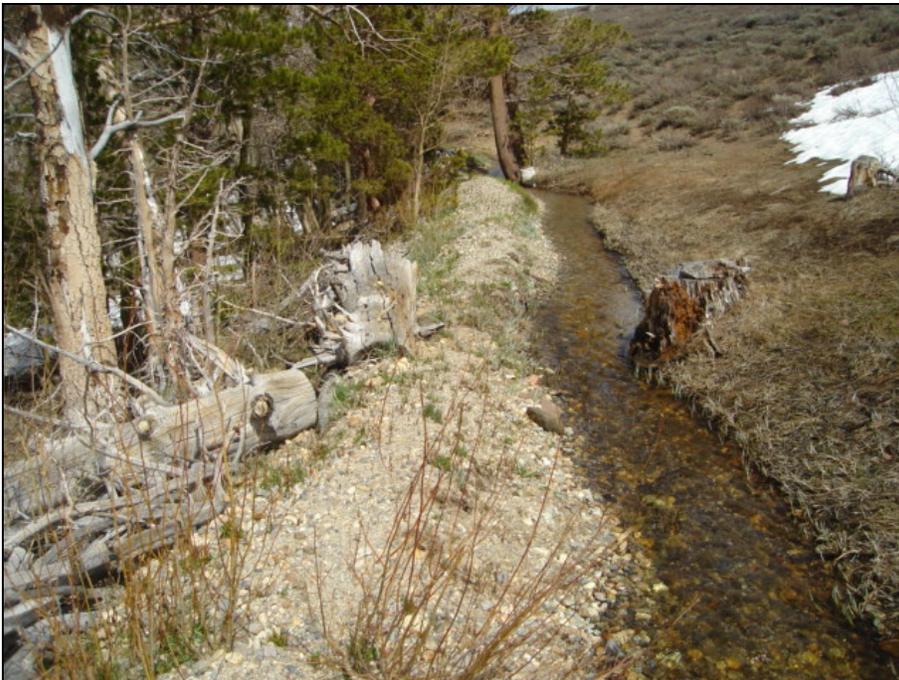
Site 16: Dunderberg Creek, Bridgeport Ranger District. Photo depicts a man made stream bank as the stream has been diverted from its natural course. The entire left stream bank has been built up using small cobbles and gravel. This site is located at UTM: N: 4219684 & E: 303363, Elev. 2583m.

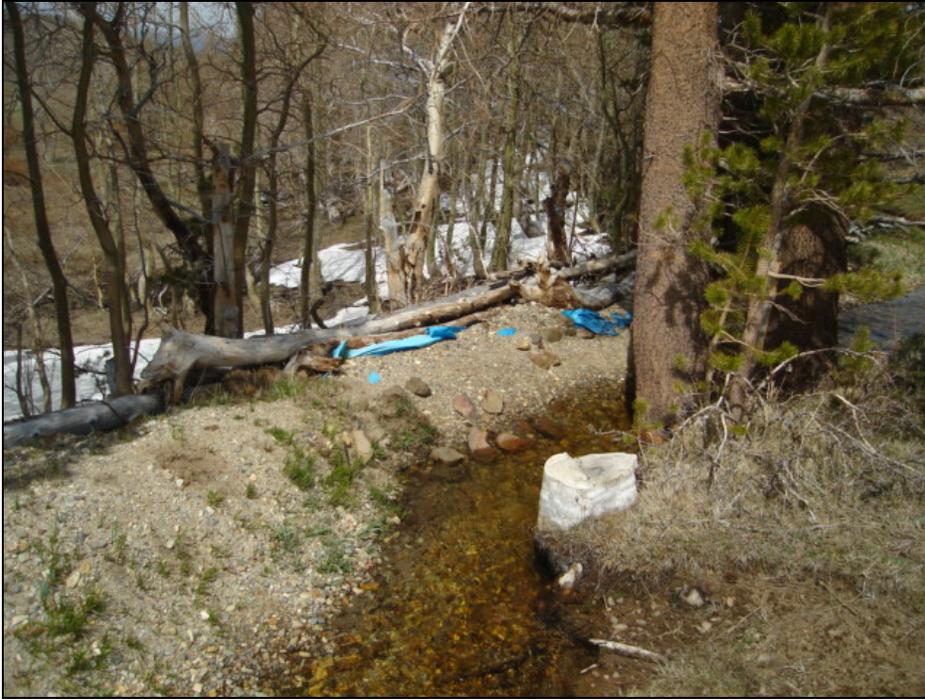
Site 16(cont'd): Dunderberg Creek, Bridgeport Ranger District. Picture shows how a tarp and gravel are used in an effort to divert the stream from its natural flow. This site is located at UTM: N: 4219684 & E: 303363, Elev. 2583m.

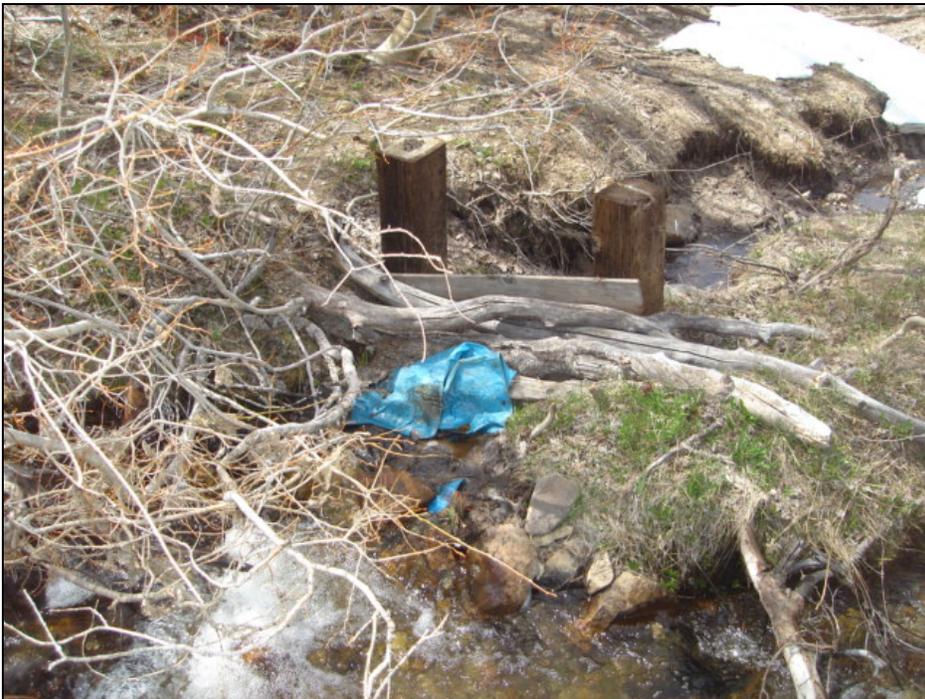
Site 17: Dunderberg Creek, Bridgeport Ranger District. Photo depicts water being diverted from its natural course. This site is located at UTM: N: 4219661 & E: 303345, Elev. 2591m.

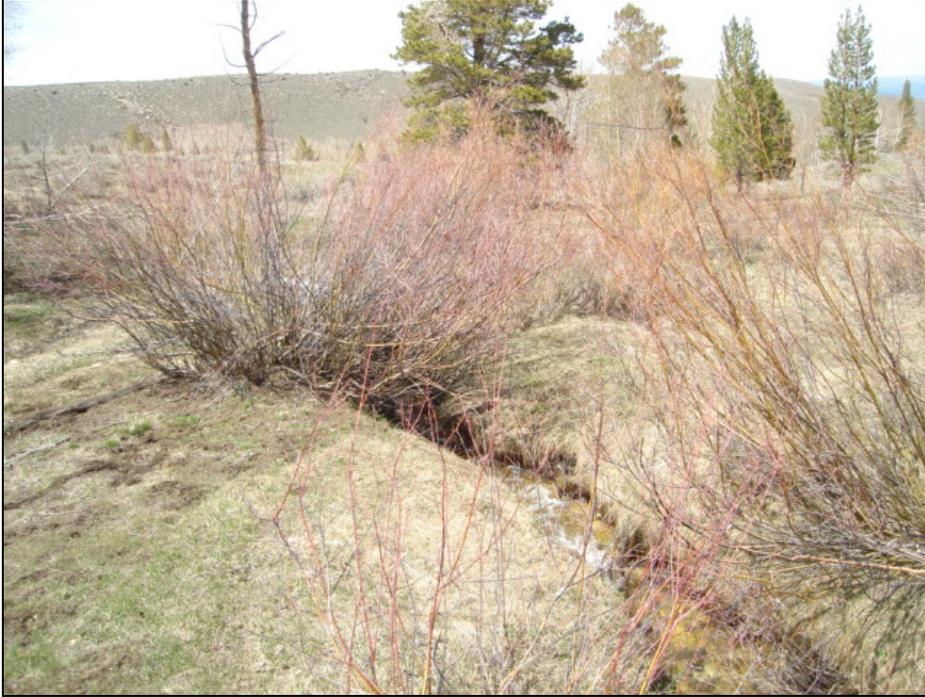
Site 18: Dunderberg Creek, Bridgeport Ranger District. The photo point here shows the characteristics of the stream as it enters a meadow. This site is located at UTM: N: 4219562 & E: 303312, Elev. 2595m.

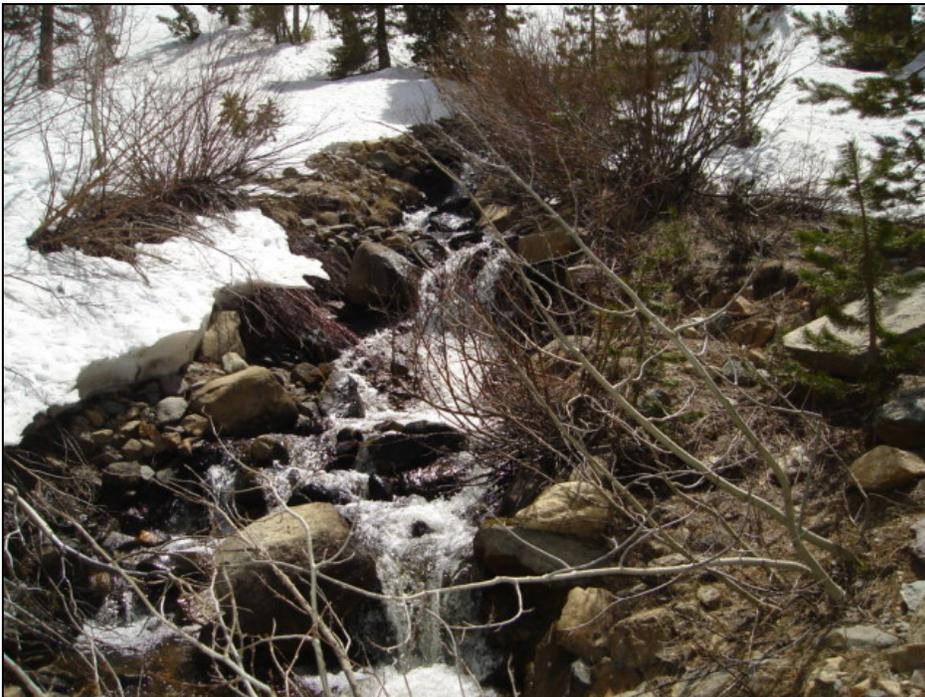
Site 19: Dunderberg Creek, Bridgeport Ranger District. This permanent fish barrier is defined by a series of cascading falls as high as 1.5m flowing at a high velocity with little to no pool depth. This site is located at UTM: N: 4219361 & E: 303141, Elev.2649m.

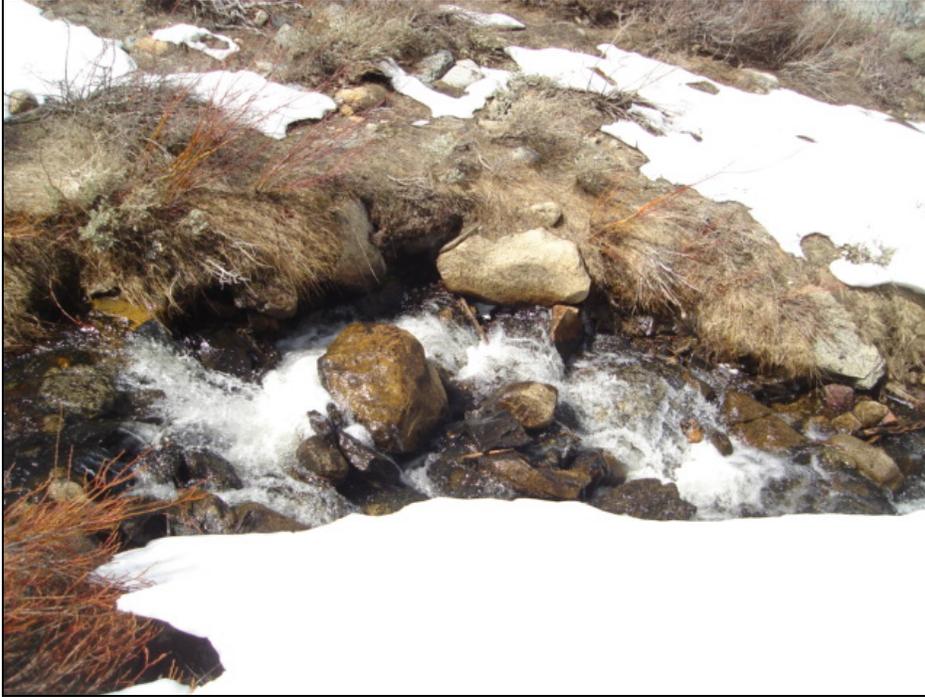
Site 20: Dunderberg Creek, Bridgeport Ranger District. Photo point shows characteristics of the stream as it exits a snow cave. This site is located at UTM: N: 4219287 & E: 303128, Elev. 2647m.

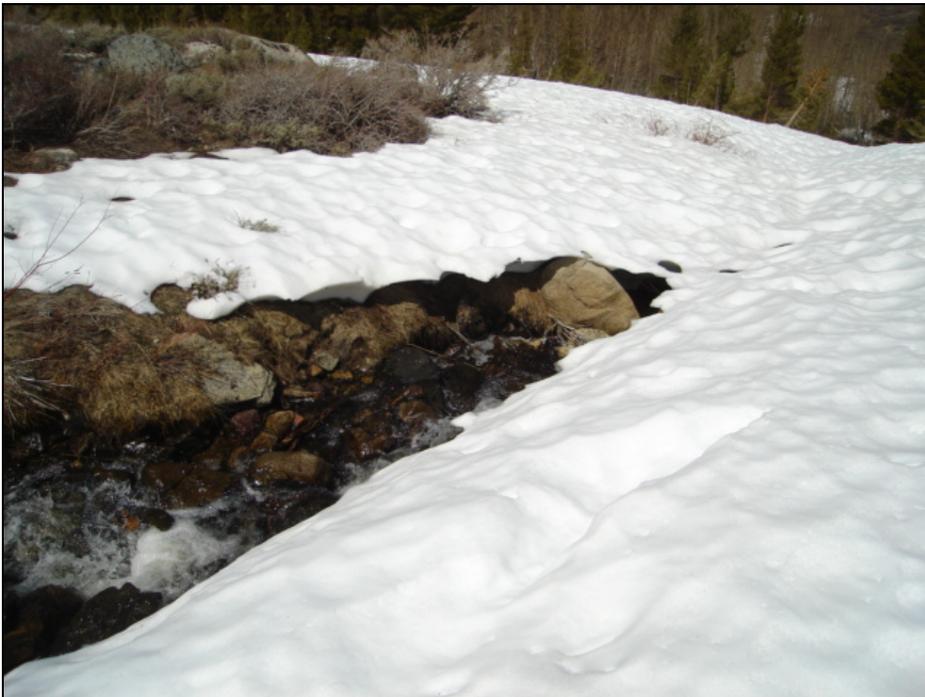
Site 21: Dunderberg Creek, Bridgeport Ranger District. This photo point shows the stream as it enters the snow cave. The creek flows under the snow for several meters. This site is located at UTM: N: 4219246 & E: 303087, Elev. 2677m.

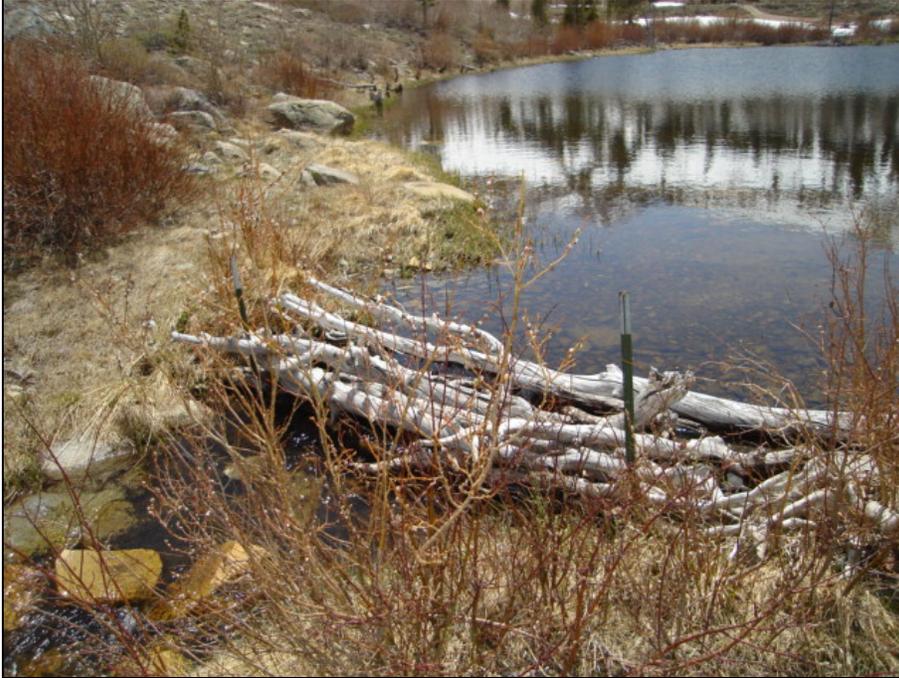
Site 22: Dunderberg Creek, Bridgeport Ranger District. Photo depicts the origin of the stream that eventually enters Dunderberg Creek at Site 5. The stream here is not marked on the Bridgeport District map as exiting the pond from this location. This site is located at UTM: N: 4219227 & E: 303041, Elev. 2686m.

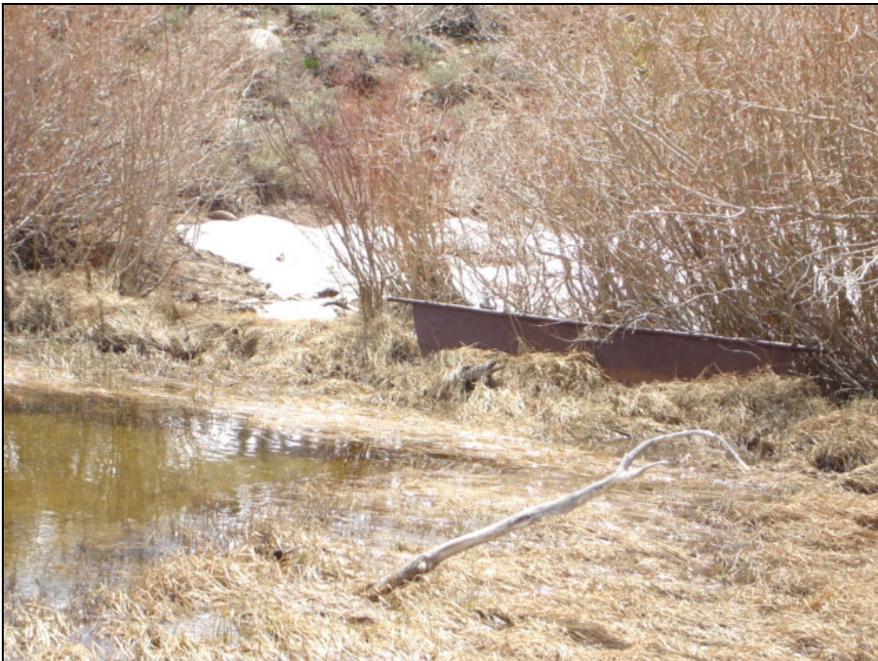
Site 23: Dunderberg Creek, Bridgeport Ranger District. The dam pictured here is where Dunderberg Creek according to the map, would normally flow out of the large pond. Due to the structure build here, the water now exits the pond at Site 22 and is flowing towards Site 5. This site is located at UTM: N: 4219175 & E: 302939, Elev. 12088.

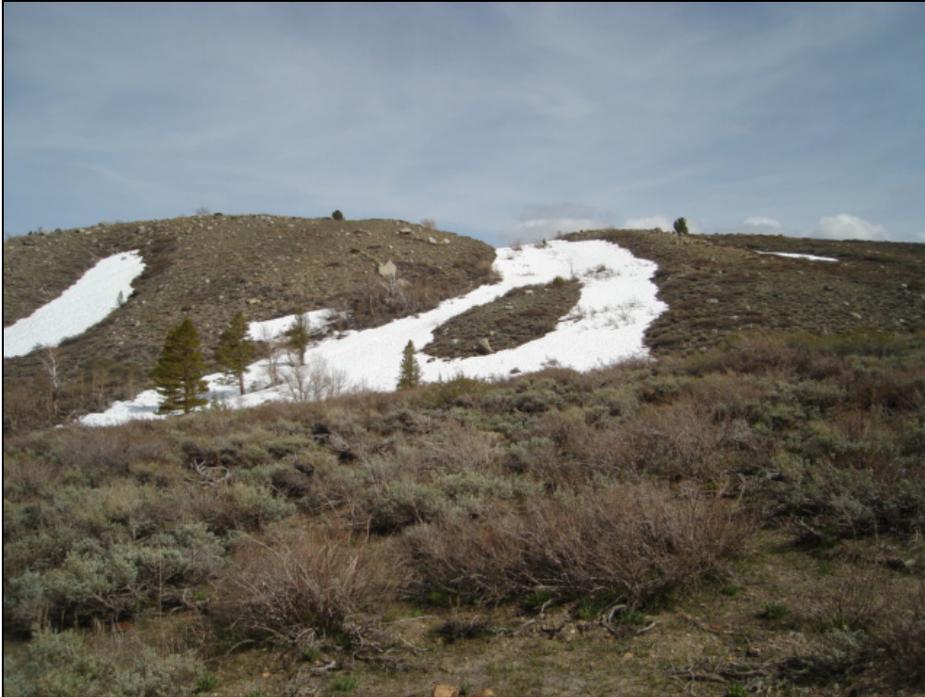
Site 23(cont'd): Dunderberg Creek, Bridgeport Ranger District. This photo shows the drainage where Dunderberg Creek would normally flow its natural course. This site is located at UTM: N: 4219175 & E: 302939, Elev. 2686m.

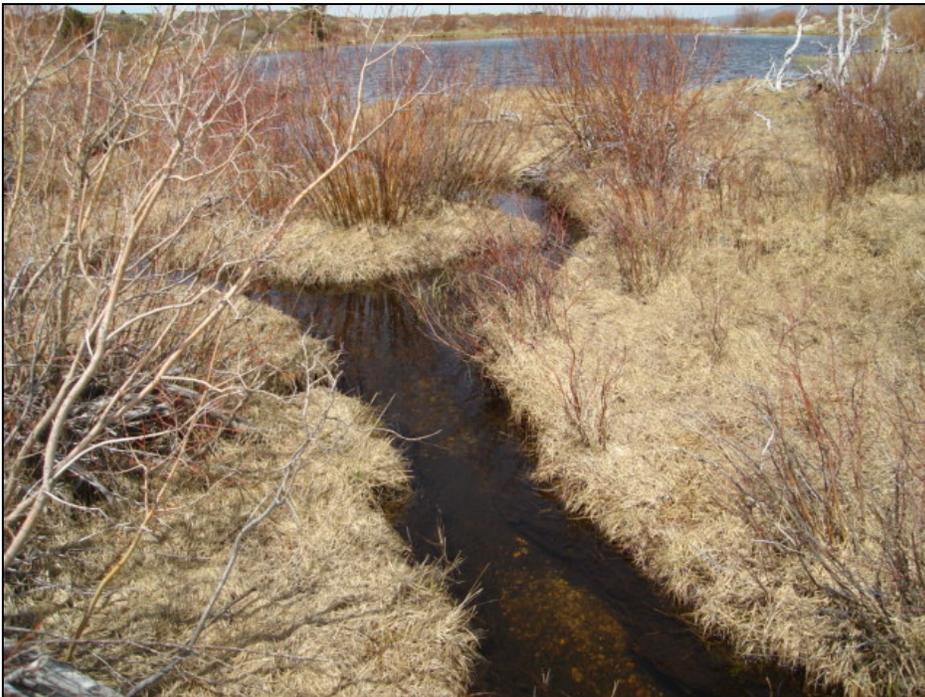
Site 24: Dunderberg Creek, Bridgeport Ranger District. Photo shows the main inlet where Dunderberg Creek enters the large pond. This deep slow flowing stream is surrounded by wet swampy ground. This site is located at UTM: N: 4219145 & E: 302978, Elev. 2687m.

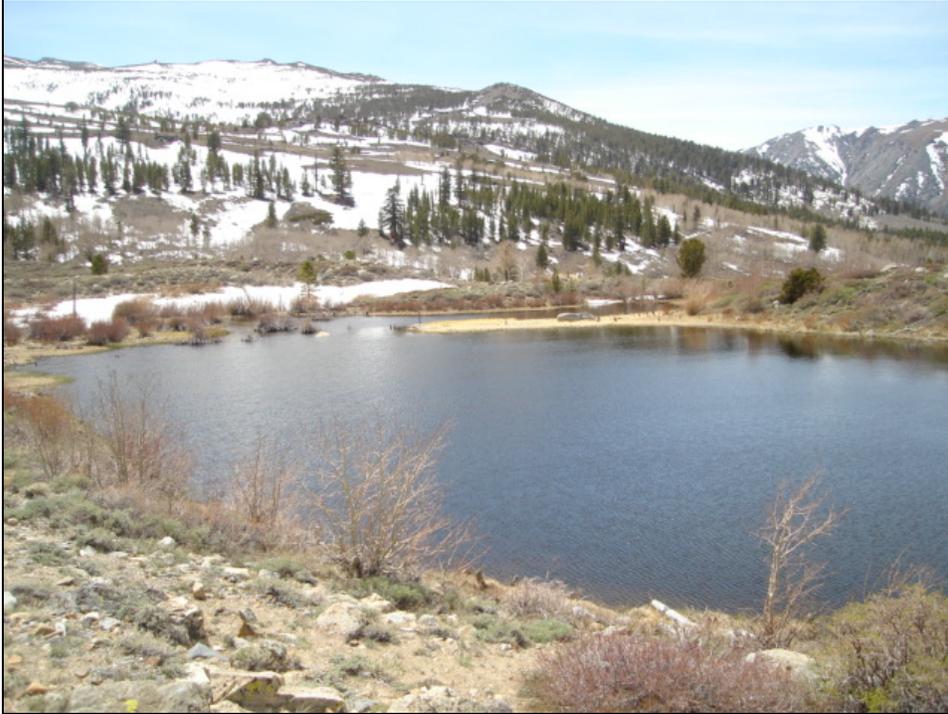
Site 24(cont'd): Dunderberg Creek, Bridgeport Ranger District. Photo shows the pond in which Dunderberg Creeks flows through. This site is located at UTM: N: 4219175 & E: 302939, Elev. 2688m.

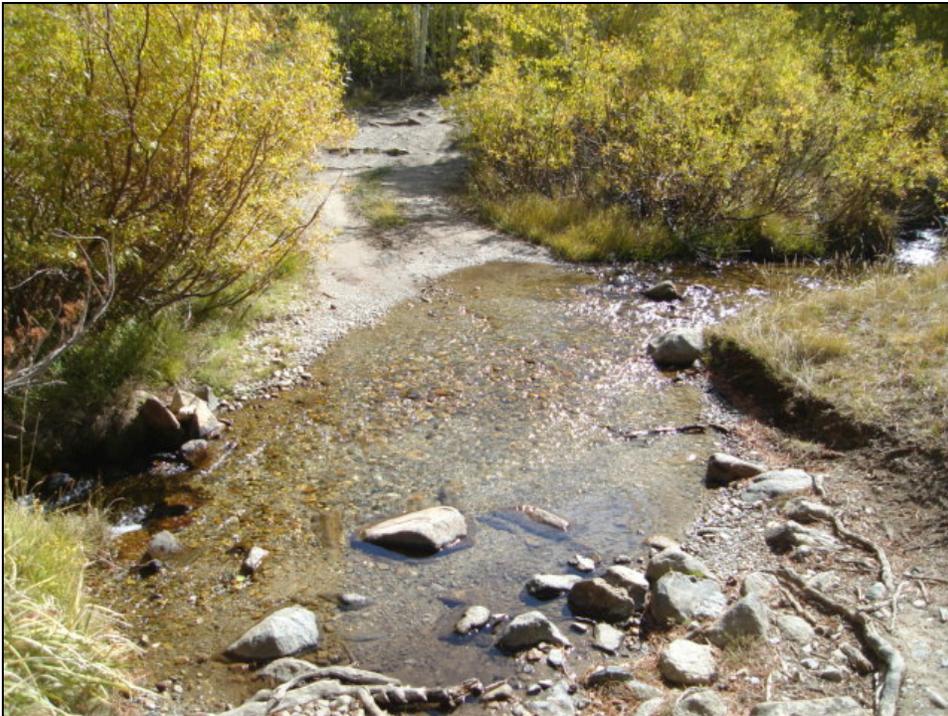
Site 25: Dunderberg Creek, Bridgeport Ranger District. Looking at a road crossing that is causing stream channel widening and sediment to enter the stream. This site is located at UTM: N: 4218674 & E: 303077, Elev. 2723m.

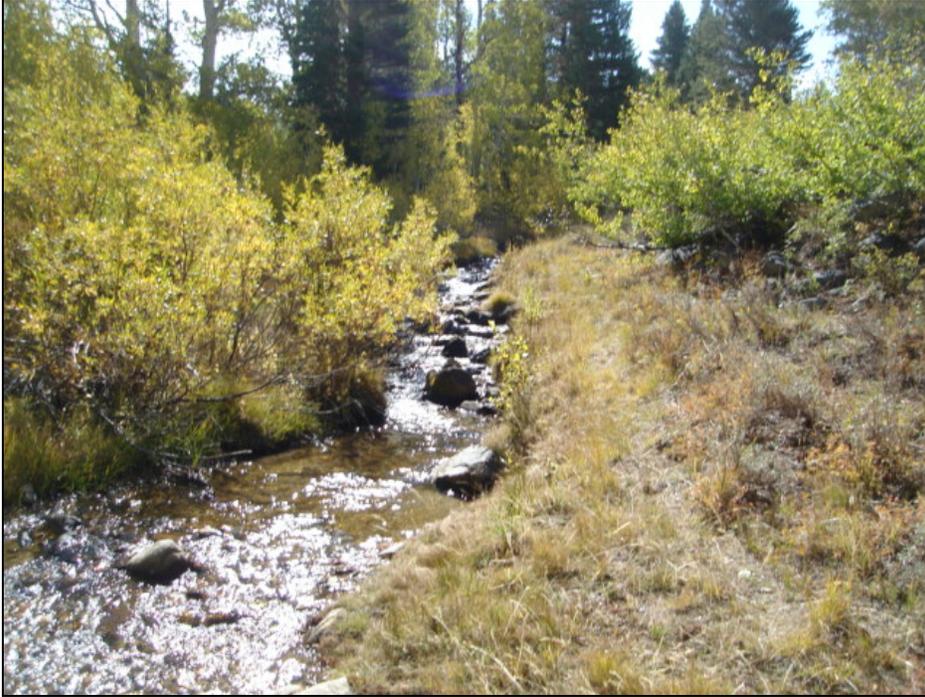
Site 25 (Continued): Dunderberg Creek, Bridgeport Ranger District. A view looking downstream from the road crossing. This site is located at UTM: N: 4218674 & E: 303078, Elev.2724m.

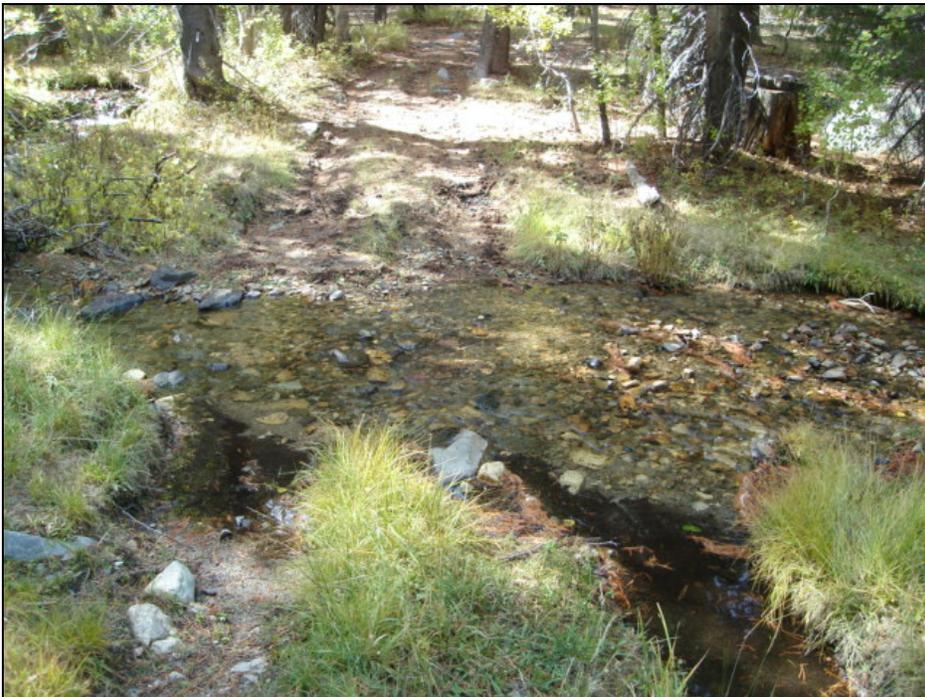
Site 26: Dunderberg Creek, Bridgeport Ranger District. Photo depicts an old two track road crossing the stream. Although some ruts are visible, it appears as if the road receives little use. This site is located at UTM: N: 4218369 & E: 303157, Elev. 2764m.

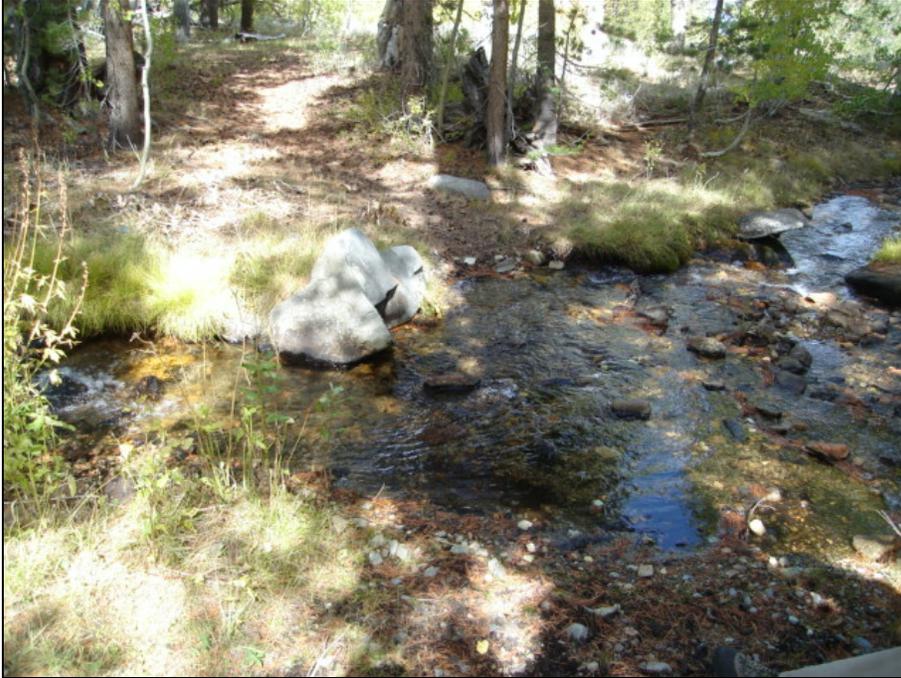
Site 27: Dunderberg Creek, Bridgeport Ranger District. An old road crossing appears to have digressed into a single track hiking trail crossing the creek. This site is located at UTM: N: 4218206 & E: 303113, Elev. 2781m.

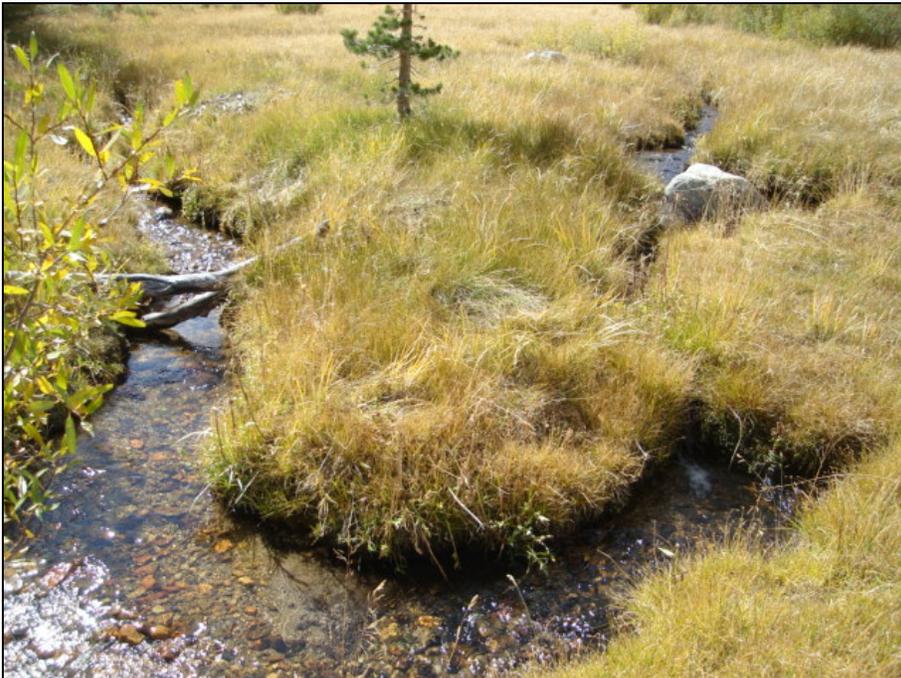
Site 28: Dunderberg Creek, Bridgeport Ranger District. A small tributary enters on the river right side contributing 50% of the overall flow. This section of stream runs through a meadow full of aspen and willows. This site is located at UTM: N: 4218109 & E: 303090, Elev. 2782m.

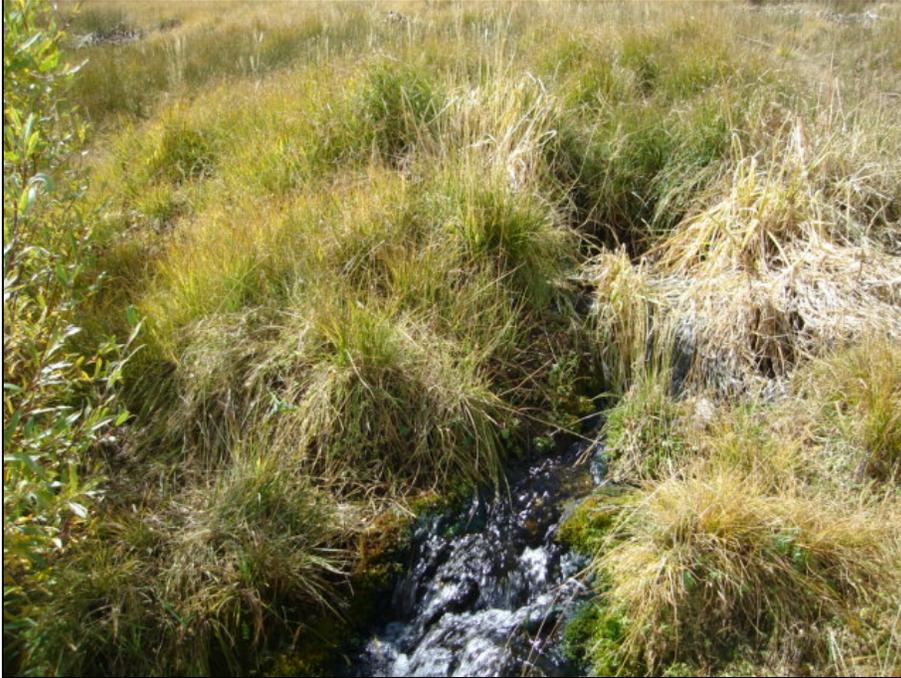
Site 29: Dunderberg Creek, Bridgeport Ranger District. Survey ends in the meadow where multiple tributaries merge to create Dunderberg Creek. Each tributary separately does not provide sustained fish habitat. Determining the main stream is also unclear through this meadow. This site is located at UTM: N: 4217876 & E: 302961.
