East Walker River

Mineral County, NV & Mono County, CA

2007 Stream Habitat Survey Report

Bridgeport Ranger District: Humboldt-Toiyabe National Forest

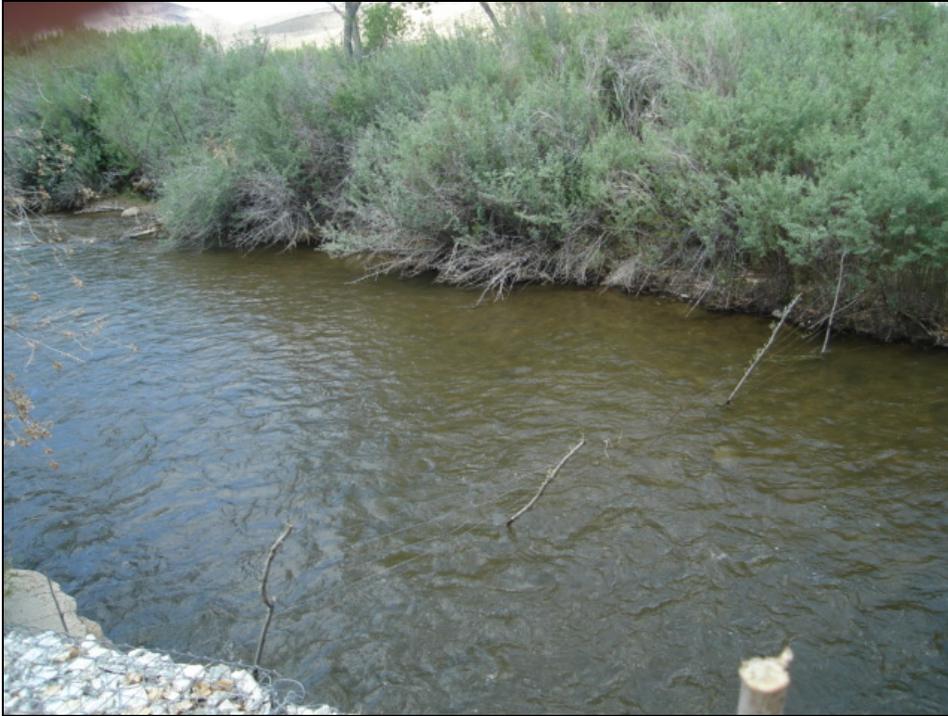
Site 1: East Walker River, Bridgeport Ranger District. Survey starts just upstream of the Flying M Hunting Club. This site is located at UTM: N: 4268222 & E: 330134, Elev. 1551m.

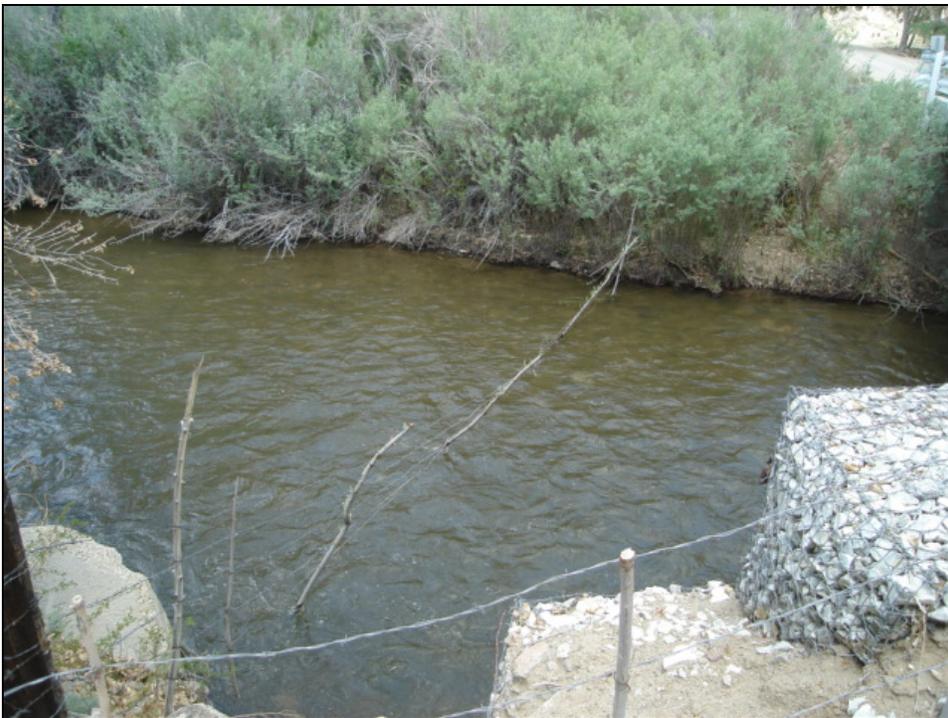
Site 2: East Walker River, Bridgeport Ranger District. A barbed wire fence stretches across the river reaching from the surface to 1.5m above water. This site is located at UTM: N: 4268222 & E: 330134, Elev. 1551m.

3. Talk with private land owners located along the river about the presence of barbed wire fencing that spans the river at several locations. Determine if these are appropriate and whether they are inhibiting recreational use of the river.

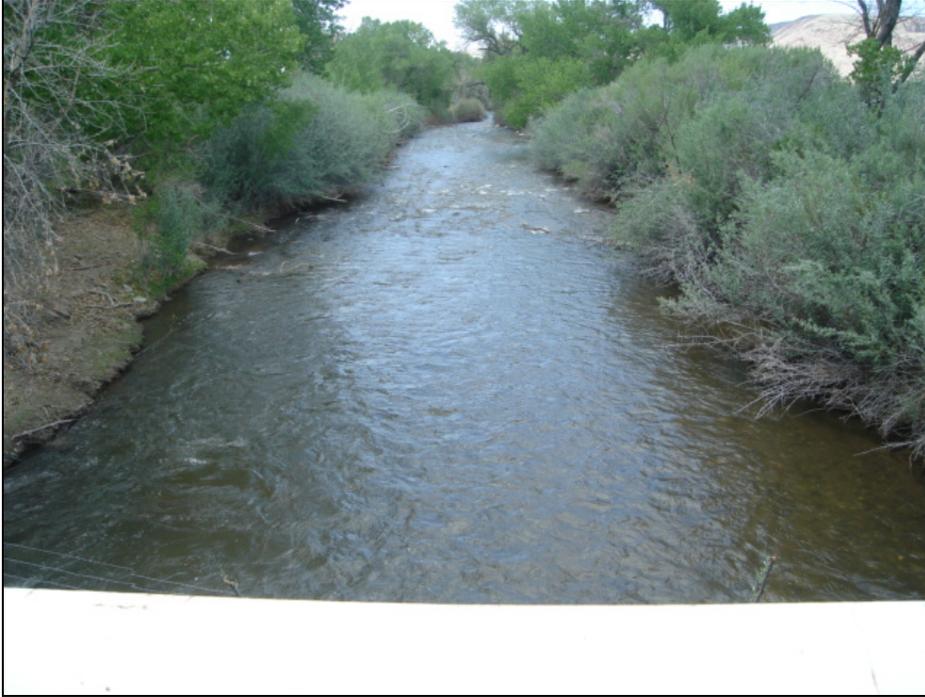
Site 3: East Walker River, Bridgeport Ranger District. Looking downstream from a bridge that crosses the river. This bridge is wide enough for one vehicle to cross at a time. Some riprap can be seen on river left downstream of the bridge. This site is located at UTM: N: 4268222 & E: 330134, Elev. 1551m.

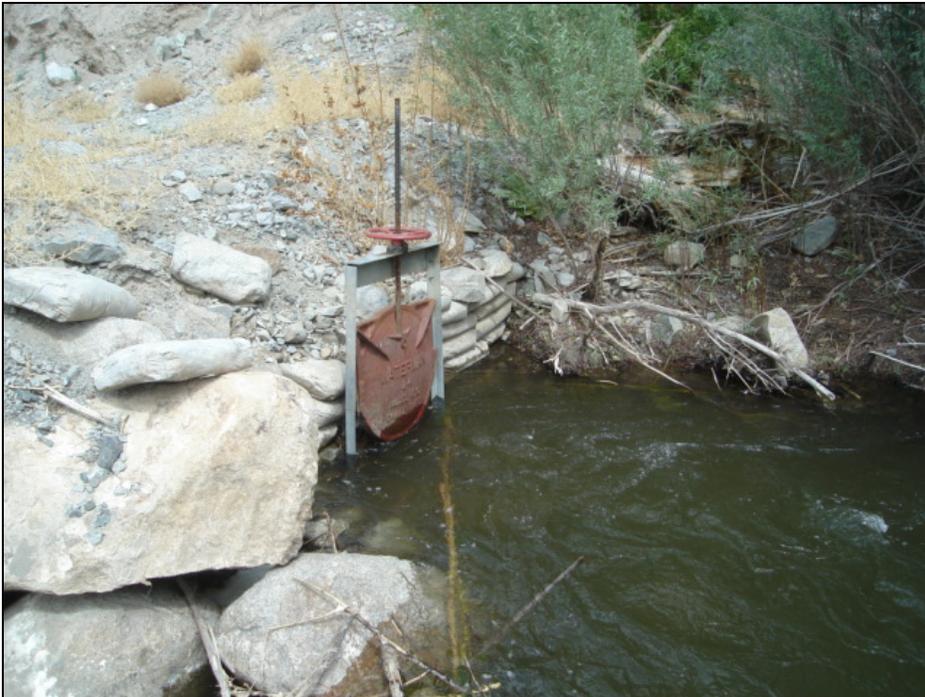
Site 4: East Walker River, Bridgeport Ranger District. A diversion canal with a gate to regulate flow is set up to irrigate a downstream ranch. This site is located at UTM: N: 4267900 & E: 330433, Elev. 1551m.

4. Investigate the destination and impacts of the diversions at Sites 4 and 6, and if possible the diversions that occur between Sites 41 and 42. Ensure that fish are not subject to terminal trips into irrigated pasture, and similarly ensure that water users are staying within the confines of their adjudicated rights.

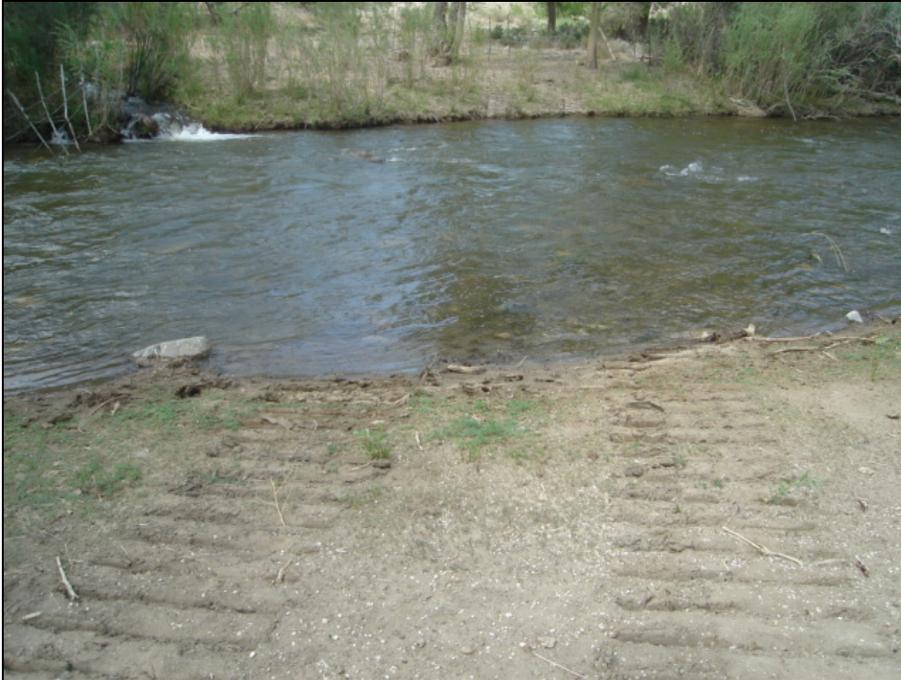
Site 5: East Walker River, Bridgeport Ranger District. Tracks shown on both sides of the river are evidence of heavy machinery crossing at this point. This site is located at UTM: N: 4267564 & E: 330157, Elev. 1564m.

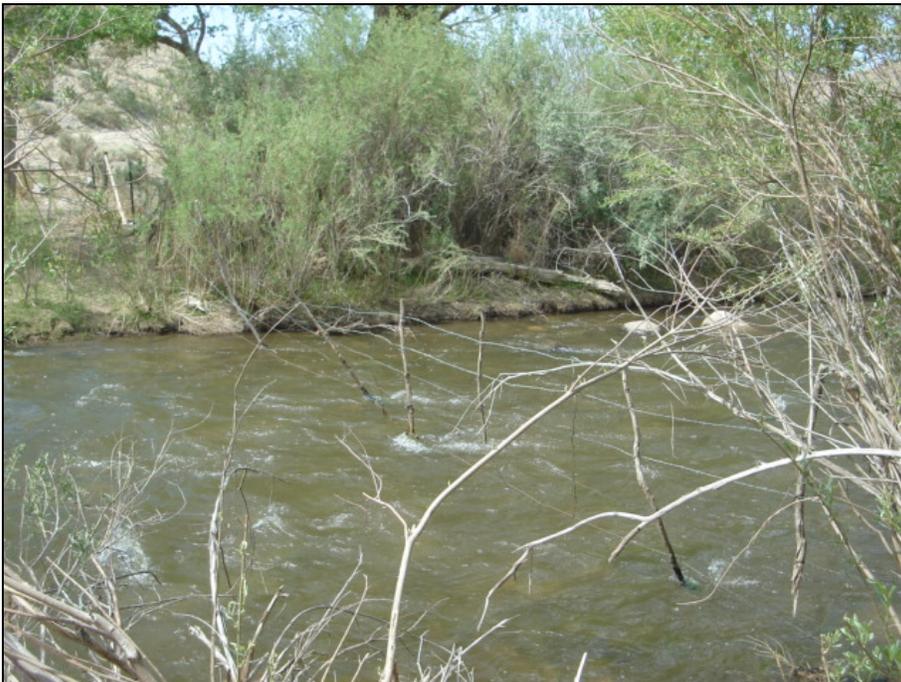
Site 5 (cont'd): East Walker River, Bridgeport Ranger District. Barbed wire fence stretches across the river on both sides of tracks approx. 20m apart. This site is located at UTM: N: 4267564 & E: 330157, Elev. 1564m.

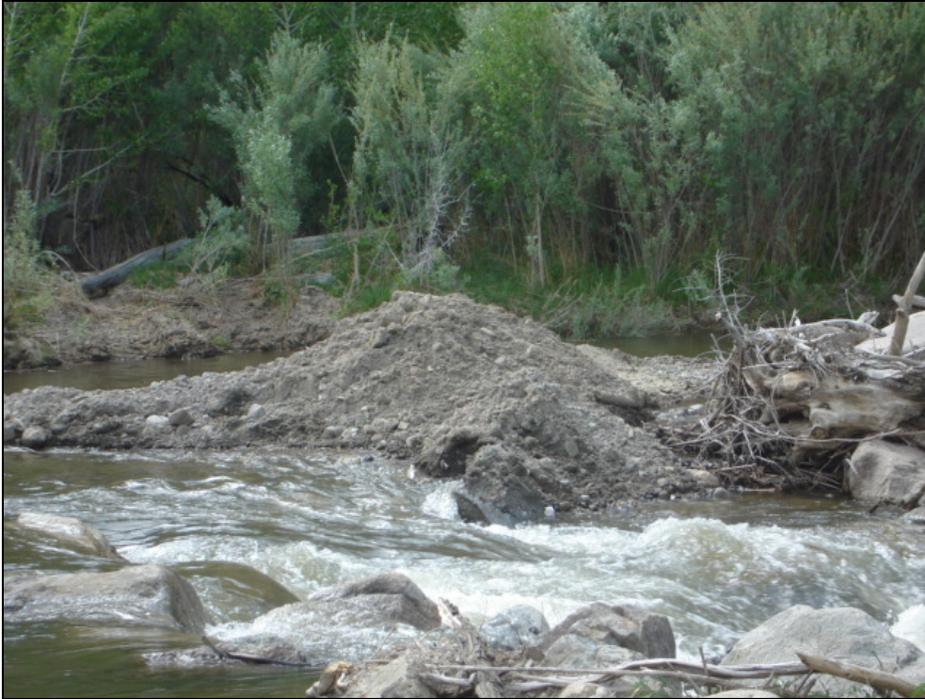
Site 6: East Walker River, Bridgeport Ranger District. Big mound of dirt moved by heavy machinery is placed in the middle of the river in order to divert some of the water to the left. Machinery tracks appear to be fresh. This site is located at UTM: N: 4267410 & E: 330026, Elev. 1560m.

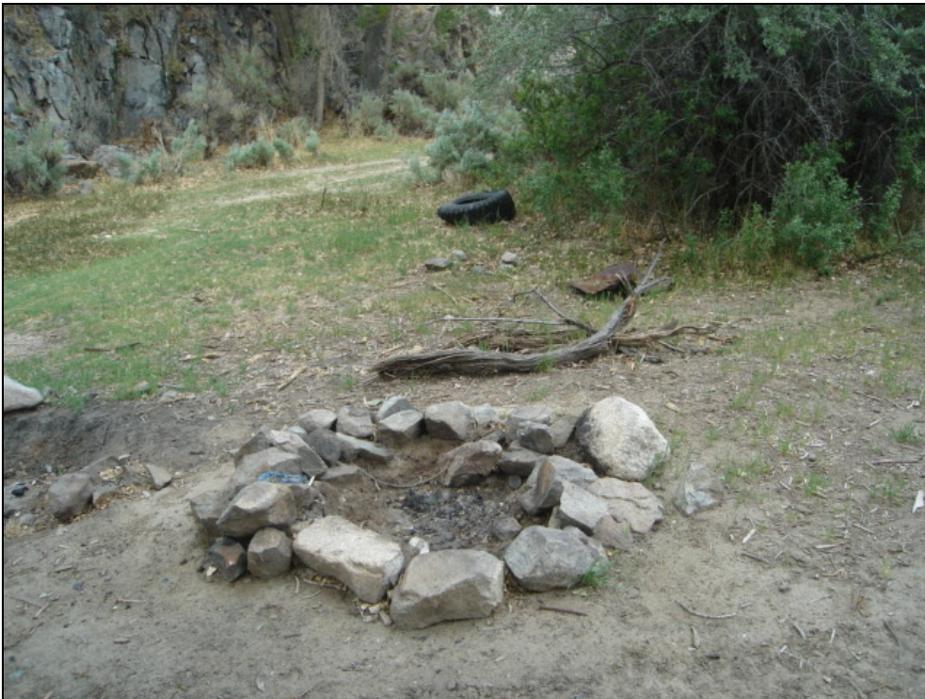
Site 7: East Walker River, Bridgeport Ranger District. A campsite with two large fire rings and lots of trash nearby. This site is located at UTM: N: 4266643 & E: 329595, Elev. 1572m.

2. Make information regarding Leave No Trace ethics more visible to the public. Decommission infrequently used campsites and encourage users to camp at least 100 feet from the river.

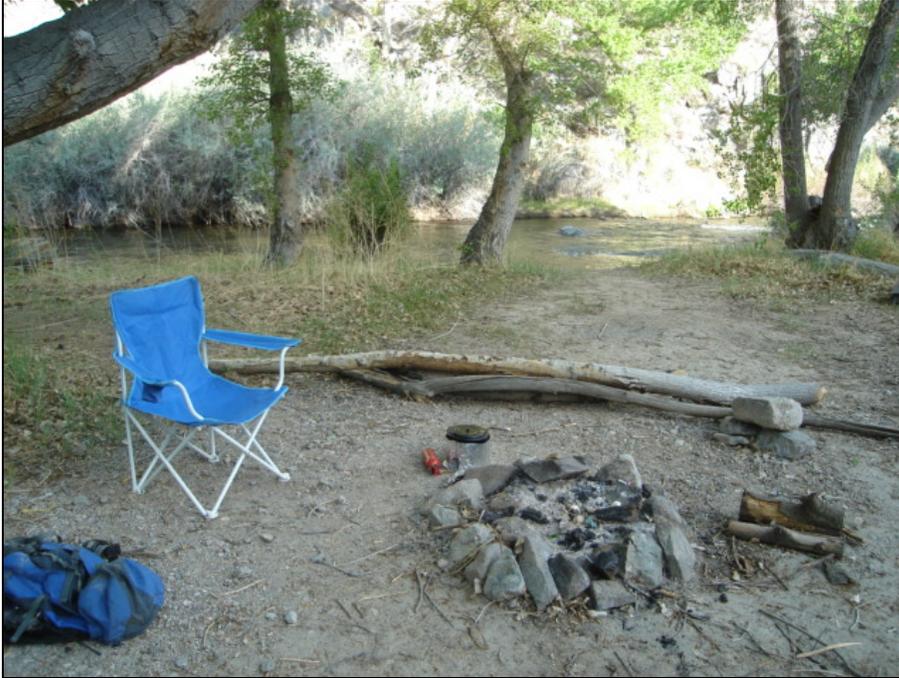
Site 8: East Walker River, Bridgeport Ranger District. A small campsite shaded by cottonwoods is located on river right 10m from the water's edge. This campsite has road access. This site is located at UTM: N: 4265610 & E: 329073, Elev. 1583m.

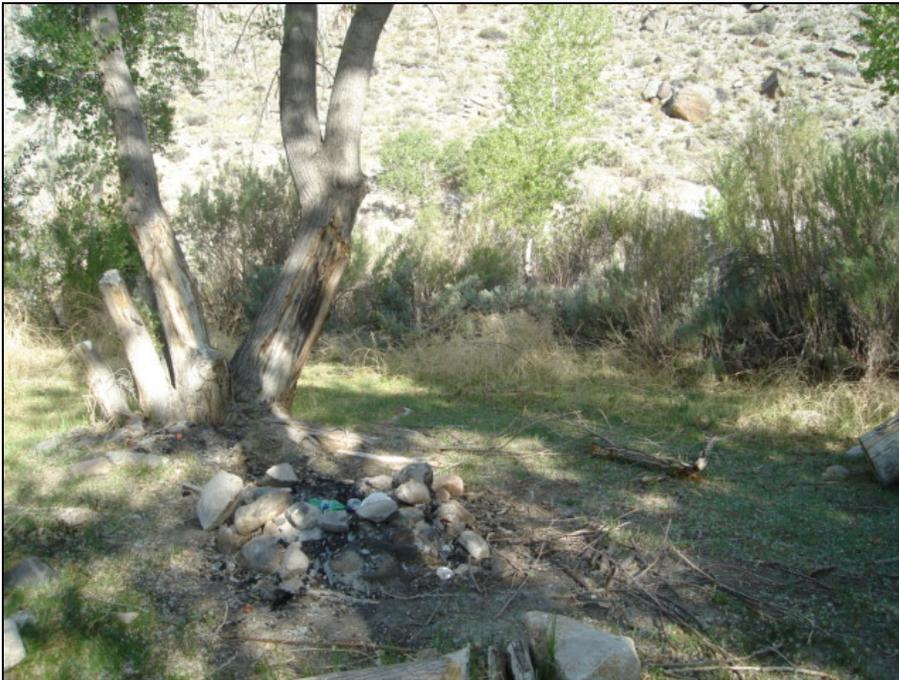
Site 9: East Walker River, Bridgeport Ranger District. Campsite containing 1 fire ring, stumps for sitting, and extra firewood is located 30m from water on river right. Wood looks as though it has been cut from a nearby tree. Lots of broken glass and tall whitetop were also seen near this area. This site is located at UTM: N: 4265517 & E: 229013, Elev. 1585m.

5. Eliminate noxious weeds (cheat grass and whitetop) where herbicides can be safely applied.
6. Consider stocking LCT into the East Walker River as a put-and-take recreational fishery.

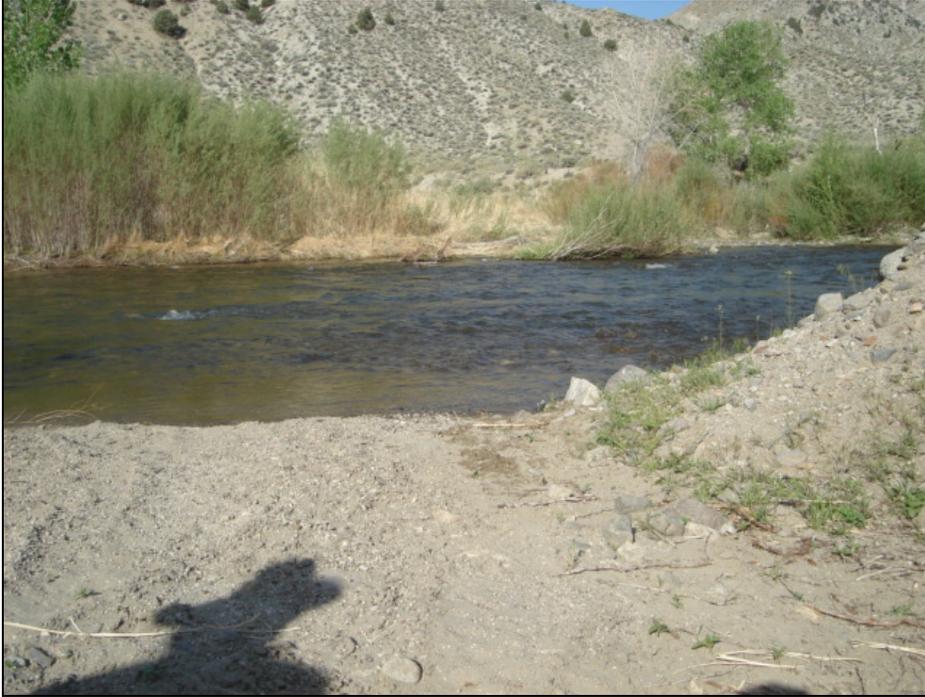
Site 10: East Walker River, Bridgeport Ranger District. ATV tracks on river right along with trampled vegetation seen on river left suggest this location is being used frequently to cross the river. This site is located at UTM: N: 4265290 & E: 329034, Elev. 1589m.

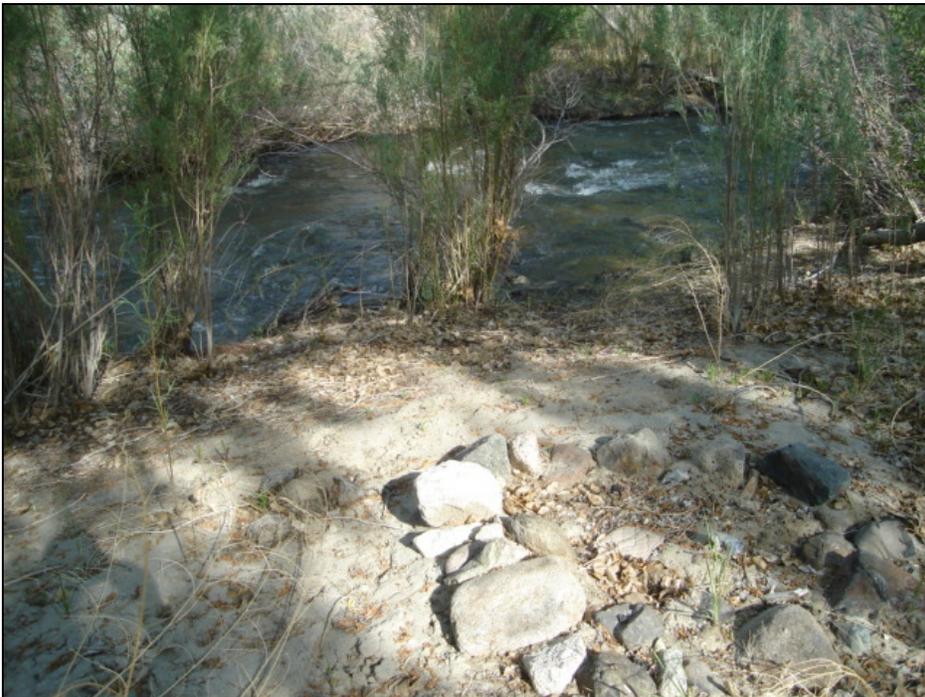
Site 11: East Walker River, Bridgeport Ranger District. Small campsite with one fire ring is located 3m from the water on river right. This site is located at UTM: N: 4265121 & E: 329047, Elev. 1590m.

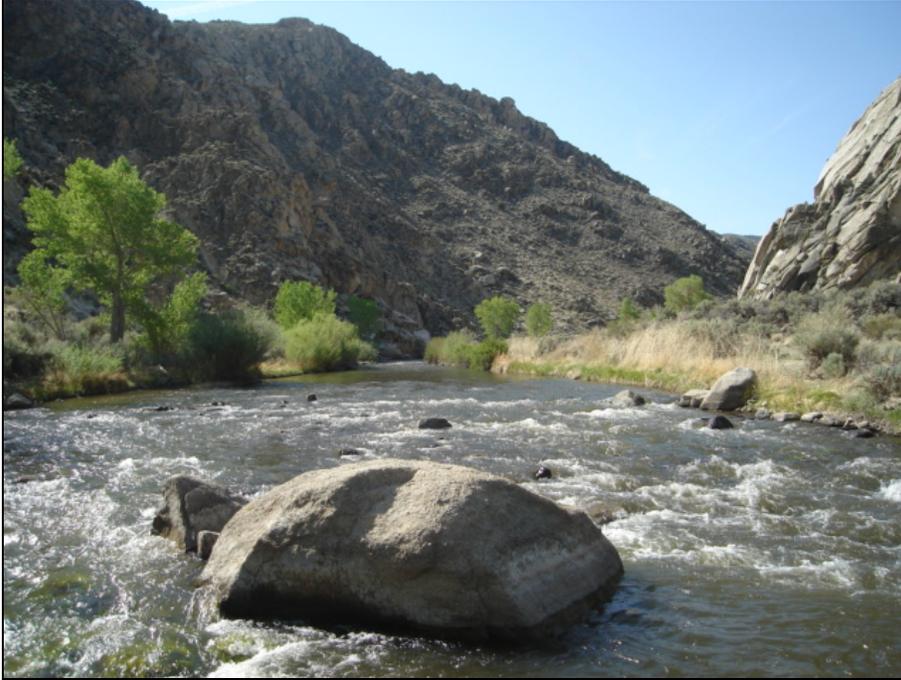
Site 12: East Walker River, Bridgeport Ranger District. Photo point shows an upstream view as the river flows through a large canyon. Downstream shows few rocks creating little rapids and heavily vegetated stream banks. This site is located at UTM: N: 4263429 & E: 328725, Elev. 1603m.

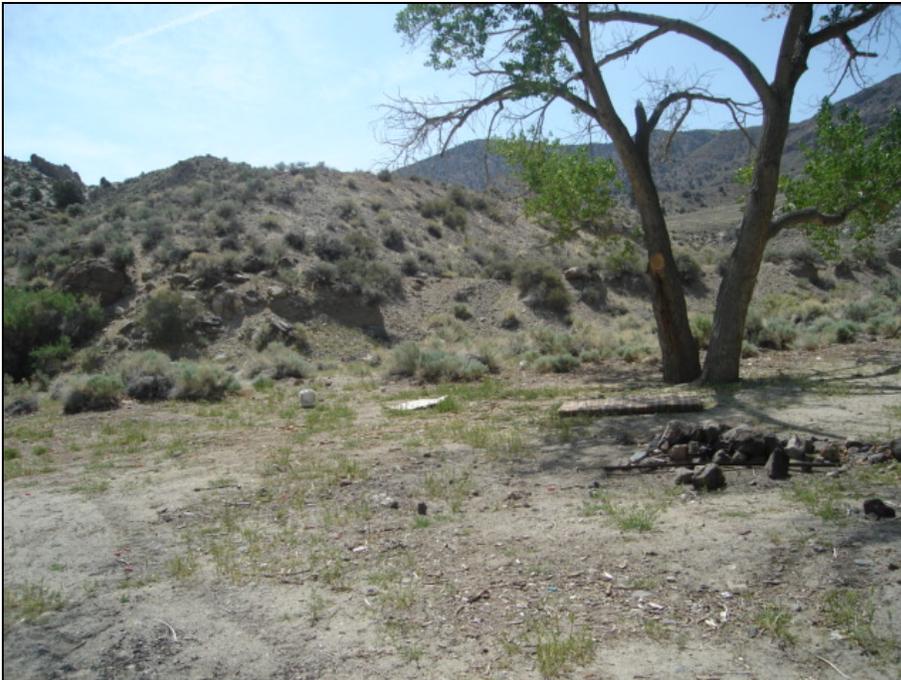
Site 13: East Walker River, Bridgeport Ranger District. Campsite contains 1 fire ring, debris such as a mattress, propane tank, and several shotgun shells. Campsite is 50m from water with road access and ATV tracks leading to site. This site is located at UTM: N: 4261923 & E: 328076, Elev. 1626m.

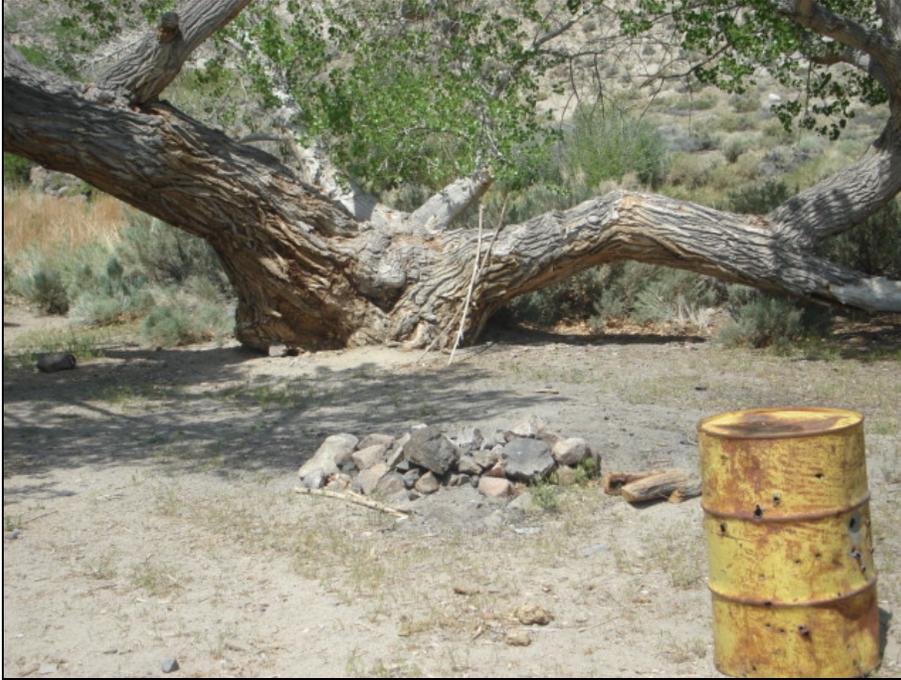
Site 14: East Walker River, Bridgeport Ranger District. One fire ring over 50m from water is found with a barrel punctured by gunshots. The campsite has road access. This site is located at UTM: N: 4261866 & E: 327987, Elev. 1628m.

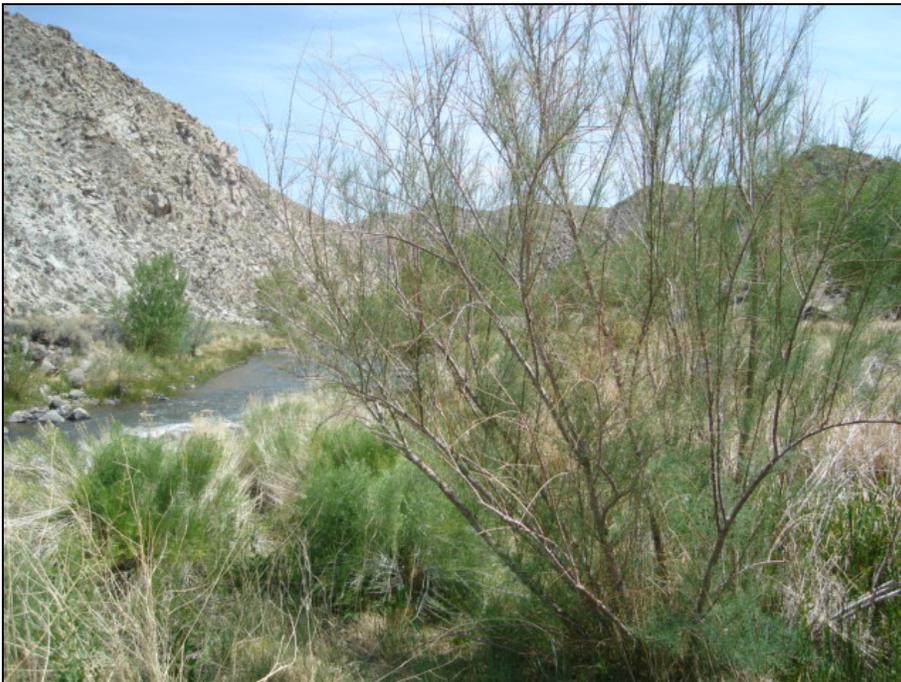
Site 15: East Walker River, Bridgeport Ranger District. Photo is of the invasive Tamarisk, a species which changes the salinity of the soil and chokes out native plants. Tamarisk can be seen all along this stretch of river bank. This site is located at UTM: N: 4261824 & E: 327907, Elev. 1629m.

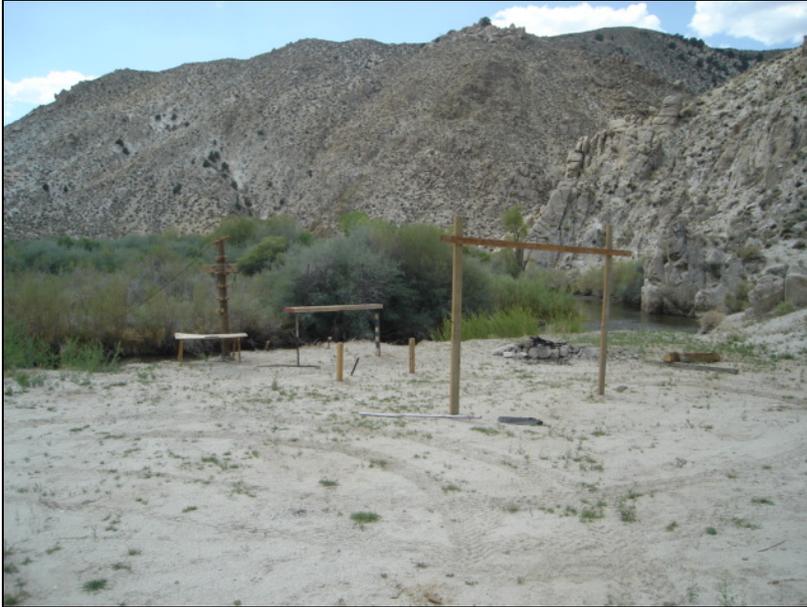
Site 17: East Walker River, Bridgeport Ranger District. Photo depicts large campsite with fire ring 2m from the water on river right. Campsite includes 5 wood structures including a zip line across the river and a sign that reads “Welcome to Refuge”. This site is located at UTM: N: 4260310 & E: 325830, Elev. 1662m.

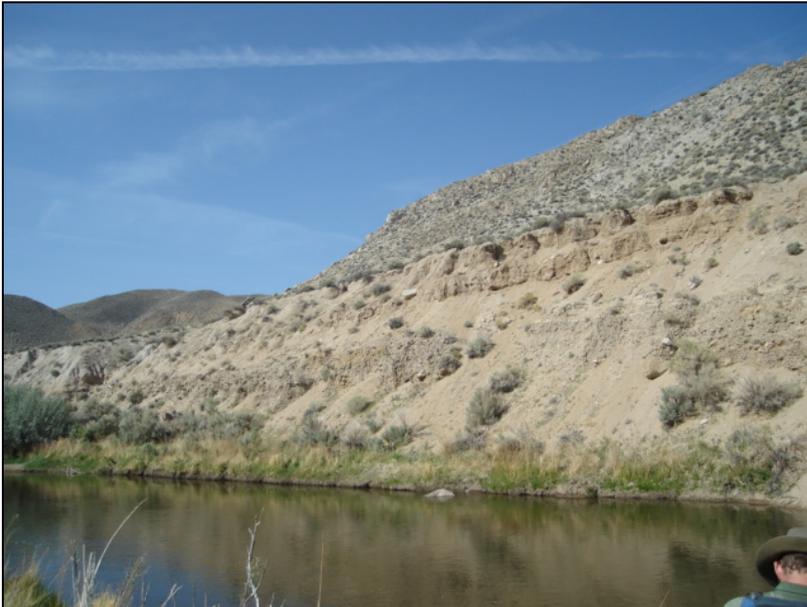
Site 18: East Walker River, Bridgeport Ranger District. Stream bank on river left shows massive erosion at this site with dimensions of approx. 15m in height and 100m in length. This site is located at UTM: N: 4259748 & E: 325532, Elev. 1666m.

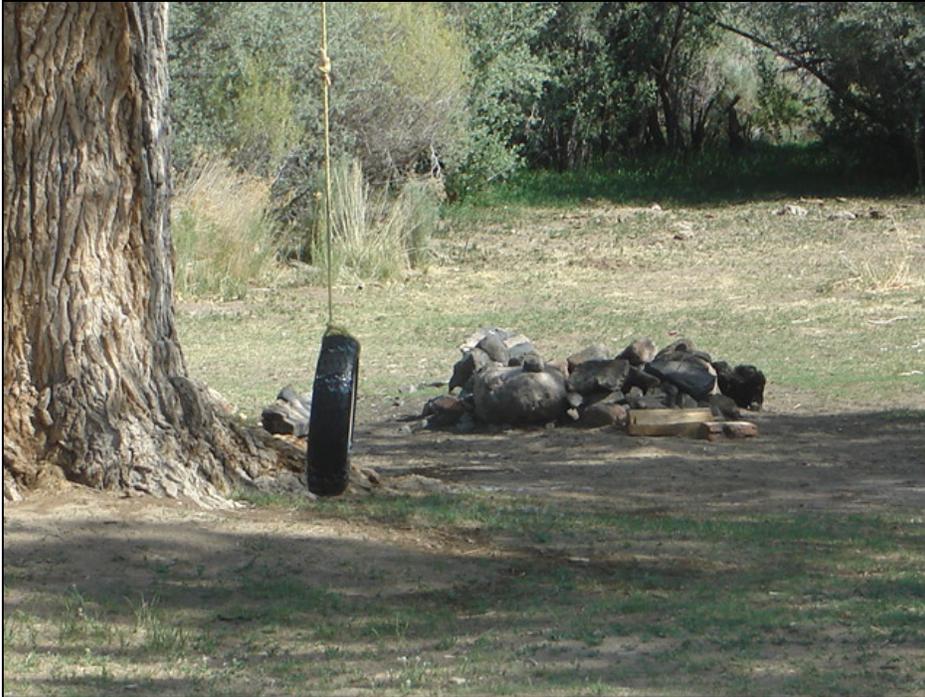
Site 19: East Walker River, Bridgeport Ranger District. One large fire ring 30m from water defines this campsite which also includes a tire swing, extra firewood, and road access. This site is located at UTM: N: 4259503 & E: 325711, Elev. 1666m.

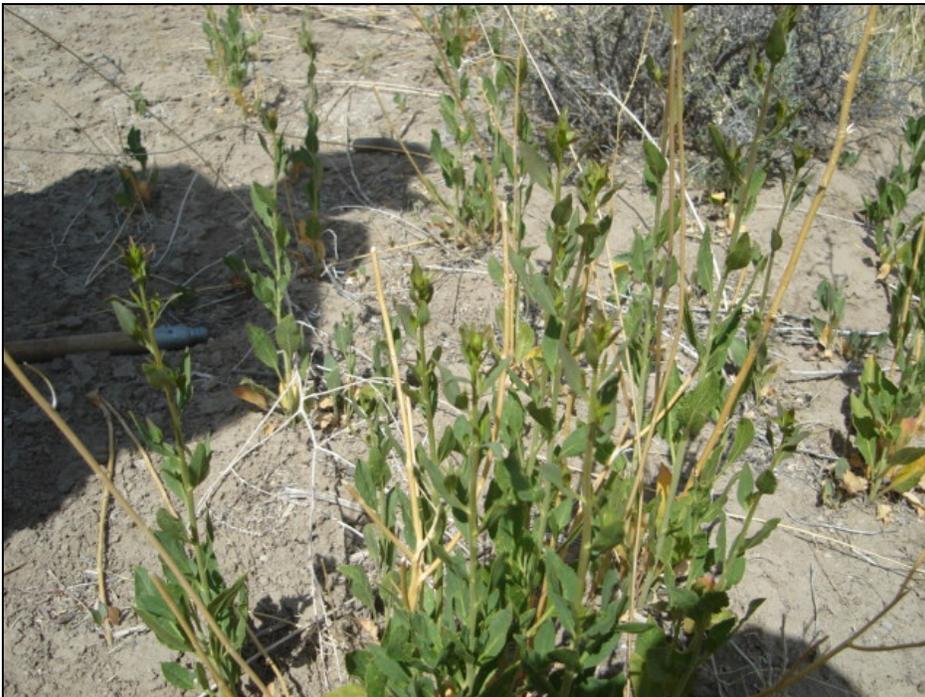
Site 20: East Walker River, Bridgeport Ranger District. This photo depicts what is believed to be hoary cress, an invasive species which outcompetes native vegetation. We found this weed on river right. This site is located at UTM: N: 4259409 & E: 324922, Elev. 1669m.

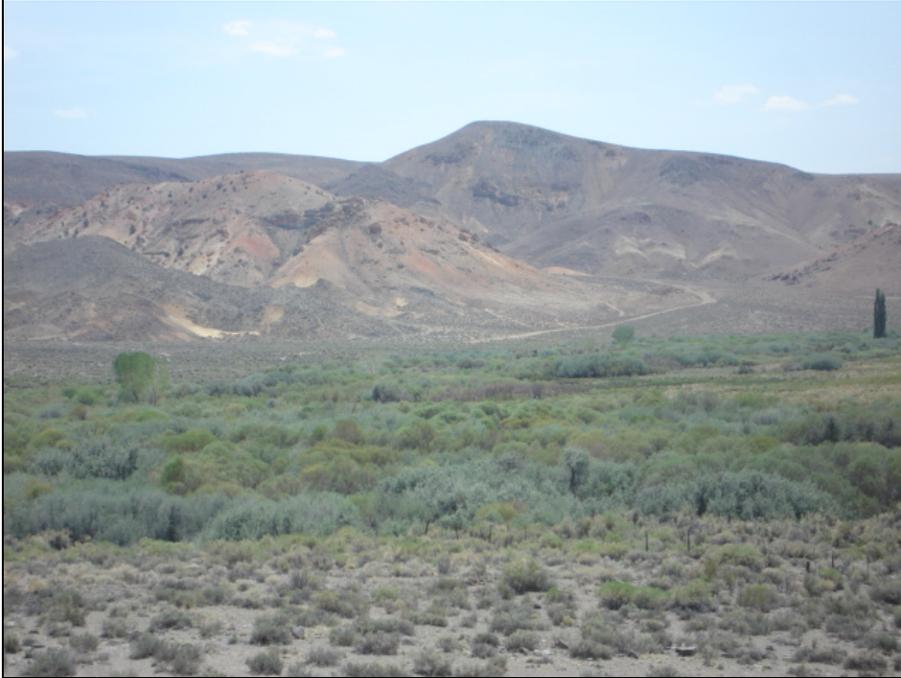
Site 21: East Walker River, Bridgeport Ranger District. Thick willows surround the river as it passes through private property. Because of the thick vegetation and trespassing laws we skipped this section of river. We suspect that some diversions may occur within this section of river. This site is located at UTM: N: 4258368 & E: 324737, Elev. 1678m.

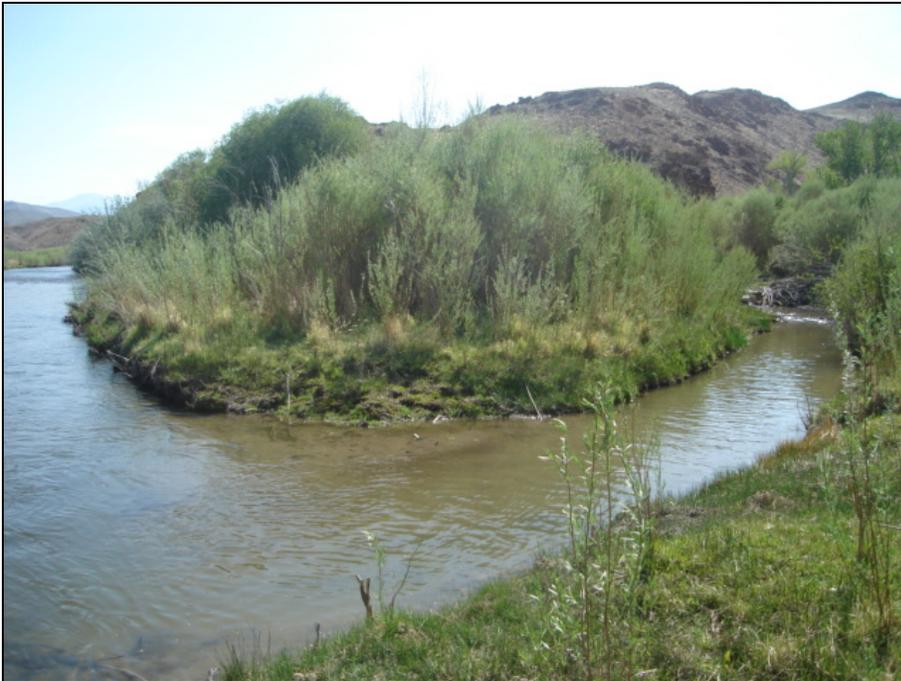
Site 22: East Walker River, Bridgeport Ranger District. Rough Creek drains into river right and contributes 5% to the overall river flow. This site is located at UTM: N: 4255771 & E: 324354, Elev. 1693m.

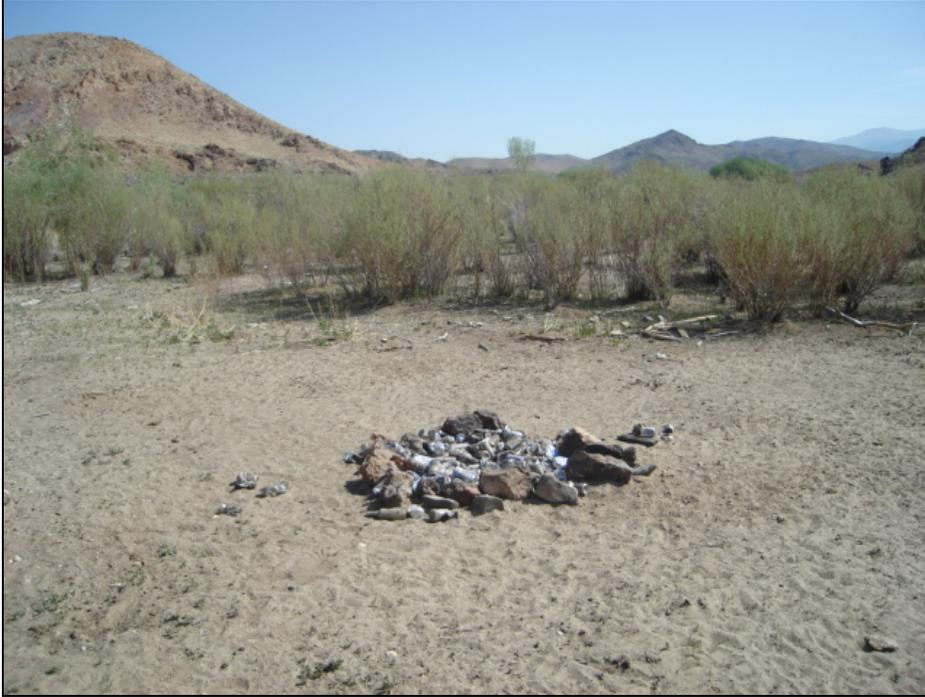
Site 23: East Walker River, Bridgeport Ranger District. Campsite containing one fire ring 15m from water is filled with empty bottles and cans. Mountain bike tracks can be seen on the trail leading to the main road 15m away. This site is located at UTM: N: 4255631 & E: 324167, Elev. 1695m.

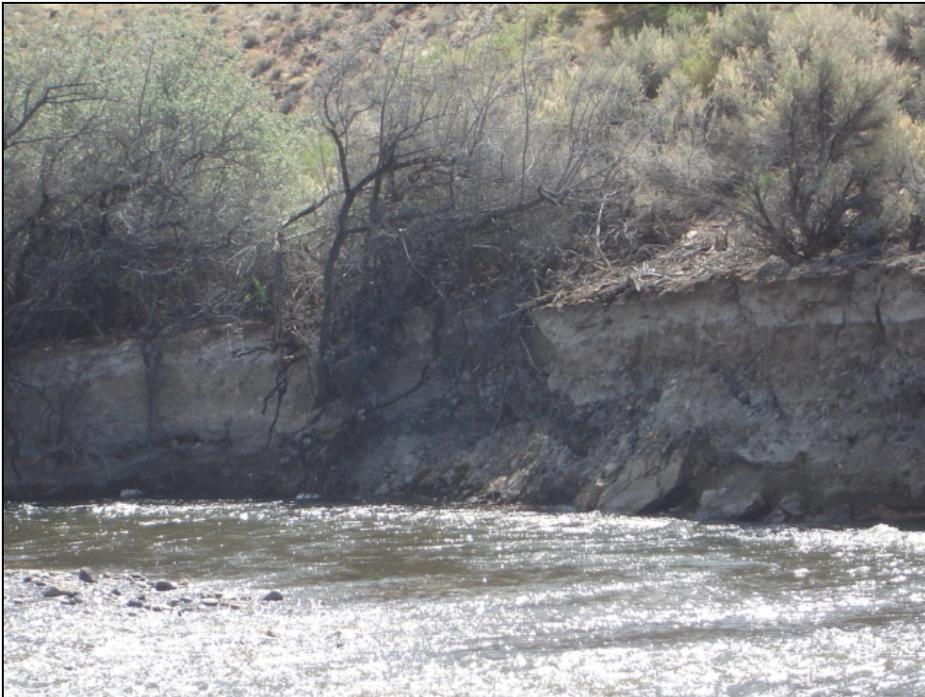
Site 24: East Walker River, Bridgeport Ranger District. Massive erosion approx. 2.5m high and 35m long is seen along a meander in the river that is almost 180°. This site is located at UTM: N: 4255022 & E: 323360.

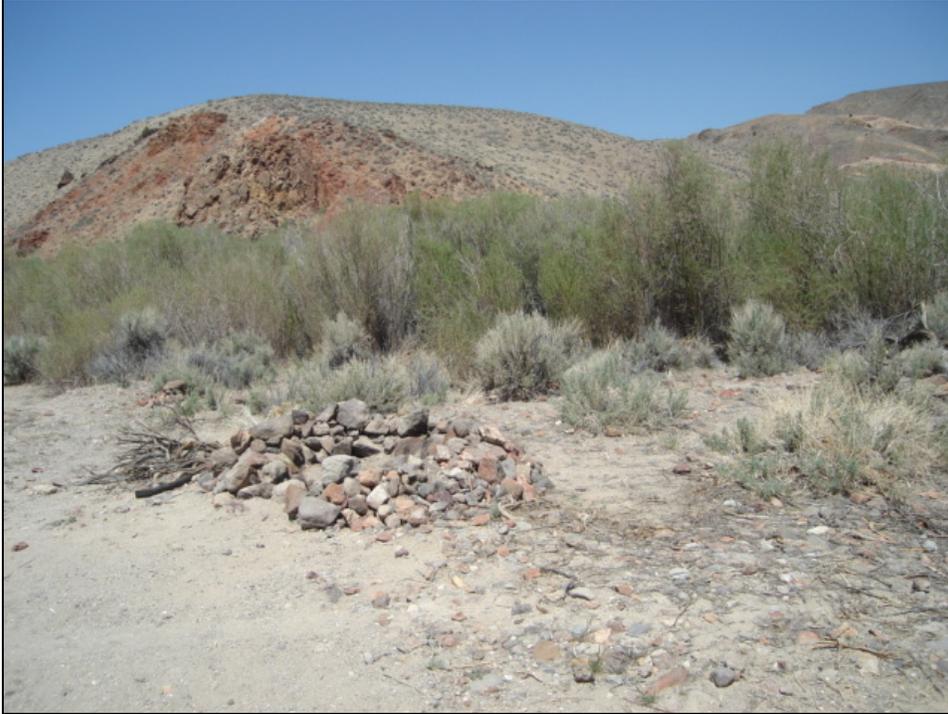
Site 25: East Walker River, Bridgeport Ranger District. Two fire rings are located 10m from water on river right. This campsite is accessible by road. This site is located at UTM: N: 4254727 & E: 322762, Elev. 1704m.

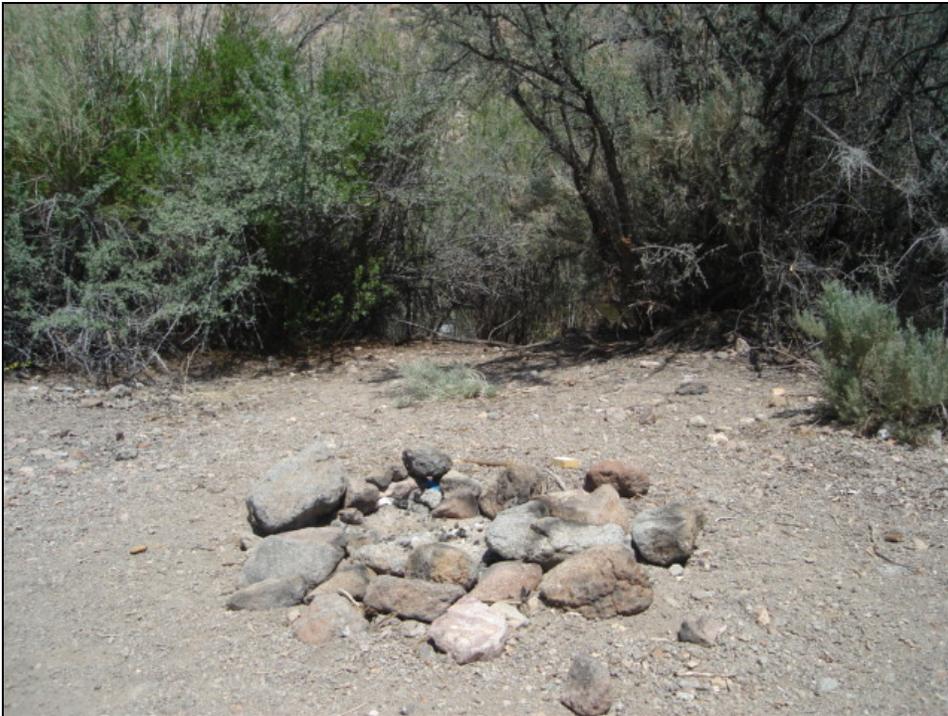
Site 26: East Walker River, Bridgeport Ranger District. Campsite lies 10m from water's edge on river right with road access and a path leading to the river. This site is located at UTM: N: 4254700 & E: 322565, Elev. 1705m.

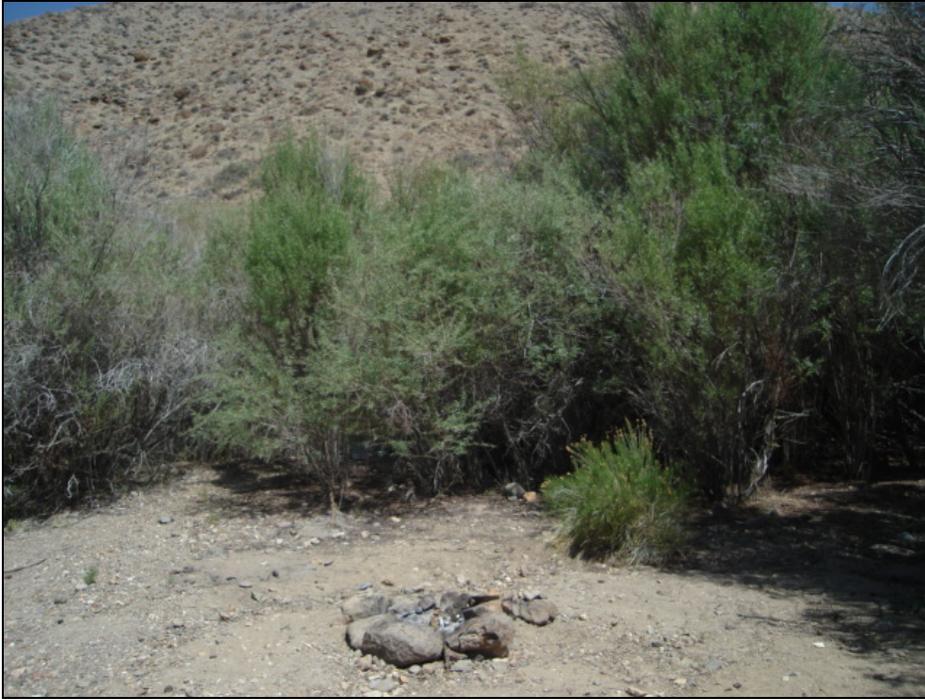
Site 27: East Walker River, Bridgeport Ranger District. 3 fire rings with road access and a path to river for fishing/swimming is located on river right. The closest ring is 15m from the water. This site is located at UTM: N: 4254683 & E: 322403, Elev. 1705m.

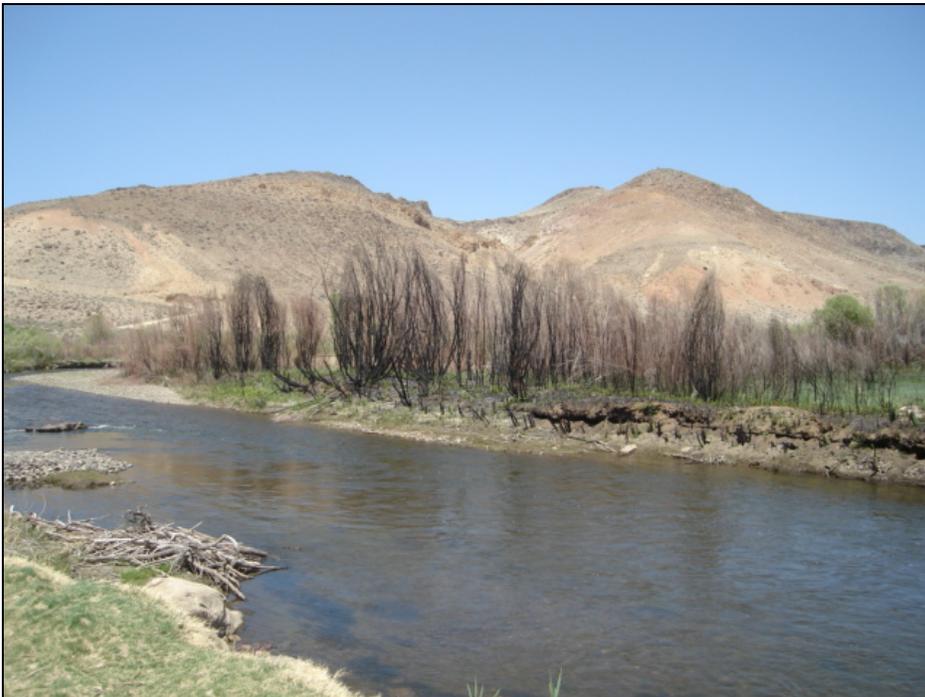
Site 28: East Walker River, Bridgeport Ranger District. A recent wildfire burned the vegetation along the river bank. Although the fire appears recent, new vegetation is evident along the bank. This site is located at UTM: N: 4254903 & E: 321714, Elev. 1708m.

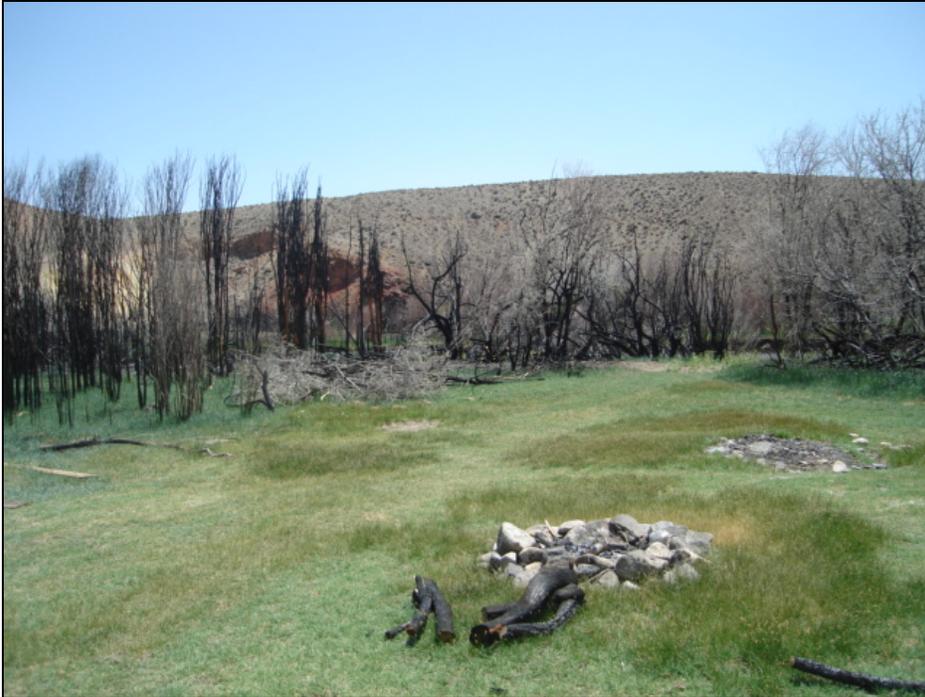
Site 29: East Walker River, Bridgeport Ranger District. Several campsites with road access are surrounded by burned vegetation from a recent fire (also see Site 28). The closest fire ring is approx. 25m from water's edge on river right. This site is located at UTM: N: 4255359 & E: 321833, Elev. 1711m.

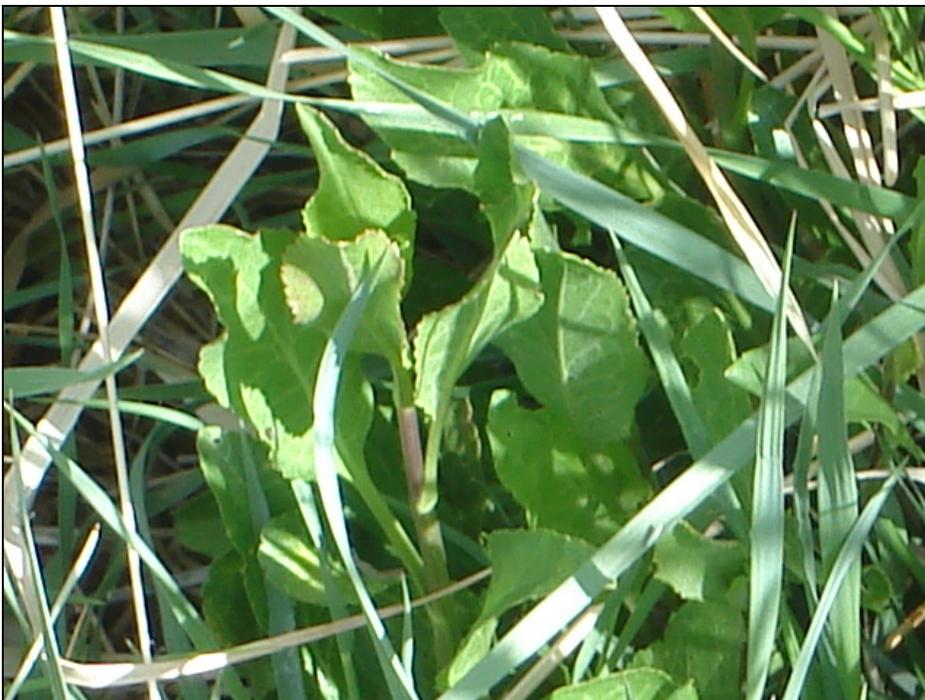
Site 30: East Walker River, Bridgeport Ranger District. A few small bunches of tall whitetop (hoary cress) is found on the river right stream bank. This site is located at UTM: N: 4256748 & E: 319189, Elev. 1735m.

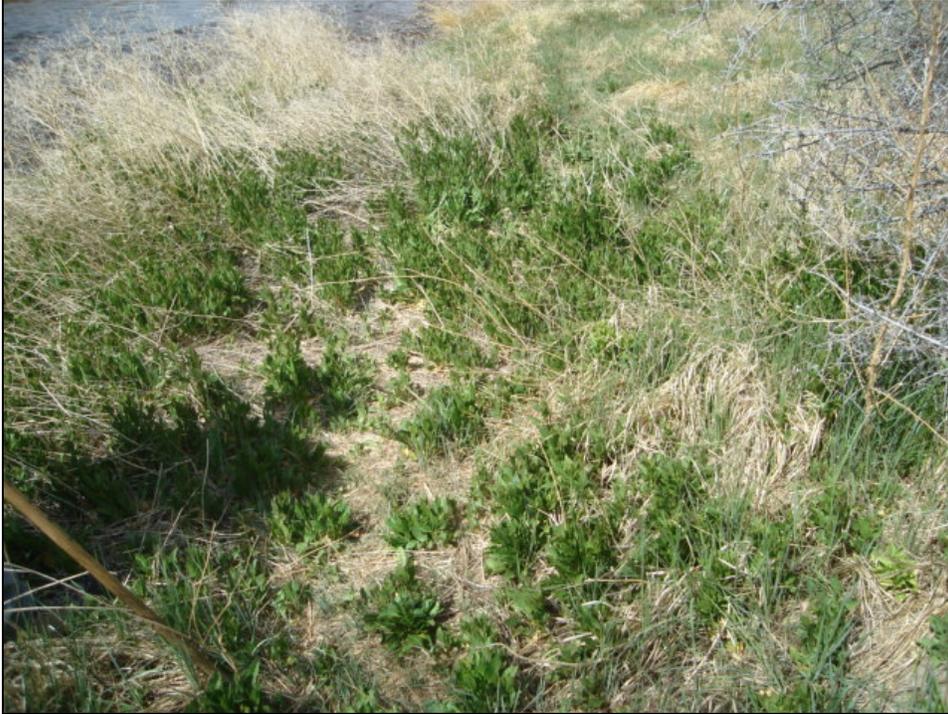
Site 31: East Walker River, Bridgeport Ranger District. Larger clumps of the noxious weed hoary cress are found at this location on river right. This site is located at UTM: N: 4256816 & E: 318589, Elev. 1737m.

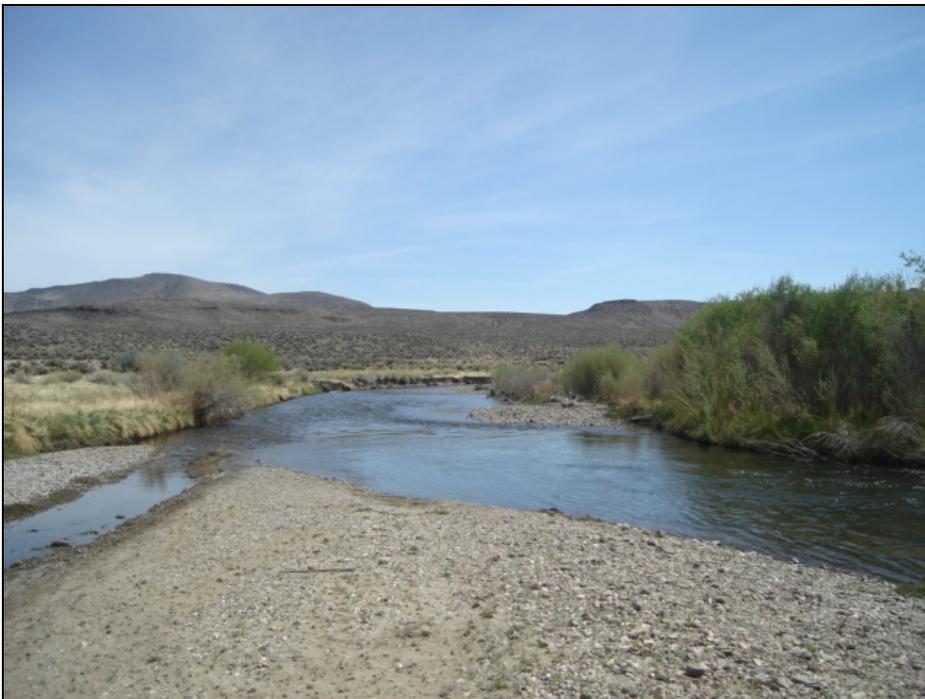
Site 32: East Walker River, Bridgeport Ranger District. This photo point shows a calm river with few rocks or rapids as the river runs semi-meandering with a few small islands. An old diversion for irrigation enters river right. This site is located at UTM: N: 4256812 & E: 318334, Elev. 1738m.
