East Walker River

Mineral County, NV & Mono County, CA

2007 Stream Habitat Survey Report

Bridgeport Ranger District: Humboldt-Toiyabe National Forest

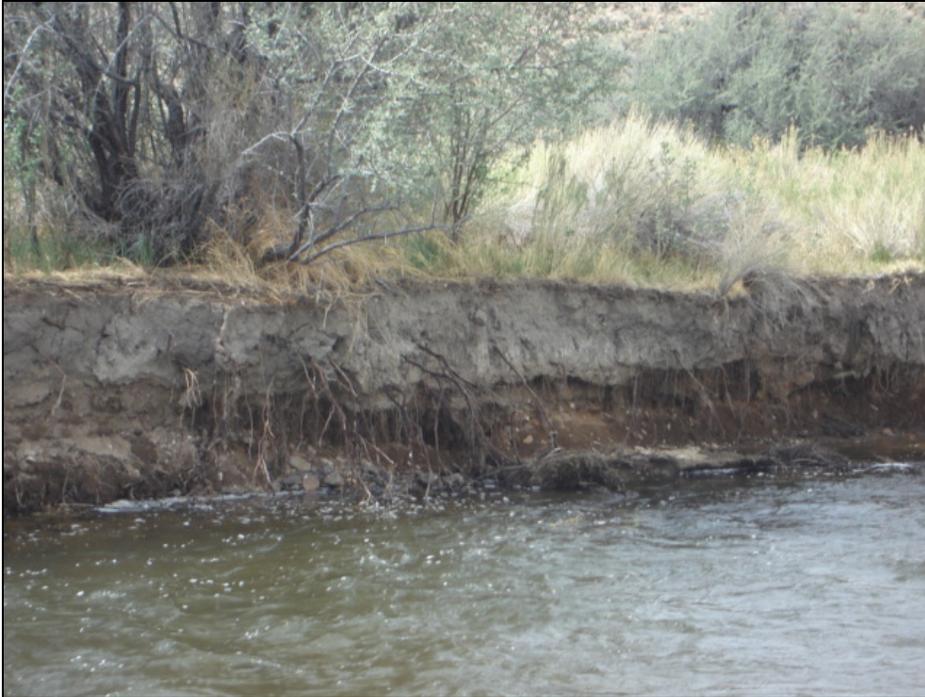
Site 33: East Walker River, Bridgeport Ranger District. Heavy erosion marks this site at a length of 80m and a height of 1.5m. This site is located at UTM: N: 4256586 & E: 318138, Elev. 1740m.

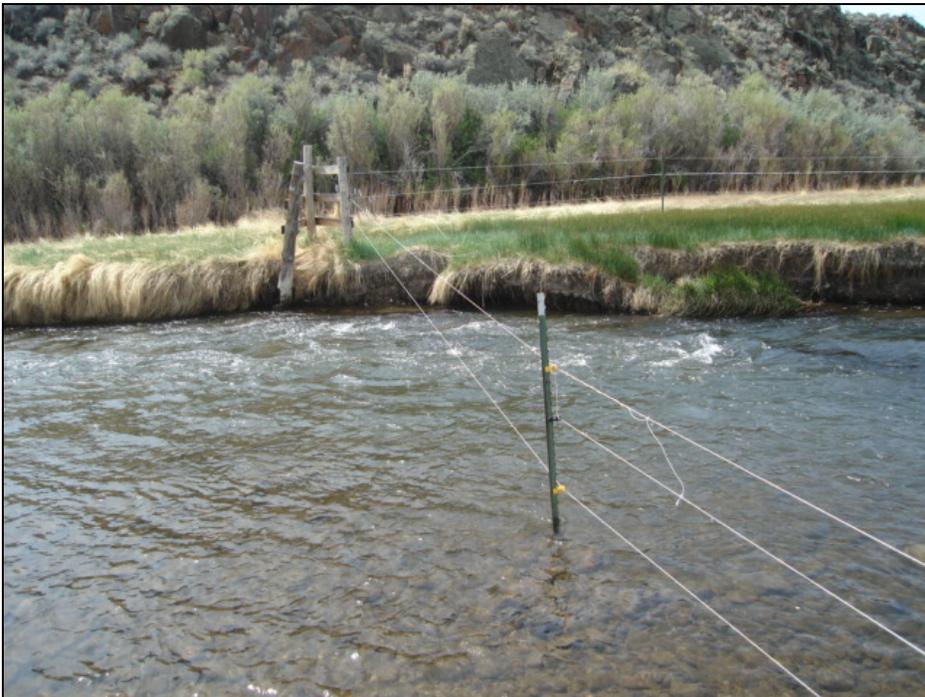
Site 34: East Walker River, Bridgeport Ranger District. Two electric fences cross the river enclosing an area of approx. 25m x 80m. Fences are presumably to keep cattle off a muddy area. This site is located at UTM: N: 4256550 & E: 317731, Elev. 1743m.

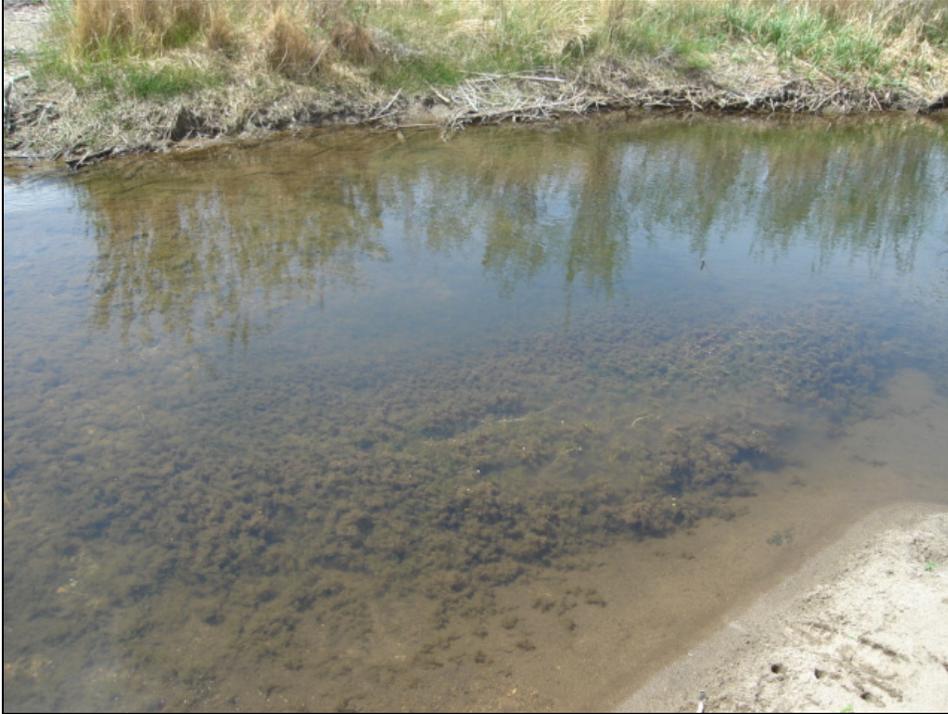
Site 35: East Walker River, Bridgeport Ranger District. As the river braids and flows around an island on river left a large school of juvenile fish can be seen in the vegetation under the water. This site is located at UTM: N: 4256595 & E: 317247, Elev. 1746m.

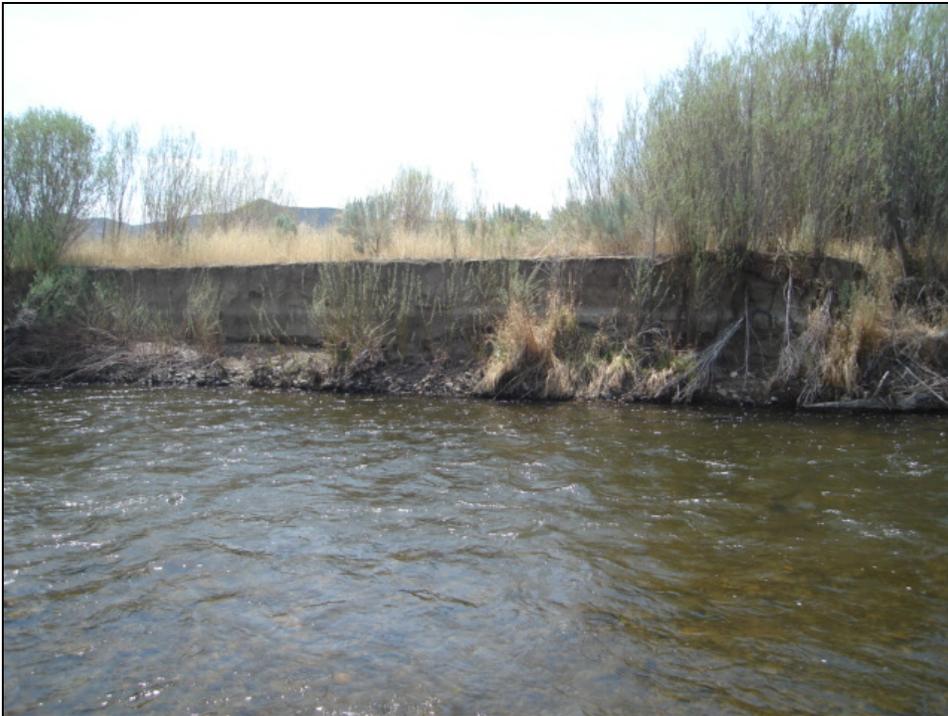
Site 36: East Walker River, Bridgeport Ranger District. Massive erosion is seen along the river bank at a height of 2m and a length of 100m. This site is located at UTM: N: 4256506 & E: 316767, Elev.1747m.

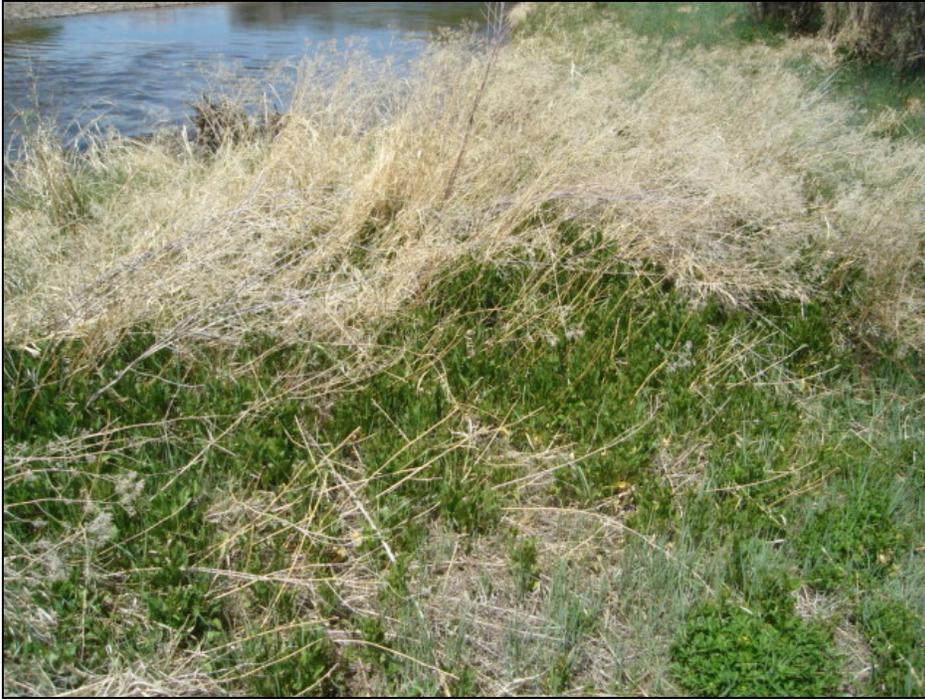
Site 37: East Walker River, Bridgeport Ranger District. Another area is found to be inhabited by the noxious weed hoary cress. This site is located at UTM: N: 4256613 & E: 316698, Elev. 1749m.

5. Eliminate noxious weeds (cheat grass and whitetop) where herbicides can be safely applied.
6. Consider stocking LCT into the East Walker River as a put-and-take recreational fishery.

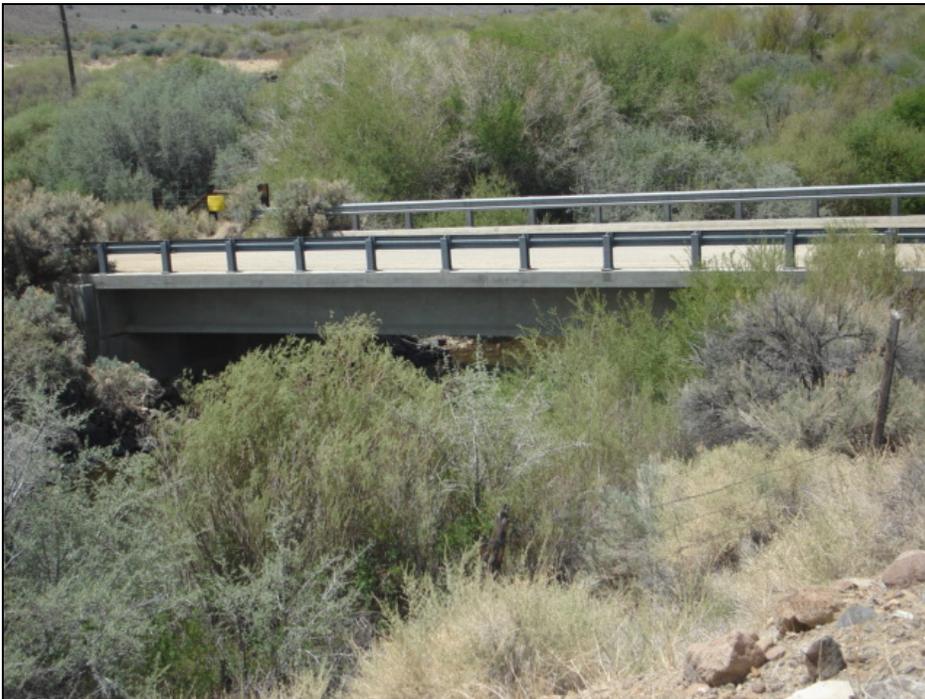
Site 38: East Walker River, Bridgeport Ranger District. Sweetwater Road crosses over the river via a bridge that is wide enough for two vehicles. Some riprap can be found along the bank to keep the bridge from being washed away. This site is located at UTM: N: 4256613 & E: 316235, Elev. 1755m.

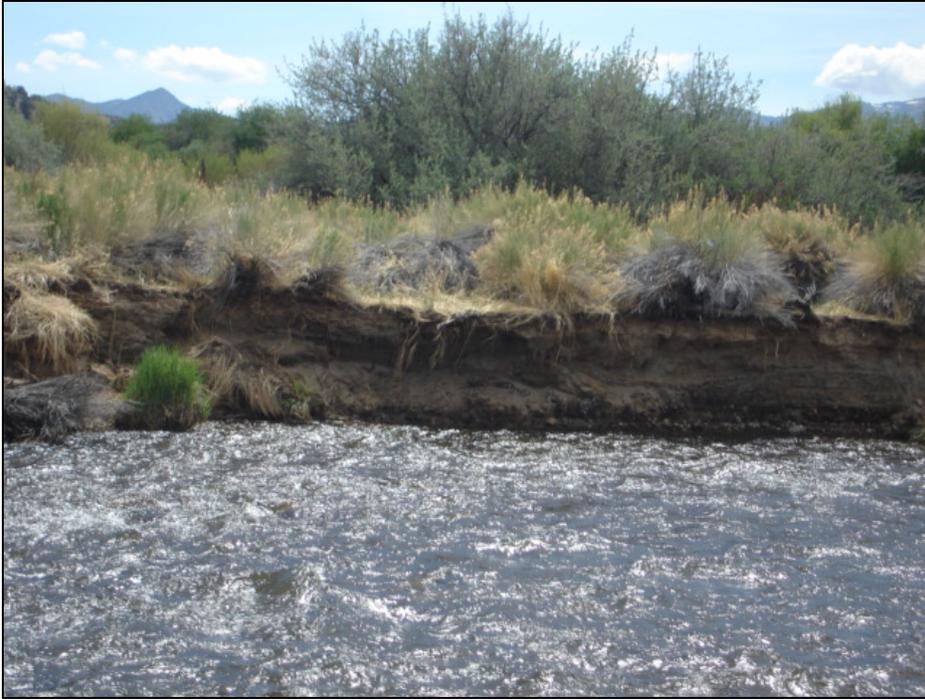
Site 39: East Walker River, Bridgeport Ranger District. The effects of erosion can be seen on the river right stream bank at a length of 30m and a height of 1.5m. This site is located at UTM: N: 4255834 & E: 314363, Elev. 1765m.

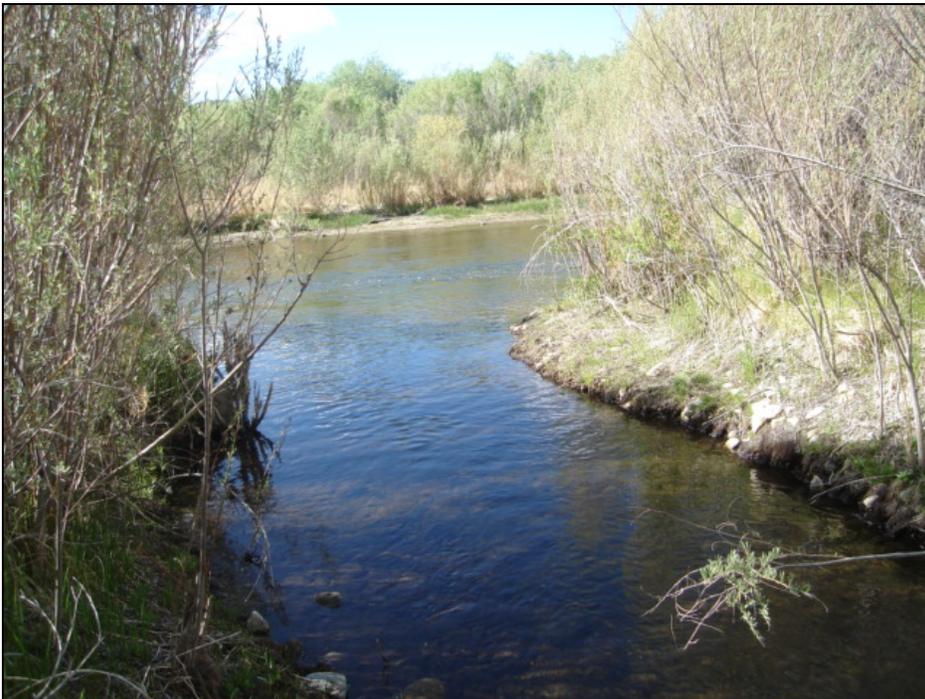
Site 40: East Walker River, Bridgeport Ranger District. Sweetwater Creek enters river left contributing 10% to the overall flow of the river. Sweetwater Creek is fairly large and may provide potential habitat for LCT. This site is located at UTM: N: 4256070 & E: 314175, Elev. 1770m.

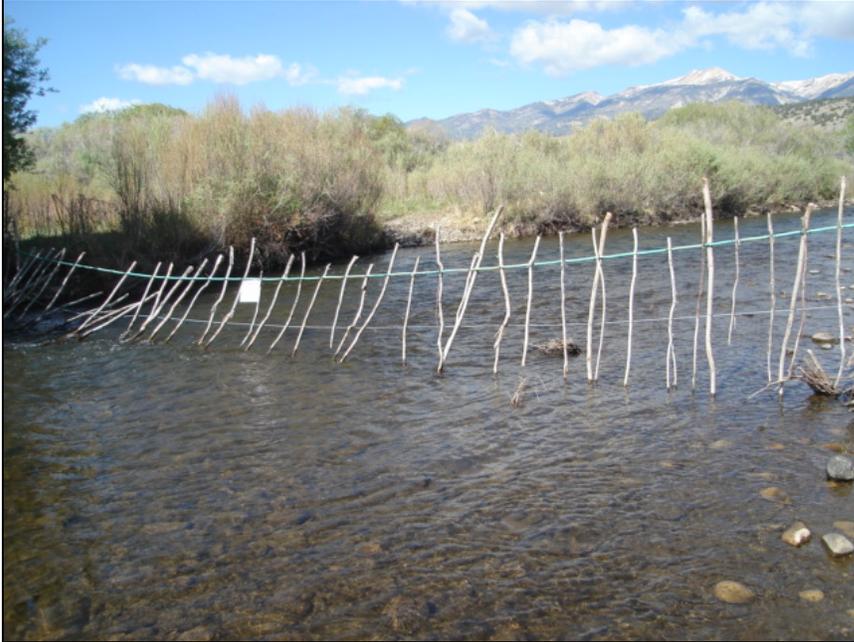
Site 41: East Walker River, Bridgeport Ranger District. Looking at a wired fence that stretches across the river as it hits private property. A sign reads “NO TRESSPASSING, HUNTING OR FISHING. VIOLATORS WILL BE PROSECUTED UNDER PENALTY OF LAW.” This forces us not to survey a section of river that appears to have many diversions. This site is located at UTM: N: 4256071 & E: 313924, Elev. 1770m.

3. Talk with private land owners located along the river about the presence of barbed wire fencing that spans the river at several locations. Determine if these are appropriate and whether they are inhibiting recreational use of the river.

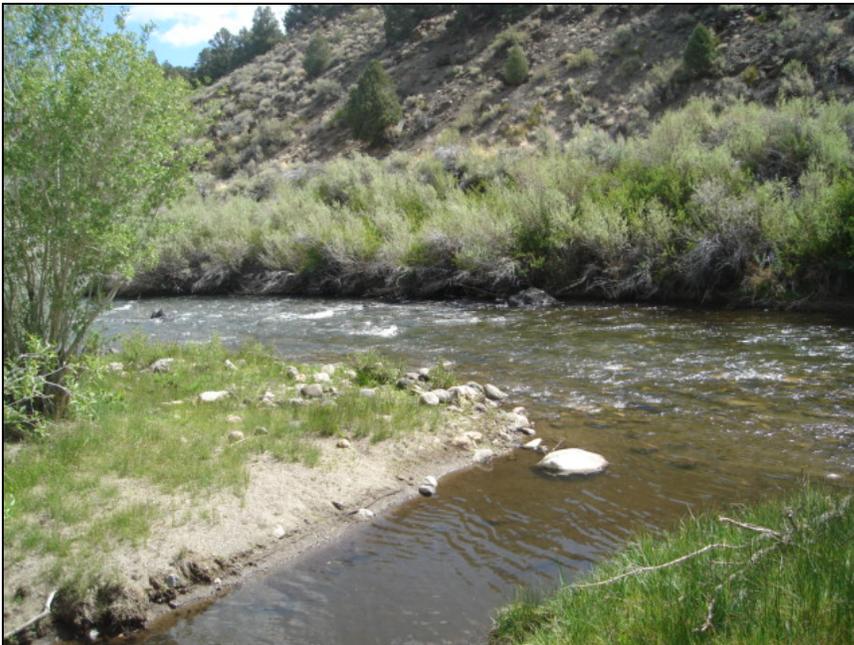
Site 42: East Walker River, Bridgeport Ranger District. Fryingpan Creek enters river left and adds less than 5% to the overall river flow. Fryingpan Creek is small and shallow but is still large enough to provide potential LCT habitat. This site is located at UTM: N: 4253175 & E: 310661, Elev. 1823m.

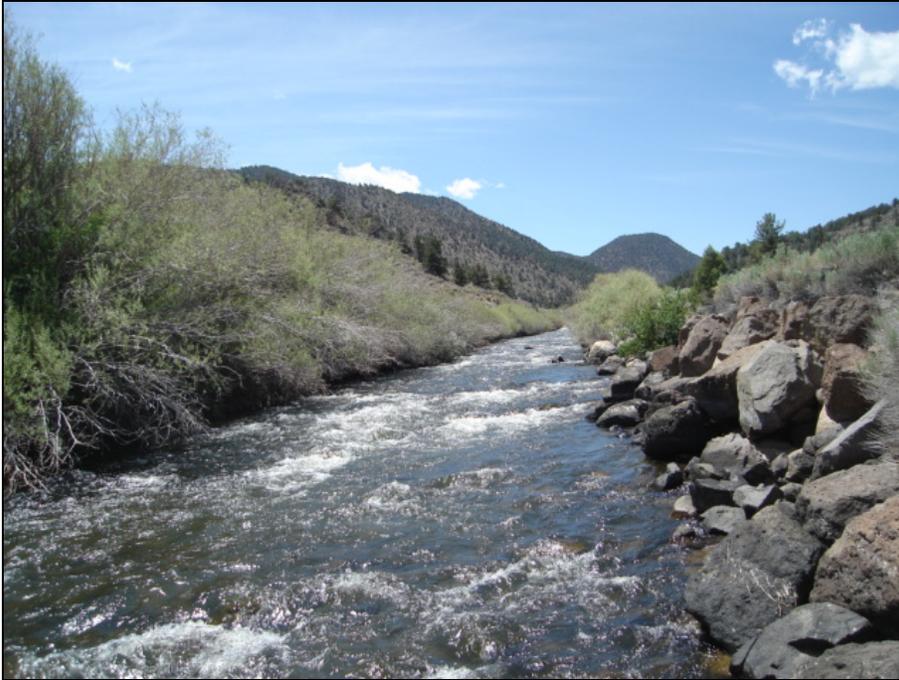
Site 43: East Walker River, Bridgeport Ranger District. Photo point shows a fast flowing river. Banks of river are heavily vegetated making surveying difficult. This site is located at UTM: N: 4251729 & E: 309953, Elev. 1849m.

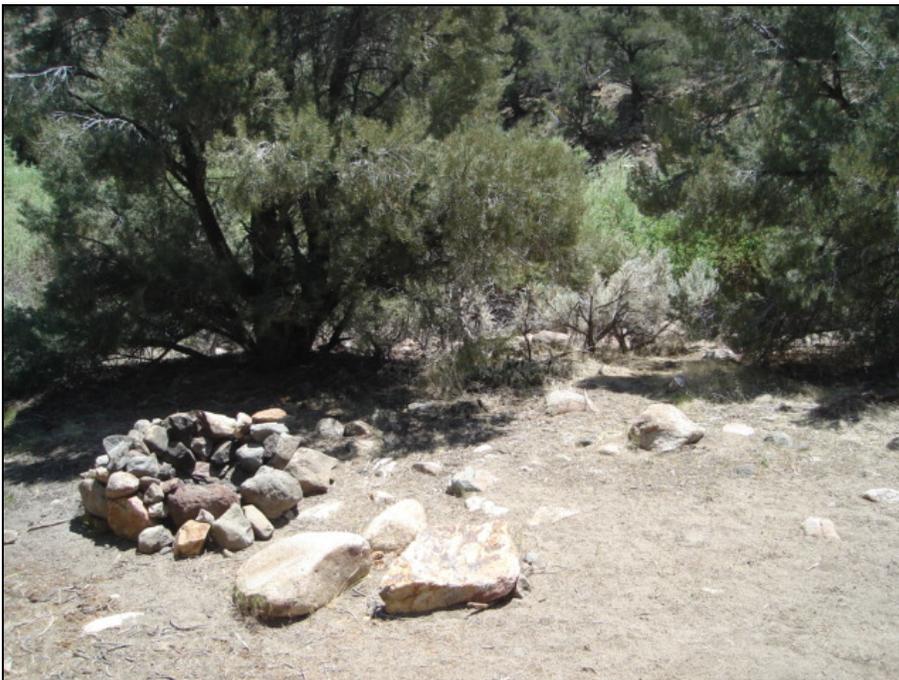
Site 44: East Walker River, Bridgeport Ranger District. One large fire ring is located 15m from water on river left. There is a road off Hwy182 that leads towards river but there is no direct access to the campsite. The only tracks seen are that of bikes. This site is located at UTM: N: 4250572 & E: 309410, Elev. 1872m.

2. Make information regarding Leave No Trace ethics more visible to the public. Decommission infrequently used campsites and encourage users to camp at least 100 feet from the river.

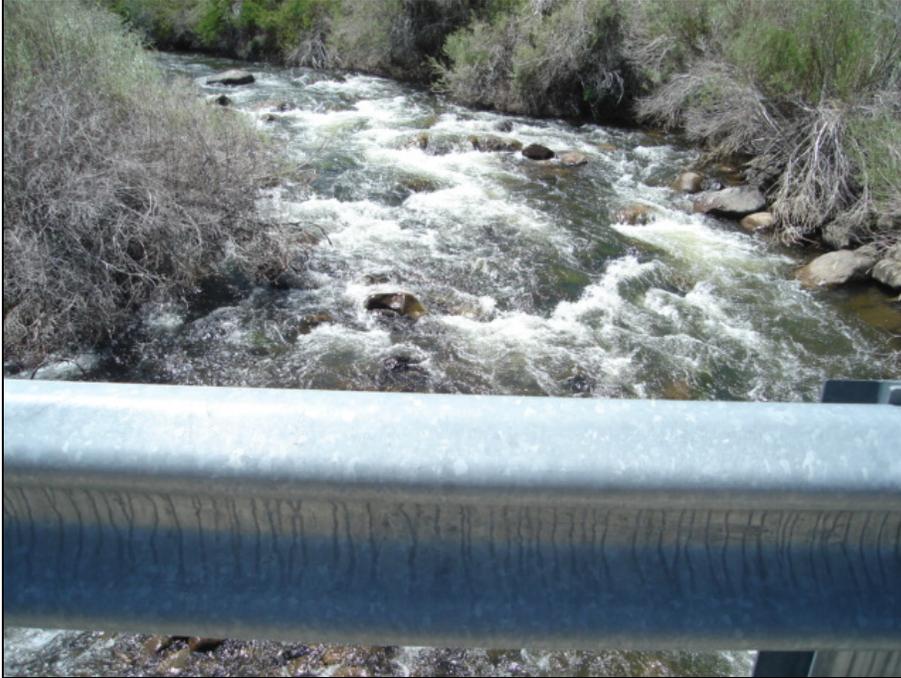
Site 45: East Walker River, Bridgeport Ranger District. A dirt road off Hwy182 crosses over the river via a bridge and proceeds upstream along river right. Bridge is wide enough for one vehicle. This site is located at UTM: N: 4250421 & E: 309166, Elev. 1880m.

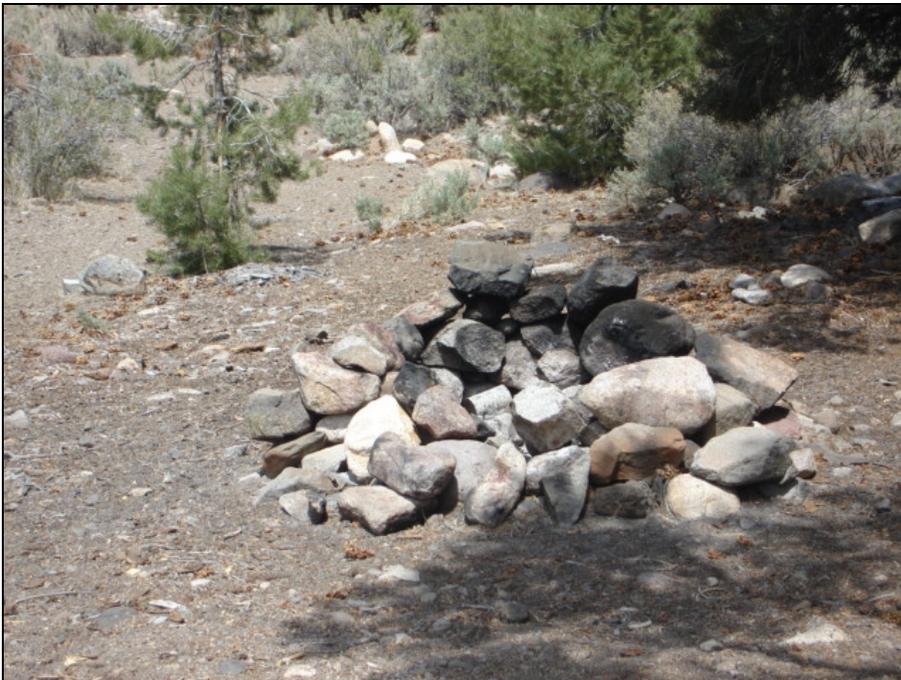
Site 46: East Walker River, Bridgeport Ranger District. One fire ring 25m from river right is accessible by a dirt road. Campsite also has a cleared trail to the river. This site is located at UTM: N: 4249861 & E: 309034, Elev. 1889m.

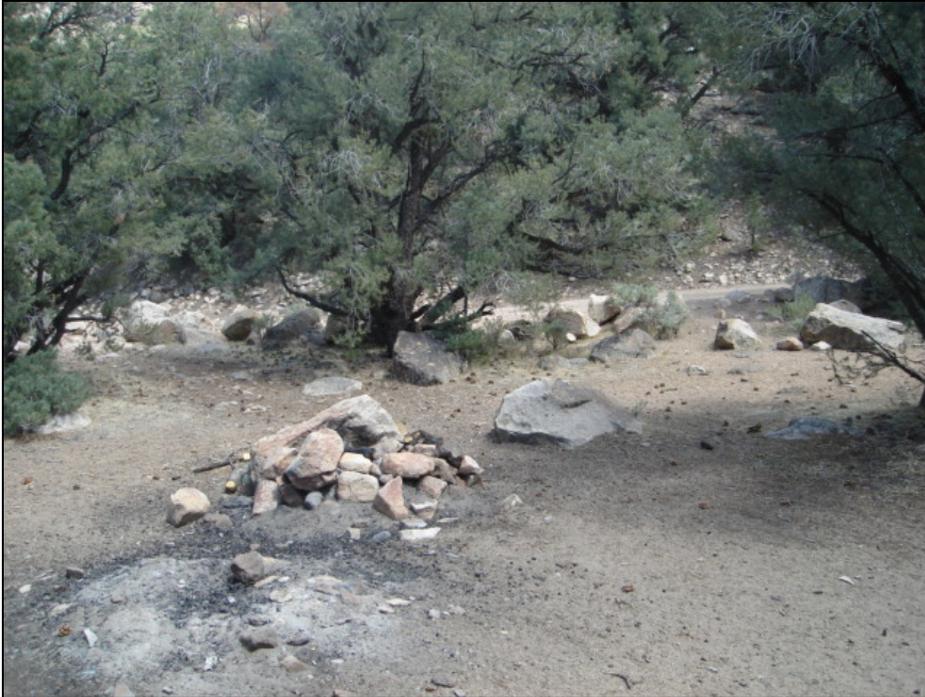
Site 47: East Walker River, Bridgeport Ranger District. This campsite located 20m from water's edge on river right has road access along with a steep grade leading to the river. This site is located at UTM: N: 4249175 & E: 308452, Elev. 1910m.

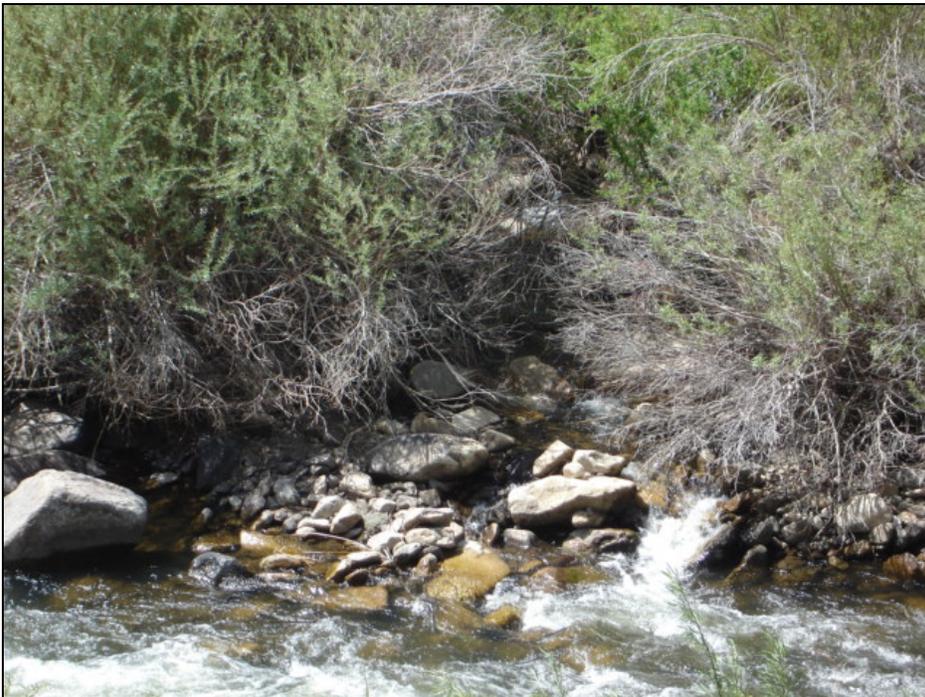
Site 48: East Walker River, Bridgeport Ranger District. Murphy Creek enters river left from under Hwy 182. This tributary cascades down some rocks before it adds less than 5% to overall flow of the river. This site is located at UTM: N: 4249032 & E: 308327, Elev. 1917m.

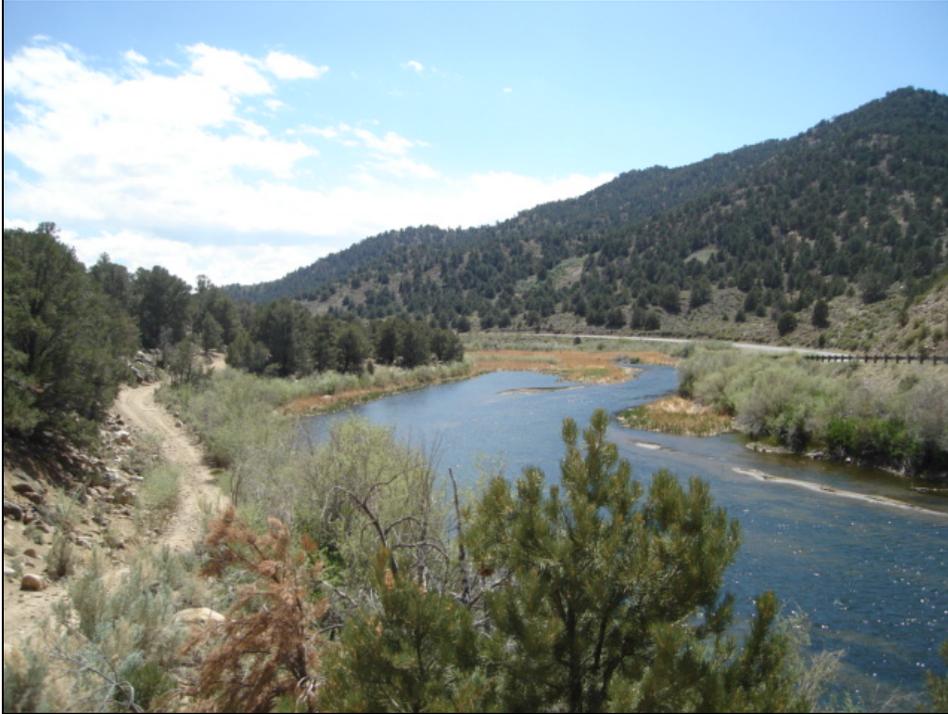
Site 49: East Walker River, Bridgeport Ranger District. Murphy's pond is created on river right as river coves outward. This site is located at UTM: N: 4248952 & E: 308290, Elev. 1923m.

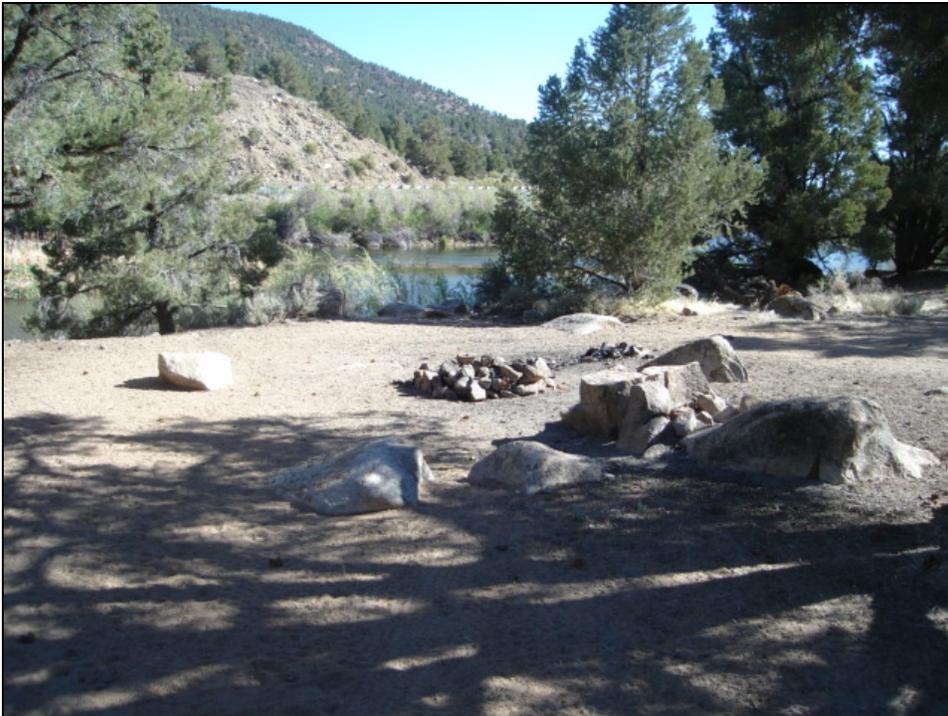
Site 50: East Walker River, Bridgeport Ranger District. Two small campsites are located on river right. This area also has a small area for parking. This site is located at UTM: N: 4248822 & E: 308195, Elev.1923m.

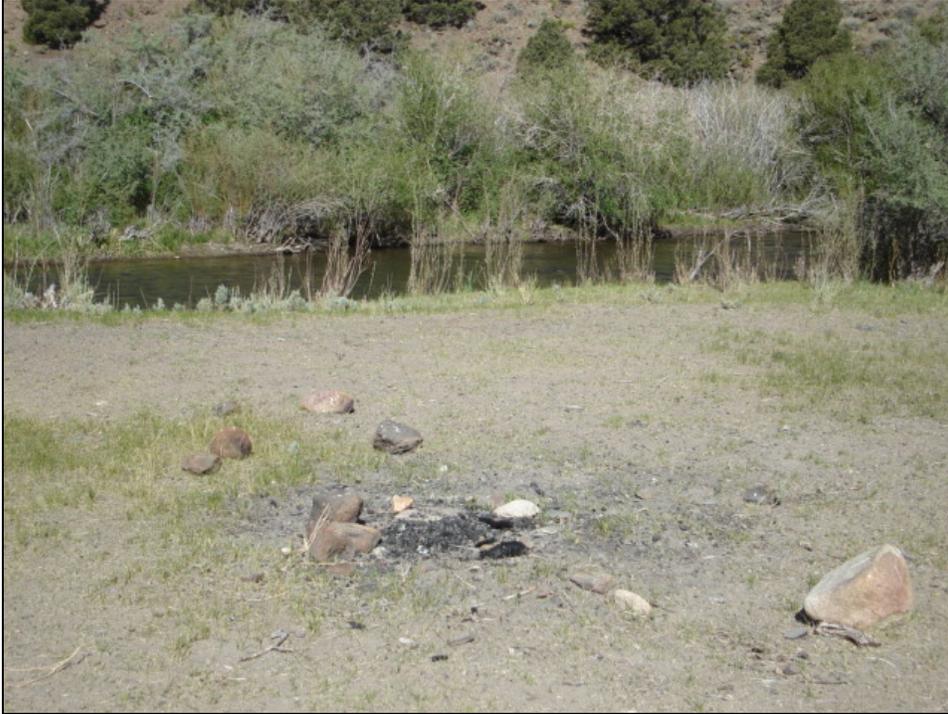
Site 51: East Walker River, Bridgeport Ranger District. A large open area contains an old dismantled fire ring and appears to be used for parking only. This site is located at UTM: N: 4247635 & E: 307638, Elev. 1923m.

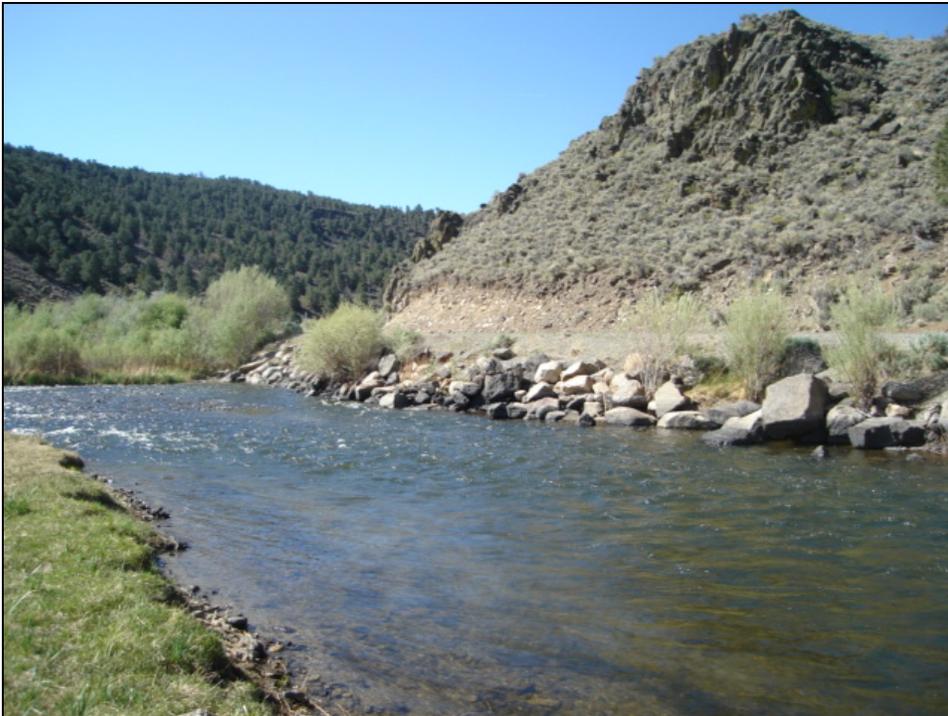
Site 52: East Walker River, Bridgeport Ranger District. As the river flows next to the road, its flow is redirected by riprap in order to keep the road from being washed away. This site is located at UTM: N: 4247385 & E: 307705, Elev. 1923m.

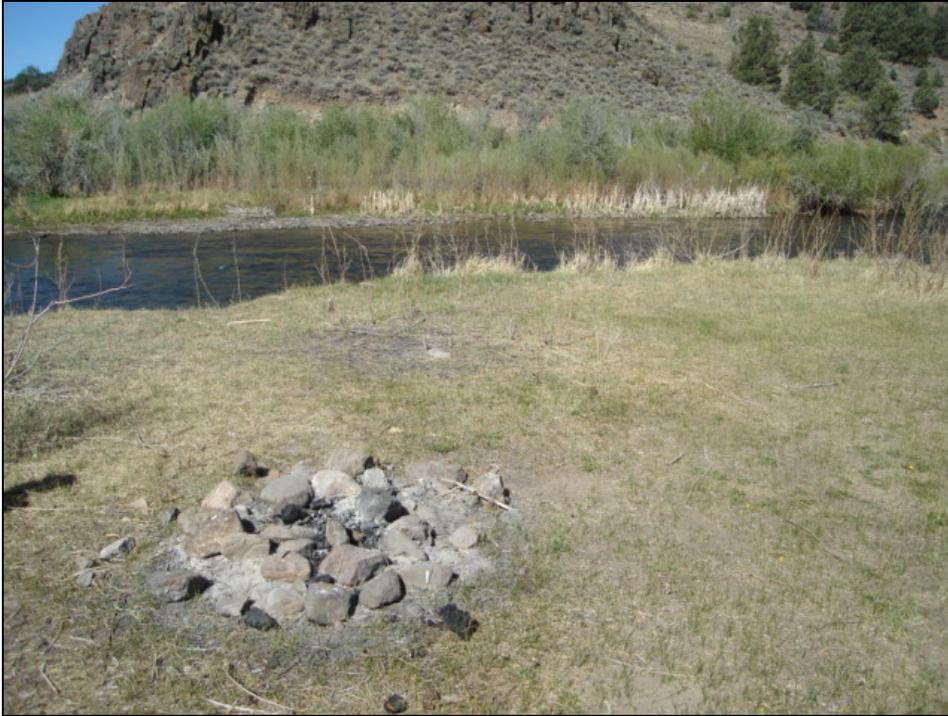
Site 53: East Walker River, Bridgeport Ranger District. A small campsite about 5m from the river has a fire ring and an area for tents and parking. This site is located at UTM: N: 4247337 & E: 307790, Elev. 1924m.

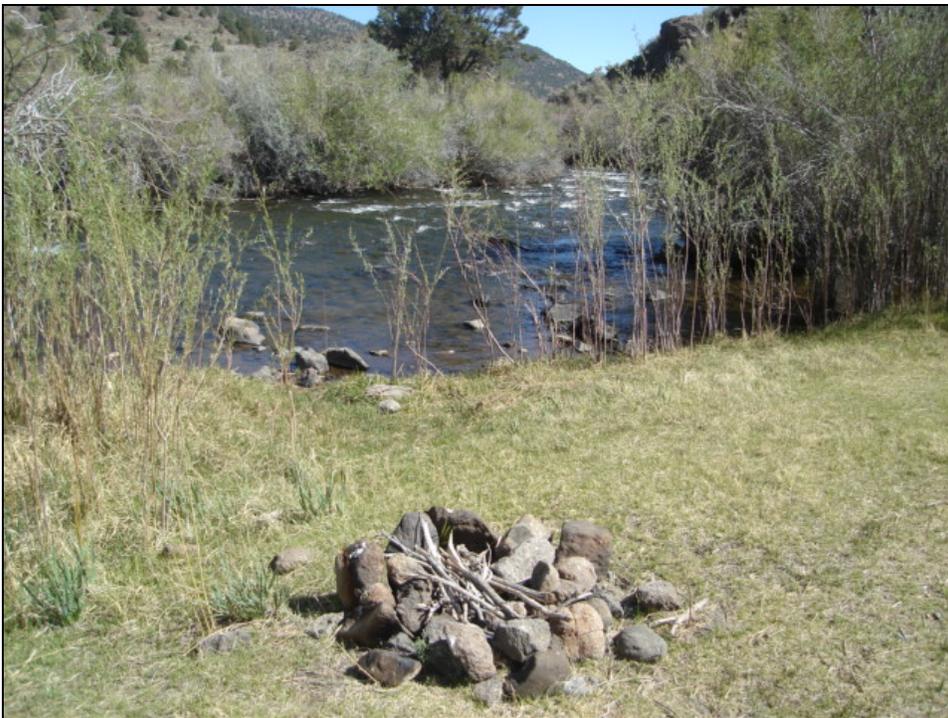
Site 54: East Walker River, Bridgeport Ranger District. A single fire ring marks this campsite that is right off the road and very close to the river (3m). This site is located at UTM: N: 4246885 & E: 307647, Elev. 1927m.

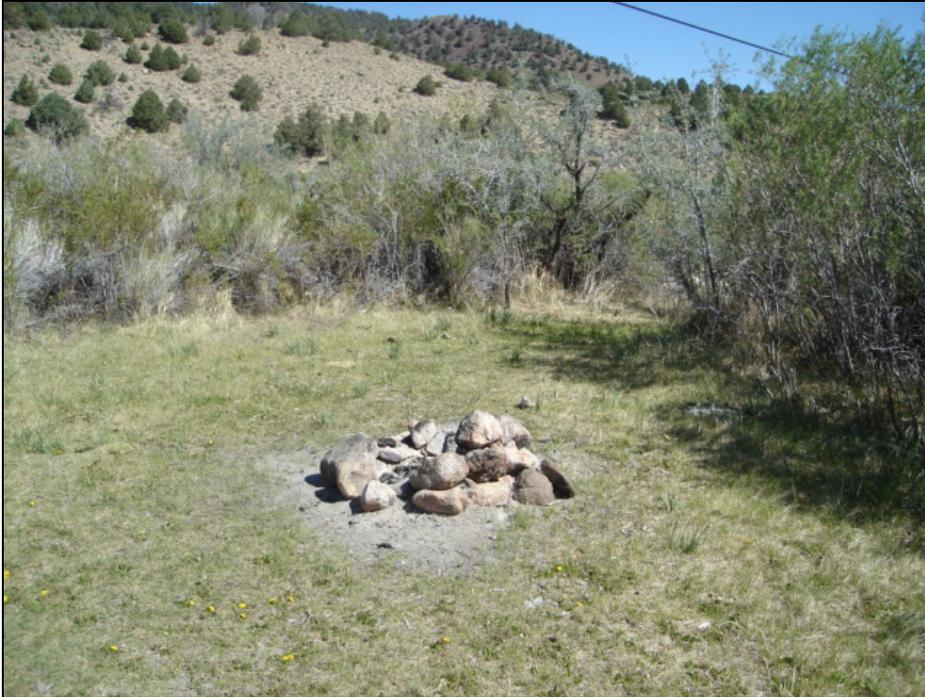
Site 55: East Walker River, Bridgeport Ranger District. Another campsite is located 15m from the edge of the river. No garbage is present and the site appears to receive little use. This site is located at UTM: N: 4246614 & E: 307215, Elev. 1932m.

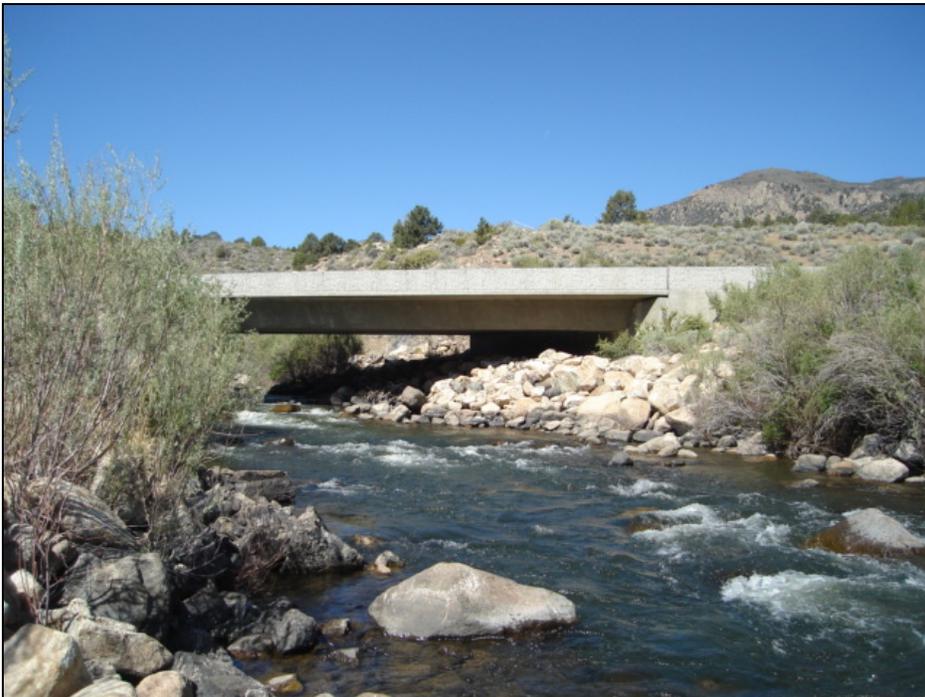
Site 56: East Walker River, Bridgeport Ranger District. A major bridge crosses the river to allow Hwy 182 to pass. The bridge incorporates a large section of riprap to control the flow of water beneath the bridge. This site is located at UTM: N: 4245907 & E: 307153, Elev. 1942m.

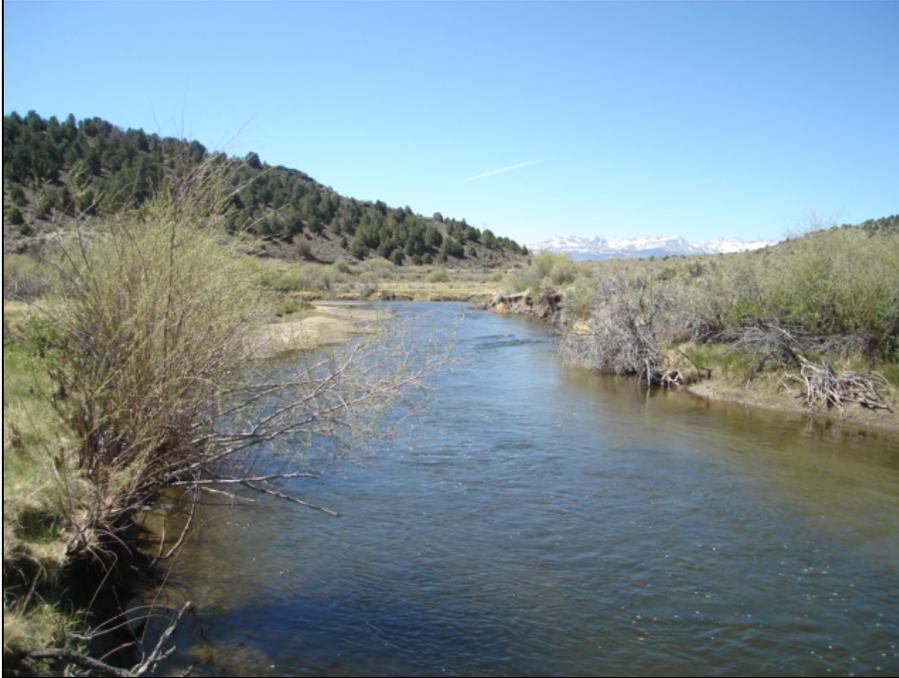
Site 57: East Walker River, Bridgeport Ranger District. This photo point depicts the river's flow at this section. Here the flow is slow as the river is deeper than other places along the river. This site is located at UTM: N: 4245077 & E: 306858, Elev. 1945m.

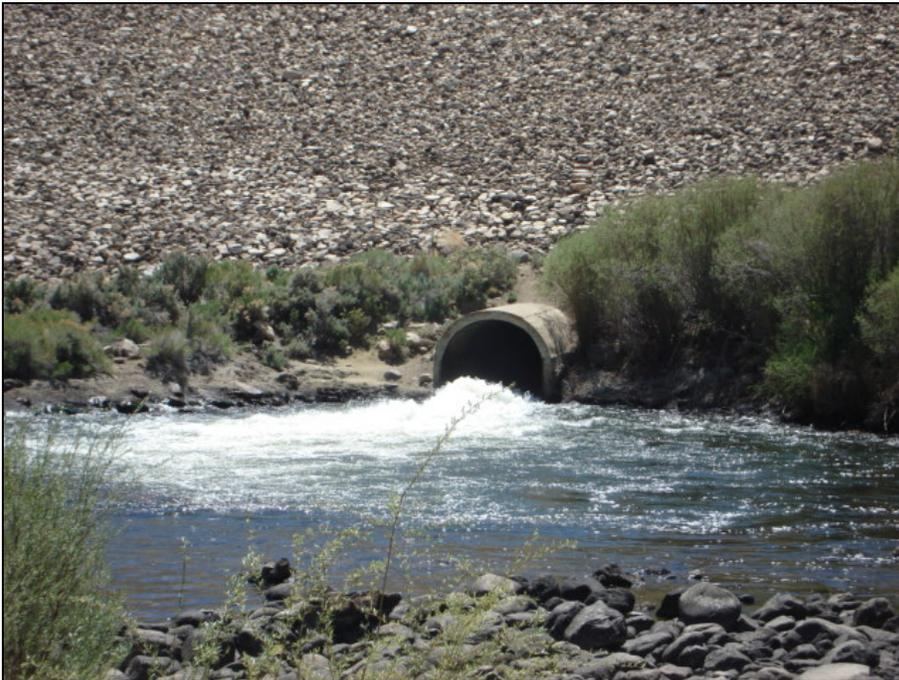
Site 58: East Walker River, Bridgeport Ranger District. This spillway is a permanent artificial fish barrier. The spillway comes from Bridgeport Reservoir and this is where the East Walker River originates. Several tributaries drain into Bridgeport Reservoir upstream of this site. This site is located at UTM: N: 4244222 & E: 306632, Elev. 1947m.

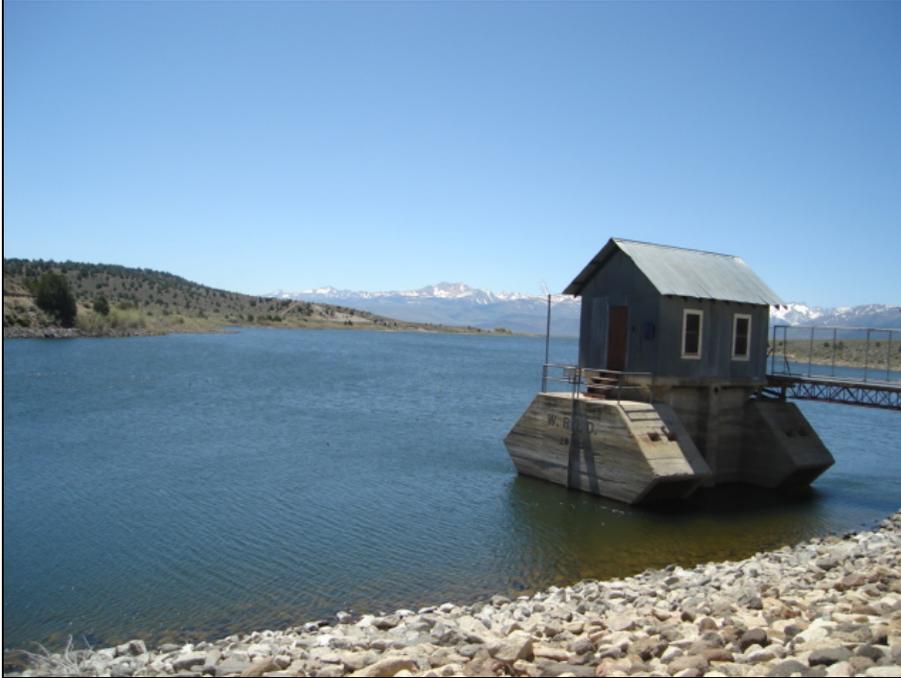
Site 59: East Walker River, Bridgeport Ranger District. Survey ends at Bridgeport Reservoir which is where the river begins. This site is located at UTM: N: 4244125 & E: 306706, Elev. 1967m.
