FRYINGPAN CREEK

Mono County, California

2006 Stream Habitat Survey Report

Humboldt-Toiyabe National Forest, Bridgeport Ranger District

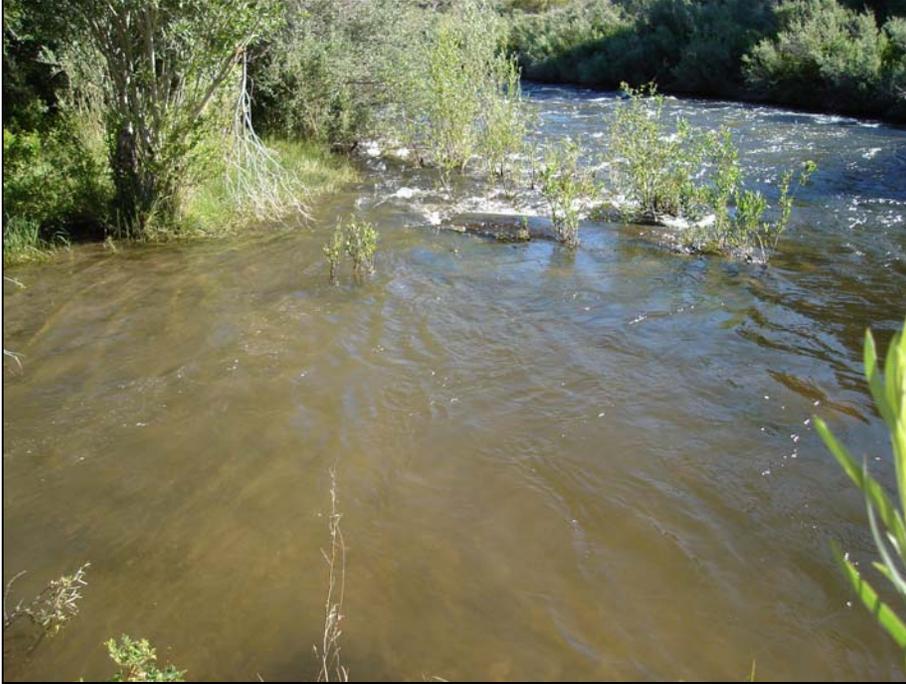
Site 1: Fryingpan Creek, Bridgeport Ranger District, looking downstream at the survey start point; the confluence of Fryingpan Creek with the East Walker River. Where Fryingpan Creek enters the East Walker River the creek is approximately 15ft. wide and 2ft. deep. This site is located at UTM: N: 4253179 & E: 310658, Elevation 1829m.

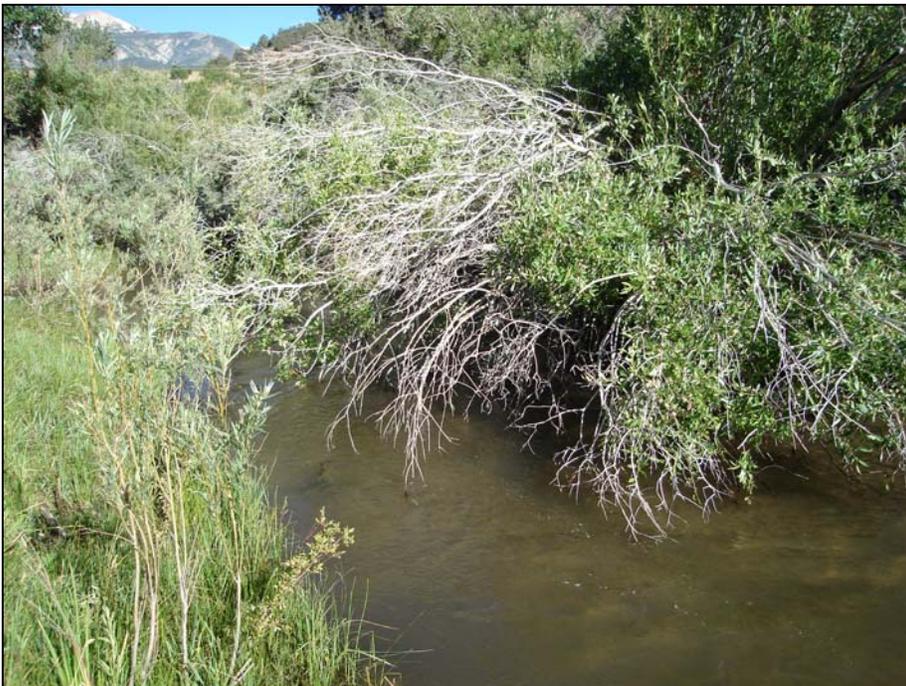
Site 1 continued: Fryingpan Creek, Bridgeport Ranger District, looking upstream from the survey start point. This site is located at UTM: N: 4253179 & E: 310658, Elevation 1829m.

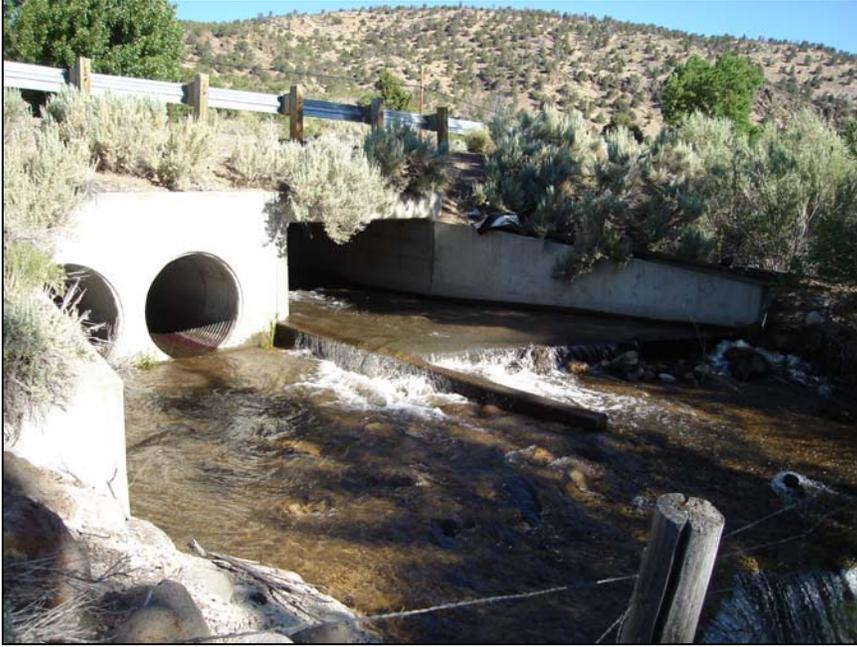
At Site 2 a 4.3 foot artificial seasonal fish barrier prevents upstream movement of fish from the East Walker River into Fryingpan Creek. This 4.3 foot feature may also very likely be a permanent fish barrier. The barrier at Site 2 may allow for a restoration project of LCT upstream of Site 2. Although those LCT would be physically and genetically isolated, they would also be protected from the non-native fish downstream in the East Walker River. If LCT were restored to Fryingpan Creek upstream of Site 2 at anytime in the future those LCT could be reconnected with the rest of the East Walker River watershed by altering the artificial structure at Site 2 to allow fish passage.

Site 2: Fryingpan Creek, Bridgeport Ranger District, looking upstream at a road-stream crossing. Water flows over bare concrete before falling approximately 1.3m (4.3ft) into the stream bed. The single fall makes it extremely difficult for fish to swim upstream. This site is classified as an artificial permanent fish barrier. Upstream of the culvert there is also a steep section of concrete. This site is located at UTM: N: 4253164 & E: 310617 Elevation 1831m.

1. Consider Fryingpan Creek to provide 3.6 miles of potential LCT habitat between Sites 1 and 12 and consider Fryingpan Creek a low candidate for restoration.
2. Further evaluate the artificial fish barrier at Site 2 to determine if it's a seasonal or permanent fish barrier. Also evaluate how reasonable/difficult would it be to restore fish passage at that Site.
3. Investigate the destination and impacts of the diversion at Site 4. Ensure that fish are not subject to terminal trips into irrigated pasture, and similarly ensure that water users are staying within the confines of their adjudicated rights.

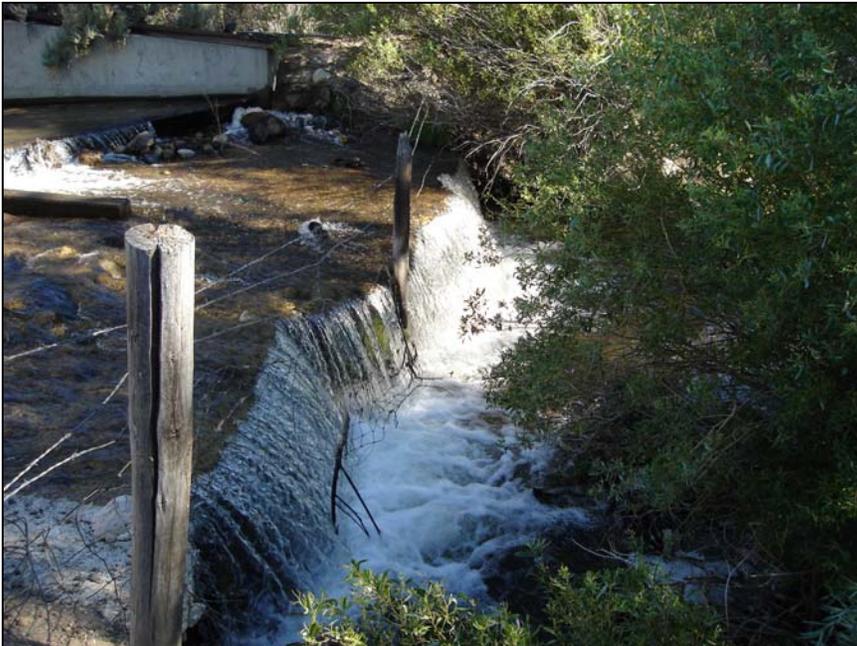
Site 2 continued: Fryingpan Creek, Bridgeport Ranger District, cross section view of water flowing over bare concrete before falling approximately 1.3m (4.3ft) into the stream bed. This site is located at UTM: N: 4253164 & E: 310617 Elevation 1831m.

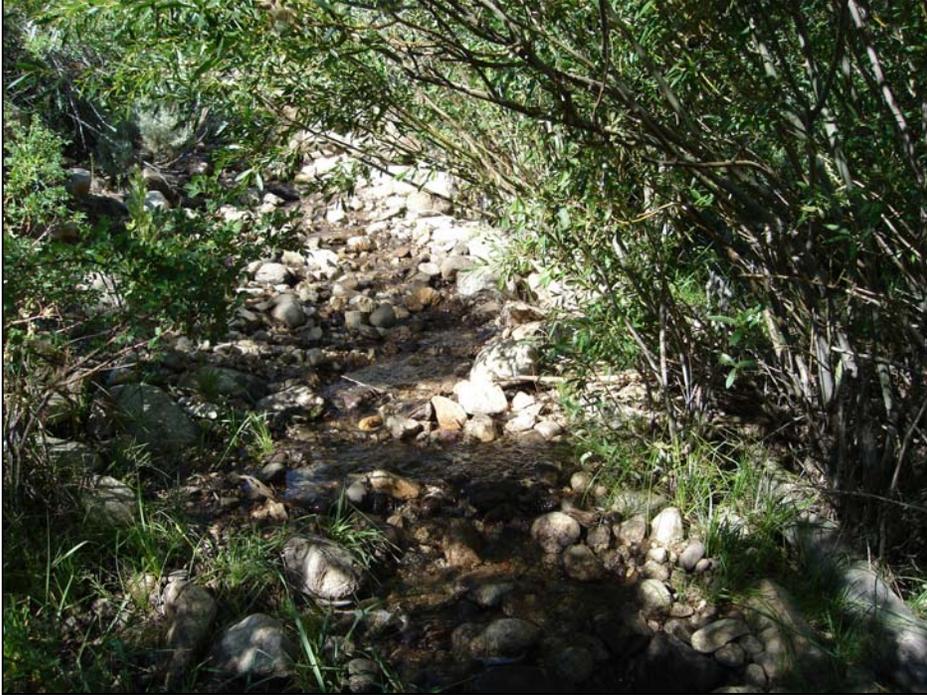
Site 3: Fryingpan Creek, Bridgeport Ranger District, looking at a small tributary that enters the stream, river right. This tributary may be an irrigation channel that re-enters the creek at this site. This site is located at UTM: N: 4253141 & E: 310394, Elevation 1843m.

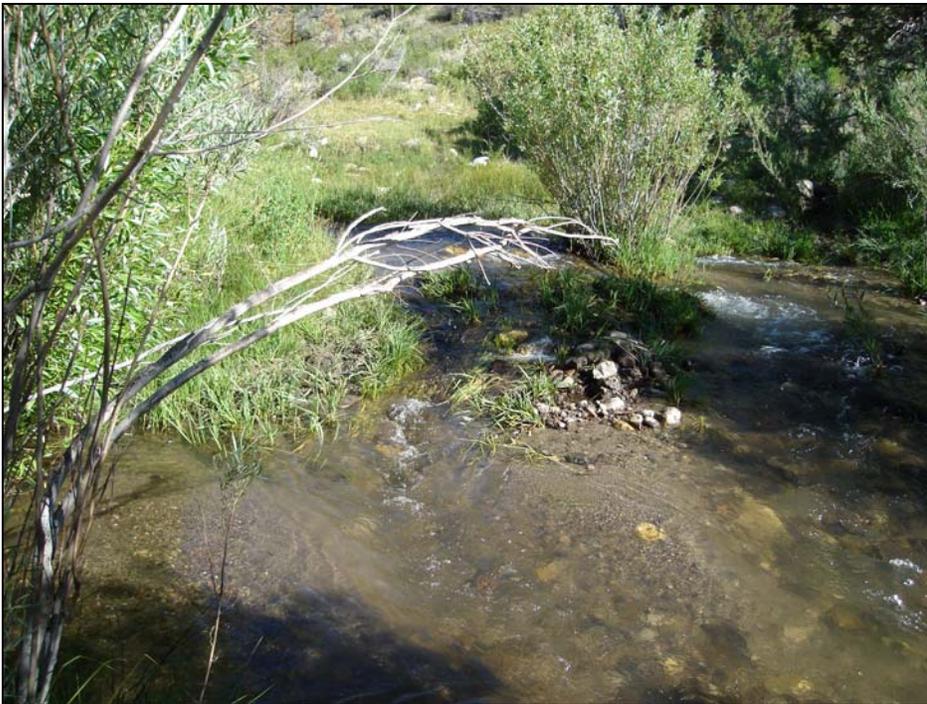
Site 3 continued: Fryingpan Creek, Bridgeport Ranger District, a cross-section view of a small tributary that enters on the river right side. This site is located at UTM: N: 4253141 & E: 310394, Elevation 1843m.

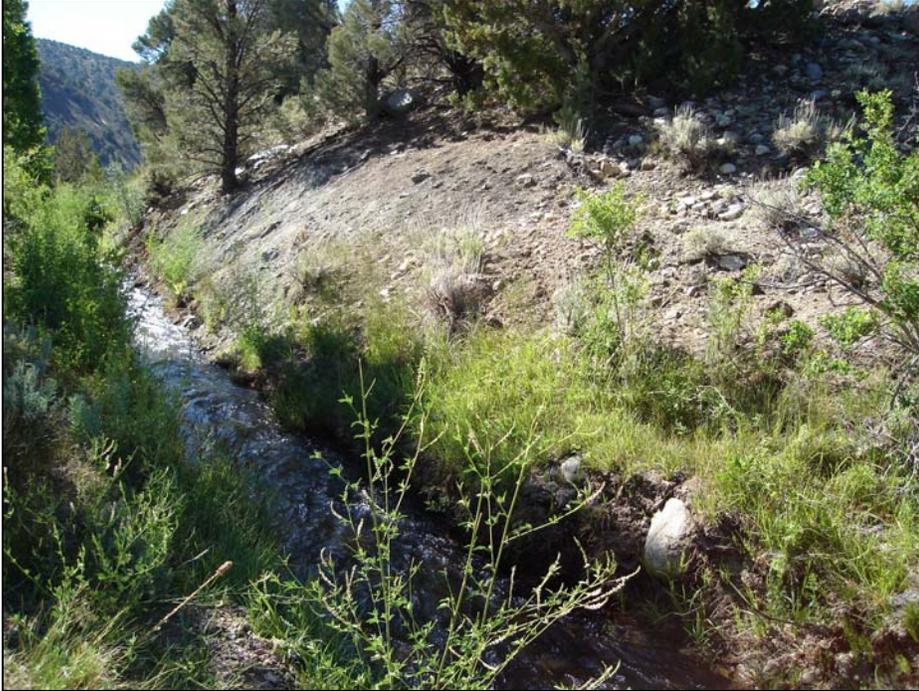
Site 4: Fryingpan Creek, Bridgeport Ranger District, looking upstream at an irrigation diversion that cuts the flow in half. The diversion is used to irrigate a cow grazing pasture. This site is located at UTM: N: 4253242 & E: 310132, Elevation 1862m.

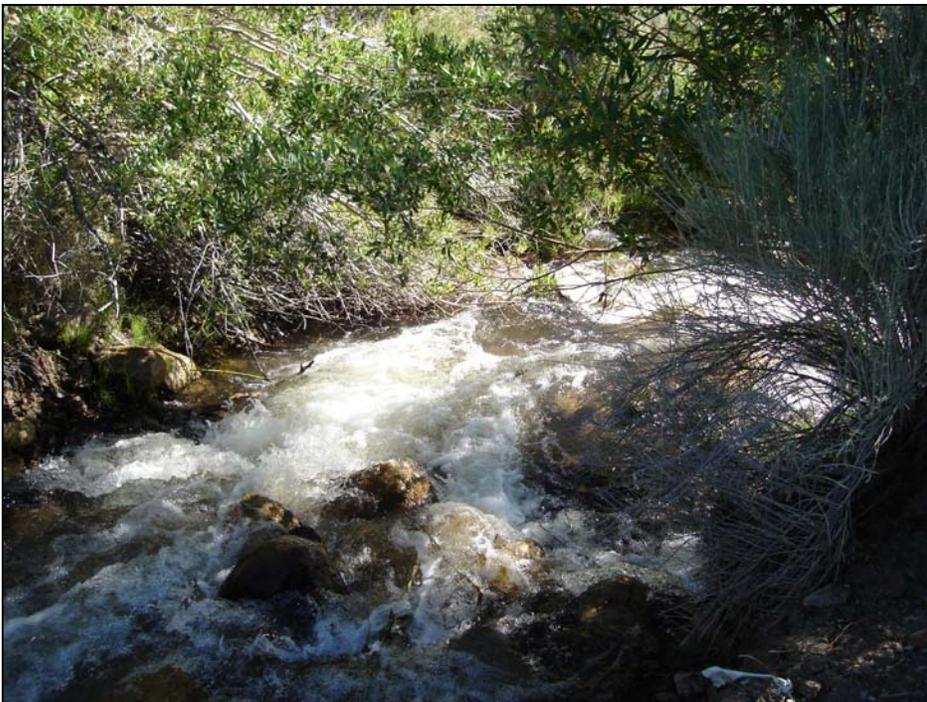
Site 4 continued: Fryingpan Creek, Bridgeport Ranger District, looking downstream at Fryingpan Creek from the diversion. This site is located at UTM: N: 4253242 & E: 310132, Elevation 1862m.

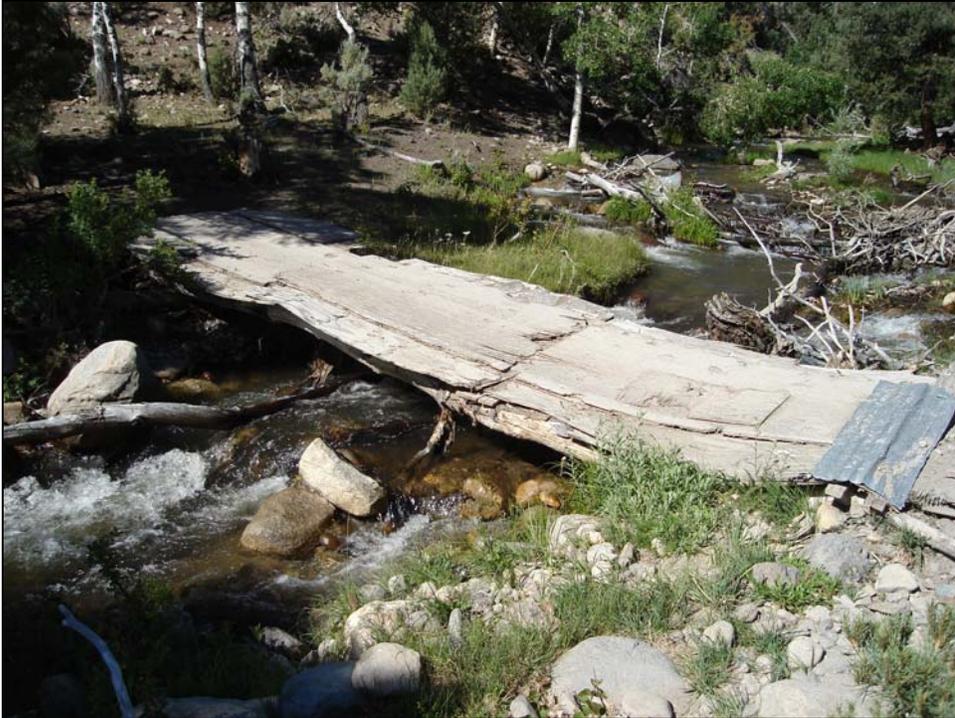
Site 5: Fryingpan Creek, Bridgeport Ranger District, looking upstream at a small ATV bridge crossing the stream. This site is located at UTM: N: 4253351 & E: 309804, Elevation 1881m.

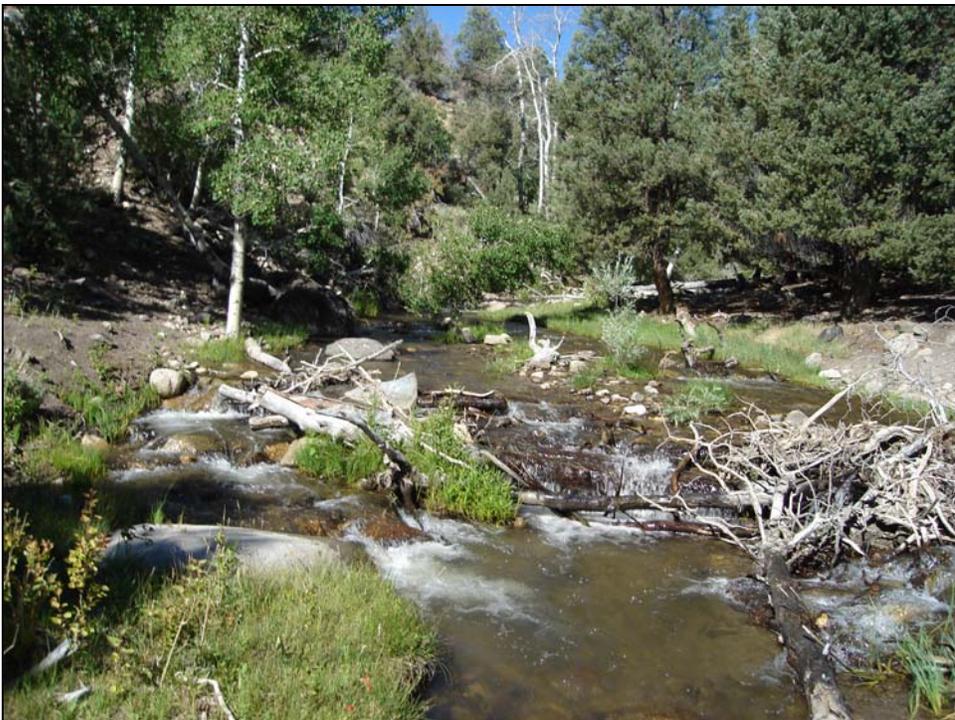
Site 5 continued: Fryingpan Creek, Bridgeport Ranger District, looking upstream from the ATV bridge. This site is located at UTM: N: 4253351 & E: 309804, Elevation 1881m.

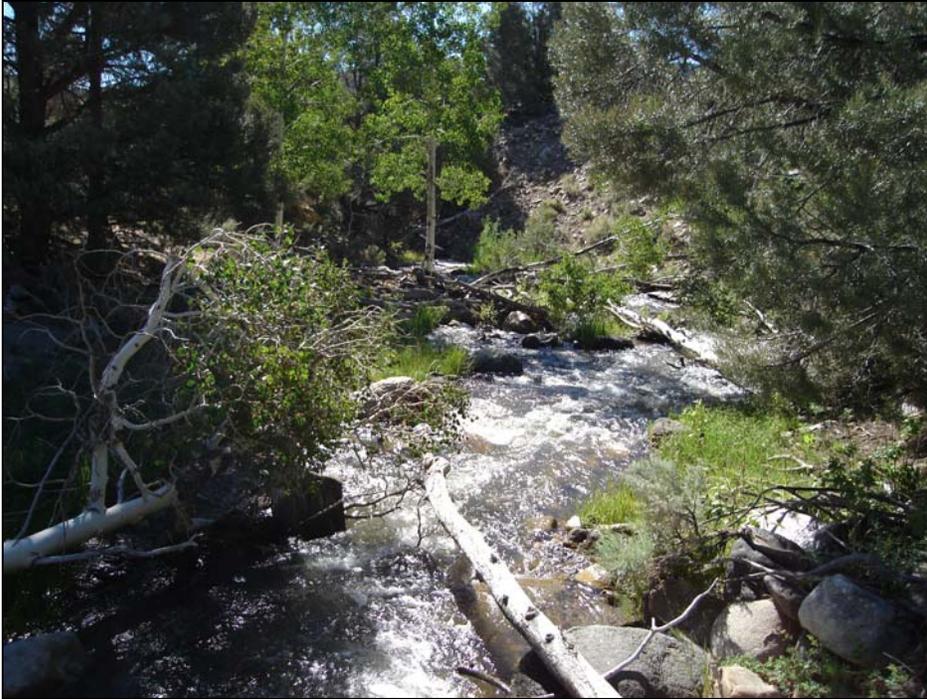
Site 5 continued: Fryingpan Creek, Bridgeport Ranger District, looking downstream from the ATV bridge. This site is located at UTM: N: 4253351 & E: 309804, Elevation 1881m.

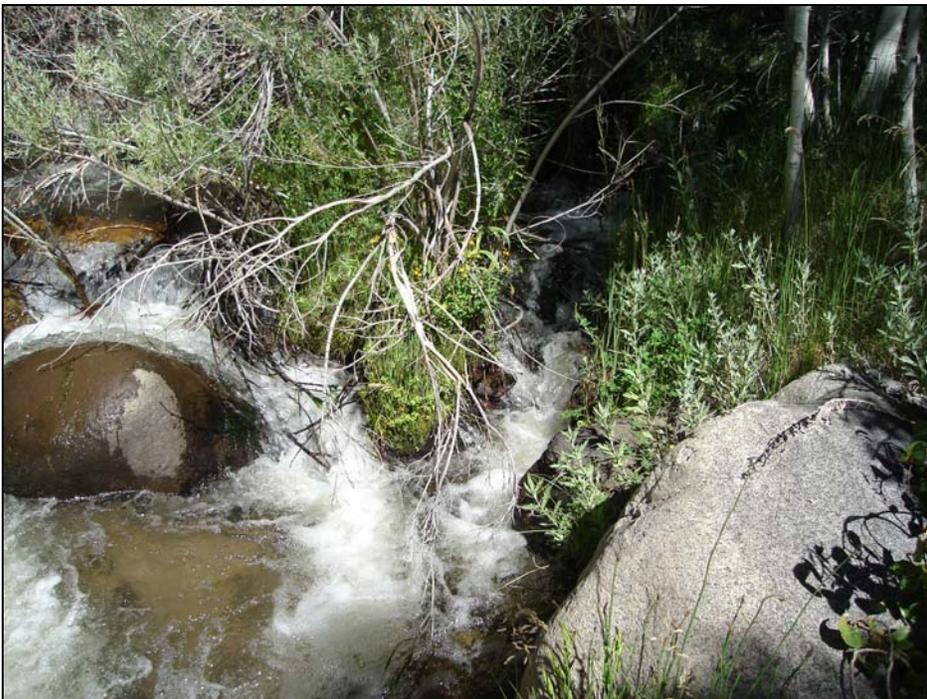
Site 6: Fryingpan Creek, Bridgeport Ranger District, a small tributary enters the main channel on the north side of the creek. This tributary contributes approximately 15% of the overall flow in Fryingpan Creek. This site is located at UTM: N: 4253372 & E: 309390, Elevation 1912m.

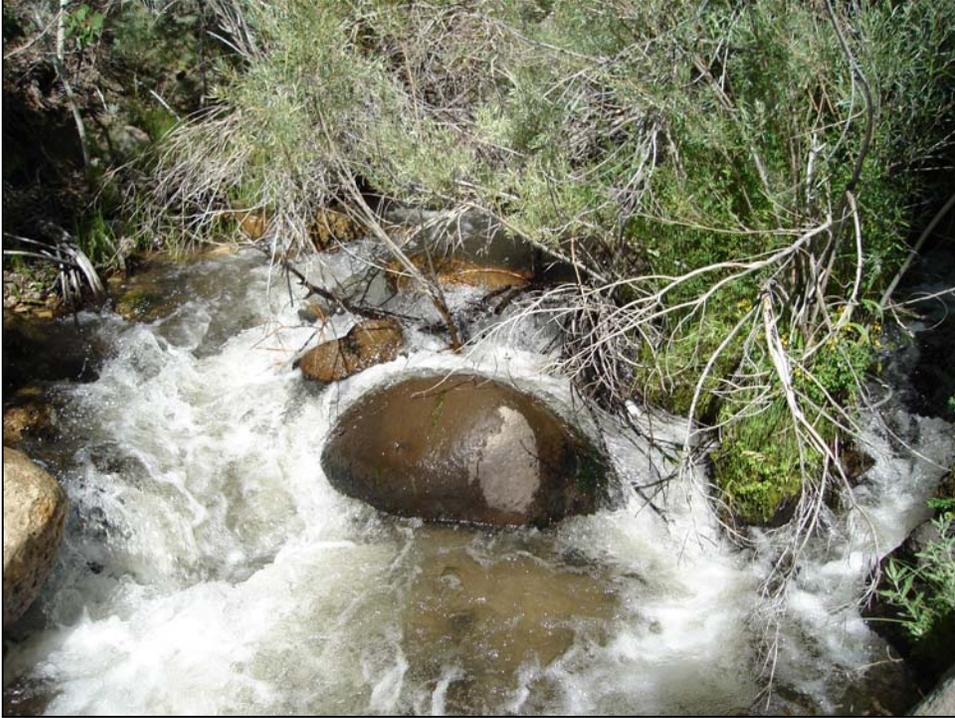
Site 6 continued: Fryingpan Creek, Bridgeport Ranger District, looking upstream at Fryingpan Creek from the tributary. This site is located at UTM: N: 4253372 & E: 309390, Elevation 1912m.

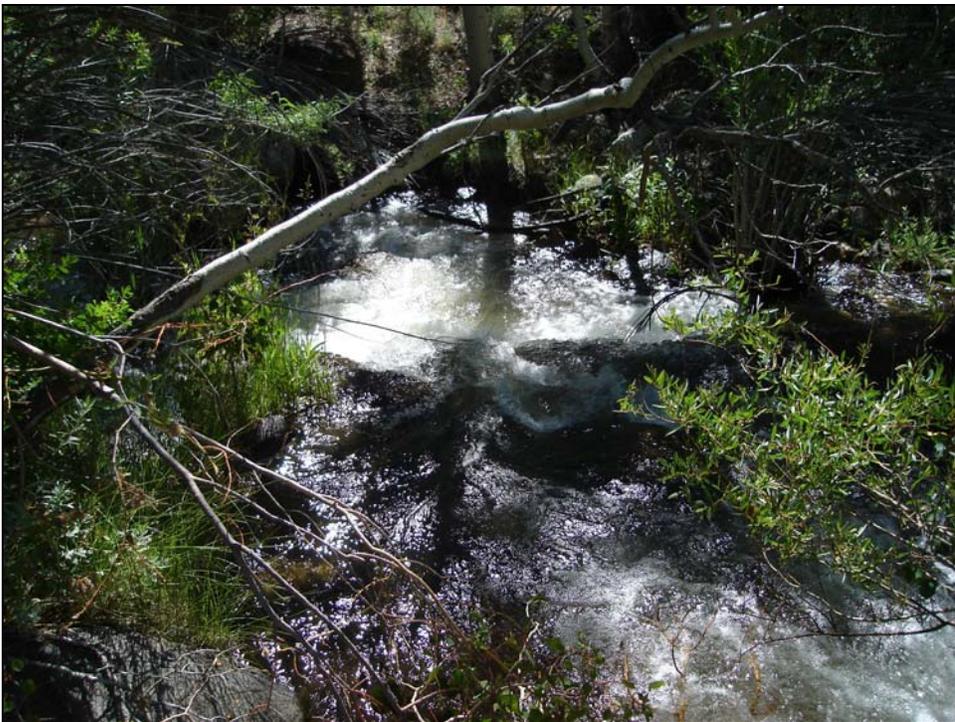
Site 6 continued: Fryingpan Creek, Bridgeport Ranger District, looking downstream at Fryingpan Creek from the tributary. This site is located at UTM: N: 4253372 & E: 309390, Elevation 1912m.

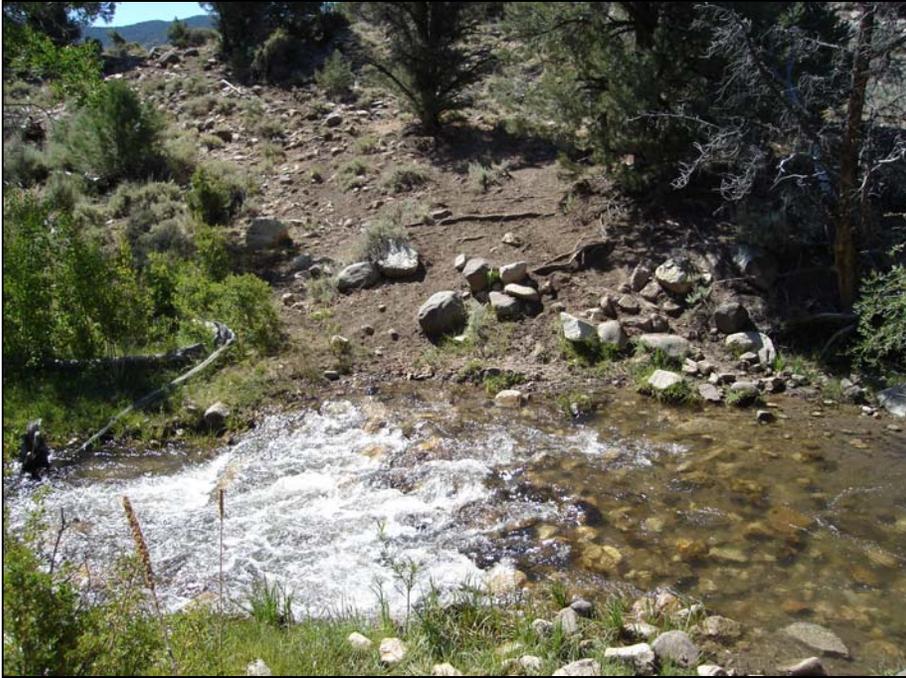
Site 7: Fryingpan Creek, Bridgeport Ranger District, cross-section view of a road crossing. This crossing has steep banks, and the heavy animal traffic has made a definite trail which during heavy rains would wash large amounts of sediment into the stream. This site is located at UTM: N: 4253351 & E: 309177, Elevation 1936m.

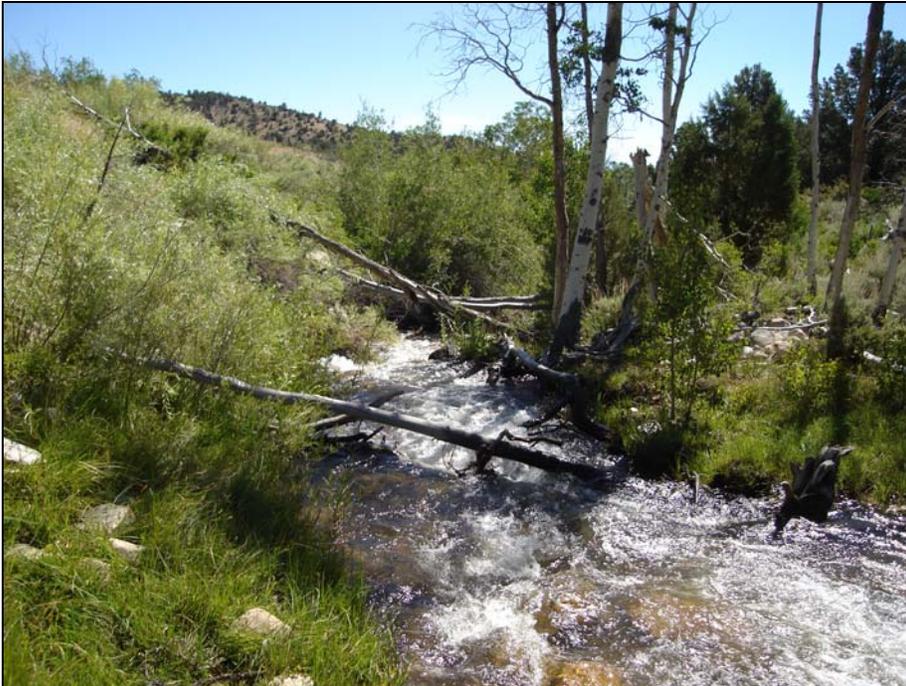
Site 7 continued: Fryingpan Creek, Bridgeport Ranger District, looking downstream from the road and cattle crossing. This site is located at UTM: N: 4253351 & E: 309177, Elevation 1936m.

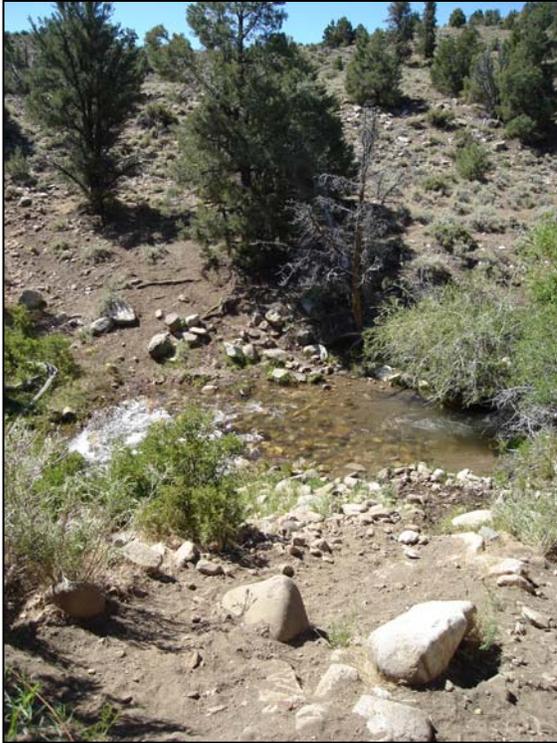
Site 8: Fryingpan Creek, Bridgeport Ranger District, cross-section view of an ATV crossing. This site is located at UTM: N: 4253337 & E: 308899, Elevation 1953m.

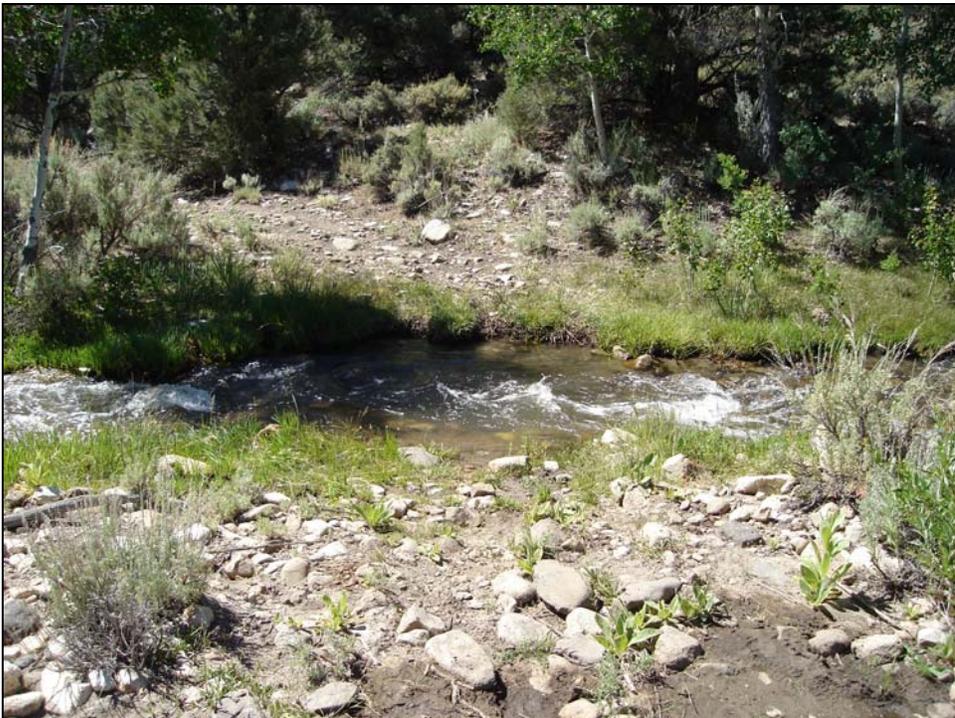
Site 9: Fryingpan Creek, Bridgeport Ranger District, cross-section view of a ford road crossing. Some stream widening and erosion accompanying the crossing is evident. This site is located at UTM: N: 4253406 & E: 308427, Elevation 1988m.

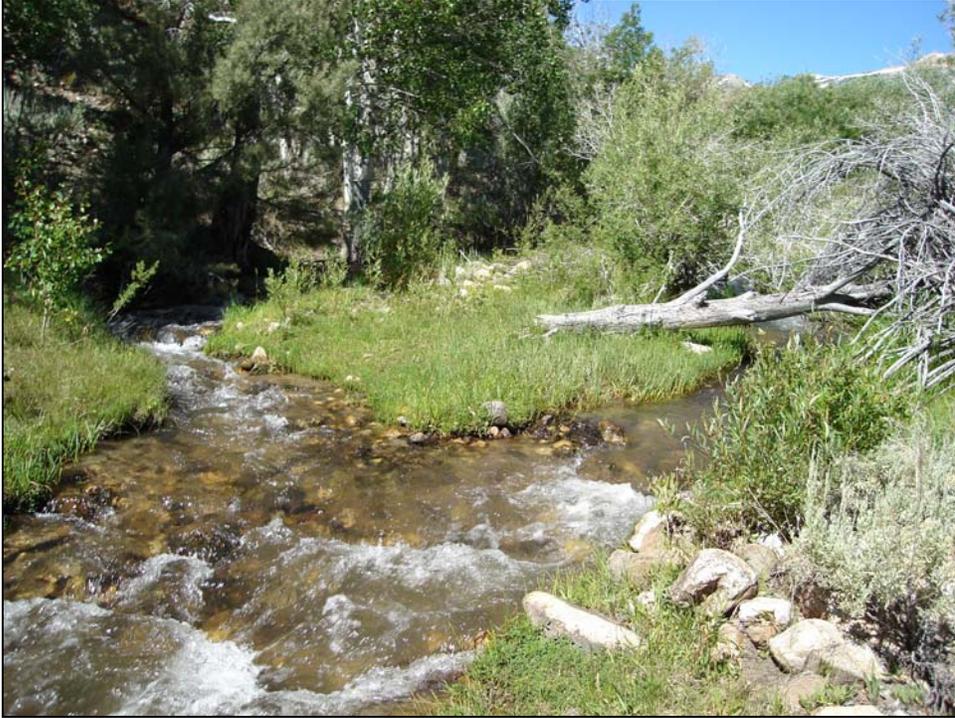
Site 9 continued: Fryingpan Creek, Bridgeport Ranger District, looking upstream from the ford road crossing. This site is located at UTM: N: 4253406 & E: 308427, Elevation 1988m.

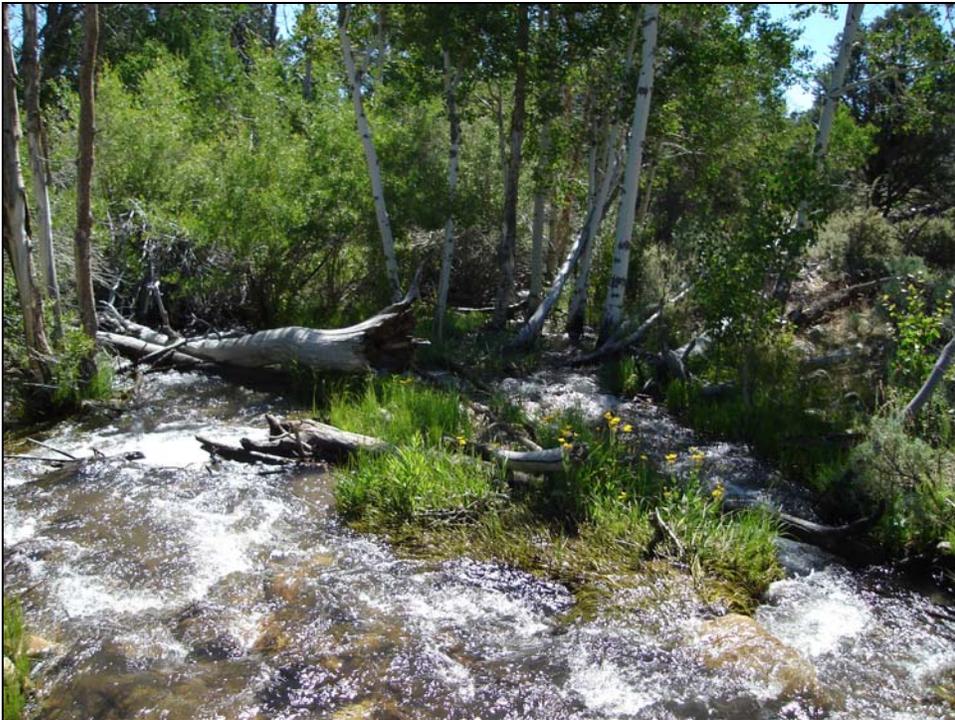
Site 9 continued: Fryingpan Creek, Bridgeport Ranger District, looking downstream from the ford road crossing. This site is located at UTM: N: 4253406 & E: 308427, Elevation 1988m.

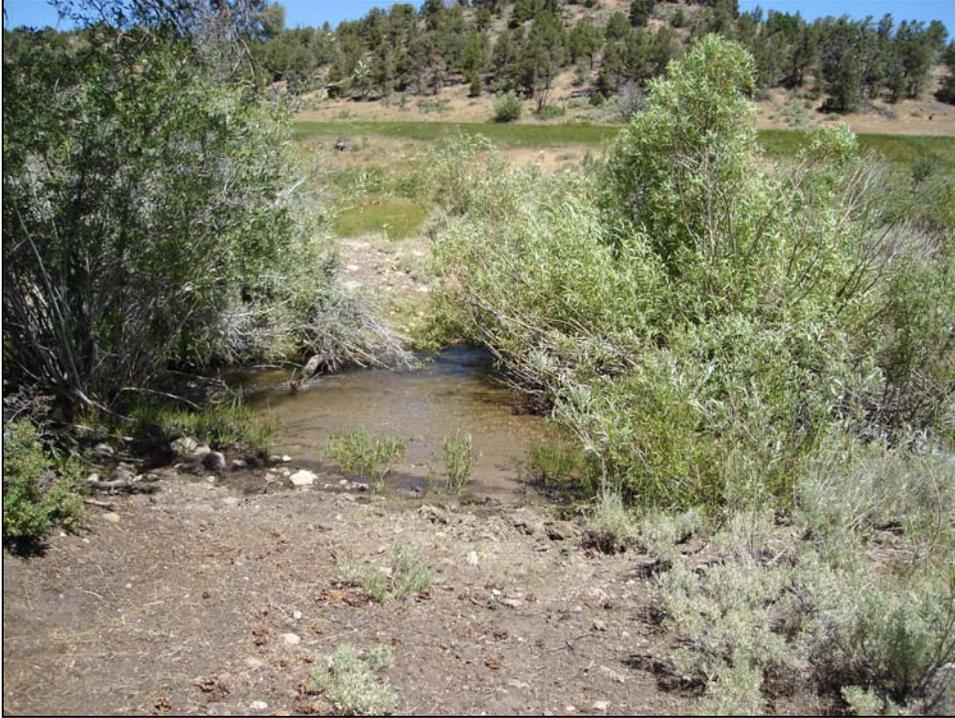
Site 10: Fryingpan Creek, Bridgeport Ranger District, cross-section view of a ford road crossing. This site is located at UTM: N: 4253345 & E: 307906, Elevation 2033m.

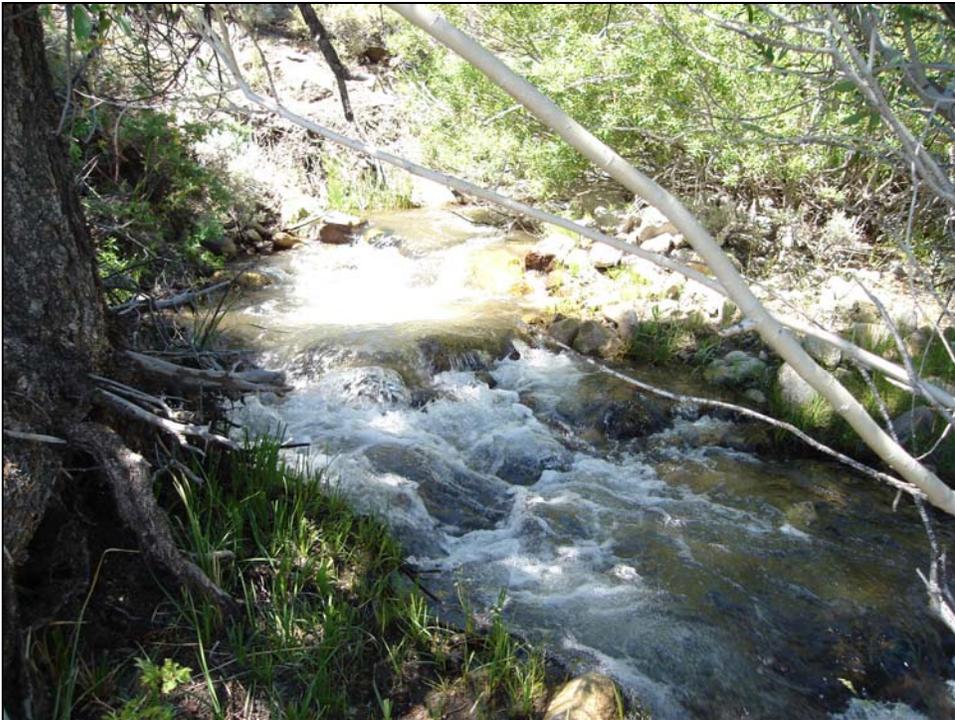
Site 10 continued: Fryingpan Creek, Bridgeport Ranger District, looking upstream from the ford road crossing. This site is located at UTM: N: 4253345 & E: 307906, Elevation 2033m.

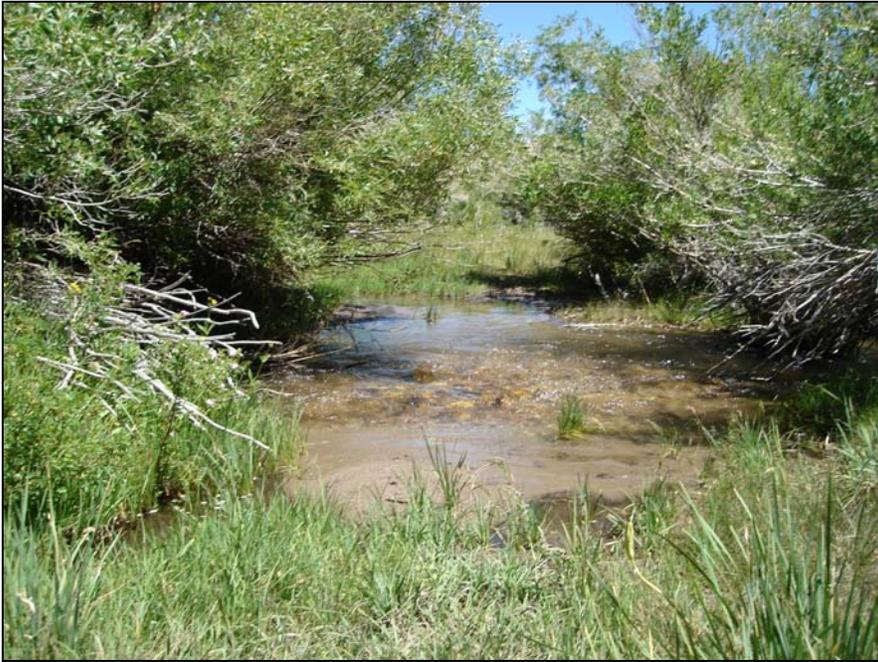
Site 11: Fryingpan Creek, Bridgeport Ranger District, looking at a small tributary that enters Fryingpan Creek. This tributary contributes approximately 10% of the overall flow in Fryingpan Creek. This site is located at UTM: N: 4253330 & E: 305611, Elevation 2223m.

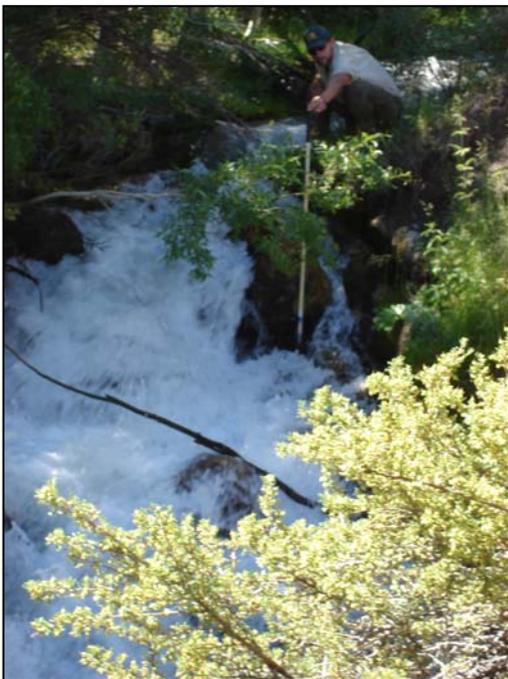
Site 12: Fryingpan Creek, Bridgeport Ranger District, looking upstream at a seasonal fish barrier. The main drop is approximately 1m (3.3ft) high, but several other minor falls are associated with it. This site is located at UTM: N: 4253049 & E: 305303, Elevation 2276m.

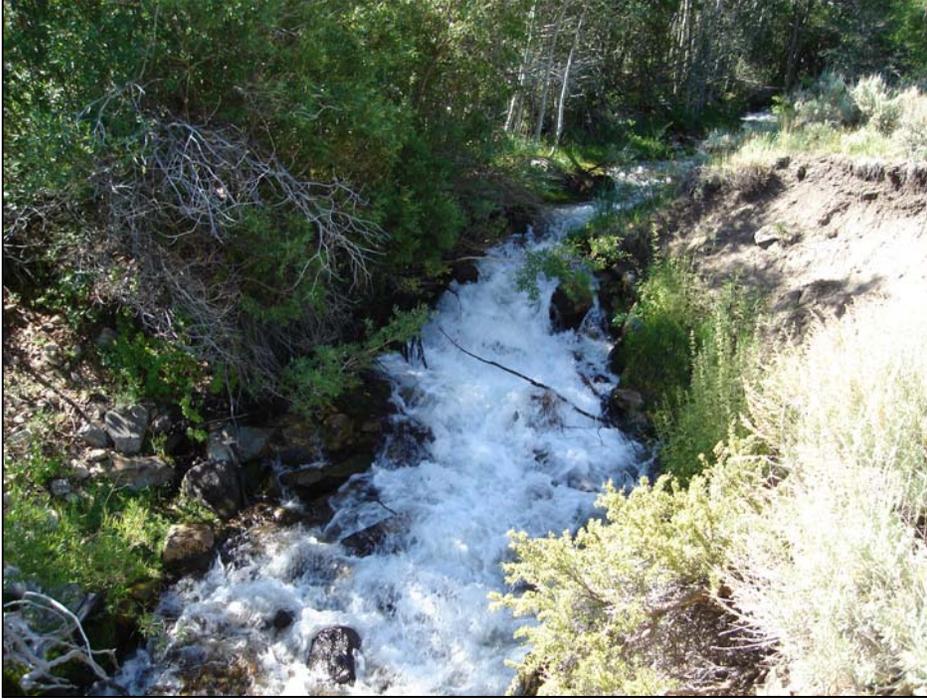
Site 12 continued: Fryingpan Creek, Bridgeport Ranger District, looking upstream from the seasonal fish barrier. This site is located at UTM: N: 4253049 & E: 305303, Elevation 2276m.

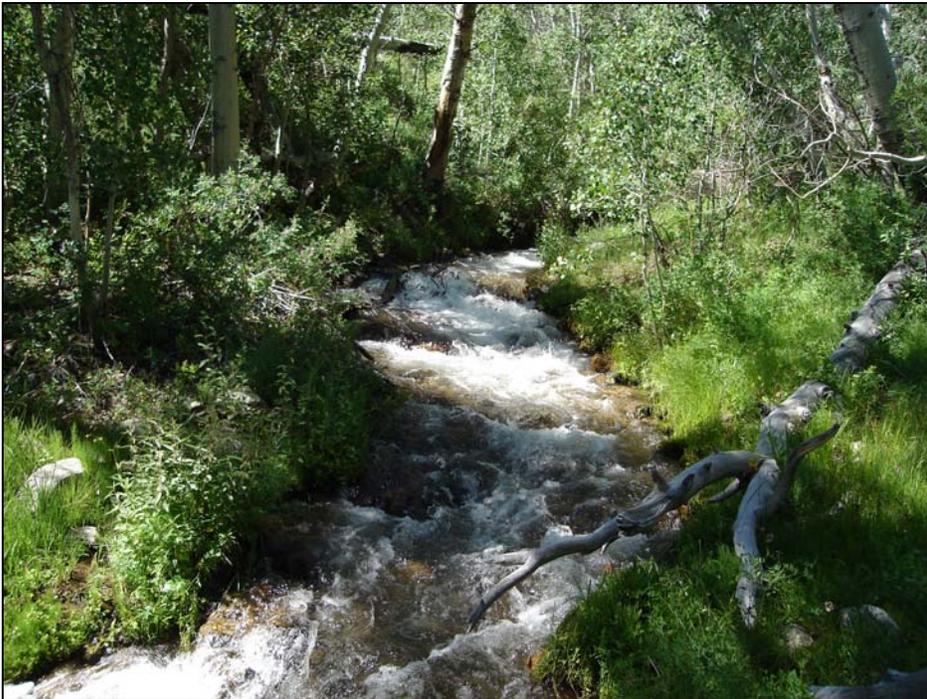
Site 13: Fryingpan Creek, Bridgeport Ranger District, looking upstream at the stream characteristics typical for this section of stream. This site is located at UTM: N: 4252623 & E: 304988, Elevation 2334m.

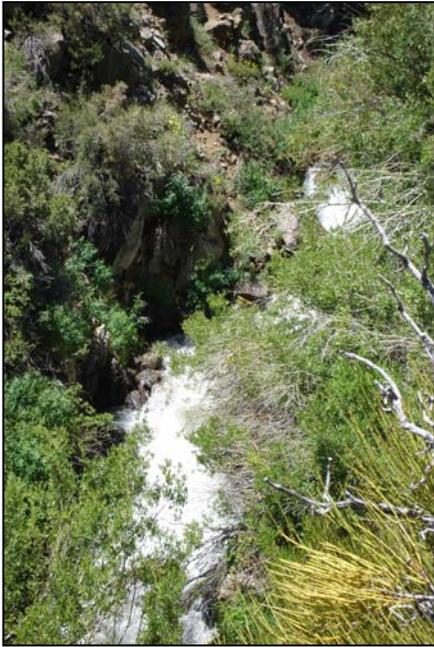
Site 15: Fryingpan Creek, Bridgeport Ranger District, looking upstream at a permanent fish passage barrier. This site has a series of waterfalls with the largest measuring approximately 3m (9.8ft) high. This site is located at UTM: N: 4252534 & E: 304135, Elevation 2454m.

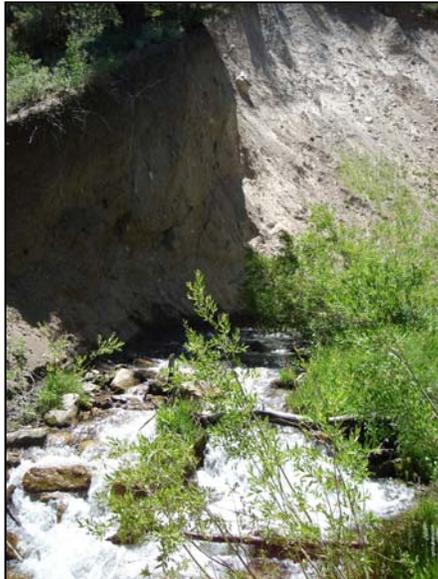
Site 16: Fryingpan Creek, Bridgeport Ranger District, looking upstream at a tributary. This tributary contributes approximately 40% of the overall flow in Fryingpan Creek. This site is located at UTM: N: 4252537 & E: 303773, Elevation 2519m.
