Little Walker River

Mono County, California

2006 Stream Habitat Survey Report

Humboldt-Toiyabe National Forest, Bridgeport Ranger District

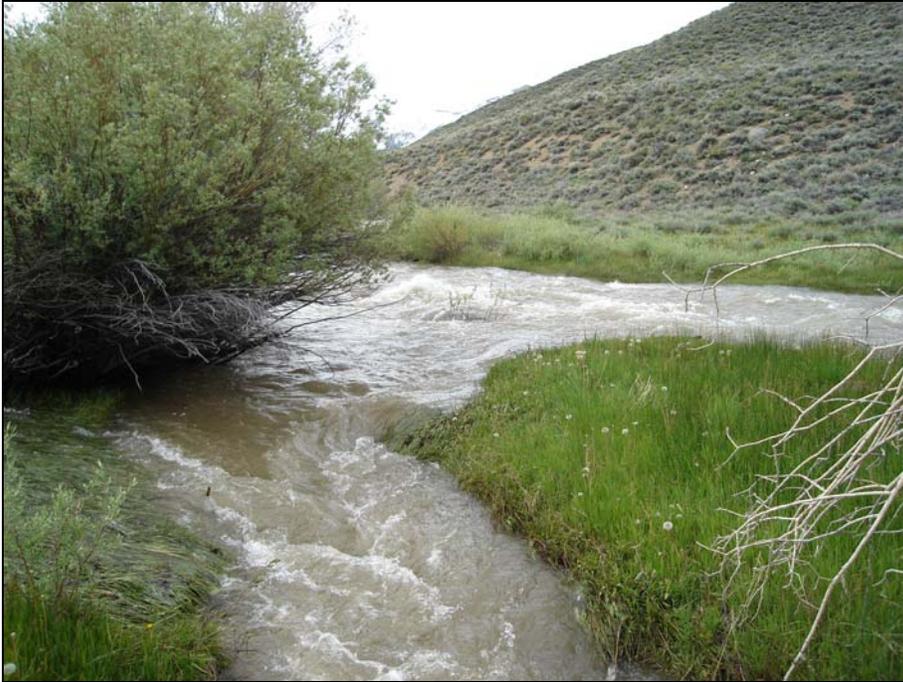
Site 1: Little Walker River, Bridgeport Ranger District, looking upstream at the survey start point and the private property-Forest Service boundary. This picture is also taken directly south of the Little Walker-Cowcamp Creek confluence. Note the turbidity on river left and high flows that have spilled over the stream banks. This site is located at UTM N: N: 4245549 & E: 286006, Elevation 2141m.

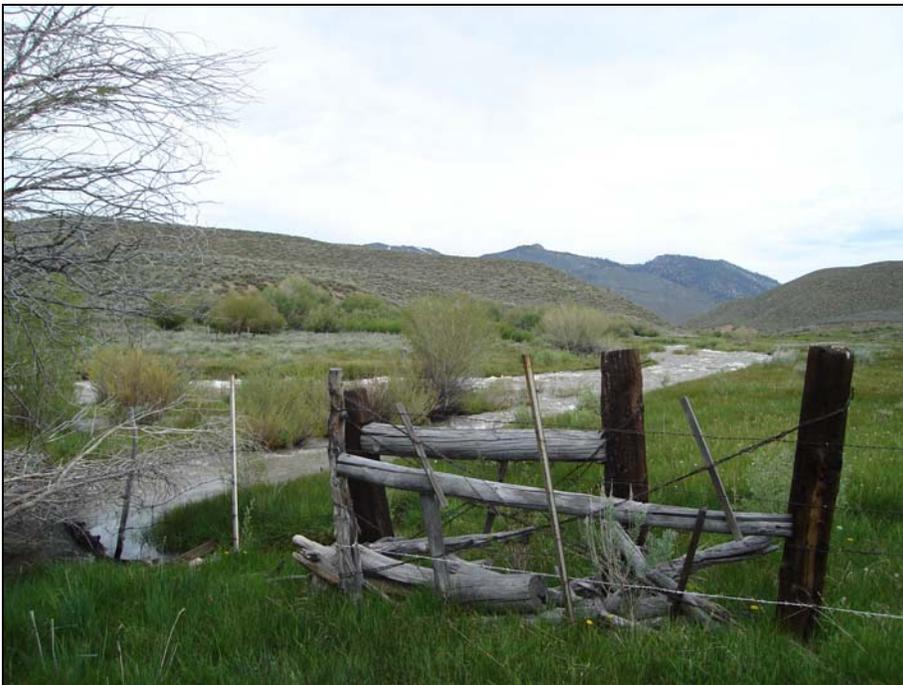
Site 1 continued: Little Walker River, Bridgeport Ranger District, looking north towards the private property. This site is located at UTM N: 4245549 & E: 286006, Elevation 2141m.

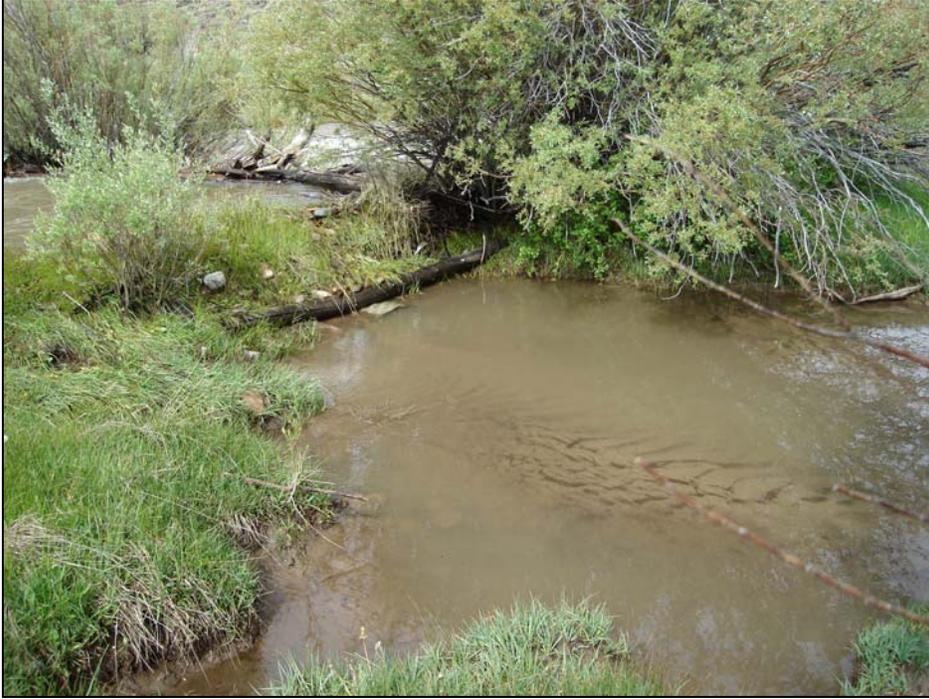
13. An inactive irrigation diversion was noted at Site 2. The average stream gradient of the Little Walker River between Site 1 and Site 21 is 4.1%.

Site 2: Little Walker River, Bridgeport Ranger District, looking at an inactive irrigation channel located upstream of the Little Walker-Cowcamp Creek confluence. This site is located at UTM: N: 4245256 & E: 286066, Elevation 2141m.

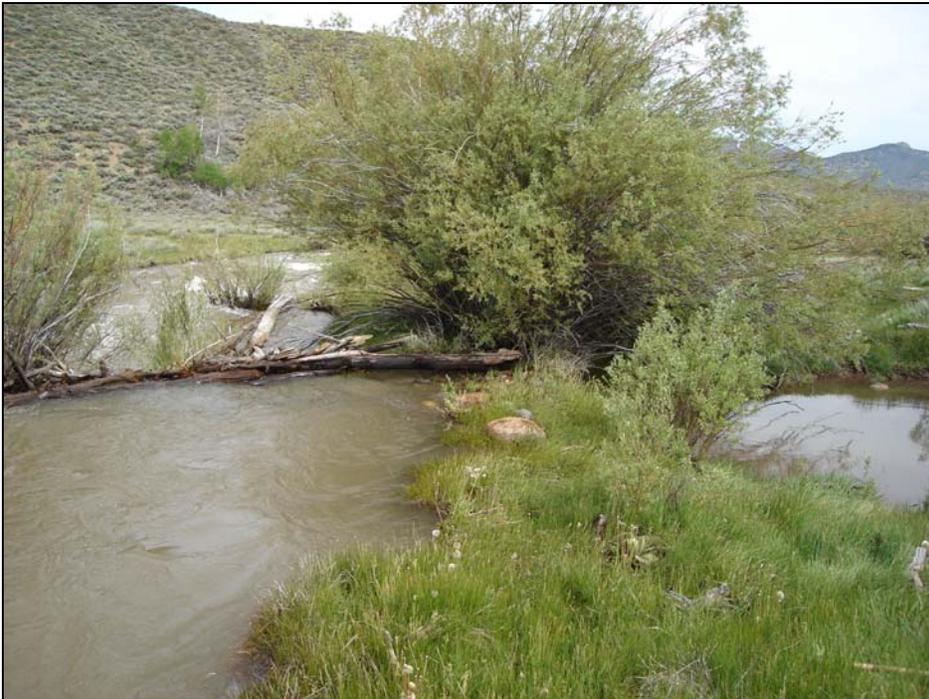
Site 2 continued: Little Walker River, Bridgeport Ranger District, another picture of the irrigation channel. This picture is taken from the river side of the diversion. This site is located at UTM N: 4245256 & E: 286066, Elevation 2141m.

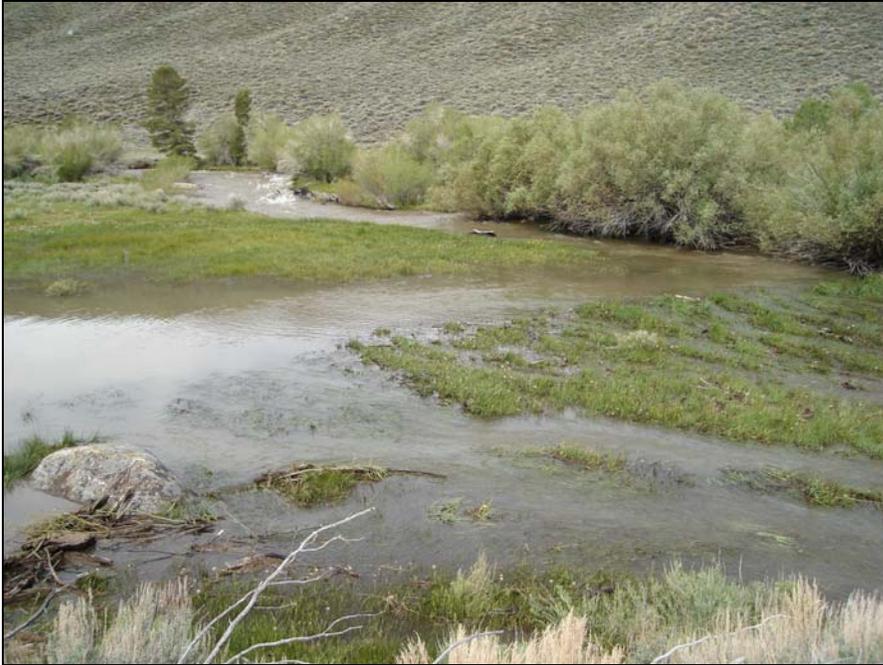
Site 3: Little Walker River, Bridgeport Ranger District, looking at the high flows during spring runoff. This site is located at UTM N: 4245078 & E: 286058, Elevation 2151m.

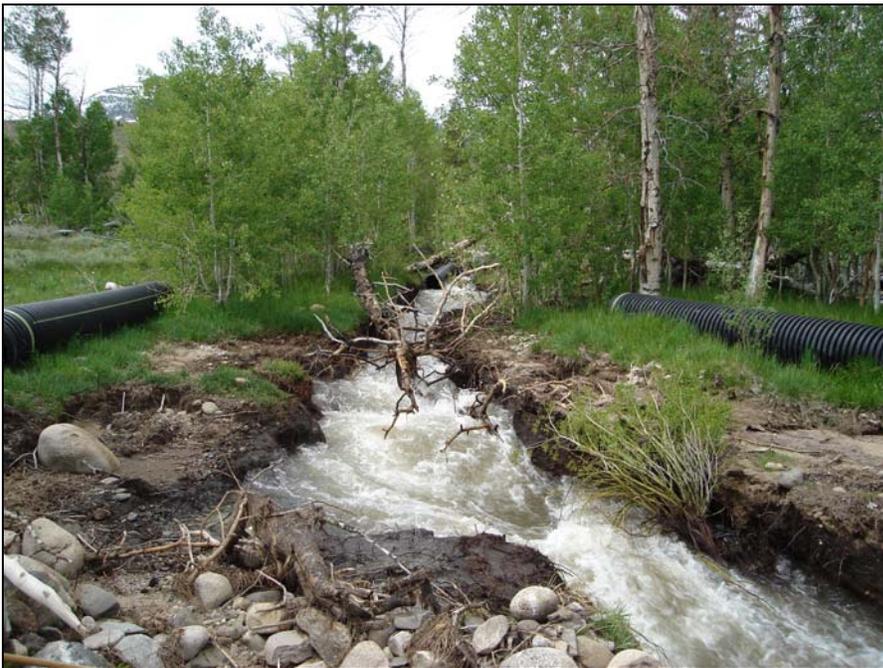
Site 4: Little Walker River, Bridgeport Ranger District, looking upstream at a braid in the stream that enters on the river left side. This photo also shows several large abandoned pipes on both banks. This site is located at UTM: N: 4243474 & E: 285699, Elevation 2189m.

4. Remove the abandoned culverts located at Site 4.

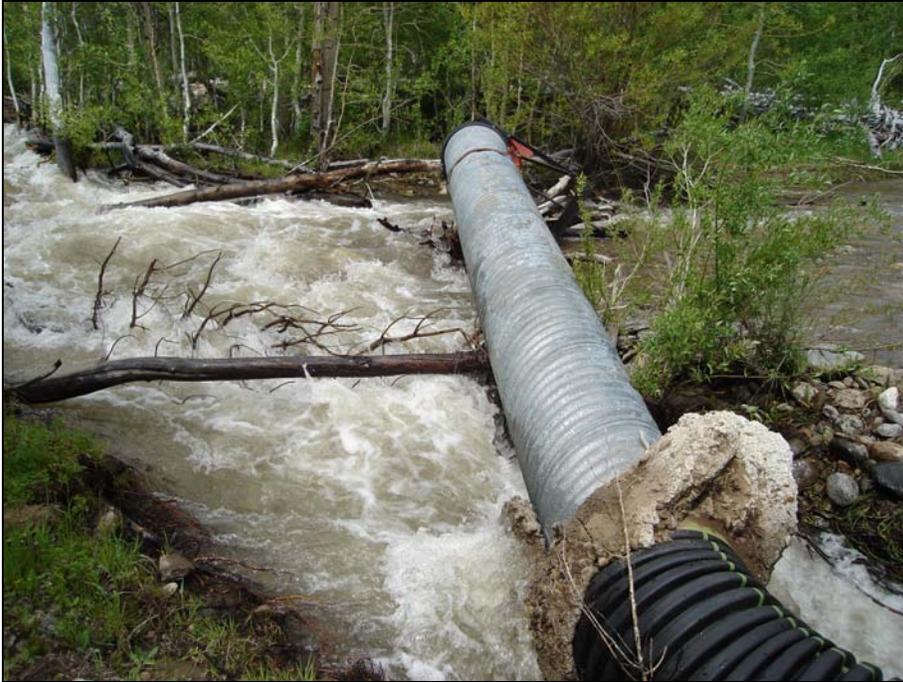
Site 4 continued: Little Walker River, Bridgeport Ranger District, a cross-sectional view of a culvert lying across the main stem of the river. This site is located at UTM: N: 4243474 & E: 285699, Elevation 2189m.

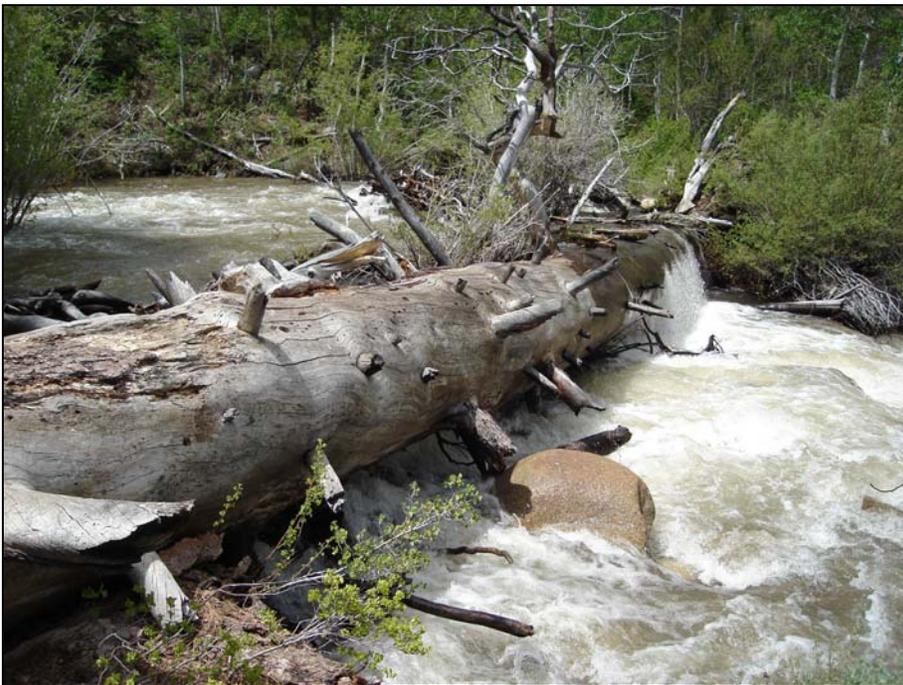
Site 5: Little Walker River, Bridgeport Ranger District, a cross-sectional photo of a large pine tree that slightly restricts flow. This site is located at UTM N: 4242503 & E: 285804, Elevation 2256m.

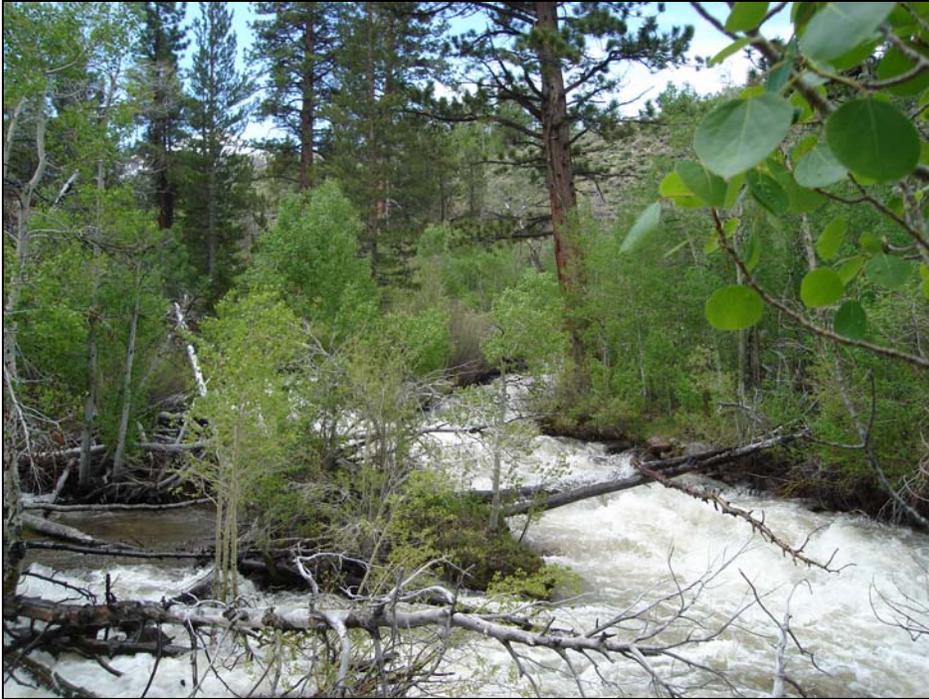
Site 6: Little Walker River, Bridgeport Ranger District, looking upstream at the confluence of Molybdenite Creek and the Little Walker River. This site is located at UTM N: 4242066 & E: 285725, Elevation 2294m.

The tributary identified at Site 6 is Molybdenite Creek, which was also surveyed in 2006. Molybdenite Creek offers an additional 7.1 miles of potential LCT habitat and it allows for the possibility of restoring a metapopulation of LCT within the Little Walker River and Molybdenite Creek watersheds

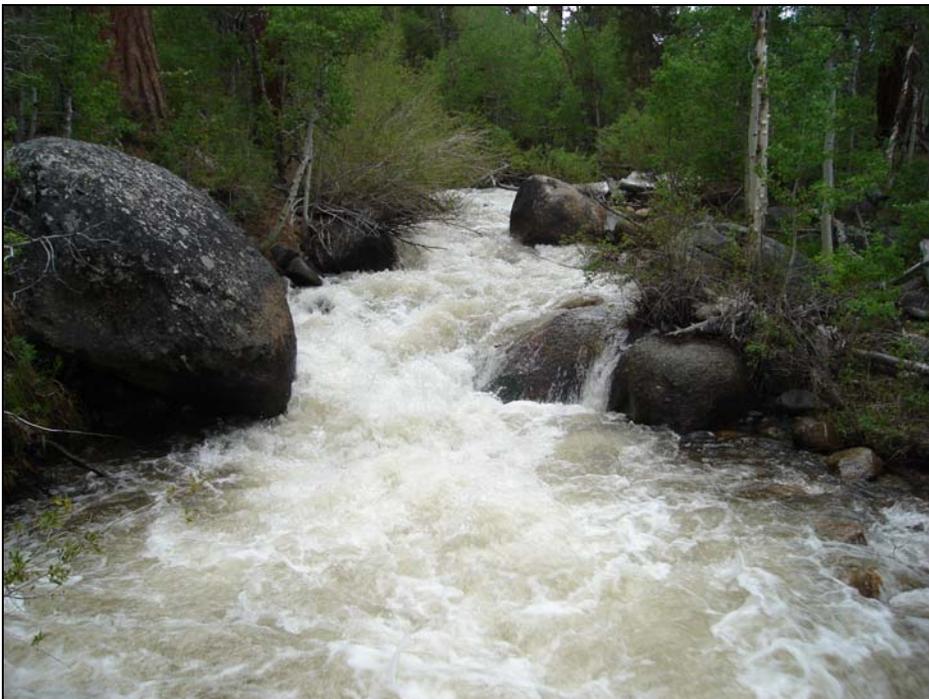
Site 6 continued: Little Walker River, Bridgeport Ranger District, looking upstream at Molybdenite Creek from its confluence with the Little Walker River. This site is located at UTM N: 4242066 & E: 285725, Elevation 2294m.

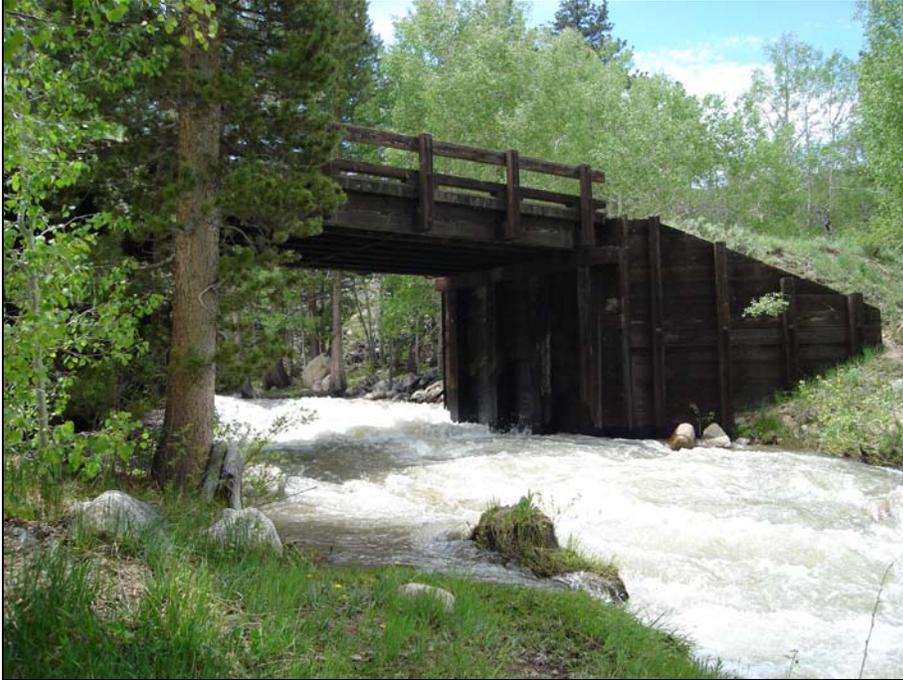
Site 7: Little Walker River, Bridgeport Ranger District, looking upstream at a road-stream crossing located just past the Burt Canyon Trailhead Parking Lot. The bridge is a solid wooden structure that does not restrict flow. This site is located at UTM N: 4241321 & E: 285782, Elevation 2346m.

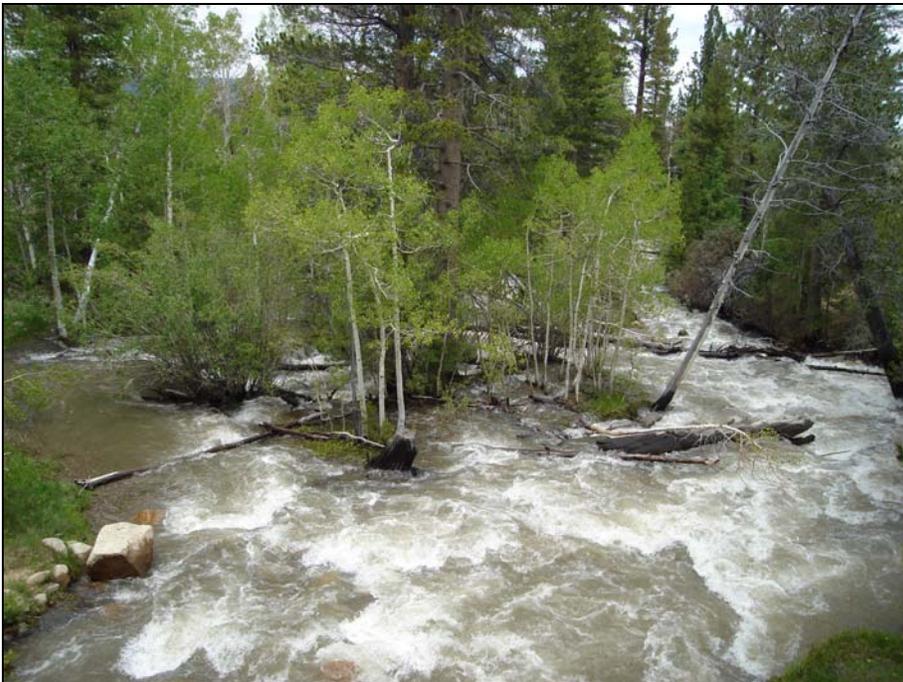
Site 7 continued: Little Walker River, Bridgeport Ranger District, looking downstream from atop the bridge. This site is located at UTM: N: 4241321 & E: 285782, Elevation 2346m.

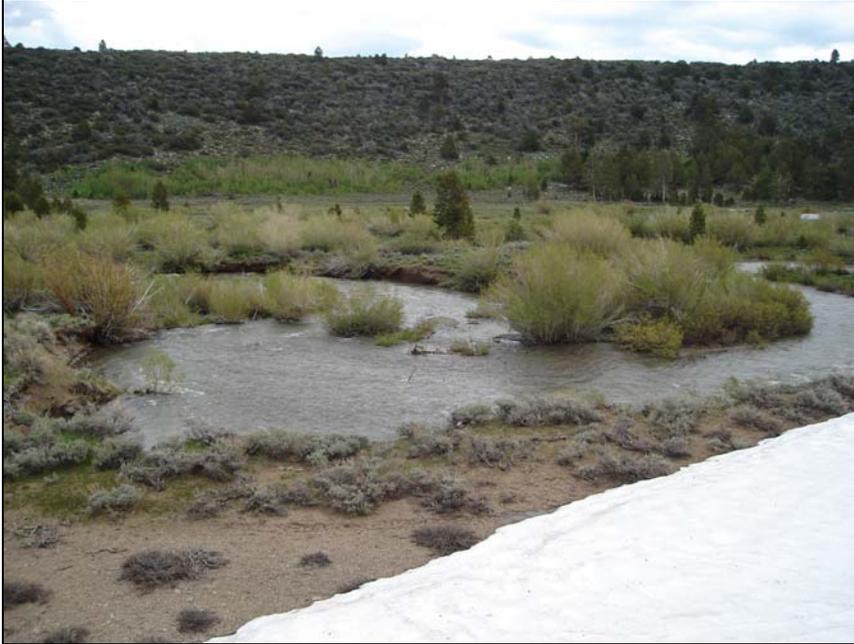
Site 8: Little Walker River, Bridgeport Ranger District, a cross-sectional photo of a meadow at Willow Flats where the stream meanders and water clarity is improved. This site is located at UTM N: 4239078 & E: 285395, Elevation 2490m.

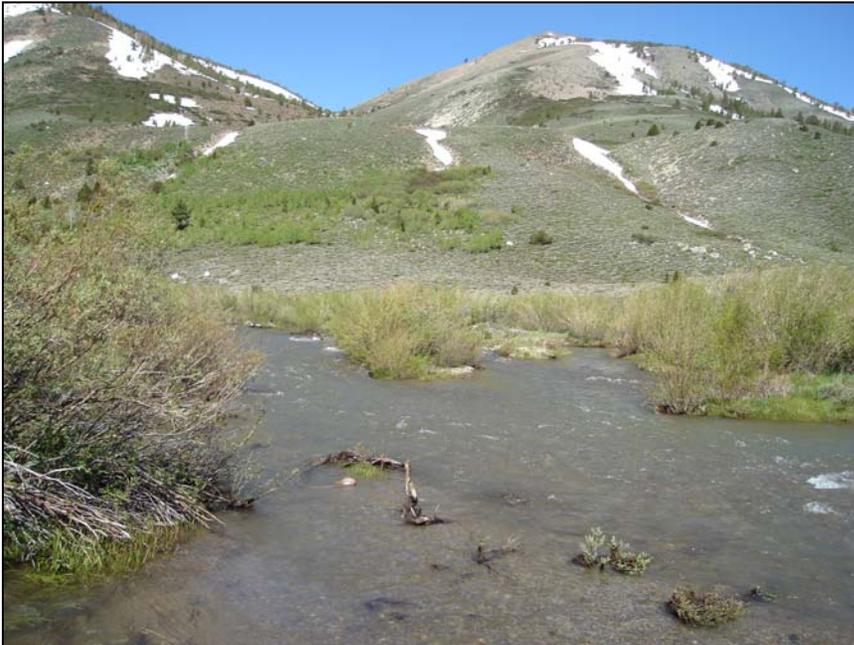
Site 9: Little Walker River, Bridgeport Ranger District, looking upstream at the southern end of the private property-Forest Service boundary in the Willow Flats area. The rocky river bed and slow meander bends look to be good fish habitat. This site is located at UTM N: 4238912 & E: 285374, Elevation 2486m.

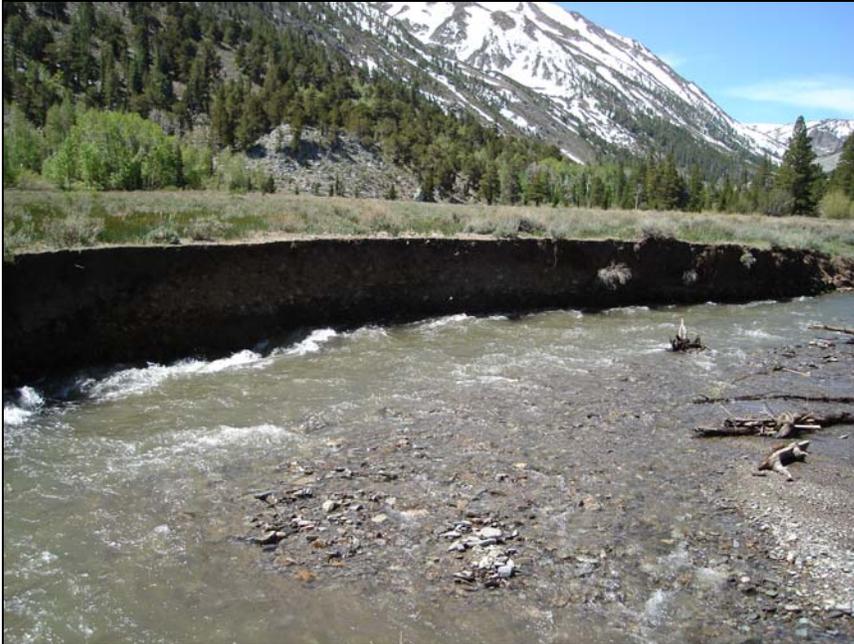
Site 10: Little Walker River, Bridgeport Ranger District, looking upstream at an eroding bank typical of the Willow Flat's meadow. This exposed bank is 25 m long and 1.5-2.0m tall. This site is located at UTM N: 4237669 & E: 285066, Elevation 2509m.

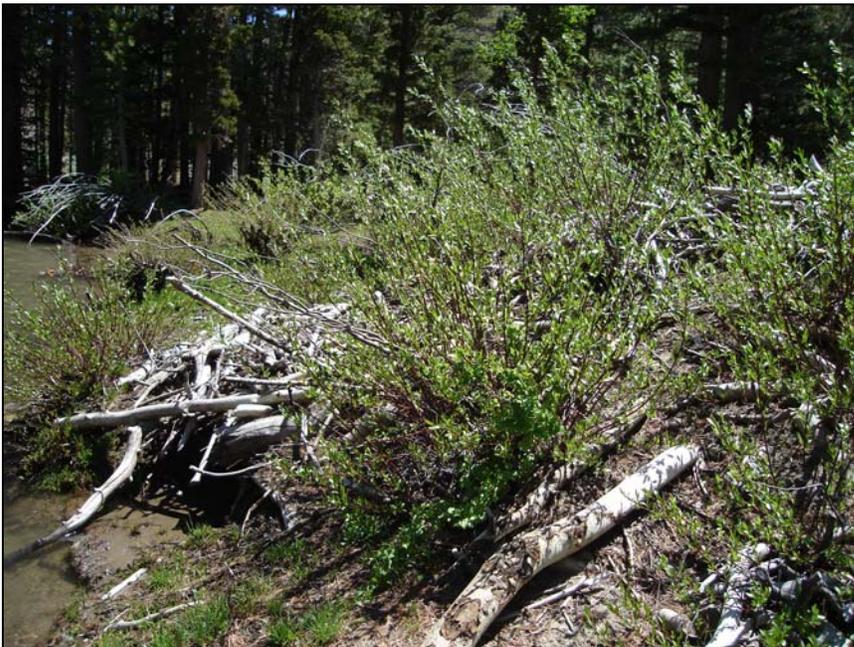
Site 11: Little Walker River, Bridgeport Ranger District, looking upstream at a remnant beaver lodge on a dry stream bank, which marks the downstream end of beaver activity. The lodge lies just upstream of the Hoover Wilderness Boundary. This site is located at UTM N: 4237449 & E: 284844, Elevation 2514m.

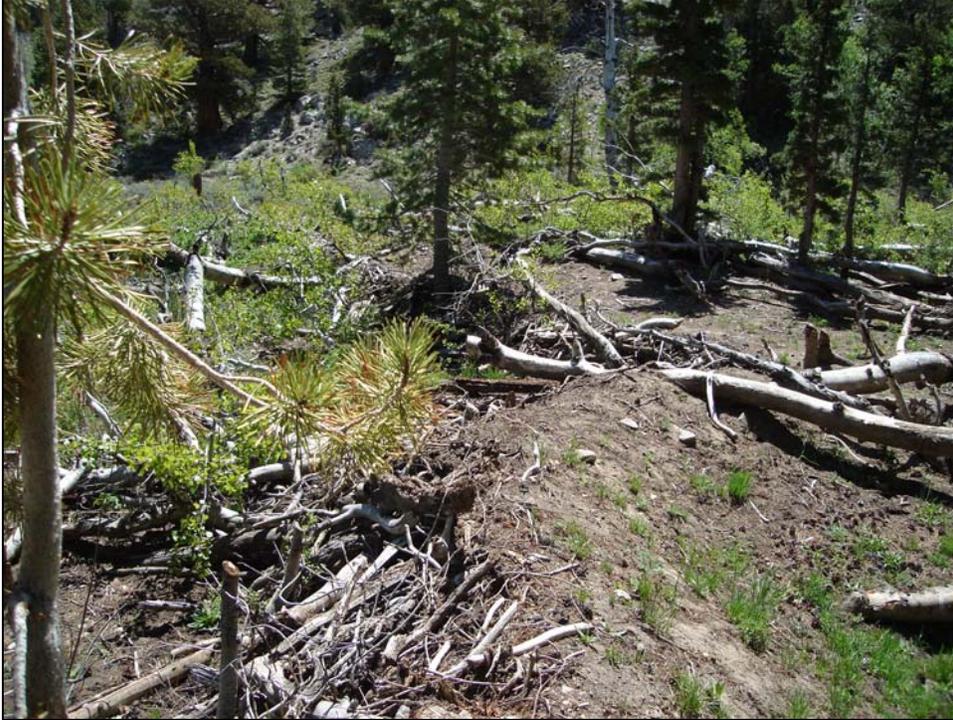
Site 11 continued: Little Walker River, Bridgeport Ranger District, cross-sectional photo of a beaver dam. This site is located at UTM: N: 4237449 & E: 284844, Elevation 2514m.

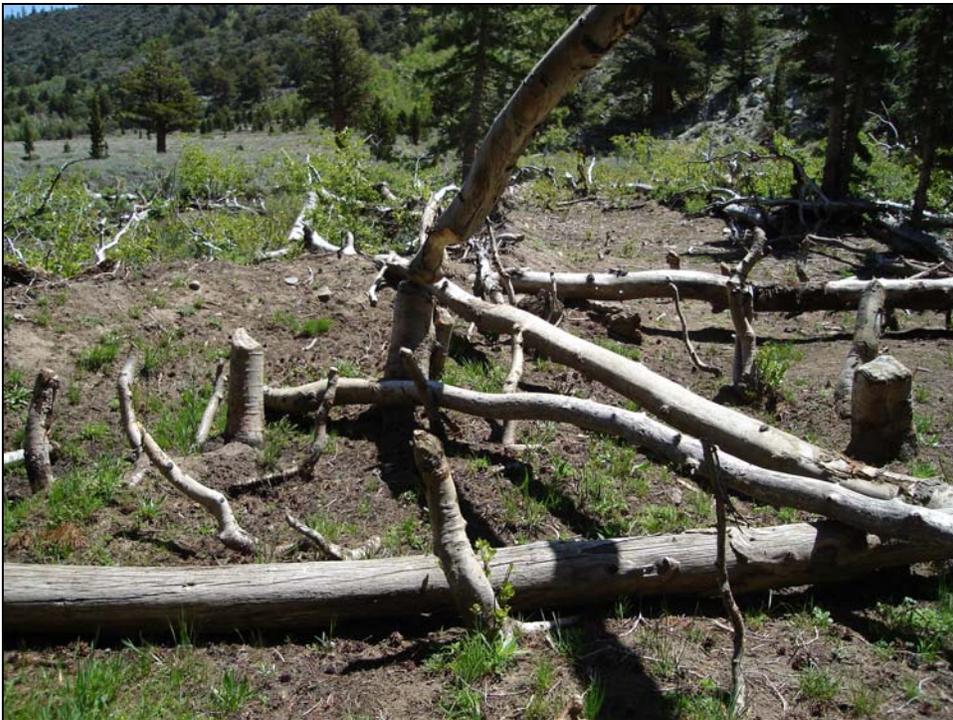
Site 11 continued: Little Walker River, Bridgeport Ranger District. Photo shows sheared Aspen trees. This site is located at UTM N: 4237449 & E: 284844, Elevation 2514m.

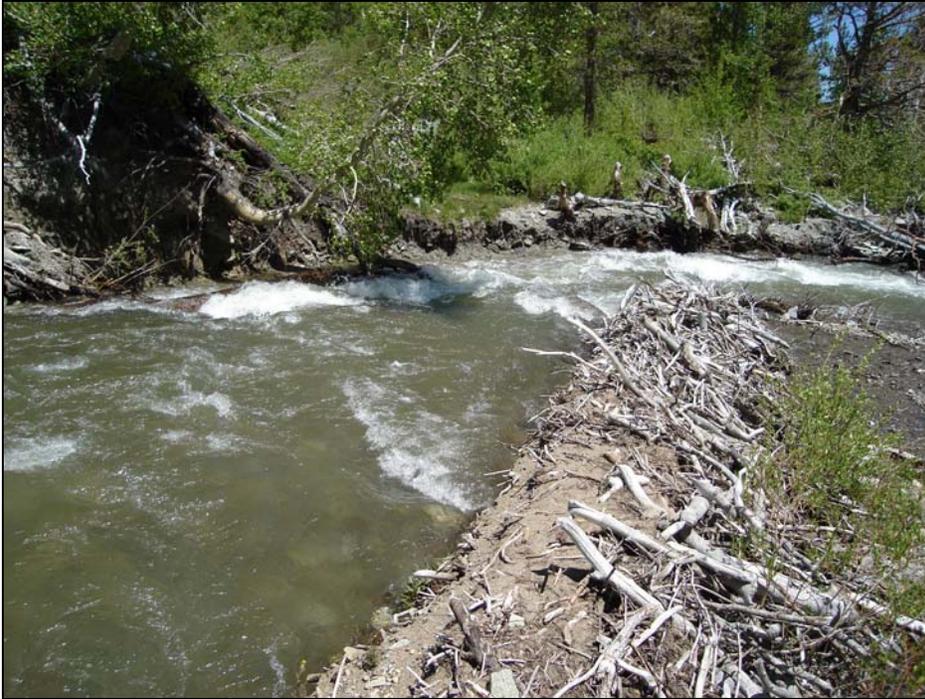
Site 12: Little Walker River, Bridgeport Ranger District, cross-sectional photo of a recently constructed beaver dam that still forces water to flow river left. This site is located at UTM N: 4237381 & E: 284724, Elevation 2528m.

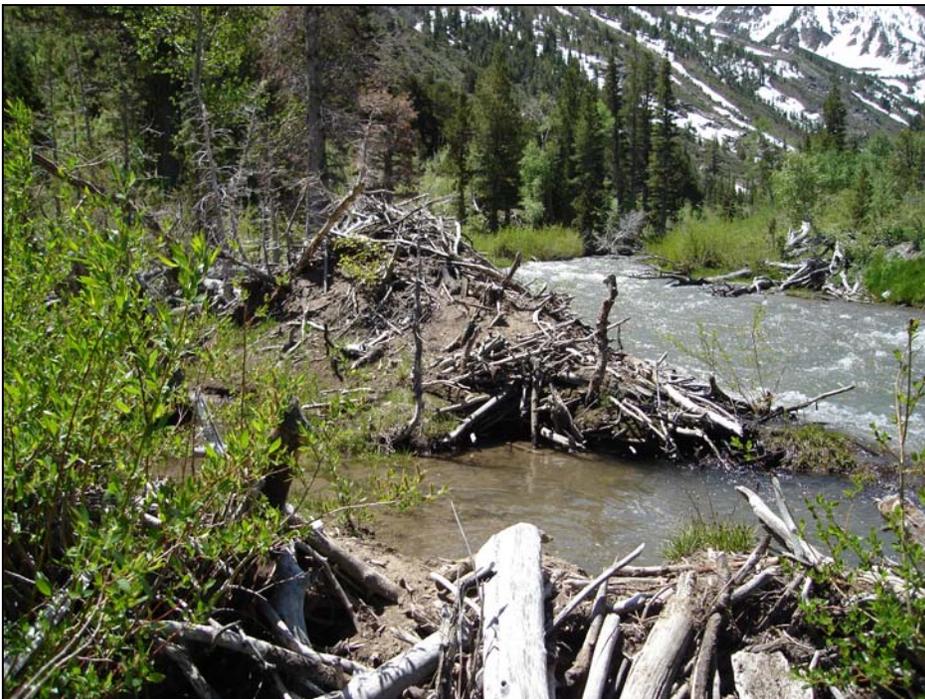
Site 12 continued: Little Walker River, Bridgeport Ranger District. Photo of a newer beaver lodge. This site is located at UTM N: 4237381 & E: 284724, Elevation 2528m.

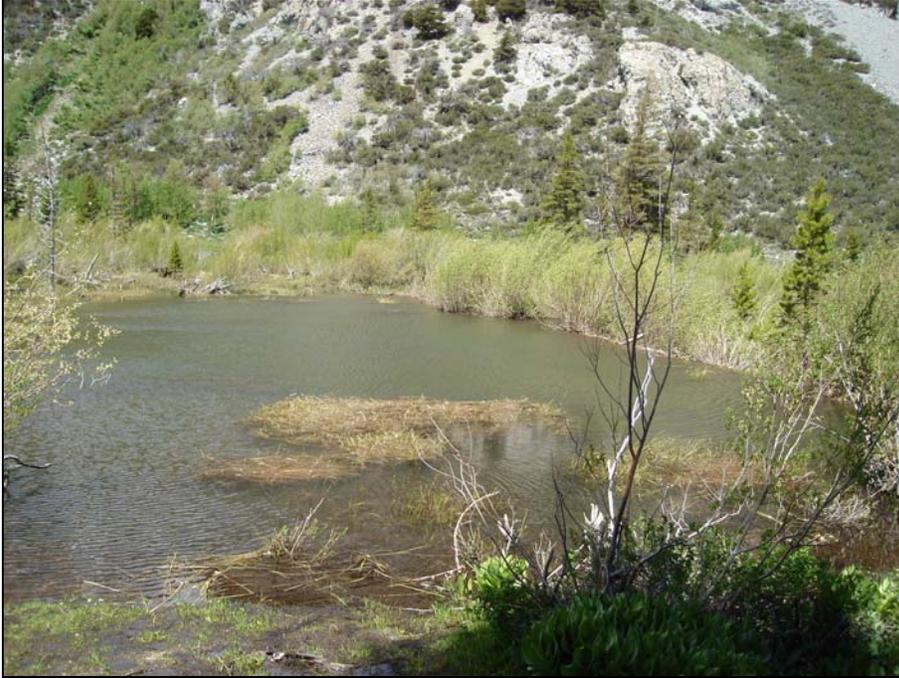
Site 13: Little Walker River, Bridgeport Ranger District, looking at the largest of several active beaver ponds. The mainstem flows to the far river left and the dams are located on river right. This site is located at UTM N: 4236937 & E: 284382, Elevation 2544m.

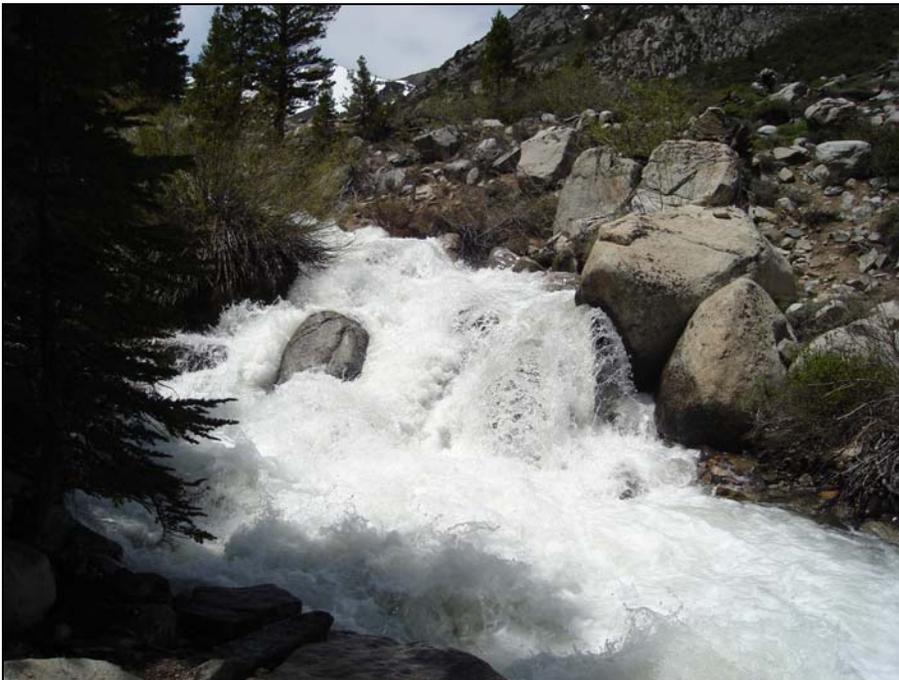
All 10.4 miles of the Little Walker River between Site 1 and Site 21 provide potential LCT habitat. Permanent fish barriers occur at Sites 14, 15, and 17; however, upstream of Site 17 the Little Walker River flows through Burt Canyon which offers some good slow water, meandering habitat (Site 19). The reach between Site 1 and Site 13 also offers some excellent habitat and a good combination of fast water and deep pools. Between Sites 8 and 13 the Little Walker River meanders for several miles through large meadows at Willow Flats. The reach in Willow Flats offers varying water depth and speed, cut banks, beaver ponds (Site 13), and adequate in-stream cover. The beaver ponds included active dam sites and lodges at Sites 11, 12, & 13.

Site 14: Little Walker River, Bridgeport Ranger District, looking upstream at a 2.0m (6.6ft) high waterfall that may still allow seasonal fish passage under ideal conditions. For consistency, this site was documented as a permanent fish barrier. This site is located at UTM N: 4236616 & E: 283670, Elevation 2588m.

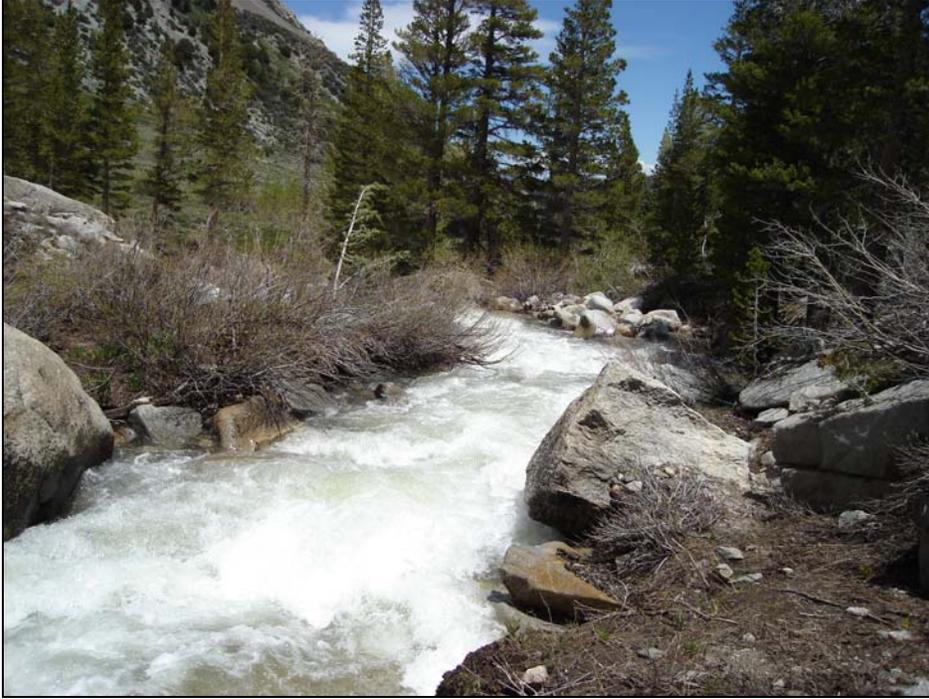
Site 14 continued: Little Walker River, Bridgeport Ranger District, looking downstream from the bottom of the fish barrier. This site is located at UTM N: 4236616 & E: 283670, Elevation 2588m.

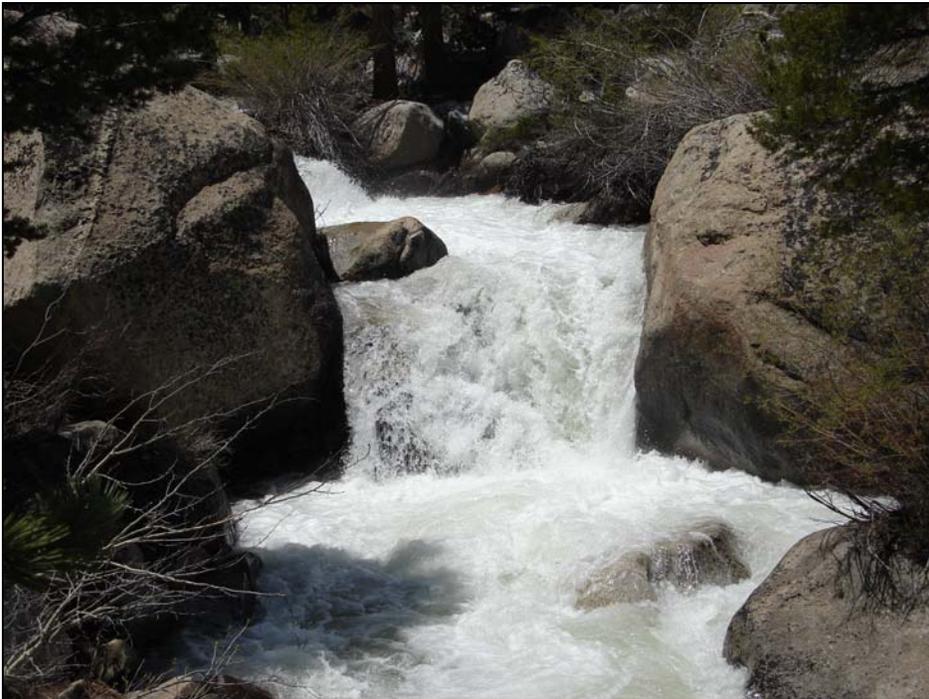
Site 15: Little Walker River, Bridgeport Ranger District, looking upstream at a 3m (9.8 ft) high waterfall, which creates a permanent fish passage barrier. This site is located at UTM N: 4236581 & E: 283626, Elevation 2609m.

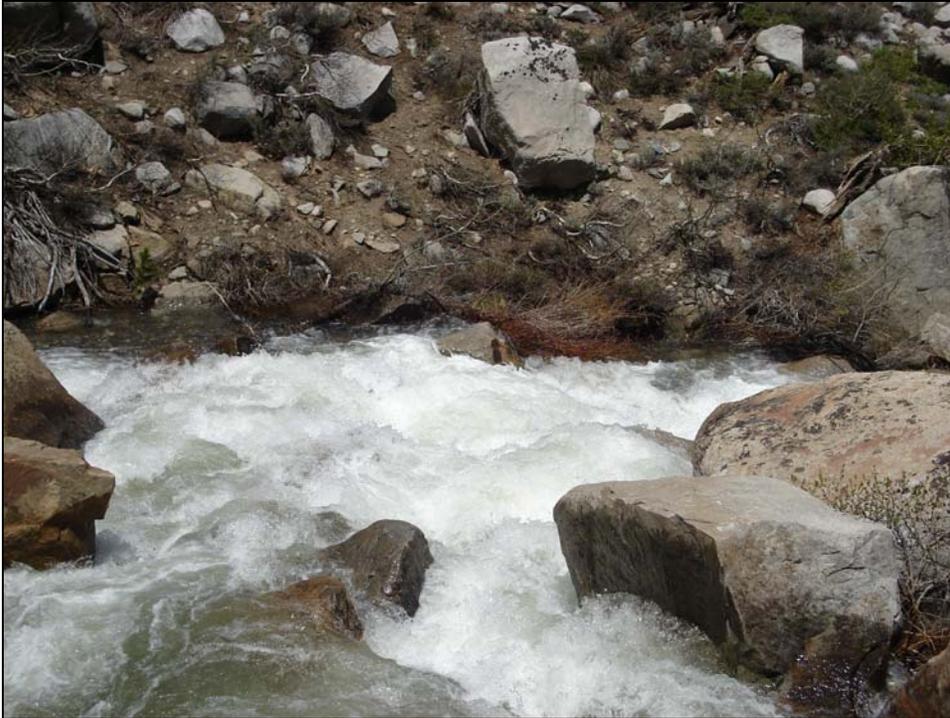
Site 15 continued: Little Walker River, Bridgeport Ranger District, looking downstream from the bottom of the barrier. This site is located at UTM N: 4236581 & E: 283626, Elevation 2609m.

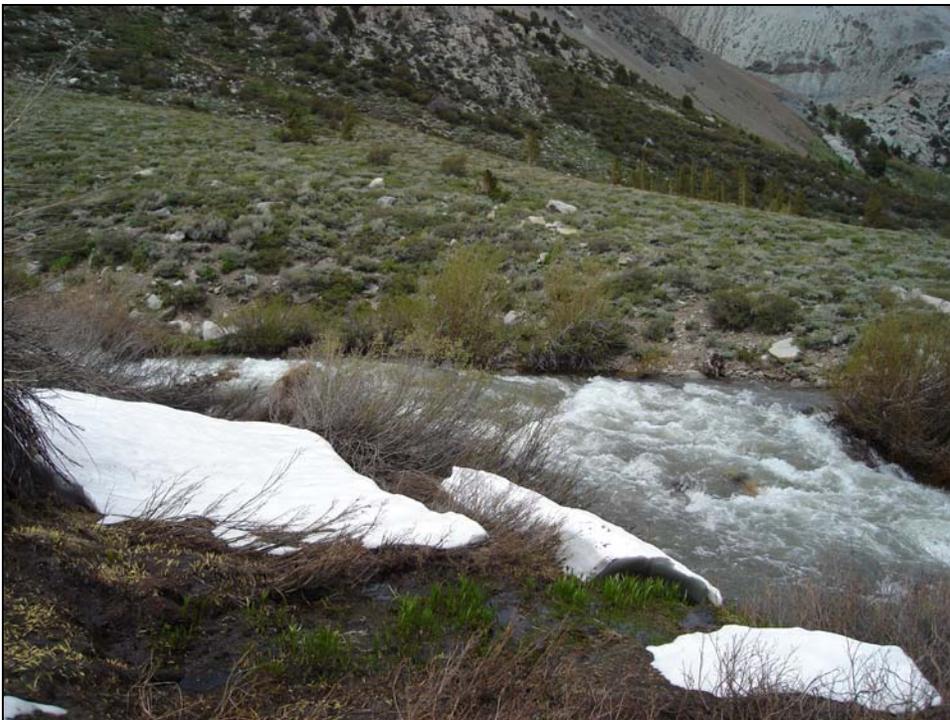
Site 16: Little Walker River, Bridgeport Ranger District, cross-sectional photo of the stream characteristics typical of this area. This site is located at UTM N: 4236502 & E: 283290, Elevation 2631m.

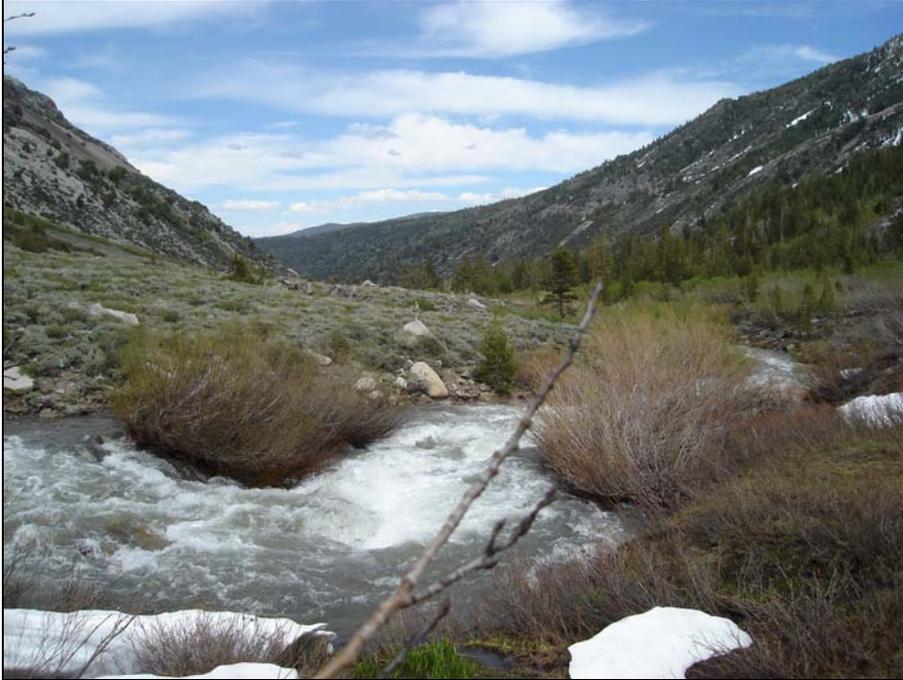
Site 16 continued: Little Walker River, Bridgeport Ranger District, looking downstream at the stream characteristics typical of this area. This site is located at UTM N: 4236502 & E: 283290, Elevation 2631m.

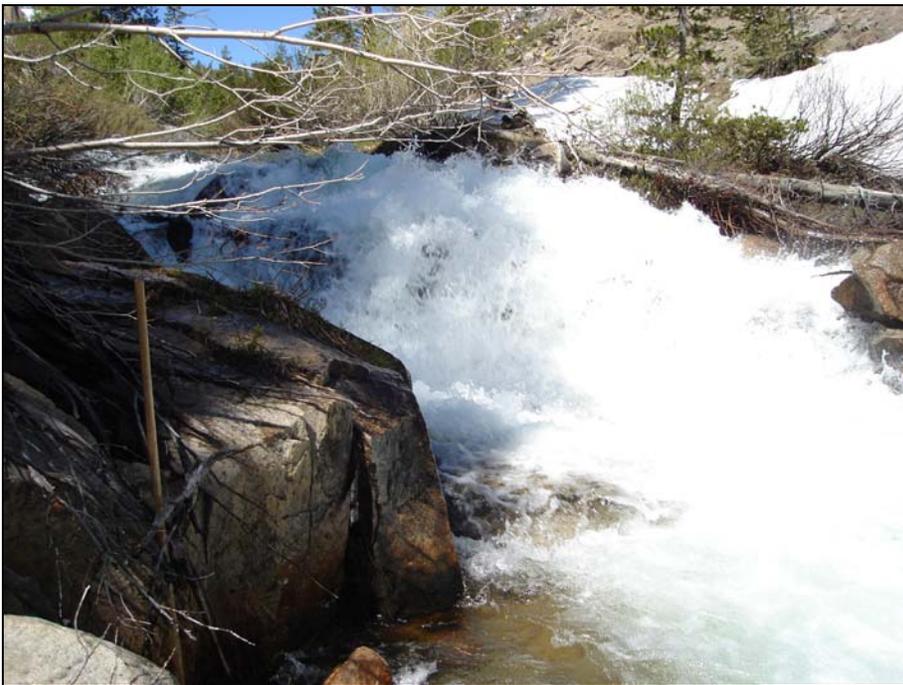
Site 17: Little Walker River, Bridgeport Ranger District, looking upstream at a 2m (6.6ft) high waterfall that may still allow seasonal fish passage on river right as a series of cascading steps under lower flow conditions. For consistency, this site was documented as a permanent fish barrier. This site is located at UTM N: 4236288 & E: 282691, Elevation 2657m.

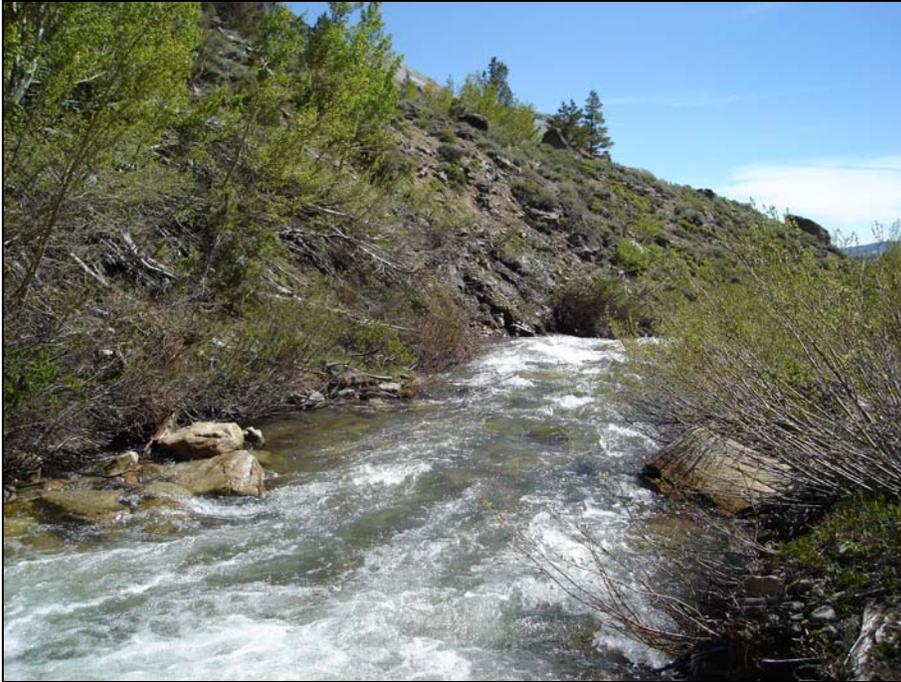
Site 17 continued: Little Walker River, Bridgeport Ranger District, looking downstream from the permanent fish barrier. This site is located at UTM N: 4236288 & E: 282691, Elevation 2657m.

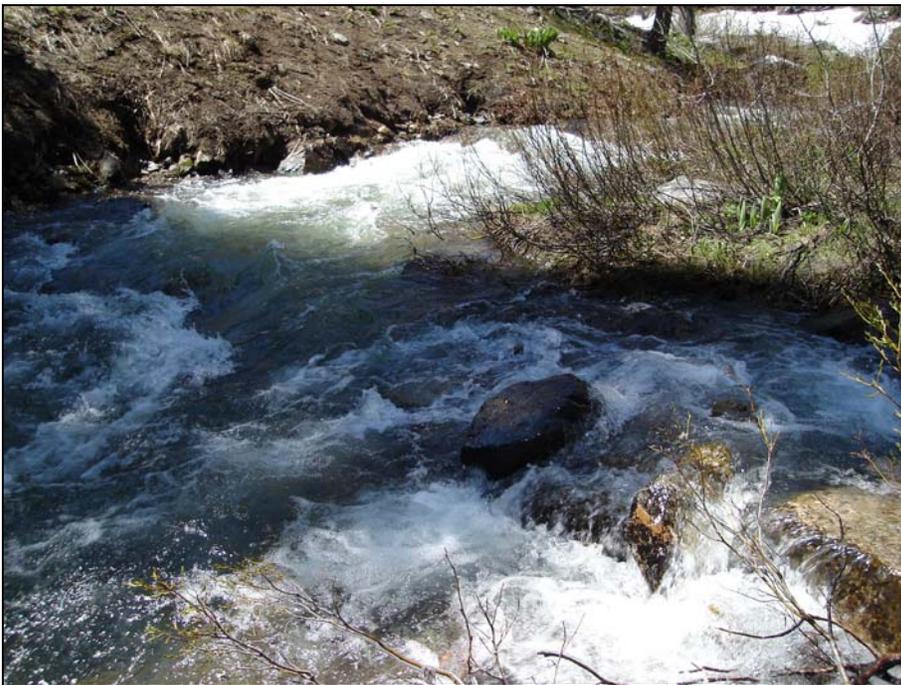
Site 18: Little Walker River, Bridgeport Ranger District, looking upstream at a medium sized tributary that enters on river left. This site is located at UTM N: 4235895 & E: 282064, Elevation 2719m.

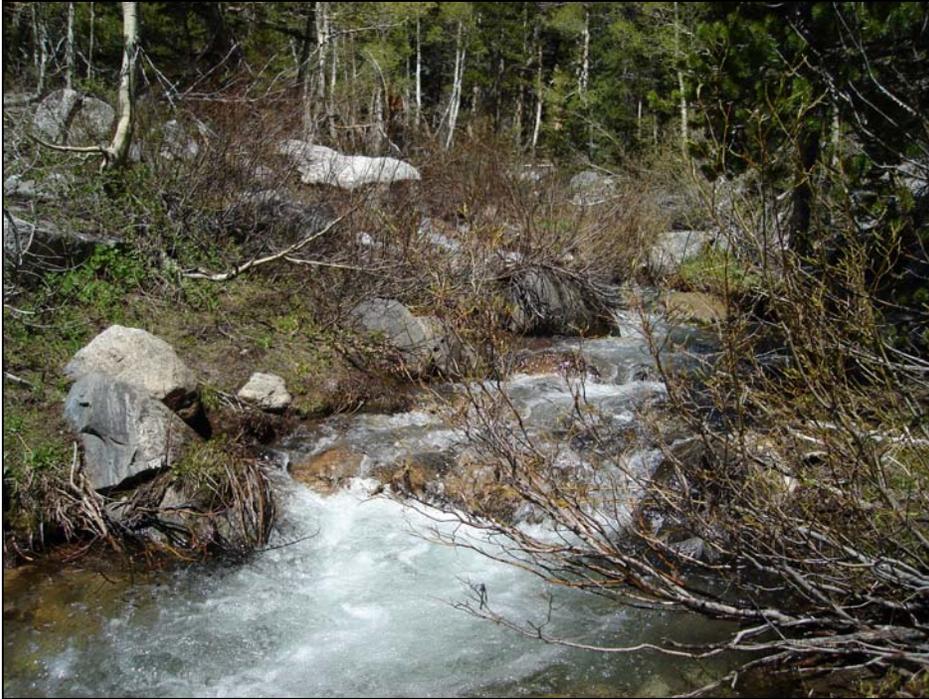
Site 18 continued: Little Walker River, Bridgeport Ranger District. View looking up the tributary. This site is located at UTM N: 4235895 & E: 282064, Elevation 2719m.

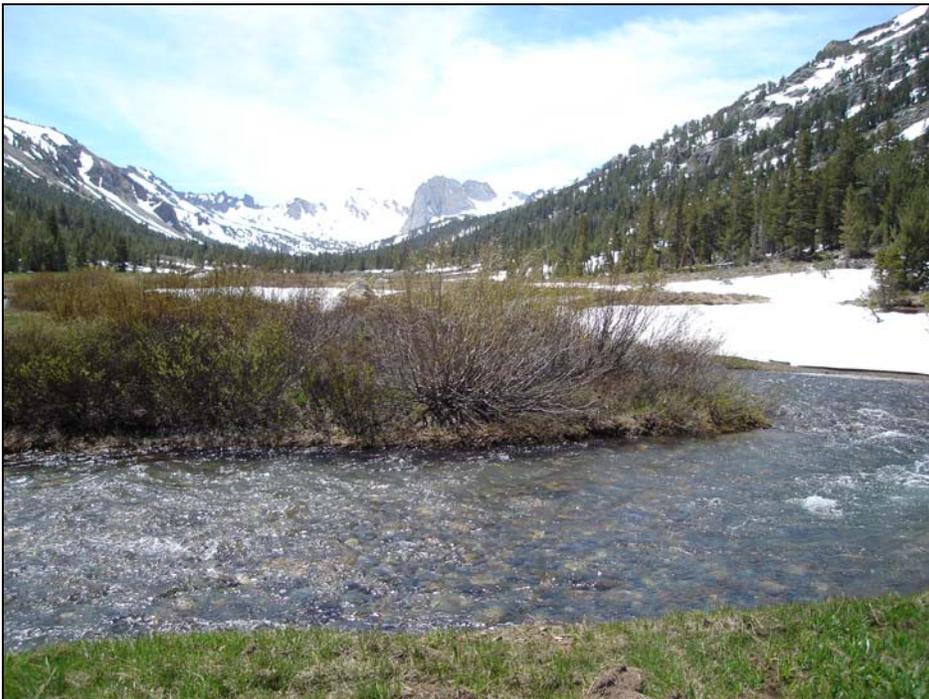
Site 19: Little Walker River, Bridgeport Ranger District, looking upstream at a wet meadow that the stream meanders through. This site is located at UTM N: 4235253 & E: 281948, Elevation 2747m.

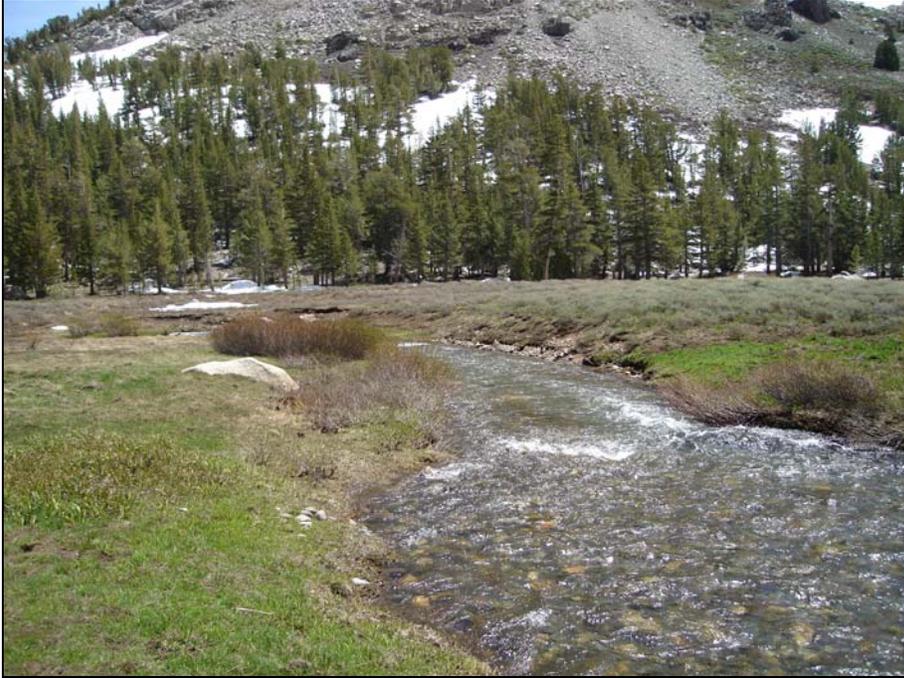
Site 19 continued: Little Walker River, Bridgeport Ranger District, view looking downstream. This site is located at UTM N: 4235253 & E: 281948, Elevation 2747m.
