Little Walker River

Mono County, California

2006 Stream Habitat Survey Report

Humboldt-Toiyabe National Forest, Bridgeport Ranger District

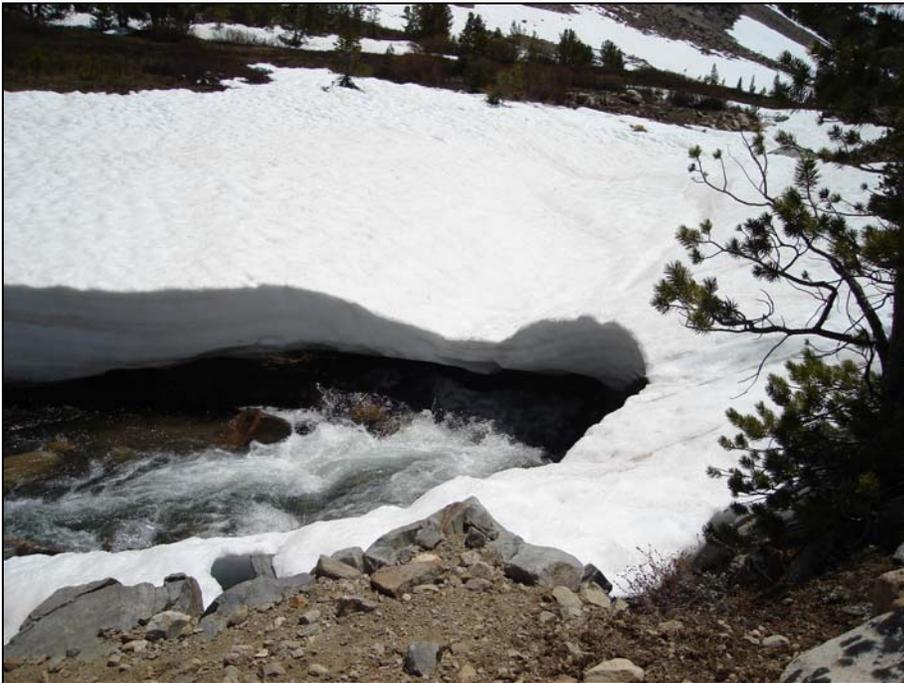
Site 20: Little Walker River, Bridgeport Ranger District, cross-sectional photo of the stream emerging from a snow tunnel. Upstream of this site the survey was difficult due to the presence of snow. This site is located at UTM N: 4233399 & E: 282242, Elevation 2805m.

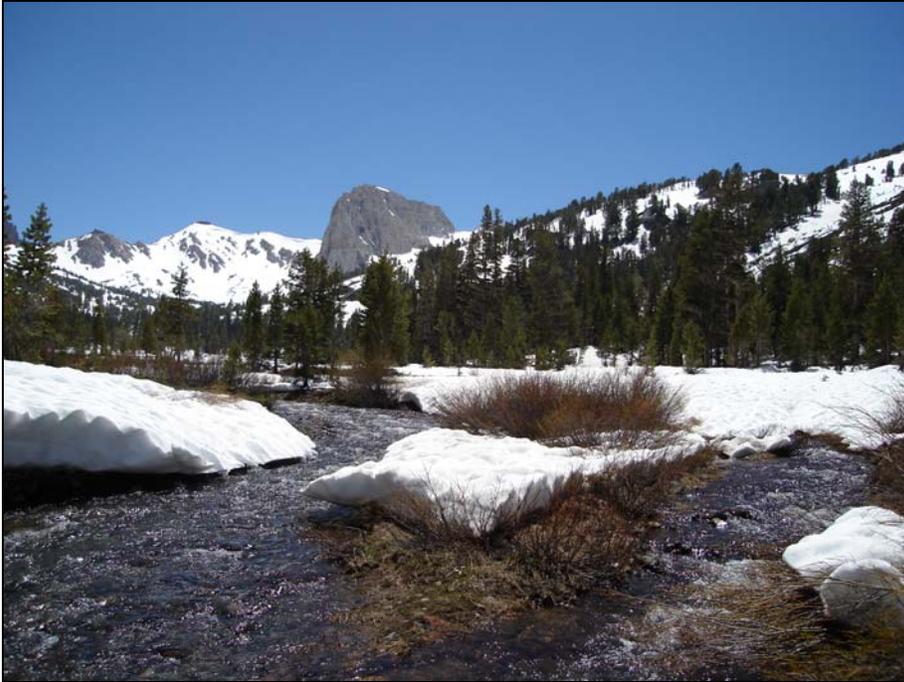
Site 21: Little Walker River, Bridgeport Ranger District, looking upstream at the survey end point, where a medium sized tributary enters the river. This site is located at UTM N: 4232922 & E: 282262, Elevation 2824m.
