LONG VALLEY CREEK

MONO COUNTY, CALIFORNIA

2006 Stream Habitat Survey Report

Humboldt-Toiyabe National Forest, Bridgeport Ranger District

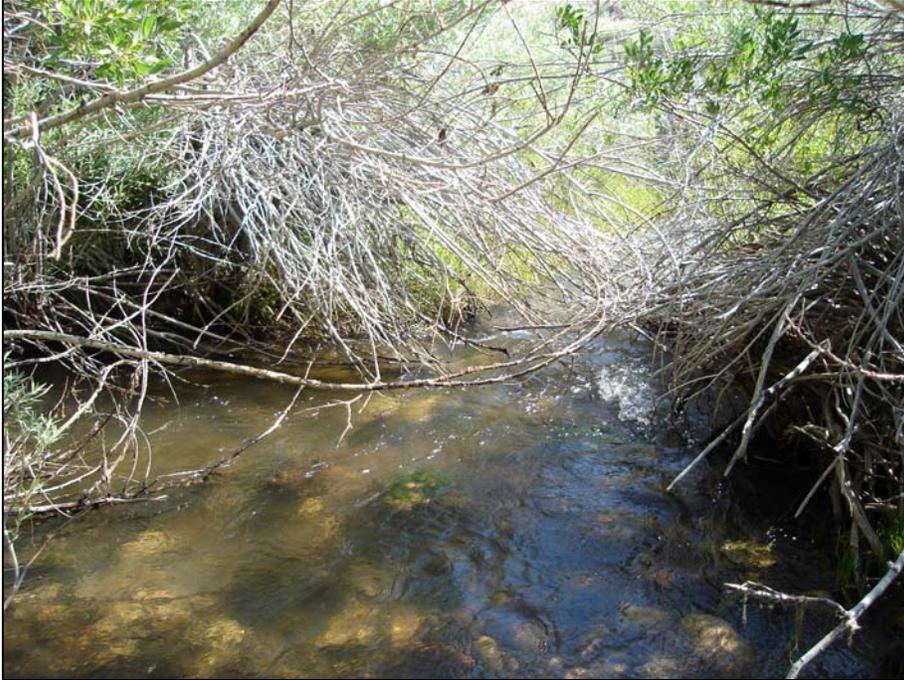
Site 1: Long Valley Creek, Bridgeport Ranger District, looking downstream from the survey start point. The survey start point is near highway 395 just upstream of the private property-National Forest boundary. This site is located at UTM: N: 4242647 & E: 296821, Elevation 2129m.

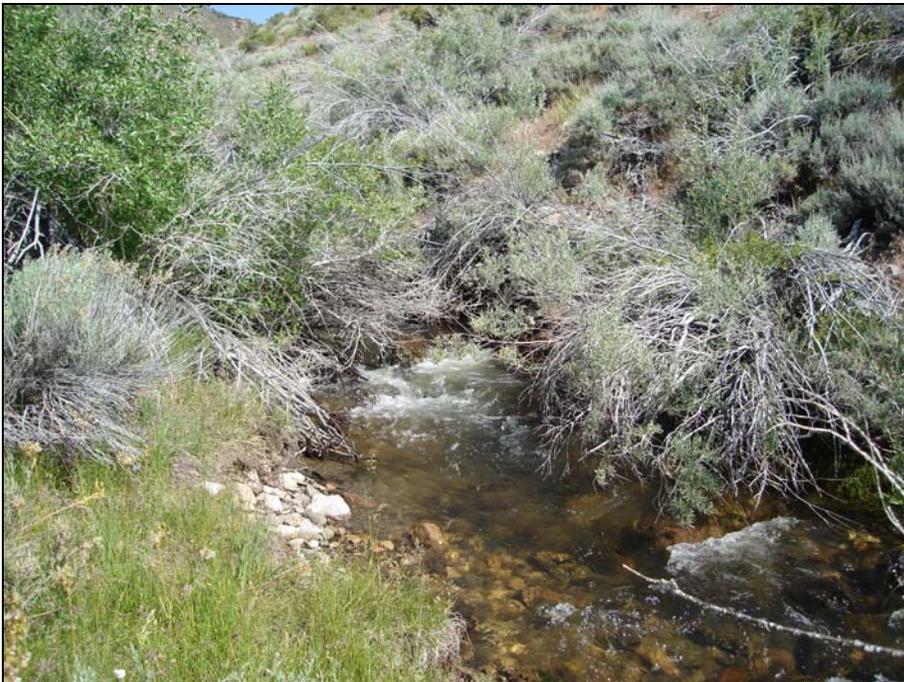
Site 1 continued: Long Valley Creek, Bridgeport Ranger District, looking upstream from the survey start point. This site is located at UTM: N: 4242647 & E: 296821, Elevation 2129m.

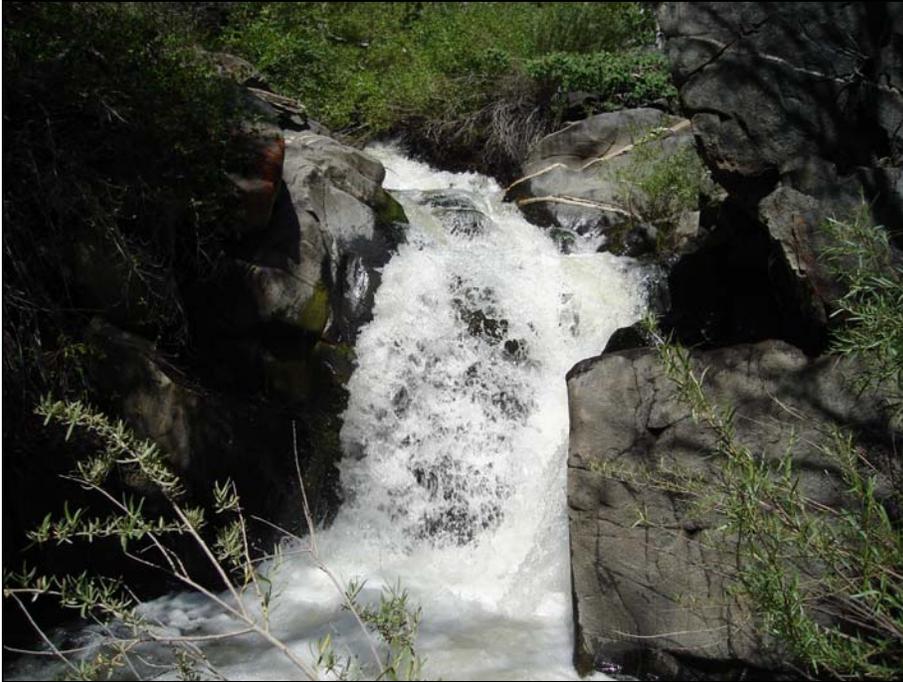
Site 2: Long Valley Creek, Bridgeport Ranger District, looking upstream at a permanent fish passage barrier. This waterfall is 2.5m (8.2ft) high. This site is located at UTM: N: 4242900 & E: 295661, Elevation 2229m.

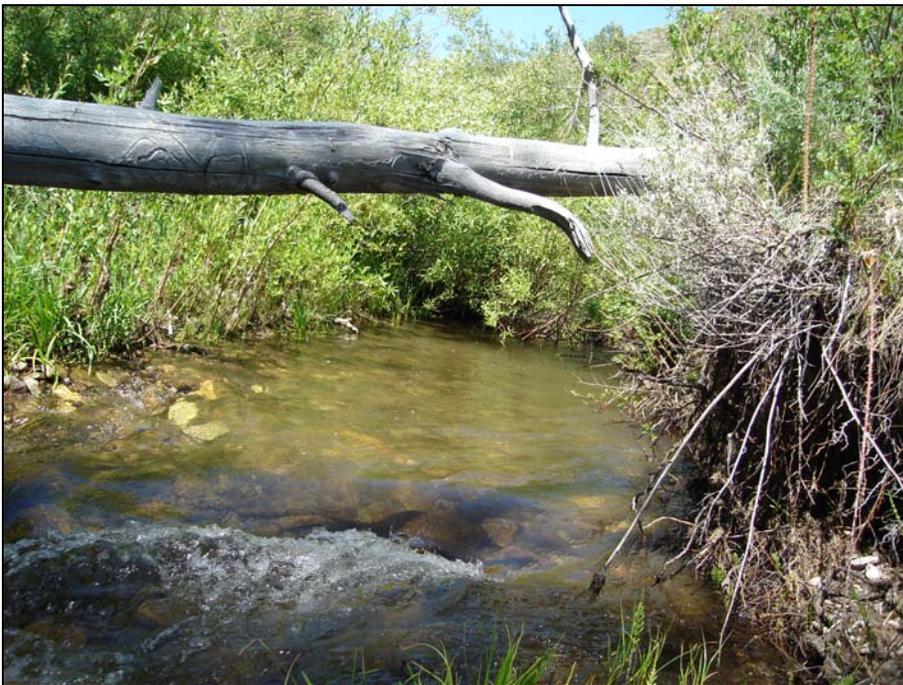
Site 3: Long Valley Creek, Bridgeport Ranger District, looking upstream at the stream characteristics typical for this section of stream. The water velocity has slowed a bit and the stream has good vegetative cover for shade and protection. This site is located at UTM: N: 4242765 & E: 295329, Elevation 2257m.

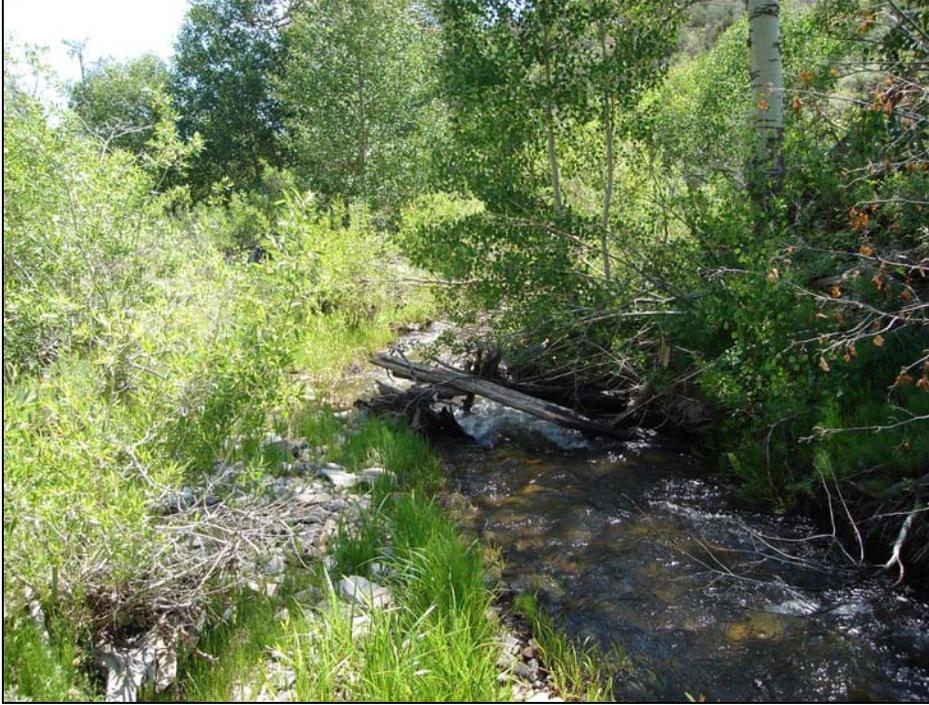
Site 3 continued: Long Valley Creek, Bridgeport Ranger District, looking downstream at the stream characteristics typical for this section of stream. The water velocity has slowed a bit and the stream has good vegetative cover for shade and protection. This site is located at UTM: N: 4242765 & E: 295329, Elevation 2257m.

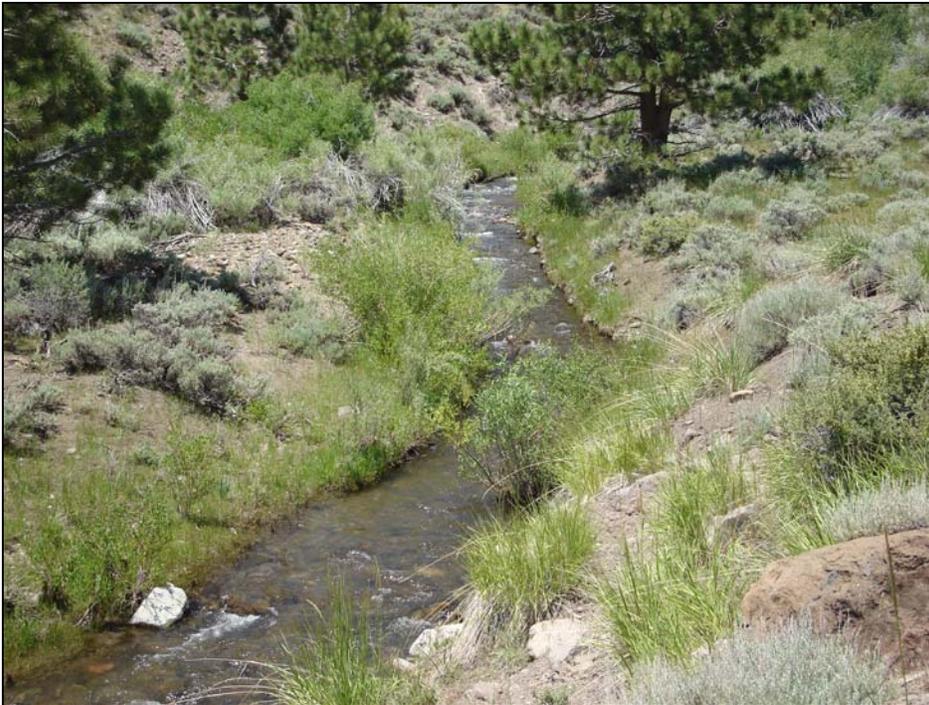
Site 4: Long Valley Creek, Bridgeport Ranger District, looking upstream at the stream characteristics typical for this section of stream. This site is located at UTM: N: 4242622 & E: 294428, Elevation 2301m.

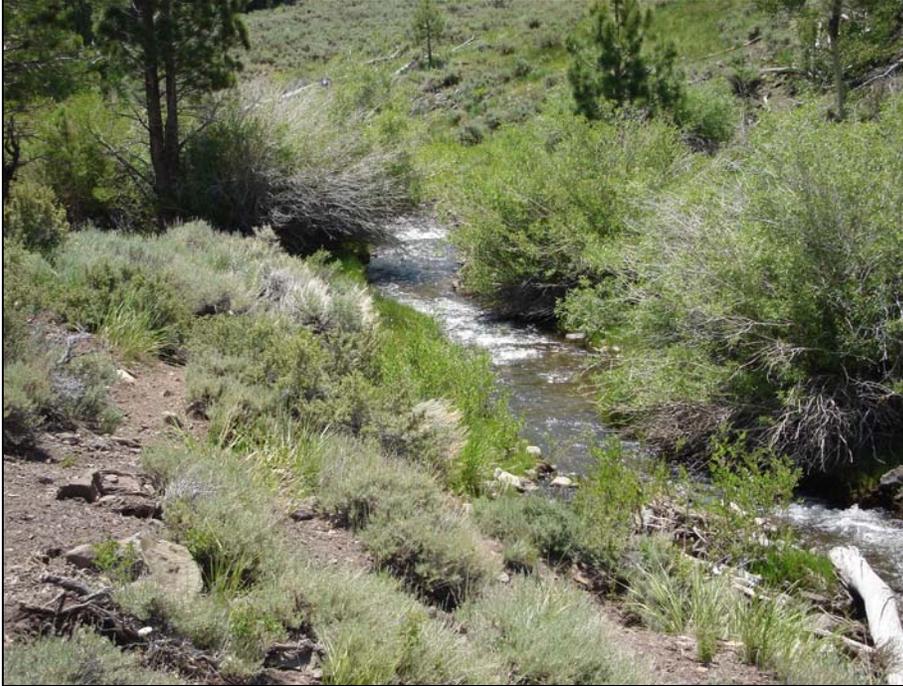
Site 4 continued: Long Valley Creek, Bridgeport Ranger District, looking downstream at the stream characteristics typical for this section of stream. This site is located at UTM: N: 4242622 & E: 294428, Elevation 2301m.

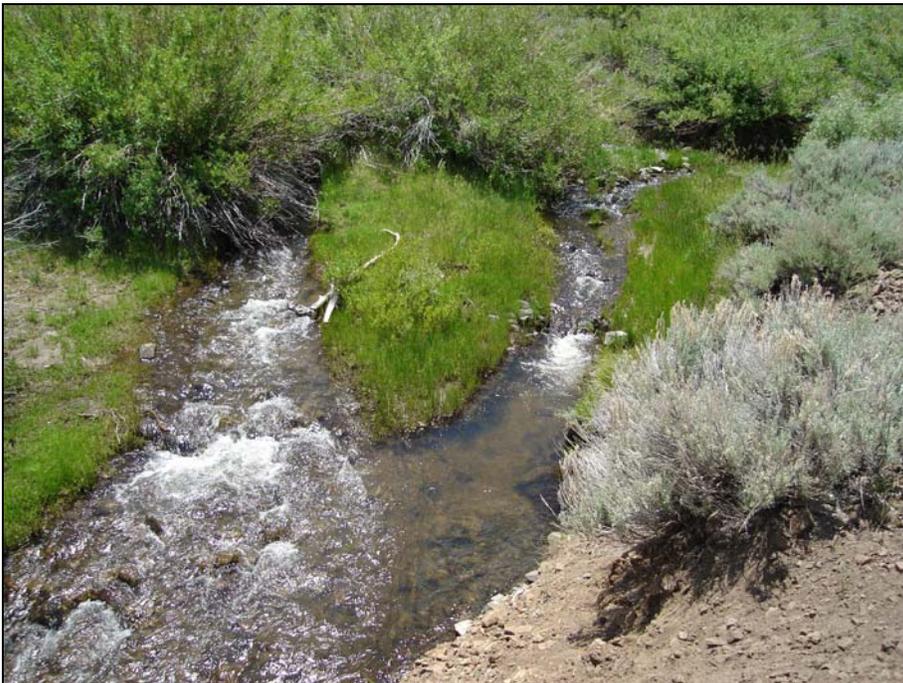
Site 5: Long Valley Creek, Bridgeport Ranger District, looking at where Huntoon Creek (picture left side) enters Long Valley Creek (picture right side). Huntoon Creek contributes approximately 60-70% of the overall flow in Long Valley Creek. This site is located at UTM: N: 4242602 & E: 294099, Elevation 2323m.

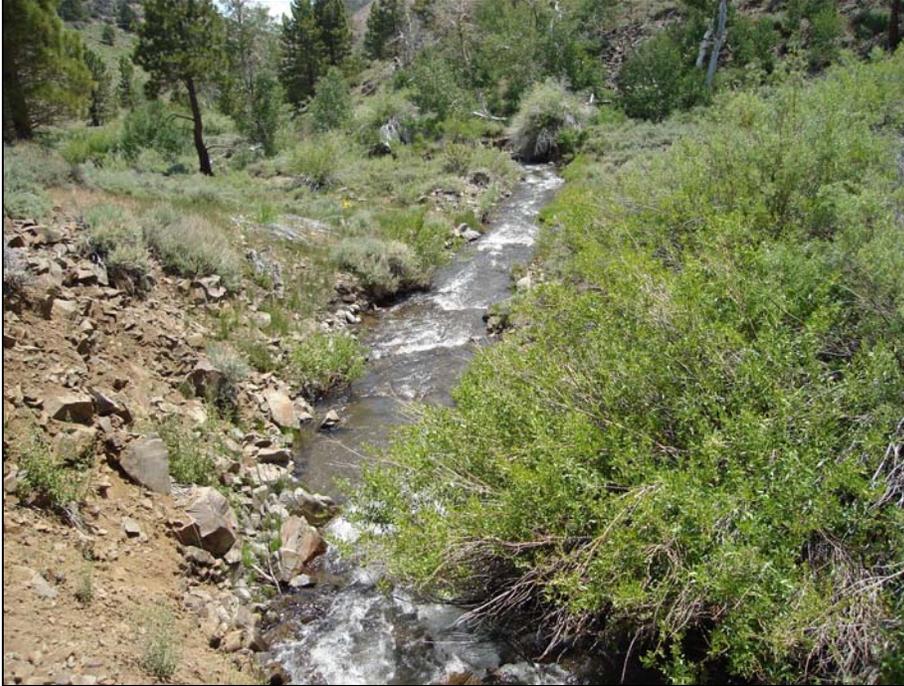
Site 5 continued: Long Valley Creek, Bridgeport Ranger District, looking downstream from the Huntoon Creek-Long Valley Creek confluence. This site is located at UTM: N: 4242602 & E: 294099, Elevation 2323m.

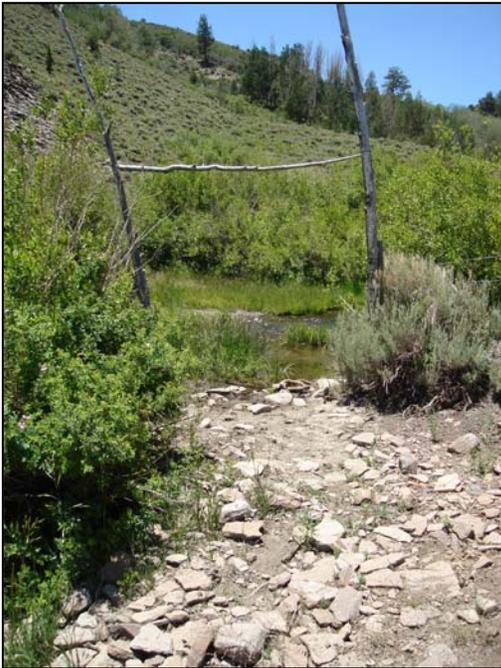
Site 6: Long Valley Creek, Bridgeport Ranger District, a cross-section view of a road crossing. This crossing appears to get little use. The gate is in disrepair and there is minimal erosion on the banks. This site is located at UTM: N: 4242649 & E: 292693, Elevation 2399m.

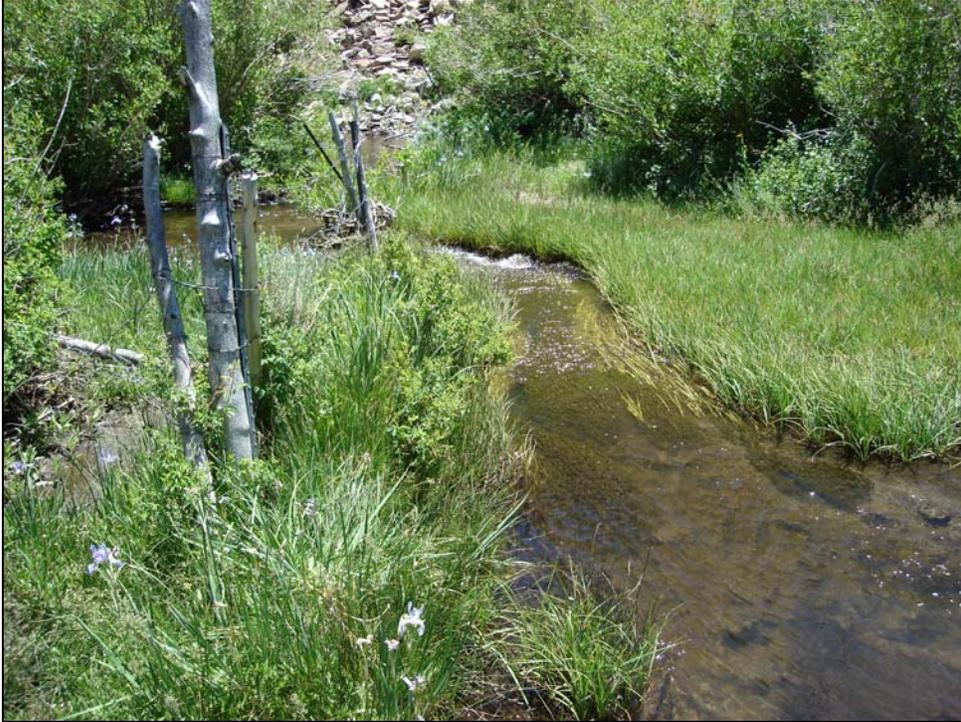
Site 6 continued: Long Valley Creek, Bridgeport Ranger District, another view of the gate looking downstream. This site is located at UTM: N: 4242649 & E: 292693, Elevation 2399m.

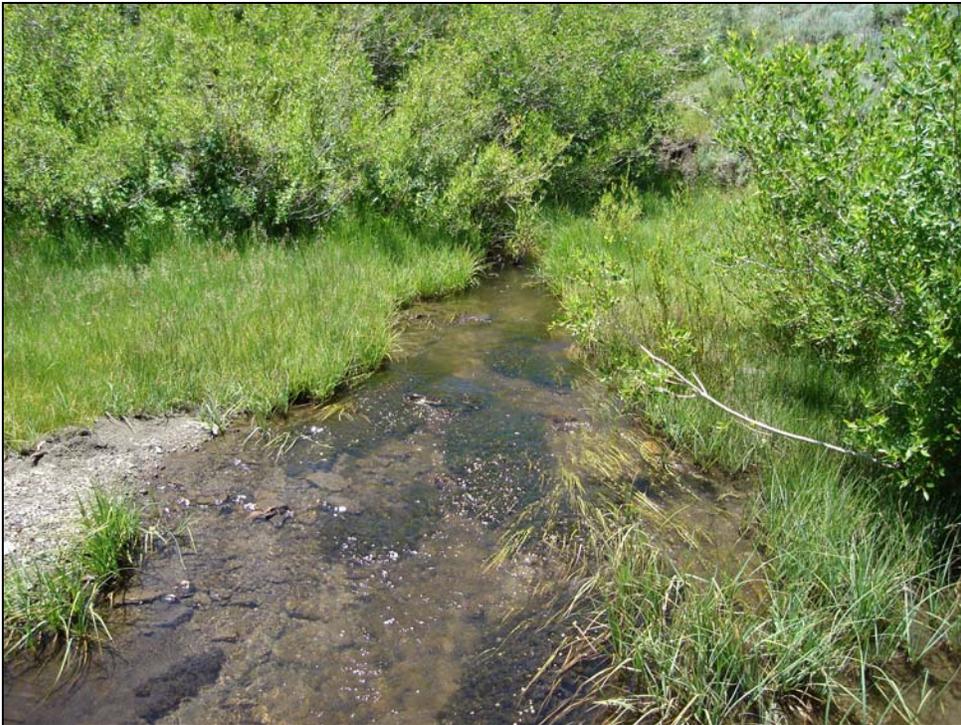
Site 6 continued: Long Valley Creek, Bridgeport Ranger District, a view looking upstream from the gate. This site is located at UTM: N: 4242649 & E: 292693, Elevation 2399m.

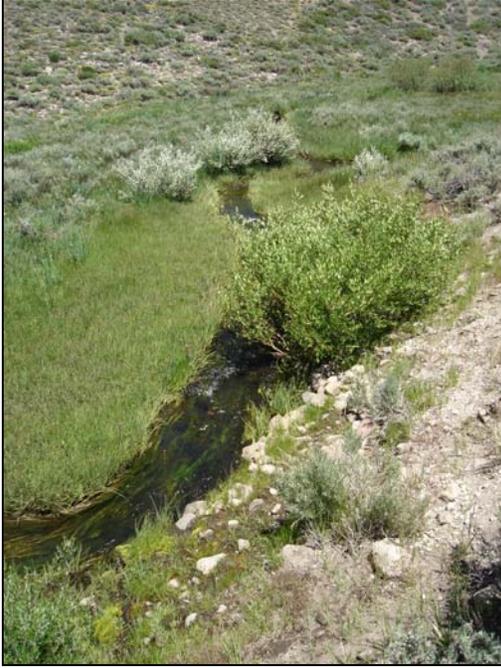
Site 7: Long Valley Creek, Bridgeport Ranger District, looking upstream at the stream characteristics typical for this section of stream. The stream here meanders heavily and has many seeps near the stream. This site is located at UTM: N: 4242914 & E: 292118, Elevation 2437m.

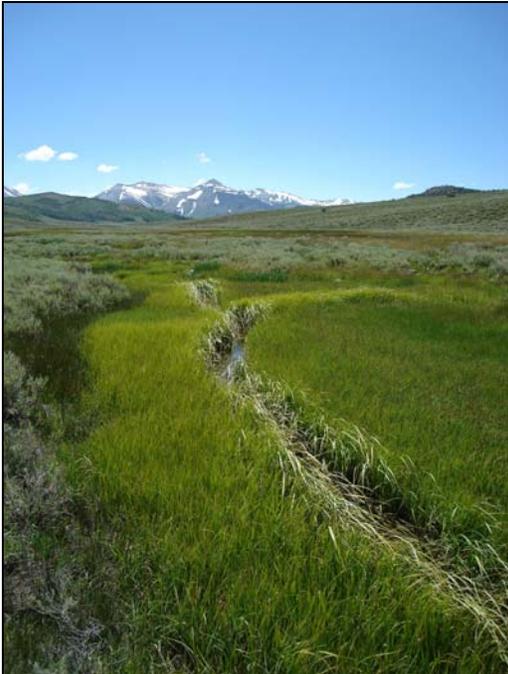
Site 8: Long Valley Creek, Bridgeport Ranger District, looking upstream from the survey end point. Upstream of this point the stream turns into a large meadow system that is extremely wet and the main channel disappears. This site is located at UTM: N: 4242879 & E: 291040, Elevation 2457m.
