**Mill Creek**  
Mono County, California

**2004 Fish & Habitat Survey Report**

**Bridgeport Ranger District**  
**Humboldt-Toiyabe National Forest**

# Mill Creek Lahontan Cutthroat Trout Survey - 2004

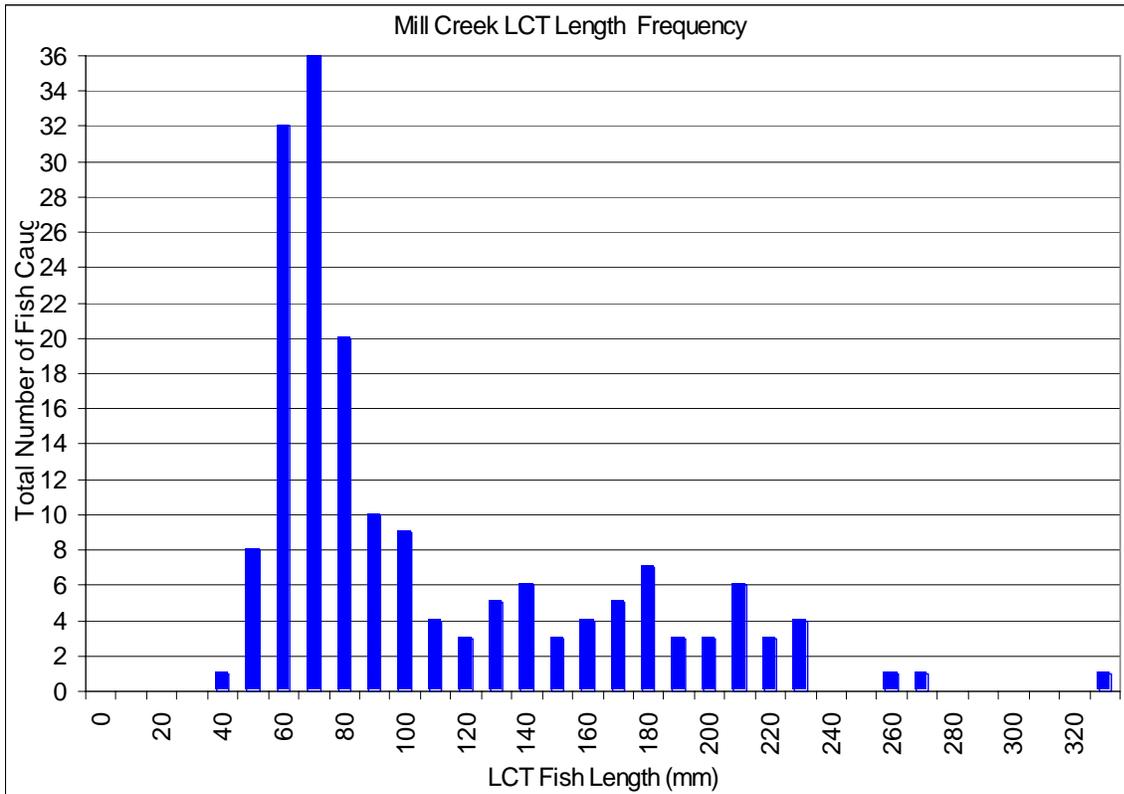
**Figure 1:** Length frequency of Lahontan cutthroat trout caught from Mill Creek, Bridgeport Ranger District. Mill Creek was surveyed from 21 September 2004 through 29 September 2004. The average length of LCT is 102 mm (4 inches).

The distribution of LCT within the Mill Creek watershed is limited to approximately 5.4 miles of Mill Creek. Lahontan cutthroat trout are distributed between Reach 2/Unit 1 and Reach 4/Unit 5 (Figures 4 & 5). The total length of LCT ranges from 38 to 325 mm total length with the average total length of LCT being 102 mm (Figure 1). The length frequency histogram (Figure 1) suggests that multiple age classes of LCT are found within the Mill Creek watershed.

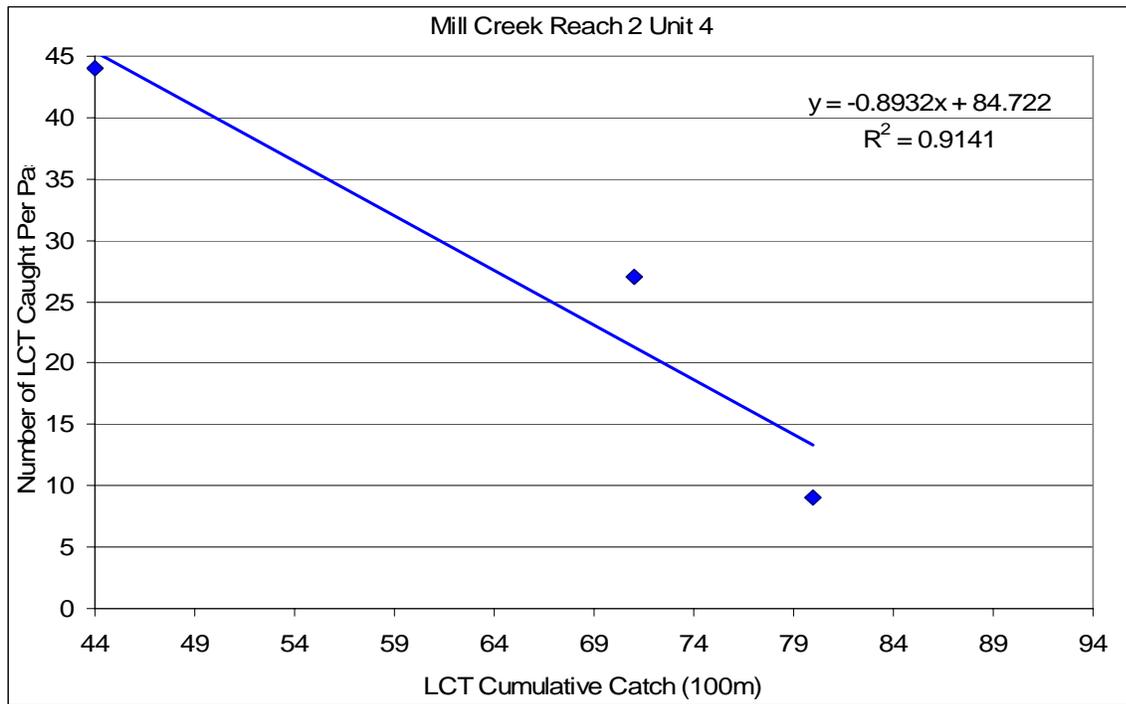
**Figure 2:** Linear regression equation for cumulative number of Lahontan cutthroat trout caught from Mill Creek, Bridgeport Ranger District, Reach 2/Unit 4. Using the linear regression equation, the estimated total number of LCT within Reach 2 Unit 4 is 95. Reach 2/Unit 4 was 100 meters long and was electroshocked three times. Block nets were set at the top and bottom of the unit to keep fish from entering and leaving the unit. Reach 2/Unit 4 is located at UTM N: 4260436 & E: 282884. Survey was conducted on 22 Sept. 2004. Forty-four fish caught on the first pass is 46% of the estimated total number of LCT within the 100 meter long unit; therefore, the estimated miss rate of LCT from Reach2/Unit 4 is 54%. Zero fish were caught at Reach 1 unit 4.

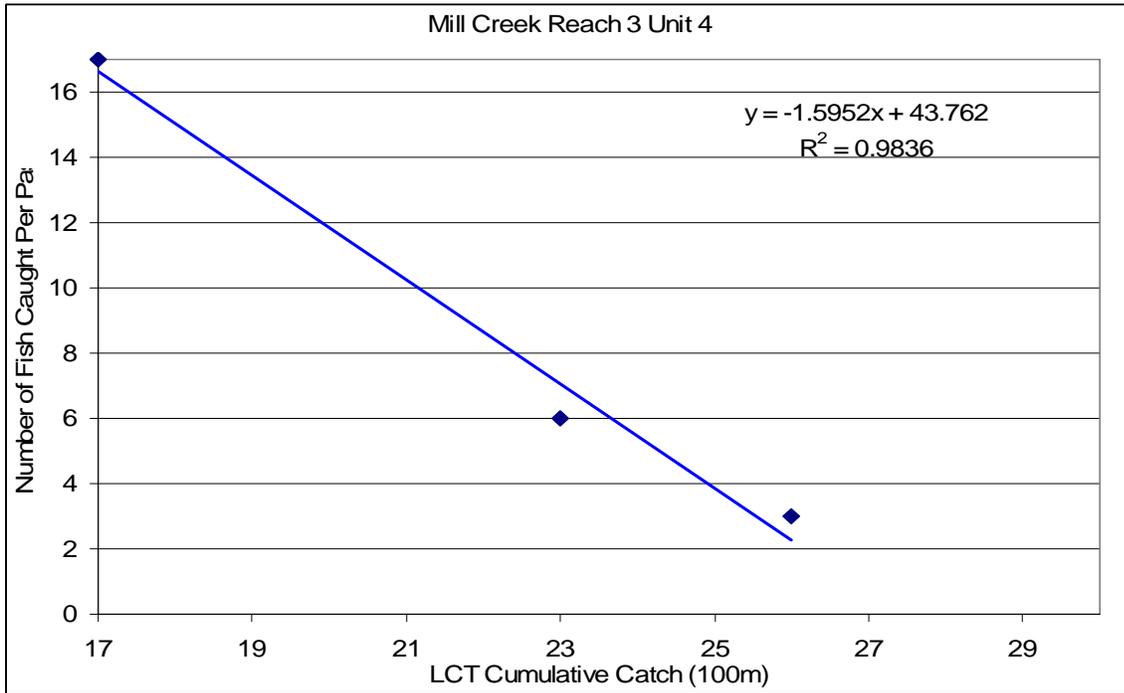
**Figure 3:** Linear regression equation for cumulative number of Lahontan cutthroat trout caught from Mill Creek, Bridgeport Ranger District, Reach 3/Unit 4. Using the linear regression equation, the estimated total number of LCT within Reach 3 Unit 4 is 27. Reach 3/Unit 4 was 100 meters long and was electroshocked three times. Block nets were set at the top and bottom of the unit to keep fish from entering and leaving the unit. Reach 3/Unit 4 is located at UTM N: 4258335 & E: 282871. Survey was conducted on 28 Sept. 2004. Seventeen fish caught on the first pass is 63% of the estimated total number of LCT within Reach 3/Unit4; therefore, the estimated miss rate of LCT from Reach 3/Unit 4 is 37%.

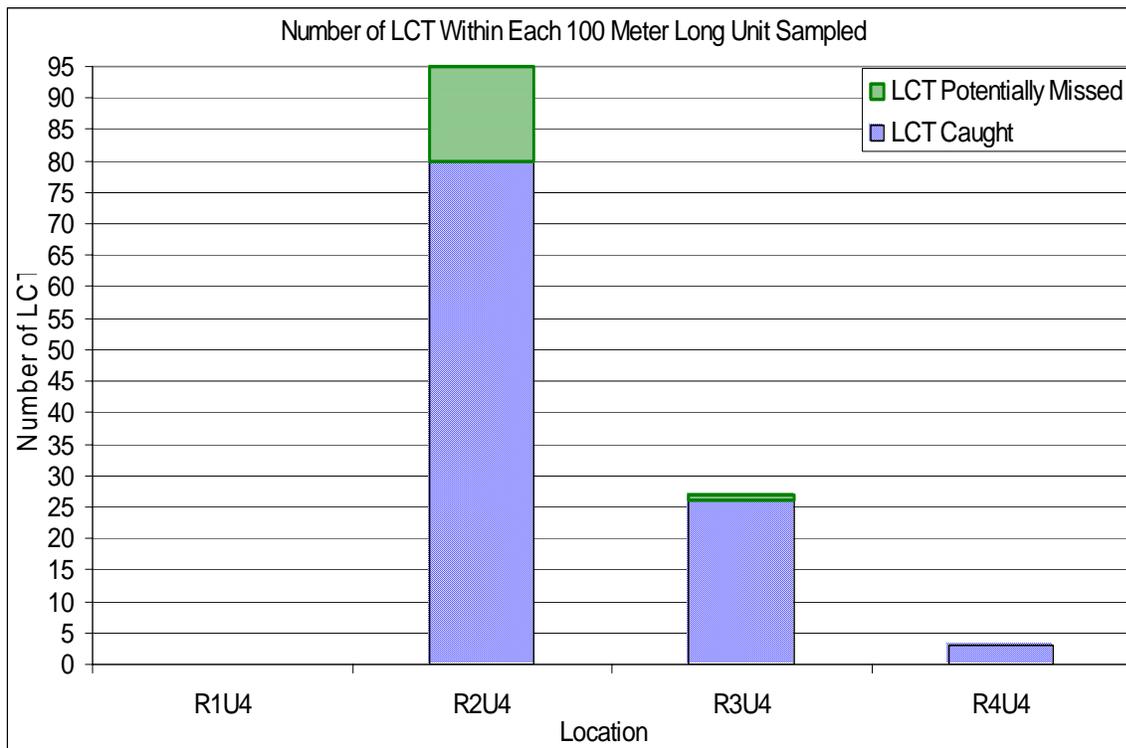
**Figure 4:** Number of LCT captured and potentially missed from each 100 meter long unit sampled on Mill Creek, Bridgeport Ranger District. Surveys were conducted from 21 September 2004 through 29 September 2004. Each unit was electrofished three times. Block nets were set up at the top and bottom of each 100 meter long unit to keep fish from entering and leaving the sample area. Linear regression equations were used to estimate the total number of LCT within each 100 meter long unit sampled (Figures 2 & 3).

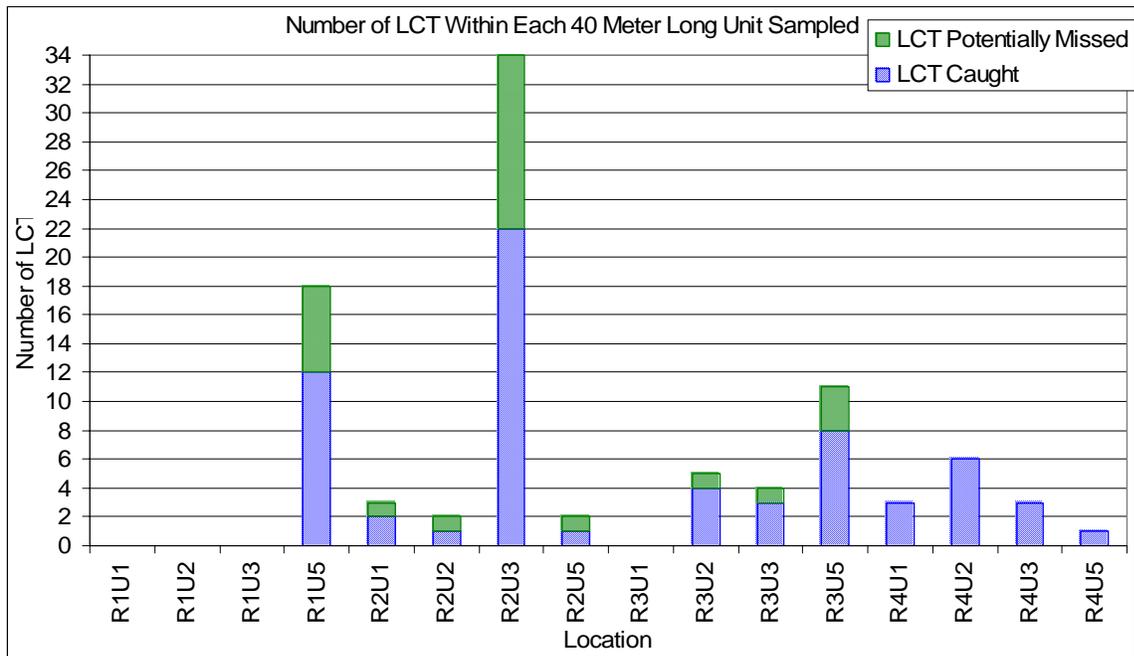
**Figure 5:** Number of LCT captured and potentially missed from each 40 meter long unit sampled on Mill Creek, Bridgeport Ranger District. Surveys were conducted from 21 September 2004 through 29 September 2004. Each unit was electrofished one time. Reach 1/Unit 5, and Reach 2/Units 1, 2, 3, and 5 all had habitat similar to the habitat within Reach 2/Unit 4. Reach 2/Unit 4 had a miss rate of 54% (Figure 1); therefore, an additional 54% of the captured LCT from each unit was added to Reach 1/Unit 5 and Reach 2/Units 1, 2, 3, and 5 to account for potentially missed LCT from each unit. Reach 3/Units 2, 3, and 5 all had habitat similar to the habitat within Reach 3/Unit 4. Reach 3/Unit 4 had an estimated miss rate of 37% (Figure 2); therefore, an additional 37% of the captured LCT from each unit was added to Reach 3/Units 2, 3, and 5 to account for potentially missed LCT. Habitat within Reach 4/Units 1, 2, 3, and 5 was not similar to the habitat within Reach 4/Unit 4 so no additional percentage of LCT was added to Reach 4 Units.

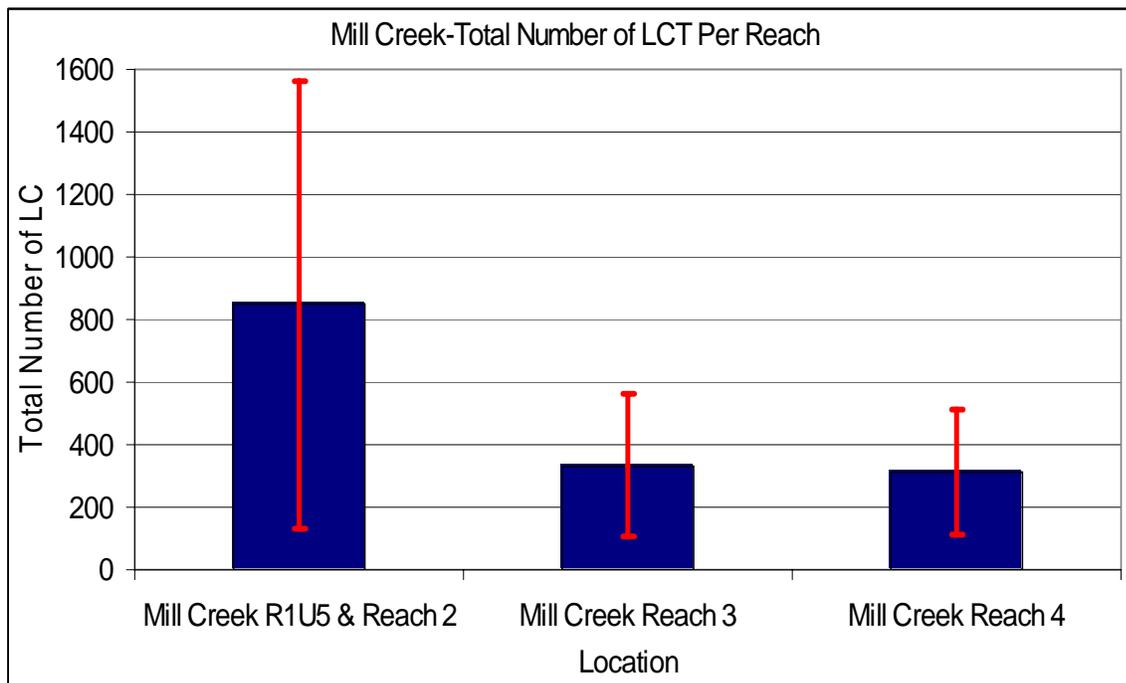
**Figure 6:** Means and 90% confidence intervals for the estimated total number of LCT within Reach 1/Unit 5 and Reach 2, Reach 3, and Reach 4 on Mill Creek, Bridgeport Ranger District. Surveys were conducted from 21 September 2004 through 29 September 2004. For R1U5 and Reach 2 the mean number of LCT is 849, the upper 90% confidence interval is 1564, and the lower 90% confidence interval is 133. For Reach 3 the mean number of LCT is 333, the upper 90% confidence interval is 562, and the lower 90% confidence interval is 103. For Reach 4 the mean number of LCT is 315, the upper 90% confidence interval is 514, and the lower 90% confidence interval is 114. The distance between R1U5 and the end of Reach 2 is approximately 1.3 miles long, the length of Reach 3 is approximately 1.34 miles long, and the length of Reach 4 is approximately 2.75 miles long.

The mean number of LCT between Reach 1/Unit 5 and the end of Reach 2 is 849 (Figure 6). The upper 90% confidence interval is 1564 and the lower 90% confidence interval is 133 (Figure 6). The distance between Reach 1/Unit 5 and the end of Reach 2 is approximately 1.3 miles. The mean number of LCT within Reach 3 is 333 (Figure 6). The upper 90% confidence interval is 562 and the lower 90% confidence interval is 103 (Figure 6). The length of Reach 3 is approximately 1.34 miles. The mean number of LCT within Reach 4 is 315 (Figure 6). The upper 90% confidence interval is 514 and the lower 90% confidence interval is 114 (Figure 6). The length of Reach 4 is approximately 2.75 miles. The mean number of LCT within the entire watershed of Mill Creek is 1496 (Figure 7). The upper 90% confidence interval is 2642 and the lower 90% confidence interval is 351 (Figure 7). The mean number of LCT/mile within the entire Mill Creek watershed is 277 (Figure 8). The upper 90% confidence interval is 489 and the lower 90% confidence interval is 65 (Figure 8).

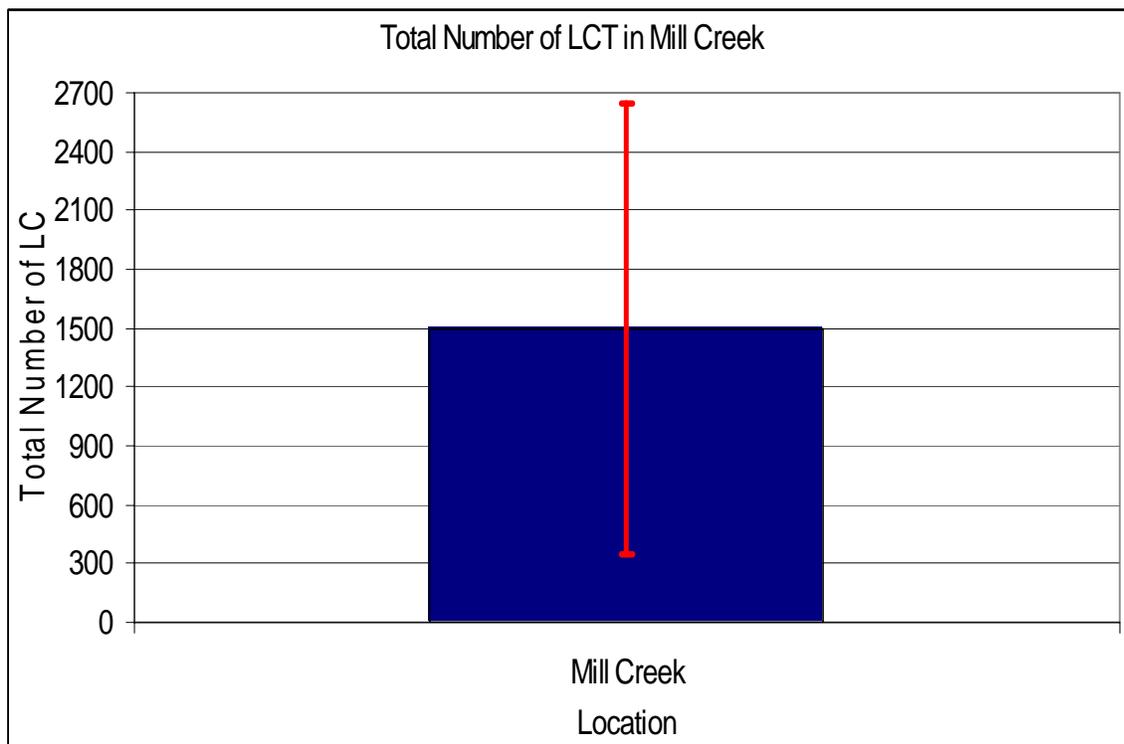
**Figure 7:** Mean and 90% confidence interval for the estimated total number of LCT within Mill Creek, Bridgeport Ranger District. Surveys were conducted from 21 September 2004 through 29 September 2004. The mean number of LCT is 1496, the upper 90% confidence interval is 2642, and the lower 90% confidence interval is 351. Lahontan cutthroat trout in Mill Creek are occupying approximately 5.4 miles of stream habitat.

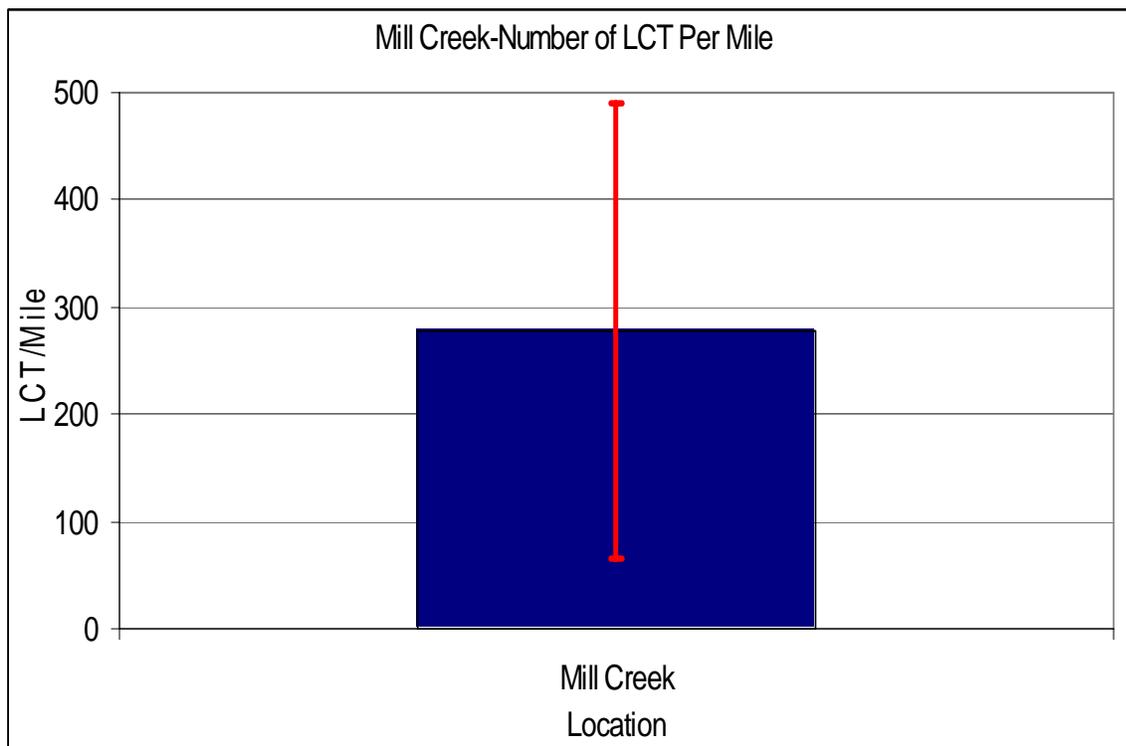
**Figure 8:** Mean number of LCT/mile and 90% confidence interval for LCT in Mill Creek, Bridgeport Ranger District. Surveys were conducted from 21 September 2004 through 29 September 2004. The mean number of LCT/Mile is 277, the upper 90% confidence interval is 489, and the lower 90% confidence interval is 65. Lahontan cutthroat trout in Mill Creek are occupying approximately 5.4 miles of stream habitat.

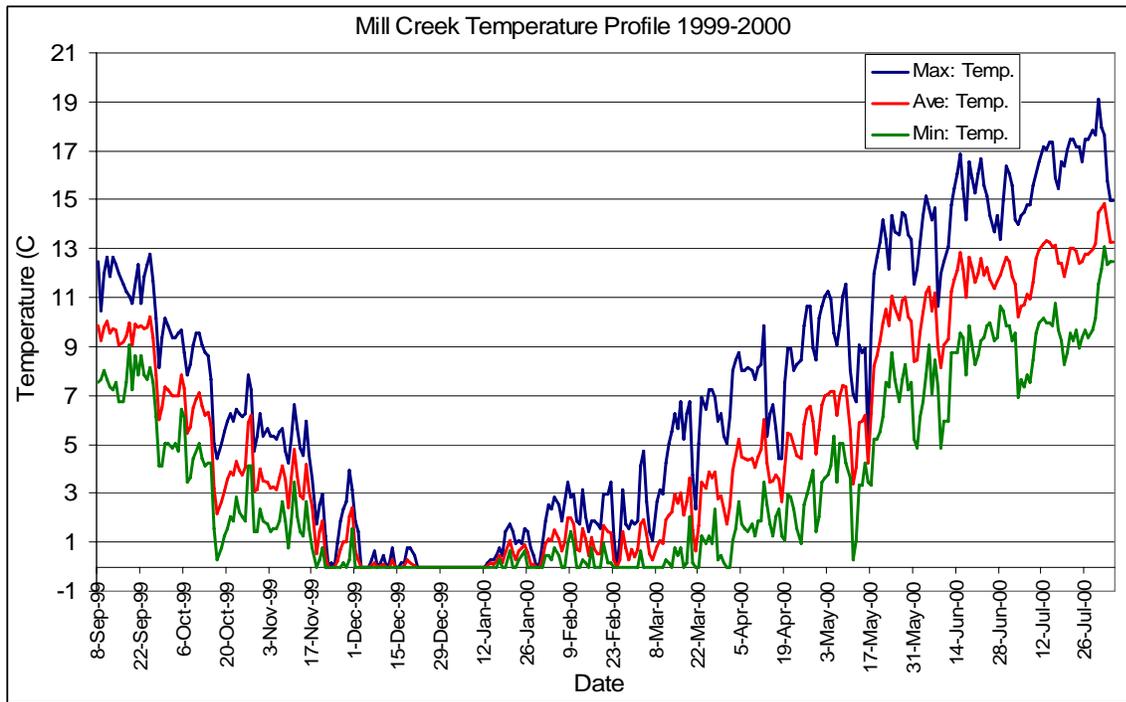
**Figure 9:** 1999-2000 temperature profile for Mill Creek, Bridgeport Ranger District. The overall maximum temperature was 19.11 degrees Celsius, the overall average temperature was 5.13 degrees Celsius, and the overall minimum temperature was -0.02 degrees Celsius. The average temperature between 1 Nov. 1999 and 31 March 2000 was 1.13 degrees Celsius. The average temperature between 8 Sept. 1999 and 31 Oct.1999, and between 1 April 2000 and 4 Aug. 2000 was 8.04 degrees Celsius. An Optic StowAway – Temp (C) Onset -4C to 38C was used to collect the temperature data. Temperature was collected from 8 Sept. 1999 to 4 Aug. 2000. Temperature was collected on California state land near Reach 2 Unit 2.

An Optic StowAway – Temp (C) Onset -4C to 38C was used to collect temperature data on California State lands near Reach 2 Unit 2 between 1999 and 2004. In 1999-2000 temperature was collected from 8 Sept. 1999 to 4 Aug. 2000. During that time period the overall maximum temperature was 19.11 degrees Celsius, the overall average temperature was 5.13 degrees Celsius, and the overall minimum temperature was -0.02 degrees Celsius. The average temperature between 1 Nov. 1999 and 31 March 2000 was 1.13 degrees Celsius. The average temperature between 8 Sept. 1999 and 31 Oct. 1999, and between 1 April 2000 and 4 Aug. 2000 was 8.04 degrees Celsius (Figure 9).

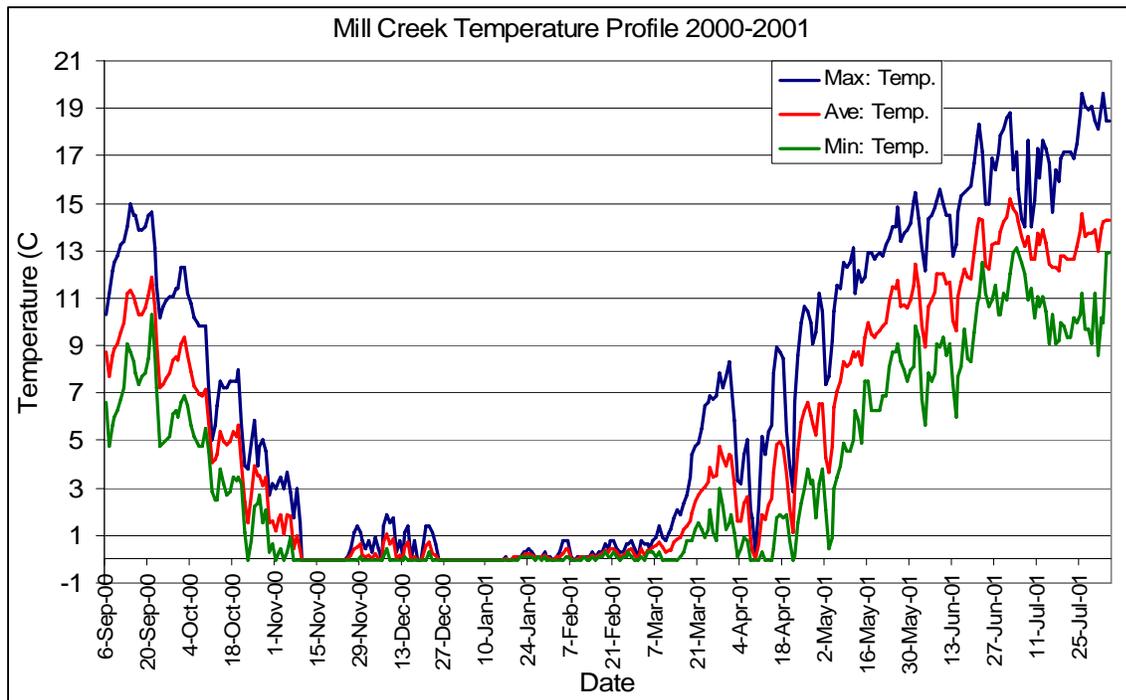
**Figure 10:** 2000-2001 temperature profile for Mill Creek, Bridgeport Ranger District. The overall maximum temperature was 19.6 degrees Celsius, the overall average temperature was 5.06 degrees Celsius, and the overall minimum temperature was -0.02 degrees Celsius. The average temperature between 1 Nov. 2000 and 31 March 2001 was 0.55 degrees Celsius. The average temperature between 6 Sept. 2000 and 31 Oct.2000, and between 1 April 2001 and 4 Aug. 2001 was 8.31 degrees Celsius. An Optic StowAway – Temp (C) Onset -4C to 38C was used to collect the temperature data. Temperature was collected from 6 Sept. 2000 to 4 Aug. 2001. Temperature was collected on California state land near Reach 2 Unit 2.

In 2000-2001 temperature was collected from 6 Sept. 2000 to 4 Aug. 2001. During that time period the overall maximum temperature was 19.6 degrees Celsius, the overall average temperature was 5.06 degrees Celsius, and the overall minimum temperature was -0.02 degrees

Celsius. The average temperature between 1 Nov. 2000 and 31 March 2001 was 0.55 degrees Celsius. The average temperature between 6 Sept. 2000 and 31 Oct.2000, and between 1 April 2001 and 4 Aug. 2001 was 8.31 degrees Celsius (Figure 10).

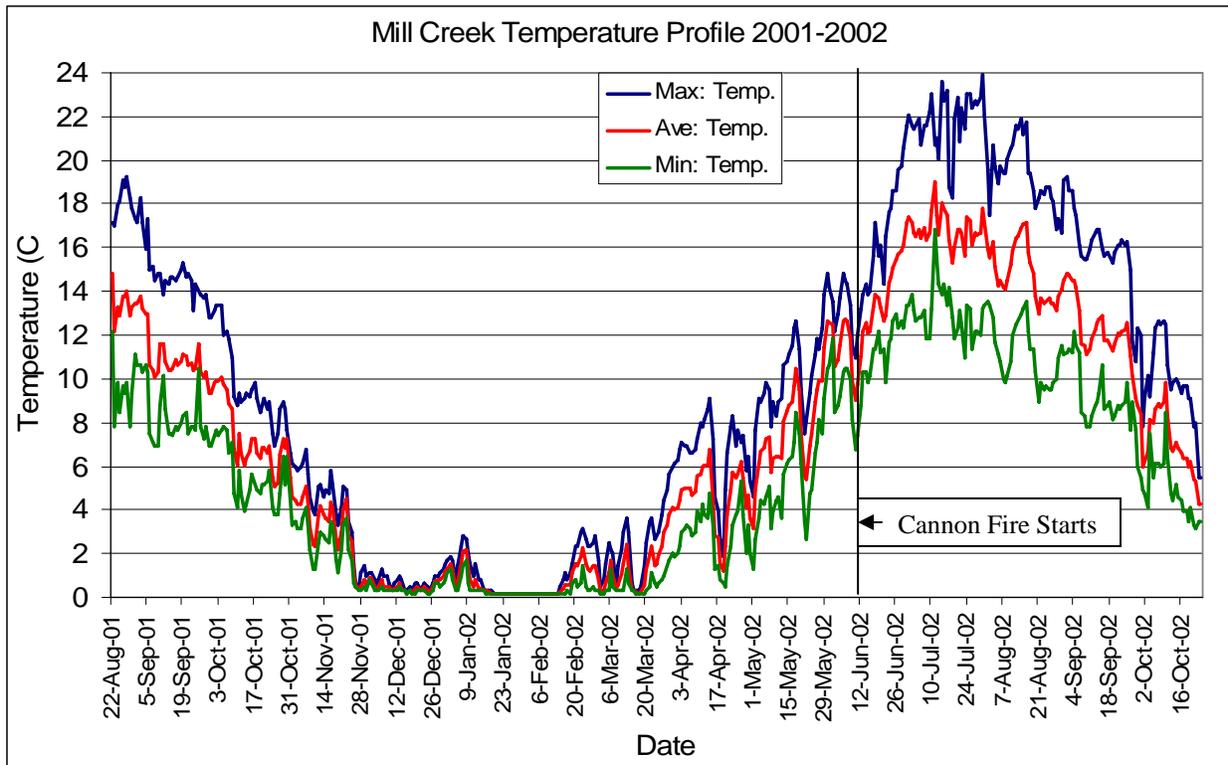
**Figure 11:** 2001-2002 temperature profile for Mill Creek, Bridgeport Ranger District. The overall maximum temperature before the Cannon Fire was 19.27 degrees Celsius, the overall average temperature before the Cannon Fire was 4.80 degrees Celsius, and the overall minimum temperature before the Cannon Fire was 0.13 degrees Celsius. The average temperature between 1 Nov. 2001 and 31 March 2002 was 1.27 degrees Celsius. The average temperature between 22 Aug. 2001 and 31 Oct.2001, and between 1 April 2002 and 14 June 2002 was 8.50 degrees Celsius. The Cannon Fire started on 15 June 2002. The maximum temperature after the Cannon Fire was 23.91 degrees Celsius. The average temperature after the Cannon Fire between 15 June 2002 and 24 Oct. 2002 was 13.17 degrees Celsius. An Optic StowAway – Temp (C) Onset -4C to 38C was used to collect the temperature data. Temperature was collected from 22 Aug. 2001 to 24 Oct. 2002. Temperature was collected on California state land near Reach 2 Unit 2.

In 2001-2002 temperature was collected from 22 Aug. 2001 to 24 Oct. 2002. During that time period the overall maximum temperature before the Cannon Fire was 19.27 degrees Celsius, the overall average temperature before the Cannon Fire was 4.80 degrees Celsius, and the overall minimum temperature before the Cannon Fire was 0.13 degrees Celsius. The average temperature between 1 Nov. 2001 and 31 March 2002 was 1.27 degrees Celsius. The average temperature between 22 Aug. 2001 and 31 Oct. 2001, and between 1 April 2002 and 14 June 2002 was 8.50 degrees Celsius. The Cannon Fire started on 15 June 2002. The maximum temperature after the Cannon Fire was 23.91 degrees Celsius. The average temperature after the Cannon Fire between 15 June 2002 and 24 Oct. 2002 was 13.17 degrees Celsius (Figure 11).

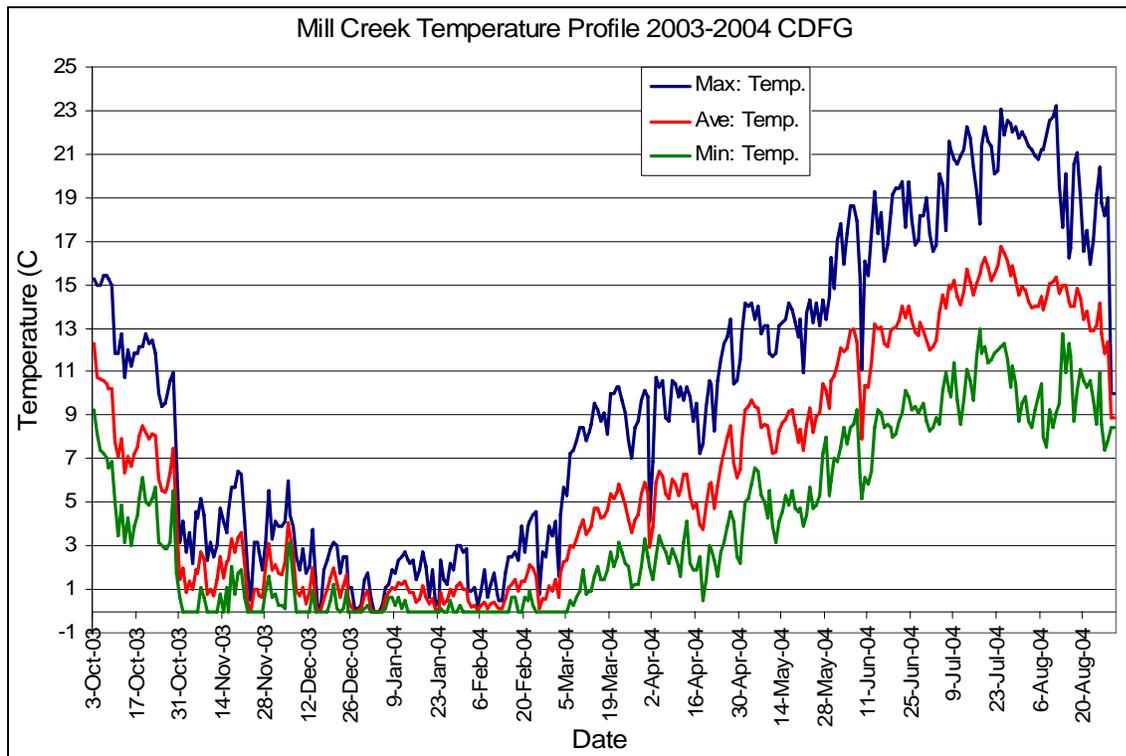
**Figure 12:** 2003-2004 temperature profile for Mill Creek, Bridgeport Ranger District. The overall maximum temperature was 23.2 degrees Celsius, the overall average temperature was 6.52 degrees Celsius, and the overall minimum temperature was -0.02 degrees Celsius. The average temperature between 1 Nov. 2003 and 31 March 2004 was 1.70 degrees Celsius. The average temperature between 3 Oct. 2003 and 31 Oct.2003, and between 1 April 2004 and 30 Aug. 2004 was 9.42 degrees Celsius. An Optic StowAway – Temp (C) Onset -4C to 38C was used to collect the temperature data. Temperature was collected from 3 Oct. 2003 to 30 Aug. 2004. Temperature was collected on California state land near Reach 2 Unit 2.

In 2003-2004 temperature was collected from 3 Oct. 2003 to 30 Aug. 2004. During that time period the overall maximum temperature was 23.2 degrees Celsius, the overall average temperature was 6.52 degrees Celsius, and the overall minimum temperature was -0.02 degrees Celsius. The average temperature between 1 Nov. 2003 and 31 March 2004 was 1.70 degrees Celsius. The average temperature between 3 Oct. 2003 and 31 Oct. 2003, and between 1 April 2004 and 30 Aug. 2004 was 9.42 degrees Celsius (Figure 12).

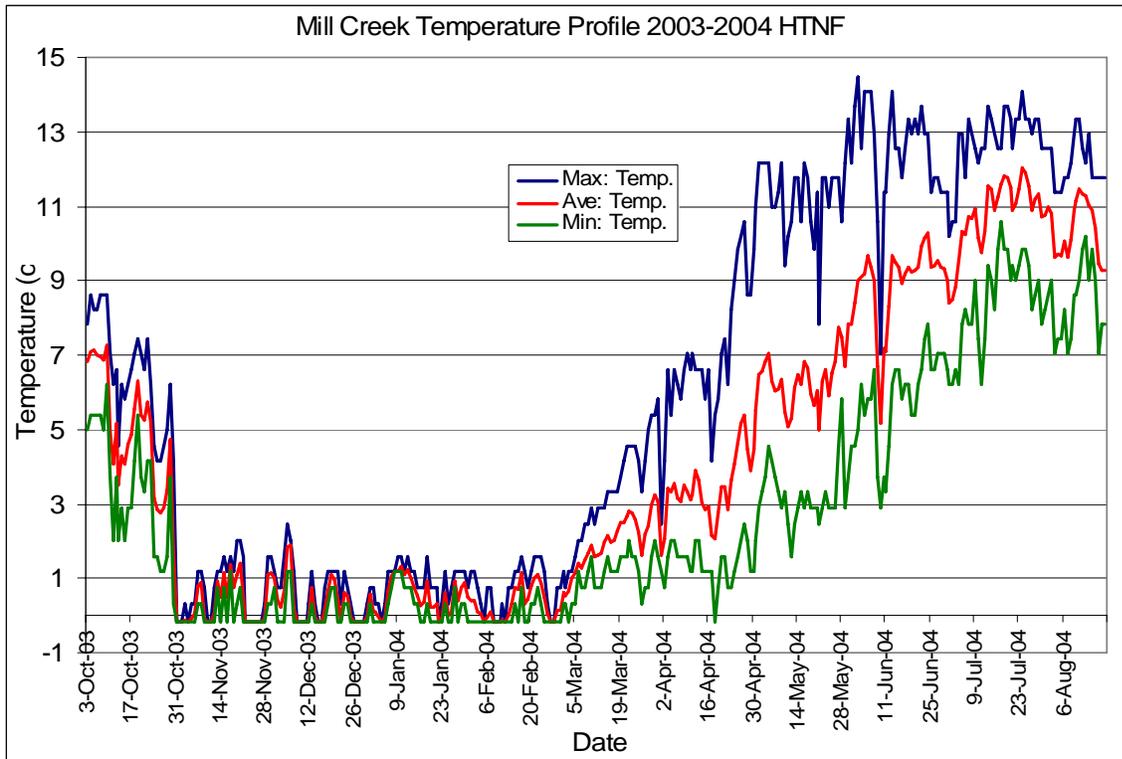
**Figure 13:** 2003-2004 temperature profile for Mill Creek, Bridgeport Ranger District. The overall maximum temperature was 14.47 degrees Celsius, the overall average temperature was 4.17 degrees Celsius, and the overall minimum temperature was -0.16 degrees Celsius. The average temperature between 1 Nov. 2003 and 31 March 2004 was 0.69 degrees Celsius. The average temperature between 3 Oct. 2003 and 31 Oct. 2003, and between 1 April 2004 and 19 Aug. 2004 was 6.30 degrees Celsius. A HOBO Temperature (C) 1996 Onset data logger was used to collect the temperature data. The HOBO Temp was located near Reach 4 Unit 2 at 7240 feet elevation. The HOBO Temp was located at UTM N: 4256941 & E: 283201 on National Forest Lands. Temperature was collected from 3 Oct. 2003 to 19 Aug. 2004.

Also in 2003-2004 a HOBO Temperature (C) 1996 Onset data logger was used to collect temperature data in Mill Creek on National Forest Lands just upstream of Reach 4 Unit 2 at 7240 feet elevation. Temperature was collected from 3 Oct. 2003 to 19 Aug. 2004. During that time period the overall maximum temperature was 14.47 degrees Celsius, the overall average temperature was 4.17 degrees Celsius, and the overall minimum temperature was -0.16 degrees Celsius. The average temperature between 1 Nov. 2003 and 31 March 2004 was 0.69 degrees Celsius. The average temperature between 3 Oct. 2003 and 31 Oct. 2003, and between 1 April 2004 and 19 Aug. 2004 was 6.30 degrees Celsius (Figure 13).

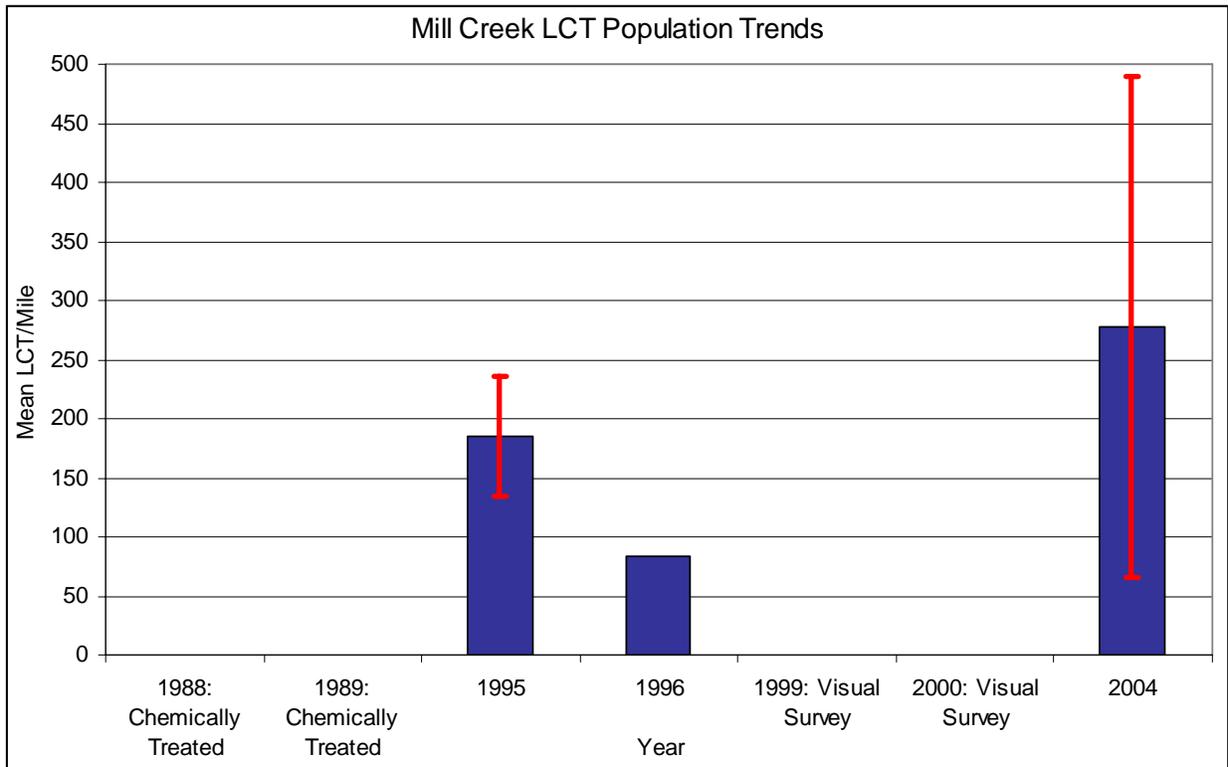
**Figure 14:** Mean number of LCT/mile and 90% confidence intervals for Lahontan cutthroat trout in Mill Creek, Bridgeport Ranger District, between 1995 and 2004. Not enough information was provided in the 1996 report to compute a confidence interval. In 2004 a 2-3 pass depletion survey was conducted. In 1995 and 1996 only a one pass depletion survey was conducted; therefore, the 185 LCT/mile in 1995 and 83 LCT/mile in 1996 are probably conservative. In 1995, LCT were occupying approximately 2 miles of stream habitat. In 2004 LCT were occupying approximately 5.4 miles of stream habitat.

The 2004 Lahontan cutthroat trout population estimate is higher than the 1995 and 1996 population estimates (Figure 14). In 1995 and 1996 only a one pass depletion survey was conducted; therefore, the 1995 and 1996 population estimates may be conservative. In 1995, LCT were occupying approximately 2 miles of stream habitat only on CDFG land within reaches 1 and 2. In 1996, LCT extended their distribution upstream onto National Forest Lands. This may be the reason why the LCT population estimate in 1996 was lower than the 1995 population estimate. In 2004 a 2-3 pass depletion survey was conducted. Visual surveys were conducted in 1999 and 2000.

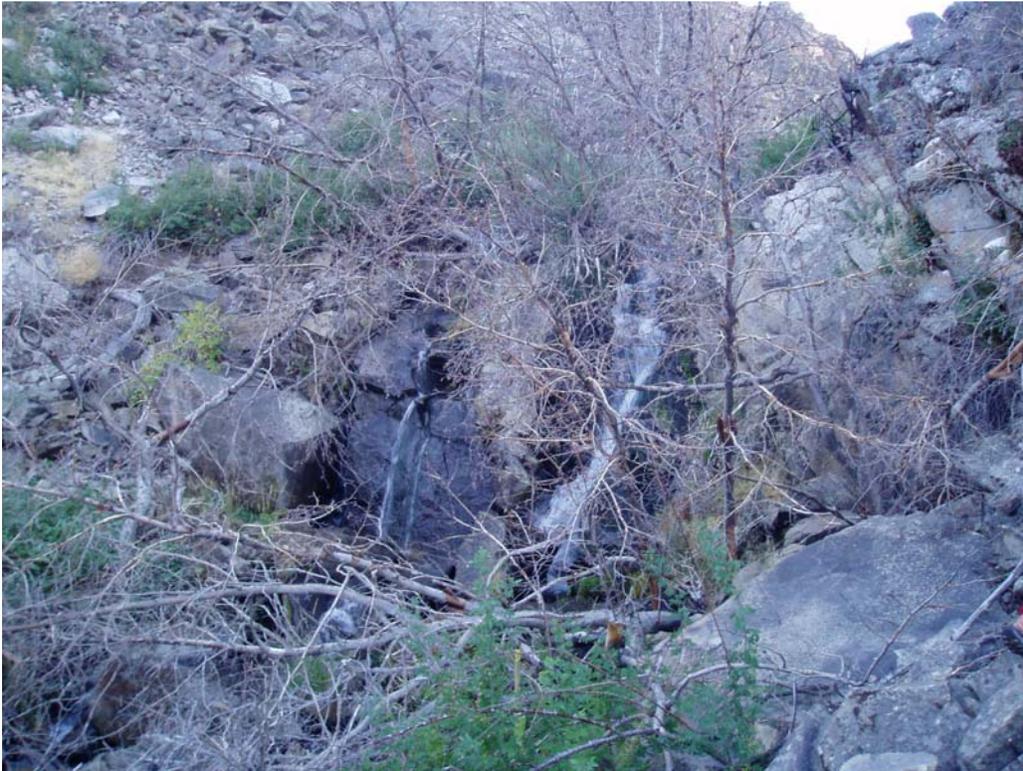
Mill Creek was broken into four reaches. Reaches 1 and 2 were located within the area that was burned by the 2002 Cannon Fire. Reach 1 started at the natural barrier (Figure 15) located just upstream of the Lost Cannon Creek-Mill Creek confluence. Reaches 1 and 2 had similar habitats, so each reach was divided into similar lengths. Reaches 1 and 2 were each approximately 1.25 miles in length. Reach 3 was above the area burned by the 2002 Cannon Fire. Reach 3 was approximately 1.3 miles in length and ends at a tributary that enters Mill Creek from the west side that contributes more than 10% to the overall Mill Creek flow. Reach 4 was approximately 2.75 miles in length and also ends at a tributary that enters Mill Creek from the west side that contributes approximately 75% to the overall Mill Creek flow. Upstream of Reach 4/Unit 5 Mill Creek became dry.

**Figure 15:** Mill Creek, Bridgeport Ranger District, fish barrier just upstream of the Lost Cannon Creek-Mill Creek confluence. Picture was taken on 21 Sept. 04. Barrier is located at UTM N: 4263238.01 & E: 283594.30 and is at 5971 feet elevation. The barrier is approximately 20 feet high.

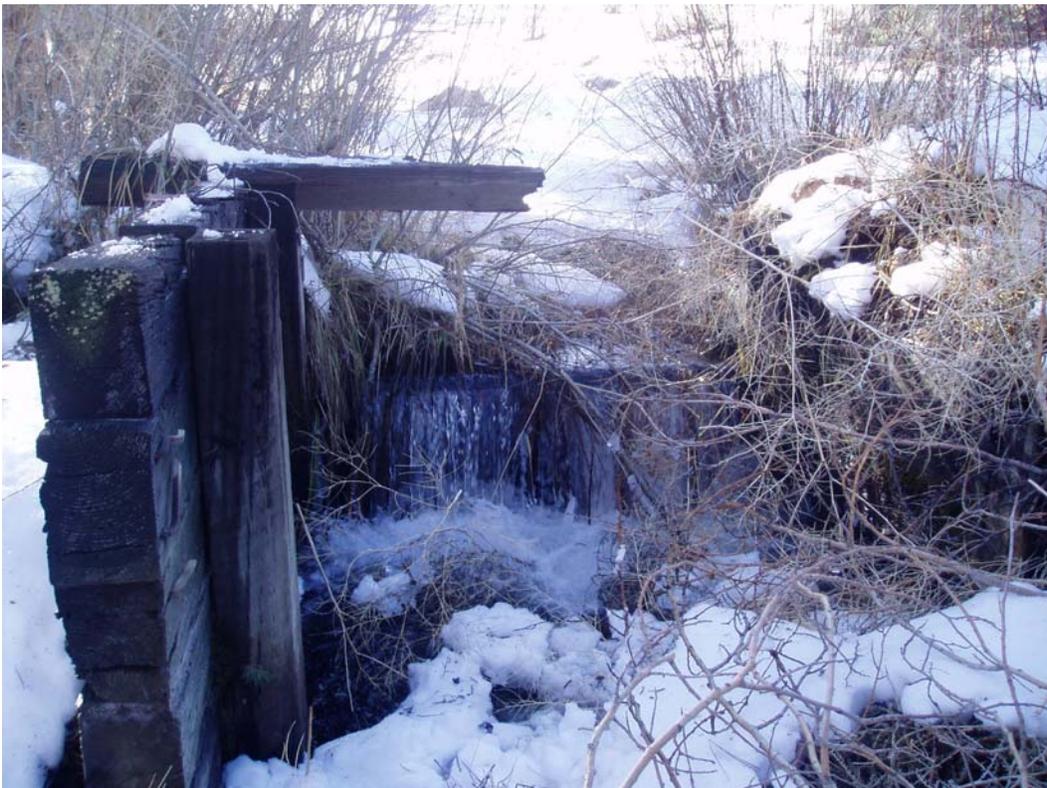
Two artificial concrete fish barriers are located on Mill Creek. The lower fish barrier is located near Reach 2 Unit 4 (Figure 32) and the upper fish barrier (Figures 37 & 38) is located just downstream of the Terry Canyon-Mill Creek intersection near Reach 3 Unit 3. The Bridgeport Ranger District and CDFG are planning to alter the two barriers in Fall 2005 to provide LCT the ability to migrate up and downstream within the watershed without unobstructed movement. Lahontan cutthroat trout were found up and downstream of each artificial barrier.

**Figure 32:** Mill Creek, Bridgeport Ranger District, artificial concrete fish barrier located just upstream of Reach 2 Unit 4 on California State land. This site is located at UTM N: 4260414 & E: 282913. The height of the wall is approximately 5 feet and has no pool below. Picture was taken in 09 Dec. 2004.

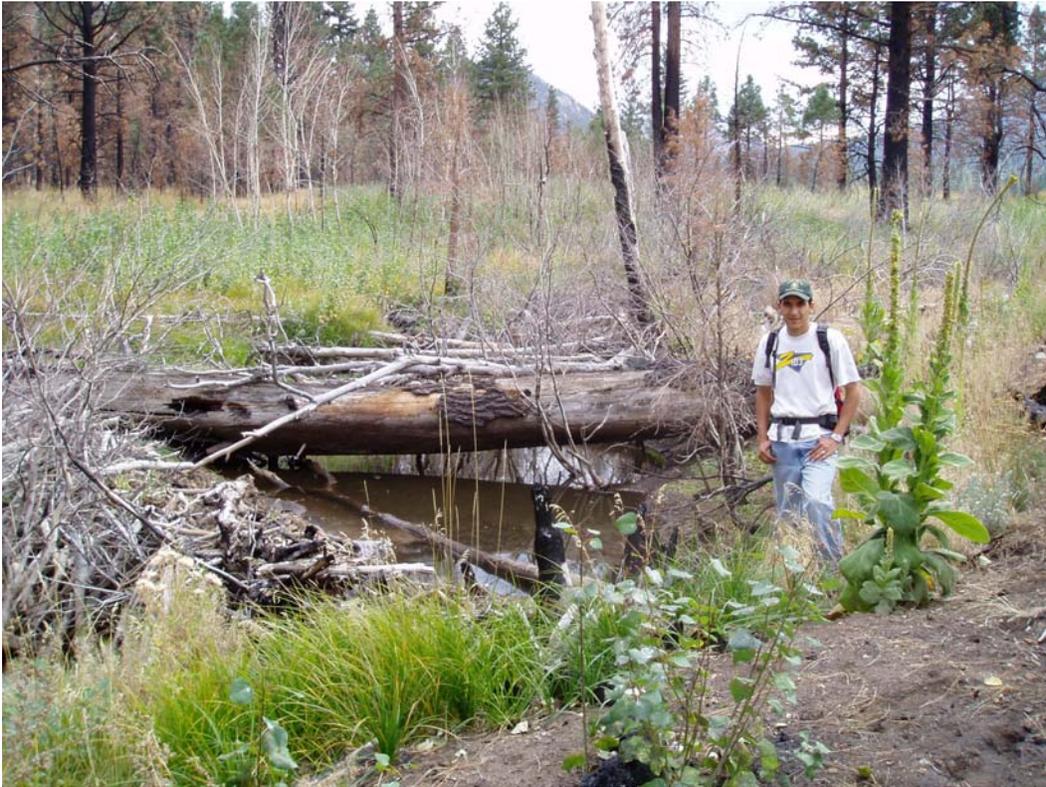
Several (40-50) active beaver dams were documented within Reach 2 (Figure 33 and 34). Some of the beaver dams may be acting as temporary fish barriers. Lahontan cutthroat trout were found up and downstream of the beaver dams. A large amount of sedimentation was noted several times while surveying Reaches 1 and 2. This large amount of sedimentation may be a result of several beaver dams and the 2002 Cannon Fire.

**Figure 33:** Mill Creek, Bridgeport Ranger District, beaver dam within Reach 2. Picture was taken on 6 Oct. 2003.

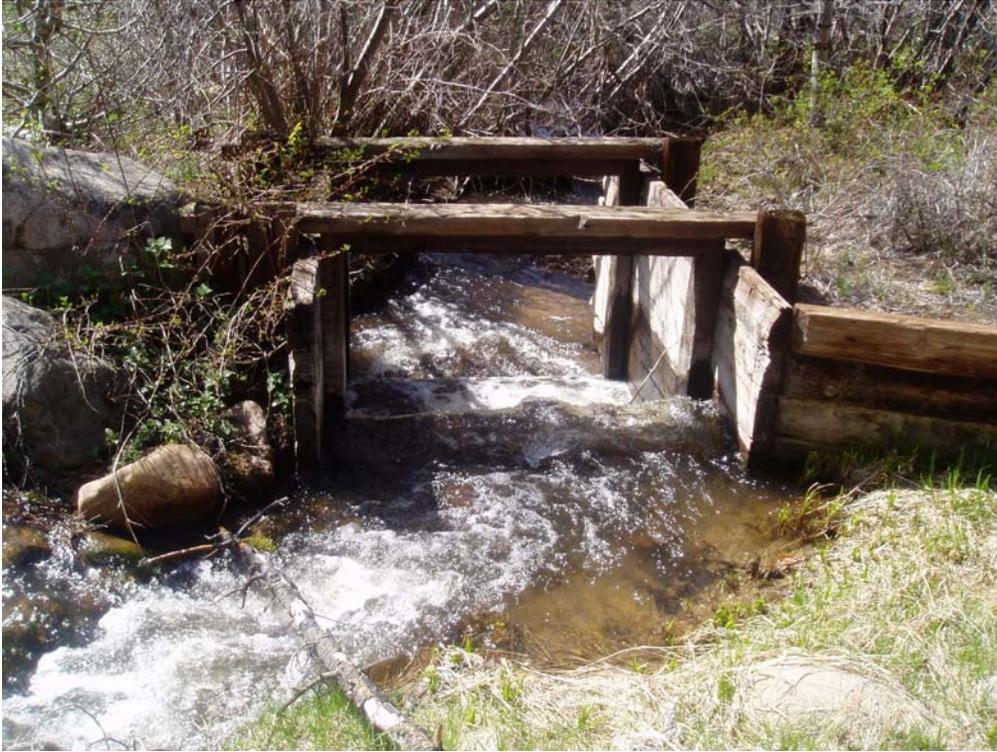
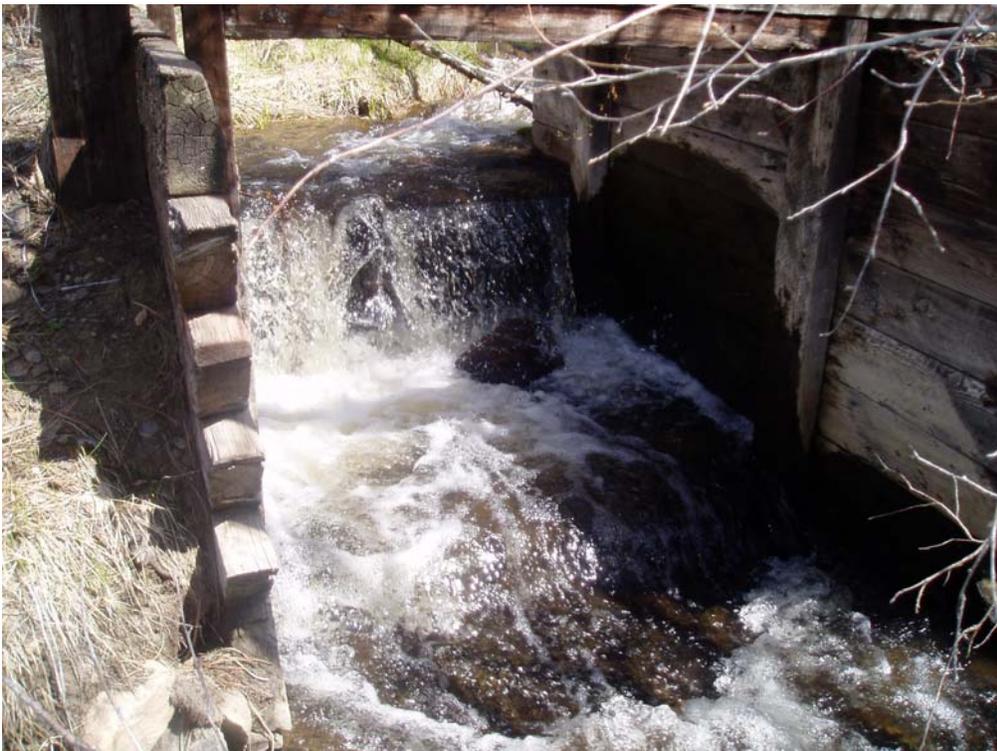
**Figure 37:** Mill Creek, Bridgeport Ranger District, artificial concrete fish barrier located just downstream of the Mill Creek-Terry Canyon road crossing (just downstream of Reach 3/Unit 3). Picture was taken on 28 April. 04.

**Figure 38:** Mill Creek, Bridgeport Ranger District, artificial concrete fish barrier located just downstream of the Mill Creek-Terry Canyon road crossing (just downstream of Reach 3/Unit 3). Picture was taken on 28 April. 04.

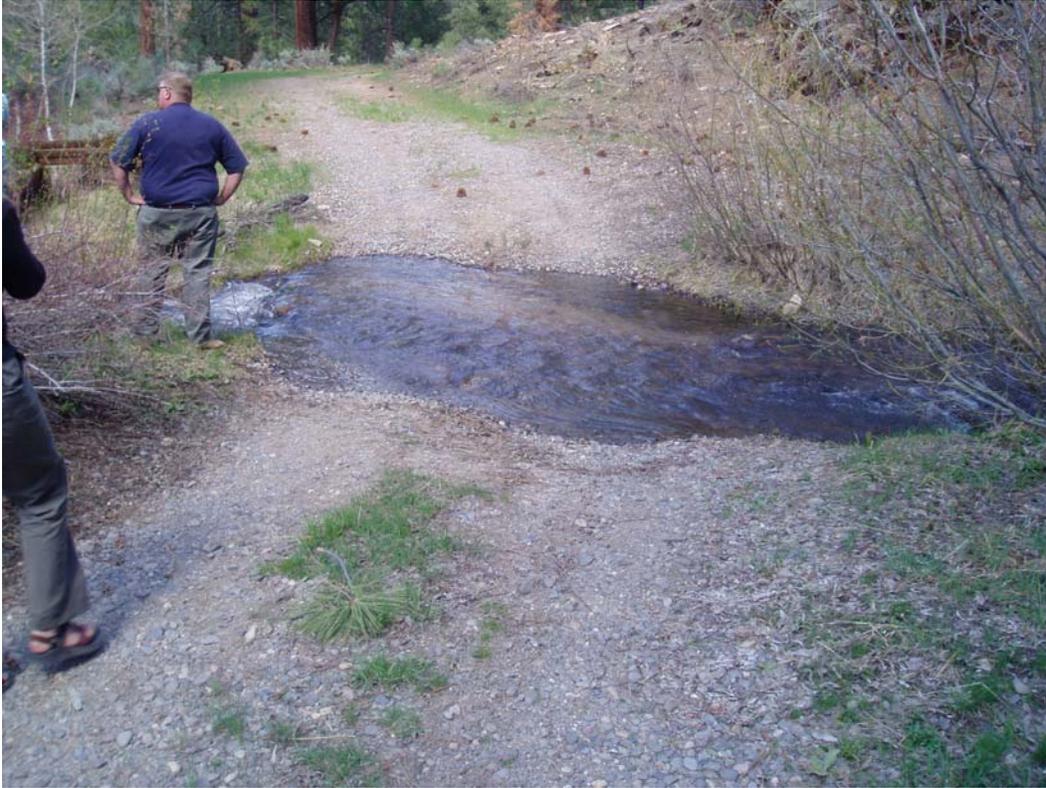
**Figure 39:** Mill Creek, Bridgeport Ranger District, Mill Creek-Terry Canyon road crossing (just downstream of Reach 3/Unit 3). Picture was taken on 28 April. 04.
