**Mill Creek**  
Mono County, California

**2004 Fish & Habitat Survey Report**

**Bridgeport Ranger District**  
**Humboldt-Toiyabe National Forest**

# Mill Creek Lahontan Cutthroat Trout Survey - 2004

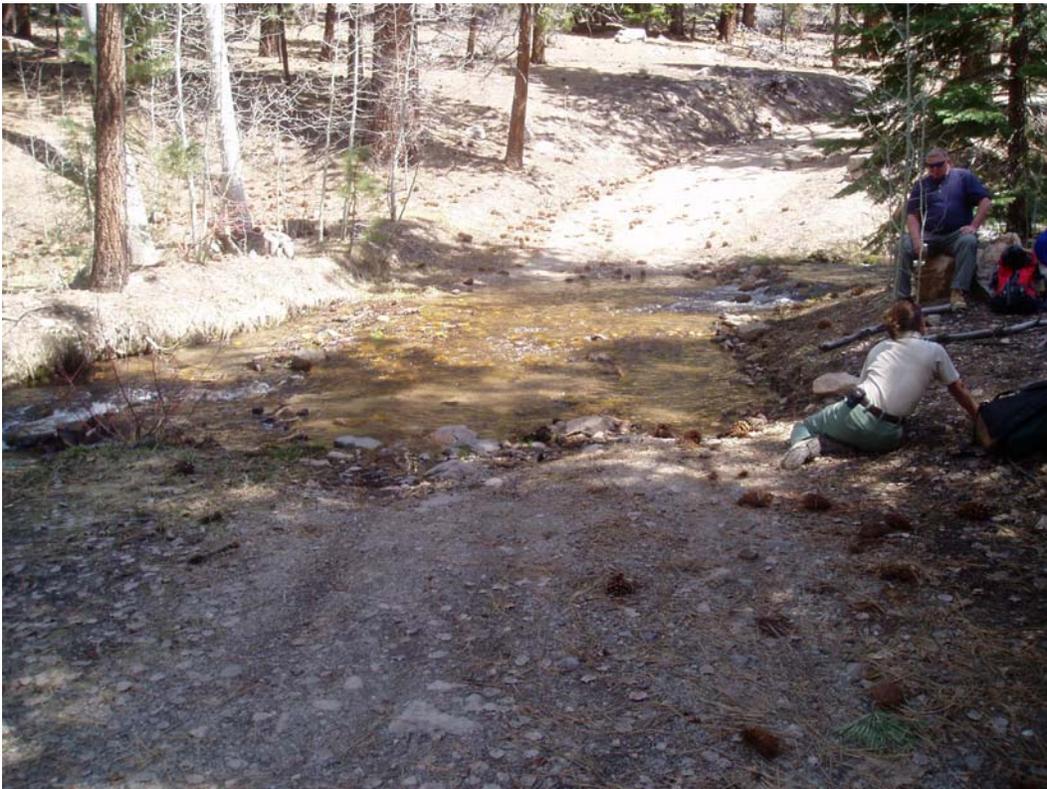
National Forest System Road 32028 parallels Mill Creek for approximately 5.5 miles from the natural barrier to just upstream of Reach 4 Unit 2. In a few locations the road comes within approximately 25 feet of the stream. Forest System Road 32028 crosses Mill Creek in two locations: 1) at the Terry Canyon-Mill Creek intersection (Figure 39), and 2) approximately ¼ mile upstream of Reach 4 Unit 2 (Figure 50). Both road-stream crossing are causing increased erosion, sedimentation, and turbidity within Mill Creek. The Bridgeport Ranger District is planning to construct a 3 sided concrete box bridge at the Terry Canyon-Mill Creek intersection in Fall 2005. A decision on how to manage the road-stream crossing upstream of Reach 4 Unit 2 needs to be decided. Mono County maintains part of Forest System Road 32028. No maintenance appears to be occurring upstream of Reach 3 Unit 2. Some general road maintenance needs to occur upstream of Reach 3 Unit 2 to reduce erosion impacts on Mill Creek. As part of an upcoming fuels project, the Bridgeport Ranger District is planning to do some general road maintenance on all of Forest System Road 32028.

**Figure 50:** Mill Creek, Bridgeport Ranger District, road-stream crossing just upstream of Reach 4/Unit 2. Picture was taken on 28 April. 04.

1. At the latest, in 2009 conduct another electrofishing LCT distribution and density survey.
2. Maintain Forest System Road 32028 to minimize erosion impacts on Mill Creek.
3. Decommission all campsites within 100 feet of Mill Creek to reduce erosion impacts.
4. Monitor water temperature within the Mill Creek watershed.
5. Monitor beaver activity within the Mill Creek watershed.
6. Once the genetic analysis is completed, implement actions consistent with the conclusions made from the analysis.
7. Make sure that all work planned for Fall 2005 related to bridge construction, road maintenance, altering artificial barriers, dispersed campsite rehabilitation, streambank restoration, and trail relocation is implemented.

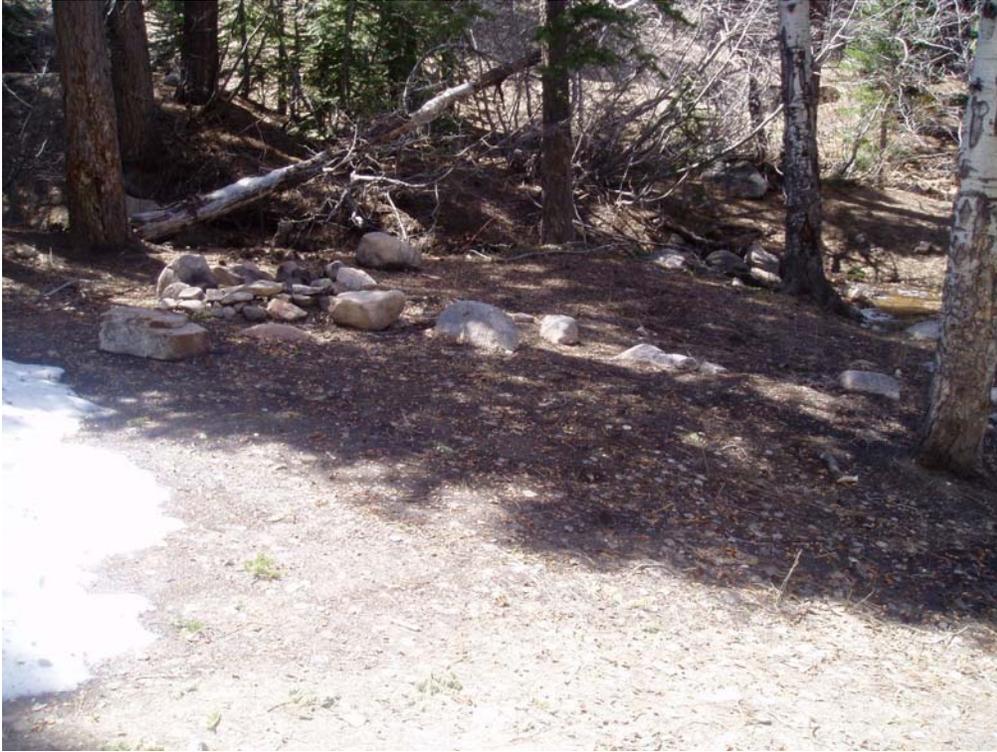
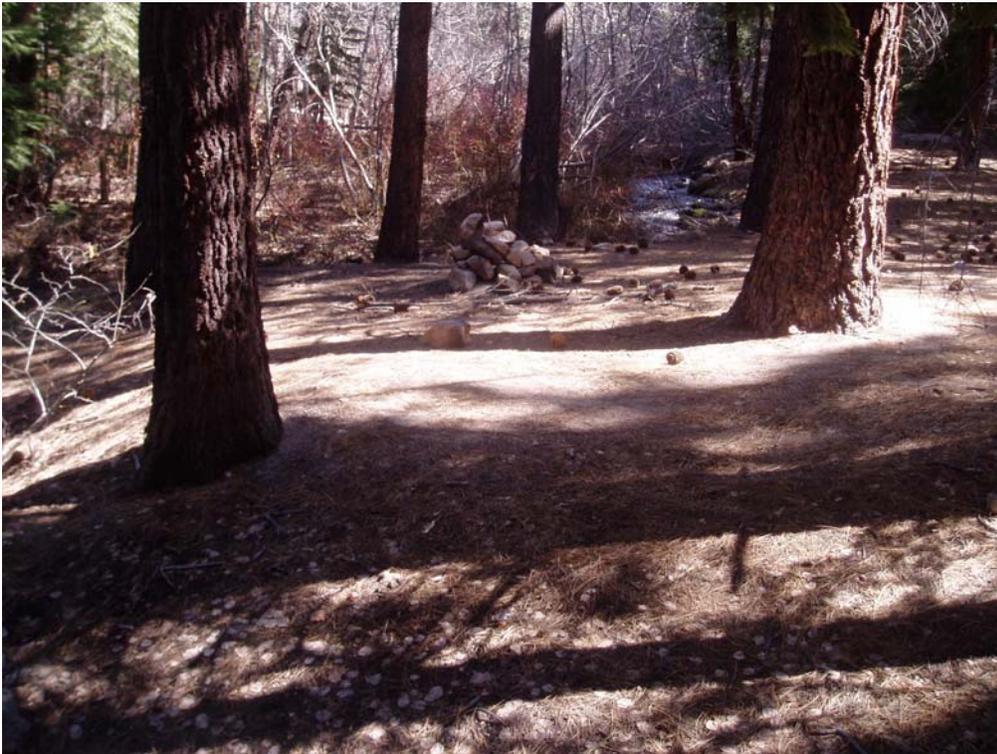
A few dispersed campsites (Figures 51 & 52) are located between Mill Creek and Forest System Road 32028; within 100 feet of Mill Creek. Most of the dispersed campsites are located between Reach 4 Unit 2 and the end of Forest System Road 32028. The dispersed campsites are causing erosion impacts on Mill Creek. The Bridgeport Ranger District is planning to do some dispersed campsite rehabilitation work in Fall 2005 to reduce erosion impacts on Mill Creek.

**Figure 51:** Mill Creek, Bridgeport Ranger District, dispersed campsite within 100 feet of Mill Creek. Campsite is located upstream of Reach 4/Unit 2 near the end of Forest System Road 32028. Picture was taken on 28 April. 04.

**Figure 52:** Mill Creek, Bridgeport Ranger District, dispersed campsite within 100 feet of Mill Creek. Campsite is located upstream of Reach 4/Unit 2 near the end of Forest System Road 32028. Picture was taken on 28 April. 04.

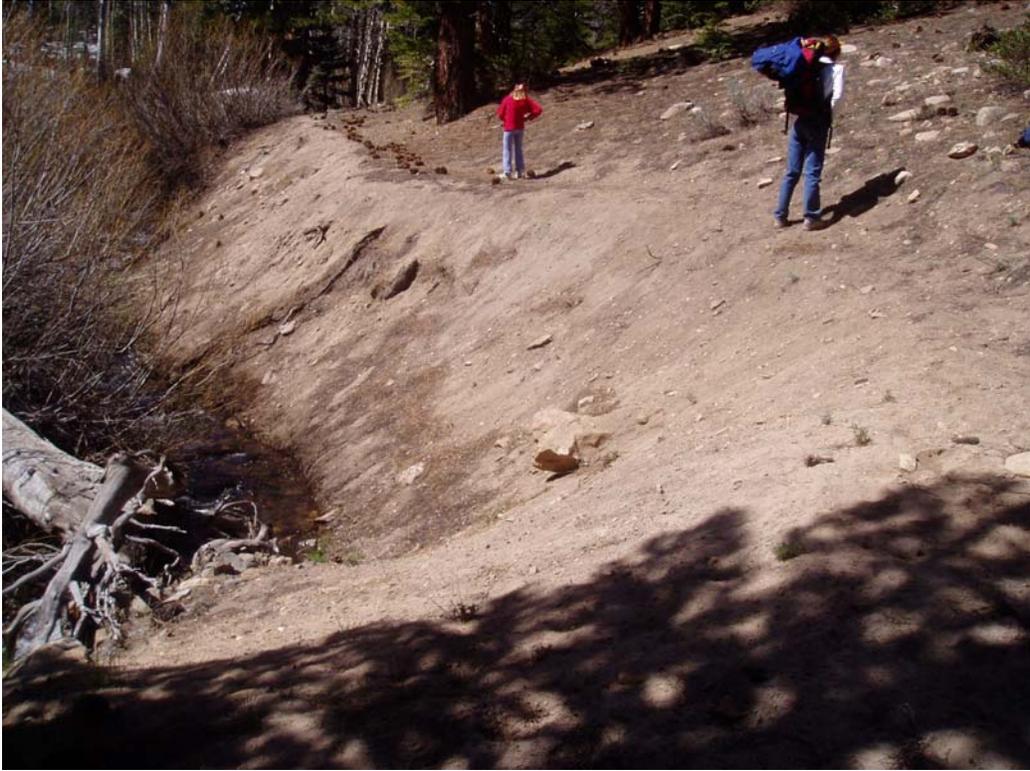
**Figure 55:** Mill Creek, Bridgeport Ranger District, unstable and eroding bank between Mill Creek and the trail. This site is located between Reach 4/Unit 3 and Reach 4/Unit 4. Picture was taken on 30 April. 04.

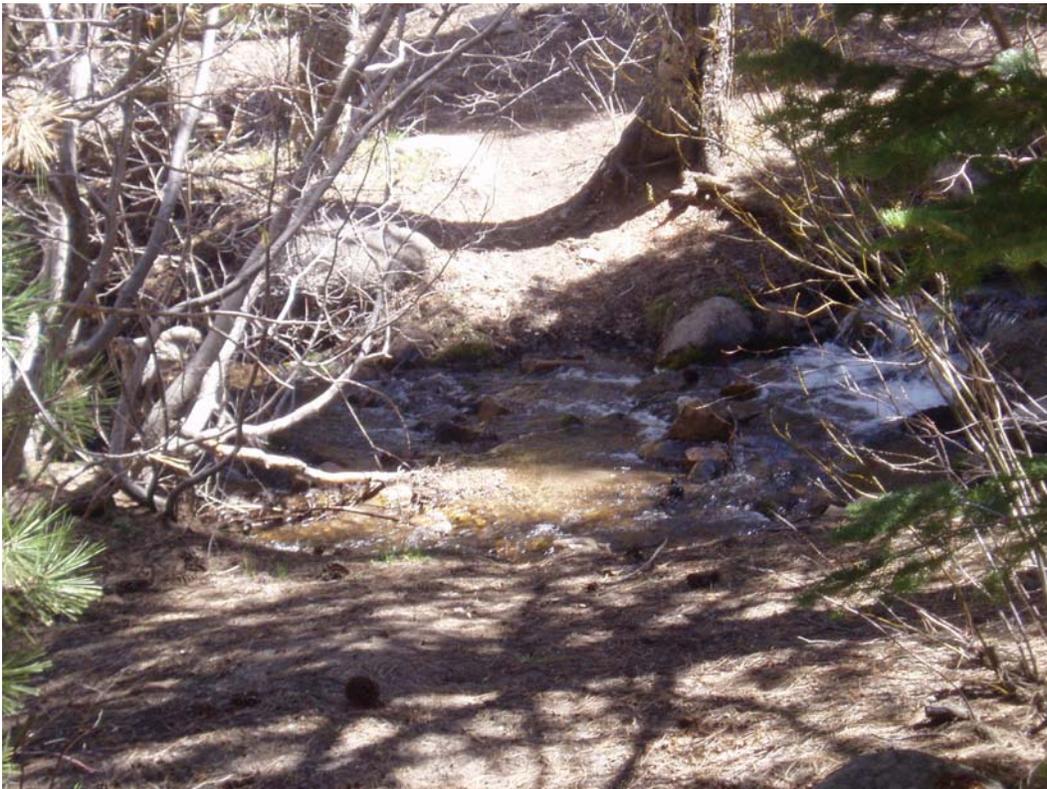
Starting at the end of Forest System Road 32028 a trail parallels Mill Creek up to the top of the watershed above Reach 4 Unit 5. The trail crosses Mill Creek in two locations: 1) just downstream of Reach 4 Unit 5 (Figure 58), and 2) just upstream of Reach 4 Unit 5 (Figure 61). No significant impacts were documented at these two trail crossing locations. Between Reach 4 Unit 3 and Reach 4 Unit 4, where the trail pinches the stream, a few unstable and eroding stream banks (Figure 55) were documented. In the headwaters of Mill Canyon above Reach 4 Unit 5 the trail also passes through a wet meadow (Figure 62) causing resource damage. The Bridgeport Ranger District is planning to do some streambank restoration (possibly installing willow waddles) and trail realignment work in Fall 2005 to reduce erosion impacts on Mill Creek.

**Figure 58:** Mill Creek, Bridgeport Ranger District, stream-trail crossing just downstream of Reach 4/Unit 5. Picture was taken on 30 April. 04.

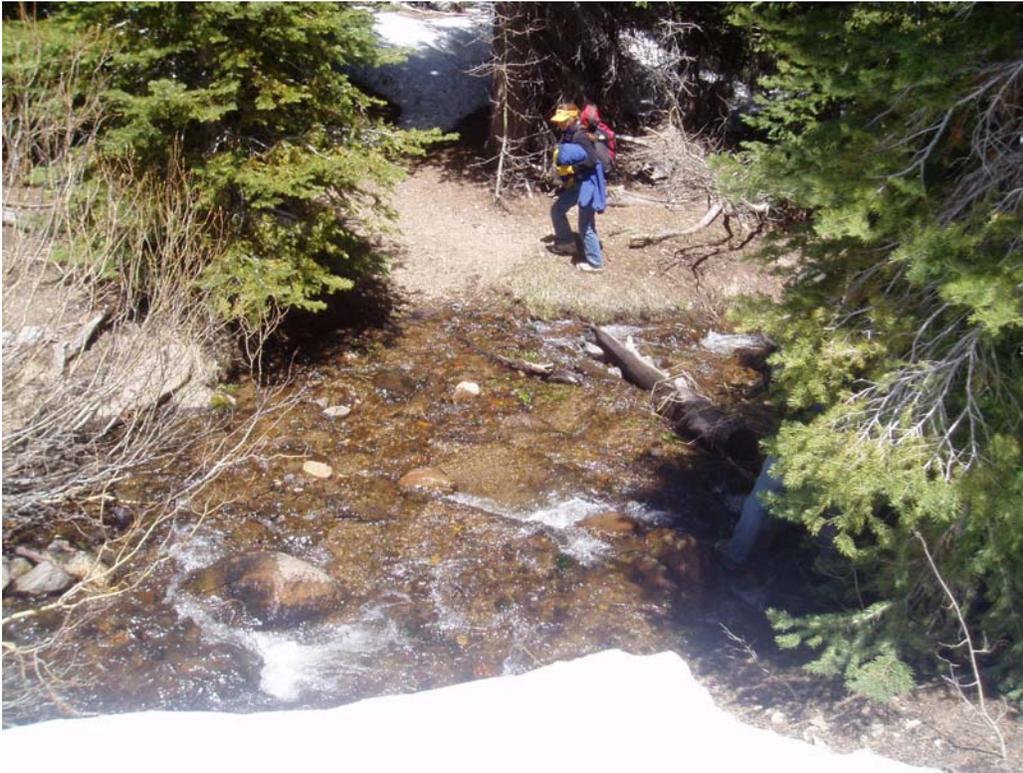
**Figure 61:** Mill Creek, Bridgeport Ranger District, stream-trail crossing just upstream of Reach 4/Unit 5. Picture was taken on 30 April. 04.

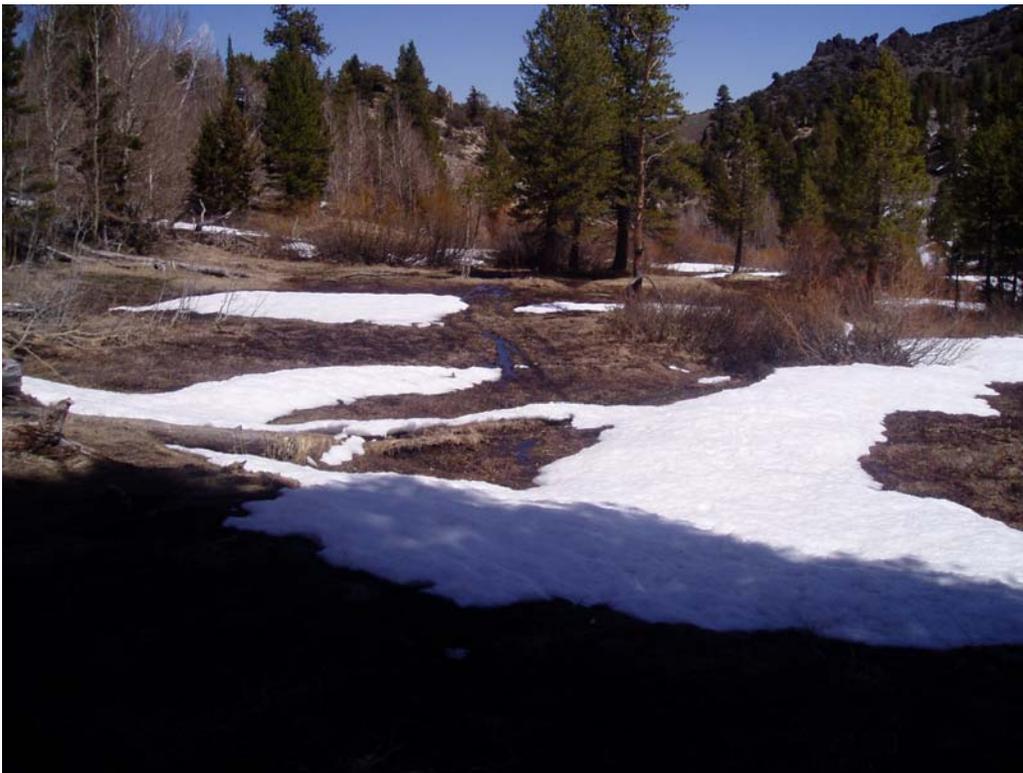
**Figure 62:** Mill Creek, Bridgeport Ranger District, trail crossing through a wet meadow. Meadow is located in the headwaters of Mill Creek upstream of the upper stream-trail crossing and Reach 4/Unit 5. Picture was taken on 30 April. 04.
