# **Poore Creek**

**Mono County, California**

## **2006 Stream Habitat Survey Report**

**Humboldt-Toiyabe National Forest, Bridgeport Ranger District**

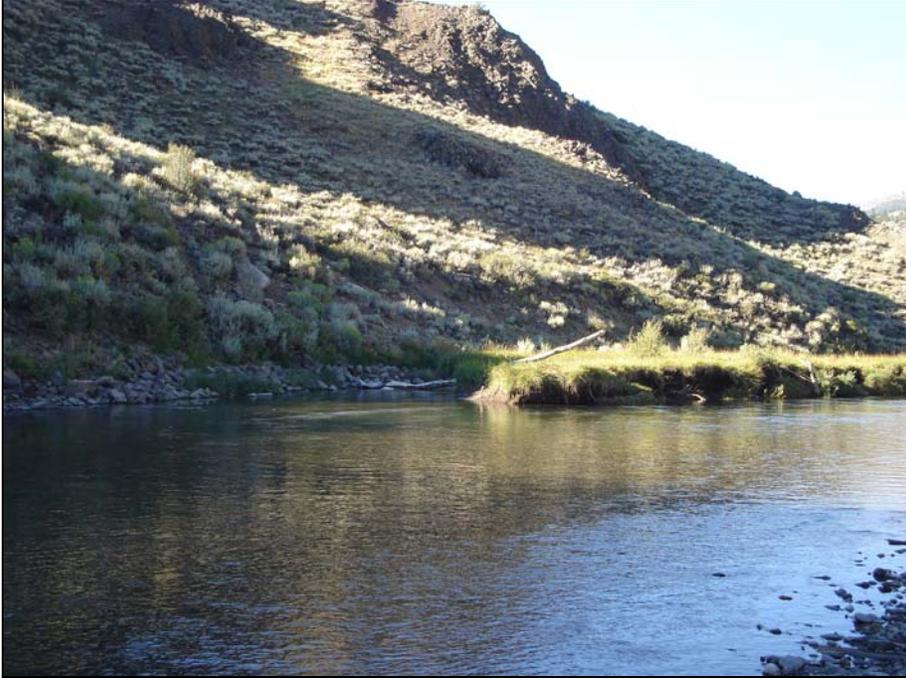
**Site 1:** Poore Creek, Bridgeport Ranger District, looking upstream at the West Walker River from the survey start point. The survey start point is at the confluence of Poore Creek and the West Walker River. Poore Creek contributes less than 10% of the overall flow in the West Walker River. This site is located at UTM: N: 4246751 & E: 279149, Elevation 2060m.

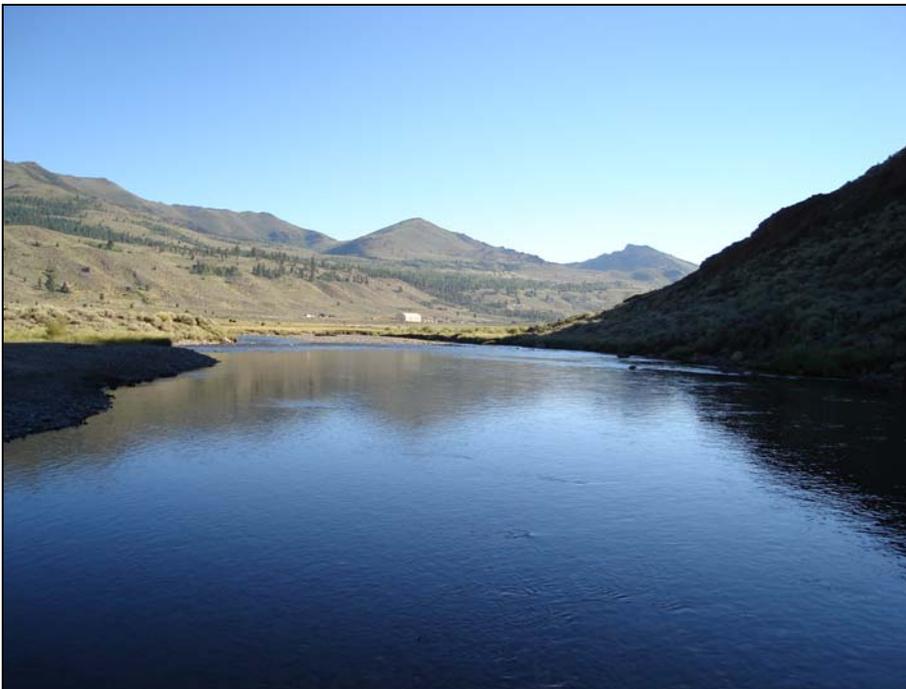
**Site 1 continued:** Poore Creek, Bridgeport Ranger District, looking downstream at the West Walker River from the survey start point. This site is located at UTM: N: 4246751 & E: 279149, Elevation 2060m.

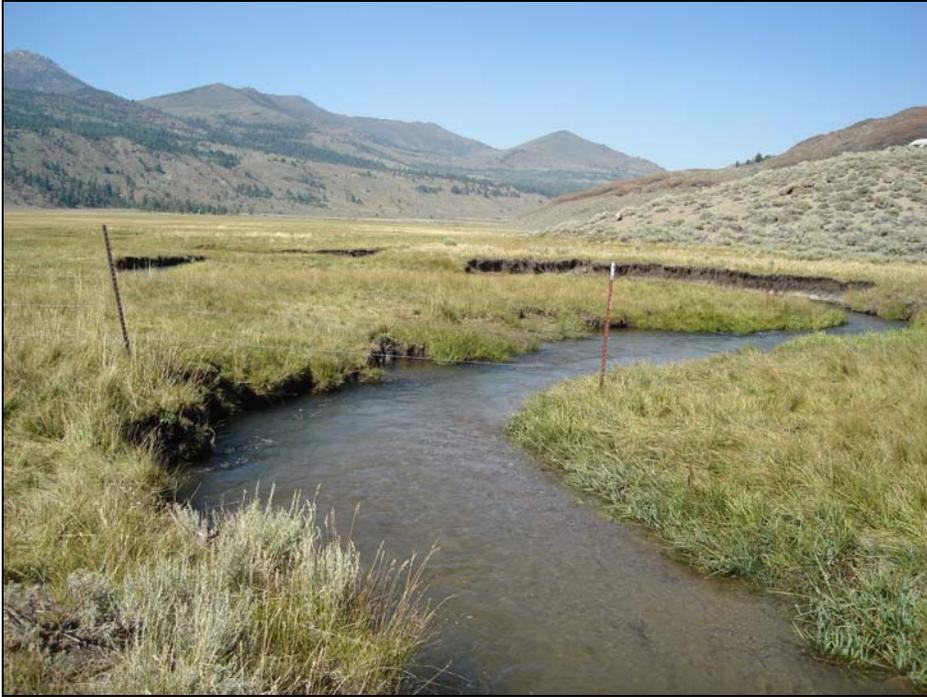
**Site 2:** Poore Creek, Bridgeport Ranger District, looking downstream at the California State Land. The state land appears to be heavily grazed by cattle and the stream banks show signs of heavy erosion. This site is located at UTM: N: 4245644 & E: 278712, Elevation 2062m.

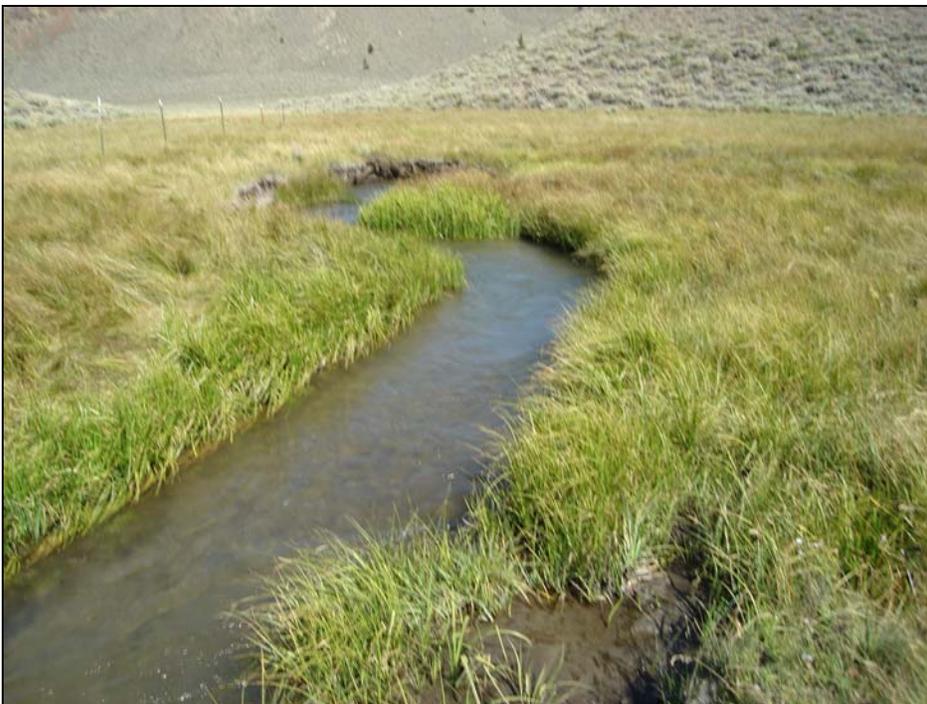
**Site 2 continued:** Poore Creek, Bridgeport Ranger District, upstream view of this section of stream. This site is located at UTM: N: 4245644 & E: 278712, Elevation 2062m.

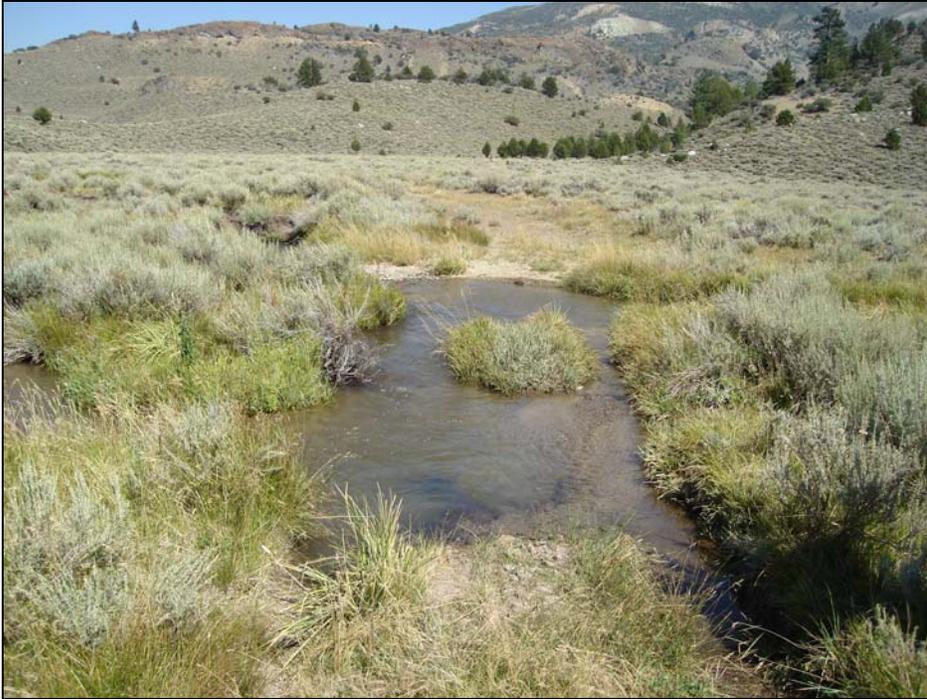
**Site 3:** Poore Creek, Bridgeport Ranger District, a cross-section view of a road-stream crossing. Note the widening of the stream channel at this location. Fish were also sighted at this location. This site is located at UTM: N: 4245241 & E: 278668, Elevation 2067

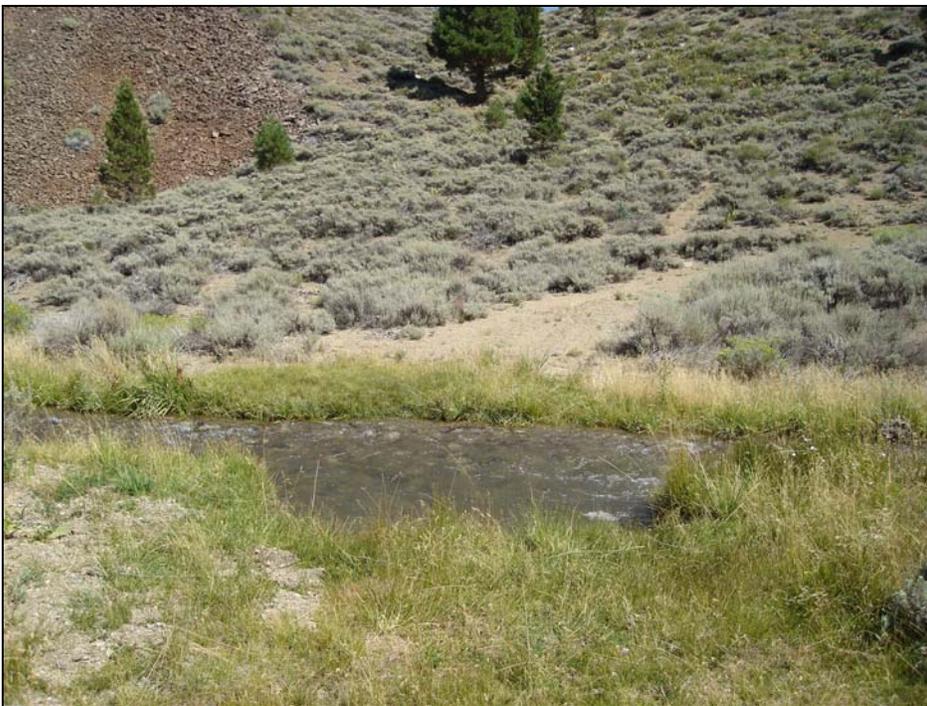
**Site 4:** Poore Creek, Bridgeport Ranger District, cross section view of a road-stream crossing. The stream channel has widened a little at this location. This site is located at UTM: N: 4244884 & E: 278688, Elevation 2075m.

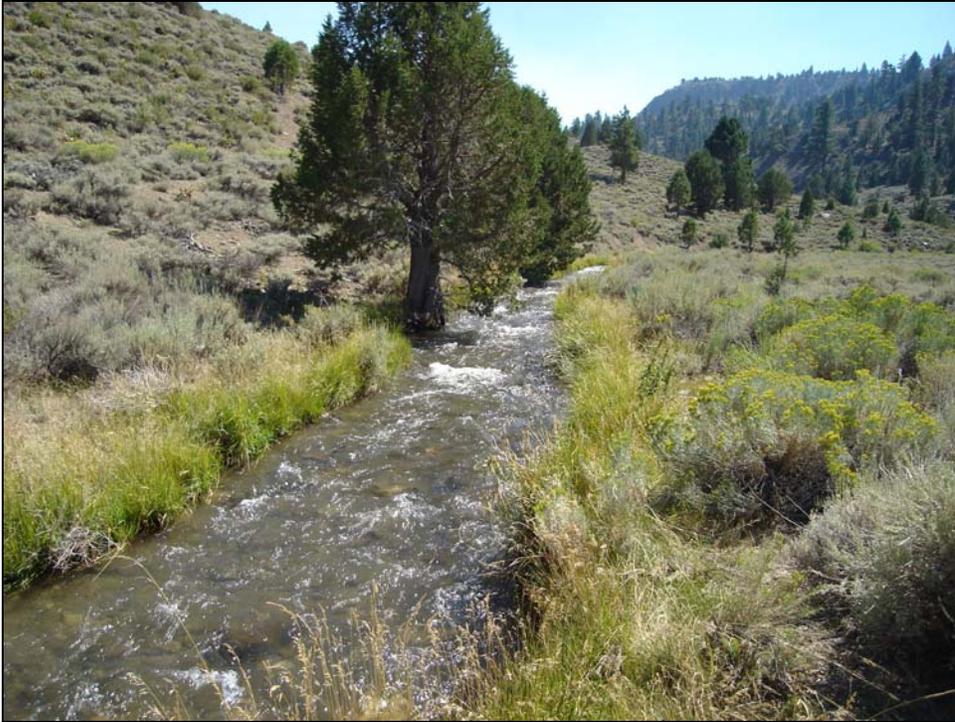
**Site 4 continued:** Poore Creek, Bridgeport Ranger District, looking upstream from the road-stream crossing. This site is located at UTM: N: 4244884 & E: 278688, Elevation 2075m.

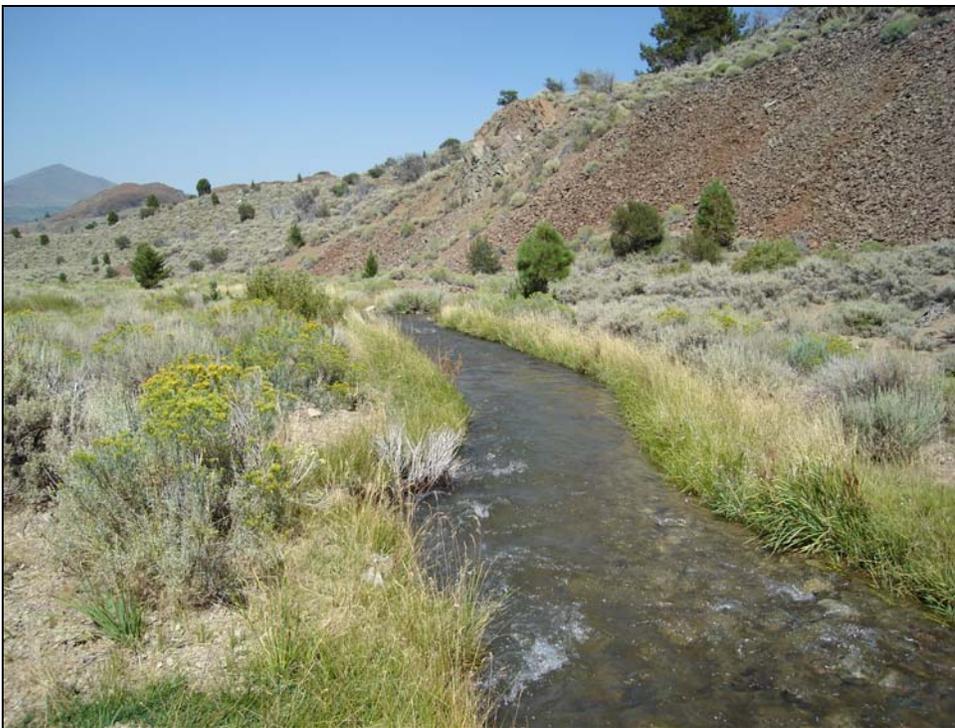
**Site 4 continued:** Poore Creek, Bridgeport Ranger District, looking downstream from the road-stream crossing. This site is located at UTM: N: 4244884 & E: 278688, Elevation 2075m

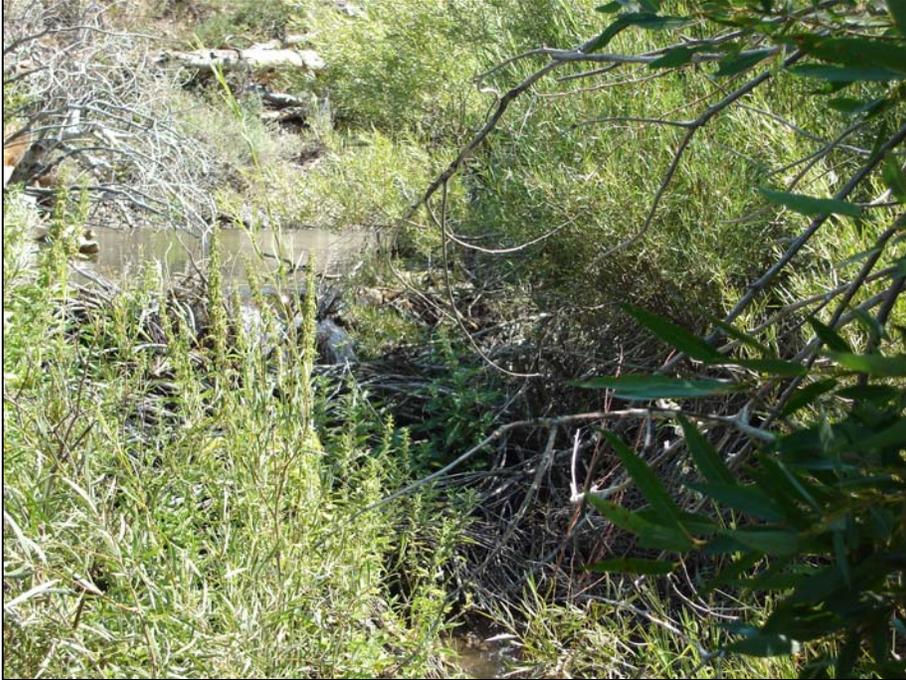
**Site 5:** Poore Creek, Bridgeport Ranger District, a cross-section view of a beaver dam. There is a small network of beaver dams in this heavily vegetated area of willows. This is a small beaver dam; however, it still slows water and has created some deep pools for fish. This site is located at UTM: N: 4244541 & E: 278572, Elevation 2089m.

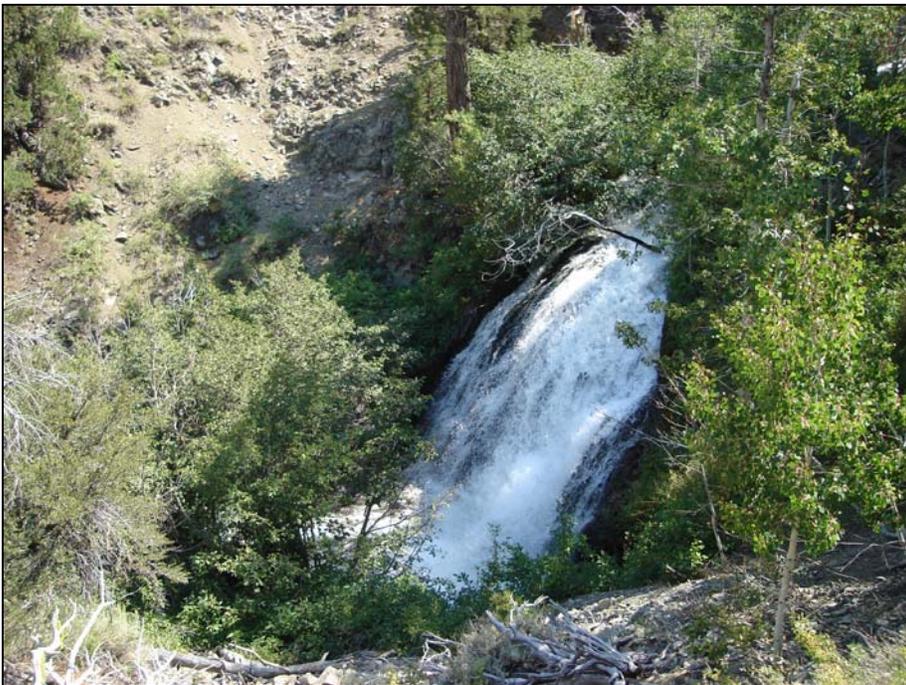
Approximately 1.6 miles of Poore Creek were surveyed between Site 2 and Site 12. One permanent fish barrier, a 33 foot high waterfall, was documented at Site 6. No seasonal fish barriers were identified. A photo point was taken at Site 1; however, because of California State lands, approximately 1 mile of stream was not surveyed between Sites 1 and 2. Everything between Site 2 and Site 12 at Poore Lake was surveyed. A campsite was documented at Site 11 and fish were sighted at Sites 3 and 10. Photo points were also taken at Sites 2, 7 and 9. Three ford road-stream

**Site 6:** Poore Creek, Bridgeport Ranger District, a cross-section view of a permanent fish barrier. This waterfall is approximately 10m (33ft) high. This site is located at UTM: N: 4244361 & E: 278566, Elevation 2122m.

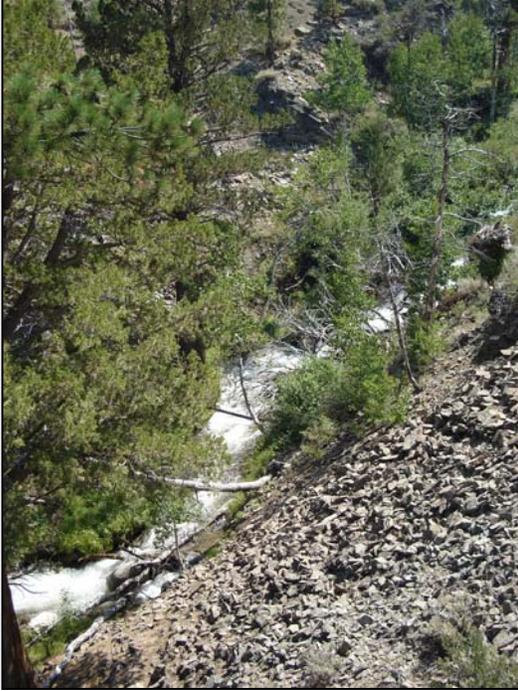
**Site 7:** Poore Creek, Bridgeport Ranger District, photo point. This photo point was taken to show that even though there is not an actual waterfall or a defined fish barrier, the water is flowing incredibly fast through this section and probably causes upstream migration to be very difficult for fish. This site is located at UTM: N: 4244318 & E: 278541, Elevation 2133m.

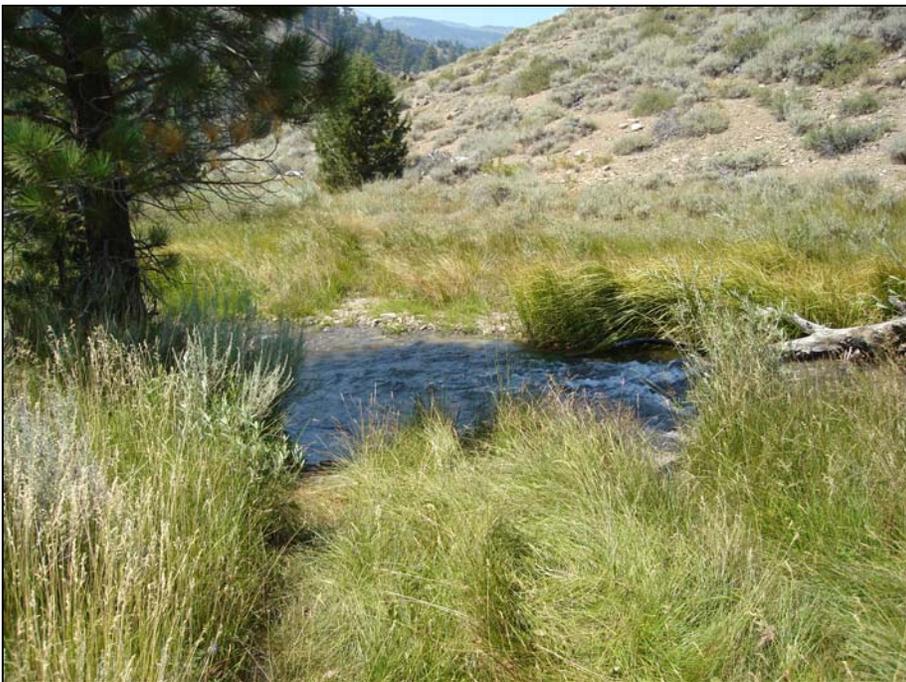
**Site 8:** Poore Creek, Bridgeport Ranger District, a cross-section view of a road-stream crossing. This site is located at UTM: N: 4244088 & E: 278737, Elevation 2147m.

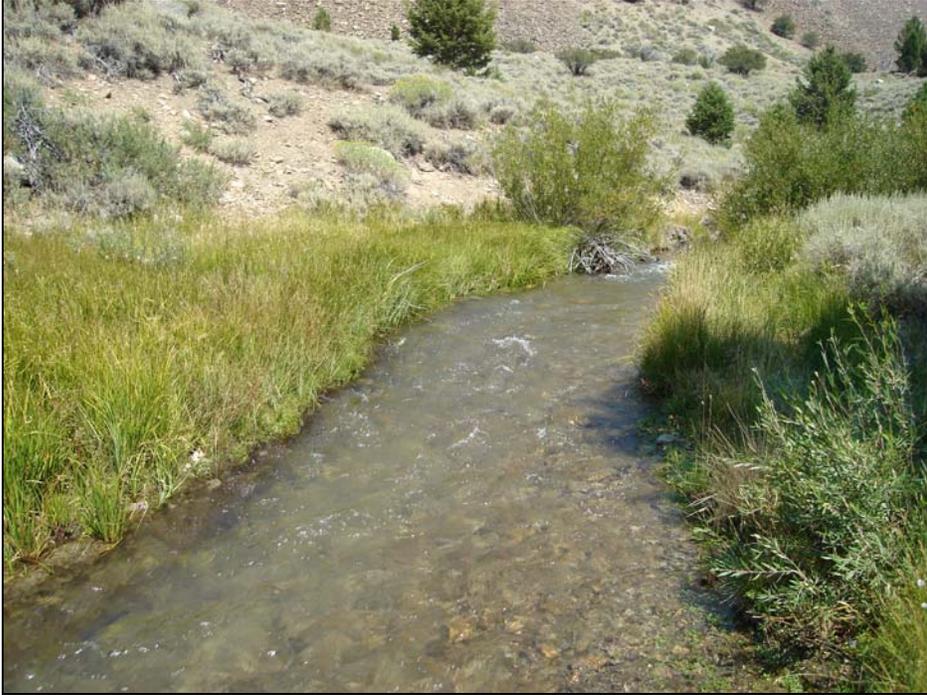
**Site 8 continued:** Poore Creek, Bridgeport Ranger District, looking upstream from the road-stream crossing. This site is located at UTM: N: 4244088 & E: 278737, Elevation 2147m.

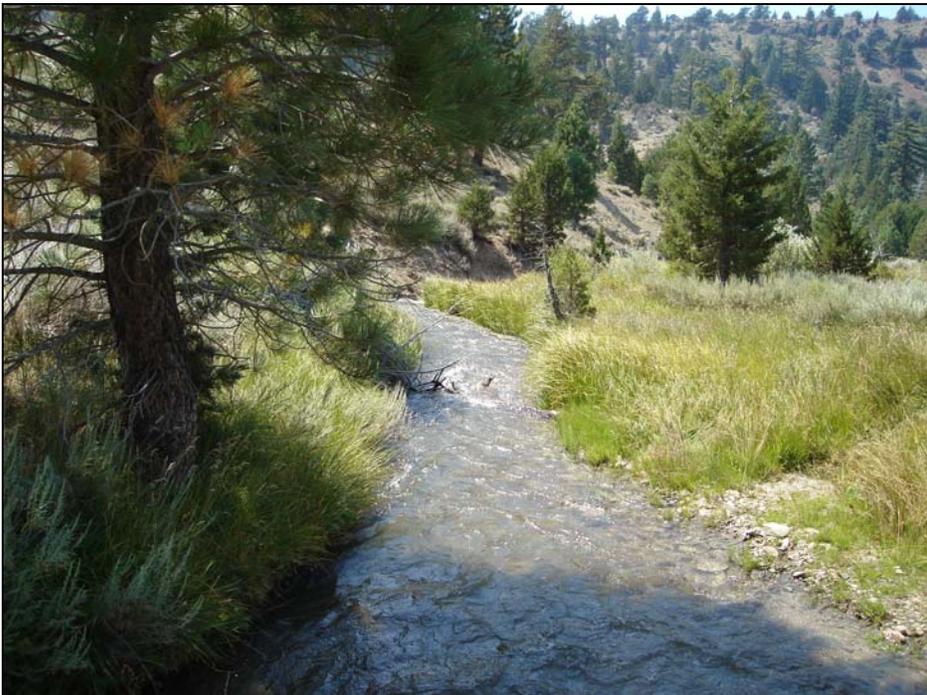
**Site 8 continued:** Poore Creek, Bridgeport Ranger District, looking downstream from the road-stream crossing. This site is located at UTM: N: 4244088 & E: 278737, Elevation 2147m.

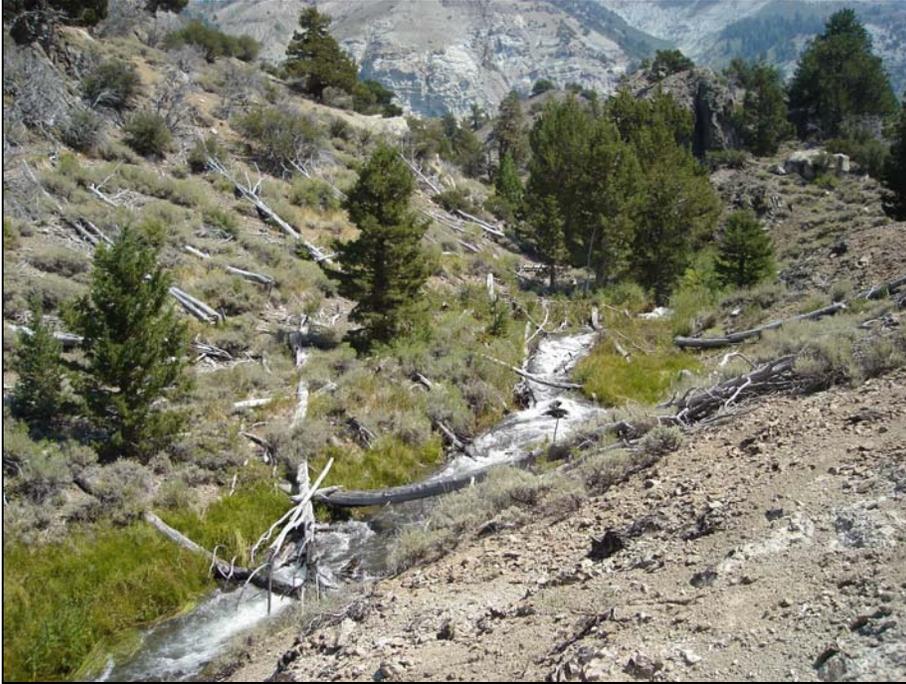
**Site 9:** Poore Creek, Bridgeport Ranger District, looking upstream at the stream characteristics typical for this section of stream. This site is located at UTM: N: 4243747 & E: 279081, Elevation 2177m.

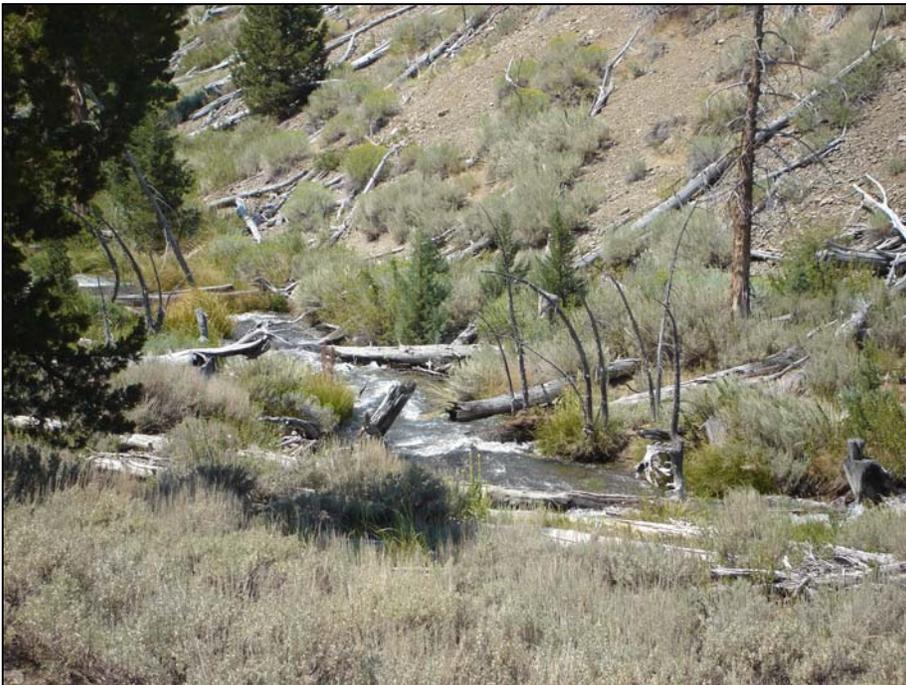
**Site 9 continued:** Poore Creek, Bridgeport Ranger District, looking downstream at the stream characteristics typical for this section of stream. This site is located at UTM: N: 4243747 & E: 279081, Elevation 2177m.

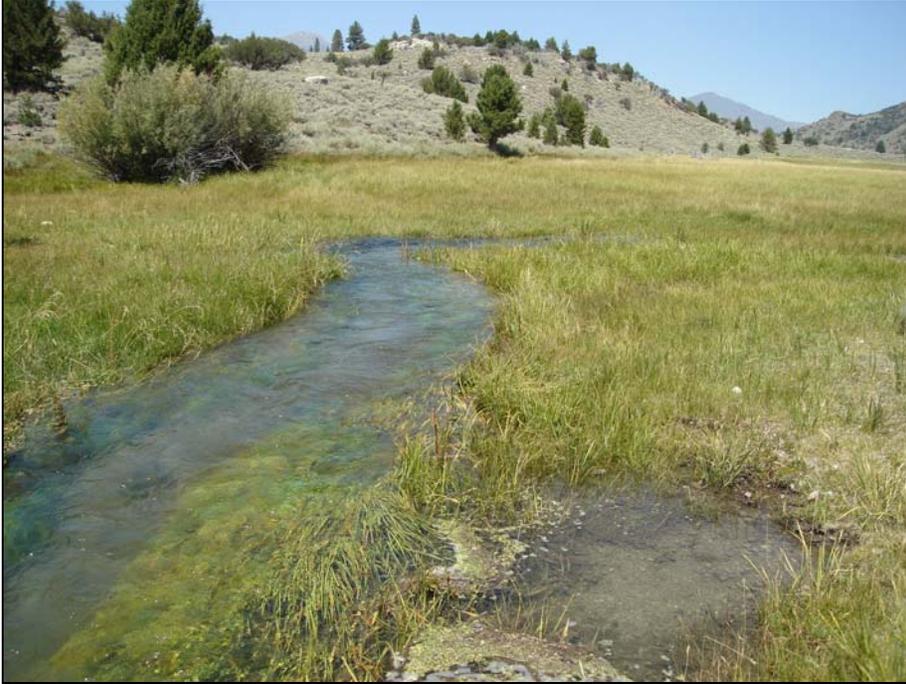
**Site 10:** Poore Creek, Bridgeport Ranger District, looking upstream at an area where several small fish were sighted. As we walked up the stream we noted a small pool off the main flow. In this pool several small fish were sighted, averaging between 1-2 inches long. This site is located at UTM: N: 4243689 & E: 279341, Elevation 2189m.

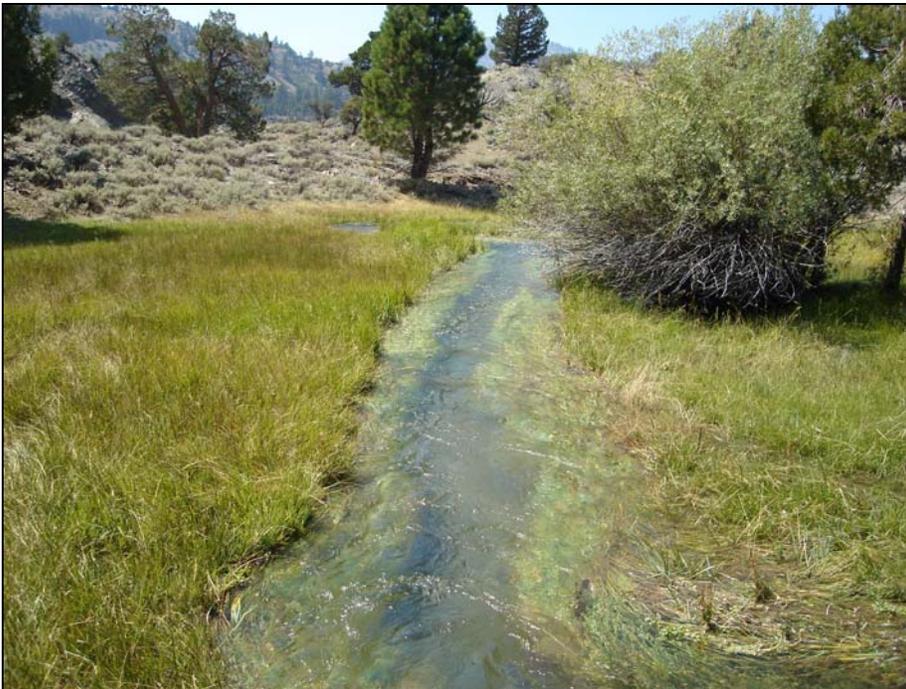
**Site 10 continued:** Poore Creek, Bridgeport Ranger District, looking downstream from where the fish were sighted. This site is located at UTM: N: 4243689 & E: 279341, Elevation 2189m.

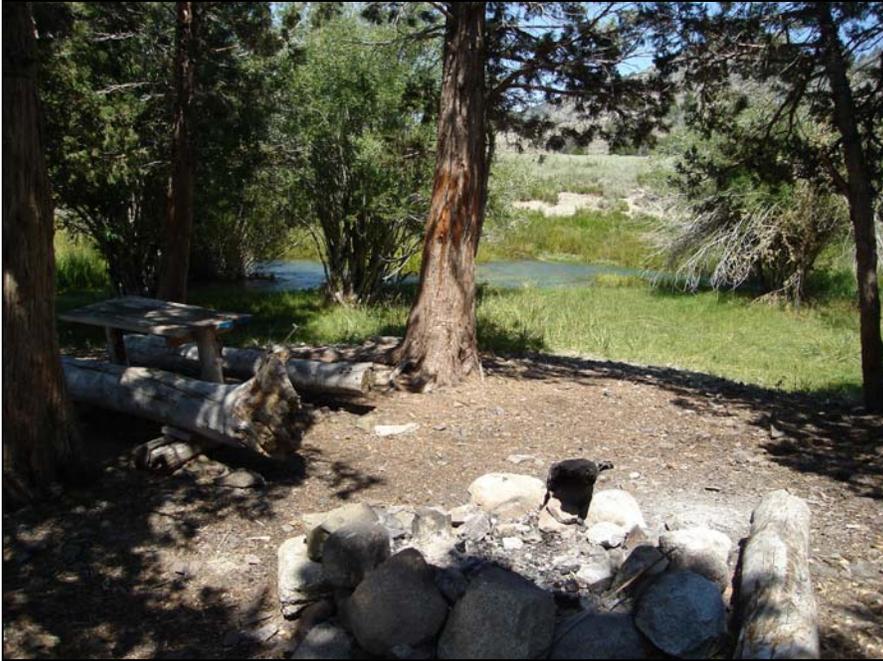
**Site 11**, Poore Creek, Bridgeport Ranger District, cross-section view of a campsite near the stream. Right at the outflow source for Poore Creek is a campsite that is marked with a picnic table and fire ring. This campsite is quite large and flat, and it is on the edge of a large meadow. This site is located at UTM: N: 4243688 & E: 279419, Elevation 2196.

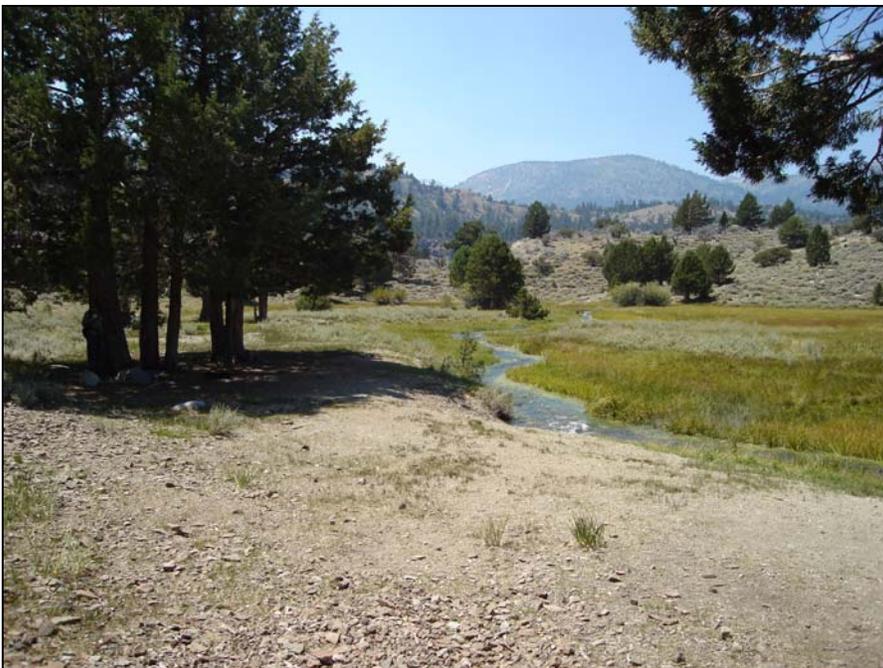
**Site 11 continued**, Poore Creek, Bridgeport Ranger District, another view of the camping area and its vicinity to the stream. This site is located at UTM: N: 4243688 & E: 279419, Elevation 2196.

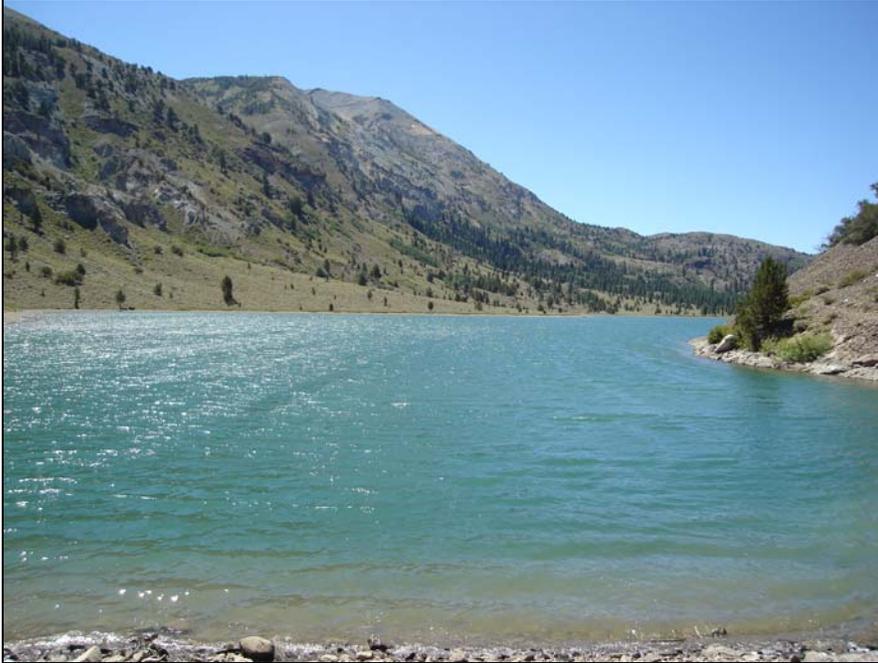
Poore Creek offers 2.6 miles of potential LCT habitat located between Sites 1 and 12. Although the 1 mile of stream between Site 1 and Site 2 was not surveyed, after reviewing a topographic map, that 1 mile section of stream would probably provide potential LCT habitat; therefore, in this report that 1 mile section of stream is considered potential LCT habitat. A stream habitat survey of that 1 mile reach would need to be completed to confirm this presumption. The average stream gradient between Site 1 and Site 12 is 3.4%. Site 6 has a 33 foot high naturally occurring waterfall; never-the-less, potential LCT habitat does exist between Site 6 and Poore Lake. Poore Creek receives its flows from Poore Lake. Poore Lake has an artificial dam/dike system (Site 12) thus controlling the amount of flow in Poore Creek.

**Site 12:** Poore Creek, Bridgeport Ranger District, a view of Poore Lake from the survey end point. The survey end point is where Poore Creek flows out of Poore Lake. Upon getting to this point it appears as if there is a man made system built to create Poore Lake. Through this dike there is some sort of valve system that when opened, water is allowed to flow into Poore Creek. This site is located at UTM: N: 4243658 & E: 279476, Elevation 2201m.

1. Consider the 2.6 mile section of Poore Creek between Sites 1 and 12 as potential LCT habitat and consider Poore Creek a low candidate for restoration.
2. If permission can be obtained, conduct a stream habitat survey on the 1 mile of Poore Creek between Site 1 and Site 2 to confirm that this section of stream does provide potential LCT habitat.
3. Close and decommission all dispersed campsites within 100 feet of Poore Creek. Only allow camping to occur more than 100 feet away from the streams edge.
4. Investigate the water allocation and water management schedules for Poore Lake. If needed, pursue the possibility of allocating more water to flow into Poore Creek during the driest parts of the year (July-September).

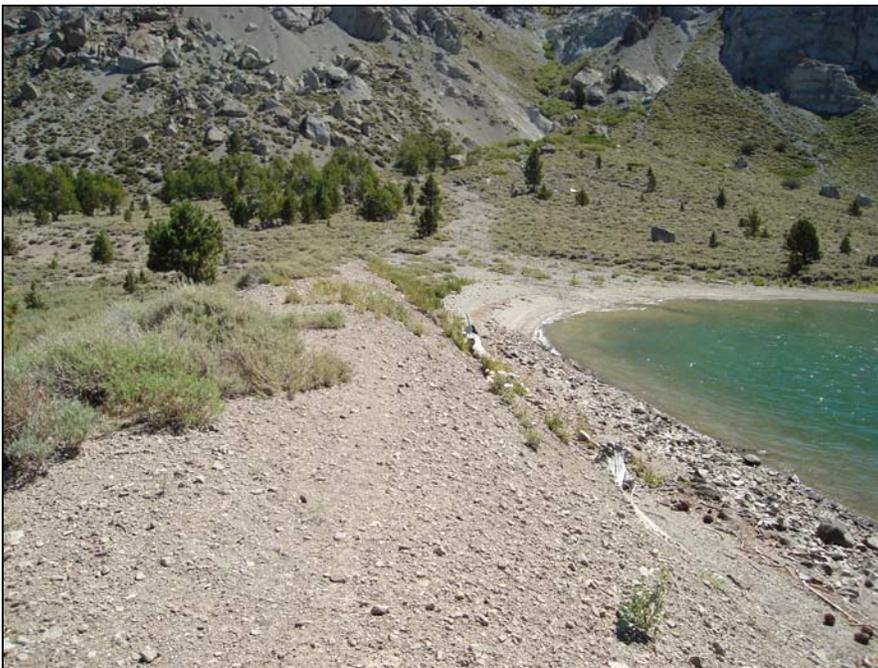
**Site 12 continued:** Poore Creek, Bridgeport Ranger District, a view of Poore Lake and the dike system. This site is located at UTM: N: 4243658 & E: 279476, Elevation 2201m.

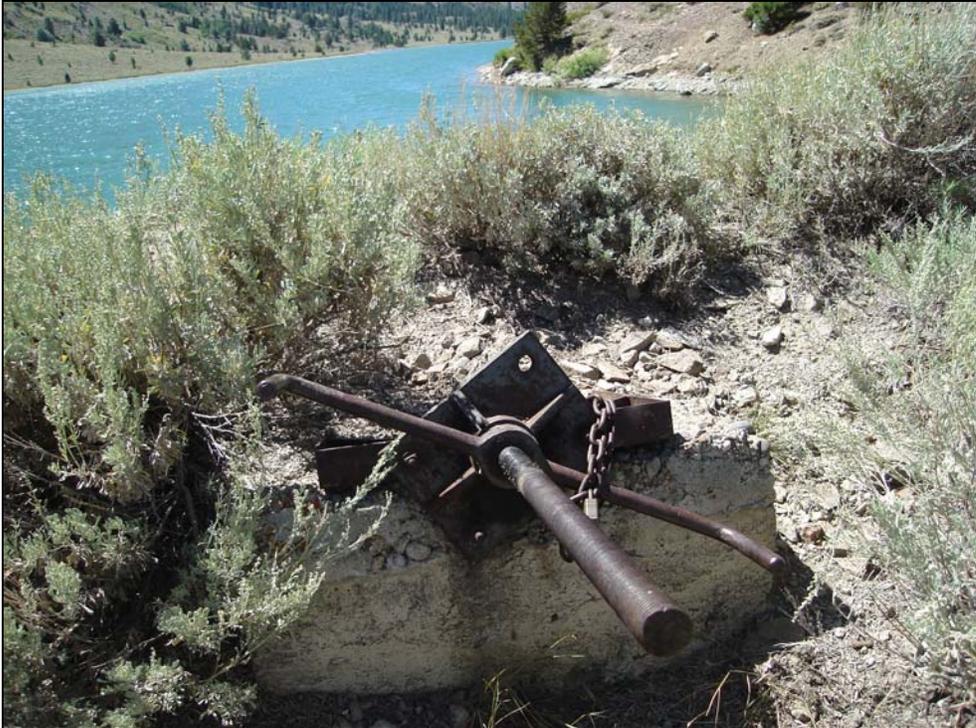
**Site 12 continued:** Poore Creek, Bridgeport Ranger District, a view of the valve system. This site is located at UTM: N: 4243658 & E: 279476, Elevation 2201m.

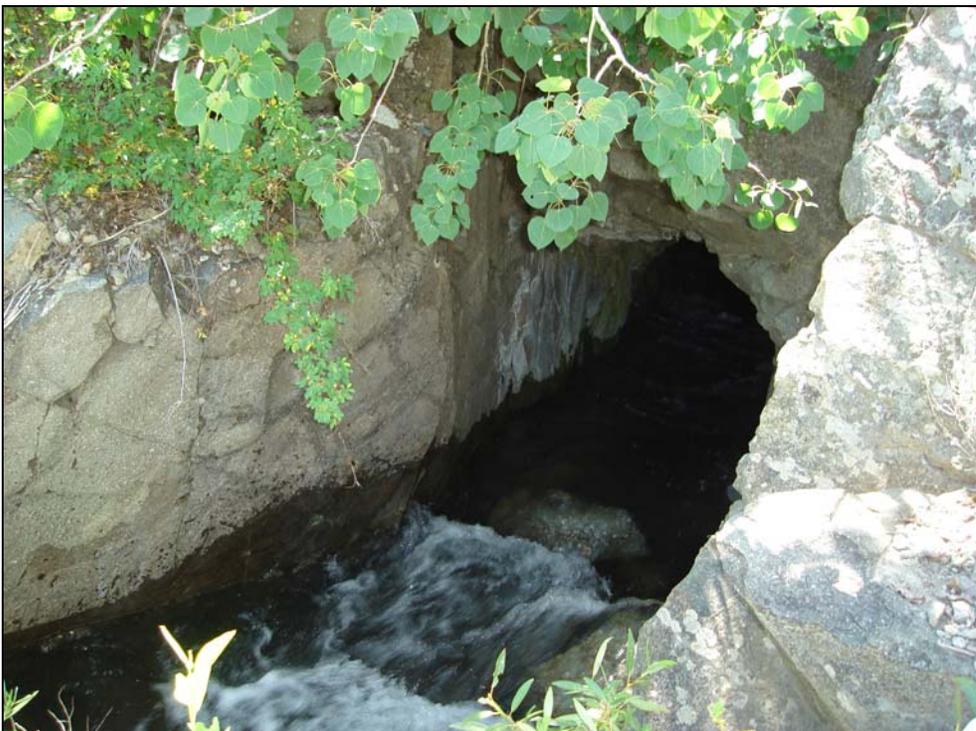
**Site 12 continued:** Poore Creek, Bridgeport Ranger District, a view of the Lakes outflow which forms Poore Creek. This site is located at UTM: N: 4243658 & E: 279476, Elevation 2201m.
