# **ROCK CREEK**

**Mono County, California**

## **2005 Stream Habitat Survey Report**

**Humboldt- Toiyabe National Forest, Bridgeport Ranger District**

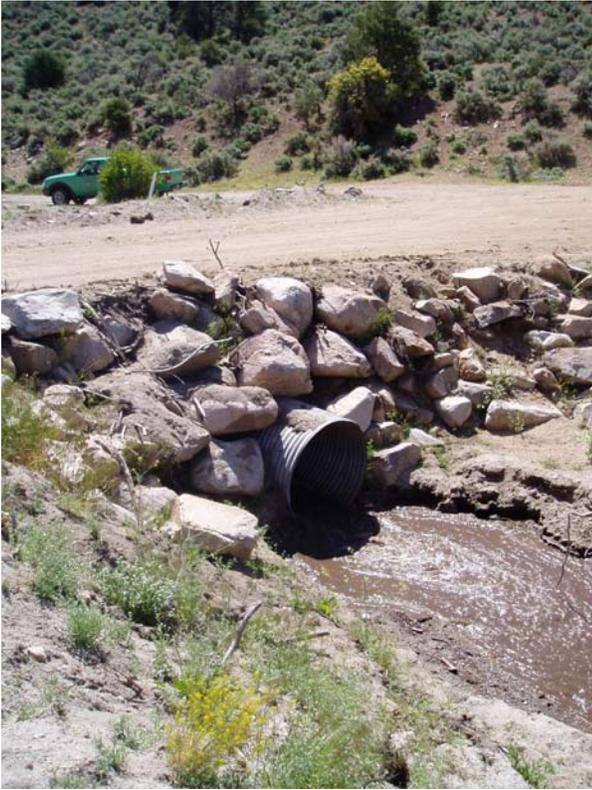
**Site 1:** Rock Creek, Bridgeport Ranger District, looking upstream at a culvert. This culvert is currently not a fish barrier. The stream habitat survey started at this site. This site is located at UTM N: 4265610 & E: 287187.

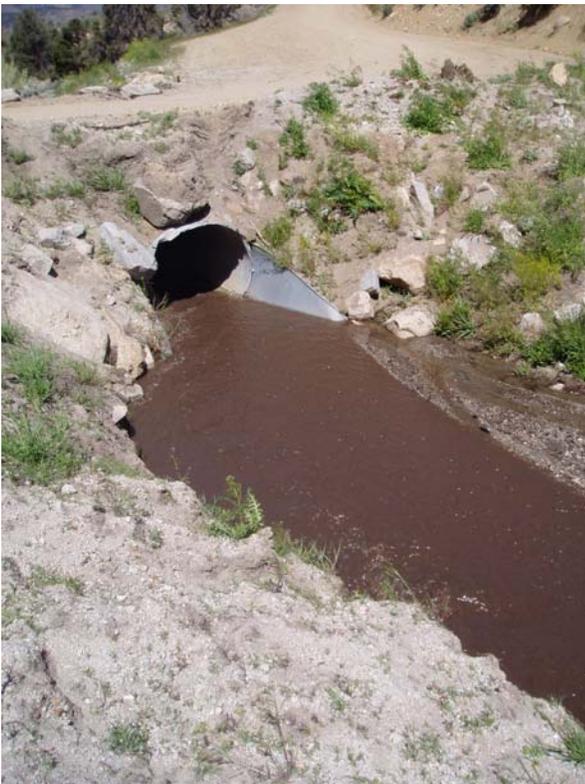
**Site 1:** Rock Creek, Bridgeport Ranger District, looking downstream at a culvert. This culvert is currently not a fish barrier. The stream habitat survey started at this site. This site is located at UTM N: 4265610 & E: 287187.

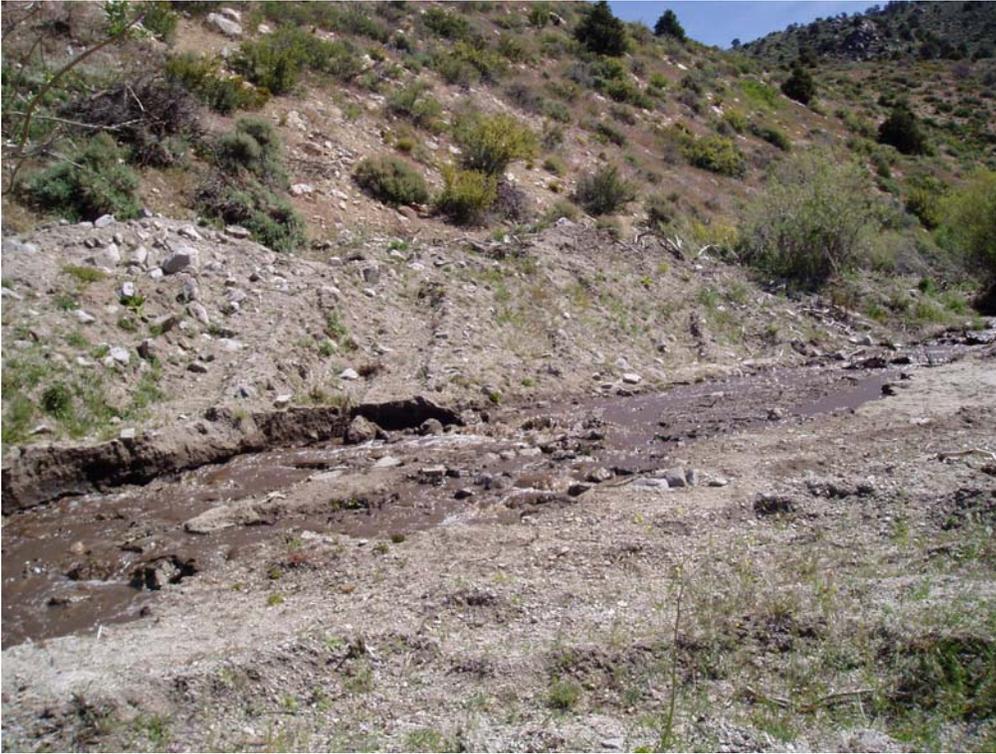
**Site 2:** Rock Creek, Bridgeport Ranger District, photo point, looking upstream at some flood evidence. This site is located at UTM: N: 4265610 & E: 287187.

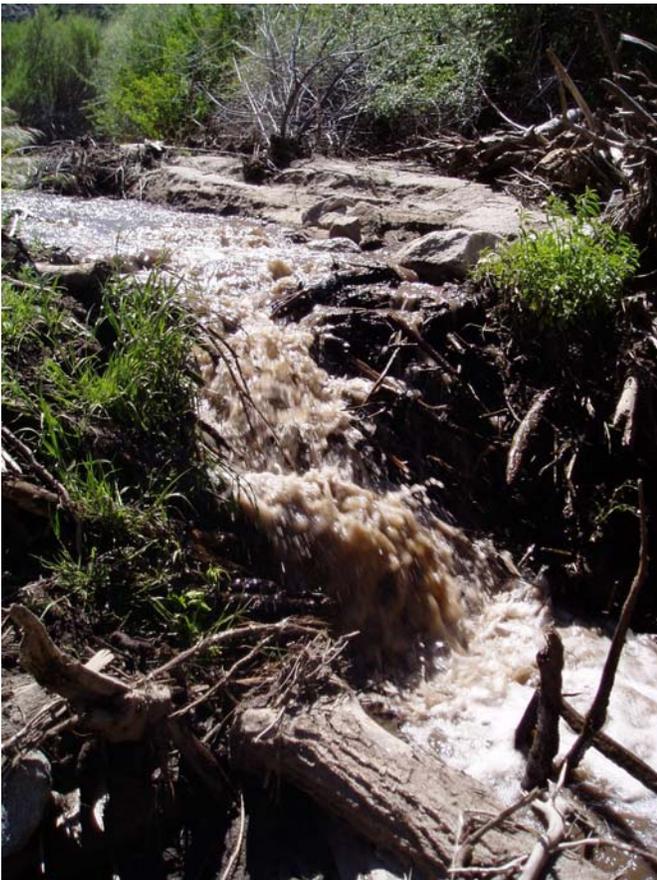
**Site 3:** Rock Creek, Bridgeport Ranger District, looking upstream at a permanent fish barrier. The height of the barrier is 4.9 feet and the depth of the pool at the bottom of the barrier is 1.1 feet deep. This site is located at UTM: N: 4265611 & E: 287332.

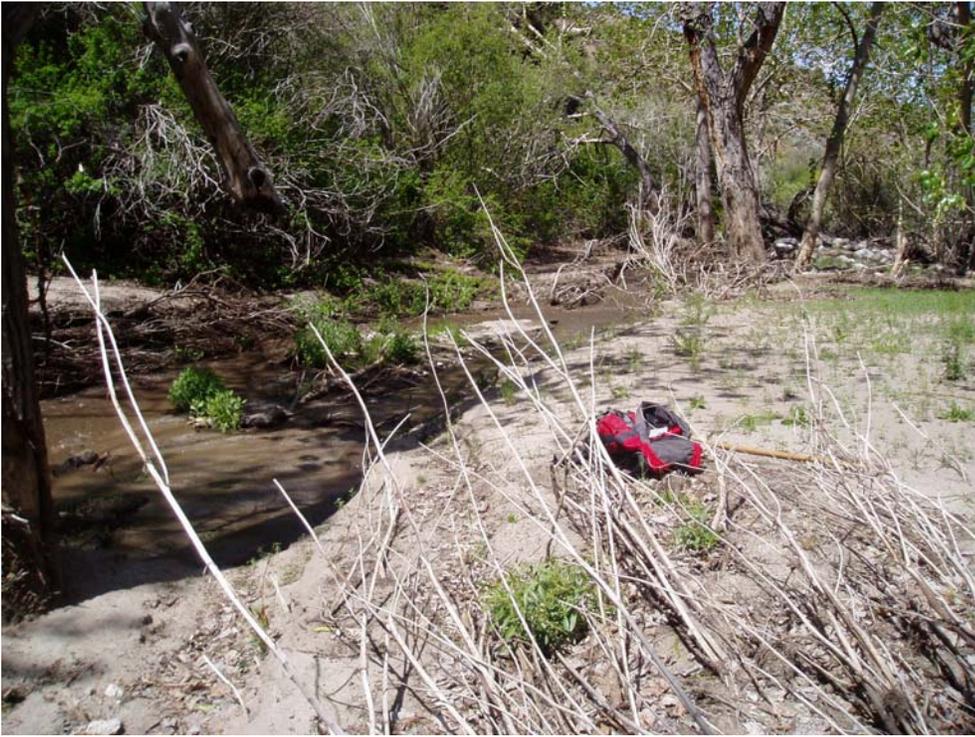
**Site 4:** Rock Creek, Bridgeport Ranger District, photo point, looking downstream. Some erosion and evidence of recent flooding is at this site. The width of the creek at this site is 5.2 feet and the average depth is 0.5 feet. This site is located at UTM N: 4265426 & E: 287667.

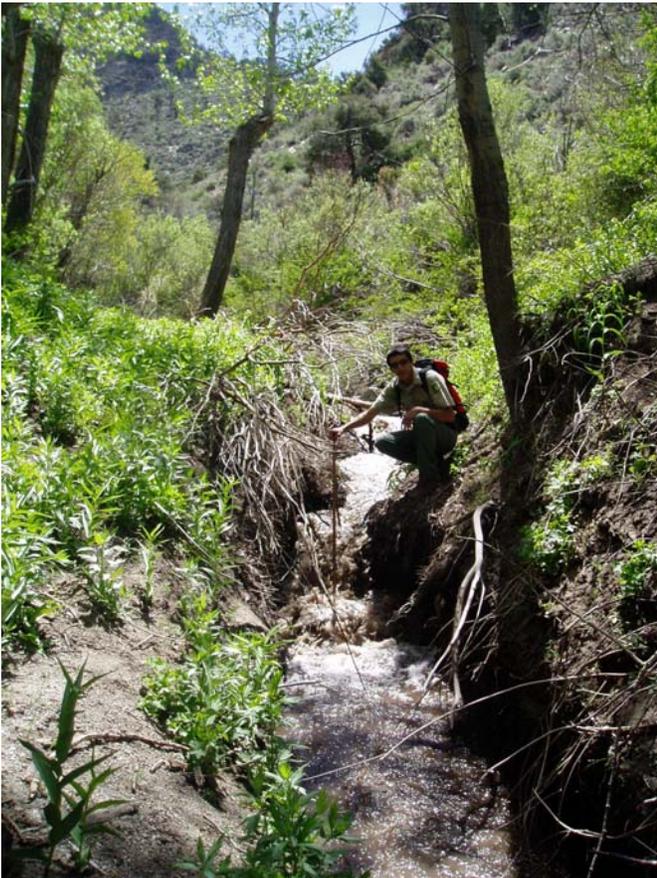
**Site 5:** Rock Creek, Bridgeport Ranger District, looking upstream at a seasonal fish barrier. This is the first/lower barrier of 3 in a series. The height of the barrier is 1.6 feet and the depth of the pool at the bottom of the barrier is 0.8 feet. This site is located at UTM N: 4265403 & E: 287812.

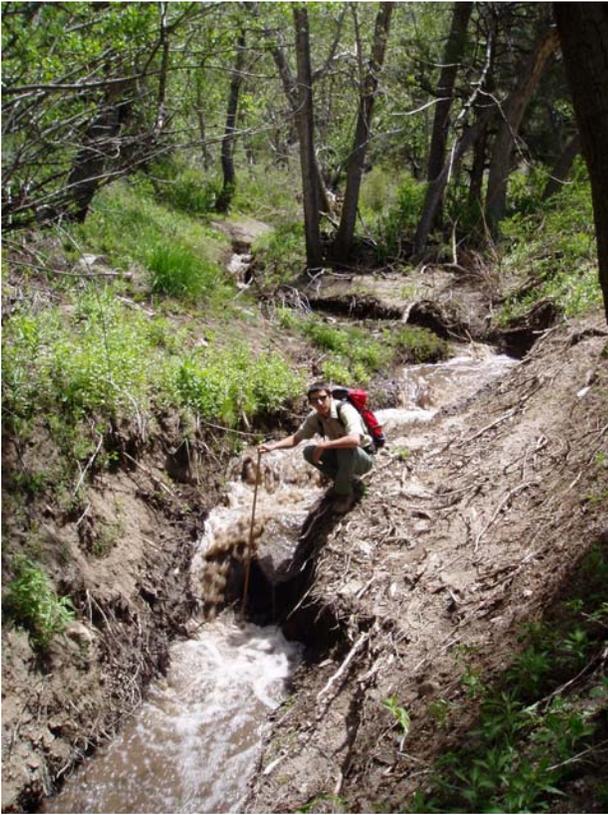
**Site 6:** Rock Creek, Bridgeport Ranger District, looking upstream at a seasonal fish barrier. The height of the barrier is 2.8 feet and the depth of the pool at the bottom of the barrier is 1.5 feet. This site is located at UTM N: 4265419 & E: 287971.

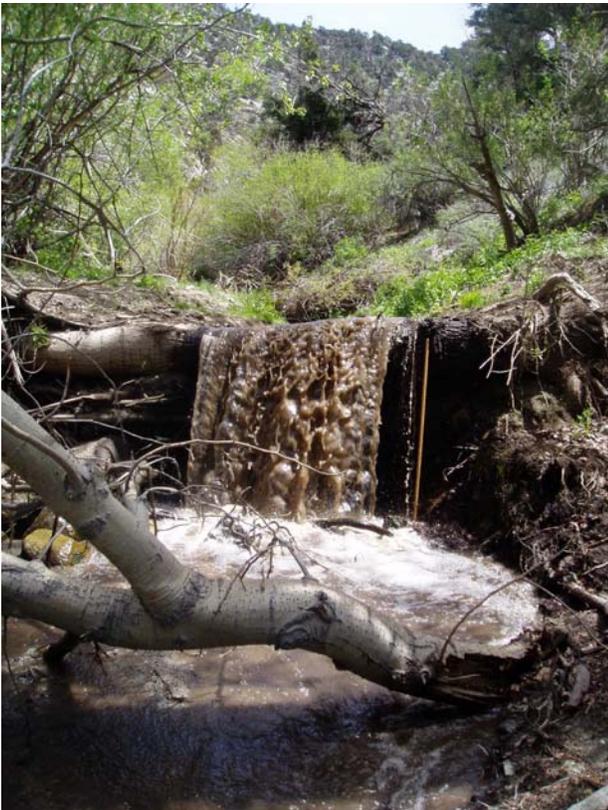
**Site 7:** Rock Creek, Bridgeport Ranger District, looking upstream at a permanent fish barrier. The height of the barrier is 5.9 feet. This site is located at UTM N: 4265438 & E: 288092.

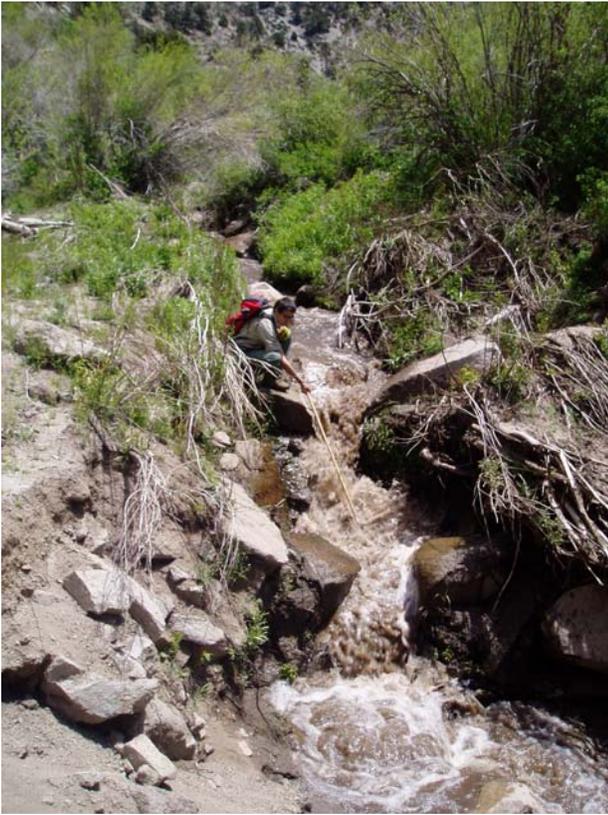
**Site 8:** Rock Creek, Bridgeport Ranger District, looking upstream at a permanent fish barrier. The height of the barrier is 9.8 feet. This site is located approximately 40 meters upstream of site 7. Site 7 is located at UTM N: 4265438 & E: 288092.

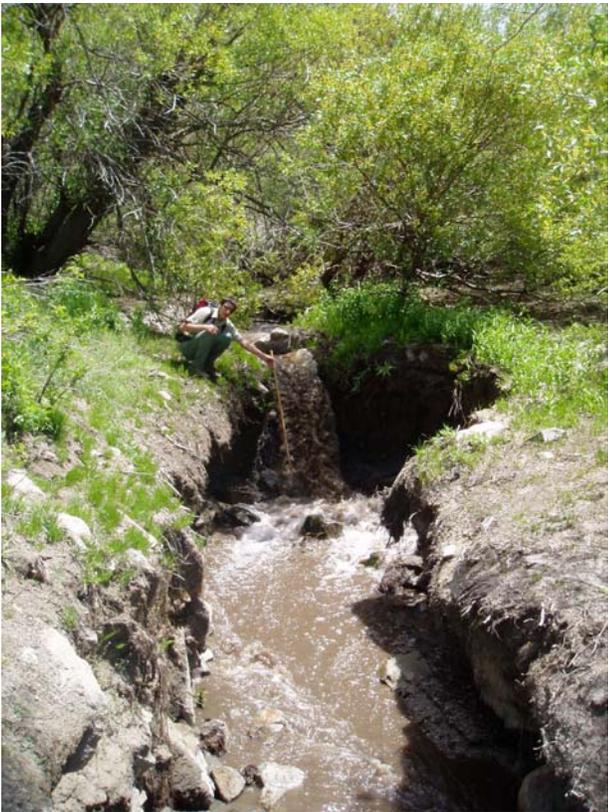
**Site 9:** Rock Creek, Bridgeport Ranger District, looking upstream at a permanent fish barrier. The height of the barrier is 6.6 feet. This site is located at UTM N: 4265486 & E: 288255.

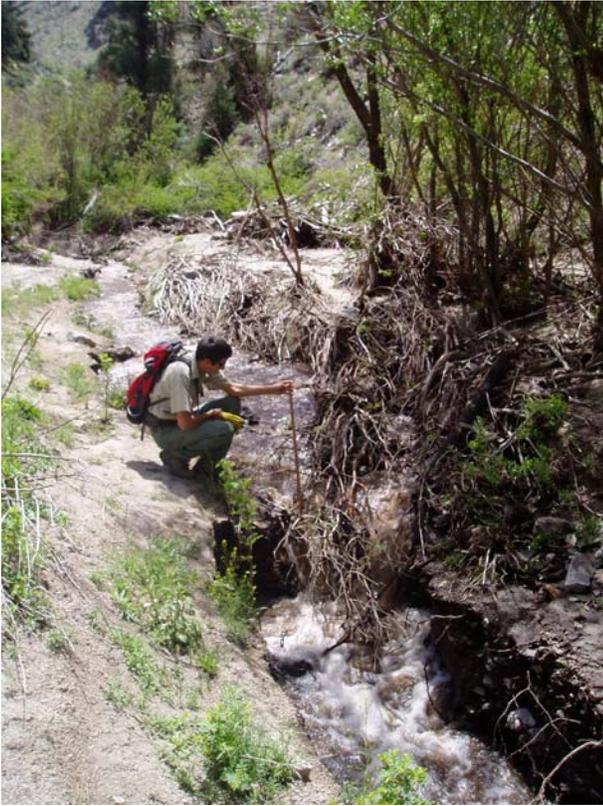
**Site 10:** Rock Creek, Bridgeport Ranger District, looking upstream at a seasonal fish barrier. The height of the barrier is 2.5 feet and the depth of the pool at the bottom of the barrier is 1.8 feet. This site is located at UTM N: 4265485 & E: 288465.

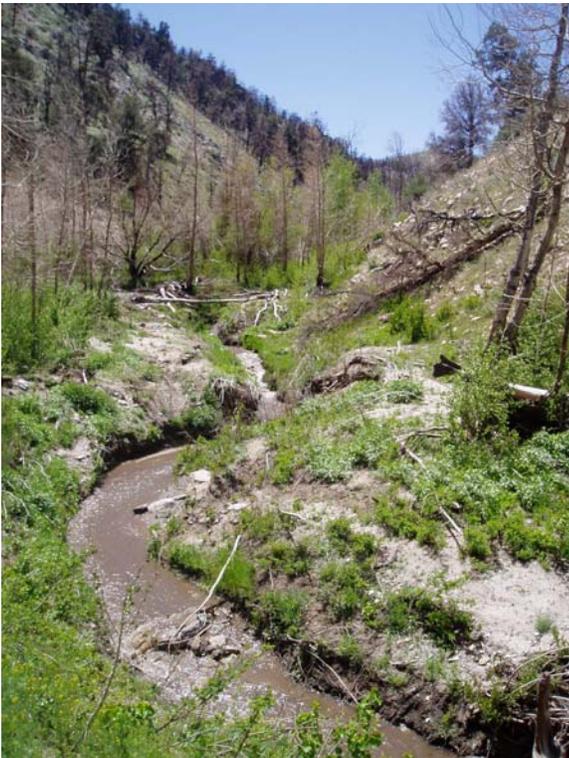
**Site 11:** Rock Creek, Bridgeport Ranger District, looking upstream at a tributary (South Fork Rock Creek) entering on the river left side. This tributary is contributing approximately 5% to the overall flow in Rock Creek. This tributary does not provide potential Lahontan cutthroat trout habitat. This site is located at UTM N: 4265316 & E: 288512.

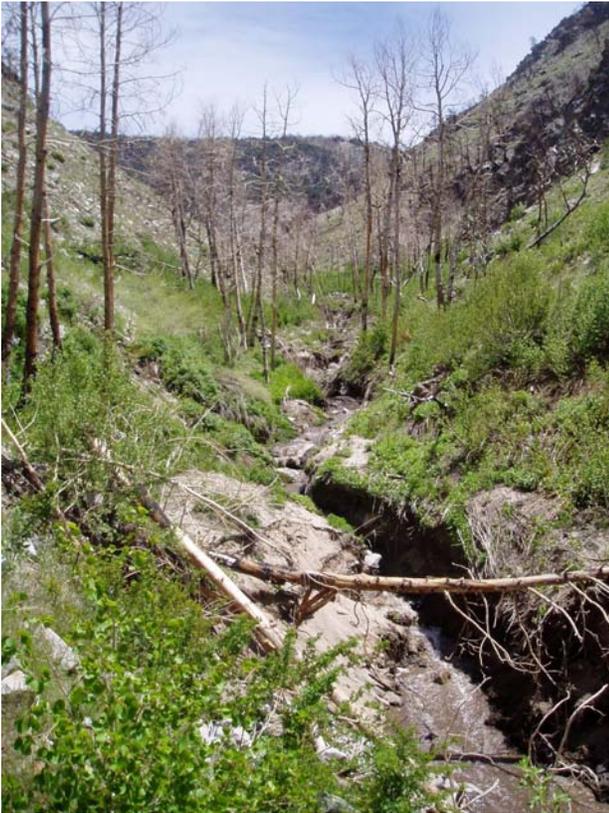
**Site 11:** Rock Creek, Bridgeport Ranger District, photo point, looking upstream at where the 2002 Cannon Fire burned. This site is located at UTM N: 4265316 & E: 288512.

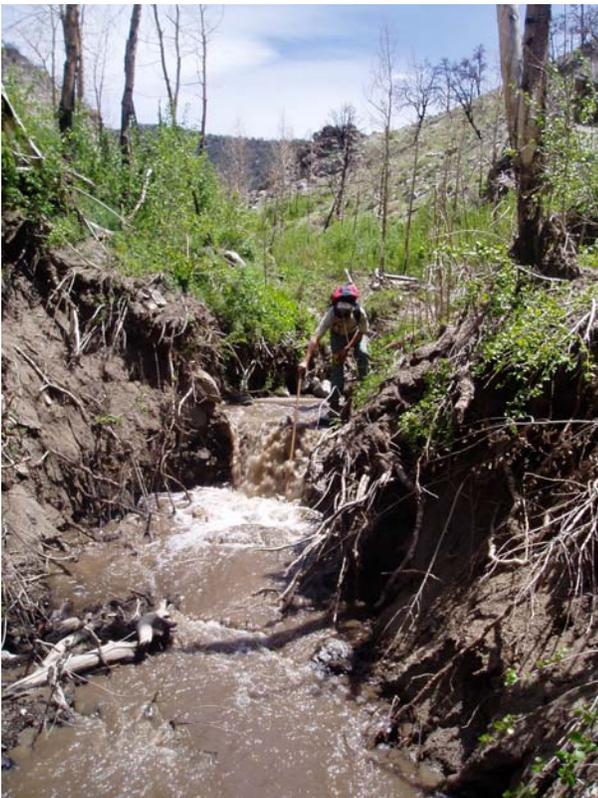
**Site 12:** Rock Creek, Bridgeport Ranger District, looking upstream at a seasonal fish barrier. The height of the barrier is 3.1 feet and the depth of the pool at the bottom of the barrier is 0.7 feet. This site is located at UTM N: 4265243 & E: 288714.

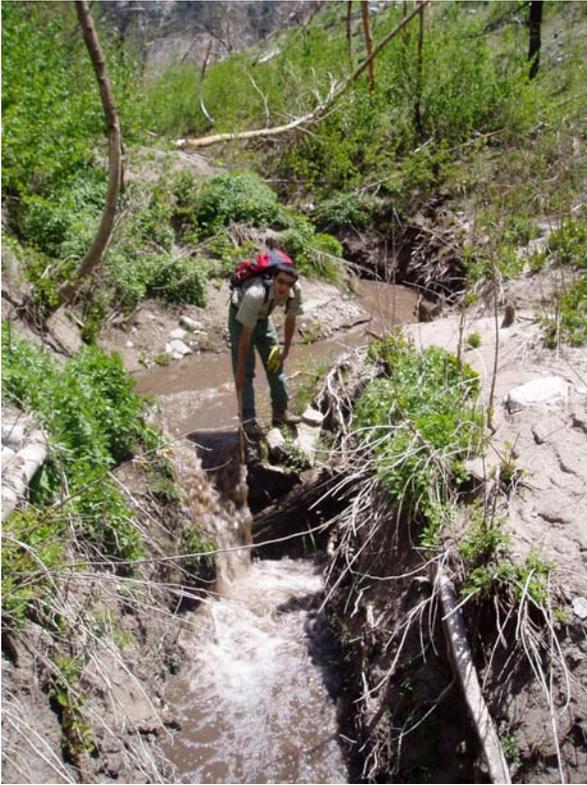
**Site 13:** Rock Creek, Bridgeport Ranger District, looking upstream at a seasonal fish barrier. The height of the barrier is 3.3 feet and the depth of the pool at the bottom of the barrier is 1.3 feet. A lot of stream bank erosion is occurring at this site. This site is located at UTM N: 4265195 & E: 288844.

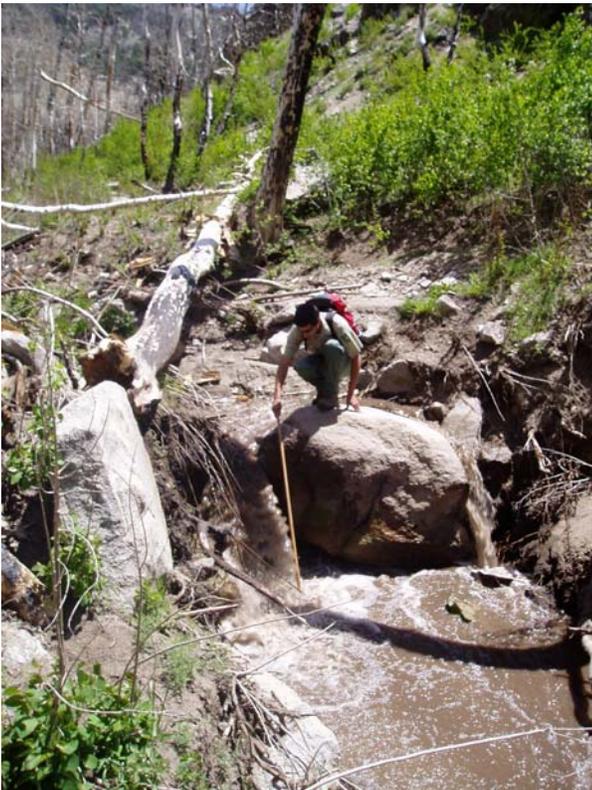
**Site 14:** Rock Creek, Bridgeport Ranger District, looking upstream at a seasonal fish barrier. The height of the barrier is 4.3 feet and the depth of the pool at the bottom of the barrier is 0.7 feet. This site is located at UTM N: 4265129 & E: 288984.

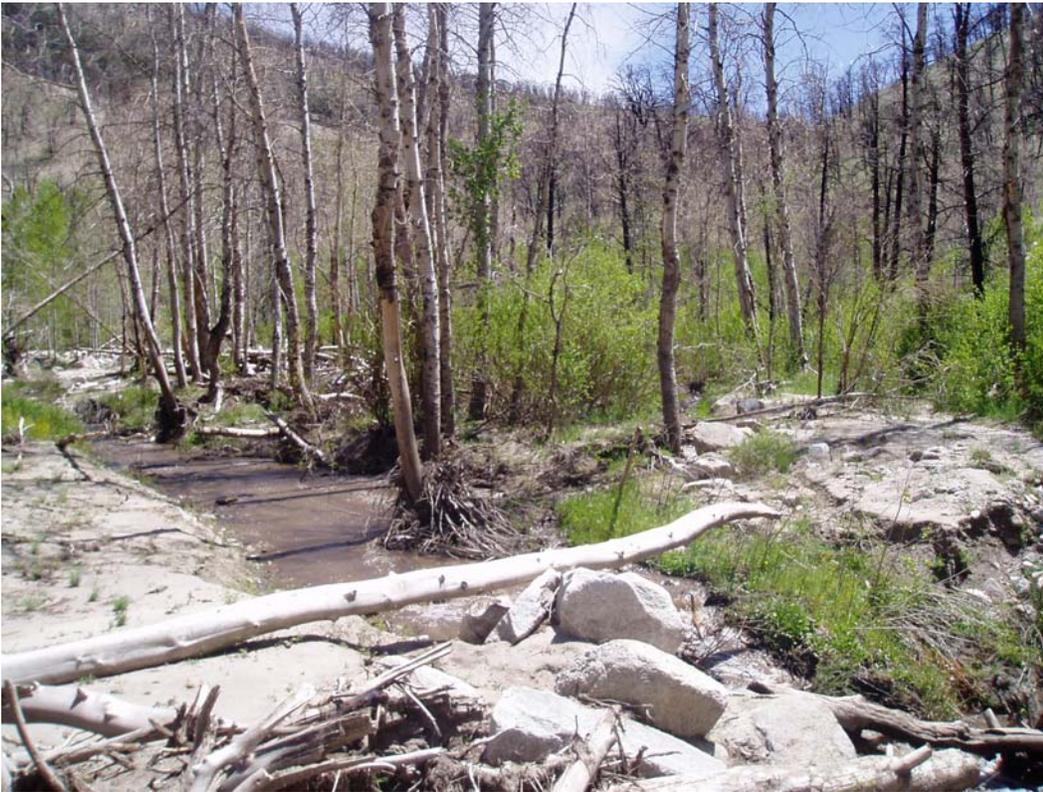
**Site 15:** Rock Creek, Bridgeport Ranger District, looking upstream at a tributary entering on the river right side. This tributary is contributing approximately 5% to the overall flow in Rock Creek. This site is located at UTM N: 4265009 & E: 289115.

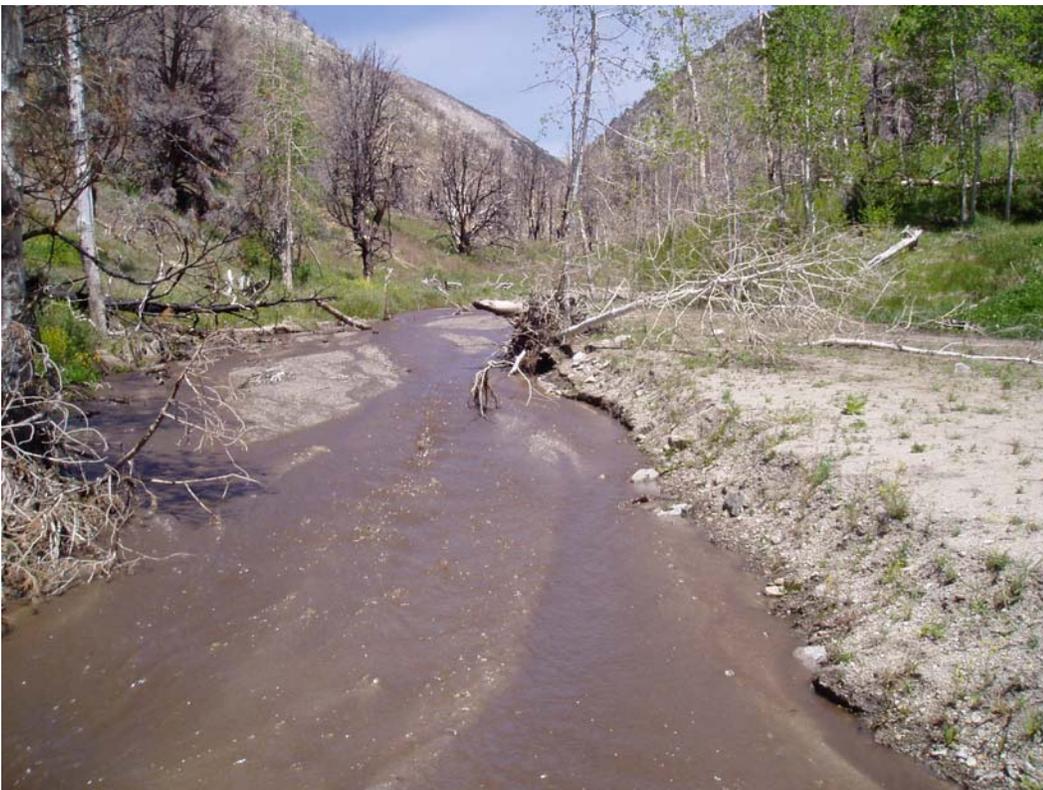
**Site 16:** Rock Creek, Bridgeport Ranger District, photo point, looking upstream. This site is located at UTM N: 4264959 & E: 289216.

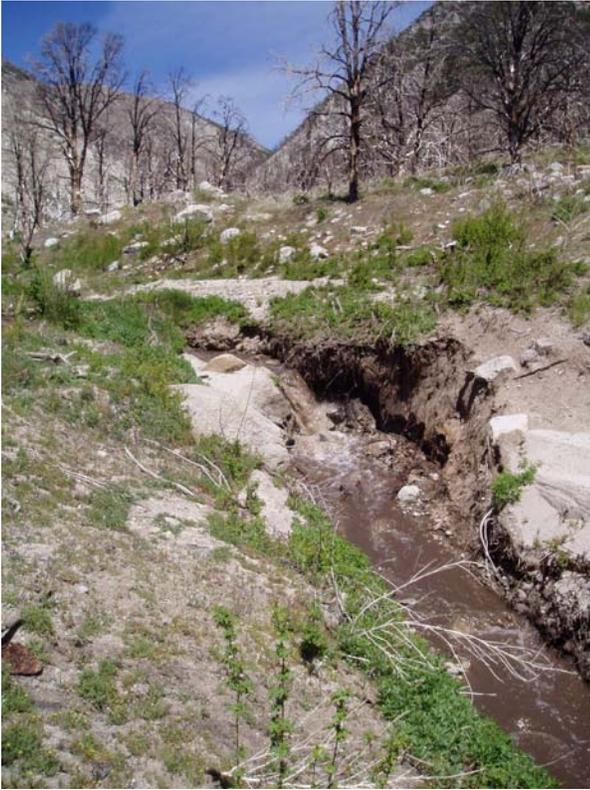
**Site 17:** Rock Creek, Bridgeport Ranger District, looking upstream at a seasonal fish barrier. The height of the barrier is 4.1 feet and the depth of the pool at the bottom of the barrier is 0.8 feet. This site is located at UTM N: 4265031 & E: 289556.

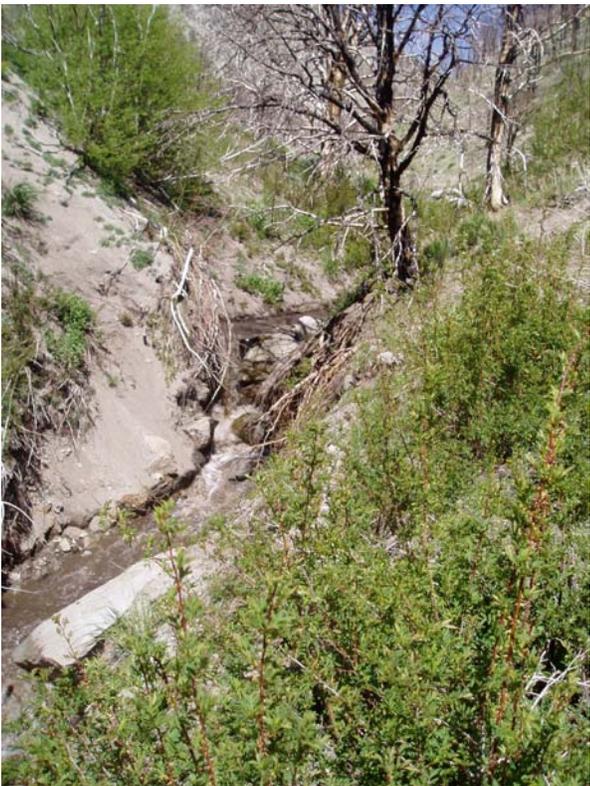
**Site 18:** Rock Creek, Bridgeport Ranger District, looking upstream at a seasonal fish barrier. The height of the barrier is 4.8 feet and the depth of the pool at the bottom of the barrier is 0.8 feet. This site is located at UTM N: 4265277 & E: 289984.

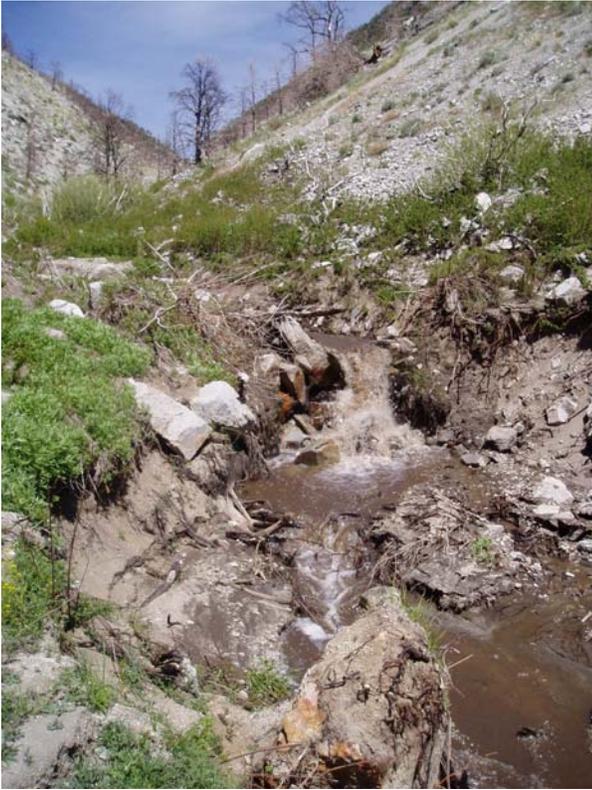
**Site 19:** Rock Creek, Bridgeport Ranger District, looking upstream at a seasonal fish barrier. The height of the barrier is 4.3 feet and the depth of the pool at the bottom of the barrier is 0.8 feet. This site is located at UTM N: 4265397 & E: 290207.

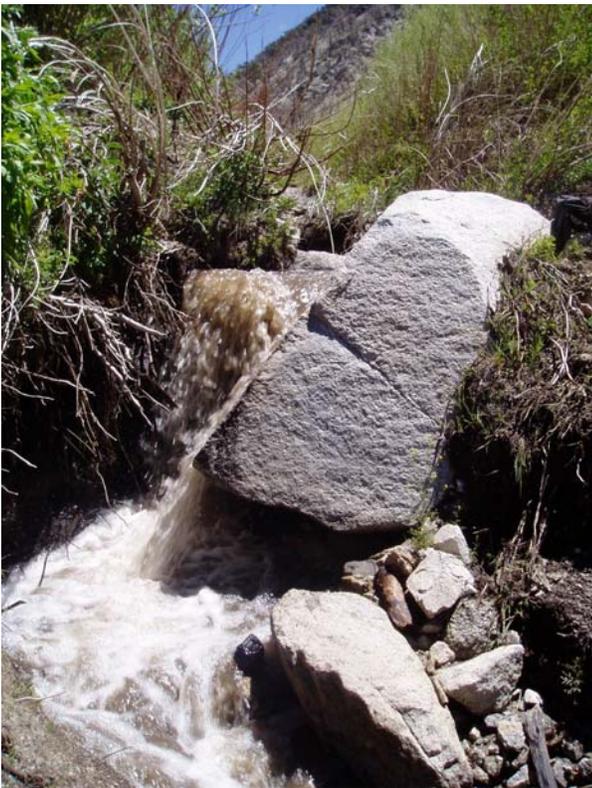
**Site 20:** Rock Creek, Bridgeport Ranger District, looking upstream at a seasonal fish barrier. The height of the barrier is 3.9 feet and the depth of the pool at the bottom of the barrier is 0.8 feet. This site is located at UTM N: 4265441 & E: 290270.

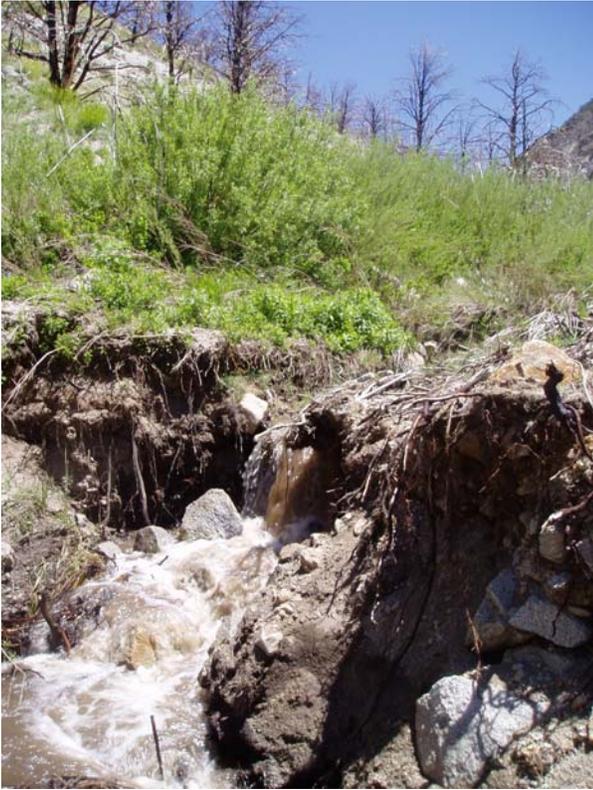
**Site 21:** Rock Creek, Bridgeport Ranger District, looking upstream at a seasonal fish barrier. The height of the barrier is 2.5 feet and the depth of the pool at the bottom of the barrier is 1.6 feet. This site is located at UTM N: 4265456 & E: 290351.

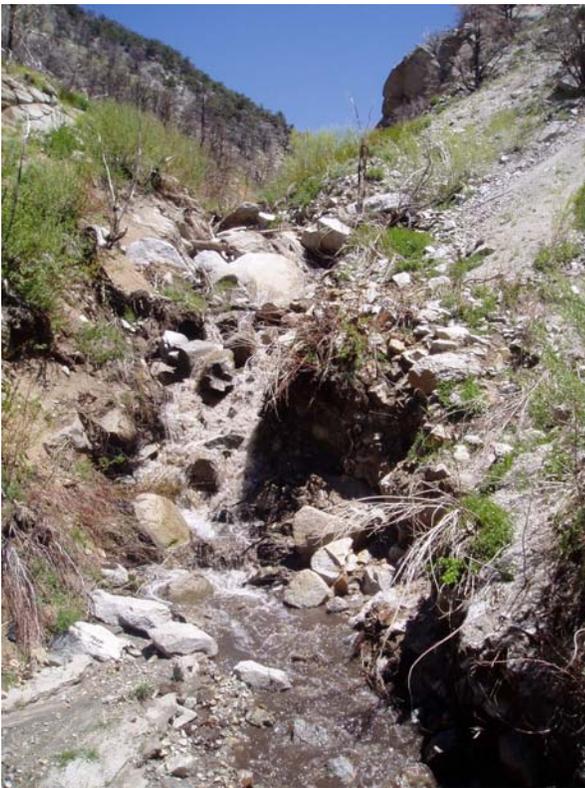
**Site 22:** Rock Creek, Bridgeport Ranger District, looking upstream at a permanent fish barrier. This barrier is the first/lower of 3 barriers in a series. The height of this barrier is 19.7 feet. The height of both of the other two barriers is 3.3 feet. This site is located at UTM N: 4265461 & E: 290448.

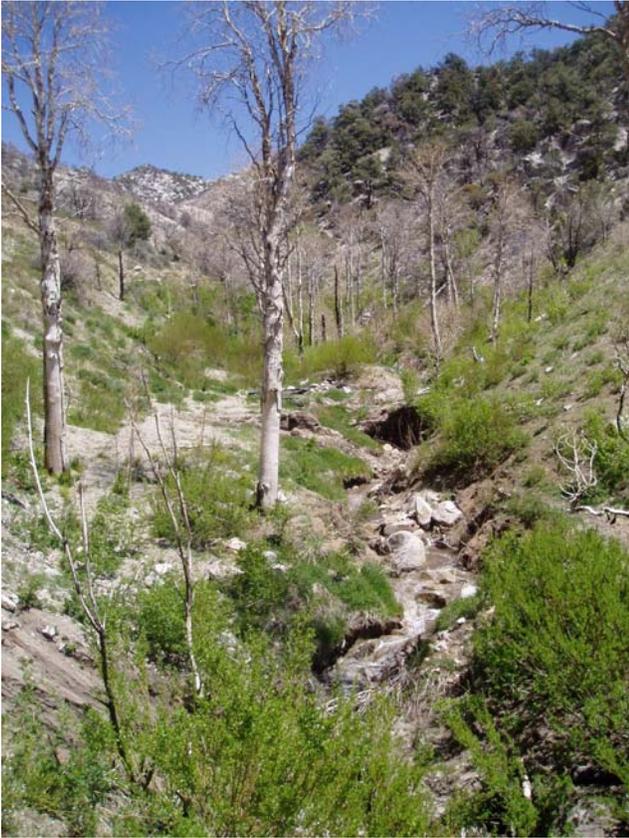
**Site 23:** Rock Creek, Bridgeport Ranger District, photo point, looking upstream. This site is located at UTM N: 4265649 & E: 291508.

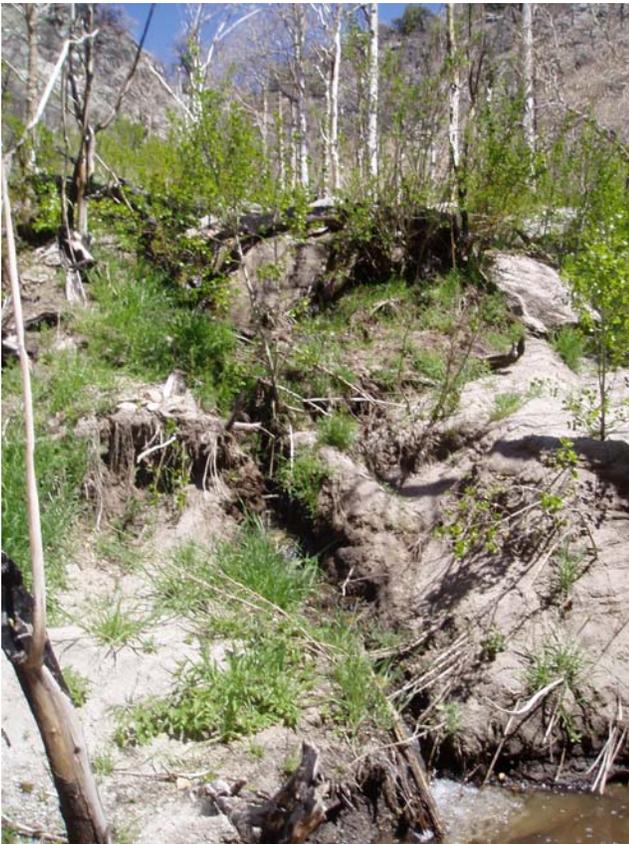
**Site 24:** Rock Creek, Bridgeport Ranger District, looking upstream at a tributary entering on the river right side. This site is located at UTM N: 4265692 & E: 291946.

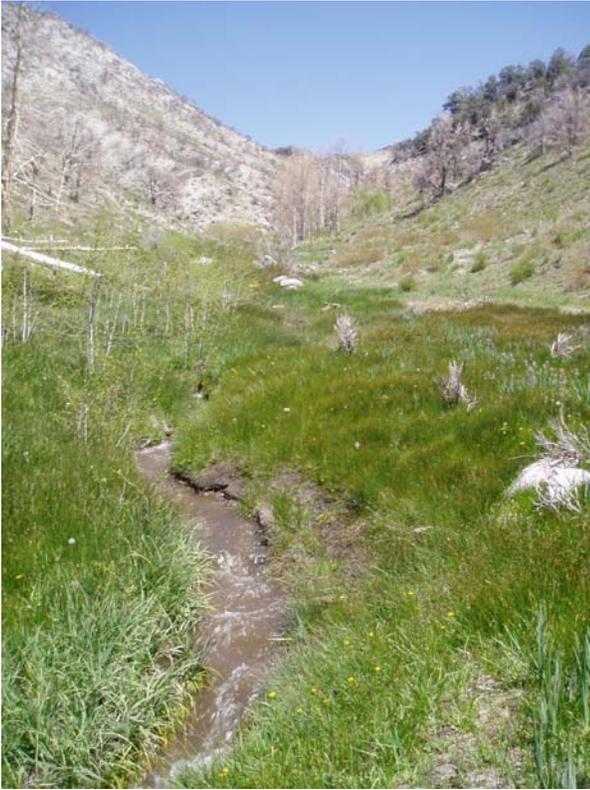
**Site 25:** Rock Creek, Bridgeport Ranger District, photo point, looking upstream. The stream habitat survey ended at this site. Stream starts to become intermittent at this site. This site is located at UTM N: 4265072 & E: 292726.

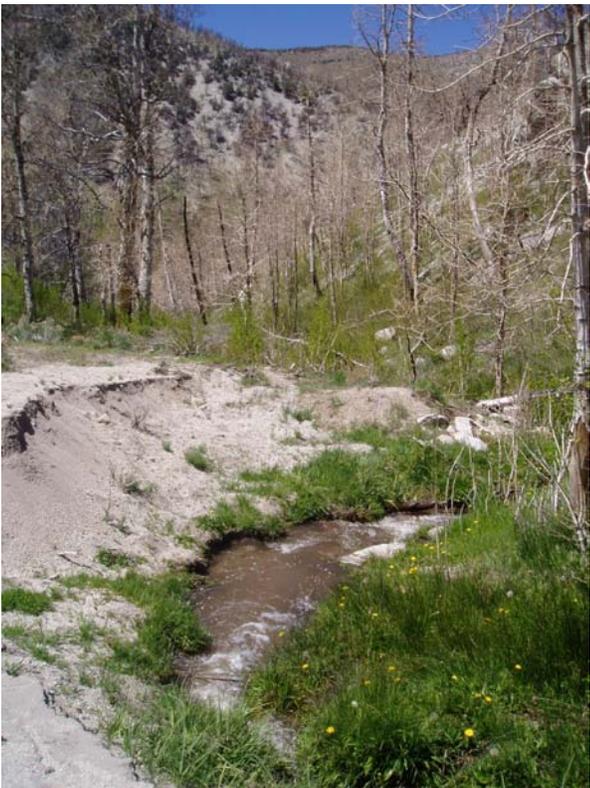
**Site 25:** Rock Creek, Bridgeport Ranger District, photo point, looking downstream. The stream habitat survey ended at this site. Stream starts to become intermittent at this site. This site is located at UTM N: 4265072 & E: 292726.
