Rough Creek

Mono County, California

2006 Stream Habitat Survey Report

Humboldt-Toiyabe National Forest, Bridgeport Ranger District

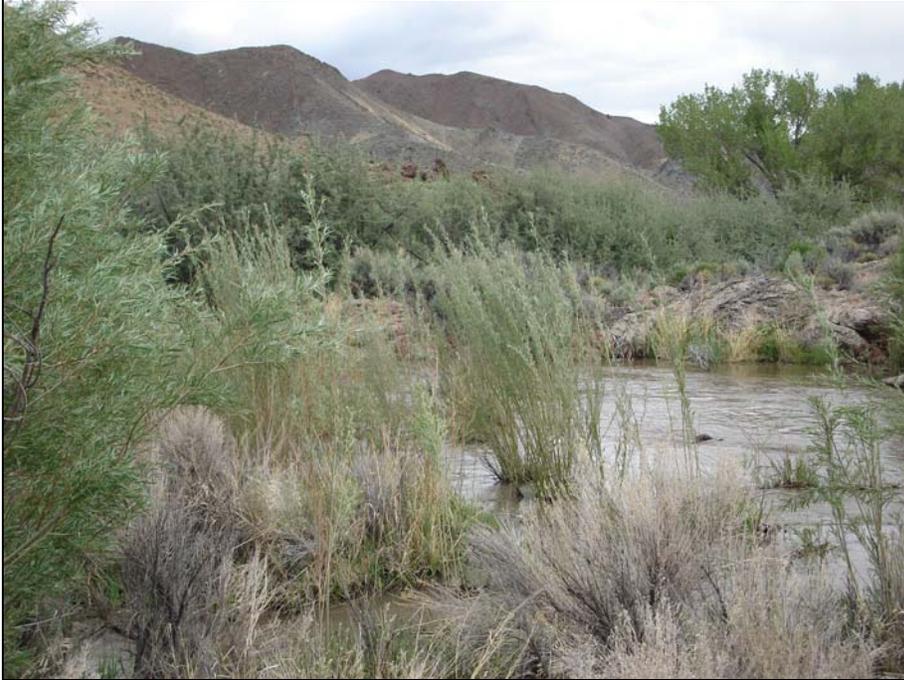
Site 1: Rough Creek, Bridgeport Ranger District, looking downstream towards the confluence of Rough Creek with the East Walker River. The stream in this area widens considerably and forms a large wetland area. Rough Creek is approximately 6m wide and 0.5m deep at this site. This site is located at UTM: N: 4255757 & E: 324428, Elevation 1700m.

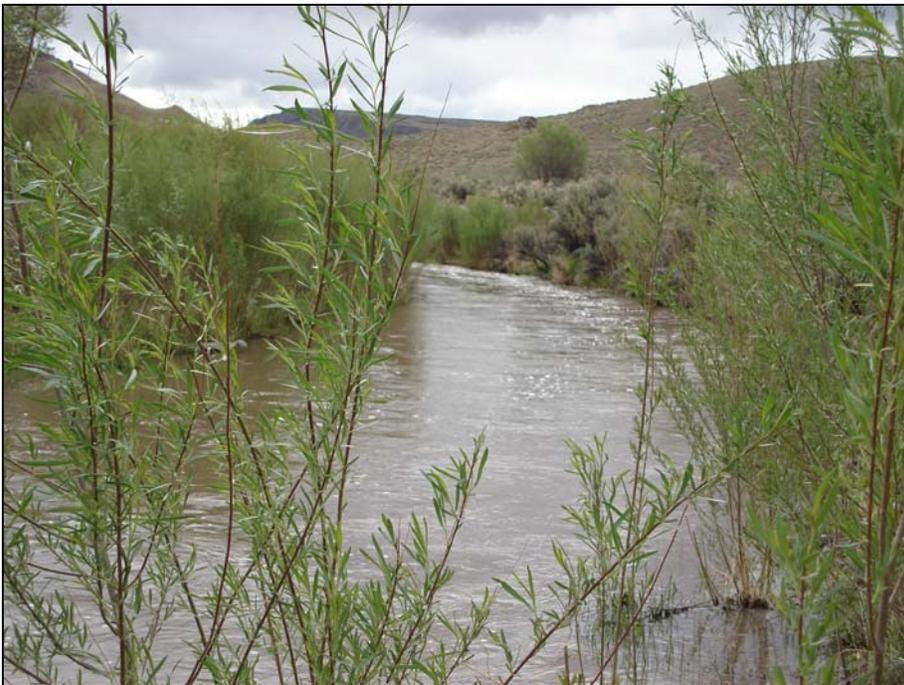
Site 1 continued: Rough Creek, Bridgeport Ranger District, looking upstream at Rough Creek from near the East Walker River. This site is located at UTM: N: 4255757 & E: 324428, Elevation 1700m.

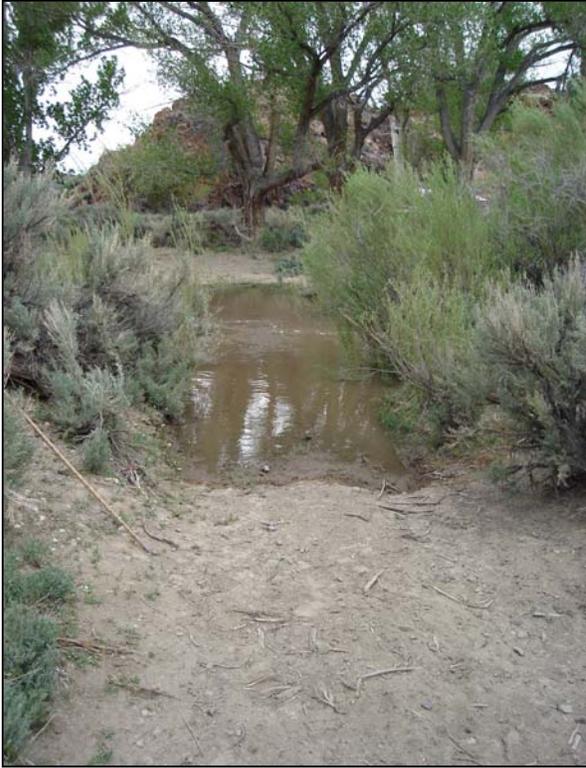
Site 2: Rough Creek, Bridgeport Ranger District. Picture of a road-stream crossing on Rough Creek. Note the large amount of sediment from the road. This section of stream is surrounded by private land and fences. This site is located at UTM: N: 4255686 & E: 324494, Elevation 1700m.

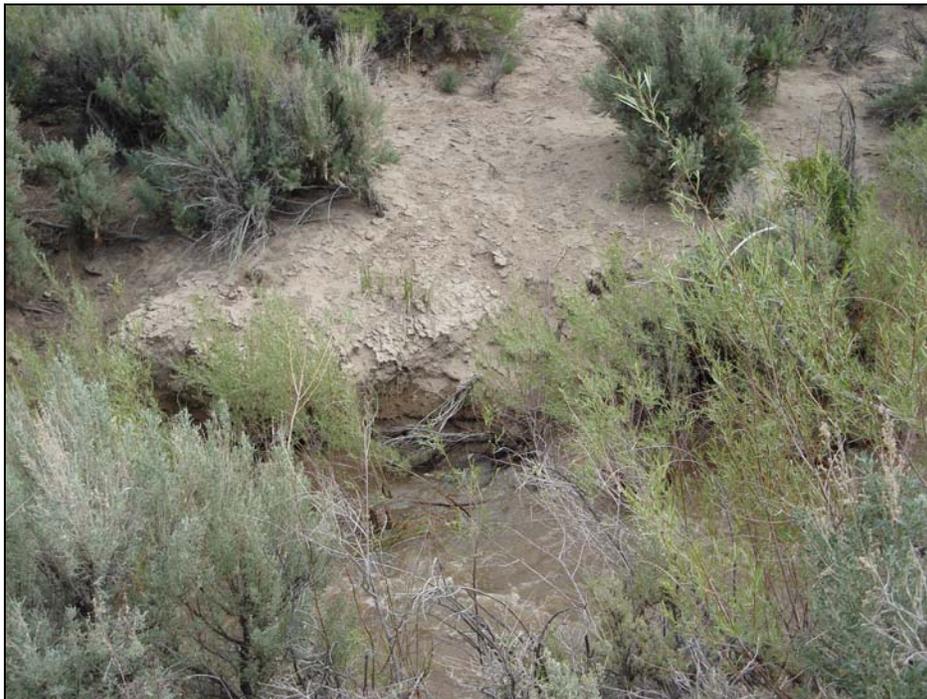
Site 3: Rough Creek, Bridgeport Ranger District. The stream banks show signs of heavy grazing and erosion due to the presence of cattle. This site is located at UTM: N: 4255415 & E: 324851, Elevation 1702m.

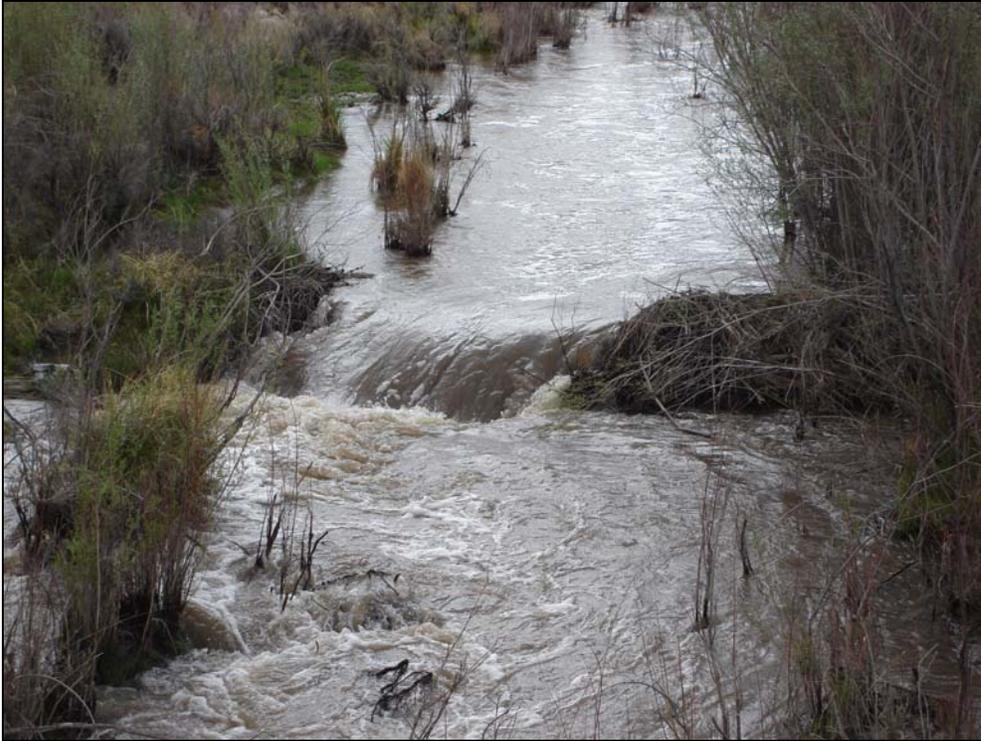
Site 4: Rough Creek, Bridgeport Ranger District, looking upstream at a beaver dam crossing the entire stream. The beaver dam height where water flows is 0.4m. This site is located at UTM: N: 4255048 & E: 325087, Elevation 1711m.

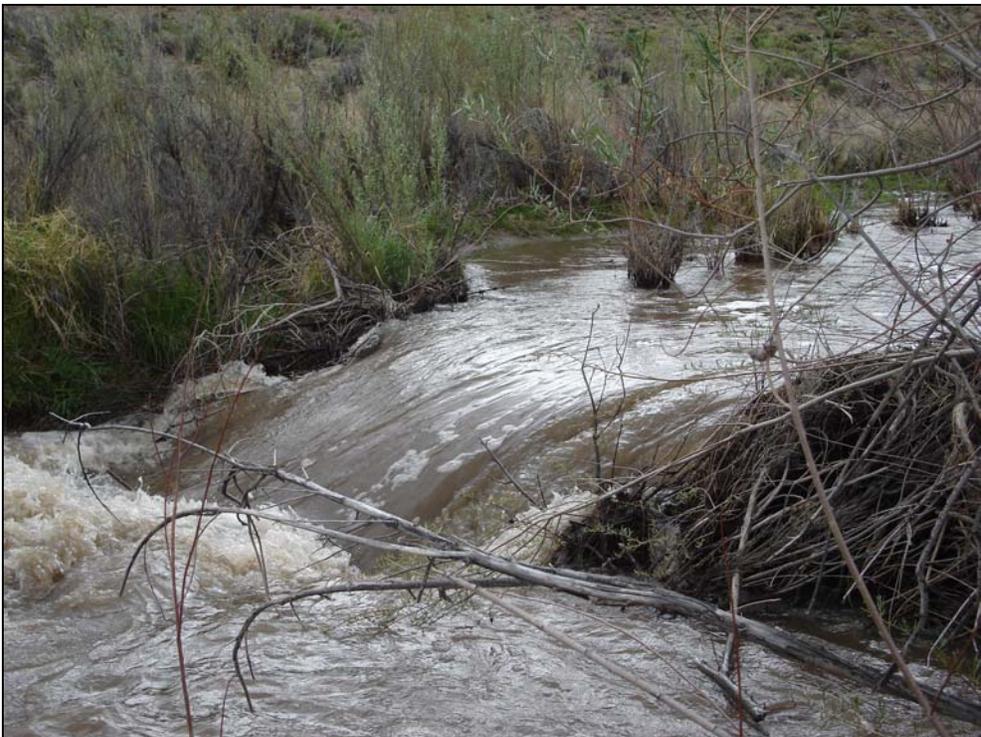
Site 4 continued: Rough Creek, Bridgeport Ranger District, another view of the beaver dam. This site is located at UTM: N: 4255048 & E: 325087, Elevation 1711m.

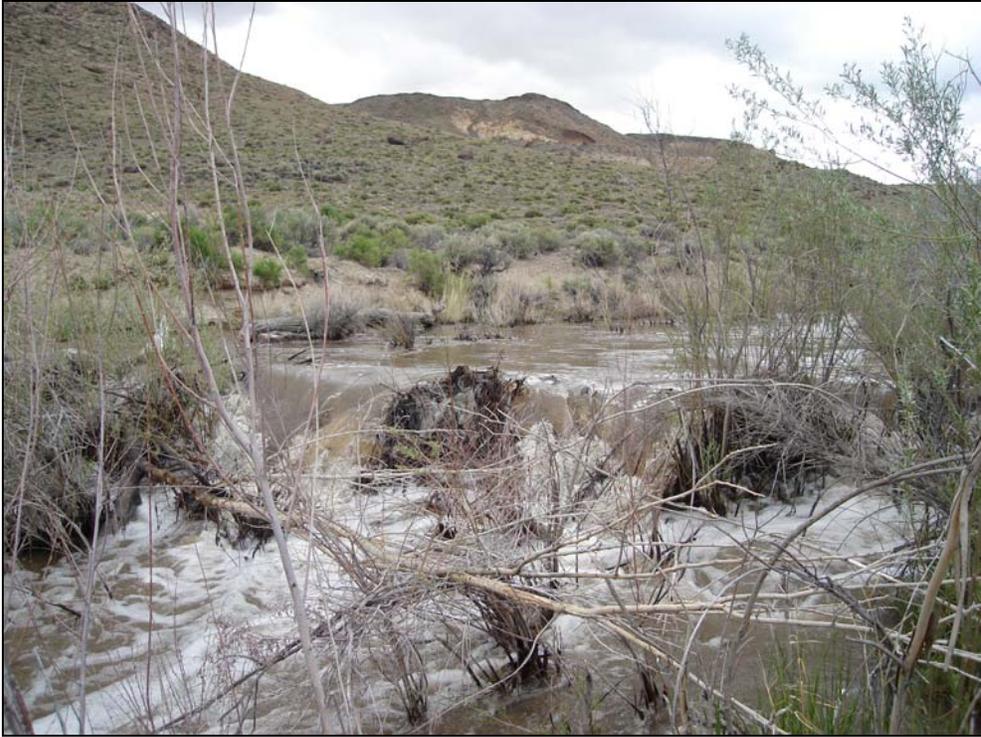
Site 5: Rough Creek, Bridgeport Ranger District. Another beaver dam located approximately 50m upstream from the beaver dam at Site 4. This beaver dam creates a large pool upstream. This site is located at UTM: N: 4255017 & E: 325114, Elevation 1711m.

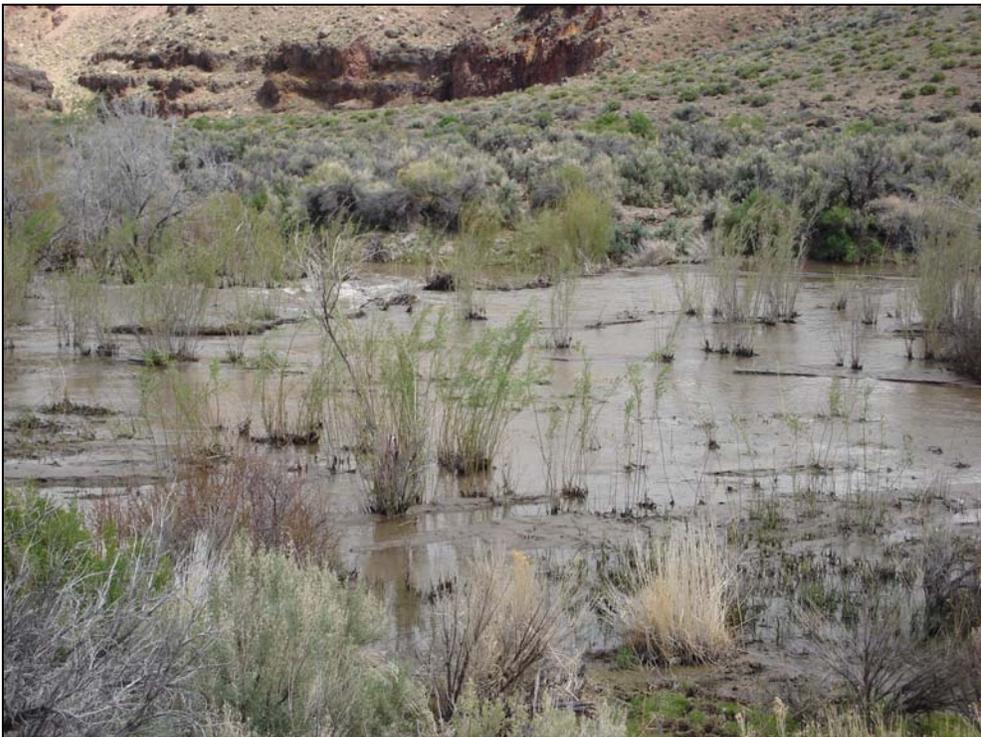
Site 5 continued: Rough Creek, Bridgeport Ranger District, looking upstream from the beaver dam at the backed up water. This site is located at UTM: N: 4255017 & E: 325114, Elevation 1711m.

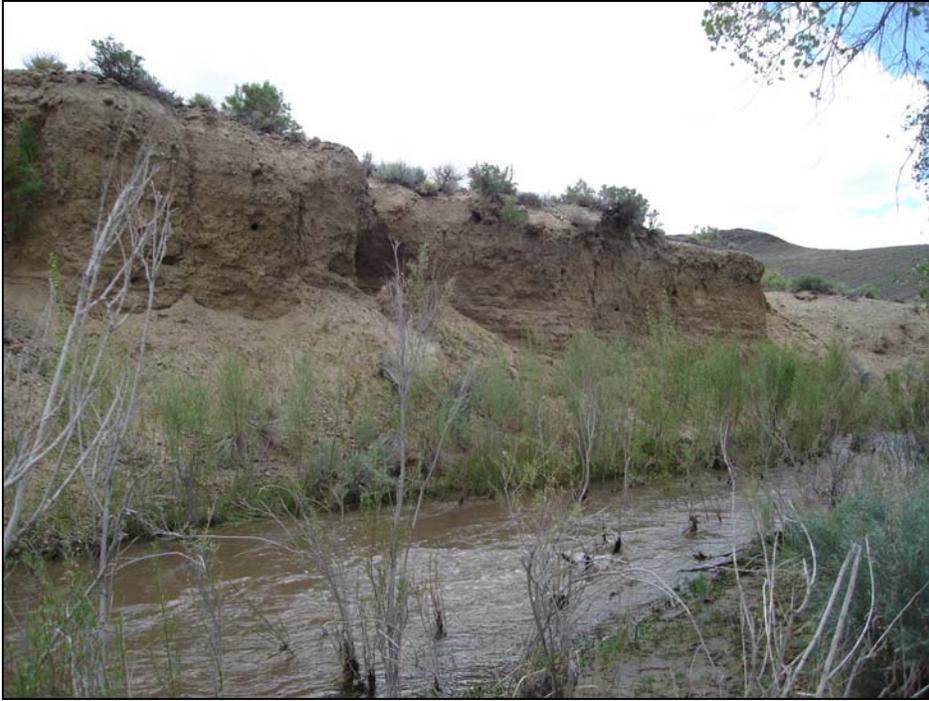
Site 6: Rough Creek, Bridgeport Ranger District. A steep 5-6m high bank with signs of heavy erosion along a 100m long section on the outside of a meander bend. This site is located at UTM: N: 4254416 & E: 325687, Elevation 1726m.

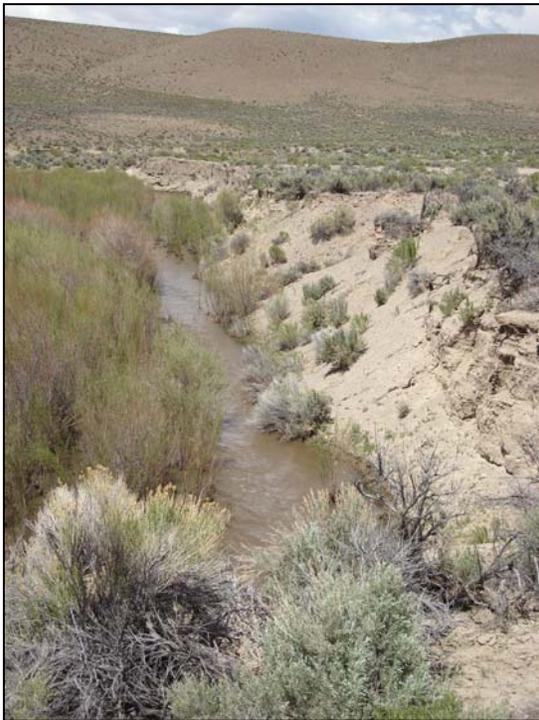
Site 7: Rough Creek, Bridgeport Ranger District, looking upstream at the Forest Service-Nine Mile Ranch property boundary. Through Nine Mile Ranch Rough Creek flows through a large valley and the stream bed is deeply cut into the valley floor. This site is located at UTM: N: 4253300 & E: 327977, Elevation 1760m.

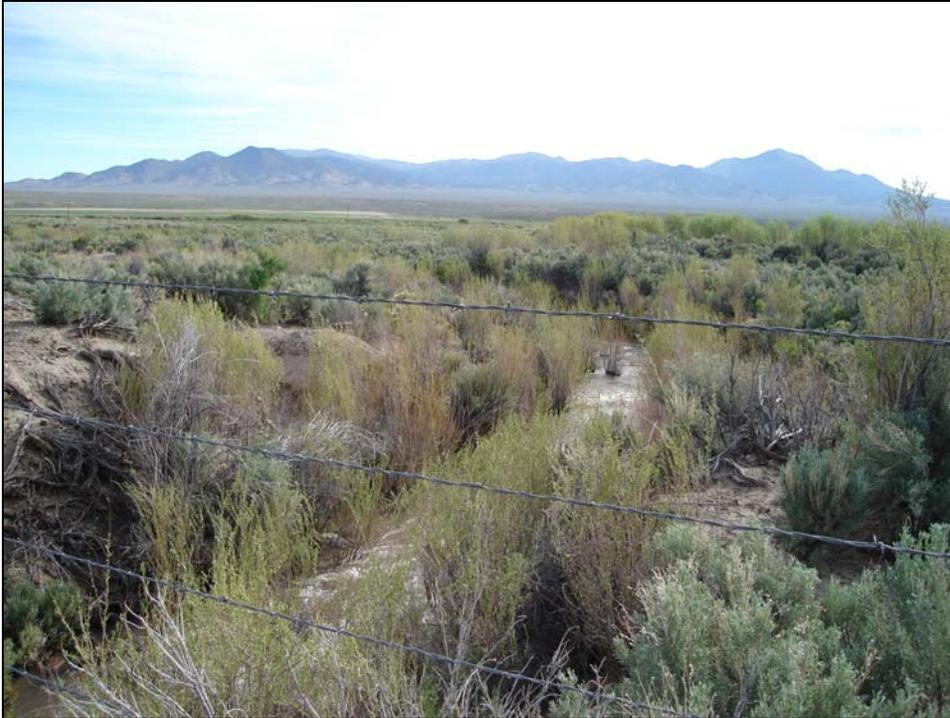
Site 8: Rough Creek, Bridgeport Ranger District, looking downstream from the Forest Service-Nine Mile Ranch property boundary. The stream depth at this site is 0.5m and the width is 2.5m. This site is located at UTM: N: 4249396 & E: 330922, Elevation 1827m.

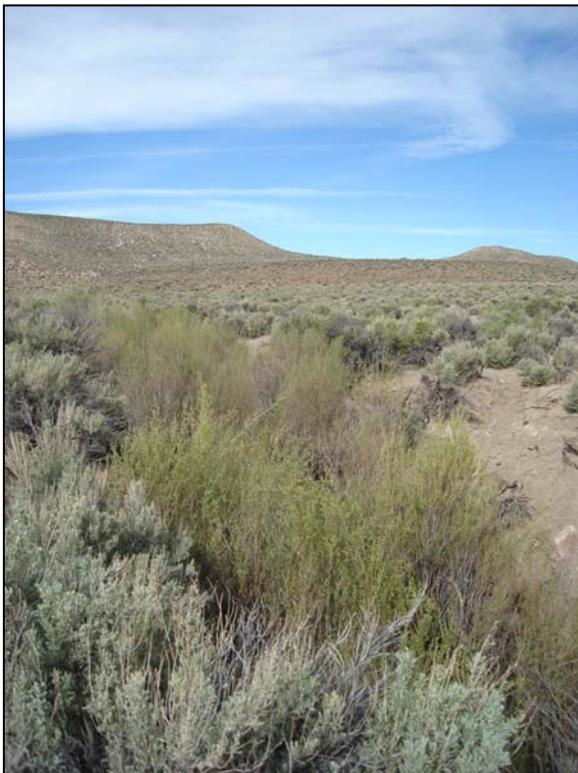
Site 8 continued: Rough Creek, Bridgeport Ranger District, looking upstream from the Forest Service-Nine Mile Ranch property boundary. This site is located at UTM: N: 4249396 & E: 330922, Elevation 1827m.

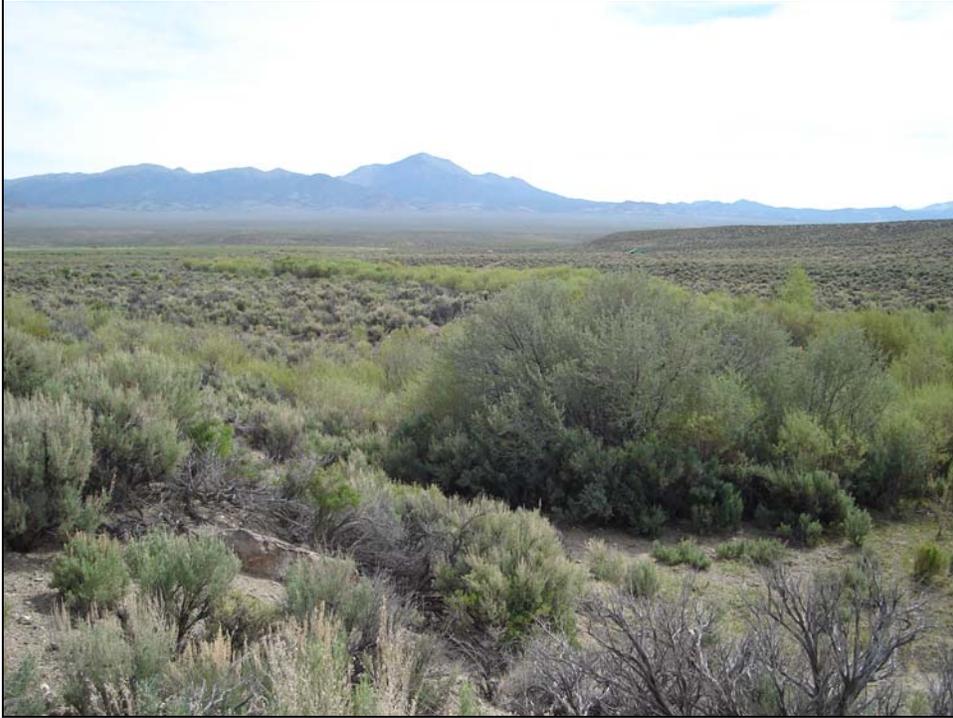
Site 9: Rough Creek, Bridgeport Ranger District. A point where the stream is diverted by an irrigation canal to allow a rancher water to flood irrigate a field for grazing. (Note the two diverging lines of willow. This site is located at UTM: N: 4249024 & E: 330716, Elevation 1830m.

2. Investigate the destination and impacts of the diversion located at Site 9. Ensure that fish are not subject to terminal trips into irrigated pasture, and similarly ensure that water users are staying within the confines of their adjudicated rights.

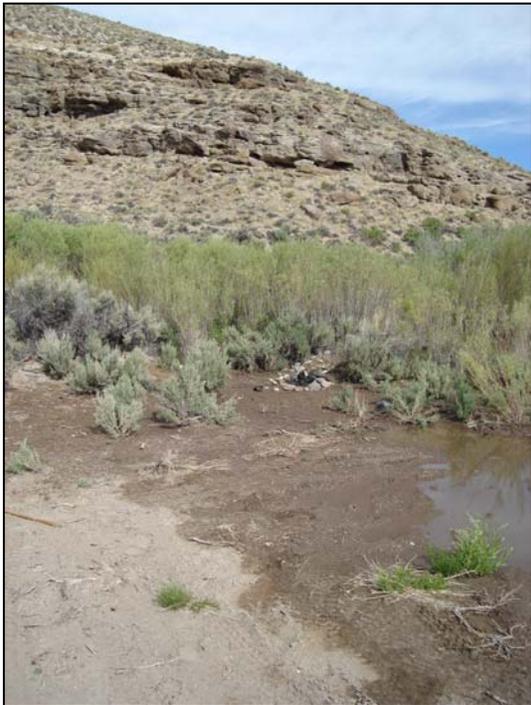
Site 10: Rough Creek, Bridgeport Ranger District, looking at an adjacent road impact. A campsite, ATV tracks, and trash were also documented at this site. This site is located at UTM: N: 4249010 & E: 330727, Elevation 1825m.

3. Decommission and or relocated the campsites at Sites 10 and 15 to a point further away from the stream.

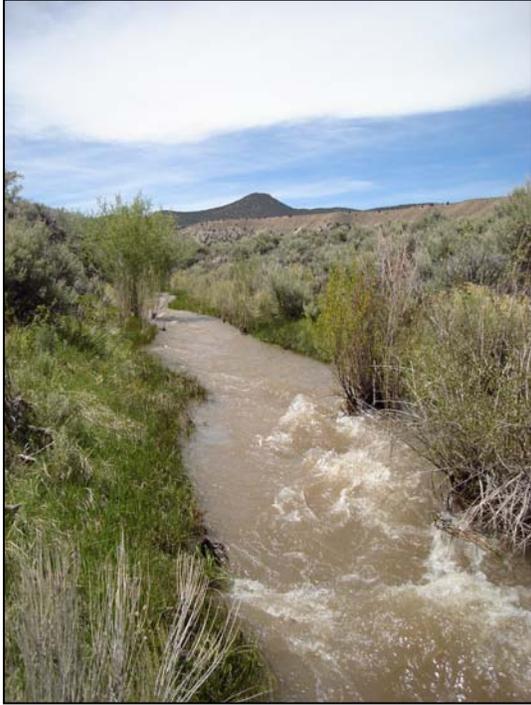
Site 11: Rough Creek, Bridgeport Ranger District, looking upstream at some good fish habitat with undercut banks. The stream at this point runs swiftly in a channel that is 2.5m wide and 0.5m deep. This site is located at UTM: N: 4247795 & E: 329201, Elevation 1870m.

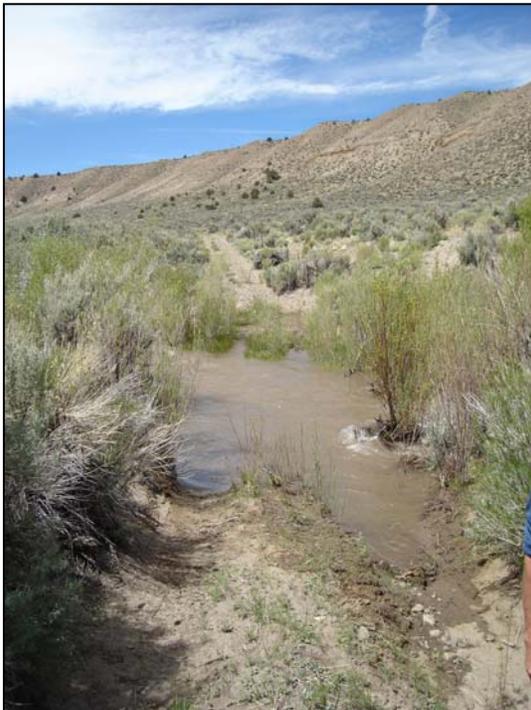
Site 12: Rough Creek, Bridgeport Ranger District, cross-sectional view of a road-stream crossing where bank erosion and vehicle ruts are present. This site is located at UTM: N: 4247530 & E: 329006, Elevation 1881m.

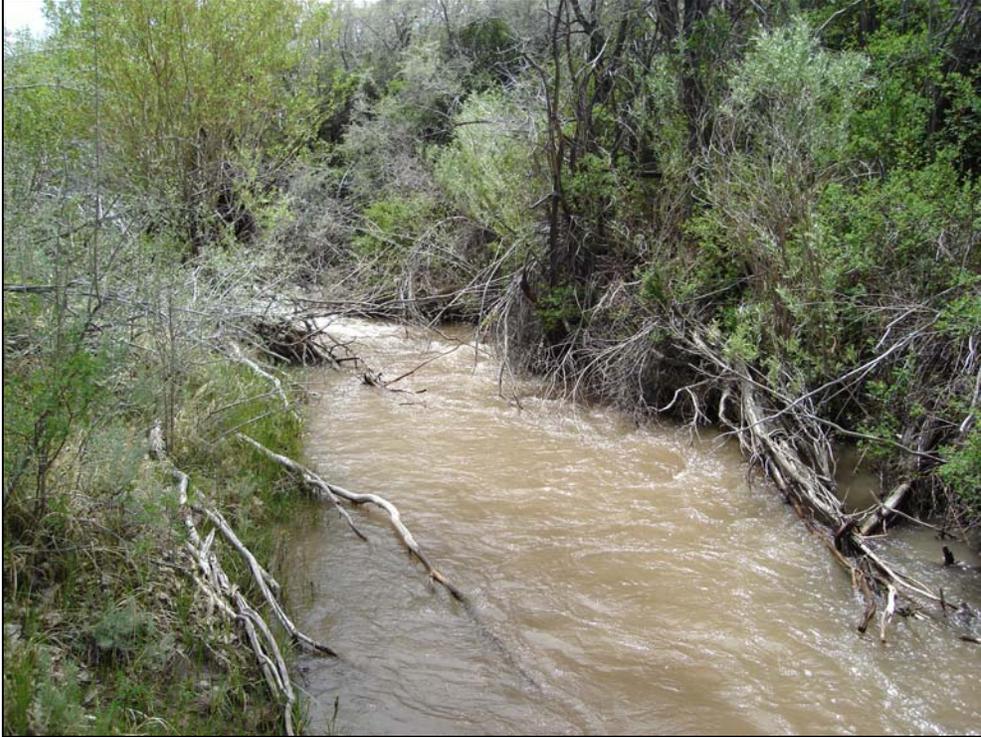
Site 13: Rough Creek, Bridgeport Ranger District, looking upstream at a section of stream that has good fish habitat. This site is located at UTM: N: 4246341 & E: 328717, Elevation 1912m.

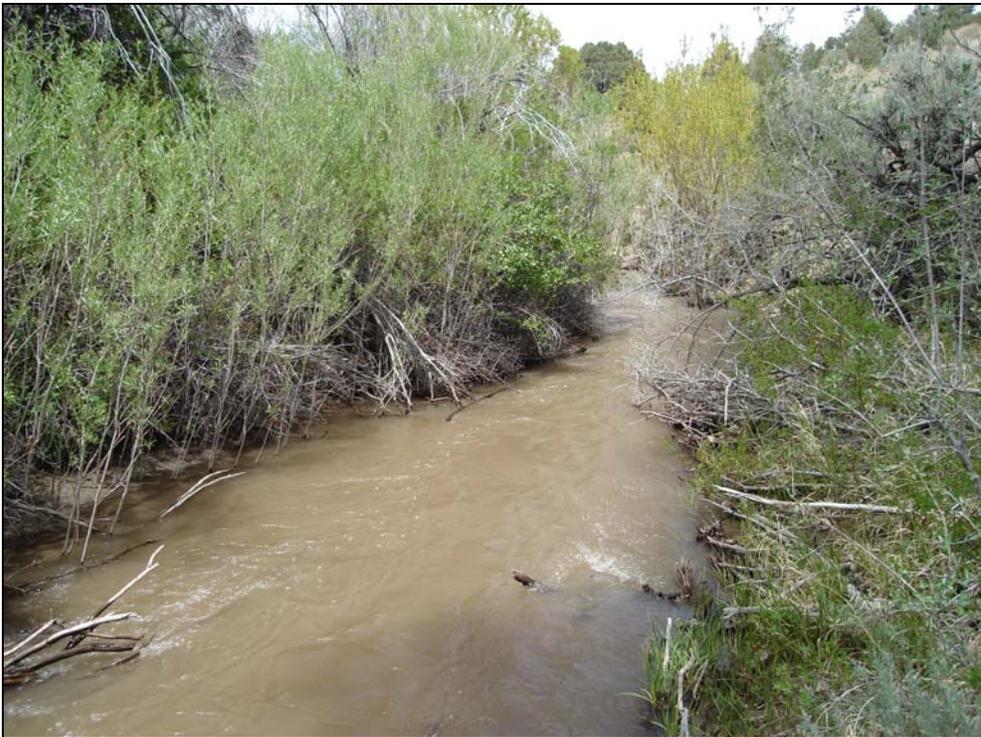
Site 13 continued: Rough Creek, Bridgeport Ranger District, looking downstream at a section of stream that has good fish habitat. This site is located at UTM: N: 4246341 & E: 328717, Elevation 1912m.

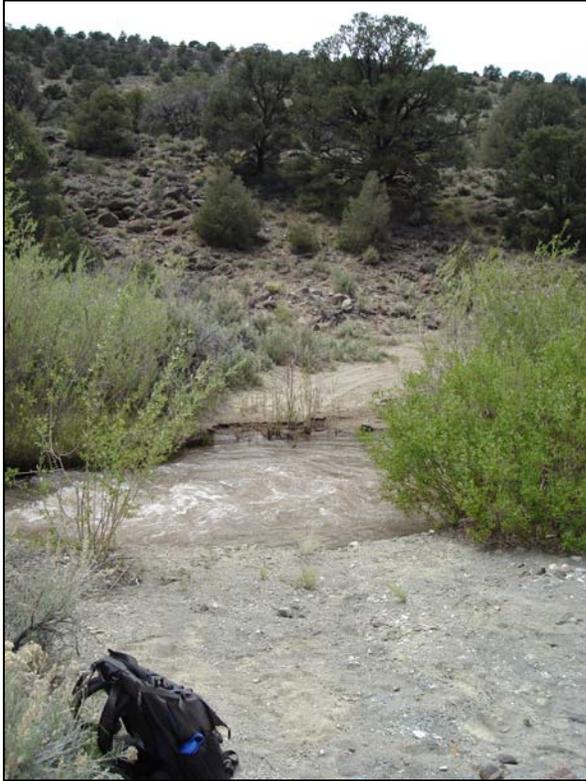
Site 14: Rough Creek, Bridgeport Ranger District, cross section view of a road-stream crossing. This site is located at UTM: N: 4245928 & E: 328749, Elevation 1928m.

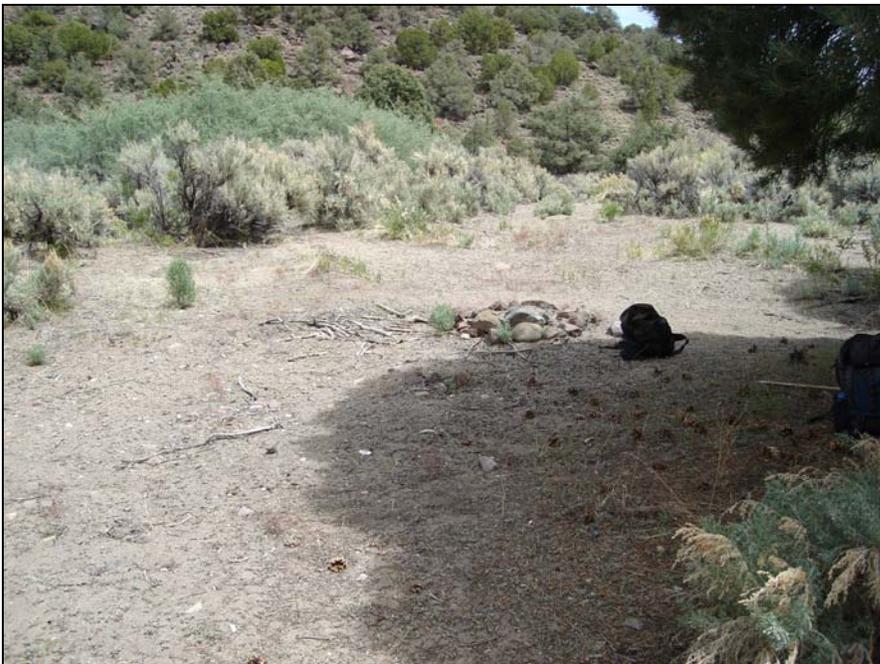
Site 15: Rough Creek, Bridgeport Ranger District. A campsite located directly on the bank of the stream. This campsite also marks the end of the road that had crossed the stream several times. A fire ring and random garbage were present at the campsite. This site is located at UTM: N: 4245348 & E: 328774, Elevation 1942m.

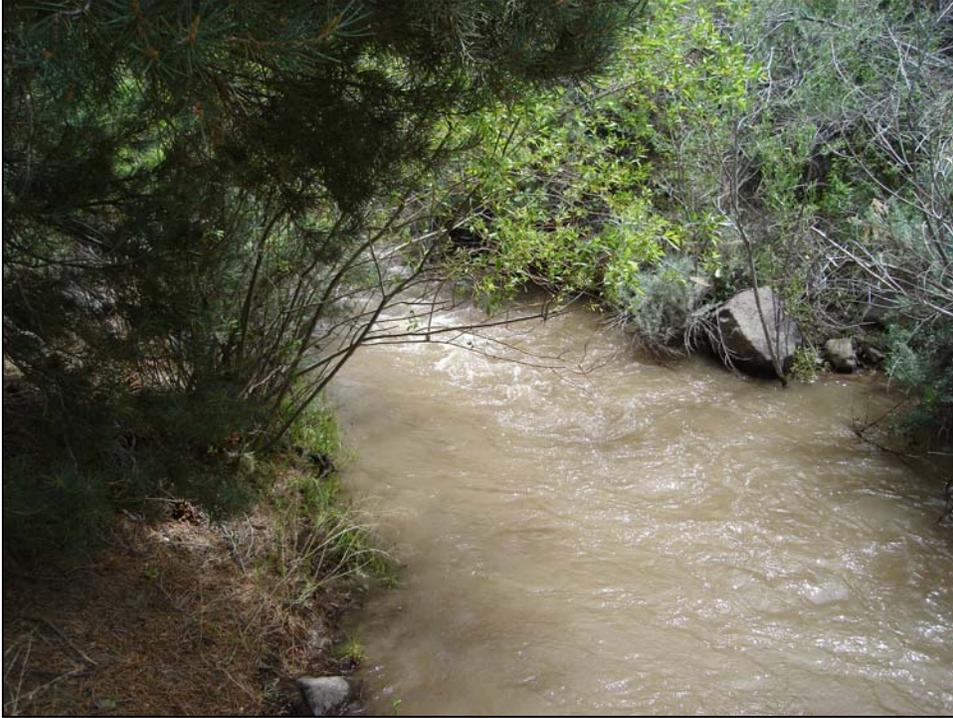
Site 15 continued: Rough Creek, Bridgeport Ranger District, looking upstream from campsite. This site is located at UTM: N: 4245348 & E: 328774, Elevation 1942m.

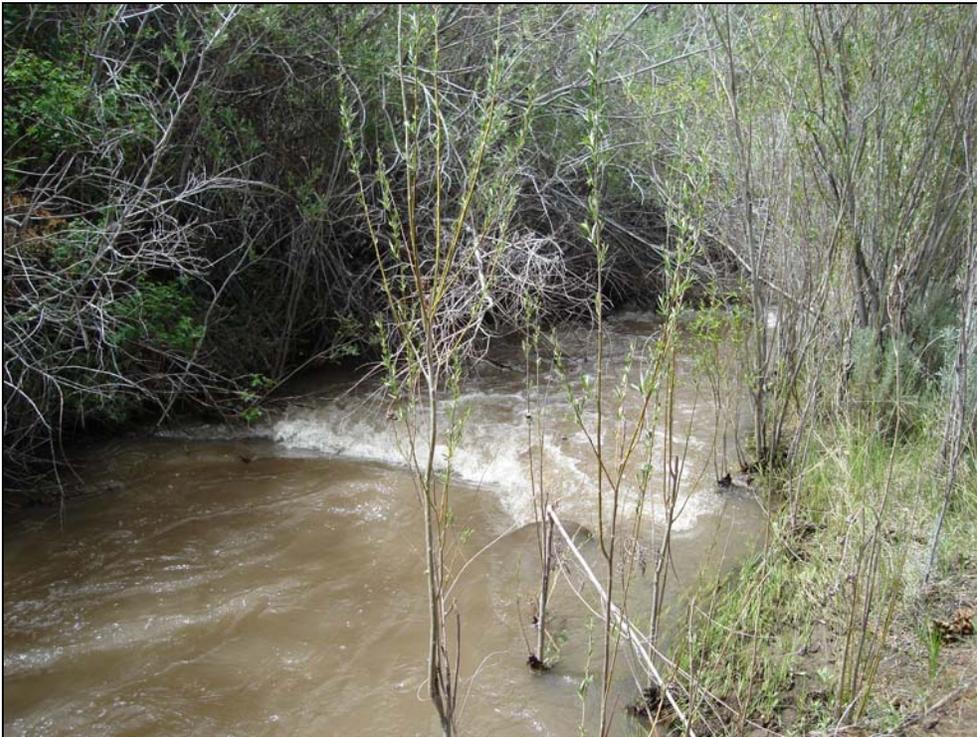
Site 15 continued: Rough Creek, Bridgeport Ranger District, looking downstream from campsite. This site is located at UTM: N: 4245348 & E: 328774, Elevation 1942m.

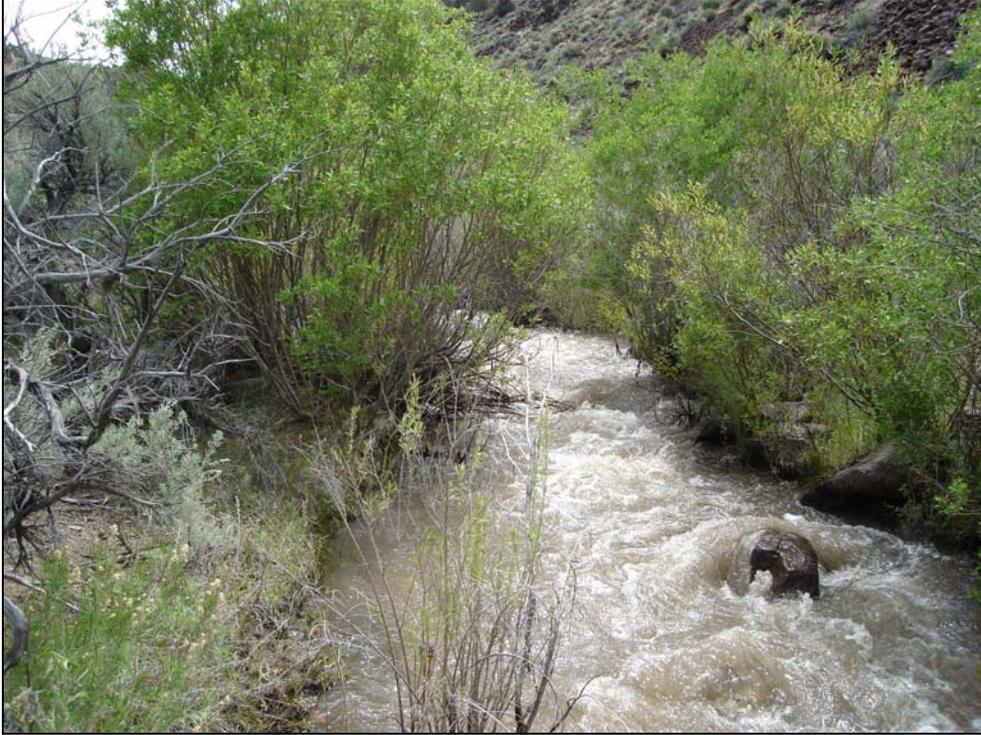
Site 16: Rough Creek, Bridgeport Ranger District, looking upstream at where the topography begins to change. Upstream of this point the stream flows from a steep canyon and downstream of this point the stream flows into a large valley. This site is located at UTM: N: 4244812 & E: 328671, Elevation 1970m.

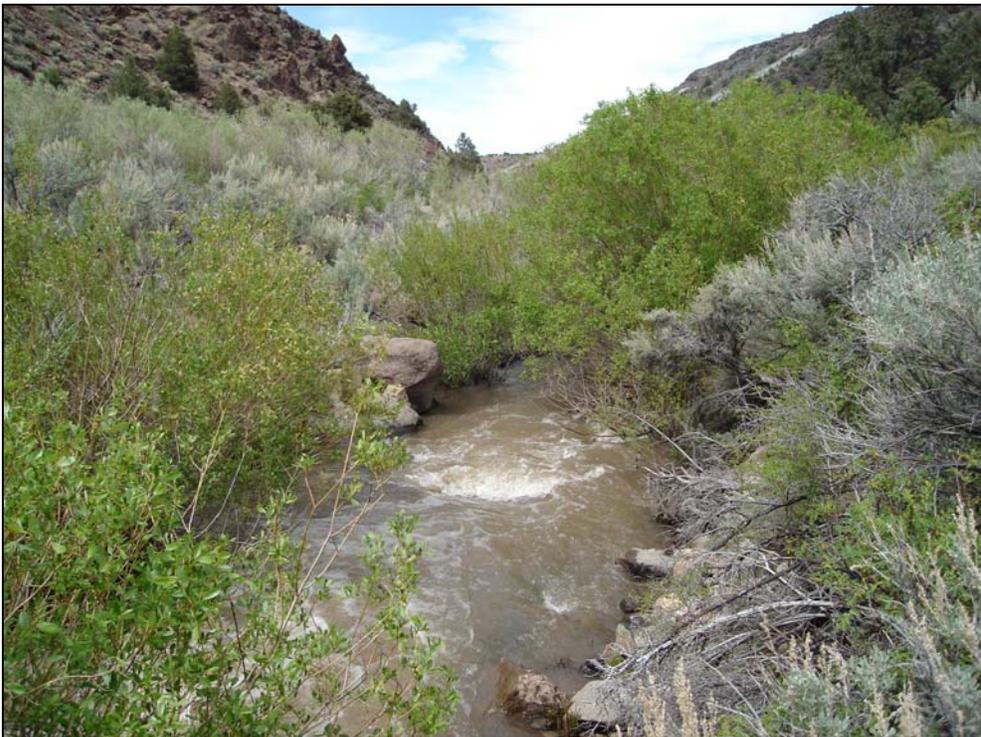
Site 16 continued: Rough Creek, Bridgeport Ranger District, looking downstream toward the valley. This site is located at UTM: N: 4244812 & E: 328671, Elevation 1970m.

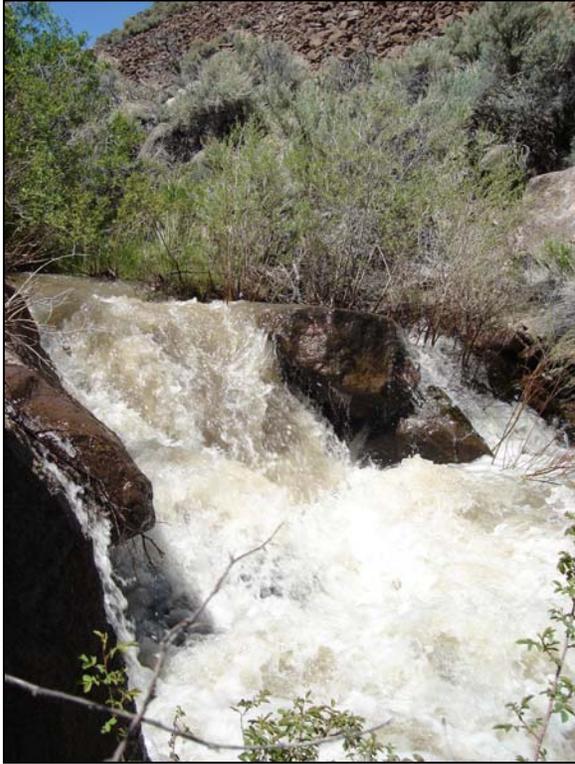
Site 17: Rough Creek, Bridgeport Ranger District, looking upstream at a seasonal fish barrier. The height of this waterfall is 1.2m (3.9 ft); however, with the high water levels at the time of the survey, there were several side routes that fish would be able to navigate through to get around the barrier. As the water levels drop those side routes may become impassable. This site is located at UTM: N: 4244396 & E: 328556, Elevation 1990m.

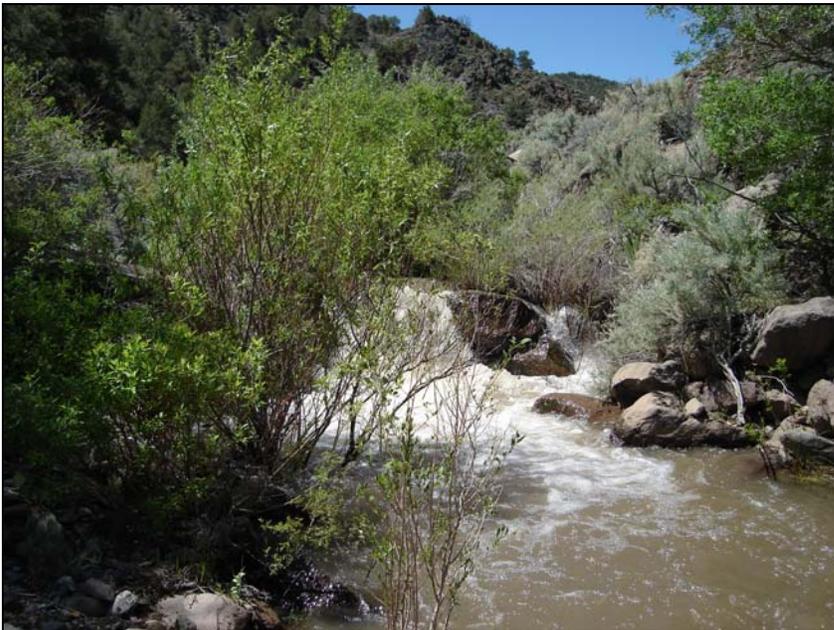
Site 17 continued: Rough Creek, Bridgeport Ranger District, another view looking upstream towards the seasonal fish barrier. This site is located at UTM: N: 4244396 & E: 328556, Elevation 1990m.

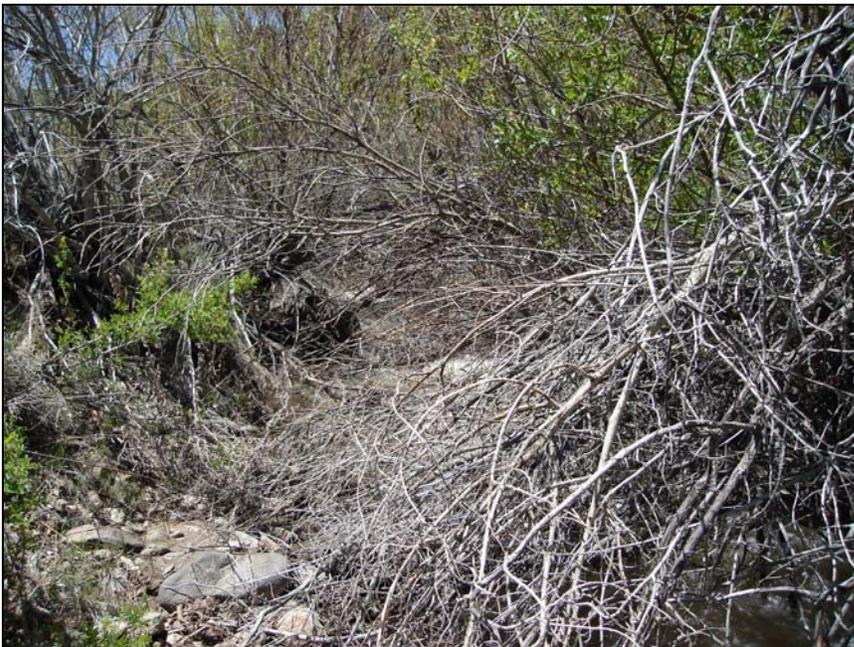
Site 18: Rough Creek, Bridgeport Ranger District. A series of photos showing the typical stream vegetation in this reach. This site is located at UTM: N: 4243883 & E: 327049, Elevation 2060m.

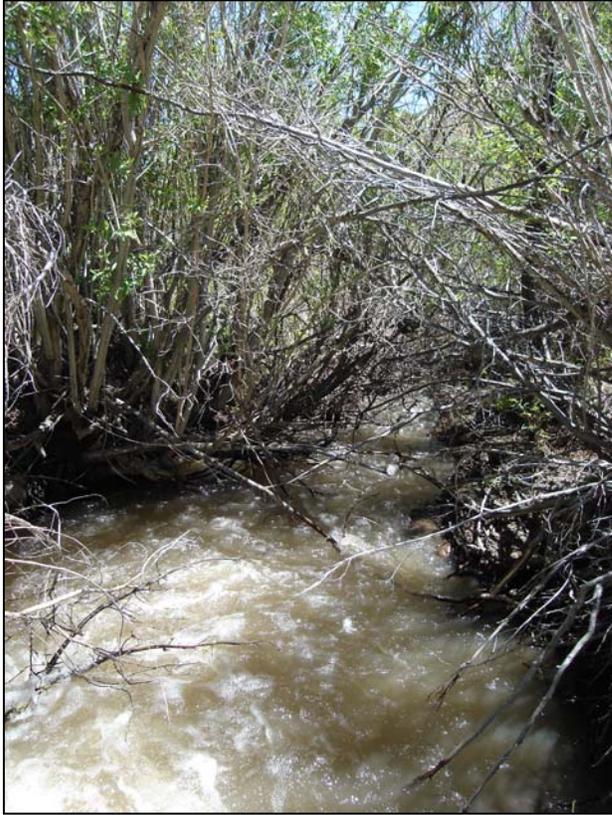
Site 18 continued: Rough Creek, Bridgeport Ranger District, viewpoint looking downstream. This site is located at UTM: N: 4243883 & E: 327049, Elevation 2060m.

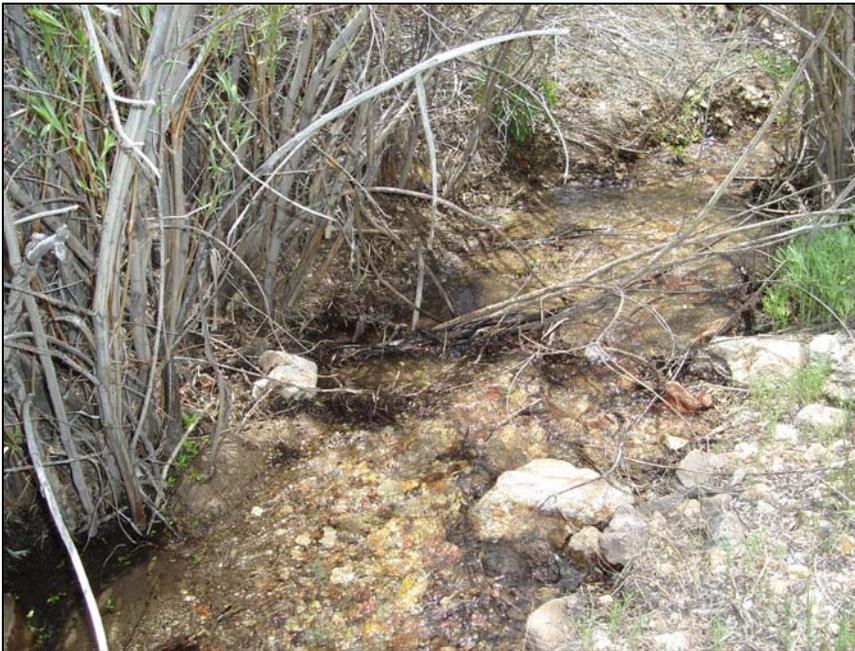
Site 19: Rough Creek, Bridgeport Ranger District. A small tributary enters Rough Creek on the river right side and contributes a very small amount to the overall total flow in Rough Creek. The confluence of the tributary and Rough Creek was not visible due to the heavy vegetation in the area. This site is located at UTM: N: 4243331 & E: 326310, Elevation 2099m.

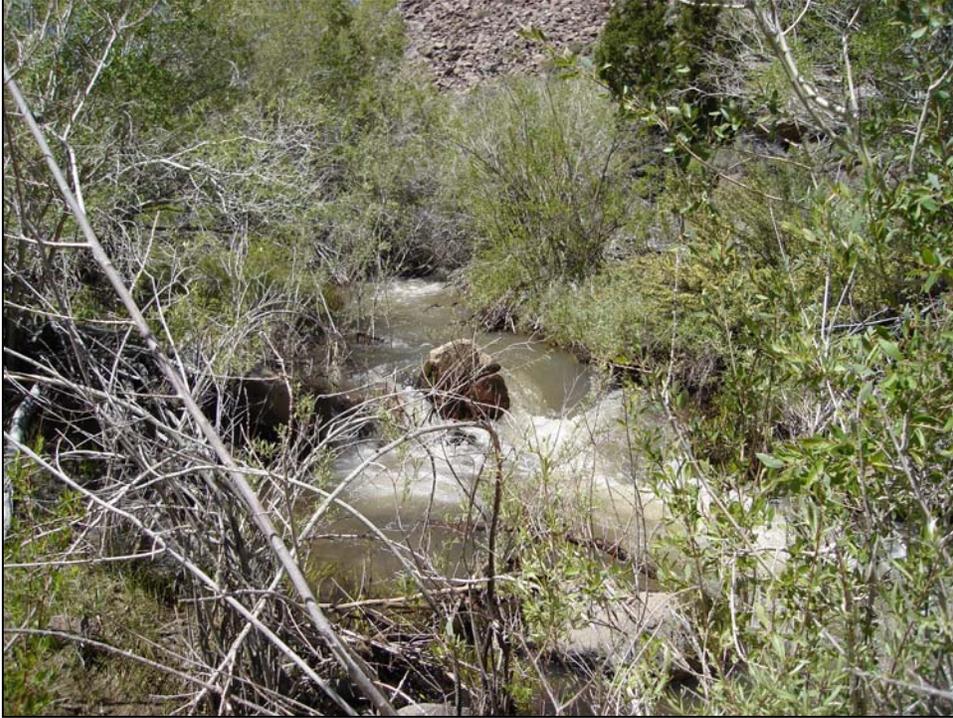
Site 20: Rough Creek, Bridgeport Ranger District, looking upstream at the typical vegetation and stream flow within this section of stream. This site is located at UTM: N: 4242778 & E: 325826, Elevation 2128m.

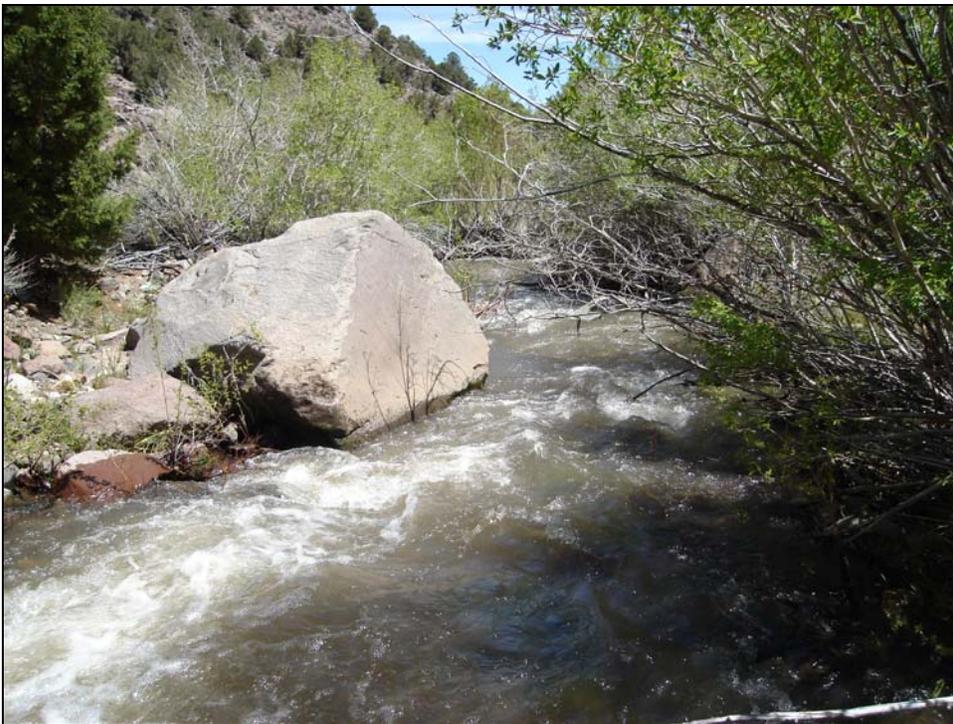
Site 20 continued: Rough Creek, Bridgeport Ranger District, looking downstream at the typical vegetation and stream flow within this section of stream. This site is located at UTM: N: 4242778 & E: 325826, Elevation 2128m.

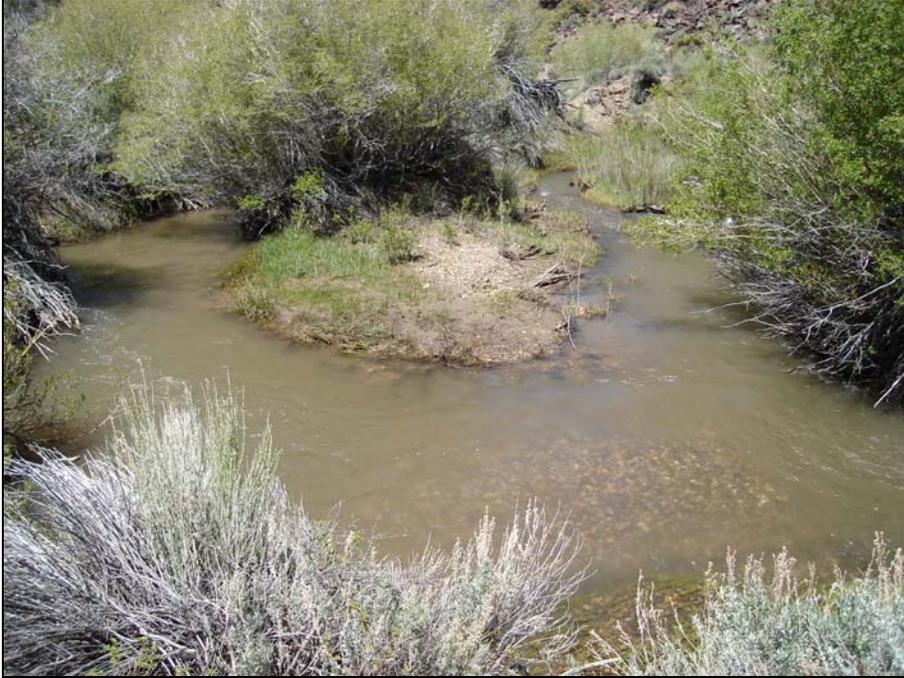
Site 21: Rough Creek, Bridgeport Ranger District, looking upstream at a point on Rough Creek where the canyon opens up and the stream appears to have been meandering through a small meadow before reaching this point. This site is located at UTM: N: 4242389 & E: 325397, Elevation 2154m.

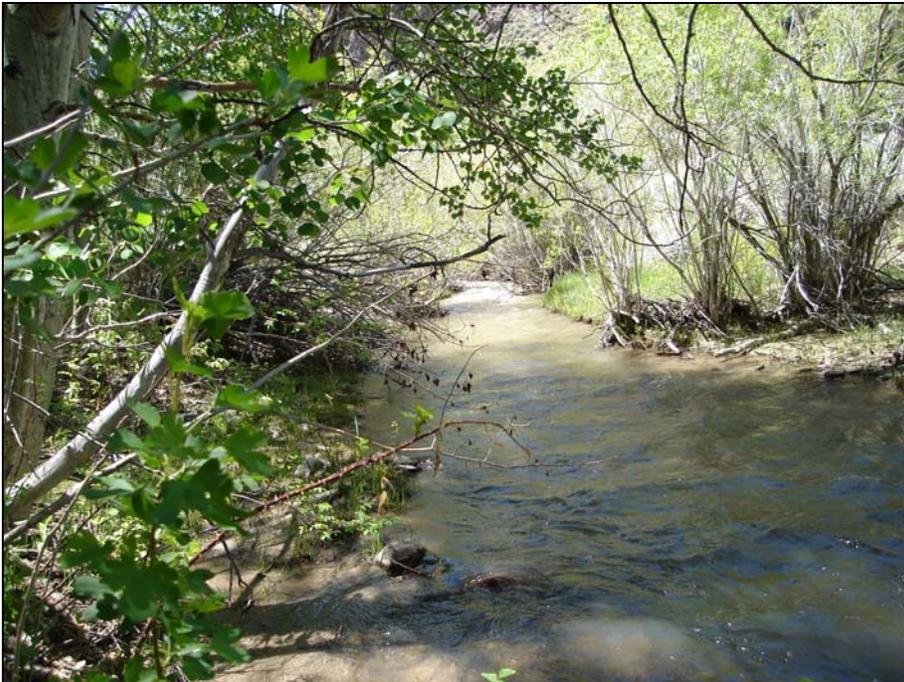
Site 22: Rough Creek, Bridgeport Ranger District, looking upstream at the survey end point near the California-Nevada state line. Upstream of this site the stream is located on private lands and lands managed by the BLM. Note the presence of willows and aspens. This site is located at UTM: N: 4241549 & E: 324775, Elevation 2192m.

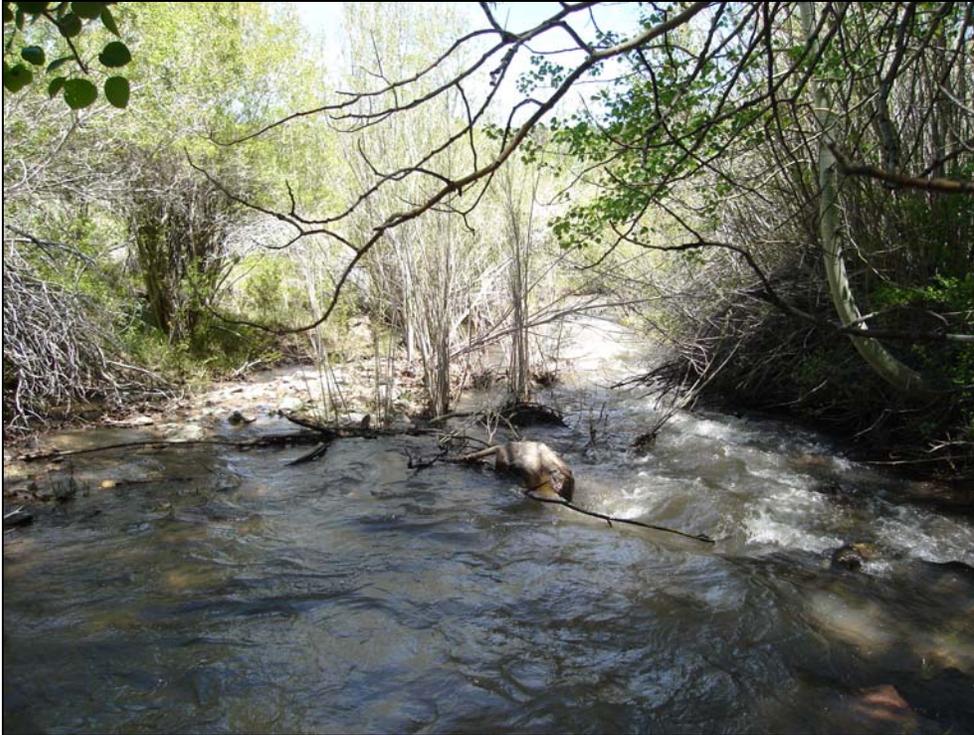
Site 22 continued: Rough Creek, Bridgeport Ranger District, looking downstream from the California-Nevada state line. This site is located at UTM: N: 4241549 & E: 324775, Elevation 2192m.
