Rough Creek

Mono County, California

2006 Stream Habitat Survey Report

Humboldt-Toiyabe National Forest, Bridgeport Ranger District

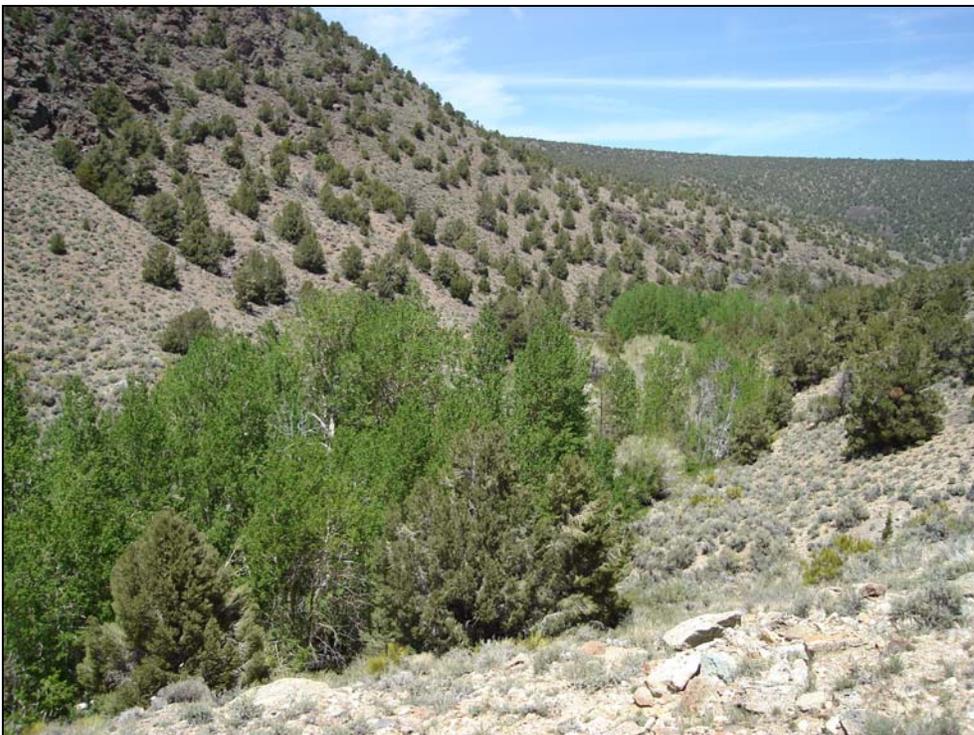
Site 22 continued: Rough Creek, Bridgeport Ranger District, looking down the drainage from the survey end point at the California-Nevada state line. This site is located at UTM: N: 4241549 & E: 324775, Elevation 2192m.
