Virginia Creek

Mono County, California

2007 Stream Habitat Survey Report

Carson Ranger District: Humbolt-Toiyabe National Forest

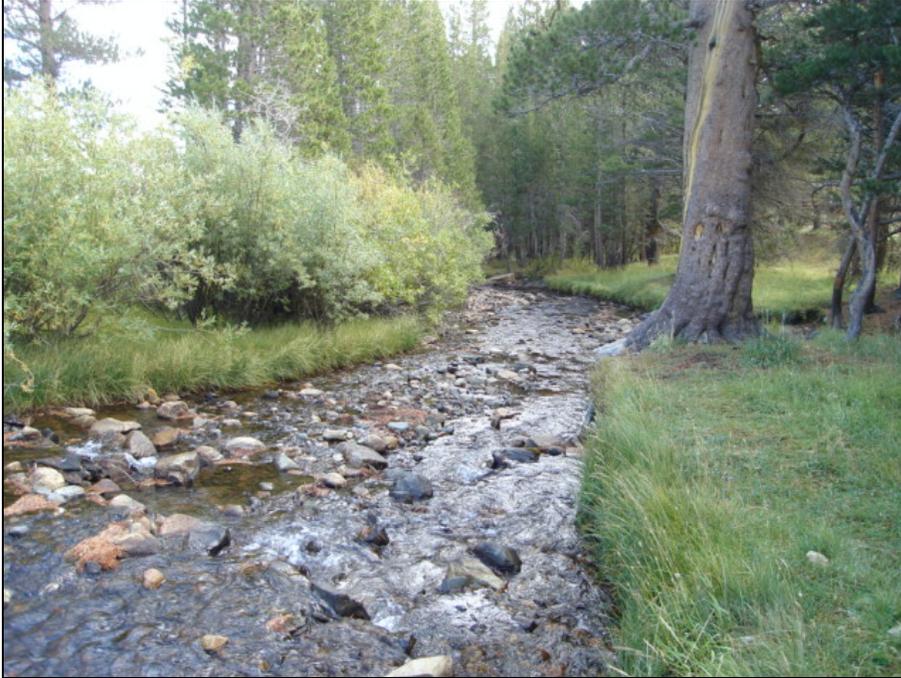
Site 1: Virginia Creek, Bridgeport Ranger District. The survey starts just downstream of the National Forest-Bureau of Land Management boundary. Photo shows downstream view of the creek at starting point. This site is located at UTM: N: 4216045 & E: 306071, Elev. 2714m.

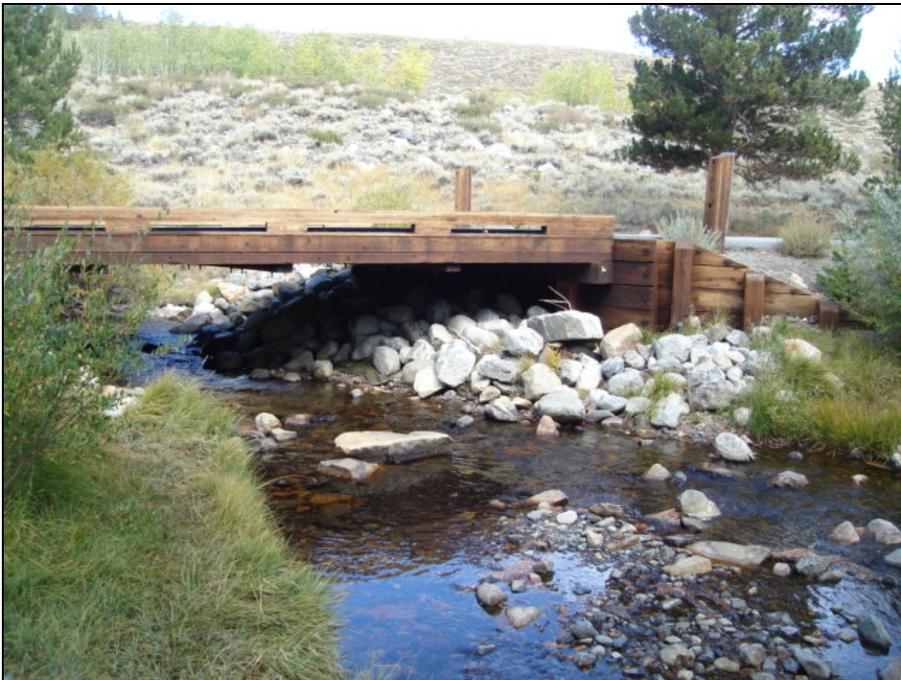
Site 2: Virginia Creek, Bridgeport Ranger District, looking upstream at a bridge constructed of railroad ties and asphalt. Boulders under the bridge keep water from eroding the stream banks under the structure. This site is located at UTM: N: 4216046 & E: 306071, Elev. 2714m.

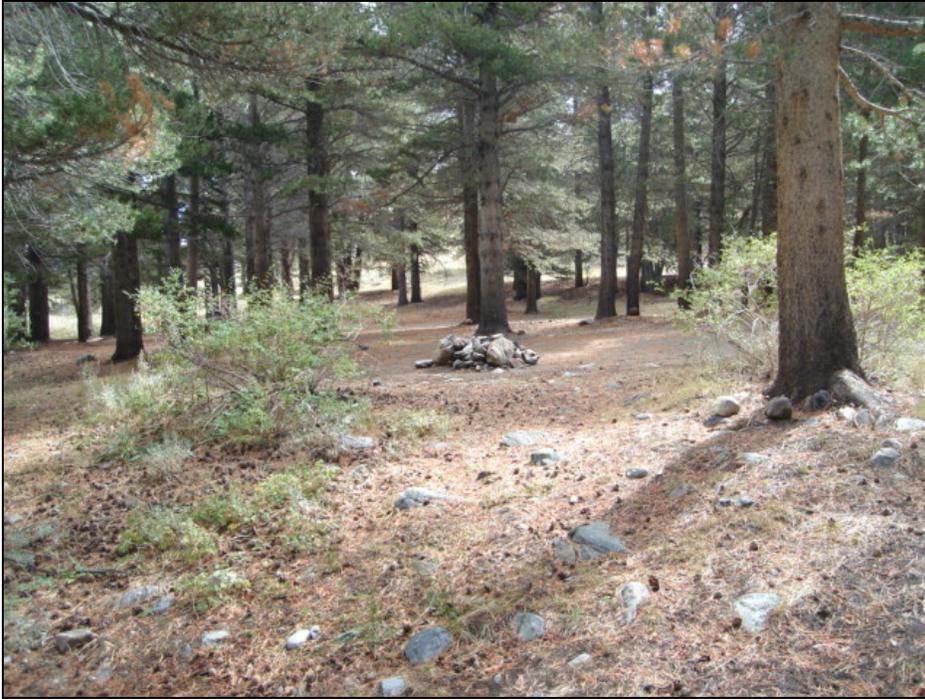
Site 3: Virginia Creek, Bridgeport Ranger District. Campsite located on river right contains a fire ring, road access, and a parking area. This site is located at UTM: N: 4215961 & E: 305892, Elev. 2717m.

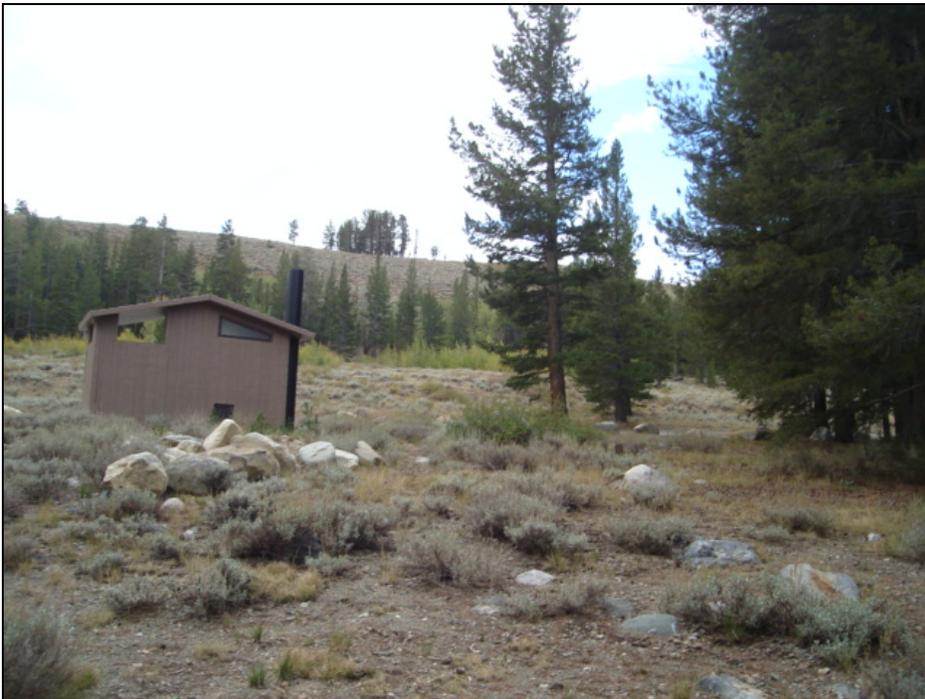
Site 4: Virginia Creek, Bridgeport Ranger District. Another campsite located on river right contains 2 metal fire rings approx. 20m from the water's edge. A large vaulted toilet is placed right next to the stream and could be a concern if ruptured. This site is located at UTM: N: 4215659 & E: 305478, Elev. 2740m.

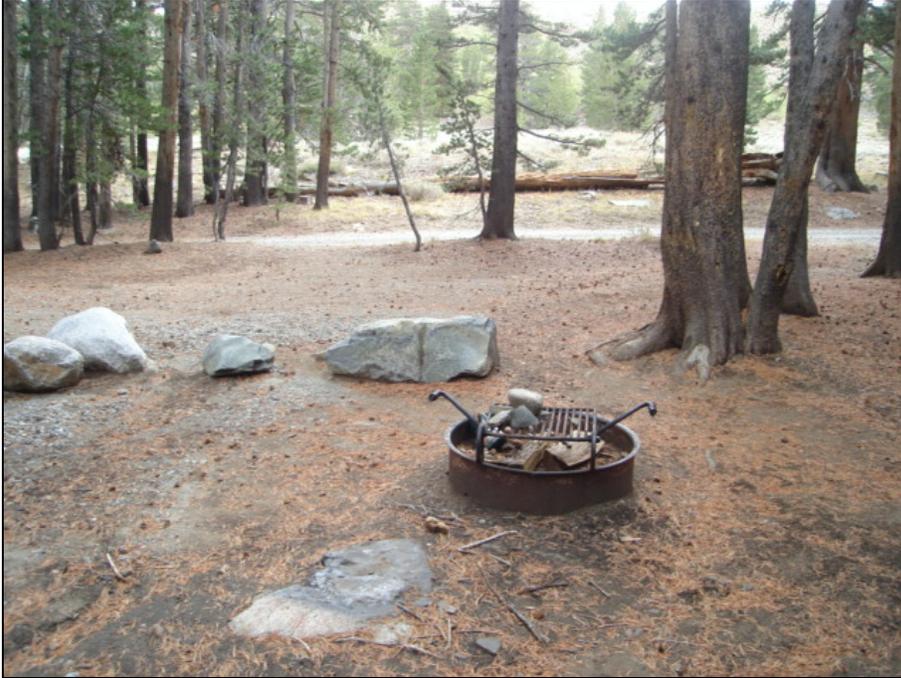
Site 5: Virginia Creek, Bridgeport Ranger District. Another smaller campsite with a fire pit, road access, and a parking area. The road is approximately 35m from the stream and it parallels the stream for a good distance. This site is located at UTM: N: 4215571 & E: 305387, Elev.2739m.

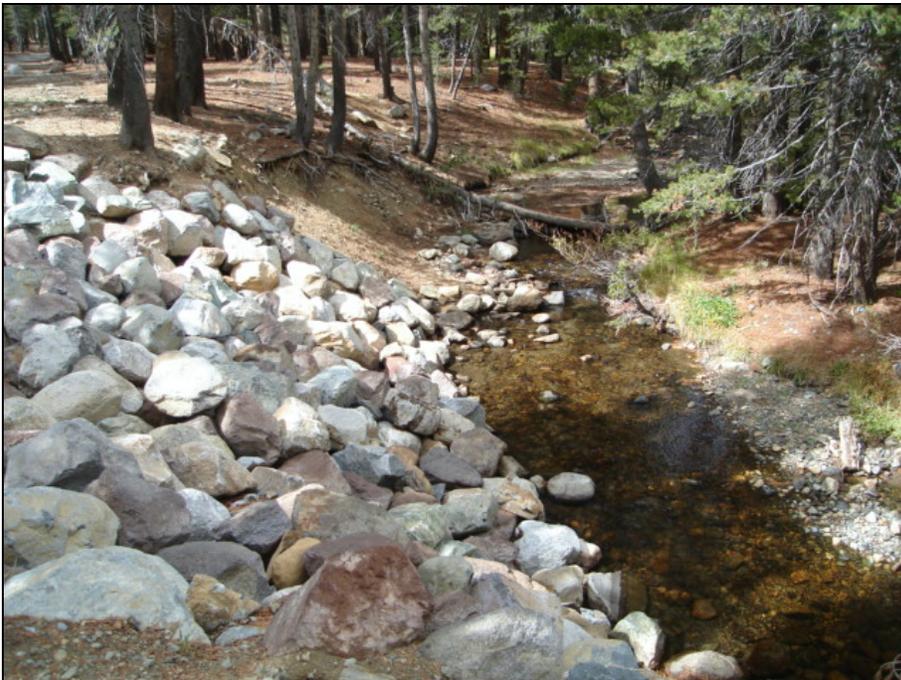
Site 6: Virginia Creek, Bridgeport Ranger District. This section of the stream bank has been covered with large boulders to prevent any further erosion. This site is located at UTM: N: 4215521 & E: 305324.

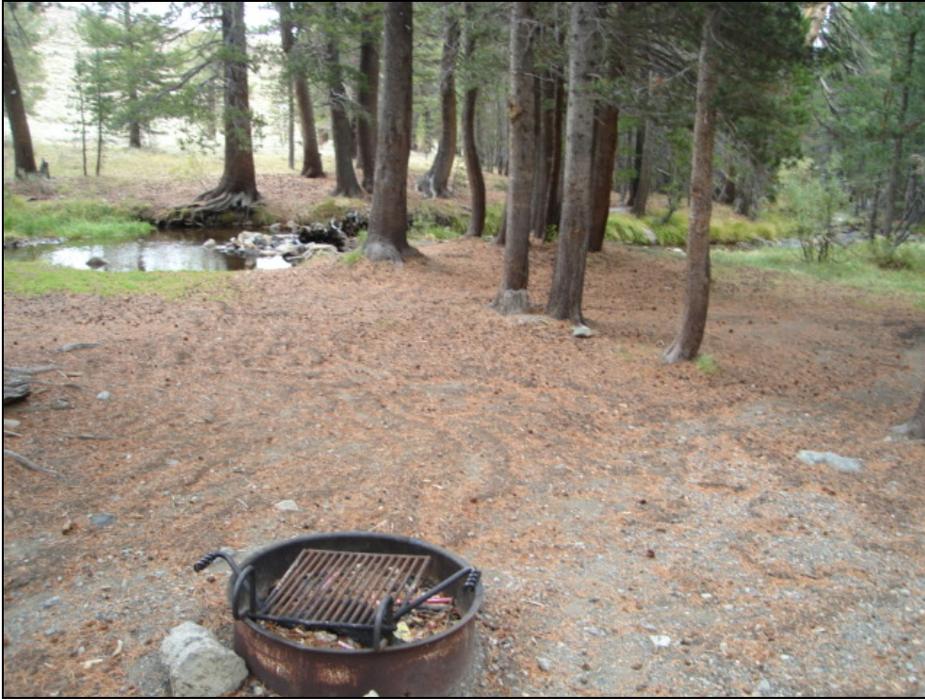
Site 7: Virginia Creek, Bridgeport Ranger District. Three large campsites are all equipped with established metal fire rings, easy road access, and parking. The closest fire ring is about 10m from the water's edge. This site is located at UTM: N: 4215501 & E: 305243, Elev. 2762m.

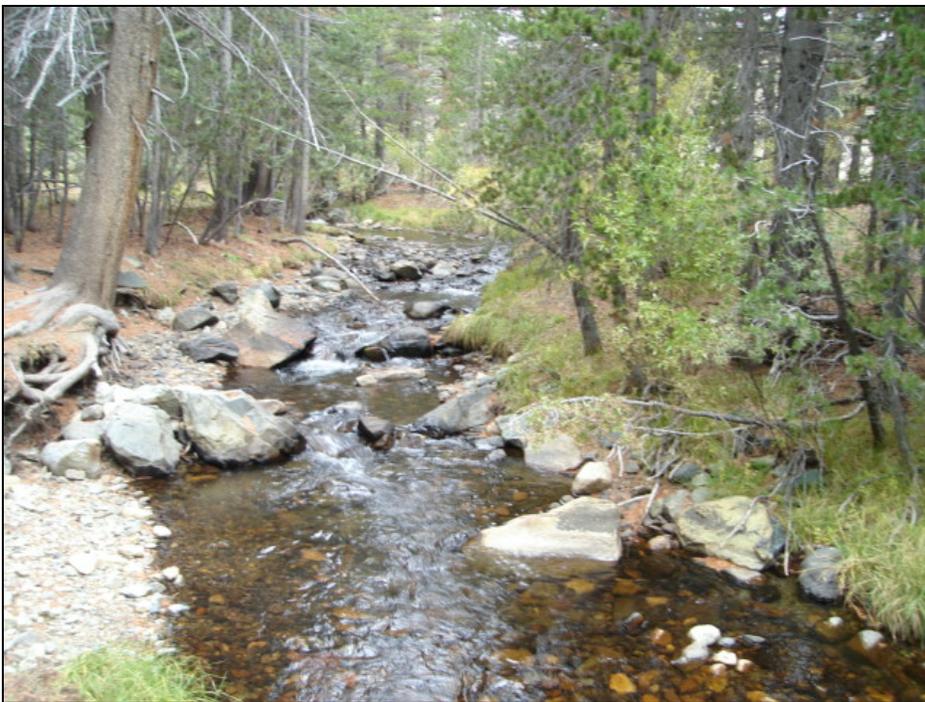
Site 8: Virginia Creek, Bridgeport Ranger District, looking upstream at where 3 large fish were sighted. The largest fish of unknown species was about 12 inches long. This site is located at UTM: N: 4215276 & E: 304907, Elev. 2769m.

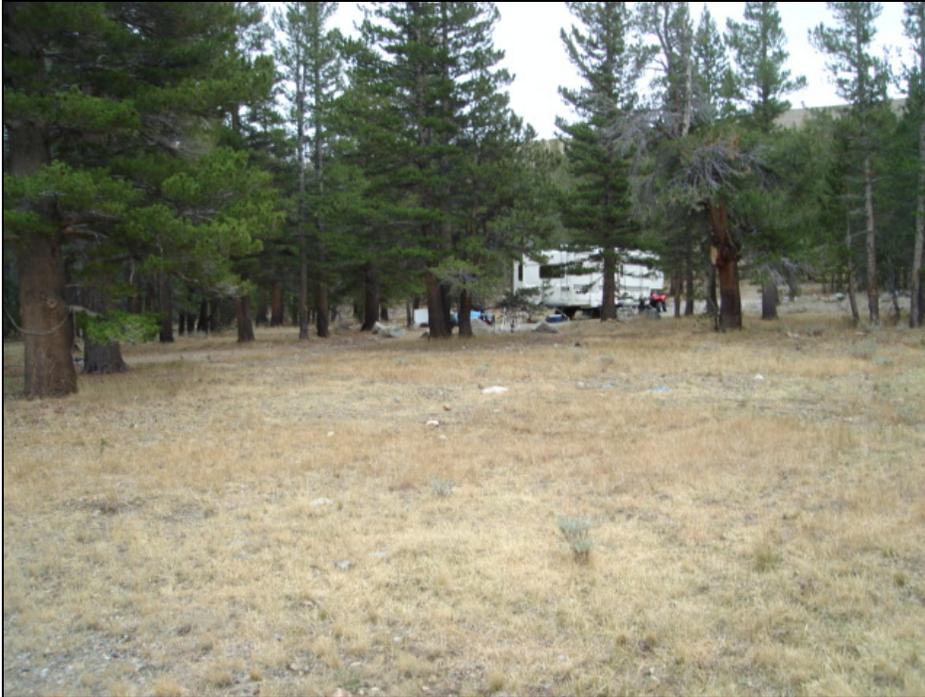
Site 9: Virginia Creek, Bridgeport Ranger District. Another cluster of campsites are seen about 40m from the creek. Area contains at least two fire rings and a vaulted toilet. Campsite is road accessible. This site is located at UTM: N: 4215135 & E: 304704, Elev. 2777m.

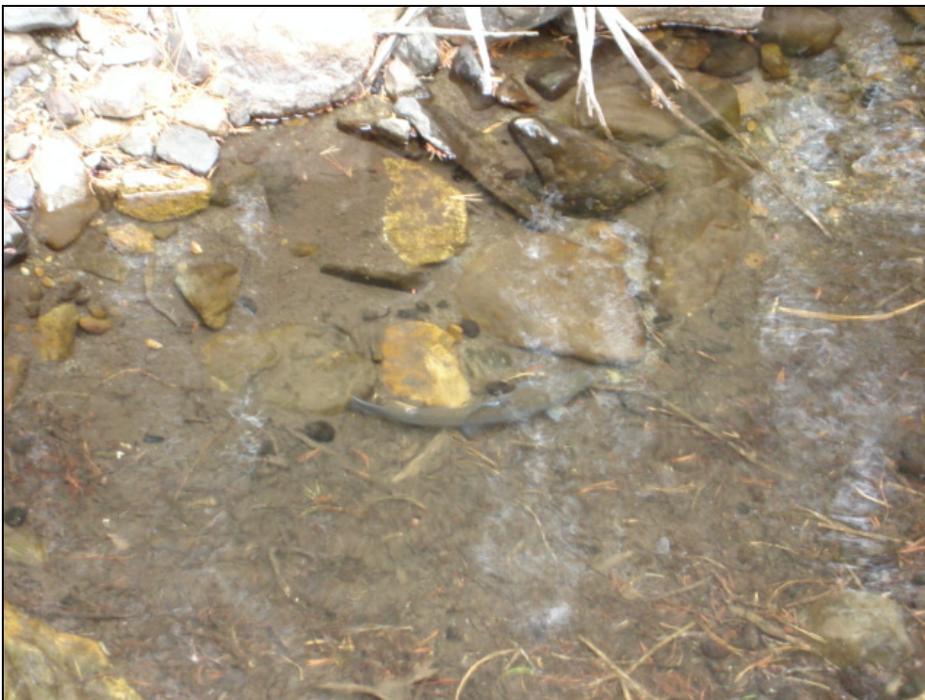
Site 10: Virginia Creek, Bridgeport Ranger District. Seven large trout are seen in this deep run. The trout range in size from 10 to 15 inches in length. This site is located at UTM: N: 4215080 & E: 304589.

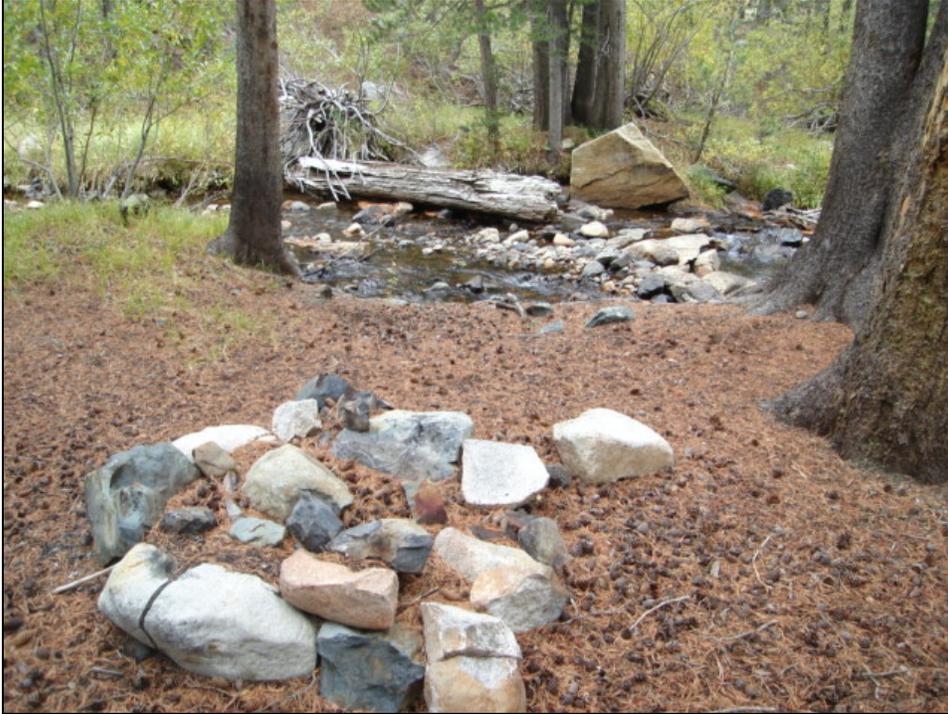
Site 11: Virginia Creek, Bridgeport Ranger District. This small dispersed campsite lies right on the creek's edge, contains a large stone fire ring, does not have road access, and appears to see little use. This site is located at UTM: N: 4214847& E: 304425.

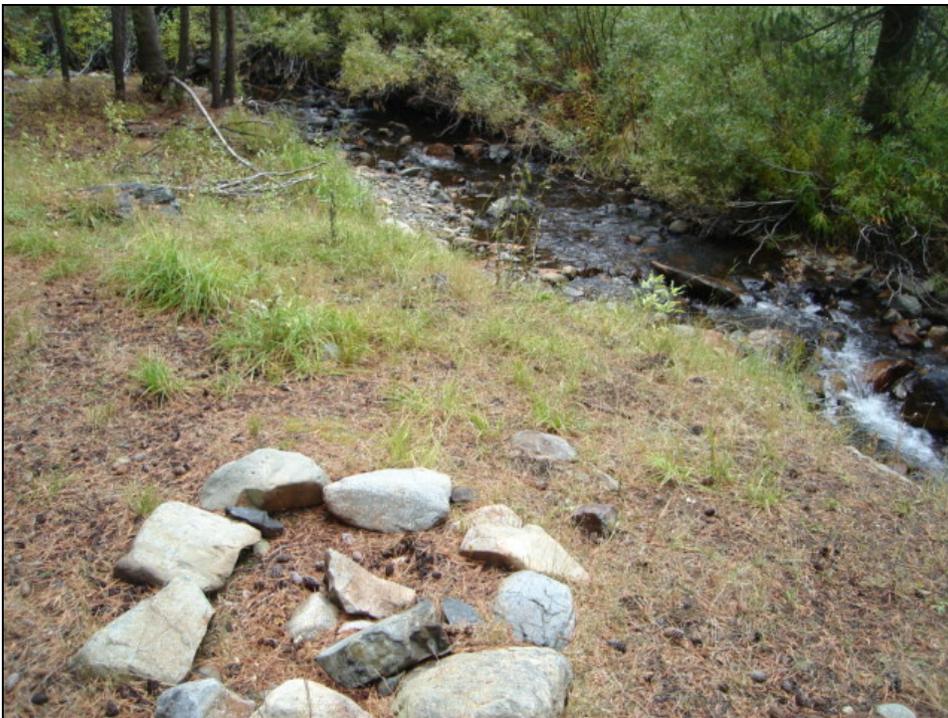
Site 12: Virginia Creek, Bridgeport Ranger District. Another small dispersed campsite with a stone fire ring 4m from the creek. Campsite also appears to see little use. This site is located at UTM: N: 4214726 & E: 304401.

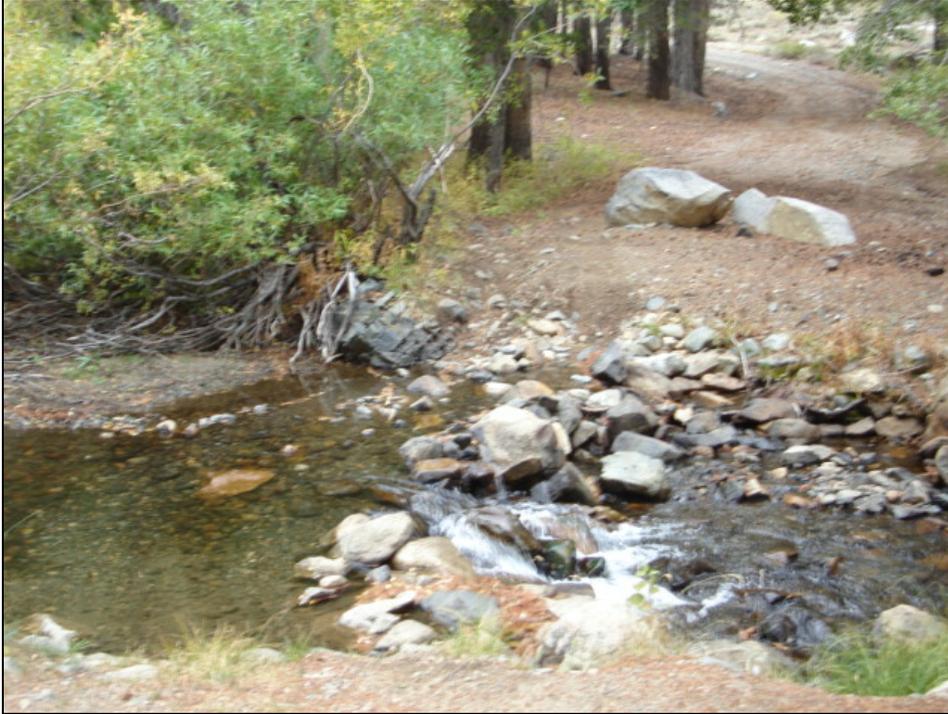
Site 13: Virginia Creek, Bridgeport Ranger District. The old road pictured above has been blocked off by large boulders. Fresh tracks; however, suggest that ATVs are still using the crossing. This site is located at UTM: N: 4214704 & E: 304368, Elev. 2797m.

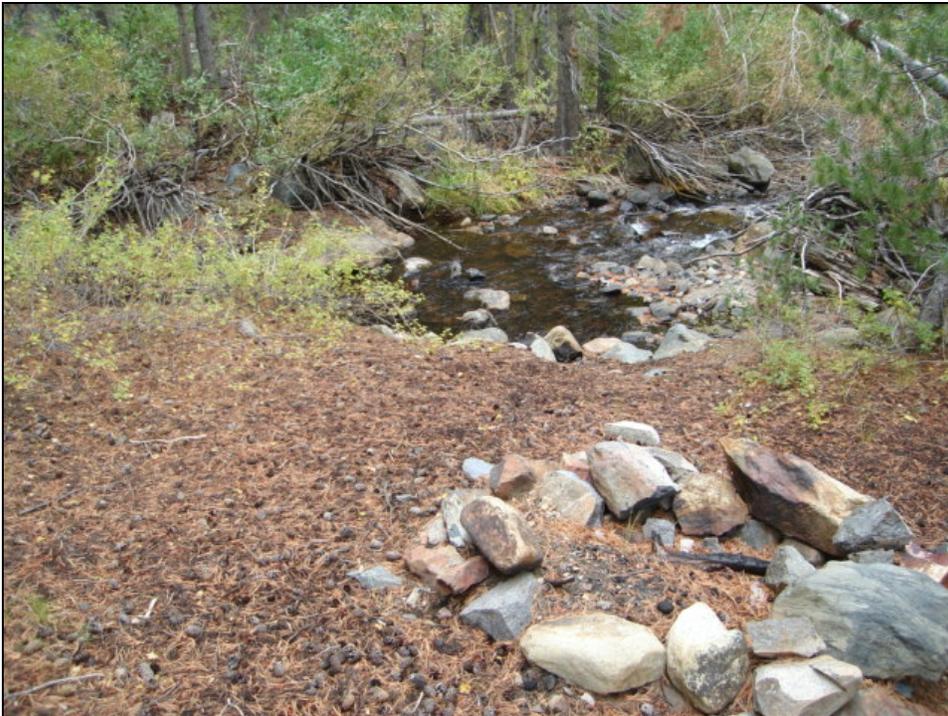
Site 14: Virginia Creek, Bridgeport Ranger District. Another seldom used stone fire ring defines this campsite located 3m from the edge of the creek. There is no road access to this campsite. This site is located at UTM: N: 4214543 & E: 304206, Elev. 2815m.

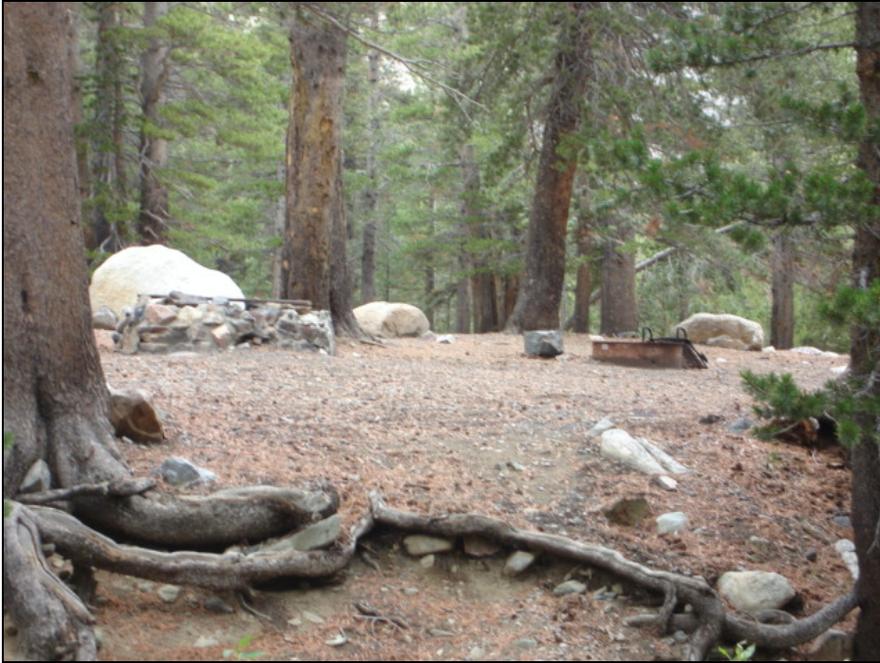
Site 15: Virginia Creek, Bridgeport Ranger District. A large campsite with a metal fire ring and a large mortared fire ring is located approx. 12m from the edge of the creek. This site is located at UTM: N: 4214455 & E: 303724, Elev. 2850m.

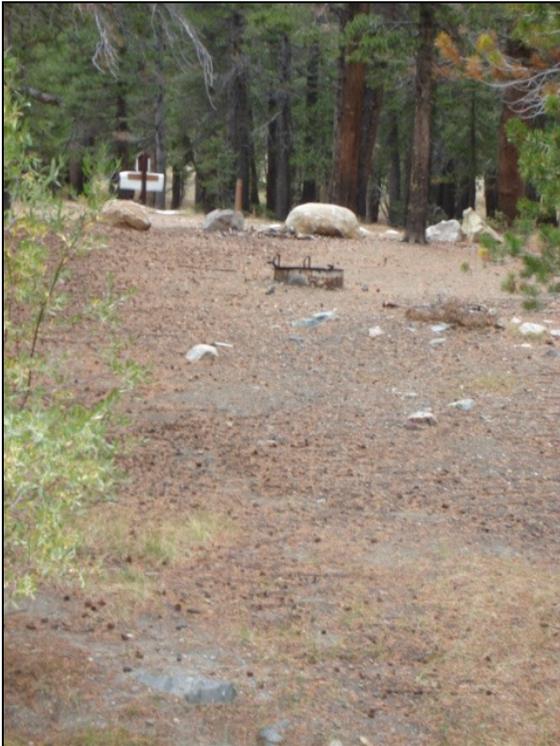
Site 16: Virginia Creek, Bridgeport Ranger District. A series of campsites are spotted on the other side of the creek. There are at least 3 metal fire rings that are at least 15m from the water. These sites can be accessed from road on the other side of the stream. This site is located at UTM: N: 4214351 & E: 303518, Elev. 2869m.

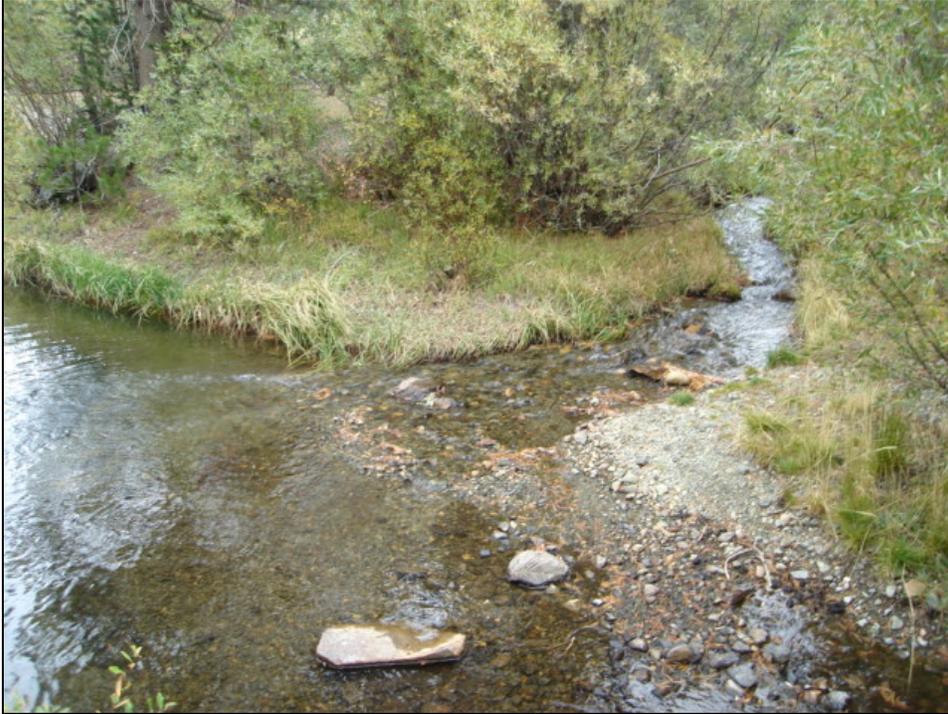
Site 17: Virginia Creek, Bridgeport Ranger District. A small tributary enters on river left in an area where the stream is flowing at a very slow pace. This tributary adds 15% to the overall flow. This site is located at UTM: N: 4214269 & E: 303360, Elev. 2868m.

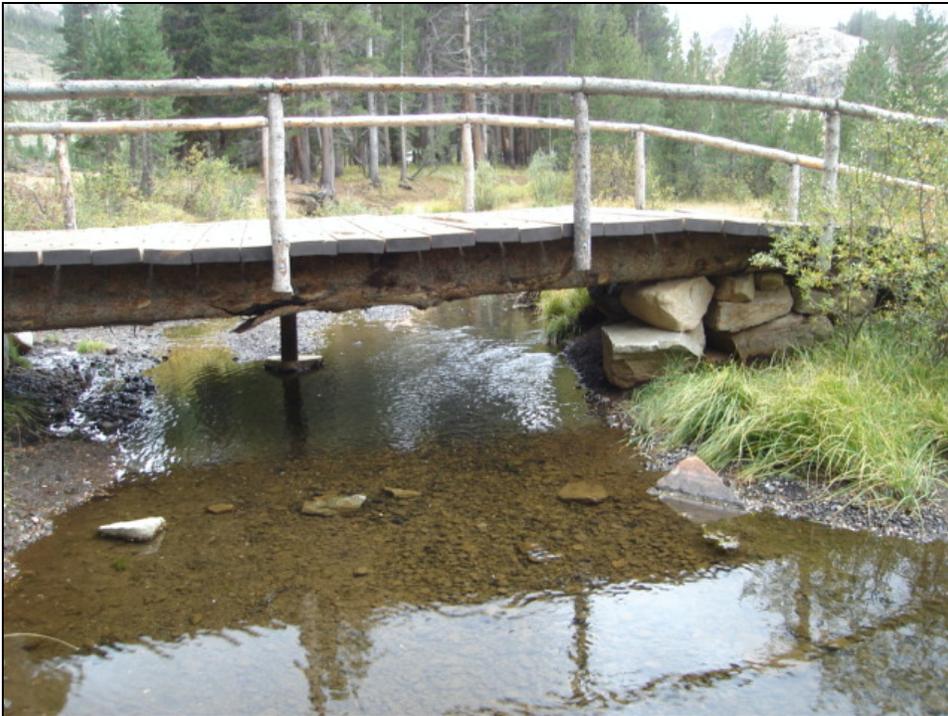
Site 18: Virginia Creek, Bridgeport Ranger District. A rustic bridge gives pedestrians access to several buildings. The bridge looks to get very little use and is still in good condition. This site is located at UTM: N: 4214030 & E: 303237, Elev. 2862m.

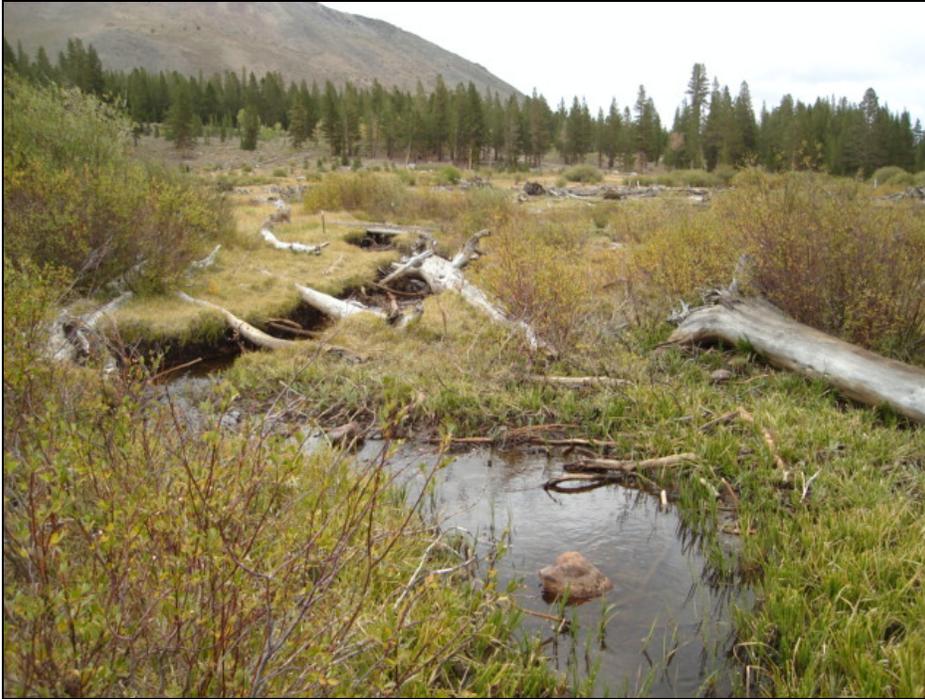
Site 19: Virginia Creek, Bridgeport Ranger District. The survey ends as we enter a large meadow. The entire meadow has been flooded and the creek seems to be partially supplied by a spring. Private property also occurs upstream of this point. This site is located at UTM: N: 4213947 & E: 302978, Elev. 2876m.
