**Wolf Creek**  
Mono County, California

**2004 Fish & Habitat Survey Report**

Bridgeport Ranger District  
Humboldt-Toiyabe National Forest

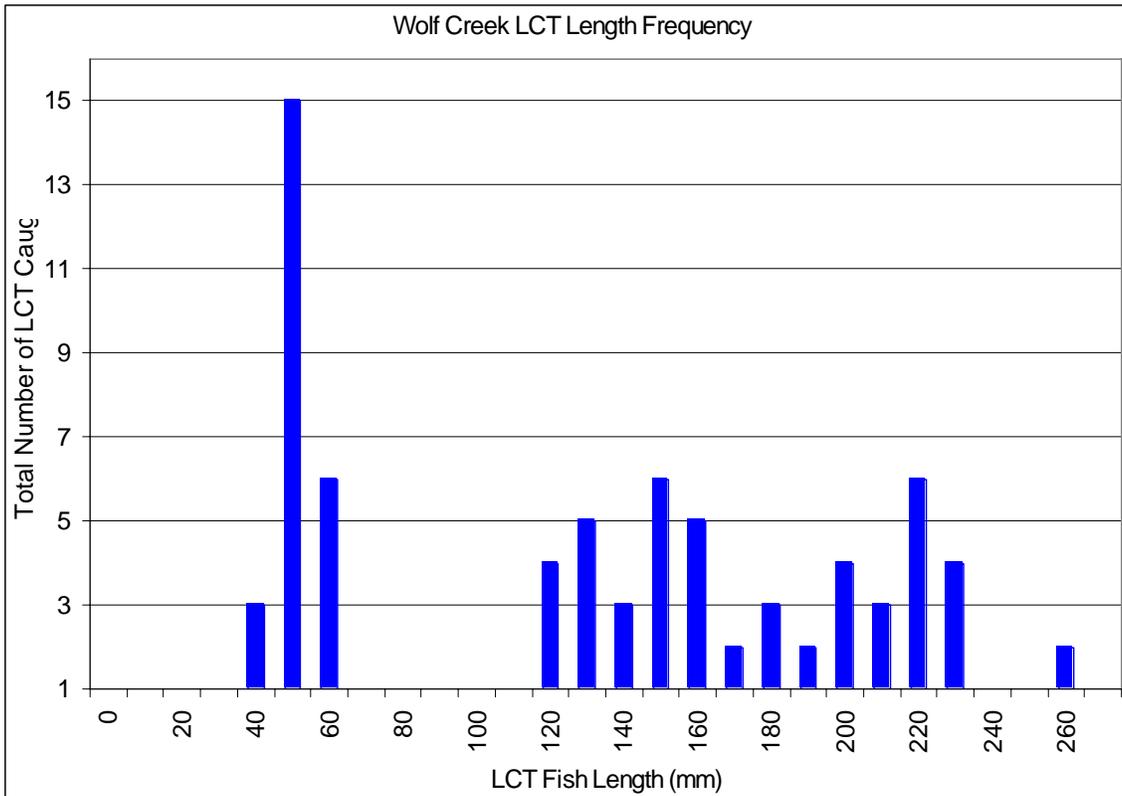
**Figure 1:** Length frequency of Lahontan cutthroat trout caught from Wolf Creek, Bridgeport Ranger District. Wolf Creek was surveyed from 30 September 2004 through 4 October 2004. The average length of LCT is 136 mm (5 inches).

The distribution of LCT within the Wolf Creek watershed is limited to approximately 3.2 miles of Wolf Creek. Lahontan cutthroat trout are distributed between Reach 1 Unit 3 and Reach 3 Unit 4 (Figures 3 & 4). The total length of LCT ranges from 38 to 268 mm total length with the average total length of LCT being 136 mm (Figure 1). The length frequency histogram (Figure 1) suggests that multiple age classes of LCT are found within the Wolf Creek watershed.

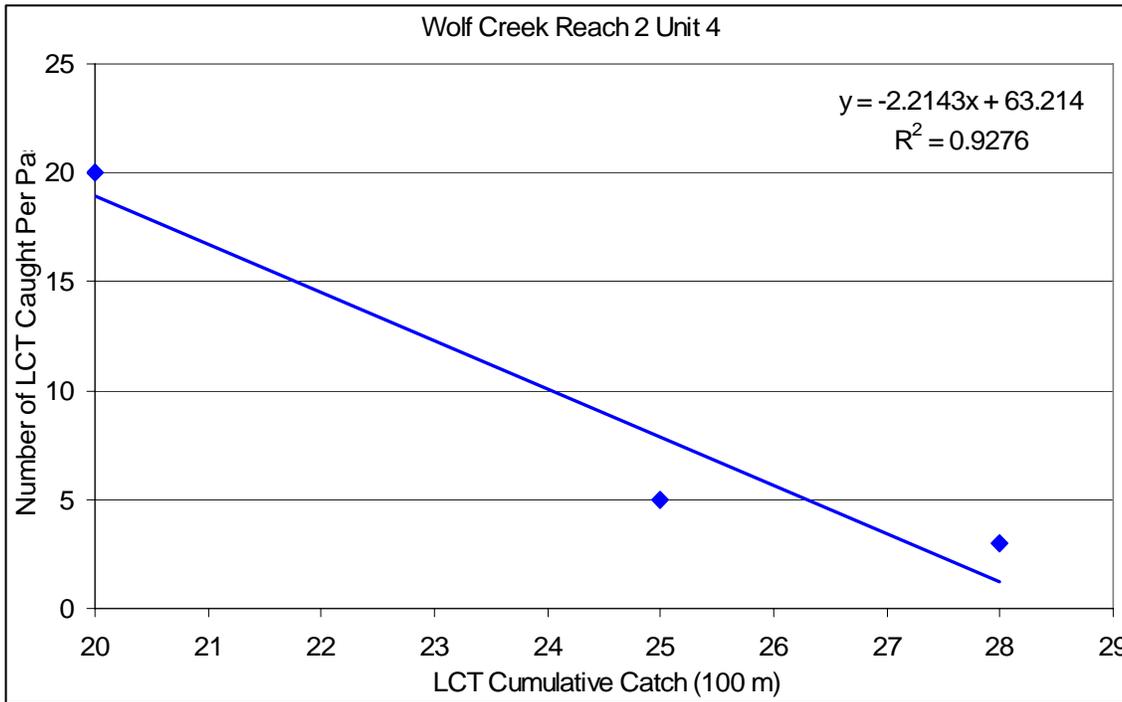
**Figure 2:** Linear regression equation for cumulative number of Lahontan cutthroat trout caught from Wolf Creek, Bridgeport Ranger District, Reach 2 Unit 4. Using the linear regression equation, the estimated total number of LCT within Reach 2 Unit 4 is 29. Reach 2 Unit 4 was 100 meters long and was electroshocked three times. Block nets were set at the top and bottom of the unit to keep fish from entering and leaving the unit. Reach 2 Unit 4 is located at UTM N: 4249191 & E: 275358. Survey was conducted on 1 Oct. 2004. Twenty fish caught on the first pass is 69% of the estimated total number of LCT within Reach 2 Unit 4; therefore, the estimated miss rate of LCT from Reach 2 Unit 4 is 31%.

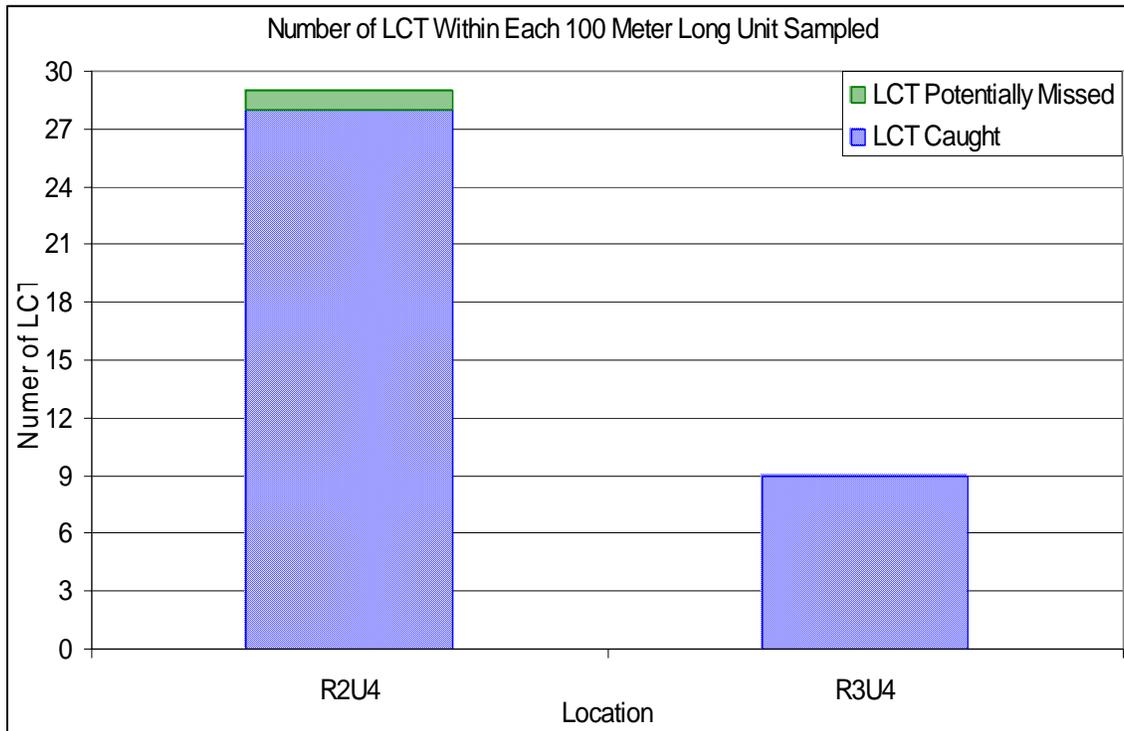
**Figure 3:** Number of LCT captured and potentially missed from each 100 meter long unit sampled on Wolf Creek, Bridgeport Ranger District. Surveys were conducted from 30 September 2004 through 4 October 2004. Reach 2 Unit 4 was electrofished three times. Reach 3 Unit 4 was electrofished two times. On Reach 3 Unit 4 zero fish were caught on the second pass; therefore, a third pass was not conducted. Block nets were set up at the top and bottom of each 100 meter long unit to keep fish from entering and leaving the sample area. A linear regression equation was used to estimate the total number of LCT within Reach 2 Unit 4 (Figure 2). Reach 1 and Reach 4 did not have 100 meter long unit.

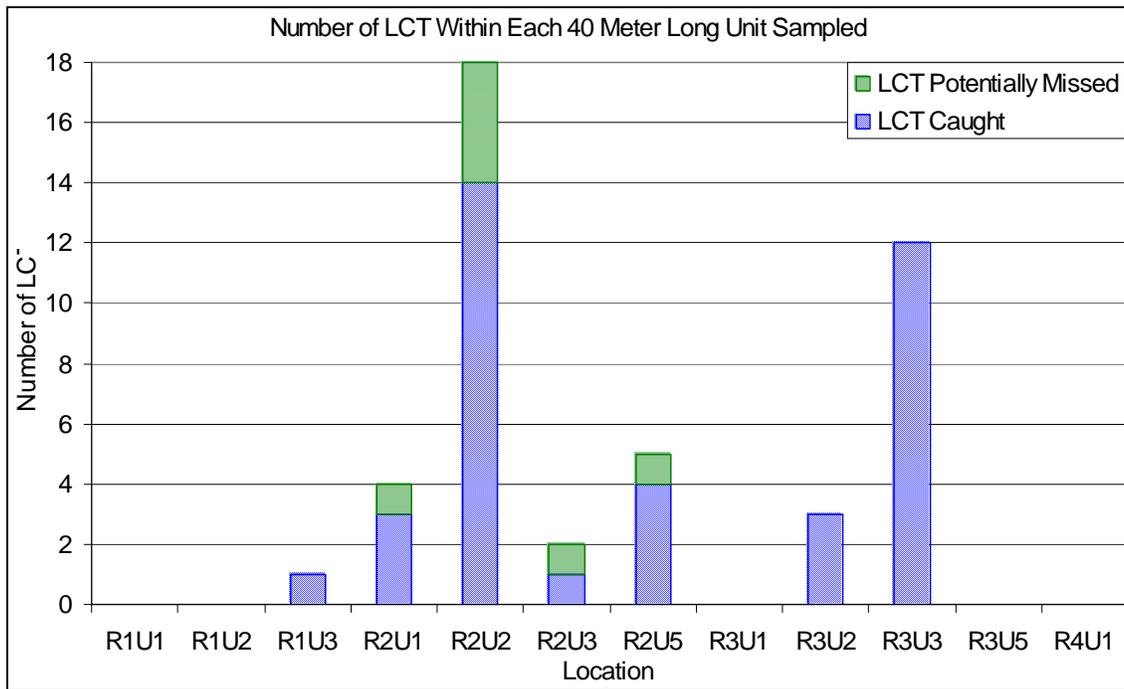
**Figure 4:** Number of LCT captured and potentially missed from each 40 meter long unit sampled on Wolf Creek, Bridgeport Ranger District. Surveys were conducted from 30 September 2004 through 4 October 2004. Each unit was electrofished one time. Reach 2 Units 1, 2, 3, and 5 all had habitat similar to the habitat within Reach 2 Unit 4. Reach 2 Unit 4 had a miss rate of 31% (Figure 2); therefore, an additional 31% of the captured LCT from each unit was added to Reach 2 Units 1, 2, 3, and 5 to account for potentially missed LCT from each unit. Reach 3 Units 2 and 3 had habitat similar to the habitat on Reach 3 Unit 4. Reach 3 Unit 4 had an estimated miss rate of 0%; therefore, no additional percentage could be added to Reach 3 Units 2 and 3 to account for potentially missed LCT. Reach 1 and Reach 4 did not have a 100 meter long unit. Reach 1 was a short reach and Reach 4 Unit 1 is where the survey ended.

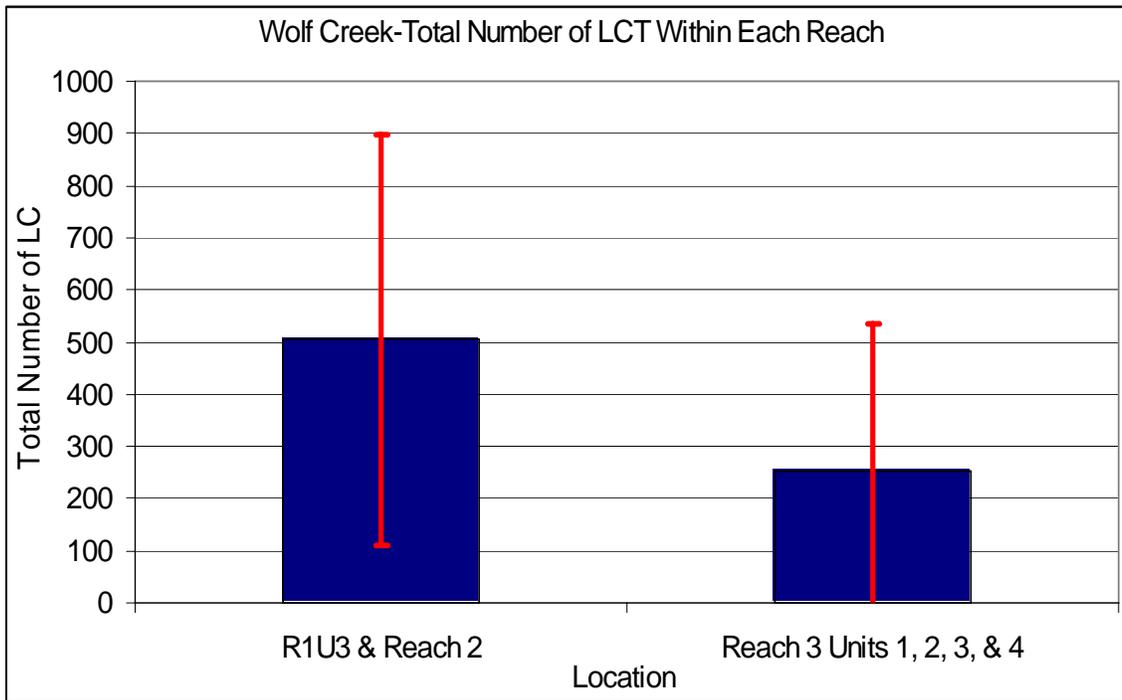
**Figure 5:** Means and 90% confidence intervals for the estimated total number of LCT within Reach 1 Unit 3 and Reach 2, and Reach 3 Units 1, 2, 3, & 4 on Wolf Creek, Bridgeport Ranger District. Surveys were conducted from 30 September 2004 through 4 October 2004. For R1U3 and Reach 2 the mean number of LCT is 504, the upper 90% confidence interval is 897, and the lower 90% confidence interval is 111. For Reach 3 Units 1, 2, 3, & 4 the mean number of LCT is 252, the upper 90% confidence interval is 534, and the lower 90% confidence interval is 0. The distance between R1U3 and the end of Reach 2 (R2U5) is approximately 1.8 miles, and the distance between R3U1 and R3U4 is approximately 1.3 miles.

The mean number of LCT between Reach 1 Unit 3 and the end of Reach 2 is 504 (Figure 5). The upper 90% confidence interval is 897 and the lower 90% confidence interval is 111 (Figure 5). The distance between Reach 1 Unit 3 and the end of Reach 2 is approximately 1.8 miles. The mean number of LCT between Reach 3 Unit 1 and Reach 3 Unit 4 is 252 (Figure 5). The upper 90% confidence interval is 534 and the lower 90% confidence interval is 0 (Figure 5). The distance between Reach 3 Unit 1 and Reach 3 Unit 4 is approximately 1.3 miles. The mean number of LCT within the entire watershed of Wolf Creek is 757 (Figure 6). The upper 90% confidence interval is 1431 and the lower 90% confidence interval is 111 (Figure 6). The mean number of LCT/mile within the entire Wolf Creek watershed is 236 (Figure 7). The upper 90% confidence interval is 447 and the lower 90% confidence interval is 35 (Figure 7).

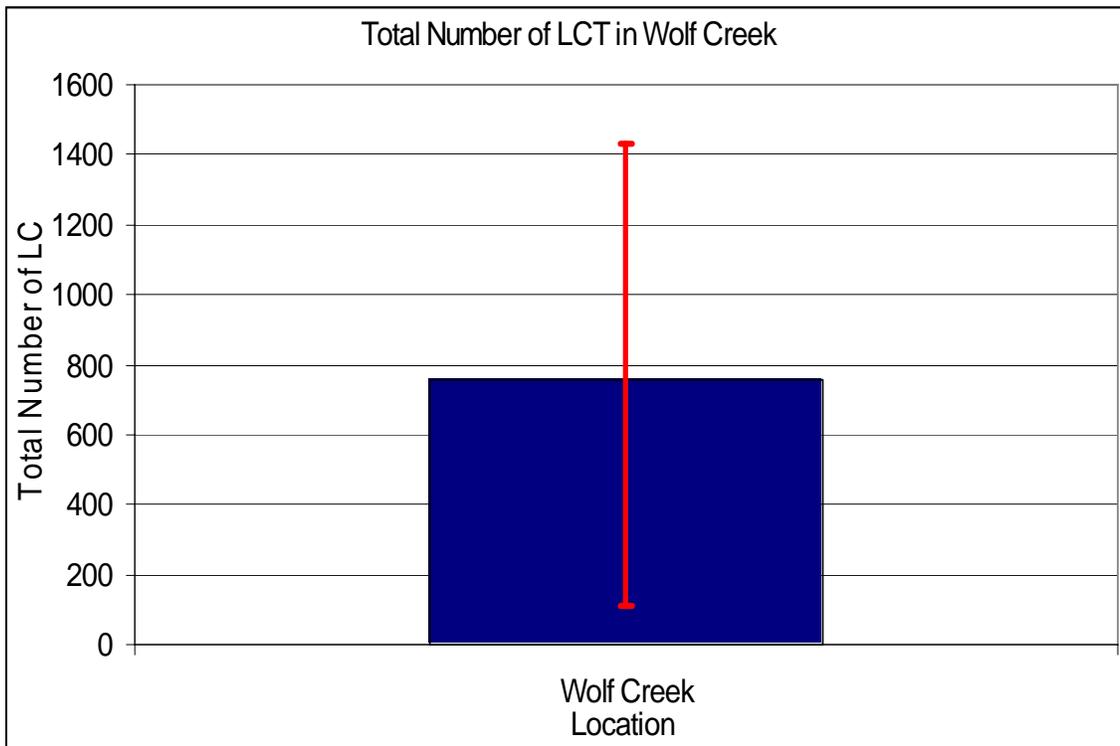
**Figure 6:** Mean and 90% confidence interval for the estimated total number of LCT within Wolf Creek, Bridgeport Ranger District. Surveys were conducted from 30 September 2004 through 4 October 2004. The mean number of LCT is 757, the upper 90% confidence interval is 1431, and the lower 90% confidence interval is 111. Lahontan cutthroat trout in Wolf Creek are occupying approximately 3.2 miles of stream habitat.

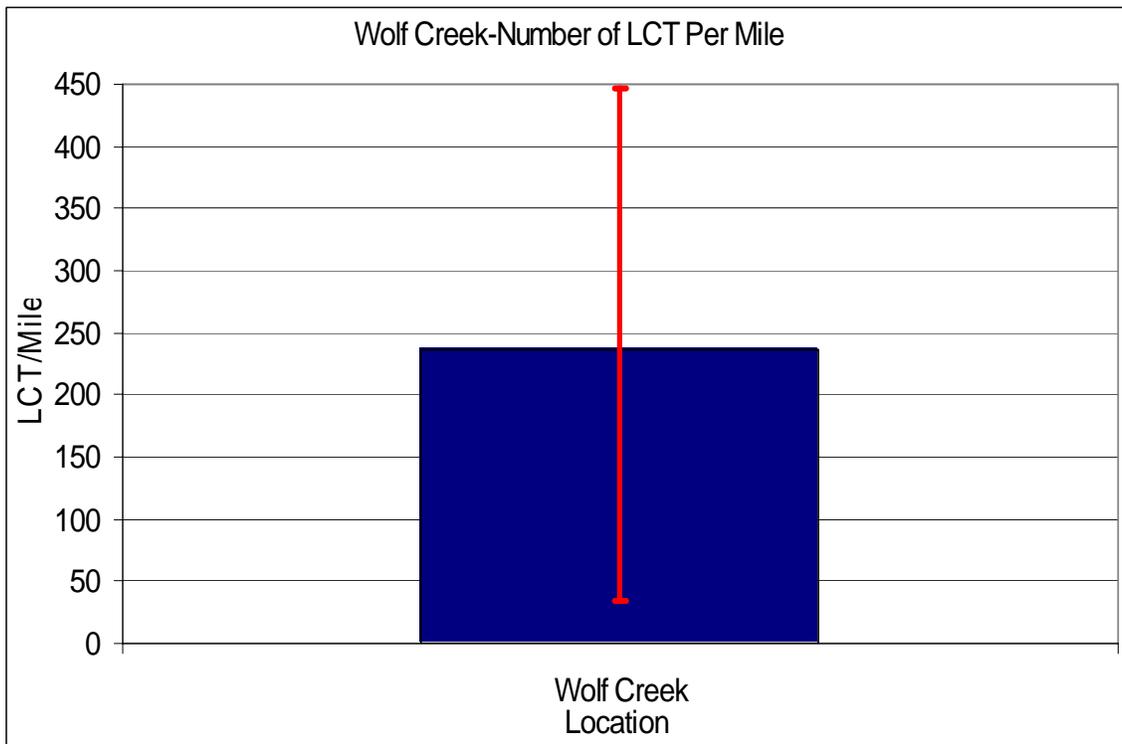
**Figure 7:** Mean number of LCT/mile and 90% confidence interval for LCT in Wolf Creek, Bridgeport Ranger District. Surveys were conducted from 30 September 2004 through 4 October 2004. The mean number of LCT/mile is 236, the upper 90% confidence interval is 447, and the lower 90% confidence interval is 35. Lahontan cutthroat trout in Wolf Creek are occupying approximately 3.2 miles of stream habitat.

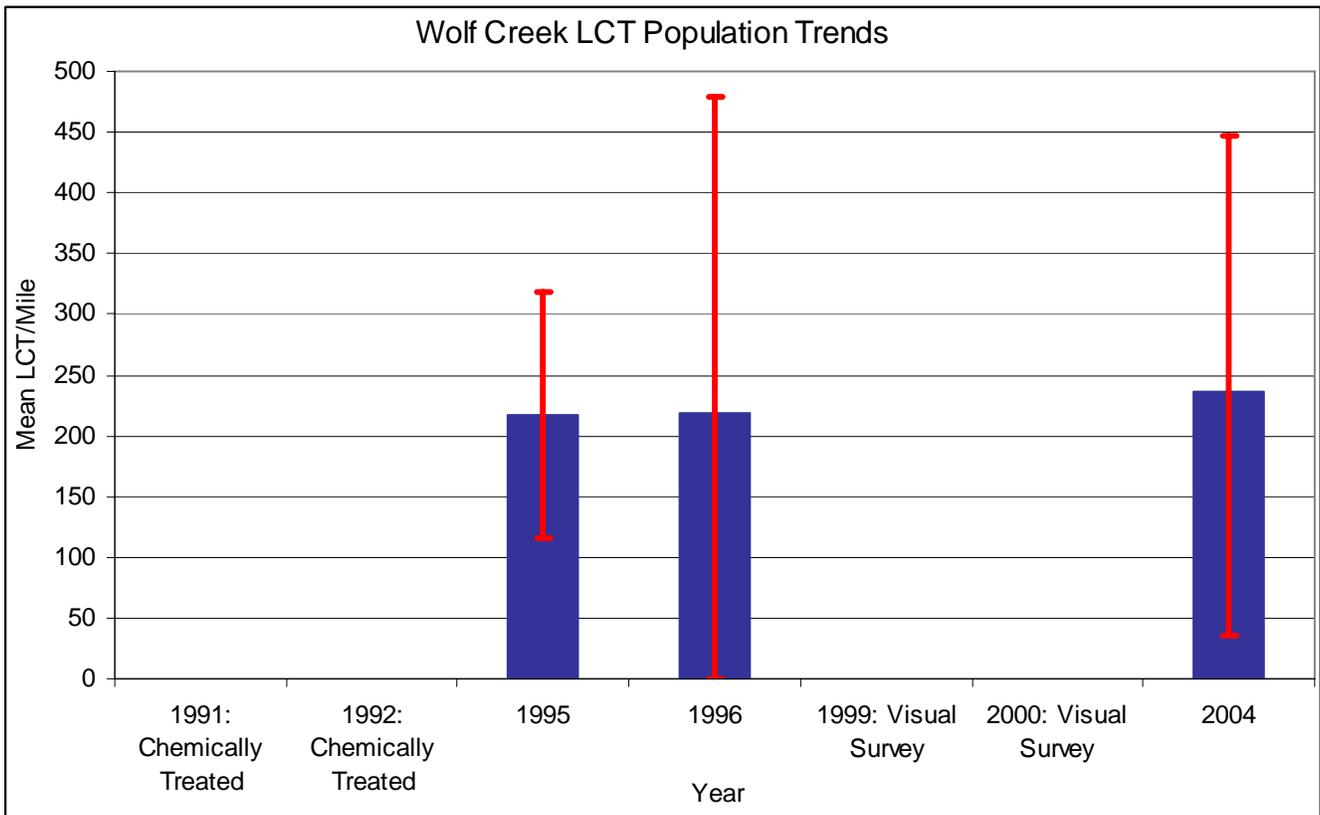
**Figure 8:** Mean number of LCT/mile and 90% confidence intervals for Lahontan cutthroat trout in Wolf Creek, Bridgeport Ranger District, between 1995 and 2004. In 2004 a 2-3 pass depletion survey was conducted. In 1995 and 1996 only a one pass depletion survey was conducted; therefore, the 217 LCT/mile in 1995 and 219 LCT/mile in 1996 are probably conservative. In 2004, LCT were occupying approximately 3.2 miles of stream habitat.

The 2004 Lahontan cutthroat trout population estimate is higher than the 1995 and 1996 population estimates (Figure 8). In 1995 and 1996 only a one pass depletion survey was conducted; therefore, the 1995 and 1996 population estimates may be conservative. In 2004 a 2-3 pass depletion survey was conducted. Visual surveys were conducted in 1999 and 2000.

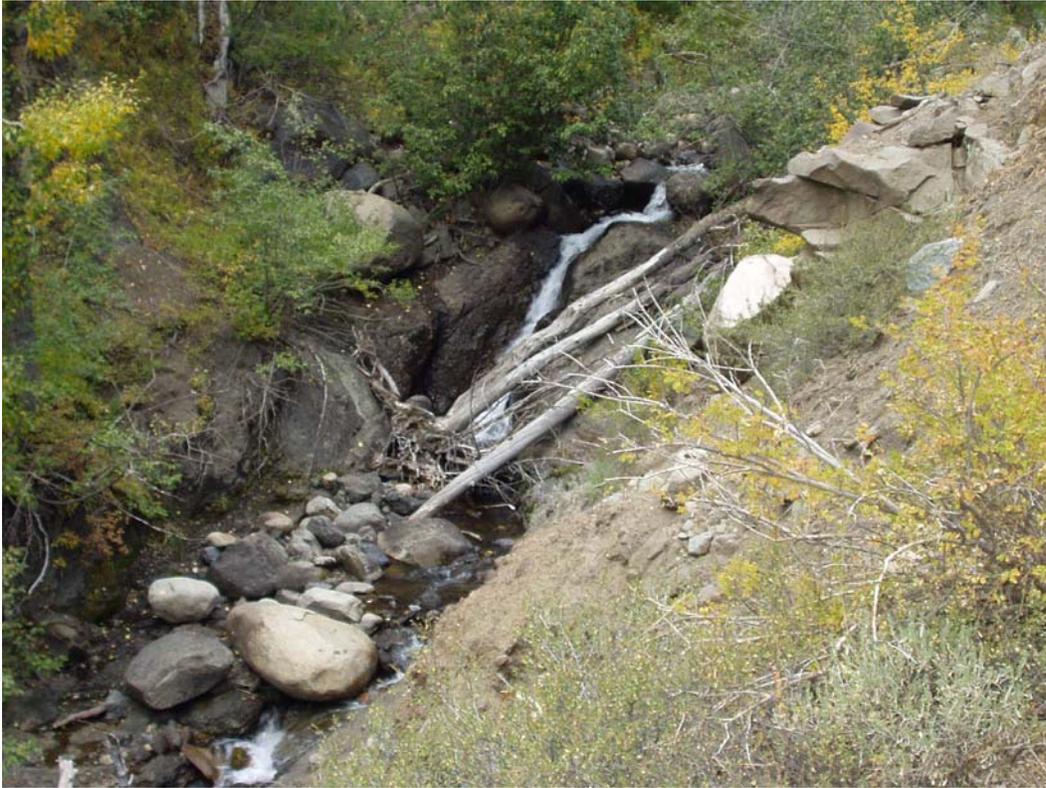
Wolf Creek was broken into four reaches. Reach 1 was very high gradient, and because of the short distance between the natural barrier (Figure 9) and where the gradient decreased, only three units were sampled in Reach 1. Reaches 2 and 3 had similar habitats, so each reach was divided into similar lengths. Reach 2 and 3 were each approximately 1.5 miles in length. Only one unit was sampled in Reach 4 because upstream of Reach 4 Unit 1 Wolf Creek became completely dry. At Wolf Creek Lake the crew walked around the lake looking for presence of fish and amphibians.

**Figure 9:** Wolf Creek natural barrier, Bridgeport Ranger District, downstream of Reach 1/Unit 1. This barrier is located at UTM N: 4248130 & E: 277746. Picture was taken on 30 Sept. 2004. Barrier is approximately 15 feet high.

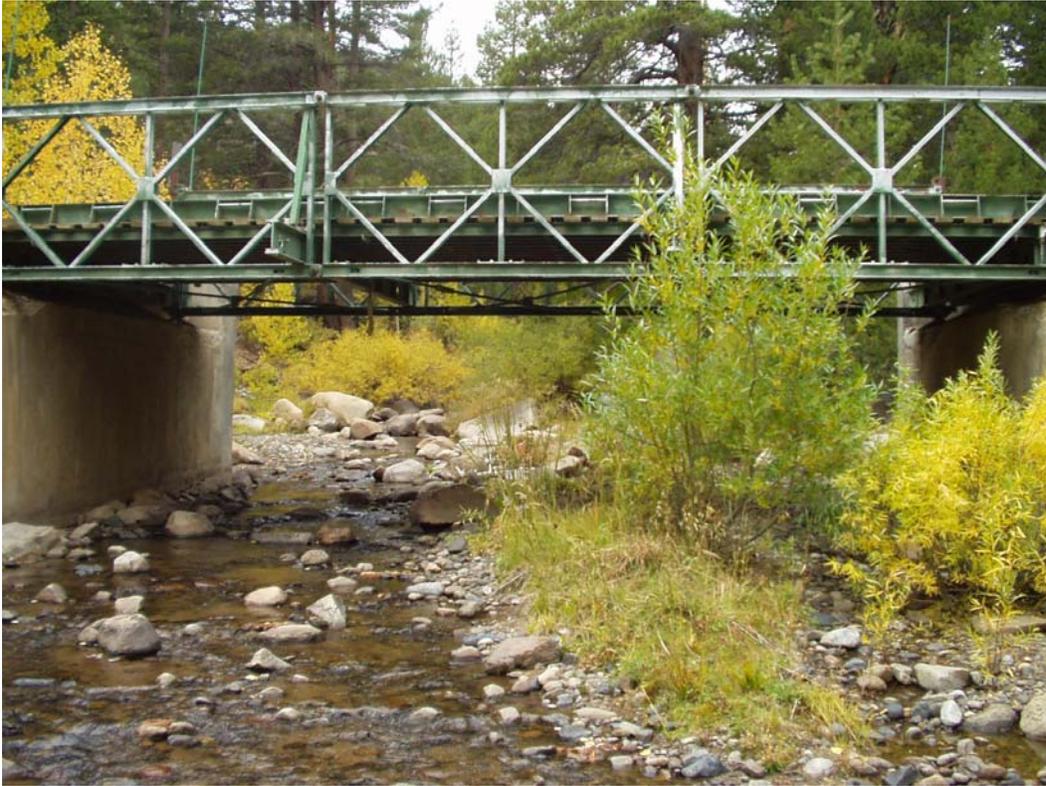
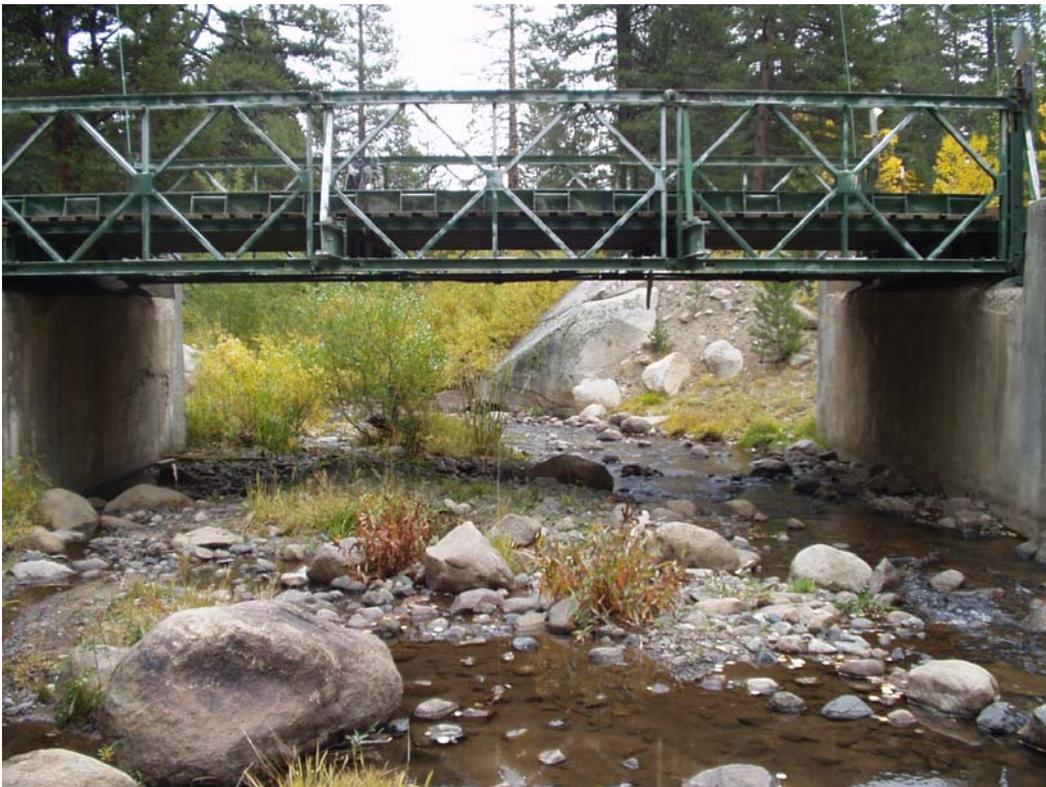
Forest System Road 042 parallels Wolf Creek for approximately 2 miles. The road has been maintained fairly well. A few dispersed campsites are located between Wolf Creek and Forest System Road 042 within 100 feet of the creek. The dispersed campsites are likely causing erosion impacts on Wolf Creek. Forest System Road 062 crosses Wolf Creek just downstream of Reach 1 Unit 3. A large bridge was constructed at the Wolf Creek/Forest System Road 062 intersection (Figures 15 & 16). No significant impacts were documented at this bridge crossing.

**Figure 15:** Wolf Creek, Bridgeport Ranger District, bridge downstream of Reach 2/Unit 1. Picture was taken on 30 Sept. 2004. Picture was taken looking upstream at bridge.

**Figure 16:** Wolf Creek, Bridgeport Ranger District, bridge downstream of Reach 2/Unit 1. Picture was taken on 30 Sept. 2004. Picture was taken looking downstream at bridge.

1. At the latest, in 2009 conduct another similar electrofishing LCT distribution and density survey.
2. Maintain Forest System Road 042 to minimize erosion impacts on Wolf Creek.

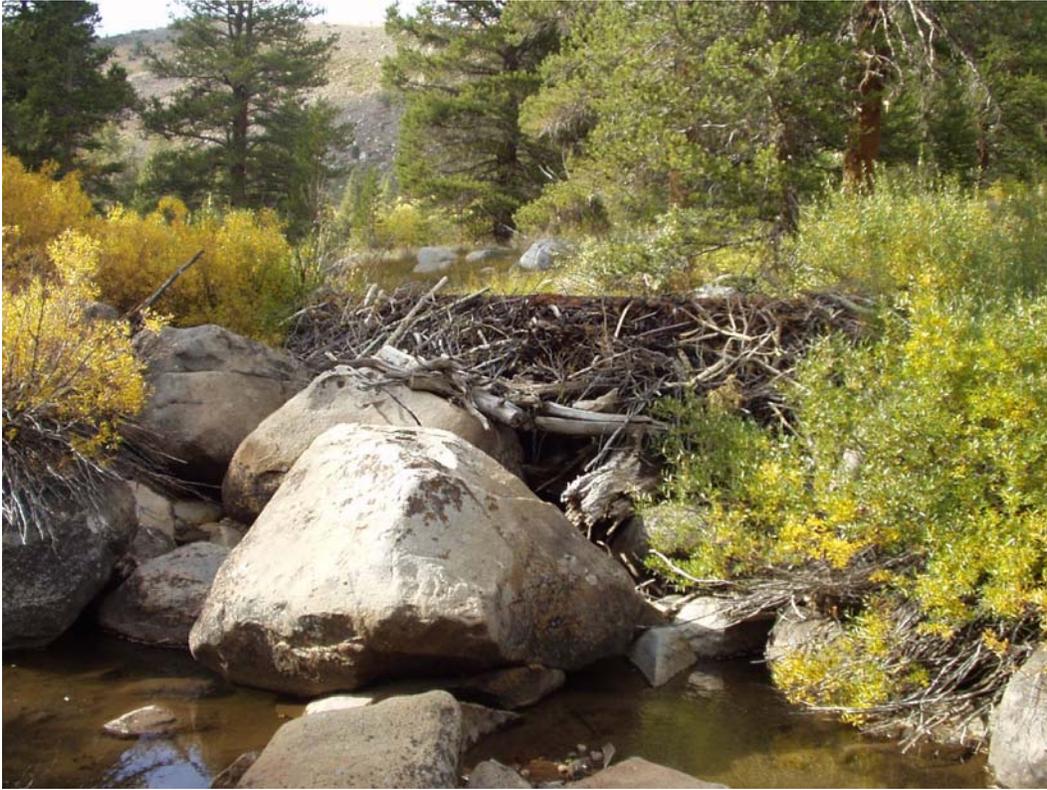
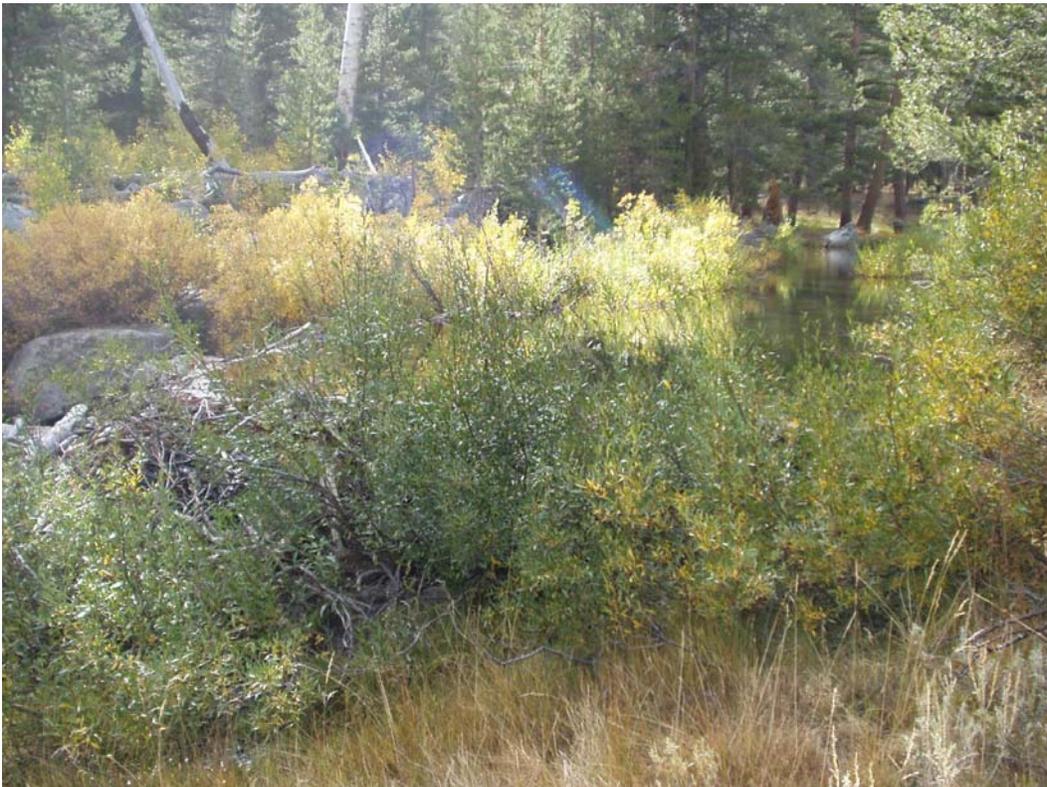
Habitat conditions in Wolf Creek between the natural barrier and Reach 4 Unit 1 are fairly good. Typical habitat consisted of riffles, pools, several pieces of large woody debris in the stream, well vegetated stream banks, some good undercut cover, and not many bare or eroding banks. Only one area was noted for having unstable banks (Figures 31 & 32); however, a large amount of sedimentation in the stream was still noted several times while conducting the survey. Just upstream of Reach 3 Unit 1 a 12 foot high waterfall (Figure 33) was documented. Lahontan cutthroat trout may be able to get around this waterfall at certain times of the year. One beaver dam (Figures 21 & 22) was also documented just upstream of Reach 2 Unit 2. The beaver dam may be a temporary fish barrier. Lahontan cutthroat trout were visually sighted upstream of the beaver dam within the beaver pond.

**Figure 21:** Wolf Creek, Bridgeport Ranger District, beaver pond located just upstream of Reach 2/Unit 2. Picture was taken on 30 Sept. 2004.

**Figure 22:** Wolf Creek, Bridgeport Ranger District, streamside view of a beaver pond located just upstream of Reach 2/Unit 2. Picture was taken on 30 Sept. 2004.

3. Decommission all campsites within 100 feet of Wolf Creek to reduce erosion impacts.
4. Monitor water temperature within the Wolf Creek watershed.
5. Monitor beaver activity within the Wolf Creek watershed.

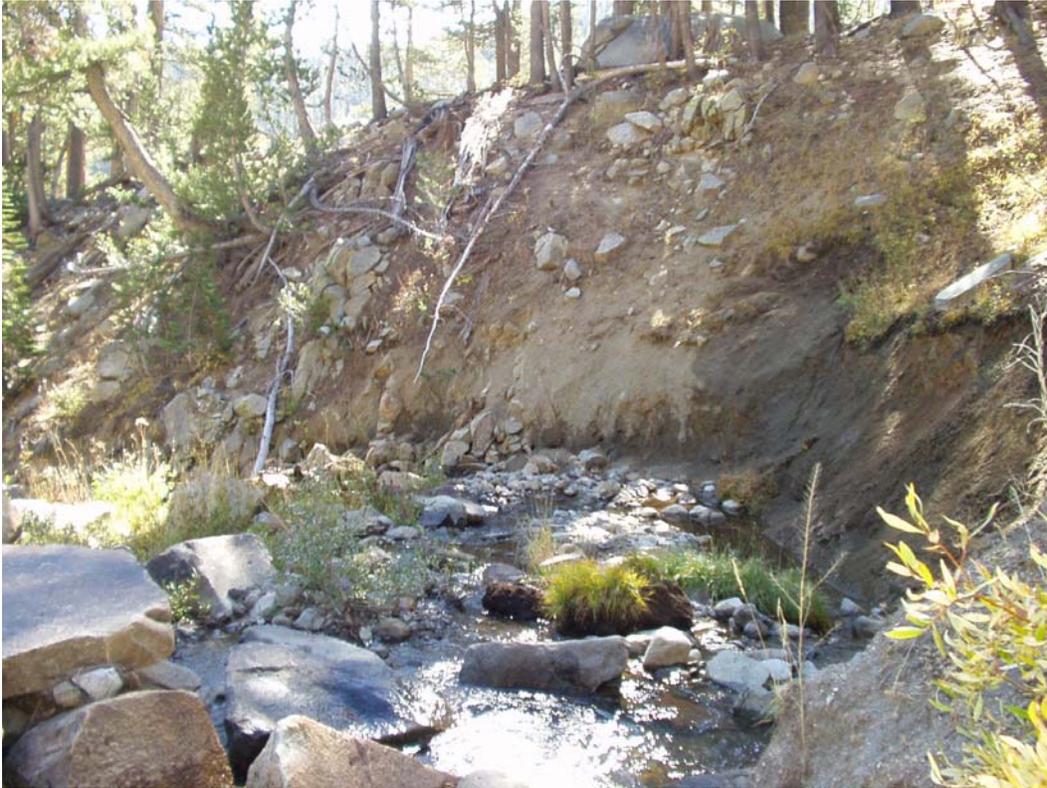
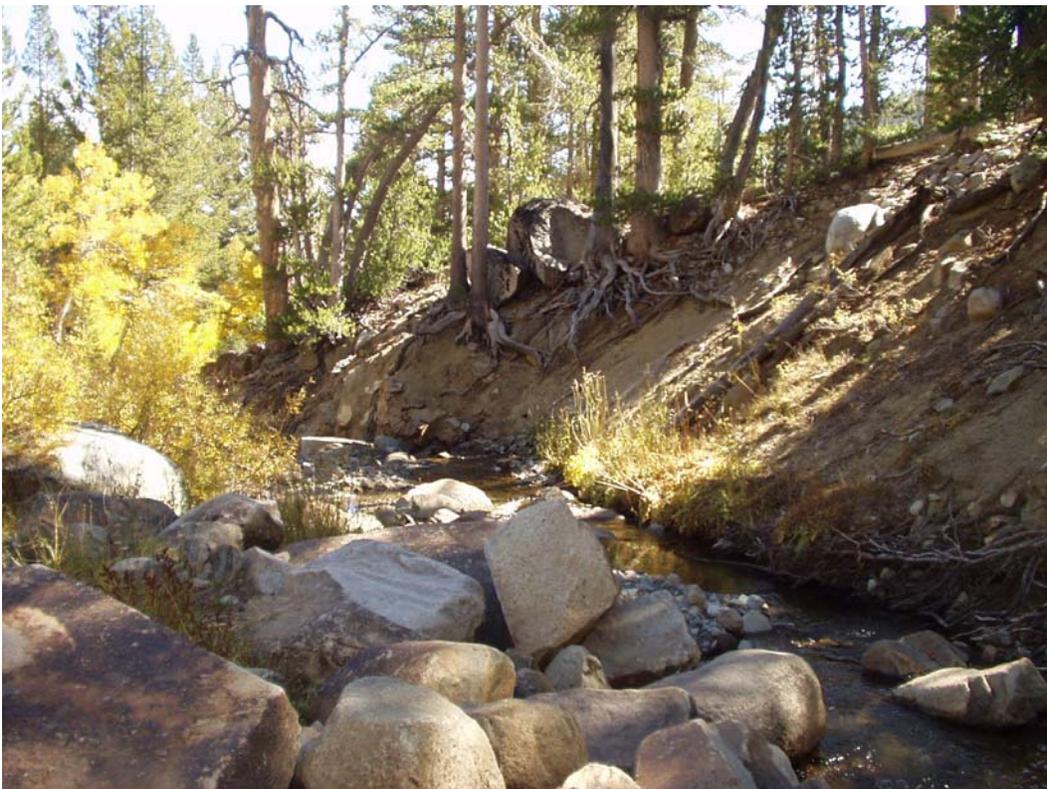
**Figure 31:** Wolf Creek, Bridgeport Ranger District, unstable south bank at Reach 3/Unit 1. This Unit is located at UTM N: 4248822 & E: 274316. Picture was taken on 1 Oct. 2004.

**Figure 32:** Wolf Creek, Bridgeport Ranger District, unstable bank at Reach 3/Unit 1. This Unit is located at UTM N: 4248822 & E: 274316. Picture was taken on 1 Oct. 2004.

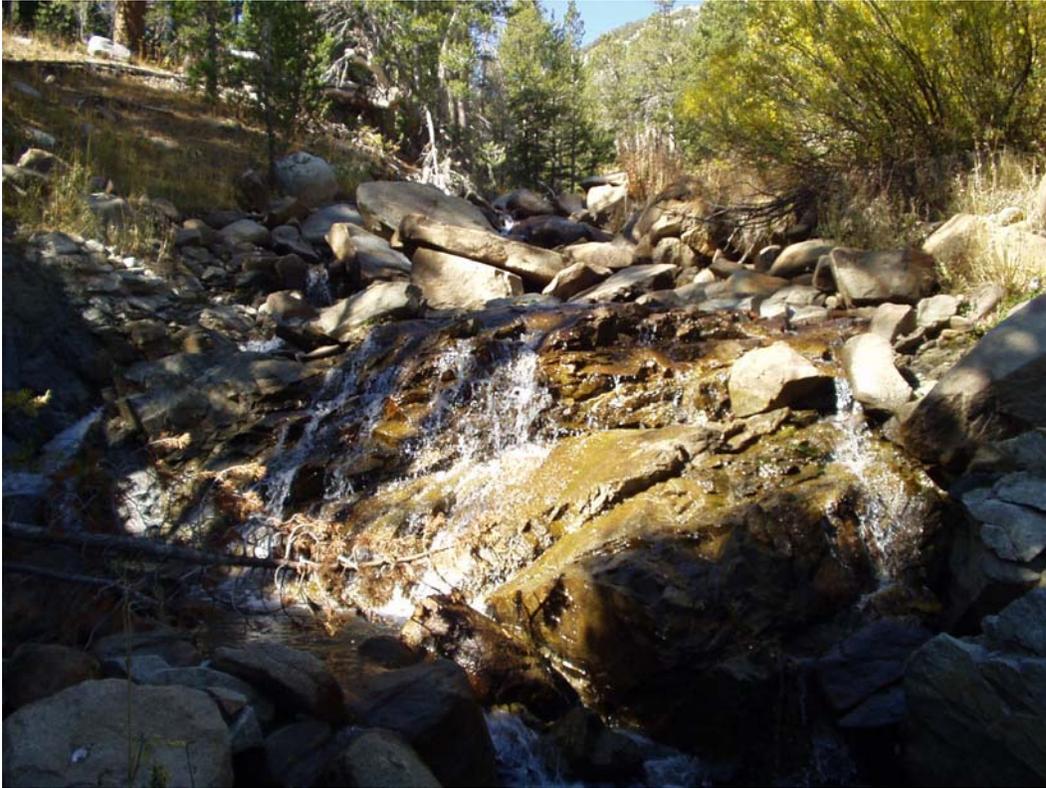
**Figure 33:** Wolf Creek, Bridgeport Ranger District, waterfall at the top of Reach 3/Unit 1. This Unit is located at UTM N: 4248822 & E: 274316. Picture was taken on 1 Oct. 2004. LCT may be able to swim around the waterfall at certain times of the year. Waterfall is approximately 12 feet high.

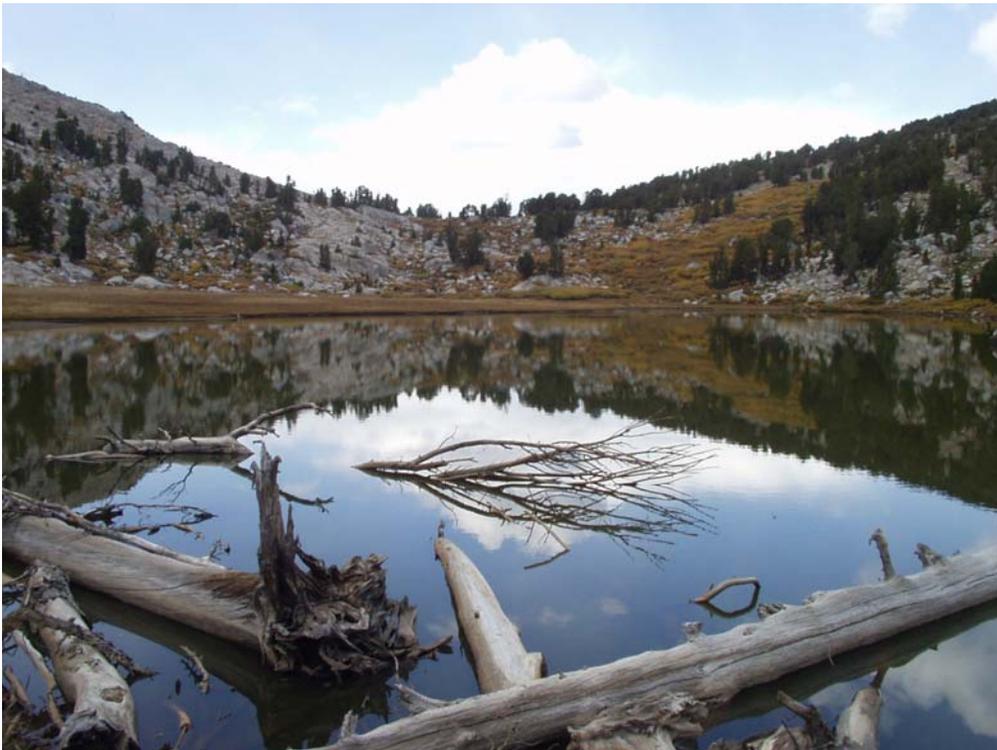
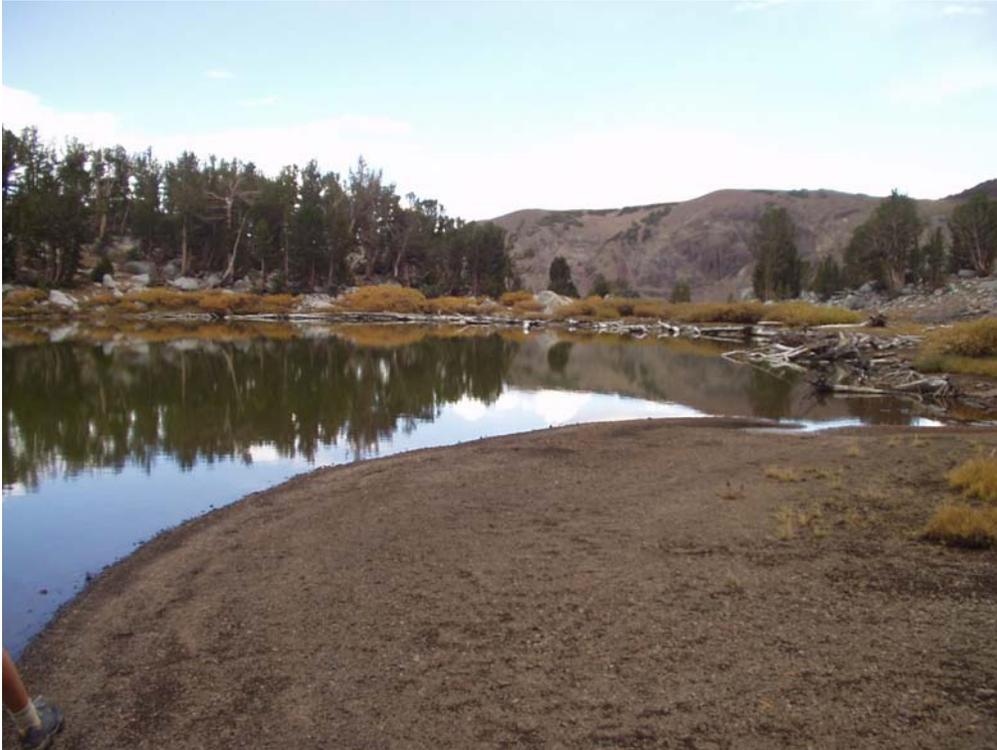
Wolf Creek Lake was surveyed for presence of amphibians. Six to 8 first year Mountain yellow-legged frog tadpoles were sighted on the west side of the lake. No fish were seen in the lake. The outlet was dry for approximately 300 meters downstream of the lake.

**Figure 44:** Wolf Creek Lake, Bridgeport Ranger District, looking north. Picture was taken on 1 Oct. 2004. No fish were seen in the lake. Approximately 6-8 first year Mountain yellow-legged frog tadpoles were sighted on the west side of the lake. The outlet of the lake was dry.

**Figure 45:** Wolf Creek Lake, Bridgeport Ranger District, looking south at the outlet. Picture was taken on 1 Oct. 2004. No fish were seen in the lake. Approximately 6-8 first year Mountain yellow-legged frog tadpoles were sighted on the west side of the lake. The outlet of the lake was dry.

8. Monitor amphibian populations at Wolf Creek Lake.
9. Work with the Mountain Warfare Training Center to minimize impacts and disturbance within all riparian areas (300 feet on each side of Wolf Creek and all tributaries).

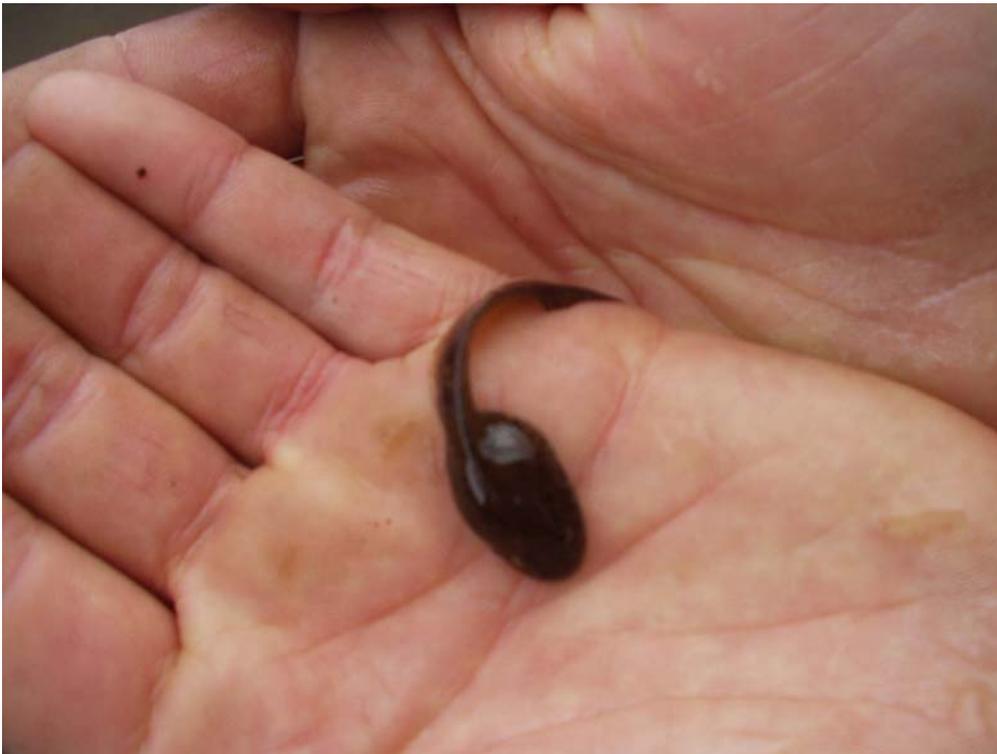
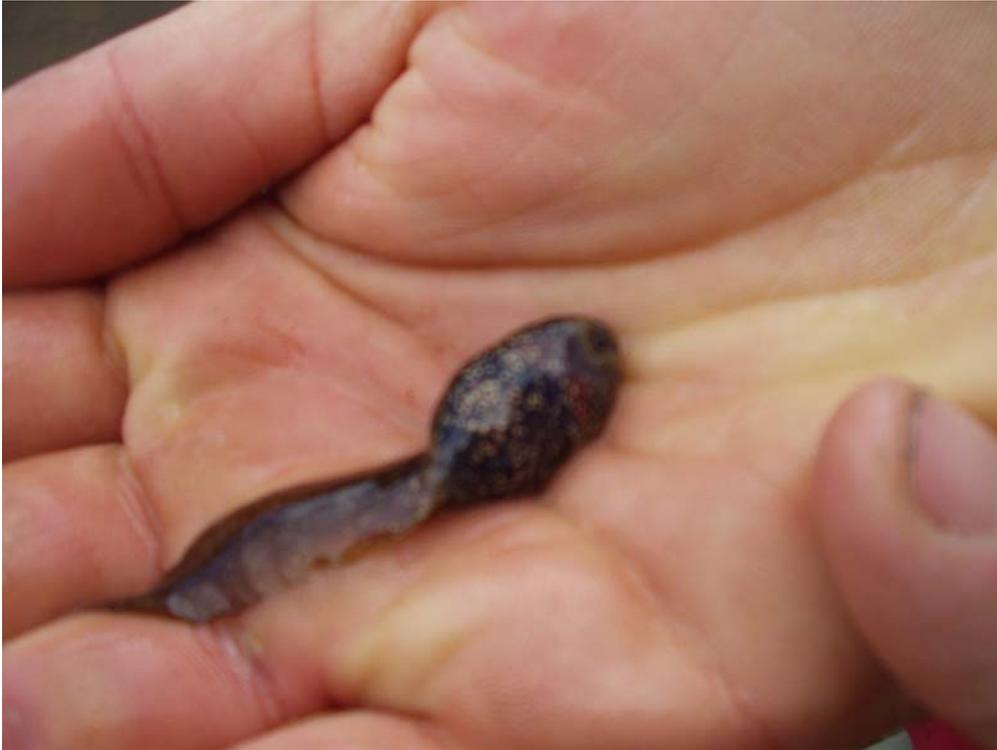
In 1999 Wolf Creek Lake was visually surveyed for presence of fish and amphibians. No fish were seen in the lake; however, Mountain yellow-legged frogs and Yosemite toads were present at the lake. In 2004, 6-8 first year Mountain yellow-legged frog tadpoles were sighted on the west side of Wolf Creek Lake (Figures 46-47).

**Figure 46:** Mountain yellow-legged frog first year tadpole caught from Wolf Creek Lake, Bridgeport Ranger District. Picture was taken on 1 Oct. 2004. No fish were seen in the lake. Approximately 6-8 first year Mountain yellow-legged frog tadpoles were sighted on the west side of the lake.

**Figure 47:** Mountain yellow-legged frog first year tadpole caught from Wolf Creek Lake, Bridgeport Ranger District. Picture was taken on 1 Oct. 2004. No fish were seen in the lake. Approximately 6-8 first year Mountain yellow-legged frog tadpoles were sighted on the west side of the lake.
