BULL CANYON CREEK

2006 Stream Habitat Survey Report

Humboldt-Toiyabe National Forest, Carson Ranger District

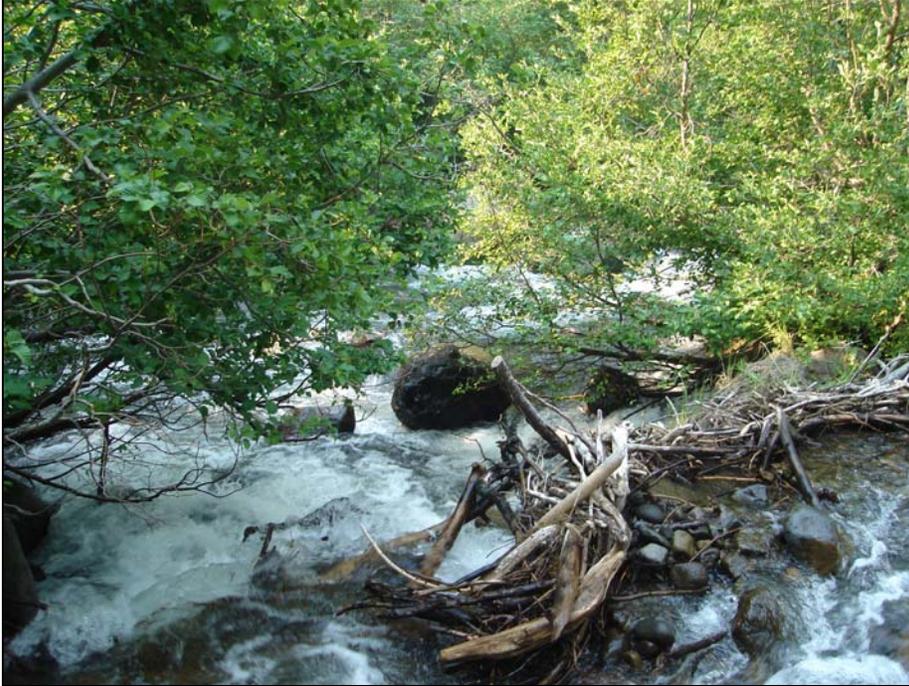
Site 1: Bull Canyon Creek, Carson Ranger District. Downstream view of confluence of Bull Canyon Creek (near) and Wolf Creek (far). This site is located at UTM: N: 4266600 & E: 262188, Elev.7810 feet (2381m).

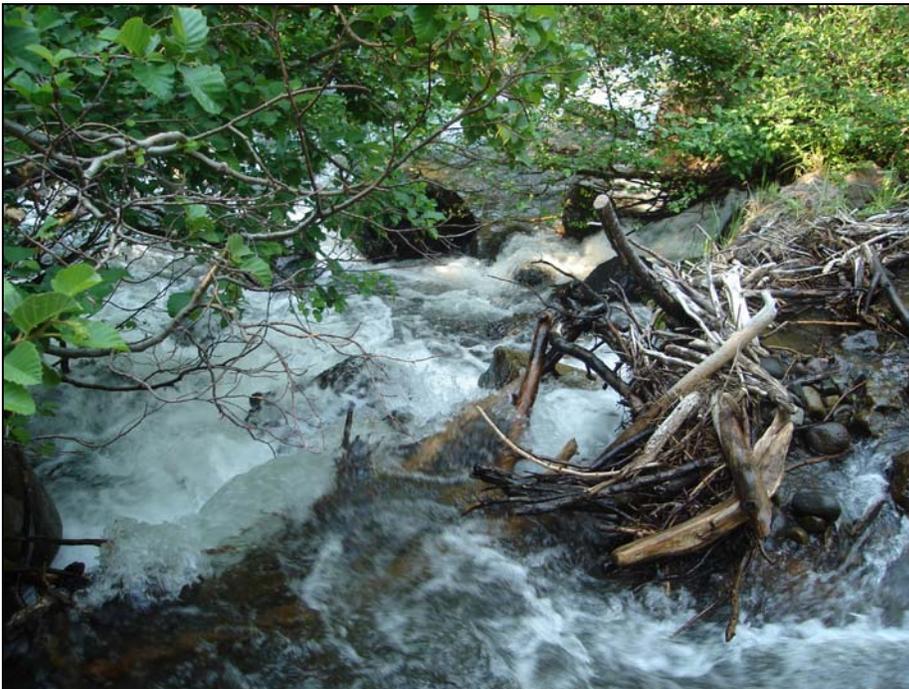
The lowermost 0.32 river miles of stream from Site 1 through Site 5 are steep and contain two sizeable permanent fish passage barriers. Site 1, also the survey start, includes a 3.6-foot drop with a maximum pool depth of 1.6 feet. At Site 3 a waterfall is divided into two adjacent barriers: the falls on river right are 10 feet high, whereas the falls on river left are comprised of two consecutive 5.5 foot drops. Between Site 3 and Site 5, multiple seasonal barriers were noted, ranging in height from 2.0 to 4.5 feet. The waterfall at Site 5 drops a total of approximately 100 vertical feet, with one single fall of over 40 feet.

Site 1: Bull Canyon Creek, Carson Ranger District. A seasonal barrier just above the confluence with a height of 3.6 feet, and max. pool depth of 1.6 feet. This site is located at UTM: N: 4266600 & E: 262188, Elev.7810 feet (2381m).

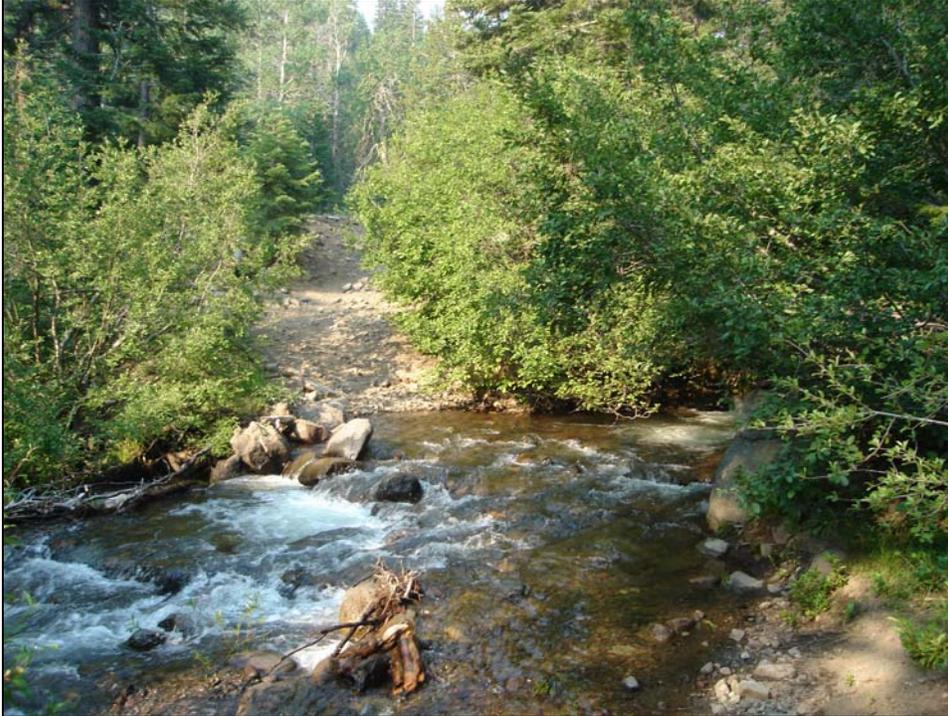
Site 2: Bull Canyon Creek, Carson Ranger District. Photo shows a ford crossing where the Wolf Creek trail intersects the stream. This site is located at UTM: N: 426656 & E: 262262.

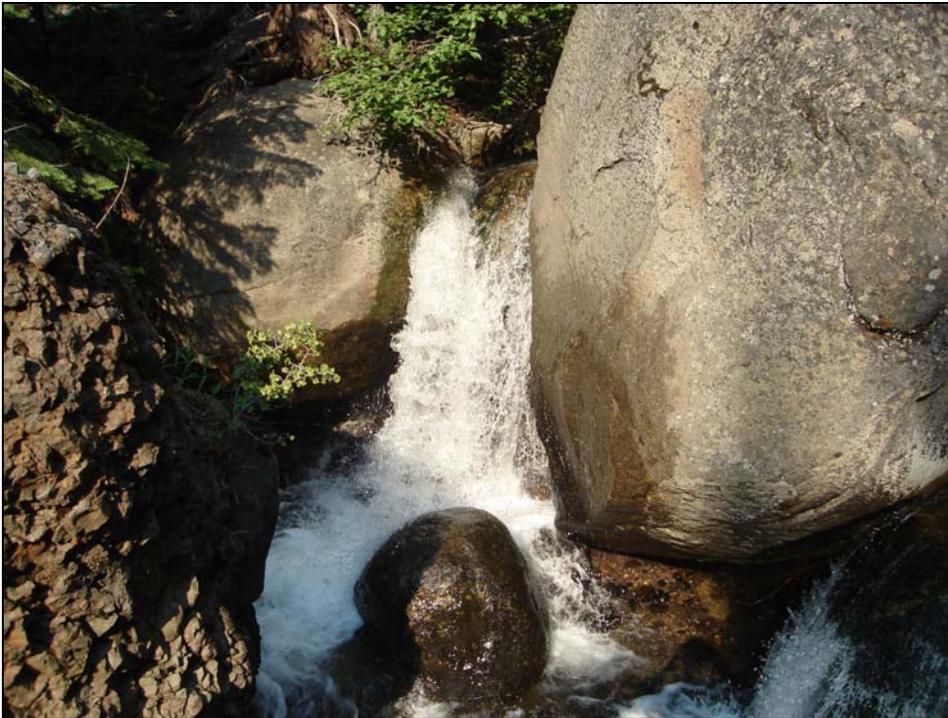
Site 3: Bull Canyon Creek, Carson Ranger District. Permanent fish barrier. Photo shows river right: a drop of approximately 10 ft, with a max/ pool depth of approximately 1.5 feet. This site is located at UTM: N: 4266638 & E: 262155.

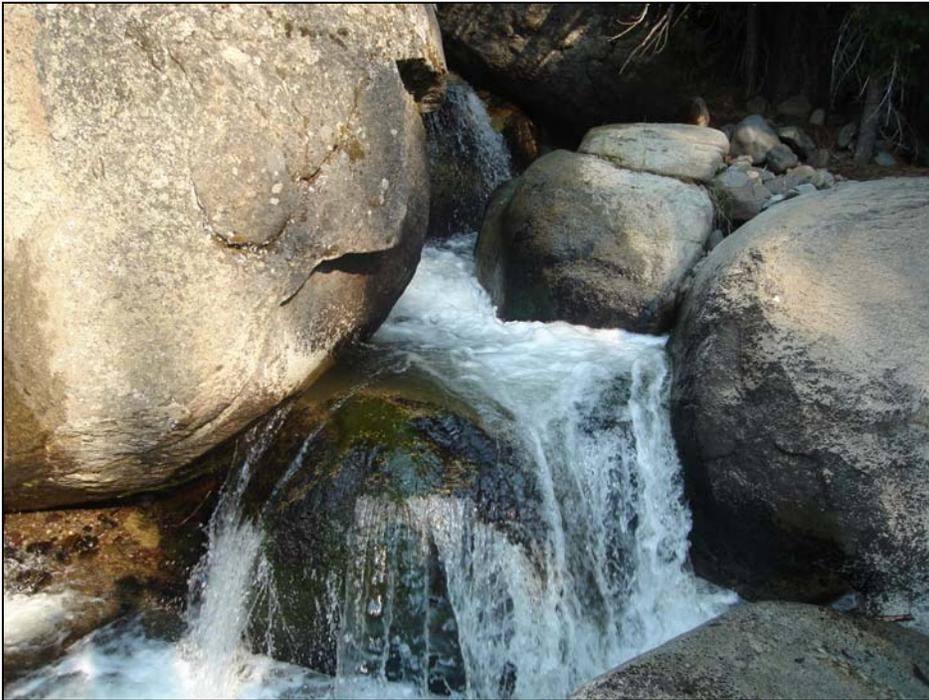
Site 3: Bull Canyon Creek, Carson Ranger District. Photo shows river left: two consecutive 5.5 foot drops, with a max pool depth of 3.0 feet. This site is located at UTM: N: 4266638 & E: 262155.

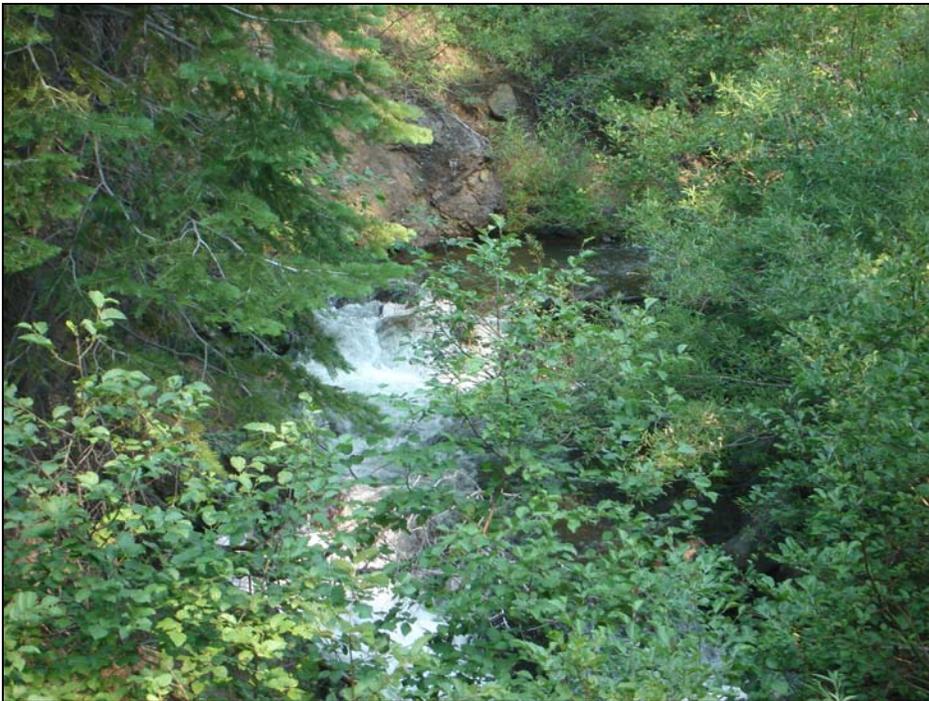
Site 4: Bull Canyon Creek, Carson Ranger District. Photo shows an upstream view of the stream where multiple seasonal barriers are present, ranging in height from 2.0-4.5 feet. This site is located at UTM: N: 4266624 & E: 262122, Elev. 7505 feet (2288m).

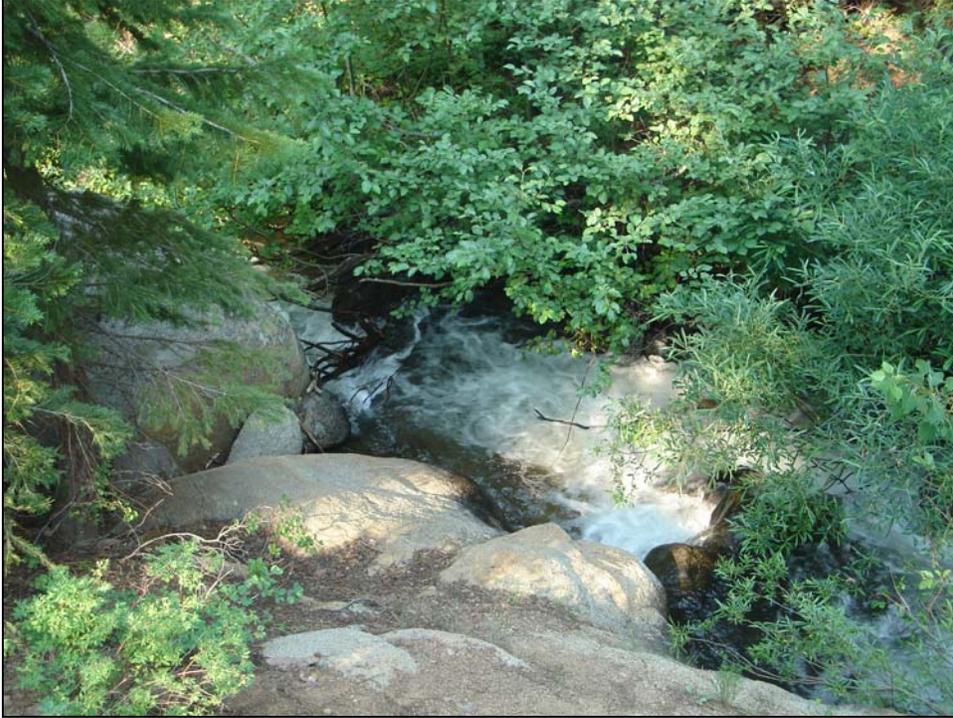
Site 4: Bull Canyon Creek, Carson Ranger District. Photo shows a downstream view of the stream where multiple seasonal barriers are present, ranging in height from 2.0-4.5 feet. This site is located at UTM: N: 4266624 & E: 262122, Elev. 7505 feet (2288m).

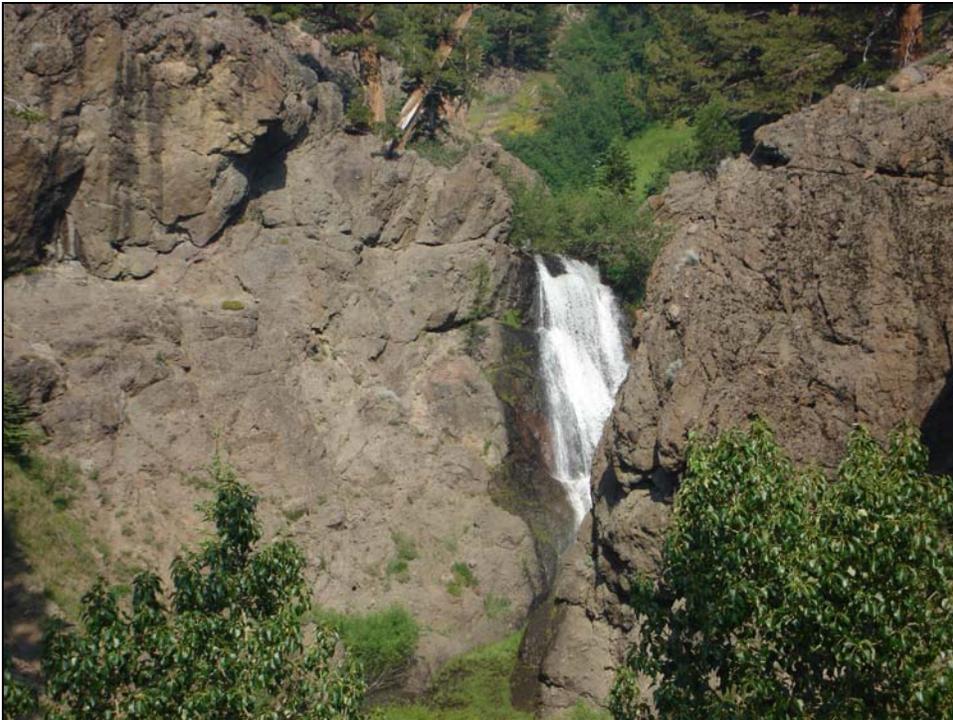
Site 5: Bull Canyon Creek, Carson Ranger District. Photo shows the upper section of a permanent fish barrier. The falls featured measure approximately 40-50 feet. This site is located at UTM: N: 4266759: & E: 261808, Elev.7646 feet (2331m).

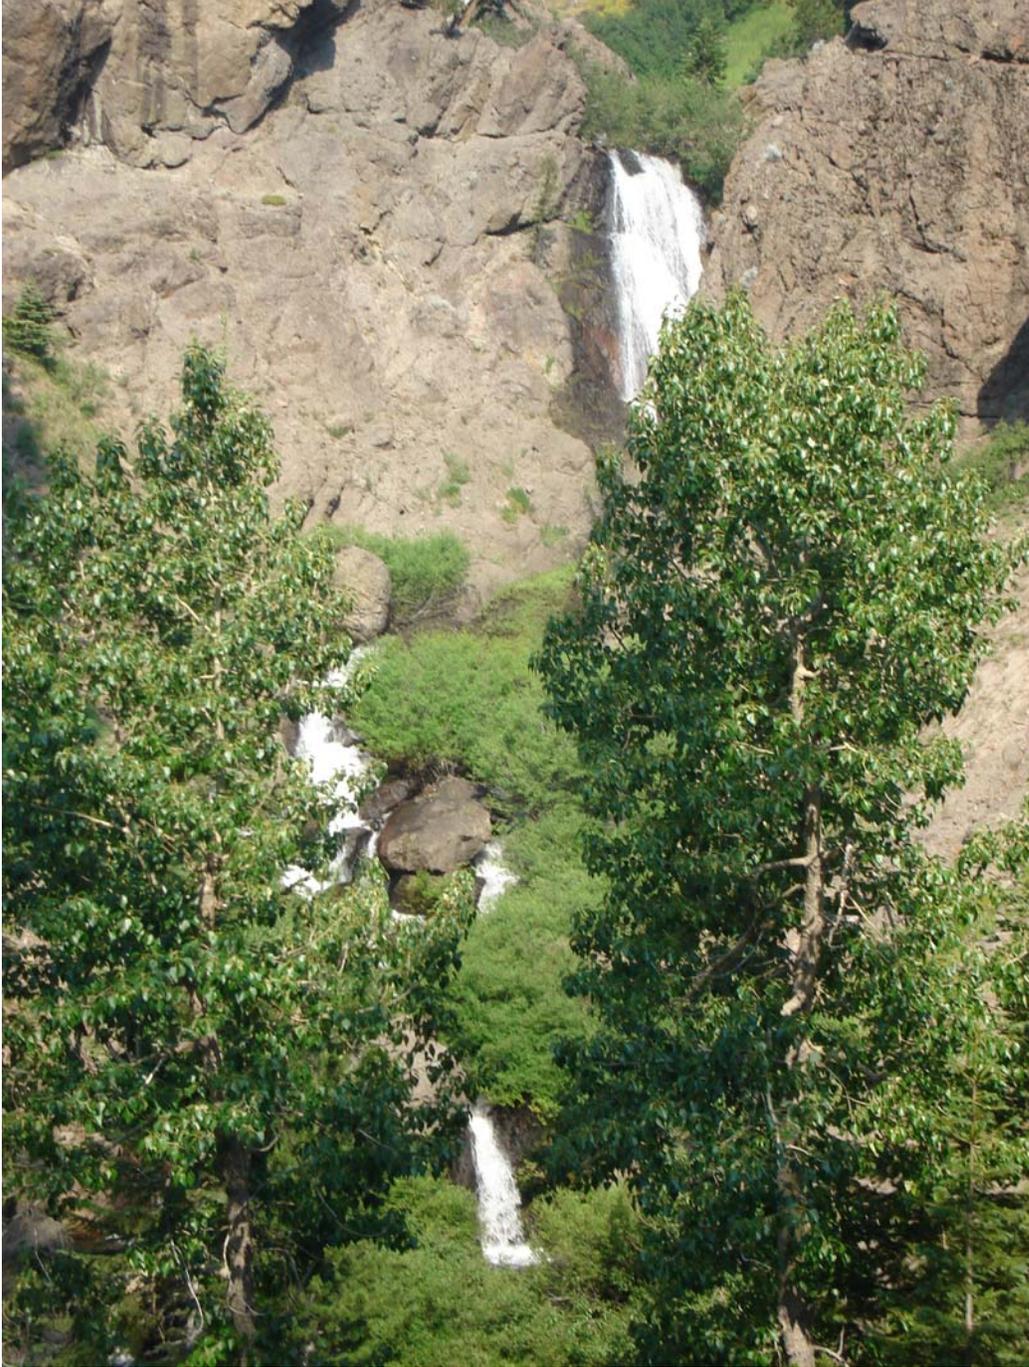
Site 5: Bull Canyon Creek, Carson Ranger District. A comprehensive view of the permanent fish barrier, which drops a total of approximately 100 vertical feet. This site is located at UTM: N: 4266759 & E: 261808, Elev.7646 feet (2331m).

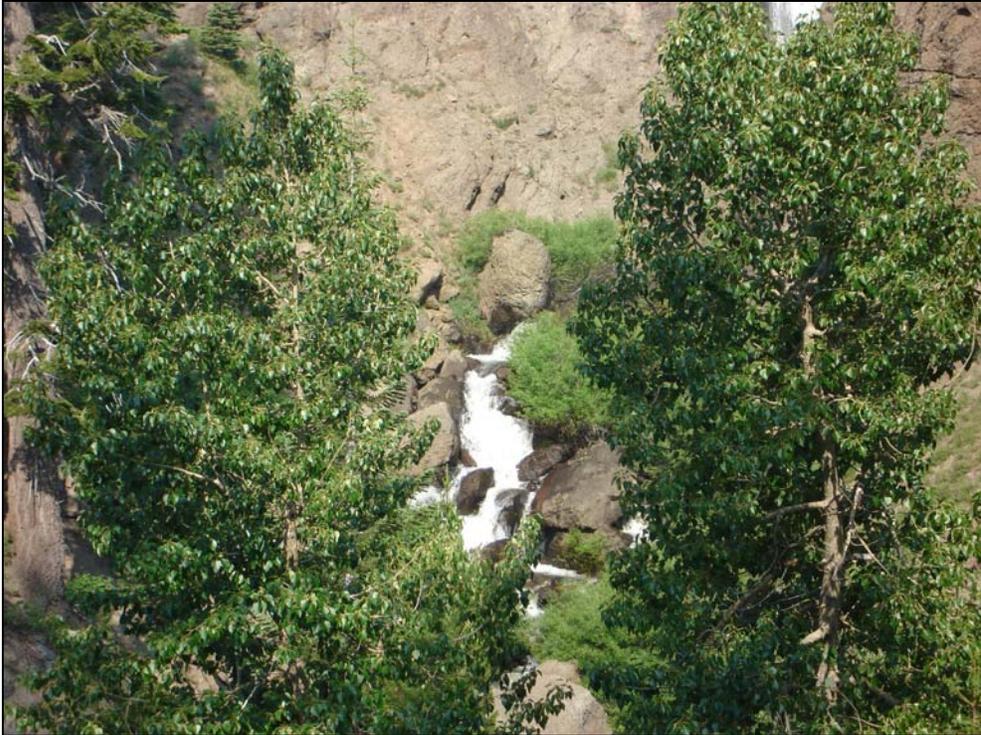
Site 5: Bull Canyon Creek, Carson Ranger District. The middle drop is 20-25 vertical feet. This site is located at UTM: N: 4266759 & E: 261808, Elev.7646 feet (2331m).

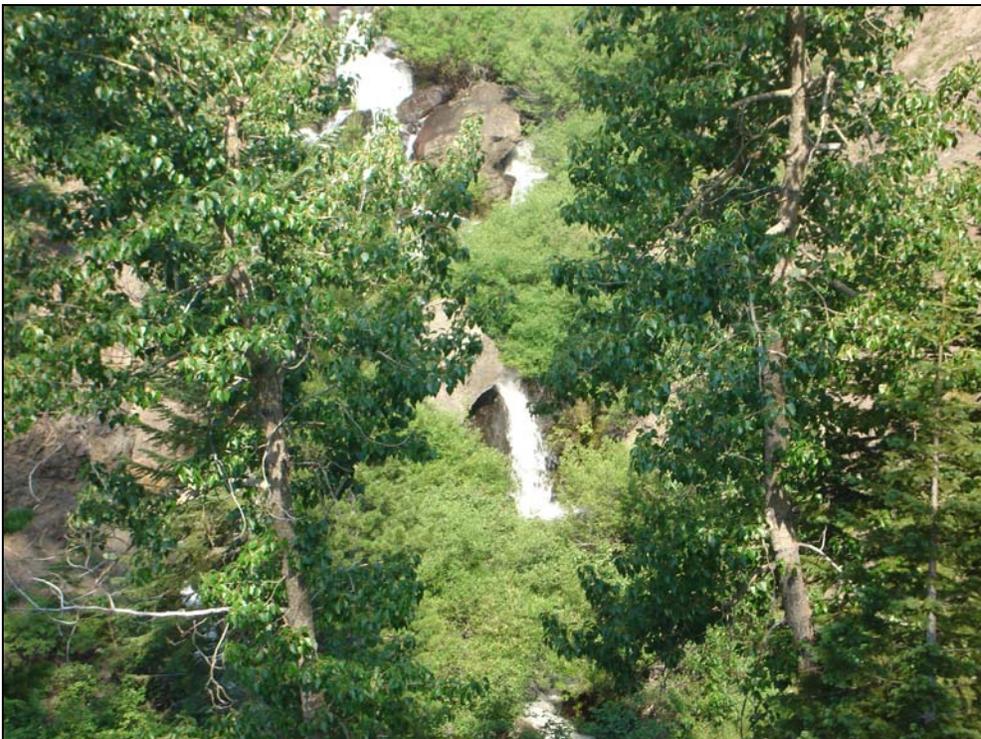
Site 5: Bull Canyon Creek, Carson Ranger District. The creek plunges an estimated 10 feet at the lowest section of falls. This site is located at UTM: N: 4266759 & E: 261808, Elev.7646 feet (2331m).

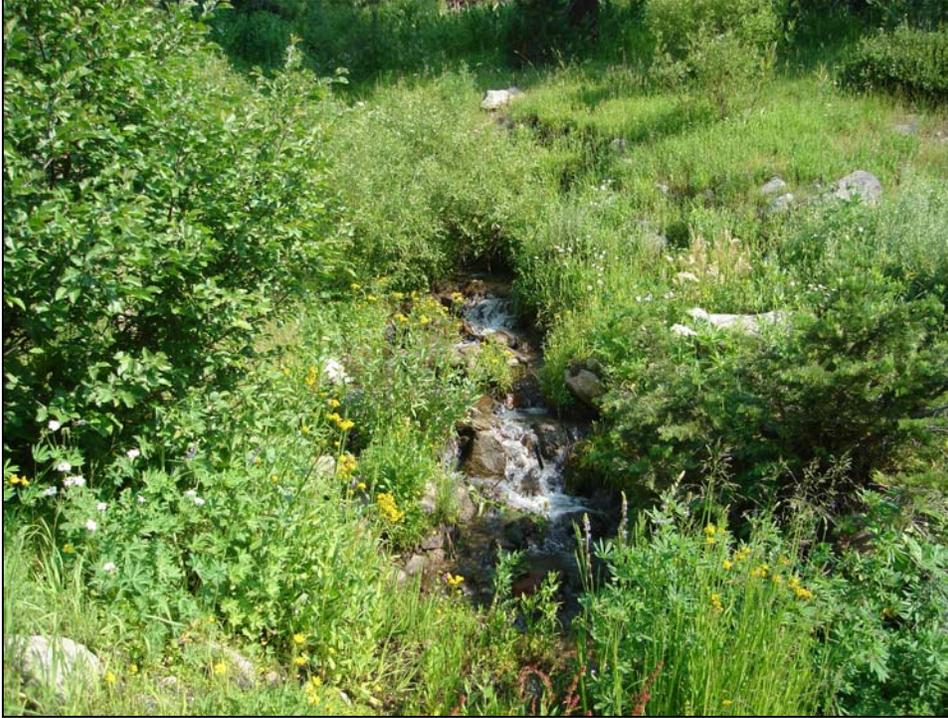
Site 6: Bull Canyon Creek, Carson Ranger District. A small tributary enters the creek on river left, and contributes 1-2% of flow to Bull Canyon Creek. This site is located at UTM: N: 4266785 & E: 261690.

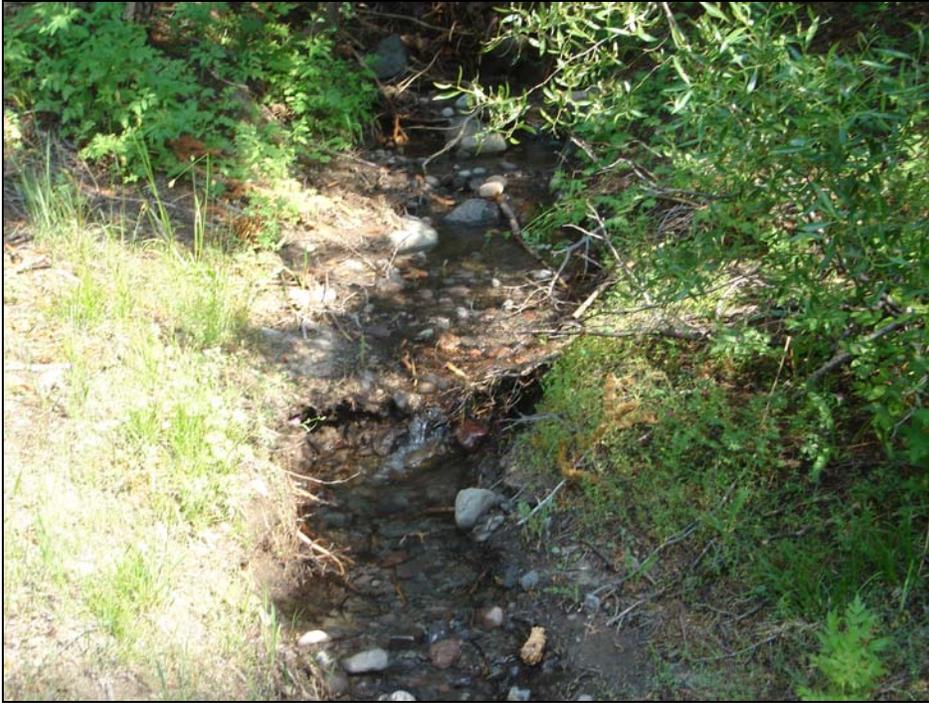
Site 7: Bull Canyon Creek, Carson Ranger District. A tributary (<1% contribution to flow) enters river left. This site is located at UTM: N: 4266682 & E: 261152, Elev. 8029 feet (2448m).

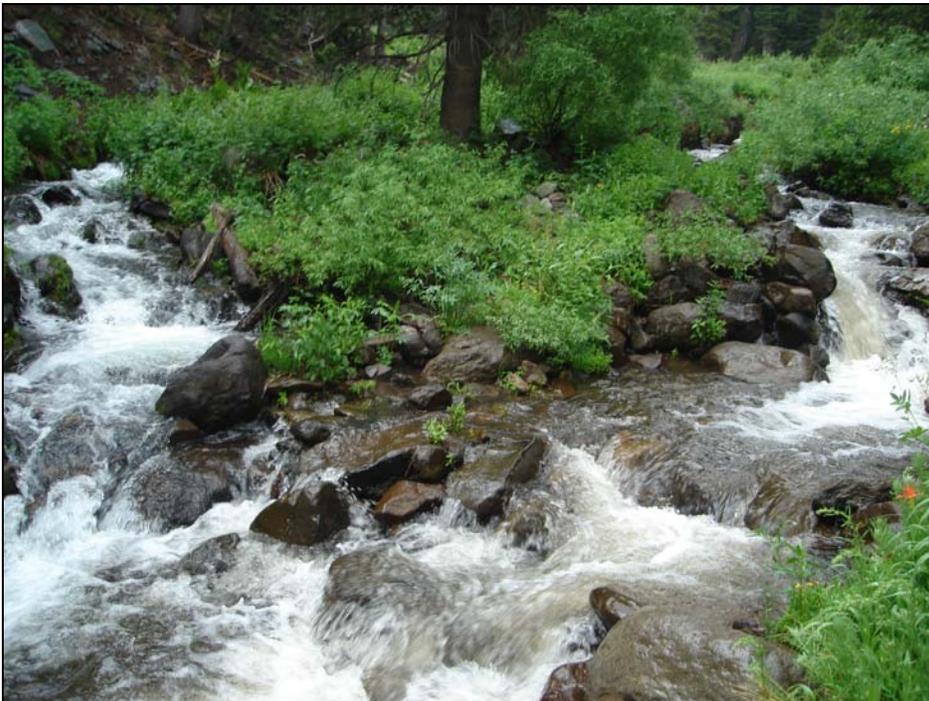
Site 8: Bull Canyon Creek, Carson Ranger District. The tributary that drains Bull Lake enters the creek on river right, accounting for approximately 40% of the downstream flow in Bull Canyon. This confluence is located at UTM: N: 4266822 & E: 260811, Elev. 8059 feet (2457m).

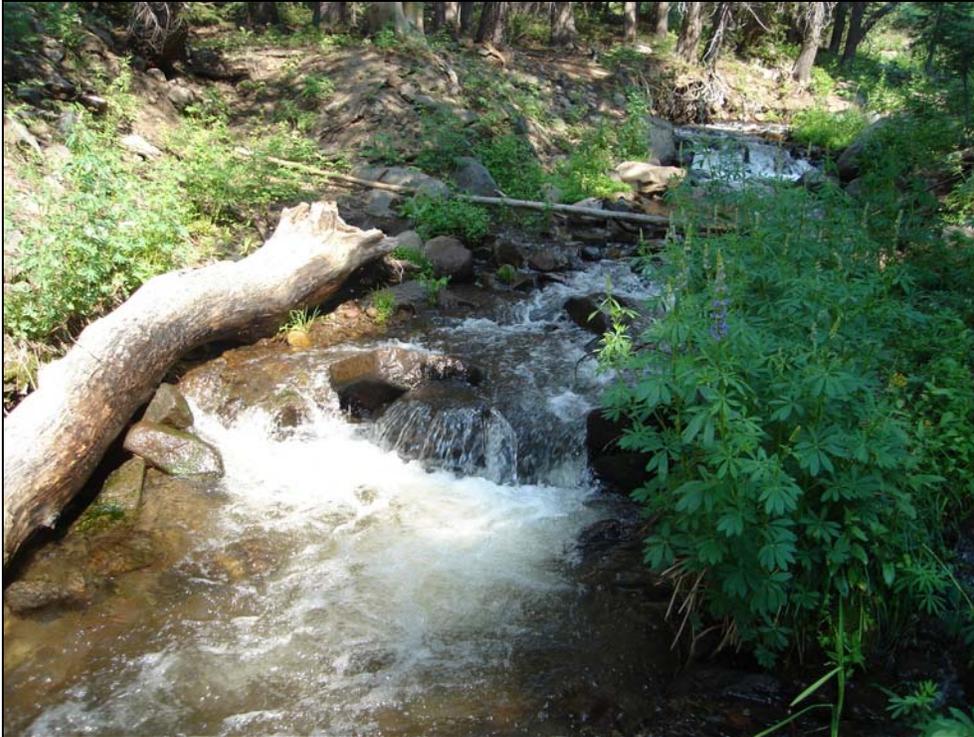
Site 9: Bull Canyon Creek, Carson Ranger District. Upstream view from a trail crossing. This ford crossing is located at UTM: N: 4267003 & E: 260695, Elev.8200 feet (2500m).

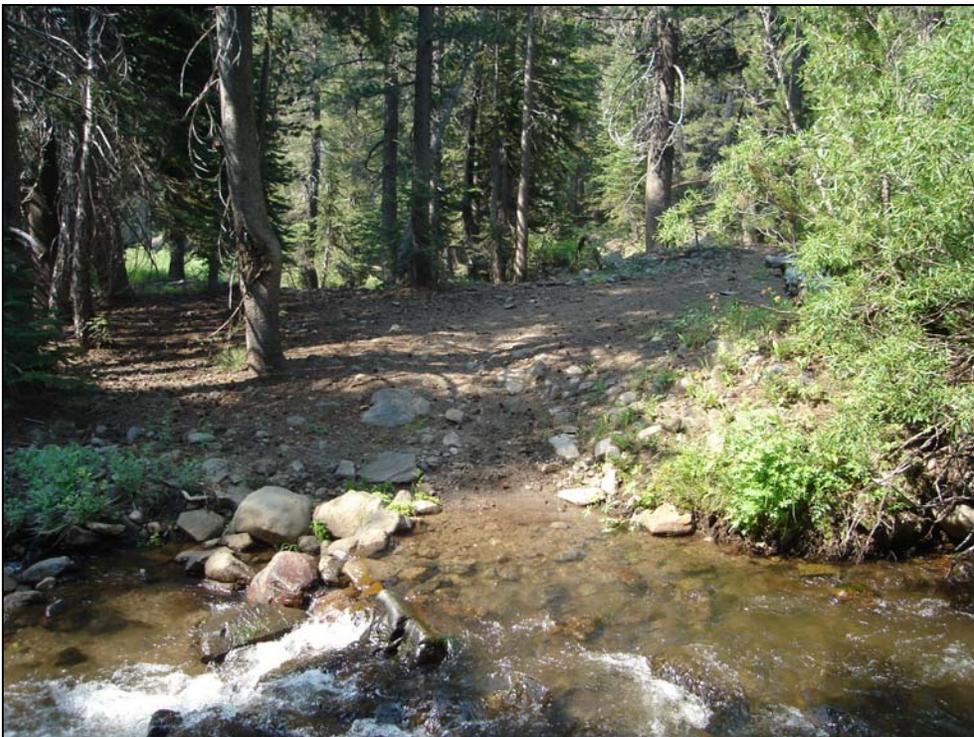
Site 9: Bull Canyon Creek, Carson Ranger District. Cross-sectional photo of trail crossing. This ford crossing is located at UTM: N: 4267003 & E: 260695, Elev.8200 feet (2500m).

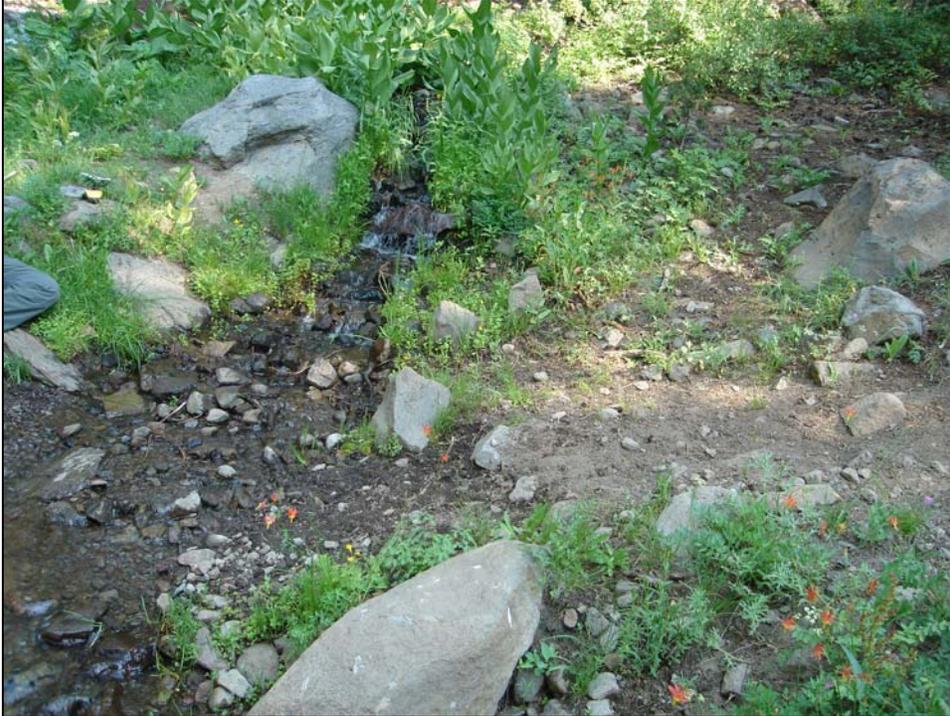
Site 9: Bull Canyon Creek, Carson Ranger District. Photo shows a small tributary that enters river left at the trail-stream crossing (1% contributing flow). This site is located at UTM: N: 4267003 & E: 260695, Elev.8200 feet (2500m).

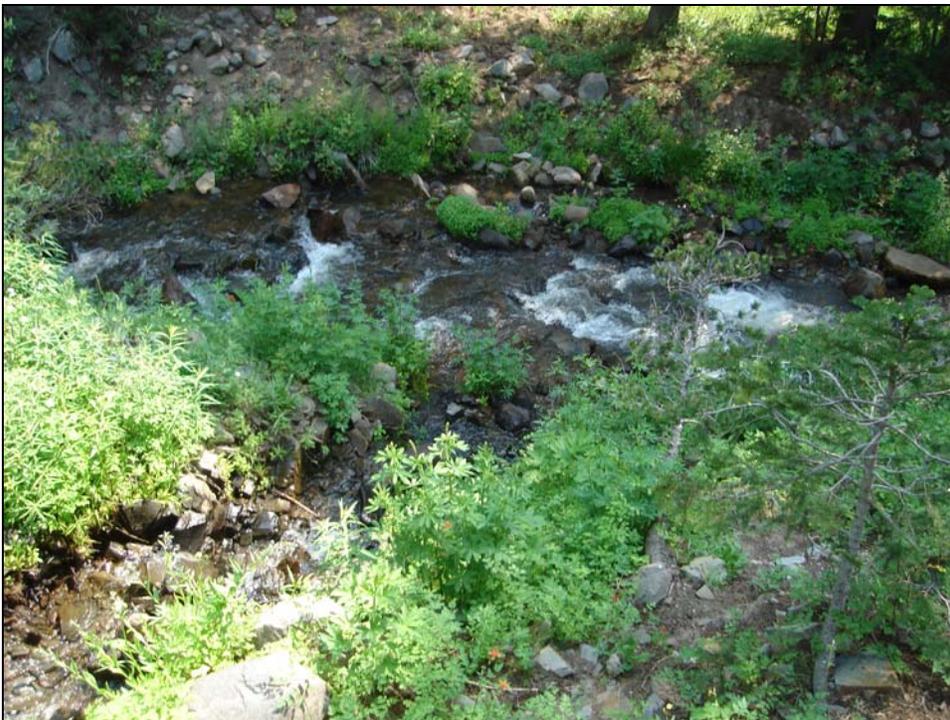
Site 10: Bull Canyon Creek, Carson Ranger District. Viewpoint looking down a tributary that enters Bull Canyon Creek on river right (3% contribution to flow). This site is located at UTM: N: 4267116 & E: 260534, Elev. 8239 feet (2512m).

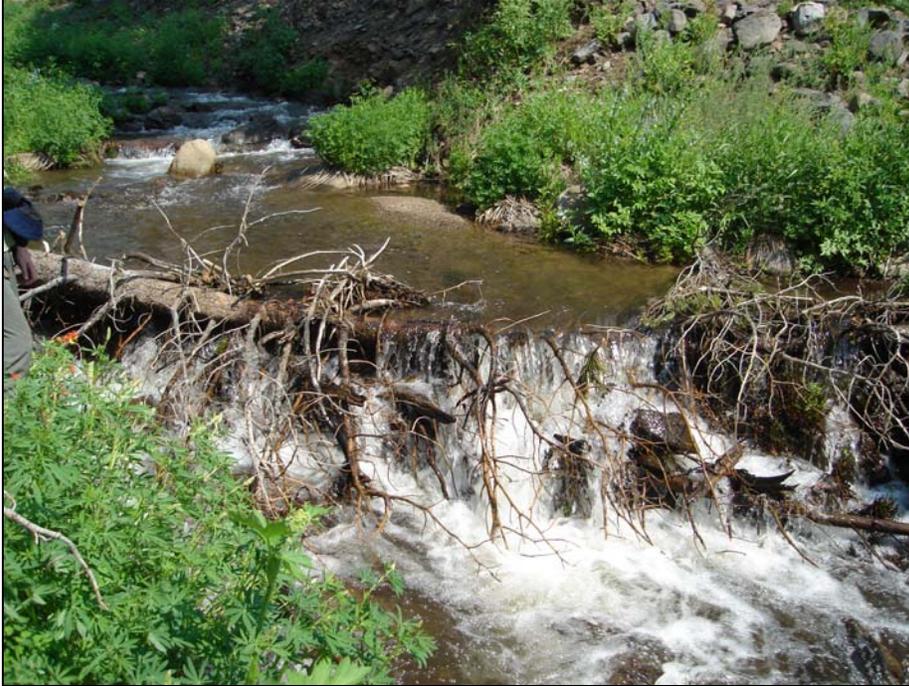
Site 11: Bull Canyon Creek, Carson Ranger District. Upstream view of a small seasonal barrier measuring 2.0 feet in height, with a max pool depth of approximately 1.0 foot. This site is located at UTM: N: 4267195 & E: 260328, Elev. 8226 feet (2508m).

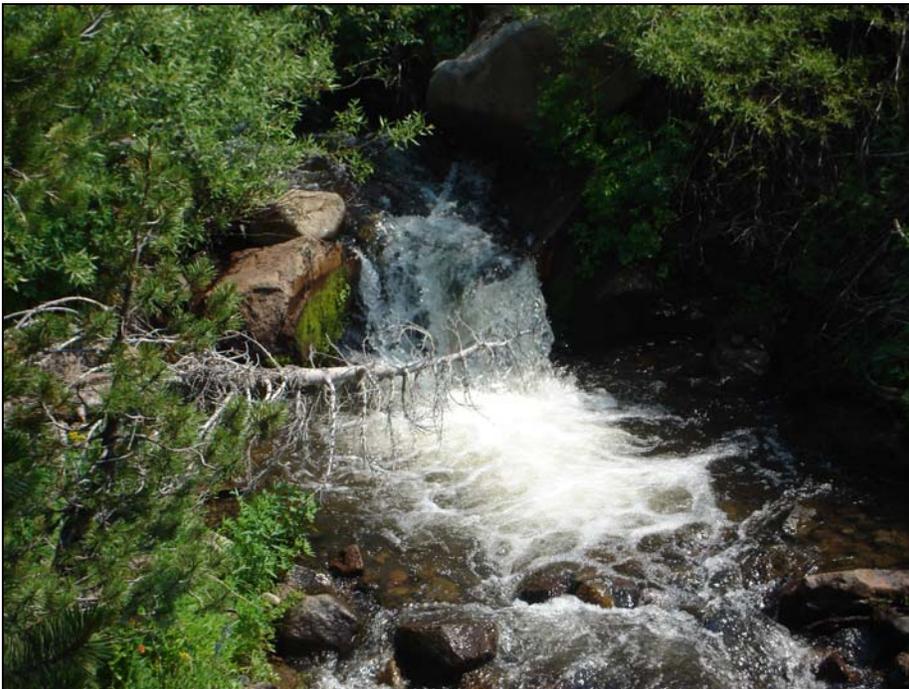
Site 11: Bull Canyon Creek, Carson Ranger District. Upstream view of a seasonal barrier. This site is located at UTM: N: 4267195 & E: 260328, Elev. 8226 feet (2508m)

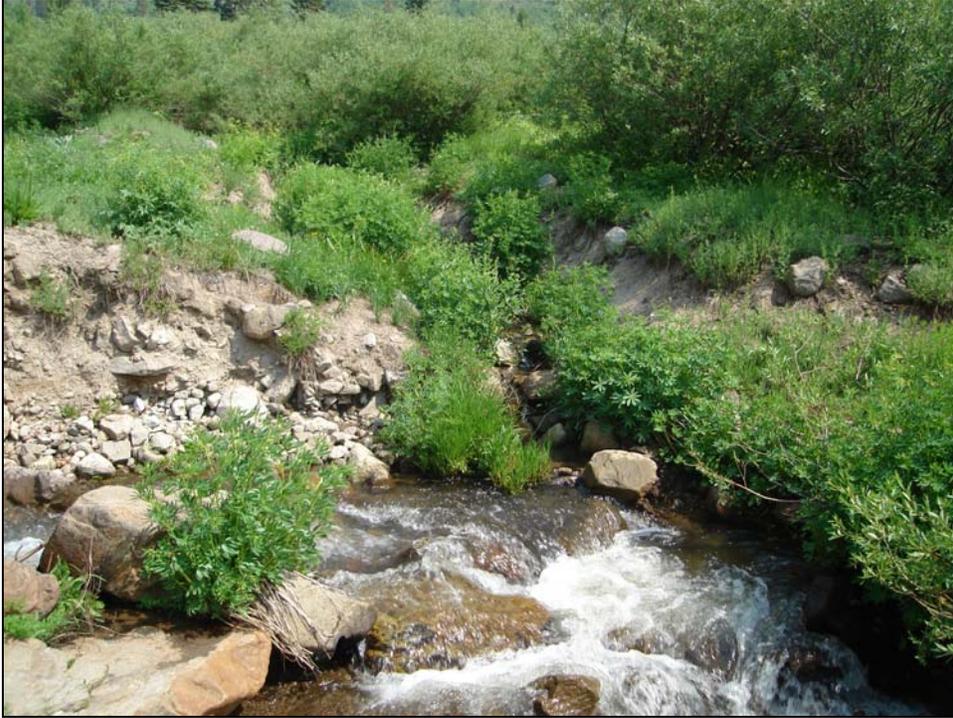
Site 12: Bull Canyon Creek, Carson Ranger District. Photo shows one braid of a tributary that enters from river left. Each braid contributes approximately 1% of flow to Bull Canyon. This is located at UTM: N: 4267282& E: 260328, Elev.8285 feet (2526m).

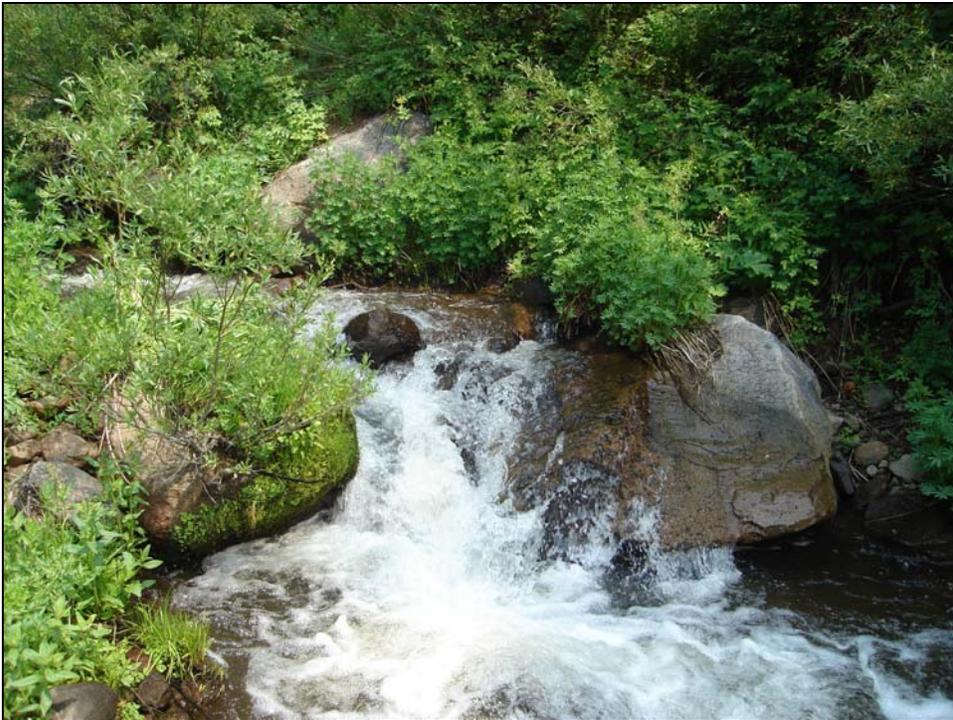
Site 13: Bull Canyon Creek, Carson Ranger District. Upstream view of a seasonal barrier measuring 3.1 feet high, with a max pool depth of 1.5 feet. This barrier is located at UTM: N: 4267345 & E: 260180, Elev. 8357 feet (2548m).

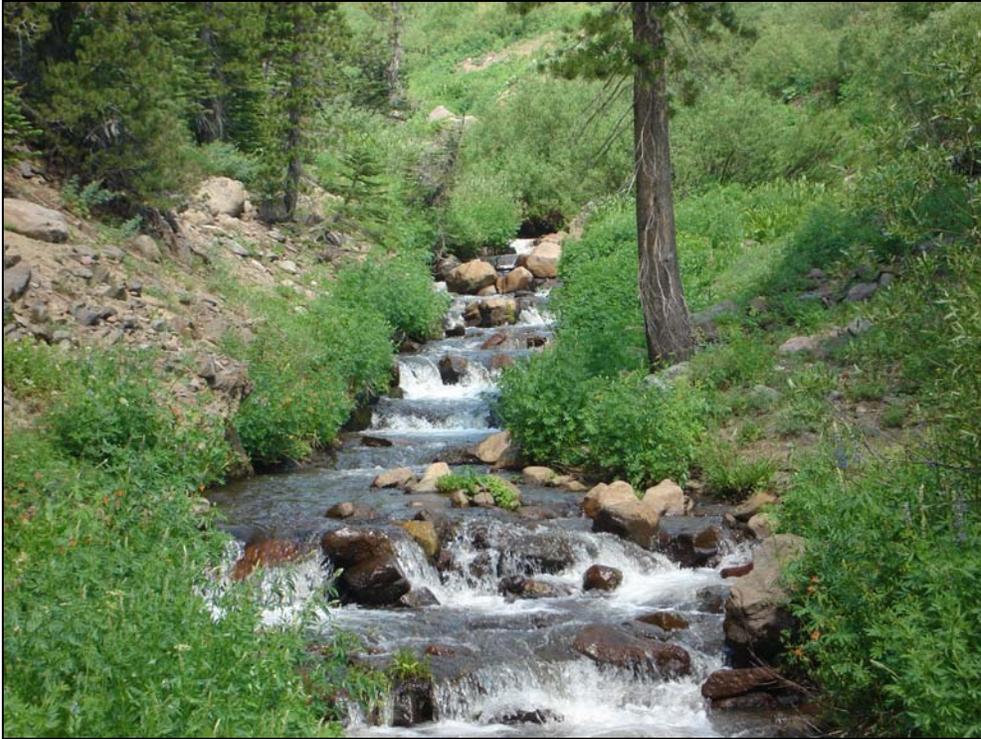
Site 13: Bull Canyon Creek, Carson Ranger District. Upstream view typical of this reach. This site is located at UTM: N: 4267345 & E: 260180, Elev. 8357 feet (2548m).

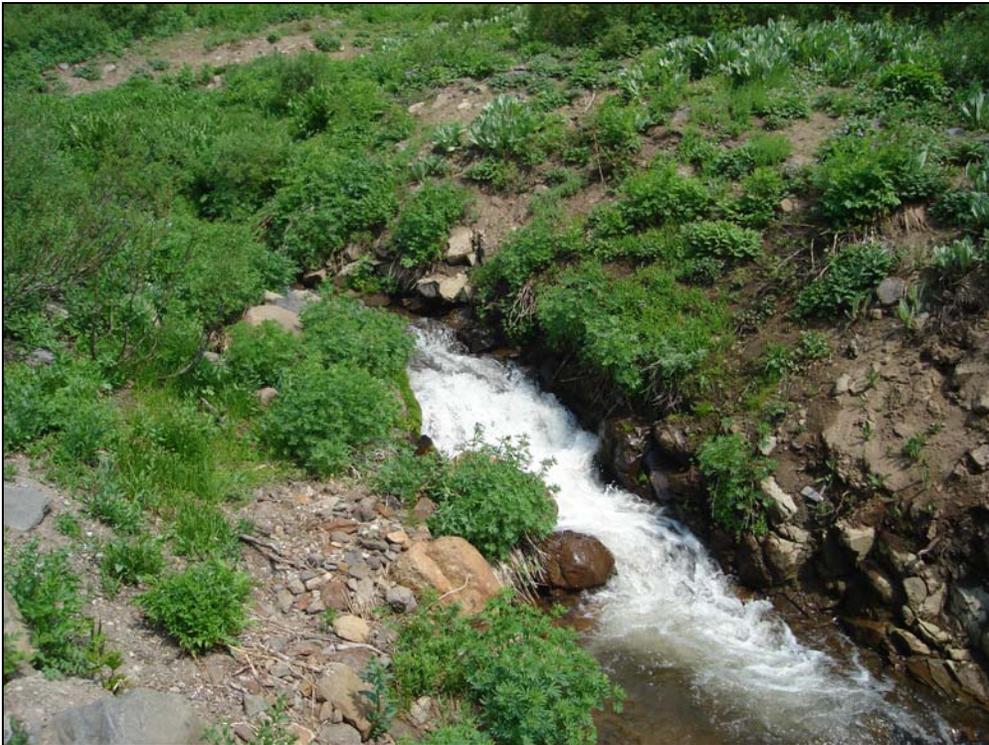
Site 14: Bull Canyon Creek, Carson Ranger District. A seasonal barrier with height 3.9 feet, and max. pool depth 1.6 feet. This site is located at UTM: N: 4267398 & E: 260091, Elev. 8394 feet (2559m).

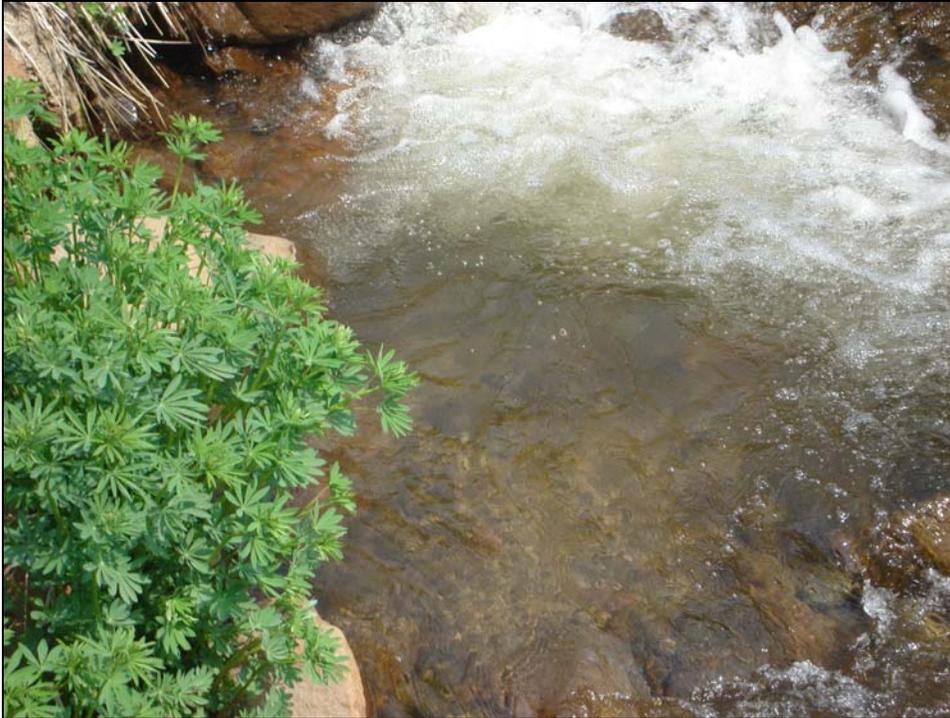
The single largest tributary to Bull Canyon Creek is an unnamed stream fed by Bull Lake. Bull Lake is known to contain “cutt-bows”, a hybrid of LCT and rainbow trout. One adult salmonid was sighted at Site 15, proving that these fish can successfully survive in

Bull Canyon Creek. Based on the appearance and location of the fish, it is believed to be a hybridized fish that migrated from Bull Lake.

Site 15: Bull Canyon Creek, Carson Ranger District. A large salmonid (estimated 12-15 inches) was sighted in this pool at the bottom of the barrier at Site 14: at UTM: N: 4267398 & E: 260091, Elev. 8394 feet (2559m).

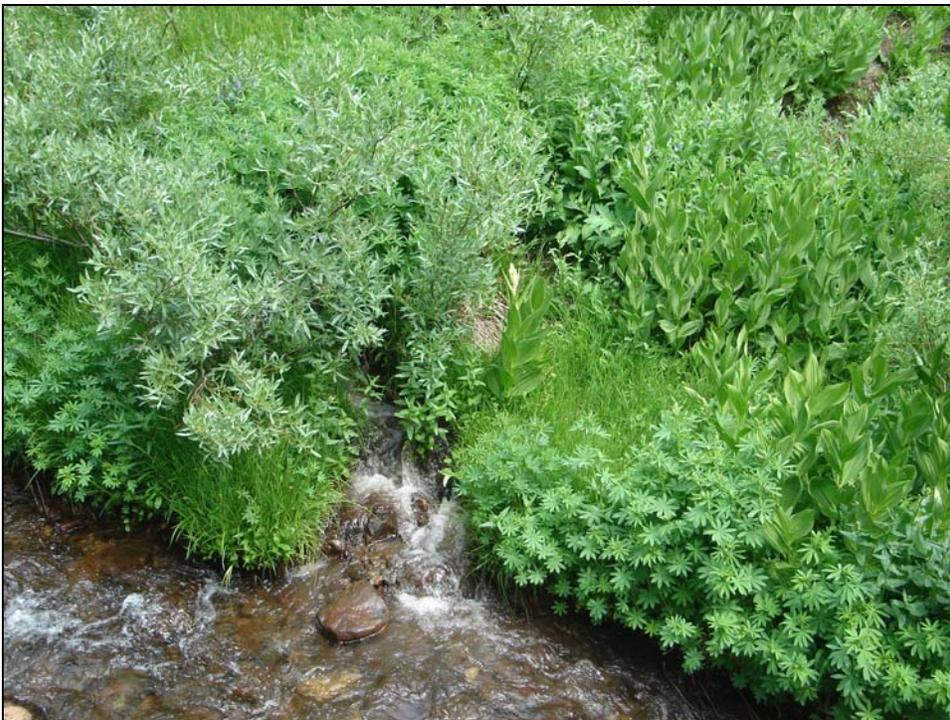
Site 16: Bull Canyon Creek, Carson Ranger District. Cross-sectional view of a tributary entering on left bank. The tributary contributes an additional 4% of flow to Bull Canyon Creek. This site is located at UTM: N: 4267416 & E: 260015, Elev. 8407 feet (2563 m).

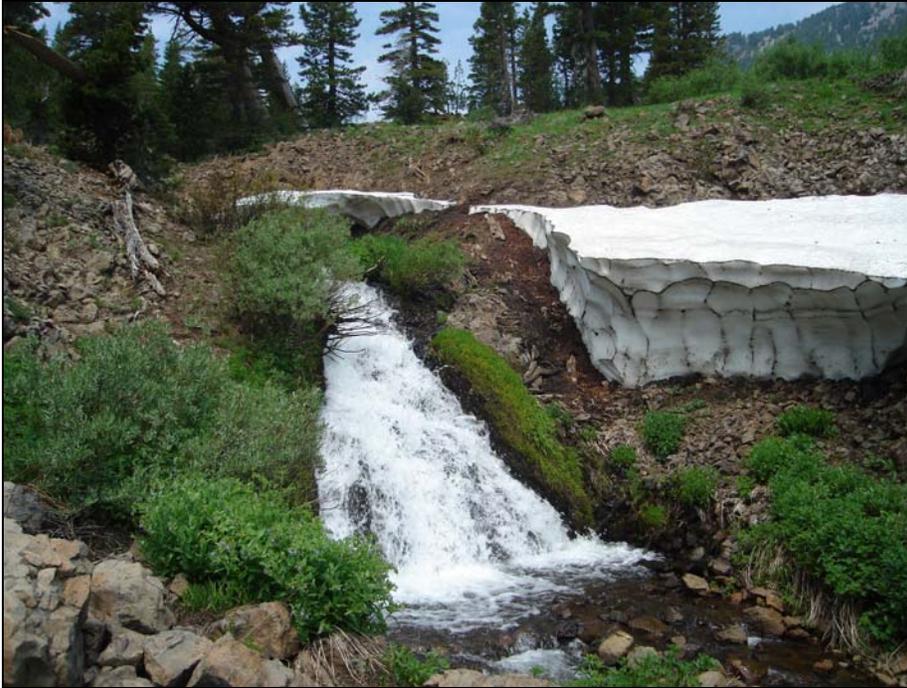
Site 17: Bull Canyon Creek, Carson Ranger District. Permanent fish barrier measuring approximately 15 feet in height, with a max. pool depth of 1.8 feet. This site is located at UTM: N: 4267439 & E: 260010, Elev. 8446 feet (2575m).

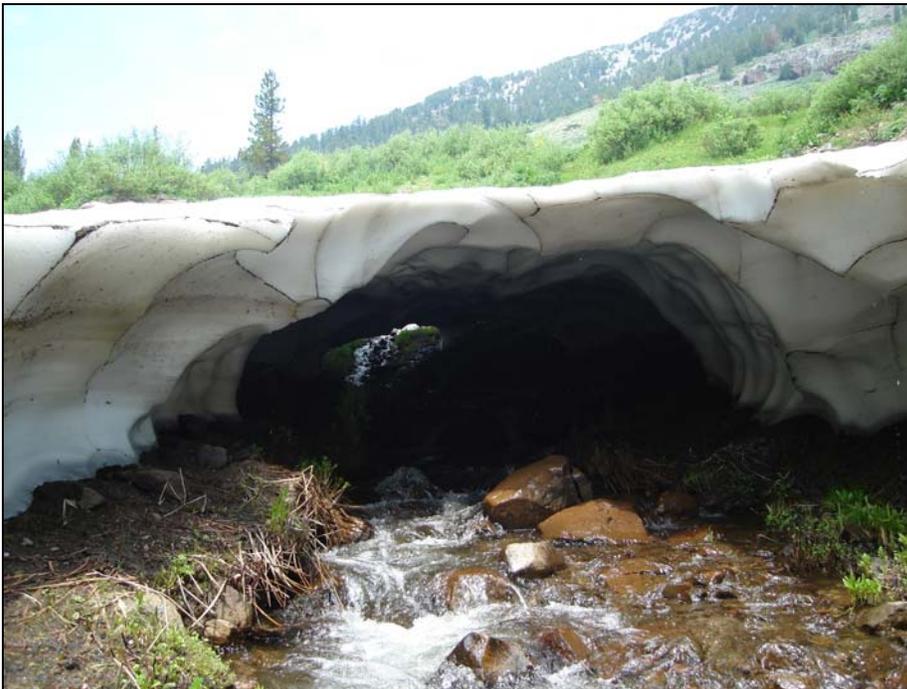
Site 17: Bull Canyon Creek, Carson Ranger District. The stream passes through a snow tunnel below the waterfall. This site is located at UTM: N: 4267439 & E: 260010, Elev. 8446 feet (2575m).

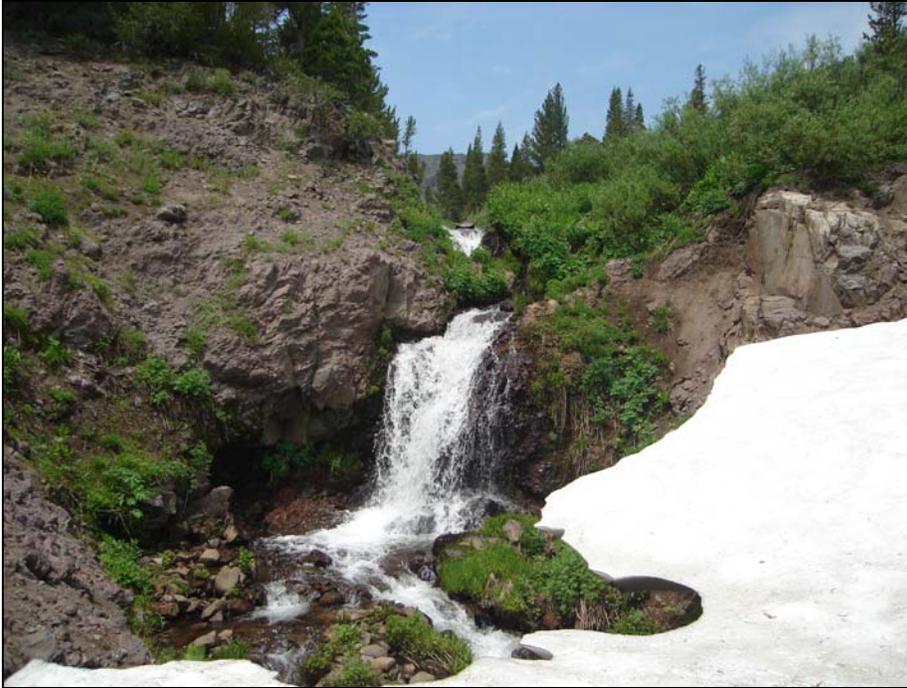
Site 18: Bull Canyon Creek, Carson Ranger District. Upstream photo of a permanent fish passage barrier with two sequential falls: 5.5 feet and 15.0 feet. This site is located at UTM: N: 4267474 & E: 259932, Elev. 8462 feet (2580m).

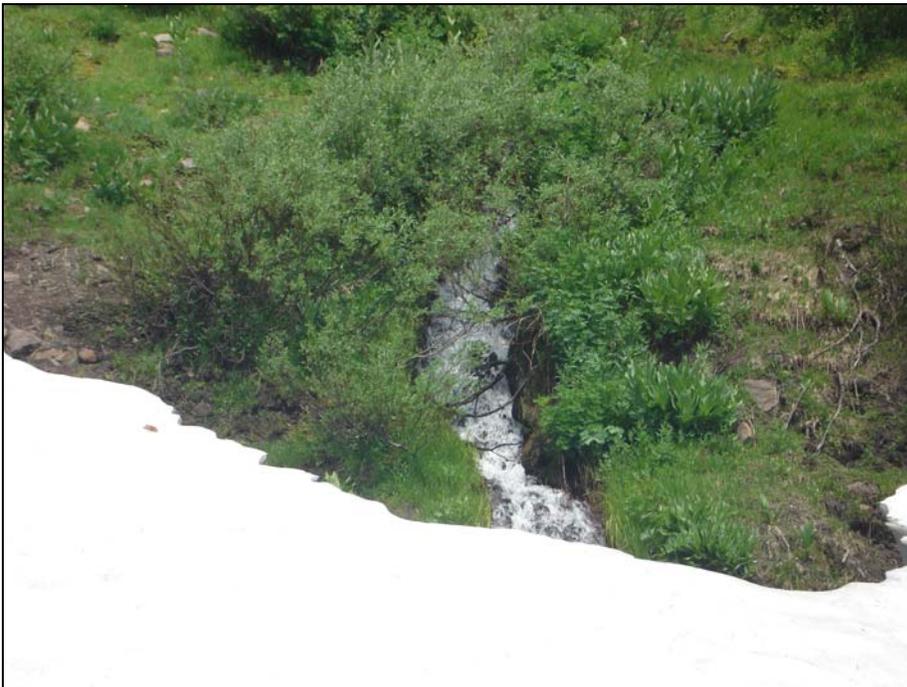
Site 18: Bull Canyon Creek, Carson Ranger District. A small, snow-fed tributary enters Bull Canyon Creek on river left. This site is located at UTM: N: 4267474 & E: 259932, Elev. 8462 feet (2580m).
