BULL CANYON CREEK

2006 Stream Habitat Survey Report

Humboldt-Toiyabe National Forest, Carson Ranger District

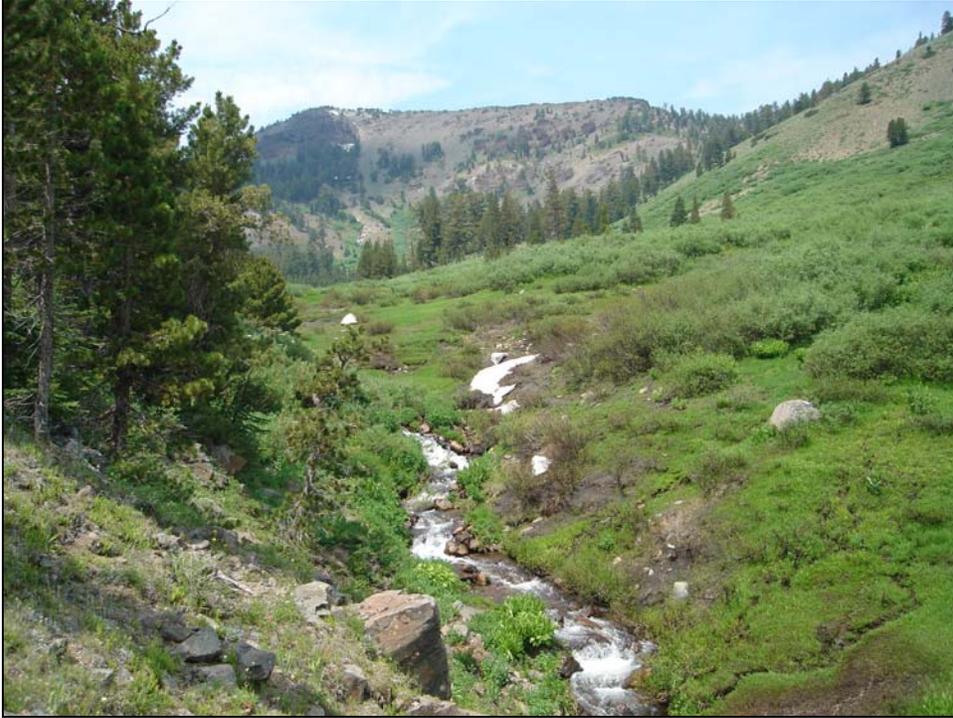
Site 19: Bull Canyon Creek, Carson Ranger District. Upstream view shows a narrow and cascading stream. This site is located at UTM: N: 4267475 & E: 259788, Elev. 8623 feet (2629m).

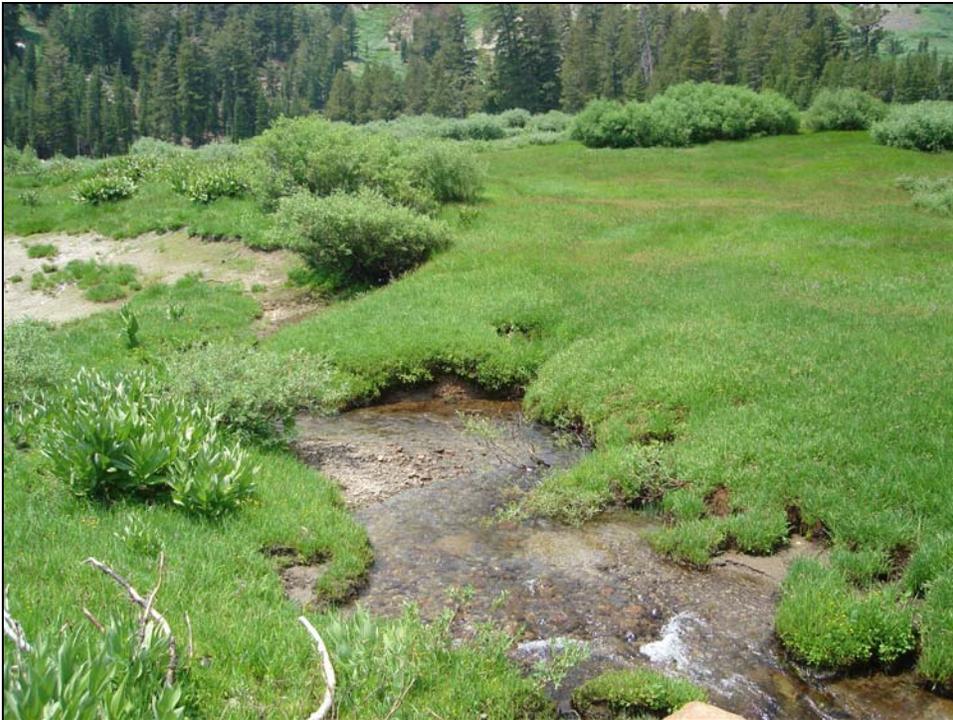
Site 20: Bull Canyon Creek, Carson Ranger District. Steep headwaters converge in a low gradient meadow to form a meandering stream. This is located at UTM: N: 4267428 & E: 259414, Elev. 8633 feet (2632m).

Between the permanent barriers at Sites 5 and 17, a section of stream measuring 1.67 miles offers potential LCT habitat. This section includes three seasonal barriers ranging in height from 2.0-3.9 feet. Two waterfalls were identified at Sites 17 and 18, both measuring at least 15 feet in height, with maximum pool depths of less than 2.0 feet. These two permanent barriers effectively segment the stream into two sections of potential LCT habitat. The 0.54 mile section of stream between Site 18 and Site 22 offers the best potential habitat for LCT based on the gradient and absence of barriers. Upstream of Site 22, several snow-fed drainages converge to form the mainstem of Bull Canyon Creek.

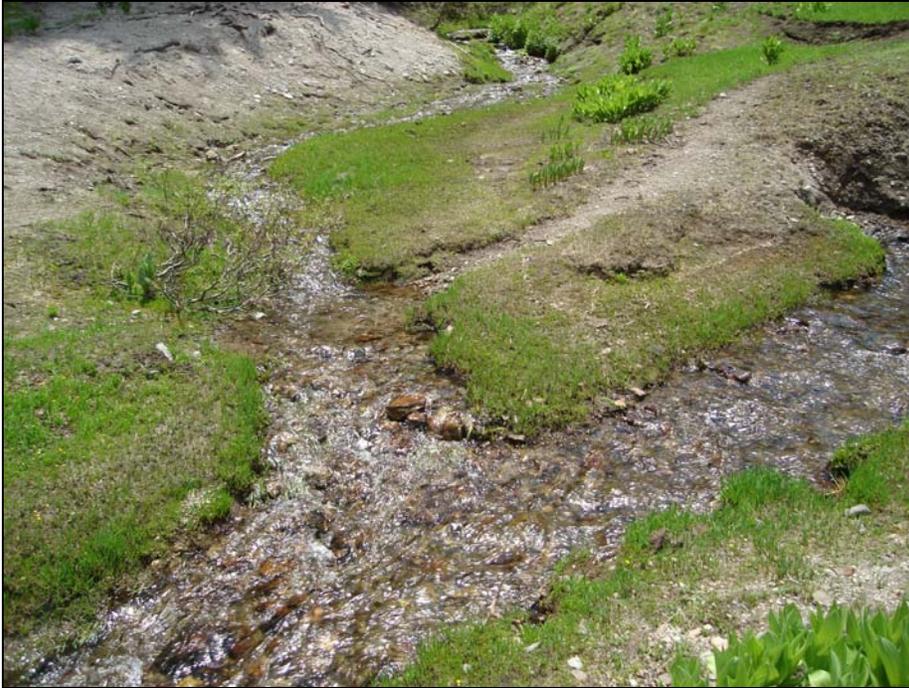
Site 21: Bull Canyon Creek, Carson Ranger District. A headwater tributary enters Bull Canyon Creek on river right. This confluence is located at UTM: N: 4267343 & E: 259407, Elev. 8676 feet (2645m).

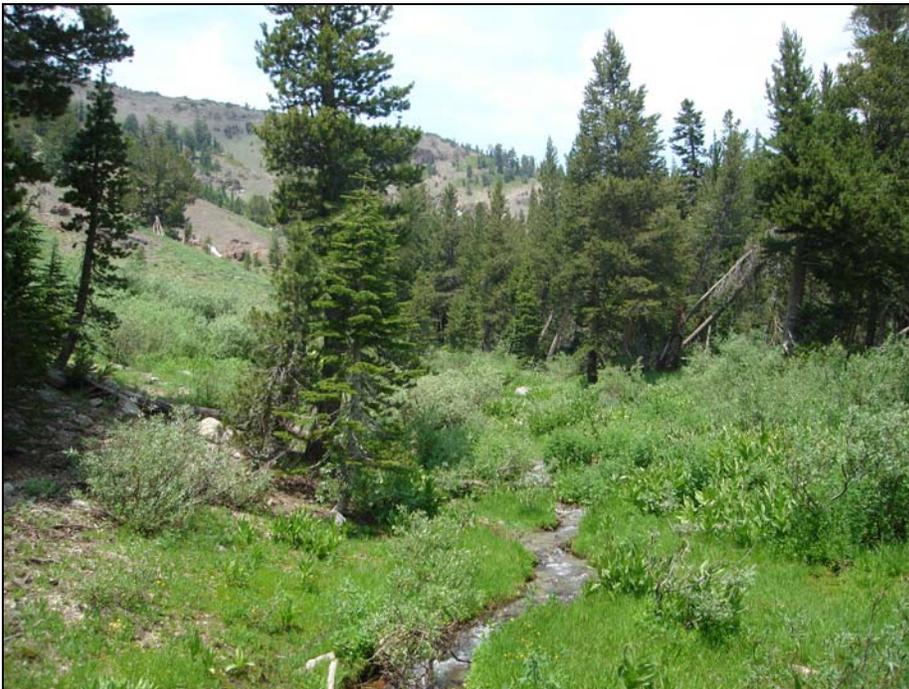
Site 22: Bull Canyon Creek, Carson Ranger District. Survey End. Photo shows the main headwater of Bull Canyon Creek entering a wet meadow. Above this elevation Bull Canyon Creek and the headwater tributaries are too small and steep to hold fish. This site is located at UTM: N: 4267320 & E: 259201, Elev. 8695 feet (2651m).

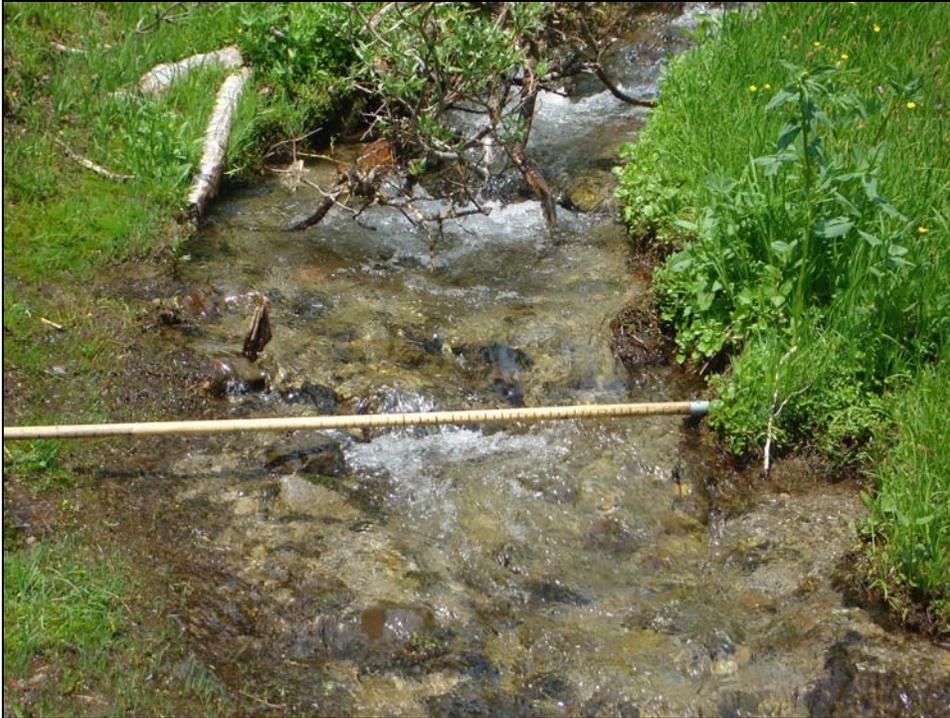
Site 22: Bull Canyon Creek, Carson Ranger District. Survey End. Photo shows the main headwater branch of Bull Canyon Creek in the upper edge of the wet meadow. This site is located at UTM: N: 4267320 & E: 259201, Elev. 8695 feet (2651m).

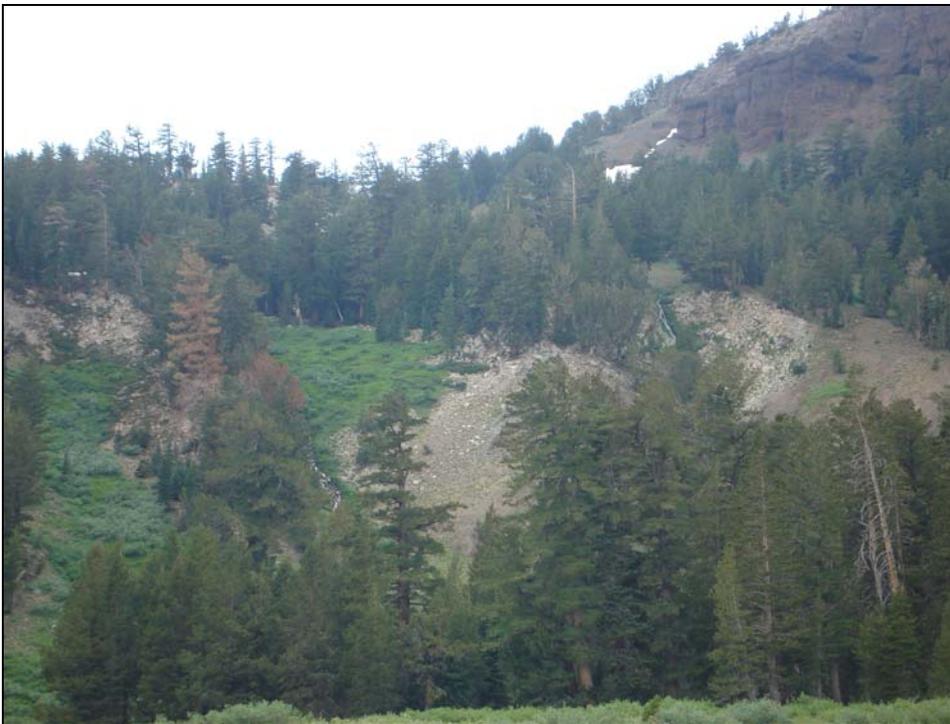
Site 22: Bull Canyon Creek, Carson Ranger District. Survey End. Barely visible as thin silver lines in the photo, are the steep drainages that form the headwaters of Bull Canyon Creek. This site is located at UTM: N: 4267320 & E: 259201, Elev. 8695 feet (2651m).
