# **CHARITY VALLEY CREEK**

**Alpine County, California**

## **2006 Stream Habitat Survey Report**

**Carson Ranger District: Humboldt- Toiyabe National Forest**

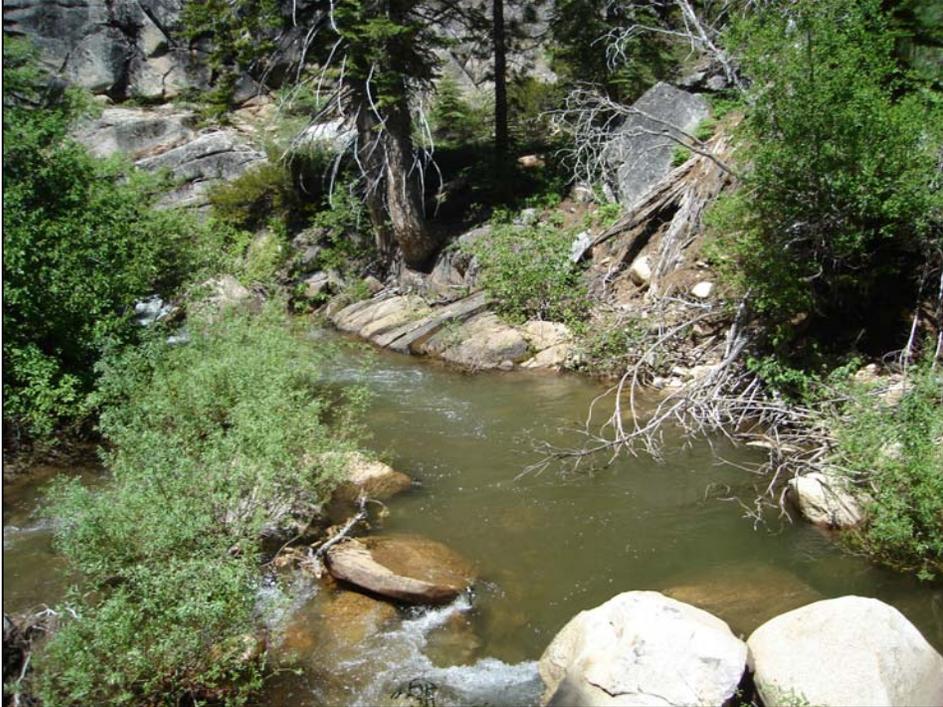
**Site 1:** Charity Valley Creek, Carson Ranger District. Upstream photo of Charity Valley Creek at the confluence with Hot Springs Creek. Charity Valley contributes 66% of flow to Hot Springs Creek. Note the turbidity. This site is located at UTM: N: 4287194 & E: 250050, Elev. 7126 ft. (2172 m).

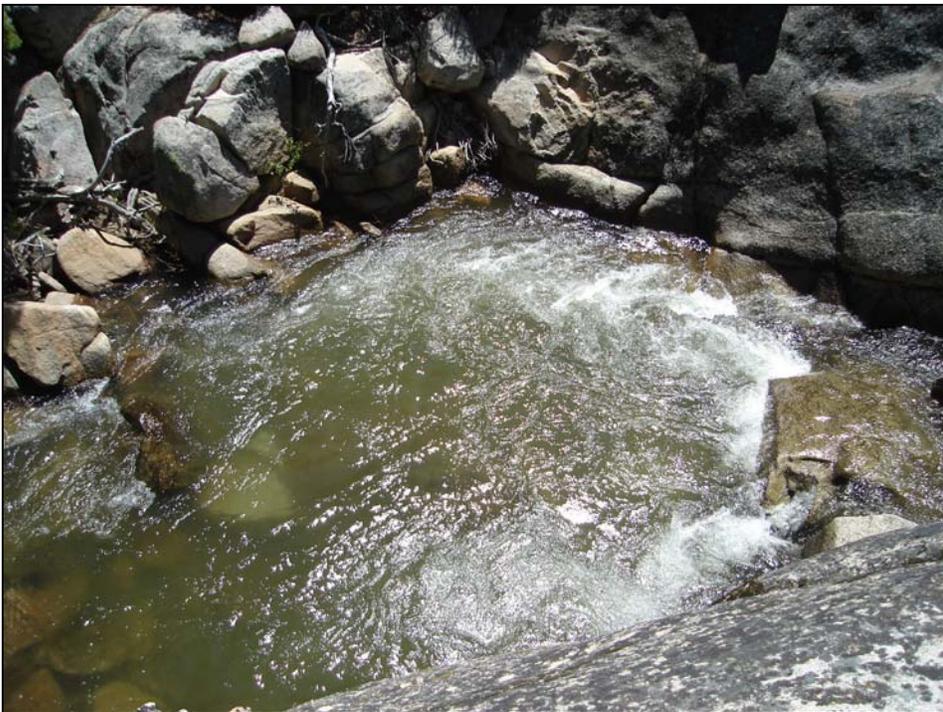
**Site 2:** Charity Valley Creek, Carson Ranger District. A downstream photo from an elevated position shows a pool characteristic of this reach. This site is located at UTM: N: 4287107 & E: 250007, Elev. 7201 ft. (2195m).

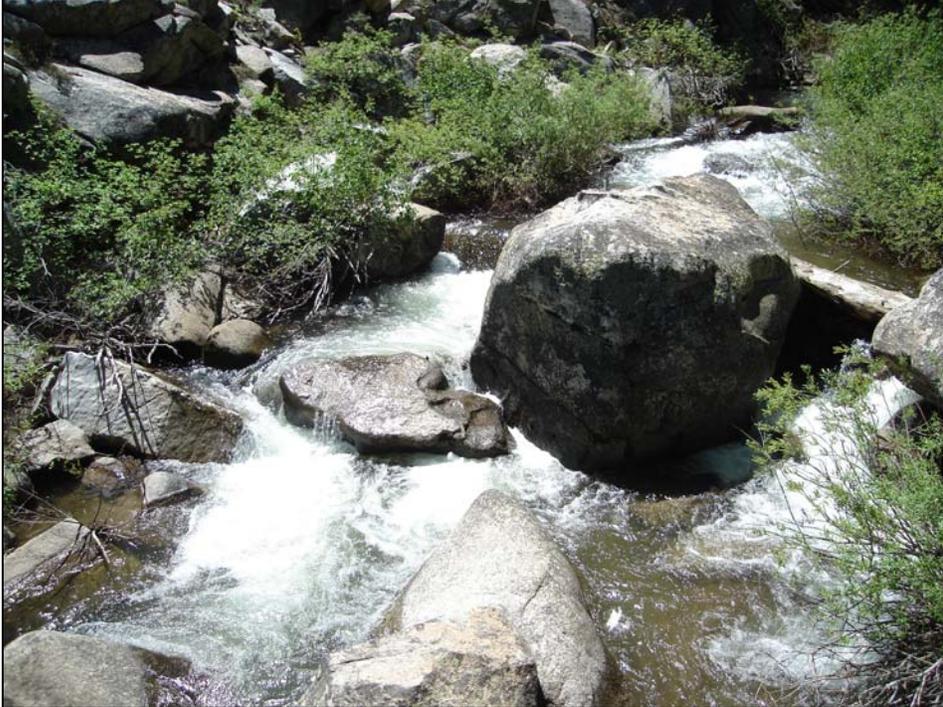
**Site 3:** Charity Valley Creek, Carson Ranger District. Upstream photo of a small seasonal fish barrier. The height of the barrier is 3.0 ft with a max. pool depth of 3.0 ft. This site is located at UTM: N: 4287098 & E: 250000, Elev. 7215 ft. (2199 m).

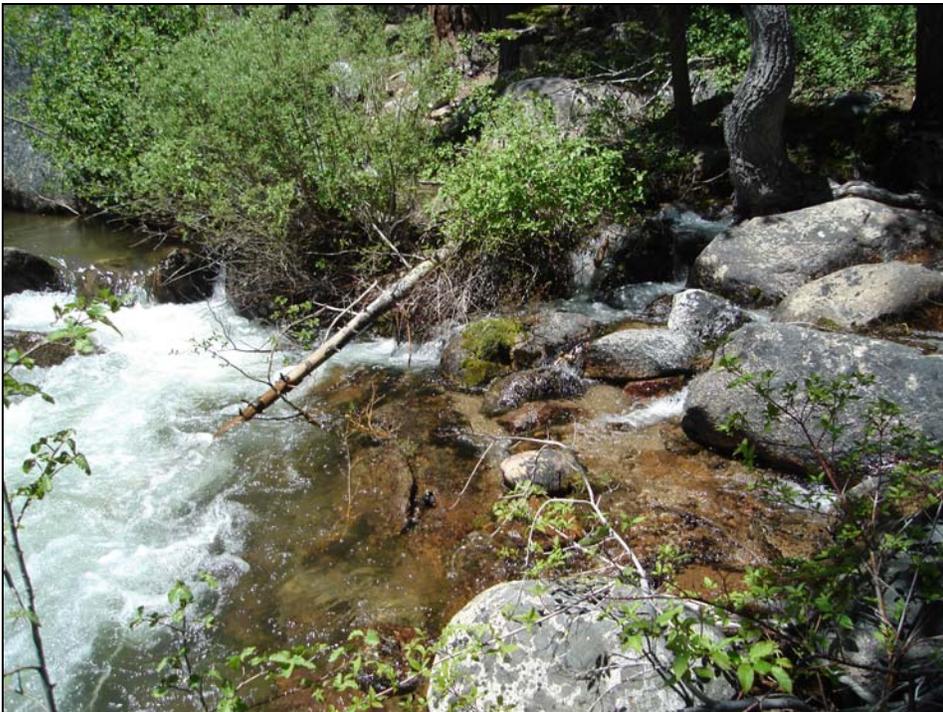
**Site 4:** Charity Valley Creek, Carson Ranger District. A small, clear running tributary flows in from river left, contributing 5% of flow. The temp of the trib. was found to be 12° C and the temp of Charity Valley was 8°C. This site is located at UTM: N: 4287078 & E: 249961, Elev. 7247 ft (2207 m).

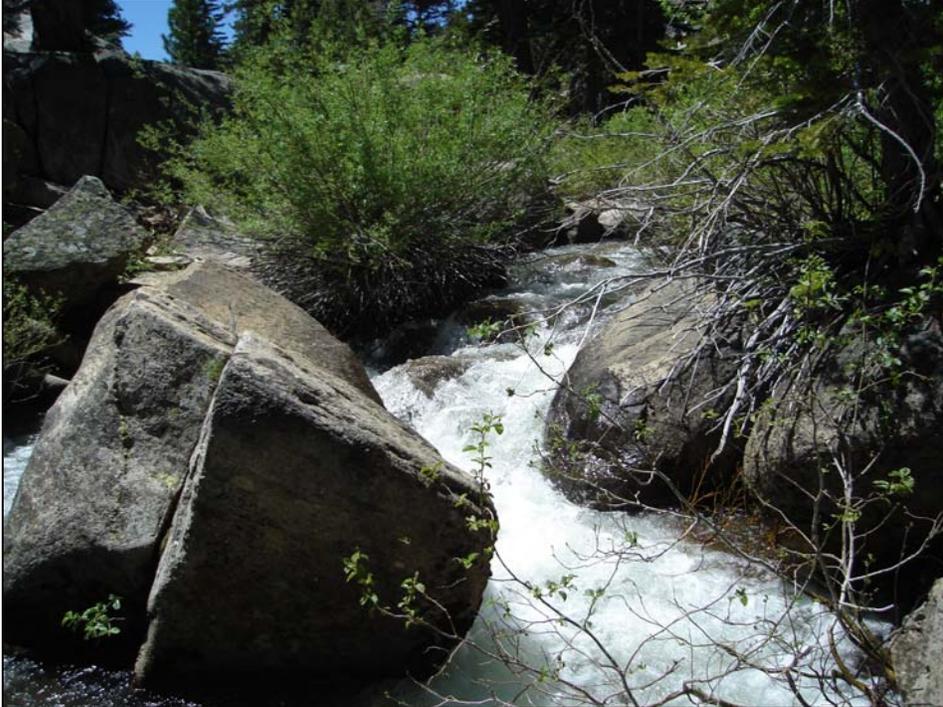
**Site 5:** Charity Valley Creek, Carson Ranger District. Upstream photo of a seasonal fish barrier that is 2.2 ft high and 8.0 ft long, with a pool depth of 2.5 ft. This site is located at UTM: N: 4287064 & E: 249940, Elev. 7241 ft (2207 m).

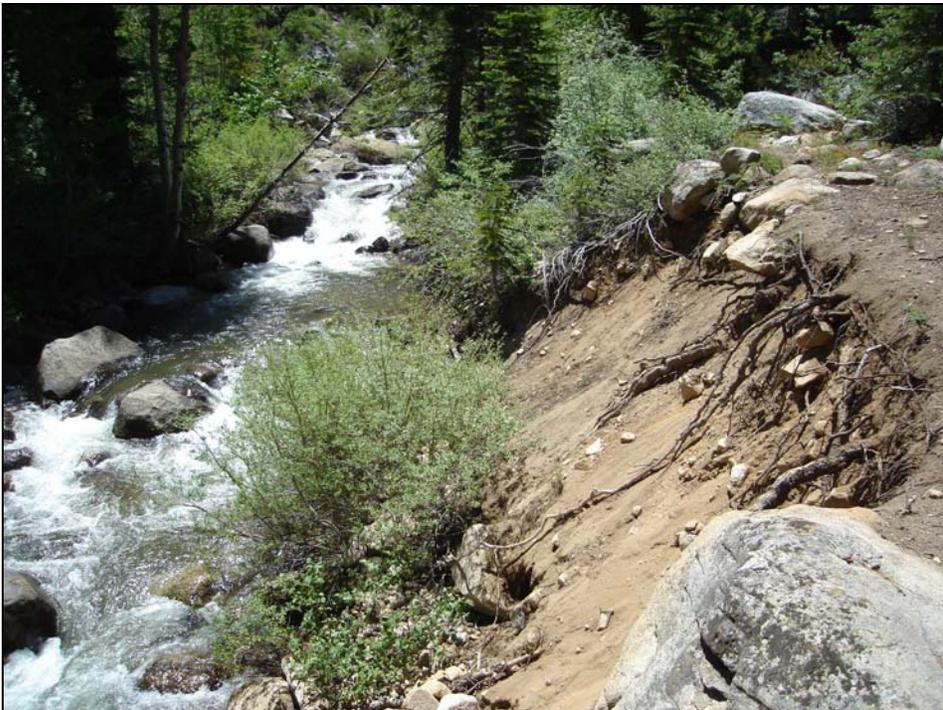
**Site 6:** Charity Valley Creek, Carson Ranger District. The erosion of the left bank is exacerbated by the adjacent footpath. This site is located at UTM: N: 42866437 E: 249927, Elev. 7169 ft (2185 m).

3. Work with forest service personnel and private landowners to re-locate the social trail running through Charity Valley on the private parcels between Blue Lakes Road and the Burnside Lake trail intersection. If relocating the trail is not possible, consider establishing a formal right-of-way through the private land.

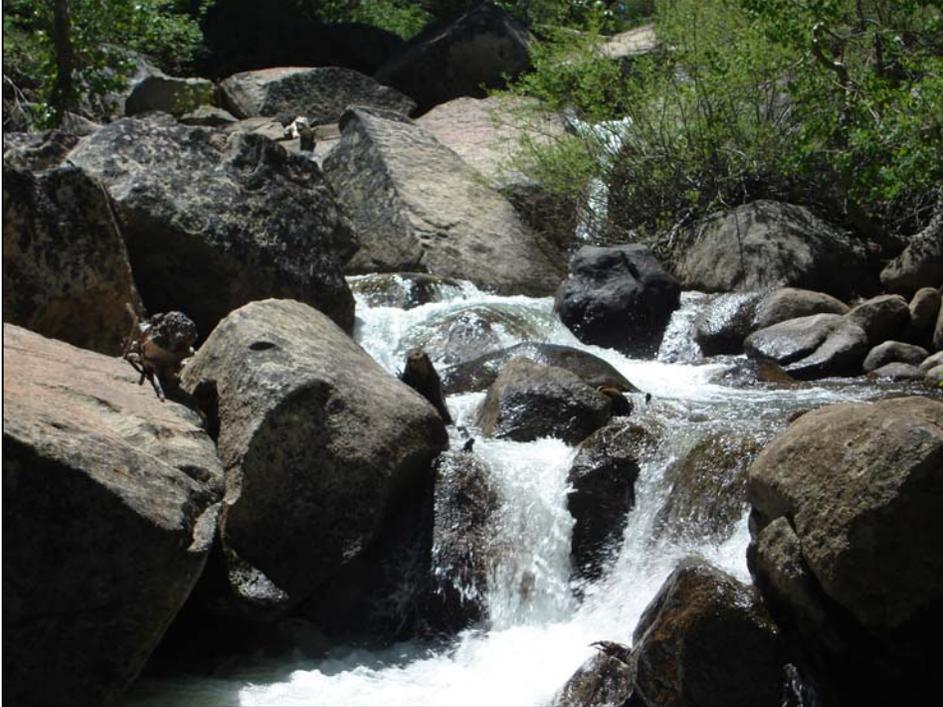
**Site 7:** Charity Valley Creek, Carson Ranger District. Upstream photo of a permanent fish barrier formed by a series of cascades up to 3.0 feet tall, with pool depths up to 3.0 ft. This site is located at UTM: N: 4286877 & E: 249935.

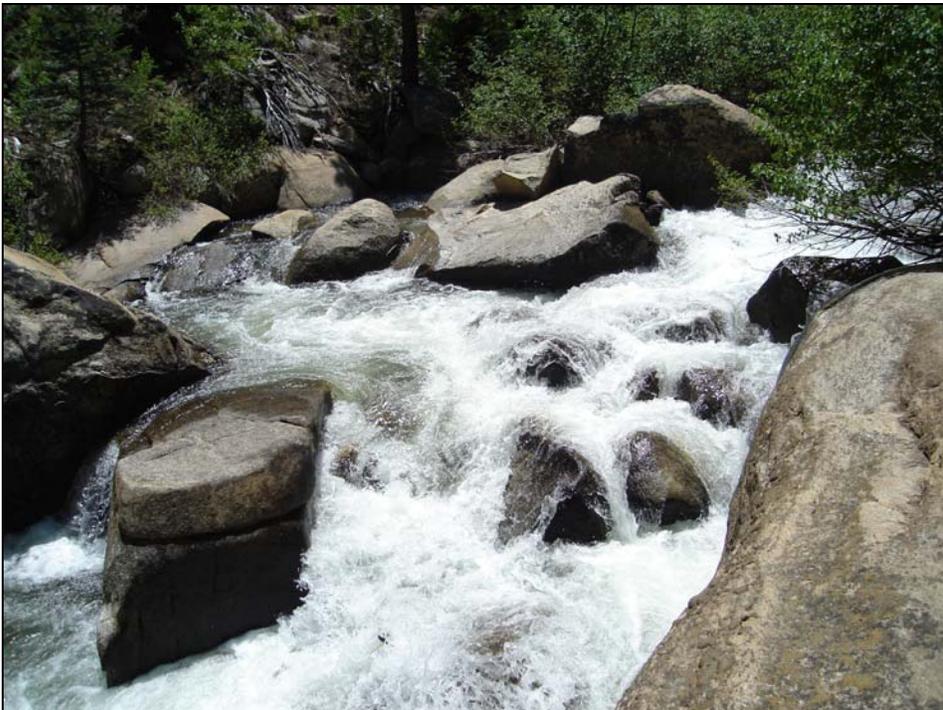
**Site 8:** Charity Valley Creek, Carson Ranger District. Upstream photo of cascades characteristic of this reach. This site is located at UTM: N: 4286788 & E: 249926.

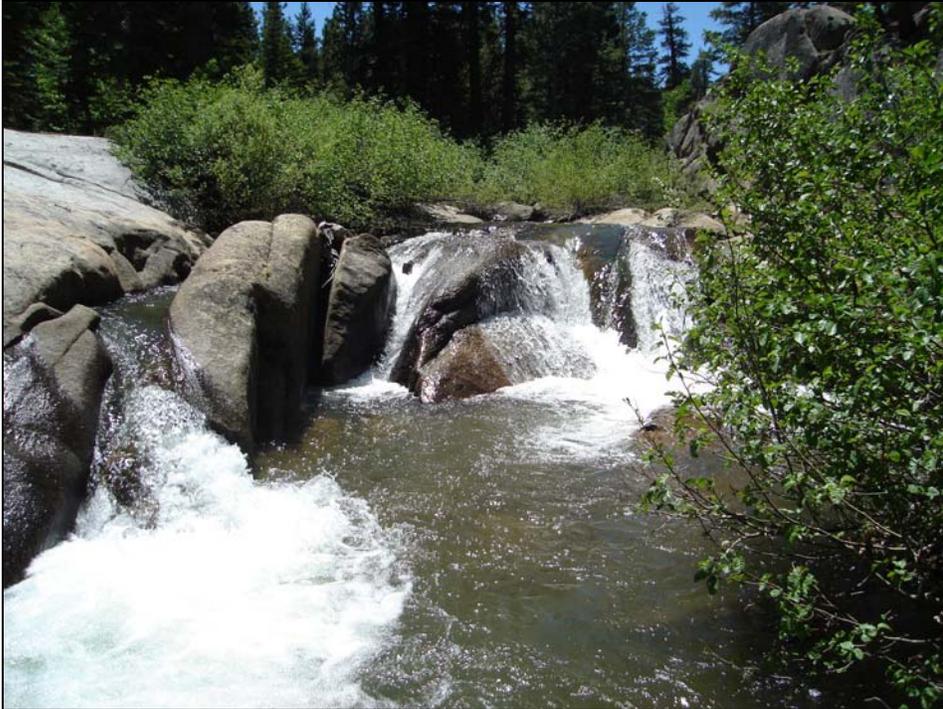
**Site 9:** Charity Valley Creek, Carson Ranger District. Upstream photo of a permanent fish barrier formed by a 5-foot waterfall (3.0 feet pool depth). This site is located at UTM: N: 4286621 & E: 249865, Elev. 7334 ft (2235 m).

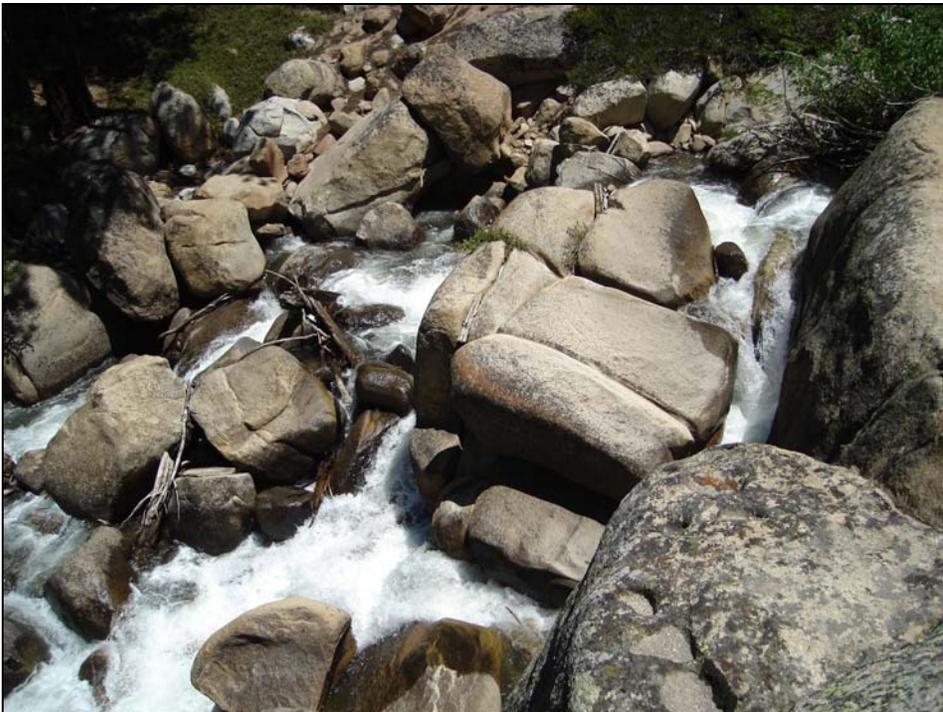
**Site 10:** Charity Valley Creek, Carson Ranger District. Cross-sectional photo of a fish barrier: 6.0 ft high with a pool depth of 1.5-2.5 ft. This site is located at UTM: N: 4286467 & E: 249910, Elev. 7392 ft (2253 m).

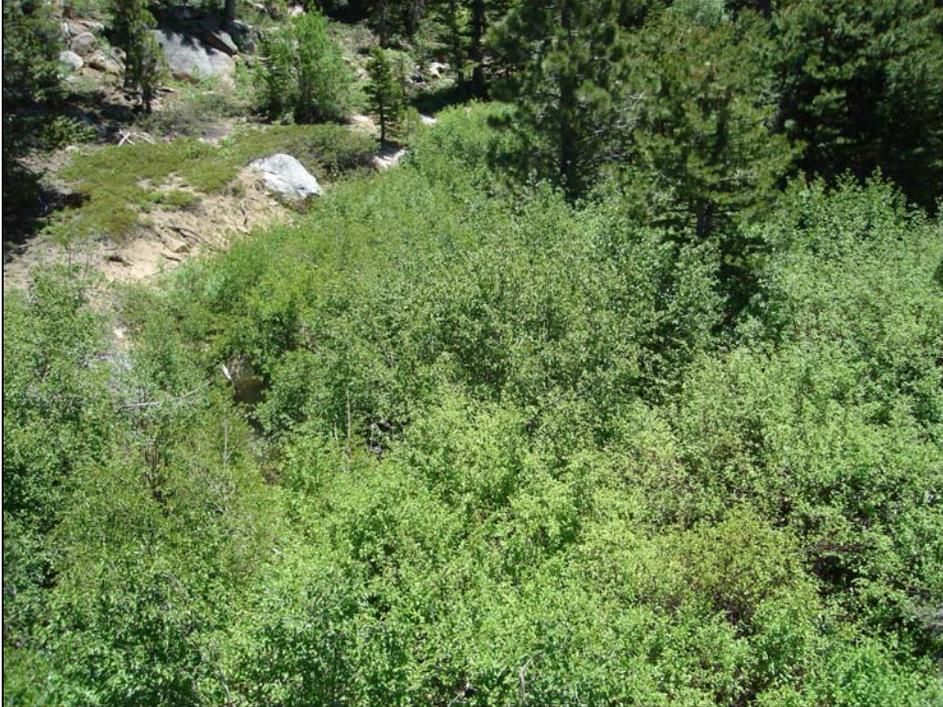
**Site 11:** Charity Valley Creek, Carson Ranger District. Upstream photo showing the abundant vegetation common to this reach. This site is located at UTM: N: 4286308 & E: 249906, Elev. 7480 ft. (2280m).

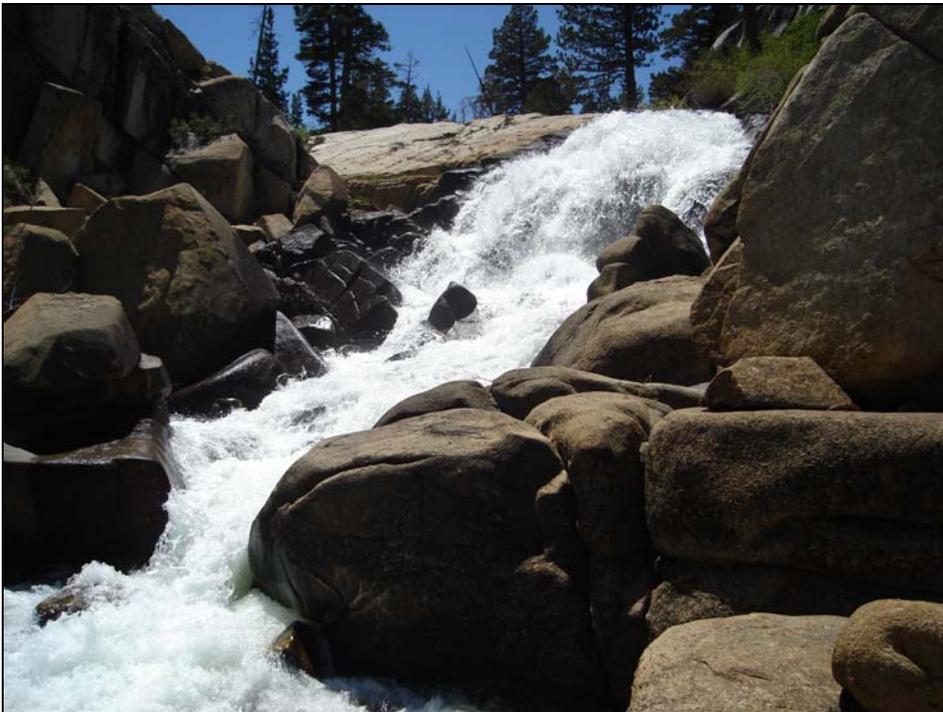
**Site 12:** Charity Valley Creek, Carson Ranger District. Upstream photo of a permanent fish barrier: the height of the waterfall sequence is 50 ft, with a max pool depth of 3.0 ft. This site is located at UTM: N: 4286087 & E: 249613, Elev. 7457 ft, (2273m).

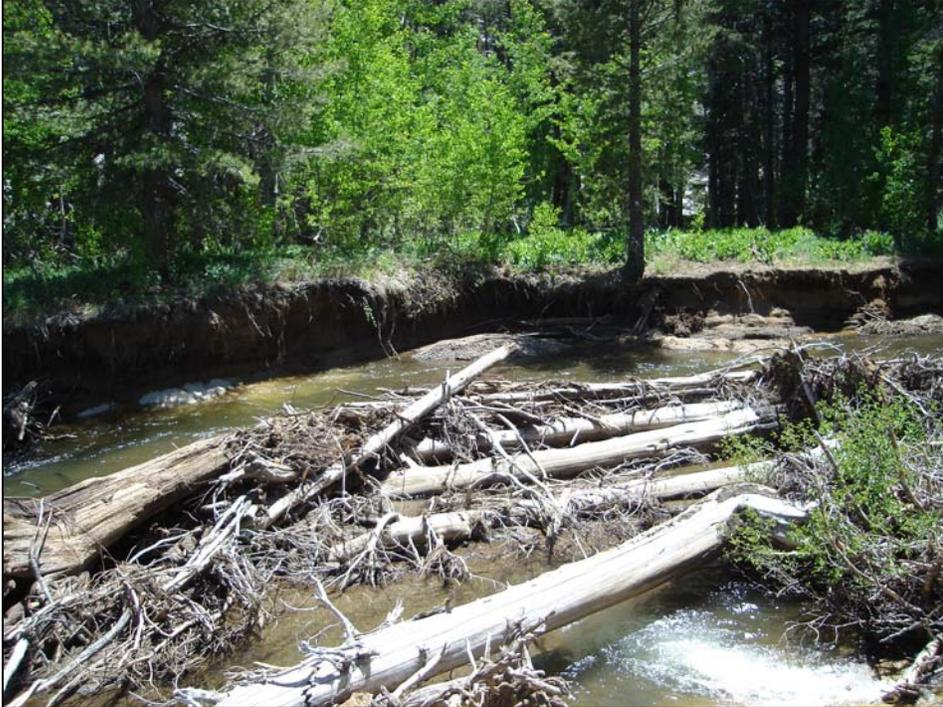
**Site 13:** Charity Valley Creek, Carson Ranger District. Upstream photo of an erosion concern found on river right. The length of the eroding bank is 30m, with a height of 1.5 m. This site is located at UTM: N: 42855773 & E: 249382, Elev. 7592 ft. (2314m).

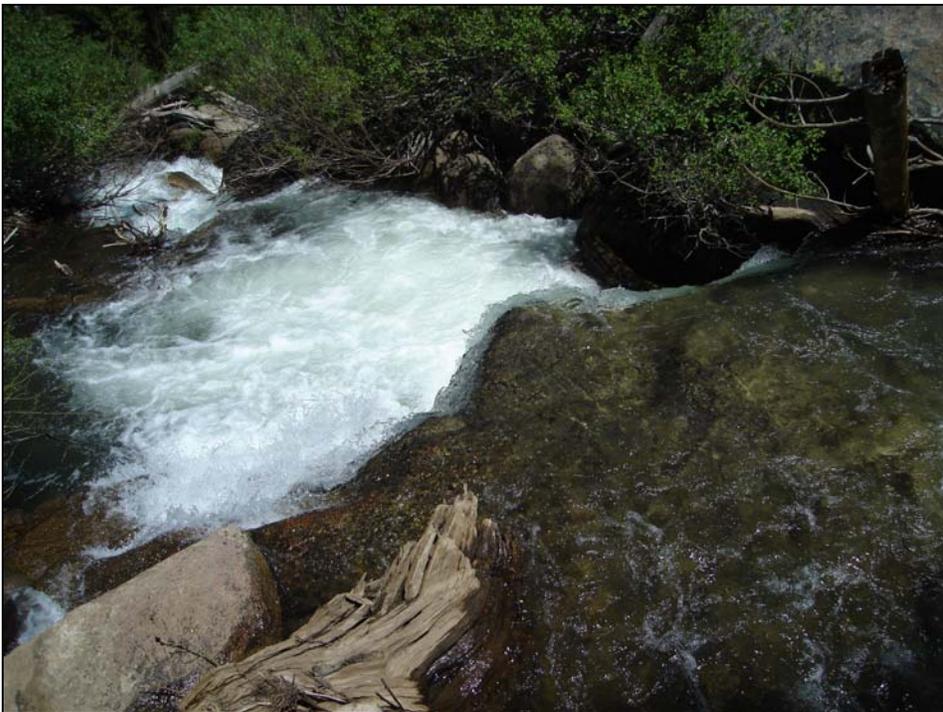
**Site 14:** Charity Valley Creek, Carson Ranger District. Downstream photo of a permanent fish barrier formed by an 8-foot waterfall. This site is located at UTM: N: 4285914 & E: 2491613, Elev. 7595 ft (2315m).

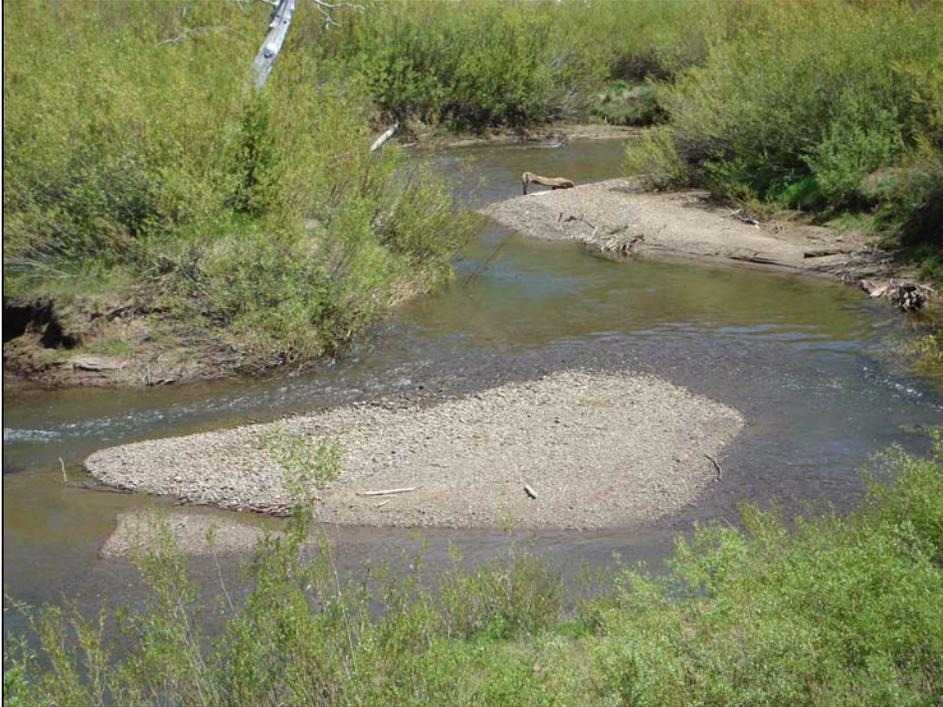
**Site 15:** Charity Valley Creek, Carson Ranger District. Cross-sectional photo of a low-gradient meadow. This site is located at UTM: N: 4285843 & E: 248987, Elev. 7657 ft (2334 m).

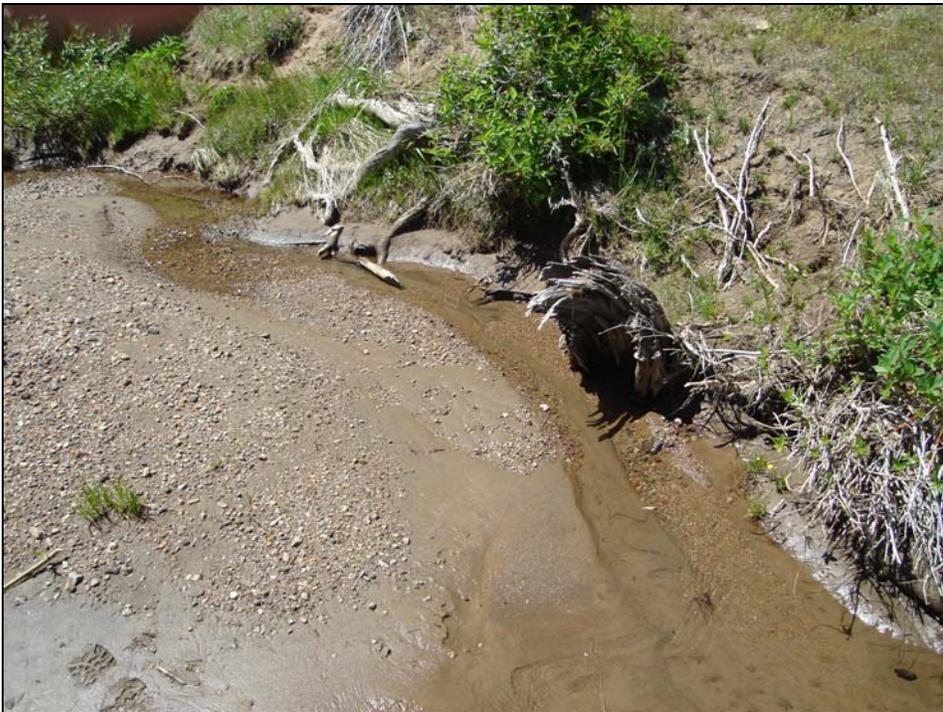
**Site 16:** Charity Valley Creek, Carson Ranger District. Upstream photo of a small tributary that enters river left. This tributary contributes 1% of flow to the stream. This site is located at UTM: N: 4285560 & E: 248823, Elev. 7648 ft (2331m).

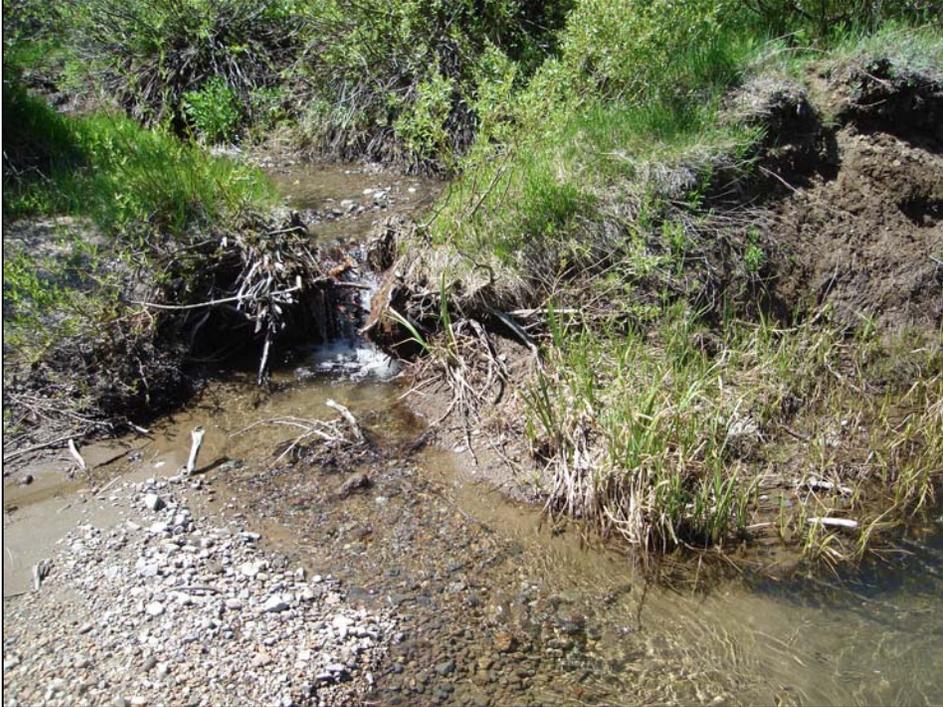
**Site 17:** Charity Valley Creek, Carson Ranger District. A small tributary enters river left and contributes 2% of flow. This site is located at UTM: N: 4285605 & E: 248699, Elev. 7644 ft (2330m).

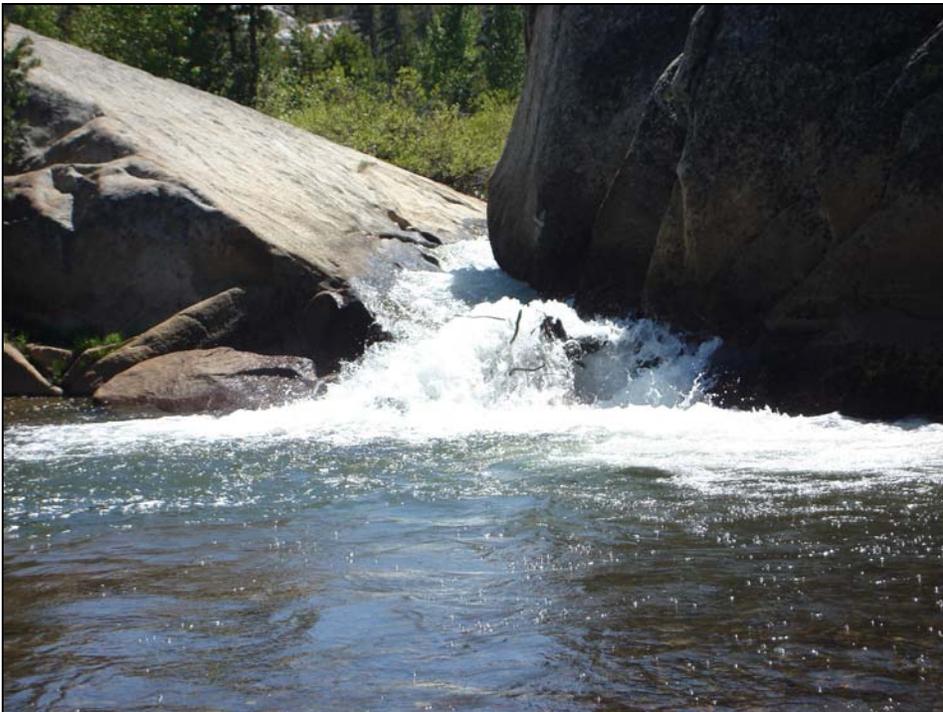
**Site 18:** Charity Valley Creek, Carson Ranger District. Upstream photo of a seasonal fish barrier formed by fast water moving through a rock flume. This site is located at UTM: N: 4285530 & E: 248571, Elev. 7664 ft (2336m).

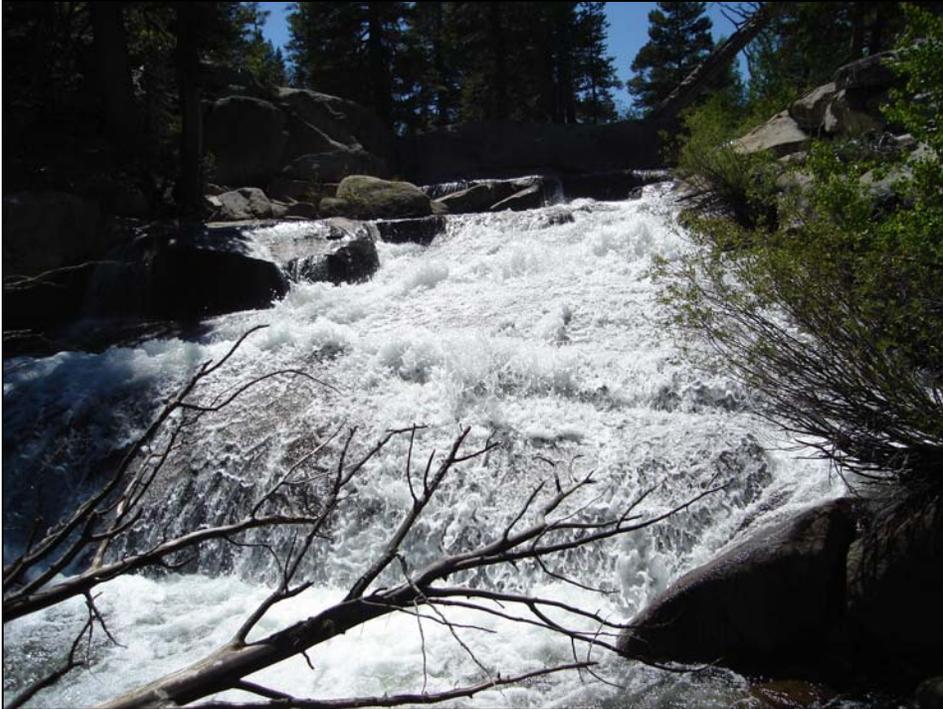
**Site 19:** Charity Valley Creek, Carson Ranger District. A permanent fish barrier formed by a 20-foot waterfall. Max. pool depth is 4-5 ft. This site is located at UTM: N: 4285289 & E: 248348, Elev. 7680 ft (2341m).

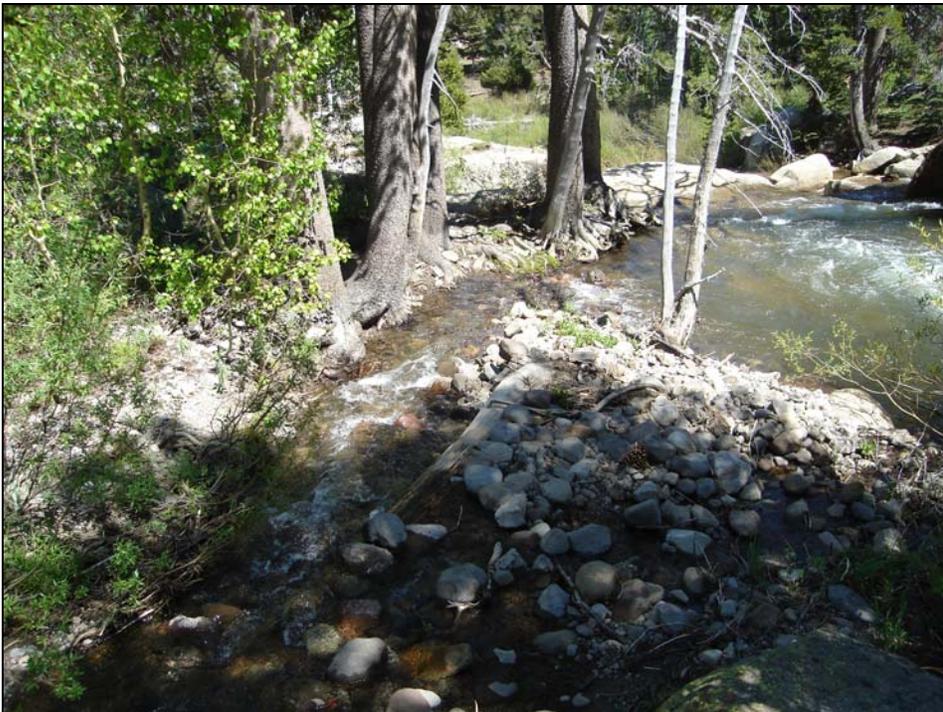
**Site 20:** Charity Valley Creek, Carson Ranger District. Downstream photo of a small tributary that enters river left. The tributary contributes 2-5% of flow in Charity Valley Creek. This site is located at UTM: N: 4285314 7 E: 248255, Elev. 7717 ft (2352m).

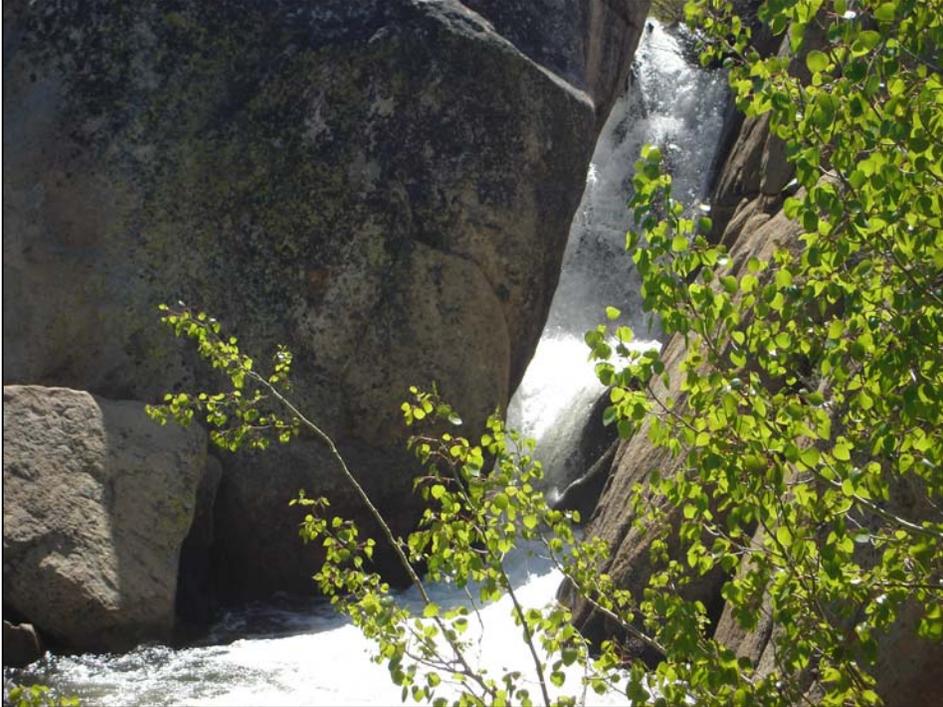
**Site 21:** Charity Valley Creek, Carson Ranger District. Upstream photo of a 20-foot waterfall that creates a permanent fish barrier. Pool depth is 3-4 ft. This site is located at UTM: N: 4285313 & E: 248255, Elev.7717 ft (2352m).

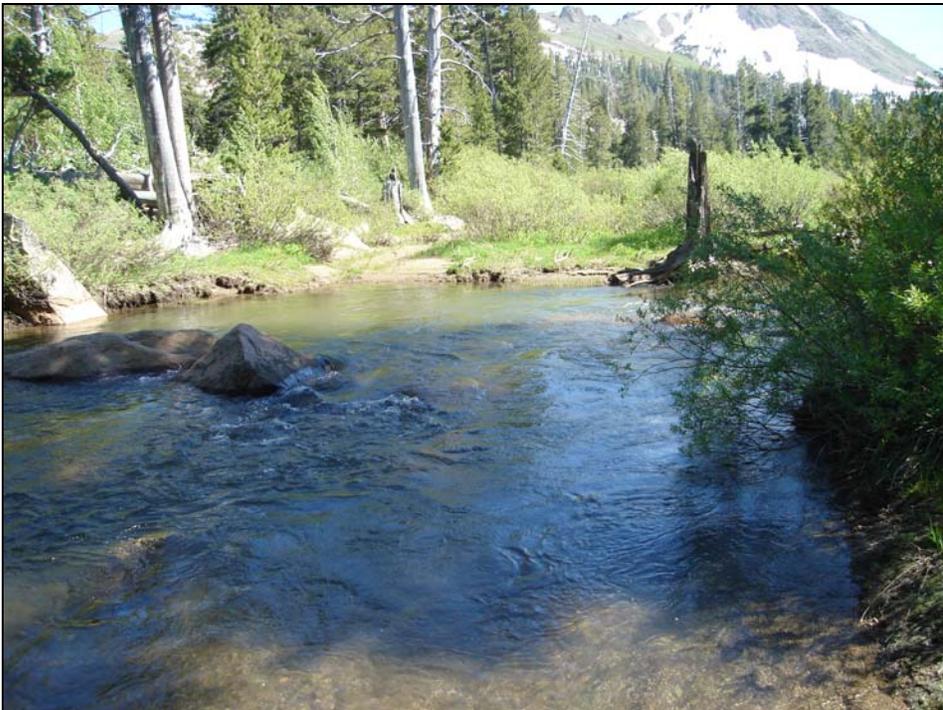
**Site 22:** Charity Valley Creek, Carson Ranger District. Upstream photo taken near the private property boundary. Note that the stream gradient is low and the habitat looks more suitable for LCT. This site is located at UTM: N: 4285251 & E: 248071, Elev. 7792 ft (2375m).

1. Consider the 1.04 mile section of Charity Valley Creek between Site 14 and Site 22 as potential LCT habitat and consider Charity Valley Creek a low candidate for restoration (individually); however, if additional LCT habitat is found upstream of Site 22 on the private property, Charity Valley Creek could become a medium candidate for restoration.
2. Contact landowners regarding the private parcels upstream of Site 22 in order to gain information regarding the stream and/or permission to survey this reach.
