CRATER LAKE CREEK

Alpine County, California

2006 Stream Habitat Survey Reports

Carson Ranger District, Humboldt-Toiyabe National Forest

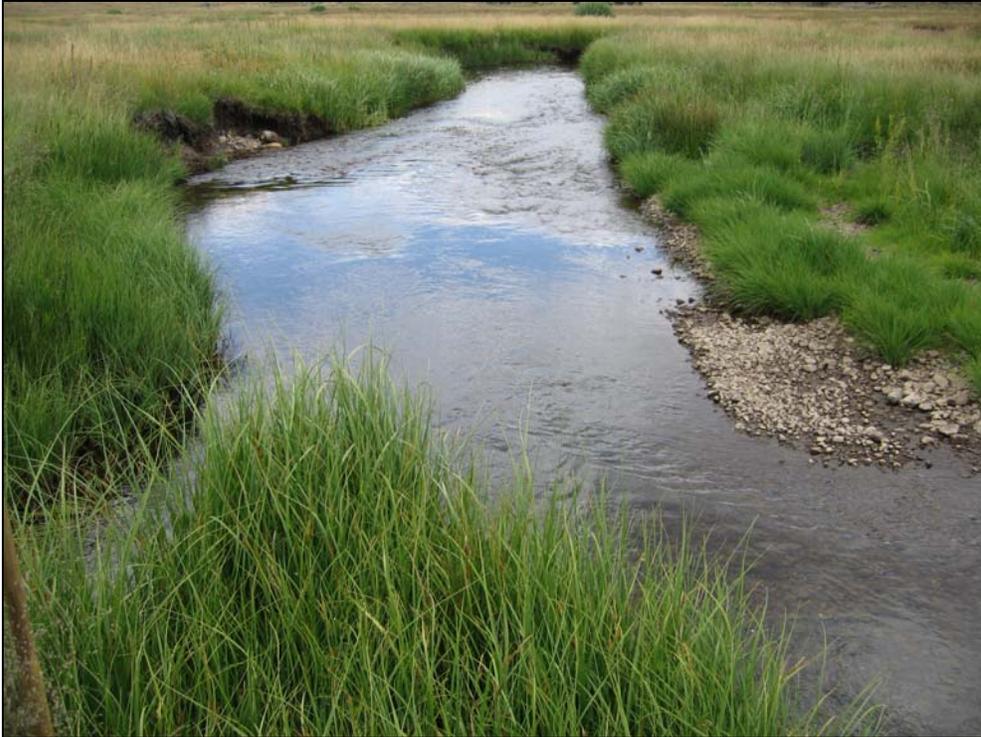
Site 1: Crater Lake Creek, Carson Ranger District. Downstream view of Red Lake Creek where Crater Lake Creek enters on river left. This site is located at UTM: 4290311 & E: 243999, Elev. 7231 feet (2225m.)

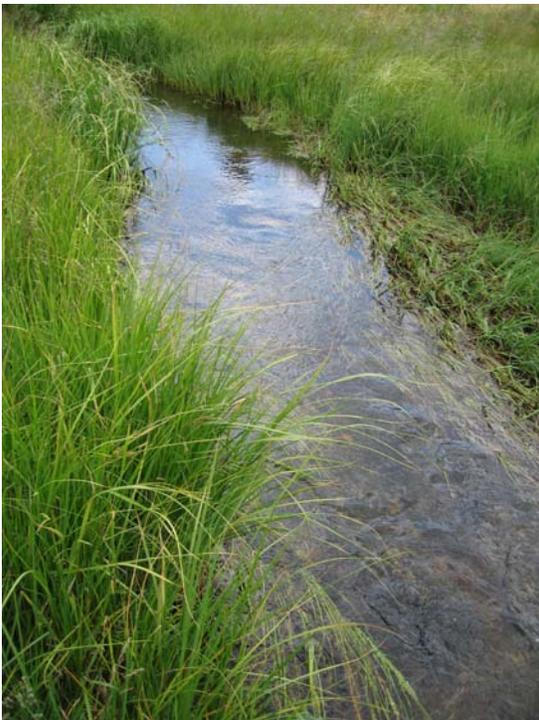
Site 1: Crater Lake Creek, Carson Ranger District. Upstream view of Crater Lake Creek just above the confluence with Red Lake Creek. This site is located at UTM: 4290311 & E: 243999, Elev. 7231 feet (2225m.)

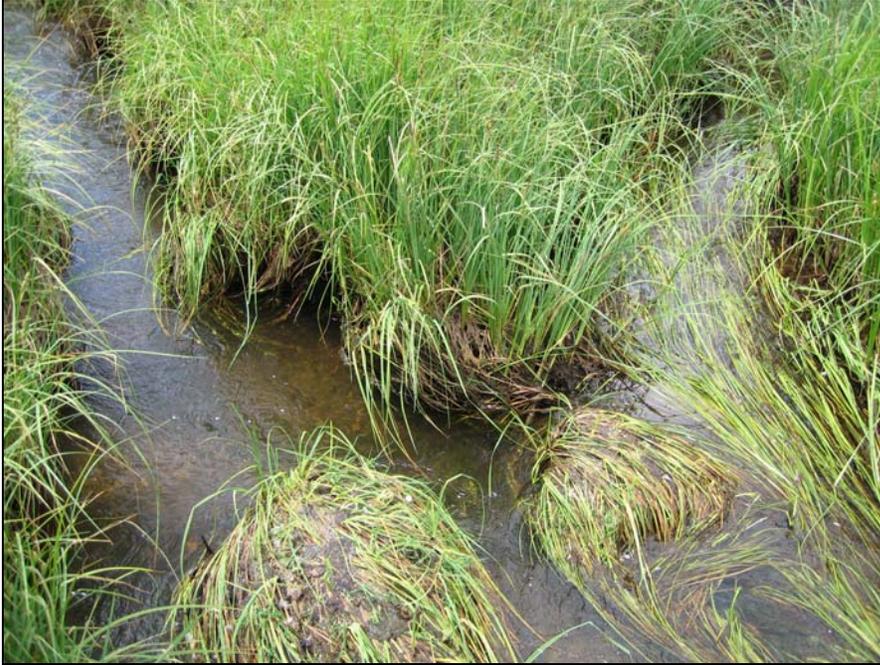
Site 2: Crater Lake Creek, Carson Ranger District. Upstream photo shows where a braid of the stream re-enters on river left in a large marshy area. This site is located at UTM: N: 4290386 & E: 243702, Elev. 7321 feet (2232m).

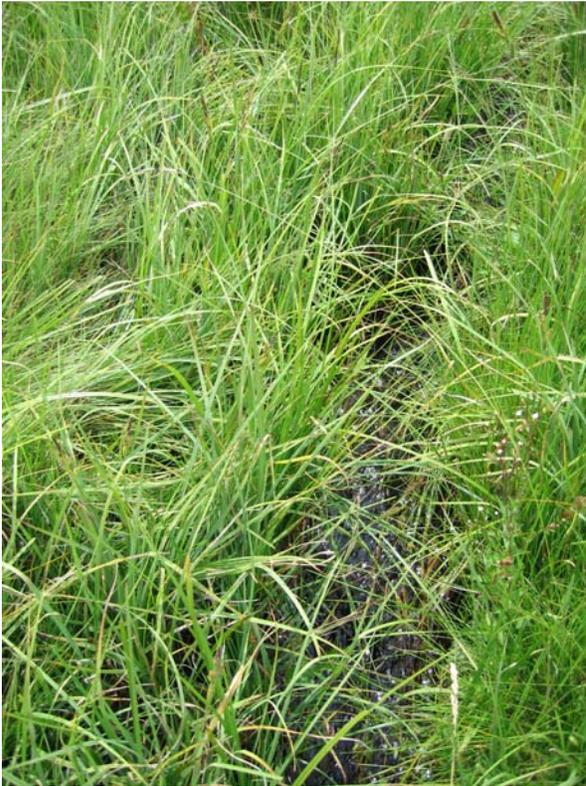
Site 3: Crater Lake Creek, Carson Ranger District. A tributary enters on river right, contributing 15-20% of total flow in the creek. This site is located at UTM: N: 4290453 & E: 243437, Elev. 7318 feet (2231m).

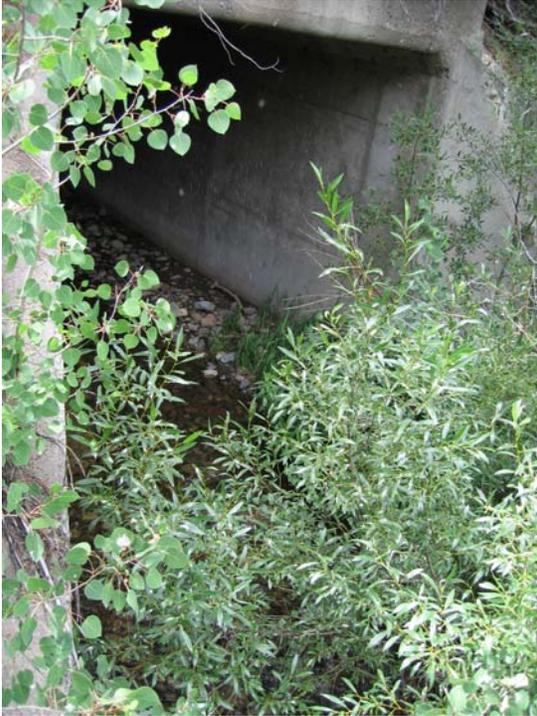
Site 4: Crater Lake Creek, Carson Ranger District. Upstream view of a box-culvert beneath Highway 88. The culvert does not impede fish passage. This site is located at UTM: 4290602 & E: 243283, Elev. 7389 feet (2250m).

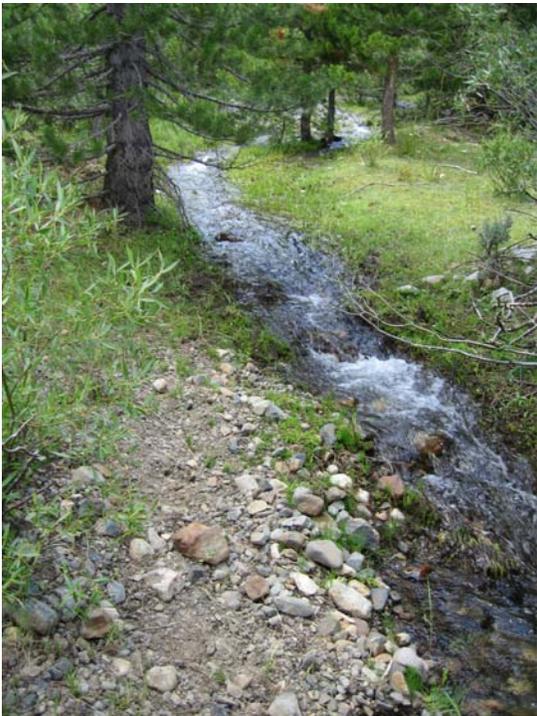
Site 5: Crater Lake Creek, Carson Ranger District. Upstream view at the river left braid near a fence line. This site is located at UTM: N: 4290615 & E: 243191, Elev. 7380 feet (2250m).

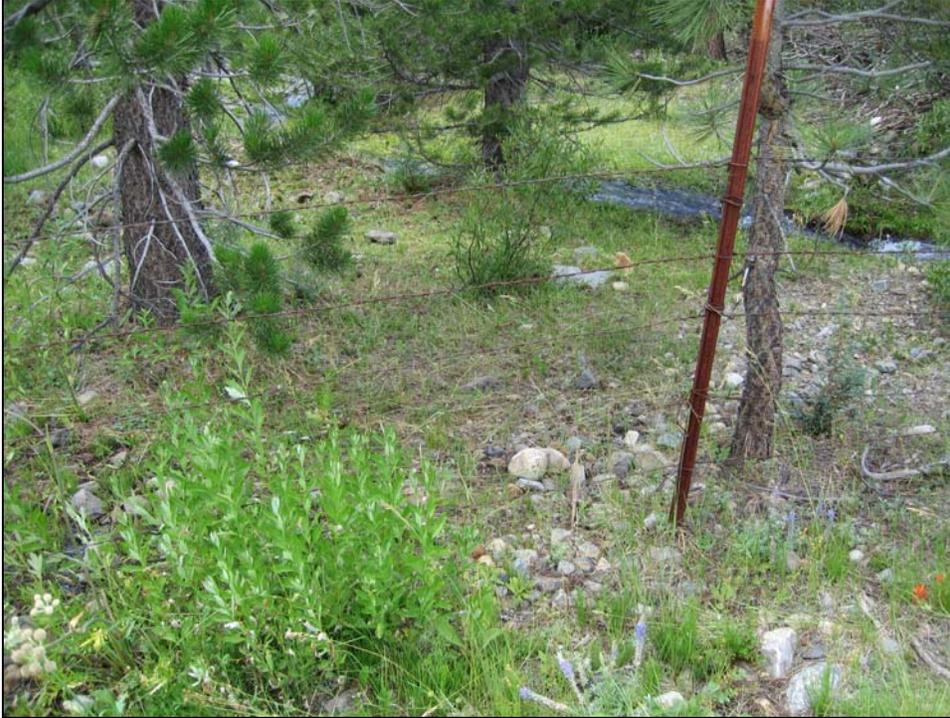
Site 5: Crater Lake Creek, Carson Ranger District. Upstream of a taught barbed-wire fence. This site is located at UTM: N: 4290615 & E: 243191, Elev. 7380 feet (2250m).

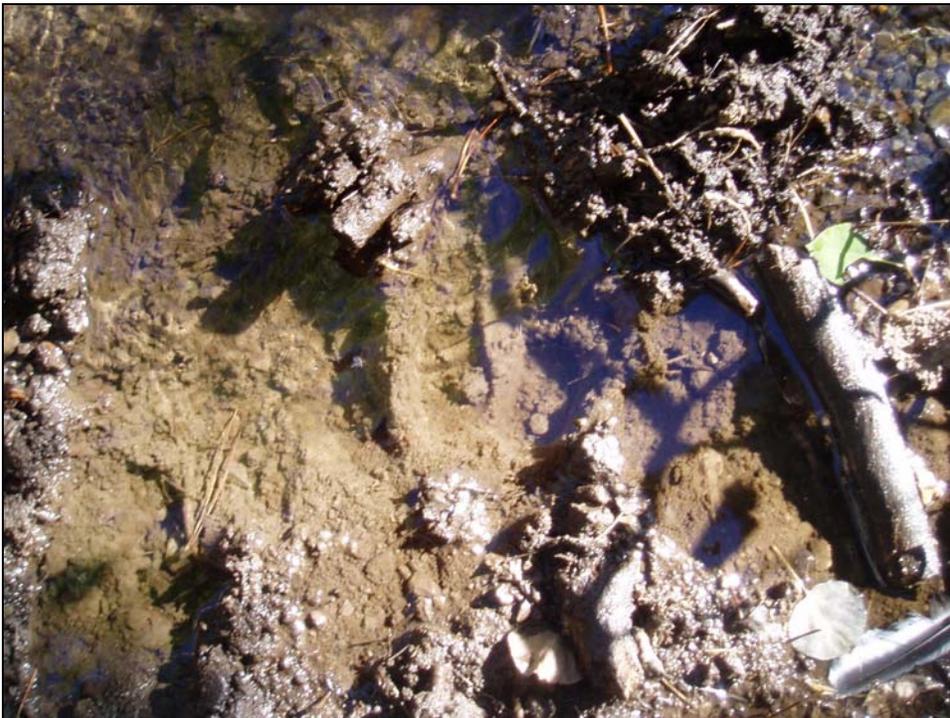
Recent cattle activity was evident because of the presence of hoof marks in the streambed and because of the abundance of cattle trails and disturbed bank vegetation between Sites 5 and 6. The water quality and health of the riparian zone would benefit by creating a buffer that limits the number of cattle crossings and access points to stream banks. The two documented campsites were both located within several meters of the stream/lake.

Site 6: Crater Lake Creek, Carson Ranger District. Photo shows fresh hoof-prints in the streambed. This site is located at UTM: N: 4290664 & E: 243102, Elev. 7308 feet (2228m).

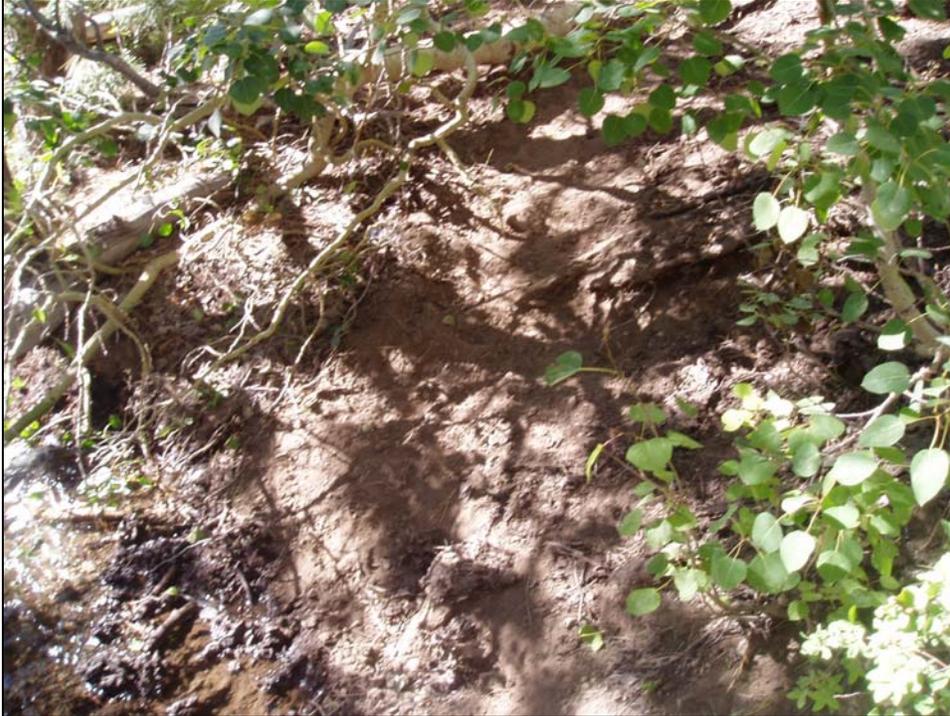
Site 6: Crater Lake Creek, Carson Ranger District. Photo shows a cattle crossing on the river right bank. This site is located at UTM: N: 4290664 & E: 243102, Elev. 7308 feet (2228m).

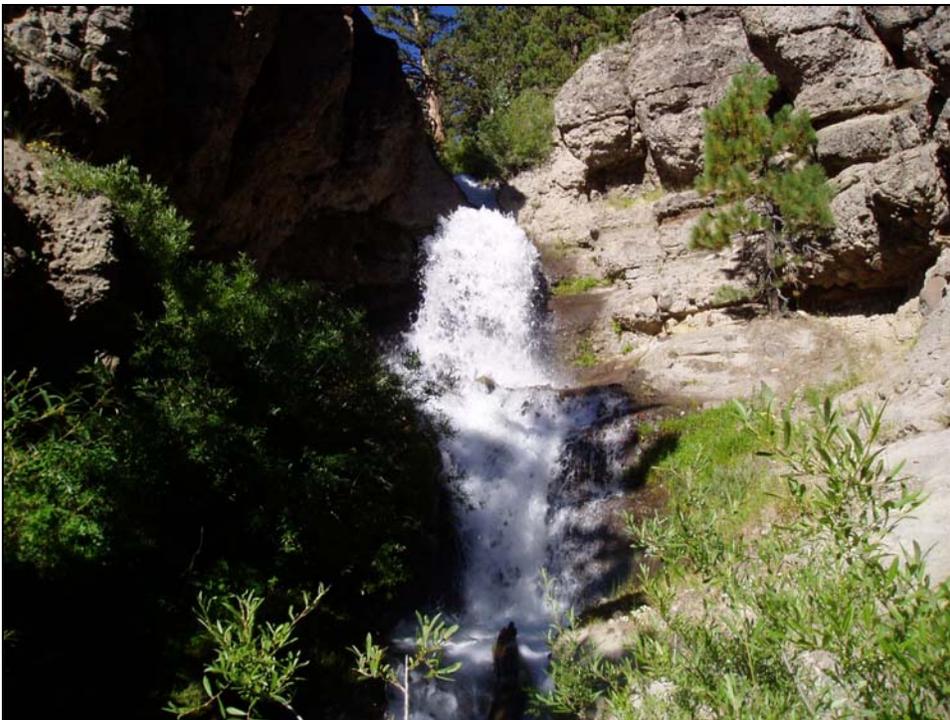
Between Site 6 and Site 16 the stream has multiple waterfalls ranging from 10 feet to 100 feet in height. Though scenic, this section of stream is far too steep to provide favorable fish habitat and the numerous waterfalls prohibit migration or fish passage.

Site 7: Crater Lake Creek, Carson Ranger District. Upstream view of a permanent fish passage barrier. The waterfall has a total height of approximately 35-40 feet. This site is located at UTM: 4290668 & E: 243055, Elev. 7472 feet (2278m.)

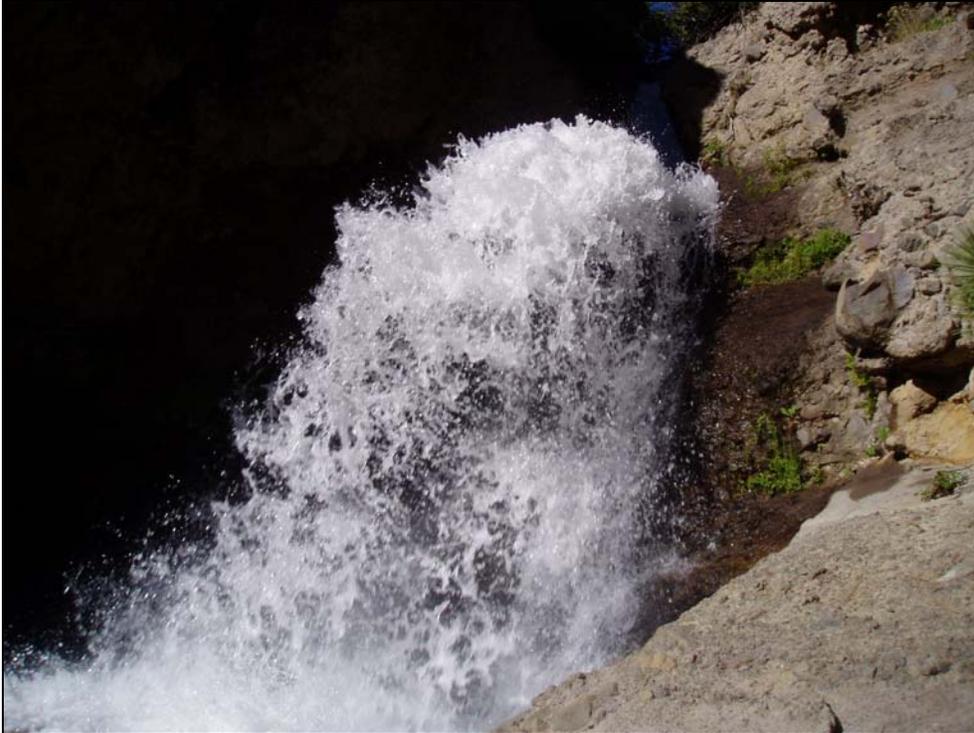
Site 7: Crater Lake Creek, Carson Ranger District. Close-up view of a “hydraulic cannon”. This site is located at UTM: 4290668 & E: 243055, Elev. 7472 feet (2278m.)

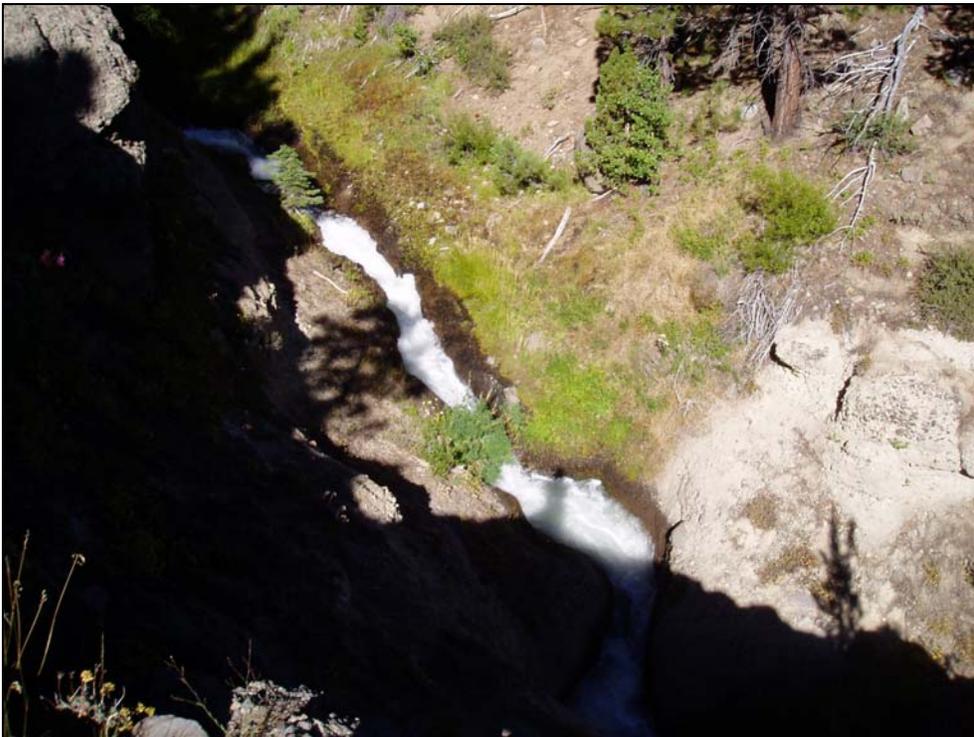
Site 7: Crater Lake Creek, Carson Ranger District. Photo shows another permanent fish barrier found just upstream of the first.

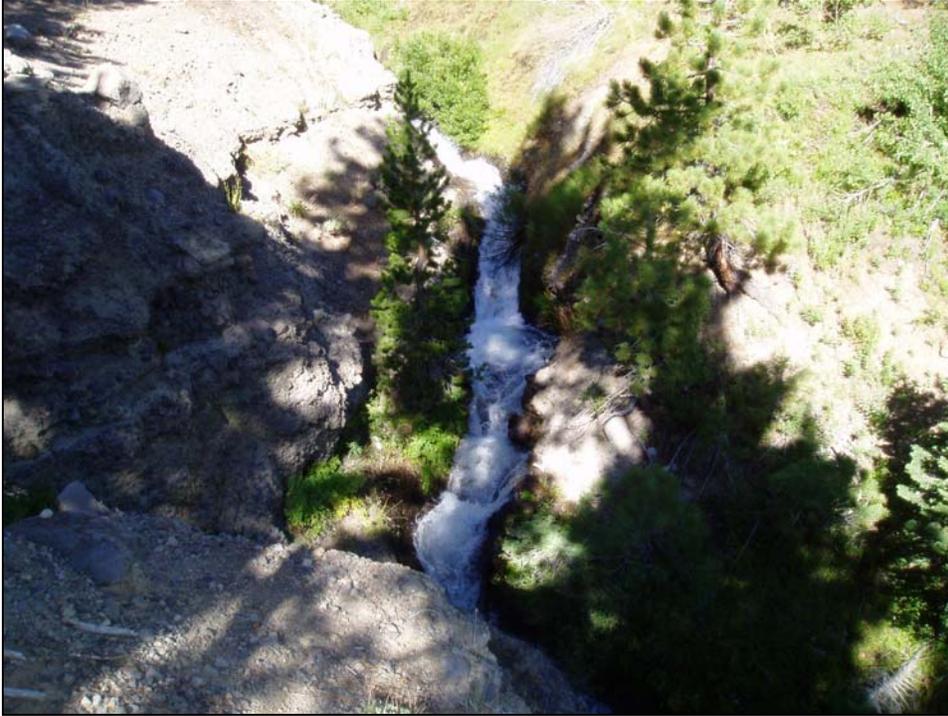
Site 7: Crater Lake Creek, Carson Ranger District. A third permanent fish passage barrier is located upstream of those shown in photos above.

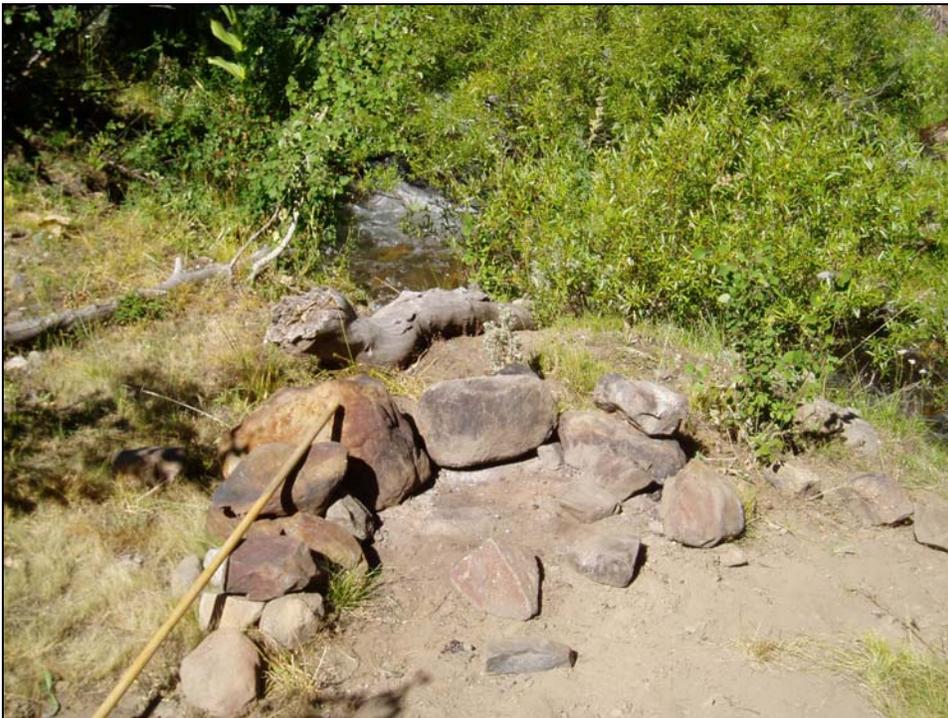
Site 8: Crater Lake Creek, Carson Ranger District. A campsite is located approximately 1m from the stream on river right. Campsite dimension is roughly 30 square meters. This site is located at UTM: 4290543 & E: 242859, Elev. 7580 feet (2311m).

1. Consider the 0.63 mile section of Crater Lake Creek between Site 1 and Site 6 as potential LCT habitat and consider Crater Lake Creek a high candidate for restoration. Crater Lake Creek could contribute towards restoring a metapopulation of LCT in the area (See 2008 Carson River Summary Report).
2. Work with livestock owners and other Forest Service personnel to minimize the effects of cattle on the stream banks and the streambed near Sites 5 and 6.
3. Utilize signs and physical barriers to discourage/prevent people from parking and camping adjacent to Crater Lake Creek.
4. Decommission and disassemble those campsites found within 100 feet of water.

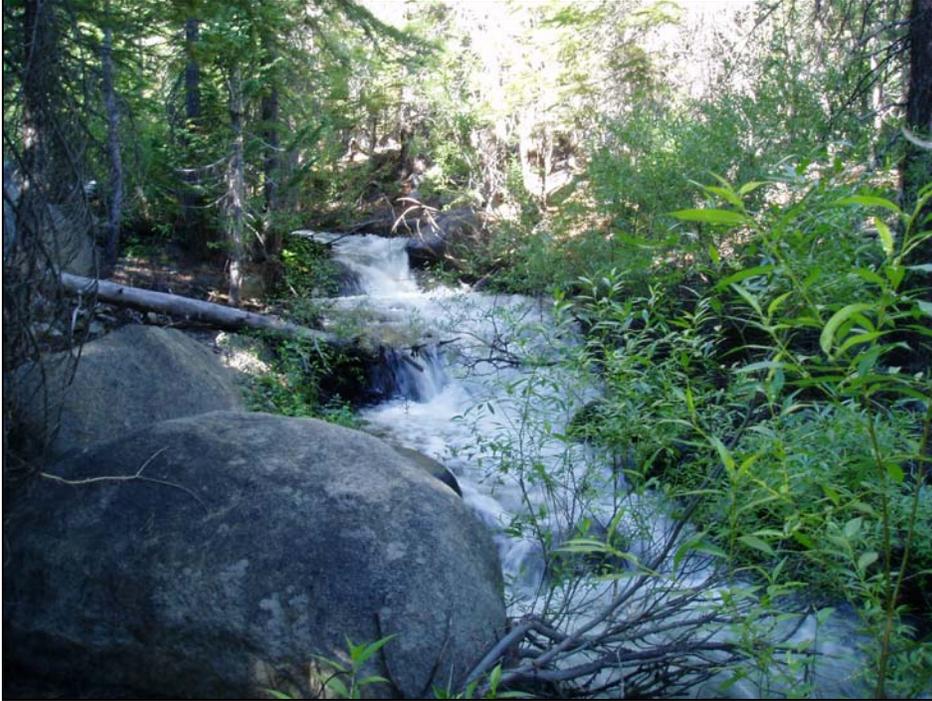
Site 9: Crater Lake Creek, Carson Ranger District. Upstream photo shows cascades characteristic of this reach. This site is located at UTM N: 4290505 & E: 242723.

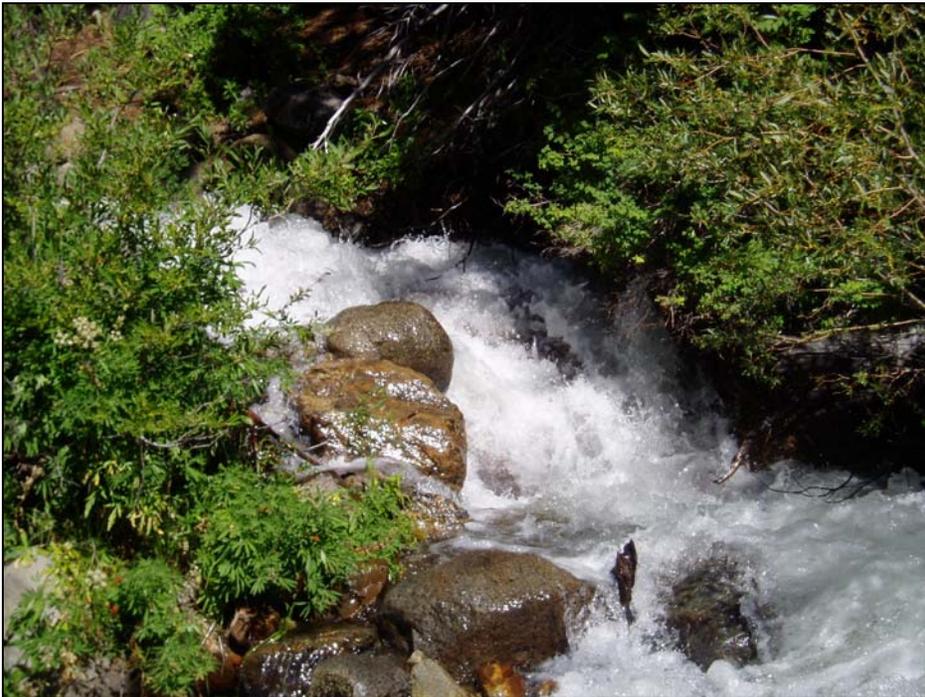
Site 10: Crater Lake Creek, Carson Ranger District. Upstream photo shows one of several seasonal barriers found in succession. This barrier measures approximately 4.0 feet in height, with a maximum pool depth of 1.5 feet. This site is located at UTM: N: 4290481 & E: 242615, Elev. 7688 feet (2344m).

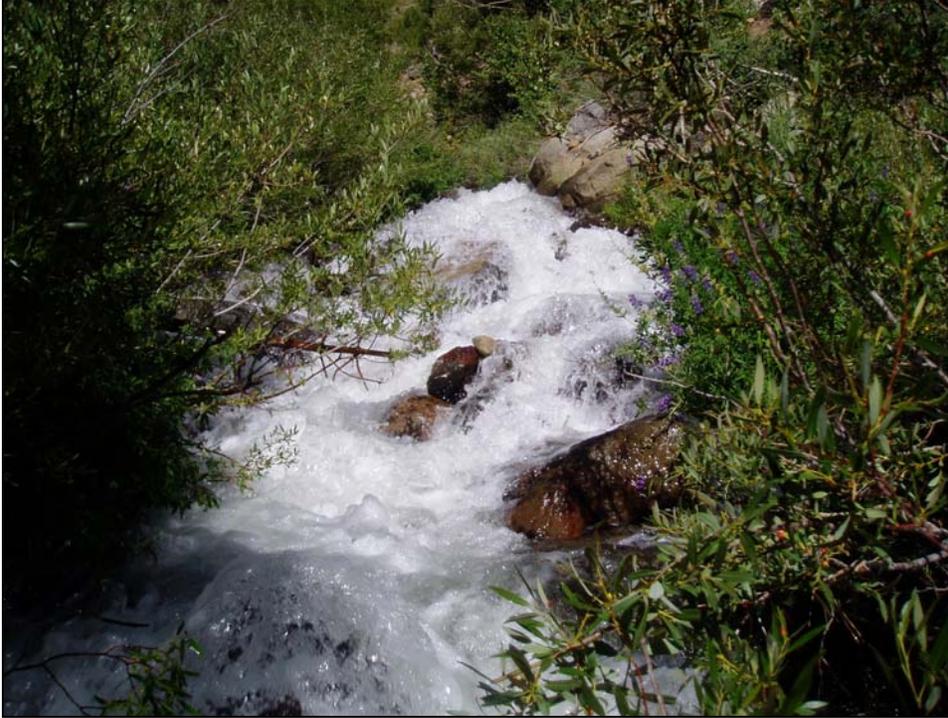
Site 11: Crater Lake Creek, Carson Ranger District. Several 10 foot rock gabions are located in sequence. Photo shows one of the several barriers. This site is located at UTM: N: 4290512 & E: 242413, Elev. 7774 feet (2370m).

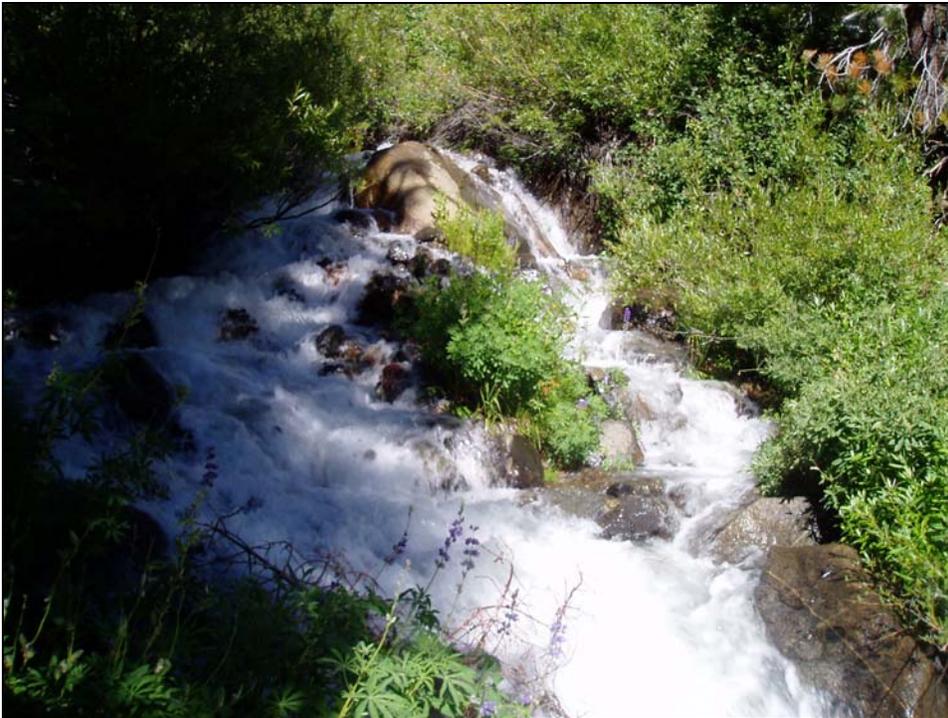
Site 11: Crater Lake Creek, Carson Ranger District. An upstream view of a rocky waterfall. This site is located at UTM: N: 4290512 & E: 242413, Elev. 7774 feet (2370m).

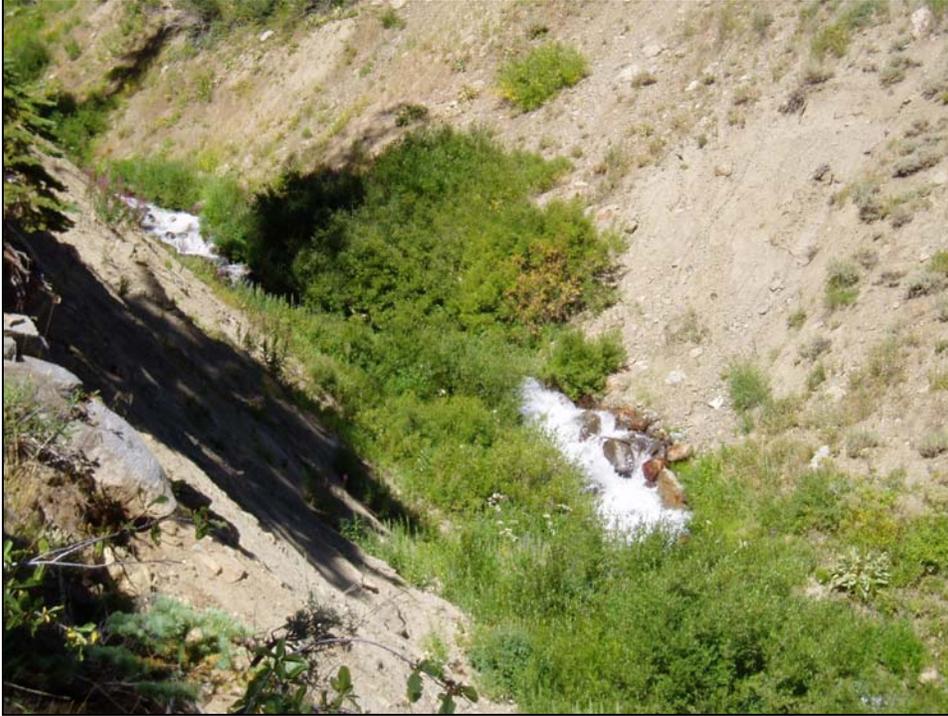
Site 11: Crater Lake Creek, Carson Ranger District. Distant photo captures the steep canyon walls and steep stream gradient. This section is unsuitable for habitat or fish passage. This site is located at UTM: N: 4290512 & E: 242413, Elev. 7774 feet (2370m).

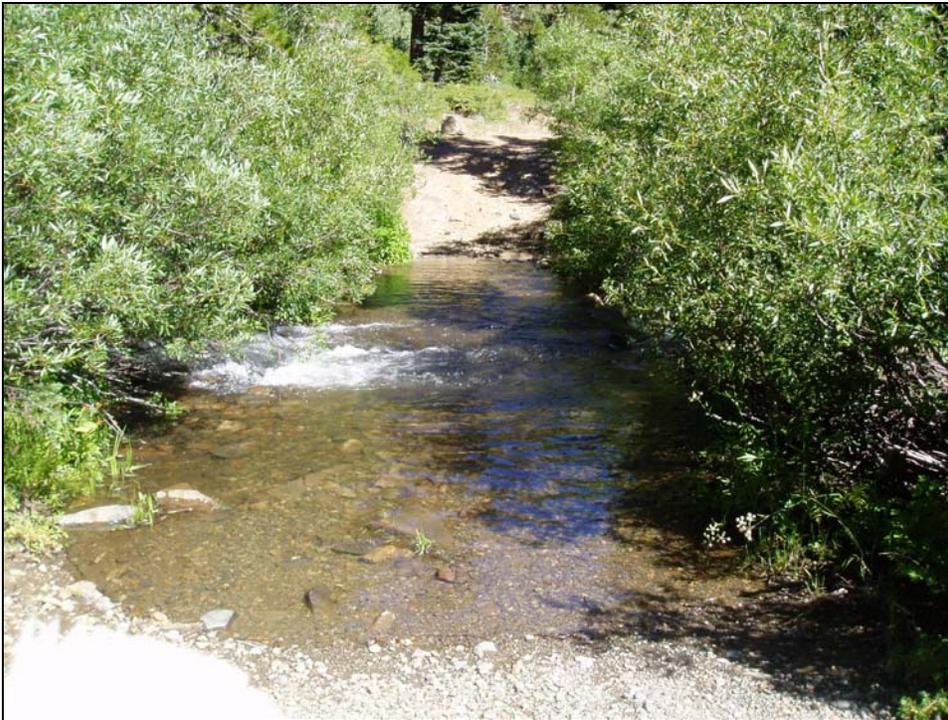
Site 12: Crater Lake Creek, Carson Ranger District. Cross-sectional view of a road-stream crossing. Road use has widened the channel by 5 feet on both banks. This intersection is located at UTM: N: 4290300 & E: 241926, Elev. 8088 feet (2466m).

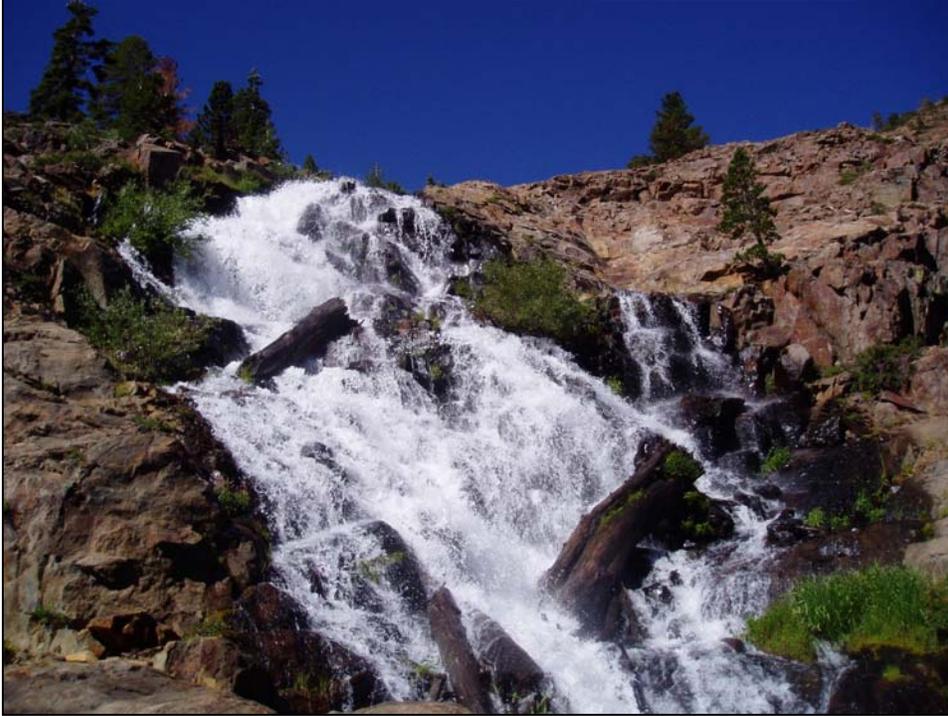
Site 13: Crater Lake Creek, Carson Ranger District. Upstream photo shows only a short section of a 100 foot waterfall. This permanent fish passage barrier is located at UTM: N: 4290269 & E: 241844, Elev. 8170 feet (2491m).

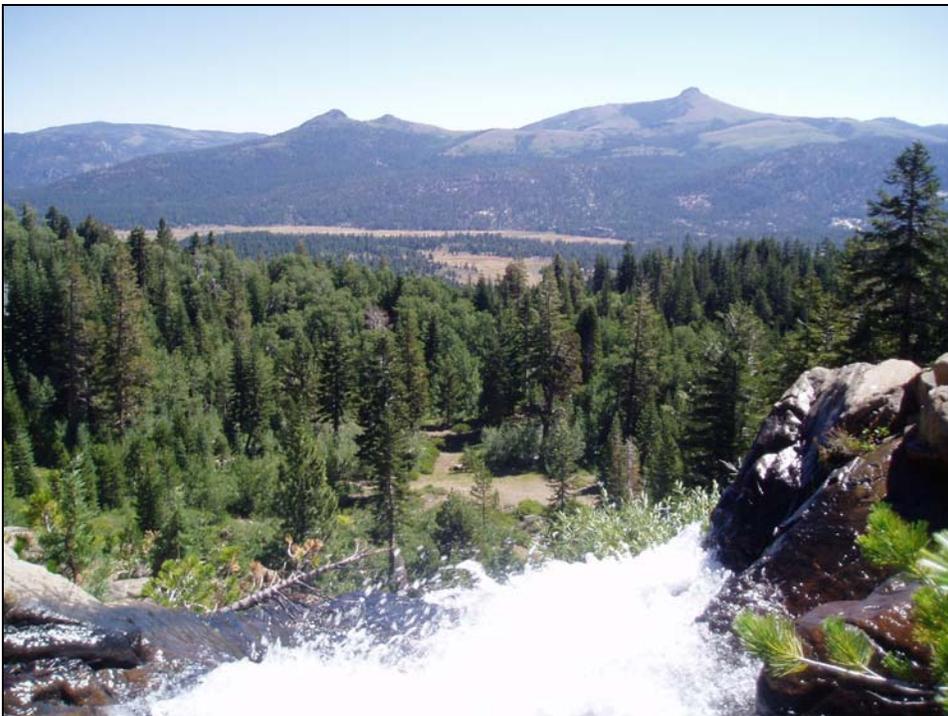
Site 13: Crater Lake Creek, Carson Ranger District. Downstream (eastern) view from atop the falls. This permanent fish passage barrier is located at UTM: N: 4290269 & E: 241844, Elev. 8170 feet (2491m).

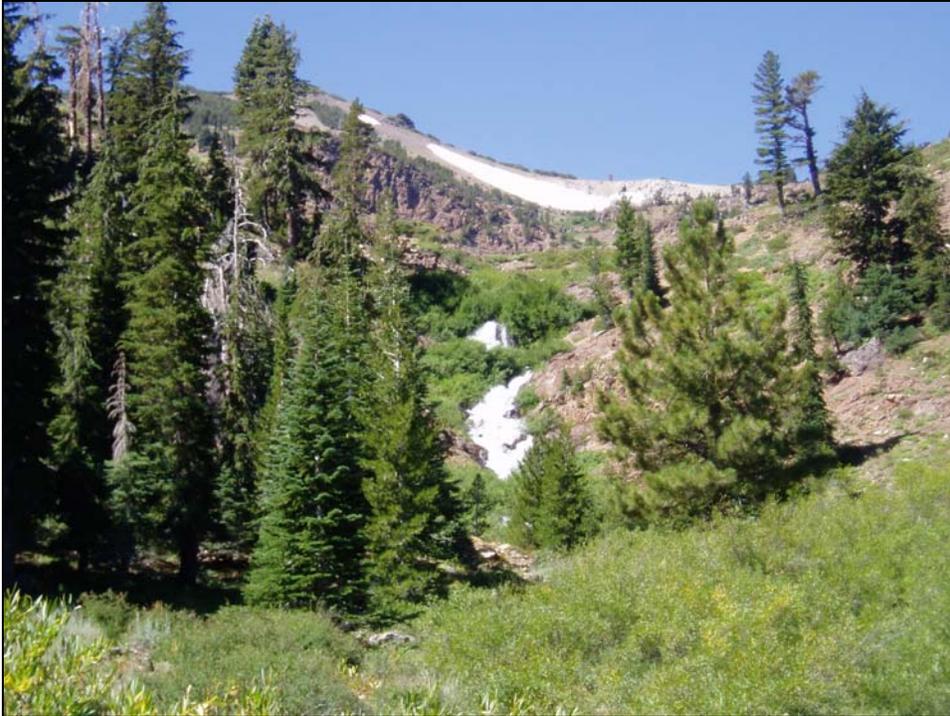
Site 14: Crater Lake Creek, Carson Ranger District. Upstream photo shows the presence of a residual snow pack and another waterfall. This site is located at UTM: N: 4290219 & E: 241693, Elev. 8430 feet (2570m).

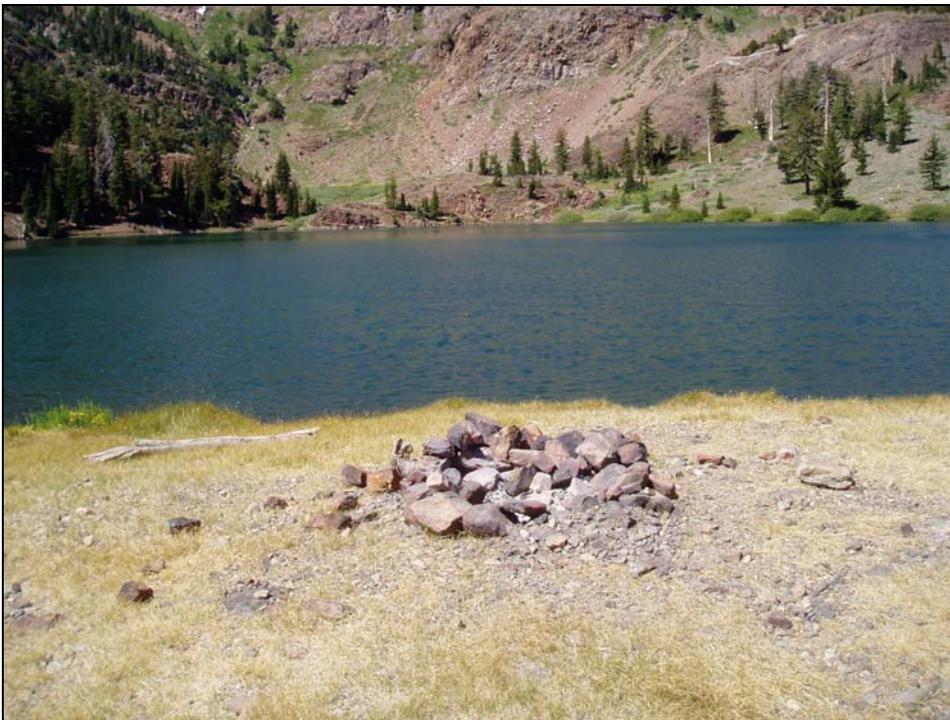
Site 15: Crater Lake Creek, Carson Ranger District. A campsite is located approximately 4 meters from the edge of Crater Lake. This site is located at UTM: N: 4290108 & E: 241523, Elev. 8610 feet (2625m).

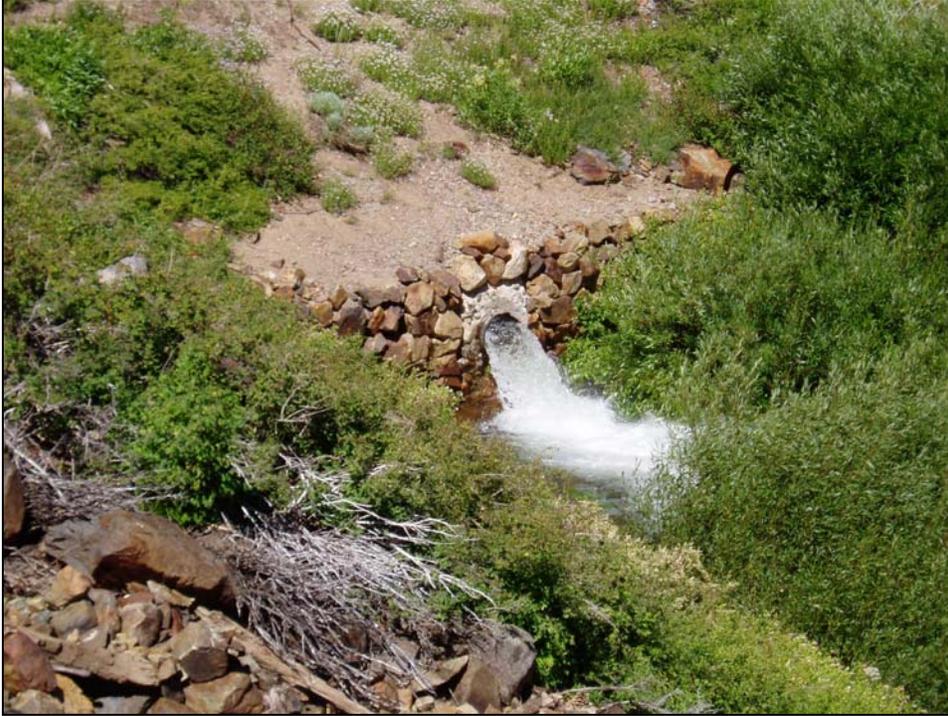
Site 16: Crater Lake Creek, Carson Ranger District. Upstream view of the spillway where the lake feeds Crater Lake Creek. This site is located at UTM: N: 4290121 & E: 241509, Elev. 8594 feet (2620m).
