EAST FORK CARSON RIVER

2006 Stream Habitat Survey Report

Carson Ranger District: Humboldt-Toiyabe National Forest

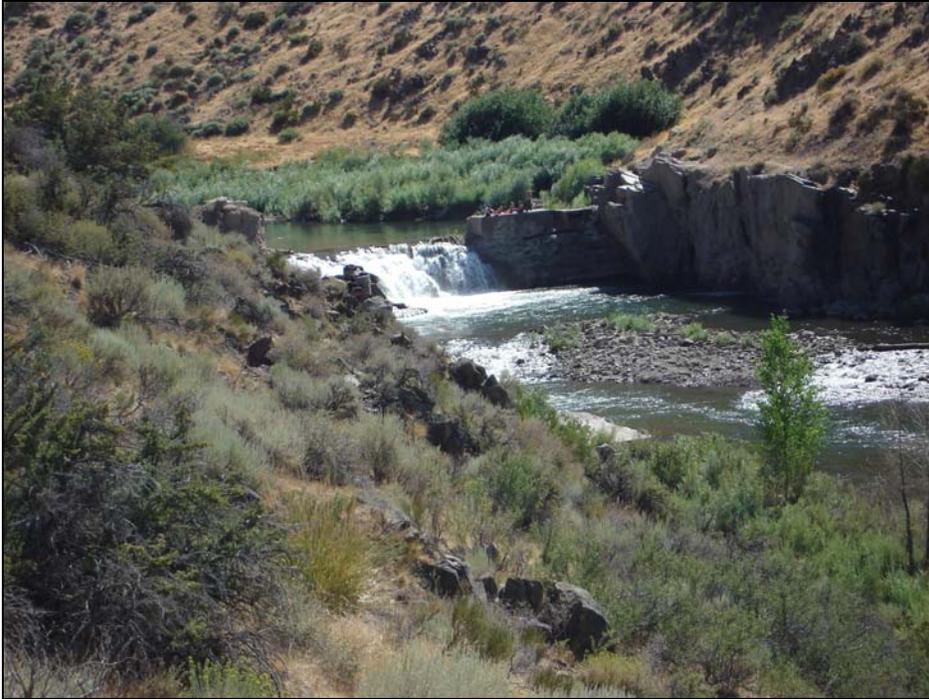
Site 1: East Fork Carson River, Carson Ranger District. Upstream photo of Ruhenstroth Dam, a permanent fish barrier with a vertical height of 10-20 feet. This site is located at UTM: N: 4305990 & E: 266589, Elev. 4930 Feet (1503m).

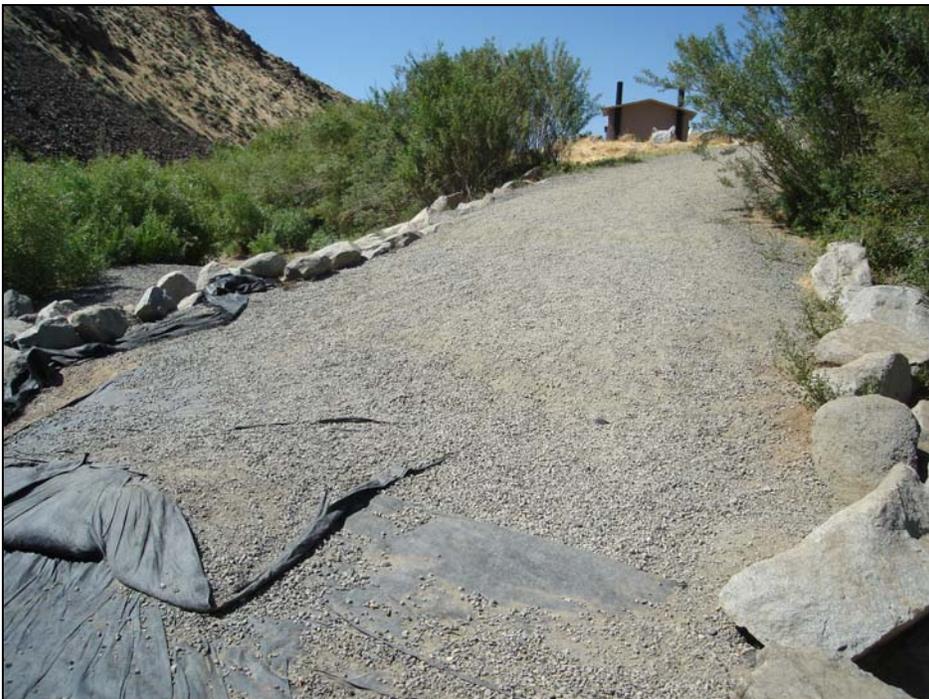
Site 2: East Fork Carson River, Carson Ranger District. Photo shows the popular rafting pull-out location. Note the presence of gravel supported by a tarp or mat. The high flows in early 2006 eroded the old bank. This site is located at UTM: N: 4305416 & E: 266489, Elev. 4946 feet (1508m).

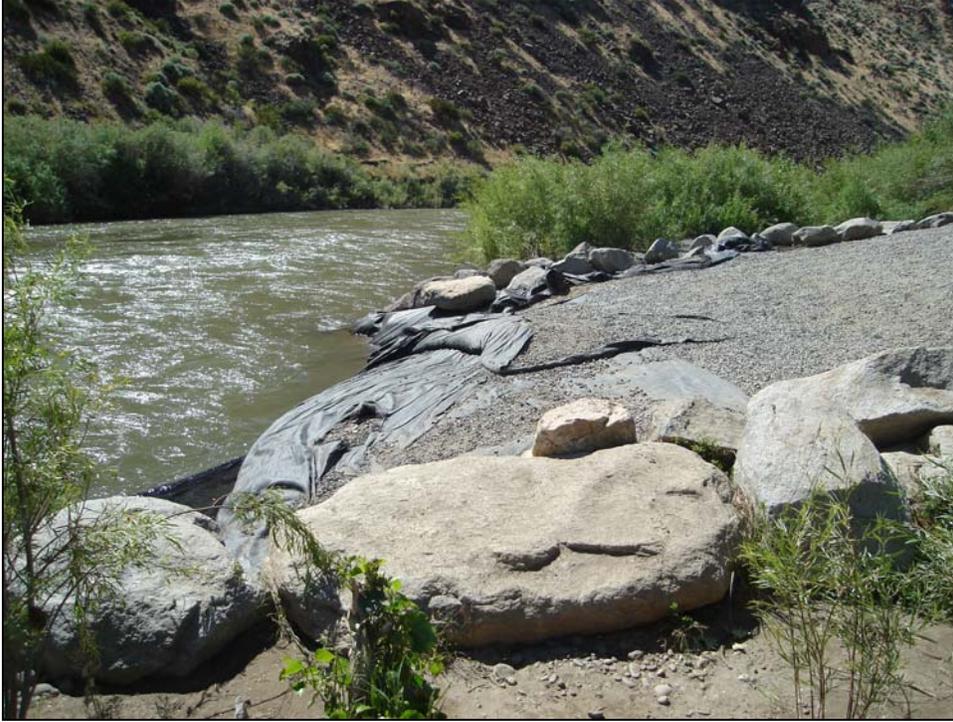
Site 2: East Fork Carson River, Carson Ranger District. Downstream view of the pull-out location. This site is located at UTM: N: 4305416& E: 266489, Elev.4946 feet (1508m).

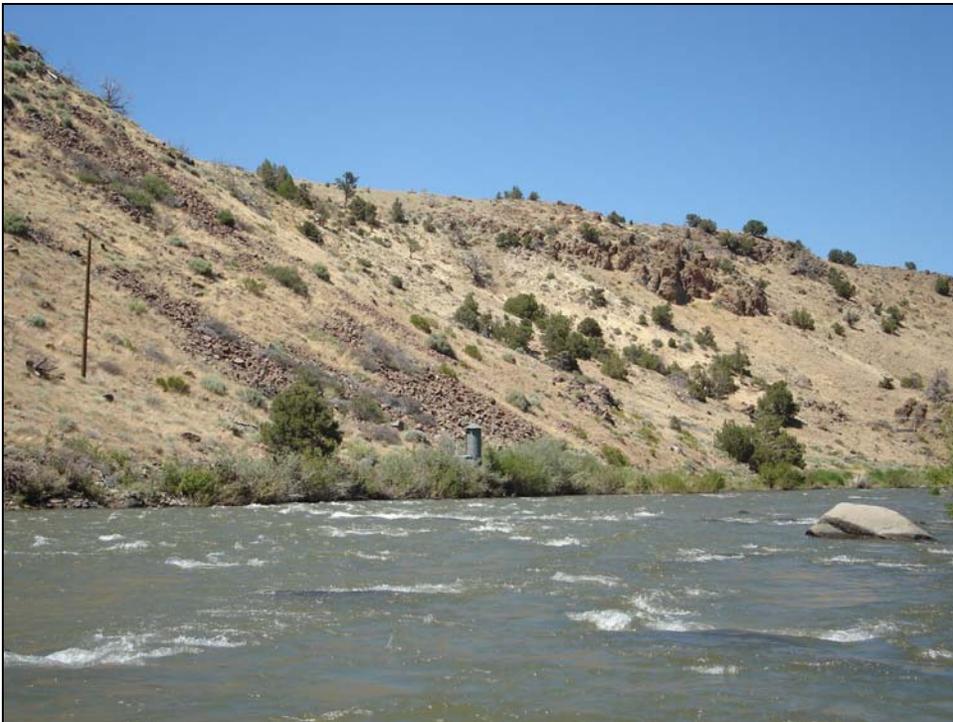
Site 3: East Fork Carson River, Carson Ranger District. Downstream view of a USGS gauging station. Gauge height is measured on the left bank. This site is located at UTM: N: 4302845 & E: 265439, Elev. 4979 feet (1518m).

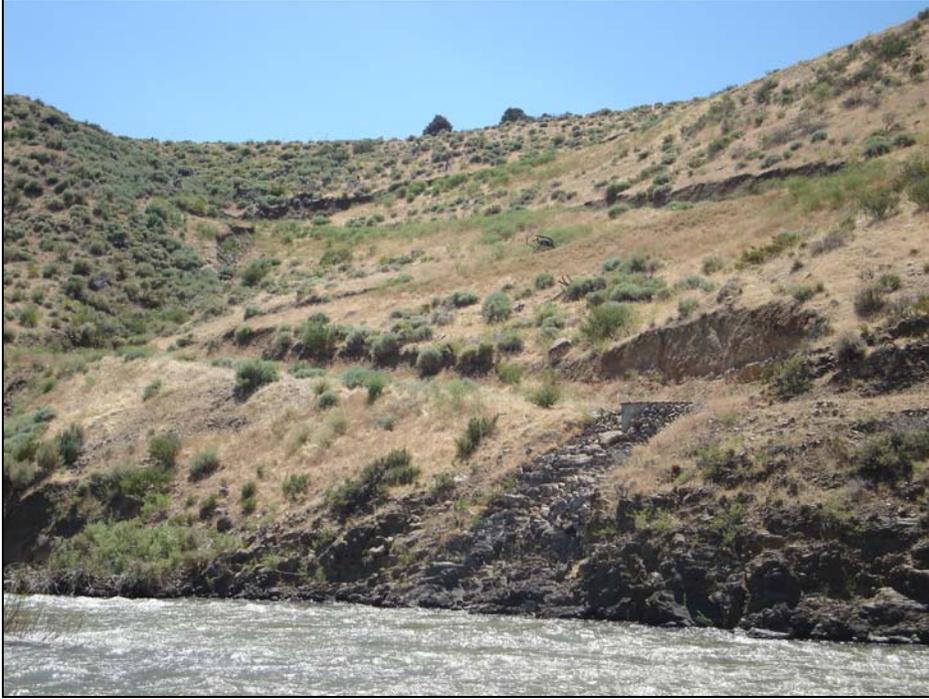
Site 4: East Fork Carson River, Carson Ranger District. Photo shows a vertical culvert buried in the river left bank. This site is located at UTM: N: 4302820 & E: 264935, Elev. 5002 feet (1525m).

8. Remove large trash/debris such as culverts, broken kayaks, etc. from the East Fork Carson River watercourse. Remove all barb wire fences not being used.

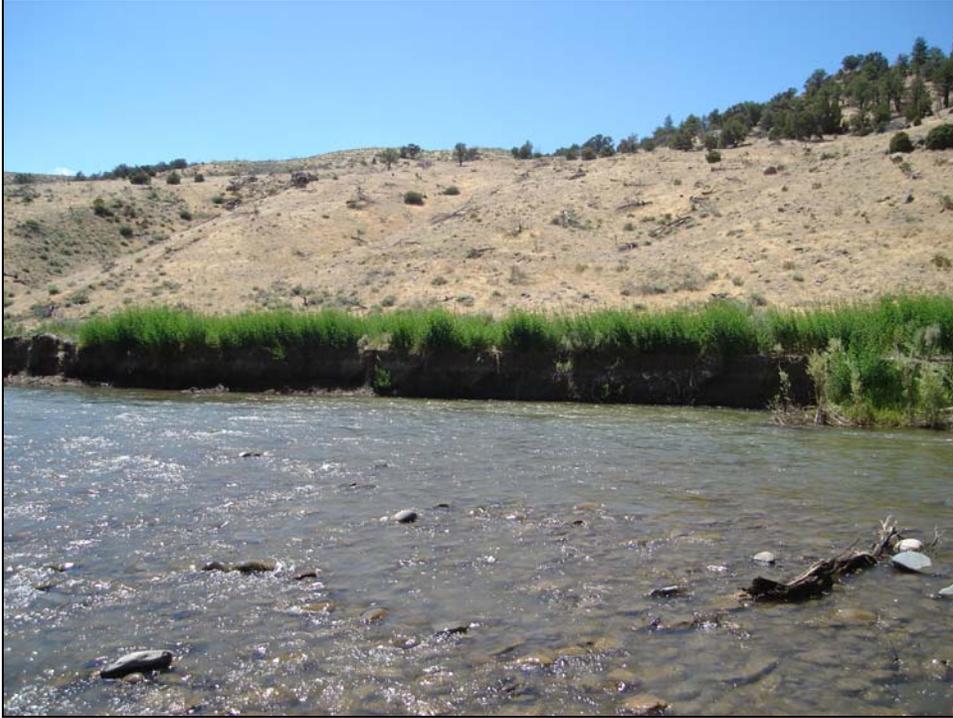
Site 6: East Fork Carson River, Carson Ranger District. Photo shows a loose vertical bank where sediment is eroding directly into the watercourse. This site is located at UTM: N: 4300704 & E: 266373, Elev. 5071 feet (1546m).

Grazing pasture and livestock activity was specifically noted as a possible cause for an erosion concern in ten locations (Sites 6, 7, 8, 9, 26, 27, 76, 81, 82, & 97). In many of these locations cattle/livestock are allowed to walk through the riparian zones and in most instances have access to enter the watercourse. The removal of vegetation as well as the degradation of stream banks by hooves is apparent at several of these locations (See photos associated with Sites 6, 26, & 81). In the vicinity of Vaquero Camp and Gray's crossing, cattle were present during the survey and had visibly depleted grass and willows along the banks for a distance of several hundred meters. In addition algae were prevalent on the streambed in the same reach, signaling a major nutrient influx. Creating a buffer zone with fencing may offer a way of reducing the impact on the riparian corridor. Providing education and incentives (i.e. cost share agreements for fencing or retired acreage) to private land owners may help to minimize grazing impacts.

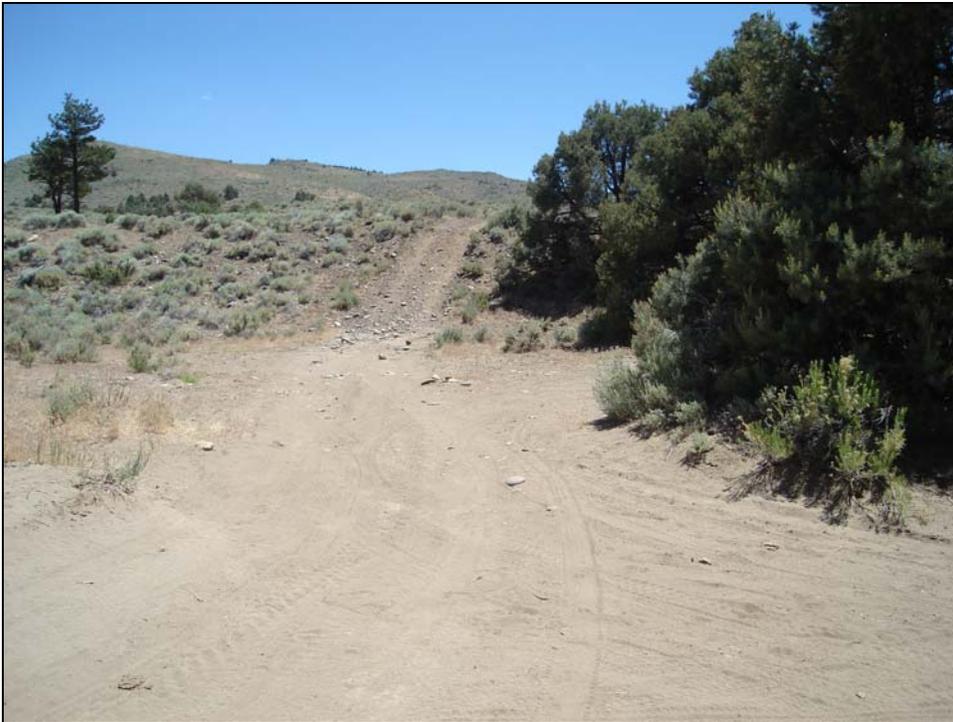
Site 7: East Fork Carson River, Carson Ranger District. Viewpoint of a road that runs perpendicular to the river. Photo shows one part of a visible road network. This site is located at UTM: N: 4300017 & E: 266259, Elev. 5071 feet (1546m).

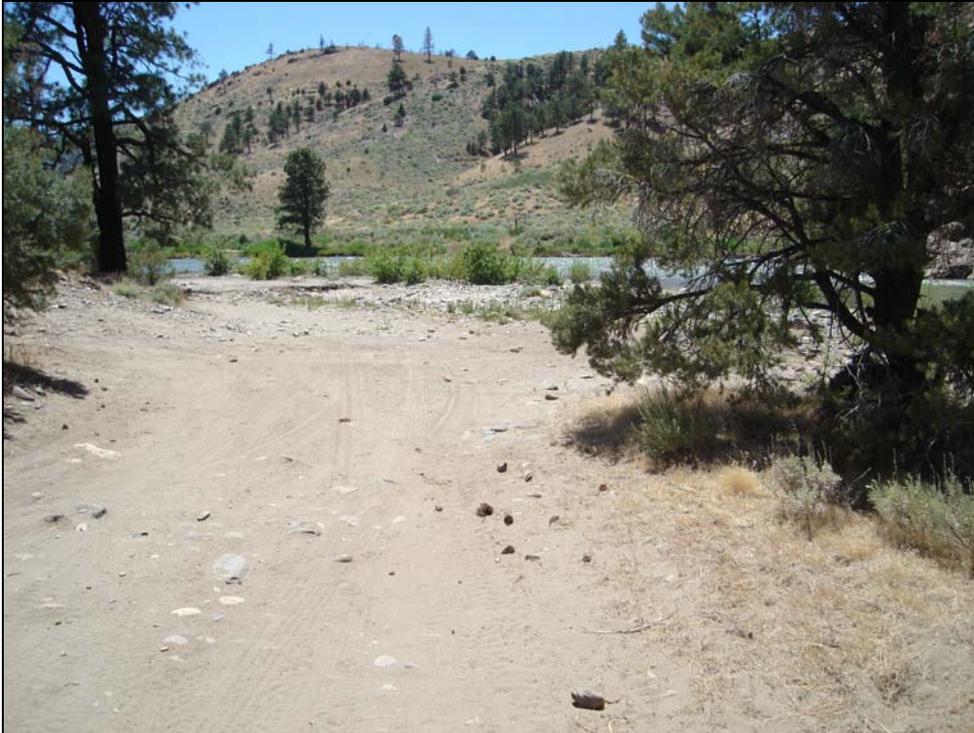
Site 7: East Fork Carson River, Carson Ranger District. Photo shows an adjacent road impact. This site is located at UTM: N: 4300017 & E: 266259, Elev. 5071 feet (1546m).

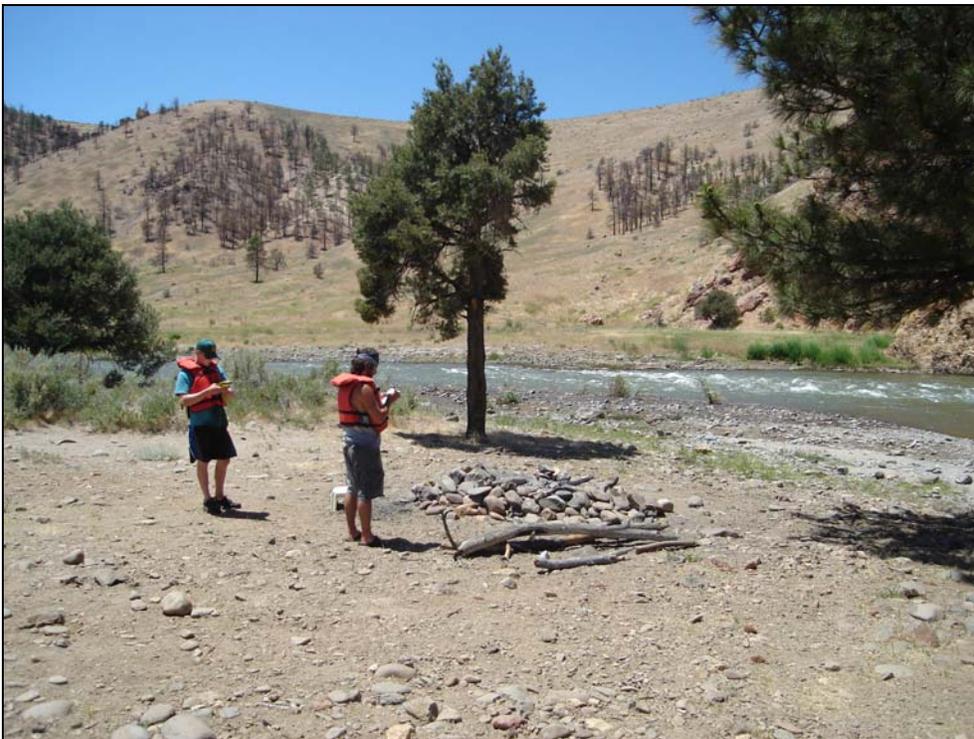
Site 8: East Fork Carson River, Carson Ranger District. Photo shows part of a well established campsite, which includes an incoming road and a tree swing. This camp is located at UTM: N: 4299299 & E: 265890, Elev. 5110 feet (1558m).

6. Close and decommission all campsites within 100 feet of the East Fork Carson River. Only allow camping to occur more than 100 feet away from the river edge.

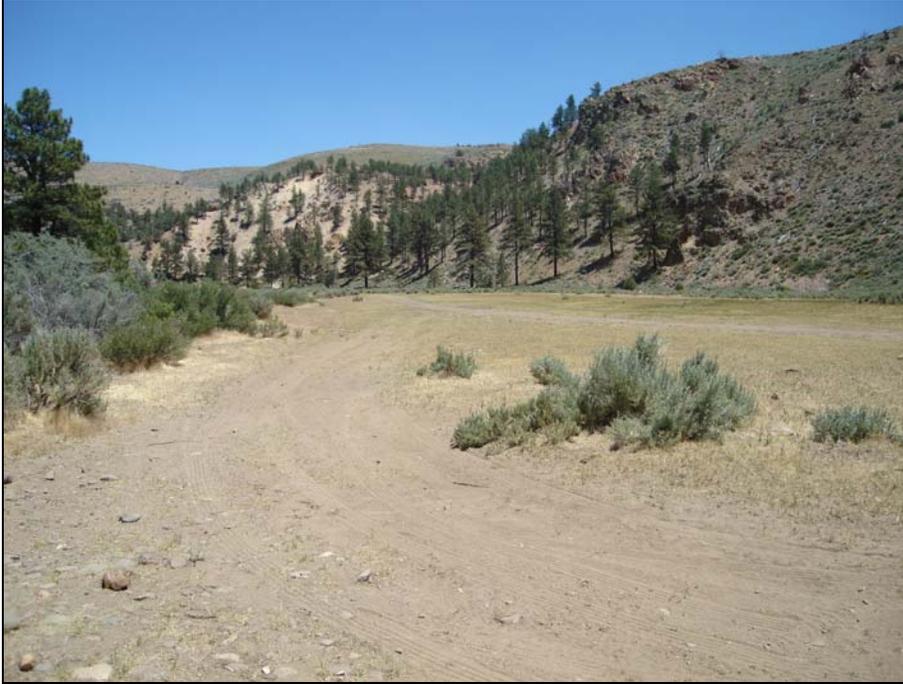
Site 8: East Fork Carson River, Carson Ranger District. Photo shows the heavily traveled road leading to the campsite. The road approaches from a downstream or northeasterly direction. This campsite is located at UTM: N: 4299299 & E: 265890, Elev.5110 feet (1558m).

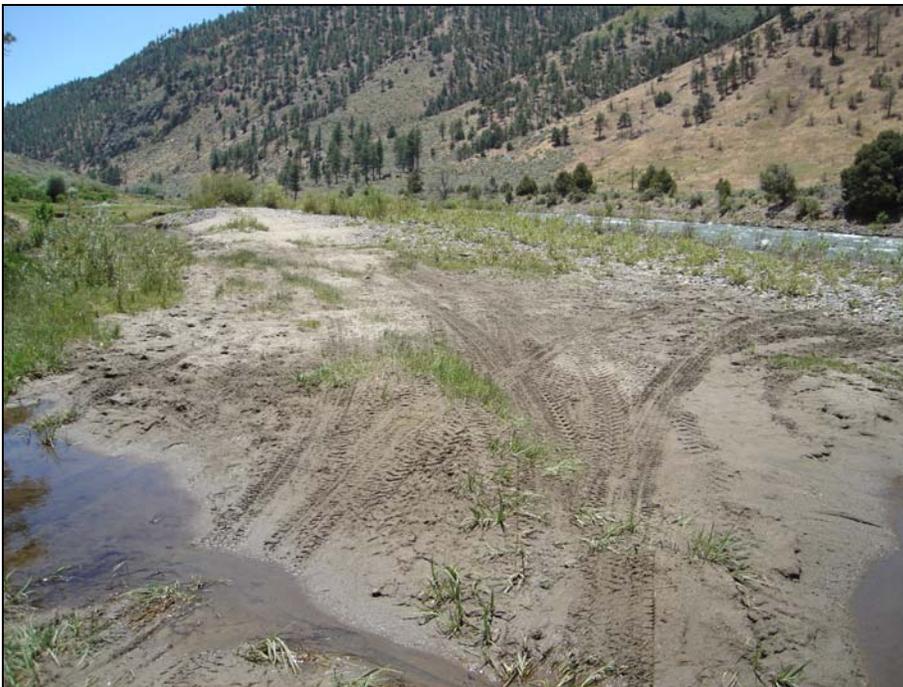
Site 9: East Fork Carson River, Carson Ranger District. Photo shows where vehicles have been driving on recently exposed bars, killing vegetation and exposing the land to increased erosion. This Site is located at UTM: N: 4299054 & E 265792, Elev. 5107 feet (1557m).

5. Encourage the use of designated OHV trails (Cottonwood Canyon, Barney Riley, and Scossa Canyon) for access to the East Fork Carson River. Utilize maps, signs, and trail markers to make designated trails known. Close and decommission all non designated roads, unwanted spurs/roadways, and social jeep trails, especially where adjacent roads are impacting the river (removal from maps, earth berms, fallen trees, etc.).

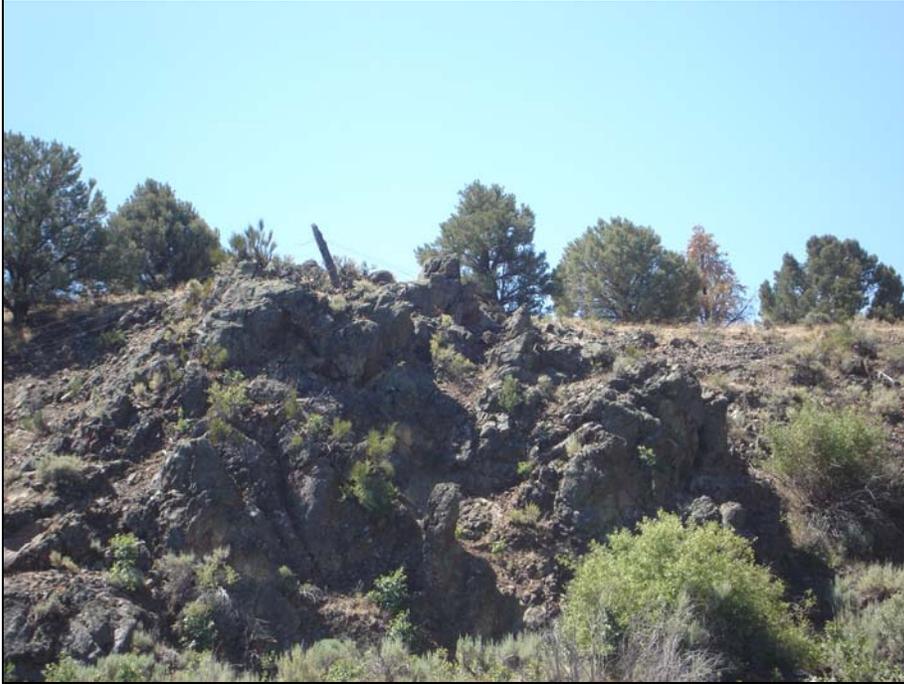
Site 13: East Fork Carson River, Carson Ranger District. Barely visible in the photo, a barbed wire fence runs up to the river's edge. During low flow, the fence is stretched across the East Fork. This site is located at UTM: 4295846 & E: 265661, Elev. 5136 feet (1566m).

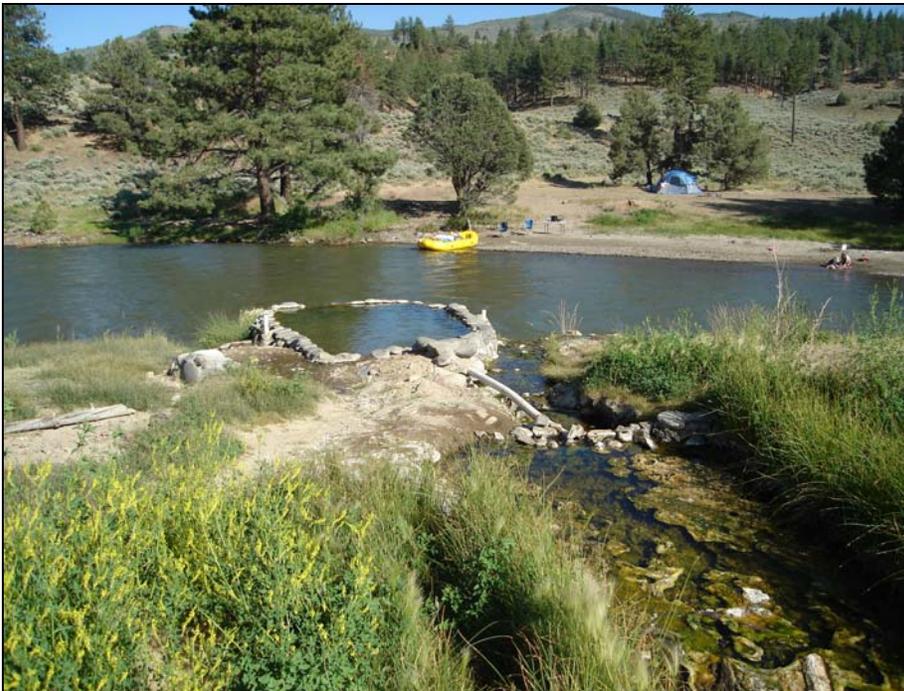
Site 14: East Fork Carson River, Carson Ranger District. The photo shows a man-made basin that catches water from the hot springs on river left. Across the stream is a frequently used campsite. At least 9 campsites were counted on both sides of the river. This site is located at UTM: N: 4294521 & E: 264232, Elev. 5179 feet (1579m).

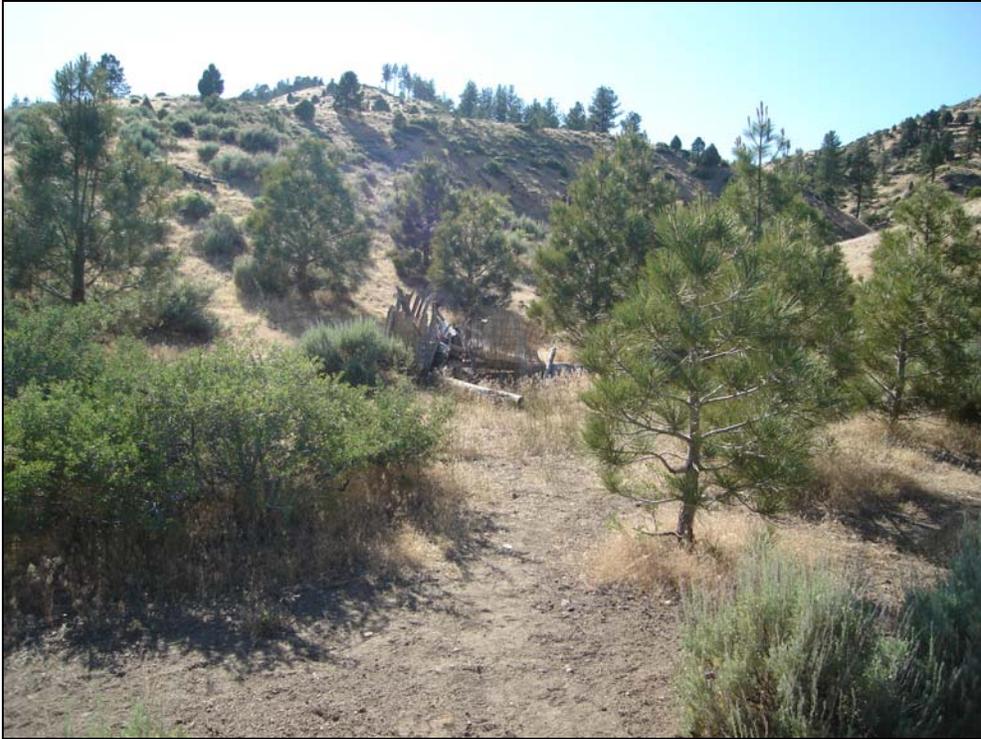
Site 14: East Fork Carson River, Carson Ranger District. Photo shows a primitive outhouse constructed by recreational visitors.

2. Require recreational users to carry out all human waste.
3. Work with the local ranchers/private land owners to reduce/eliminate livestock grazing impacts within the East Fork Carson River riparian areas. Monitor and enforce terms of grazing permits. Investigate the effects of livestock with respect to nutrient loading (TMDL).

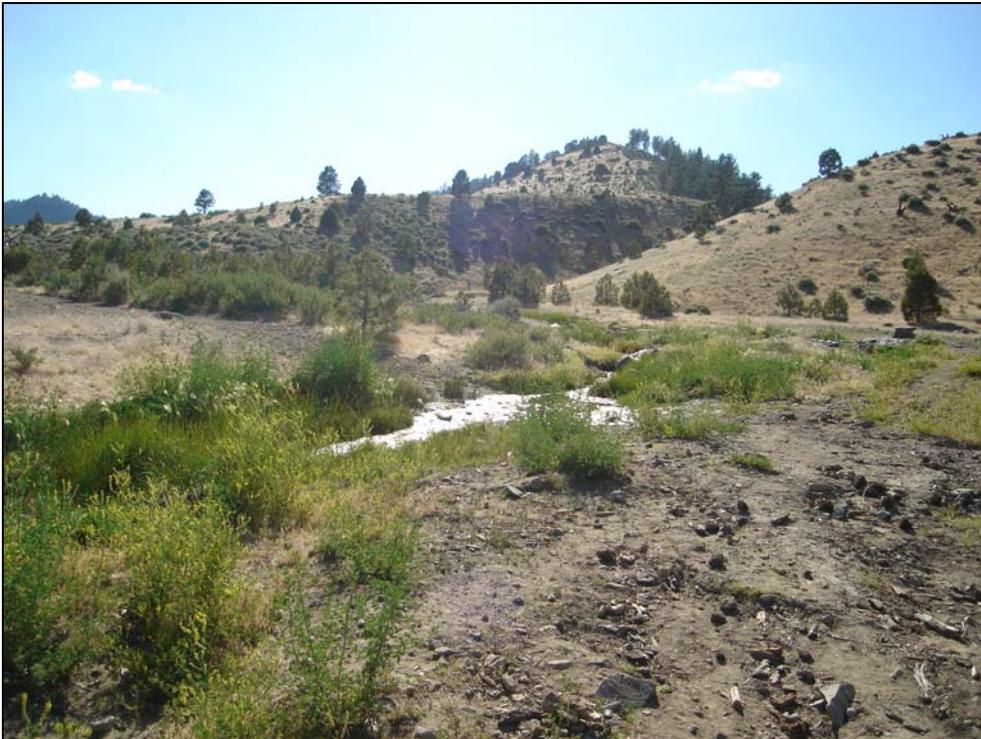
Site 14: East Fork Carson River, Carson Ranger District. A 4x4 road descends to the stream, running adjacent to the source of the hot springs. Jeep trails are visible on both sides of the river.

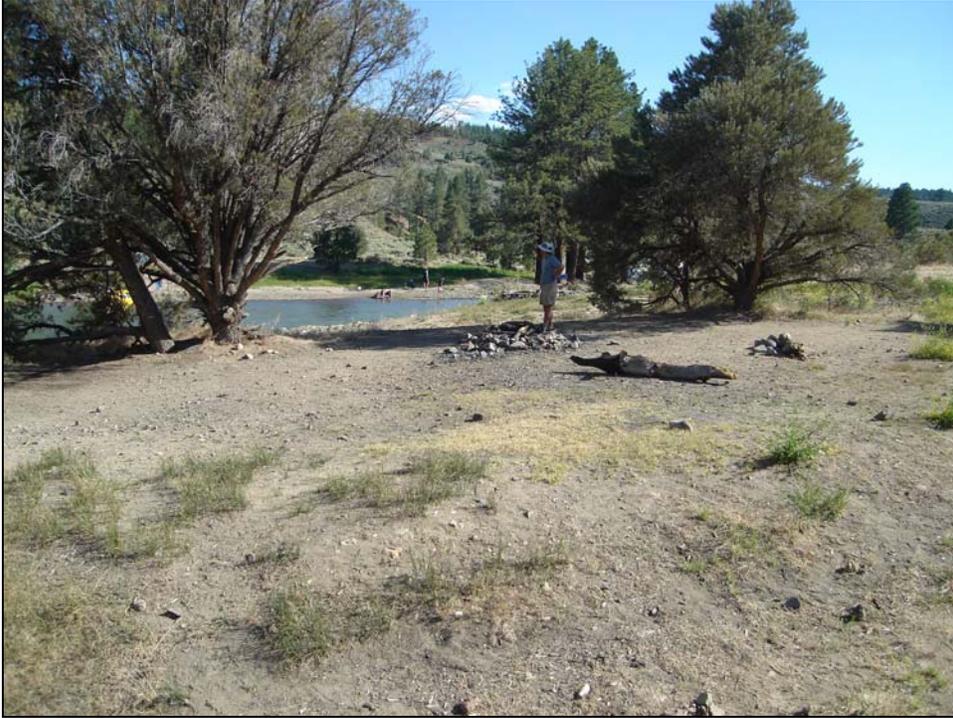
Site 14: East Fork Carson River, Carson Ranger District. One of nine campsites identified near this location. Blackened fire rings and barren ground indicate repeated use by the public.

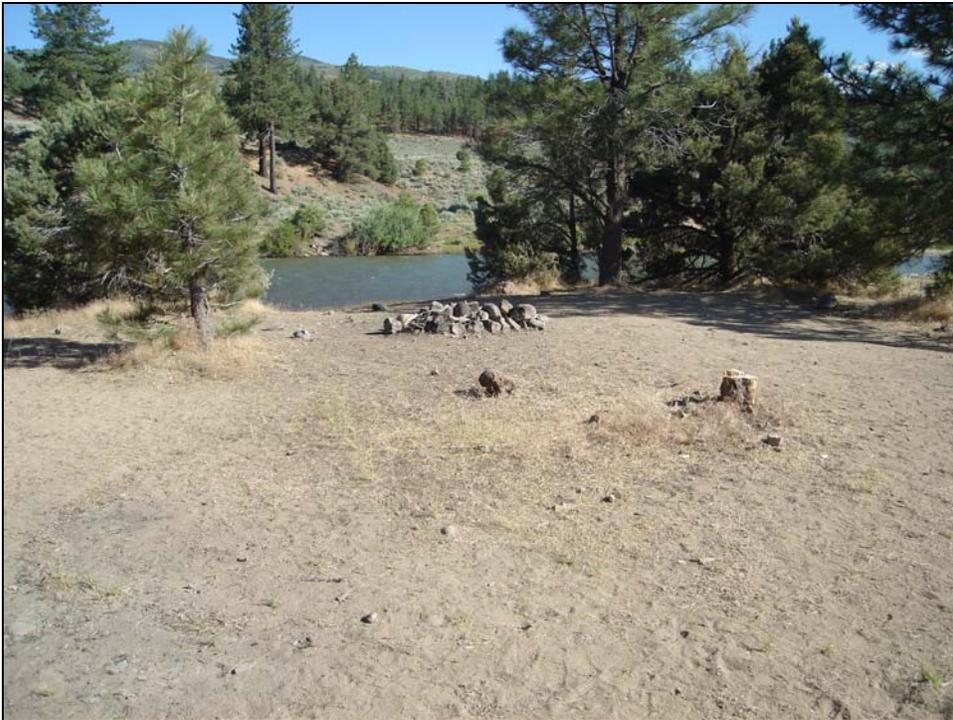
Site 15: East Fork Carson River, Carson Ranger District. A campsite marks the downstream end of a 1/8 mile string of dispersed campsites on river left. This site is located at UTM: N: 4294228 & E: 263869, Elev. 5215 feet (1590m).

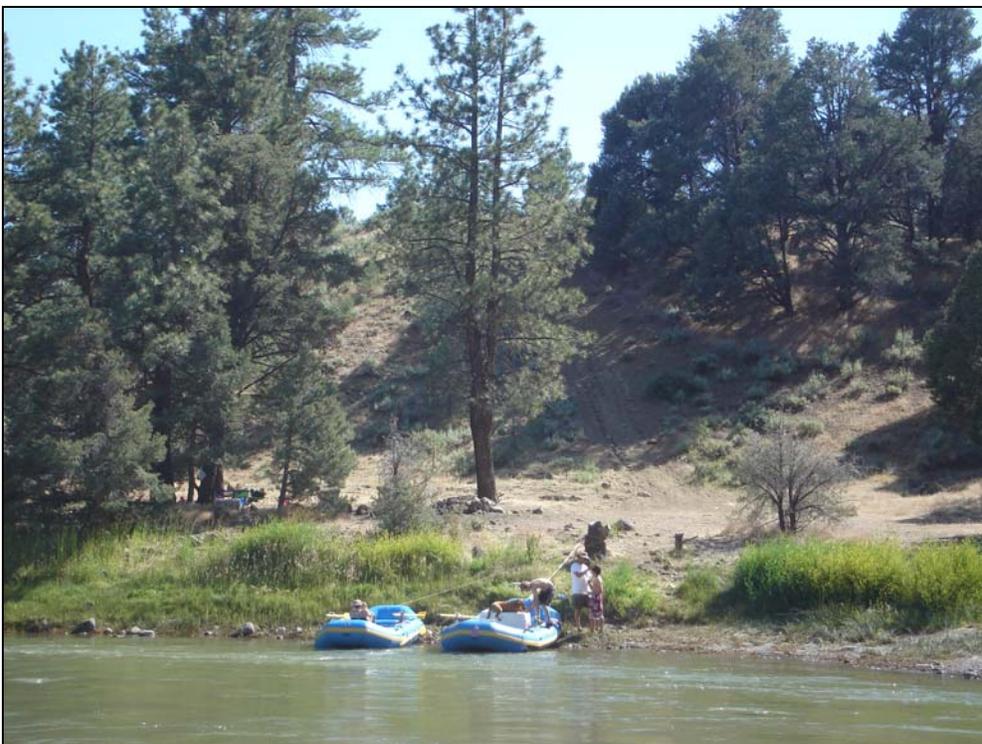
Site 16: East Fork Carson River, Carson Ranger District. Campsites, campers, and jeep trails indicate heavy use directly across from the hot spring on river left.

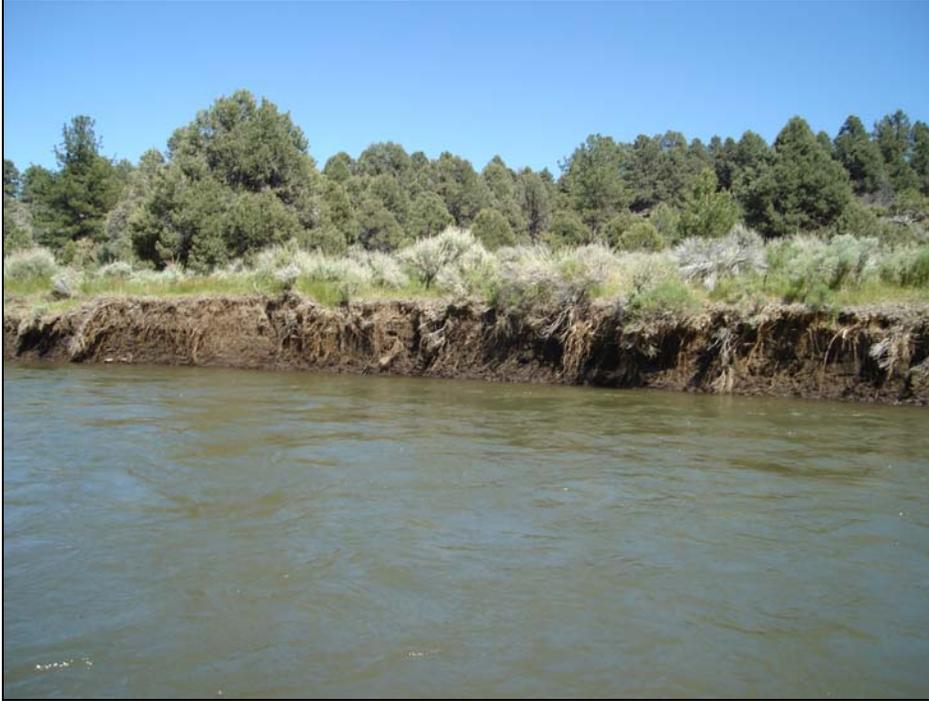
Site 18: East Fork Carson River, Carson Ranger District. Photo shows a loose vertical right bank. A low-use road runs adjacent to the river approximately 30 feet from the waters edge. This site is located at UTM: N: 4294112 & E: 263162, Elev. 5232 feet (1595m).

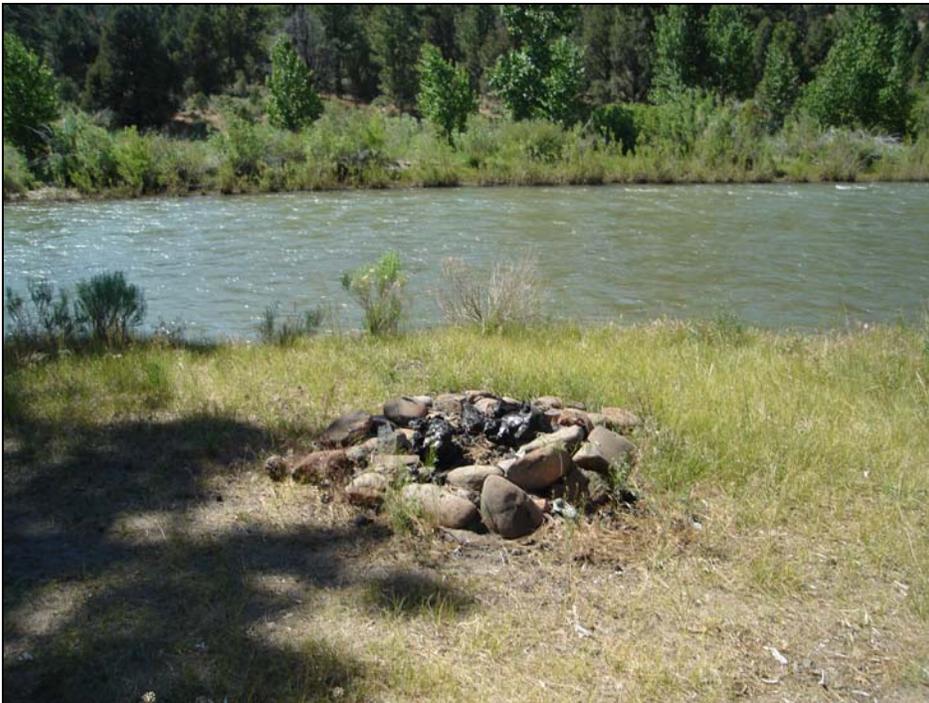
Site 19: East Fork Carson River, Carson Ranger District. A small campsite (45 ft x 75 ft) is located on the river right bank, approximately 1 m from the waters edge. This site is located at UTM: N: 4294033 & E: 263117, Elev. 5228 feet (1594m).

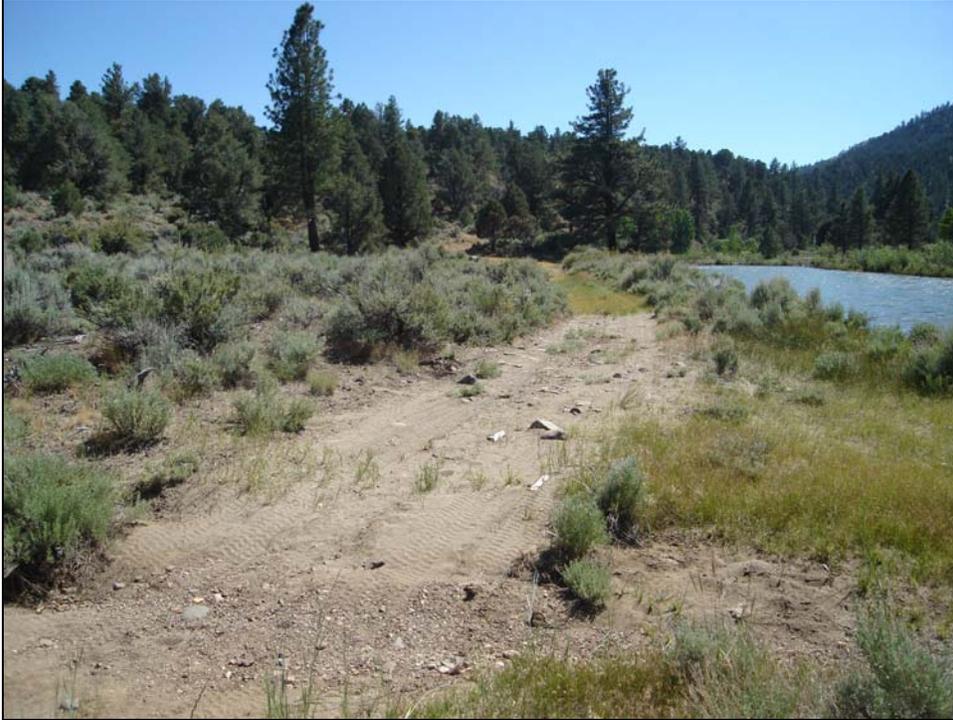
Site 19: East Fork Carson River, Carson Ranger District. A road leading to the campsite runs adjacent to the river for approximately 200 feet. This site is located at UTM: N: 4294033 & E: 263117, Elev. 5228 feet (1594m).

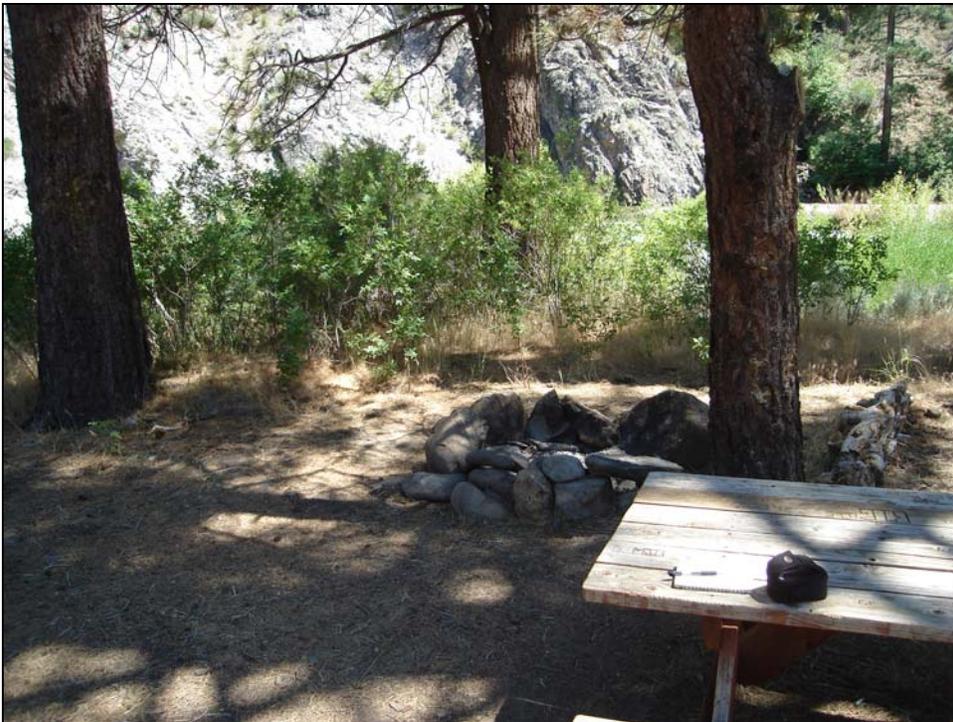
Site 20: East Fork Carson River, Carson Ranger District. A large campsite, including a wooden picnic table (100 ft x 130 ft), is located on river left. This site is located at UTM: N: 4292117 & E: 262096, Elev. 5307 feet (1618m).

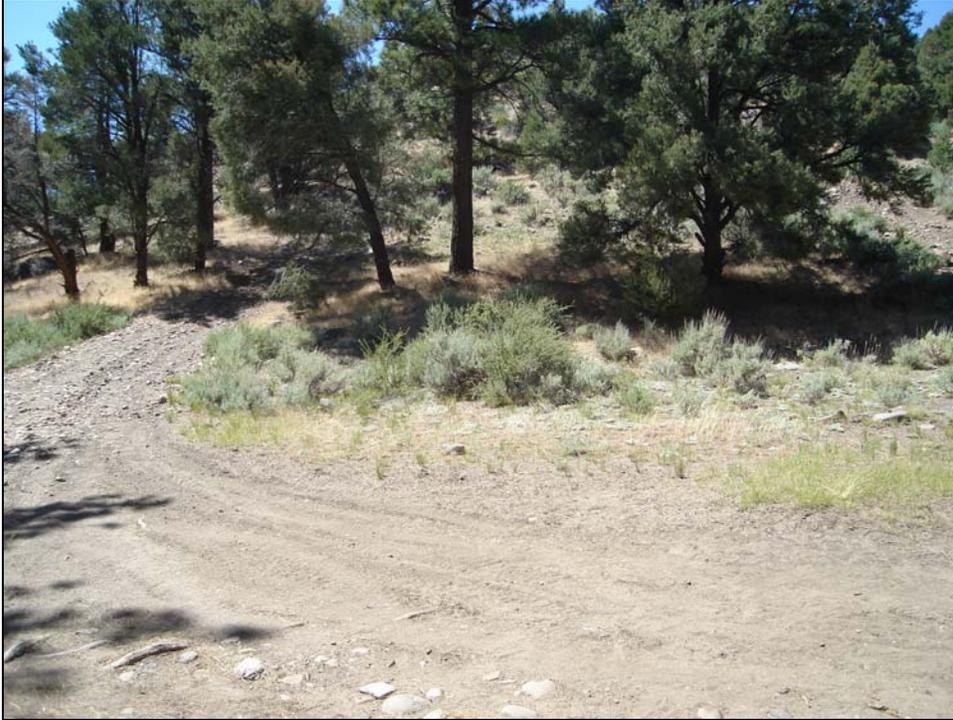
Site 20: East Fork Carson River, Carson Ranger District. The campsite/parking area lacks vegetative cover. This site is located at UTM: N: 4292117 & E: 262096, Elev. 5307 feet (1618m).

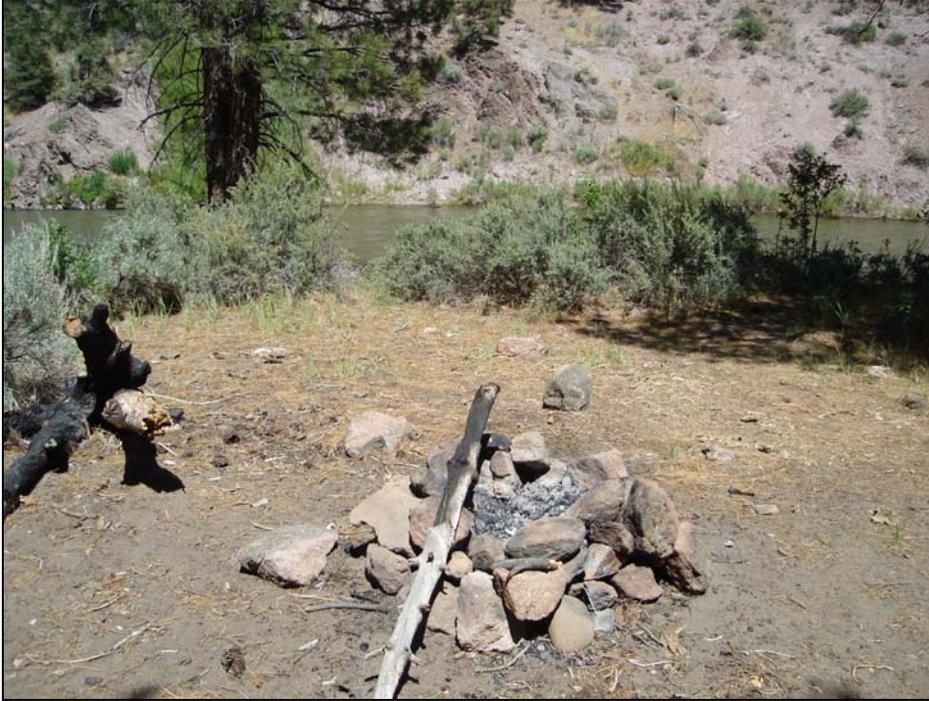
Site 21: East Fork Carson River, Carson Ranger District. Photo shows part of a campsite which shows signs of frequent use by rafters. The camp was located 10 meters from the waters edge and the barren ring around the fire is approximately 20 meters in diameter. This camp is located at UTM: N: 4291827 & E: 261433, Elev. 5317 feet (1621m).

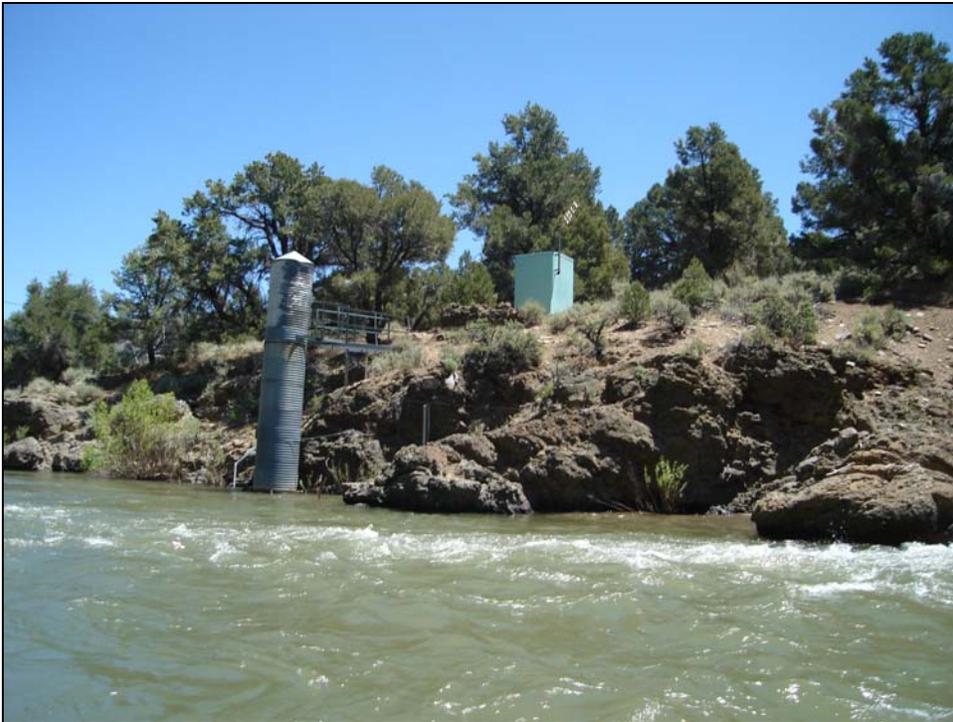
Site 23: East Fork Carson River, Carson Ranger District. Photo shows a USGS gauging station on river right (USGS 10308200). This station is located at UTM: N: 4288511 & E: 259683, Elev. 5399 feet (1646m).

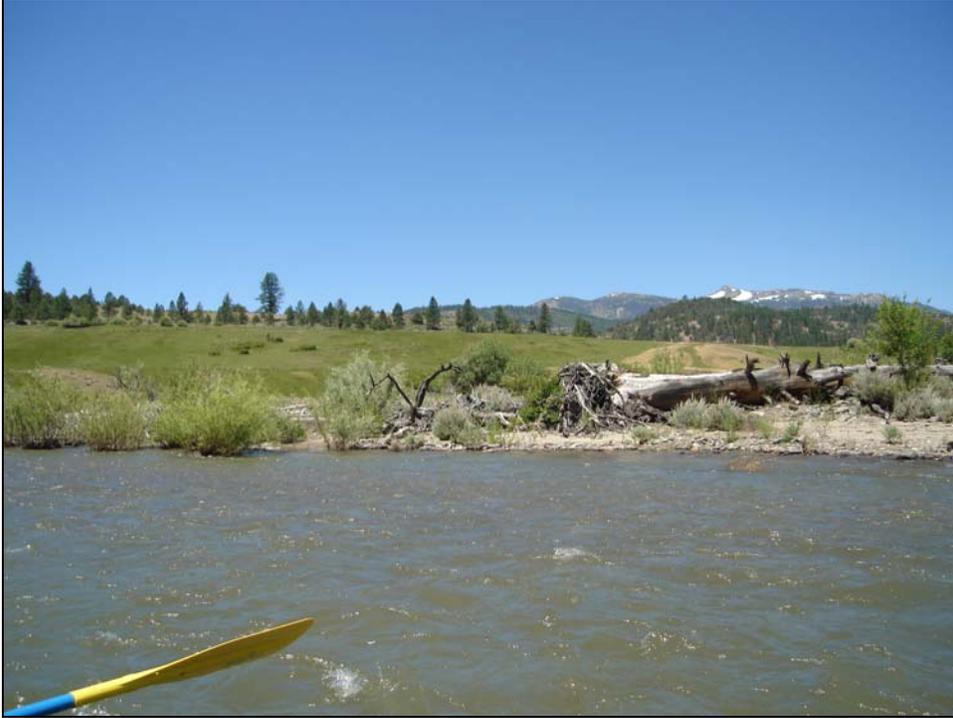
Site 26: East Fork Carson River, Carson Ranger District. Photo shows left bank of the river where grazing pasture is visible. Grazing was evident on both banks. This site is located at UTM: 4287448 & E: 259510, Elev. 5415 feet (1651m).

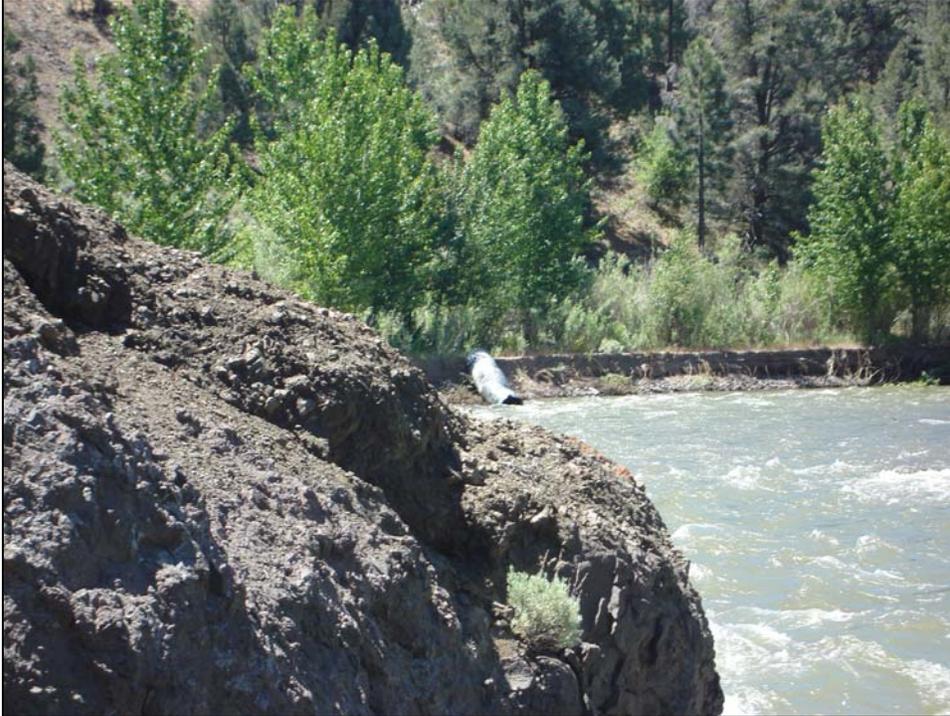
Site 28: East Fork Carson River, Carson Ranger District. Upstream view of a trash culvert deposited during high flows. This site is located at UTM: N: 4286230 & E: 259579, Elev. 5415 feet (1651m).

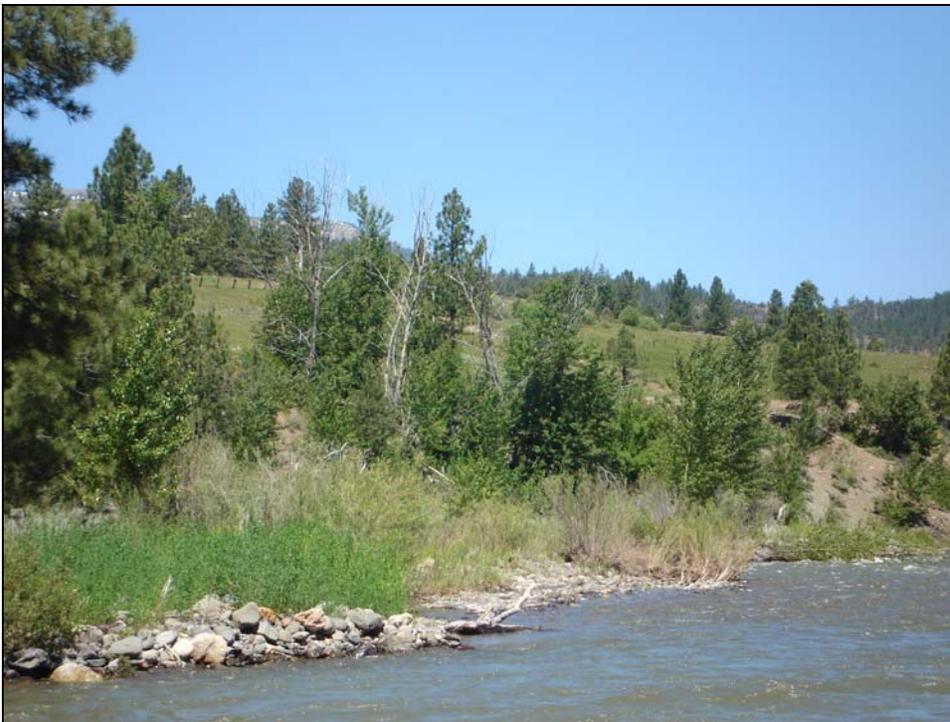
Site 28: East Fork Carson River, Carson Ranger District. Downstream view of grazing land on river left. This site is located at UTM: N: 4286230 & E: 259579, Elev. 5415 feet (1651m).

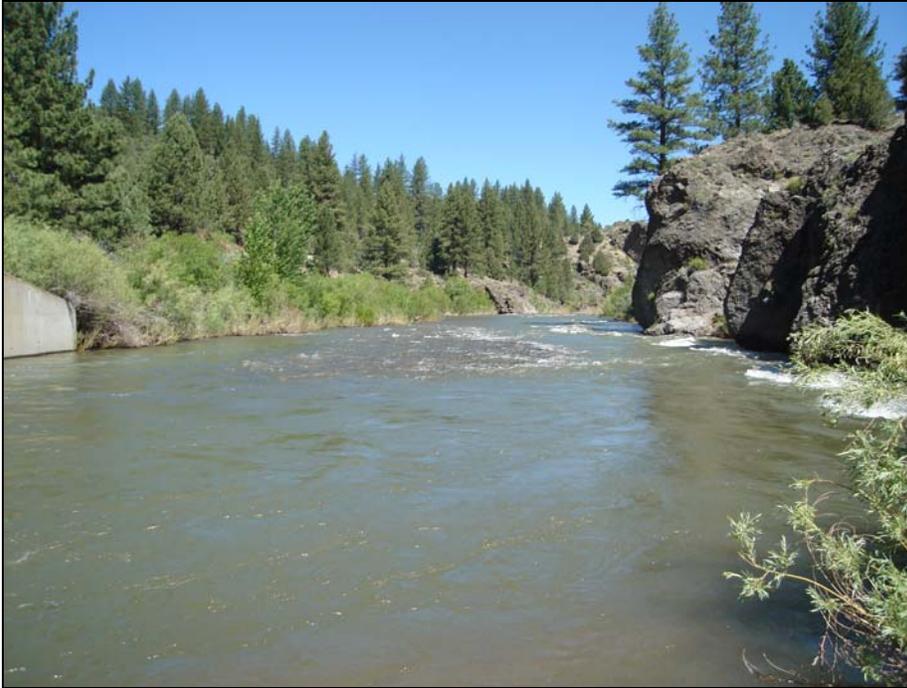
Site 29: East Fork Carson River, Carson Ranger District. Downstream view from Hangman's Bridge. This site is located at UTM: N: 4285774 & E: 259577, Elev. 5481 feet (1671m).

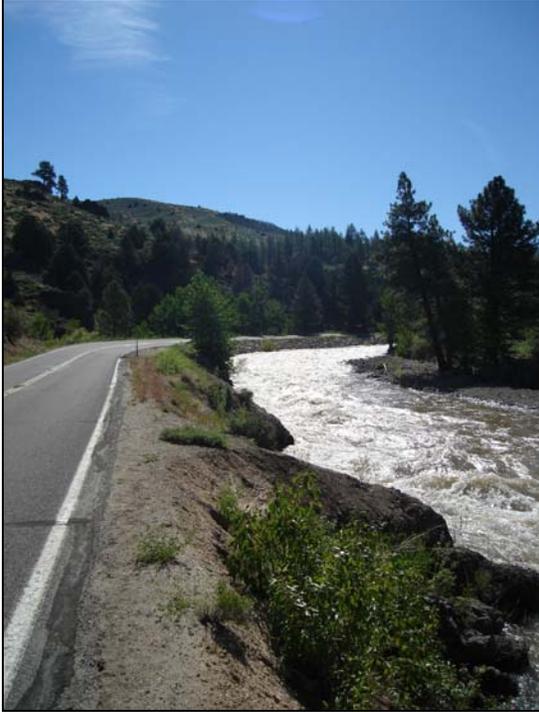
Site 30: East Fork Carson River, Carson Ranger District. Upstream view shows how the highway is confining the channel by cutting off the floodplain. This site is located at UTM: N: 4285738 & E: 260106, Elev. 5478 feet (1670m).

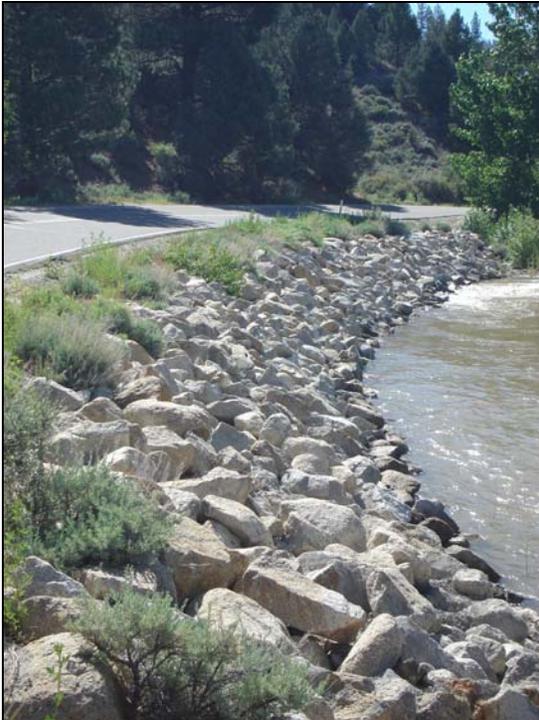
Site 31: East Fork Carson River, Carson Ranger District. Rip-rap is used to protect the highway from erosion on the outside of a river bend. This site is located at UTM: N: 4285737 & E: 260239, Elev. 5402 feet (1674m).
