EAST FORK CARSON RIVER

2006 Stream Habitat Survey Report

Carson Ranger District: Humboldt-Toiyabe National Forest

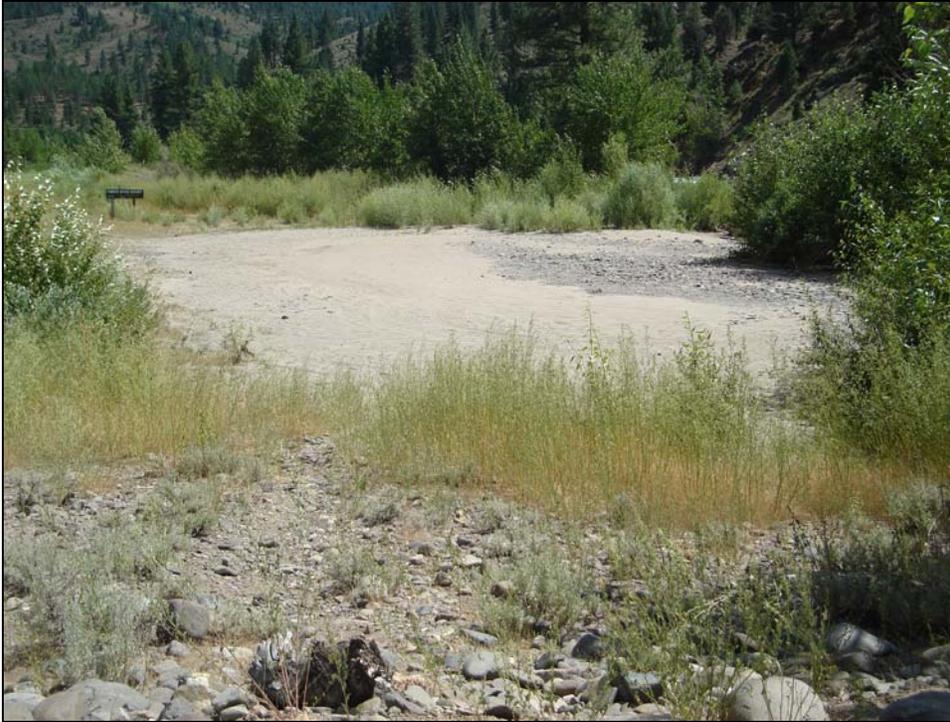
Site 32: East Fork Carson River, Carson Ranger District. Recreational boaters, anglers, etc. drive vehicles on stream banks and into channel. This site is located at UTM: 4285513 & E: 260471, Elev. 5537 feet (1688m).

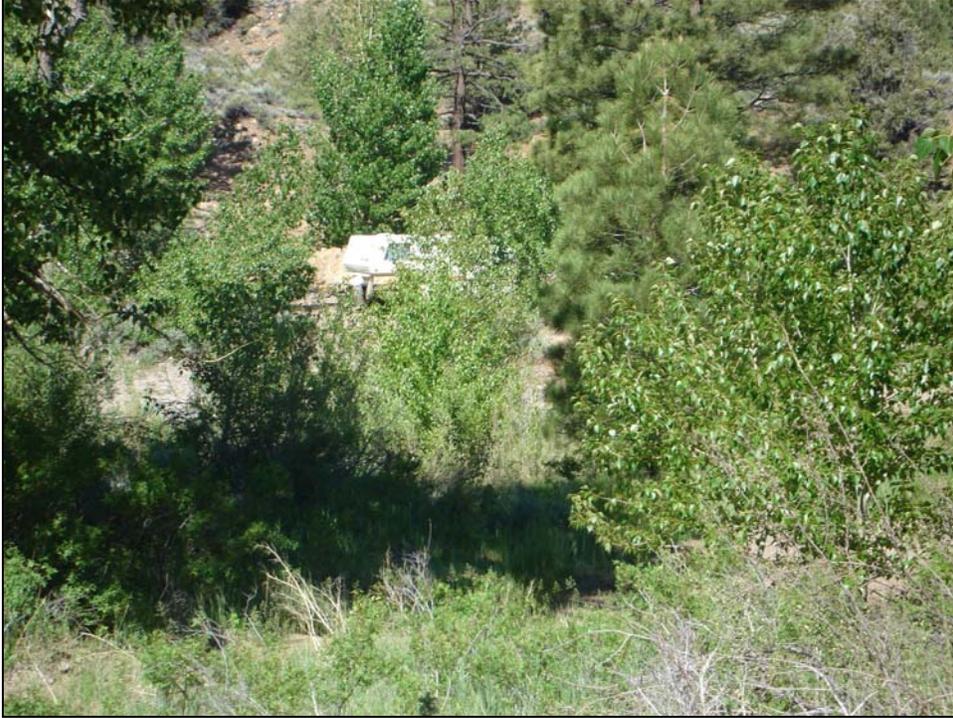
Site 34: East Fork Carson River, Carson Ranger District. A private campground is located on river right. Centered in the photo is a large RV. This site is located at UTM: N: 4284715 & E: 260843, Elev. 5520 feet (1683m).

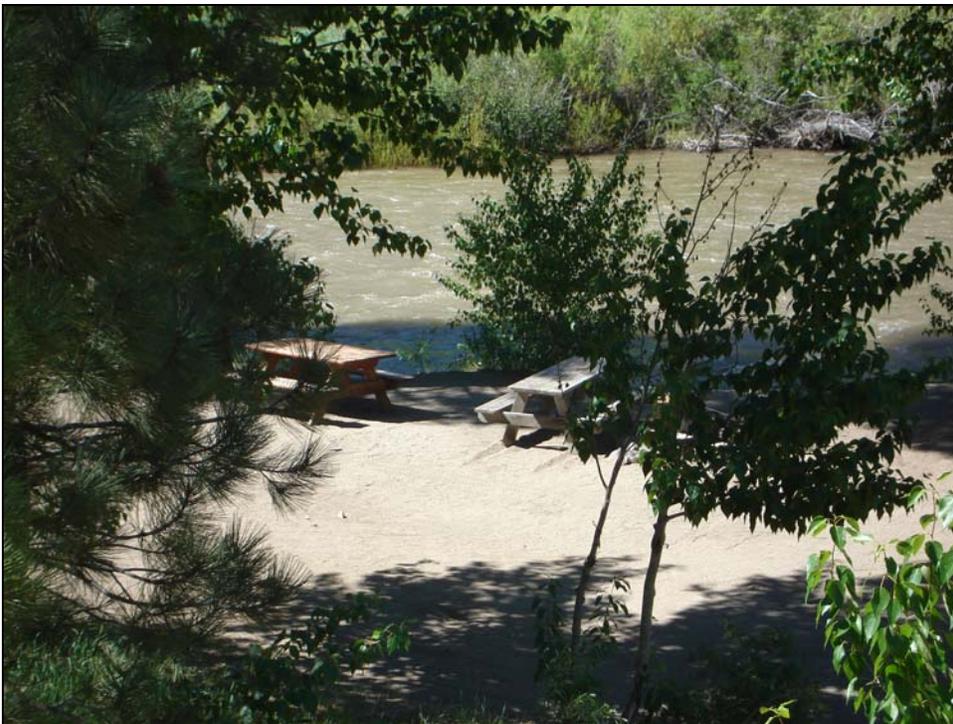
Site 34: East Fork Carson River, Carson Ranger District. A private campground is located on river right. Photo shows picnic tables located near the waters edge. This site is located at UTM: N: 4284715 & E: 260843, Elev. 5520 feet (1683m).

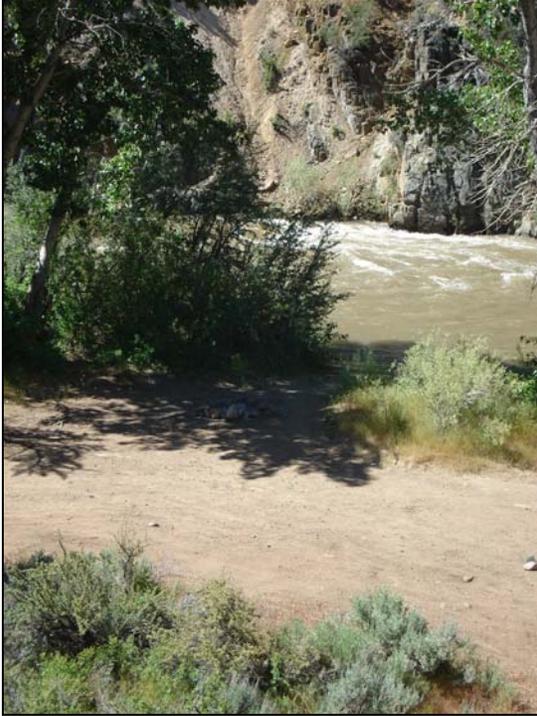
Site 35: East Fork Carson River, Carson Ranger District. Photo shows a small (15m x 30m) campsite located on river right. This camp is located at UTM: N: 4284570 & E: 261113, Elev. 5556 feet (1694m).

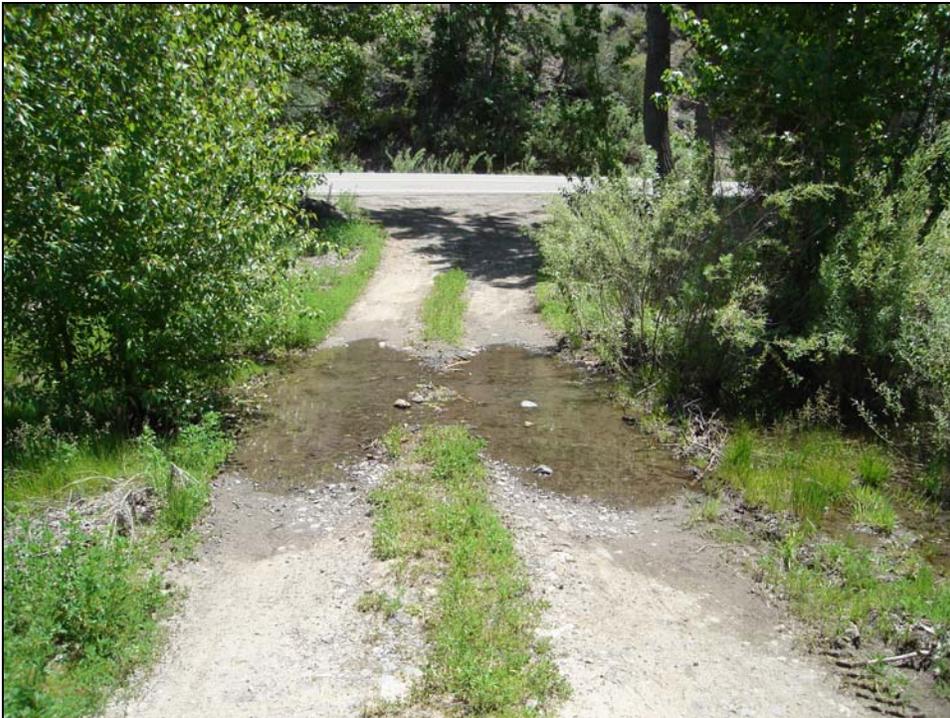
Site 43: East Fork Carson River, Carson Ranger District. A gravel road connects the jetty to the highway. This site is located at UTM: N: 4281743 & E: 263005, Elev. 5704 feet (1739m).

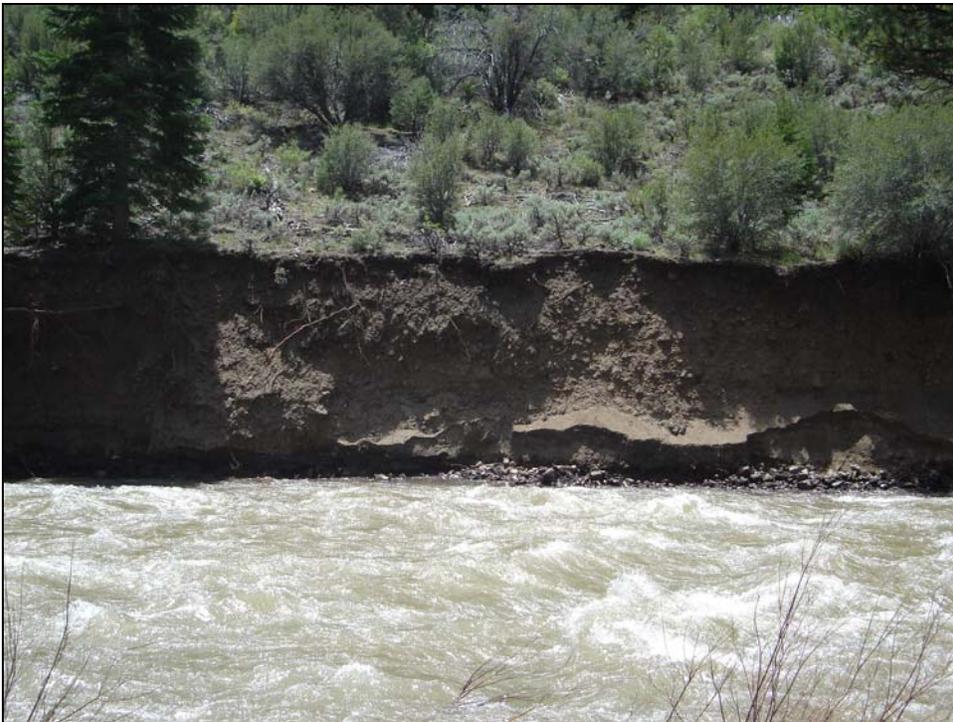
Site 47: East Fork Carson River, Carson Ranger District. Erosion concern. Loose bank measures 1-3 m in height and approximately 80 m in length. This site is located at UTM: N: 4280932 & E: 262756, Elev. 5743 feet (1751m).

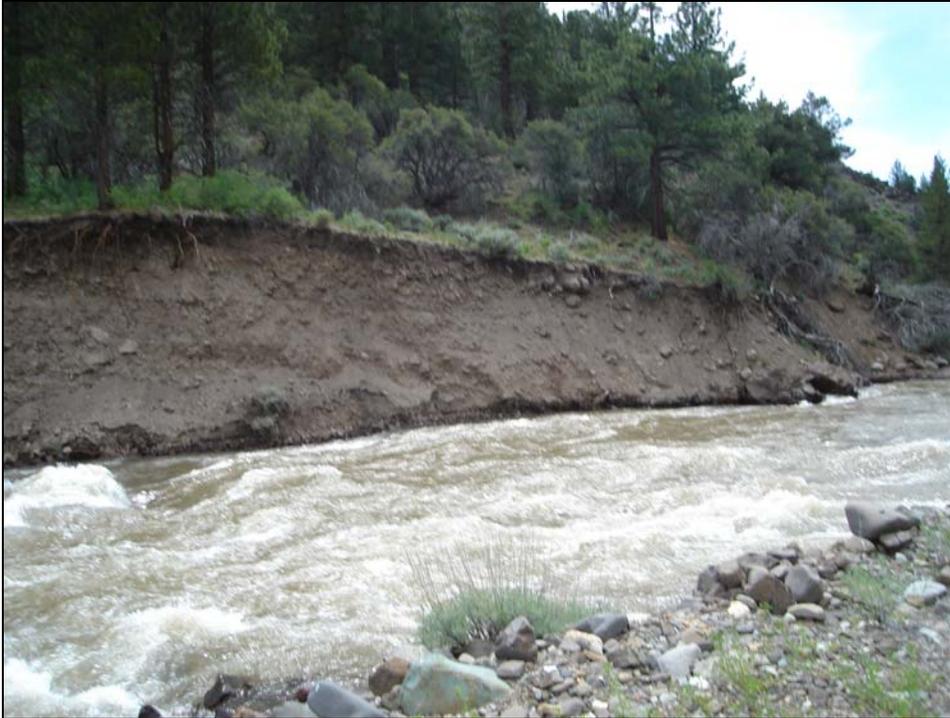
Site 50: East Fork Carson River, Carson Ranger District. Photo shows a 60 m x 8 m eroding bank on river right. This site is located at UTM: N: 4279801 & E: 263057, Elev. 5809 feet (1771m).

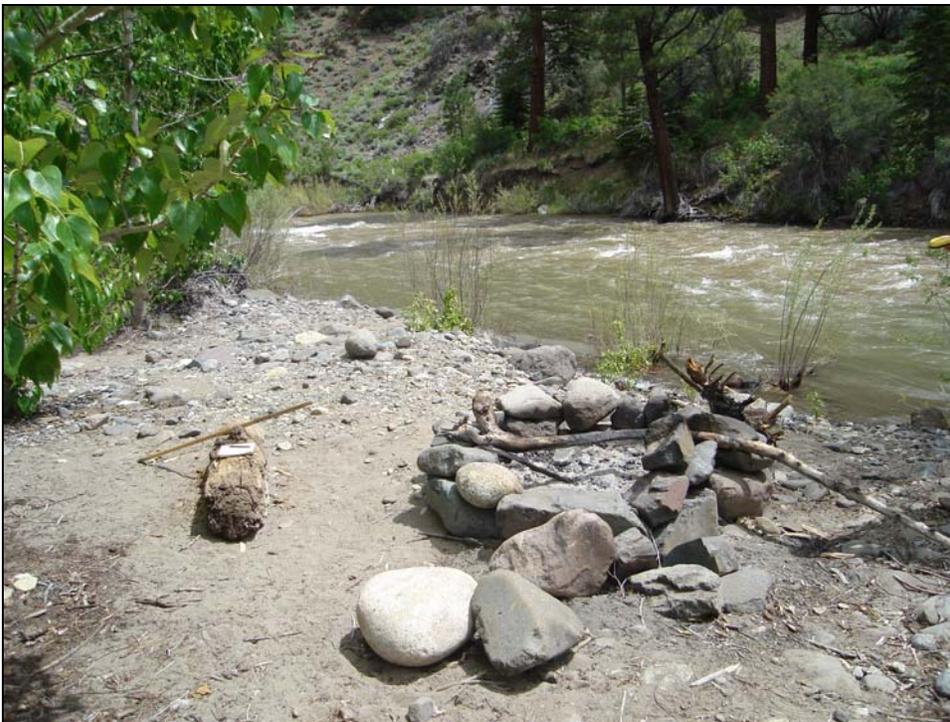
Site 51: East Fork Carson River, Carson Ranger District. Photo shows a campsite established on the river left bank, approximately 10m from the water. This campsite is located at UTM: N: 4279243 & E: 263313, Elev. 5848 feet (1783m).

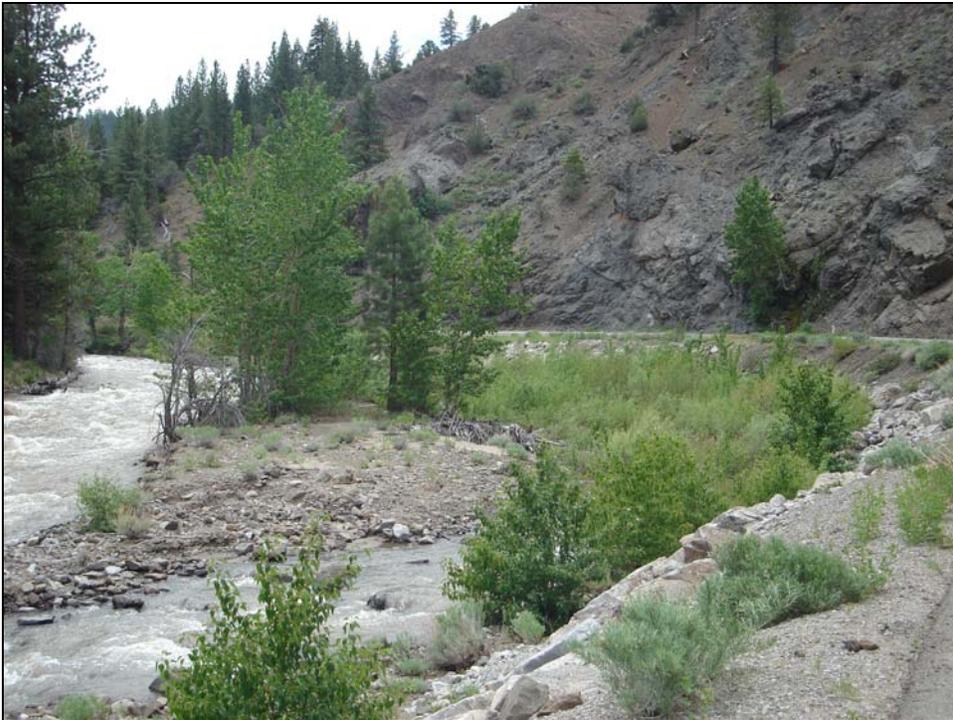
Site 55: East Fork Carson River, Carson Ranger District. Upstream photo shows where Wolf Creek Road has confined the channel, requiring rip-rap to minimize erosion. This site is located at UTM: N: 4278370 & E: 263239, Elev. 5881 feet (1793m).

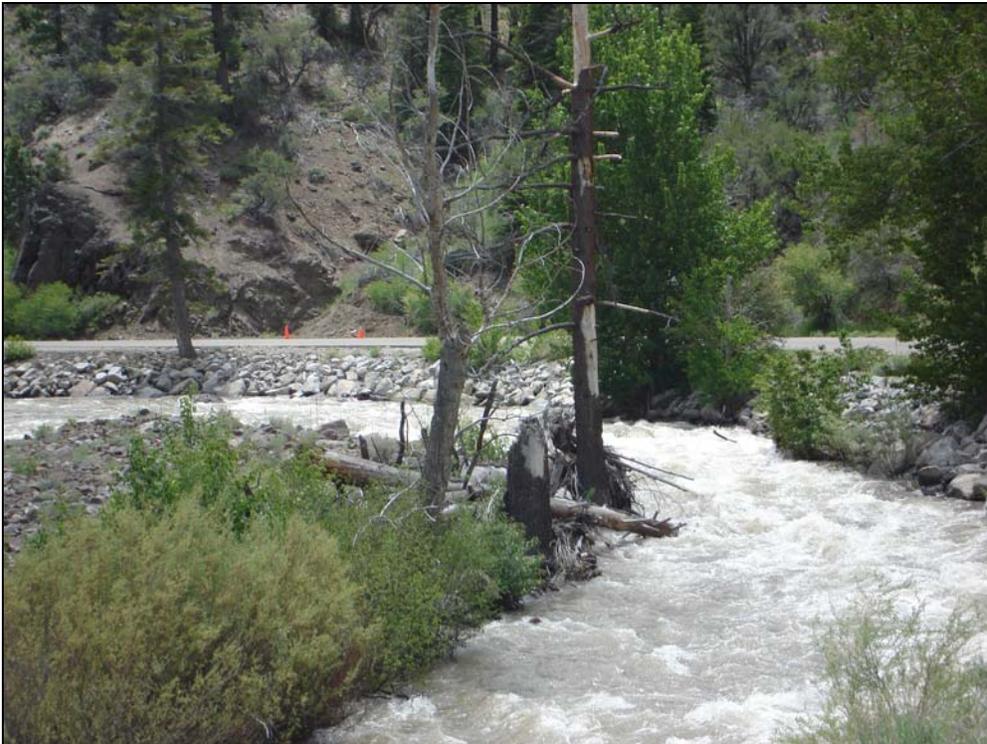
Site 57: East Fork Carson River, Carson Ranger District. Upstream photo shows adjacent road and required rip-rap to prevent the river from undercutting the roadway. This site is located at UTM: N: 4278042 & E: 263548, Elev. 5914 feet (1803m).

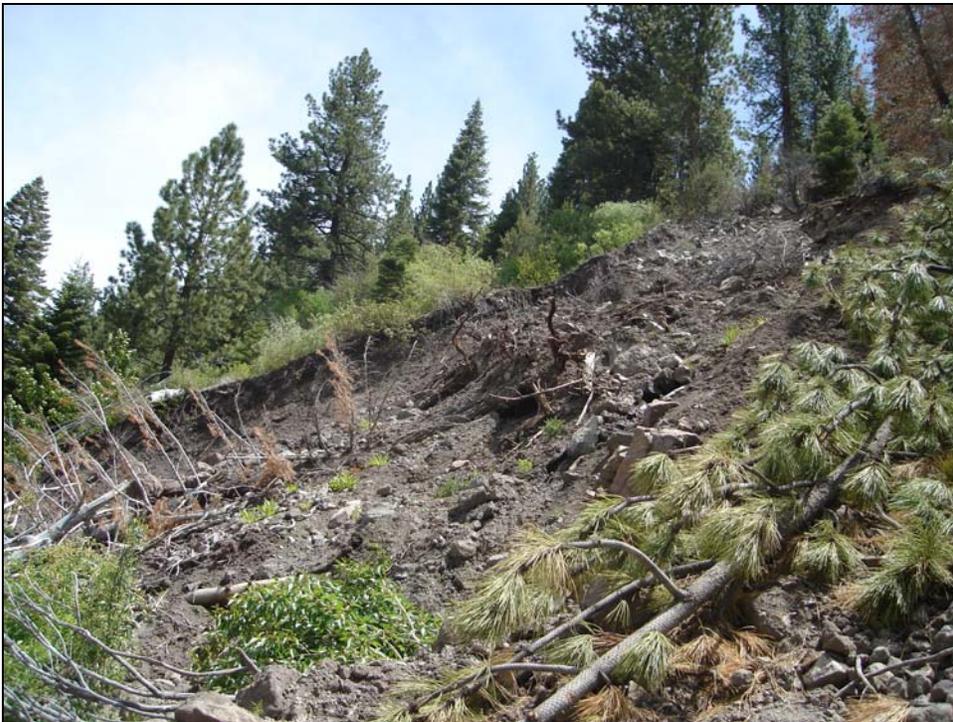
Site 61: East Fork Carson River, Carson Ranger District. Photo shows a large slump on left bank. This site is located at UTM: N: 4277571 & E: 264296, Elev. 5963 feet (1818m).

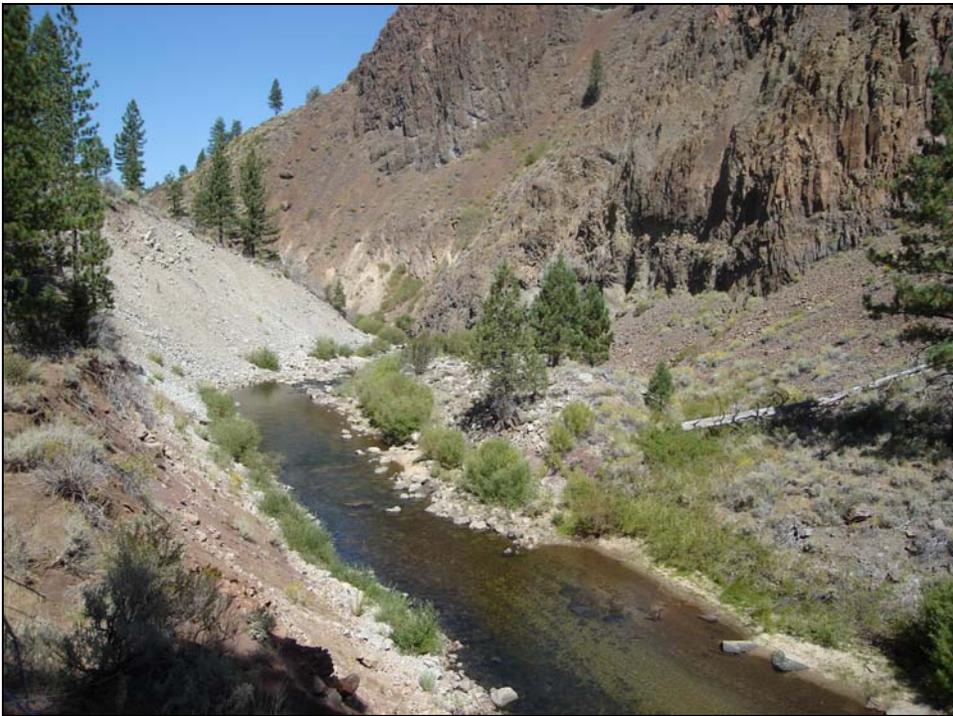
Site 70: East Fork Carson River, Carson Ranger District. A large open slide has downed trees and left a big exposed face of erosion. This site is located at UTM: N: 4275714 & E: 267235.

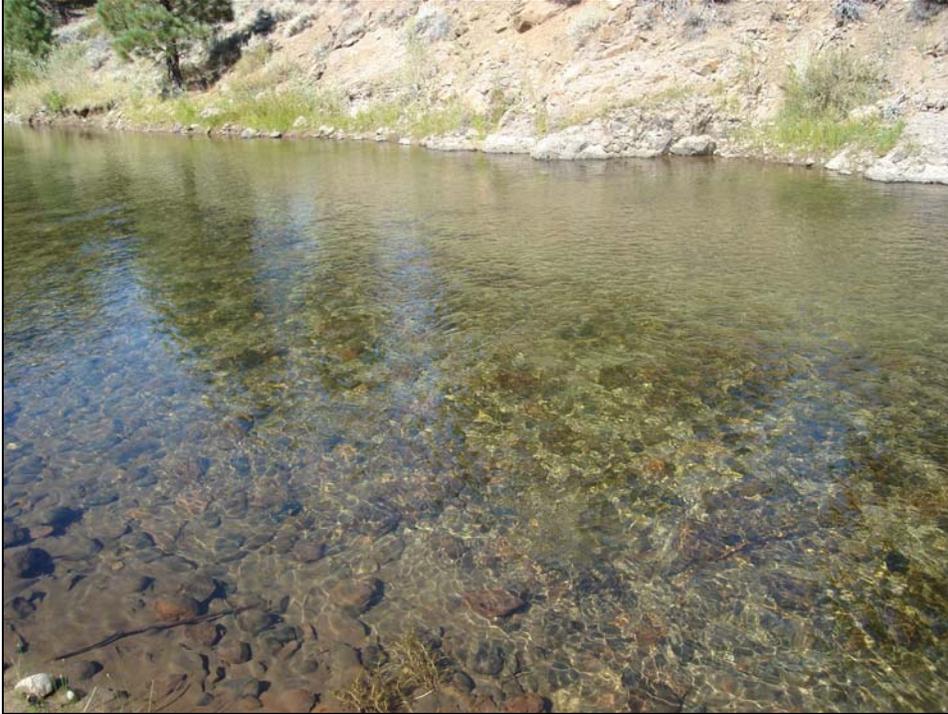
Site 72: East Fork Carson River, Carson Ranger District. Photo shows a run where a single fish was sighted. This site is located at UTM: N: 4275309 & E: 267897, Elev. 6212 feet (1894m).

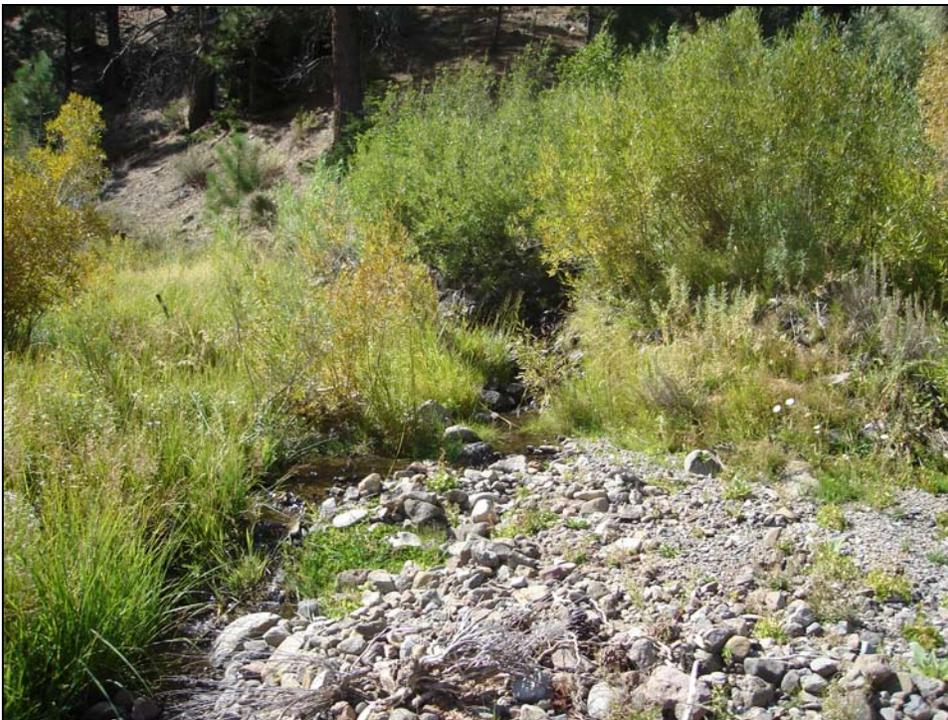
Site 73: East Fork Carson River, Carson Ranger District. Photo shows the mouth of Railroad Canyon where a tributary enters on river left. This site is located at UTM: N: 4275196 & E: 268025, Elev. 6239 feet (1902m).

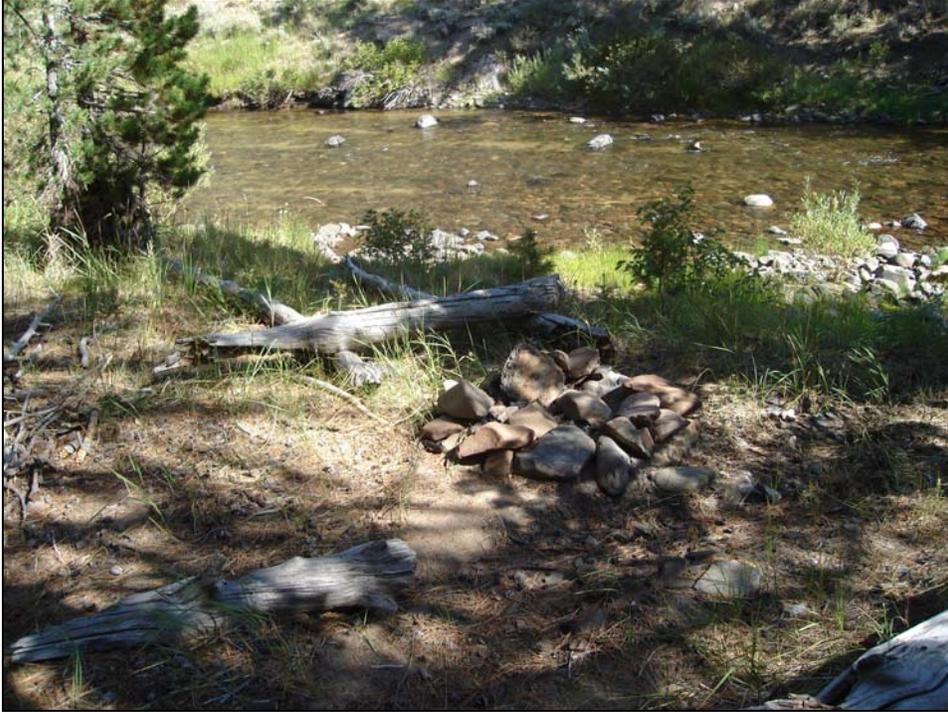
Site 74: East Fork Carson River, Carson Ranger District. A campsite is located approximately 10 meters from the left bank. This campsite is located at UTM: N: 4274968 & E: 268479, Elev. 6242 feet (1903m).

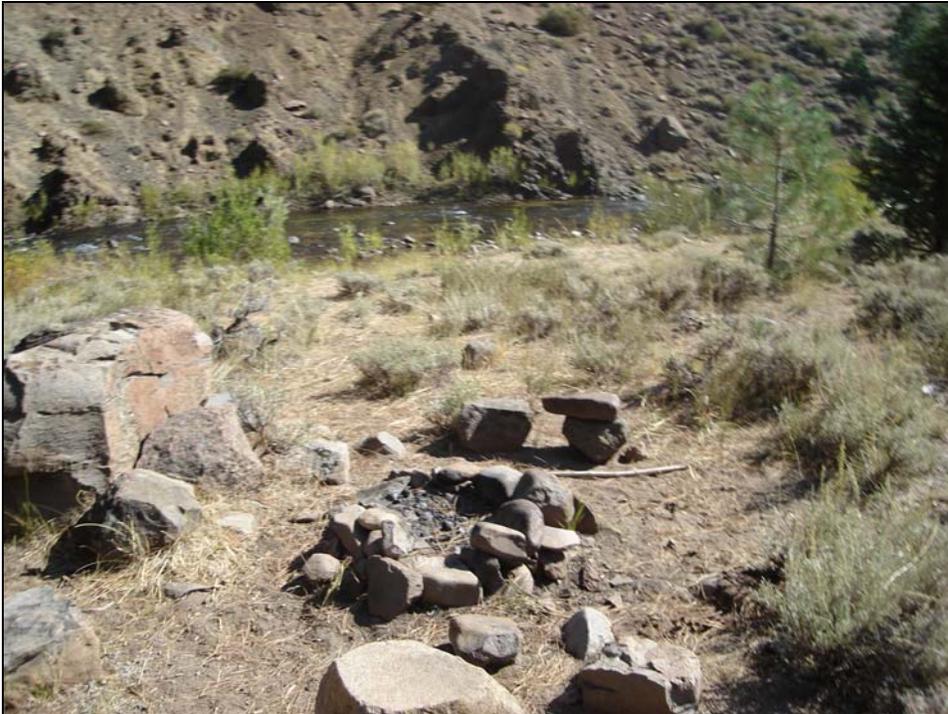
Site 75: East Fork Carson River, Carson Ranger District. Photo shows a campsite with dimensions 10 m x 20 m. This site is located at UTM: N: 4274740 & E: 268617, Elev. 6255 feet (1907m).

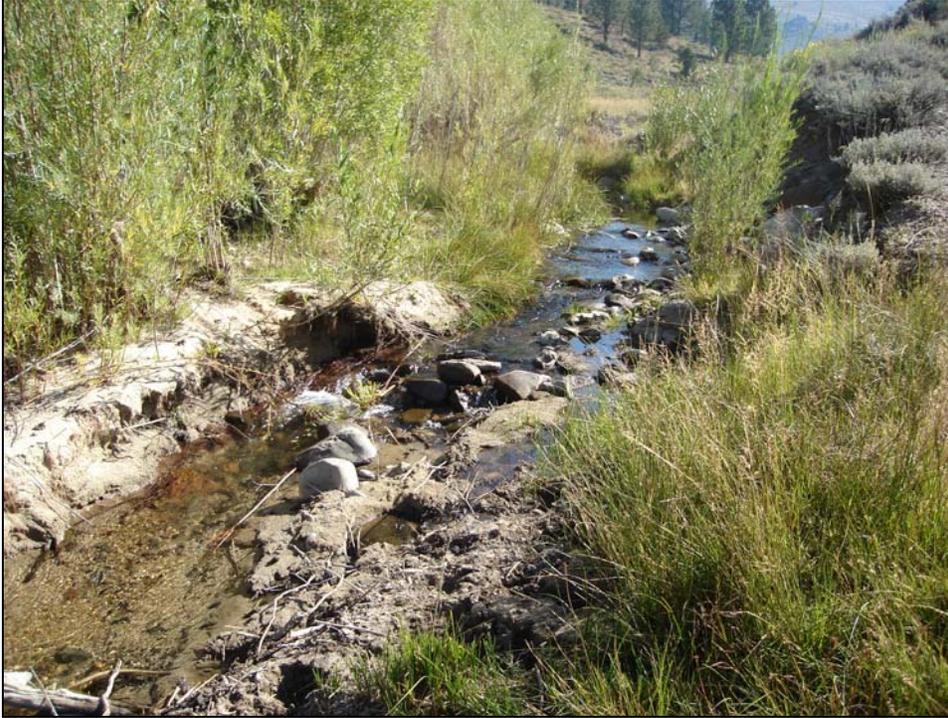
Site 76: East Fork Carson River, Carson Ranger District. Looking up Bagley Creek, which enters the East Fork on river right. This confluence is located at UTM: N: 4274645 & E: 268694, Elev. 6255 feet (1907m).

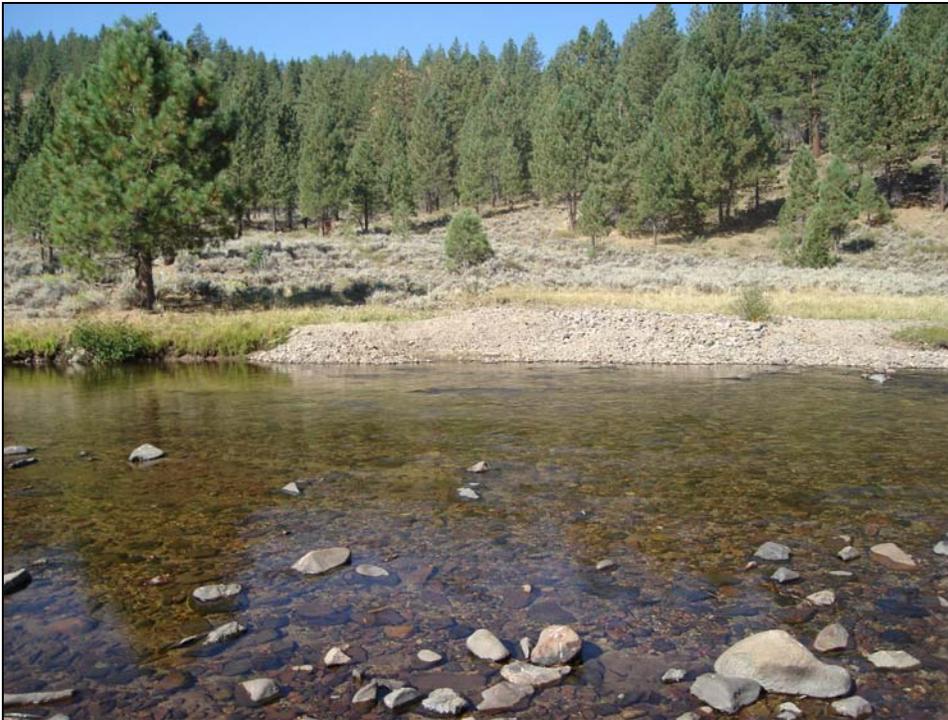
Site 77: East Fork Carson River, Carson Ranger District. Cross-sectional view of Gray's crossing, where foot traffic and pack stock ford the river. This site is located at UTM: N: 4274639 & E: 268697, Elev. 6265 feet (1910m).

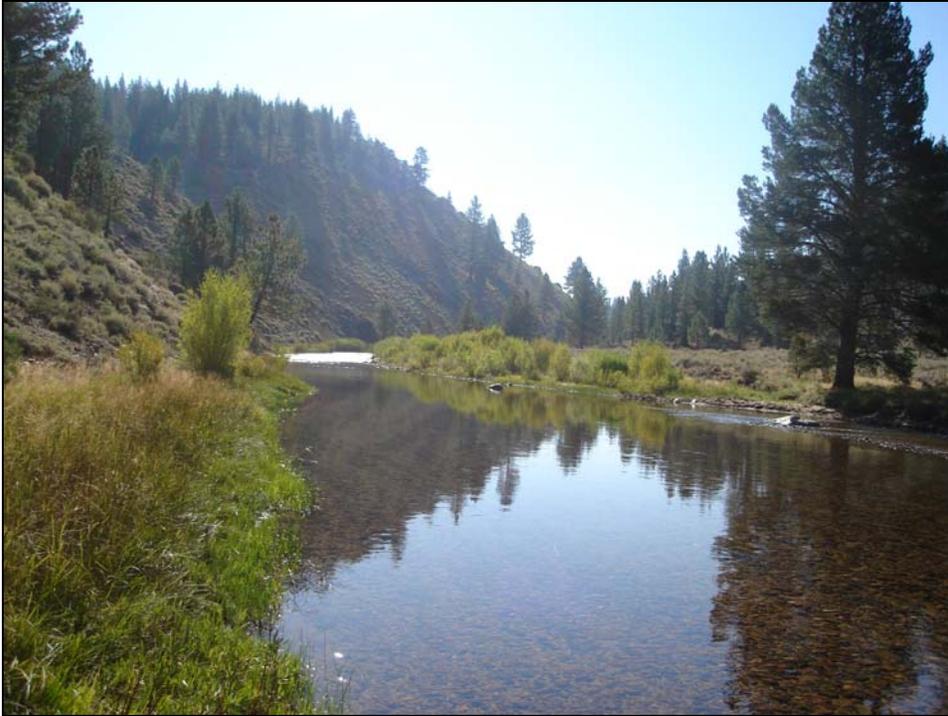
Site 78: East Fork Carson River, Carson Ranger District. Upstream view of a long and wide riffle. This site is located at UTM: N: 4274410 & E: 268791, Elev. 6229 feet (1899m).

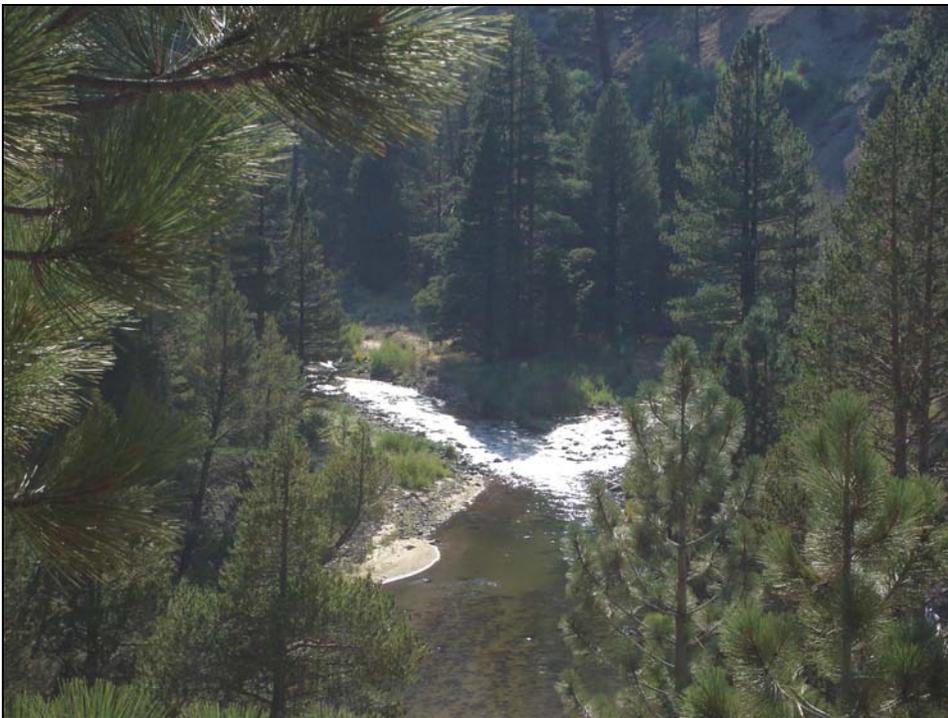
Site 79: East Fork Carson River, Carson Ranger District. Looking upstream from the wall of a short canyon adjacent to Bagley Valley. This site is located at UTM: N: 4273251 & E: 269845, Elev. 6465 feet (1971m).

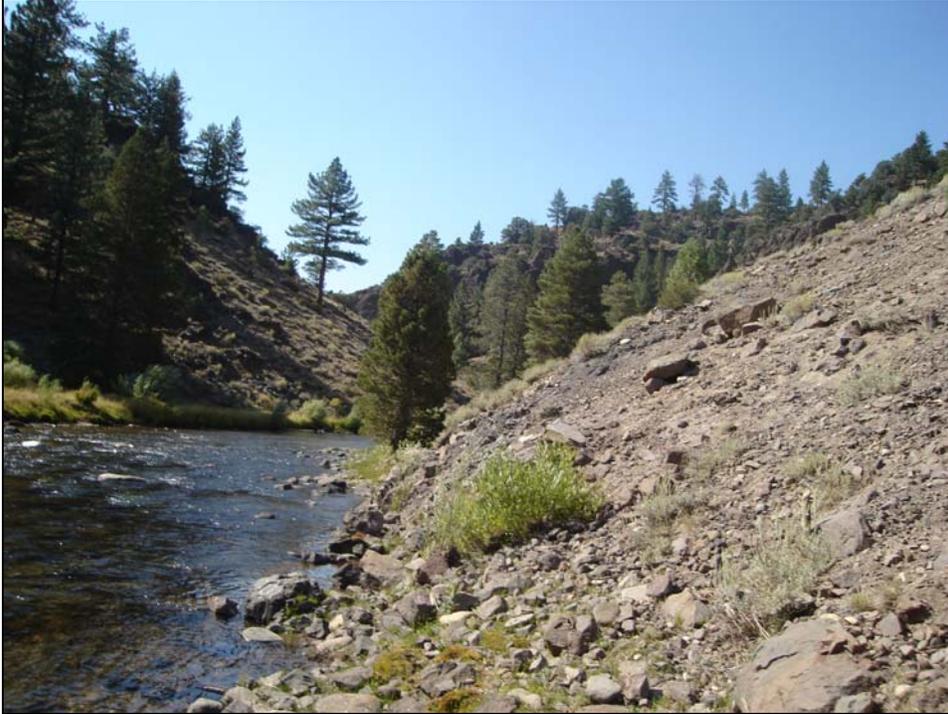
Site 80: East Fork Carson River, Carson Ranger District. Downstream view of point where the river enters a small canyon. This site is located at UTM: N: 4272604 & E: 270232, Elev. 6366 feet (1941).

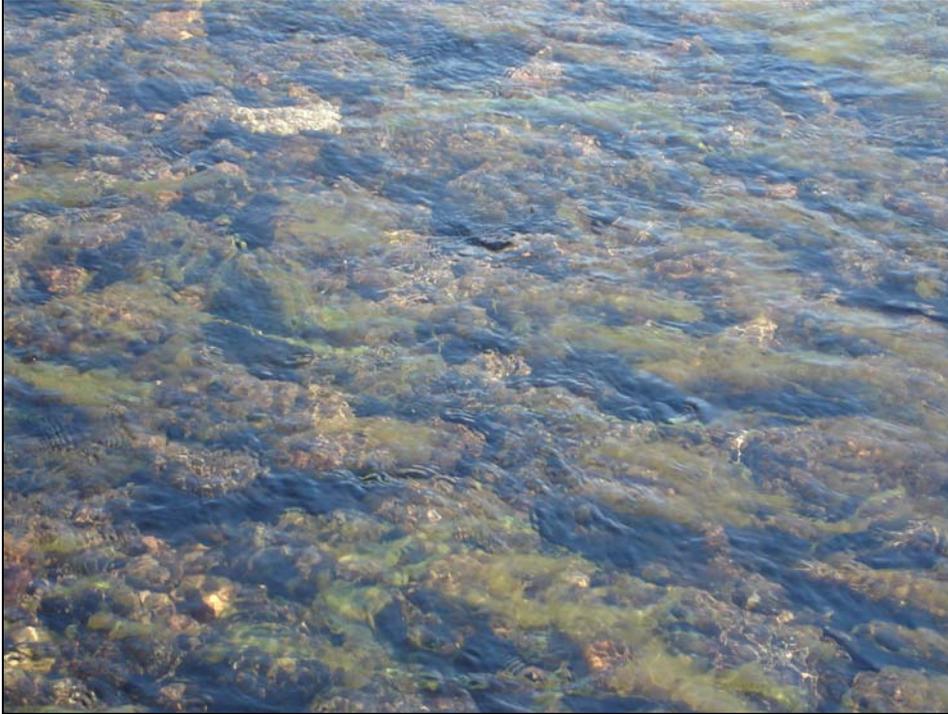
Site 81: East Fork Carson River, Carson Ranger District. Photo shows abundant algae in the stream near Vaquero Camp. This site is located at UTM: N: 4272743 & E: 279499, Elev. 6370 feet (1942m).

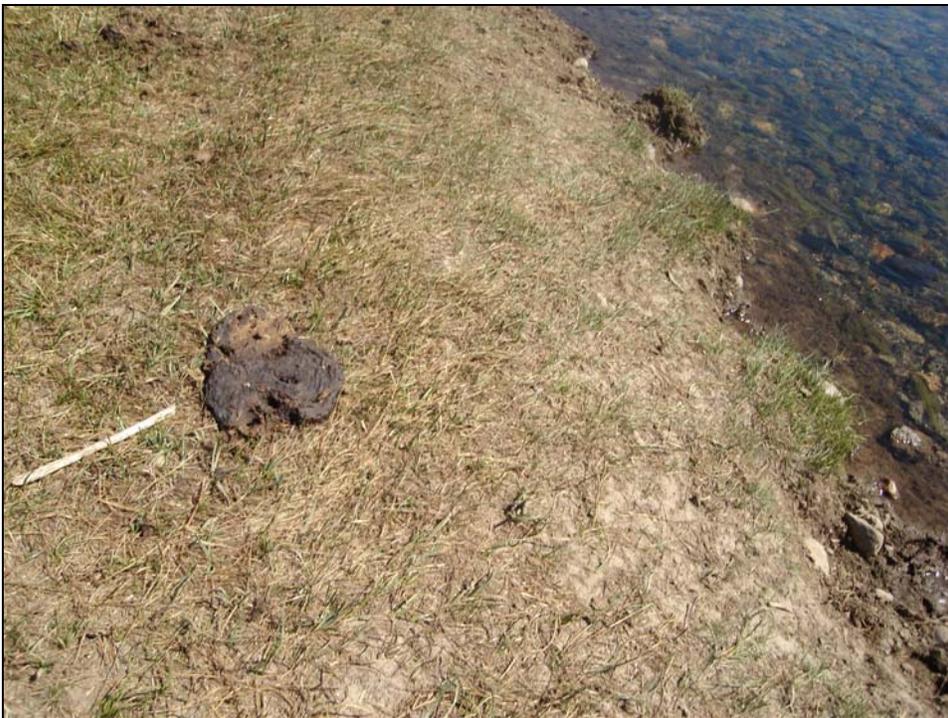
Grazing pasture and livestock activity was specifically noted as a possible cause for an erosion concern in ten locations (Sites 6, 7, 8, 9, 26, 27, 76, 81, 82, & 97). In many of these locations cattle/livestock are allowed to walk through the riparian zones and in most instances have access to enter the watercourse. The removal of vegetation as well as the degradation of stream banks by hooves is apparent at several of these locations (See photos associated with Sites 6, 26, & 81). In the vicinity of Vaquero Camp and Gray's crossing, cattle were present during the survey and had visibly depleted grass and willows along the banks for a distance of several hundred meters. In addition algae were prevalent on the streambed in the same reach, signaling a major nutrient influx. Creating a buffer zone with fencing may offer a way of reducing the impact on the riparian corridor. Providing education and incentives (i.e. cost share agreements for fencing or retired acreage) to private land owners may help to minimize grazing impacts.

Site 81: East Fork Carson River, Carson Ranger District. Zoomed view of livestock effects on stream banks. This site is located at UTM: N: 4272743 & E: 279499, Elev. 6370 feet (1942m).

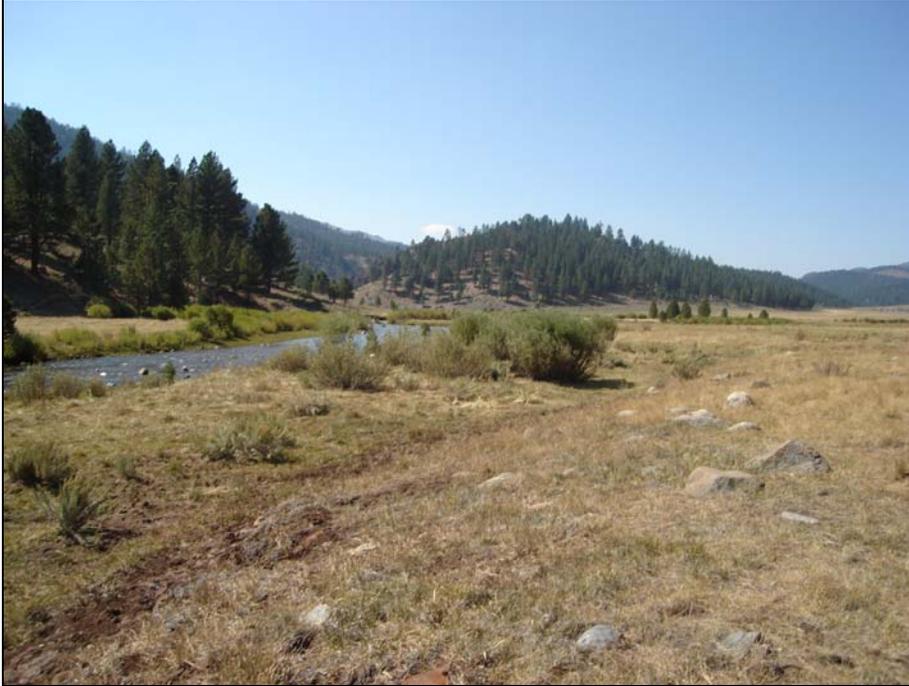
Site 82: East Fork Carson River, Carson Ranger District. Downstream view of East Fork and Bagley Valley. This site is located at UTM: N: 4272334 & E: 271083, Elev. 6386 feet (1947m).

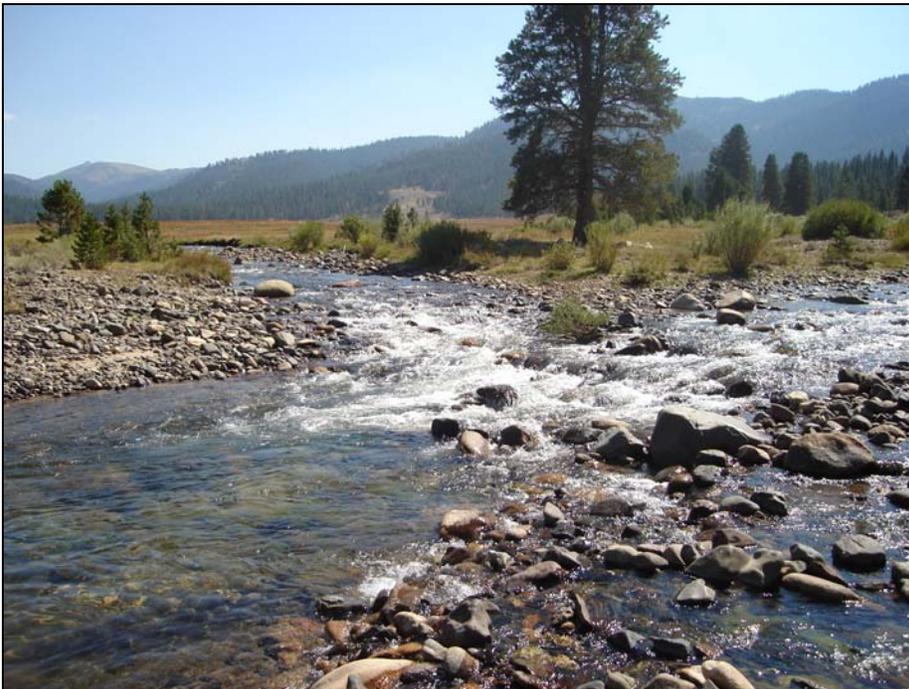
Site 83: East Fork Carson River, Carson Ranger District. Upstream view of confluence of Silver King Creek and the east Fork Carson River. Silver King contributes approximately 35% of total flow. This site is located at UTM: N: 4271943 & E: 271193, Elev. 6409 feet (1954m).

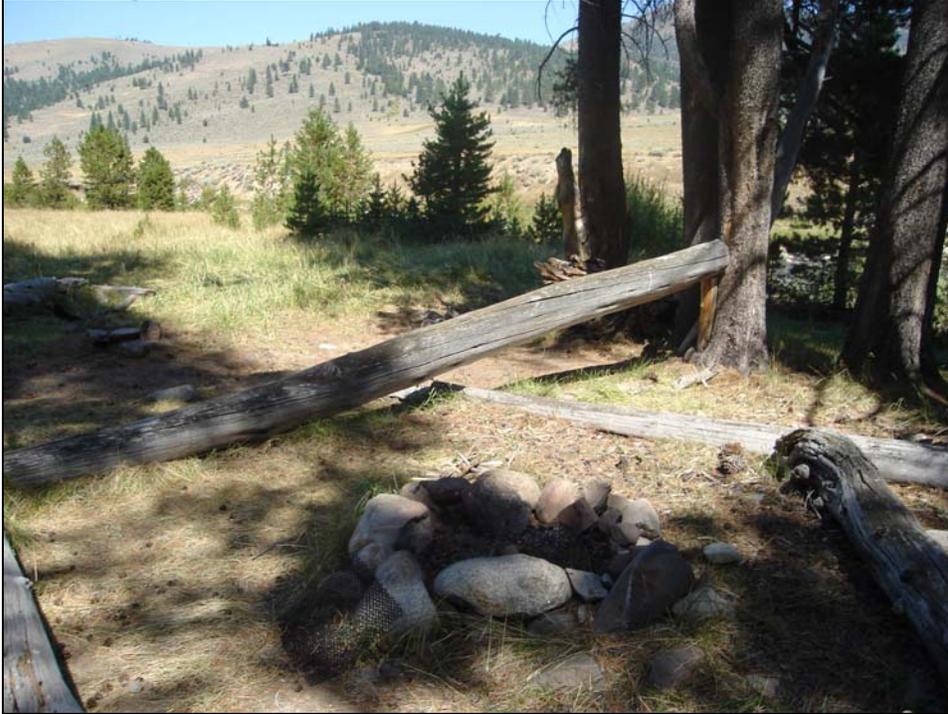
Site 84: East Fork Carson River, Carson Ranger District. Photo shows a campsite located on river left approximately 10 meters from the water. This site is located at UTM: N: 4271490 & E: 271206, Elev. 6439 feet (1963).

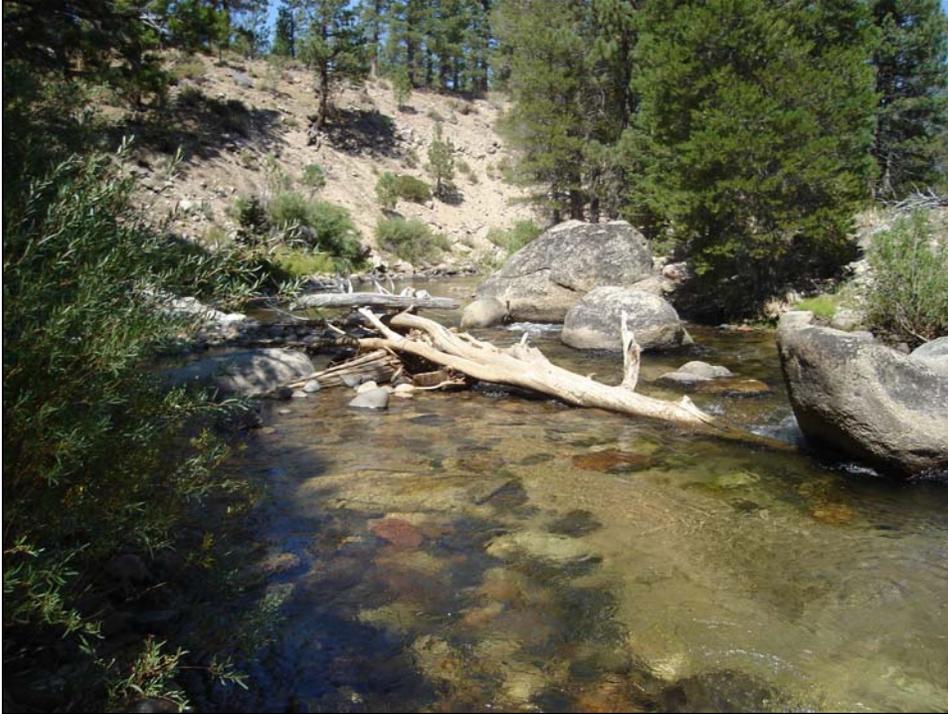
Site 86: East Fork Carson River, Carson Ranger District. Downstream photo of river where it enters a small medium gradient canyon. This site is located at UTM: N: 4270707 & E: 270885, Elev. 6448 feet (1984m).

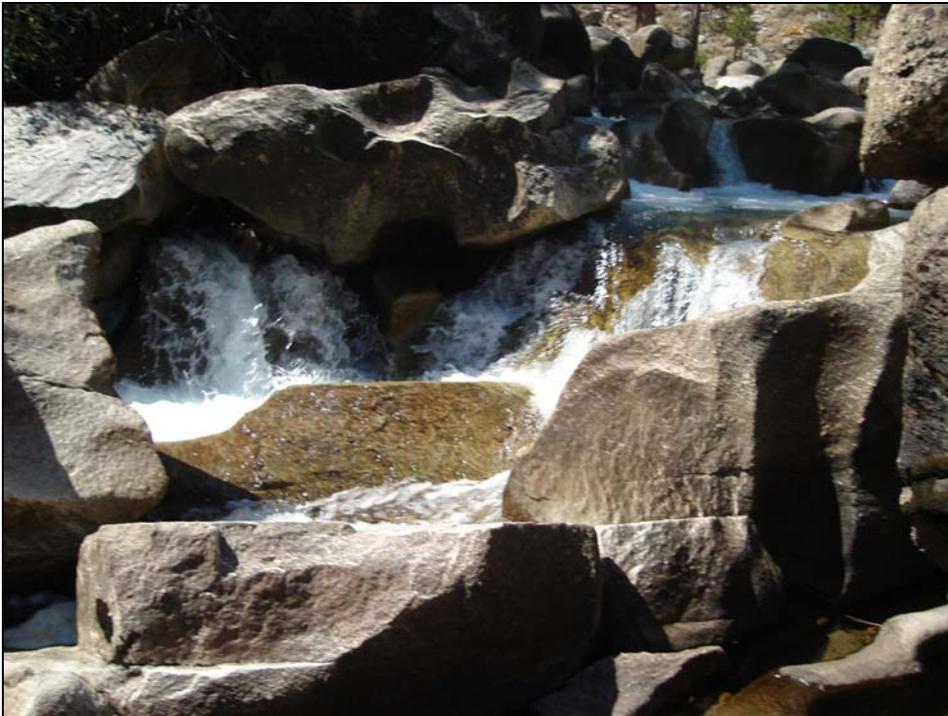
Site 87: East Fork Carson River, Carson Ranger District. Photo shows a seasonal fish barrier with height 3.5 feet and max. pool depth 5.0 feet. This site is located at UTM: N: 4270054 & E: 270488, Elev. 6544 feet (1995m).

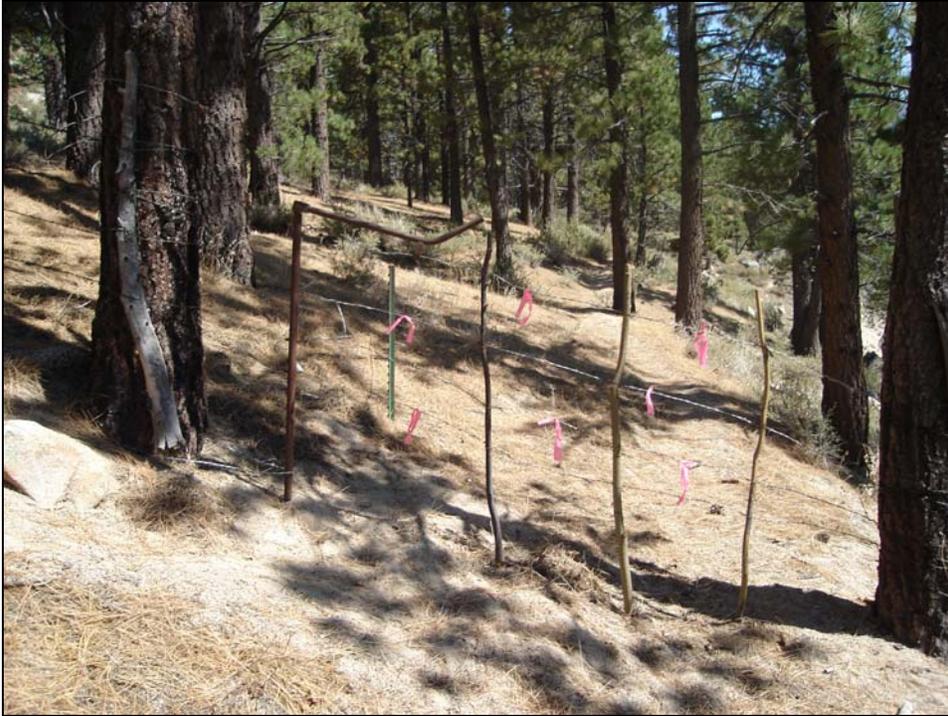
Site 88: East Fork Carson River, Carson Ranger District. A barbed wire fence crosses the Carson River trail and runs down to the water edge. This site is located at UTM: N: 4269791 & E: 270126, Elev. 6606 feet (2014m).

8. Remove large trash/debris such as culverts, broken kayaks, etc. from the East Fork Carson River watercourse. Remove all barb wire fences not being used.

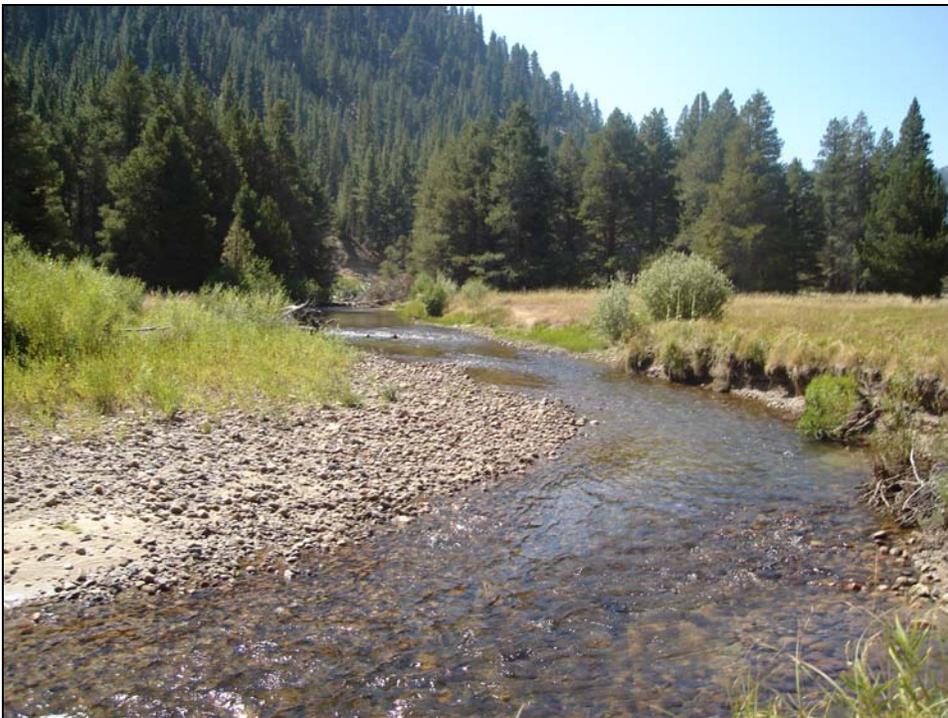
Site 89: East Fork Carson River, Carson Ranger District. Upstream photo shows meanders through meadows and interspersed trees. This site is located at UTM: N: 4269739 & E: 270051, Elev. 6550 feet (1997m).

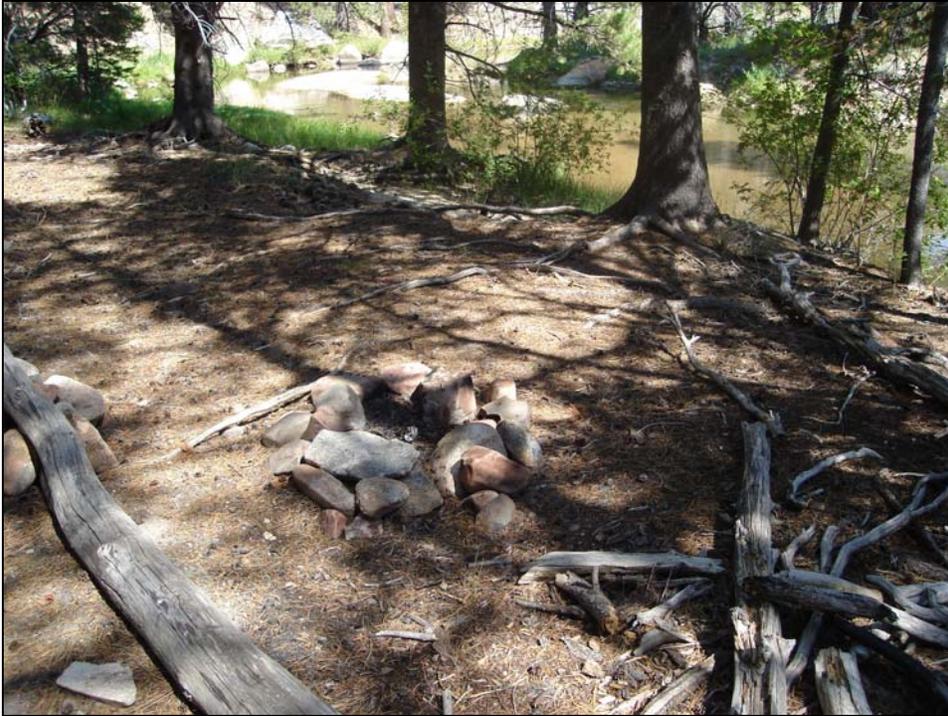
Site 90: East Fork Carson River, Carson Ranger District. A campsite (15 m x 15 m) is located 3 meters from the river. This camp is located at UTM: N: 4269248 & E: 269051, Elev. 6629 feet (2021m).
