EAST FORK CARSON RIVER

2006 Stream Habitat Survey Report

Carson Ranger District: Humboldt-Toiyabe National Forest

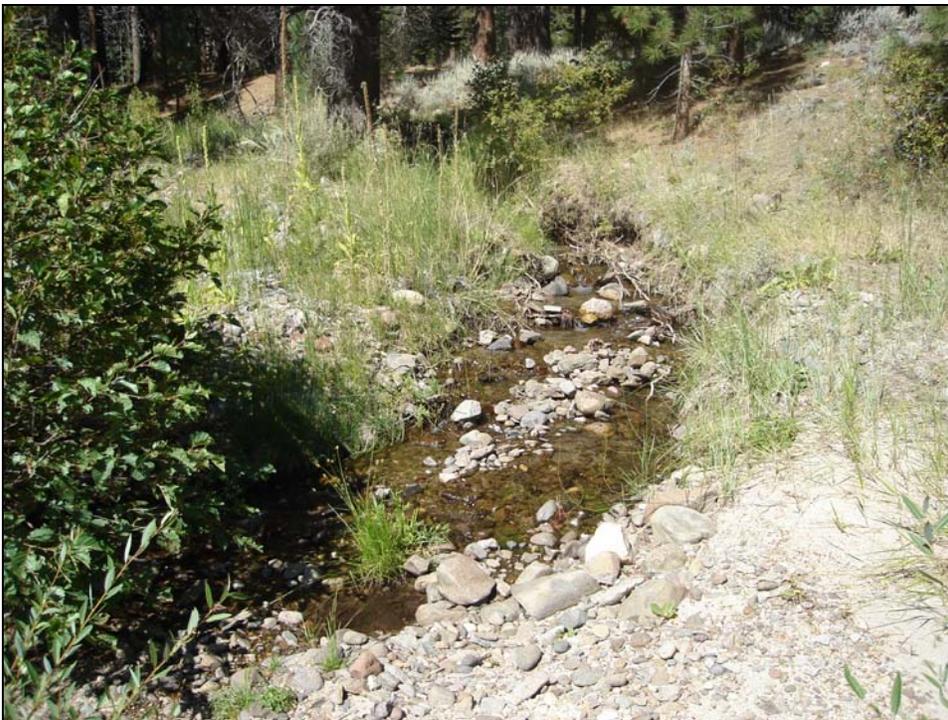
Site 91: East Fork Carson River, Carson Ranger District. Bryant Creek (upper) enters on river left, contributing approximately 3 percent of flow to the East Fork. This site is located at UTM: N: 4269131 & E: 268847, Elev. 6530 feet (1991m).

7. Investigate the impacts of contaminated tributaries at the confluence with the East Fork Carson River (i.e. Bryant Creek and Monitor Creek) and develop recommendations that will reduce/eliminate impacts from the contaminated tributaries.

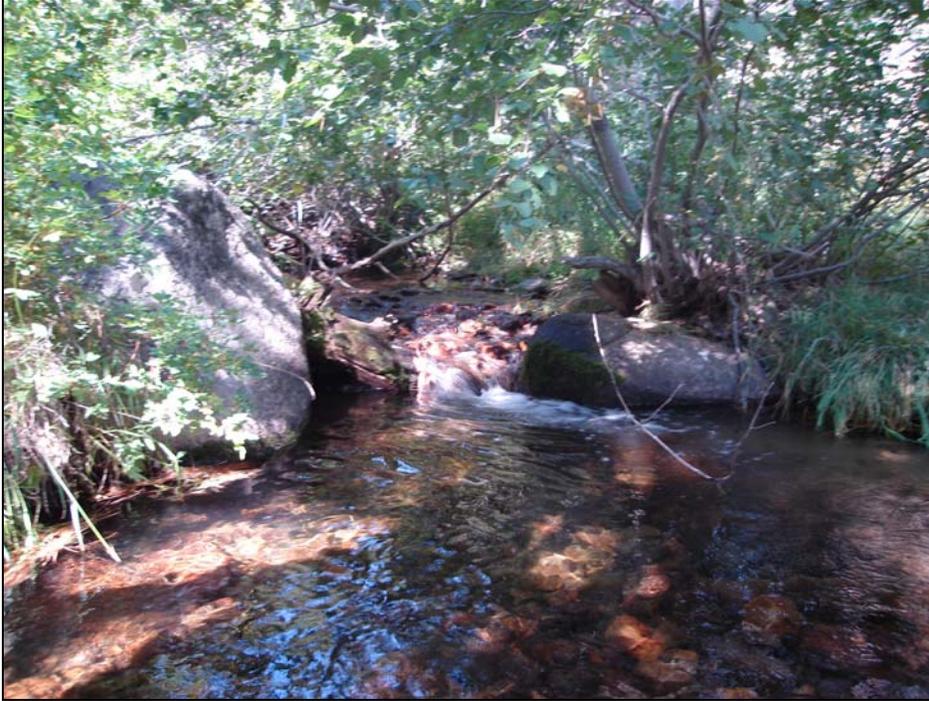
Site 92: East Fork Carson River. Upstream view of Jones Canyon Creek just above the confluence with the East Fork. This tributary adds an additional 5 percent to the total flow in the East Fork. This site is located at UTM: N: 4268685 & E: 268505, Elev. 6645 feet (2026m).

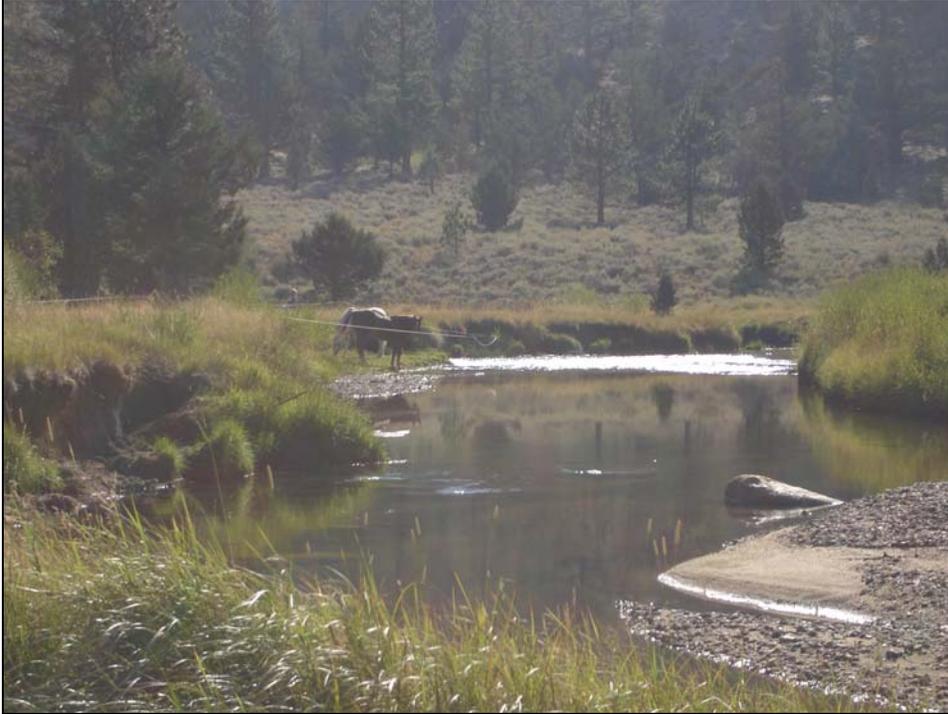
Grazing pasture and livestock activity was specifically noted as a possible cause for an erosion concern in ten locations (Sites 6, 7, 8, 9, 26, 27, 76, 81, 82, & 97). In many of these locations cattle/livestock are allowed to walk through the riparian zones and in most instances have access to enter the watercourse. The removal of vegetation as well as the degradation of stream banks by hooves is apparent at several of these locations (See photos associated with Sites 6, 26, & 81). In the vicinity of Vaquero Camp and Gray's crossing, cattle were present during the survey and had visibly depleted grass and willows along the banks for a distance of several hundred meters. In addition algae were prevalent on the streambed in the same reach, signaling a major nutrient influx. Creating a buffer zone with fencing may offer a way of reducing the impact on the riparian corridor. Providing education and incentives (i.e. cost share agreements for fencing or retired acreage) to private land owners may help to minimize grazing impacts.

Site 97: East Fork Carson River, Carson Ranger District. Downstream view of horses picketed along the river. This site is located at UTM: N: 4266101 & E: 268596, Elev. 2035m).

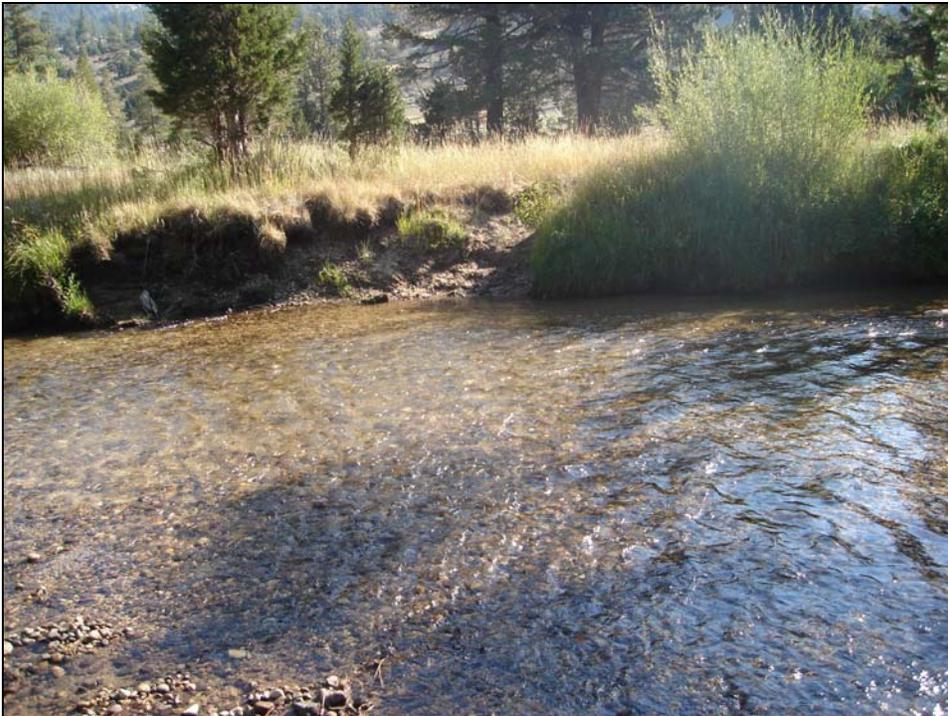
Site 98: East Fork Carson River, Carson Ranger District. Cross-sectional view of a trail-stream crossing in Dumont's Meadows. This site is located at UTM: N: 4266013 & E: 268628, Elev. 2035m).

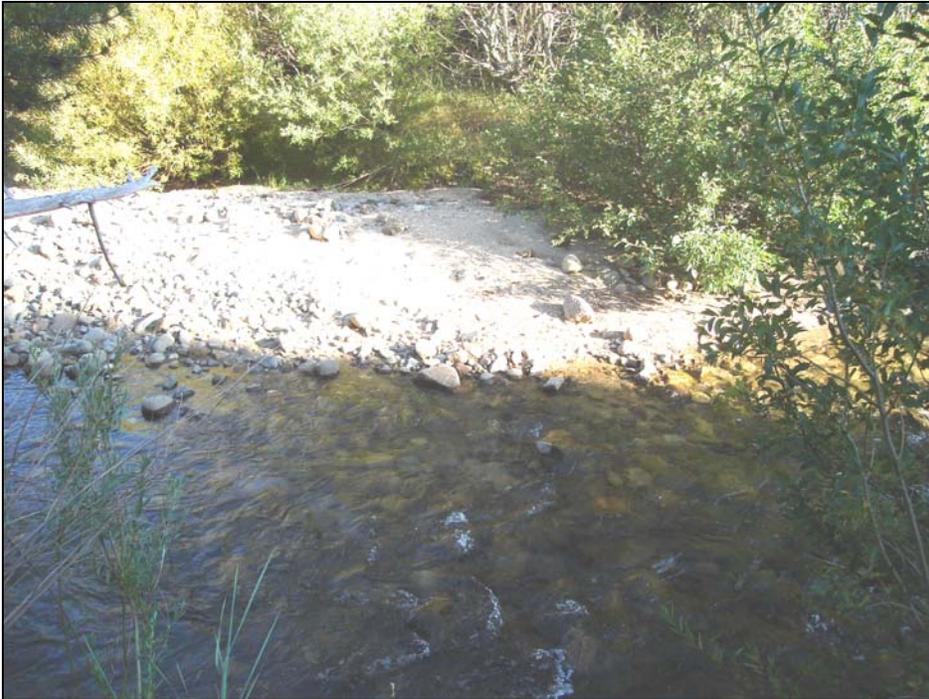
Site 101: East Fork Carson River, Carson Ranger District. Cross-sectional view of a trail-stream crossing. This site is located at UTM: N: 4265037 & E: 267469, Elev. 2062m).

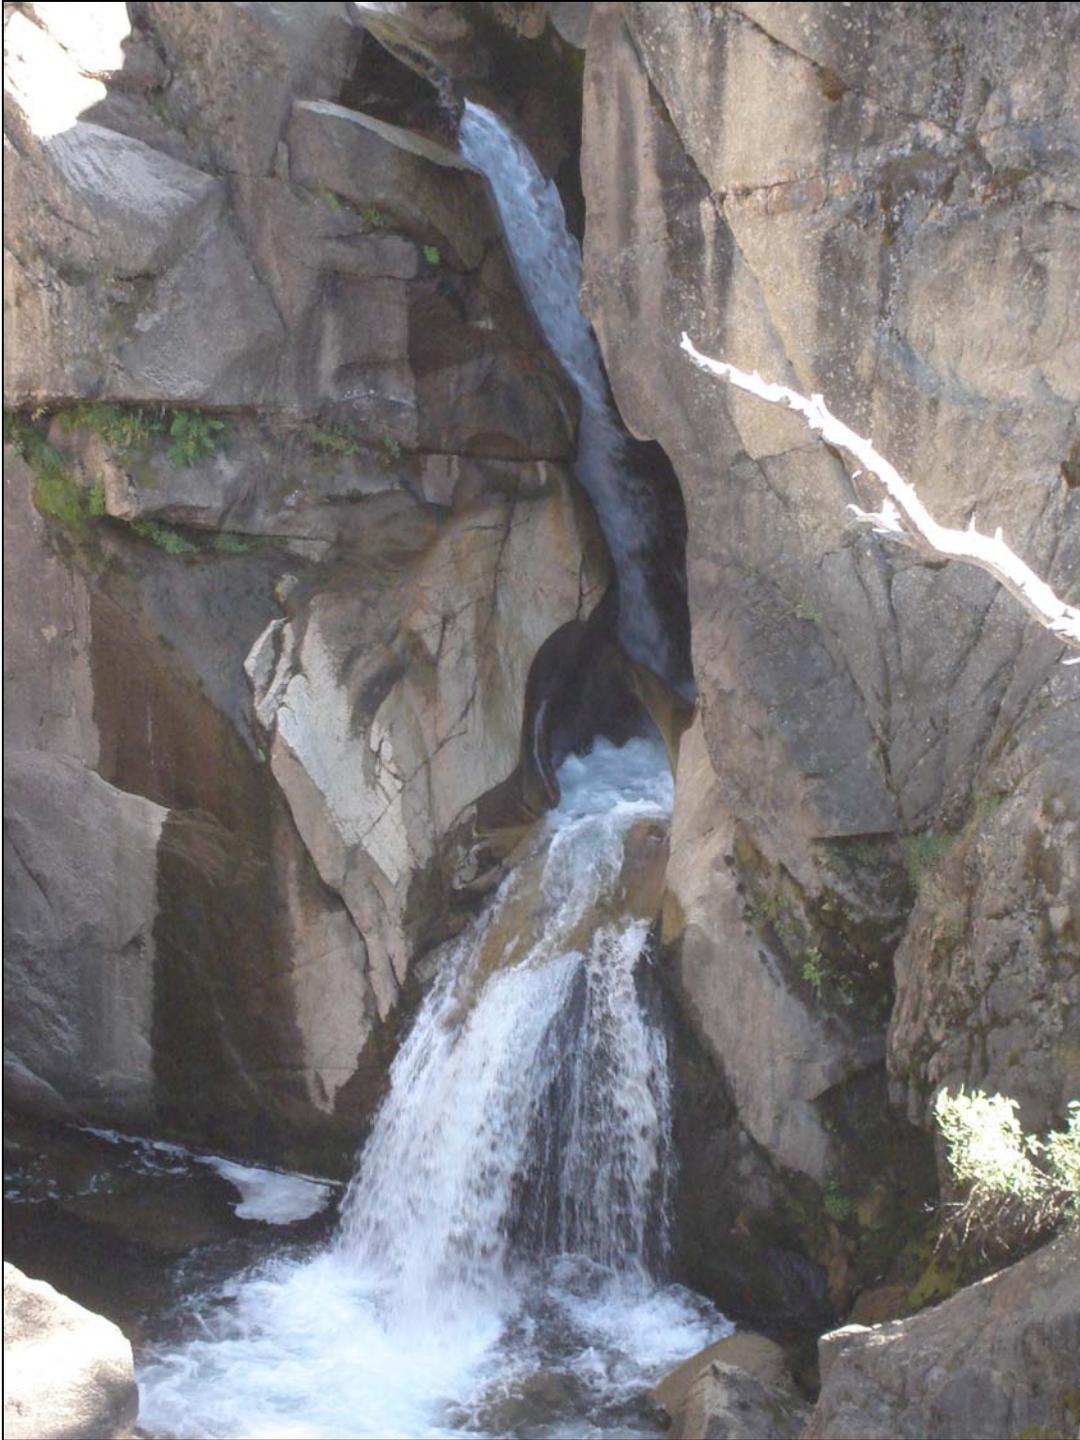
Fish passage barriers were noted and categorized into one of four categories: natural-permanent, natural-seasonal, artificial-permanent, and artificial-seasonal. A permanent barrier is categorized as an obstacle, waterfall, or drop in excess of 5ft that would prevent passage of fish year-round (specifically LCT). A stadia rod was used to measure barriers where applicable. Barriers categorized as permanent barriers may actually be seasonal barriers, and some seasonal barriers may actually act as a permanent barrier. (In the case of the East Fork, Ruhlenstroth Dam and Carson Falls were immediately recognized as permanent barriers).

Site 107: East Fork Carson River, Carson Ranger District. Upstream view of Carson Falls, a permanent fish passage barrier with a height of approximately 80 feet. This site is located at UTM: N: 4263308 & E: 266088, Elev. 2129m).

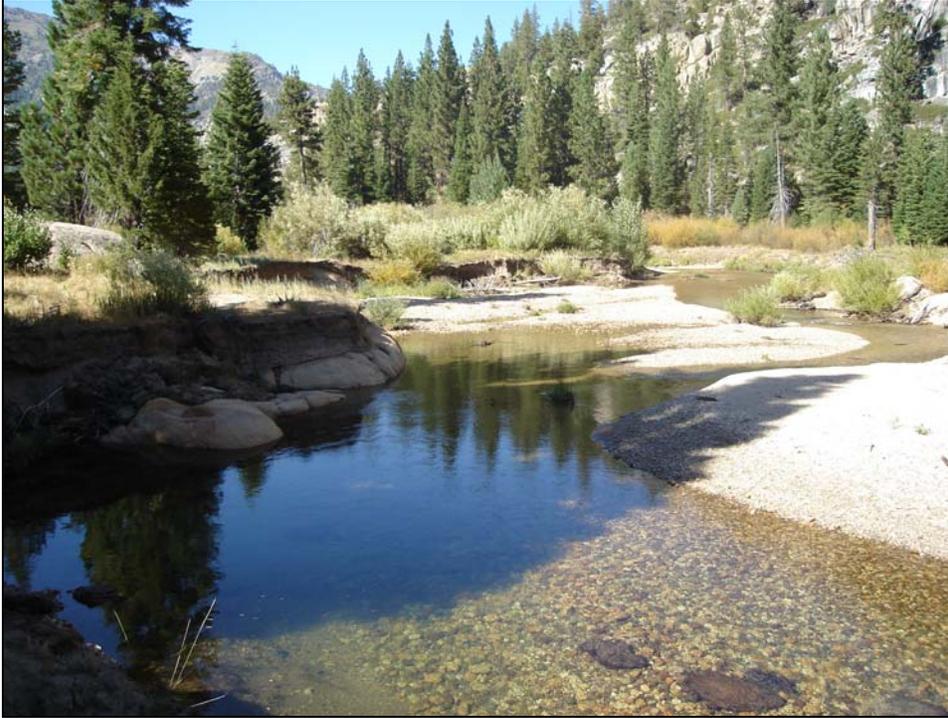
Site 108: East Fork Carson River, Carson Ranger District. Downstream view from left bank. The trail runs along the left bank and has exacerbated bank erosion, causing slumping. This site is located at UTM: N: 4263004 & E: 266278, Elev. 2152m).

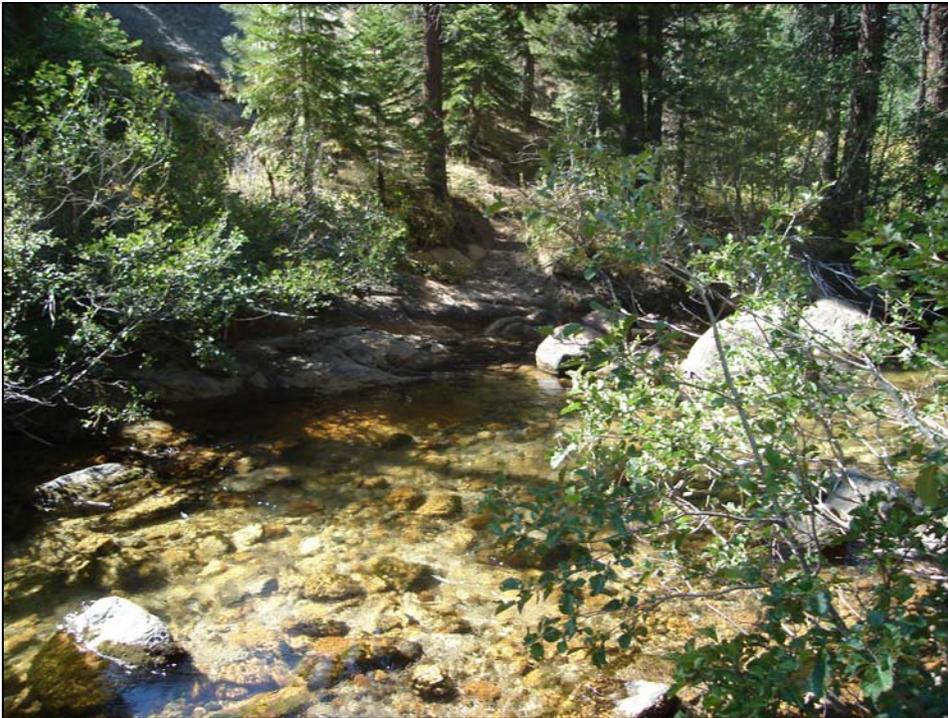
Site 109: East Fork Carson River, Carson Ranger District. Cross-sectional view of a trail-stream intersection which requires a ford crossing. This site is located at UTM: N: 4262760 & E: 266461, Elev. 2167m).

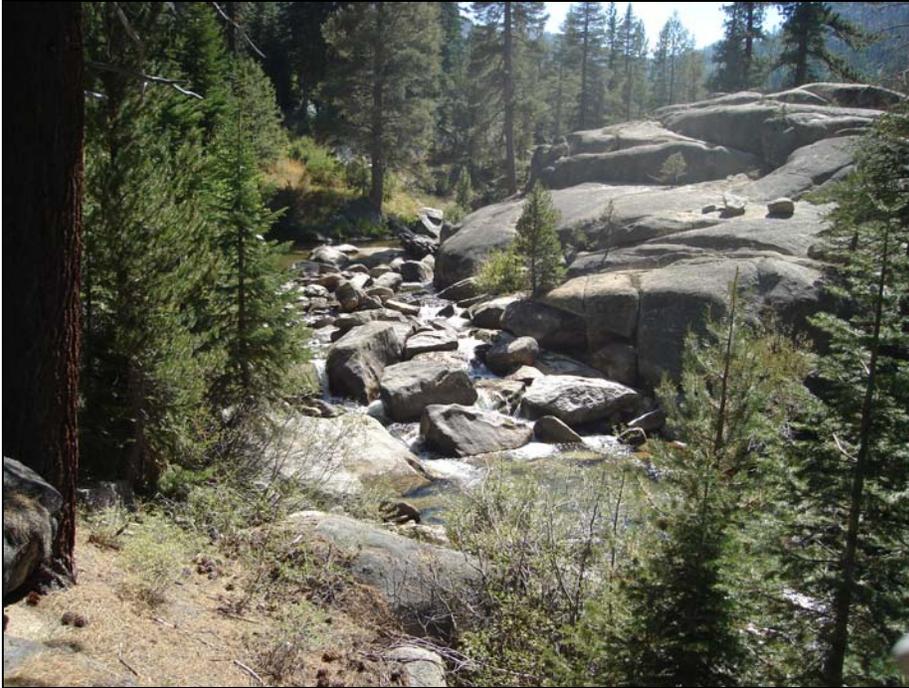
Site 110: East Fork Carson River, Carson Ranger District. Upstream view of a seasonal barrier comprised of multiple 2-3 foot cascades. Maximum pool depth varies from 1-4 feet. This site is located at UTM: N: 4262247 & E: 266675, Elev. 2174m).

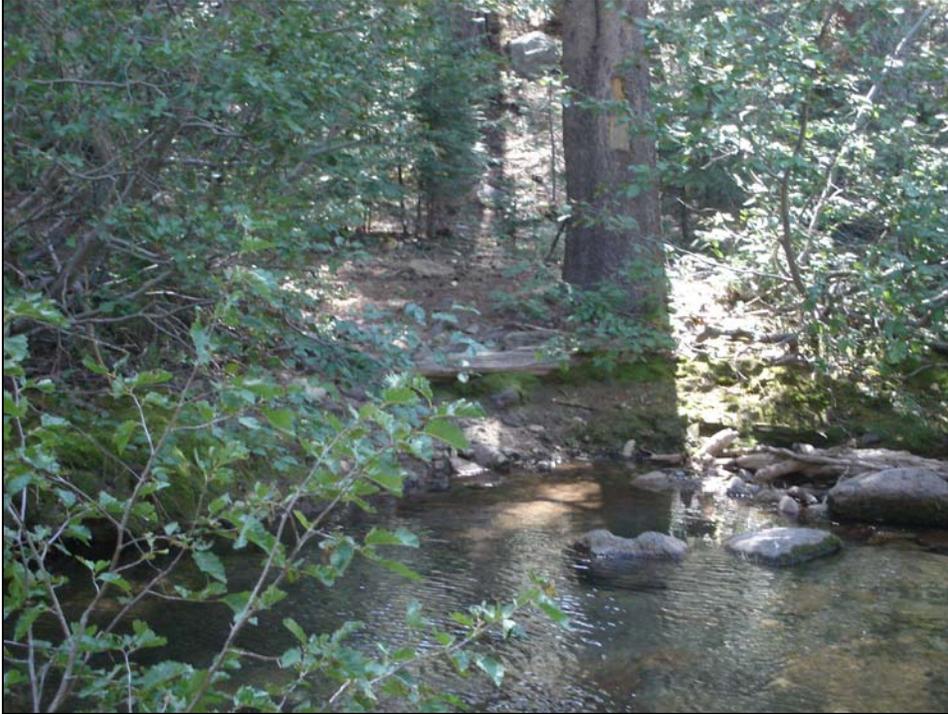
Site 112: East Fork Carson River, Carson Ranger District. Cross-sectional view of intersection where the Golden canyon trail crosses the river. This site is located at UTM: 4261761 & E: 266468, Elev. 2168m).

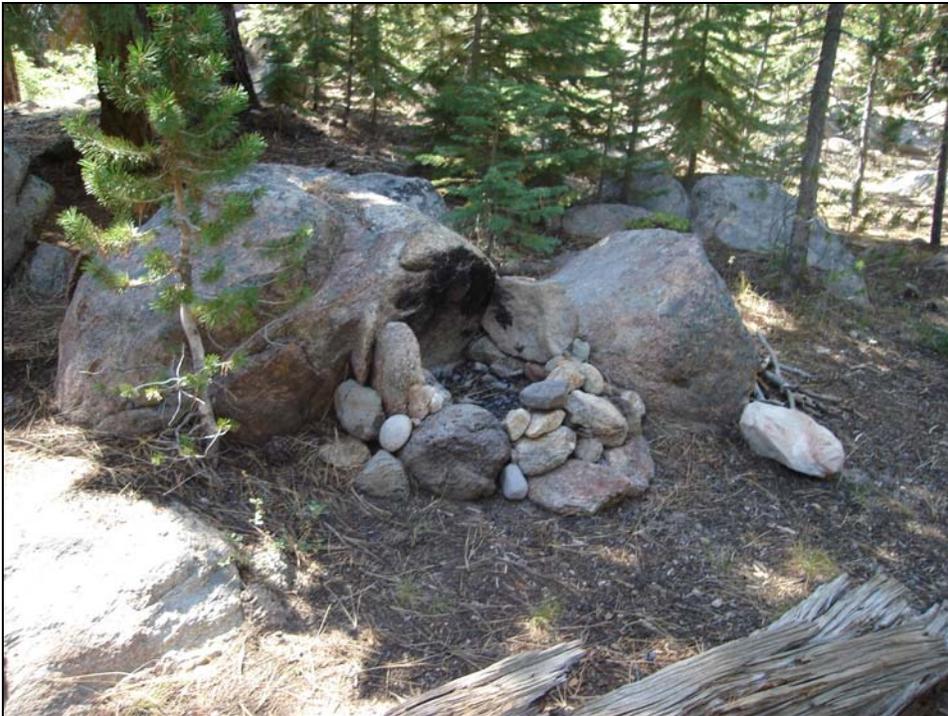
Site 113: East Fork Carson River, Carson Ranger District. Photo shows an elaborate fire ring and campsite located approximately 20 meters from the river's right bank. This site is located at UTM: N: 4261725 & E: 266547, Elev. 2156m).

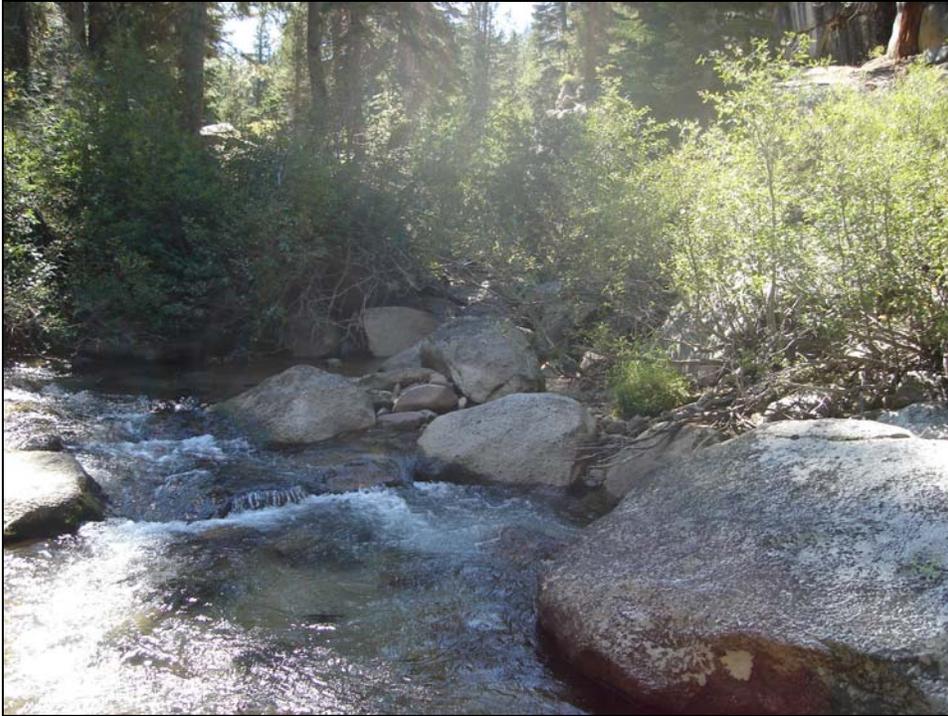
Site 114: East Fork Carson River, Carson Ranger District. Upstream view of confluence of East Fork and Golden canyon Creek. This tributary contributes 15 percent to overall flow. This site is located at UTM: N: 4261598 & E: 266565, Elev. 2267m).

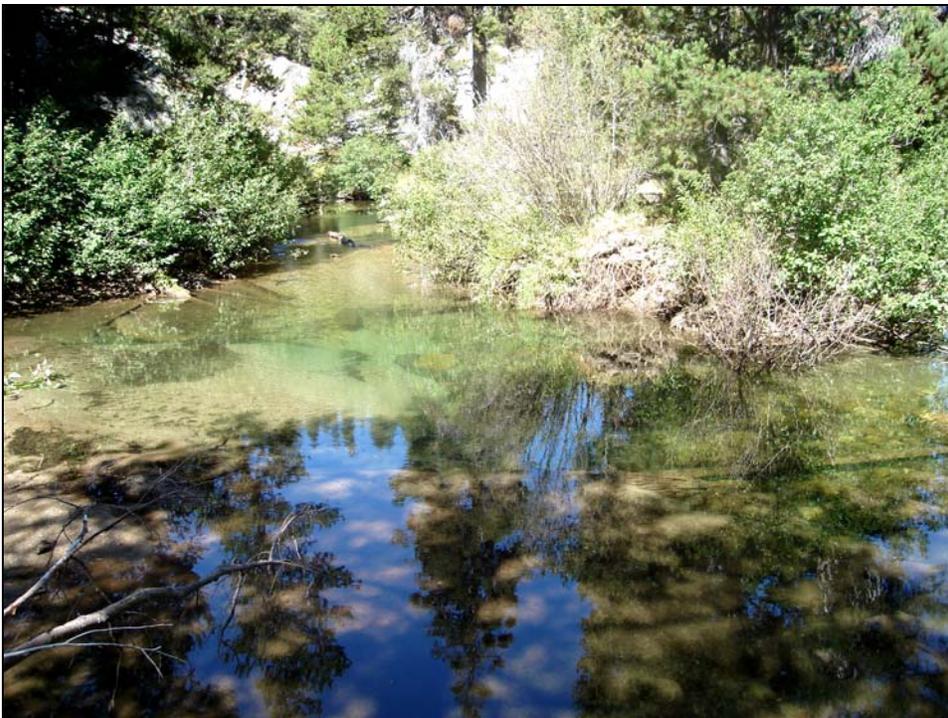
Site 115: East Fork Carson River, Carson Ranger District. Photo shows a pool in a low gradient reach where two fish were sighted. This site is located at UTM: N: 4260622 & E: 266947, Elev. 2242m).

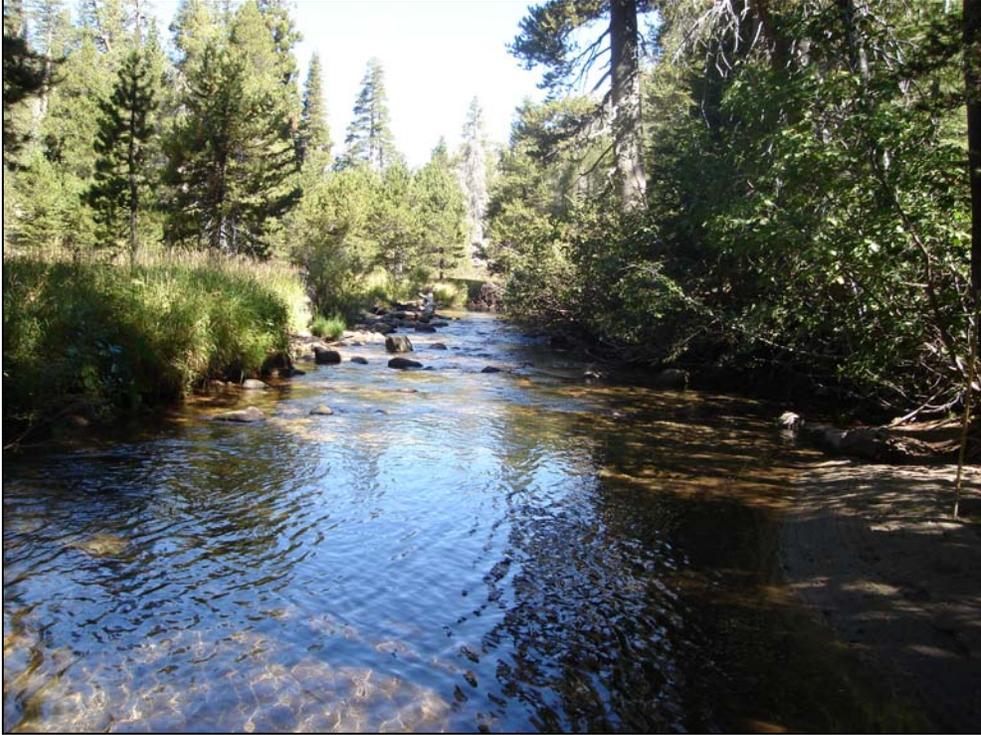
Site 116: East Fork Carson River, Carson Ranger District. Downstream view of favorable habitat. This site is located at UTM: N: 4260457 & E: 266788, Elev. 2278m).

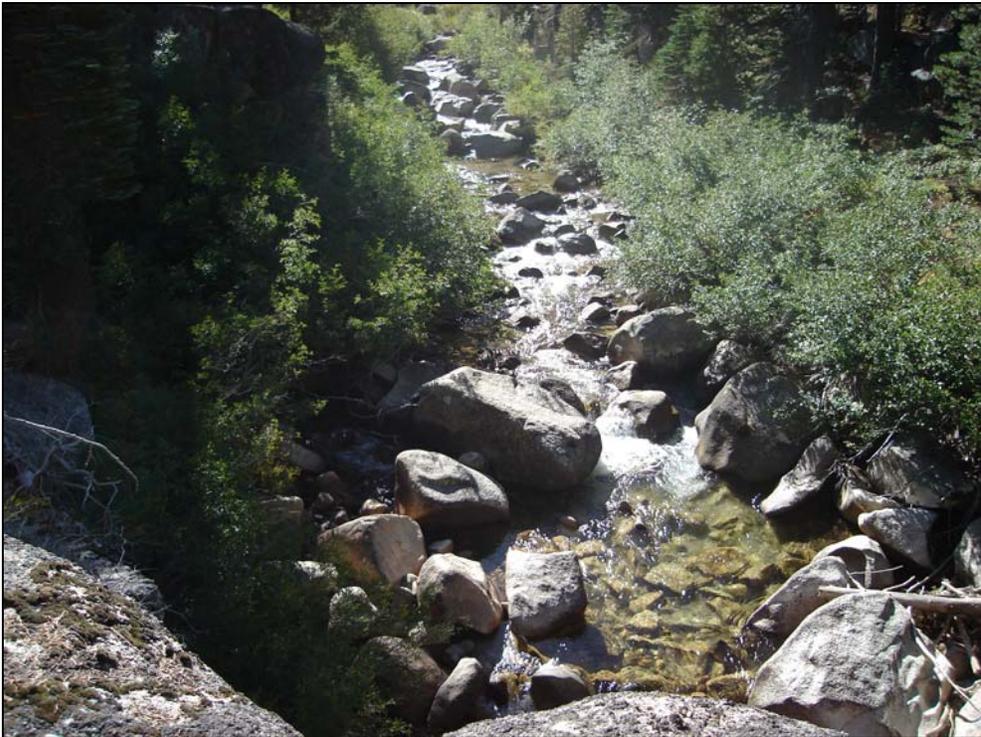
Site 117: East Fork Carson River, Carson Ranger District. Upstream view of an unnamed tributary that adds 15 percent to overall flow in the East Fork. This confluence is located at UTM: N: 4258972 & E: 266899, Elev. 2325m).

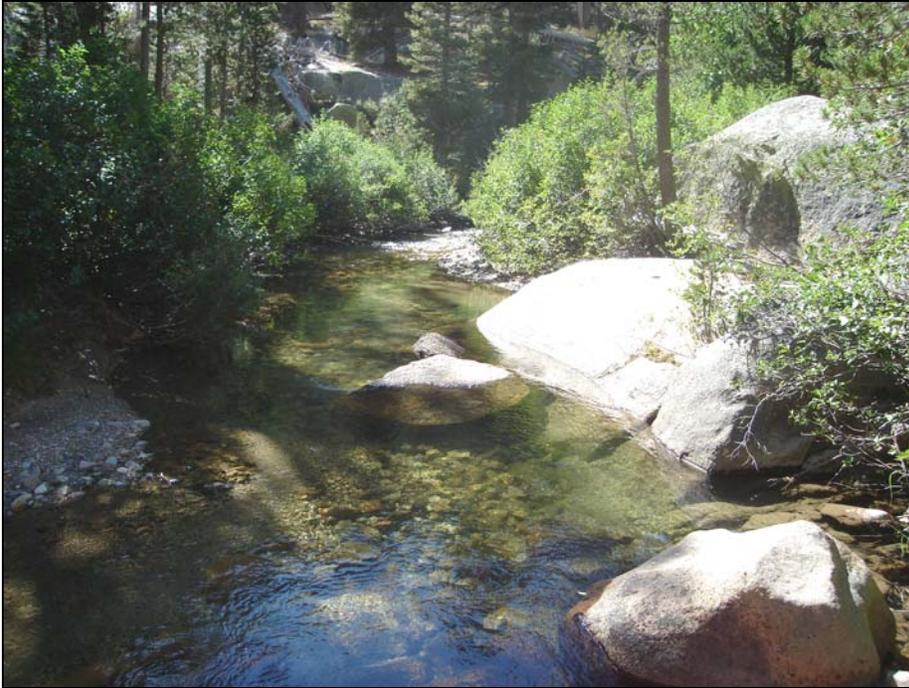
Site 118: East Fork Carson River, Carson Ranger District. Downstream view of river within White Canyon. This site is located at UTM: N: 4258003 & E: 266841.

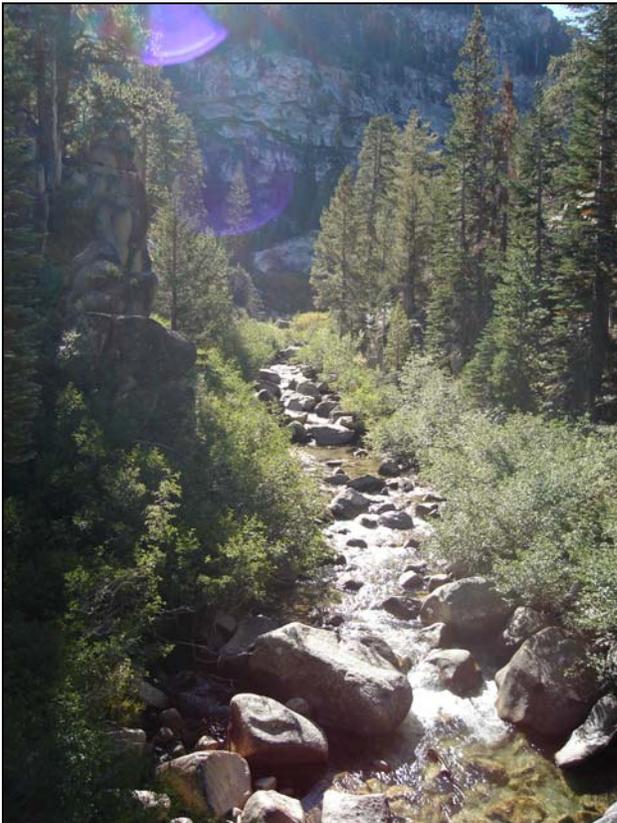
Site 118: East Fork Carson River, Carson Ranger District. Upstream view within White Canyon.

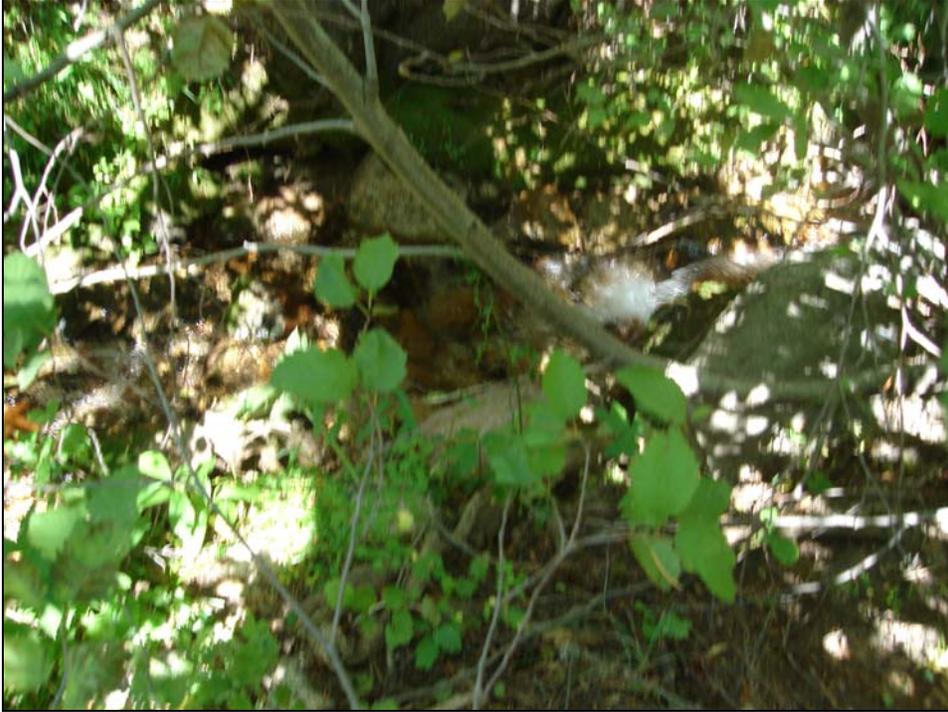
Site 119: East Fork Carson River, Carson Ranger District. Photo shows two small tributaries entering through the brush on river right. This site is located at UTM: N: 4257567 & E: 267025.

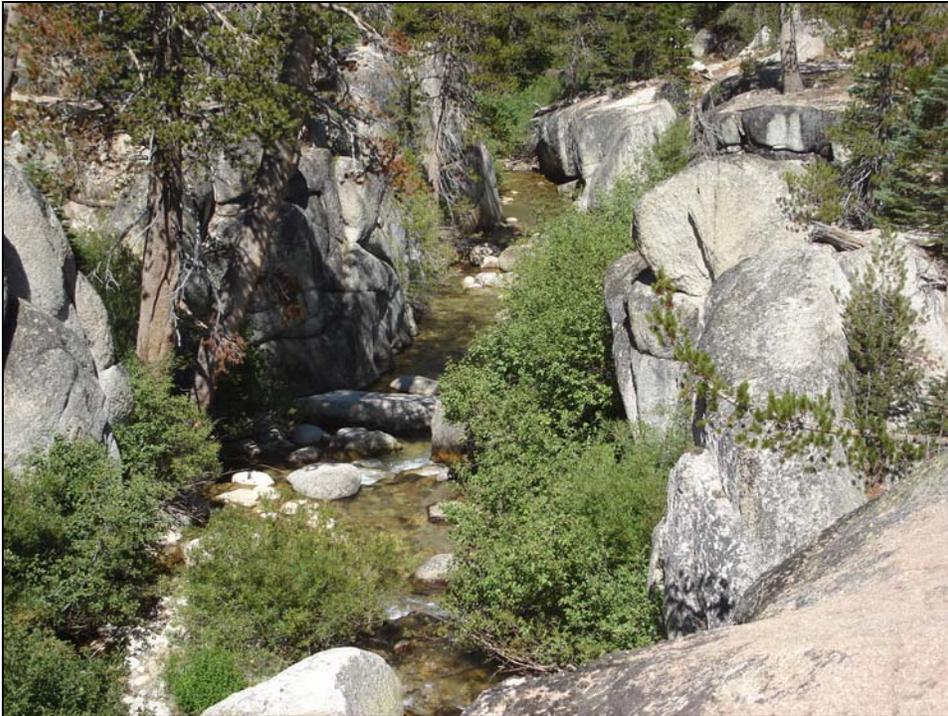
Site 120: East Fork Carson River, Carson Ranger District. Downstream view from upper White Canyon. This site is located at UTM: N: 4256255 & E: 267453, Elev. 2407m).

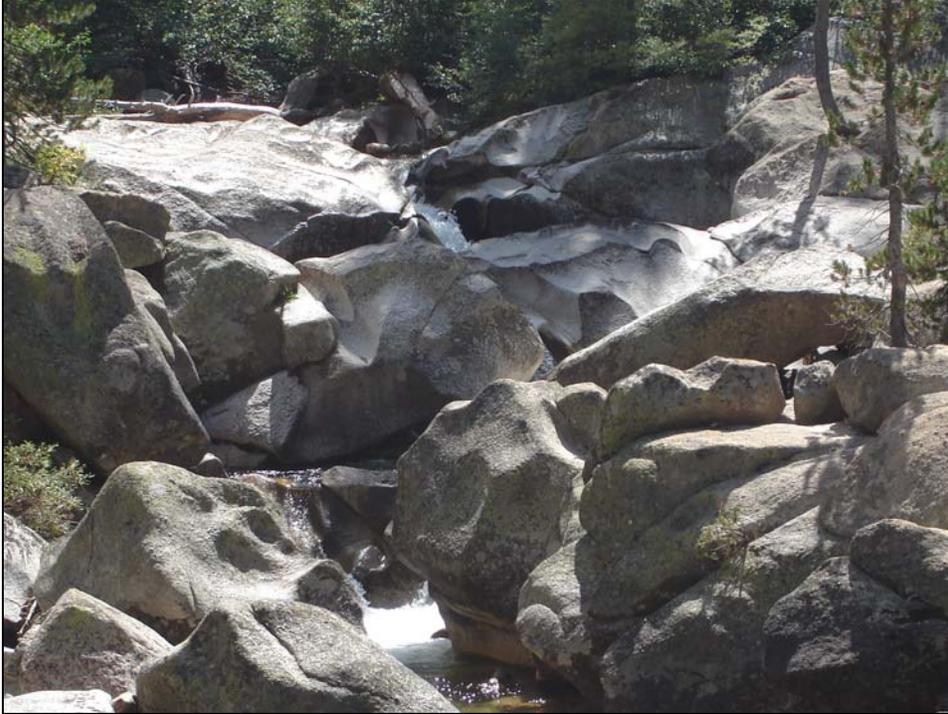
Site 121: East Fork Carson River, Carson Ranger District. Upstream view of high gradient cascades entrenched in granite. This site is located at UTM: N: 4255426 & E: 267375, Elev. 2433m).

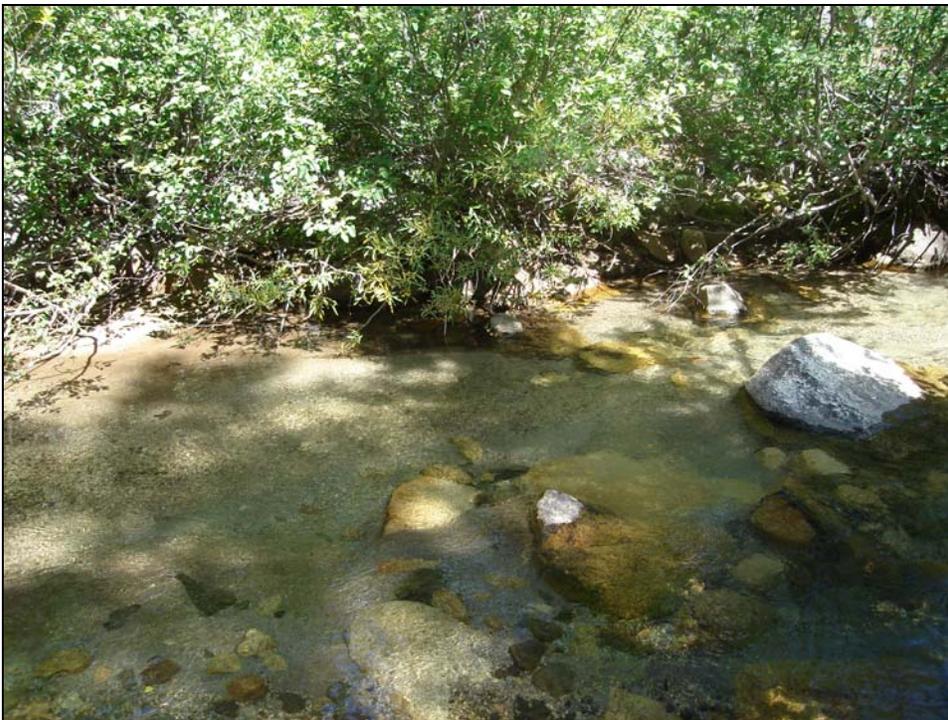
Site 122: East Fork Carson River, Carson Ranger District. Cross-sectional view of a decommissioned trail-stream crossing. This site is located at UTM: N: 4254772 & E: 267321, Elev. 2436m).

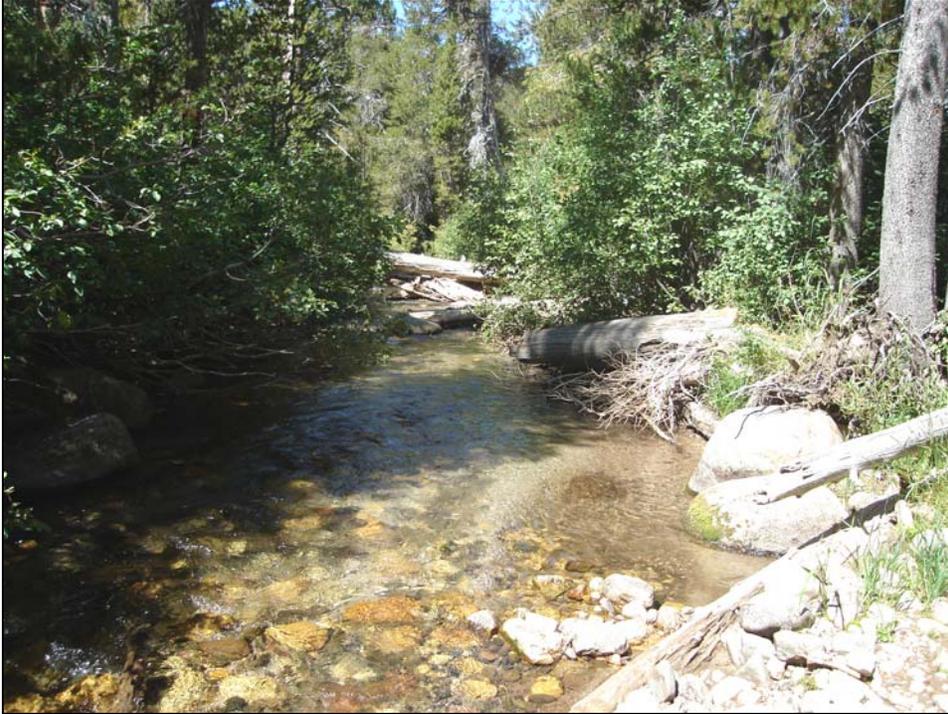
Site 123: East Fork Carson River, Carson Ranger District. Downstream view of a low to medium gradient reach where alders are prevalent. This site is located at UTM: 4254318 & E: 267621, Elev. 2474m).

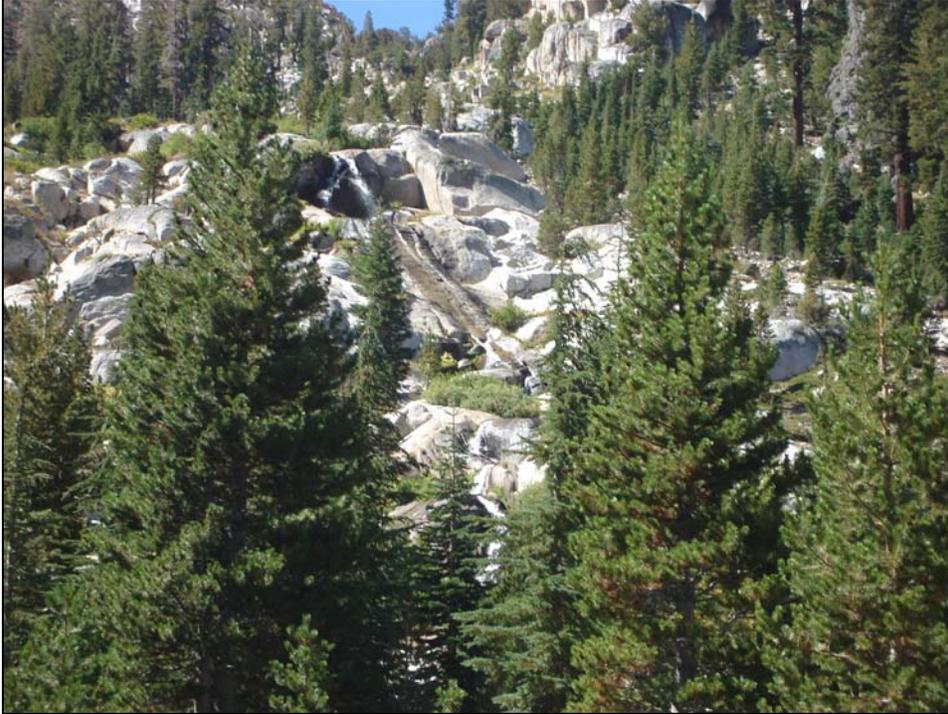
Site 125: East Fork Carson River, Carson Ranger District. Upstream view of a waterfall on a tributary that enters on river left and adds 10 percent to the overall flow in the East Fork at that point. This site is located at UTM: N: 4253110 & E: 268104, Elev. 2617m).

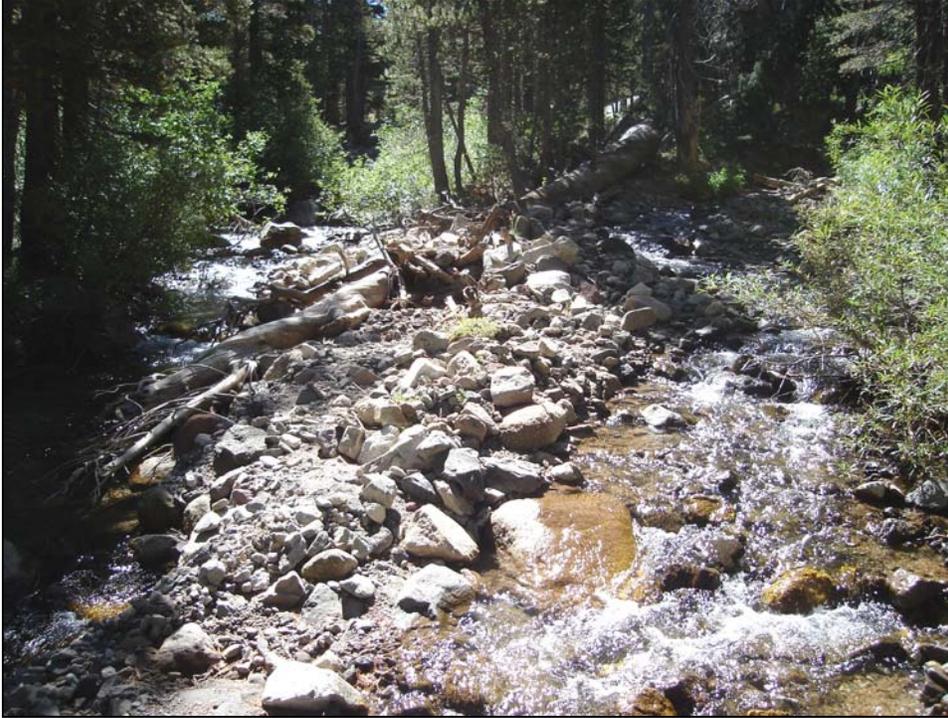
Site 127: East Fork Carson River, Carson Ranger District. Upstream view of confluence of East Fork and an unnamed tributary which adds approximately 35 percent to the total discharge of the East Fork. This site is located at UTM: N: 4252712 & E: 268270.

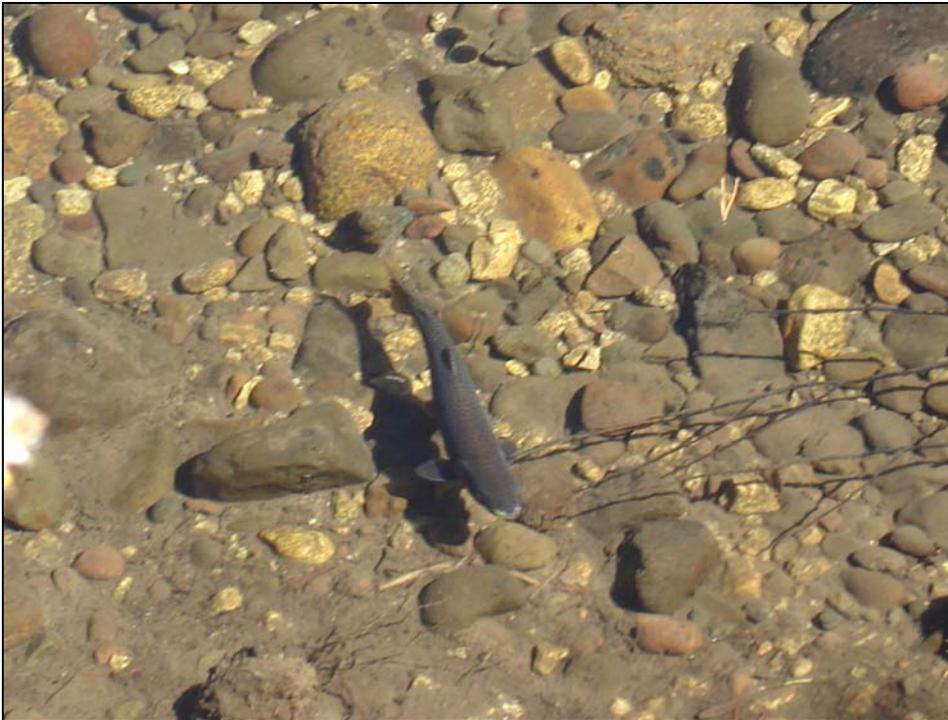
Site 128: East Fork Carson River, Carson Ranger District. Two LCT were sighted, including this large fish in the photo. This site is located at UTM: N: 4252341 & E: 268792, Elev. 2647m).

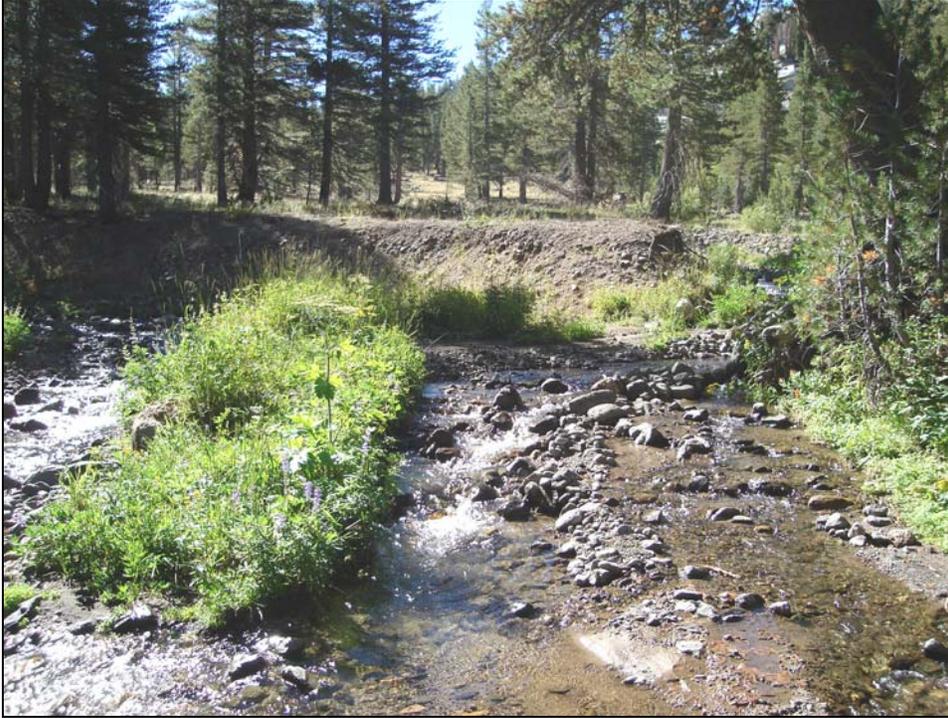
Site 129: East Fork Carson River, Carson Ranger District. Upstream view of confluence of headwater branches. Each branch contributes approximately half the flow in the East Fork. This site is located at UTM: N: 4251842 & E: 269316, Elev. 2715m).

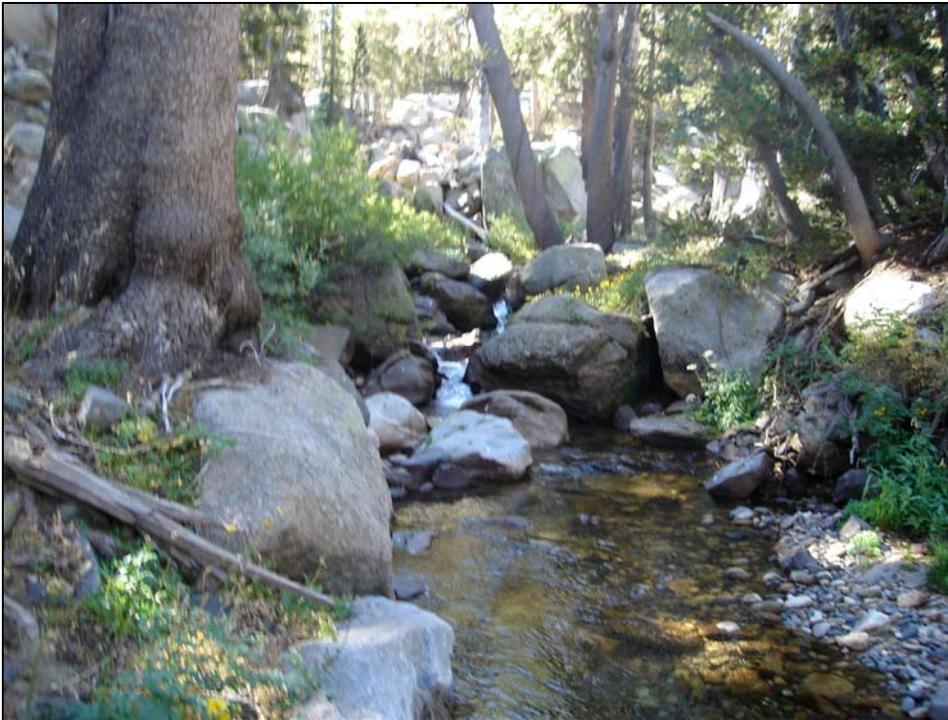
Site 130: East Fork Carson River, Carson Ranger District. Photo shows upstream view of a series of seasonal barriers. Continuous LCT habitat is located downstream of this point. This site is located at UTM: N: 4251769 & E: 269495, Elev. 2700m).

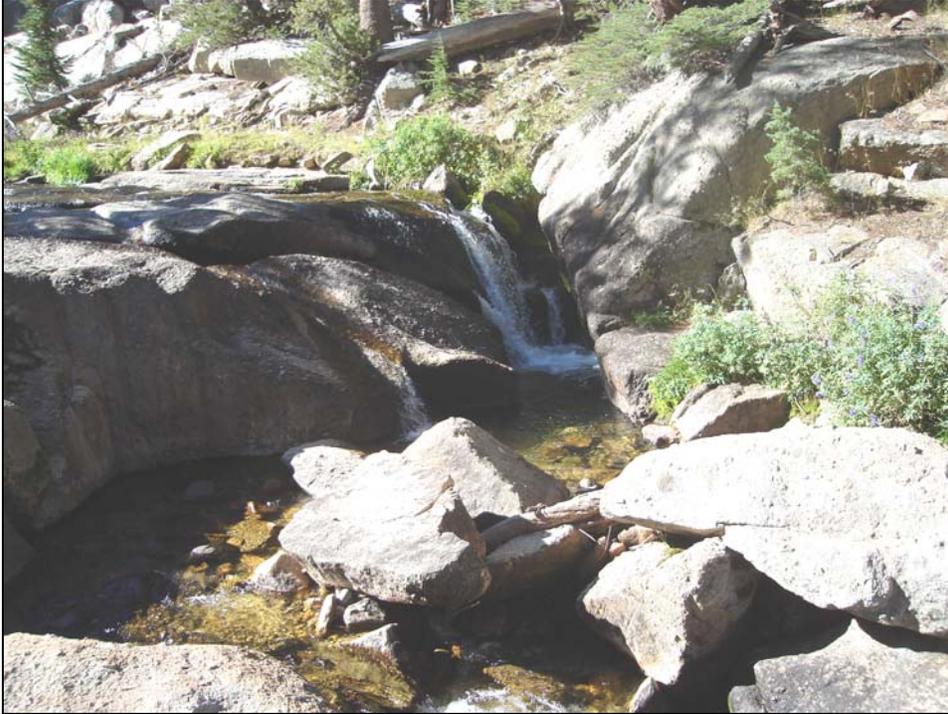
Site 131: East Fork Carson River, Carson Ranger District. A 9.0 foot waterfall creates a permanent fish passage barrier (max. pool depth 3.0 feet). This site is located at UTM: N: 4251172 & E: 269738, Elev. 2752m).

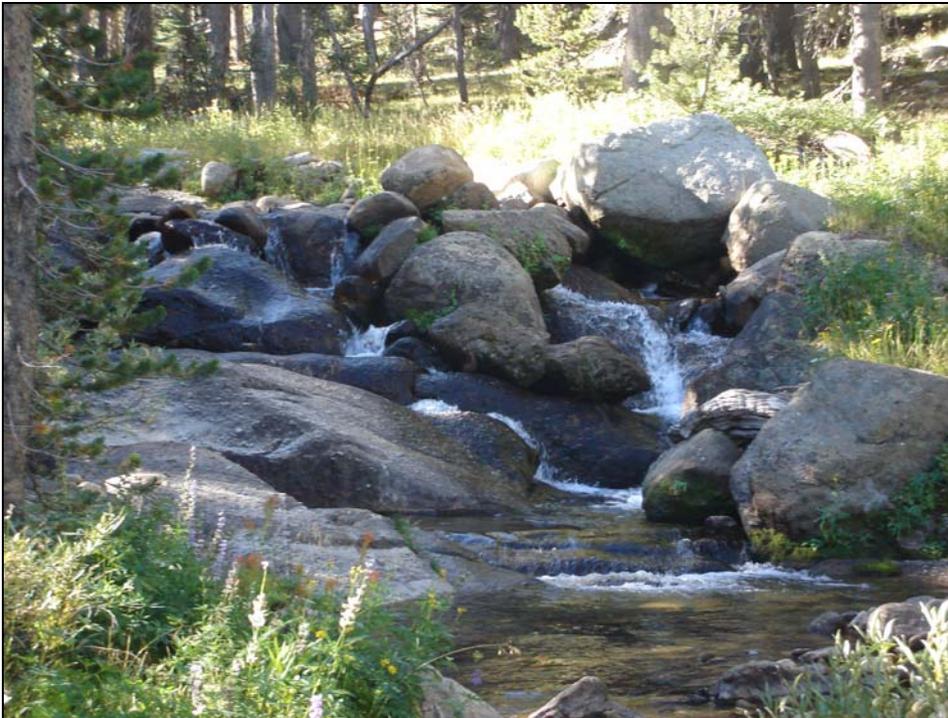
Site 132: East Fork Carson River, Carson Ranger District. Photo shows the survey end point: an 8-9 foot permanent fish passage barrier. This site is located at UTM: N: 4251066 & E: 269810, Elev. 2775m).
