EAGLE CREEK

Alpine County, California

2006 Stream Habitat Survey Report

Carson Ranger District: Humboldt-Toiyabe National Forest

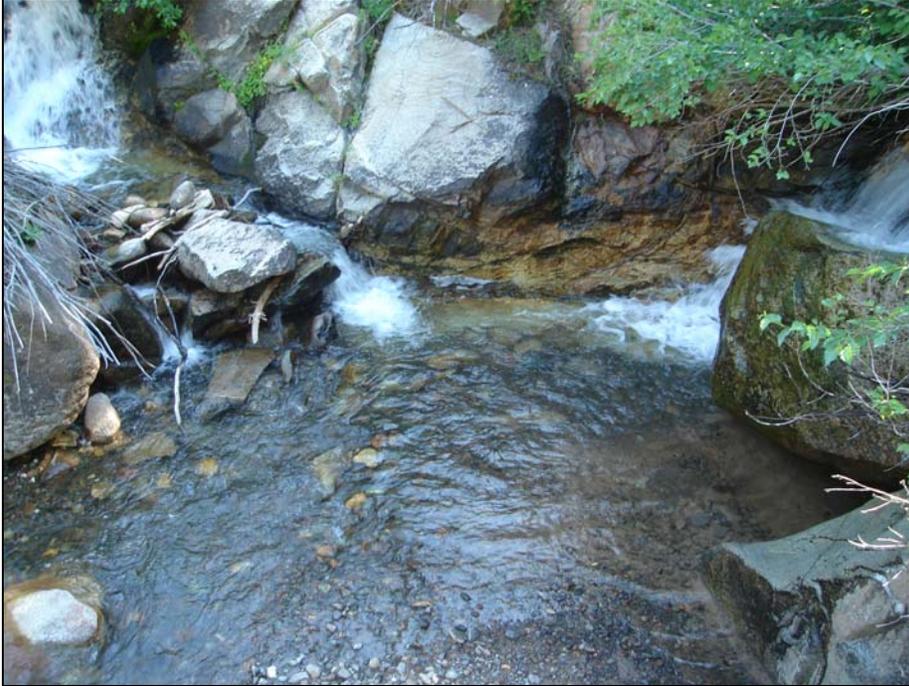
Site 1: Eagle Creek, Carson Ranger District. Upstream view of confluence, where Eagle Creek (right) feeds into Raymond Meadows Creek (left). This site is located at UTM: N: 4274246 & E: 255619, Elev. 7741 feet (2360m).

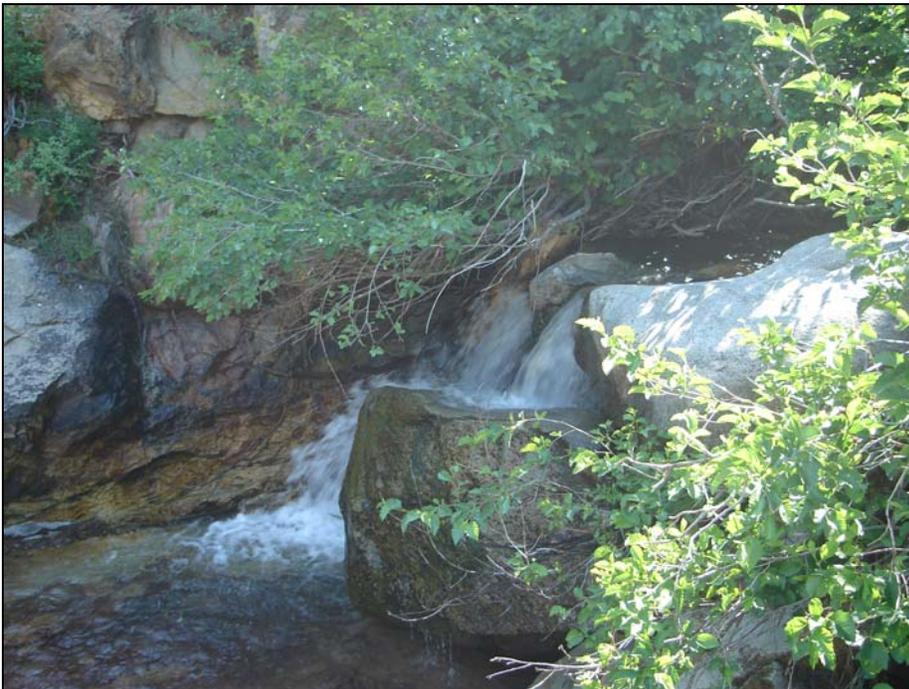
Site 1: Eagle Creek, Carson Ranger District. Photo shows a permanent fish barrier just above the confluence. The falls measure 9.0 feet tall, with a max. pool depth of 0.5 feet. This site is located at UTM: N: 4274246 & E: 255619, Elev. 7741 feet (2360m).

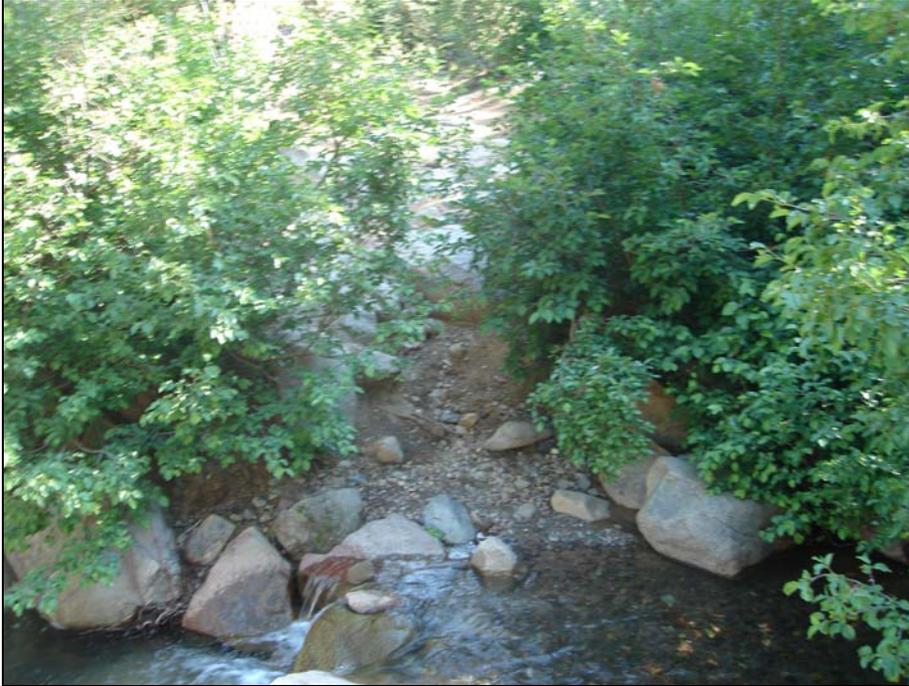
Site 2: Eagle Creek, Carson Ranger District. Cross-sectional view of a ford crossing, where Forest Service Road 112 intersects Eagle Creek. The road entry looks suitable for only foot-traffic. This crossing is located at UTM: N: 4274255 & E: 255595, Elev. 7731 feet (2357m).

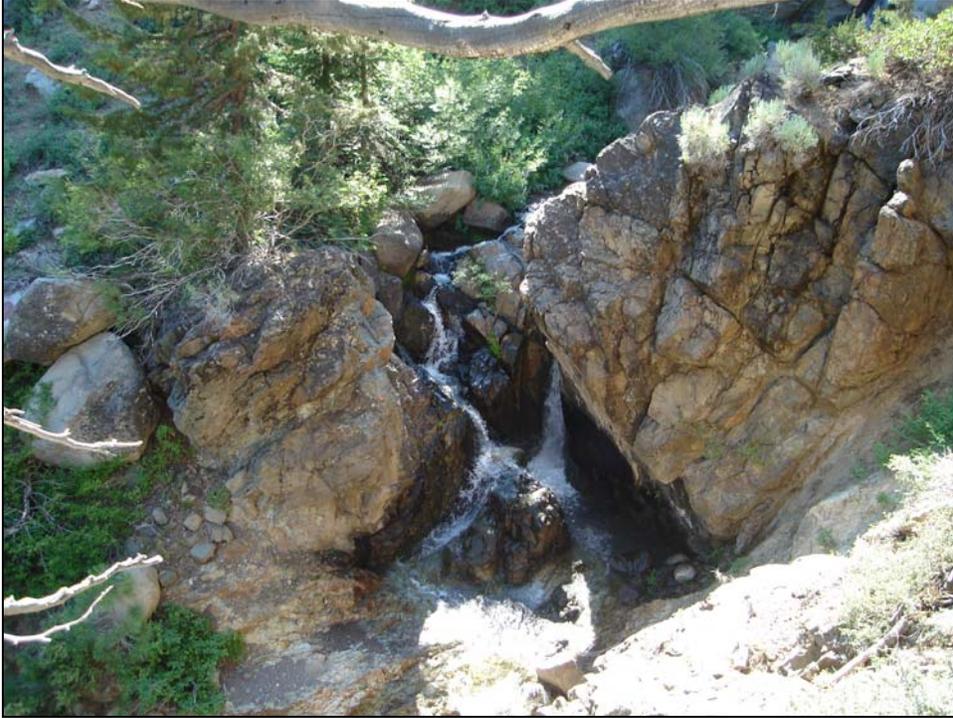
Site 3: Eagle Creek, Carson Ranger District. Upstream view of a 20.0 foot waterfall that creates a permanent fish passage barrier. This site is located at UTM: N: 4274284 & E: 255455, Elev. 7826 feet (2386m).

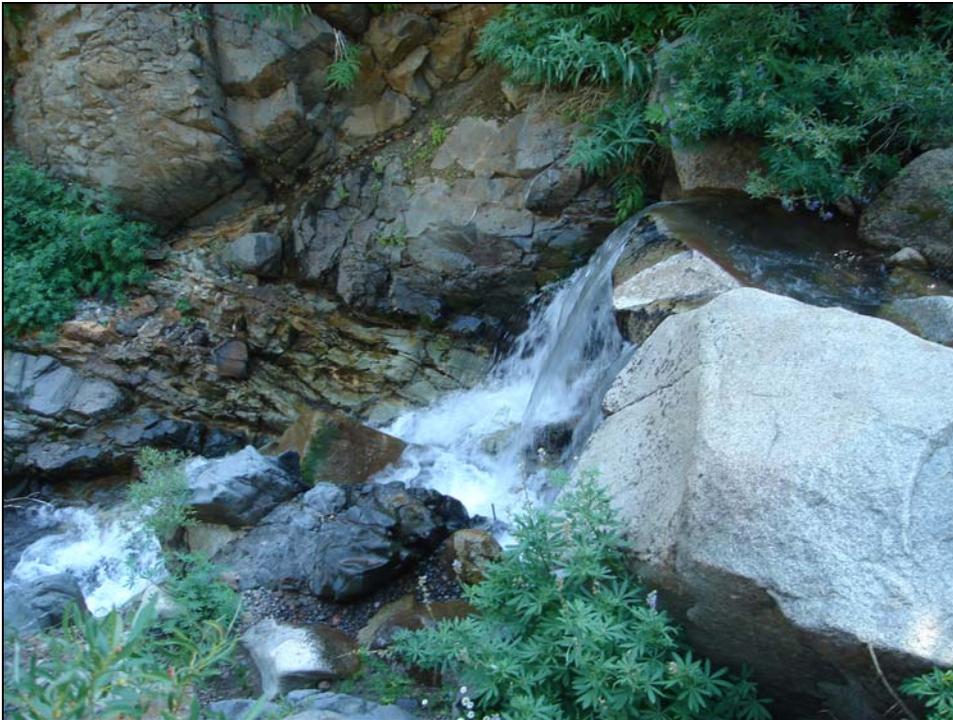
Site 4: Eagle Creek, Carson Ranger District. Photo taken from left bank shows a small waterfall measuring 6.0 feet high, with a max. pool depth of 2.0 feet. This site is located at UTM: N: 4274342 & E: 255356.

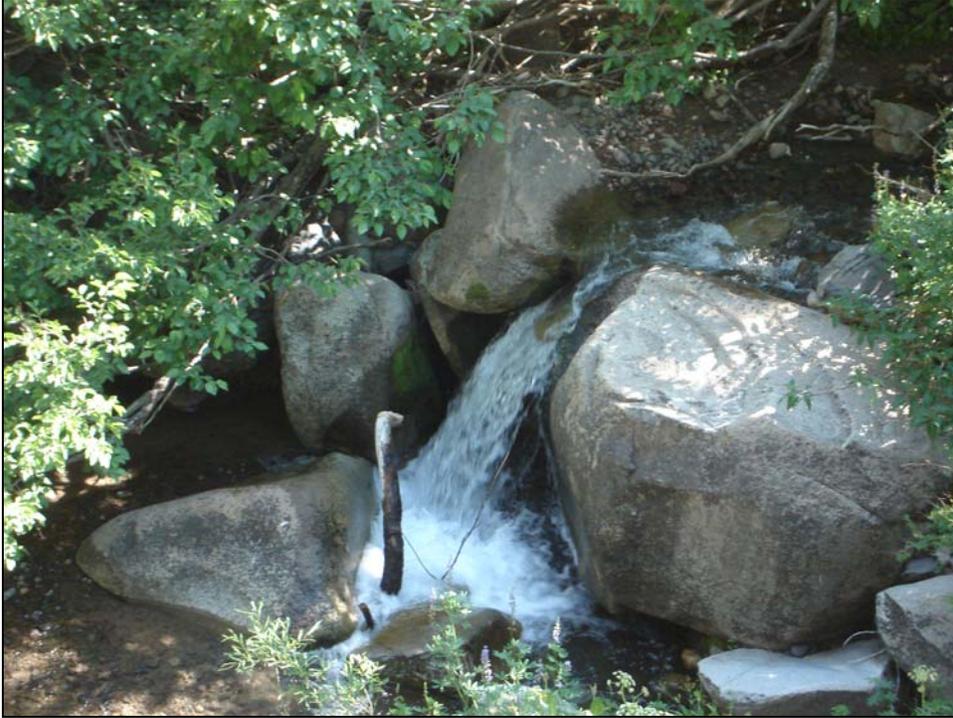
Site 5a: Eagle Creek, Carson Ranger District. Photo shows one fish barrier in a sequence of multiple seasonal fish barriers. This site is located at UTM: N: 4274386 & E: 255257, Elev. 7892 feet (2406m).

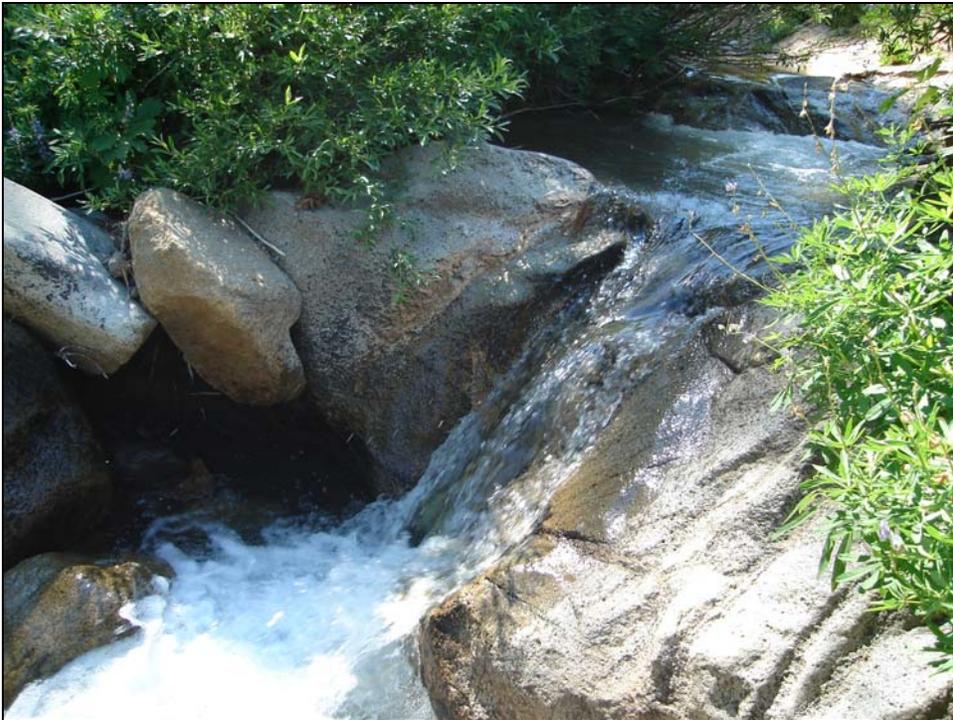
Site 5b: Eagle Creek, Carson Ranger District. Photo shows one fish barrier in a sequence of seasonal fish barriers. This site is located at UTM: N: 4274386 & E: 255257, Elev. 7892 feet (2406m)

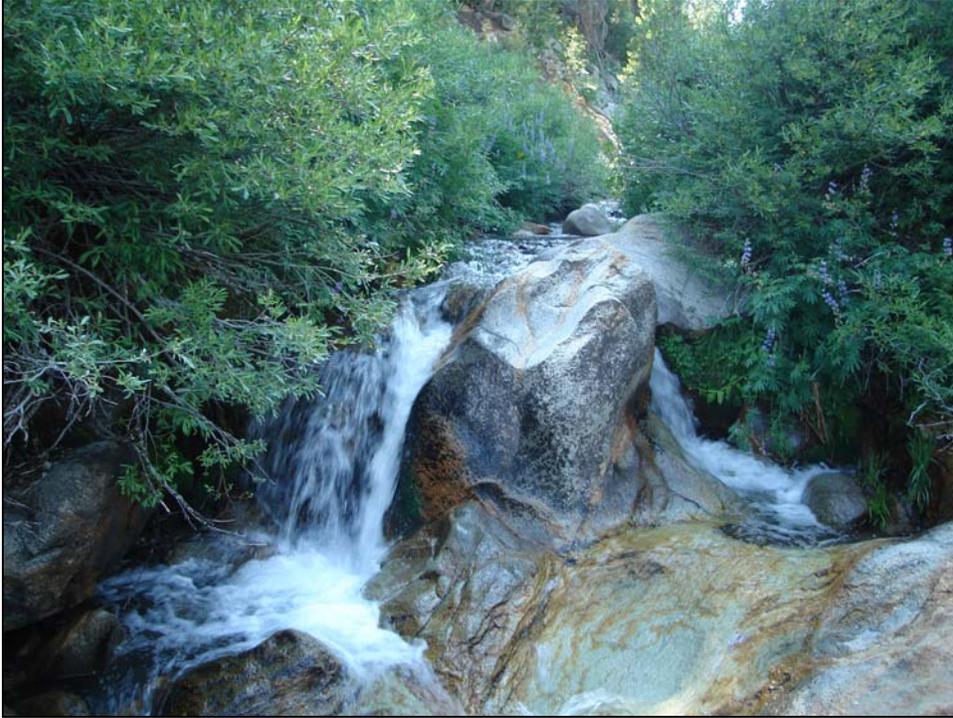
Site 5c: Eagle Creek, Carson Ranger District. Photo shows one fish barrier in a sequence of seasonal fish barriers. This site is located at UTM: N: 4274386 & E: 255257, Elev. 7892 feet (2406m).

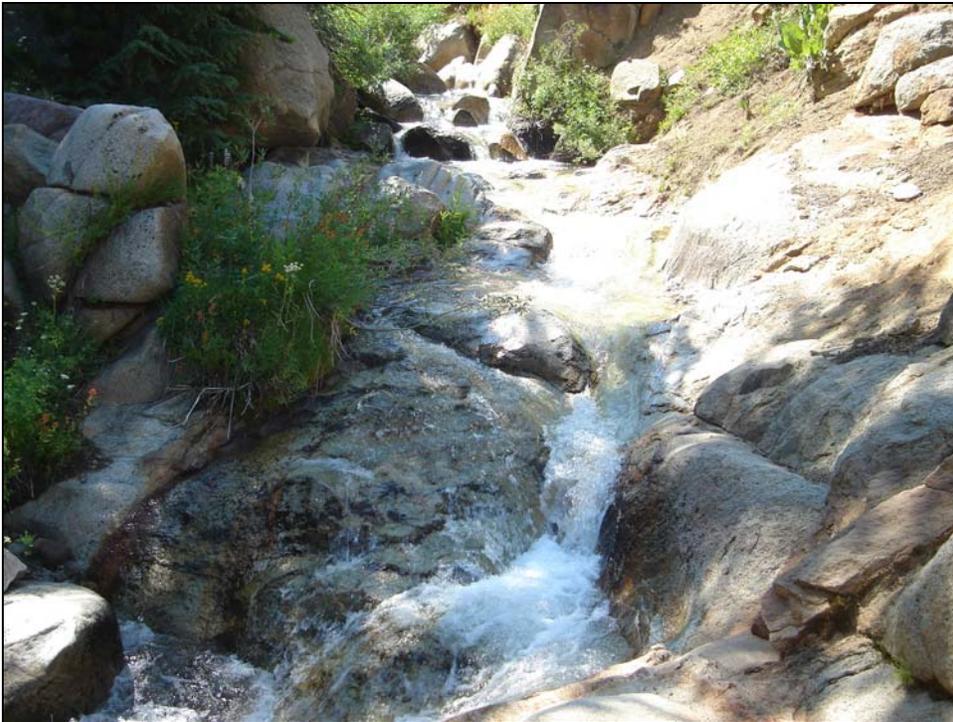
Site 5d: Eagle Creek, Carson Ranger District. Photo shows one fish barrier in a sequence of seasonal fish barriers. The slide measured 8.0 ft in longitudinal distance. This site is located at UTM: N: 4274386 & E: 255257, Elev. 7892 feet (2406m).

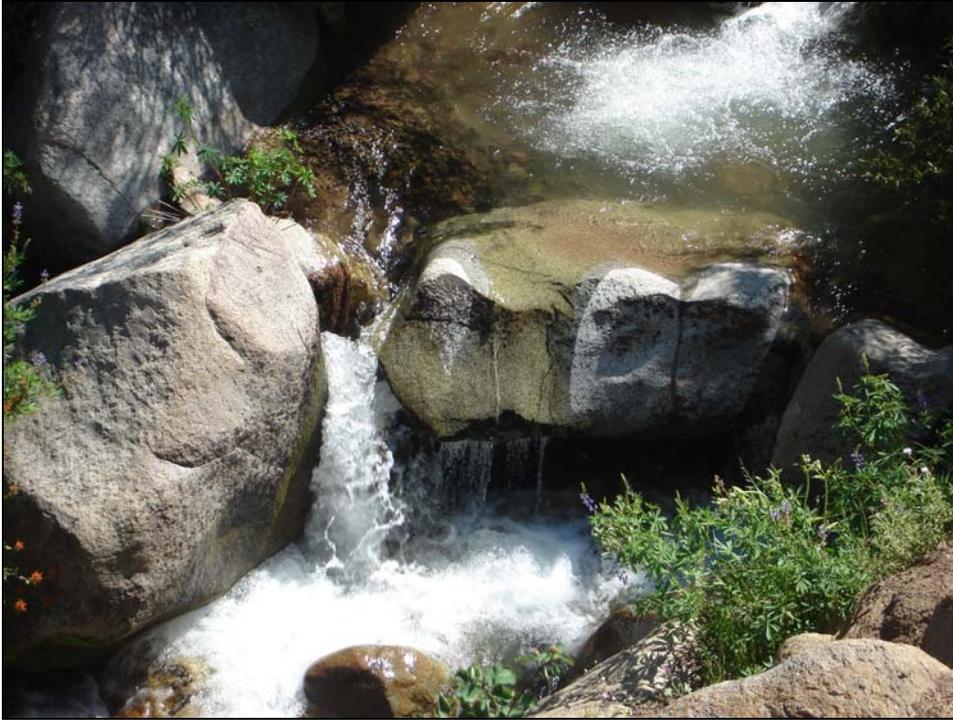
Site 5e: Eagle Creek, Carson Ranger District. Photo shows a 5.0 foot barrier (.8 foot max. pool depth) in a sequence of seasonal fish barriers. This site is located at UTM: N: 4274386 & E: 255257, Elev. 7892 feet (2406m).

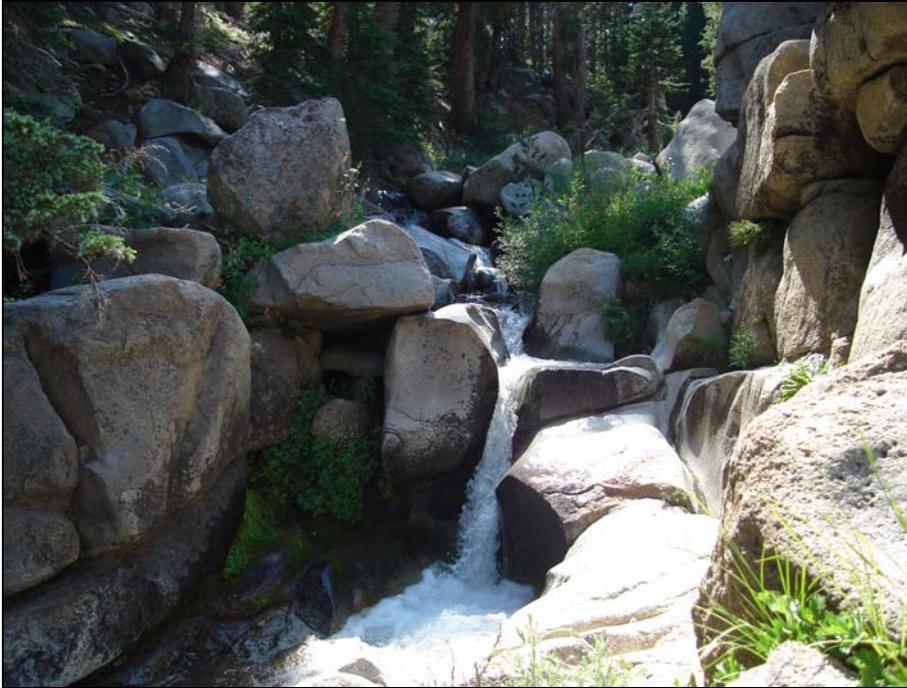
Site 7a: Eagle Creek, Carson Ranger District. Upstream view of a 5.0 foot drop with a 3.0 foot maximum pool depth. This site is located at UTM: N: 4274430 & E: 254991, Elev. 8023 feet (2446m).

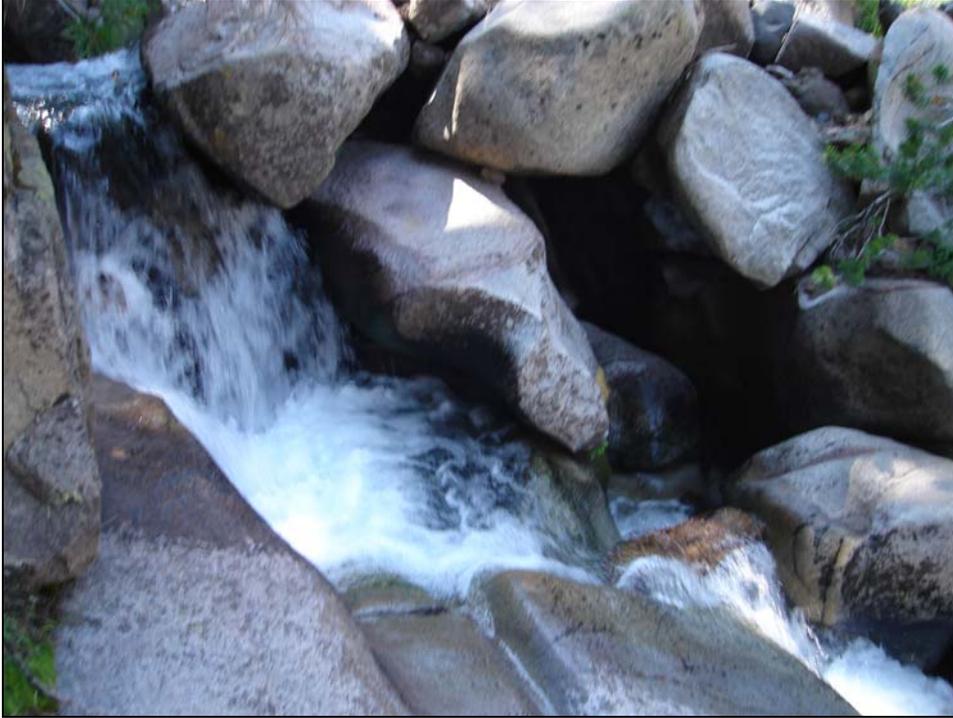
Site 7c: Eagle Creek, Carson Ranger District. Photo shows a side view of one of two consecutive 9.0 foot permanent barriers. The maximum pool depth is approximately 1.5 feet. This site is located at UTM: N: 4274430 & E: 254991, Elev. 8023 feet (2446m).

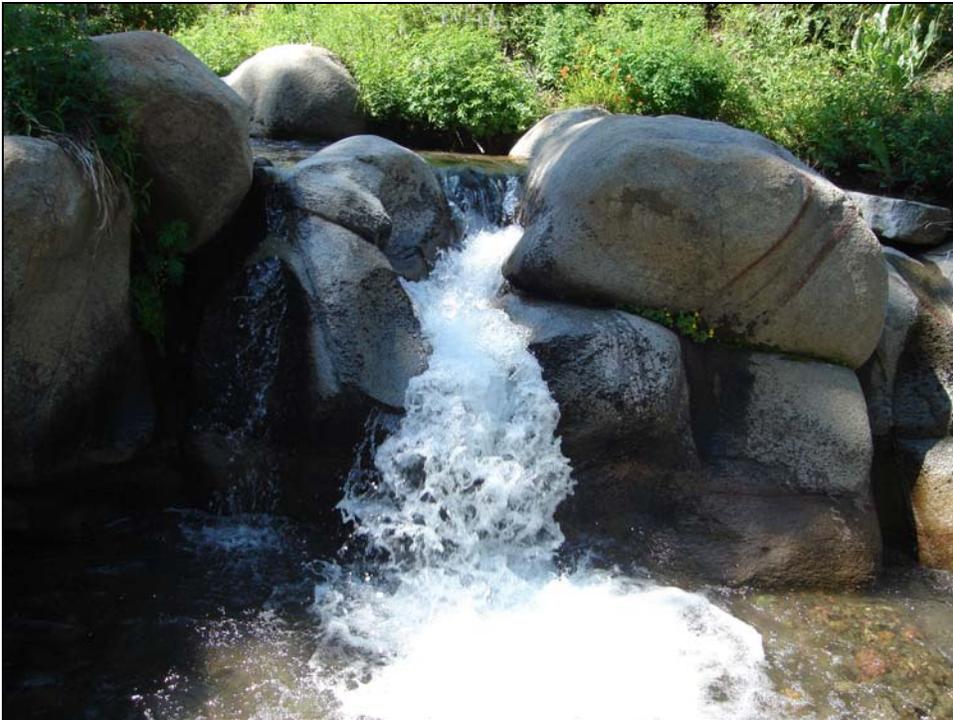
Site 8: Eagle Creek, Carson Ranger District. Upstream view of a 5.5 foot waterfall, max. pool depth 1.2 feet. This permanent barrier is located at UTM: N: 4274447 & E: 254922, Elev. 8075 feet (2462m)

1. Consider the 0.73 mile section of Eagle Creek between Site 8 and Site 12 and the 0.23 mile section of stream between Site 13 and Site 15 (total 0.96 miles) as potential LCT habitat, and consider Eagle Creek a low candidate for restoration.

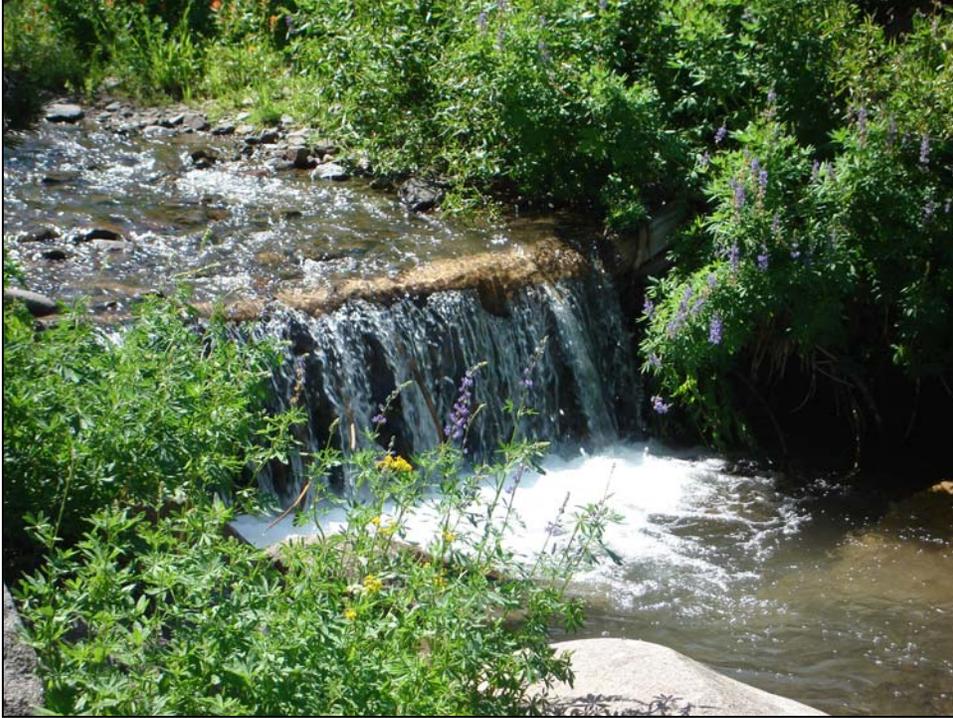
Site 8: Eagle Creek, Carson Ranger District. Photo shows a 2.7 foot seasonal barrier, located just upstream of the permanent barrier. This barrier is located at UTM: N: 4274447 & E: 254922, Elev. 8075 feet (2462m).

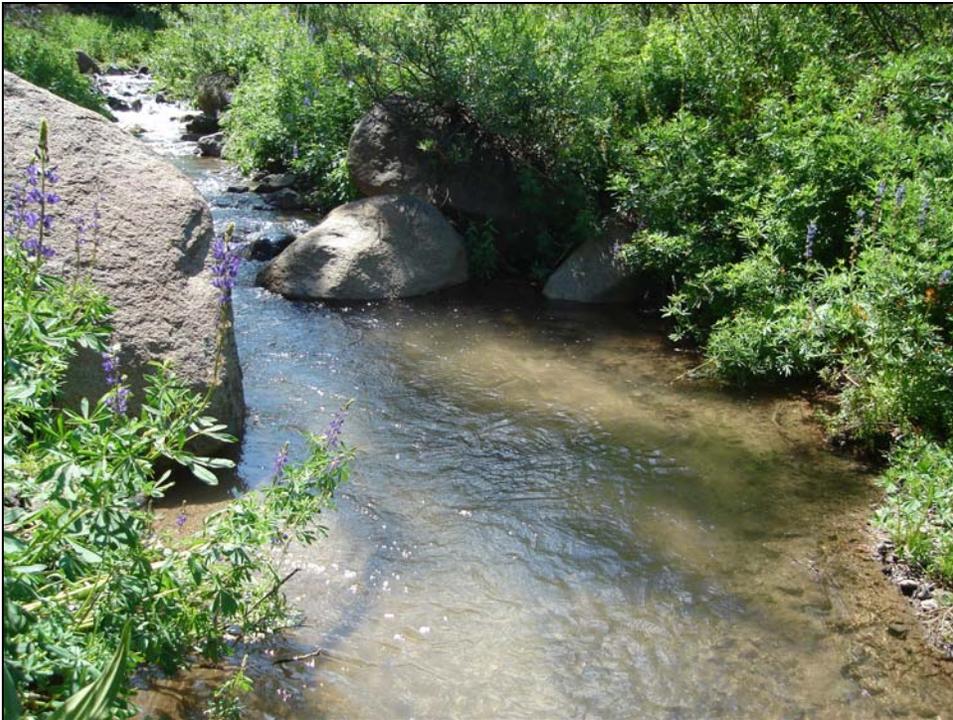
Site 9: Eagle Creek, Carson Ranger District. Photo shows an upstream view of a relatively large pool, measuring 2.1 feet deep. This site is located at UTM: N: 4274444 & E: 254879, Elev. 8095 feet (2468m).

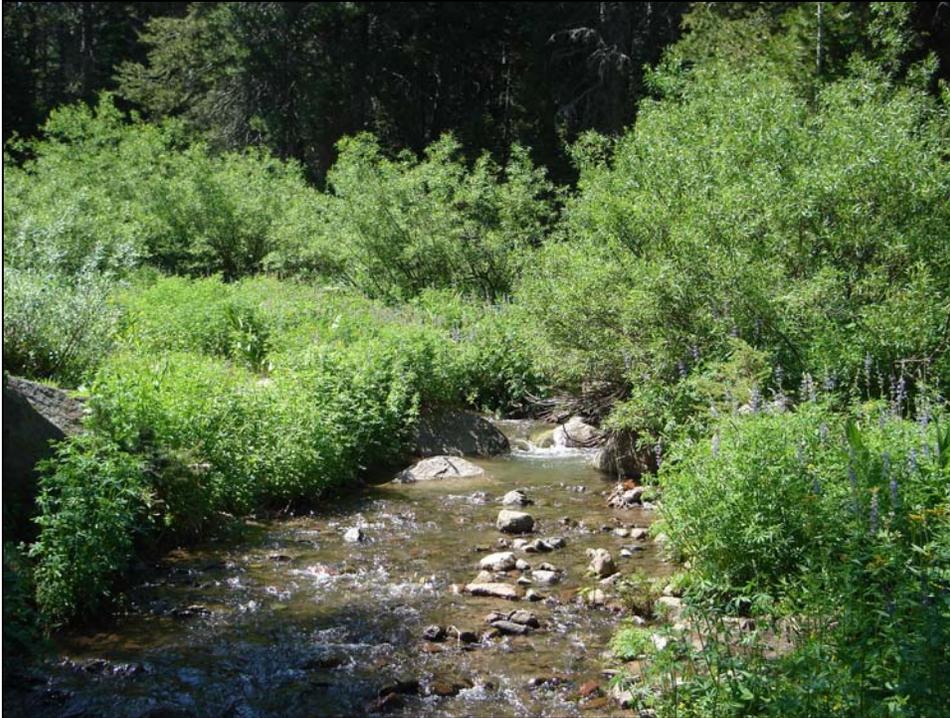
Site 10: Eagle Creek, Carson Ranger District. Upstream photo shows a short section of low gradient stream. The banks are lined with willows and wildflowers. This site is located at UTM: N: 4274374 & E: 254472, Elev. 8200 feet (2500m).

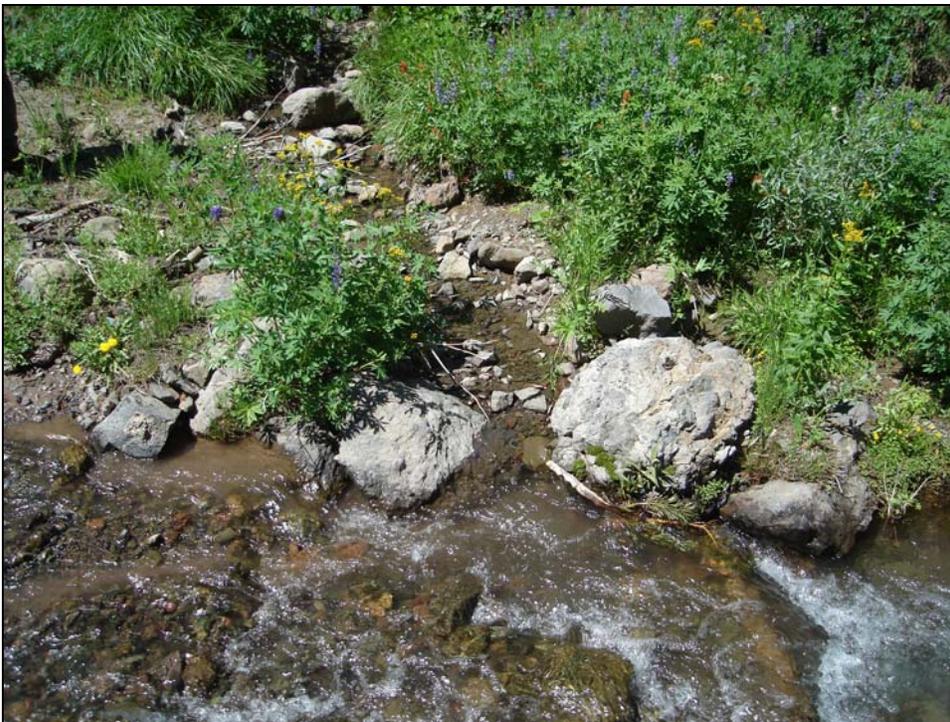
Site 11: Eagle Creek, Carson Ranger District. A small tributary (1-3% contributing flow) enters on river left. This site is located at UTM: N: 4274563 & E: 253918, Elev. 8308 feet (2533m).

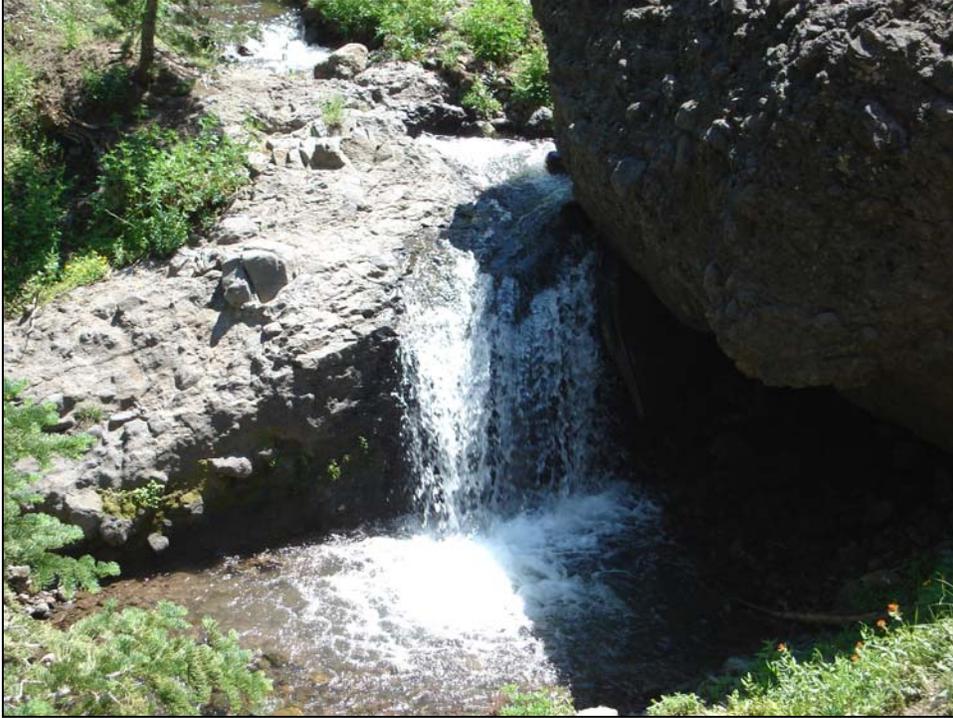
Site 12: Eagle Creek, Carson Ranger District. Photo shows a permanent fish barrier measuring 6.5 feet high, with a 1.5 foot max. pool depth. This site is located at UTM: N: 4274568 & E: 253863, Elev. 8331 feet (2540m).

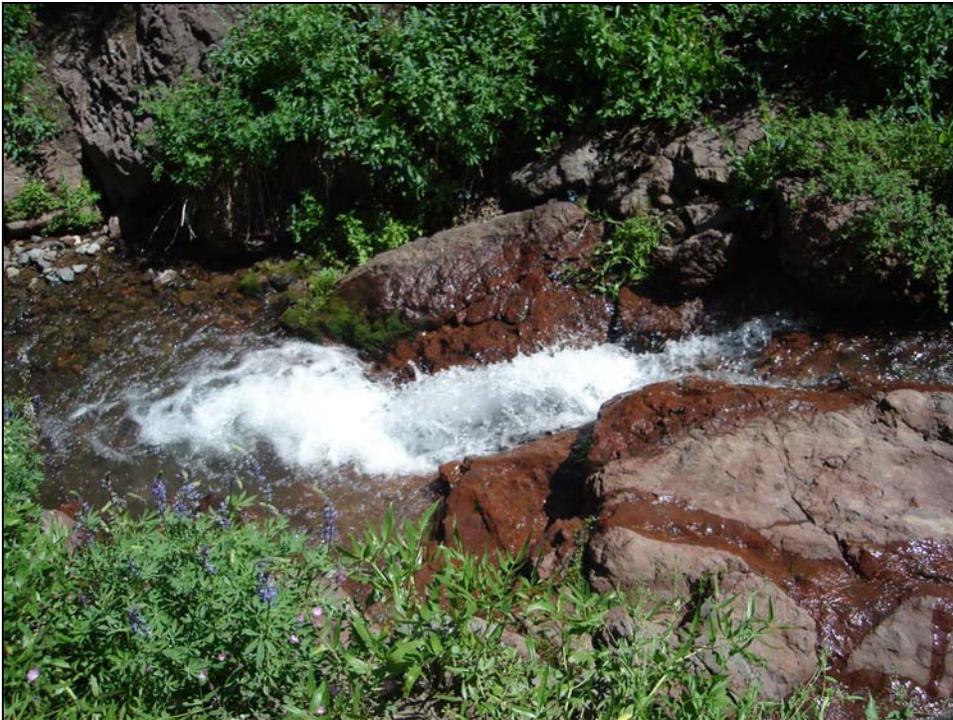
Site 13: Eagle Creek, Carson Ranger District. Photo shows a seasonal barrier where water slides through bedrock. This site is located at UTM N: 4274437 & E: 253635, Elev. 8384 feet (2556m).

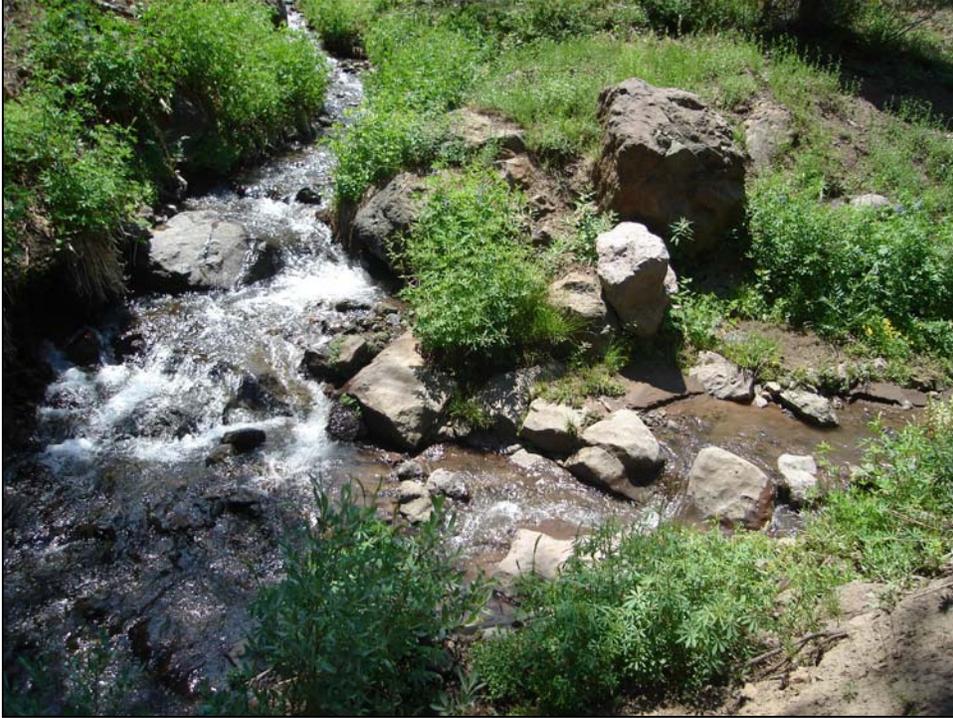
Site 14: Eagle Creek, Carson Ranger District. Photo shows an upstream view of a headwater stream entering the creek from river left. This site is located at UTM: N: 4274372 & E: 253451, Elev. 8410 feet (2564m).

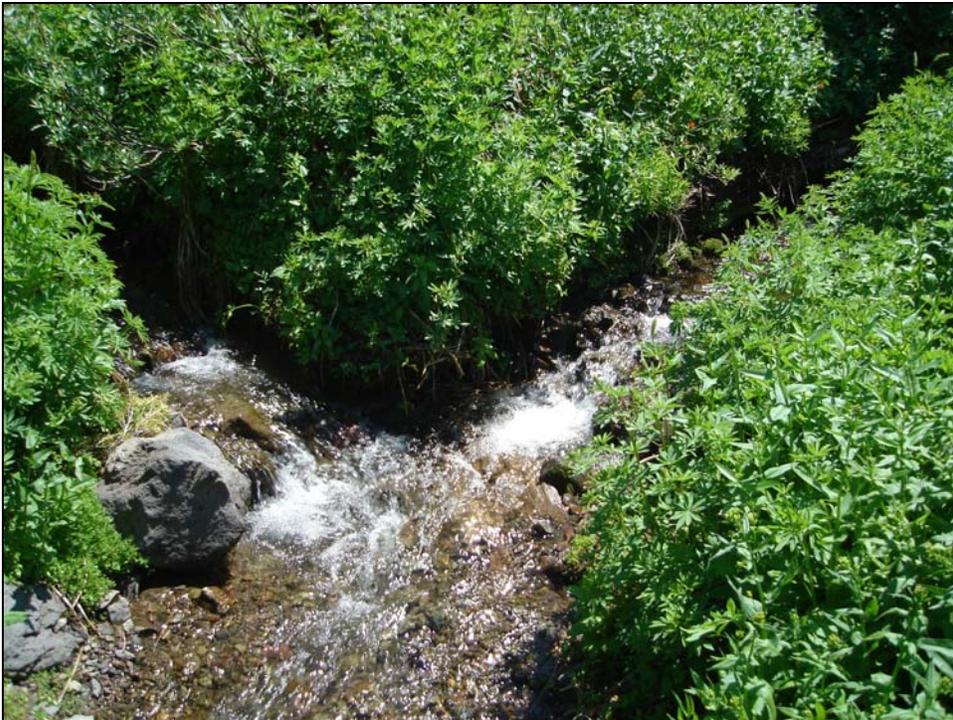
Site 15: Eagle Creek, Carson Ranger District. Several headwater streams converge to form the mainstem of Eagle Creek. This site is located at UTM: N: 4274249 & E: 253330, Elev. 8508 feet (2594m).

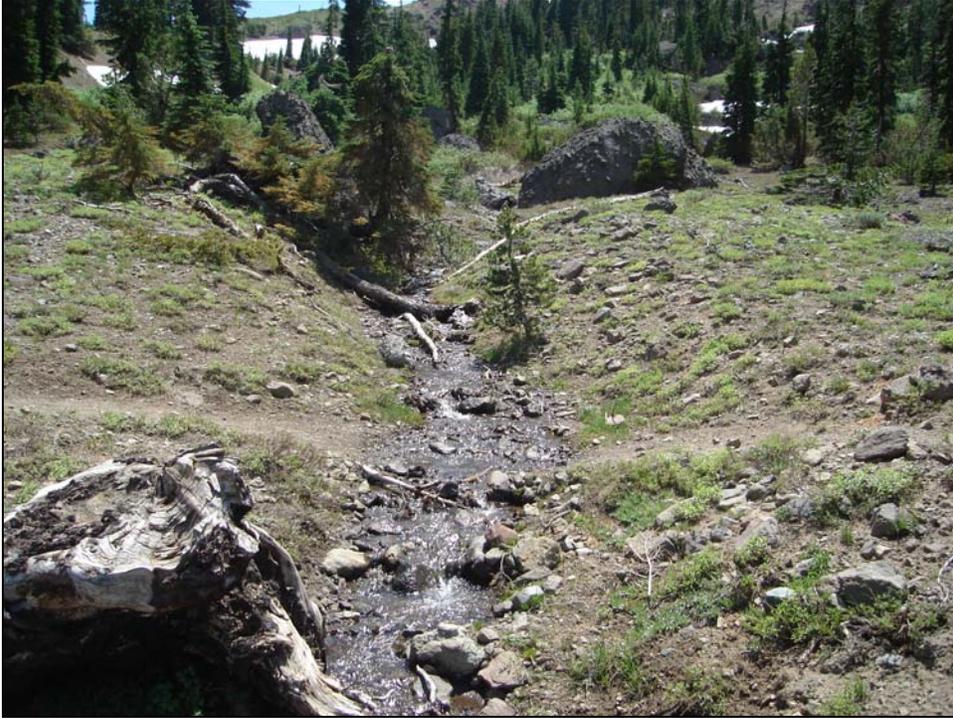
Site 16: Eagle Creek, Carson Ranger District. Photo shows the PCT crossing a headwater of Eagle Creek. This site, which marks the survey end point, is located at UTM: N: 4274156 & E: 253289, Elev. 8482 feet (2568m).

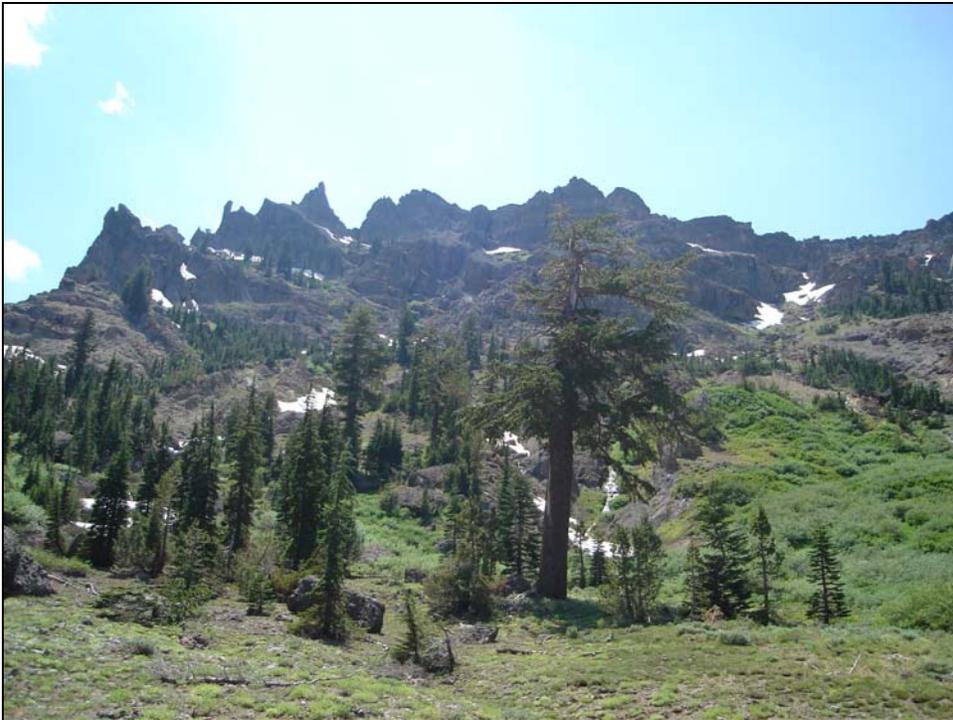
Site 16: Eagle Creek, Carson Ranger District. Water from Reynold's Peak form the headwaters of Eagle Creek. This site, which marks the survey end point, is located at UTM: N: 4274156 & E: 253289, Elev. 8482 feet (2568m).

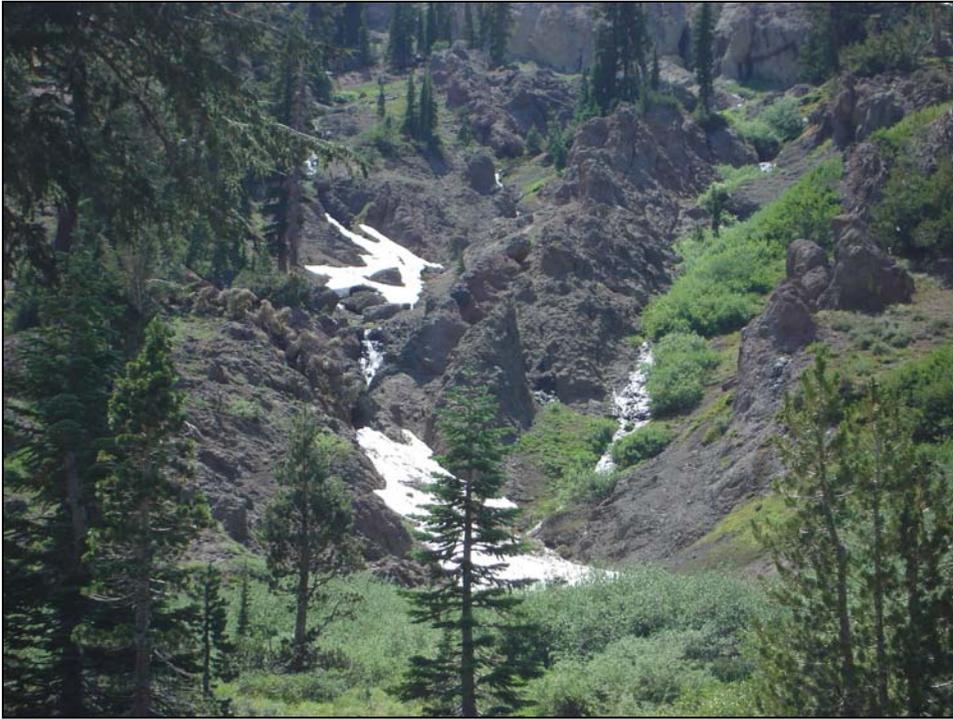
Site 16: Eagle Creek, Carson Ranger District. Photo shows water coming down off Reynold's Peak. This site, which marks the survey end point, is located at UTM: N: 4274156 & E: 253289, Elev. 8482 feet (2568m).
