ELDER CREEK

Alpine County, California

2006 Stream Habitat Survey Report

Carson Ranger District: Humboldt-Toiyabe National Forest

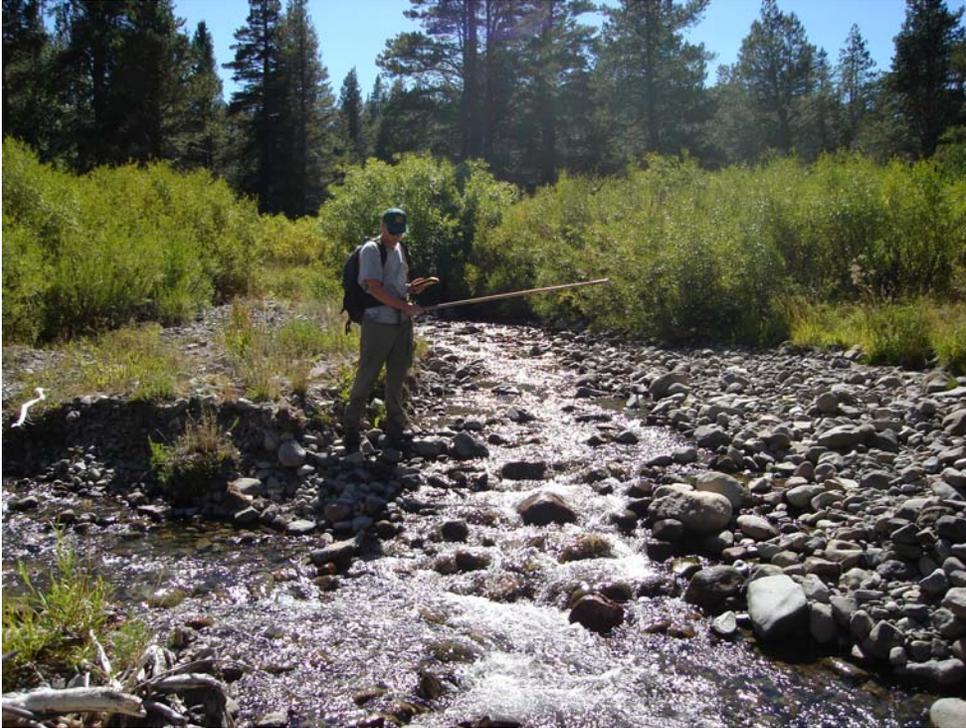
Site 1: Elder Creek, Carson Ranger District. An upstream photo of Elder Creek at the confluence with Wolf Creek. Note that each stream contributes 50% of the flow. This site is located at UTM: N: 4264625 & E: 261092, Elev. 7720 ft (2353 m).

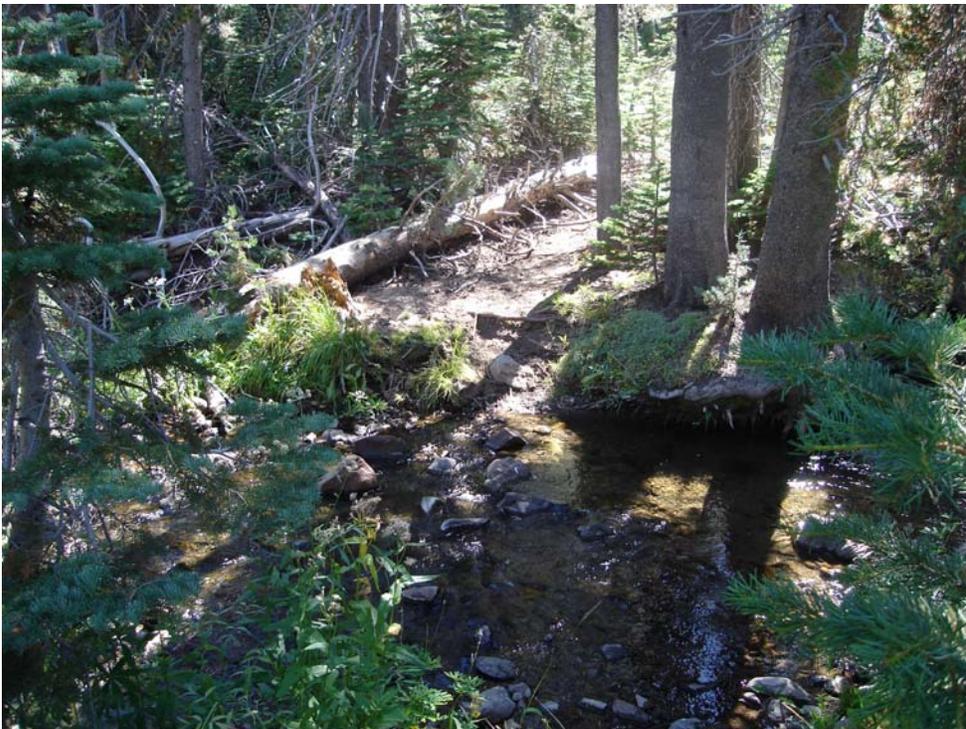
Site 2: Elder Creek, Carson Ranger District. A cross-section of Elder Creek showing a trail crossing on the right bank. This site is located at UTM: N: 264585 & E: 261001, Elev. 7789 ft (2374 m).

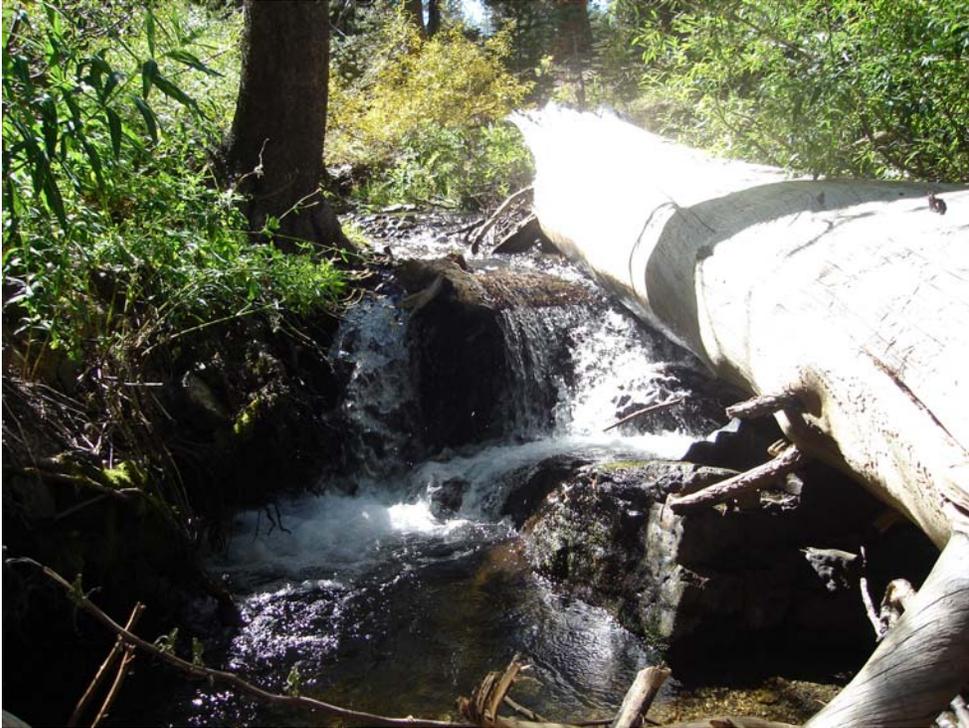
Site 3: Elder Creek, Carson Ranger District. An upstream photo of a seasonal fish barrier measuring 3.0 ft tall with a max pool depth of 1.8 ft. Note the complex LWD. This site is located at UTM: N: 4264493 & E: 260750, Elev. 7848 ft (2392 m).

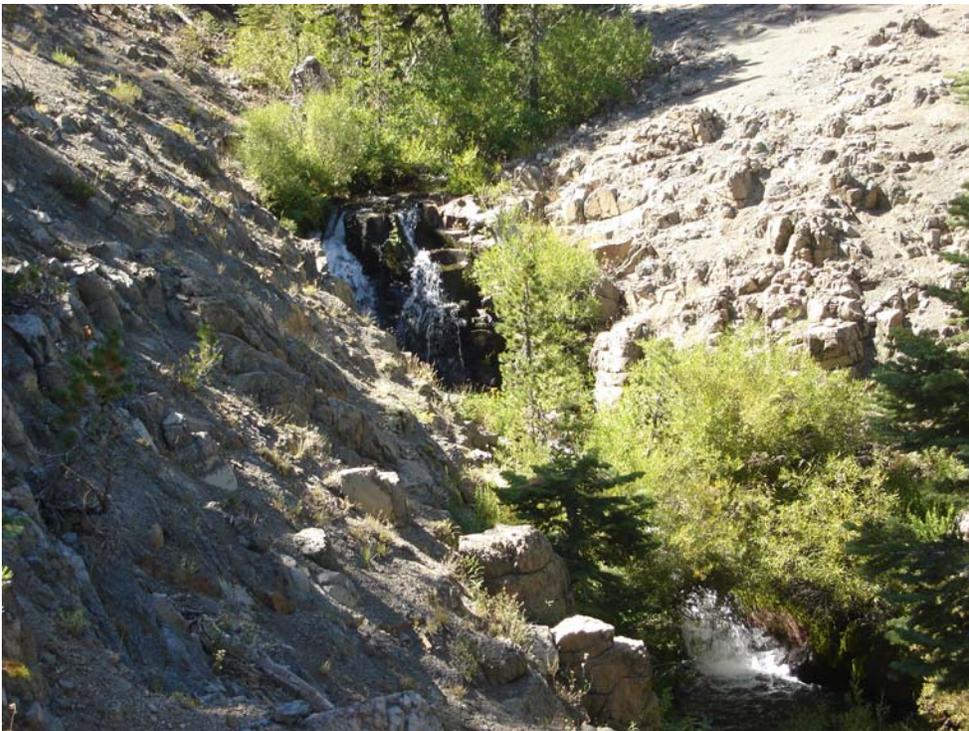
Site 4: Elder Creek, Carson Ranger District. Upstream photo of a permanent fish barrier: a natural waterfall 12.0 ft high, with a max pool depth of 2.0 ft (estimated for safety reasons). This site is located at UTM: N: 4264515 & E: 260629, Elev. 7880 ft (2402 m).

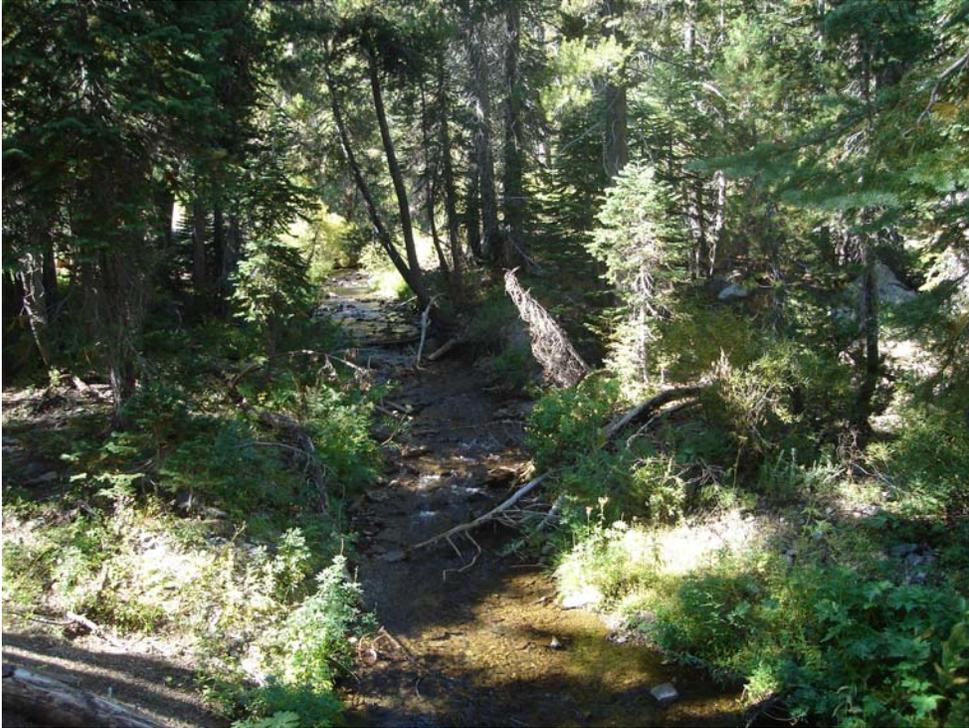
Site 5: Elder Creek, Carson Ranger District. An upstream photo showing characteristic habitat of this reach. This site is located at UTM: N: 4264483 & E: 260420, Elev. 7940 ft (2420 m).

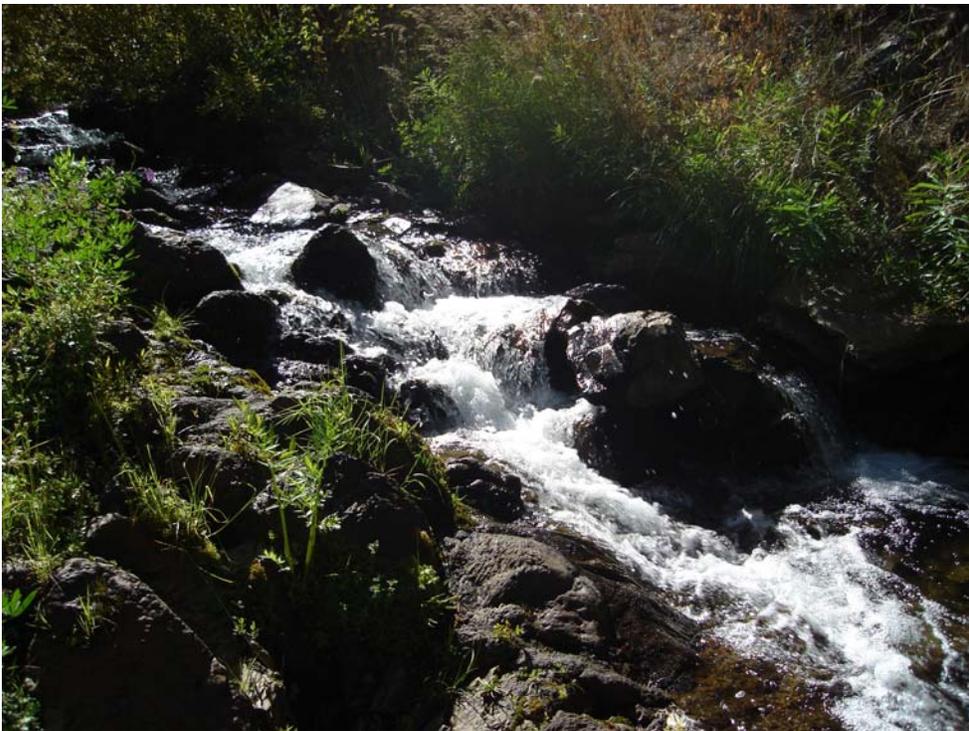
Site 6: Elder Creek, Carson Ranger District. An upstream photo showing a seasonal barrier formed by a 3.0 ft rocky cascade with a max pool depth of 1.3 ft. This site is located at UTM: N: 4264546 & E: 260208, Elev. 7972 ft (2430 m).

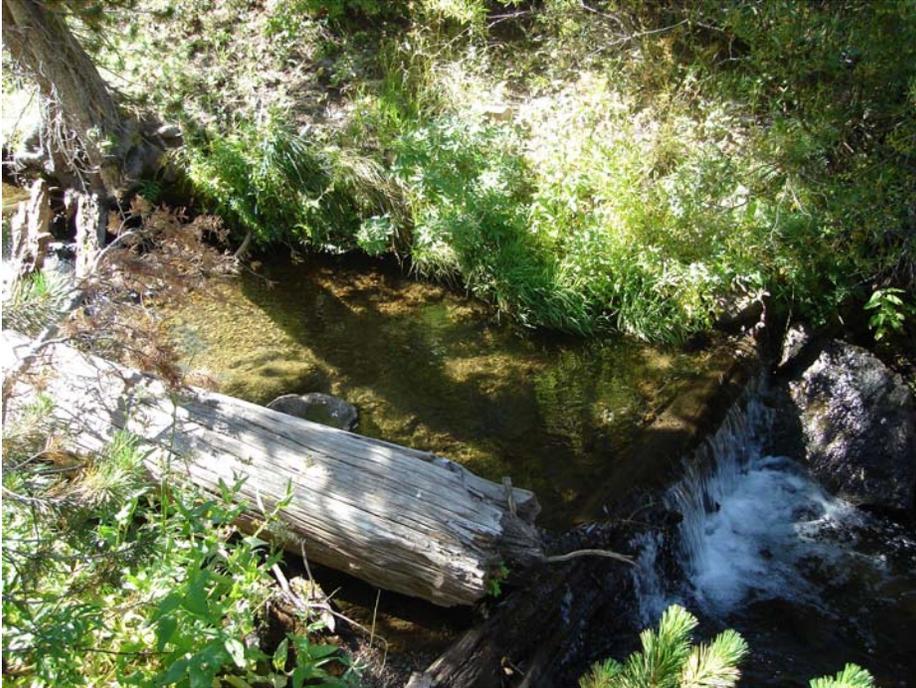
Site 7: Elder Creek, Carson Ranger District. Cross-sectional photo of a pool where a small salmonid was sighted. This site is located at UTM: N: 4264515 & E: 260152, Elev. 8054 ft (2455 m).

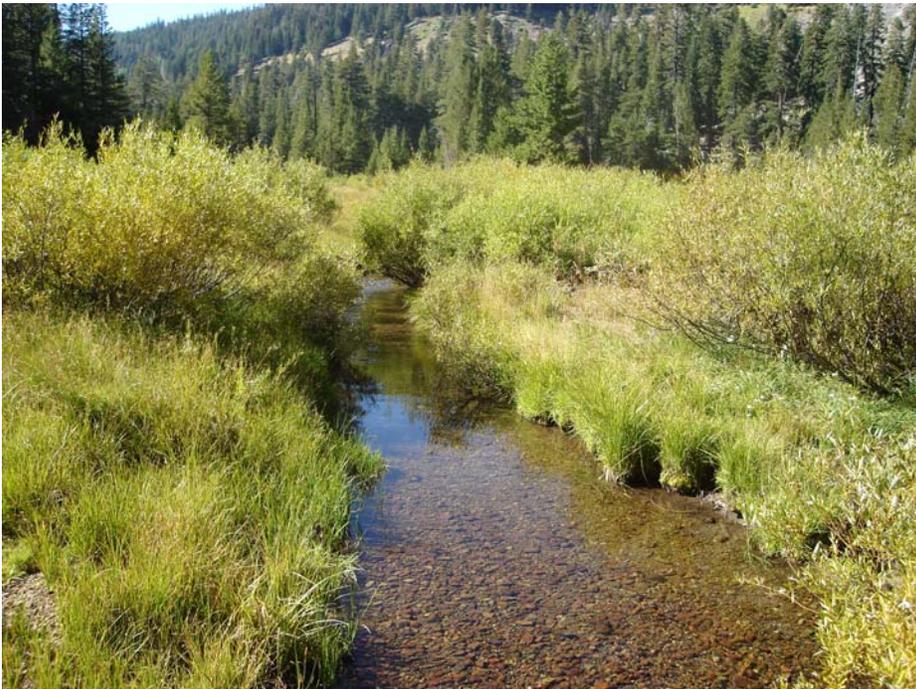
Site 8: Elder Creek, Carson Ranger District. An upstream photo showing a meadow with undercut banks and favorable LCT habitat. This site is located at UTM: N: 4264491 & E: 260042, Elev. 8071 ft (2460 m).

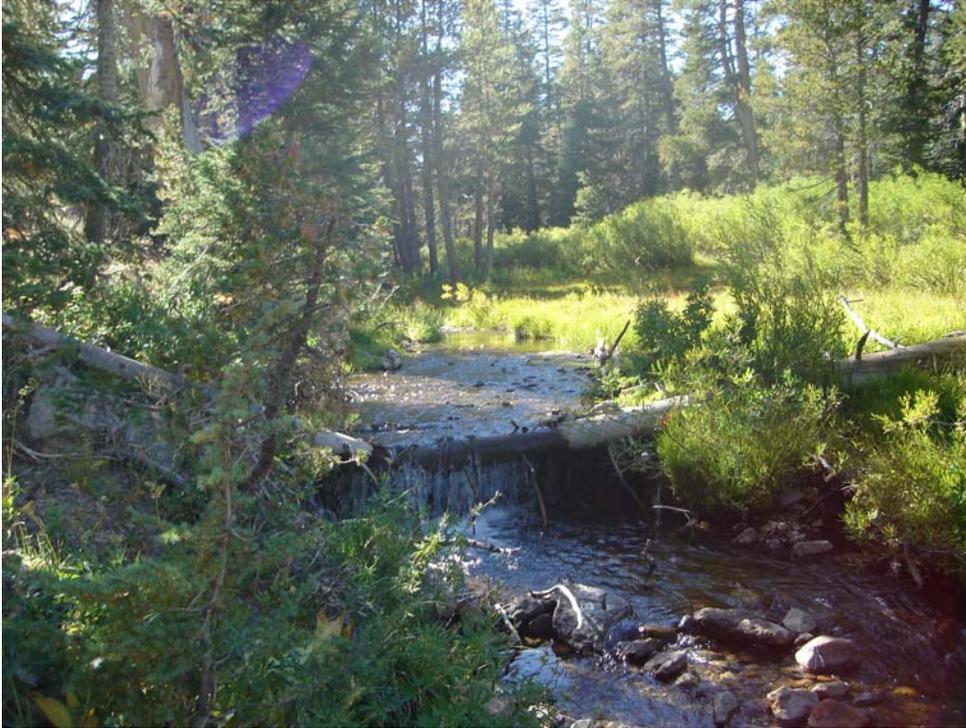
Site 9: Elder Creek, Carson Ranger District.. Upstream photo of a seasonal fish barrier formed by large woody debris. Maximum barrier height is 2.2 feet with a max pool depth of 2.1 ft. This site is located at UTM: N: 42646509 & E: 259798, Elev. 8123 ft (2476 m).

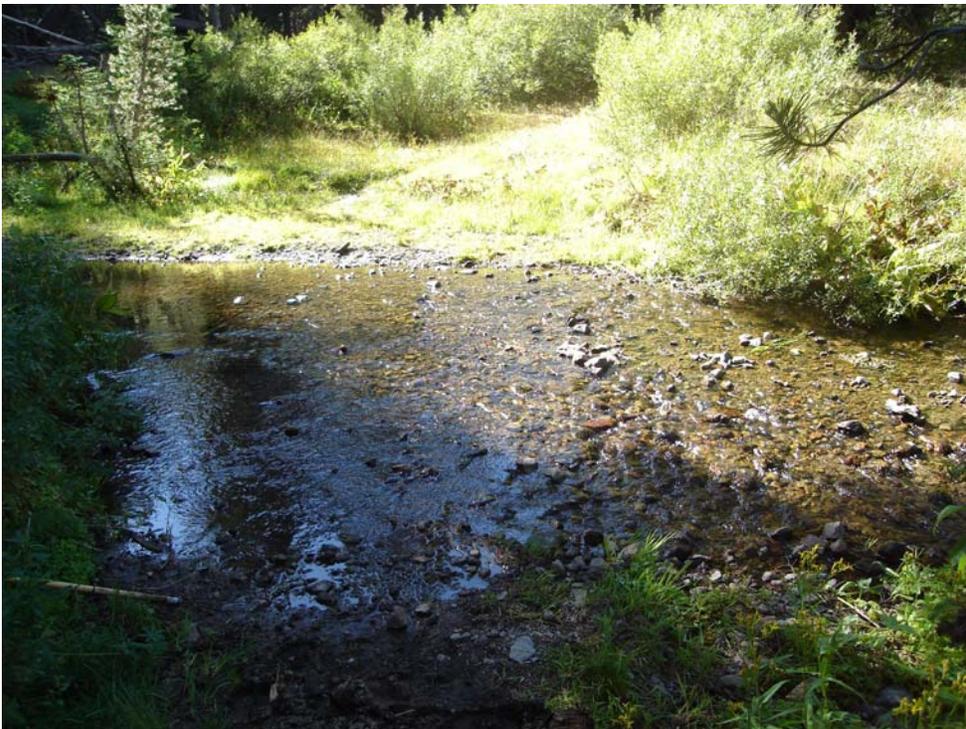
Site 10: Elder Creek, Carson Ranger District. A cross-sectional photo showing a trail crossing on the right bank. This trail is for foot traffic and stock animals. This site is located at UTM: N: 4264630 N & E: 259512, Elev. 8068 ft (2459 m).

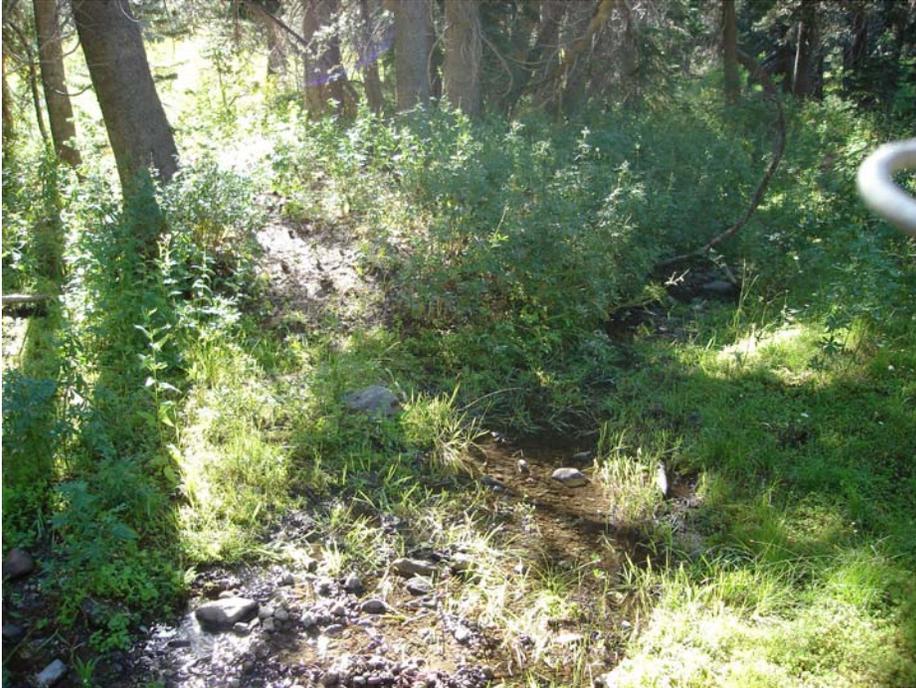
Site 11: Elder Creek, Carson Ranger District. A small tributary contributing 1% of flow is located on the left bank. This site is located at UTM: N: 4264658 & E: 259402, Elev. 8123 ft (2476 m).

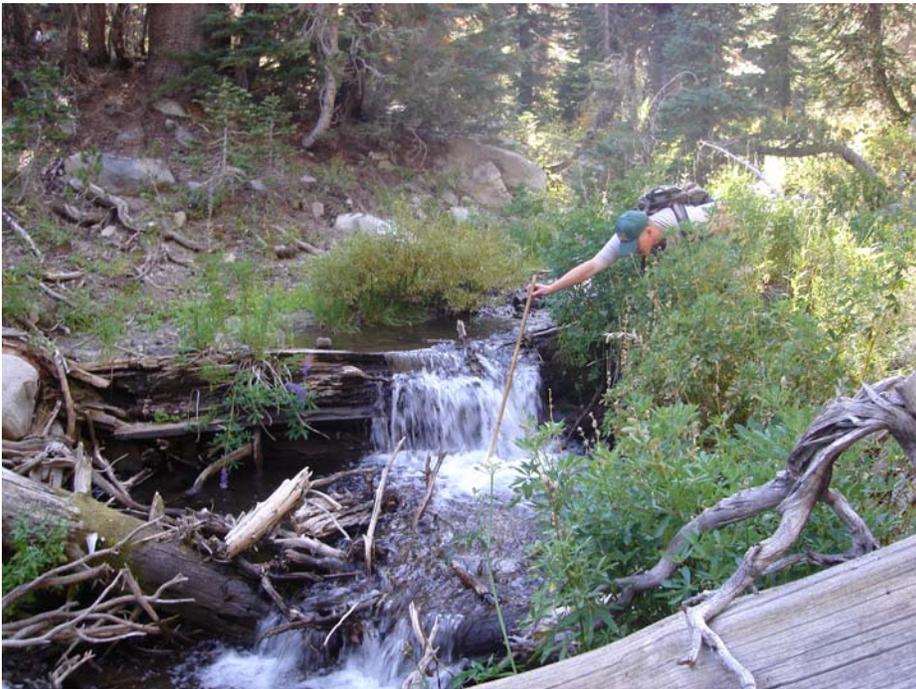
Site 12: Elder Creek, Carson Ranger District. An upstream photo showing a small seasonal fish barrier formed by large woody debris. The height of the barrier is 2.2 ft with a max pool depth of 1.3 ft. This site is located at UTM: N: 4264805 & E: 259111, Elev. 8209 ft (2502 m).

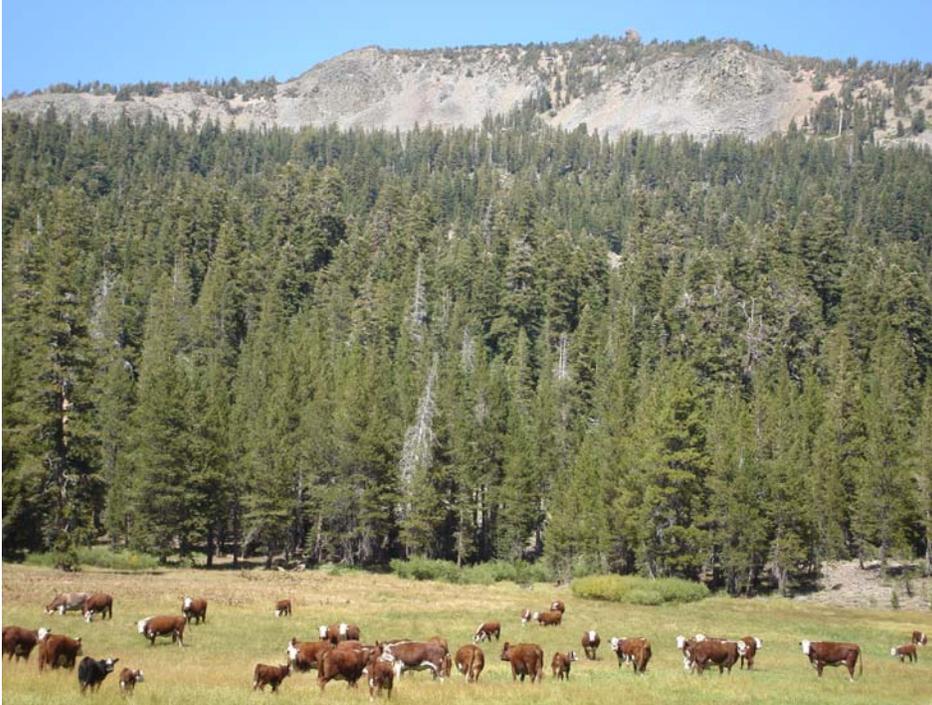
A small group of cattle was sighted in the Elder Creek drainage (Site 13), though livestock impacts were negligible. In addition, evidence of human presence or activity was limited to the existence of a trail and the presence of one fire ring located away from the stream.

Site 13: Elder Creek, Carson Ranger District. Note: cattle were seen at Site 13 earlier in the day, though were not present during the survey. This photo shows the small herd that was previously sighted at Site 13. This site is located at UTM: N: 4264856 & E: 259102, Elev. 8235 ft (2510 m).

1. Consider the 1.5 mile section of Elder Creek between Site 1 and Site 15 as potential LCT habitat and consider Elder Creek a medium candidate for restoration.
2. Monitor the impact of grazing in the area to maintain the existing integrity of the riparian corridor.

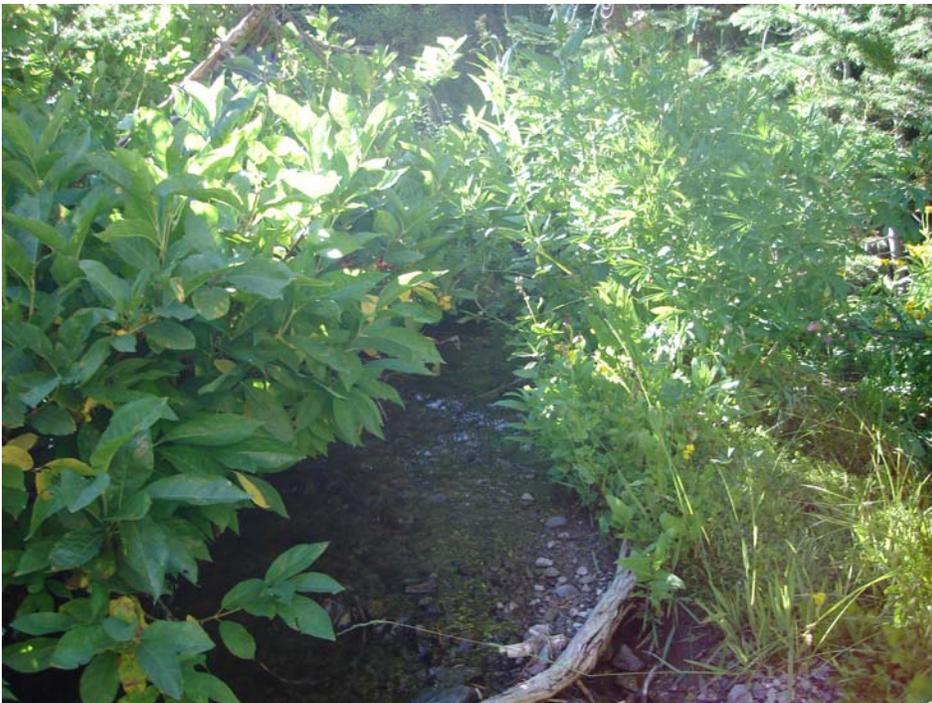
Site 14: Elder Creek, Carson Ranger District. Upstream photo of a tributary found on the left bank. This tributary contributes 10% flow and was found to be 3 ft wide and .5 ft deep. This site is located at UTM: N: 4264850 & E: 259006, Elev. 8238 ft (2511 m).

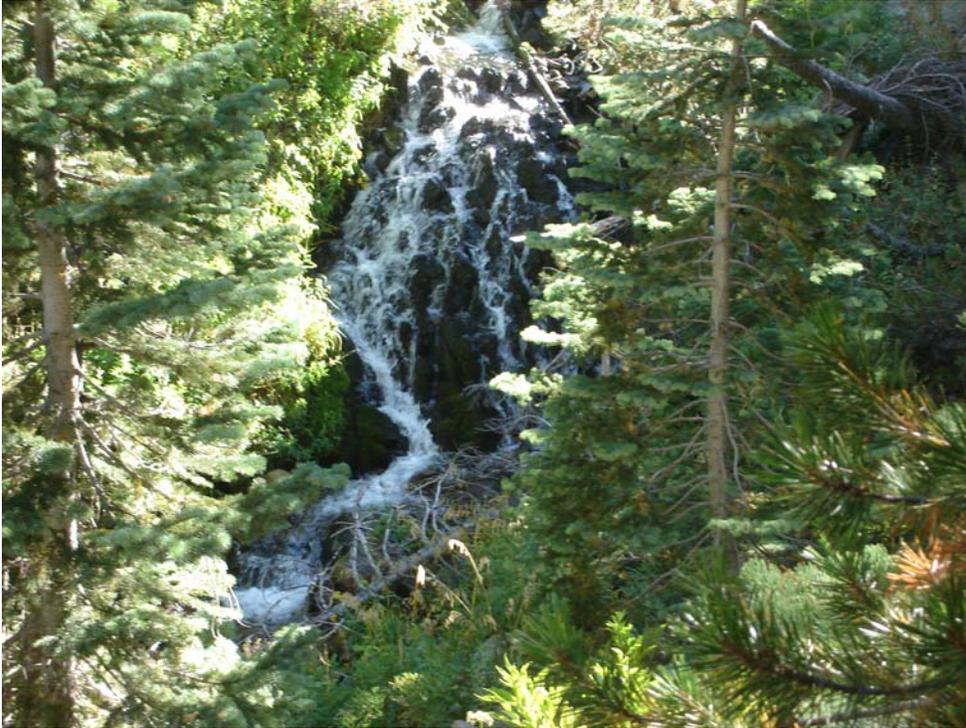
Site 15: Elder Creek, Carson Ranger District. Upstream photo of a permanent fish barrier formed by a 10-foot high rock waterfall with a max. pool depth of 0.8 feet. This site is located at UTM: N: 4264838 & E: 258919, Elev. 8245 ft (2513 m).

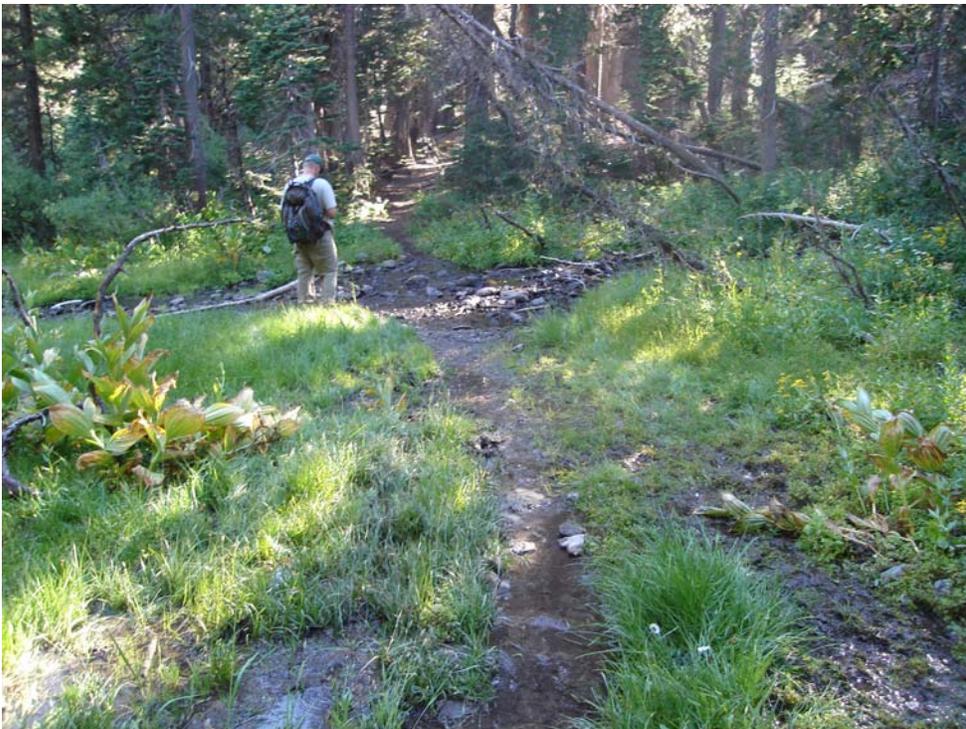
Site 16: Elder Creek, Carson Ranger District. Cross-sectional photo showing a trail-stream intersection. This site is located at UTM: N: 4264849 & E: 258847, Elev. 8350 ft (2545 m).

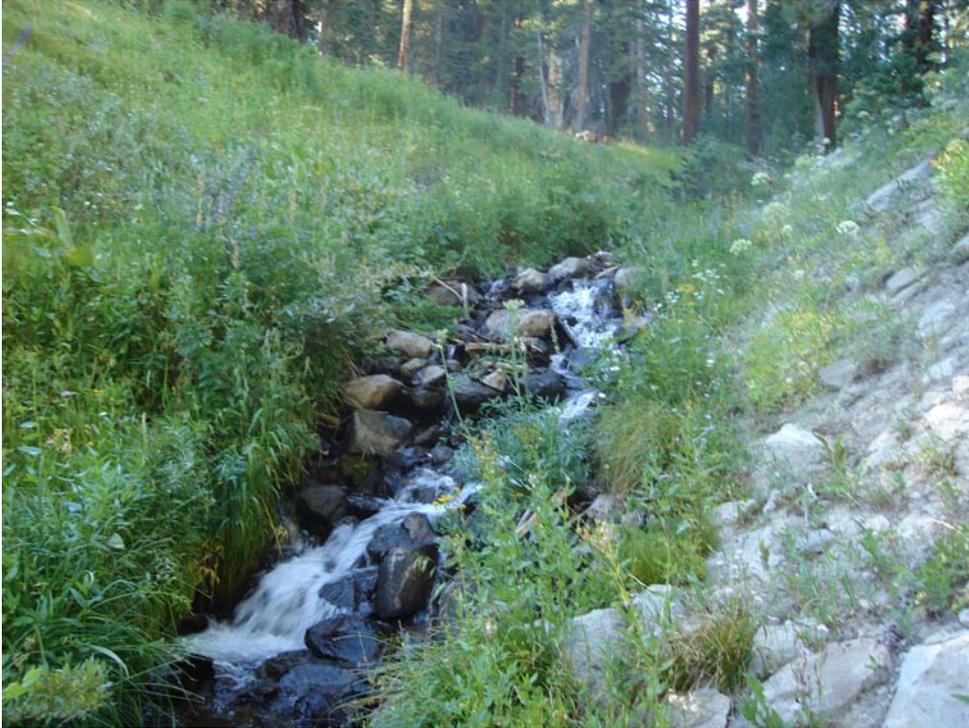
Site 17: Elder Creek, Carson Ranger District. Upstream photo taken at the survey end point. Above this point the stream lacks sustainable fish habitat. This site is located at UTM: N: 4264917 N & E: 258793, Elev. 8396 ft (2559 m).
