# **HOT SPRINGS CREEK**

## **2006 Stream Habitat Survey Report**

Carson Ranger District: Humboldt-Toiyabe National Forest

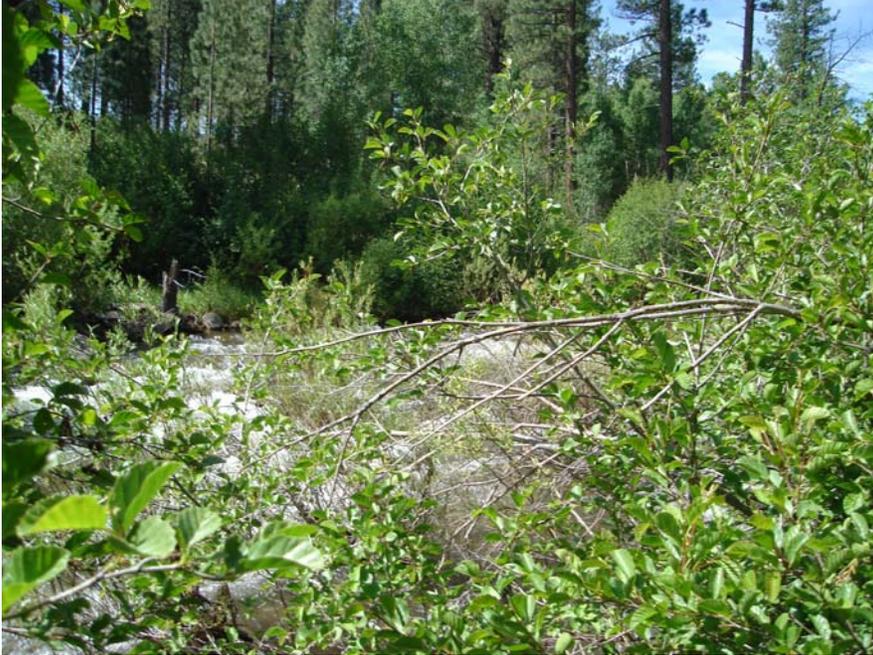
**Site 1:** Hot Springs Creek, Carson Ranger District. Start point of survey looking upstream through some underbrush. This photo portrays the general characteristics of this reach. This site is located at UTM: N: 4286067 & E: 256133, Elev. 5620 ft (1713 m).

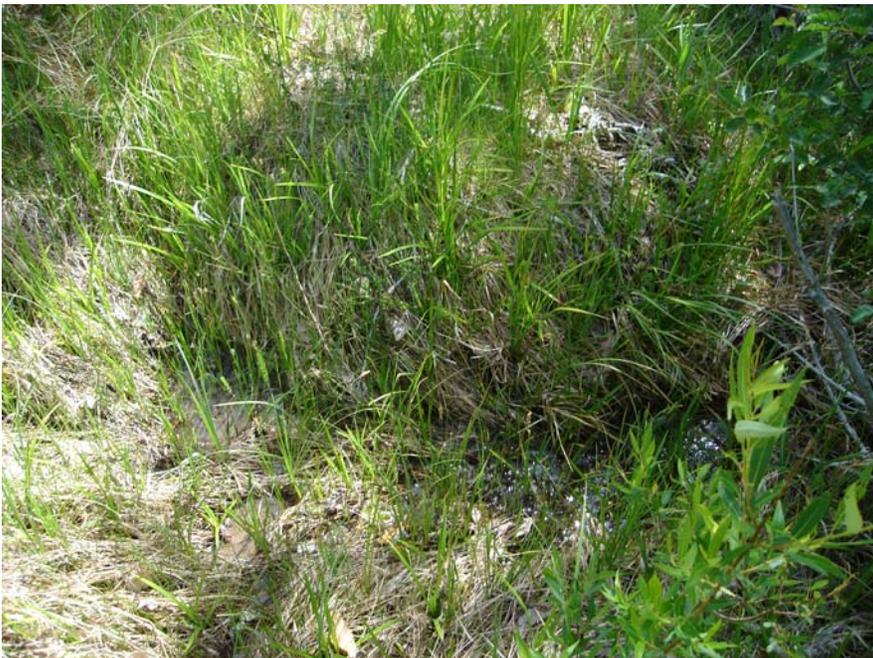
**Site 2:** Hot Springs Creek, Carson Ranger District, looking down at a small tributary on the river's left bank. This tributary contributes less than 1% of total volume. Site 2 is located at UTM: N: 4286056 & E: 256097, Elev. 5627 ft (1715 m).

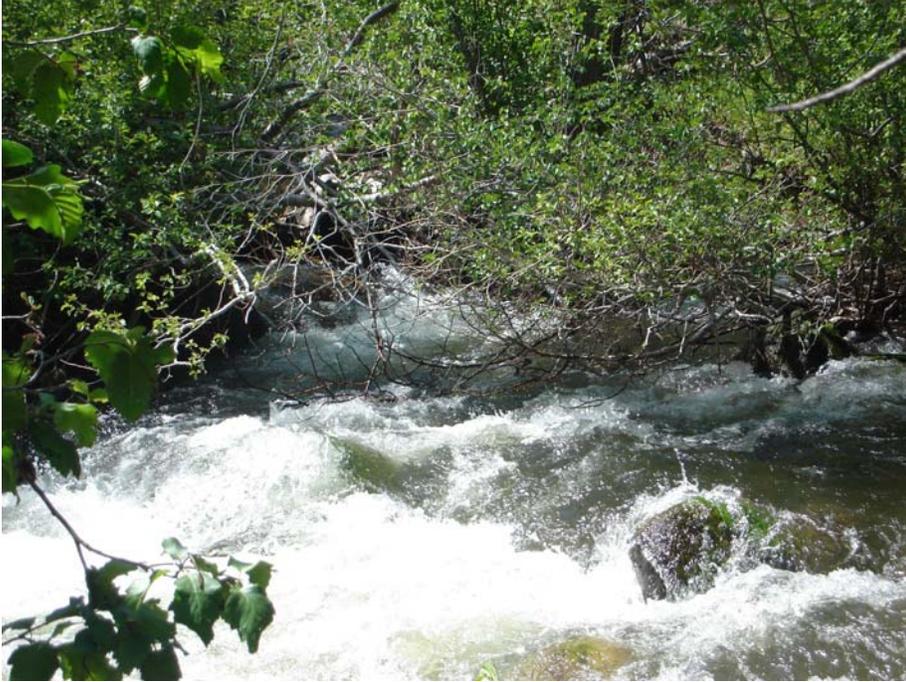
**Site 3:** Hot Springs Creek, Carson Ranger District, a cross-stream photo looking at a tributary on the river's right bank. This tributary contributes 20% of the volume to Hot Springs Creek. This site is located at UTM: N: 4286040 & E: 256032, Elev. 5627 ft (1715 m).

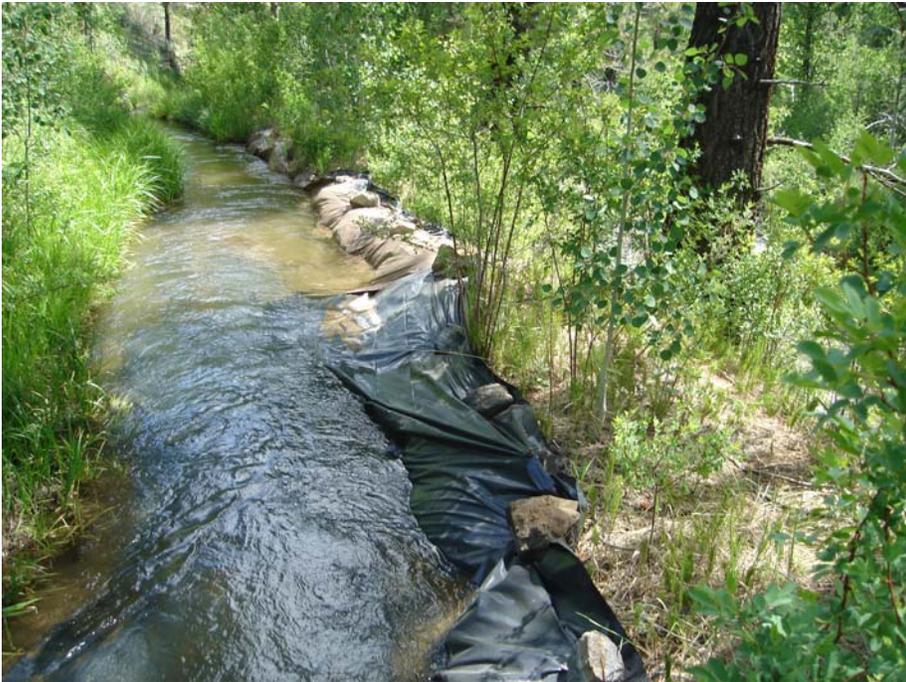
**Site 4:** Hot Springs Creek, Carson Ranger District, a downstream photo looking at an irrigation canal located on the river's left bank. This site is located at UTM: N: 4285987 & E: 255900, Elev. 5652 ft (1723 m).

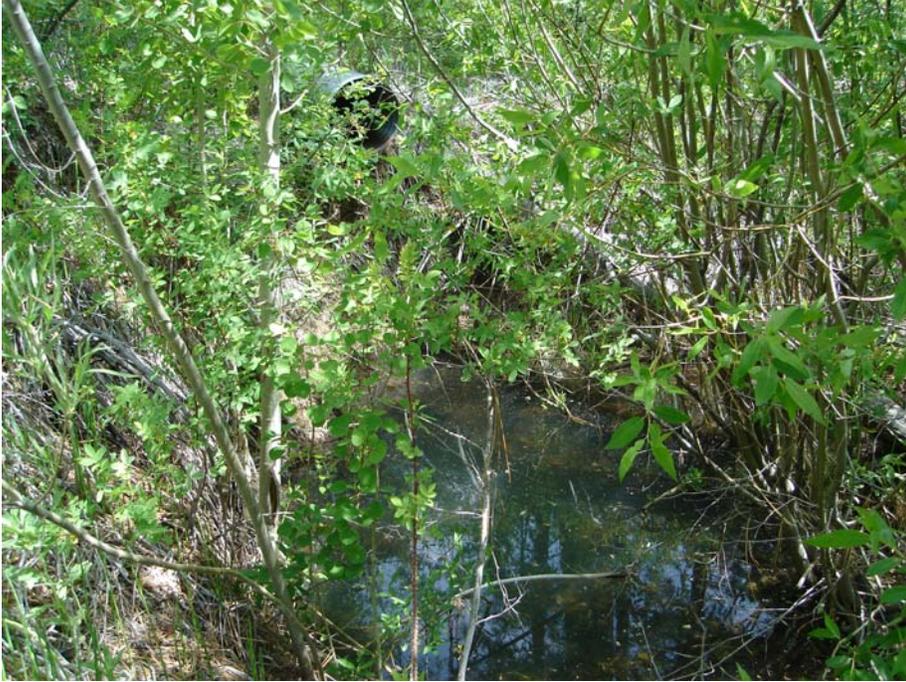
**Site 5:** Hot Springs Creek, Carson Ranger District. Photo of a culvert and stagnant water pool located on the river's left bank. This site is located at UTM: N: 4285942 & E: 255750, Elev. 5656 ft (1724 m).

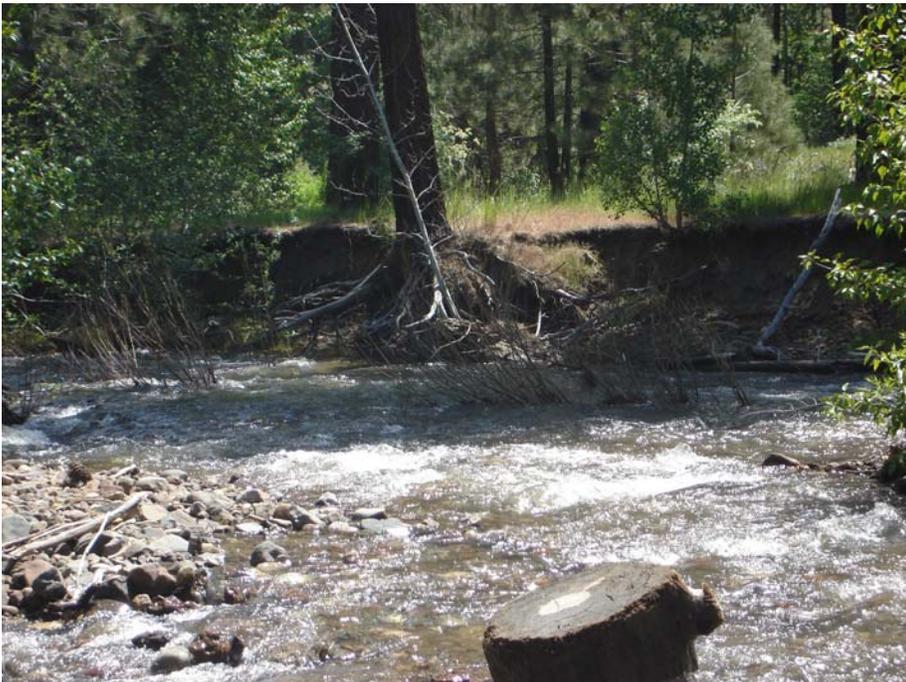
**Site 6:** Hot Springs Creek, Carson Ranger District. Cross-sectional photo taken of an erosion concern located river right. This site is located at UTM: N: 4285894 & E: 255625, Elevation 5646 ft (1721 m).

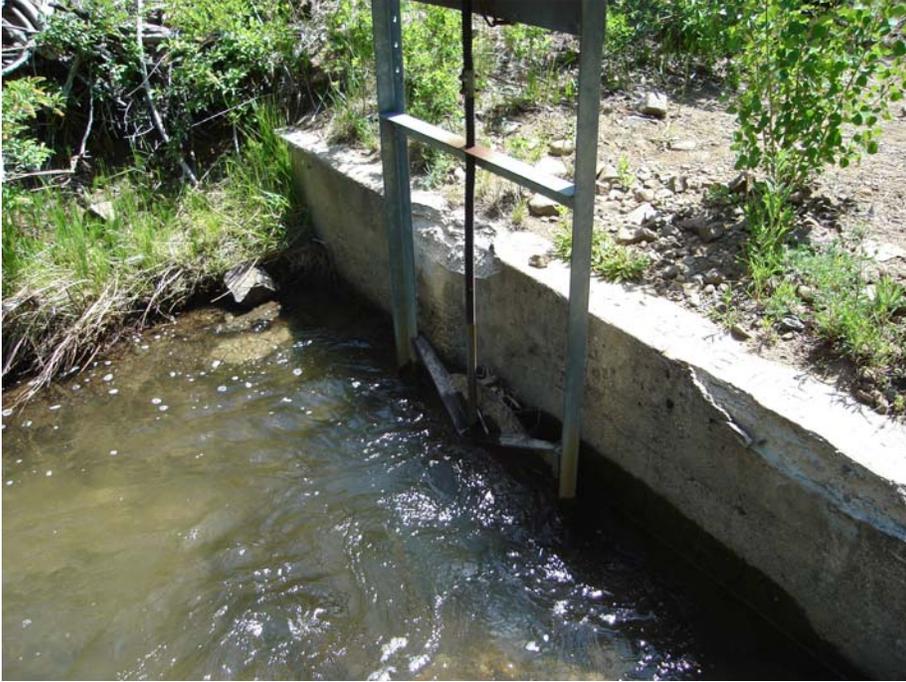
**Site 7:** Hot Springs Creek, Carson Ranger District. Downward photo taken of the diversion canal gate. Note that the canal is diverting 3% of flow from the stream. This site is located at UTM: N: 4285933 & E: 255583, Elev. 5676 ft (1730 m).

2. Assess the efficiency and impact of the diversion canal (Site 7), making sure it is not acting as a one-way fish trap, nor diverting a quantity of water that exceeds the adjudicated rights.

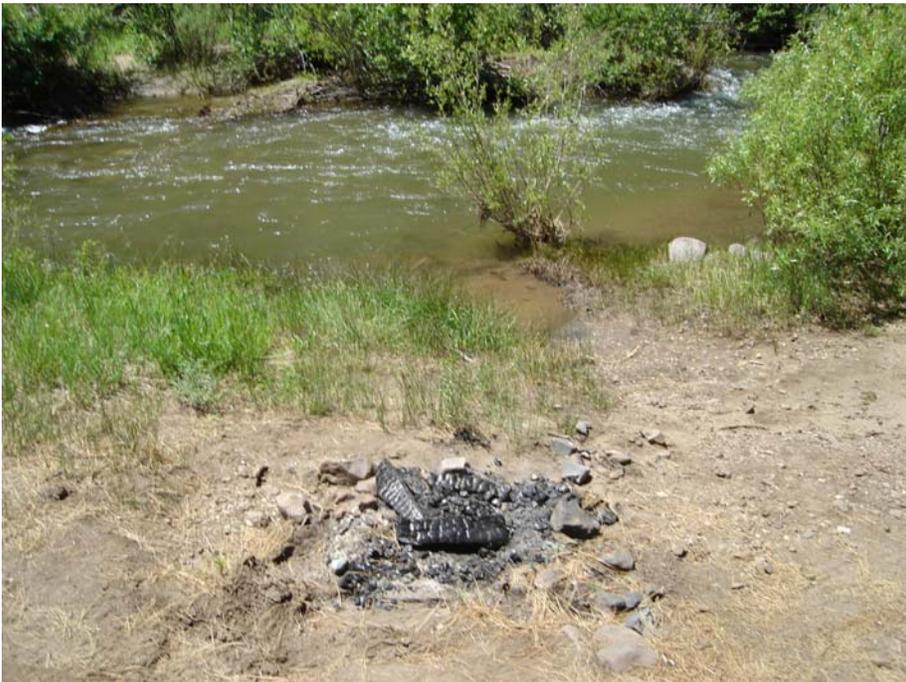
**Site 8:** Hot Springs Creek, Carson Ranger District. Cross-sectional photo of a campsite located on the rivers left bank. This site is located at UTM: 4285968 & E: 255410, Elev. 5663 ft (1726 m).

3. Decommission those campsites located directly adjacent to the stream (within 100 ft), and close roadways allowing vehicle access into these camps. (See Sites 8, 9, 11, & 12).

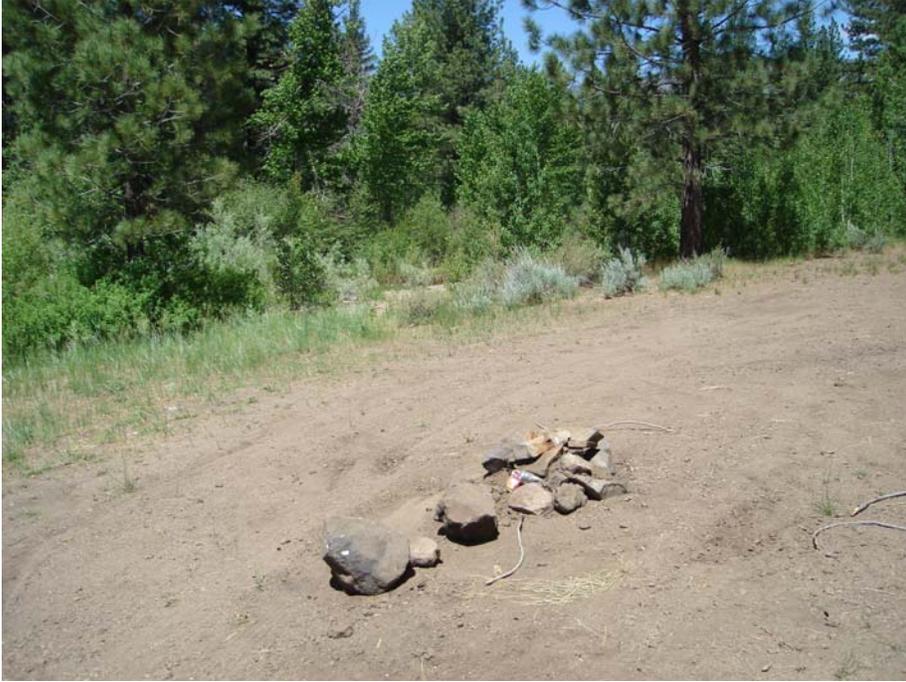
**Site 9:** Hot Springs Creek, Carson Ranger District. Photo of a dispersed campsite located on the river's left bank. This site is located at UTM: N: 4286003 & E: 255257, Elev. 5669 ft (1728 m).

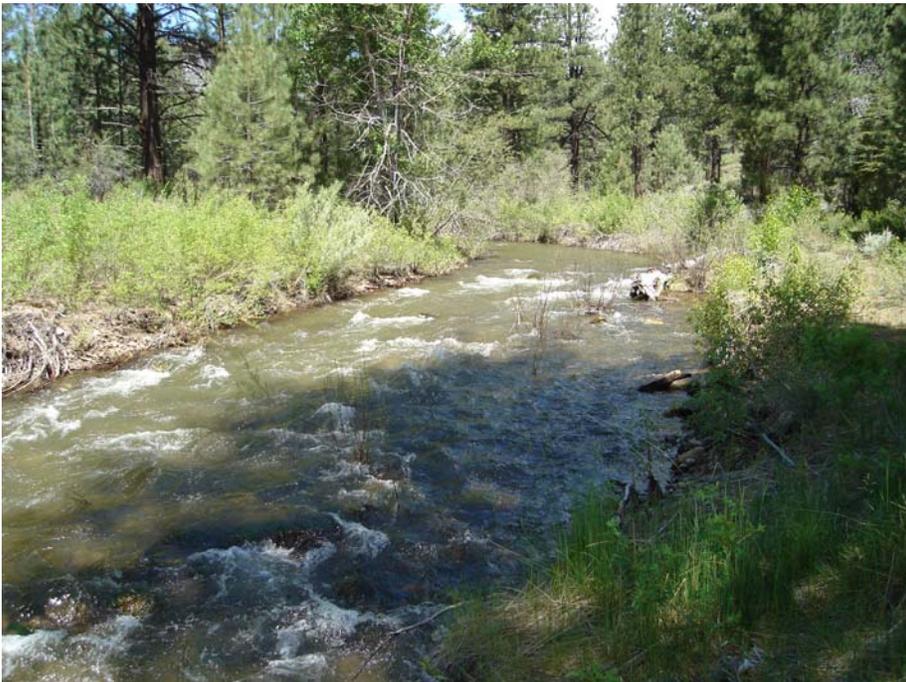
**Site 10:** Hot Springs Creek, Carson Ranger District. Upstream photo of the habitat characteristic of this reach.

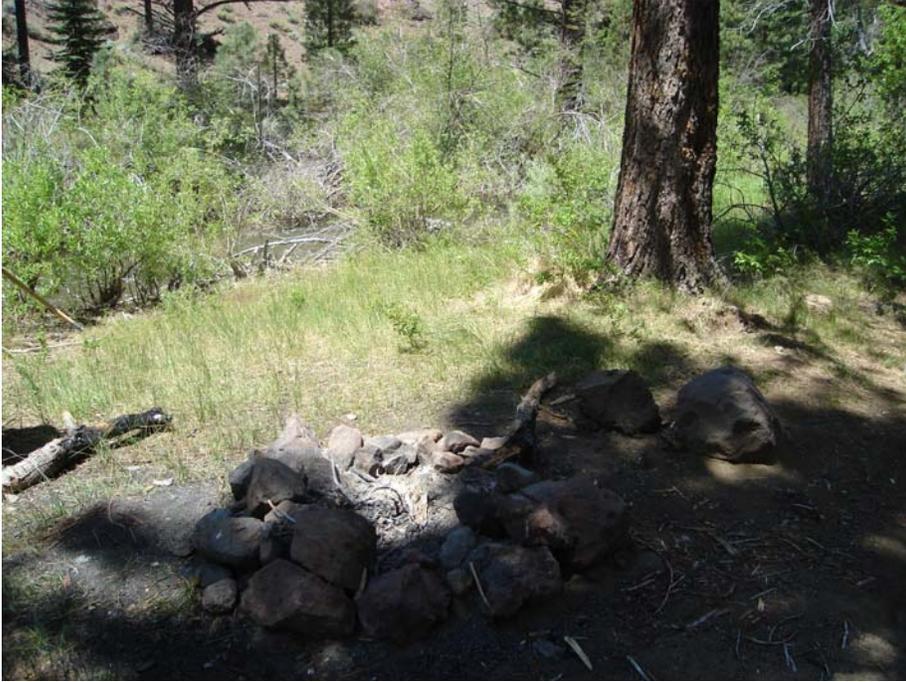
**Site 11:** Hot Springs Creek, Carson Ranger District. Campsite located 5 m from the stream on the river's left bank. This site is located at UTM N: 4286260 & E: 255045, Elev. 5686 ft (1733 m).

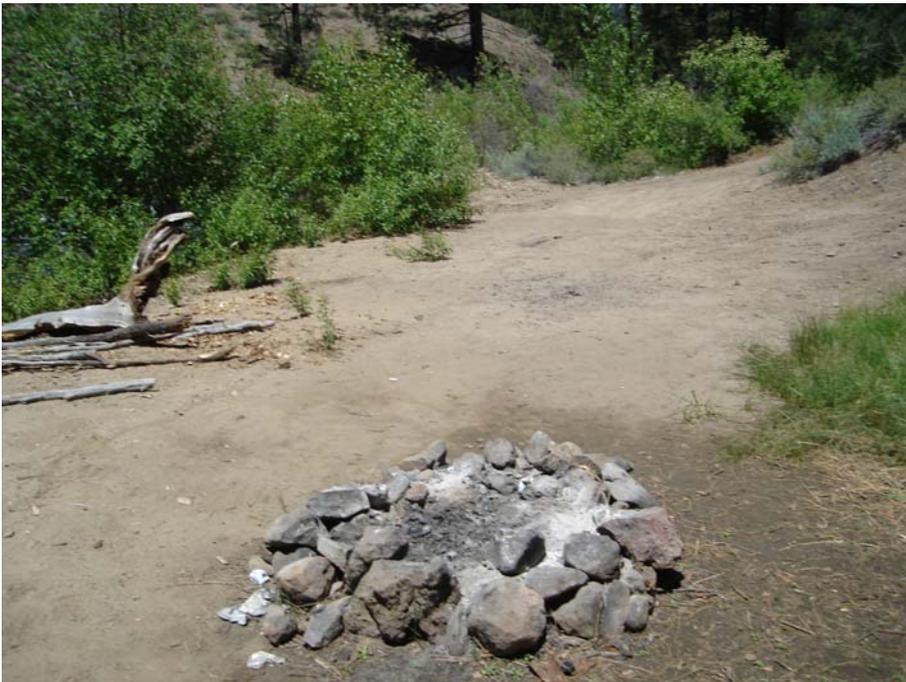
**Site 12:** Hot Springs Creek, Carson Ranger District. Photo of a dispersed campsite. This site is located at UTM: N: 4288433 & E: 254924, Elev. 5692 ft (1735 m).

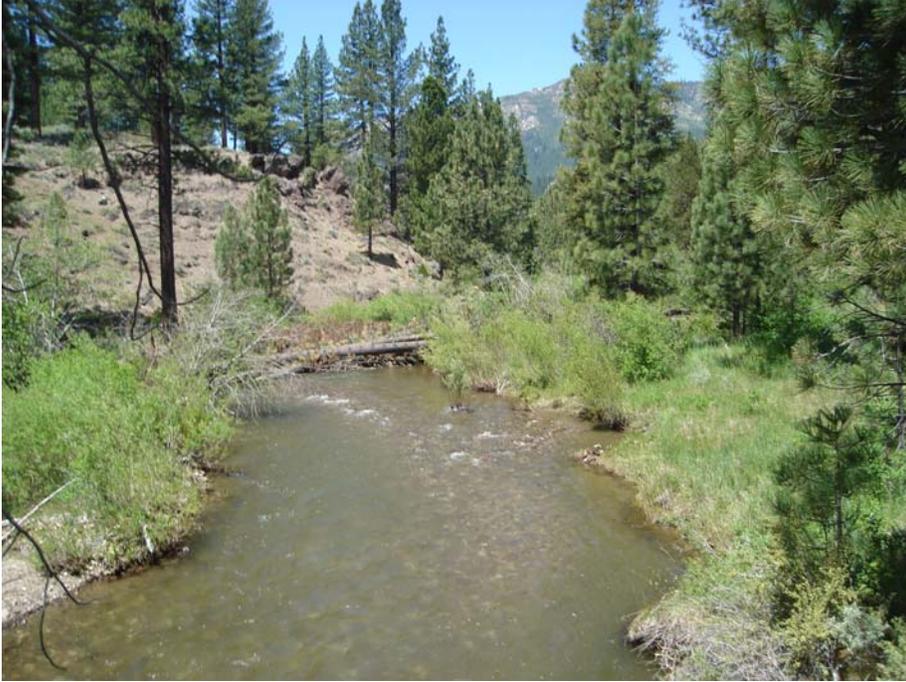
**Site 13:** Hot Springs Creek, Carson Ranger District. Upstream photo of characteristic habitat. Note that it is a meandering stream. This site is located at UTM: N: 4286585 & E: 254847, Elev. 5679 ft (1731 m).

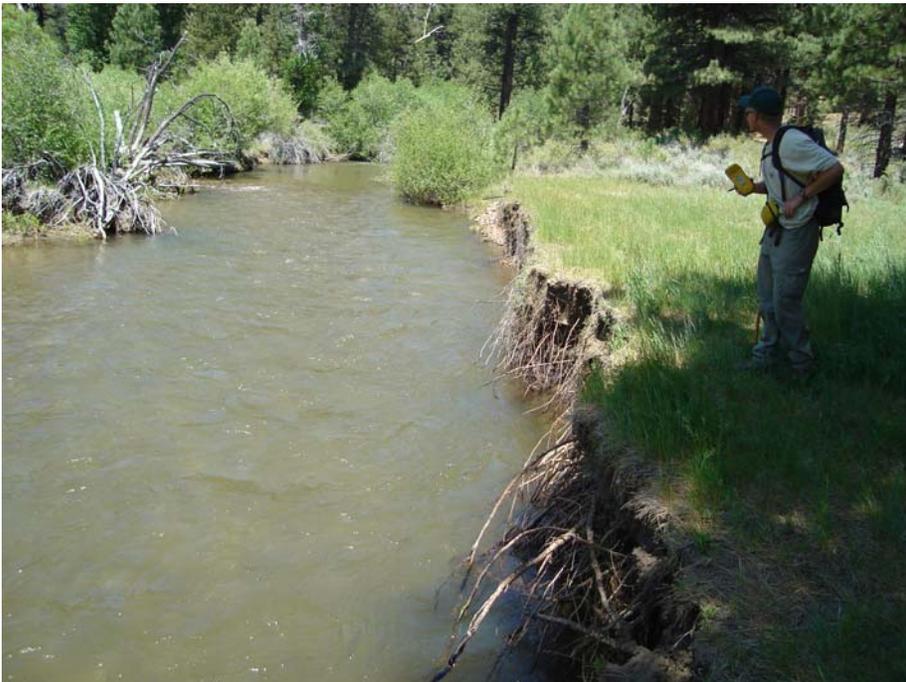
**Site 14:** Hot Springs Creek, Carson Ranger District. Photo of an erosion concern occurring on the river's left bank. The dimensions of the eroding bank are 1 m high by 30 m long. This site is located at UTM: N: 4286805 & E: 254554, Elev. 5712 ft (1741 m).

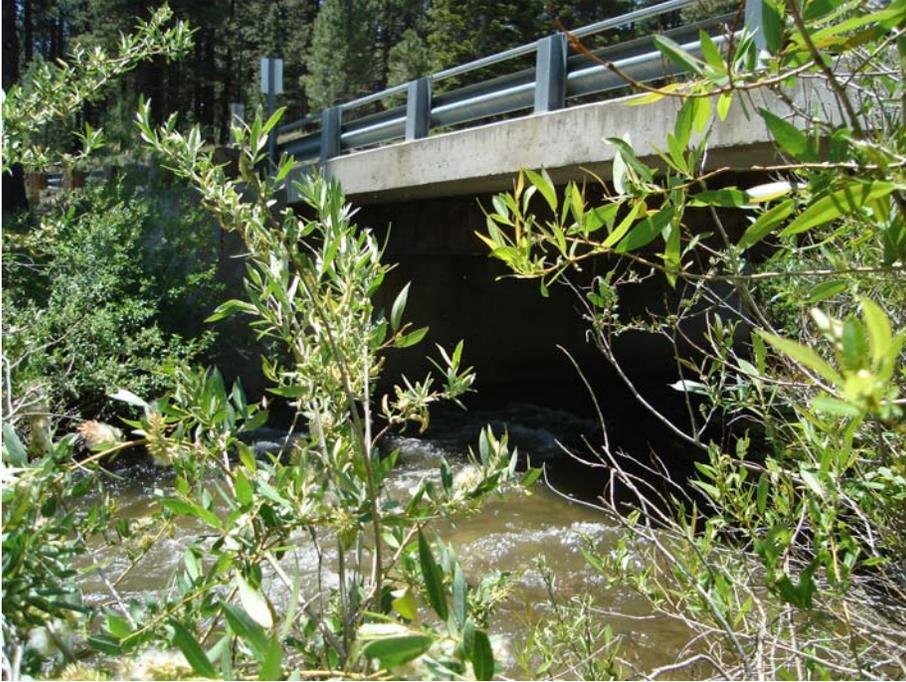
**Site 15:** Hot Springs Creek, Carson Ranger District. Upstream shot of a bridge-type road-stream crossing. This site is located at UTM: N: 4286919 & E: 254320, Elev. 5735 ft (1748 m).

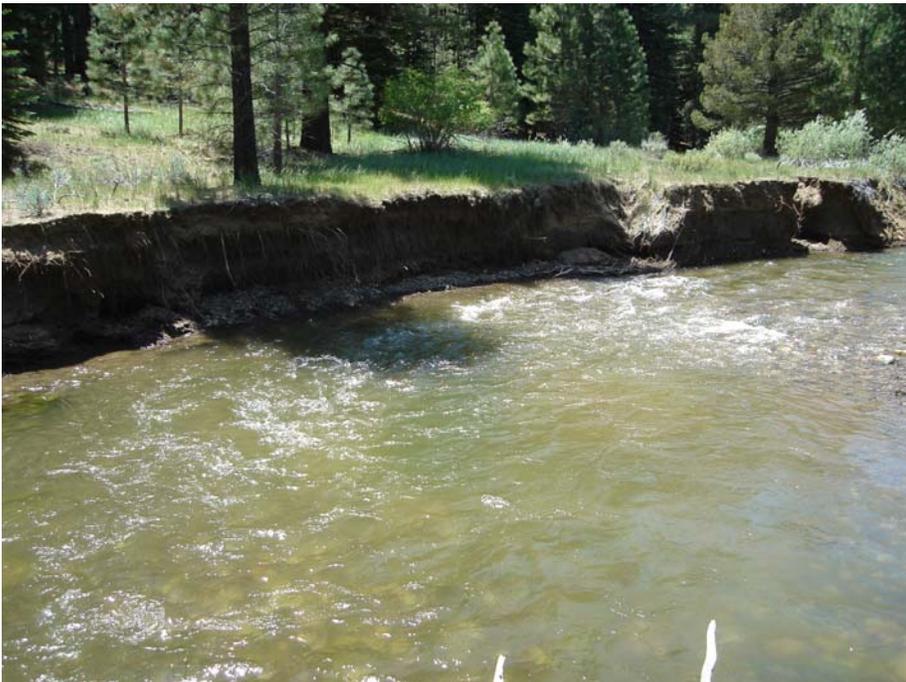
**Site 16:** Hot Springs Creek, Carson Ranger District. Cross-sectional photo of an erosion concern. The dimensions of the eroding bank are 2 m high by 30 m long. This site is located at UTM: N: 4286919 & E: 254320, Elev. 5735 ft (1748 m).

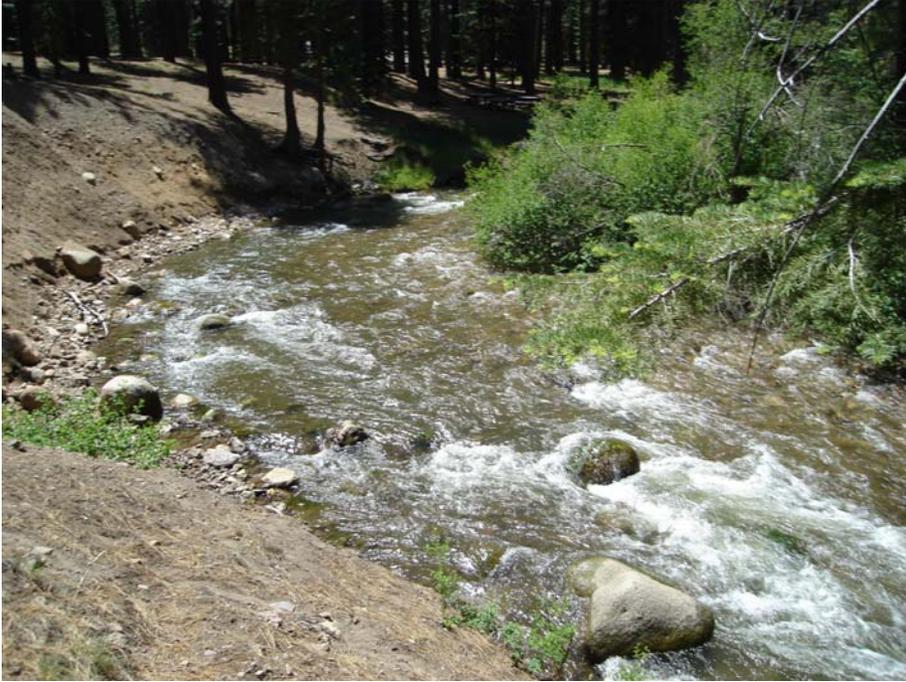
**Site 17:** Hot Springs Creek, Carson Ranger District. Upstream photo of potential LCT habitat: pools and riffles are characteristic of this section. This site is located at UTM: N: 4286711 & E: 253567, Elev. 5797 ft (1767 m).

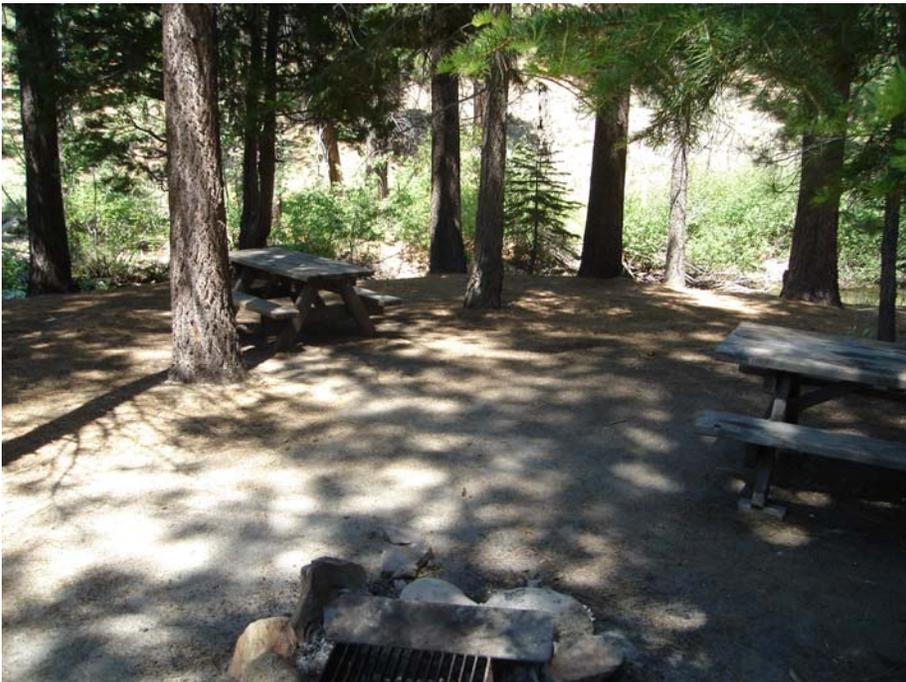
**Site 18:** Hot Springs Creek, Carson Ranger District. Photo point of the campground located on the stream banks of Grover Hot Springs State Park, on the river right bank.

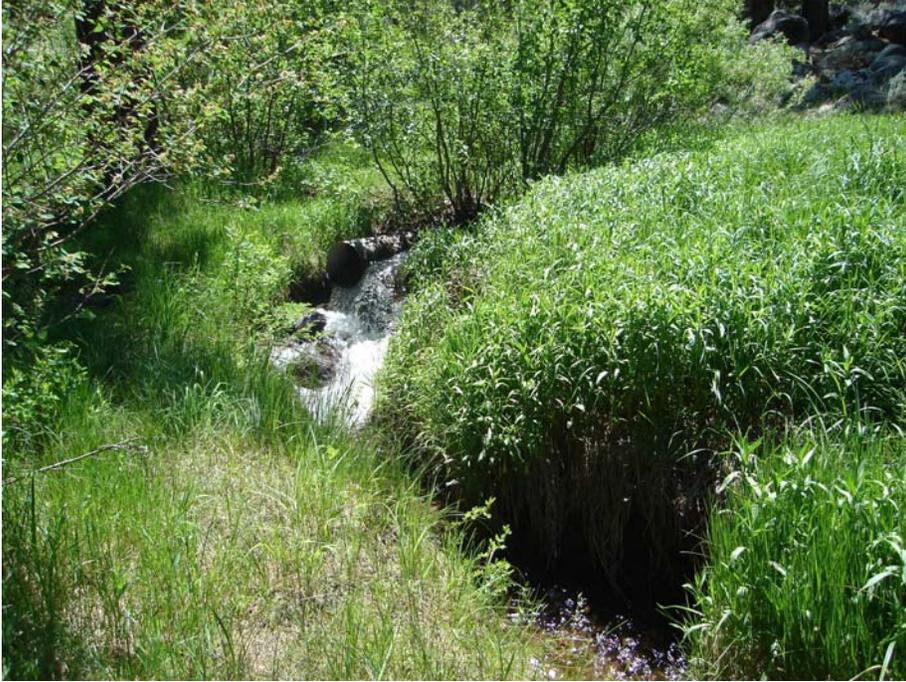
**Site 19:** Hot Springs Creek, Carson Ranger District. Photo of a small tributary entering on river right. The tributary contributes 3% to the volume in Hot Springs Creek.

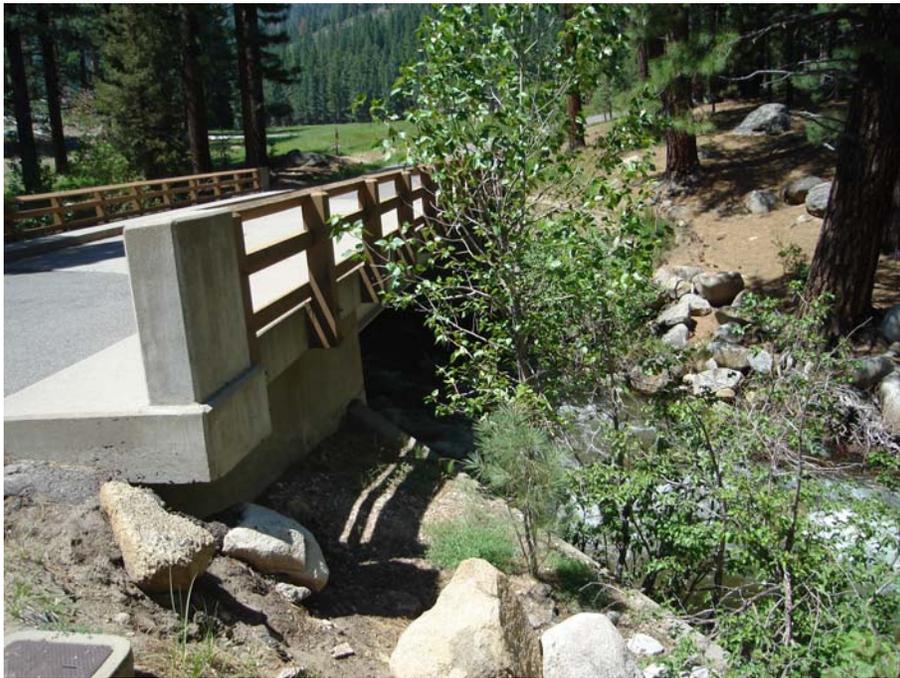
**Site 20:** Hot Springs Creek, Carson Ranger District. Cross-sectional photo of a bridge over Hot Springs Creek. This site is located at UTM: N: 4286864 & E: 253324, Elev. 5850 ft (1783 m) taken from bridge.

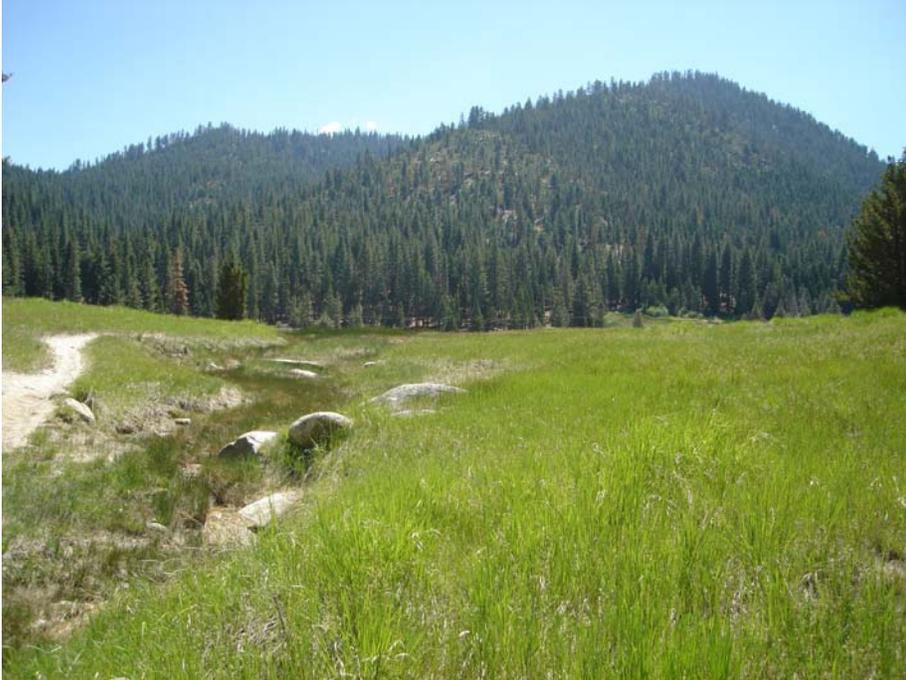
**Site 21:** Hot Springs Creek, Carson Ranger District. Photo of a small tributary flowing in from the hot springs on the creek's right bank. This tributary contributes 1% of flow. This site is located at UTM: N: 4286878 & E: 253165, Elev. 5837 ft (1779 m).

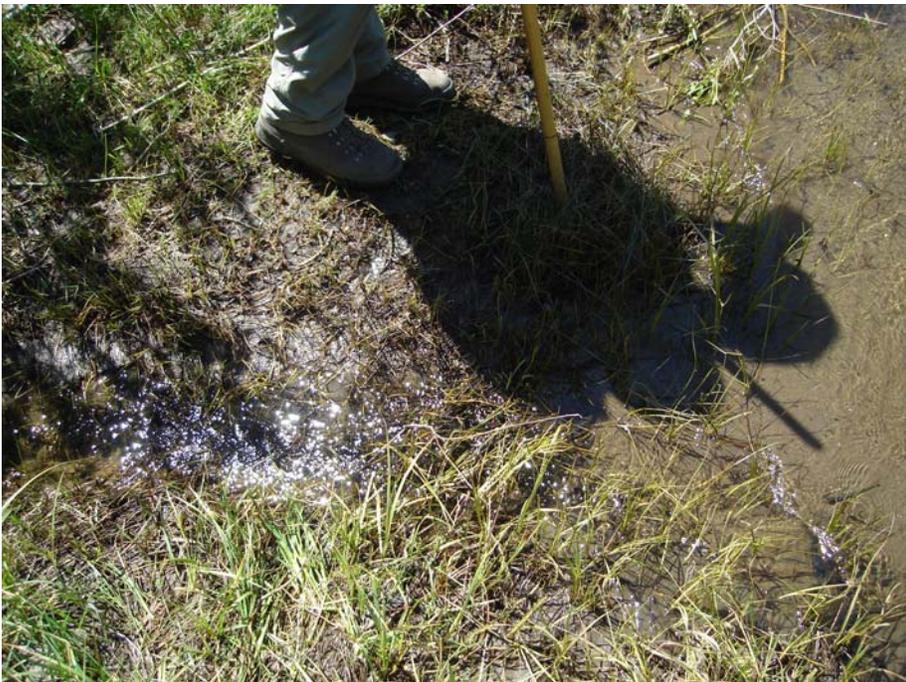
**Site 22:** Hot Springs Creek, Carson Ranger District. Photo of a small tributary on the river's right bank that contributes less than 1% of flow. This site is located at UTM: N: 4286929 & E: 252867, Elev. 5840 ft (1780 m).

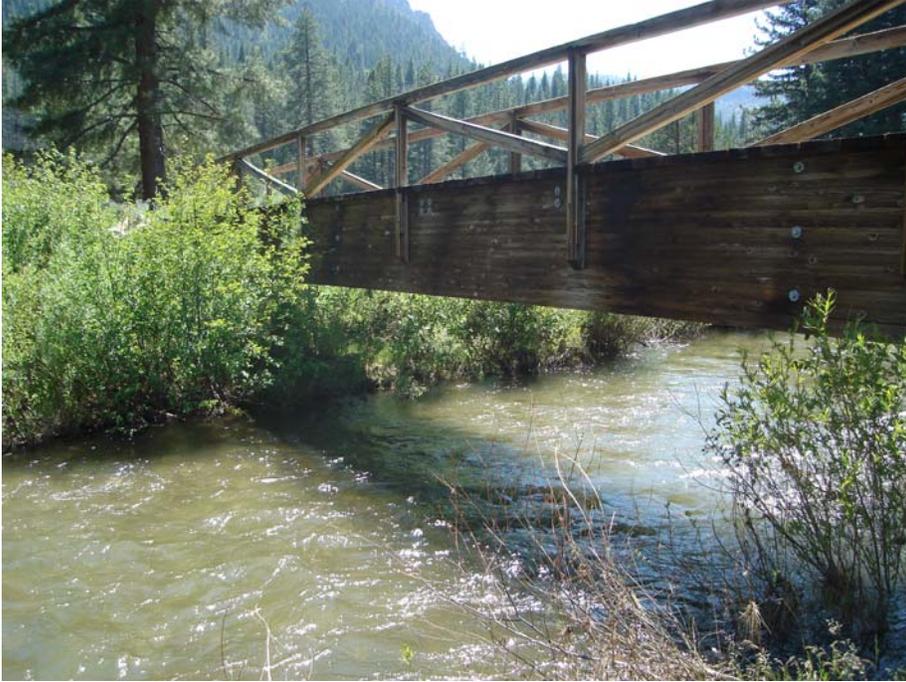
**Site 23:** Hot Springs Creek, Carson Ranger District. Cross-sectional photo of a footbridge crossing the stream. This site is located at UTM: N: 4287041 & E: 252657, Elev. 5846 ft (1782 m).

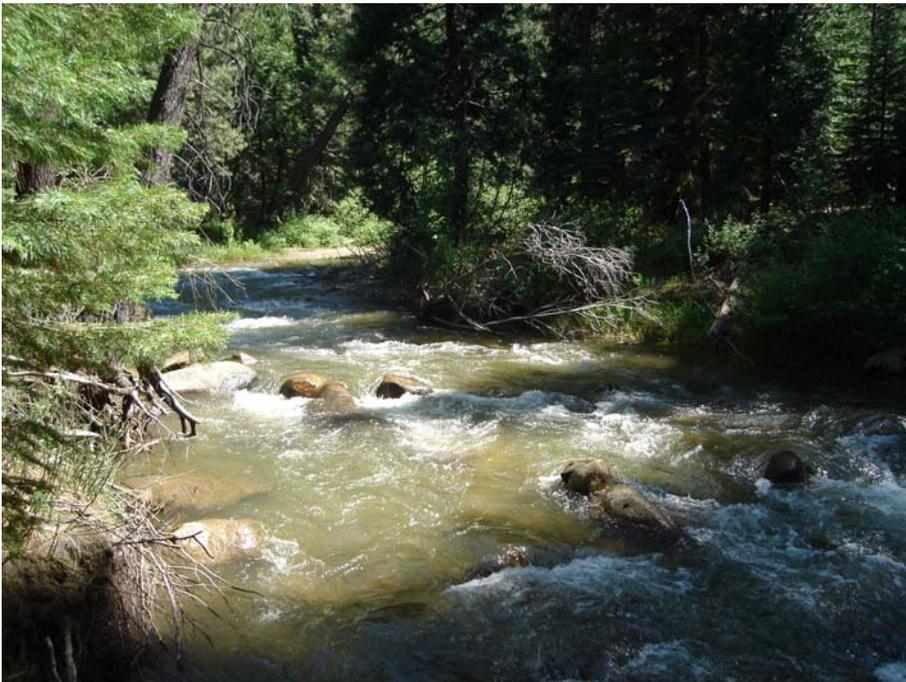
**Site 24:** Hot Springs Creek, Carson Ranger District. Upstream photo of habitat characteristic of this reach. This site is located at UTM: N: 4287050 & E: 252216, Elev. 5889 ft (1795 m).

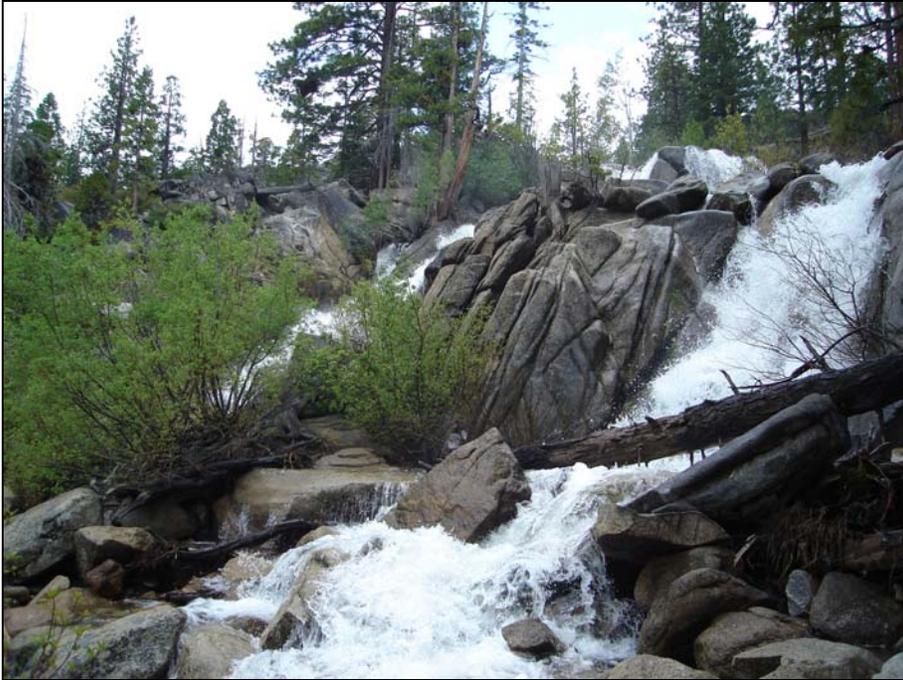
Between Sites 25 and 31, Hot Springs Creek has a high gradient with documented barriers at Sites 25, 26, & 31. The photo associated with Site 31 effectively illustrates the gradient and presence of several barriers between Site 25 and Site 31. One group of salmonids was observed in this region at Site 29. However, their location in small isolated pools provided limited connectivity with the rest of the drainage. Therefore, the reach between Sites 25 and 31 could be inhabited by LCT only by incidental downstream movement.

**Site 25:** Hot Springs Creek, Carson Ranger District. Cross-sectional photo of a permanent fish barrier. The waterfall was estimated to be 50 ft tall. This site is located at UTM: N: 4286751 & E: 251478, Elev. 5978 ft (1822 m).

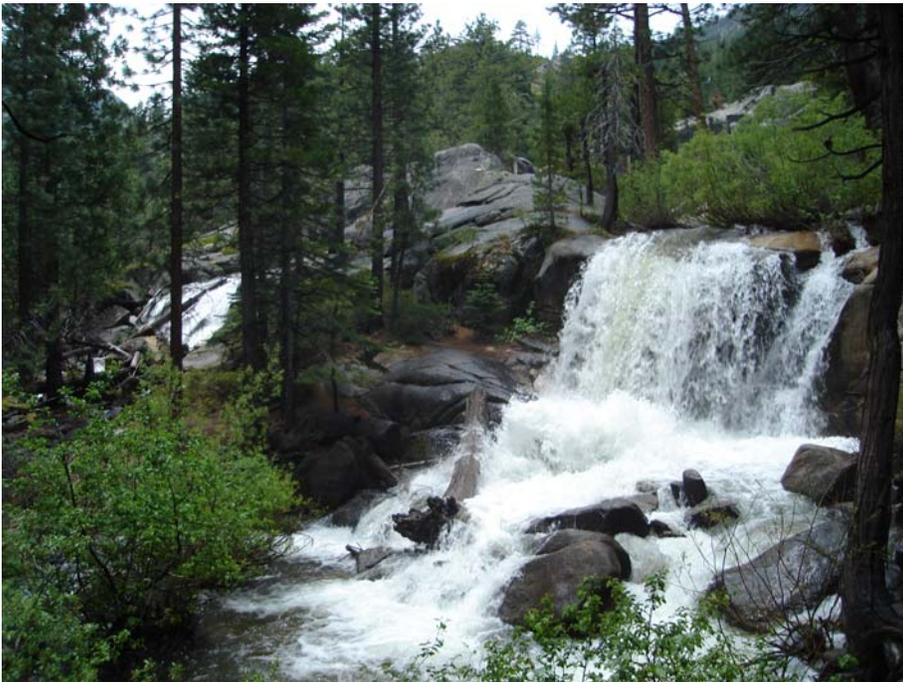
**Site 26:** Hot Springs Creek, Carson Ranger District. Upstream view of a permanent fish barrier: the waterfalls are an estimated 20 ft high.

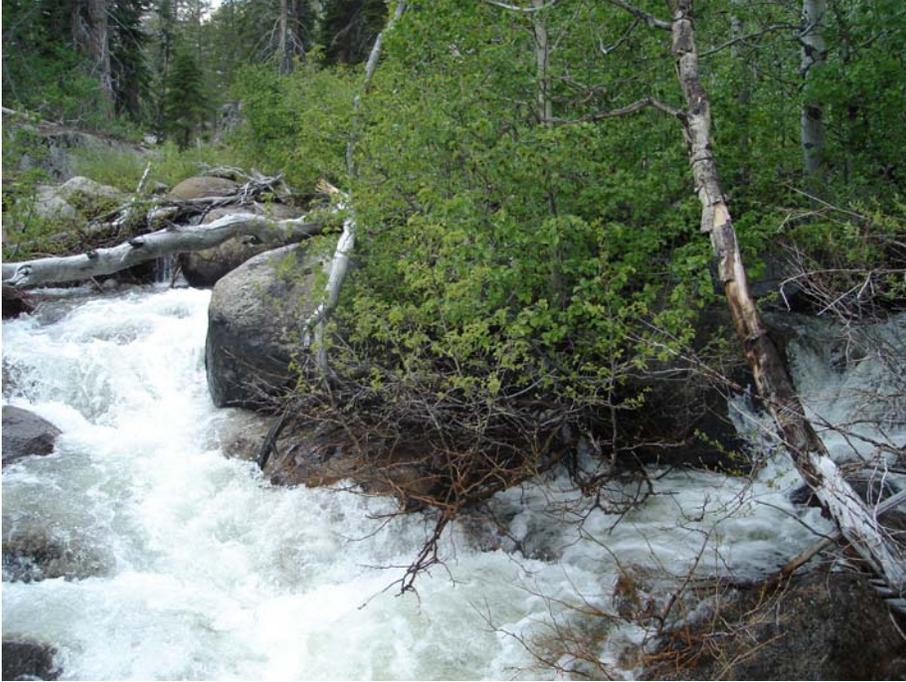
**Site 28:** Hot Springs Creek, Carson Ranger District. The tributary Charity Valley Creek contributes approximately 66% of flow to Hot Springs Creek. Hot Springs is located on the right hand side of the photo. This site is located at UTM: N: 4287194 & E: 250084, Elev. 7100 ft (2164 m).

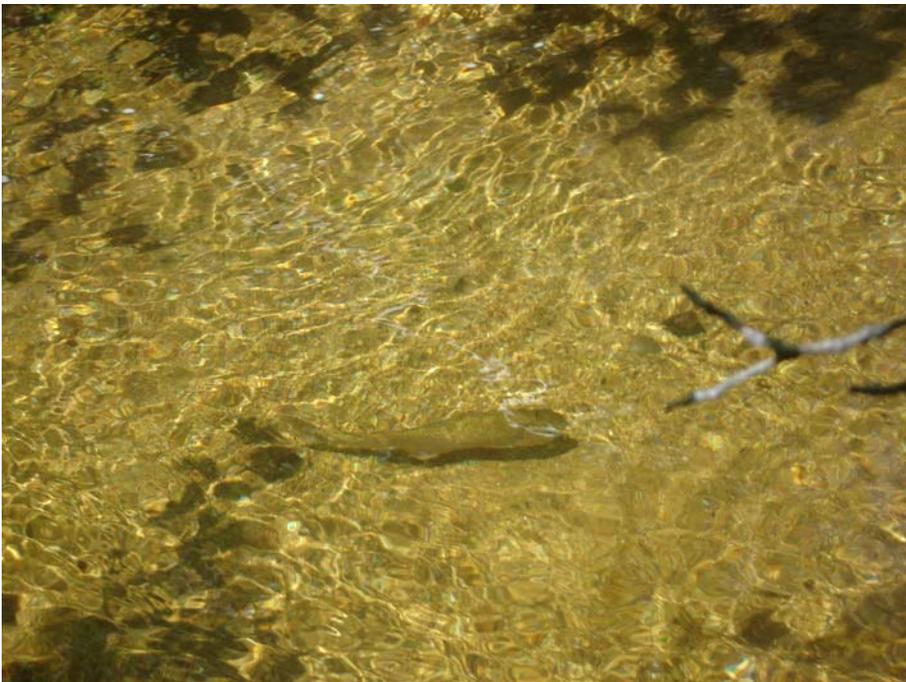
**Site 29:** Hot Springs Creek, Carson Ranger District. Photo of a small salmonid observed in a pool just above the confluence of Hot Springs and Charity Valley Creeks.

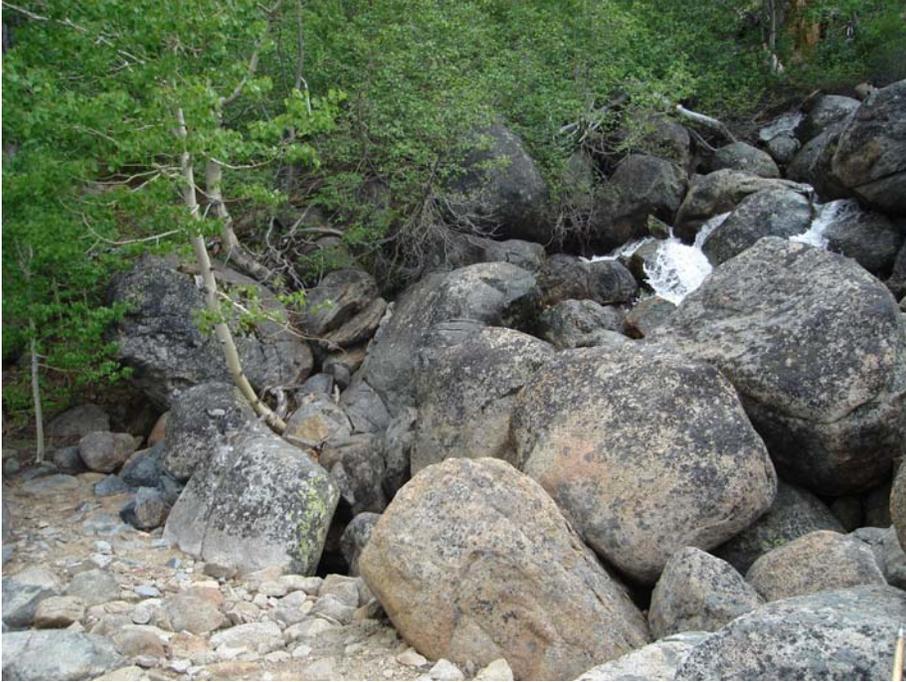
**Site 30:** Hot Springs Creek, Carson Ranger District. Photo of a trail-stream crossing open to foot traffic only. This site is located at UTM: N: 4287384 & E: 250004, Elev. 7362 ft (2244 m).

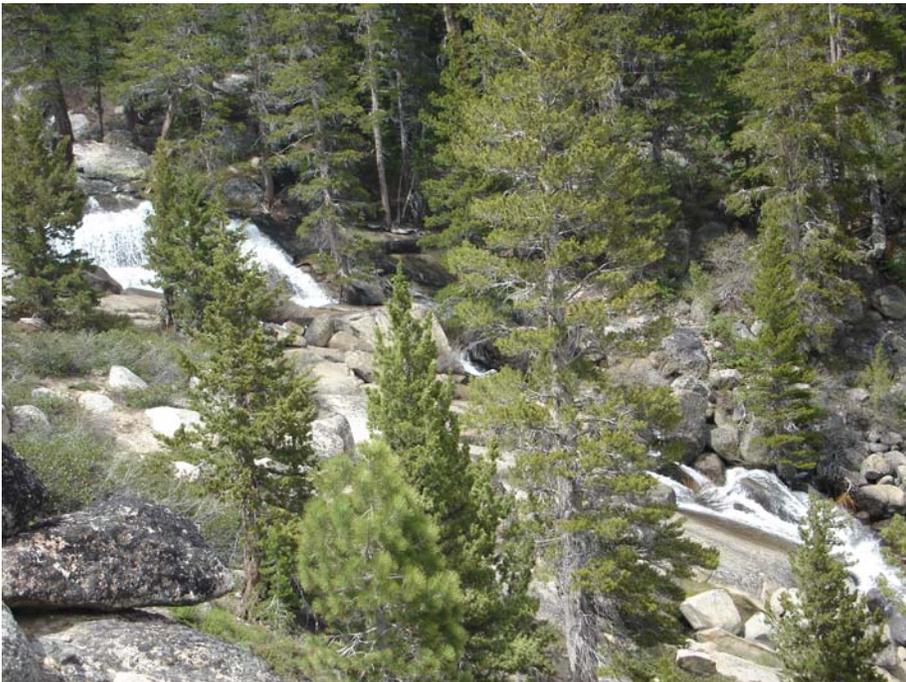
**Site 31:** Hot Springs Creek, Carson Ranger District. Cross-sectional photo of a permanent fish barrier formed by a waterfall. This site is located at UTM: N: 4287789 & E: 249694, Elev. 7927 (2416 m).

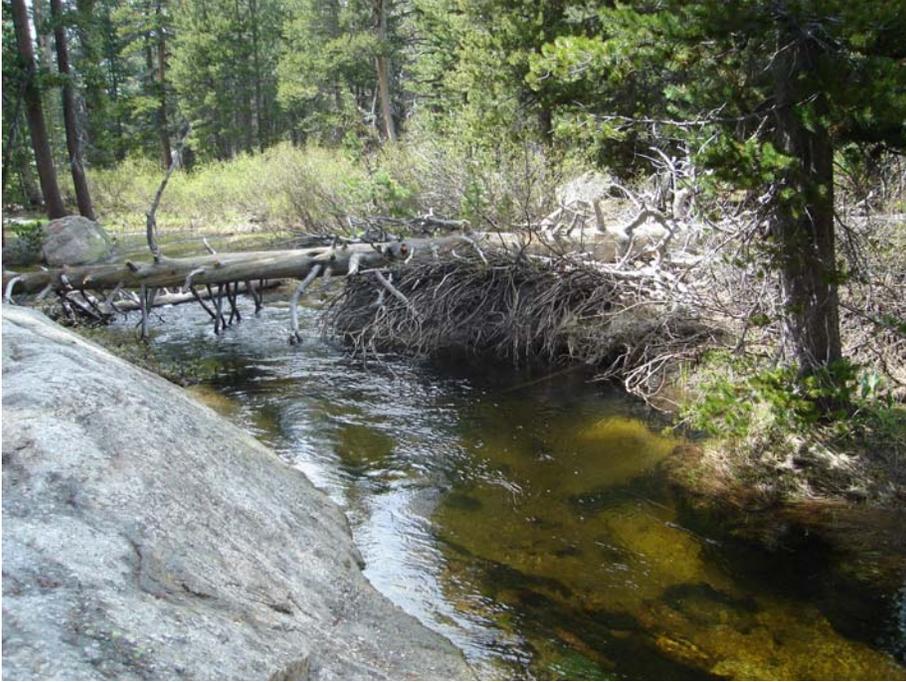
**Site 32:** Hot Springs Creek, Carson Ranger District. Upstream photo of Hot Springs Creek. The stream goes through a low gradient marsh and forest. This site is located at N: 4288249 & E: 249439, Elev. 8120 ft (2475 m).

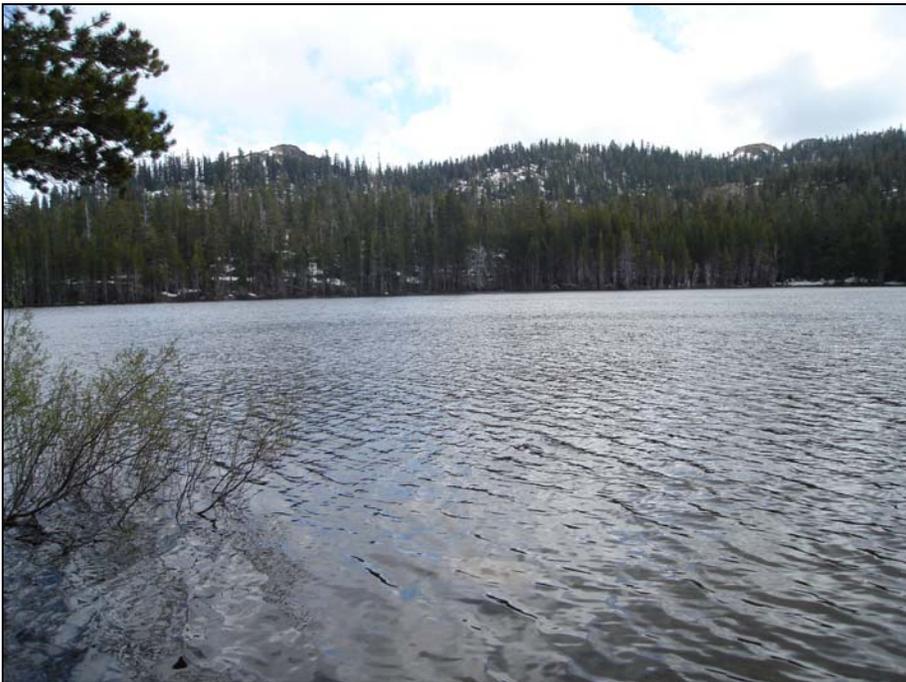
**Site 33:** Hot Springs Creek, Carson Ranger District. Photo of Burnside Lake. This site is located at UTM: N: 4288738 & E: 248847, Elev. 8143 ft (2482 m).

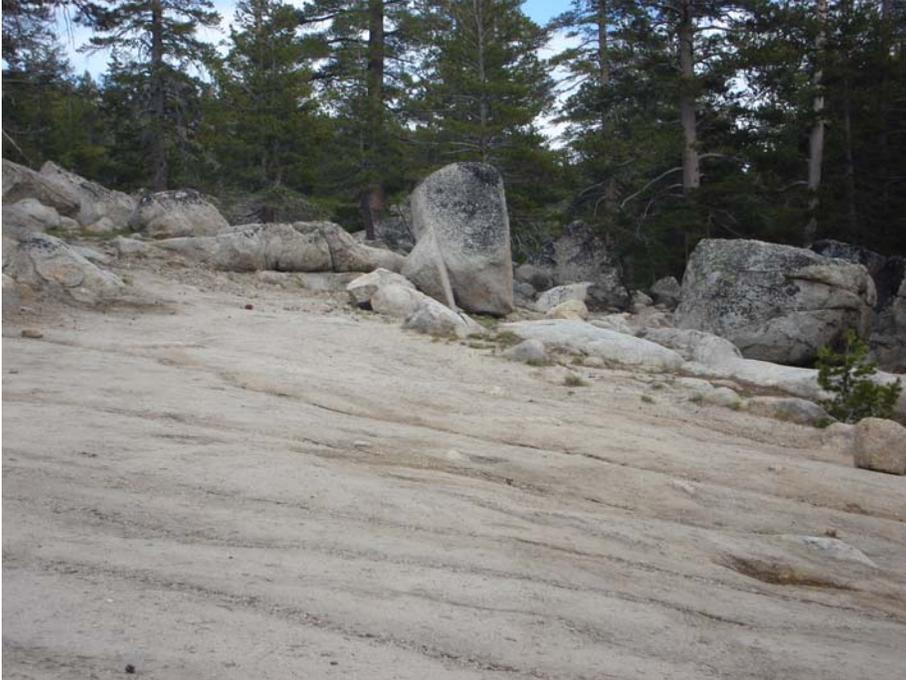
**Site 34:** Hot Springs Creek, Carson Ranger District. Trailhead of path down to Grover Hot Springs State Park. Note the absence of a sign, which is one reason that this trail is difficult to follow between Site 32 and Site 34. This site is located at UTM: N: 4288738 & E: 248847, Elev. 8143 ft (2482 m).

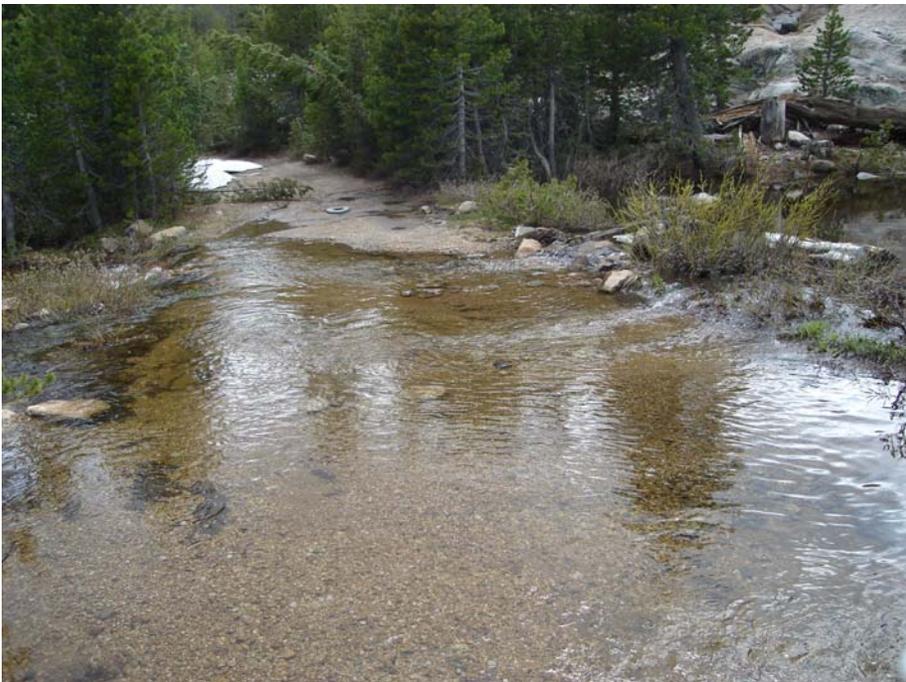
**Site 35:** Hot Springs Creek, Carson Ranger District. Survey endpoint above Burnside Lake, where the headwaters of Hot Springs Creek enter the basin. This site is located at UTM: N: 4288981 & E: 248573, Elev. 8140 ft (2481 m).
