INDIAN CREEK

Alpine County, California

2006 Stream Habitat Survey Report

Carson Ranger District: Humboldt-Toiyabe National Forest

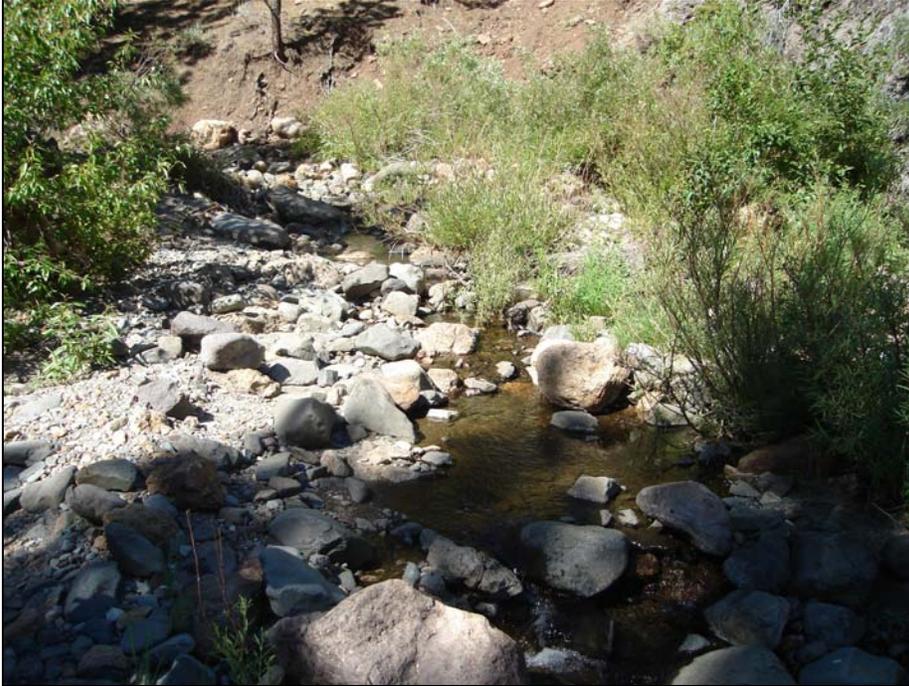
Site 1: Indian Creek, Carson Ranger District. Upstream view of Indian Creek at the confluence with the East Fork Carson River. This site is located at UTM: N: 4285742 & E: 259543, Elev. 5589 feet (1704 m).

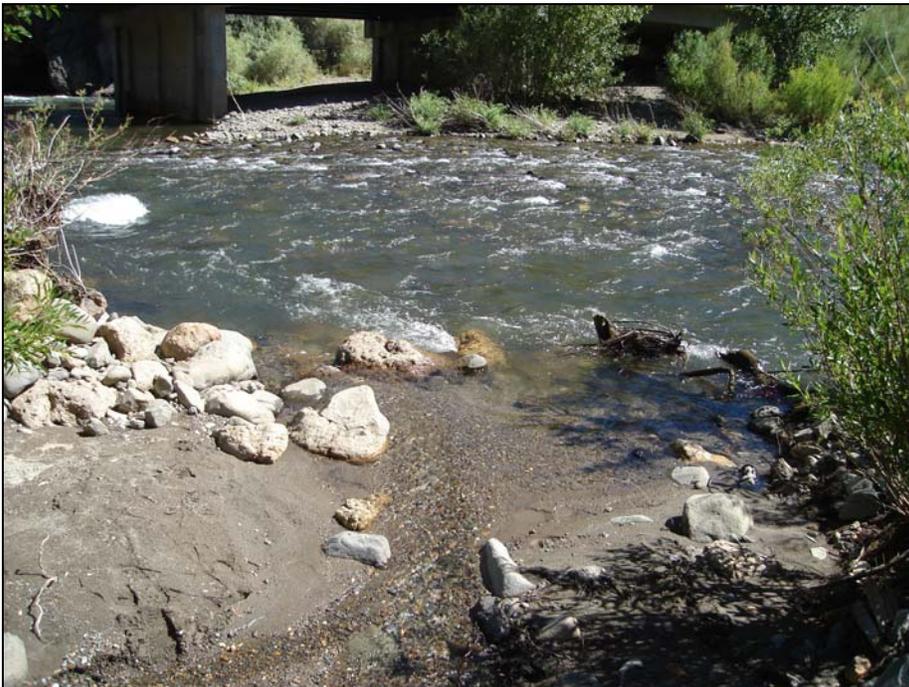
Site 1: Indian Creek, Carson Ranger District. Downstream view of Indian Creek at the confluence with the East Fork Carson River. This site is located at UTM: N: 4285742 & E: 259543, Elev. 5589 feet (1704 m).

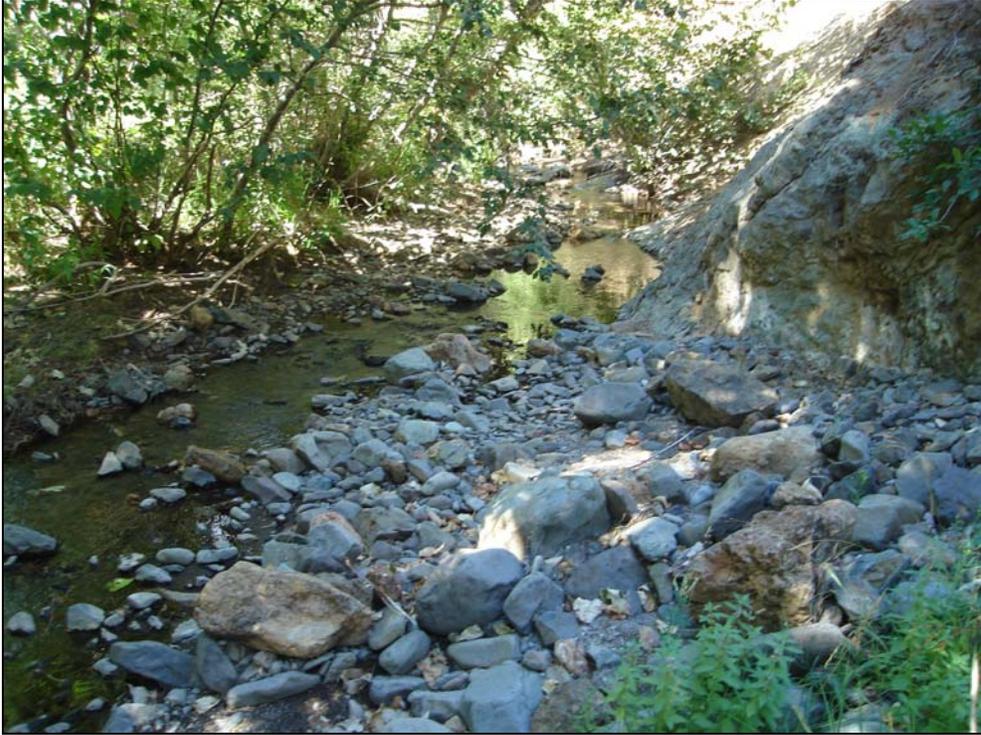
Site 2: Indian Creek, Carson Ranger District. Upstream viewpoint. This site is located at UTM: N: 4285528 & E: 259430, Elev. 5720 feet (1744m).

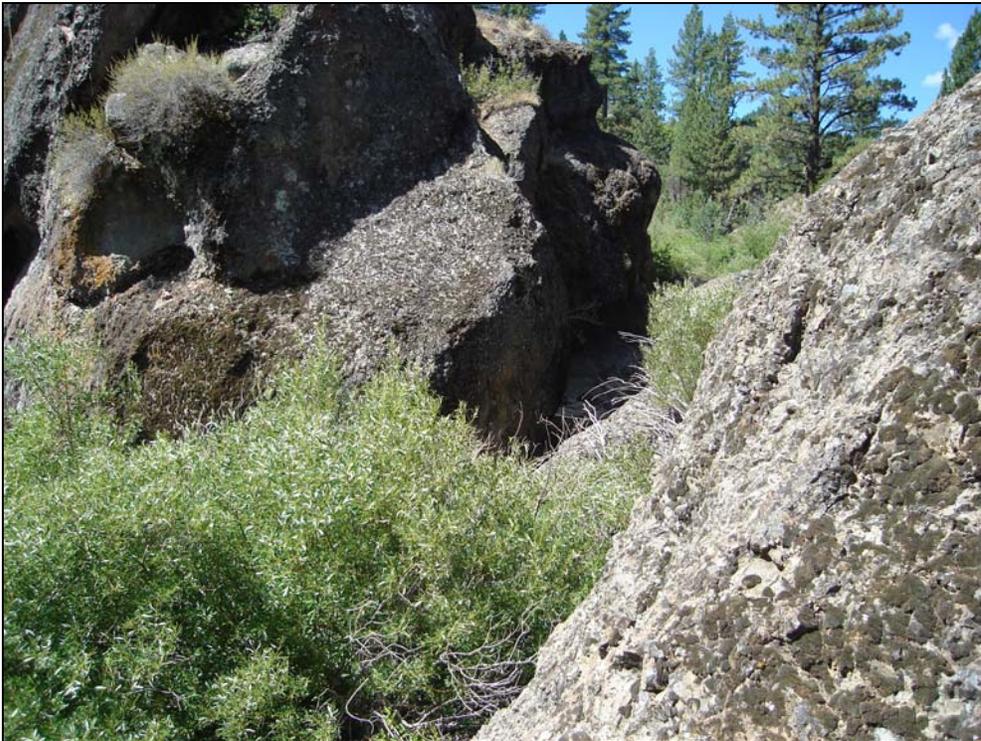
Site 3: Indian Creek, Carson Ranger District. Photo shows a steep rocky ravine containing Indian Creek. This site is located at UTM: N: 4285367 & E: 259243, Elev. 5573 feet (1699m).

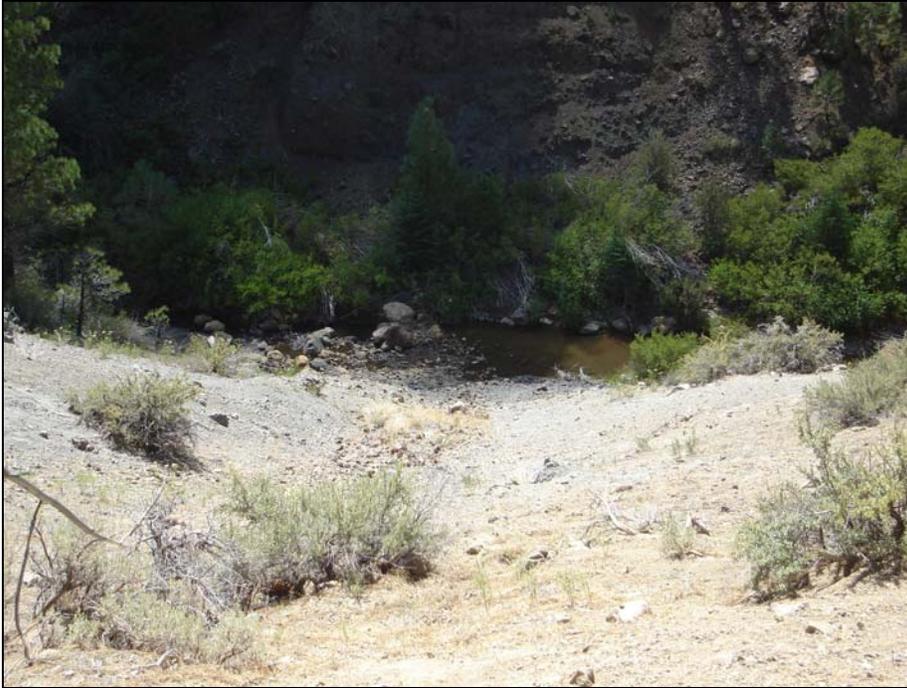
Site 3: Indian Creek, Carson Ranger District. View from high above left bank shows ravine containing Indian Creek. This site is located at UTM: N: 4285367 & E: 259243, Elev. 5573 feet (1699m).

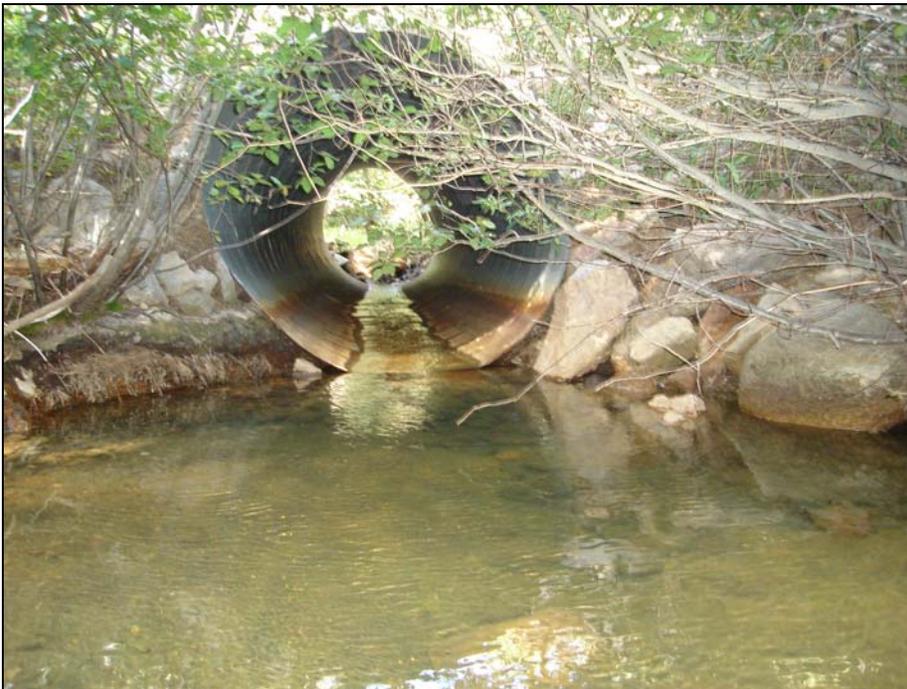
Due to the presence of several permanent fish passage barriers at Site 9 and a lack of sustainable flows upstream of that point, the 1.52 river miles of Indian Creek located downstream of Site 9 provide the best potential LCT habitat. The road-stream crossing at Site 4 looks to allow passage under normal flow conditions. The water depth within the culvert is approximately 0.3 feet deep, velocities are moderate, and the maximum pool depth below the culvert is 1.5 feet. At base flow levels, the water depth within the culvert may hinder passage. Indian Creek Road runs adjacent to the stream for a short distance: recorded in Site 8. The road is located 3-4 meters from the waters edge, and may provide an increased source of sediment, especially under wet conditions.

Site 4: Indian Creek, Carson Ranger District. Looking through the culvert where Indian Creek road crosses the stream. This crossing is located at UTM: N: 4285131 & E: 258860, Elev. 6025 feet (1837m).

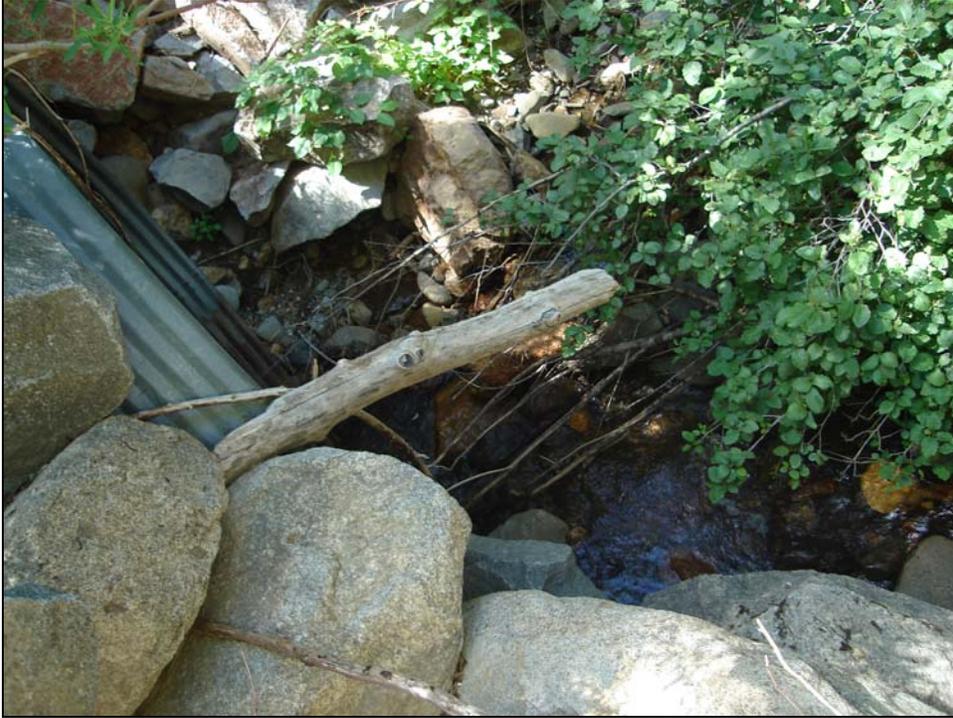
Site 4: Indian Creek, Carson Ranger District. Bird's eye view of upstream end of the culvert beneath Indian Creek Road. This crossing is located at UTM: N: 4285131 & E: 258860, Elev. 6025 feet (1837m).

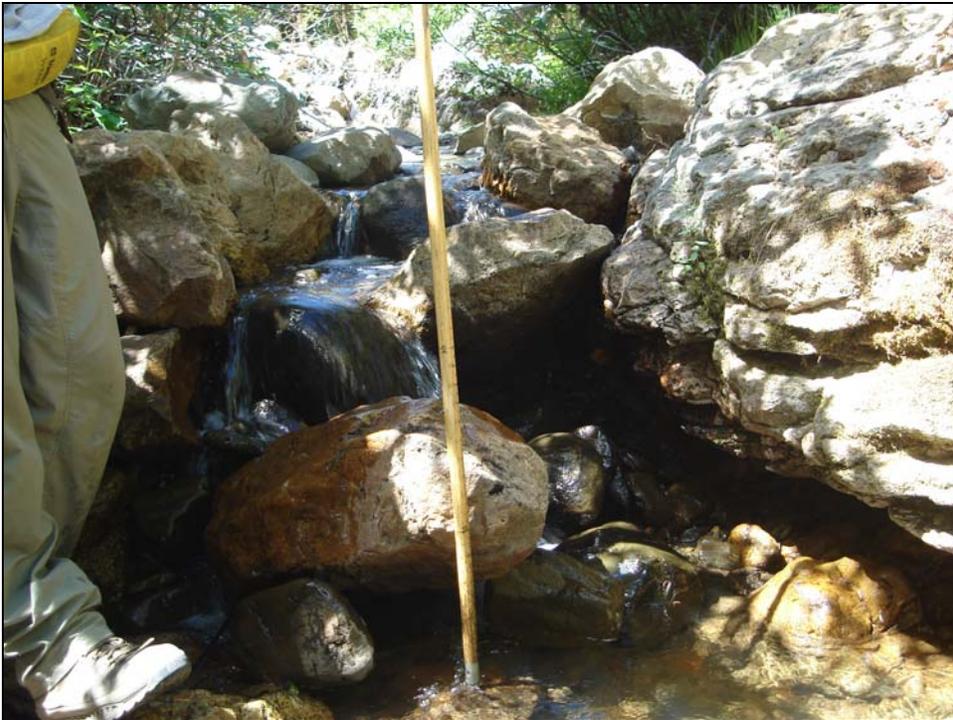
Site 5: Indian Creek, Carson Ranger District. Upstream photo of a small seasonal barrier, measuring 1.9 feet high, 3.5 long, with a max pool depth of 1.6 feet. This site is located at UTM: N: 4284993 & E: 258647, Elev. 5448 feet (1661m).

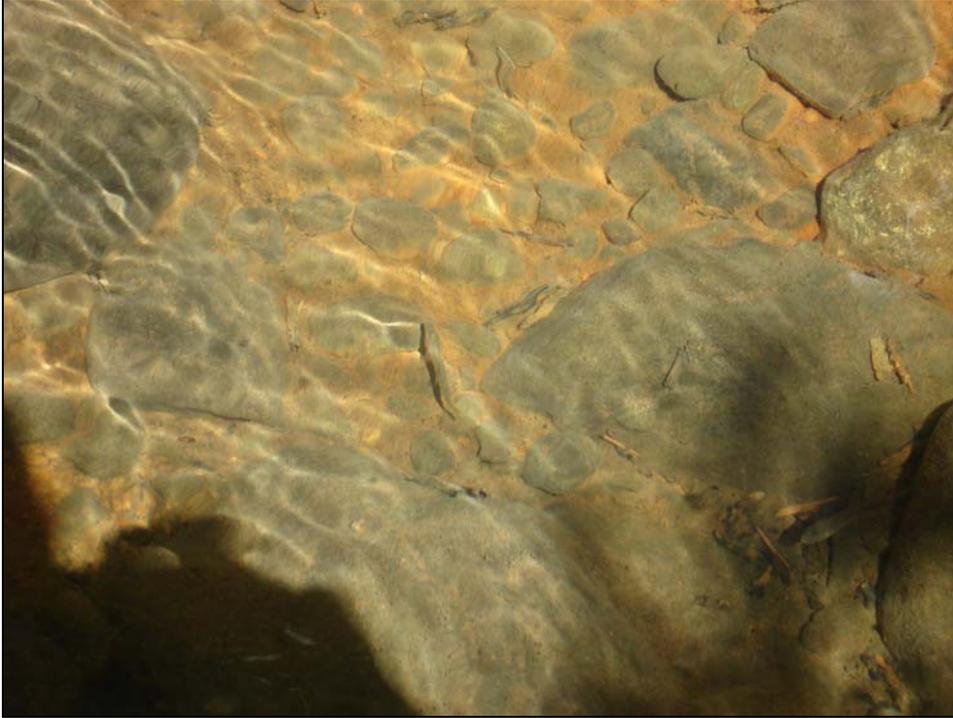
Site 5: Indian Creek, Carson Ranger District. Photo shows a 4-inch fish in a pool directly below the barrier. This site is located at UTM: N: 4284993 & E: 258647, Elev. 5448 feet (1661m).

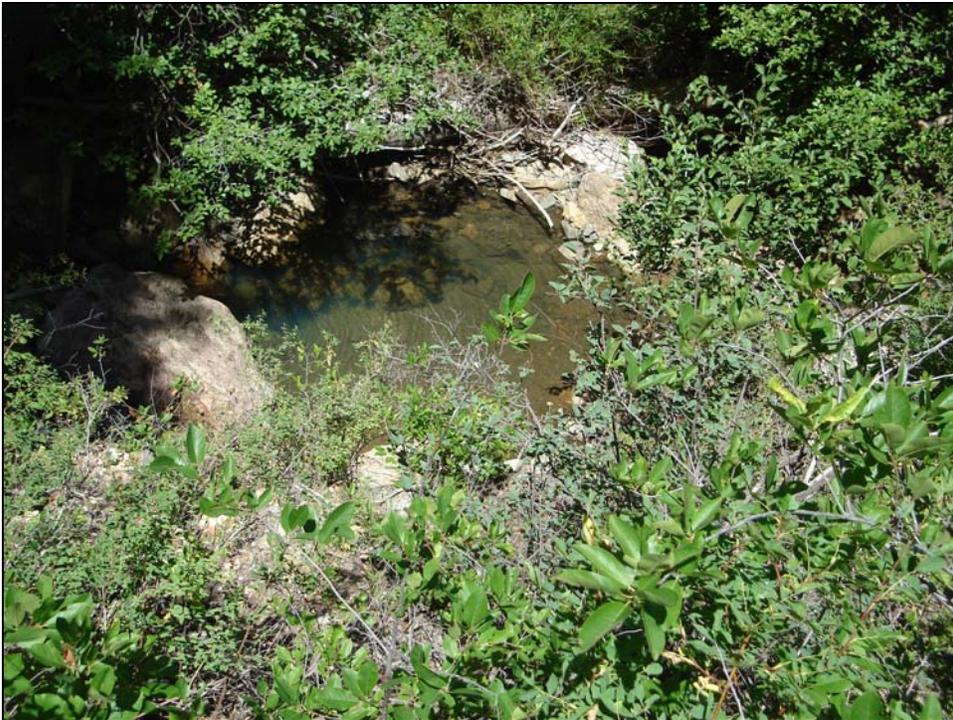
Site 6: Indian Creek, Carson Ranger District. A 10-12 inch fish, believed to be a trout based on shape and size, was sighted in this pool. Photo taken from high right bank. This pool is located at UTM: N: 4284910 & E: 258575, Elev. 5678 feet (1731m).

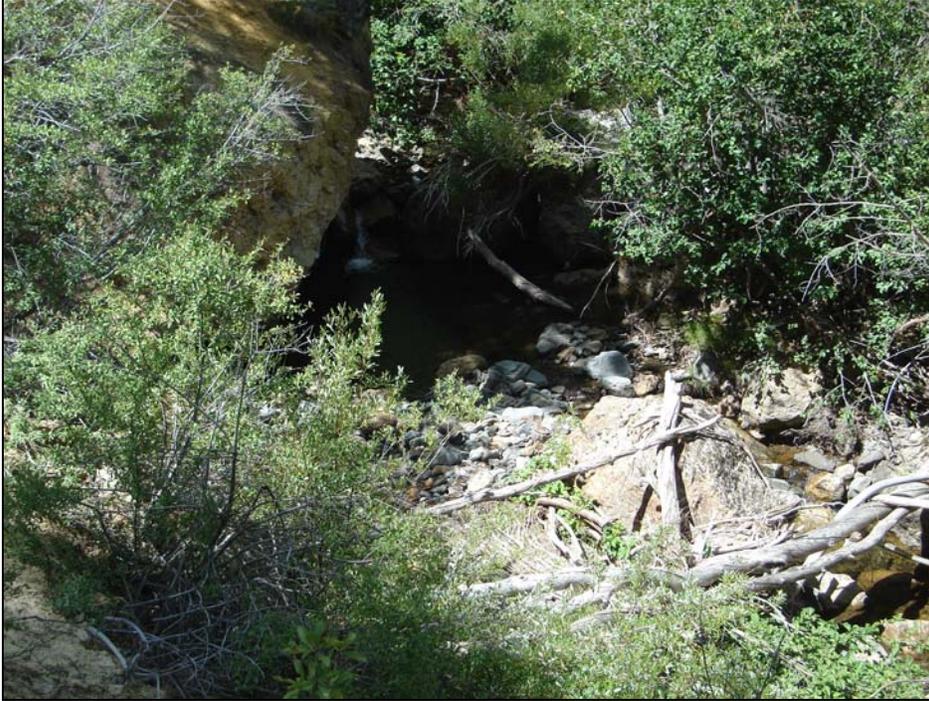
Site 7: Indian Creek, Carson Ranger District. Upstream view shows a seasonal fish barrier, masked in shadows in the photo. The barrier measured 2.5 ft high, with a max. pool depth of 3.0 feet. This site is located at UTM: N: 4284477 & E: 258404, Elev. 5809 feet (1771m).

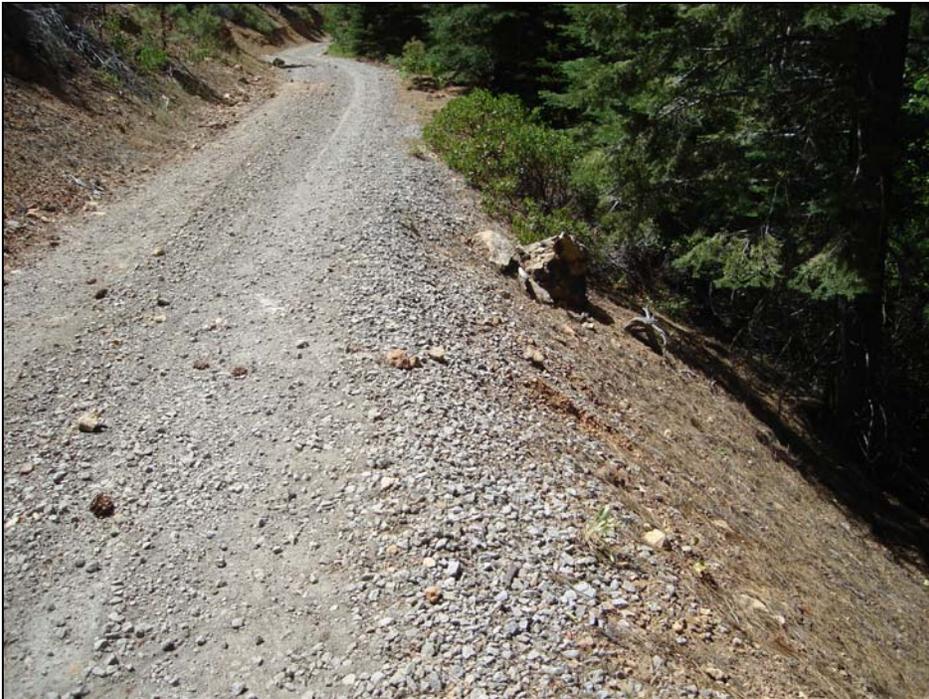
Site 8: Indian Creek, Carson Ranger District. Photo shows a possible road impact where Indian Creek Road runs adjacent to the stream. This site is located at UTM: N: 4284246 & E: 258300.

1. Consider the 1.52 mile section of Indian Creek between Site 1 and Site 9 as potential LCT habitat and consider Indian Creek a low candidate for restoration.
2. Examine the upstream reaches of Indian Creek to ensure that low flows are a natural condition and not created by water diversions, etc.
3. Consider minor road work to prevent a road slump or point-source of sediment at Site 8.

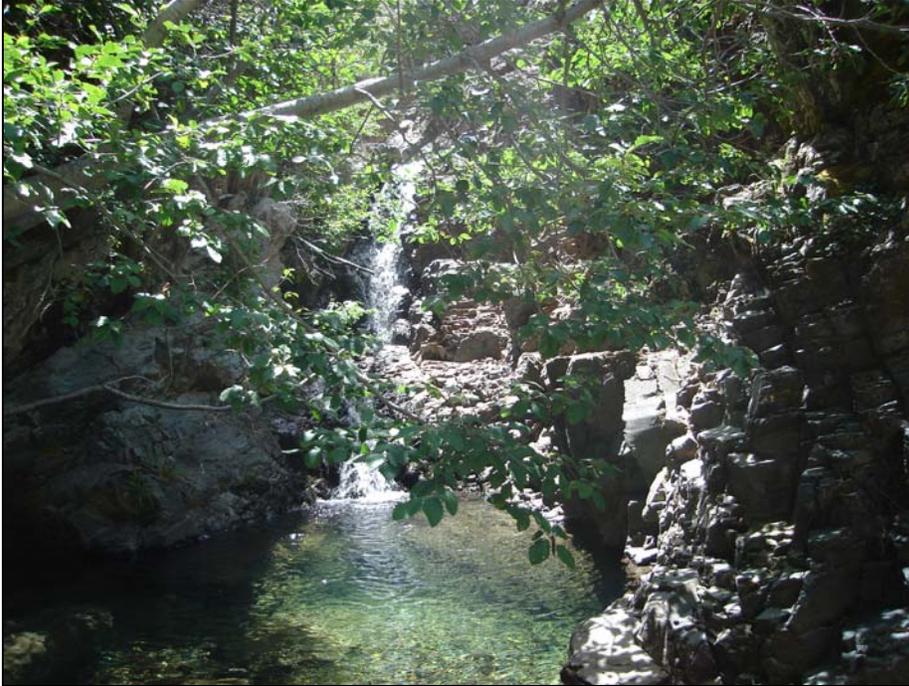
The permanent barrier at Site 9 consists of an 11.0 foot waterfall followed by a 5.1 foot waterfall, both of which are preceded by a 6.0 foot waterfall. (Max. pool depths 3.5-4.0 feet). Downstream of the waterfalls, the pools are deep and have adequate in-stream and overhanging cover for fish. Above Site 9 and below Site 11, the stream is confined to a narrow and rocky ravine. The seasonal barrier at Site 10 measures 2.9 feet high, with a maximum pool depth of 1.75 feet.

Site 9: Indian Creek, Carson Ranger District. Upstream view of an 11 foot waterfall which creates a permanent fish passage barrier (max. pool depth 3.5-4.0 feet). This site is located at UTM: N: 4284075 & E: 258418, Elev. 5979 (1823m).

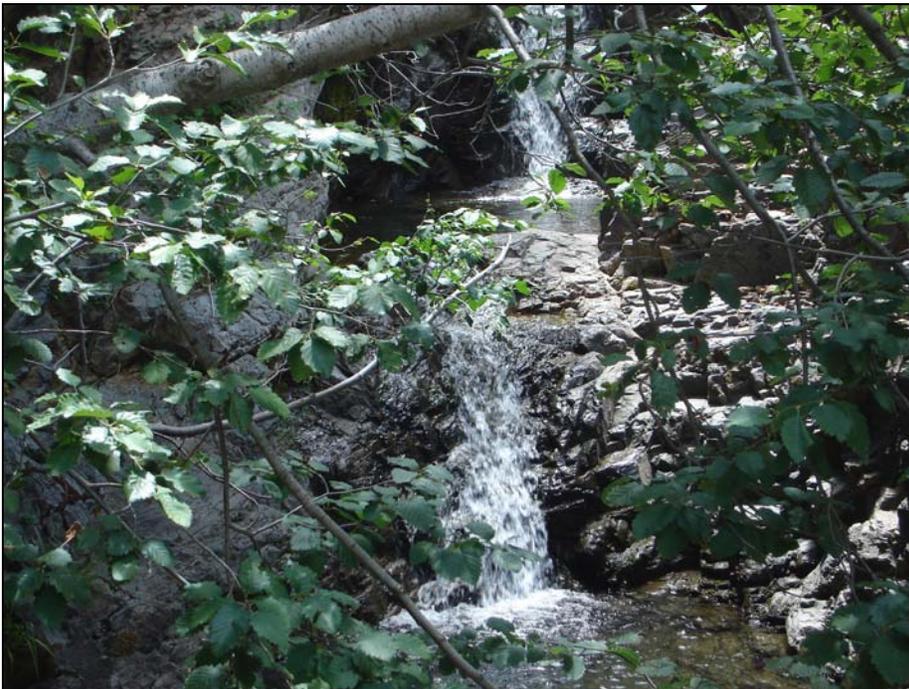
Site 9: Indian Creek, Carson Ranger District. Upstream view of a 5.1 foot waterfall, which is directly downstream of the 11 foot falls (max. pool dept 3.5-4.0 feet). This site is located at UTM: N: 4284075 & E: 258418, Elev. 5979 (1823m).

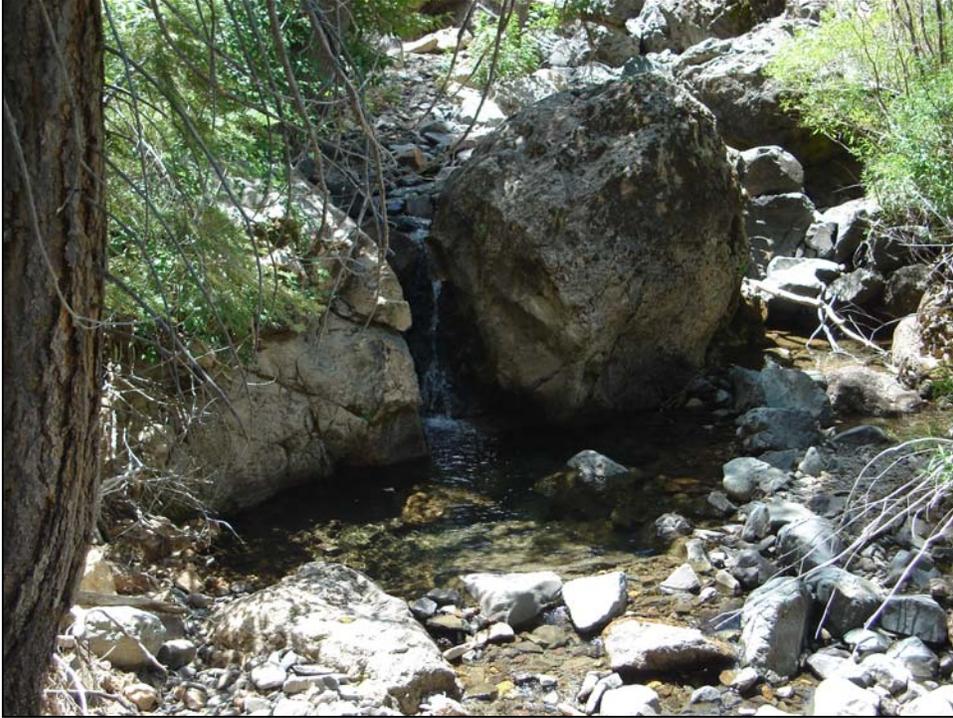
Site 9: Indian Creek, Carson Ranger District. Upstream view of a 6.0 foot waterfall, which is directly upstream of the 11 foot falls. This site is located at UTM: N: 4284075 & E: 258418, Elev. 5979 (1823m).

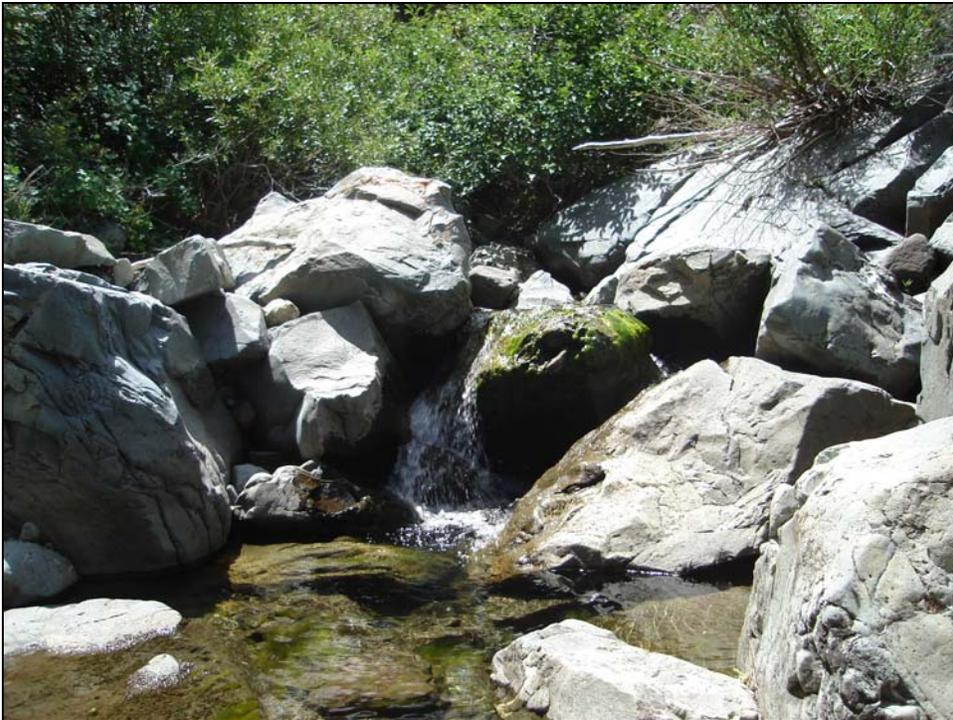
Site 10: Indian Creek, Carson Ranger District. Photo shows a seasonal barrier measuring 2.9 feet high, with a maximum pool depth of 1.75 feet. This site is located at UTM: N: 4283836 & E: 258294, Elev. 6068 feet (1850m).

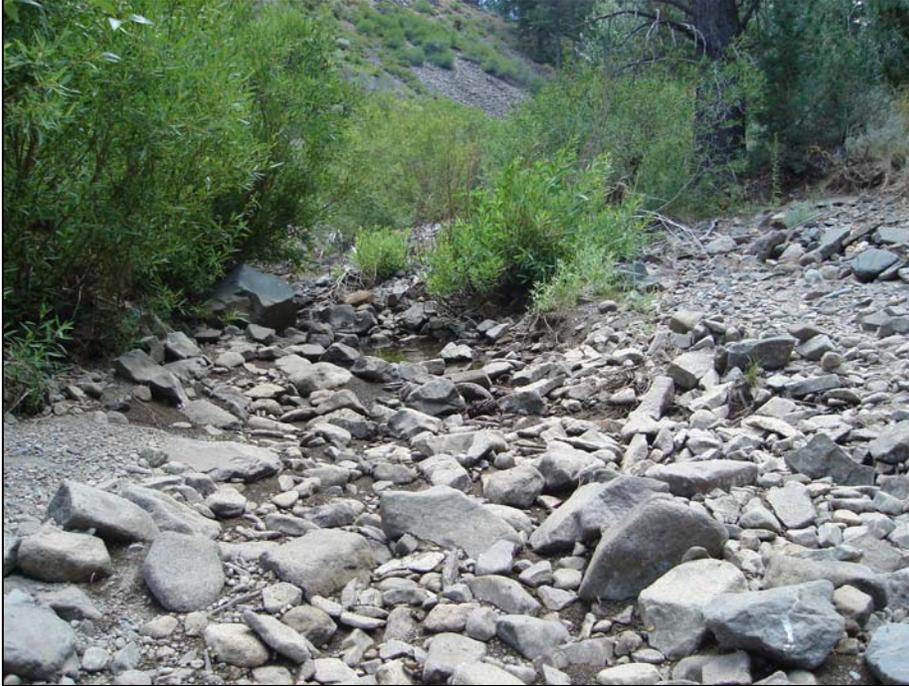
The survey was ended well downstream of the headwaters because parts of Indian Creek are intermittent and the stream goes sub-surface at Site 11. The survey was continued an additional distance of approximately one-half mile above Site 11. At the survey end point (Site 12), flows were minimal and the stream ran beneath large rock bars.

Site 11: Indian Creek, Carson Ranger District. Upstream photo shows a location where the stream goes sub-surface, leaving a dry-streambed. This site is located at UTM: N: 4283719 & E: 258287, Elev. 6038 feet (1841m).

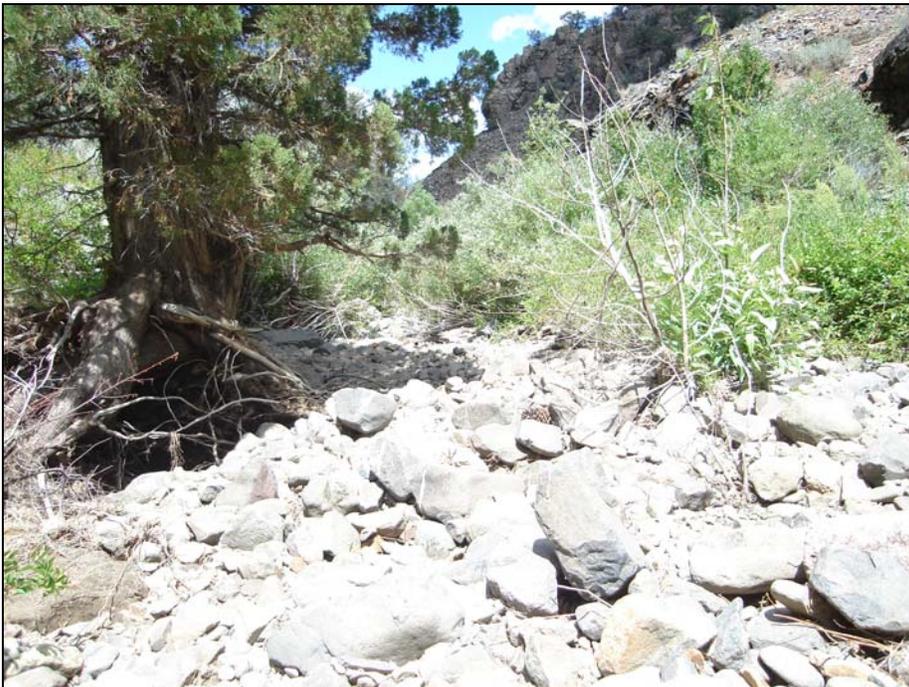
Site 11: Indian Creek, Carson Ranger District. Downstream photo shows a location where the stream runs several feet beneath a rocky dry streambed. This site is located at UTM: N: 4283719 & E: 258287, Elev. 6038 feet (1841m).

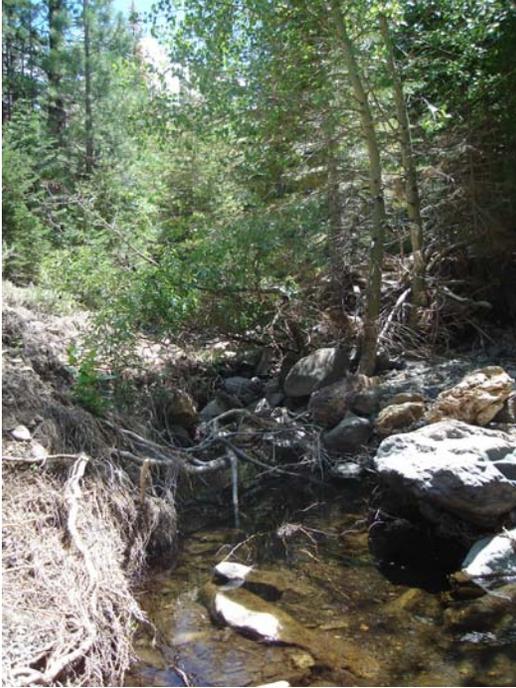
Site 12: Indian Creek, Carson Ranger District. Photo shows the survey endpoint. Flows are minimal and sub-surface in some locations. This site is located at UTM: N: 4283087 & E: 258634, Elev. 6166 feet (1880m).
